Subject:        NOTICE OF VIOLATION  
                 Carothers Farms – (TNR 242073)  
                 Carothers Road, La Vergne, Tennessee

# Photographic Log

<b>Client or Facility Name:</b> Carothers Farms – Phase 3, Sections 2 & 3		<b>Site Location:</b> 35.984244, -86.613608	<b>Project No.:</b> TNR 242073
<b>Photo No.</b> 1	<b>Date</b> 5/16/2019

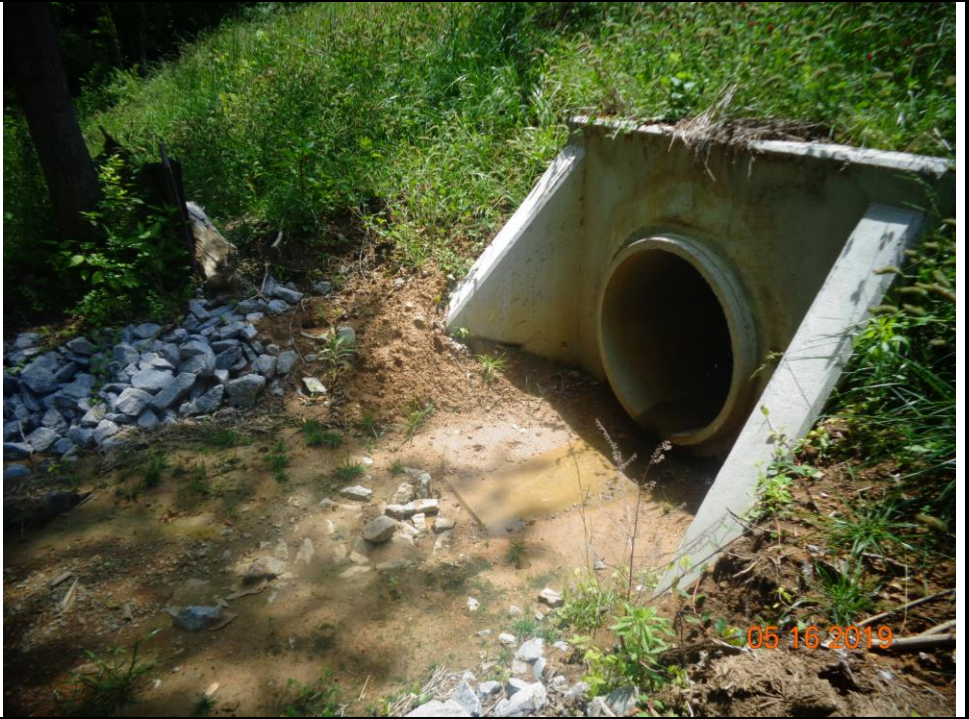
<b>Description</b> Outfall from sediment basin in Section 2

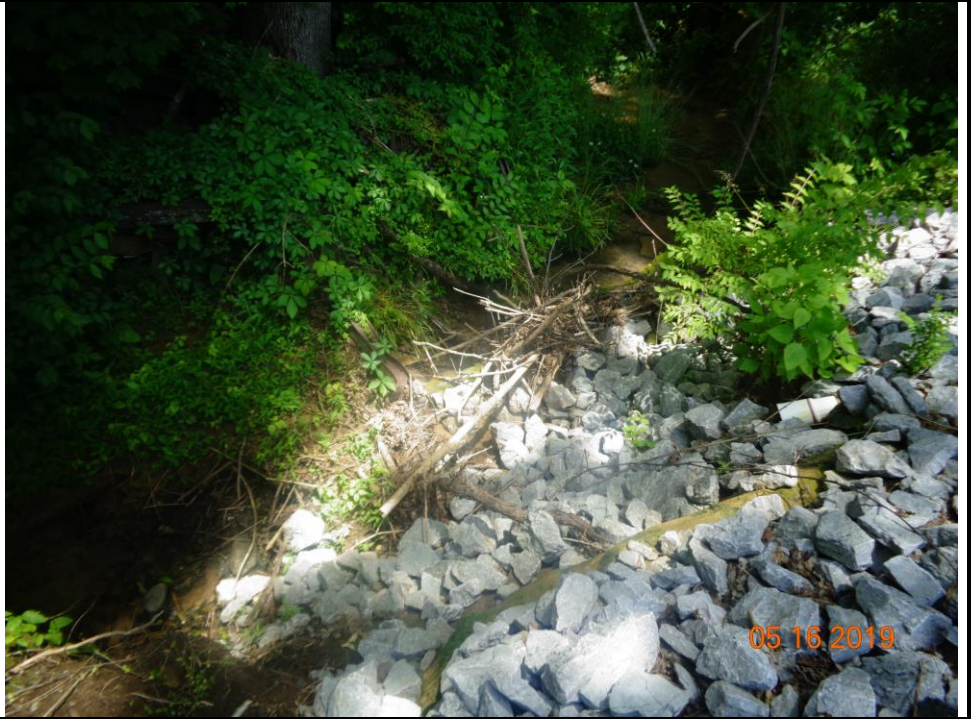
<b>Client or Facility Name:</b> Carothers Farms – Phase 3, Sections 2 & 3		<b>Site Location:</b> 35.984244, -86.613608	<b>Project No.:</b> TNR 242073
<b>Photo No.</b> 3	<b>Date</b> 5/16/2019

<b>Description</b> Rip rap in stream (Unnamed trib to E. Branch of Hurricane Creek #1) from outfall in Section 2

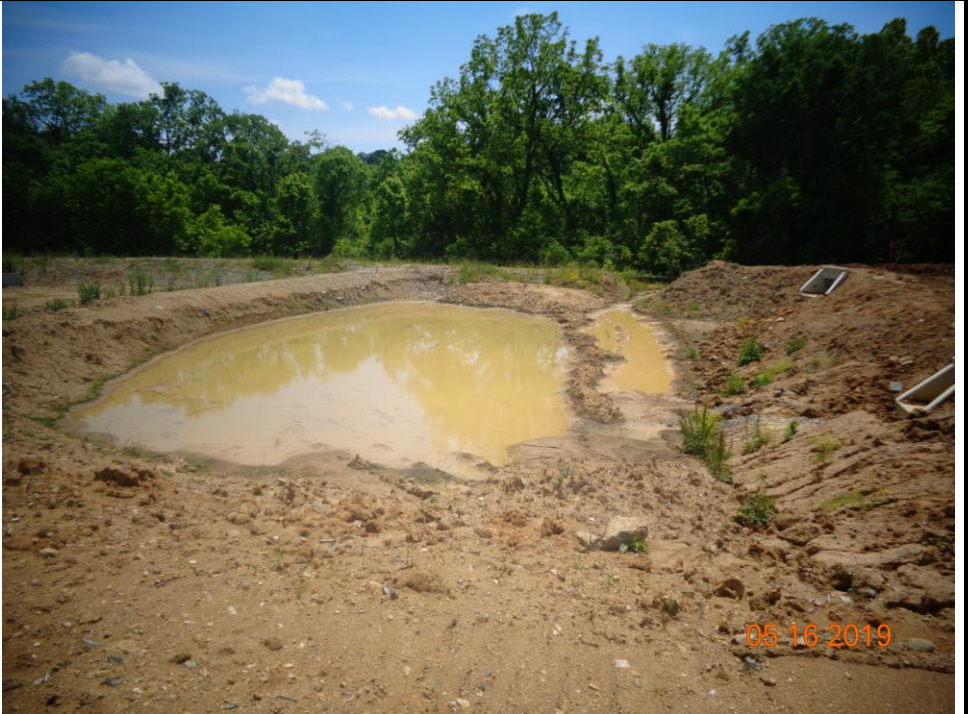
<b>Photo No.</b> 6	<b>Date</b> 5/16/2019

<b>Description</b> Sediment basin not functioning/stabilized in Section 3

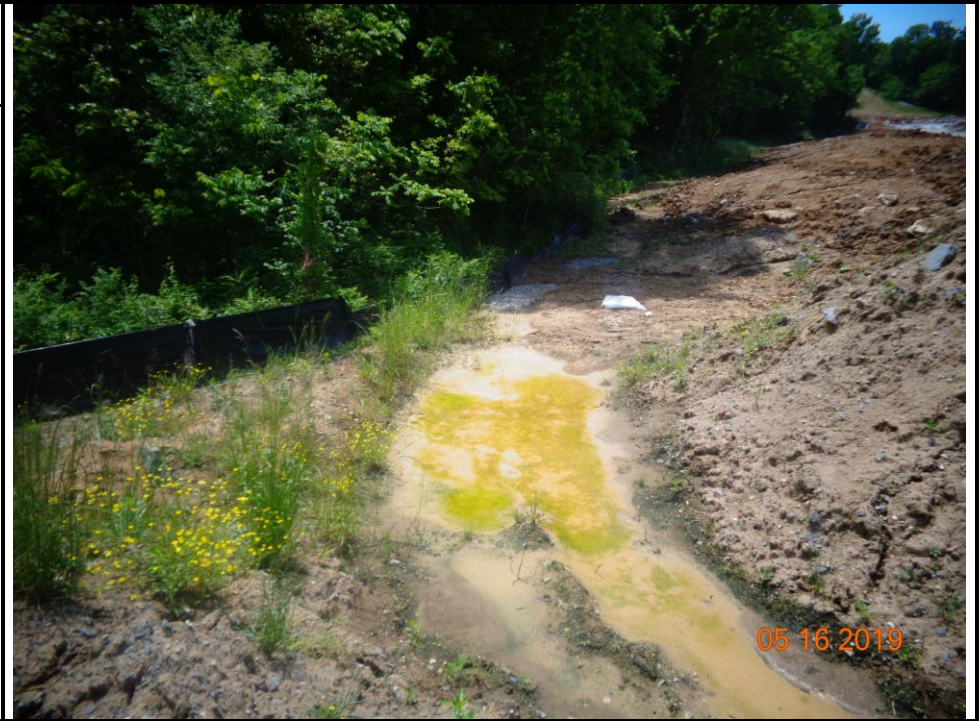
<b>Photo No.</b> 7	<b>Date</b> 5/16/2019
-----------------------	--------------------------

**Description**  
Ditch dug from sediment basin in Section 3

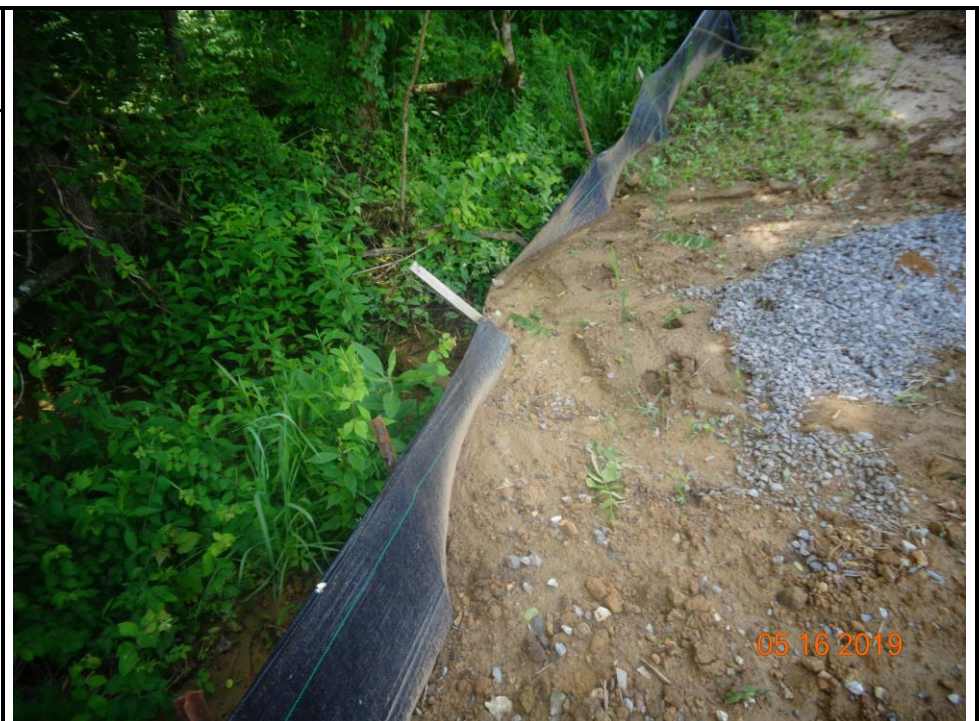
<b>Photo No.</b> 8	<b>Date</b> 5/16/2019
-----------------------	--------------------------

**Description**  
Ditch directing sediment to overloaded silt fence in Section 3

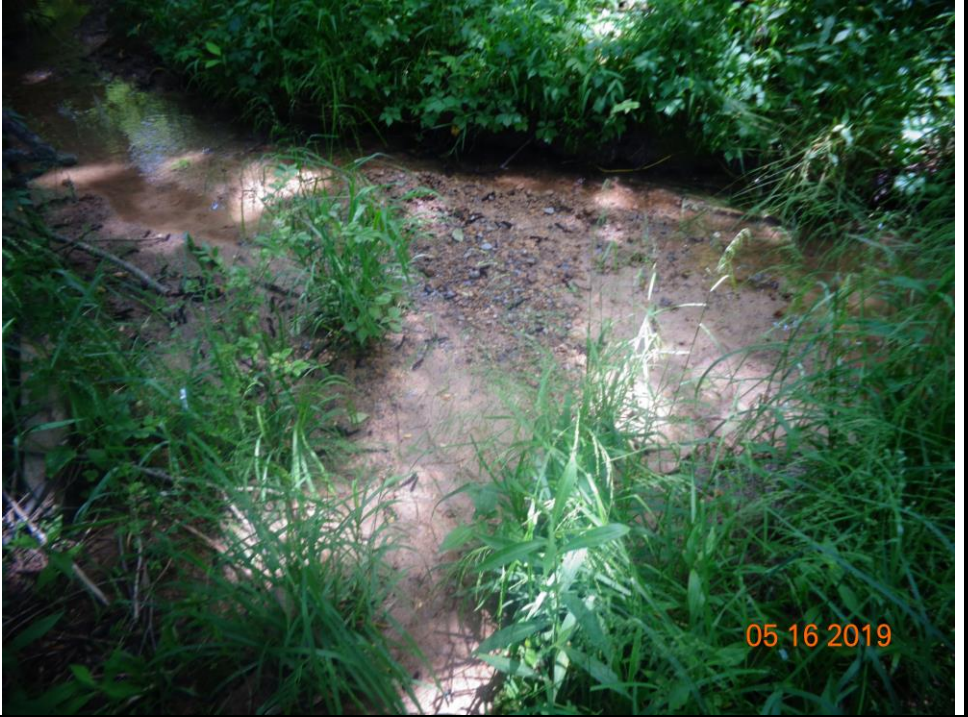
<b>Client or Facility Name:</b> Carothers Farms – Phase 3, Sections 2 & 3		<b>Site Location:</b> 35.984244, -86.613608	<b>Project No.:</b> TNR 242073
<b>Photo No.</b> 9	<b>Date</b> 5/16/2019

<p>05 16 2019</p>	
<b>Description</b> Sediment from overloaded silt fence entering Unnamed trib. to E. Branch of Hurricane Creek #2 in Section 3

2. Within 7 days of receipt of this letter, remove any sediment deposited in the stream. This work must be done without the use of heavy equipment where surface water is present (e.g. using only a shovel and bucket or tools that can be carried by hand). The division does not authorize access to private property. Arrangements concerning the removal of sediment on adjacent properties must be settled between you and the adjacent land owners.

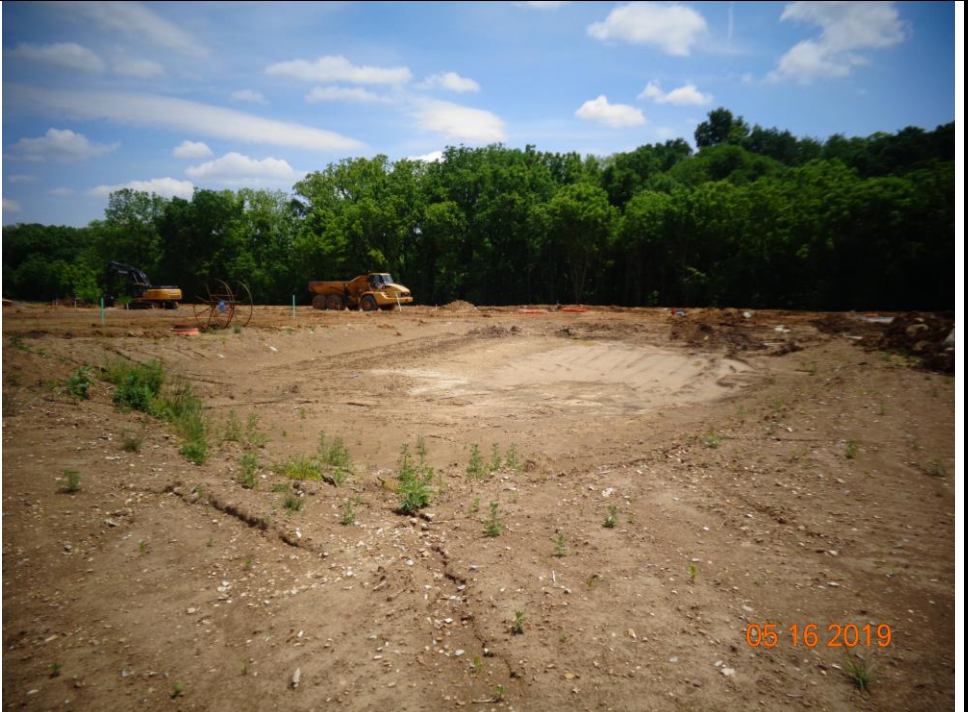
<b>Photo No.</b> 10	<b>Date</b> 5/16/2019

<p>05 16 2019</p>	
<b>Description</b> Sediment traps not installed properly in Section 3

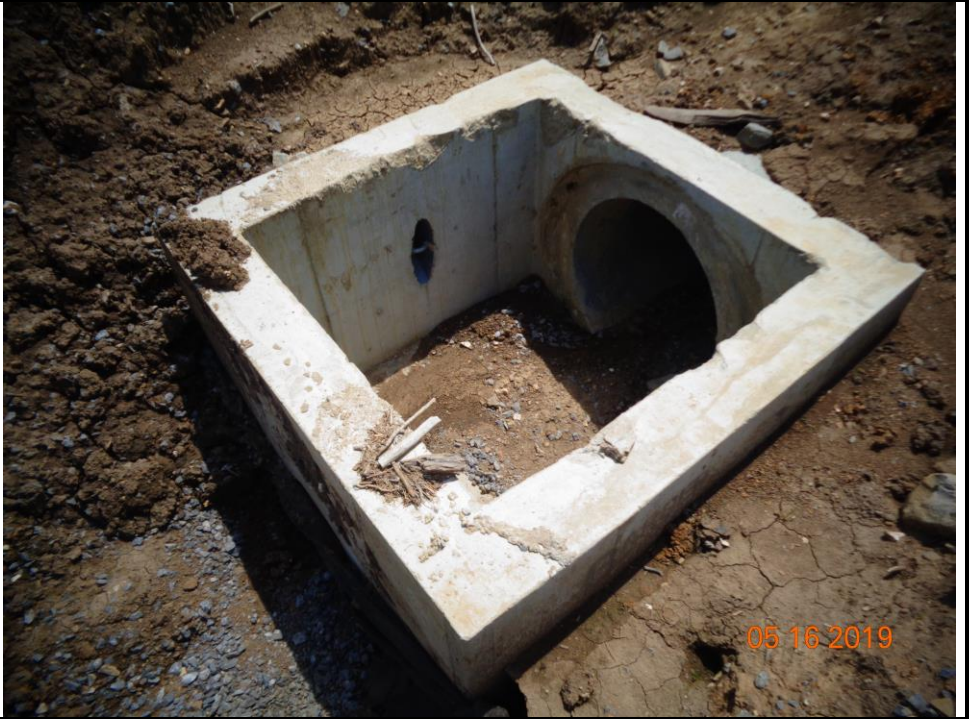
<b>Client or Facility Name:</b> Carothers Farms – Phase 3, Sections 2 & 3		<b>Site Location:</b> 35.984244, -86.613608	<b>Project No.:</b> TNR 242073
<b>Photo No.</b> 11	<b>Date</b> 5/16/2019

<p>05 16 2019</p>	
<b>Description</b> Inlet for sediment trap in Section 3, no protections in place.

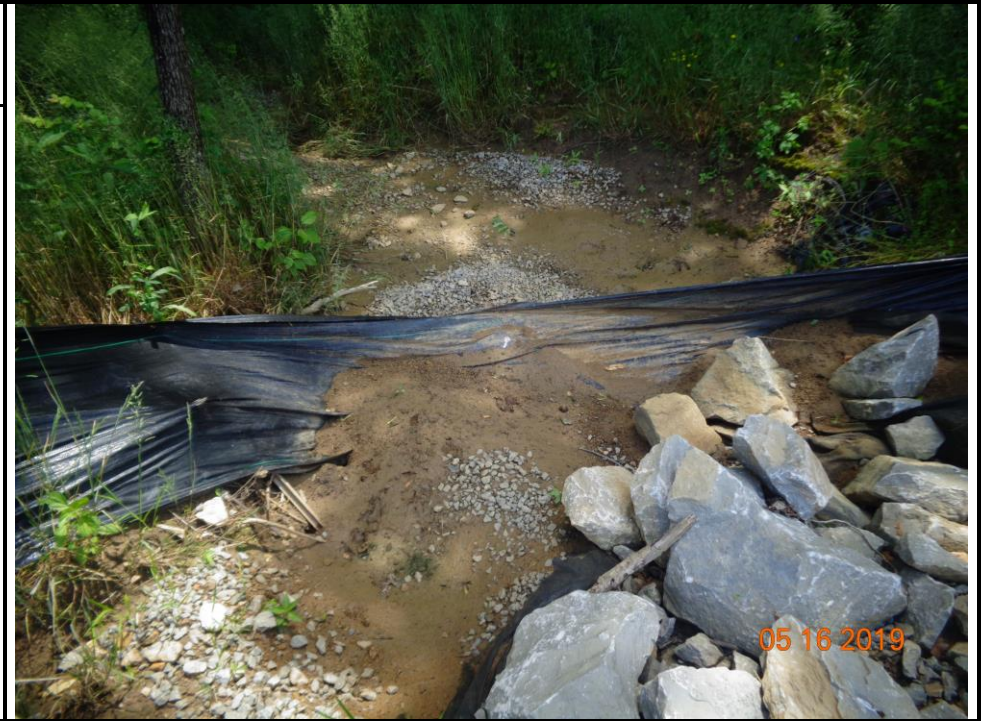
<b>Photo No.</b> 13	<b>Date</b> 5/16/2019
------------------------	--------------------------

**Description**

Overloaded silt fence, sediment from outlet of sediment trap in Section 3. Sediment observed leaving site.

1. Immediately install effective EPSC measures to prevent sediment from leaving the site. This may include the installation of all required silt fences and outfall protections. Within 7 days of receipt of this letter provide date and time stamped photographic documentation showing EPSC measures have been installed.

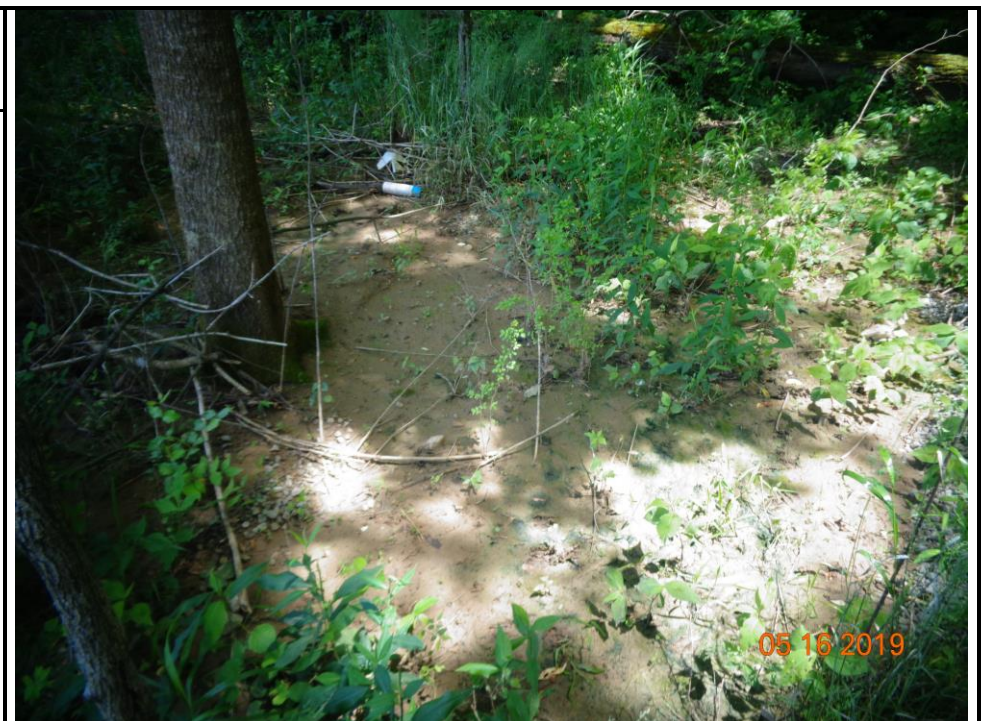
<b>Photo No.</b> 14	<b>Date</b> 5/16/2019
------------------------	--------------------------

**Description**

Sediment accumulating offsite/entering Unnamed trib. to E. Branch of Hurricane Creek #2

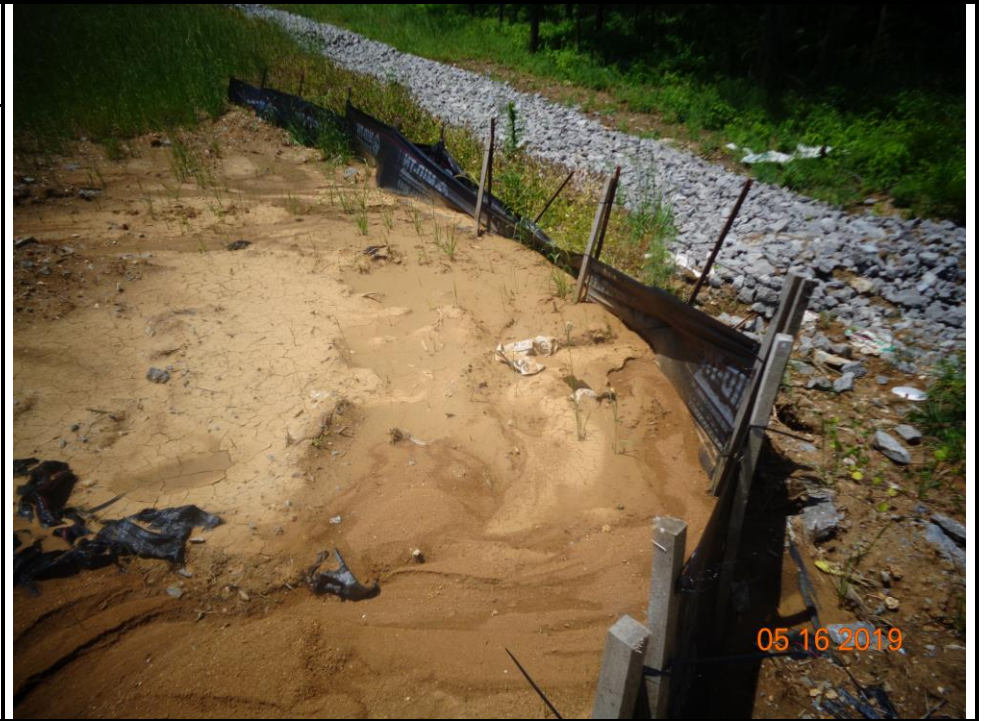
<b>Photo No.</b> 17	<b>Date</b> 5/16/2019
------------------------	--------------------------

**Description**  
Need to maintain EPSCs in Section 2

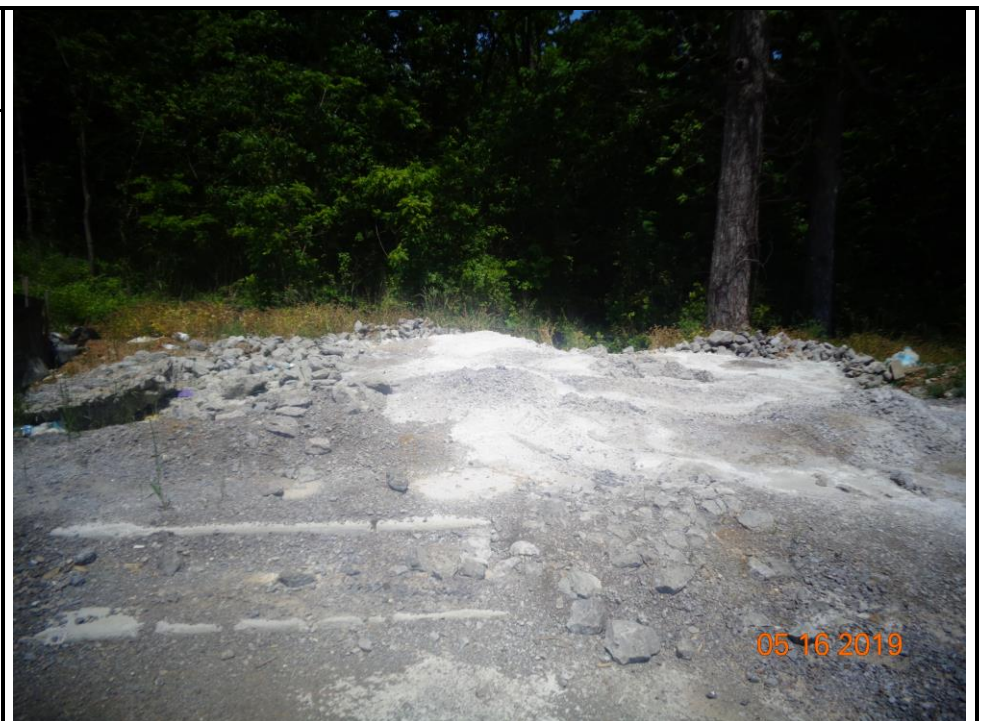
<b>Photo No.</b> 18	<b>Date</b> 5/16/2019
------------------------	--------------------------

**Description**  
Concrete washout near edge of property.

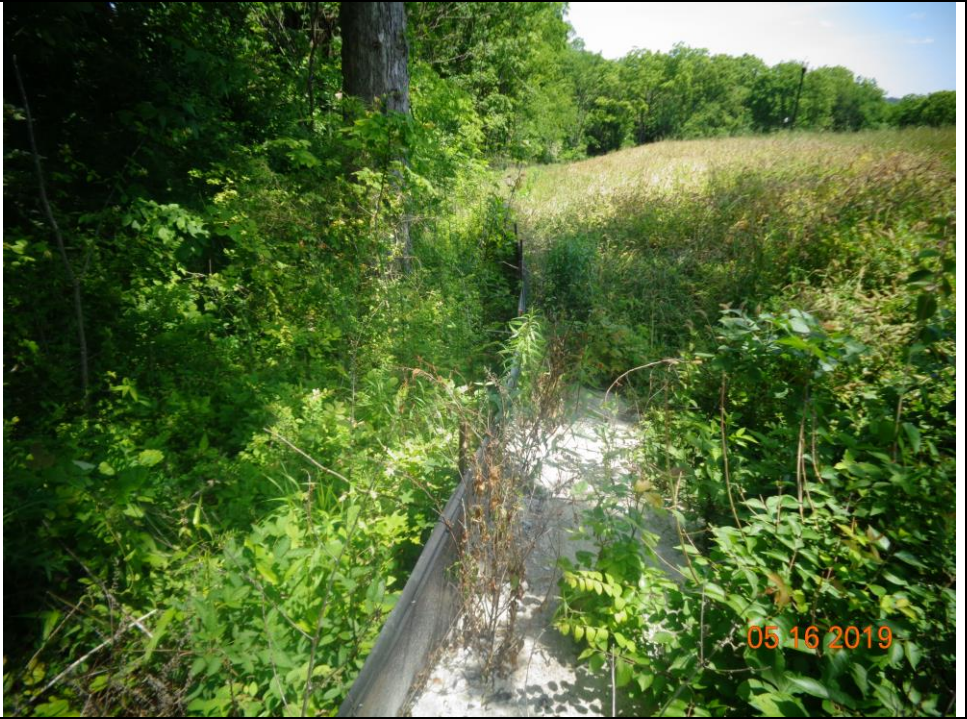
19	5/16/2019		
Description			
Need to maintain EPSCs in Section 2 to prevent sediment/rip rap/concrete washout from leaving site. Channel behind silt fence drains into stream.
