Please find the attached pdf of subject document titled, “**NATIONAL POLLUTANT DISCHARGE ELIMINATION SYSTEM (NPDES) PERMIT WATER QUALITY PROTECTION PLAN (WQPP) ANNUAL DATA AND EVALUATION REPORT**,” dated April 27, 2024. A hard copy will not be sent. All distribution has been made.

**Subject:** NPDES PERMIT WQPP ANNUAL DATA AND EVALUATION REPORT Email 1 of 3

U.S. Department of Energy  
Oak Ridge National Laboratory  
Water Quality Protection Plan  
NPDES Permit TN0002941  
2023 Data and Evaluation Report

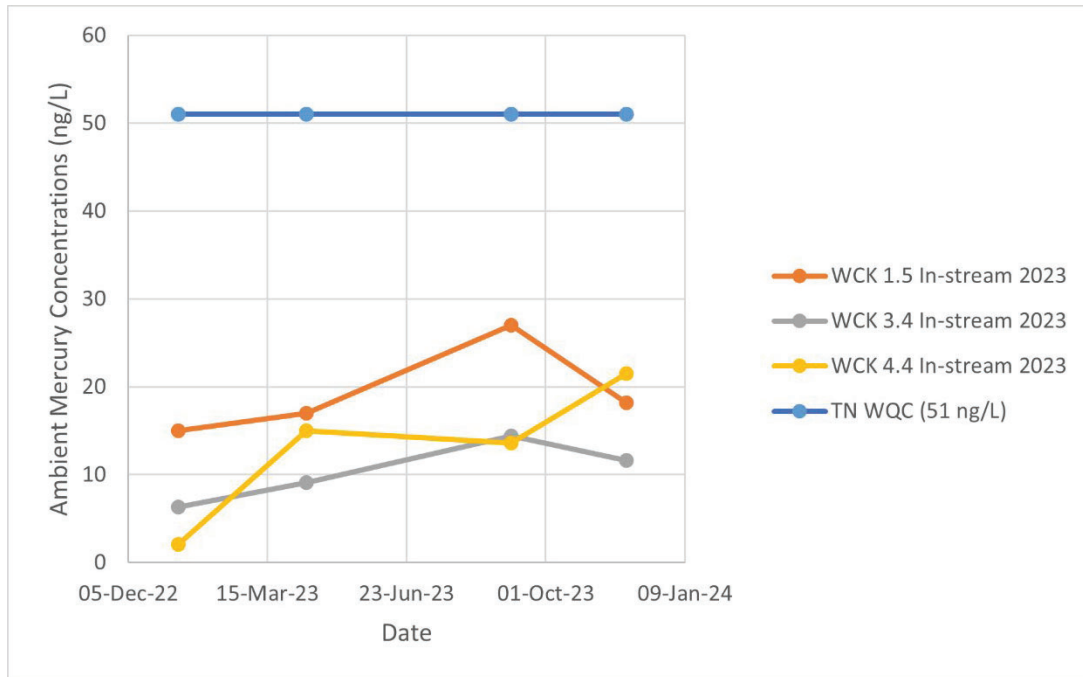
Figure 13. In-stream 24-Hr-Composite Sample Results for Mercury at ORNL - 2023

Aqueous in-stream mercury monitoring in the WOC watershed continued in 2023 with quarterly sampling at three in-stream sites throughout the WOC watershed: WCK 1.5, WCK 3.4, and WCK 4.4. The aqueous in-stream mercury monitoring was done at these three locations using 24-hr-composite samples. The results of the in-stream 2023 sampling efforts are shown in Figure 13. Samples collected for this in-stream monitoring effort tend to be most representative of seasonal-base flow conditions (dry weather, clear flow), since historical sampling results show that mercury concentrations are typically higher under these conditions yielding a more conservative estimate of

mercury concentration in-stream. The 24-hr-composite sample results of in-stream mercury monitoring tend to be a more accurate representation of the data over time.

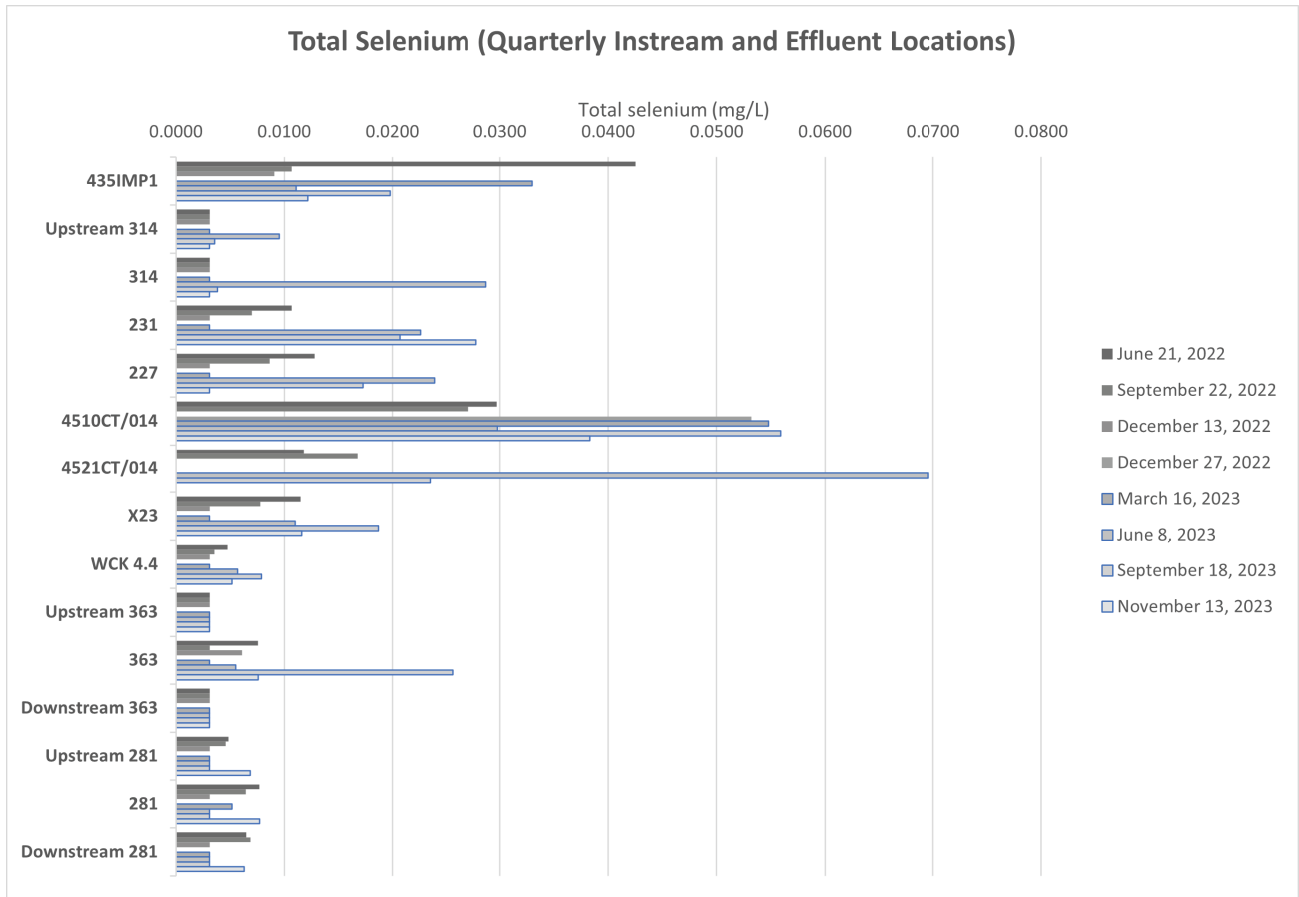
**Figure 31. Total Selenium results measured in quarterly in-stream and at effluent point source locations on White Oak Creek, Fifth Creek, and a tributary to Melton Branch in 2022 and 2023 (2023 values highlighted).**

stream. The results start from up-to-downstream locations in WOC (435IMP1 to WCK 4.4), then Fifth Creek (up and downstream of 363), and then a tributary to Melton Branch (up and downstream of 281). Note that Figure 31 does not include in-stream water quality criteria for comparison since both ambient in-stream and point source concentrations are presented. Also, the Outfall 014 samples were taken directly at the discharge boxes of the cooling tower blowdown instead of at Outfall 014 in order to better discern the impacts from each cooling tower separately. This direct sampling approach of the blowdown tends to result in greater concentrations of selenium because the blowdown is not mixed with other non-process waters like it typically would be at the end of an outfall pipe, yielding a more conservative result.

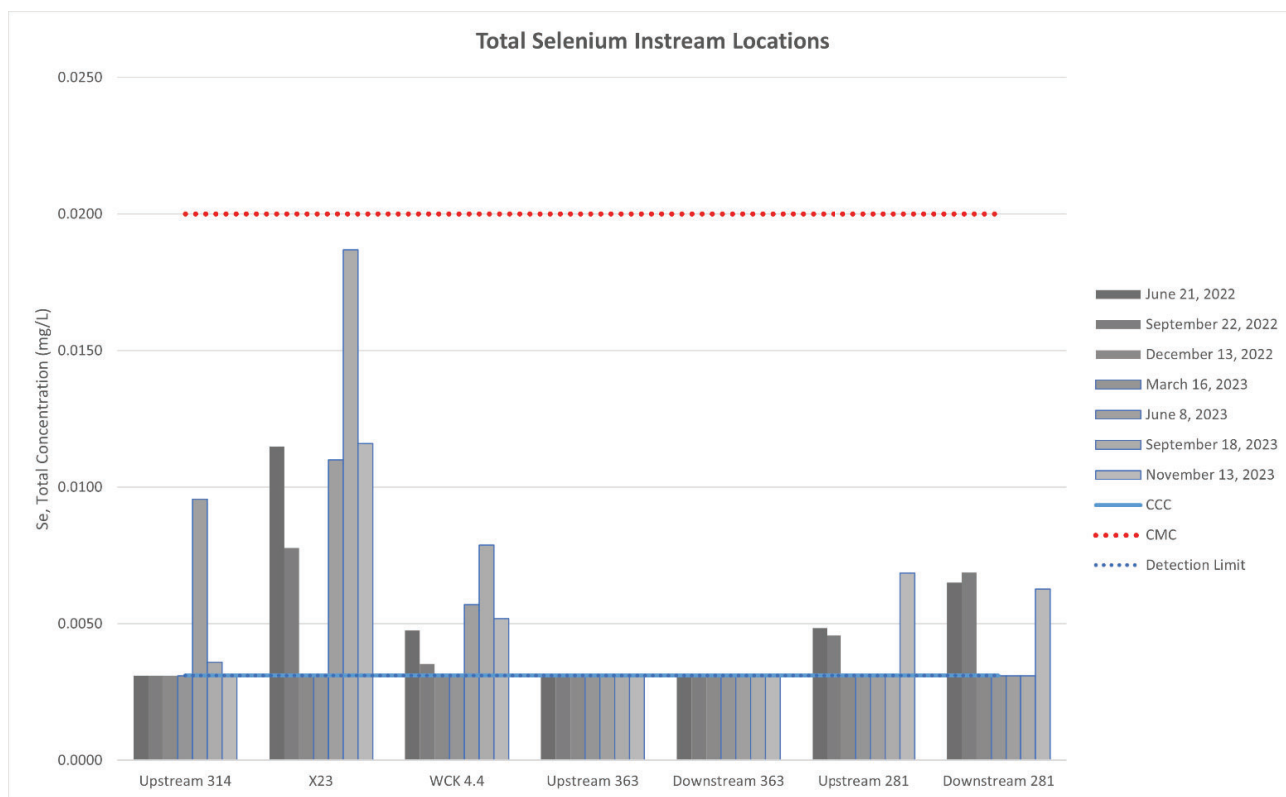
**Figure 32. Total selenium measured quarterly in-stream across White Oak Creek, Fifth Creek, and the tributary to Melton Branch compared against the CCC and CMC 2022 - 2023.**

Total selenium in Fifth Creek was monitored up and downstream from Outfall 363, which discharges cooling tower blowdown from the 5300/5309 cooling towers. Elevated selenium was not observed in Fifth Creek during the 2023 monitoring effort, but total selenium appears to increase slightly throughout the year at the Outfall 363 discharge.

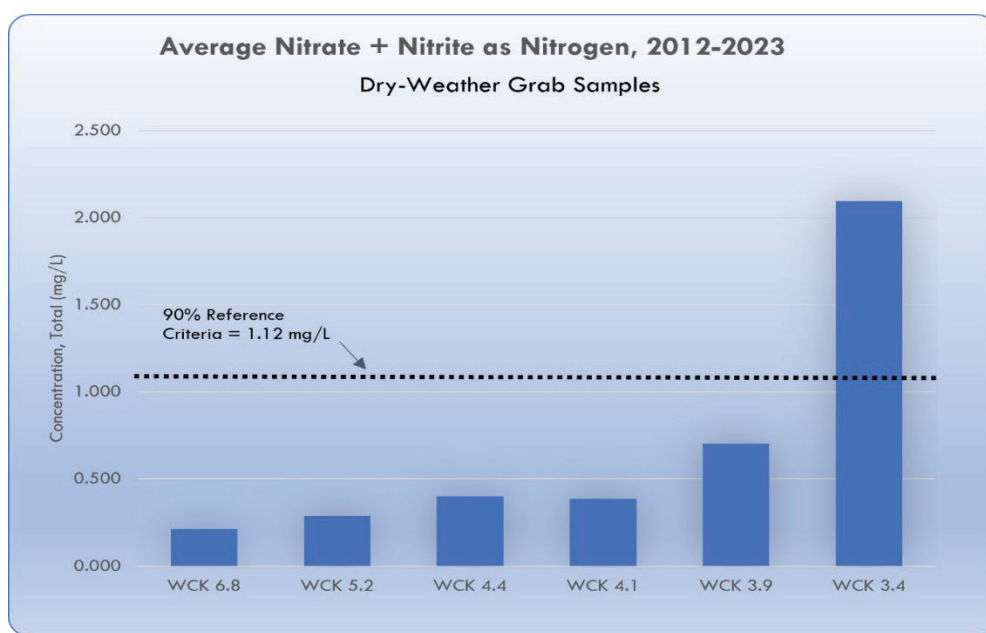
Long-term average concentrations of nitrate/nitrite and phosphorus are also presented in Figure 35 and Figure 36, respectively. As depicted in Figure 35, the long-term average nitrate/nitrite concentrations are below the reference criteria at all sites except WCK 3.4, the most downstream monitoring site, where nitrogen contributions from the STP are significant. Planned upgrades to the STP facility are expected to improve nitrogen contributions upon completion in 2024/2025.
