Bledsoe County Correctional Complex

SIXTH YEAR WETLAND AND STREAM MITIGATION MONITORING REPORT

October 17, 2017

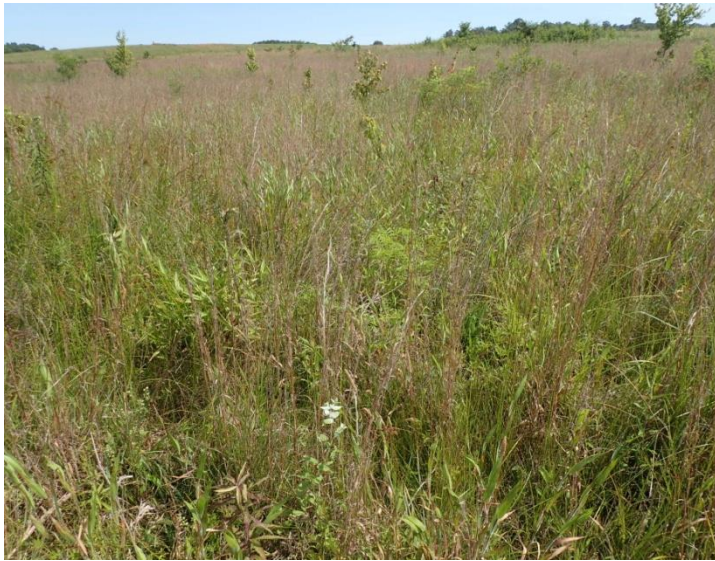
Photo 1.

Creation Area, Photo Reference Point C2: North

Comments: Corrective actions such as installing coir logs has helped a great deal to trap eroding soils and by doing so, provided a growth medium for planted and naturally invading vegetation.

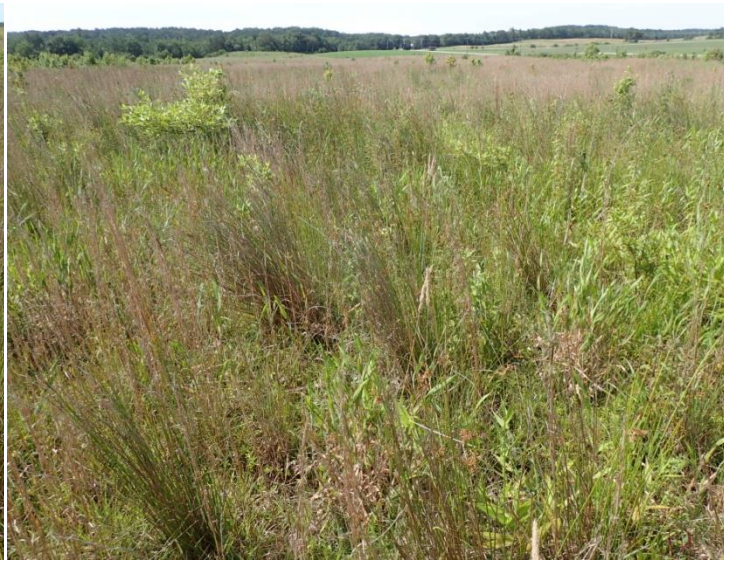
Photo 2.

Creation Area, Photo Reference Point C2: South

Comments: Despite severe drought, which lasted throughout the latter half of 2016, wetland vegetation has persisted into the current growing season, thanks in part to accreted soils.

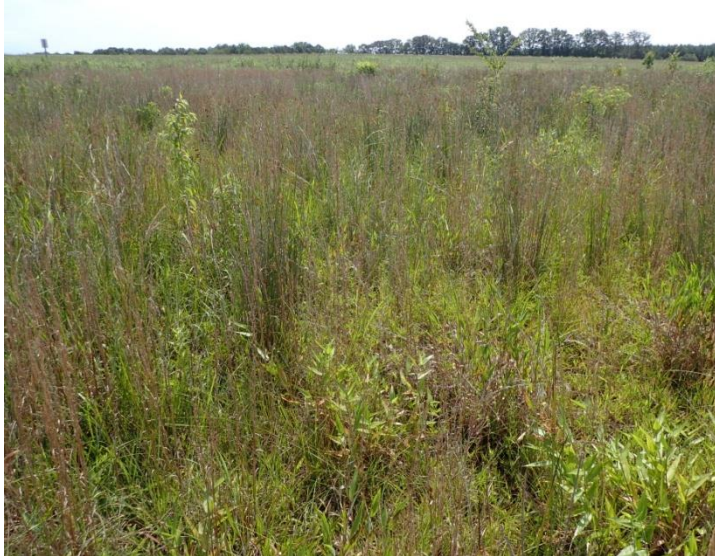
Photo 3.

Creation Area, Photo Reference Point C2: East

Comments: Deeper soils, especially on the northern half of the creation area, have helped to increase herb populations, but planted woody species have struggled somewhat because of low soil fertility.

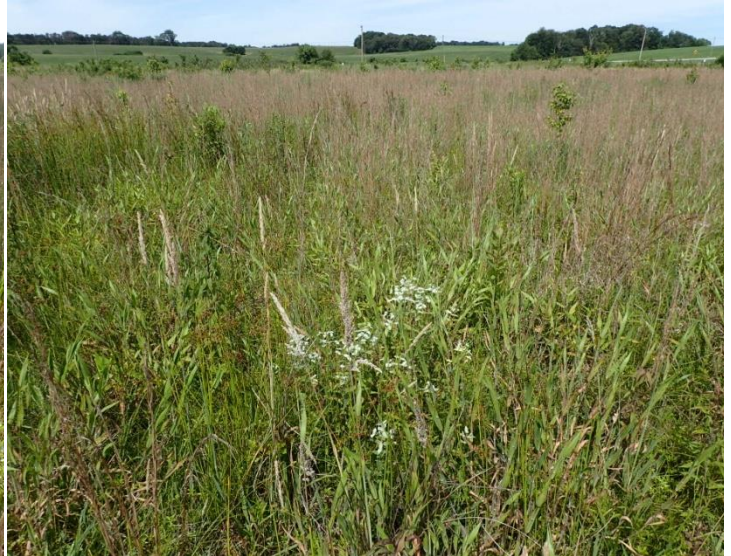
Photo 4.

Creation Area, Photo Reference Point C2: West

Comments: Although soils in the creation area are largely infertile, planted false indigobush, a nitrogen fixing shrub, is beginning to reproduce naturally.

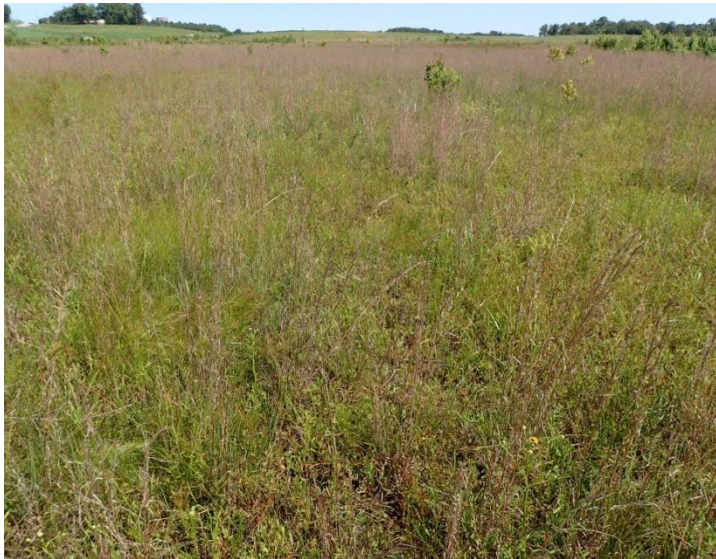
Photo 5.

Creation Area, Photo Reference Point C4: North

Comments: Many of the planted trees and shrubs are stunted and sometimes difficult to find among the herbs. While this is due in part to poor soils, seasonal ponding of concave surfaces also plays a role.

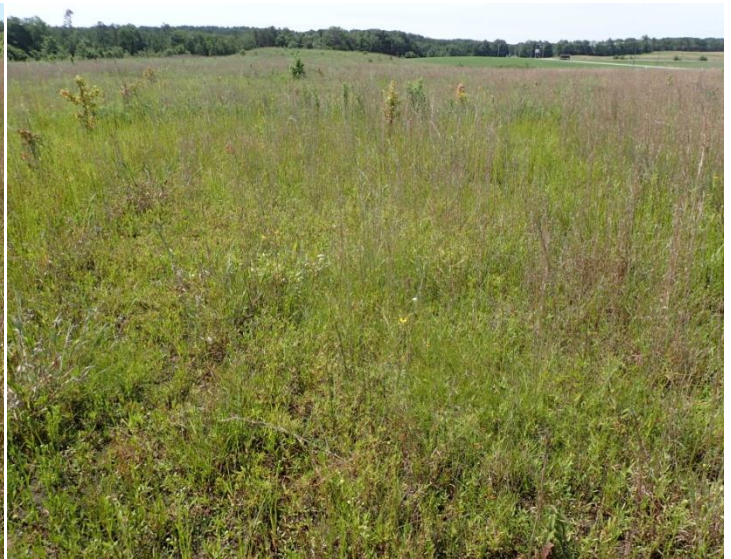
Photo 6.

Creation Area, Photo Reference Point C4: South

Comments: Parts of the creation area are wet in winter through early summer. By mid-summer and fall they dry significantly. Such locations typically contain a mixture of wetland and non-wetland species.

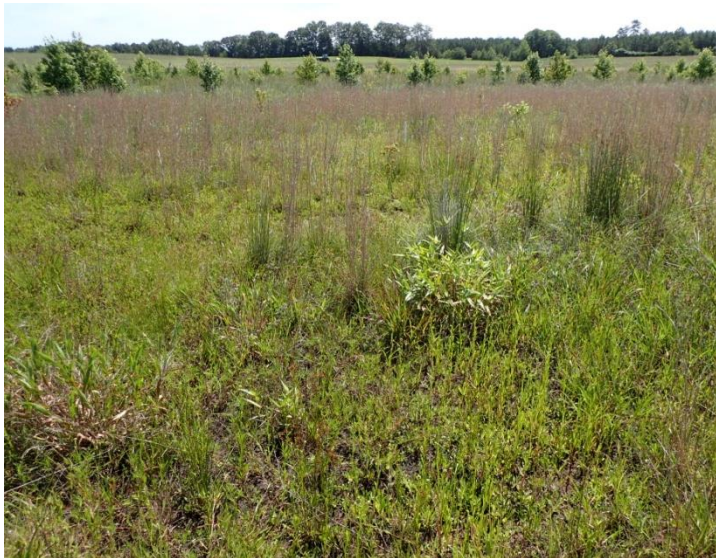
Photo 7.

Creation Area, Photo Reference Point C4: East

Comments: A shallow, relatively impervious fragipan restricts rooting in this area. It also traps water at the surface. After heavy rains this area can become ponded. Dried cyanobacteria (*Nostoc* sp.) were commonly observed on the soil surface.

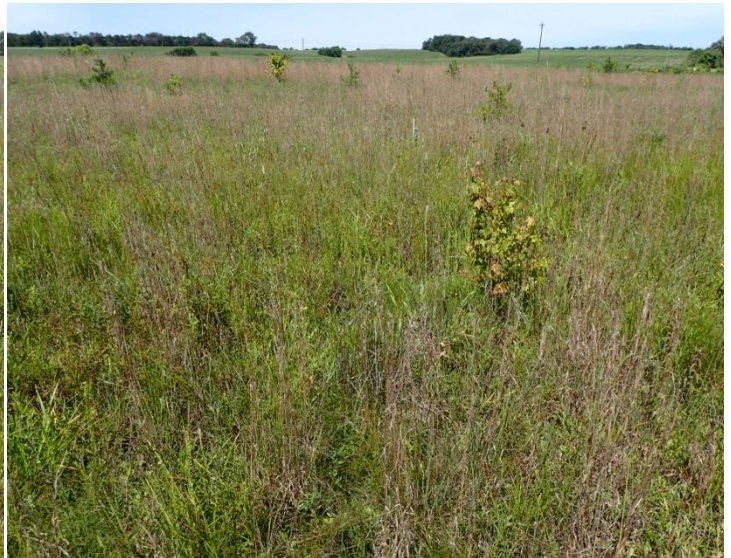
Photo 8.

Creation Area, Photo Reference Point C4: West

Comments: Other indicators of positive wetland hydrology that were noted include silt deposits on low-lying vegetation, and, in one instance, saturated soils and perched water within 3 in. of the surface.

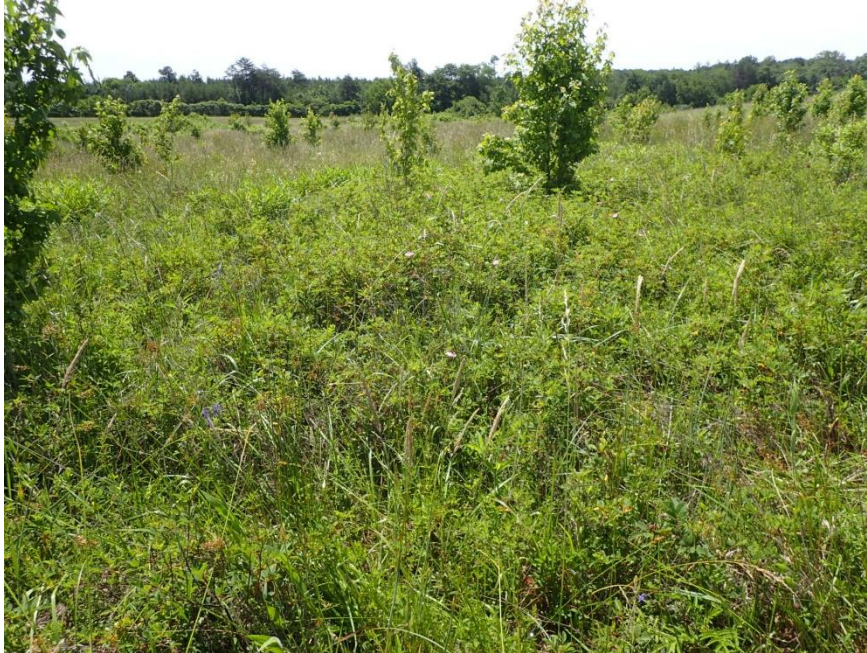
Photo 9.

Enhancement Areas: Former wetland fields and pastures were enhanced by planting tree and shrub seedlings at the rate of 435 trees/acre. The most dominant woody species include sweetgum and red maple, but blackgum and wetland oaks are also frequently observed. These enhancement areas, along with the rest of the mitigation site will be protected from future disturbance by placing them under a deed restriction or conservation easement. Because they have consistently met or exceeded performance standards in all phases (vegetation, soils, hydrology), the oversight agencies are no longer requiring monitoring at these locations.

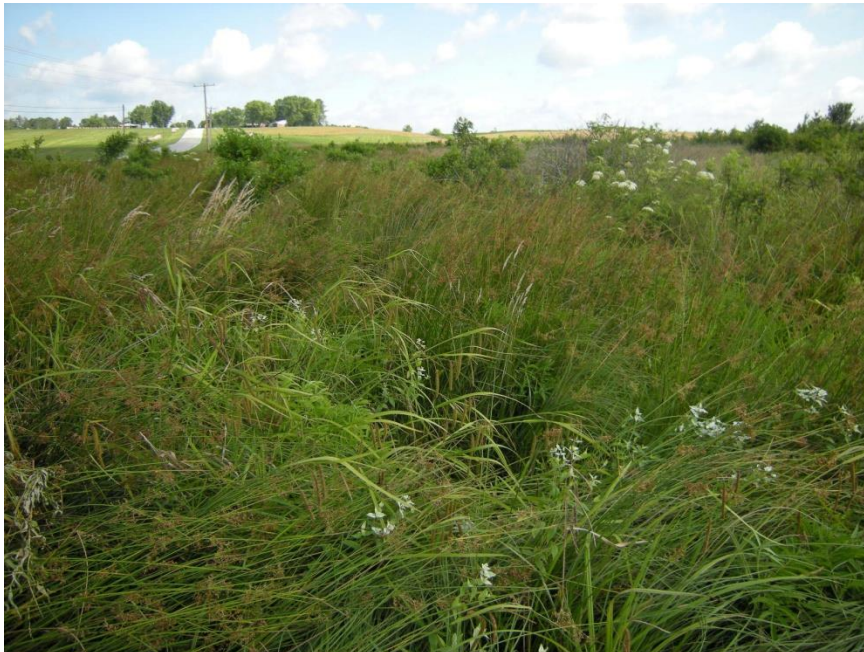
Photo 10.

Enhancement Areas: On the wettest parts of the enhancement areas planted wetland shrubs such as buttonbush, elderberry, and false indigobush are more commonly encountered than trees. Dense stands of rushes and sedges are responsible for retarding the establishment of trees.

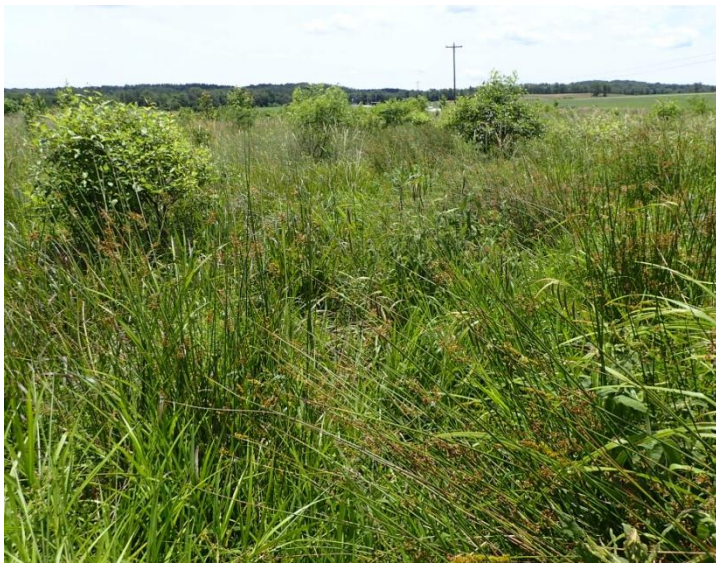
Photo 11.

Stream 1 Enhancement Area:

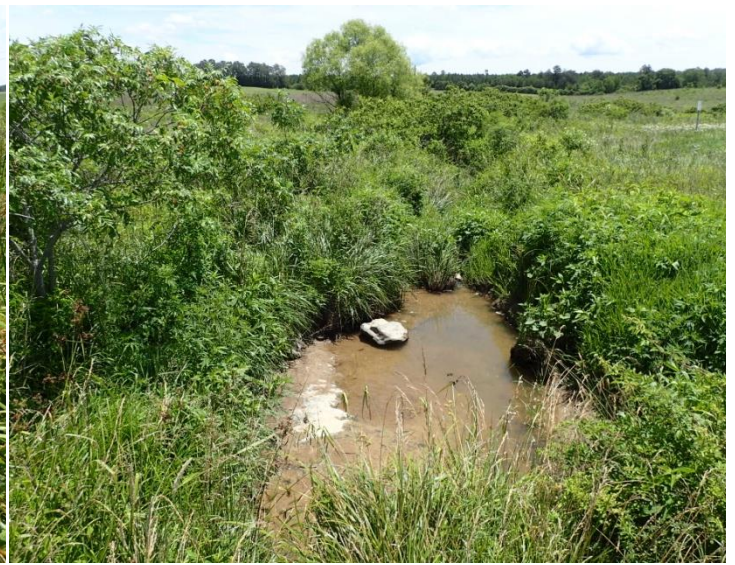
Photo 12.

Stream 2 Enhancement Area:

The riparian zone around Stream 2 is also very stable. This view looking downstream demonstrates how quickly the vegetation has recovered after the cessation of agricultural activities. Typical woody plants include black willow, silky dogwood, and winged sumac, while dominant herbs are rice cut grass and soft rush.

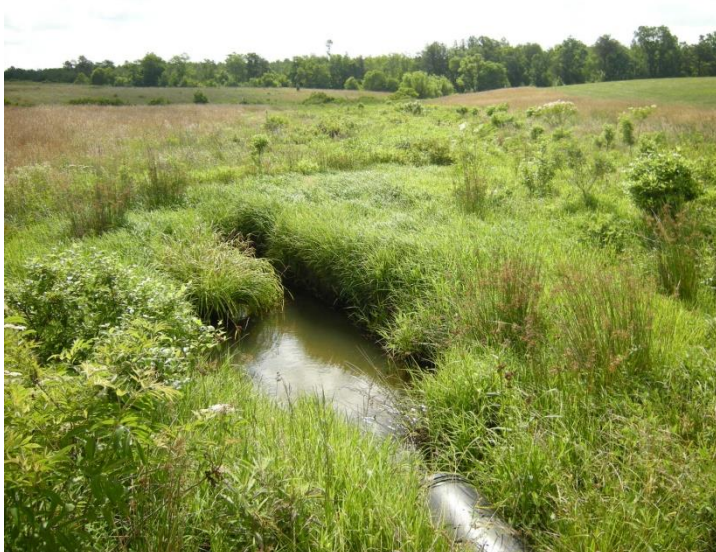
Photo 13.

Stream 3 Enhancement Area:

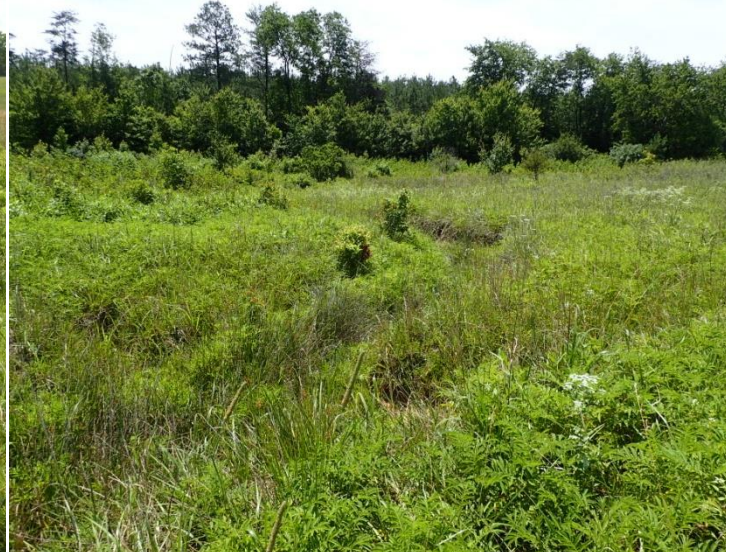
Photo 14.

Stream 4 Enhancement Area:

Stream 4 is positioned at the extreme southeastern corner of the mitigation site and lies below the discharge point of a farm pond. Embankments are completely vegetated with a mixture of herbs such as deer-tongue grass, harvest-lice and clustered mountain mint. The shrub layer is very strongly dominated by swamp rose. The upper half of the channel was dry at the time of the survey.

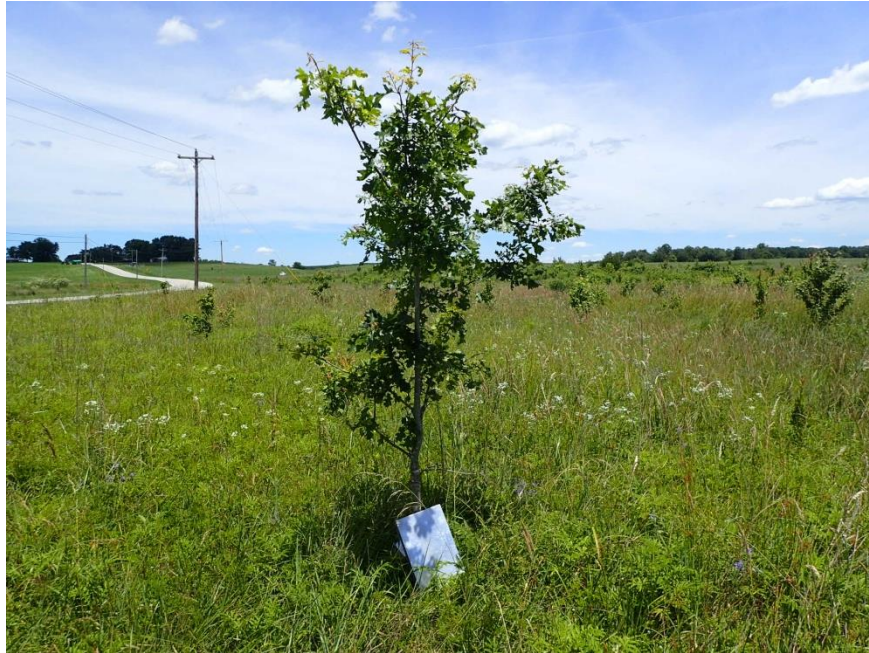
Photo 15.

Upland Buffers: The site's mitigation plan called for the establishment of 25 ft wide upland buffers around all mitigated streams and wetlands. These areas were then planted with a mixture of oaks. Competition from residual pasture grasses and heavy deer browsing has slowed growth of some individuals while others, such as this white oak, are approaching 8 ft tall.

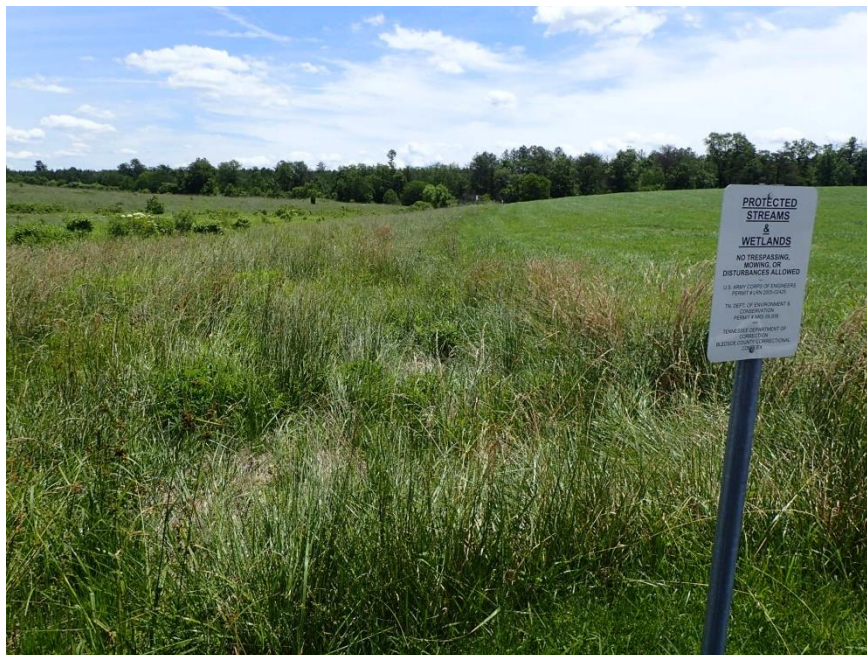
Photo 16.

Upland Buffers: In order to compensate for the failure to establish enough woody plants (and also the proper species ratios) in some areas, TDEC requested that the buffer zones around the west side of Stream 1, the south side of Stream 2, and both sides of Stream 3 be expanded from 25 to 50 ft. Also because of mowing incursions into the buffer zones, TDEC also asked that signs be erected to prevent this from happening in the future. This photo was taken looking east along an upland buffer lying adjacent to Stream 3.

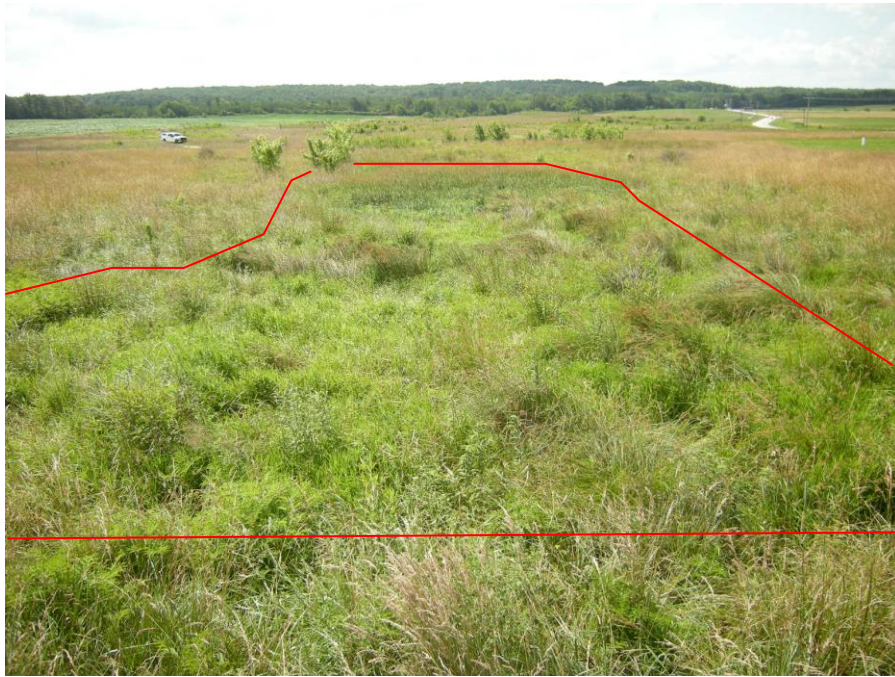
Photo 17.

Wetland Addition: As another way to compensate for the failure to establish enough woody vegetation in some locales, TDEC requested that a seepage wetland lying immediately to the north of the mitigation property also be incorporated into the mitigation effort and protected in perpetuity from future disturbance. This photo of the wetland addition taken in 2016 is looking southward. Its approximate boundaries are outlined in red. Total wetland area is approximately 0.6 acre.

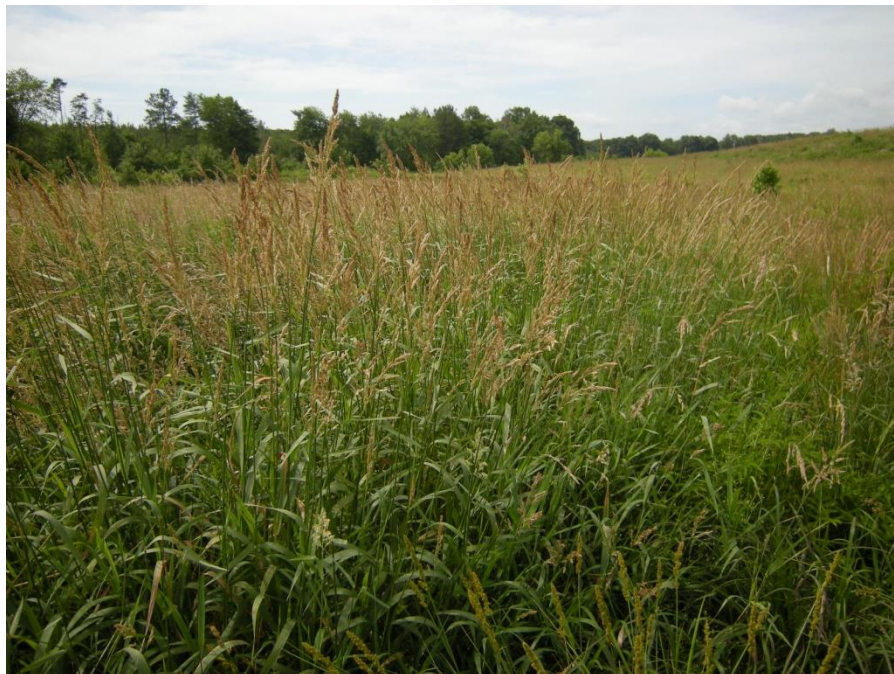
Photo 18.

Reed Canary Grass Control: Non-native strains of reed canary grass (rcg) are aggressive invaders of open wetland areas. If left unchecked, they could jeopardize the success of wetland mitigation efforts. As of 2015, nine small populations of rcg had been identified. With the consent of TDOC, EnSafe began an herbicide spraying regimen designed to bring rcg under control and prevent its future spread.

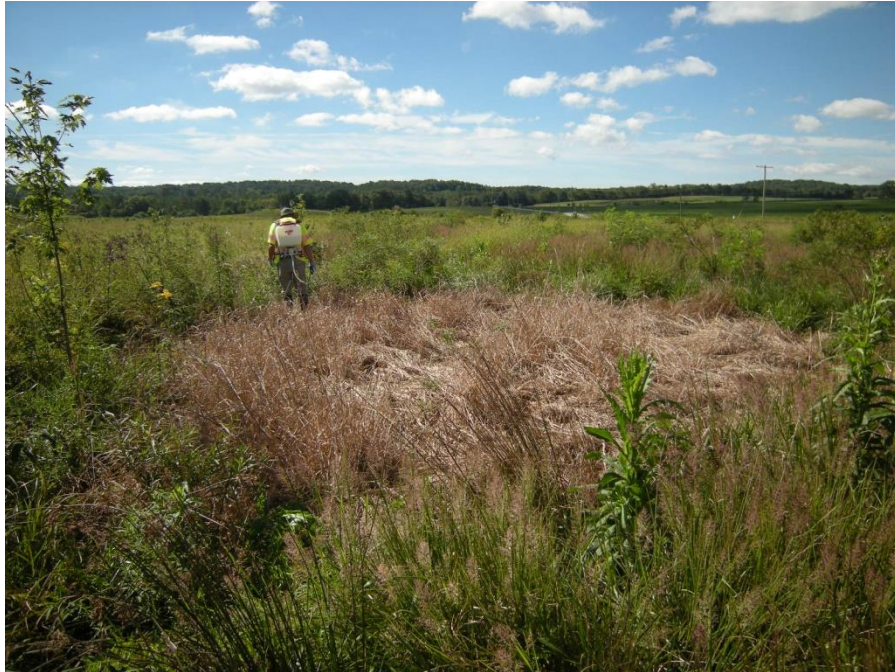
Photo 19.

Reed Canary Grass Control: This small patch was treated with herbicide in the early summer 2016. Follow-up monitoring showed that some plants continued to survive so they were treated again in late August. Experience has shown that after rcg is eliminated, native wetland herbs quickly become reestablished. Complete elimination, however, almost always requires repeated herbicide applications.

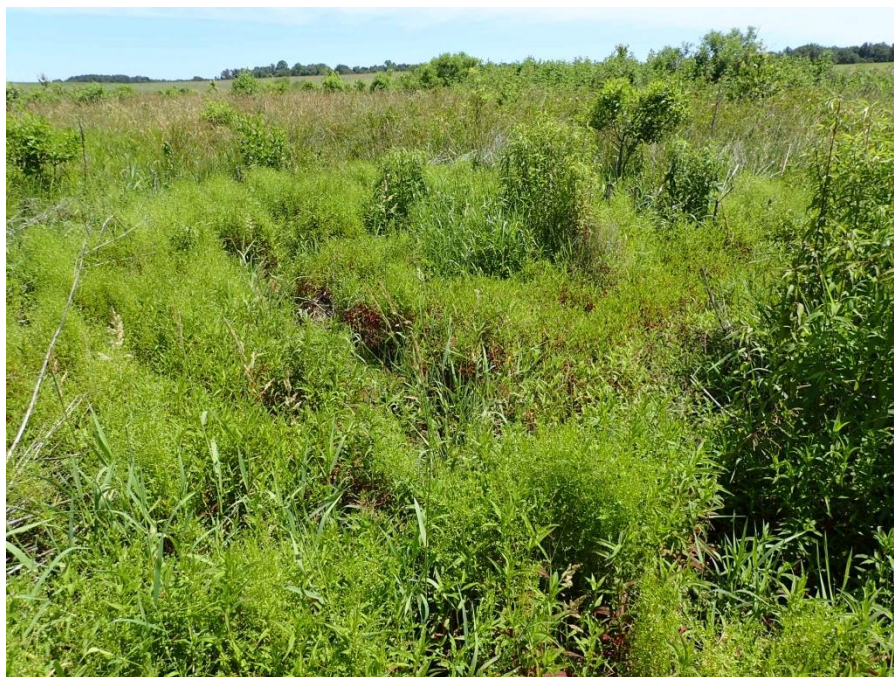
Photo 20.

Reed Canary Grass Control: This view of the same rcg population taken from the opposite direction one year later indicates a significant improvement. While small sprigs of rcg are visible in the foreground, the majority of plants are native hydrophytes such as marsh bedstraw, purpleleaf willowherb, and giant goldenrod.

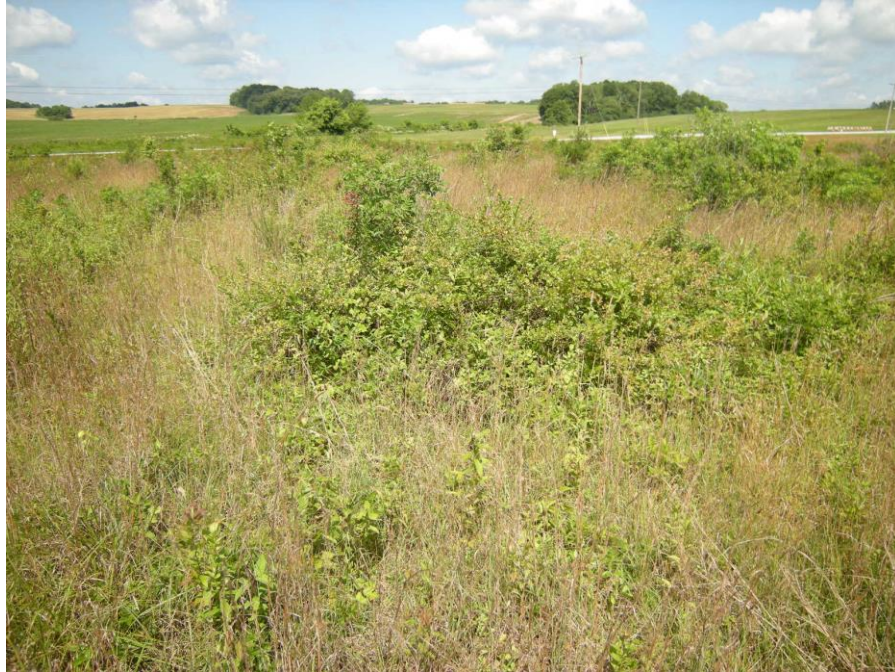
Photo 21.

Gooseberry Transplant Area: The BCCX Mitigation Area is important for the protection of a variety of stream and wetland functional values. Beyond this it is also important since it provides habitat for 5 state-listed rare plant species. Rare granite gooseberry shrubs, rescued from the prison construction site, and transplanted to the mitigation area in 2009, have survived and thus far appear to be doing relatively well. Despite weather extremes and strong competition from Japanese honeysuckle vines and native blackberries, they have managed to maintain themselves for eight growing seasons. (See text below.)

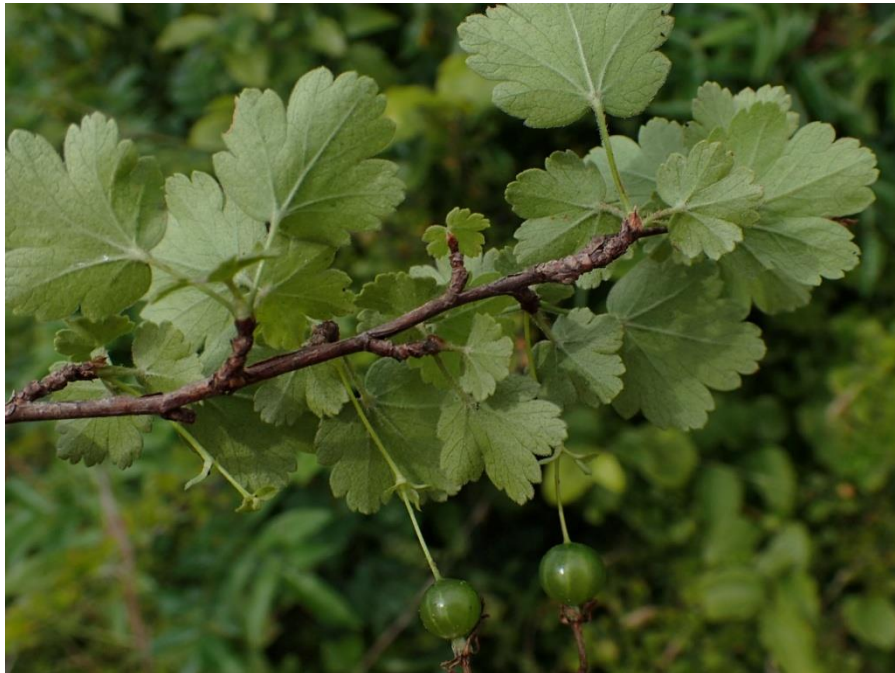
Photo 22.

Rare Species: The granite gooseberry is listed by TDEC's Division of Natural Areas as "threatened". While relatively common in the immediately vicinity of BCCX, there are five or fewer other known populations in the state.

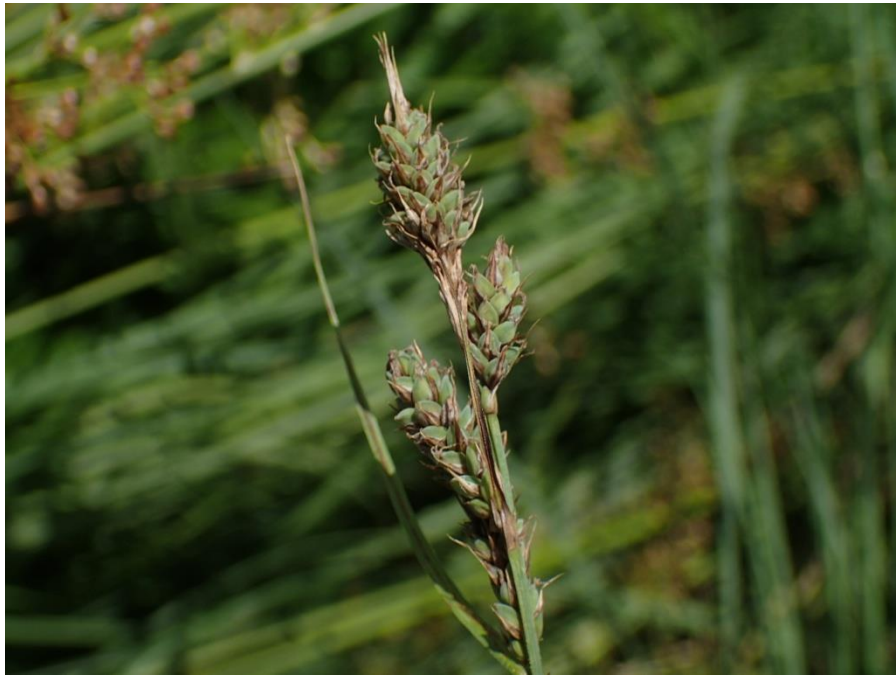
Photo 23.

Rare Species: Perhaps the rarest plant on the mitigation property is the grass-like brown bog sedge. Like the granite gooseberry, there are fewer than five known occurrences statewide. But because the populations contain so few individuals, it is listed by TDEC as “endangered”.

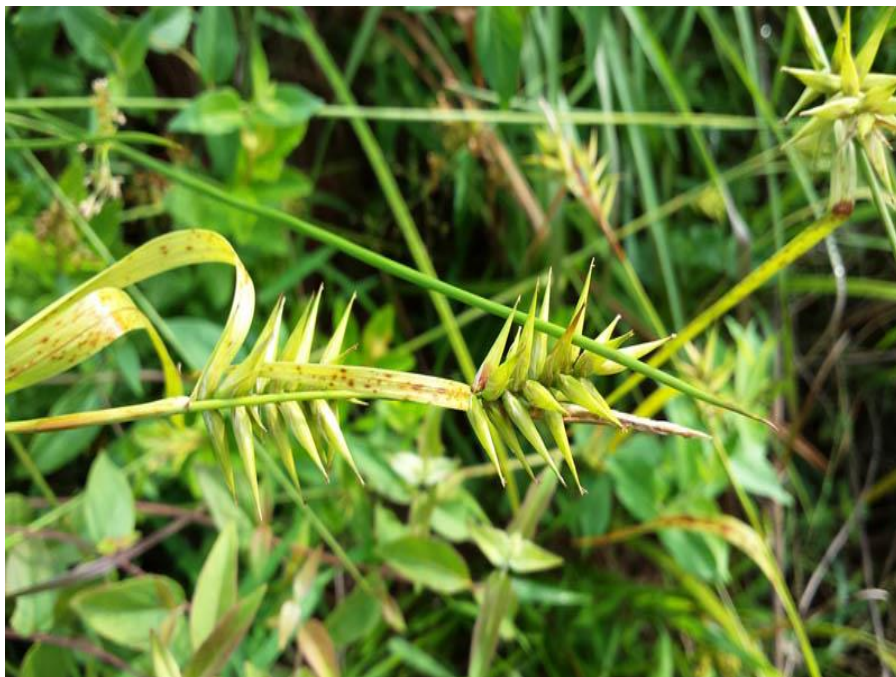
Photo 24.

Rare Species: Also “endangered” is the southern long sedge. Other than Bledsoe County, it has been documented from only one other TN county (Lincoln).

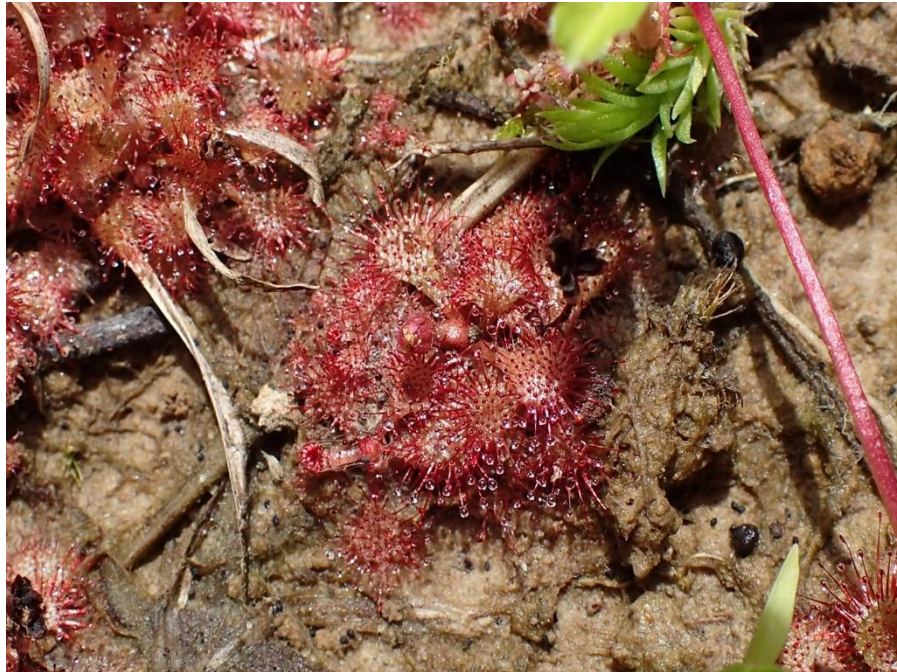
Photo 25.

Rare Species: Resurgent this year is the dwarf sundew; a state “threatened” species. This tiny plant was last seen onsite in 2015 but this year hundreds of individuals were observed. The reason for their disappearance in 2016 remains a mystery. Sundews inhabit nitrogen poor soils and supplement their nutrient intake by capturing insect prey. This is done by trapping insects with sticky hairs that coat the leaf surface and then dissolving the prey with specialized enzymes. The nutrients from the insect are then absorbed through the leaves.

Hundreds of dwarf sundew, a state-listed Threatened species, were discovered growing in the Creation Area and the area between the splitter pond and the Creation Area in 2017. This plant had been discovered growing in the Creation Area in 2014 and in 2015 it was found in the splitter

pond area. During the extended drought in 2016 the plant appeared to have disappeared from the area. Repeated searches in June and August 2016 failed to locate a single plant. A more normal rainfall pattern during the spring and summer of 2017 may have contributed to the plant's resurgence in 2017.

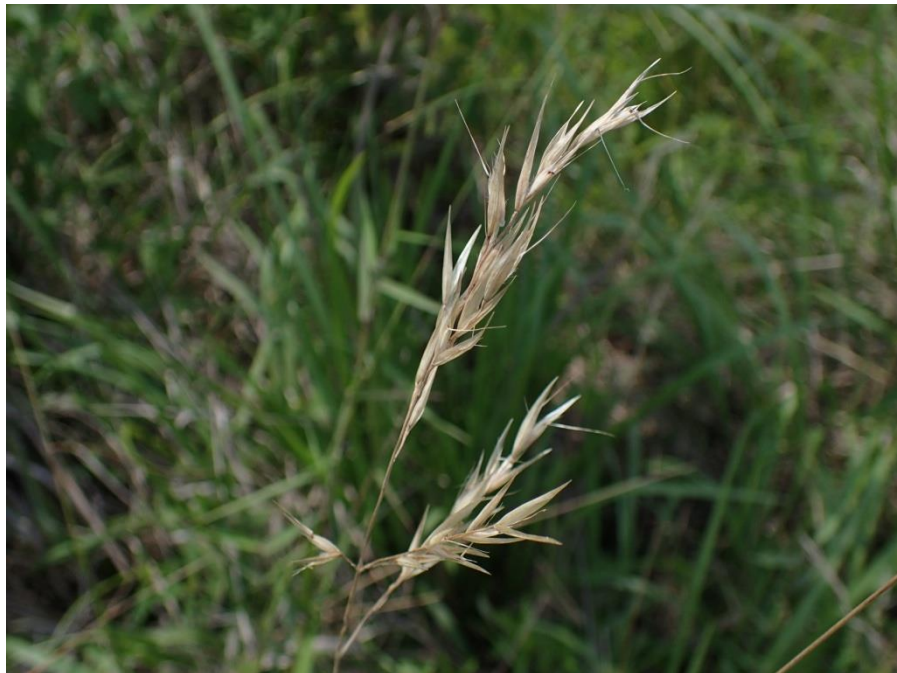
Photo 26.

Rare Species: Newly discovered at the BCCX mitigation site is bog oat grass. TDEC’s Division of Natural Areas considers it to be a species of “special concern”. This ranking applies to plants that are uncommon in Tennessee, or have unique or highly specific habitat requirements or scientific value.
