FOLLOW UP COMPLIANCE EVALUATION INSPECTION

SECOND NOTICE OF VIOLATION HARDEMAN COUNTY LANDFILL SNL350000223

SOLID WASTE INSPECTION REPORT

Bolivar-Hardeman County Landfill SNL350000223
75 Landfill Lane
Bolivar, TN
731-658-2884

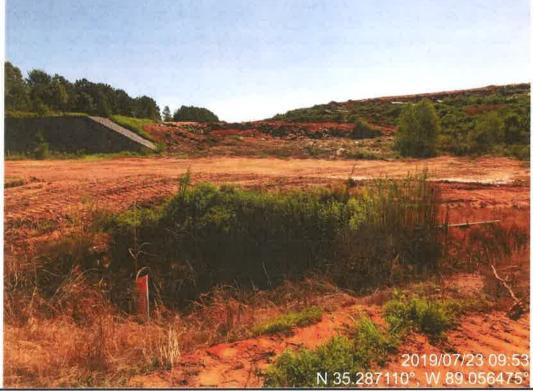
Photo 1. View over Phase IV of the current working face on Phase III. Note some trees still remain on the liner.

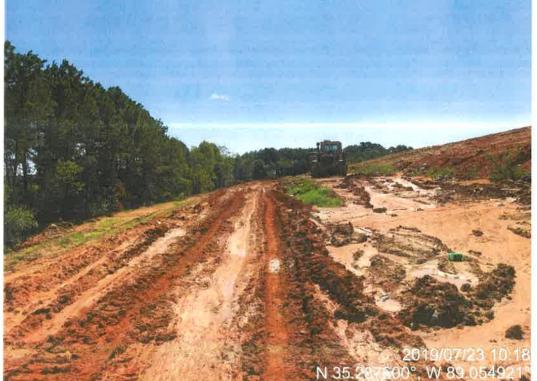
Photo 2. View East along North edge of Phase III. Note that while extensive sediment and rain water damage is shown that no leachate is present.

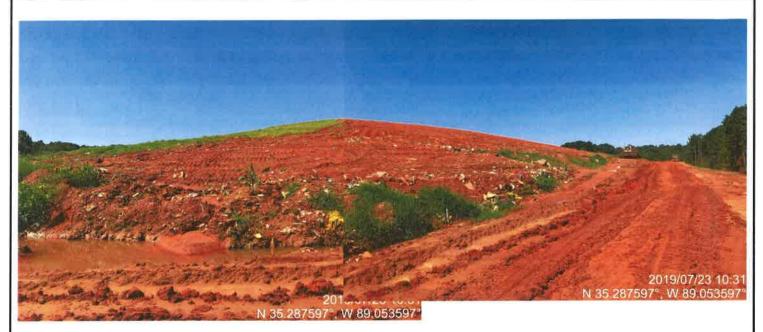
Photo 3. Panorama from the Northeast corner of Phase III. Note that all observed water is rain water and not leachate.

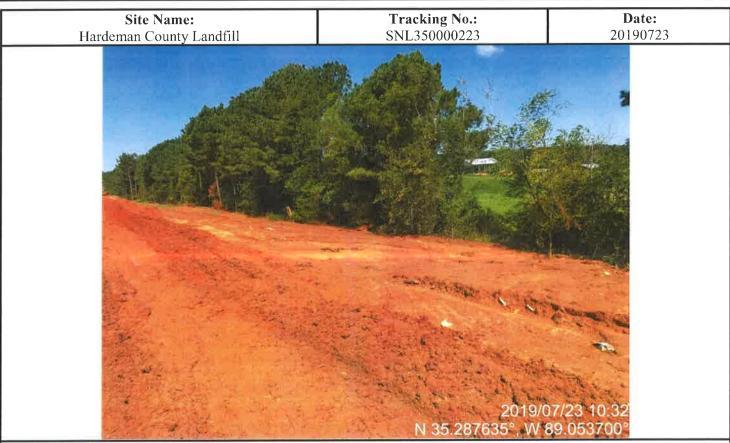
Photo 4. View over the North road. Note the absence of leachate.

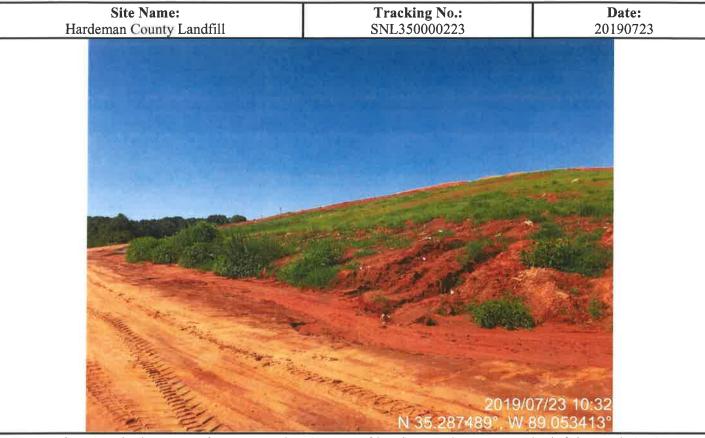
Photo 5. View South along East face. Note the absence of leachate. The water to the left is ponded rain water. There is still significant erosion and sediment deposits.

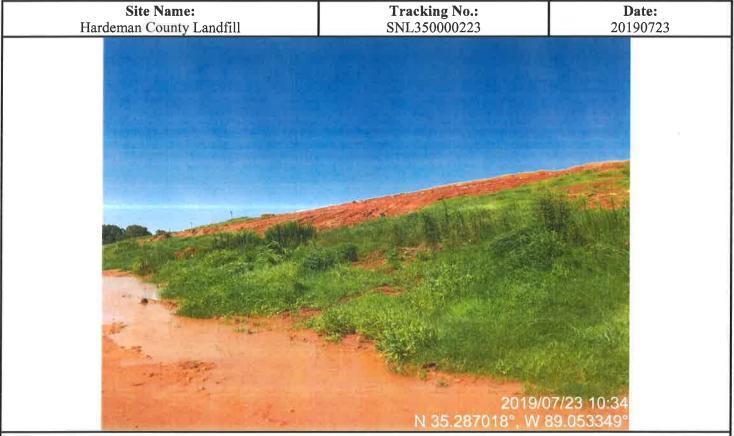
Photo 6. View of the East face. Note the reduced exposed waste and the absence of leachate. Also note that there are still significant erosion gullies on the slope and considerable sediment movement.

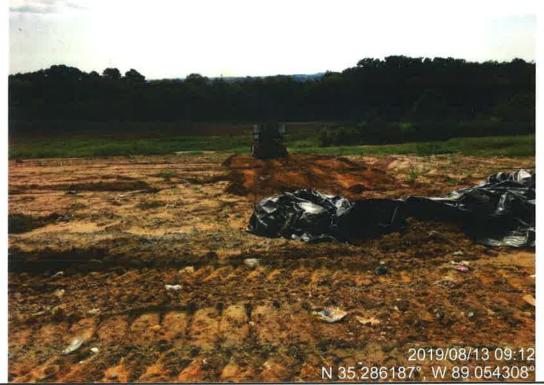
At the time of the July 23, 2019, inspection all of phase II and most of phase IV had been covered. At the time of the August 13, 2019, inspection this cover was heavily eroded and waste was exposed (photographs 2, 3, 4, 5, 7, and 8).

Photo 2. Intermediate cover replacement on the East face.

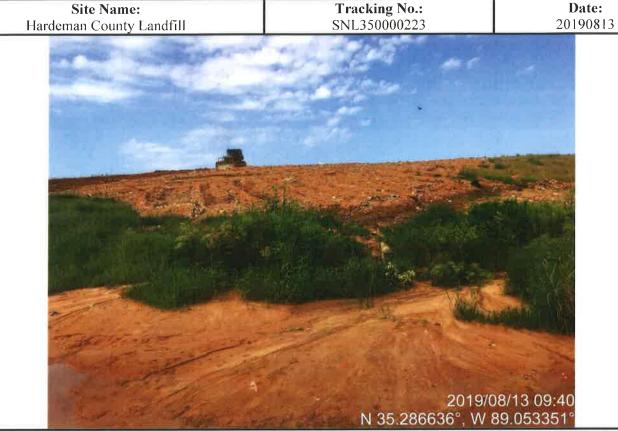
Solid Waste Exposed – The erosion of phases II and III cover had exposed waste during the August 13, 2019, inspection.

Photo 5. View up the East face. Note the exposed waste and the sediment fan at the bottom.

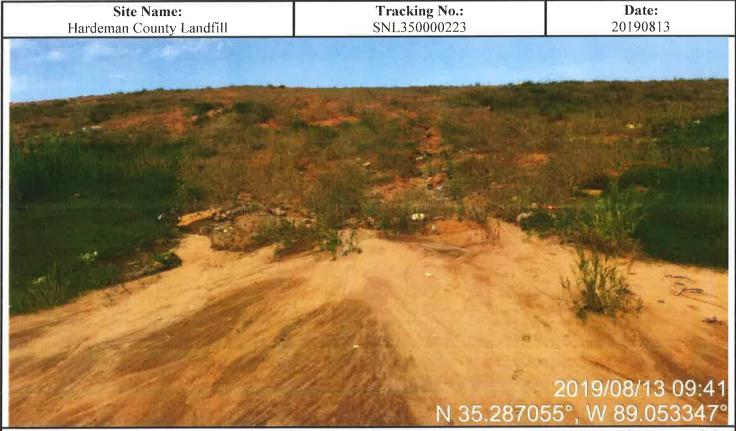
Photo 6. View up the East face from near the North end. Note the erosion on areas that have thin grass and the large sediment fan at the bottom. Picture has been cropped to remove excess sky.

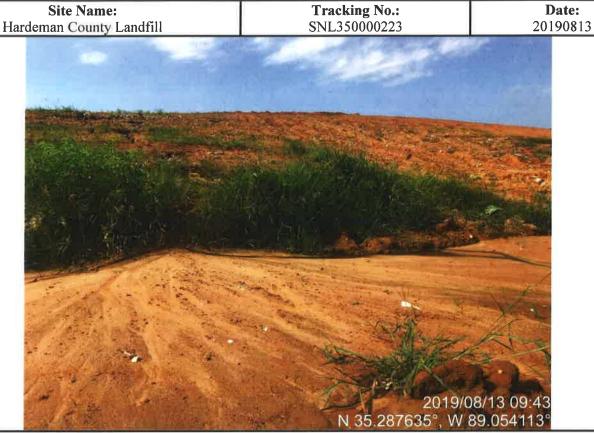
Photo 7. View of the North face with exposed waste from erosion and leachate at the bottom.

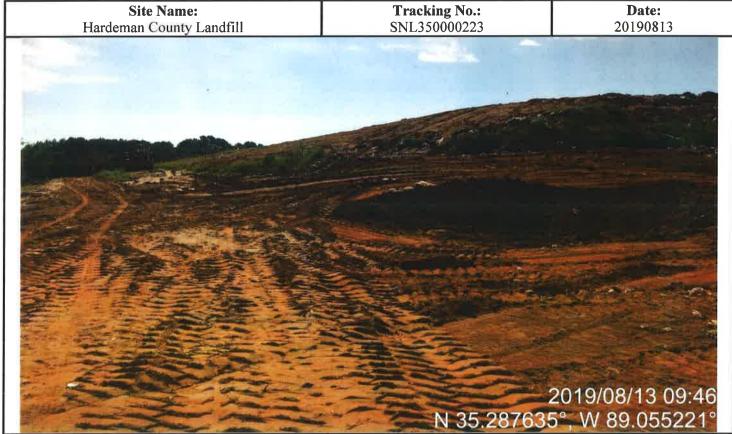
Photo 8. View East along the North face. Note the exposed waste on the older cover areas. Foreground cover is initial cover. Picture has been cropped to remove excess sky.

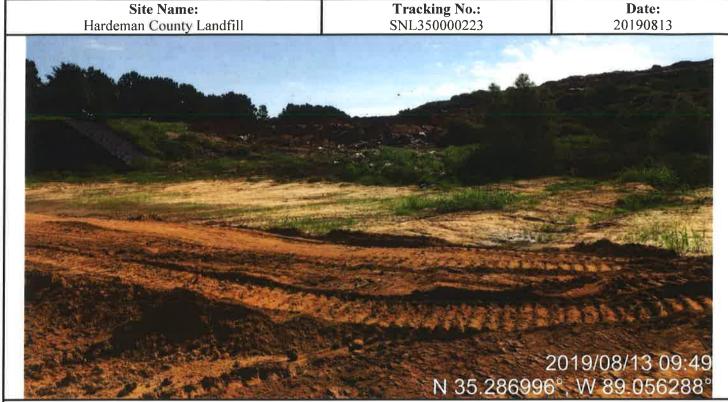
Photo 9. View of the northern part of the West face from Phase IV. Picture has been cropped to remove excess sky.

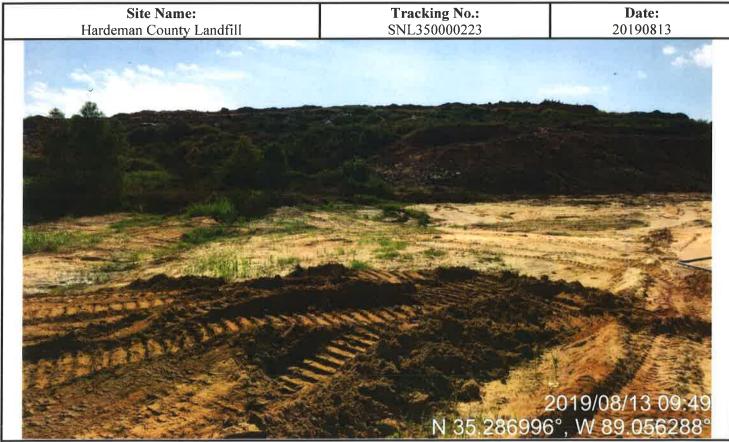
Photo 10. View of the center of the West face of Phase III from Phase IV. Note the cleared area to the right. Picture has been cropped to remove excess sky.

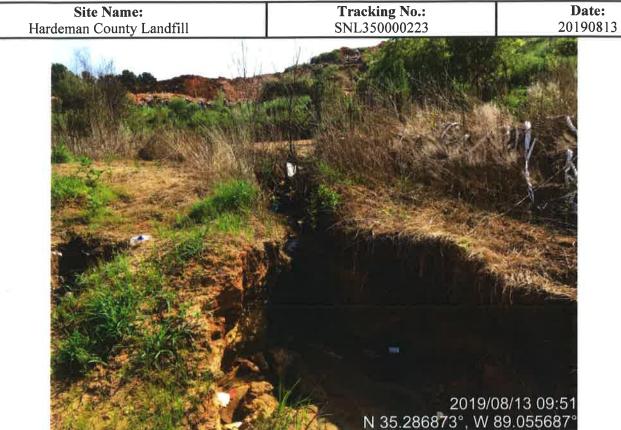
ADDITIONAL COMMENTS 8570 - The leachate collection pit is no longer effective. The pit is completely filled with sediment and any leachate entering the pit flows out through the breach in the levee. The compliance agreement of July 5, 2016, requires 2 feet of fretboard. The specific violations related to the reconstruction of Phase IV (8340, 8320, and 8570) are not included in the follow-up inspection date listed above. EROSION CONTROL - Most temporary erosion control measures shown in the Tennessee Erosion Prevention and Sediment Control Program Level I course book do not require a permit modification to be implemented. The current approved plans have an inadequate storm water management and erosion control plan. More effort needs to be placed on reducing the erosive effects The primary problem for this facility in establishing and maintaining intermediate cover is the poor quality of the available soils. The primary soil is a very slightly clayey sand that has no cohesion when exposed to weathering. Hardeman County should either find a different source of soil that has a higher clay content or take aggressive stabilization measures. Until a more cohesive cover soil is found the County will continue to spend employee time and resources replacing the washed away cover-A Compliance Review Meeting to determine a corrective action plan for the ongoing cover and erosion violations has been scheduled for Wednesday, September 4, 2019 at 10:00 AM in the Jackson Environmental Field Office. A formal letter announcing this will be sent shortly.

Photo 11. The breach in the levee for the Phase III leachate pit. Note the exposed liner material in the bottom of the cut.

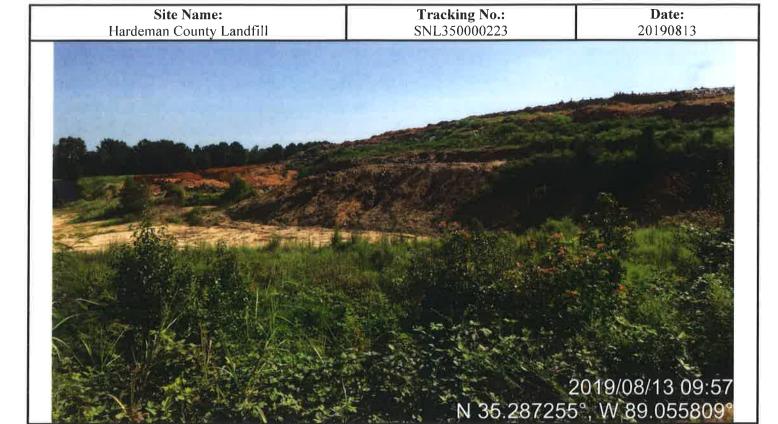
Photo 13. View of the West face of Phase III.

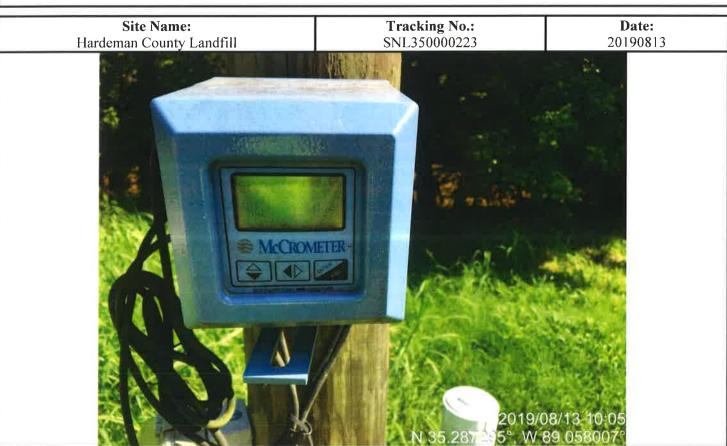
| *SEE DISCLAIMER ON LAST PAGE | | | | |
|---|---|---|---|--|
| COMMENTS | The window on the leachate flow meter is crazed and it is had no free board, was inaccessible due to mud. This item is | very difficult to read the meter. The temporary l addressed in the Phase IV renovation plan. | eachate pit on Phase III | |

Photo 14. The leachate flow gauge.
