Re: **Hazardous Waste Compliance Evaluation Inspection**
University of Tennessee, Austin Peay Building
EPA ID # TN0 00-087-9809, Knox Co.

HAZARDOUS WASTE INSPECTION REPORT

University of Tennessee, Austin Peay Building
Room 123, Austin Peay Building
Knoxville, TN 37996
EPA ID # TN0 00-087-9809
County: Knox

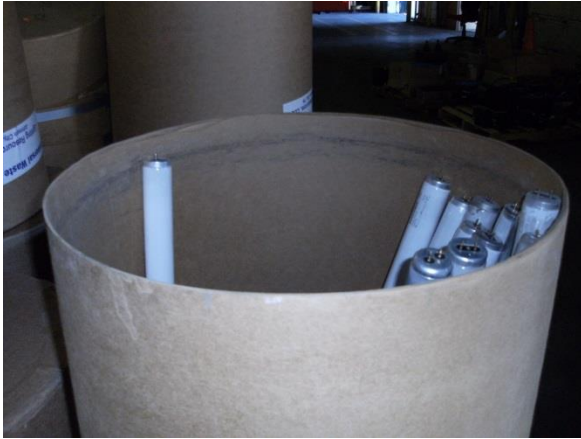
Several universal waste lamp containers were observed in storage. One box was found open (labeled lid found on pallet next to box) and the box was not dated to demonstrate storage time (Photo 1). University of Tennessee procedure to demonstrate storage time involves placing a storage date on the box. An additional box of lamps was found stored for more than one year (Photo 2).

Photo 1) One box of universal waste lamps was found open and not dated.

The University of Tennessee, Austin Peay Building failed to store one box of lamps in a closed, structurally sound container (Photo 1). This box was identified at the Fleming Warehouse.

The University of Tennessee, Austin Peay Building failed to demonstrate the storage time for one box of lamps stored at the Fleming Warehouse (Photo 1).

All universal waste lamps must be stored in closed, structurally sound containers to prevent breakage.

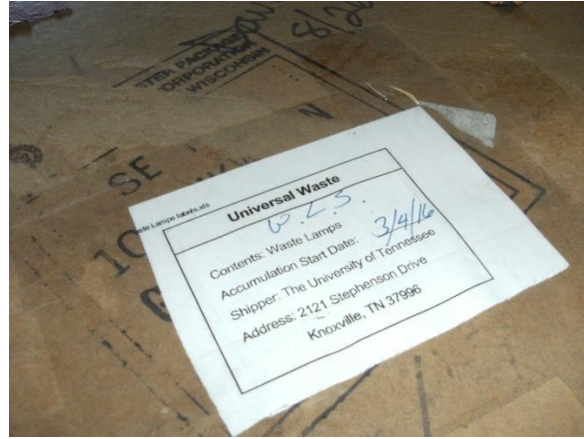
Photo 2) One box of universal waste was found stored for more than one year. This container was dated 3/4/2016.

The University of Tennessee, Austin Peay Building stored one box of universal waste lamps for more than one year. This box of lamps was observed at the Fleming Warehouse (Photo 2).

Small quantity handlers of universal waste may only accumulate universal waste for no longer than one year prior to recycling.

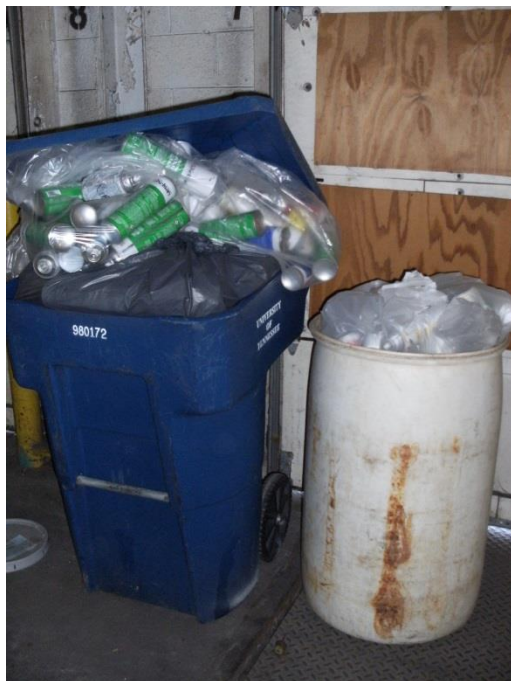
Photo 3) Two containers full of aerosol cans were found stored in a 90 day storage area. The containers were not labeled, open, and not dated. Additionally, weekly inspections are not conducted for containers in this area.

The University of Tennessee, Austin Peay Building failed to provide accumulation start dates for two containers of waste aerosol cans located in Fleming Warehouse 90 day storage area (Photo 3) and four containers located in the Science and Engineering 90 day storage area (Photos 4-7).

The University of Tennessee, Austin Peay Building failed to close two containers of waste aerosol cans located in the Fleming Warehouse 90 day storage area (Photo 3).

The University of Tennessee, Austin Peay Building failed to label two containers of waste aerosol cans located in the Fleming Warehouse 90 day storage area with the words “hazardous waste” (Photo 3).

The University of Tennessee, Austin Peay Building failed to conduct weekly inspections on containers of waste aerosol cans located in the 90 day storage area at the Fleming Warehouse (Photo 3).

The facility must ensure all hazardous waste containers located in 90 day storage areas are marked with an accumulation start date.

The facility must ensure all containers of hazardous waste located in 90 day storage areas are kept closed.

The facility must ensure all containers of hazardous waste located in 90 day storage areas are labeled with the words “hazardous waste”.

Weekly inspections must be conducted on containers located in 90 day storage areas to ensure containers are in compliance with hazardous waste management requirements.

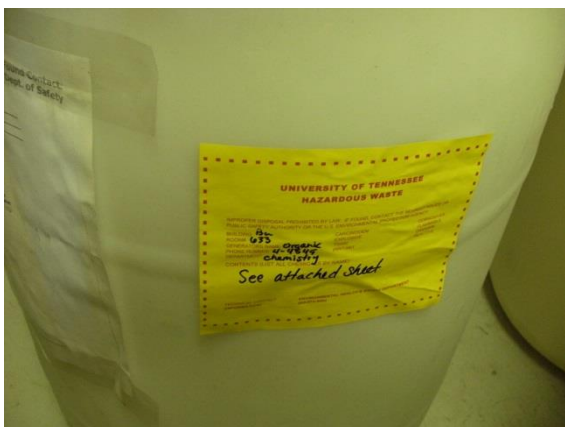
Photo 4) 90 Day Area: One 30-gallon container of hazardous waste was not dated.

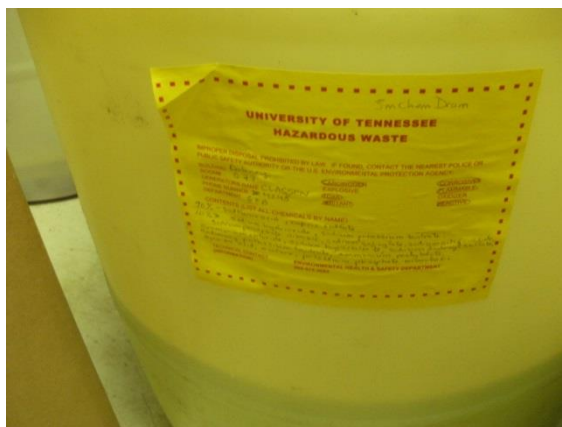
Photo 5) 90 Day Area: One 30-gallon container of hazardous waste was not dated.

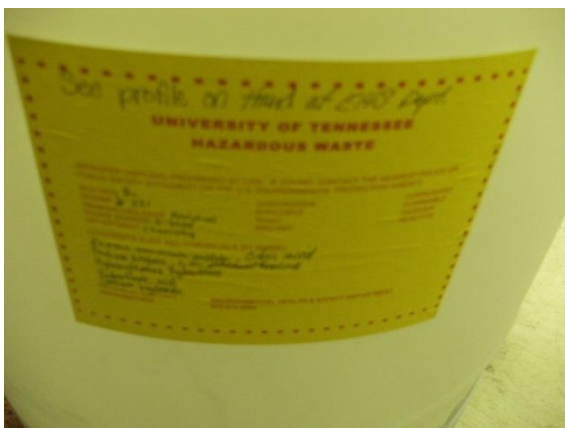
Photo 6) 90 Day Area: One 30-gallon container of hazardous waste was not dated.

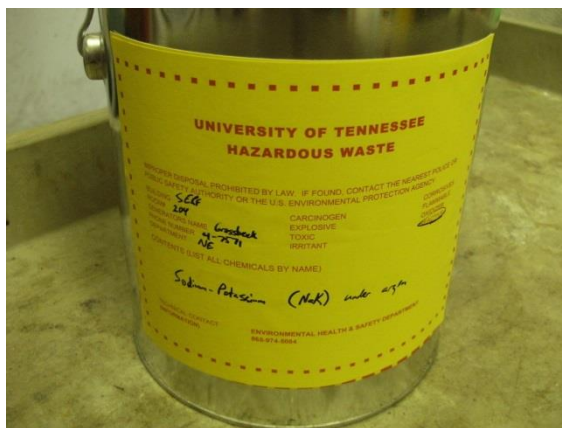
Photo 7) 90 Day Area: One 1-gallon container of hazardous waste was not dated.

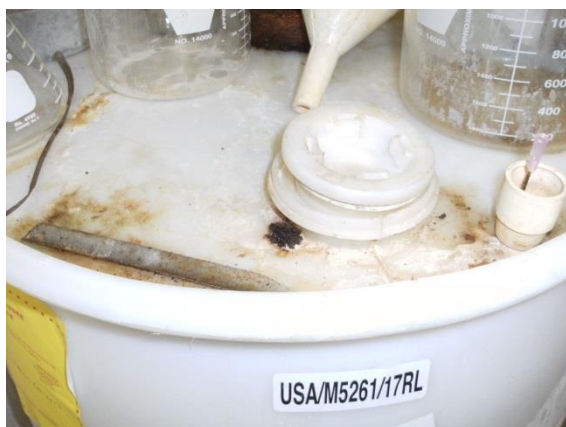
- Room 217: Several containers of hazardous waste were observed. While all were found labeled “hazardous waste,” one 30-gallon container and one 15-gallon container were not properly closed (Photos 8-9). The Division recommends personnel improve housekeeping for its hazardous waste satellite storage by making all hazardous waste labels clearly visible and removing other obstacles in the storage area. Also observed were various chemical glassware stored on top of hazardous waste labels which were placed on the tops of the container lid. Since the glassware held or previously held chemicals, the integrity of the label is compromised. As a best management practice, lab personnel should place hazardous waste labels on the side of the container.

Photo 8) Room 217: One 30-gallon container of hazardous waste was not properly closed. The bung was not screwed into the container.

All satellite containers of hazardous waste must be closed during storage, except when the operator is adding or removing waste.

3. Concerning Room 217 at the Science and Engineering Building, the Division strongly recommends lab personnel improve housekeeping for its hazardous waste satellite storage by making all hazardous waste labels clearly visible and removing other obstacles in the storage area. Also observed were various chemical glassware stored on top of hazardous waste labels which were placed on the tops of the container lid. Since the glassware held or previously held chemicals, the integrity of the label is compromised. As a best management practice, lab personnel should place hazardous waste labels on the side of the container.

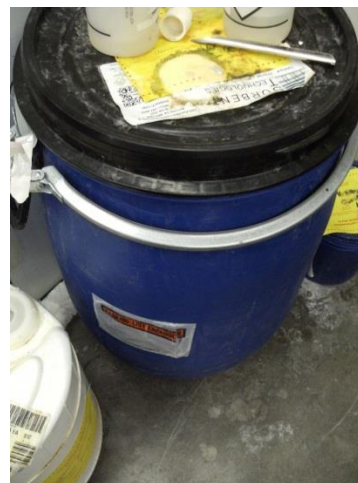
Photo 9) Room 217: One 15-gallon container of hazardous waste was not properly closed. The metal ring was not fastened to the lid to prevent spillage.

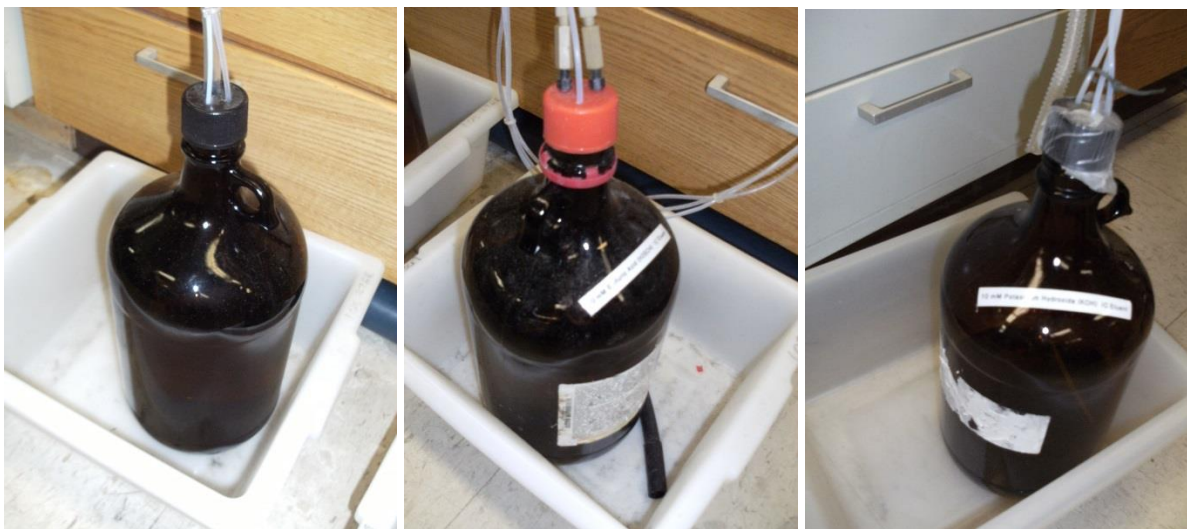
- Room 705: Four 4L, one 1L, and several small containers were stored in the lab hood. All were labeled and closed.
- Room 702: This large lab manages several satellite areas at each of their five lab hoods. All were found properly closed and labeled. However, three 4L ion chromatography (IC) effluent containers of hazardous waste were observed. These three were not labeled or properly closed (Photos 10-12).

Photos 10-12) Room 702: Three 4L containers of IC hazardous waste effluent were observed (from left to right: waste methonal, waste sulfuric acid, waste potassium hydroxide). None were labeled or closed properly. These lids were not fully fastened onto their waste container.

All satellite containers of hazardous waste must be labeled with the words "hazardous waste" or with words to identify the waste contents while in storage.

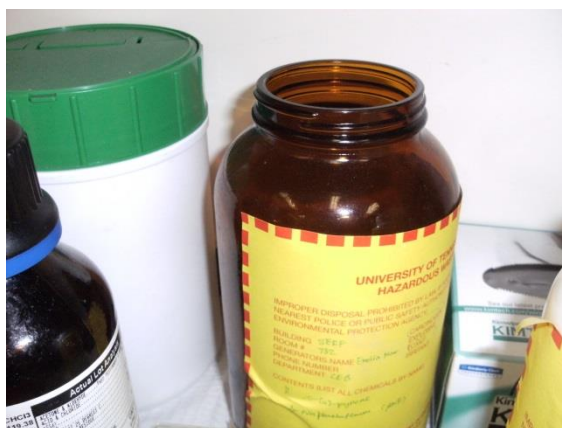
- Room 722B: Several various-sized containers of hazardous waste were observed. All were found labeled but one 500 mL container was found open (Photo 13). All others were closed.

Photo 13) Room 722B: One 500 mL container of hazardous waste was found open.

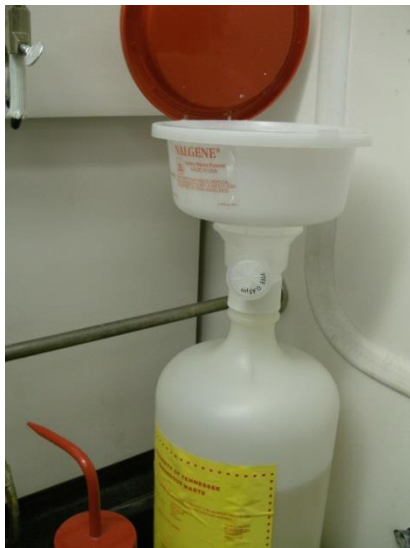
- Rooms 602-603: Four 1-gallon containers of hazardous waste were stored in various lab hoods. While all four were labeled, all four were found open (Photos 14-17). Hazardous waste is also stored in various-sized container inside a flammable cabinet in this room. All of these containers were labeled and closed.
- Room 663: Several containers of hazardous waste were observed. All were labeled and closed.
- Room 458: One 30-gallon and four 4L containers of hazardous waste were observed. All were labeled and closed.
- Room 432: Three 4L containers of hazardous waste were observed. While all were labeled, one 4L was not fully closed (Photo 18).

Photo 14) Room 602-603: One 1-gallon of hazardous waste was open.

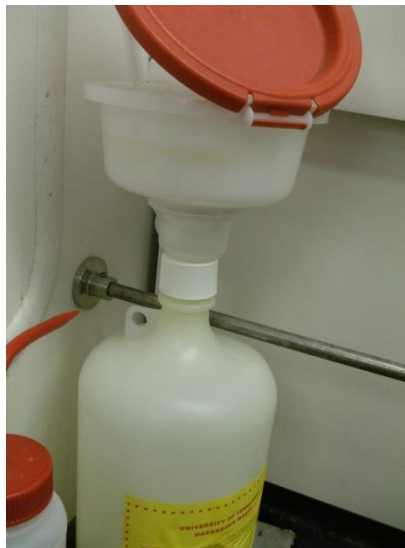
Photo 15) Room 602-603: One 1-gallon of hazardous waste was open.

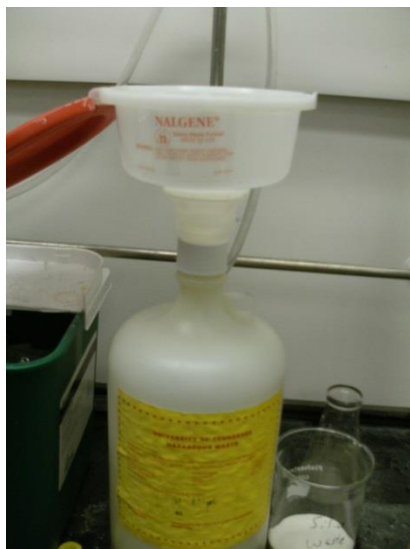
Photo 16) Room 602-603: One 1-gallon of hazardous waste was open.

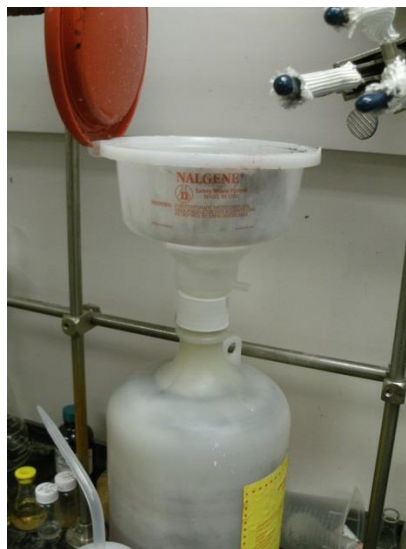
Photo 17) Room 602-603: One 1-gallon of hazardous waste was open.

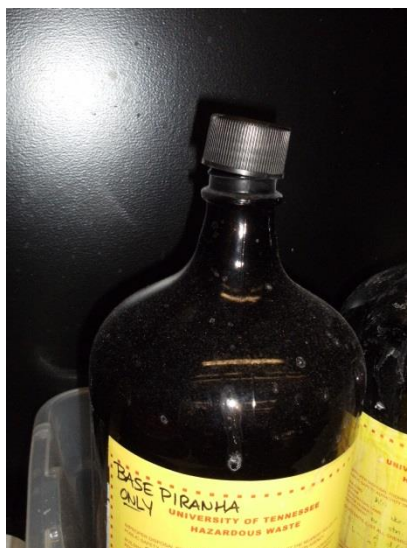
Photo 18) Room 432: One 4L container of hazardous waste was not fully closed.

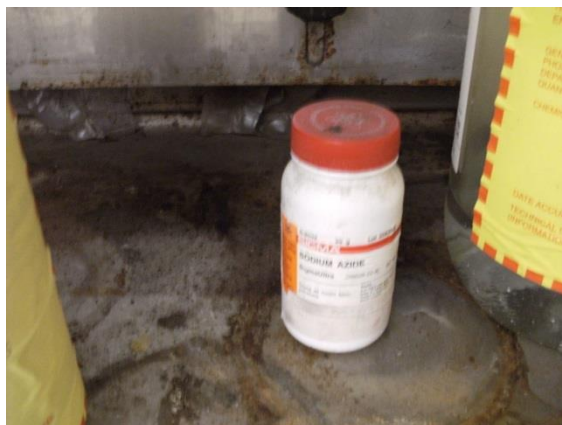
Photo 19) Room D413: One small container of waste sodium azide (P105) was not labeled, as required.

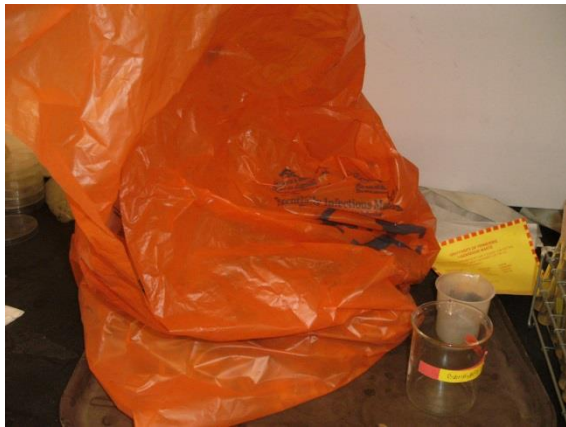
- Room 434: One 4L container of hazardous waste was observed labeled and closed.
- Room 433: Several containers of hazardous waste were observed in the lab hood. One baggie of hazardous waste was not properly labeled or closed (Photo 20). The Division does not approve of placing hazardous waste in bags marked as biohazard. Since hazardous waste is managed and ultimately treated/disposed of differently than biohazard waste, improper storage containers may cause waste to be mismanaged and ultimately not treated/disposed of properly, in accordance with TN Rules for Hazardous Waste.

Photo 20) Room 433: One bag of hazardous waste was found not labeled or closed. Additionally, the Division does not approve of using biohazard bags to store hazardous waste as this may not facilitate proper disposal/treatment management, in accordance with TN Rules for Hazardous Waste.

2. The Division does not approve of using biohazard bags to store hazardous waste. Since hazardous waste is managed and ultimately treated/disposed differently than biohazard waste, improper storage containers may cause waste to be mismanaged and ultimately not treated/disposed properly, in accordance with TN Rules for Hazardous Waste.

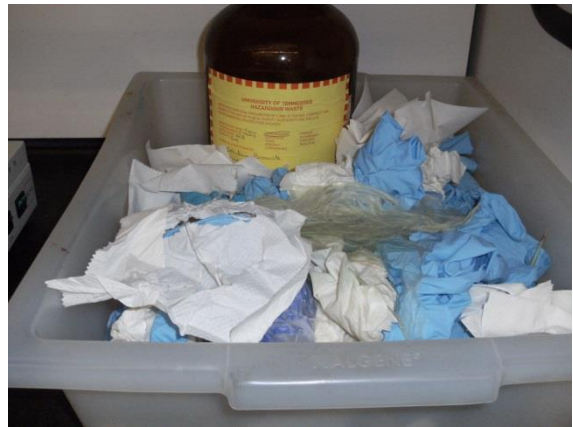
- Room 438: One 4L container and one pan of hazardous waste-contaminated wipes and personal protective equipment (PPE) were observed. The wipes and PPE were not properly containerized in a labeled, closed container (Photo 21).

Photo 21) Room 438: One pan of hazardous waste-contaminated PPE and wipes were found observed. The wipes and PPE were not properly containerized in a labeled, closed container.

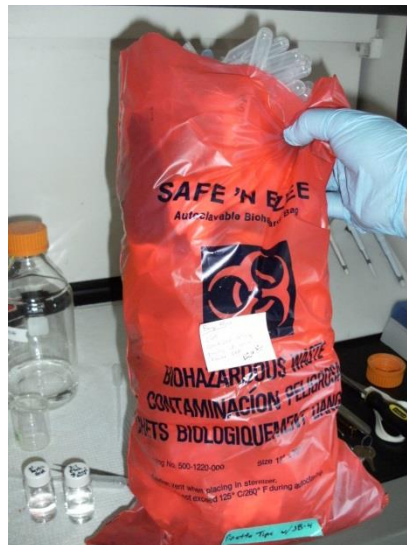
- Room 317: Several various-sized containers of hazardous waste were observed. One bag of waste osmium tetroxide-contaminated (P087) pipettes was observed. This bag was not

closed or labeled, as required (Photo 22). Additionally, this waste was accumulated in a biohazard bag. As stated above, the Division does not approve of placing hazardous waste in bags marked as biohazard. Since hazardous waste is managed and ultimately treated/disposed of differently than biohazard waste, improper storage containers may cause waste to be mismanaged and ultimately not treated/disposed of properly, in accordance with TN Rules for Hazardous Waste.

Photo 22) Room 317: One bag of waste osmium tetroxide-contaminated (P087) pipettes was observed. This bag was not closed or labeled, as required. Additionally, the Division does not approve of using biohazard bags to store hazardous waste as this may not facilitate proper disposal/treatment management, in accordance with TN Rules for Hazardous Waste.
