Re: **Hazardous Waste Follow-Up Inspection**
University of Tennessee, Austin Peay Building
EPA ID # TN0 00-087-9809, Knox Co.

HAZARDOUS WASTE FOLLOW-UP INSPECTION REPORT

University of Tennessee, Austin Peay Building
Room 123, Austin Peay Building
Knoxville, TN 37996
EPA ID # TN0 00-087-9809
County: Knox

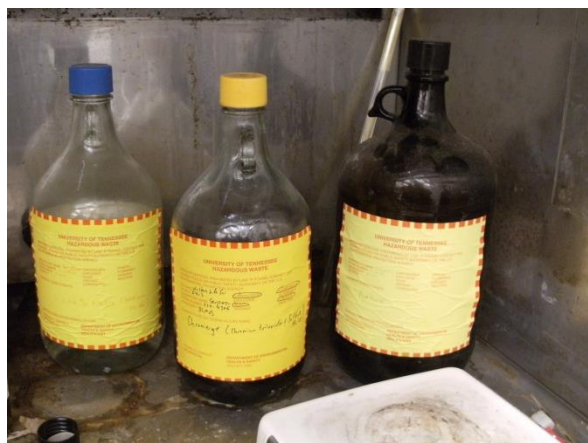
During the previous inspection, one small container of waste sodium azide (P105) was not properly labeled when stored in its satellite accumulation area in Room D413. This container was turned in to EHS personnel at the 90 day storage area for handling. According to Mr. Rotella, this item was recently shipped off site for disposal. Three containers of hazardous waste were observed during the follow-up visit. All were found labeled and closed, as required (Photo 1).

Photo 1) Room D413: The previous unlabeled container was collected by EHS personnel for disposal. Three containers of hazardous waste were observed. All were labeled and closed.

All satellite containers of hazardous waste were observed closed at the time of the follow-up inspection. While some of the containers previously identified have been collected for disposal, any containers located in the same satellite storage areas were found in compliance (Photos 1-2, 4, and 7-14).

All satellite containers of hazardous waste were observed properly labeled at the time of the follow-up inspection. This is demonstrated in photos (Photos 1-2, 4, and 7-14).

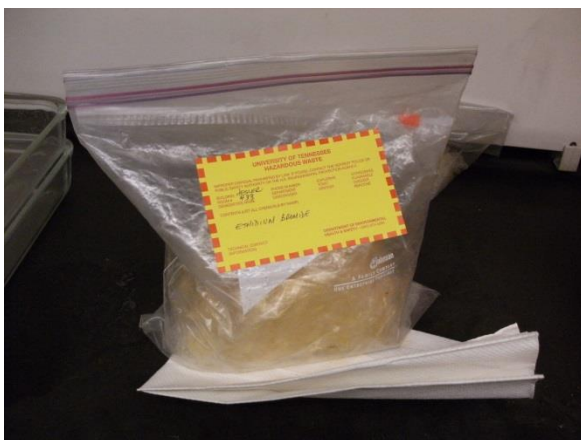
- Room 433: Previously, hazardous waste was placed in a biohazard bag for storage. Additionally, the bag was not labeled or dated. Hazardous waste is currently stored in zip-lock bags with proper labeling and segregated from any biohazard waste (Photo 2).
- Room 438: Previously, hazardous waste-contaminated PPE and wipes were not properly containerized in a labeled, closed container. At the time of the follow-up, the satellite storage area was found empty as personnel had moved out of this lab (Photo 3).
- Room 317: Previously, P-listed waste (P087) was found in an unlabeled and open biohazard bag. This waste is currently storage in a large clear baggie which was found closed and labeled (Photo 4).

Photo 2) Room 433: Hazardous waste is segregated from biohazardous waste and stored in labeled and closed baggies.

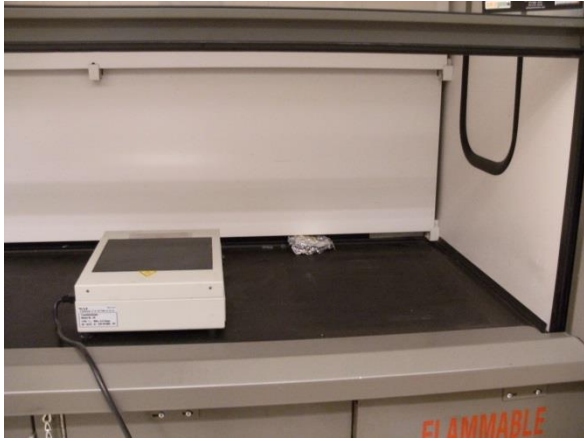
Photo 3) Room 438: This satellite storage area was found empty.

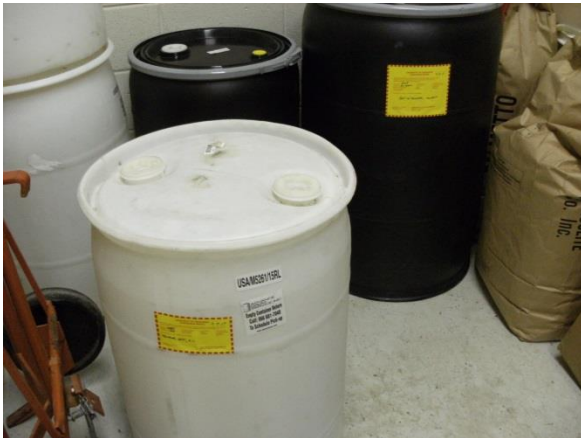
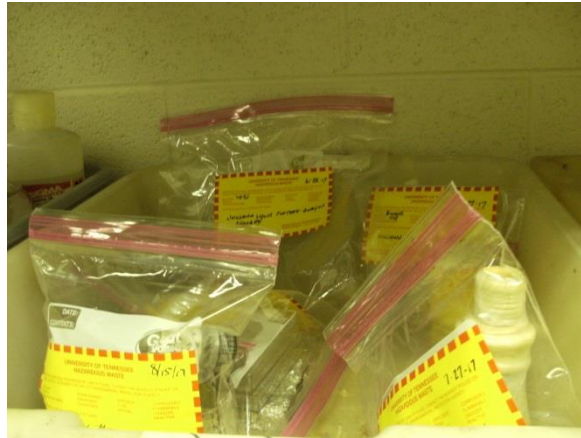
During the initial inspection, four containers of hazardous waste were identified without accumulation start dates. While the facility had recently shipped waste off site for disposal, a total of 23 various-sized containers were found in storage. All were inspected and found labeled, closed, and dated. A couple representative photos were taken for compliance demonstration (Photos 5-6).

Photo 5) 90 Day Area: All containers were labeled, closed, and dated.

Photo 6) 90 Day Area: All containers were labeled, closed, and dated.

All containers observed in the 90 day storage area in the Science and Engineering Building were found with accumulation start dates (Photos 5-6). The 90 day storage area previously identified at Fleming Warehouse for the accumulation of aerosol cans was closed and hazardous waste is no longer stored here (Photo 15).

The 90 day storage area at the Fleming Warehouse was closed and hazardous waste is no longer stored here (Photo 15). The 90 day storage area at Science and Engineering was also visited during this follow-up inspection and all containers were found closed (Photo 5-6).

The 90 day storage area at the Fleming Warehouse was closed and hazardous waste is no longer stored here (Photo 15). The 90 day storage area at Science and Engineering was also visited during this follow-up inspection and all containers were found labeled (Photo 5-6).

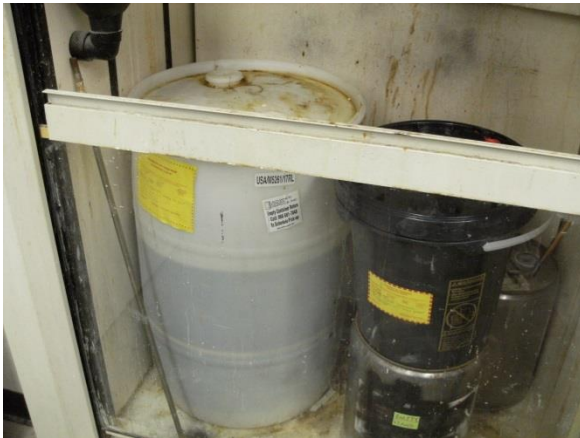
- Room 217: Previously, two containers of hazardous waste were found not properly closed. During the follow-up inspection, two containers found in satellite storage were observed closed and labeled (Photo 7).

Photo 7) Room 217: Containers of hazardous waste were found closed and labeled.

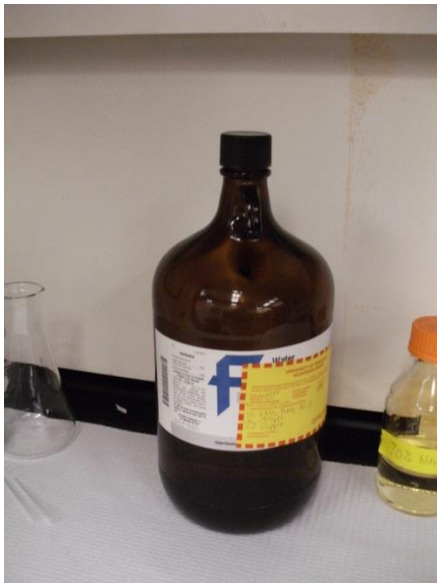
- Room 722B: Previously, one 500 mL container of hazardous waste was found open. During the follow-up inspection, one 4L container was observed in satellite storage. The container was both labeled and closed (Photo 8).

Photo 8) Room 722B: The open 500mL container of waste previously identified was collected by EHS personnel for storage. However, one 4L container observed was found both labeled and closed.

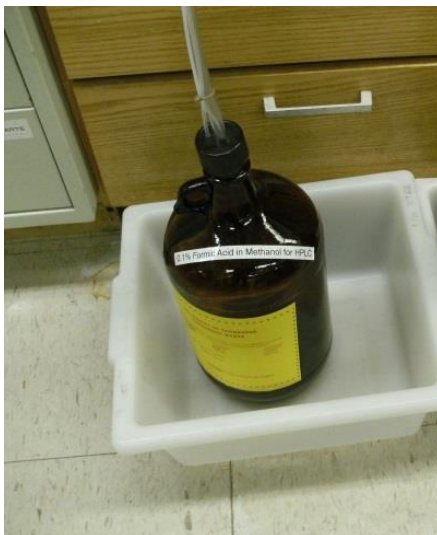
- Room 702 (actually 705): During the initial inspection, three 4L containers were identified at the IC machines. As a result of conversations with lab personnel at the time, Division personnel understood that all three containers were receiving waste effluent from the analytical machines. However, due to new information provided by EHS personnel after discussing the process with the Laboratory Primary Investigator, it was determined that only one of the containers (waste methanol) is used to collect waste. The remaining two containers were product used by the IC machine for analysis. Regarding the container of waste methanol previously identified during the initial inspection, the container was found unlabeled and open. During the follow-up inspection, the container was found labeled and closed (Photo 9).

Photo 9) Room 702: The one container of waste methanol was found properly labeled and closed.

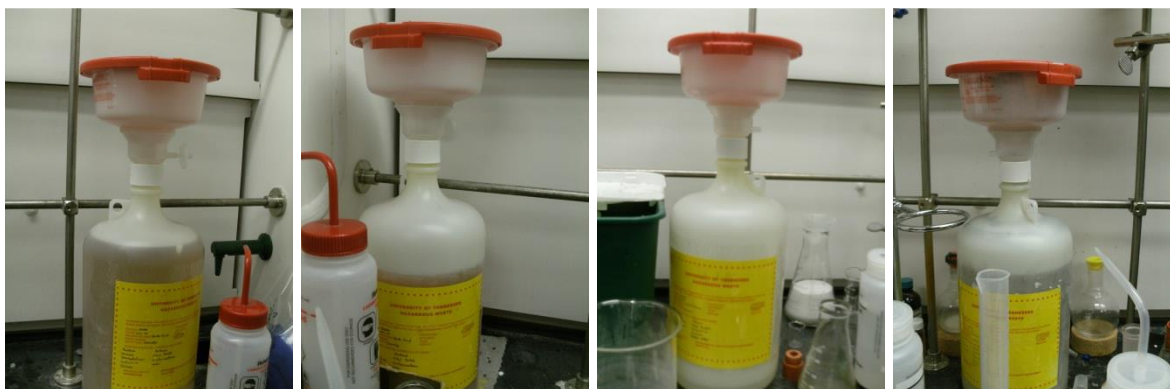
- Room 602-603: Previously, four 1-gallon containers were found open. All four were observed closed during the follow-up inspection (Photos 10-13).
- Room 432: Previously, one 4L container was observed open. During the follow-up inspection a total of three 4L containers were found in storage and all were properly closed as well as labeled. (Photo 14).

Photos 10-13) Room 602-603: The four 1-gallon storage containers were found properly closed as well as labeled.

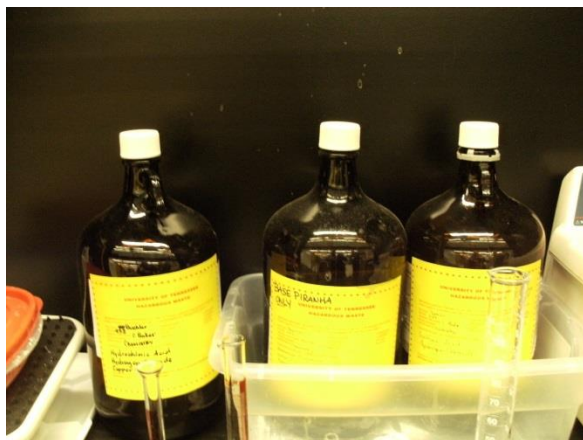
Photo 14) Room 432: Three 4L containers were found properly labeled and closed.

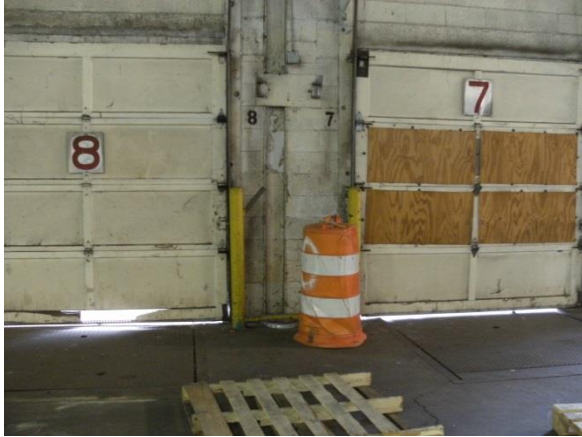
During the previous inspection, the facility was collecting aerosol cans in a 90 day storage area. However, the storage containers were not properly labeled, dated, or closed. In addition, weekly inspections of the area were not conducted on this area. EHS personnel and university staff have decided to discontinue the 90 day storage area at this location. Aerosol cans are no longer stored at this location but immediately taken to the 90 day storage area at the Science and Engineering Building. No hazardous waste was observed in this area at the time of the follow-up inspection (Photo 15).

Photo 15) Fleming Warehouse: This was the previous location of the 90 day storage area for the accumulation of aerosol cans. This storage area has been closed.

The 90 day storage area at the Fleming Warehouse was closed and hazardous waste is no longer stored here (Photo 15). Therefore, weekly inspections are no longer required.

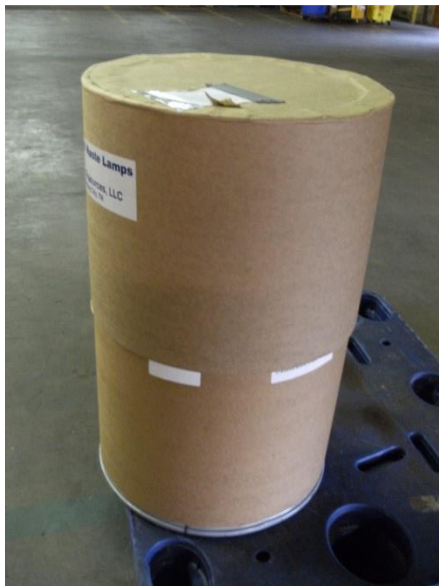
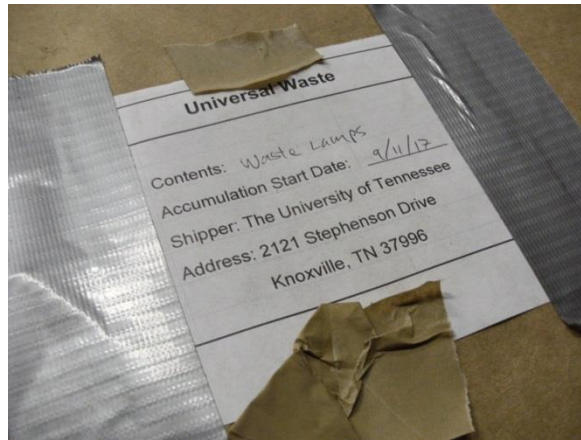
In addition to the 90 day storage area, universal waste is collected and stored at this facility prior to shipment for recycling. Previously, one box of lamps was found open and undated while an additional box was found stored for more than one year. During the follow-up inspection, one box of lamps was observed in storage. The lamps were properly closed, labeled, and a storage date was placed on the label (Photos 16-17). The lamps previously observed during the initial inspection were shipped off site.

Photo 16-17) Fleming Warehouse: One box of lamps was observed. The box was properly labeled, closed, and a storage date was provided.

One box of universal waste lamps was observed at the Fleming Warehouse. The box was properly closed (Photos 16-17).

A storage date was provided on the container of universal waste lamps observed at the Fleming Warehouse (Photos 16-17).
