**Re: Compliance Evaluation Inspection October 8, 2015  
Dennis Yoder State Operating Permit SOPC00283  
6025 Briarpatch LK Road, Henry County, TN**

ICIS NPDES Facilities Inspection Report

**Compliance Inspection for Concentrated Animal Feeding Operation (CAFO)**

**Subject: 10-8-15 Pictures from Dennis Yoder Facility Inspection**

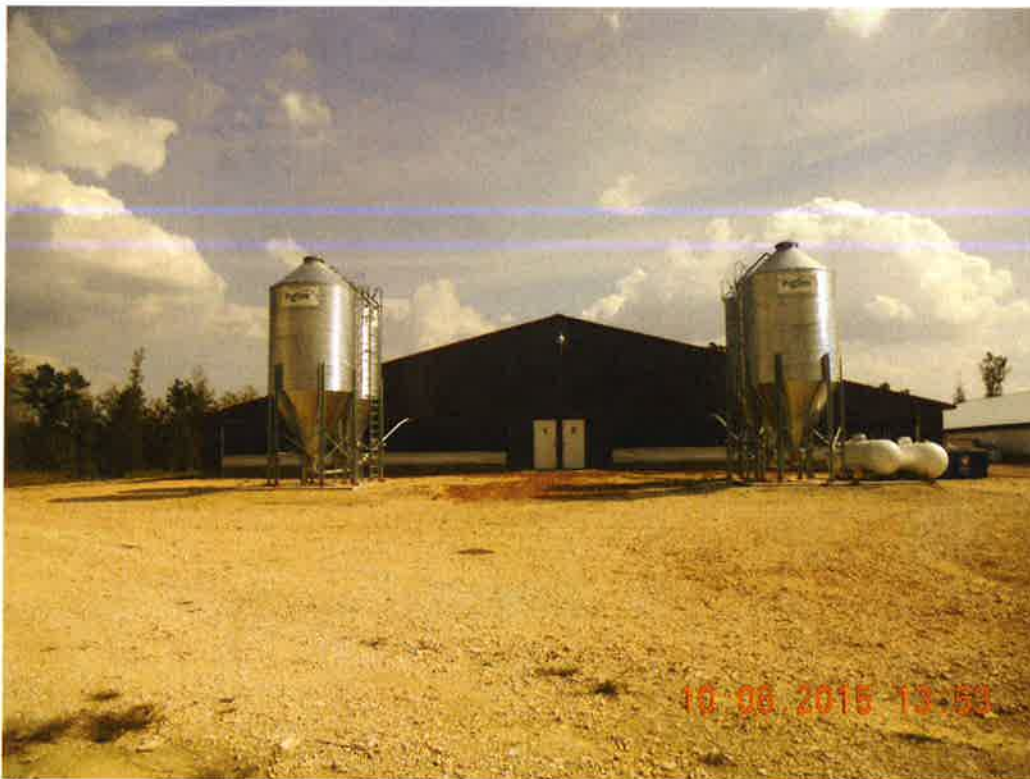
**Picture 1**

**Date of Photo: 10/8/2015. Photo taken by: Kevin Smith. Location/Site Name: Dennis Yoder Facility/SOPC00283. TDWR personnel Present: Kevin Smith. Remarks: Picture is of northern pit barn. Picture was taken on west side of northern pit barn facing east.**

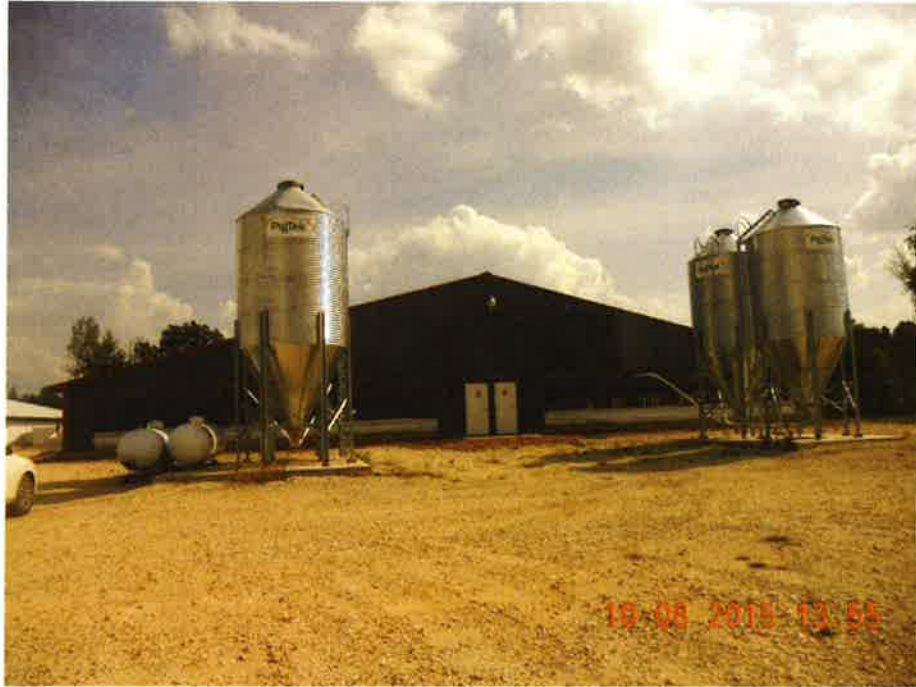
**Picture 2**

**Date of Photo: 10/8/2015. Photo taken by: Kevin Smith. Location/Site Name: Dennis Yoder Facility/SOPC00283. TDWR personnel Present: Kevin Smith. Remarks: Picture is of southern pit barn. Picture was taken on west side of southern pit barn facing east.**

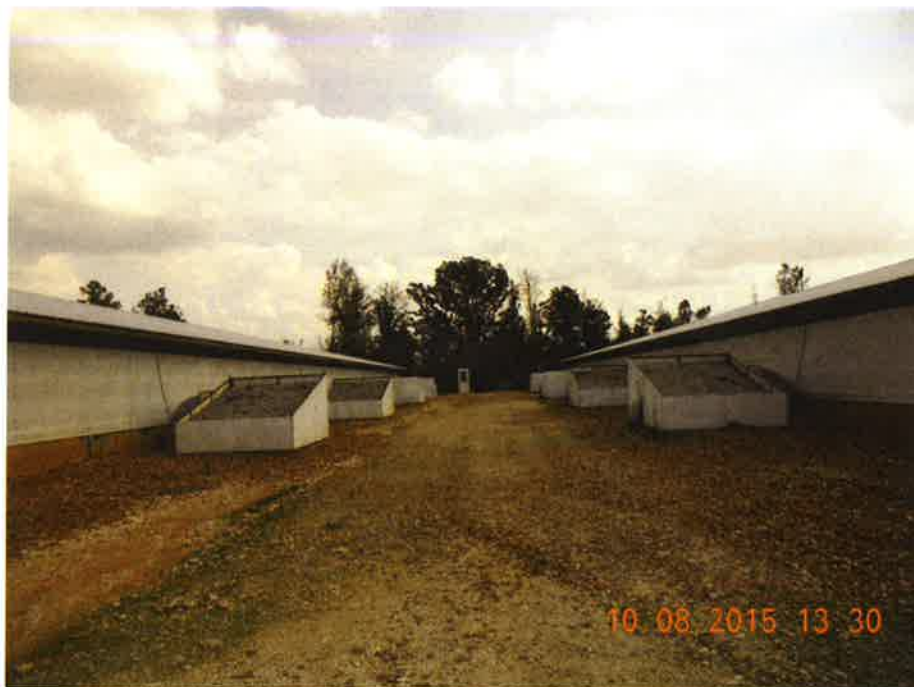
**Picture 3**

Producer's barns have biofilter boxes on the pit exhaust fans to improve air quality by reducing the amount of odor emitted by the pit exhaust fans. Mr. Danny Ham with Tosh Pork indicated this facility is the first Tosh built facility which has these biofilter boxes. Mr. Ham indicated Tosh plans to put these biofilter boxes on all future pit barns built by Tosh. These biofilter boxes contain mulch and are kept moist using a sprinkler system to apply water. On the day of my inspection there was water noted around the biofilter boxes.

TDEC was first unsure if this water was leachate from the biofilter boxes or overspray from the sprinkler system used to keep mulch moist. After returning to the office and researching biofilters it seems unlikely that there would be a substantial amount of leachate coming from the biofilter boxes, unless there was a heavy rainfall event or malfunction of the watering system used to keep the biofilter media moist. TDEC contacted Mr. Dennis Yoder, the producer for the facility, on 10-15-15 and discussed the biofilter boxes. Mr. Yoder indicated that the water on the ground around the biofilter boxes was from overspray from the sprinklers used to keep the mulch moist. Mr. Yoder indicated he has not observed any leachate coming

**Date of Photo: 10/8/2015. Photo taken by: Kevin Smith. Location/Site Name: Dennis Yoder Facility/SOPC00283. TDWR personnel Present: Kevin Smith. Remarks: Picture is of biofilter boxes used to improve air quality by reducing odor emitted from the pit exhaust fans. Picture was taken on western side of pit barns facing east.**

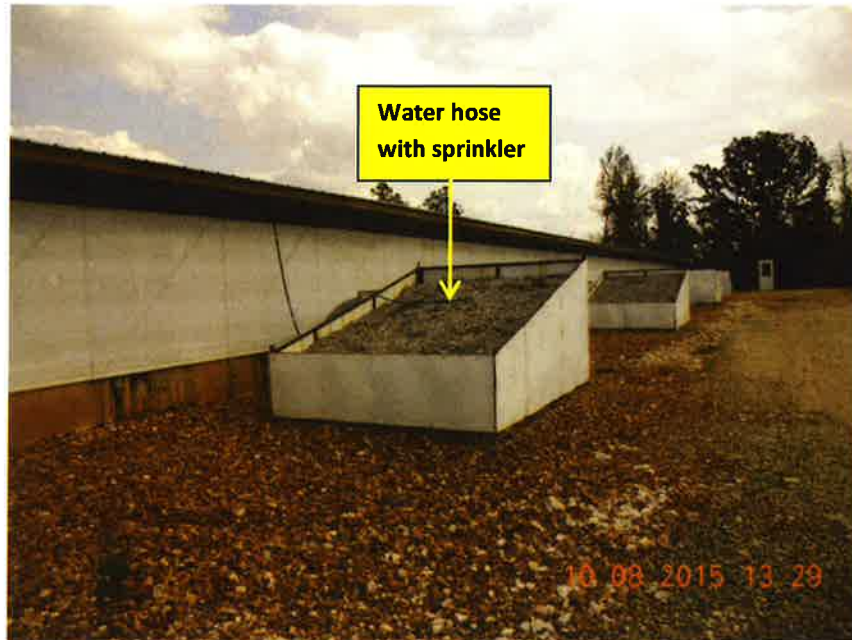
Picture 4

Date of Photo: 10/8/2015. Photo taken by: Kevin Smith. Location/Site Name: Dennis Yoder Facility/SOPC00283. TDWR personnel Present: Kevin Smith. Remarks: Picture is of biofilter box used to improve air quality by reducing odor emitted from pit exhaust fans. Biofilter boxes are filled with mulch and water is sprayed on mulch by a sprinkler. Picture was taken on western side of pit barns facing northeast.

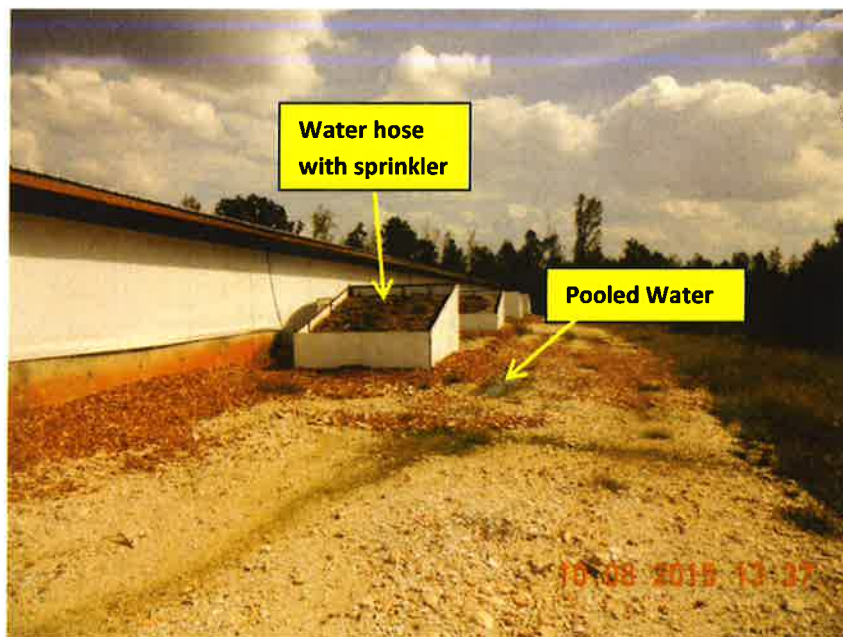
Picture 5

Date of Photo: 10/8/2015. Photo taken by: Kevin Smith. Location/Site Name: Dennis Yoder Facility/SOPC00283. TDWR personnel Present: Kevin Smith. Remarks: Picture is of biofilter boxes used to improve air quality by reducing odor emitted from the pit exhaust fans. Producer indicated water in picture is freshwater from the sprinkler on the biofilter boxes. It is not leachate from the biofilter boxes. Picture was taken standing on south side of pit barns facing east.

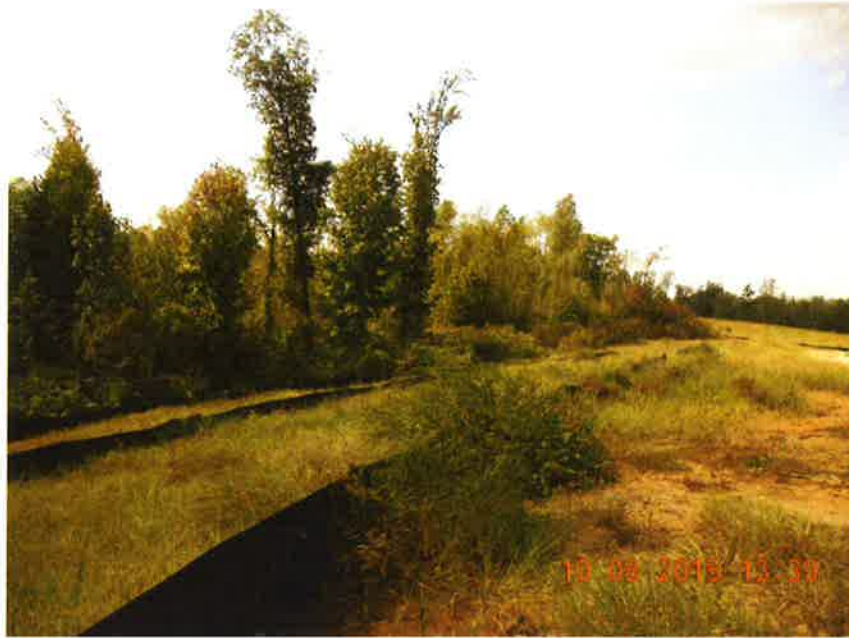
**Picture 6**

- There were areas of unstable soil around the facility. Producer still has Stormwater Construction permit coverage and still has erosion control measures in place. Producer plans to rock unstable areas in the near future.

**Date of Photo: 10/8/2015. Photo taken by: Kevin Smith. Location/Site Name: Dennis Yoder Facility/SOPC00283. TDWR personnel Present: Kevin Smith. Remarks: Producer still has Stormwater Construction Permit coverage. Picture is of silt fence installed on southern portion of facility. There were three rows of silt fence on the southern slope of the facility. The ground down-gradient of the top silt fence appeared to be stabilized on the day of my visit. Picture was taken standing on southeastern portion of facility facing southwest/west.**

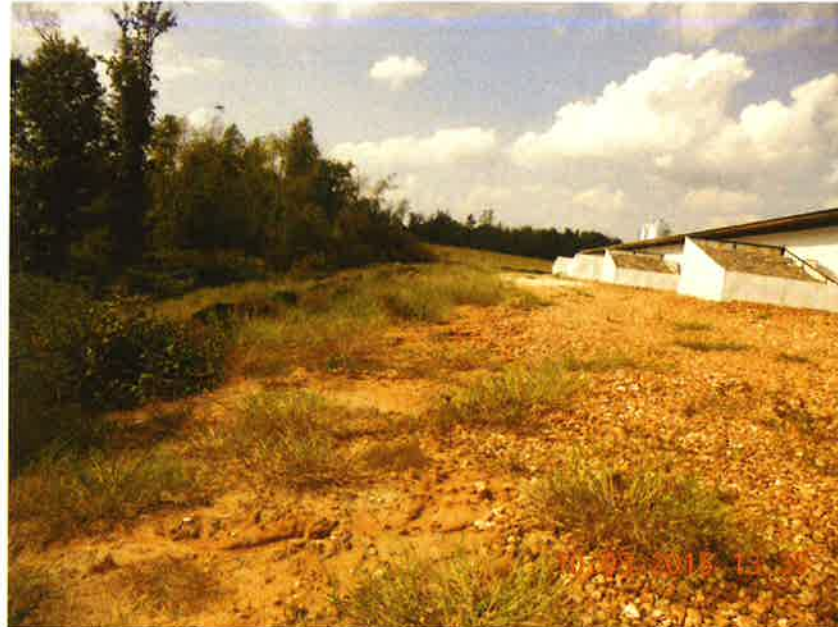
**Picture 7**

**Date of Photo: 10/8/2015. Photo taken by: Kevin Smith. Location/Site Name: Dennis Yoder Facility/SOPC00283. TDWR personnel Present: Kevin Smith. Remarks: Picture is of unstable ground located up-gradient of top silt fence located along southern portion of facility. Producer indicated he plans to rock this area down to top silt fence. Picture was taken standing on southeastern portion of facility facing west.**

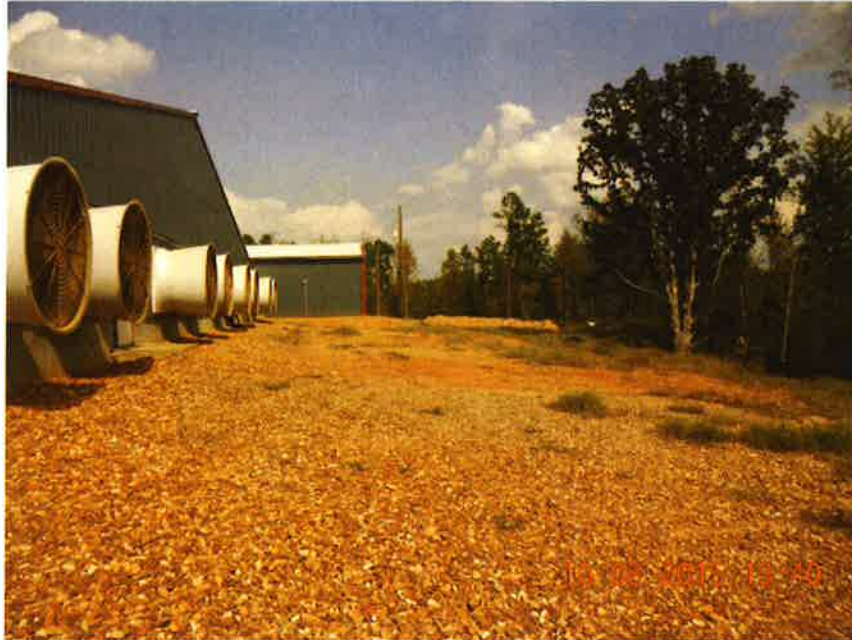
**Picture 8**

**Date of Photo: 10/8/2015. Photo taken by: Kevin Smith. Location/Site Name: Dennis Yoder Facility/SOPC00283. TDWR personnel Present: Kevin Smith. Remarks: Picture is of eastern portion of facility. There are areas of unstable ground on this portion of the facility. Producer has silt fence installed down-gradient of this area and intends to rock this area down to silt fence. Picture was taken at southeast corner of facility facing north.**

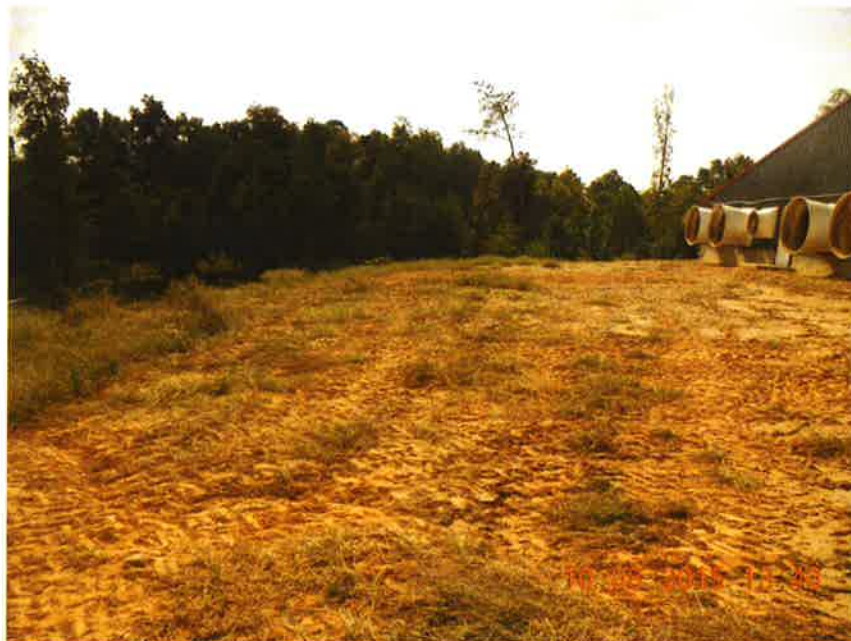
**Picture 9**

**Date of Photo: 10/8/2015. Photo taken by: Kevin Smith. Location/Site Name: Dennis Yoder Facility/SOPC00283. TDWR personnel Present: Kevin Smith. Remarks: Picture is of eastern portion of facility. There are areas of unstable ground on this portion of the facility. Producer has silt fence installed down-gradient of this area and intends to rock this area down to silt fence. Picture was taken standing on east side of facility facing south.**

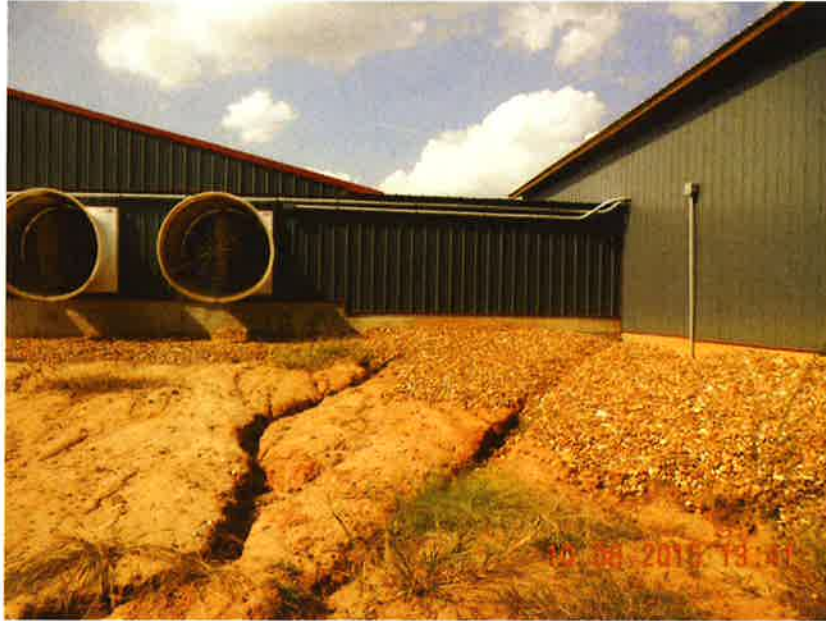
Picture 10

Date of Photo: 10/8/2015. Photo taken by: Kevin Smith. Location/Site Name: Dennis Yoder Facility/SOPC00283. TDWR personnel Present: Kevin Smith. Remarks: Picture is of gullies formed on eastern portion of facility. Producer indicated he has been talking with NRCS about placing gutters around the facility. Producer intends to rock this area in the near future. Silt fenced is installed down-gradient of this area. Picture was taken standing on east side of facility facing west.

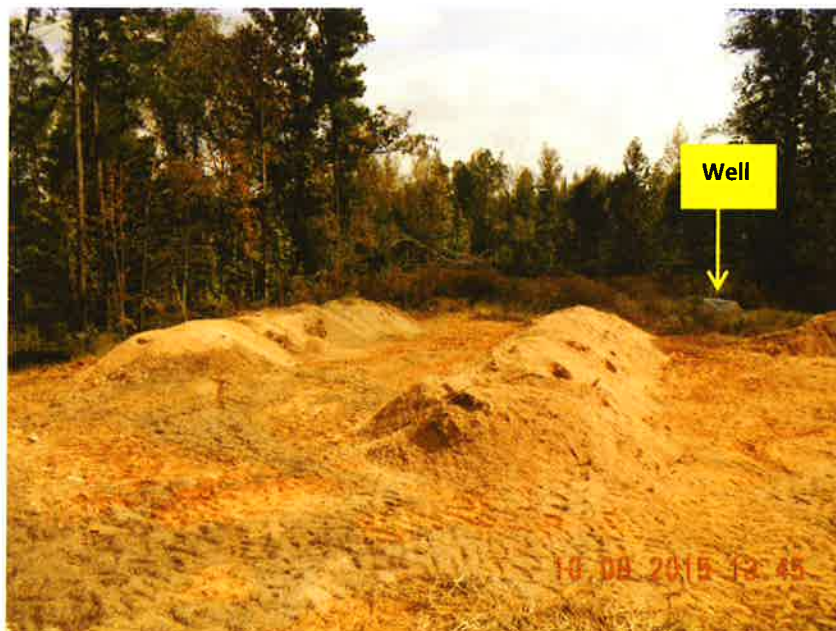
Picture 11

Producer is currently composting on the ground in windrows. Producer's CNMP indicated he would build compost shed to handle mortalities at the facility. On the day of inspection producer indicated he plans to install an Ecodrum to compost mortalities in. Producer indicated that composting on the ground in windrows is only a temporary means of handling mortalities until he has the Ecodrum installed at the facility. Producer has been talking with NRCS in regards to building a compost shed verses using an Ecodrum to dispose of mortalities. TDEC did not observe any contaminated run-off leaving the compost area on the day of inspection; however there was a small amount of leachate observed coming from both the northern and southern windrows. TDEC indicated to producer he should watch for leachate and add additional sawdust as needed to keep leachate from running off.

Date of Photo: 10/8/2015. Photo taken by: Kevin Smith. Location/Site Name: Dennis Yoder Facility/SOPC00283. TDWR personnel Present: Kevin Smith. Remarks: Picture is of producer's current compost location. Producer is composting on top of ground in windrows. Producer indicated this is temporary and plans to install an Ecodrum at his facility for composting in the near future. This area is on a slight slope which slopes to the east/northeast. Note well in background. Picture was taken standing near northeast corner of hog barn facing east.

Talked with producer on 10-15-15 and he indicated he planned to move compost piles around to the front of the barns in a field. Producer indicated this would be done by Saturday 10-17-15. Producer indicated this area was fairly level and should not receive rainfall runoff from other areas. This location will be over 500 feet from well location.

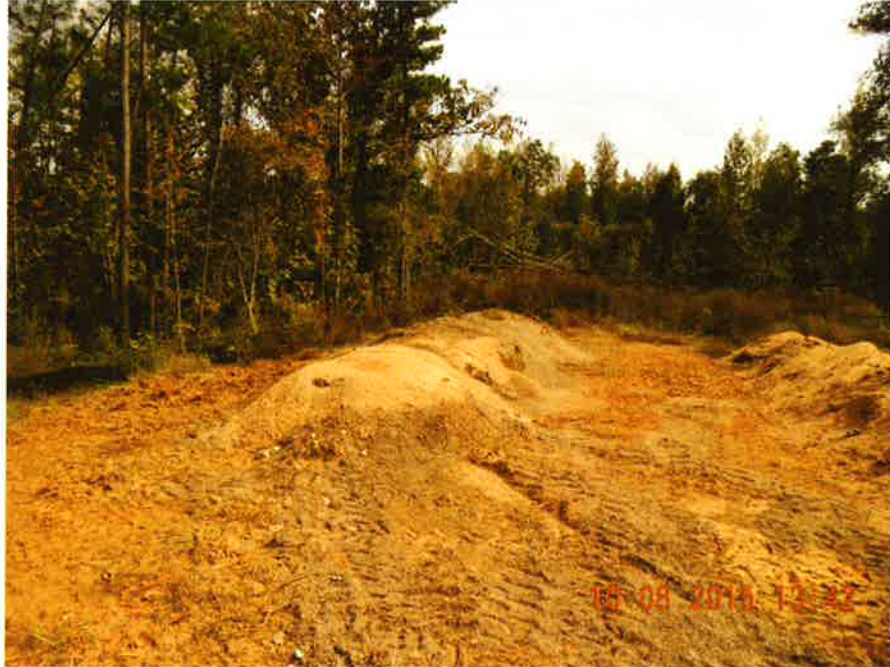
Picture 12

- Current compost location is located less than 30 feet from well.
- The compost windrows were located on a slight slope and rainwater is not being diverted around the windrows.
- There is no means to collect contaminated run-off and since the windrows are on a slope it would appear likely that during rainfall events there is contaminated run-off from the windrows.

Date of Photo: 10/8/2015. Photo taken by: Kevin Smith. Location/Site Name: Dennis Yoder Facility/SOPC00283. TDWR personnel Present: Kevin Smith. Remarks: Picture is of northern compost windrow. Picture was taken standing near northeast corner of hog barn facing east.

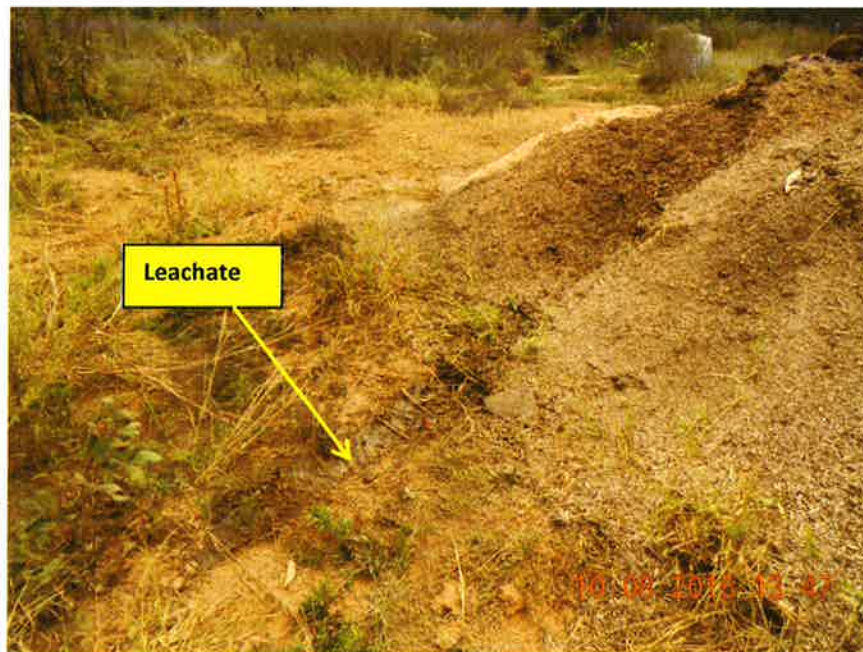
Picture 13

Date of Photo: 10/8/2015. Photo taken by: Kevin Smith. Location/Site Name: Dennis Yoder Facility/SOPC00283. TDWR personnel Present: Kevin Smith. Remarks: Picture is of a small amount of leachate observed coming from northeast corner of northern windrow pile. Indicated to producer needed to watch for leachate and add sawdust to keep leachate from running off. Picture was taken standing on northeast side of northern compost windrow facing south.

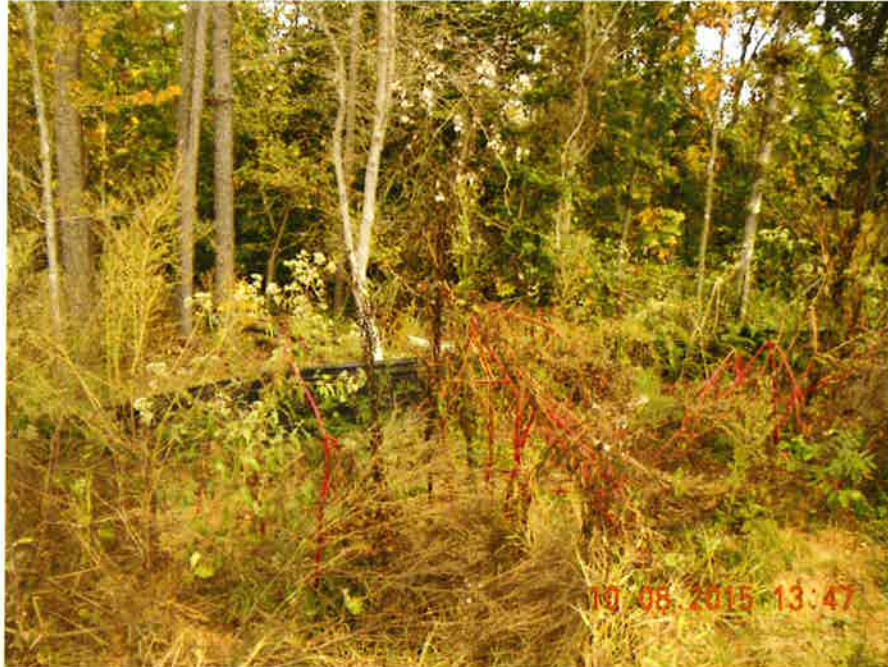
Picture 14

Date of Photo: 10/8/2015. Photo taken by: Kevin Smith. Location/Site Name: Dennis Yoder Facility/SOPC00283. TDWR personnel Present: Kevin Smith. Remarks: Picture was taken standing at northeast corner of northern compost windrow, where leachate was observed in Picture 13, facing northeast in the direction leachate would run off to.

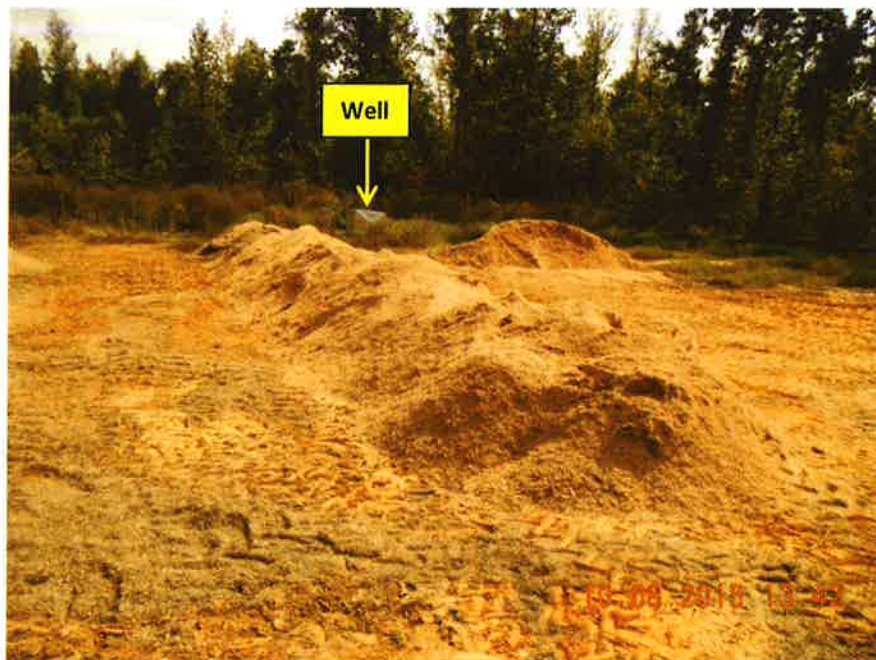
Picture 15

Date of Photo: 10/8/2015. Photo taken by: Kevin Smith. Location/Site Name: Dennis Yoder Facility/SOPC00283. TDWR personnel Present: Kevin Smith. Remarks: Picture is of southern compost windrow. Note well in background of picture. Picture was taken standing near northeast corner of hog barn facing east.

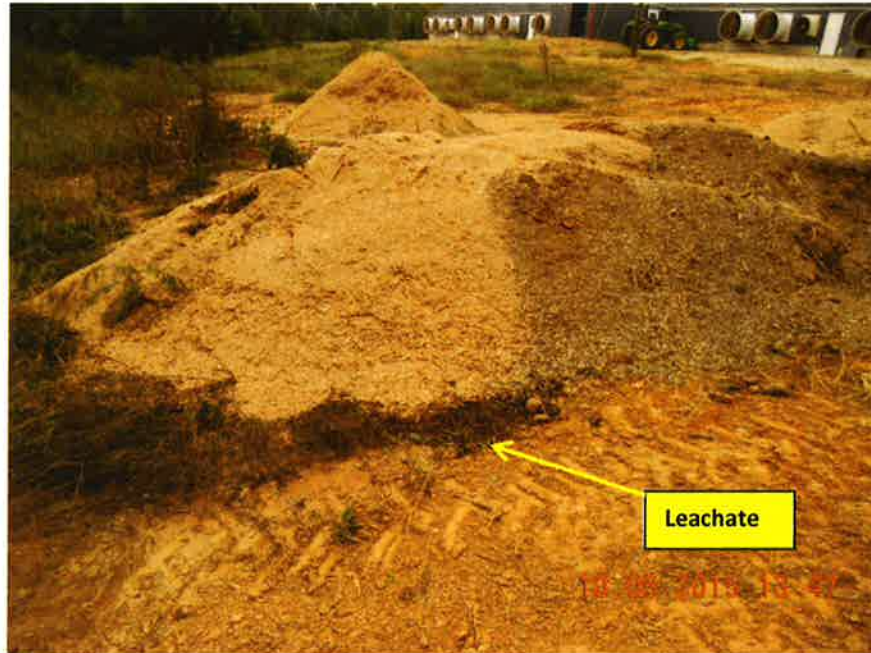
Picture 16

Date of Photo: 10/8/2015. Photo taken by: Kevin Smith. Location/Site Name: Dennis Yoder Facility/SOPC00283. TDWR personnel Present: Kevin Smith. Remarks: Picture is of small amount of leachate observed coming from northeast corner of southern compost windrow. Indicated to producer needed to watch for leachate and add sawdust to keep leachate from running off. Picture was taken standing on northeast side of southern compost windrow facing south/southwest.

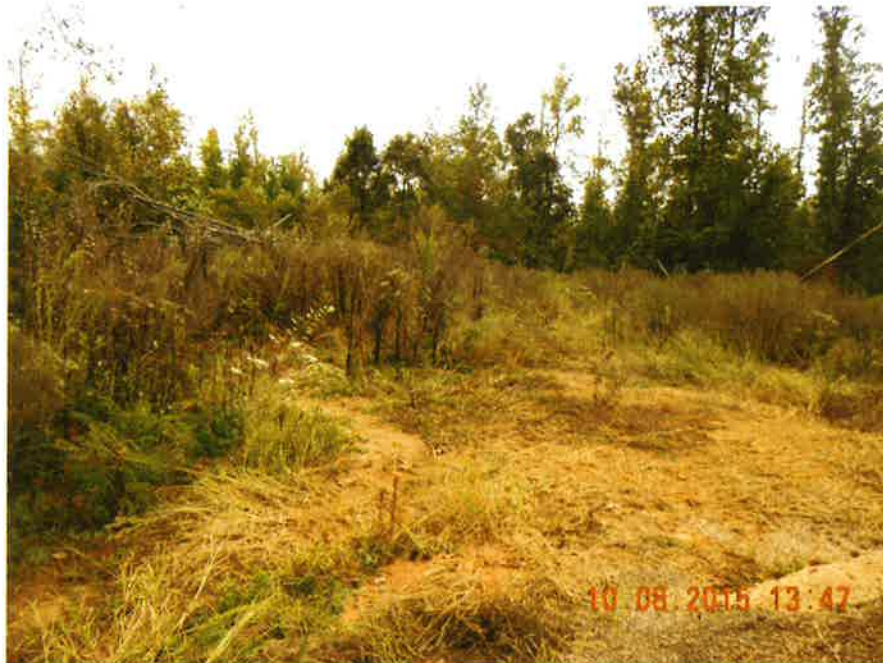
Picture 17

Date of Photo: 10/8/2015. Photo taken by: Kevin Smith. Location/Site Name: Dennis Yoder Facility/SOPC00283. TDWR personnel Present: Kevin Smith. Remarks: Picture is of area down-gradient (east) of compost windrows. Picture was taken on east side of compost windrows facing east.

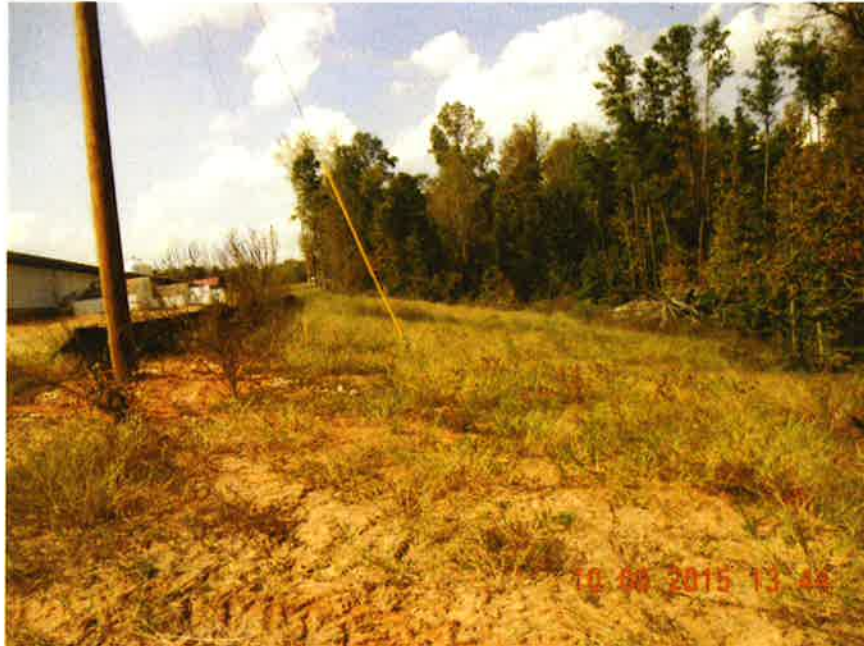
Picture 18

Date of Photo: 10/8/2015. Photo taken by: Kevin Smith. Location/Site Name: Dennis Yoder Facility/SOPC00283. TDWR personnel Present: Kevin Smith. Remarks: Picture is of slope on northern side of pit barns. Silt fence is still installed in this area. Picture was taken standing on northeast side of pit barns facing west.

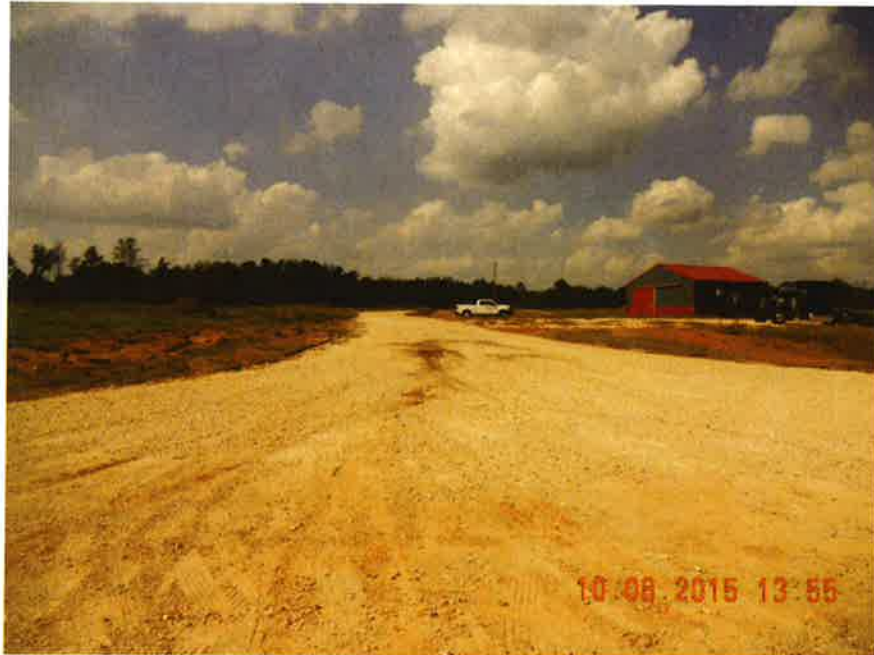
Picture 20

Date of Photo: 10/8/2015. Photo taken by: Kevin Smith. Location/Site Name: Dennis Yoder Facility/SOPC00283. TDWR personnel Present: Kevin Smith. Remarks: Picture is of unstable areas located on western side of facility. Erosion control measures are still in place at facility. Picture was taken standing on west side of facility facing west.

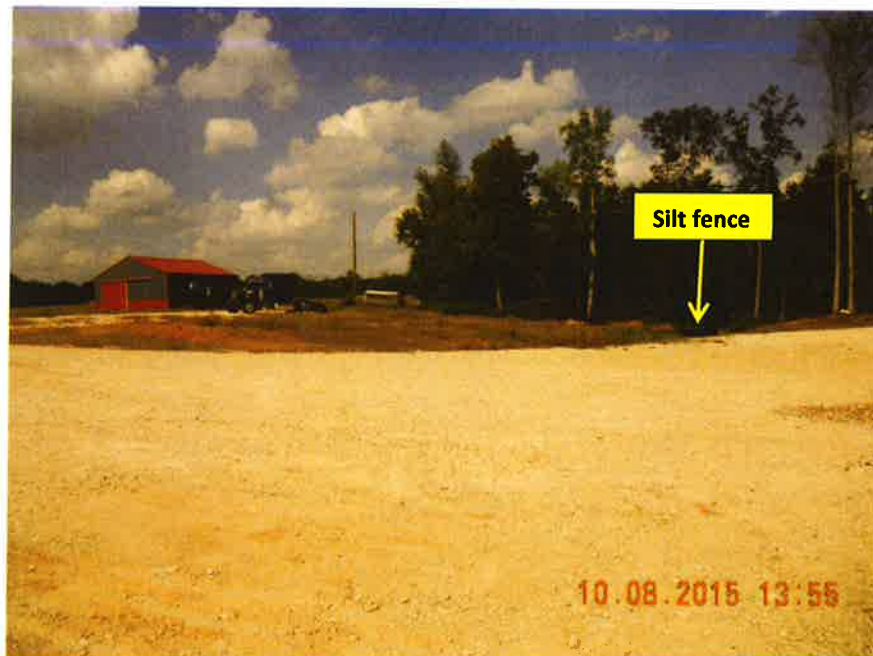
Picture 21

Date of Photo: 10/8/2015. Photo taken by: Kevin Smith. Location/Site Name: Dennis Yoder Facility/SOPC00283. TDWR personnel Present: Kevin Smith. Remarks: Picture is of unstable areas located on western side of facility. Erosion control measures are still in place at facility. Picture was taken standing on west side of facility facing northwest.

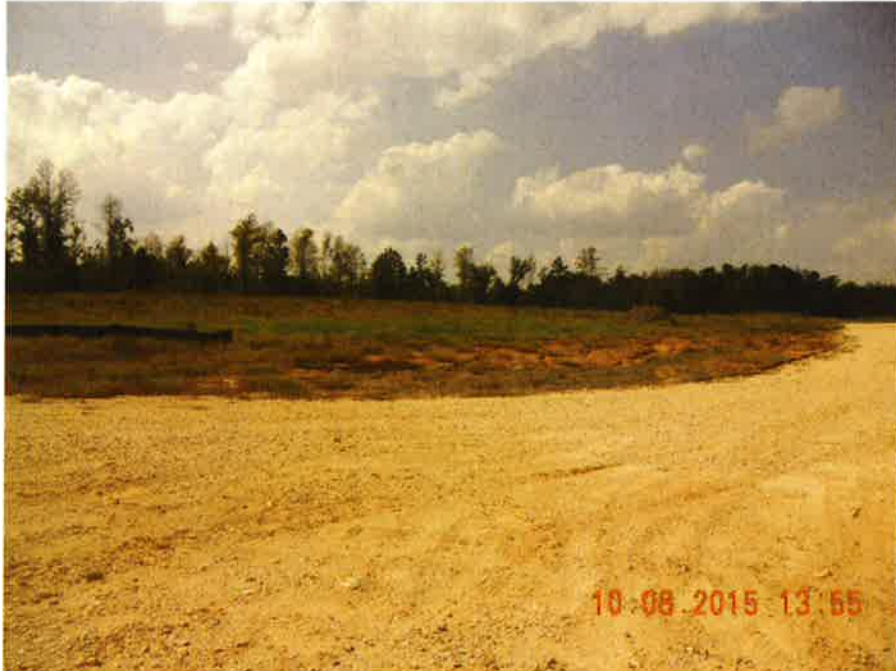
**Picture 22**

**Date of Photo: 10/8/2015. Photo taken by: Kevin Smith. Location/Site Name: Dennis Yoder Facility/SOPC00283. TDWR personnel Present: Kevin Smith. Remarks: Picture is of unstable areas located on western side of facility. Erosion control measures are still in place at facility. Picture was taken standing on west side of facility facing southwest.**
