ATTACHMENT – Pictures

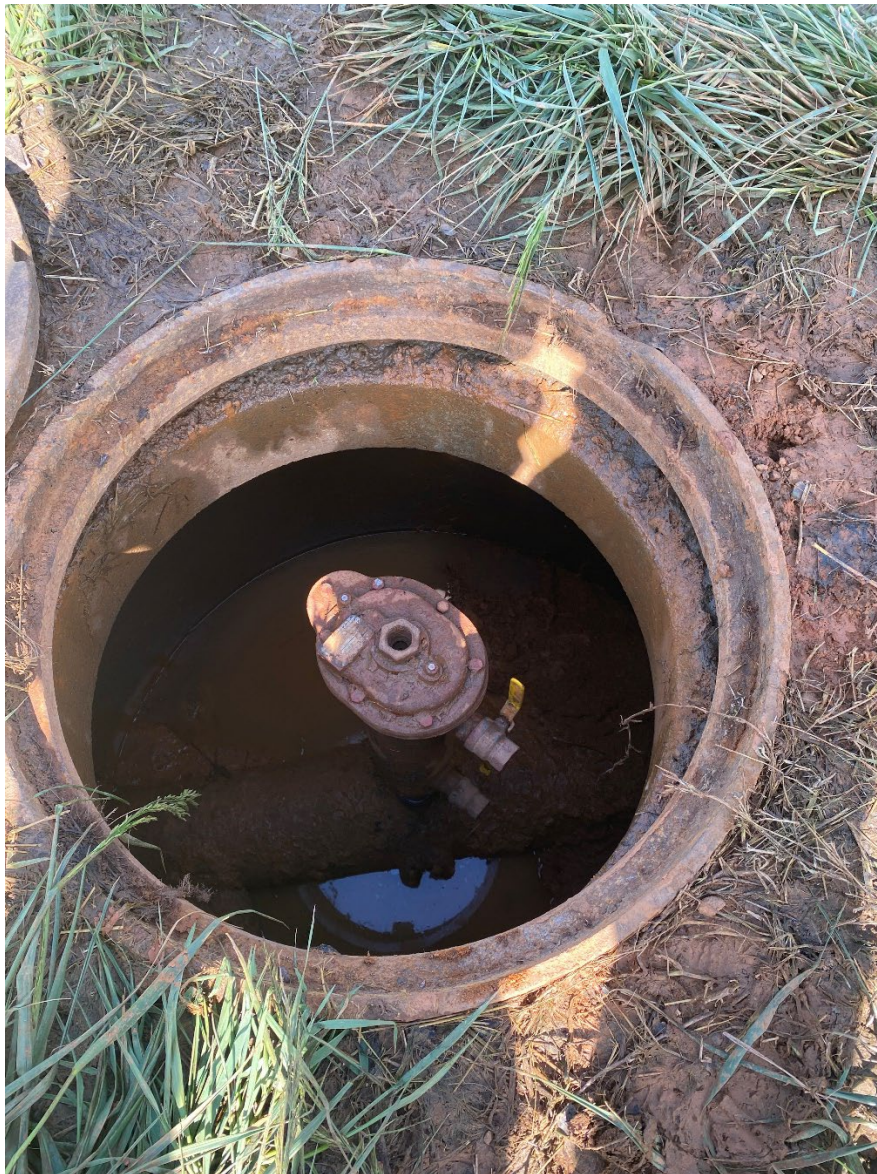
Overflowing manhole after being pumped out showing air relief valve in center of the manhole. The leaking pipe nipple was located at the bottom of the air relief valve.

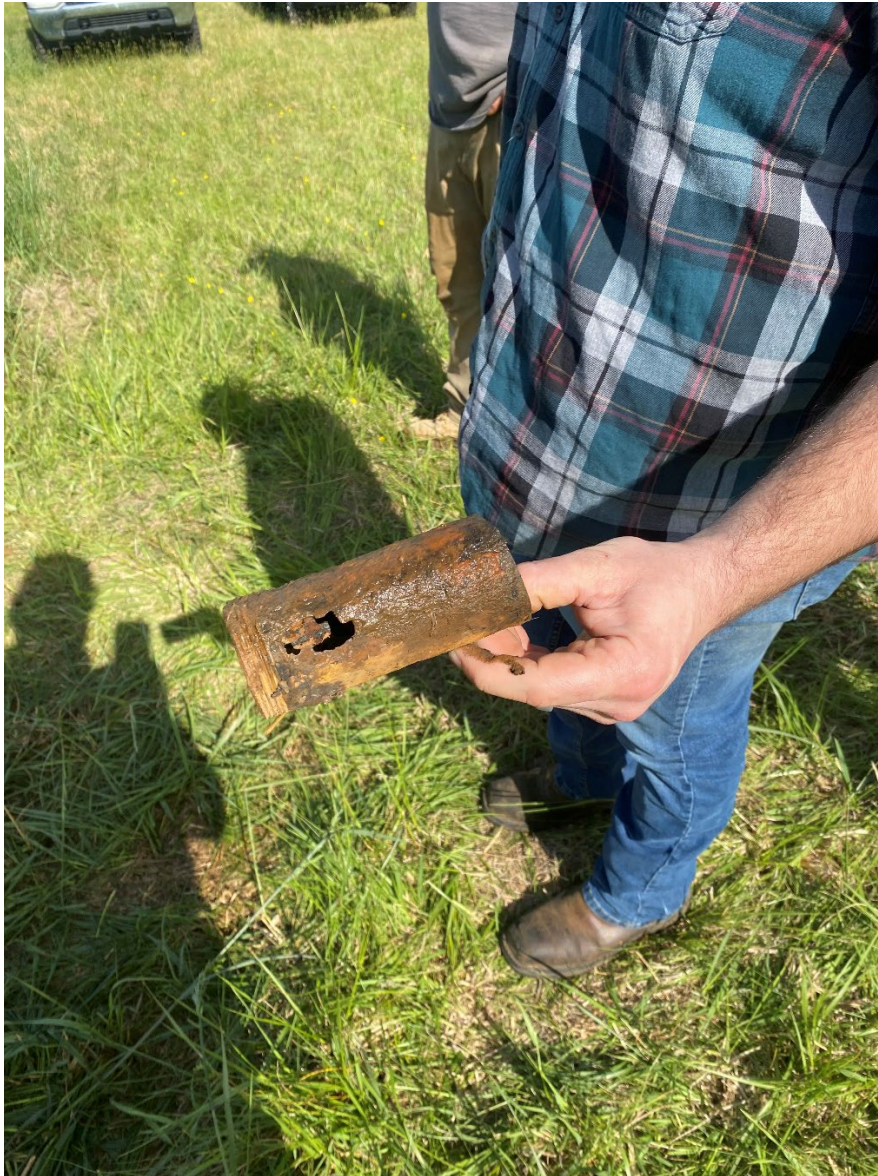
2-inch pipe nipple.

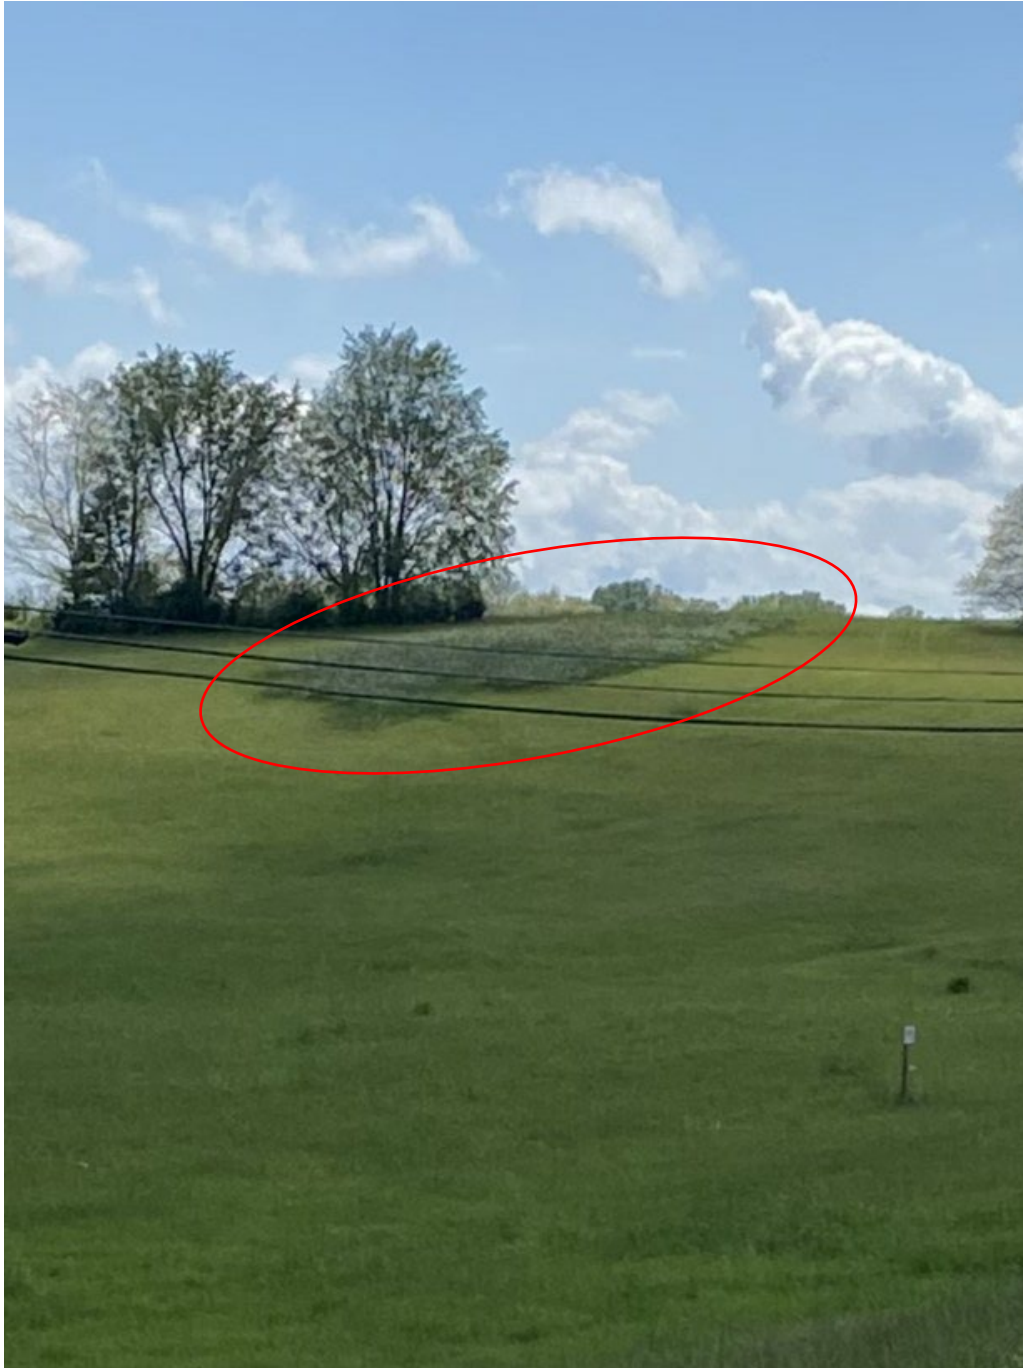
Location of overflow as seen from Highway 11E. Notice the area of high grass growth showing where the overflow went.
