RE: COMPLIANCE EVALUATION INSPECTION
NOTICE OF VIOLATION
HARDEMAN COUNTY LANDFILL
SNL 35-0223

SOLID WASTE INSPECTION REPORT

Hardeman County Landfill
SNL 35-0223
75 Landfill Way
Bolivar, TN 38008
731-658-2884

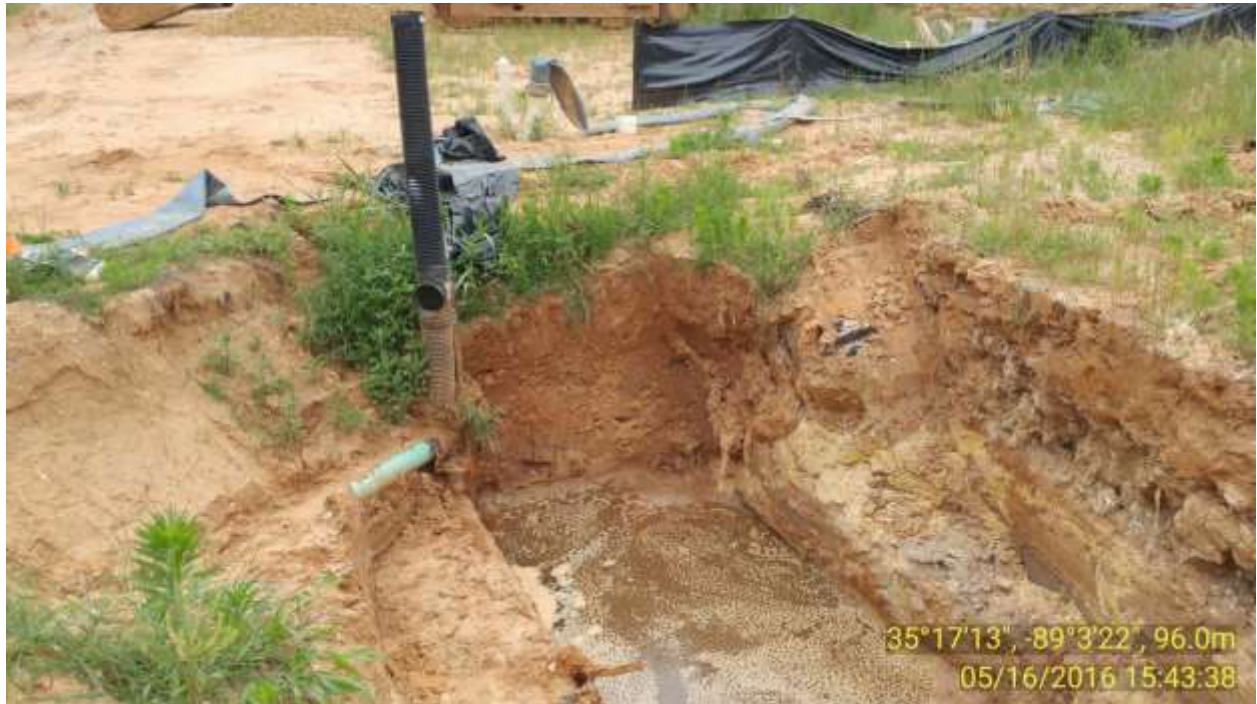
Picture 1. Stack where temporary leachate by-pass (green-blue colored pipe) joins with leachate line to run towards the leachate collection tank.

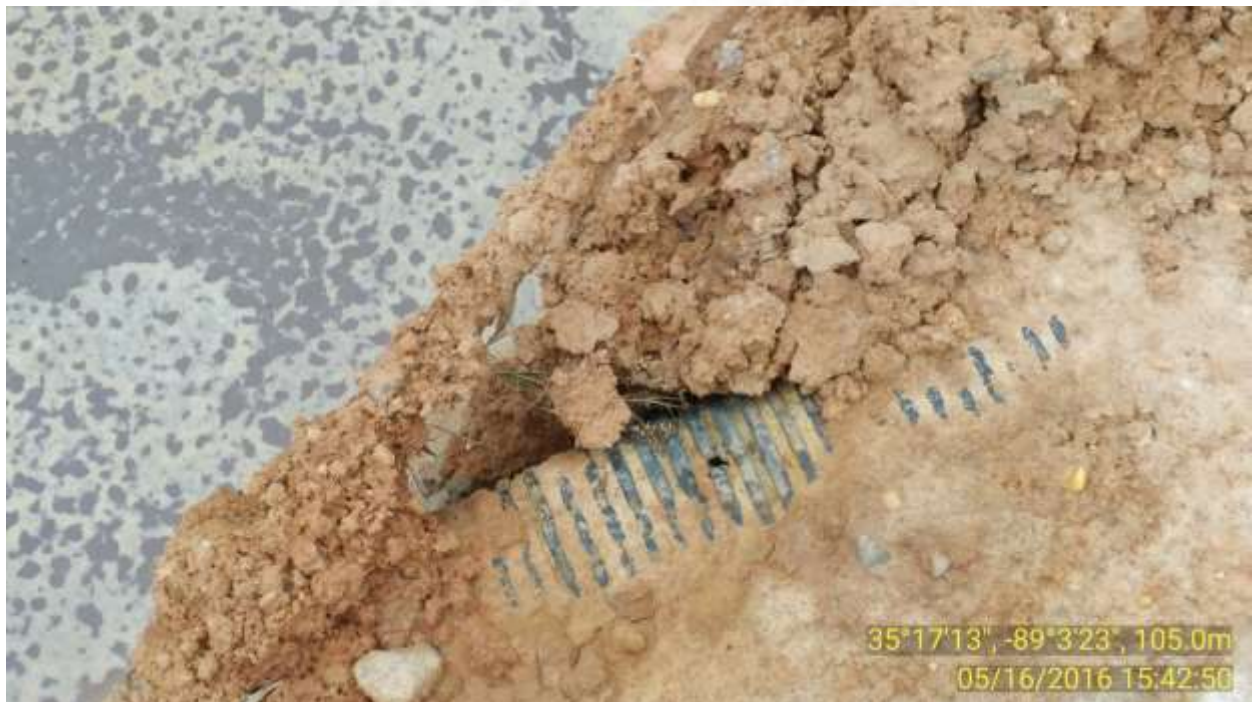
Leachate observed at site – There is an area near the pipe stack where the temporary leachate by-pass and installed leachate collection lines join together before running towards the leachate collection tank beyond the installed liners for the landfill. During the repair work the area near this stack was excavated. The installed leachate collection line appeared to have been nicked during the excavation work performed near the stack. A liquid having the appearance of leachate was observed pooled at the bottom of this excavated area.

Picture 2. Closer view of the leachate collection pipe in the “stack” area. Note the nick in the pipe in the center of the picture. Liquid in the excavated area appears to be similar to other leachate observed at the landfill.

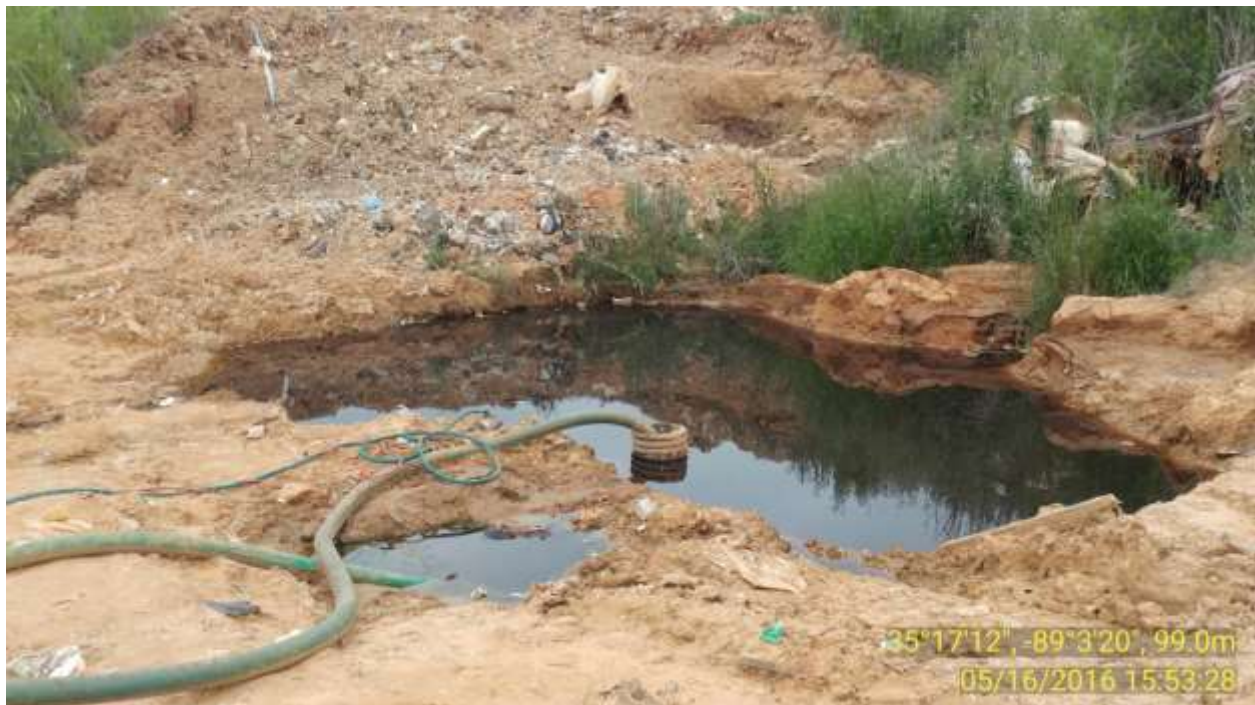
Picture 3. Primary dewatering area on the Phase III liner. This is in the area near where the original Phase IV leachate collection pipe attempted to tie-in to the Phase III leachate system. The indentation in the ground on the middle left of the picture is where this area flows into a second pit dug by Hardeman County Landfill's construction contractor, Ronald Franks Construction.

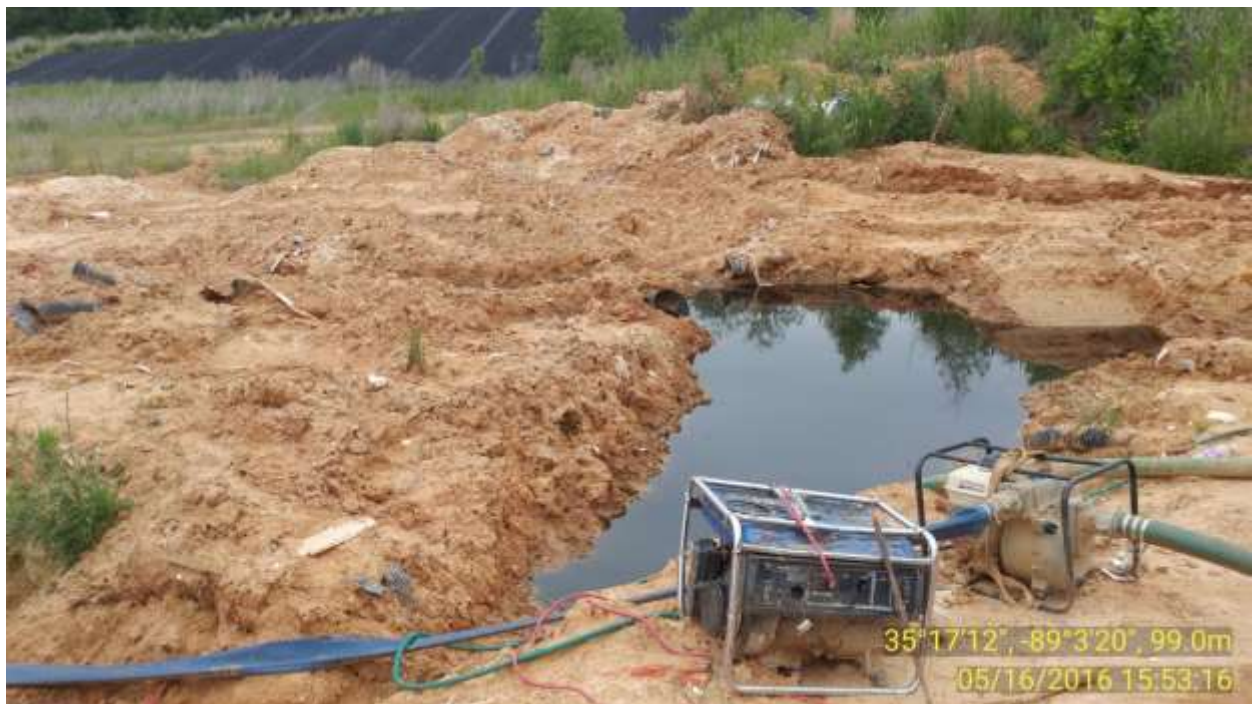
Picture 4. View of the "secondary containment" pit which appears to be located on both the Phase III and Phase IV liners. Two 3-inch pumps which were used to dewater the work area are pictured in the foreground.

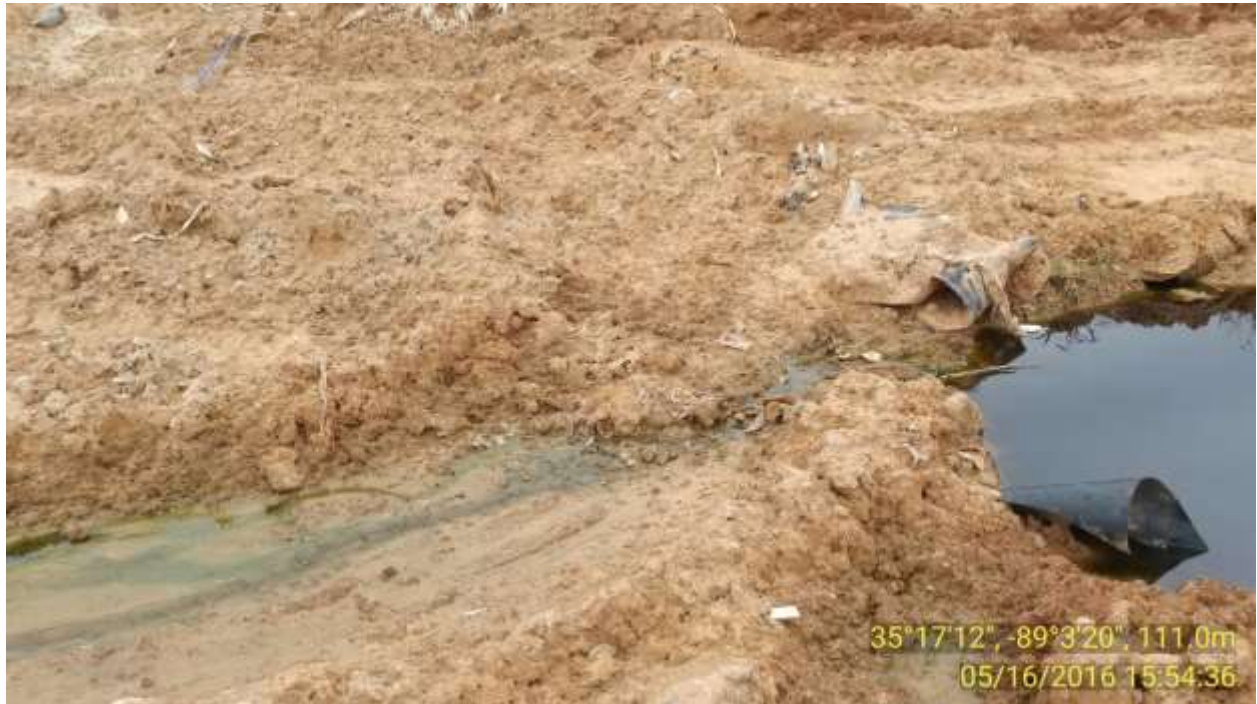
Inadequate maintenance of leachate management system – There is a temporary leachate by-pass pipe near the berm between Phase III and Phase IV which has been approved by the DSWM. This by-pass should be maintained such that leachate does not overflow the berm or flow over Phase IV. At the time of inspection, the temporary by-pass was not keeping the leachate on the Phase III side of the berm and leachate was flowing on top of the Phase IV cell which has not been approved for use. There is what appears to be a secondary berm constructed by Hardeman County Landfill's construction contractor which spans both Phase III and Phase IV areas. This secondary containment area was full of leachate and was draining into one of the excavated channels over the Phase IV liner and running towards the stack area and/or being collected by the Phase IV leachate collection system.

Picture 5. Leachate flowing out of the “secondary containment” area into an excavated channel on the Phase IV liner.
