RE: Hydrologic Determination Request Package for the  
Nazemi Properties  
Nashville, Davidson County, Tennessee

# NAZEMI PROPERTIES NASHVILLE, TENNESSEE

## HYDROLOGIC DETERMINATION REQUEST PACKAGE

3790100  
June 2022

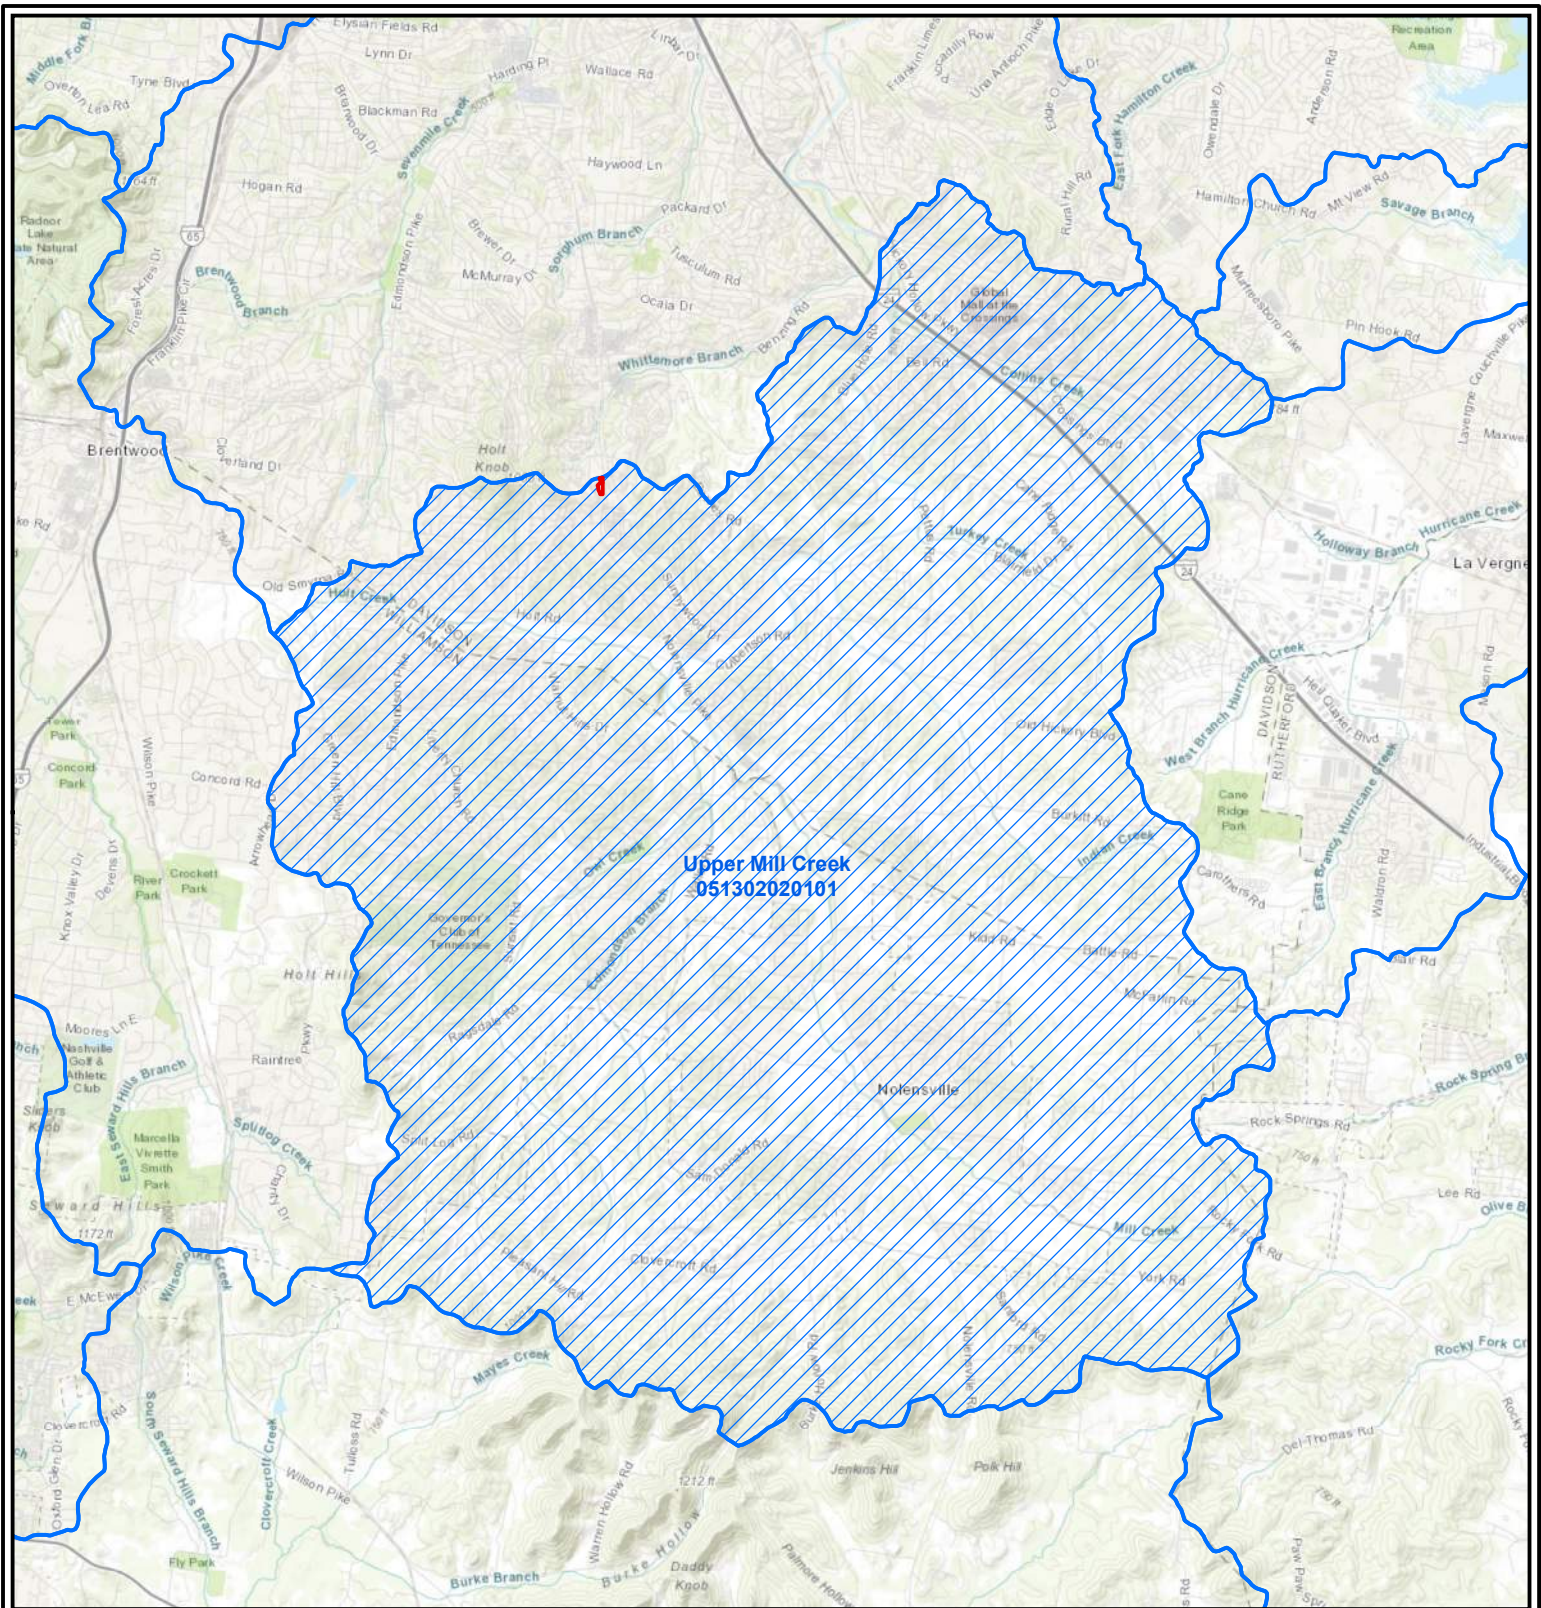
**FIGURE 3**

TITLE:  
**PROJECT WATERSHED MAP**

The subject property is located at the intersection of Kinhawk Drive and Nolensville Pike, approximately one mile south of the Nolensville Pike and Old Hickory Boulevard intersection, in Nashville, Davidson County, Tennessee (Appendix A, Figure 1). This area falls within the Interior Plateau (71) Tennessee ecoregion and is further categorized into the Outer Nashville Basin (71h) sub-ecoregion of Tennessee. The subject properties are within the Antioch, Tennessee, topographic quadrangle (Appendix A, Figure 2), and the properties are located within the Upper Mill Creek (051302020101) lower HUC-12 watershed, within the Lower Cumberland-Sycamore HUC-8 watershed (05130202), which is ultimately within the Cumberland River Basin (Appendix A, Figure 3).

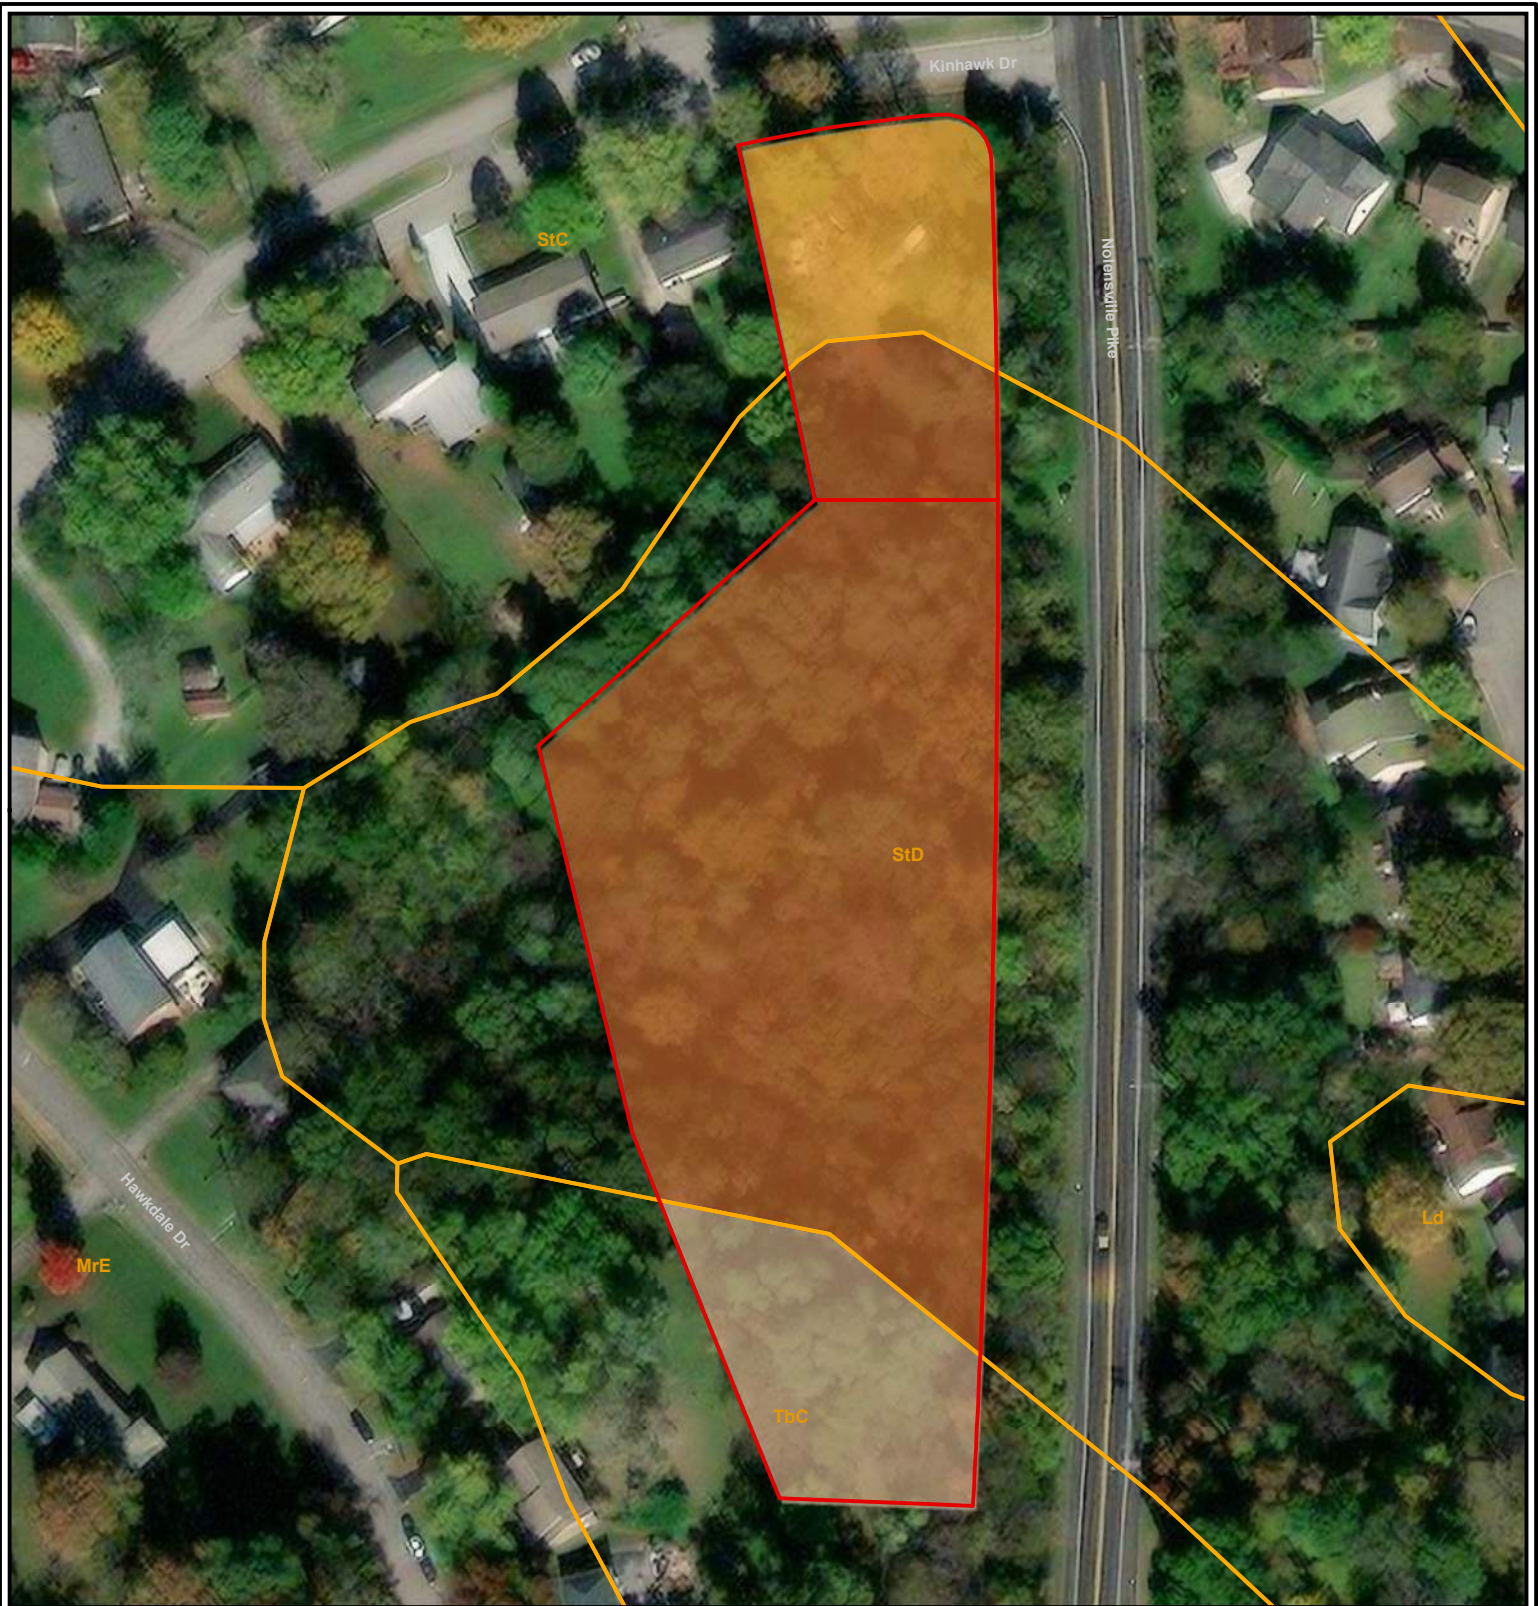
**FIGURE 4**

Soil Unit  
 StC  
 StD  
 TbC

**PROJECT SOIL UNIT MAP**

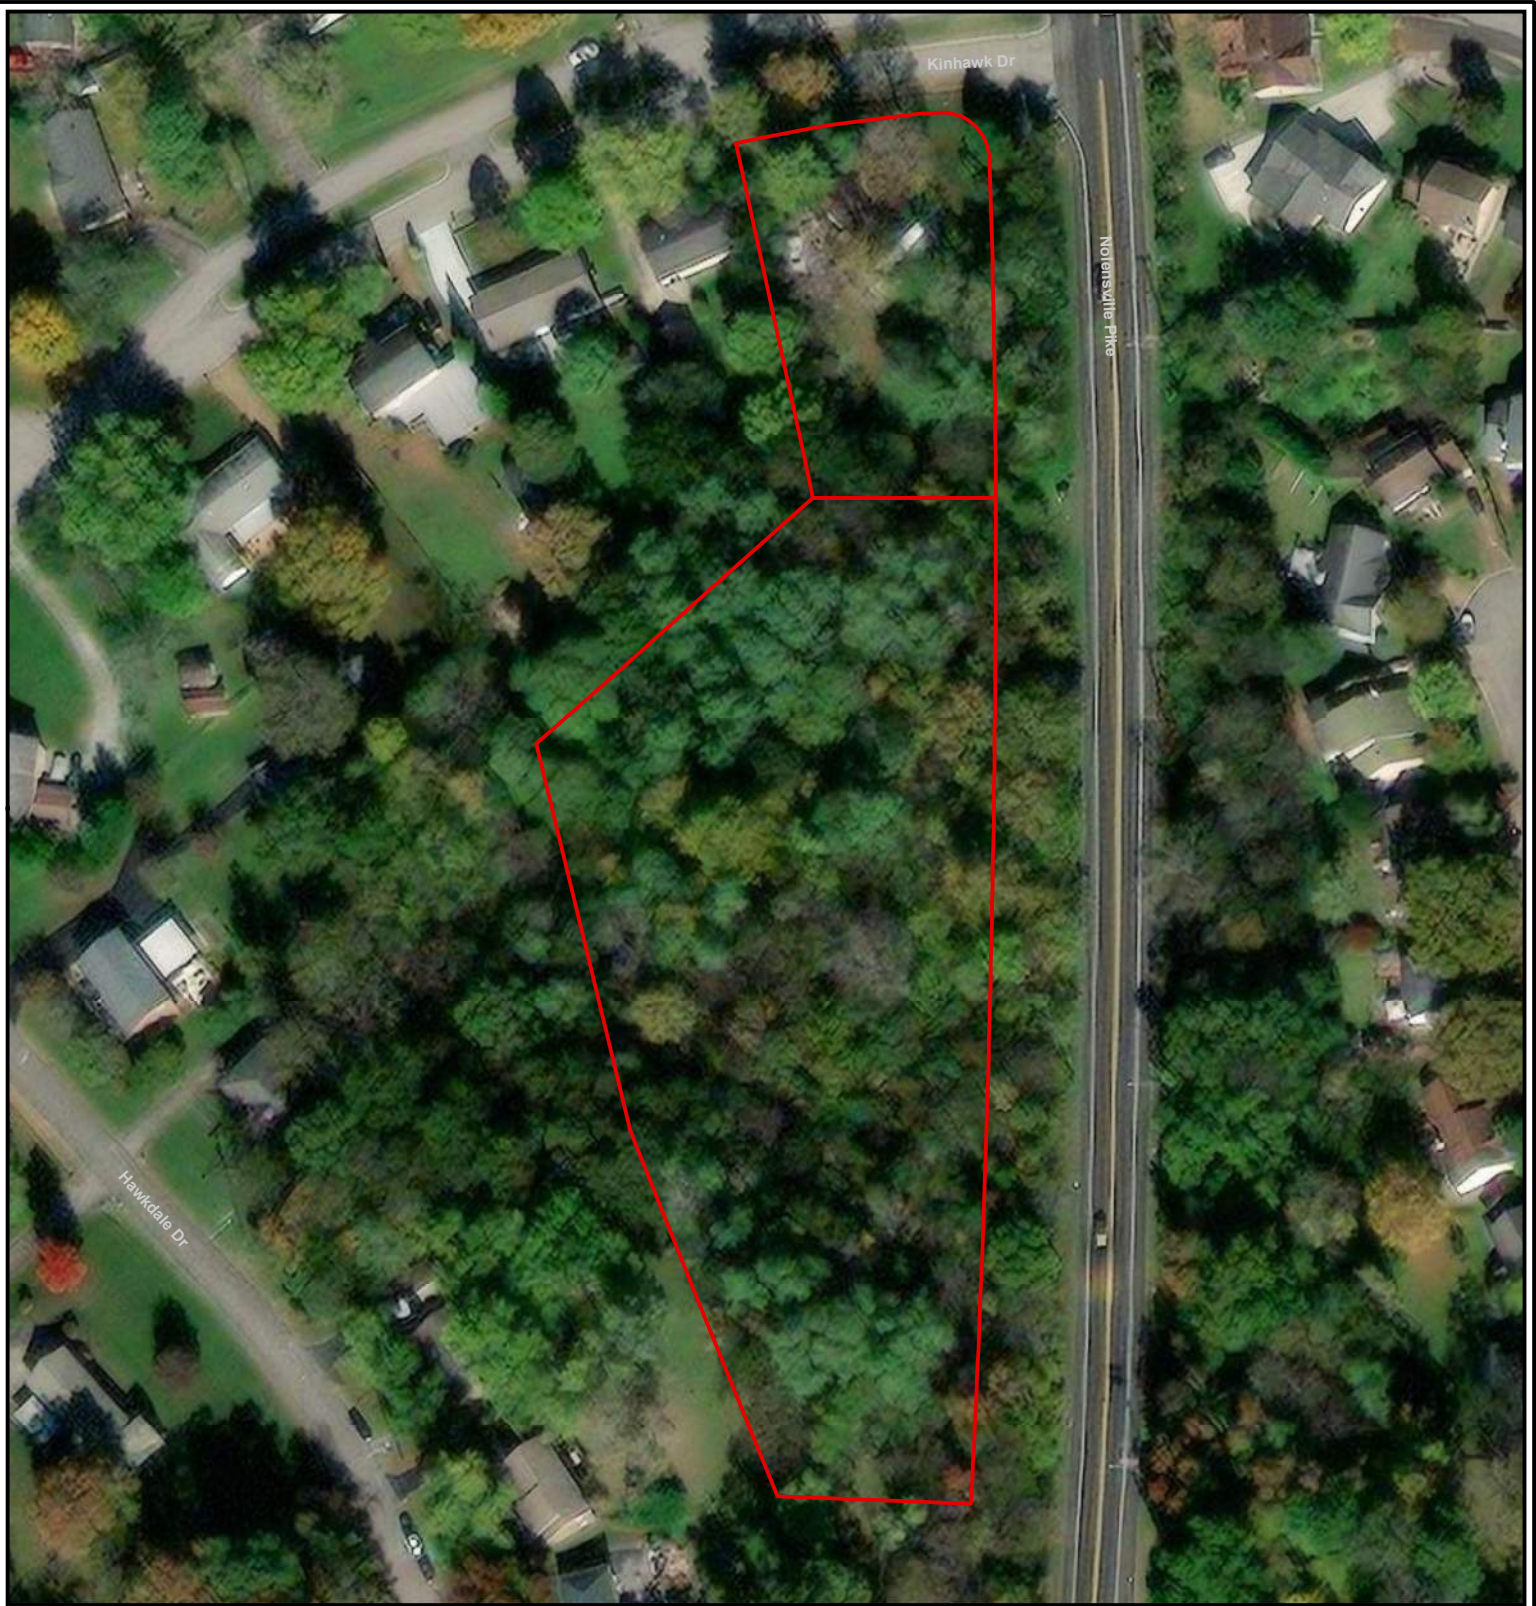
PROJECT:		Nazemi Properties Nashville, Davidson County, Tennessee	
TITLE:		<b>NATIONAL WETLAND INVENTORY MAP</b>	
PROJ NO: 3790100		<b>FIGURE 5</b>	
DATE: June 2022			
<b>BARGE</b> DESIGN SOLUTIONS			
615 3rd Avenue South, Suite 700 Nashville, TN 37210

No wetlands were observed within the subject properties. All low depressional areas within the subject properties were inspected for identification of suitable hydrology, hydrophytic vegetation, and hydric soils. The absence of potential wetlands is also represented on the NWI Map provided in Figure 5, Appendix A.

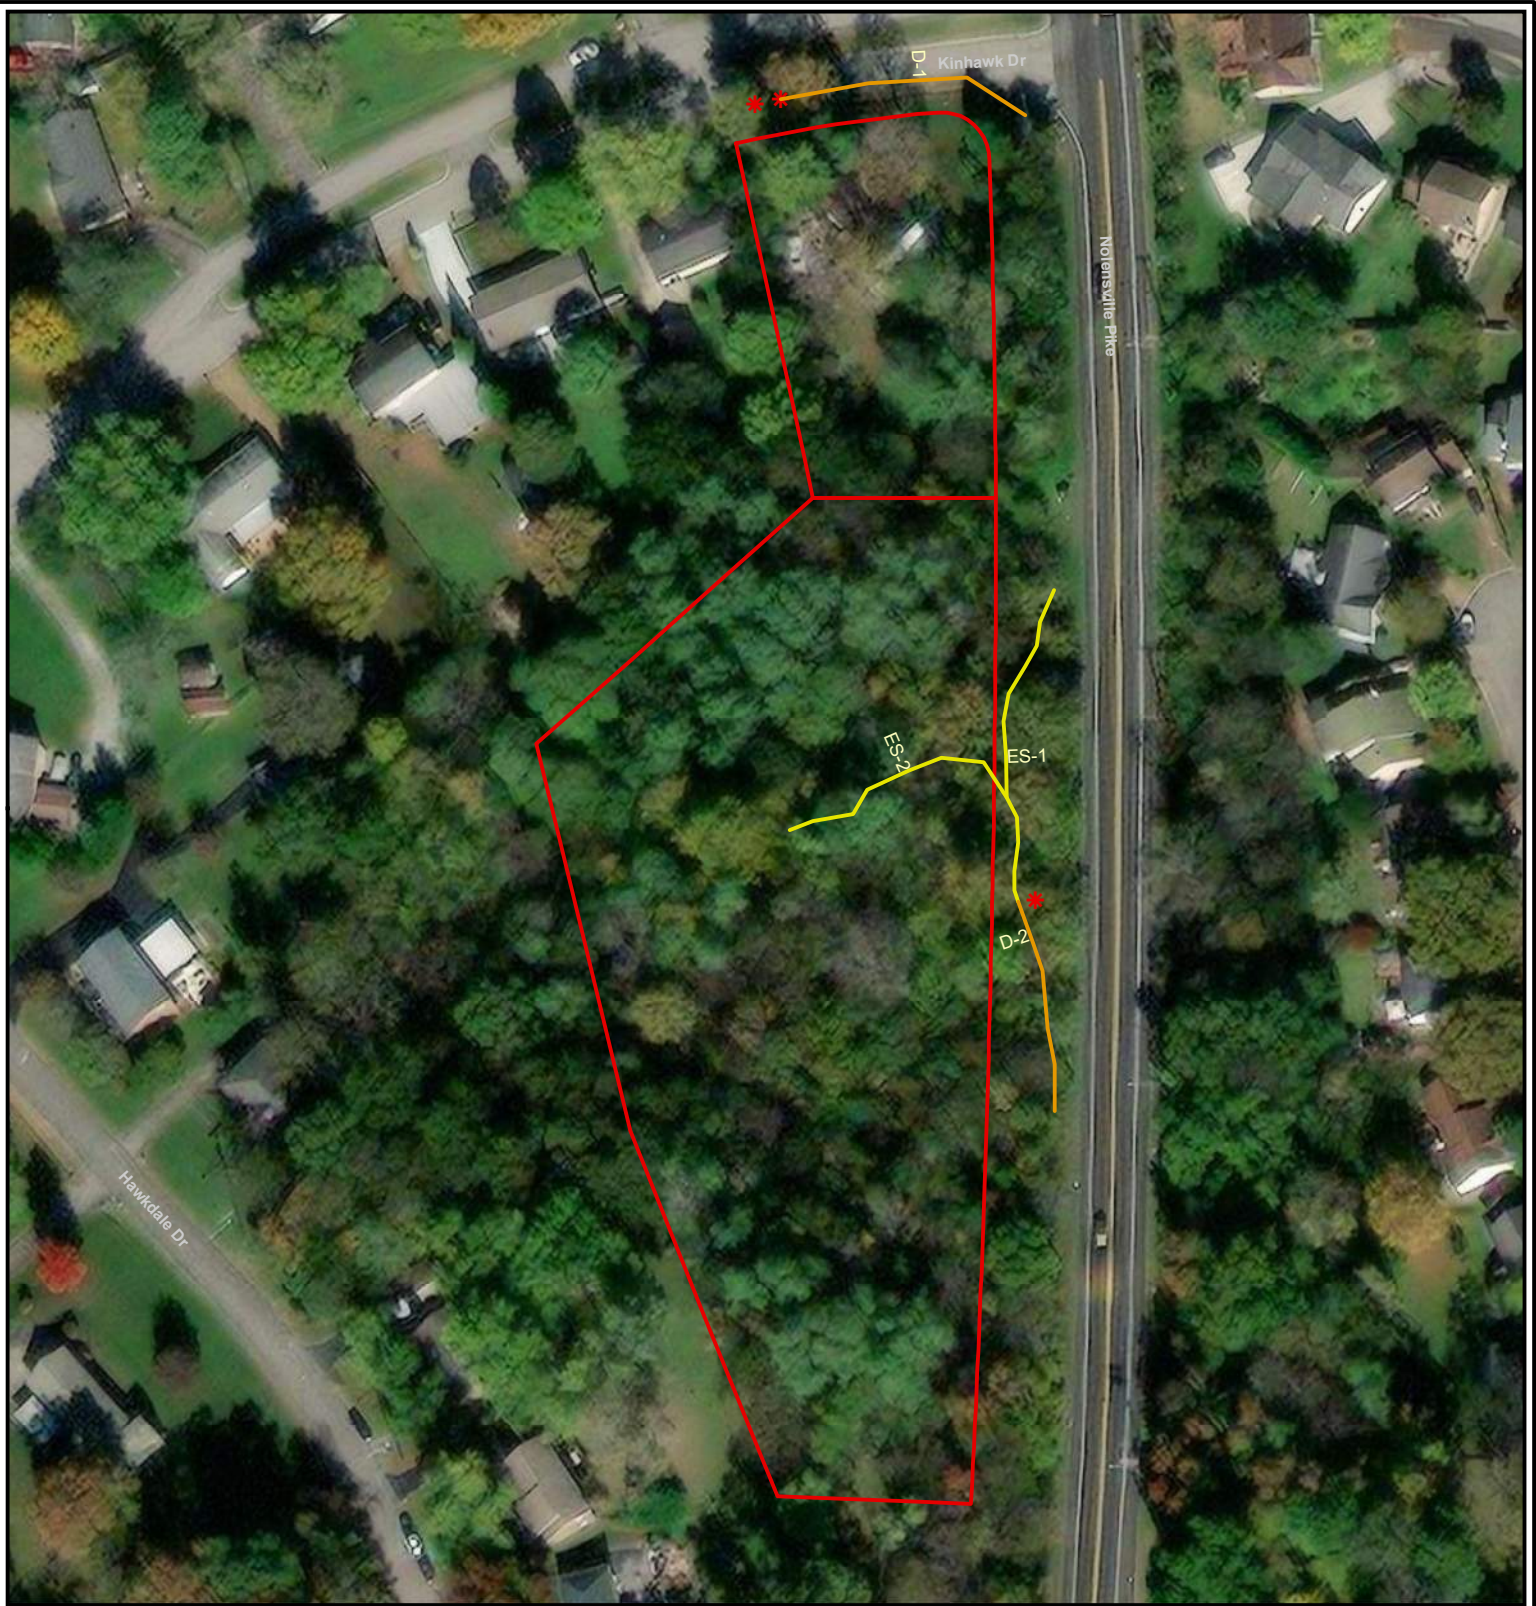
**FIGURE 6**

Two erosional swales and two man-made drainage ditches were identified during the field investigation of the subject properties. The Existing Conditions Map (Figure 6, Appendix B) visually represents the boundaries of the non-wetland waters delineated within the project area. Table 1 (Appendix C) also summarizes the current locations and linear footages of each feature, and the determination data forms for the delineated natural resources are provided in Appendix D.

- Non-Jurisdictional Erosional Swale
- Non-Jurisdictional Drainage Ditch
- \* Culvert Location
- Subject Properties

**EXISTING CONDITIONS MAP**

Furthermore, two man-made drainage ditches were observed within the subject properties. These man-made ditches were created to divert stormwater runoff from the adjacent roadway to an intake pipe in the center of the southern property. Figure 6 – Existing Conditions Map (Appendix A) illustrates the locations of the man-made ditches within the subject properties, and Table 1 (Appendix B) details the locations and lengths of the features. Photographs of each feature are provided in Appendix E.

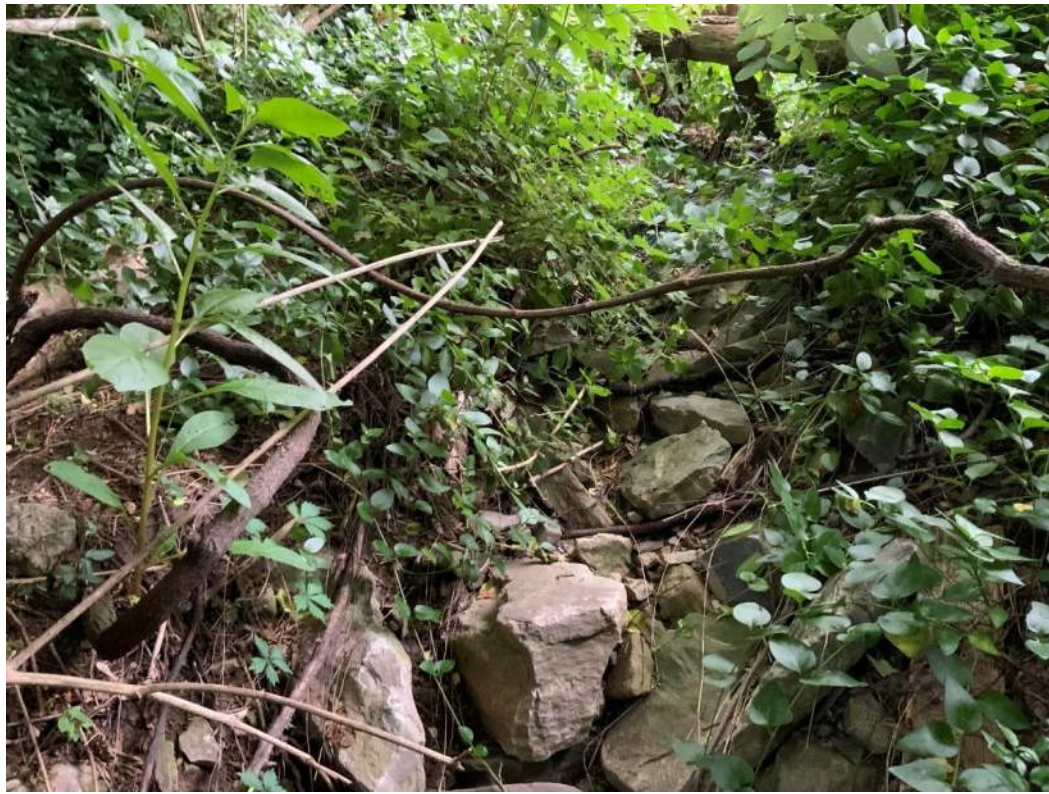
**Photo: 1**

Representative conditions of ES-1 at the start of the reach adjacent to Nolensville Pike.

Erosional Swale-1 (ES-1) was observed directly adjacent to Nolensville Pike in the southern property and likely was established by roadside runoff from the parallel roadway. Bed and bank was slightly present at the upslope and mid channel portions of the reach. ES-1 was observed with some sorting of gravel and sand below the rip-rap lined portion of channel, which also served as a small grade control. ES-1 also had a slight presence of a floodplain and was heavily covered with greater periwinkle (*Vinca major*) and Japanese honeysuckle (*Lonicera japonica*) in the lower portion of the reach, prior to the confluence with ES-2. ES-1 is potentially non-jurisdictional to the USACE and non-jurisdictional to the TDEC as a wet weather conveyance.

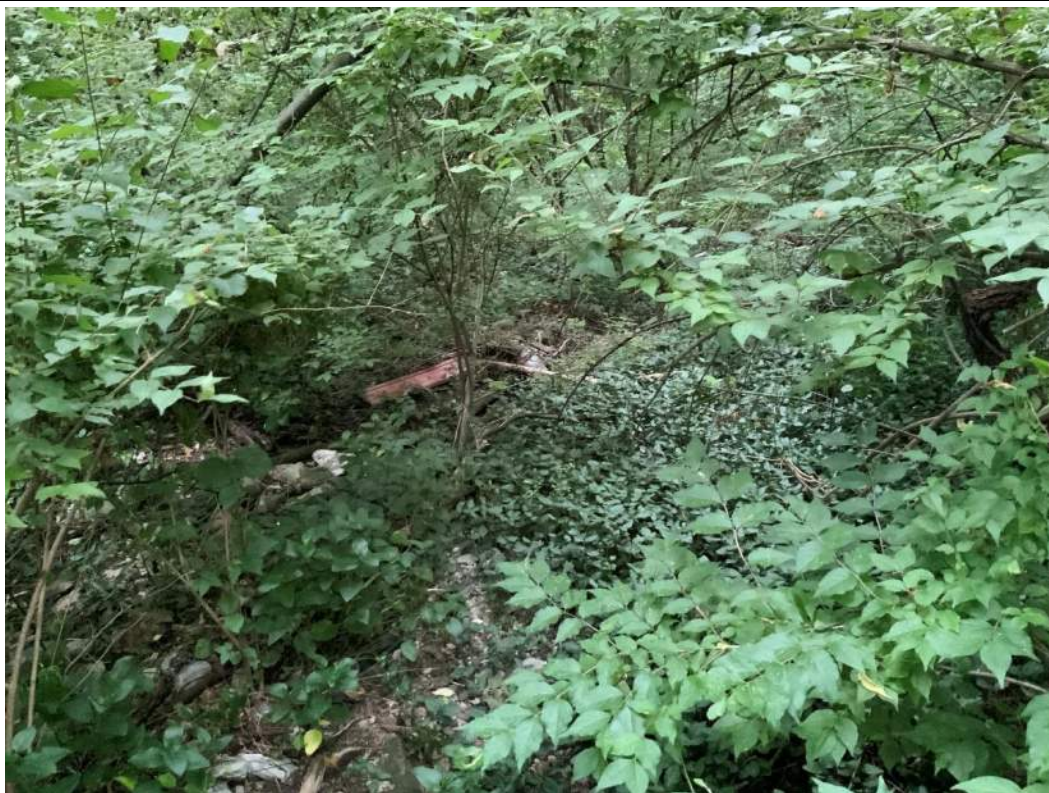
**Photo: 2**

Representative conditions of ES-1 of the lower portion of reach. Note the dominance of Japanese honeysuckle in the channel.

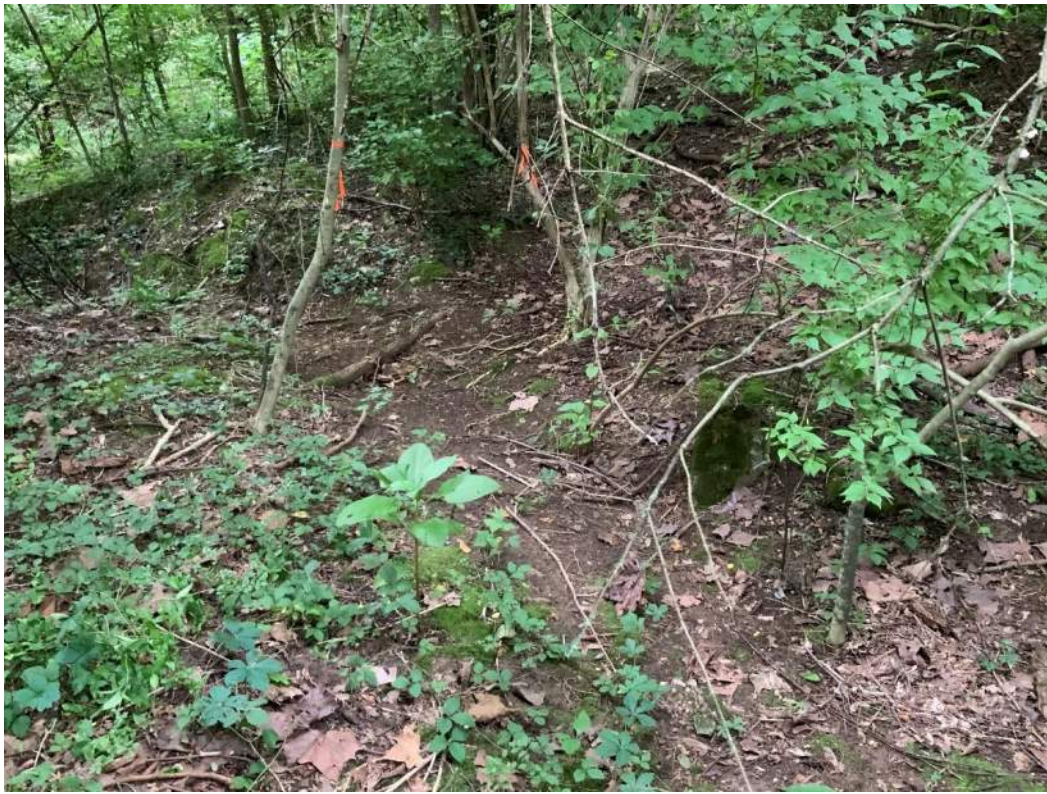
**Photo: 3**

Representative conditions of ES-2 at the start of the reach.

ES-2 was observed in the center of the southern property and likely receives excess stormwater runoff from adjacent western residential properties. Bed and bank was mostly present within the mid channel and downslope portions of the reach. ES-2 was observed with some sorting of silt, sand, and gravel channel substrate. Additionally, two small headcuts were observed near the end of the reach, downslope of the confluence with ES-1. All excess surface water from ES-2 drains directly into a stormwater culvert under Nolensville Pike. ES-2 is potentially non-jurisdictional to the USACE and non-jurisdictional to the TDEC as a wet weather conveyance.

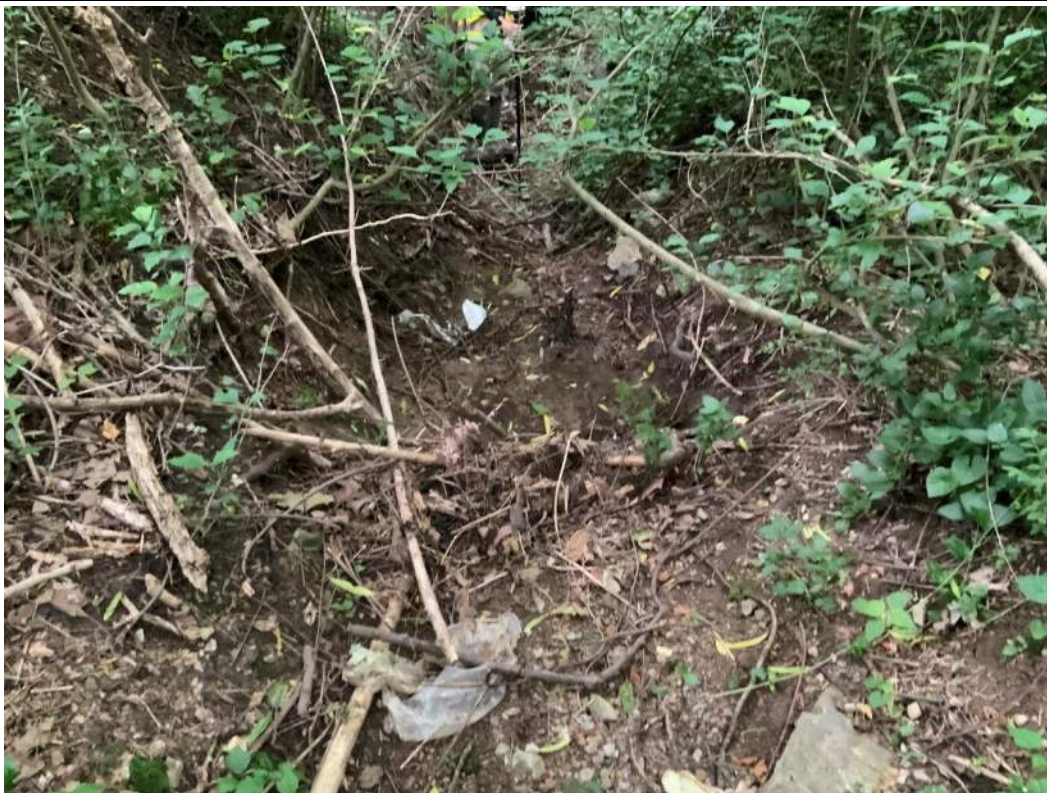
**Photo: 4**

Representative conditions of ES-2 before conveying into a stormwater intake pipe at the end of the reach.

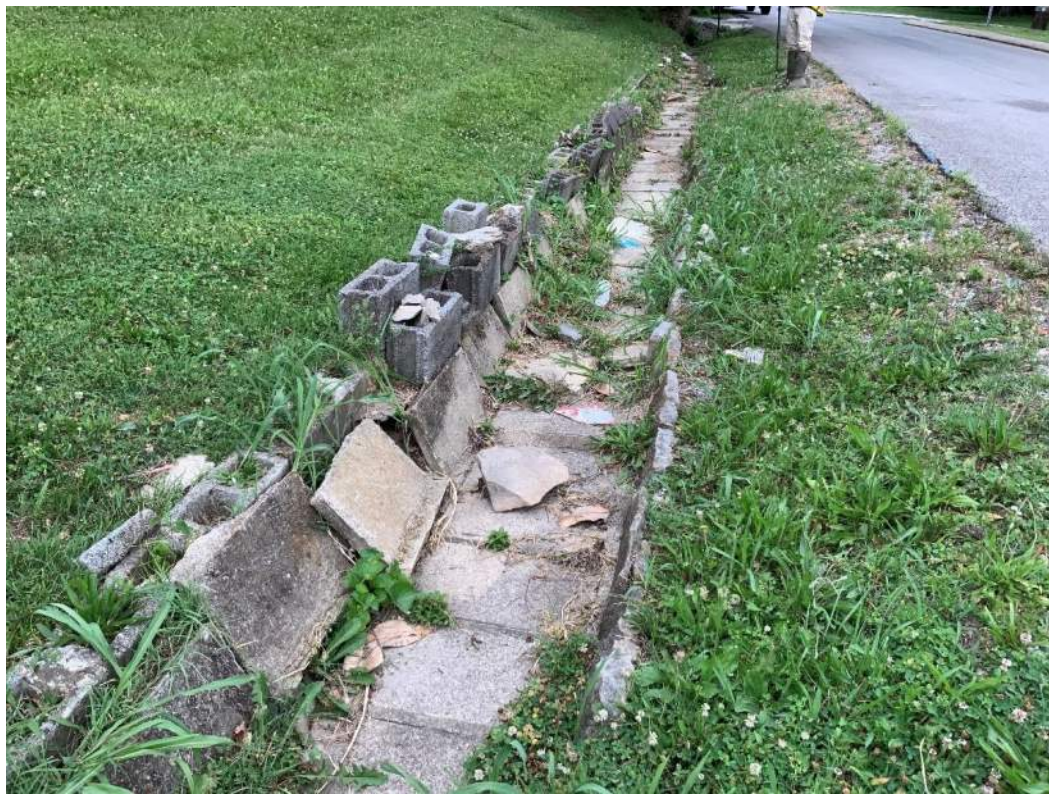
**Photo: 5**

Representative conditions of man-made drainage D-1 along Kinhawk Dr.

Man-made drainage ditches D-1 and D-2 were observed directly adjacent to Kinhawk Drive and Nolensville Pike. D-1 originates from roadside and residential stormwater runoff from Kinhawk Drive in the northern property, and D-2 originates from stormwater runoff from Nolensville Pike in the center area of the southern property. Both channels were man-made and were either cement lined or rip-rap lined. D-1 dissipates to overland sheet flow adjacent to the Kinhawk Drive and Nolensville Pike intersection, and D-2 drains directly into the culvert end of ES-2. Both D-1 and D-2 are assumed to be non-jurisdictional to the USACE and TDEC.

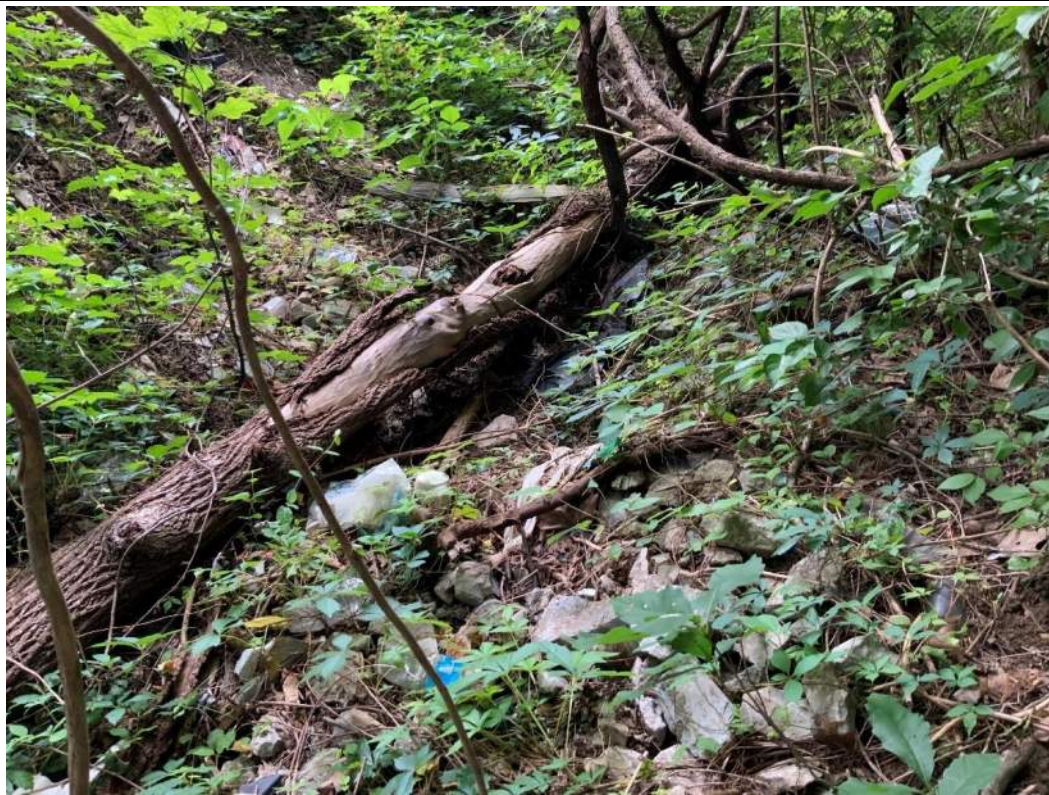
**Photo: 6**

Representative conditions of roadside ditch D-2, which lined with rip rap.

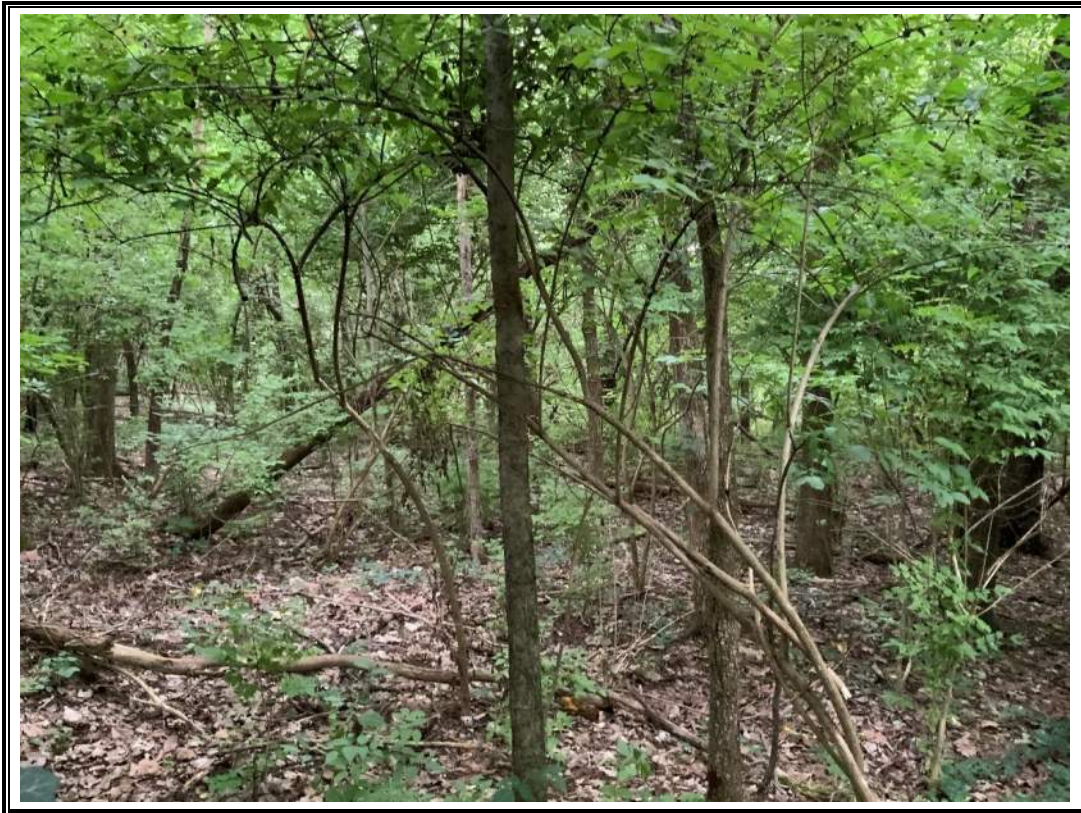
**Photo: 7**

Representative conditions of the wooded area within the southern subject property.
