Jurisdictional Waters Report  
Brandywine Farm  
Spring Hill, Williamson County, Tennessee  
S&ME Project No. 218947

Reference: **Jurisdictional Waters Report**  
**Brandywine Farm**  
Spring Hill, Williamson County, Tennessee  
S&ME Project No. 218947

## USGS TOPOGRAPHIC QUADRANGLE

## DATABASE REVIEW

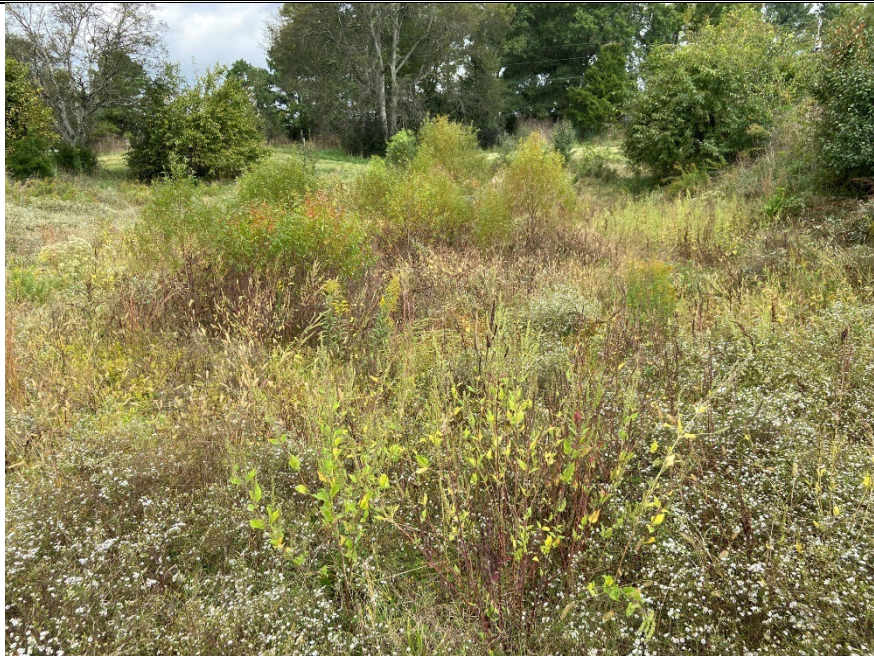
| 1 | Location / Orientation | Refer to Figure 5 for location. |

| | Remarks | Dry pond located near the northern boundary of the site; no hydric soils present. |

| <b>Remarks:</b><br>Upland point is located within an area shown as an open-water pond on historic aerial photographs. No inundation observed during the site visit, and soils within the depression are not hydric. Feature likely only holds rainfall for a short term. | |

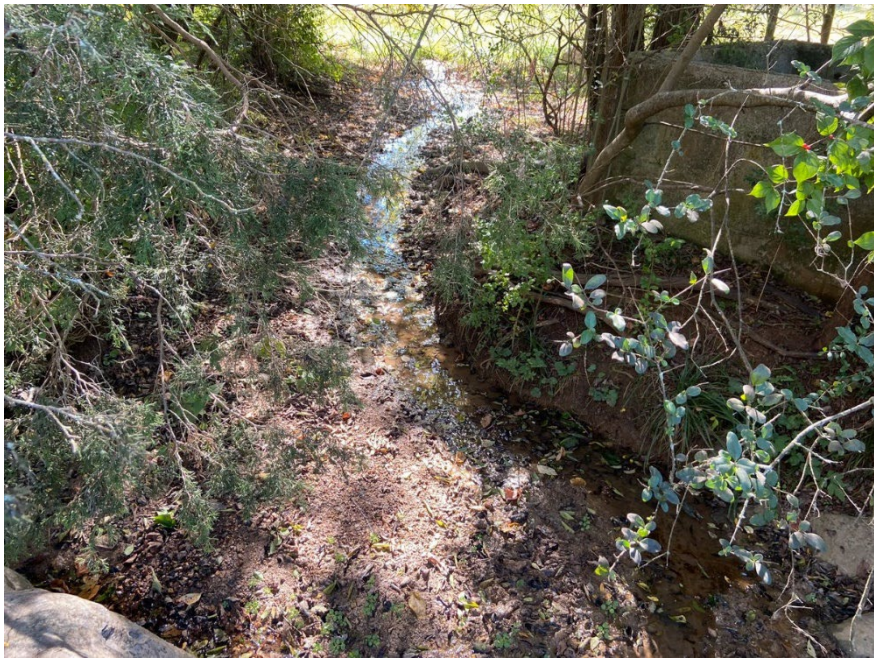
| 5 | Location / Orientation | Refer to Figure 5 for location. |

S1 is an intermittent stream that originates at a limestone outcrop near the northern end of the site and continues south until converging with Aenon Creek. S1 ranges from one to ten feet wide, has a substrate of bedrock, cobble, and silt, and a narrow riparian buffer on the northern half of the site where it is grazed and impacted by cattle use. Stream flow is variable as it continues south, with much of the southern reach observed to be dry during the site

| | Remarks | Headwaters of intermittent stream S1, facing downstream. |

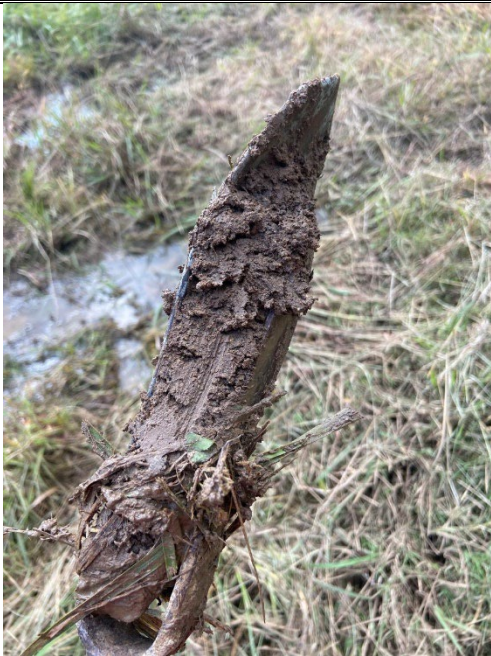
| 7 | Location / Orientation | Refer to Figure 5 for location. |

Wetlands WA and WB are both palustrine emergent (PEM) features that abut S1 near the northern end of the site and are located in grazed cattle pasture. Both wetlands obtain their hydrology from groundwater seeps, a shallow water table over bedrock, overland flow from S1, and stormwater input from the surrounding slopes. Dominant vegetation includes sedges (*Carex* sp.), ladythumb (*Polygonum persicaria*), mountain mint (*Mentha arvensis*), and mistflower (*Conoclinium coelestinum*). Detailed descriptions of the wetlands and the associated upland data points can be found in Appendix II on the USACE Wetland Determination Data Sheets (WA, UpA, WB, UpB).

| | Remarks | Hydric soils with a depleted matrix observed in WA. |

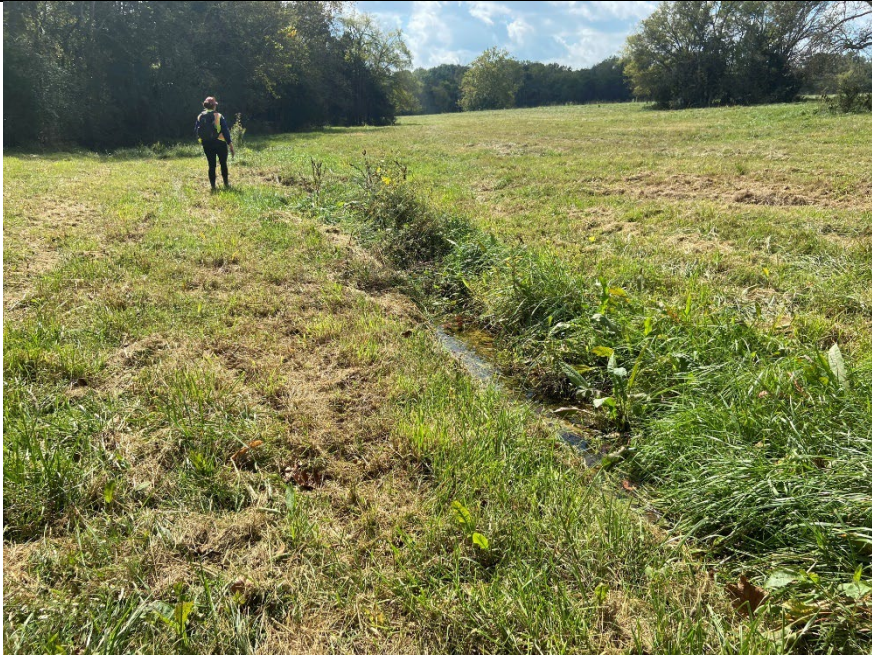
| 9 | Location / Orientation | Refer to Figure 5 for location. |

| | Remarks | S1 facing downstream. |

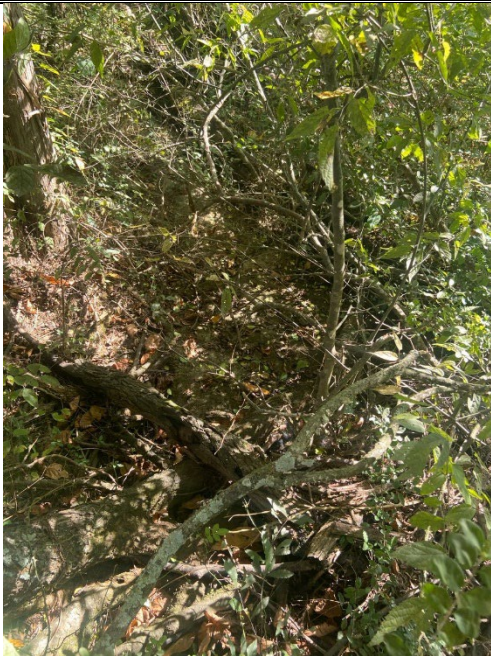
| 11 | Location / Orientation | Refer to Figure 5 for location. |

S2E is an ephemeral stream/WWC that consists of a rarely-flowing headwater drainage with a silt/gravel substrate that drains to the intermittent tributary to Aenon Creek. The channel is poorly defined and is dominated by upland vegetation in many areas. S2E has a narrow, forested buffer surrounded by frequently mowed and grazed pasture.

| | Remarks | Ephemeral stream S2E origin, facing upstream. |

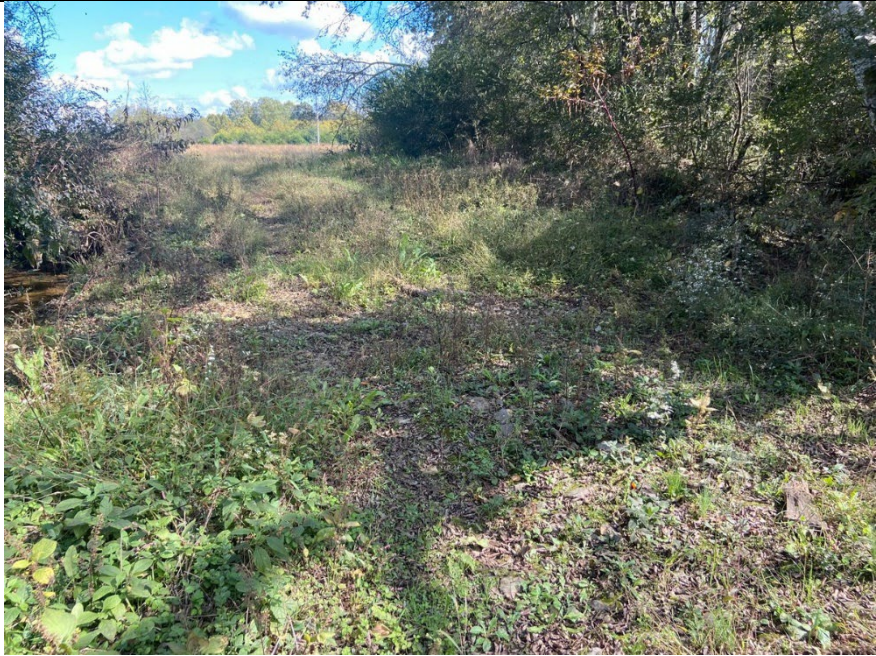
| 13 | Location / Orientation | Refer to Figure 5 for location. |

| | Remarks | Ephemeral stream S2E where it loses definition downstream and is dominated by upland vegetation. |

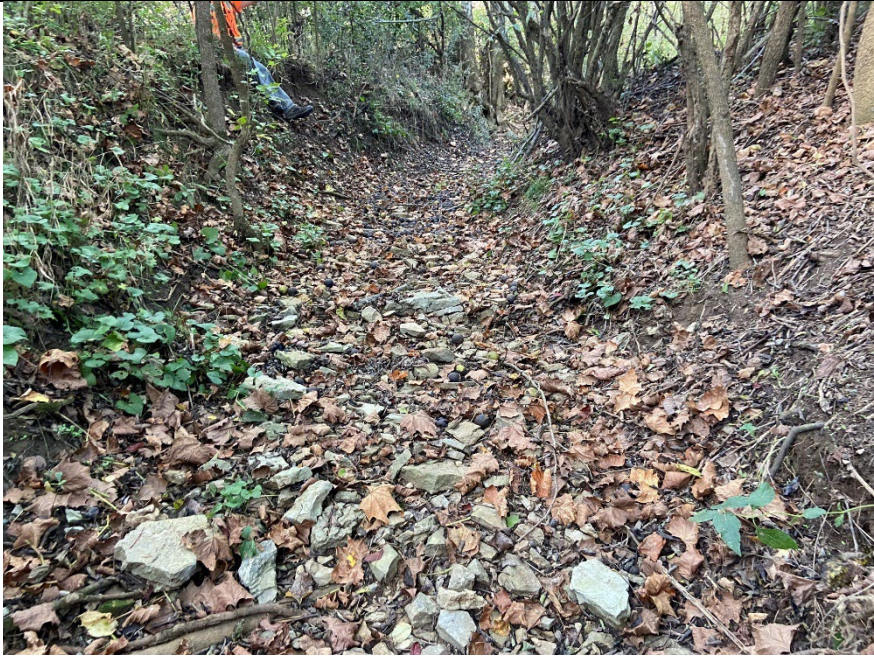
| 15 | Location / Orientation | Refer to Figure 5 for location. |

visit. The stream develops a well-forested buffer to the south as it approaches Aenon Creek; at this point the stream also meanders through a more natural alignment within the floodplain.

| | Remarks | Lower reach of S1, facing upstream. |

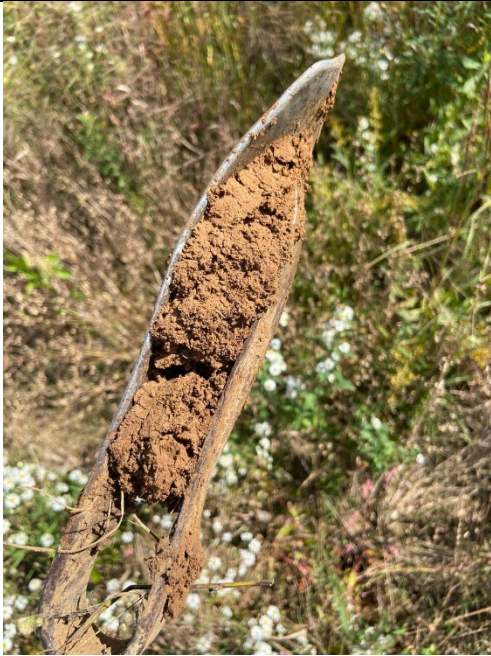
| 17 | Location / Orientation | Refer to Figure 5 for location. |

| | Remarks | No hydric soils observed within the Aenon Creek floodplain. |
