Subject: Hydrologic Determination
Hidden Harbor Drive Property (±18 Acres)
Mt. Juliet, Wilson County, Tennessee
Latitude 36.244700° North and Longitude -86.558100° West
Project No. 3611-001-31

Request for Hydrologic Determination

**Hidden Harbour Property
Mt. Juliet, Wilson County, Tennessee**

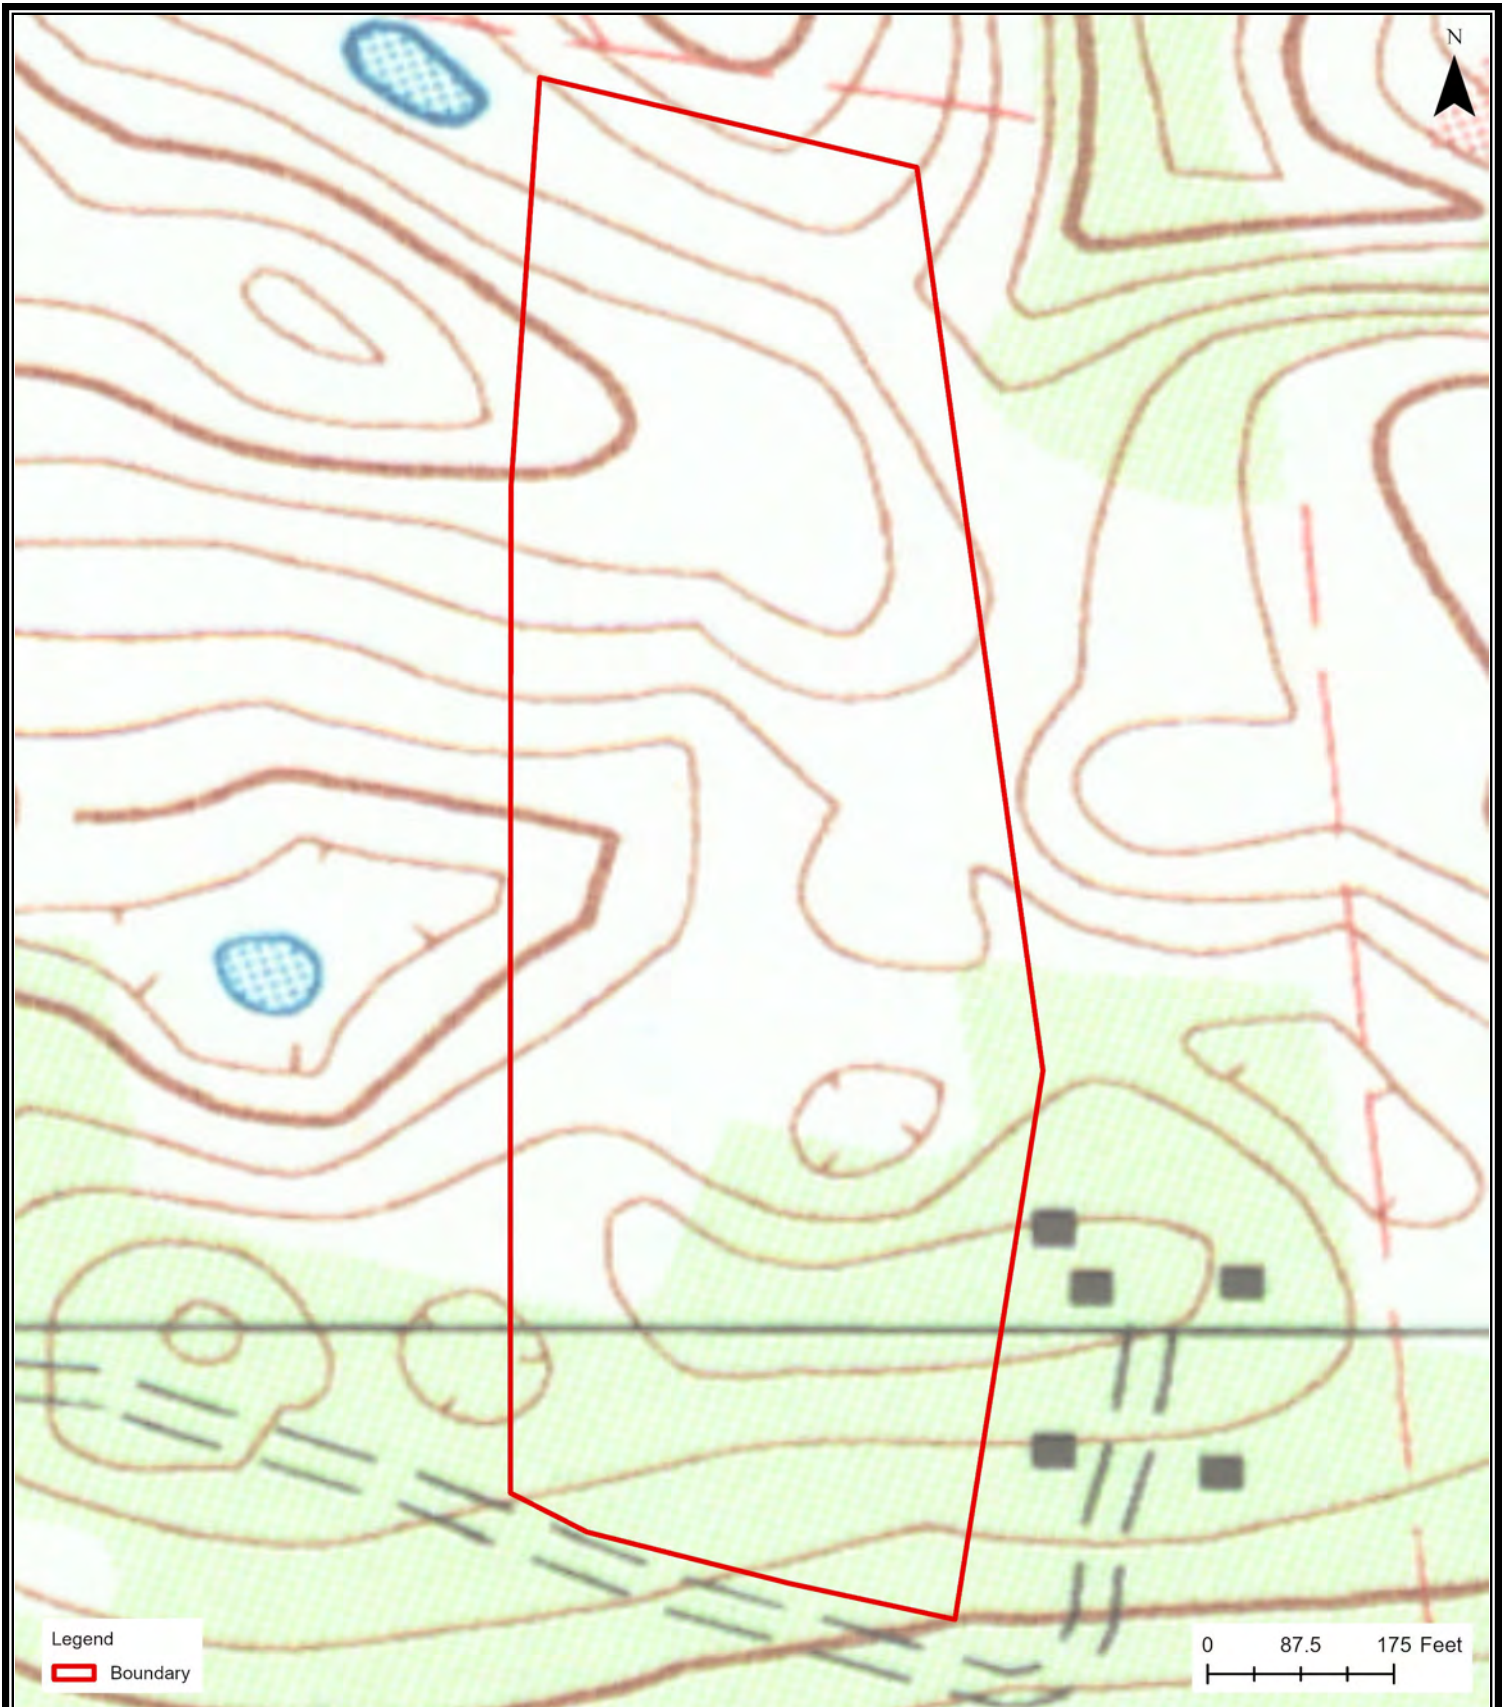
TITLE
Figure 1 — Site Location Map Hydrologic Determination Doug Myhand Construction Hidden Harbor Drive Mt. Juliet, Wilson County, Tennessee

Spectrum performed a jurisdictional determination of a ±15.9-acre site located south of Hidden Harbour Drive in Mt. Juliet, Wilson County, Tennessee. Project Area is centered at Latitude 36.244700° North and Longitude -86.558100° West (Figure 1). The Project Area is located in the Cumberland River-Shutes Branch watershed (HUC12-051302010605), which is part of the Lower Cumberland – Old Hickory Lake (HUC8-05130201) watershed.

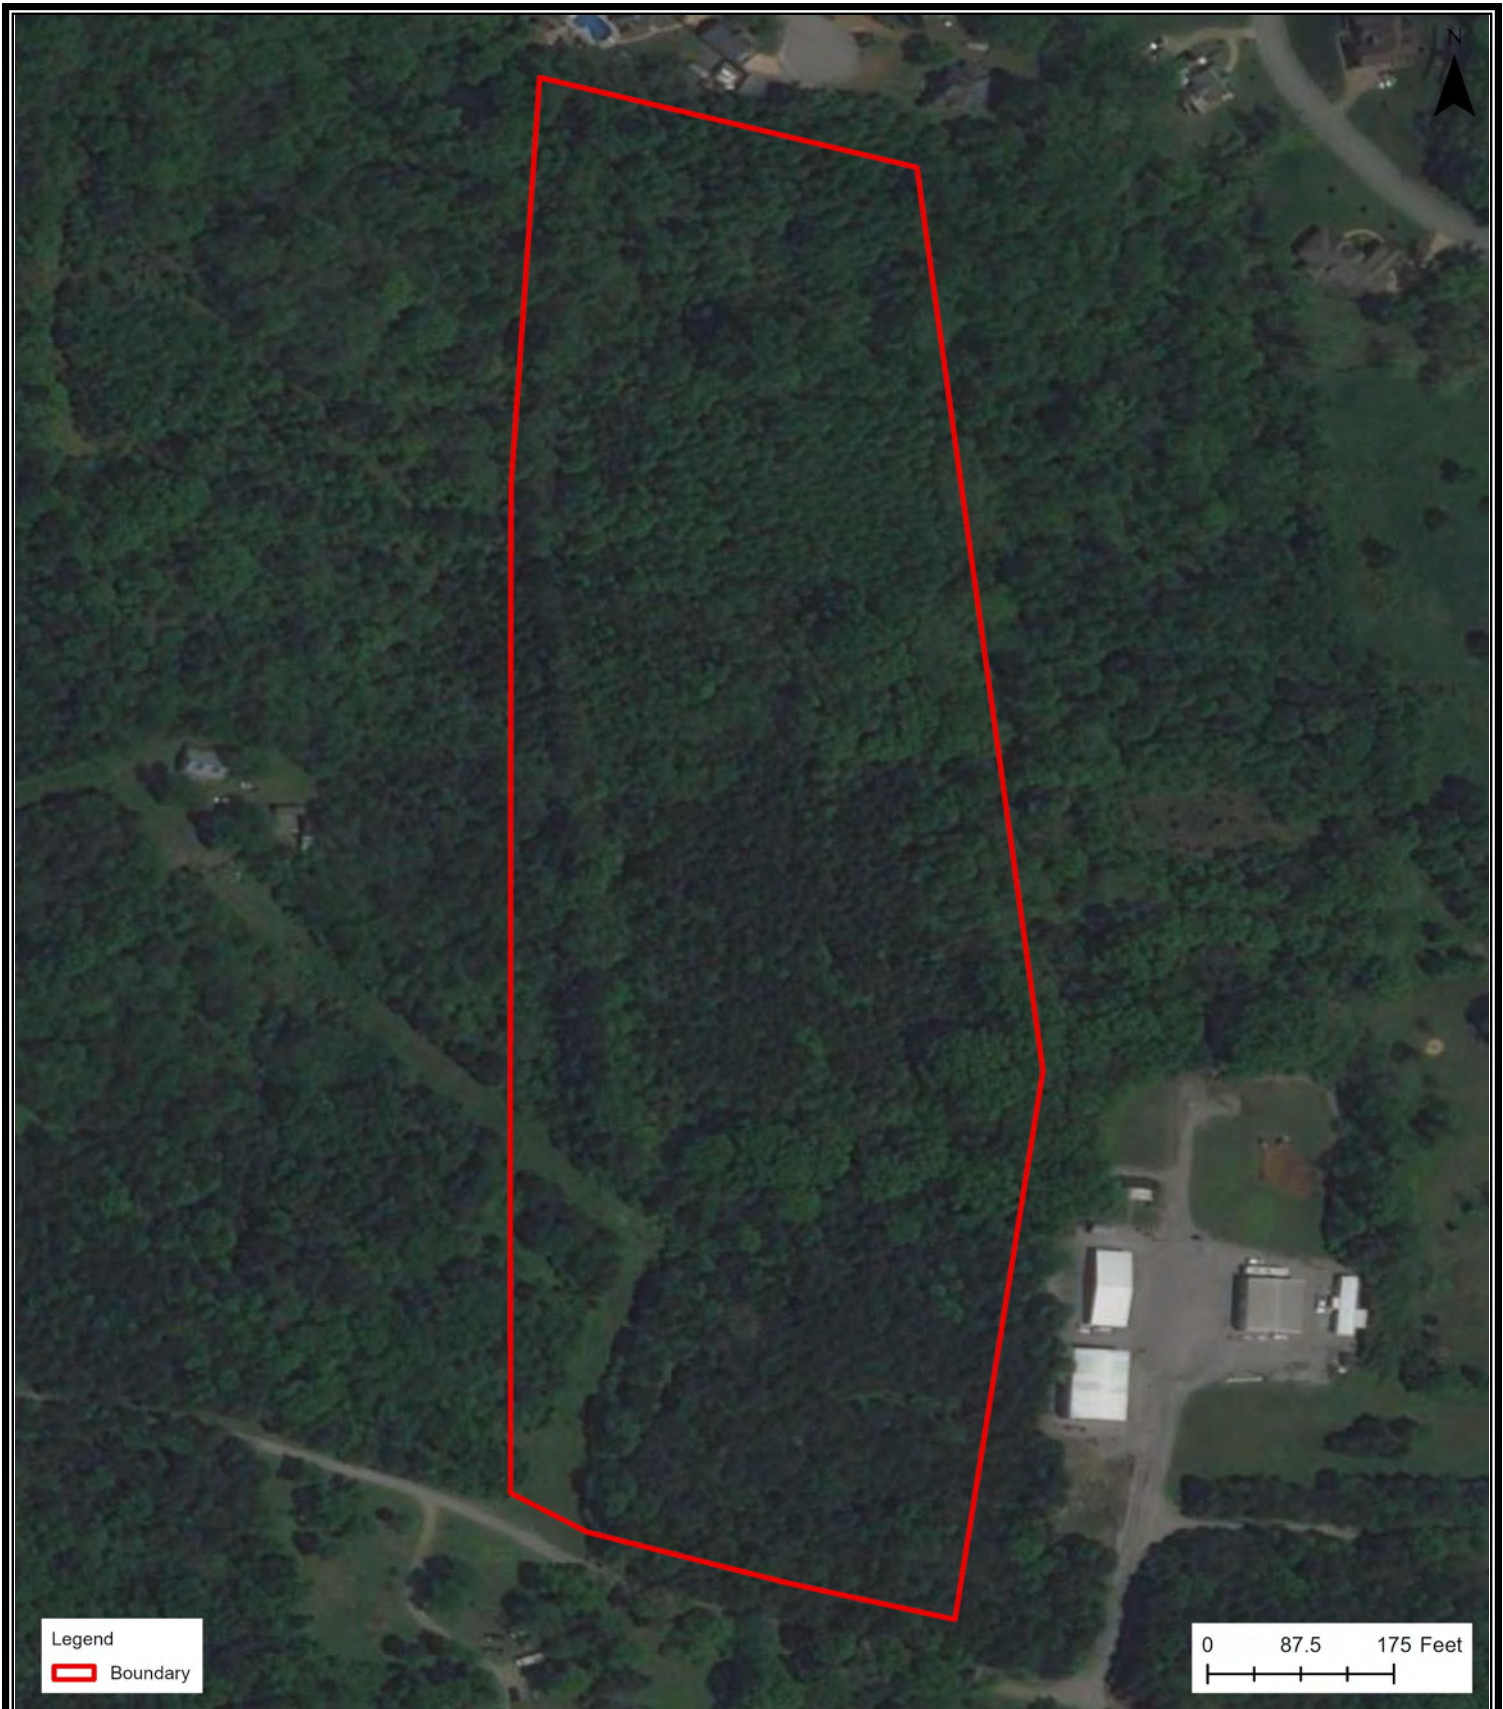
Prior to the site reconnaissance visits, Spectrum conducted a desktop assessment of the Project Area. The United States Geological Survey (USGS) 7.5 Minute Hopkinsville Topographic map depicts one karst feature located within the southern portion of the Project Area (Figure 2). In general, the topography of the northern portion of the Project Area is characterized by a ridge trending east-to-west. Generally, the topography of the Project Area exhibits higher elevations in the north and south creating a shallow trough which opens towards the east. Similarly, the Light Detection and Ranging (LiDAR) imagery depicts a pond within the western portion of the Project Area (Figure 3). An aerial depiction dated October 2021 reflects forested coverage of the Project Area (Figure 4). The NWI map does not depict any wetland or reverence features (Figure 5).

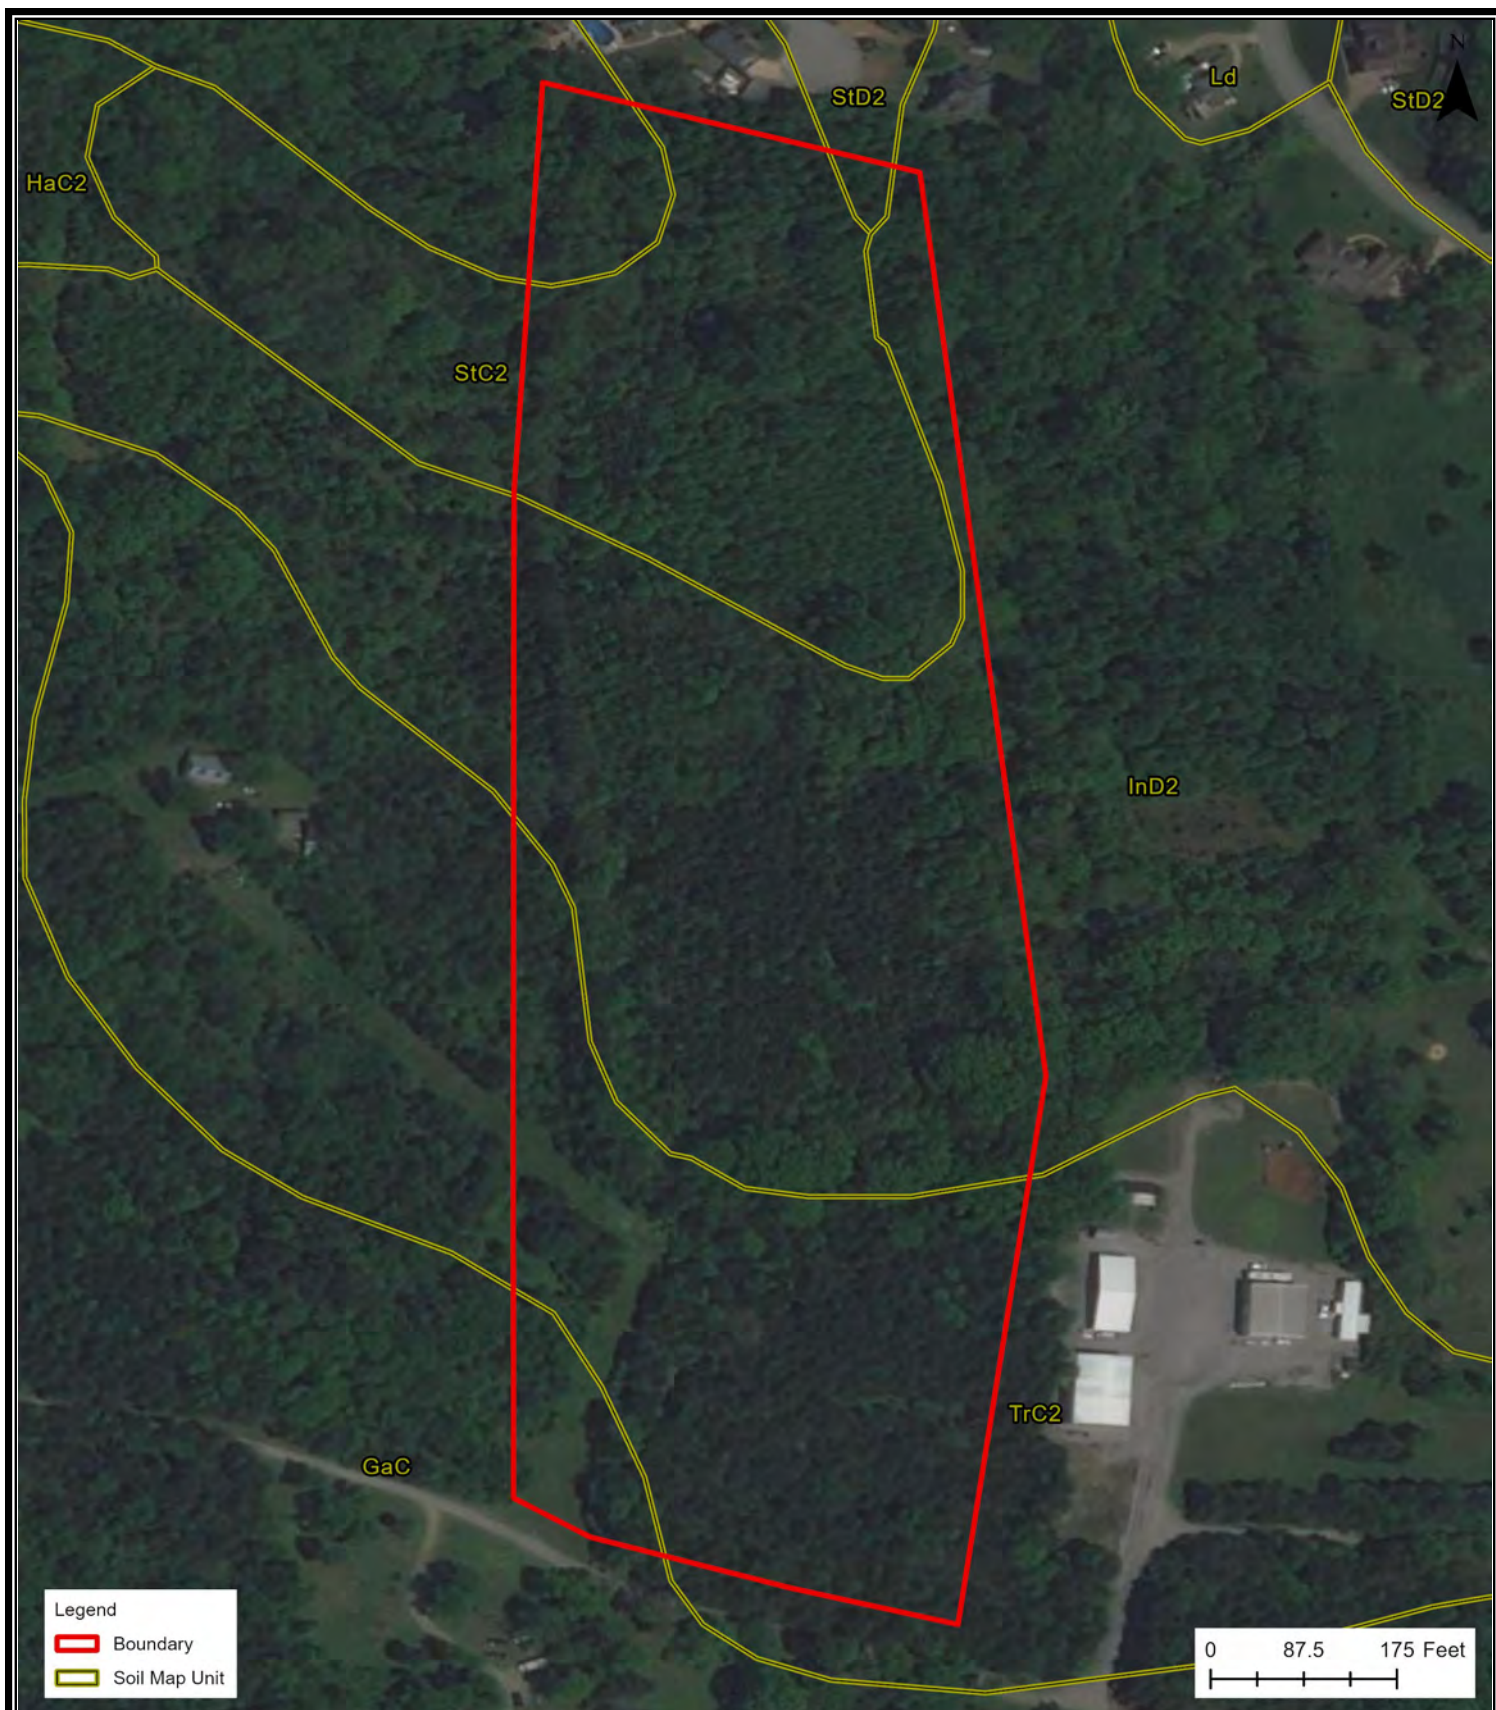
TITLE
Figure 6 — Site Soils Map Hydrologic Determination Doug Myhand Construction Hidden Harbor Drive Mt. Juliet, Wilson County, Tennessee

Spectrum utilized the NRCS web soil survey to identify the soils present within the Project Area (Figure 6). Two hydric soils were identified within the Project Area, Guthrie silt loam and Lindell silt loam. In summary the soils present within the Project Area belong to the:

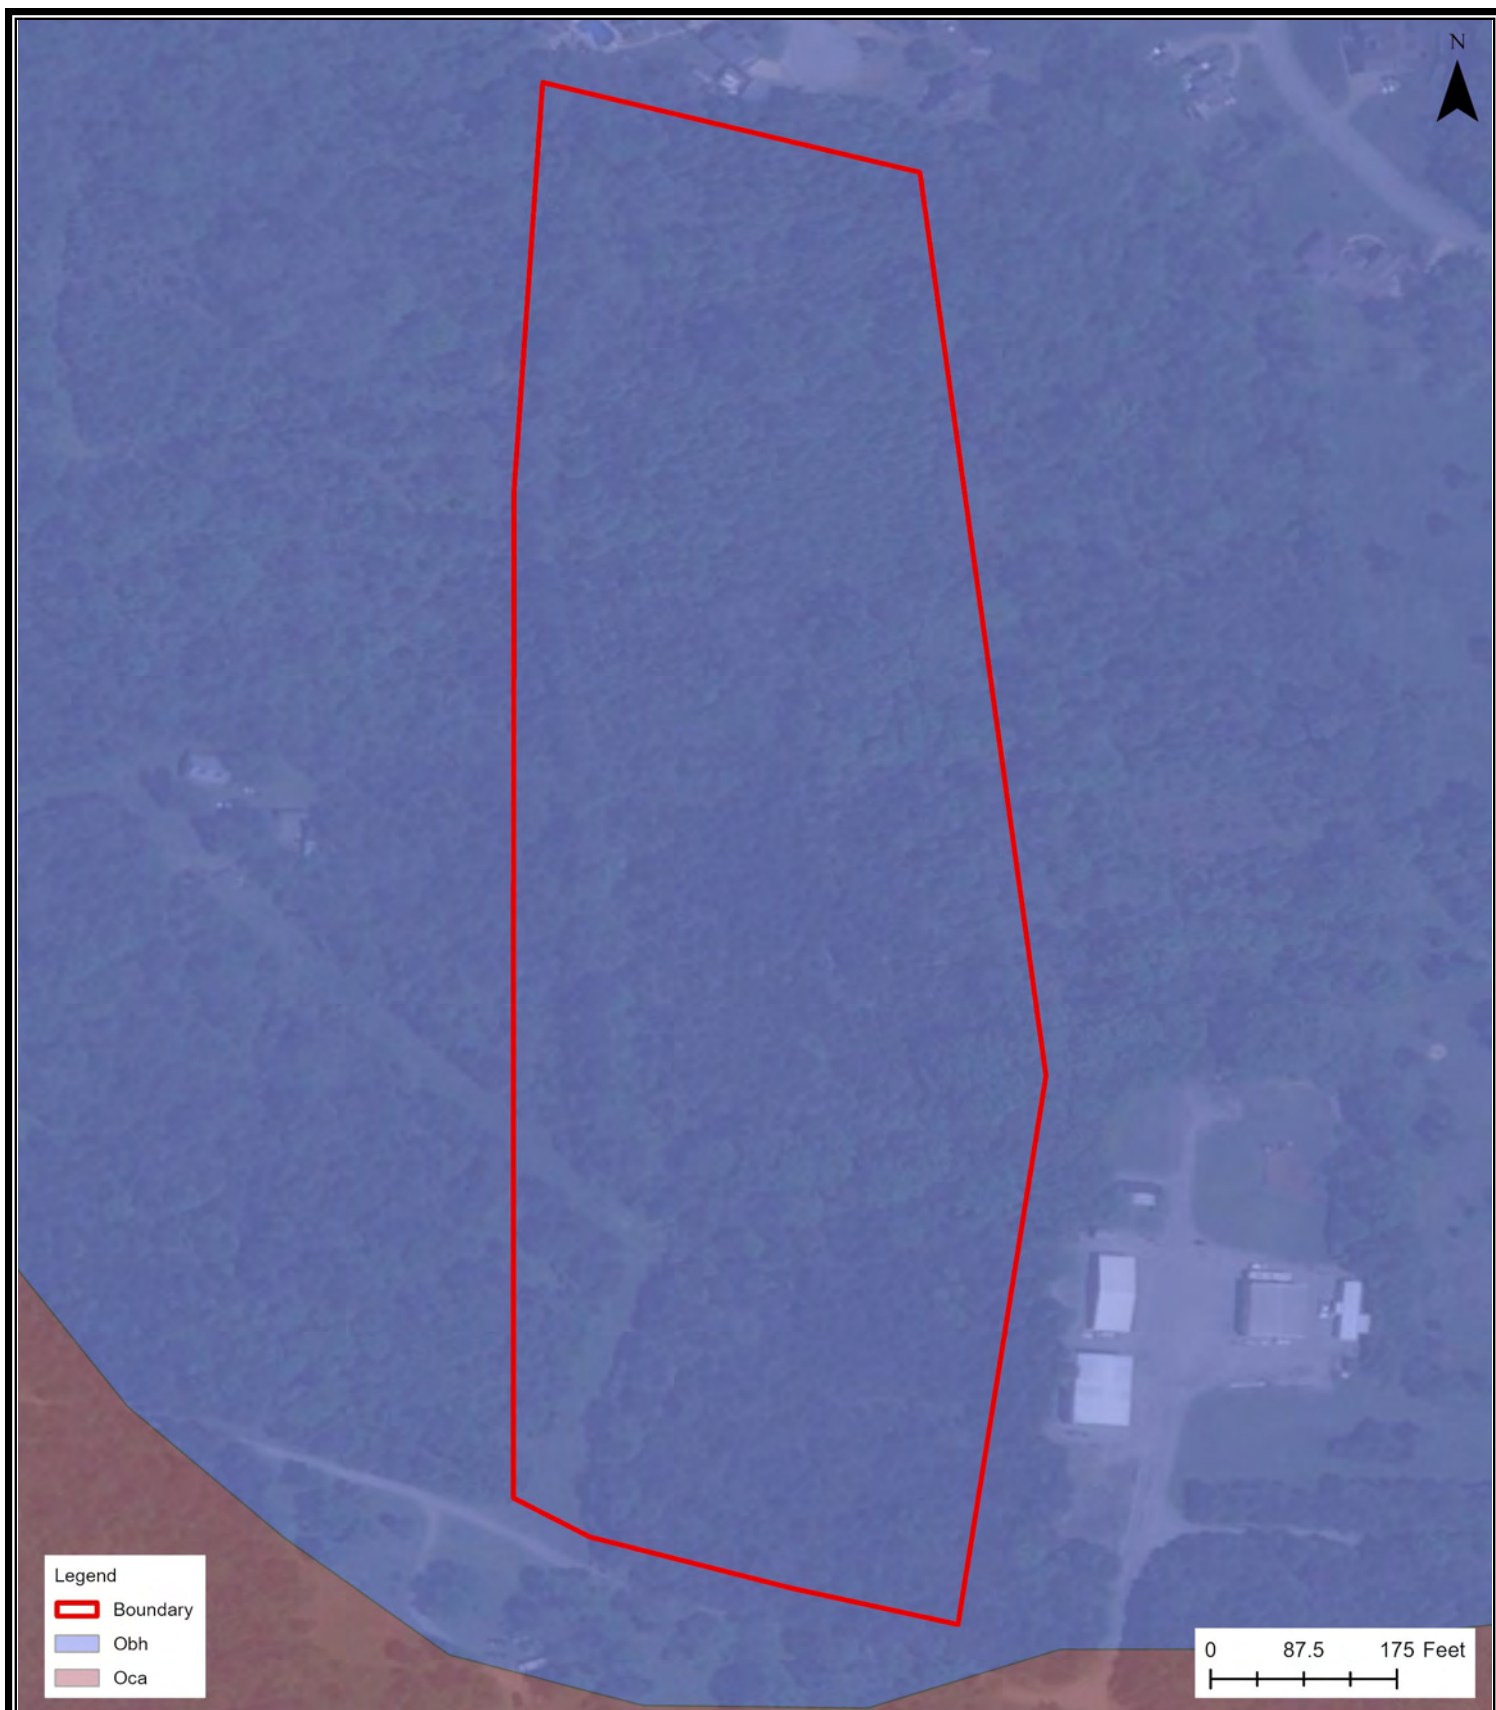
TITLE
Figure 7 — Site Geologic Map Hydrologic Determination Doug Myhand Construction Hidden Harbor Drive Mt. Juliet, Wilson County, Tennessee

The surface geology of the Project Area is underlain by the Nashville Group; Bigby-Cannon Limestone and Hermitage Formation (Figure 7). The Bigby-cannon limestone formation is characterized by brownish-gray phosphatic calcarenite and light-gray to brownish-gray, crypto grained to medium-grained, even bedded limestone. The thickness of this formation ranges from 50 to 125 feet. The Hermitage Formation is characterized by thin-bedded to laminated, sandy and argillaceous limestone with shale, nodular shaly limestone, coquina, and phosphatic calcarenite. The thickness ranges from 50 to 100 feet (Greene, 2000).

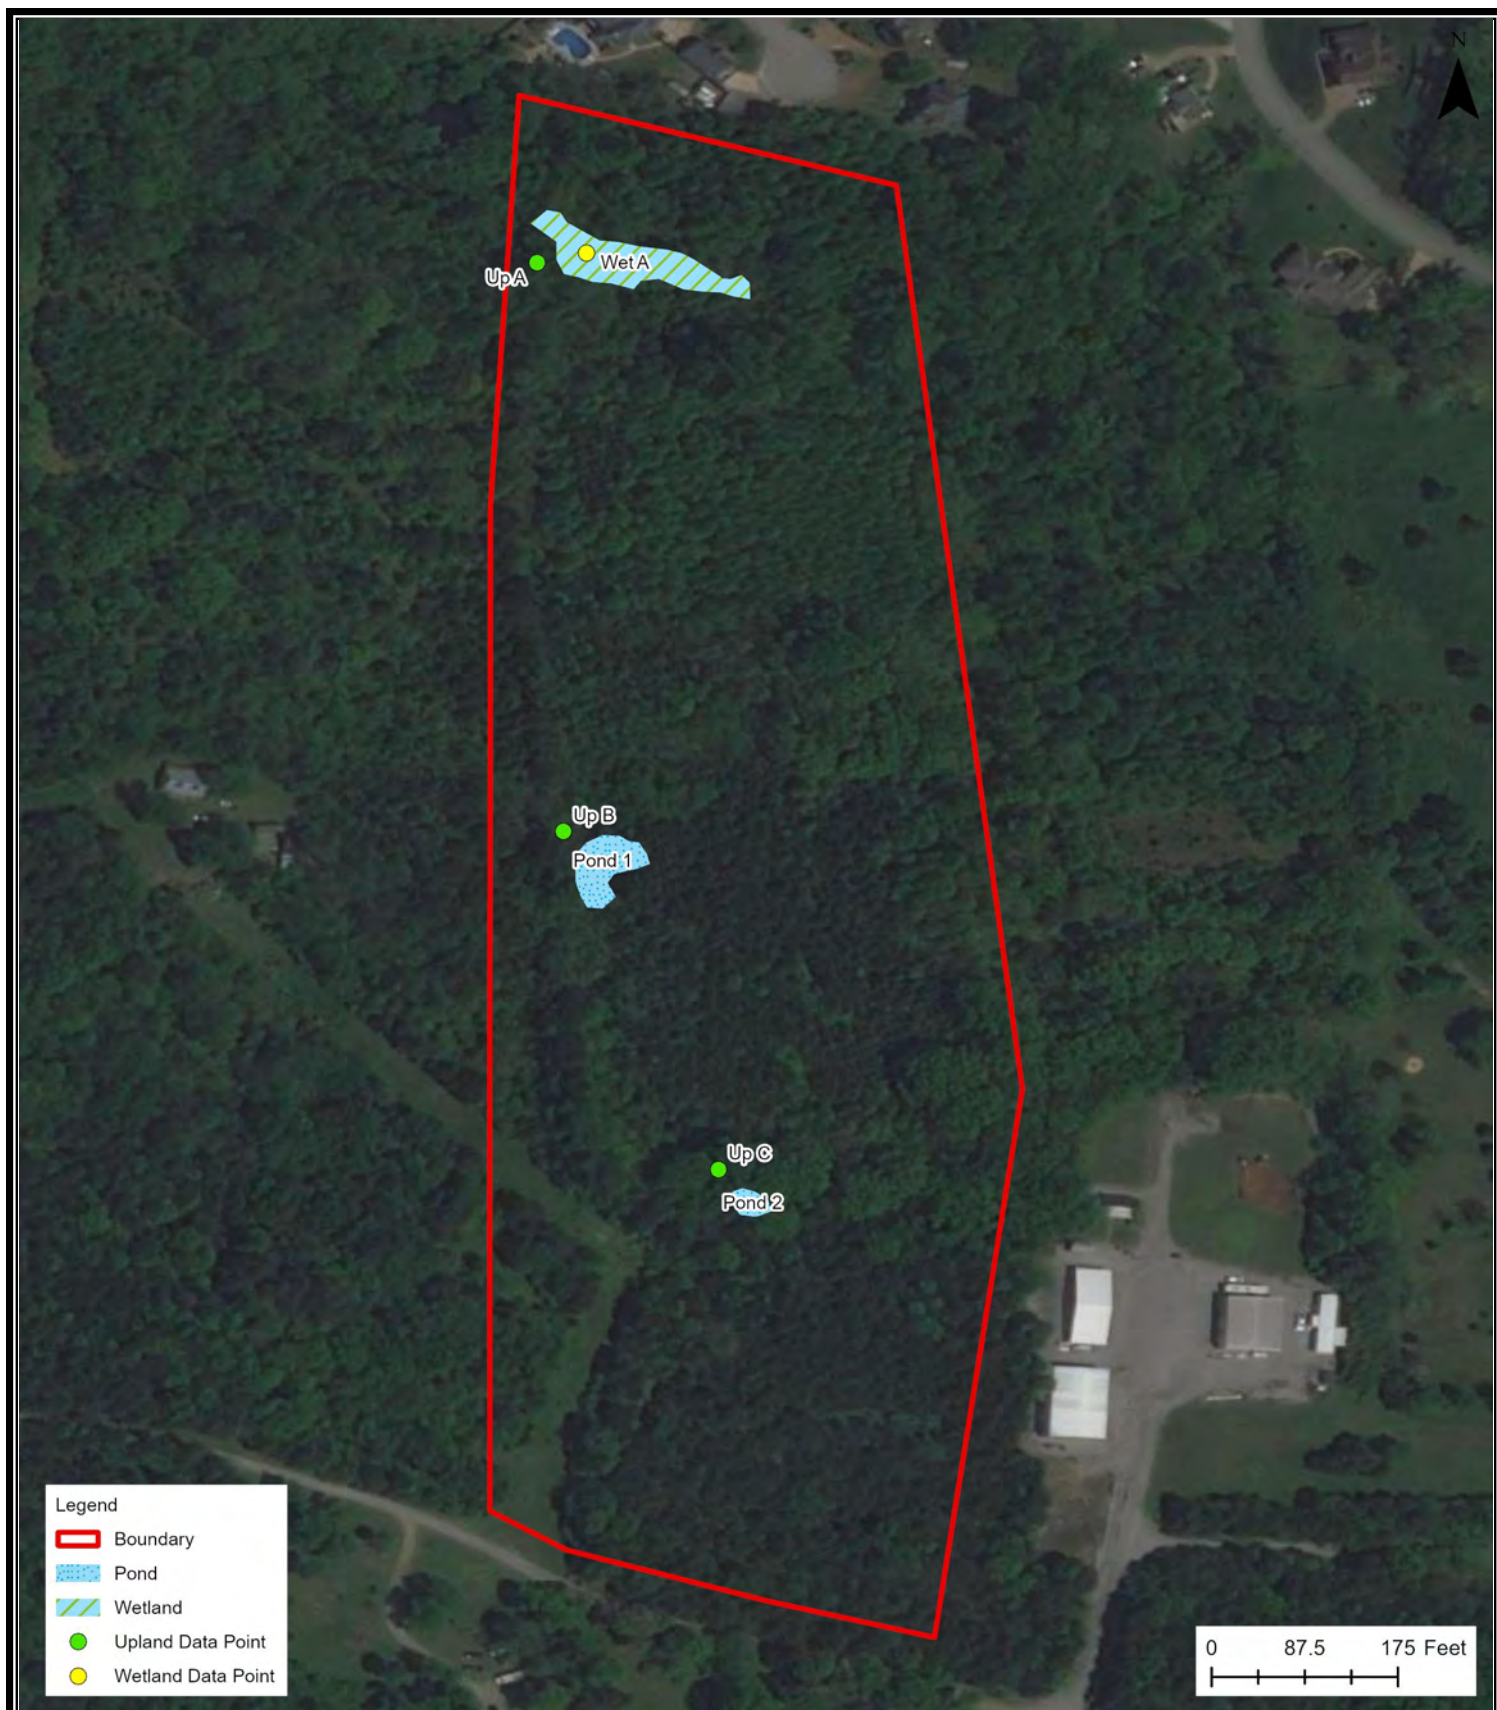
Site ID	Latitude (Decimal Degrees)	Longitude (Decimal Degrees)	Total Mapped		Average Width at OHWM	Classification	
			LF	Acre		Type	Cowardin
Pond 1	36.244549	-86.558506	-	0.08	-	Open Water Pond	-
Pond 2	36.243478	-86.558045	-	0.02	-	Open Water Pond	-
Wet A	36.246478	-86.558425	-	0.18	-	Forested Wetland	PFO1A

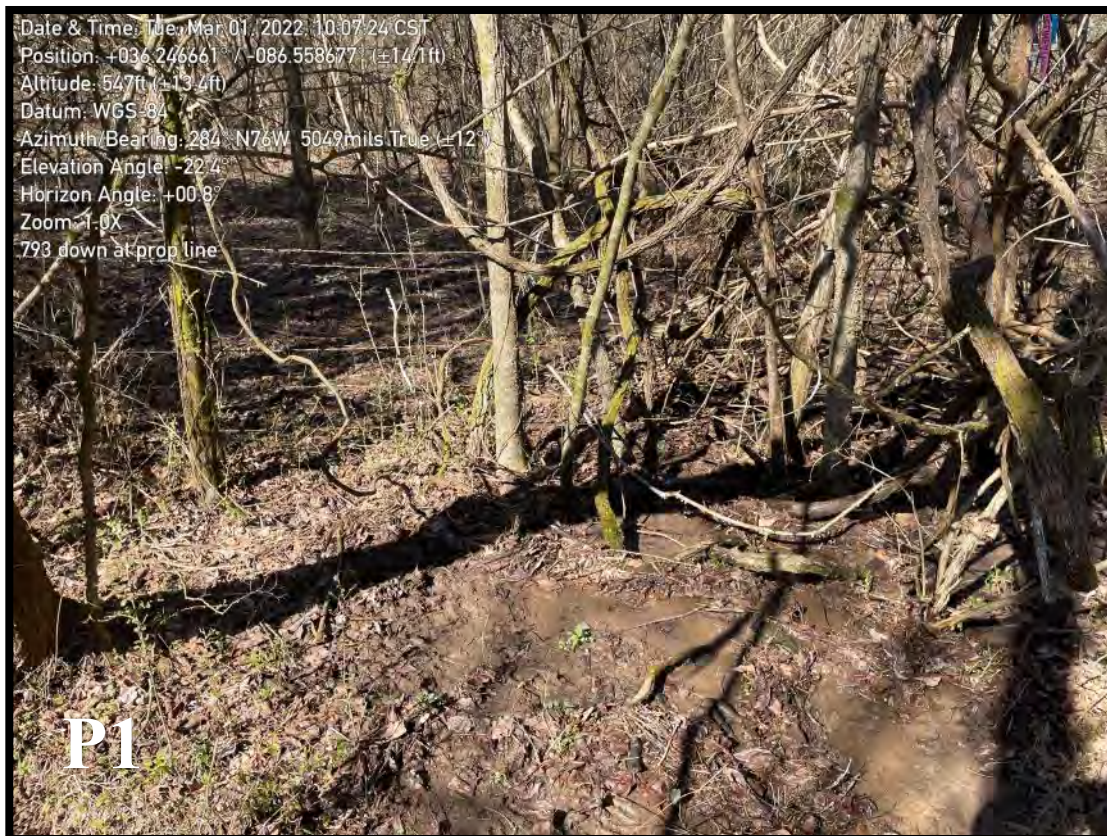
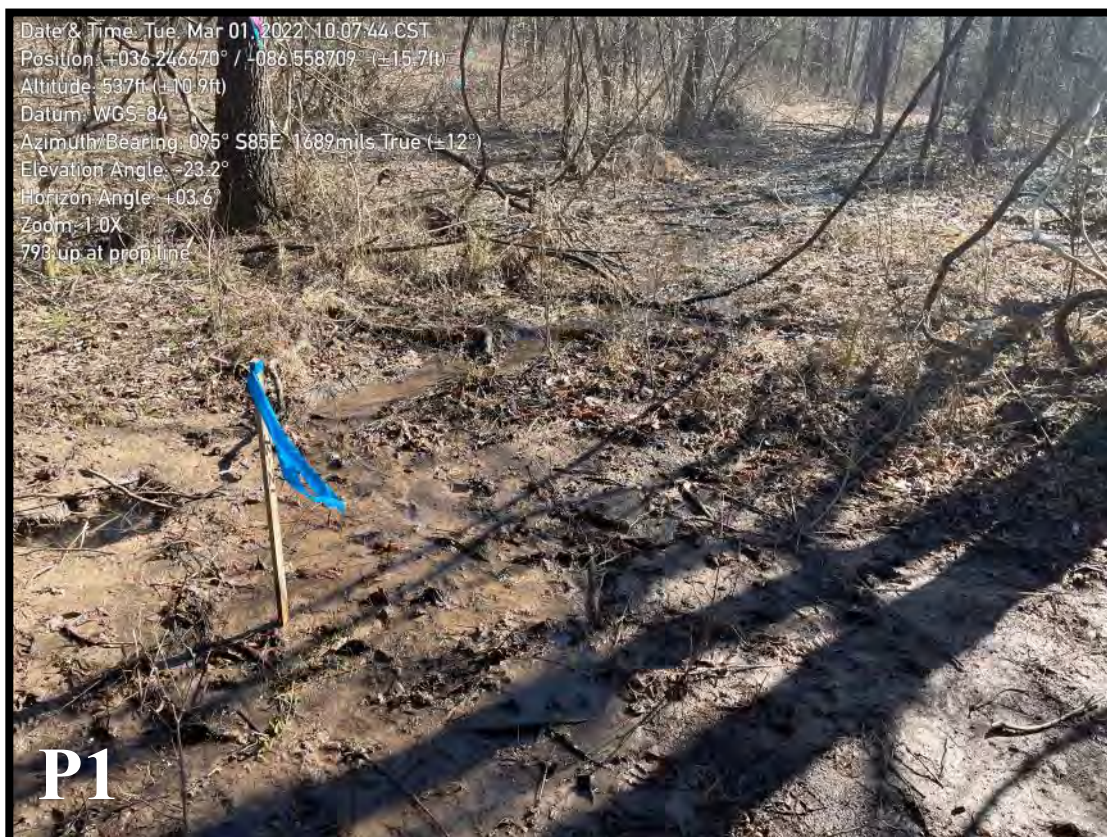
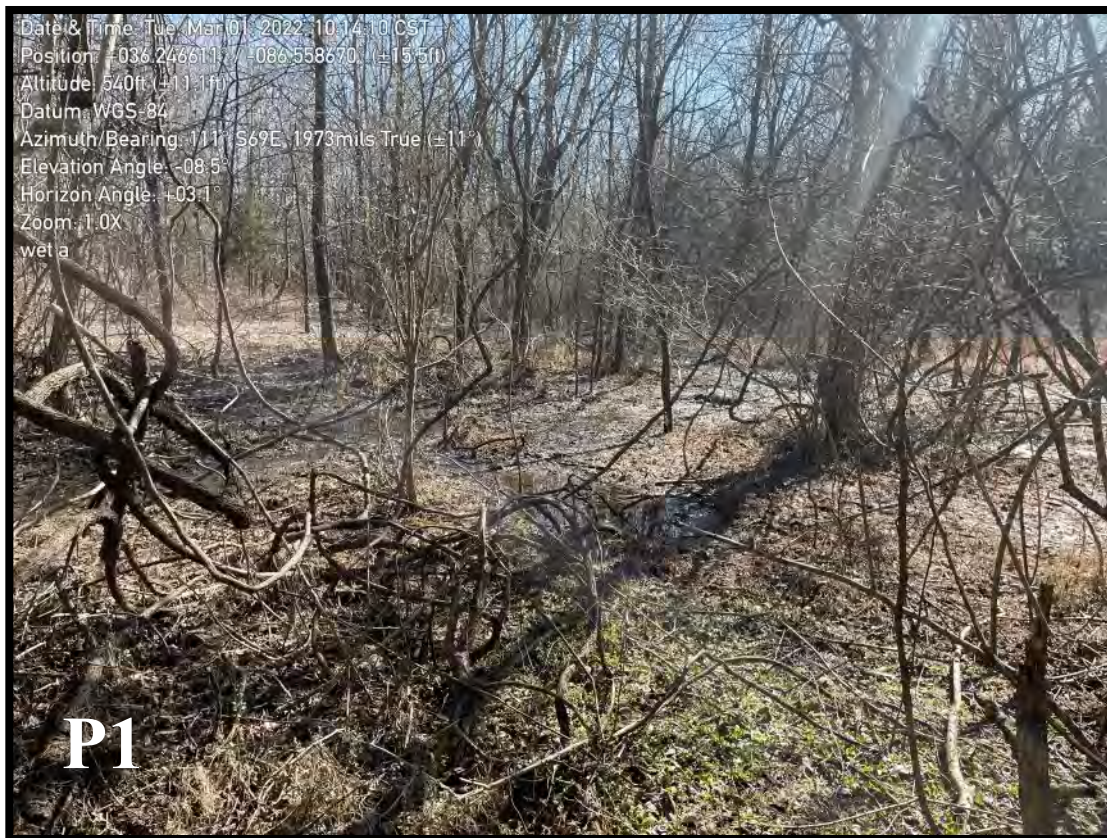
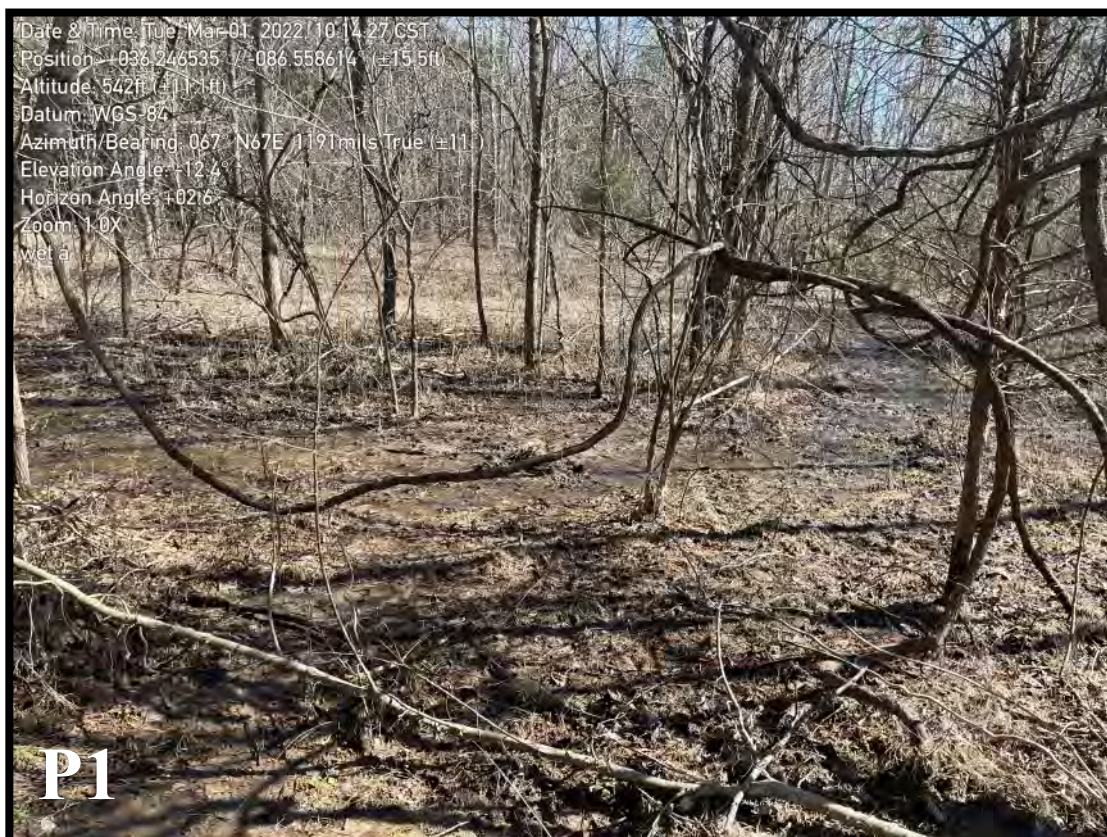
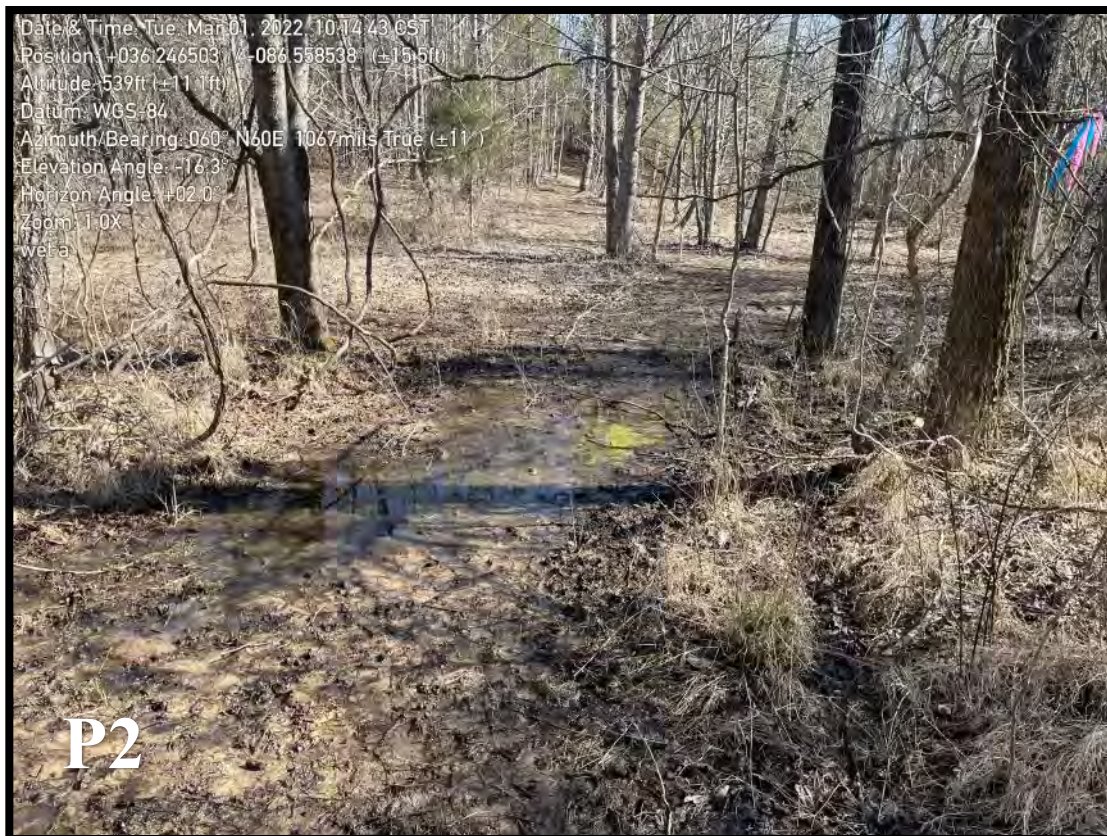
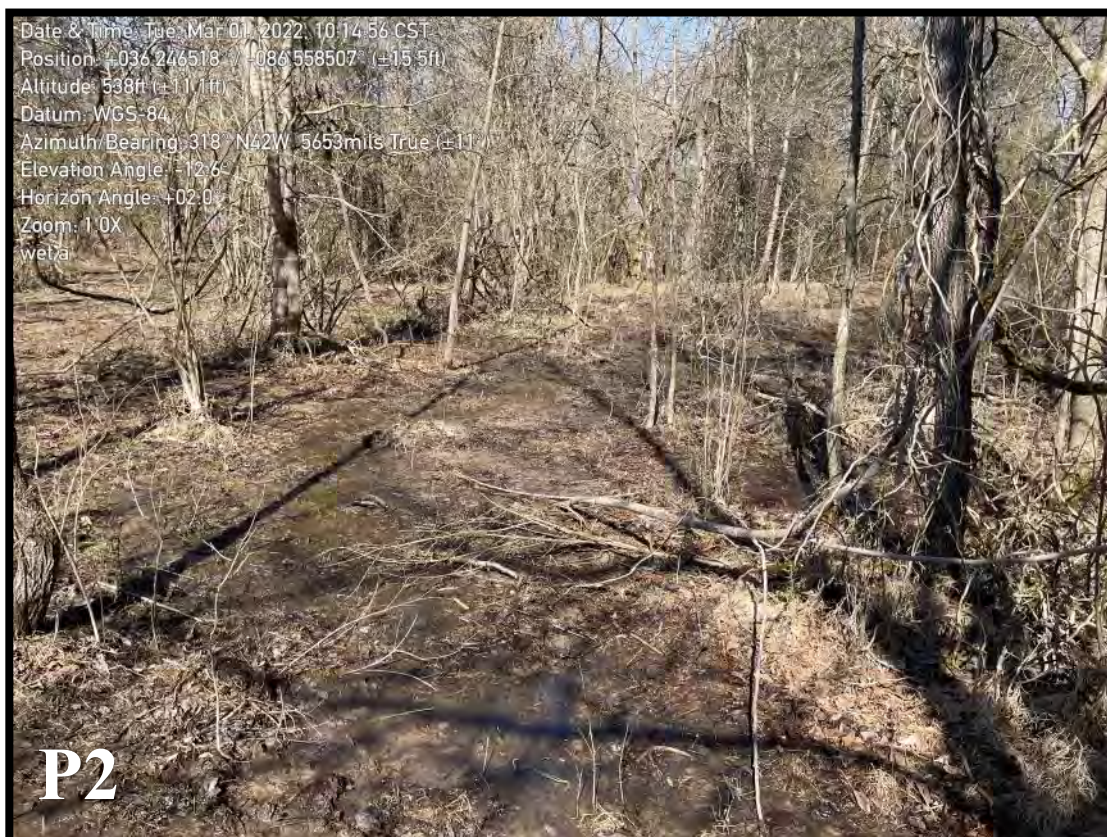
Wetland A (Wet A) is an isolated forested wetland measuring approximately 0.18 acres within the northern portion of the Project Area. During the March 1, 2022 site reconnaissance, surface water was observed within the boundary of the wetland. However, it was noted the wetland lacked connection to natural surface water features. Additional hydrology indicators include saturation, drift deposits, algal crust, water-stained leaves, geomorphic position, and FAC-neutral test. The dominant vegetation of Wet A includes Chinese privet (*Ligustrum sinense*), Amur honeysuckle (*Lonicera maackii*), Sugarberry (*Celtis laevigata*), Pin Oak (*Quercus palustris*), and Sweetgum (*liquidambar styraciflua*). Wetland A soils were acutely hydric within the first 0 to 4 inches having a matrix color of 10YR 4/2 with 2% redox concentrations of 7.5YR 4/3. The soil at a depth of 4 to 10 inches had a matrix color of 10YR 5/2 with 85% redox concentrations of 7.5YR 4/4. This soil qualified for the depleted matrix (F3) hydric soil indicator.

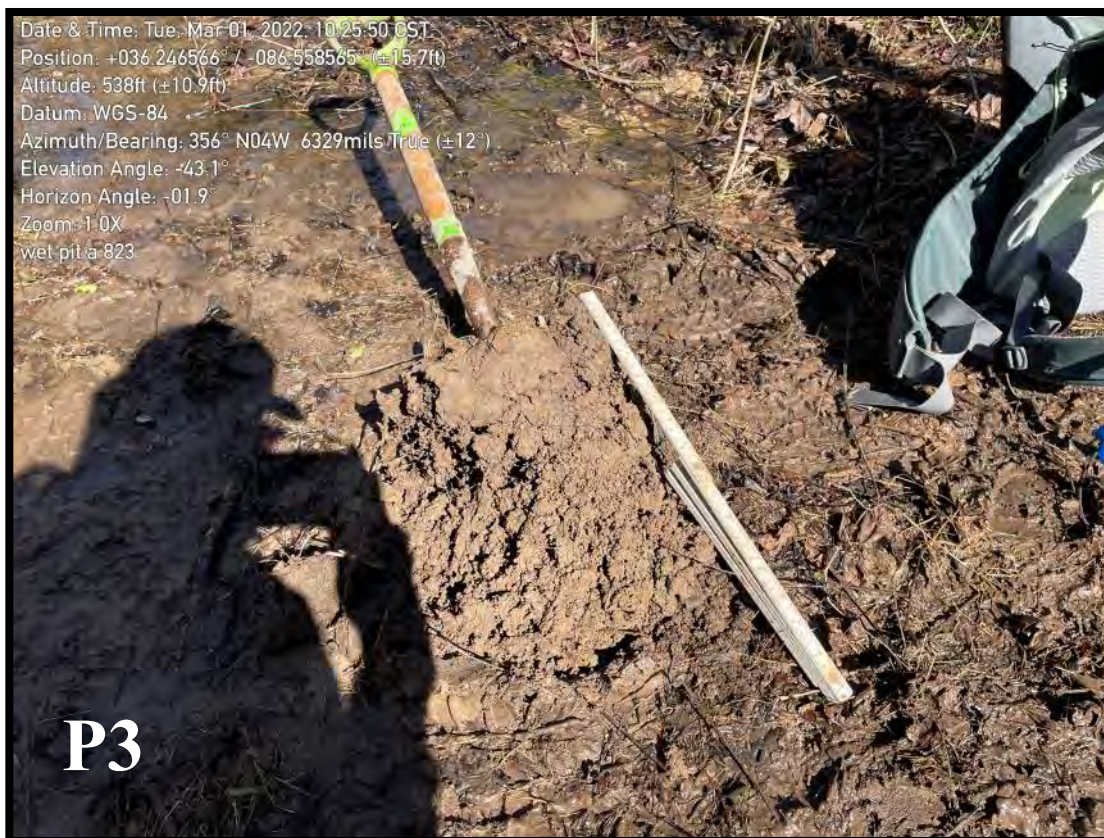
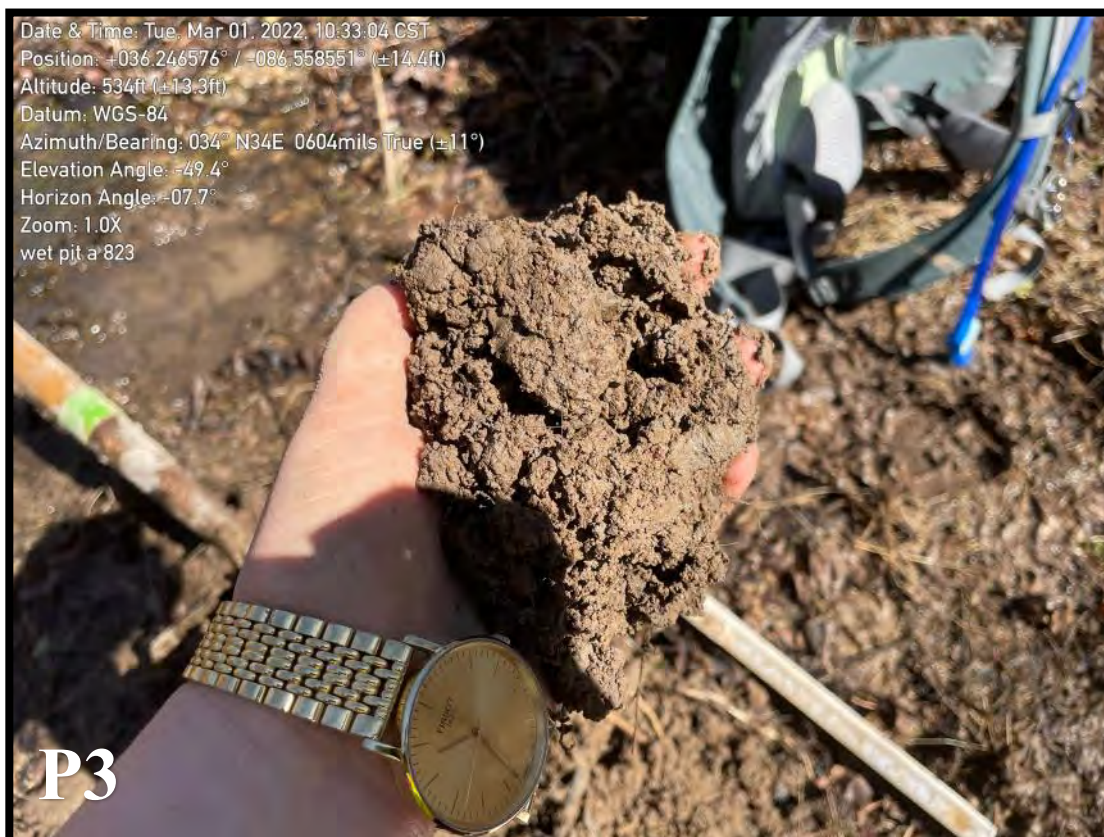
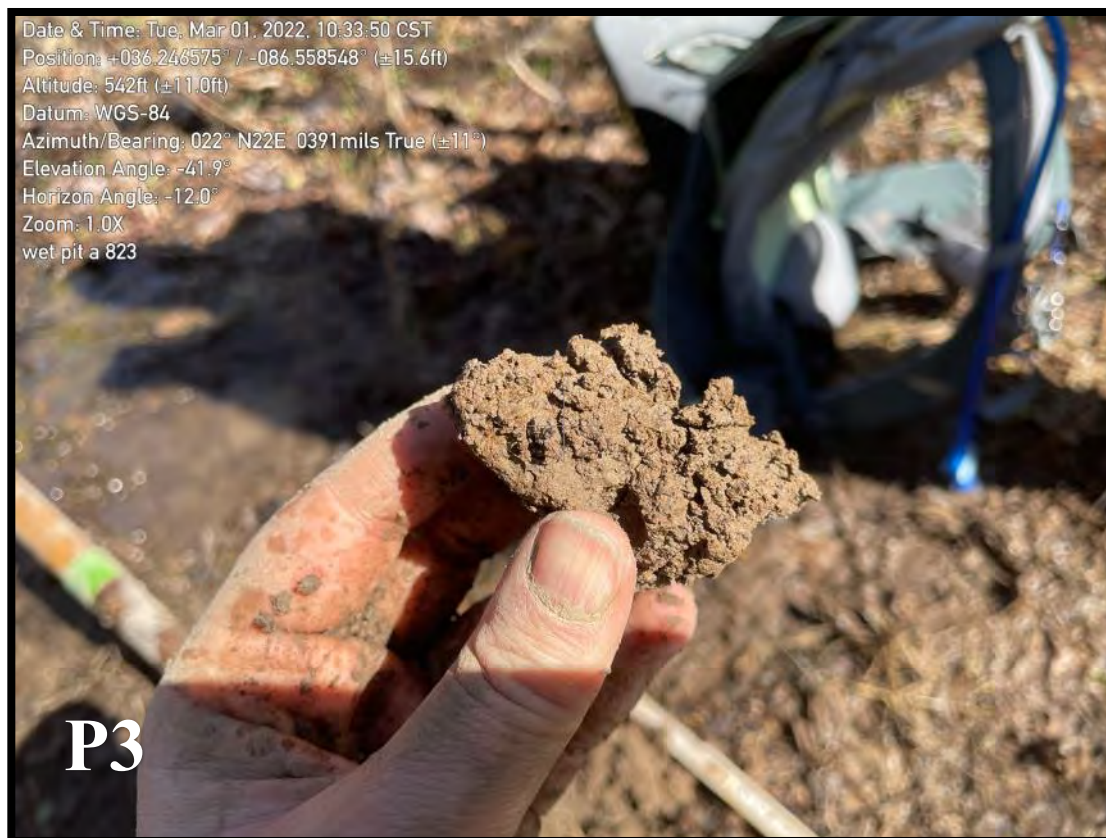
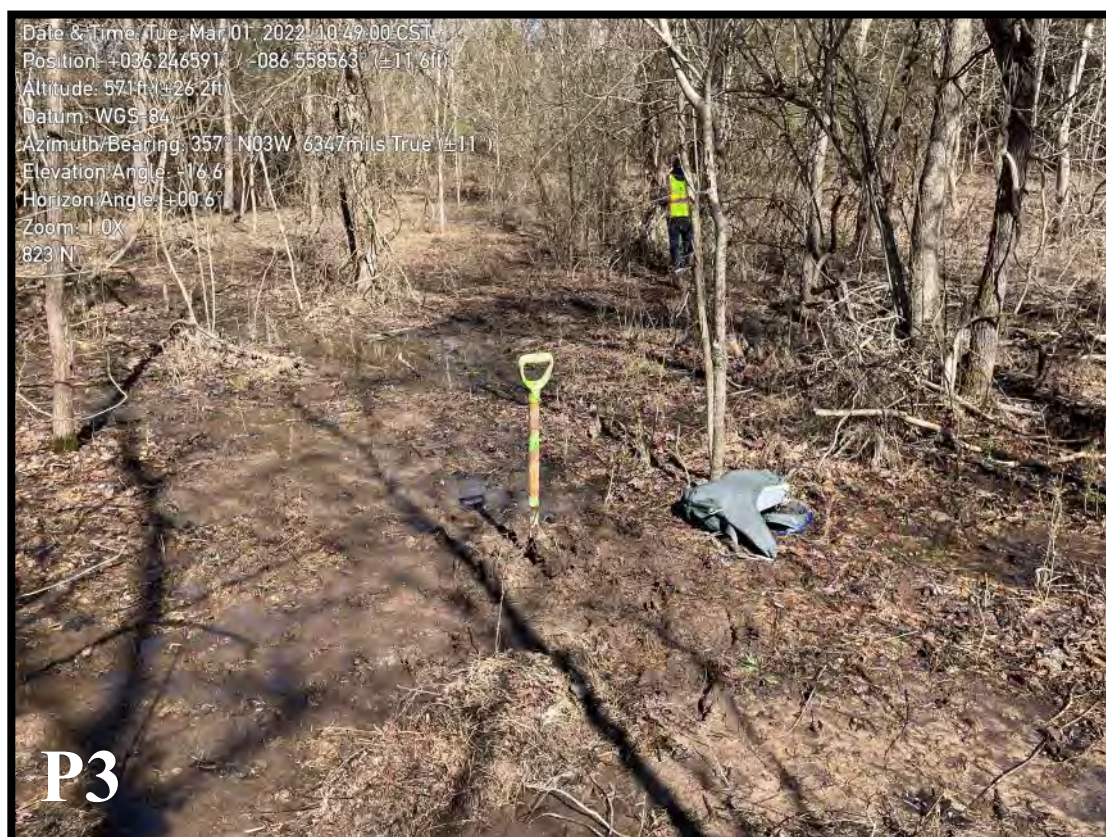
Wet Pit A

Depth (inches)	Matrix		Redox Features				Texture	Remarks
	Color (moist)	%	Color (moist)	%	Type ¹	Loc ²		
0-4	10YR 4/2	98	7.5YR 4/3	2	C	M	Loamy/Clayey	Faint redox concentrations
4-10	10YR 5/2	85	7.5YR 4/4	15	C	M	Loamy/Clayey	Distinct redox concentrations
