Subject: Hydrologic Determination
Hidden Harbor Drive Property (±18 Acres)
Mt. Juliet, Wilson County, Tennessee
Latitude 36.244700° North and Longitude -86.558100° West
Project No. 3611-001-31

Request for Hydrologic Determination

**Hidden Harbour Property
Mt. Juliet, Wilson County, Tennessee**

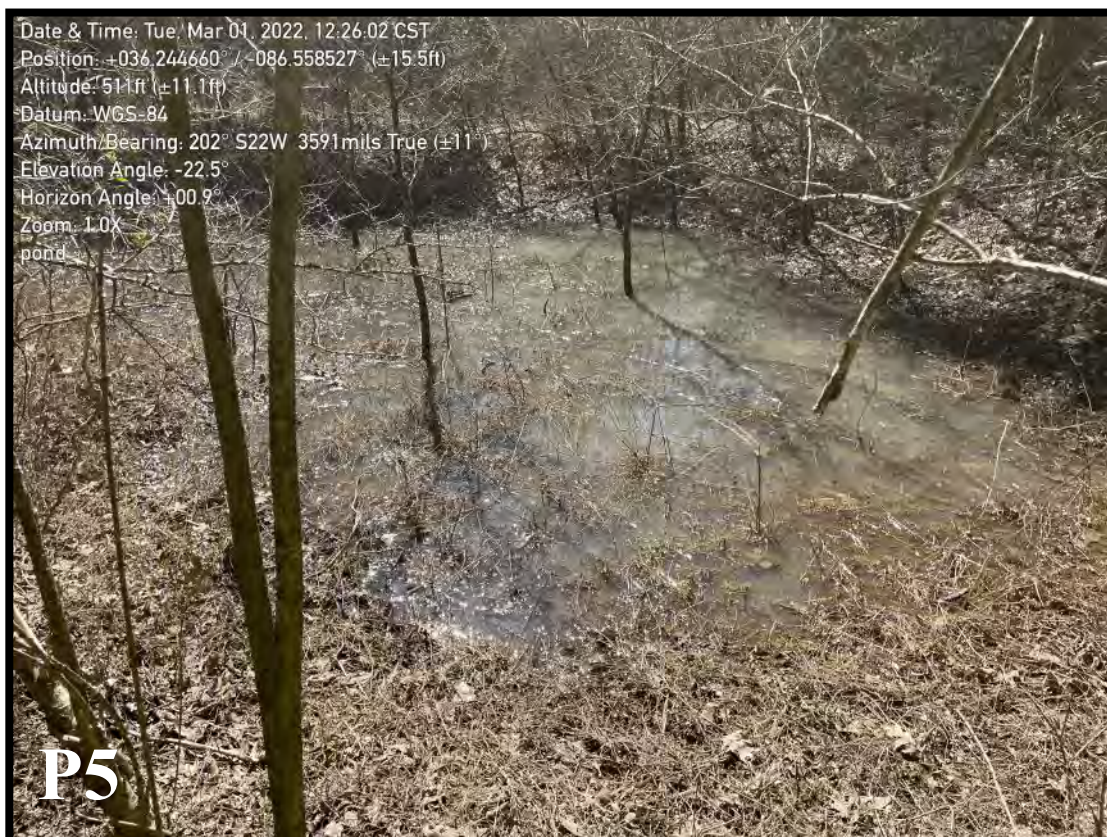
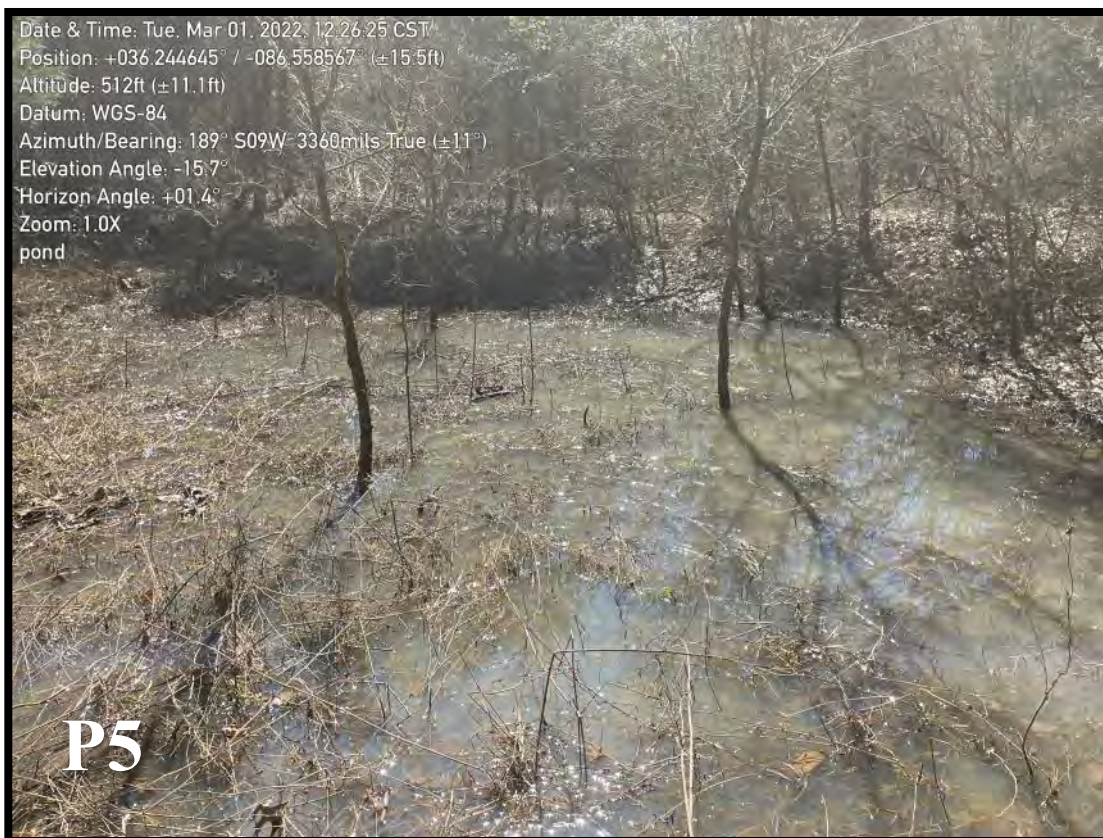
Pond 1 is an artificial pond excavated in the upland within the central portion of the Project Area adjacent to the western project boundary. This pond measures approximately 0.08 acres and receives runoff from the adjacent upland to the east. An earthen berm was constructed along the western and north-western perimeter of the pond. During the March 1, 2022 site reconnaissance, water was observed within the confines of the pond. However, it was noted the pond lacked connection to natural surface water features. A follow-up site visit on April 29, 2022, was conducted to determine if artificial Pond 1 had direct connectivity with groundwater. A soil boring, Boring A, was advanced immediately outside of Pond 1 to a depth of 30” below soil surface. No groundwater was observed during the advancement of the boring. After an hour, the boring was reevaluated, and no groundwater was observed. Figure 9 provides a plan view of the location of this soil boring. This data supports the determination that Pond 1 is an artificial pond lacking connectivity to groundwater. Further, Pond 1 was observed to only capture non-point source surface water runoff from the adjacent upland.

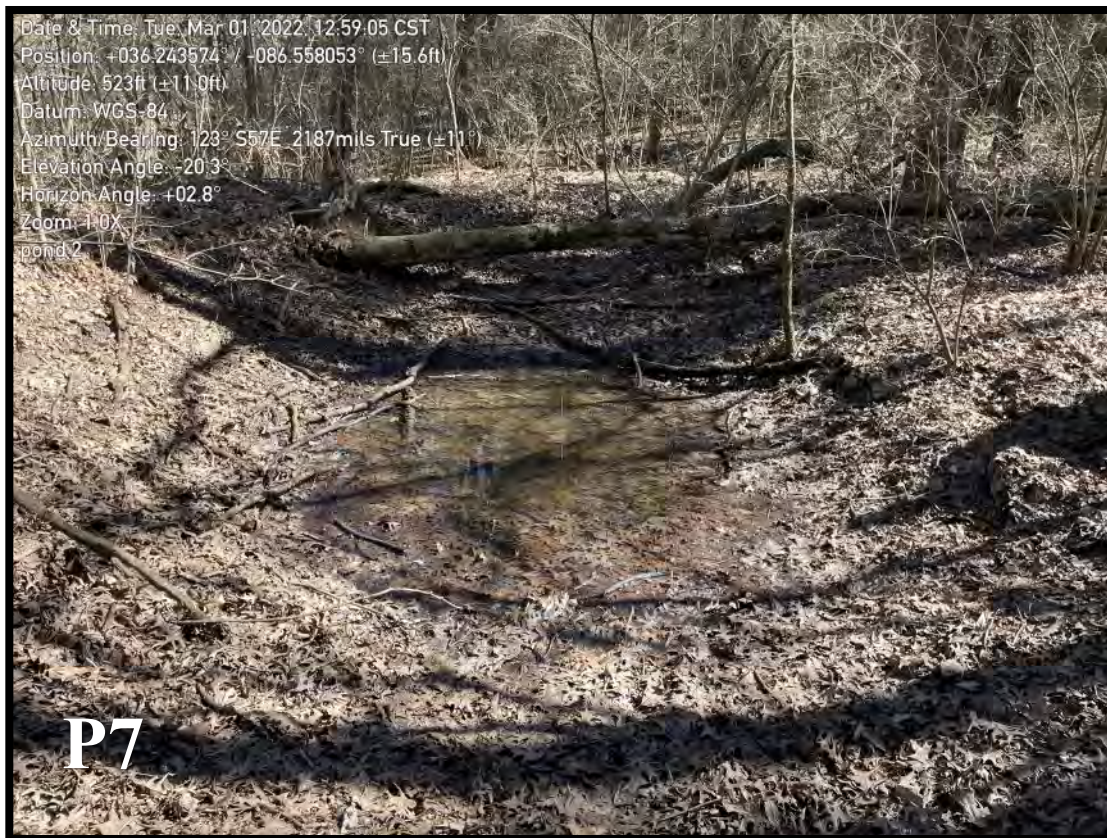
Pond 2 is an artificial pond excavated in the upland located within the southern portion of the Project Area. This pond measures approximately 0.02 acres and receives runoff from the adjacent upland to the south. An earthen berm surrounds the perimeter of the pond. During the March 1, 2022 site reconnaissance, water was observed within the confines of the pond, however the pond lacked connection to natural surface water features. A follow-up site visit on April 29, 2022, was conducted to determine if Pond 2 had direct connectivity with groundwater. Spectrum advanced one soil boring, Boring B, in a lower gradient area northwest of Pond 2. This soil boring was terminated in a dense, silty clay at a depth of 25” below surface. No groundwater was observed during the advancement of the boring. After an hour, the boring was reevaluated, and no groundwater was observed. Figure 9 provides a plan view of the location of this soil boring. This data supports the determination that Pond 2 is an artificial pond lacking connectivity to

groundwater. Further, Pond 2 was observed to only capture non-point source surface water runoff from the adjacent upland.

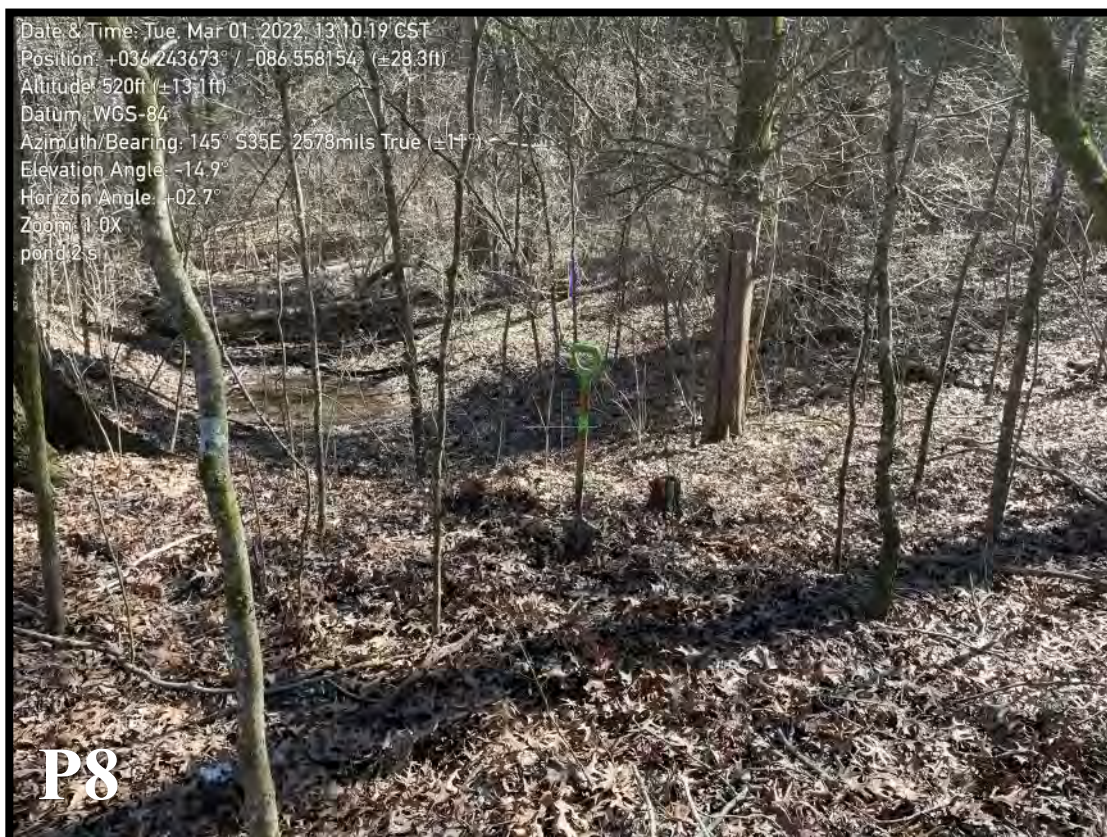
Up Pit C looking south
