Re: Hydrologic Determination and Pond Assessment  
Adams Circle Site (Tax Map 42 Parcel 34.00)  
Fairview, Williamson County, Tennessee

### ***Hydrologic Determination***

### ***Ponds***

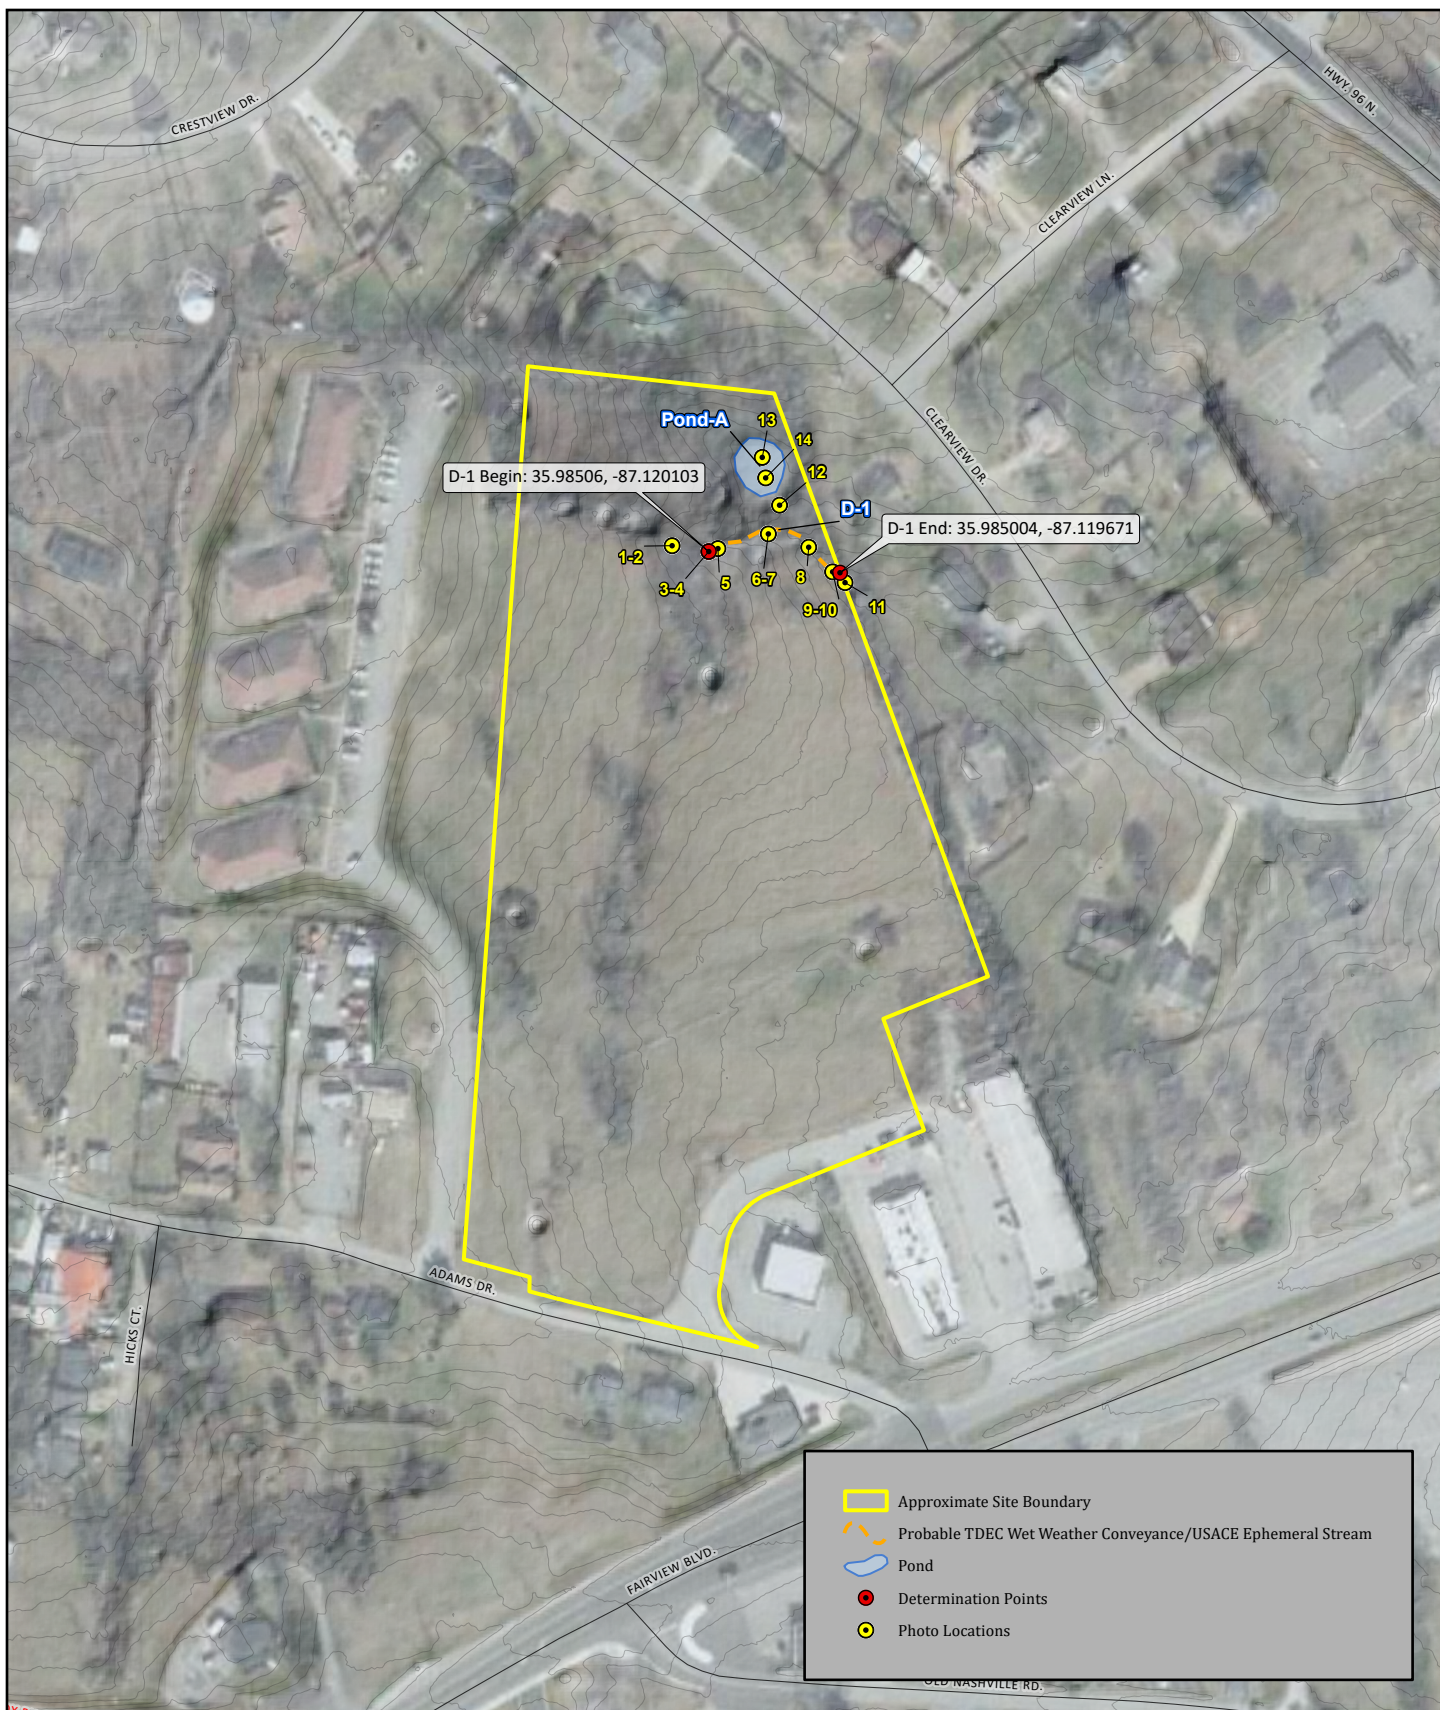
**Figure 2. Summary of aquatic resources and locations of photographs.**  
**Adams Circle Site**  
**Fairview, Williamson County, Tennessee**

The assessed watercourse is mapped on Figure 2. A summary of the assessed watercourse is included in Table 1. The Hydrologic Determination Field Data Sheet for the assessed watercourse is included in Appendix 4. Representative photographs of the assessed watercourse are included in Appendix 5 and the locations of the photographs are shown on Figure 2.

A pond (Pond-A) located in the northern portion of the site, upslope of D-1, is shown on Figure 2 and summarized in Table 2. Representative photographs of the pond have been included in Appendix 5 and the locations of the photographs are shown on Figure 2. This pond is formed by an earthen dam constructed across a topographic swale. At the time of the site visit, the feature was dry, and no evidence of a groundwater connection was noted. The soils did not exhibit hydric characteristics and the flora of the immediate area was not dominated by hydrophytic species.

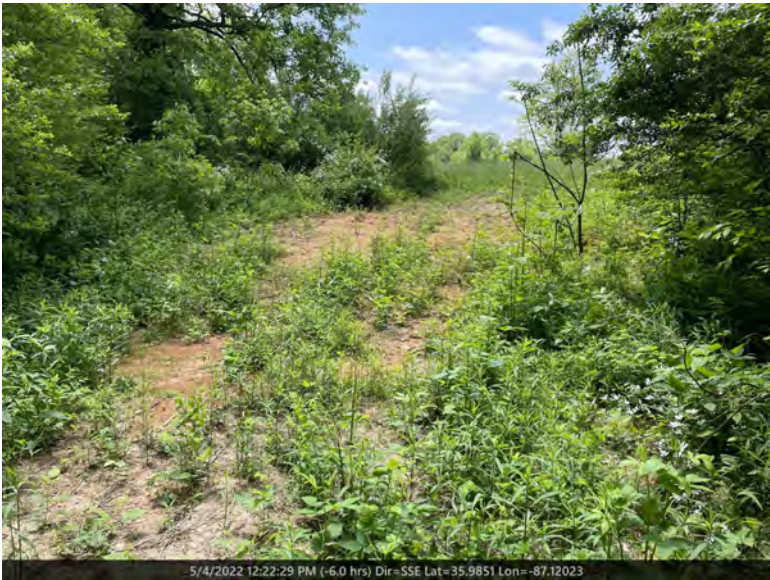
1 View of disturbed area upgradient of D-1 origin, facing southeast.

Upper portion of reach appears to have been filled, vegetation is cleared and mowed. Channel forms below this area, travels downslope adjacent to dry pond, then exits the property and loses definition in residential yard.

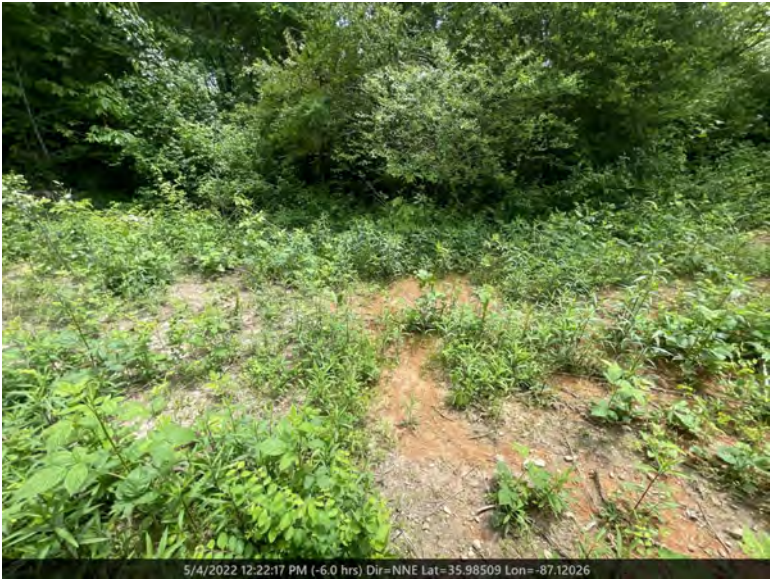
2 View from disturbed area upgradient of D-1 origin point, looking toward the assessed channel and facing northeast.

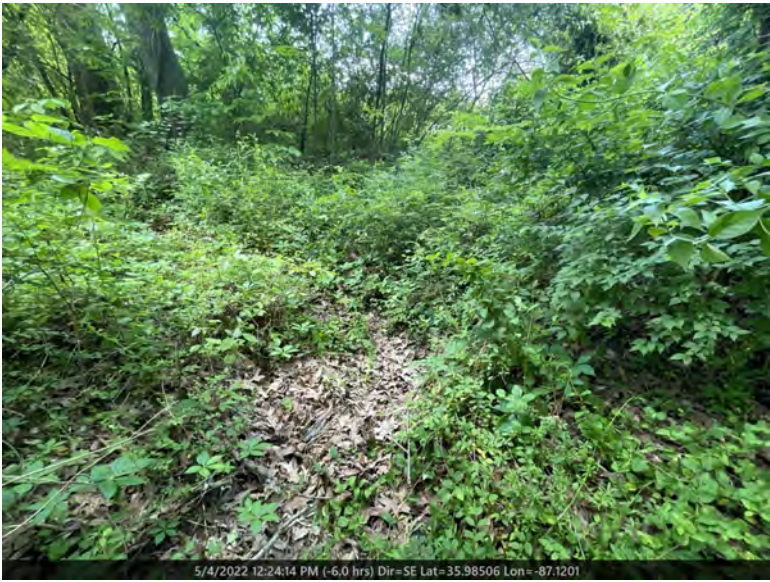
3      View of D-1 origin showing dense vegetation and leaf litter upgradient of origin point, facing southwest.

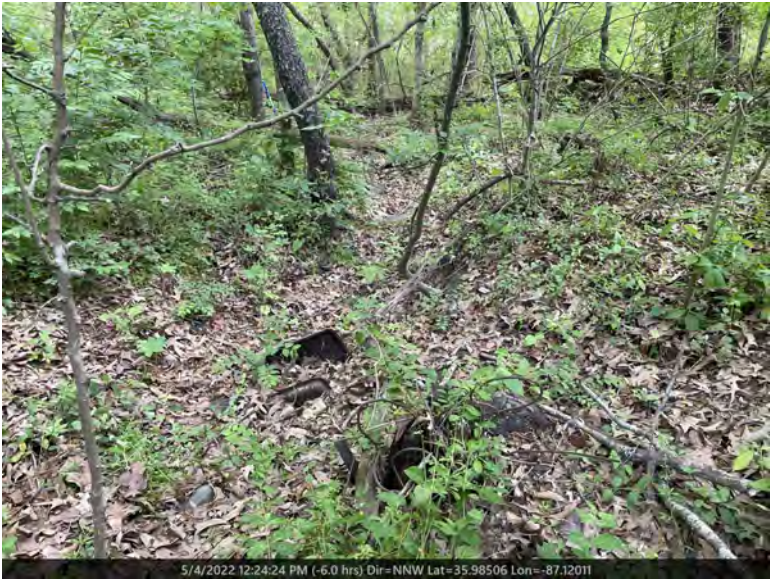
4      View of D-1 origin showing dense leaf litter and dumped trash, facing downgradient to the northeast.

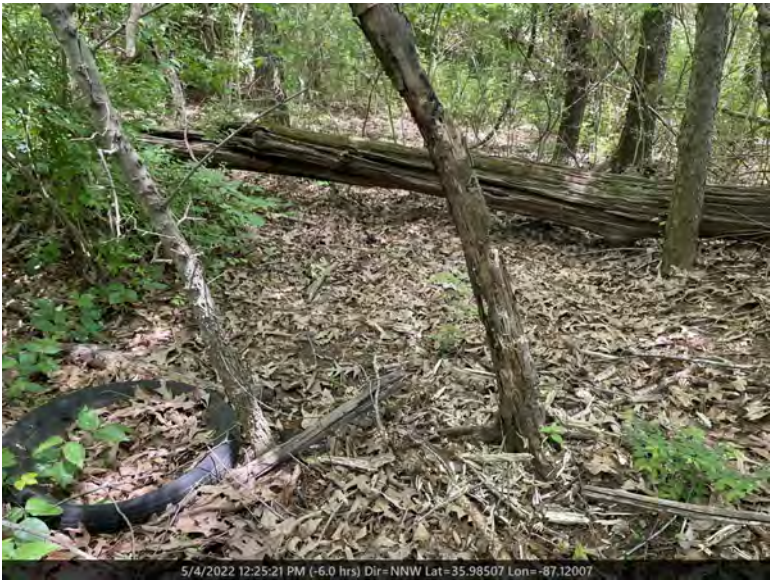
5      View of poorly defined channel within upper reach of D-1, facing downgradient to the northeast.

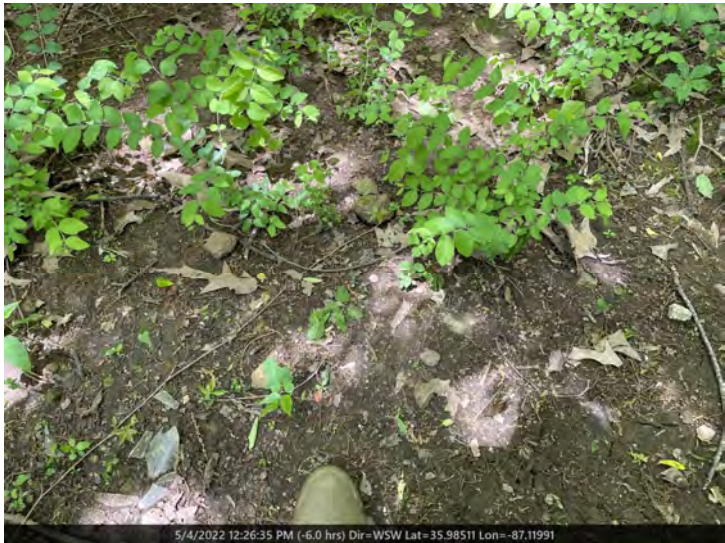
6      View of soil substrate and upland vegetation within D-1 mid-reach, facing down.

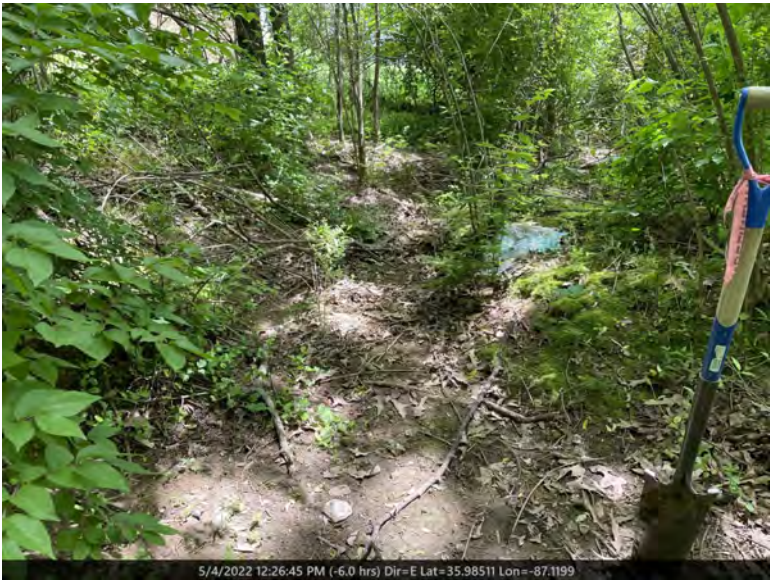
7      View of small debris piles and soil substrate within the poorly-defined D-1 channel, facing downgradient to the east.

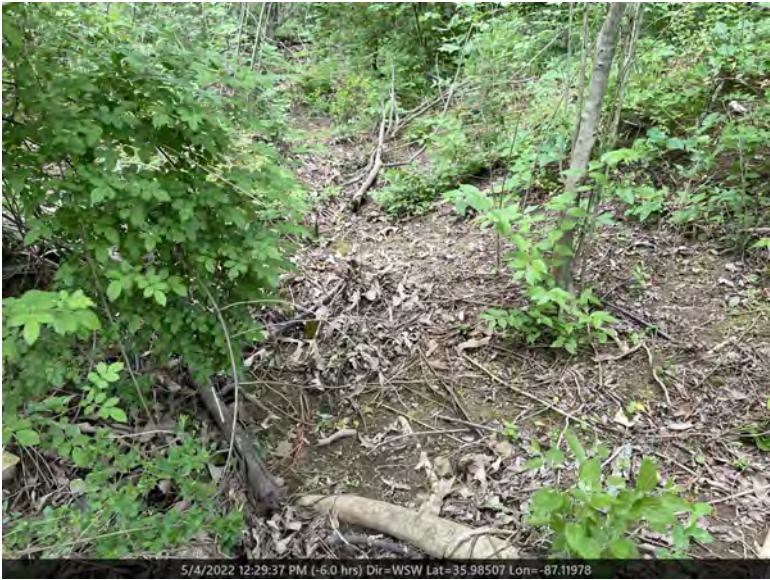
8      View of organic debris piles within D-1, facing upgradient to the northwest.

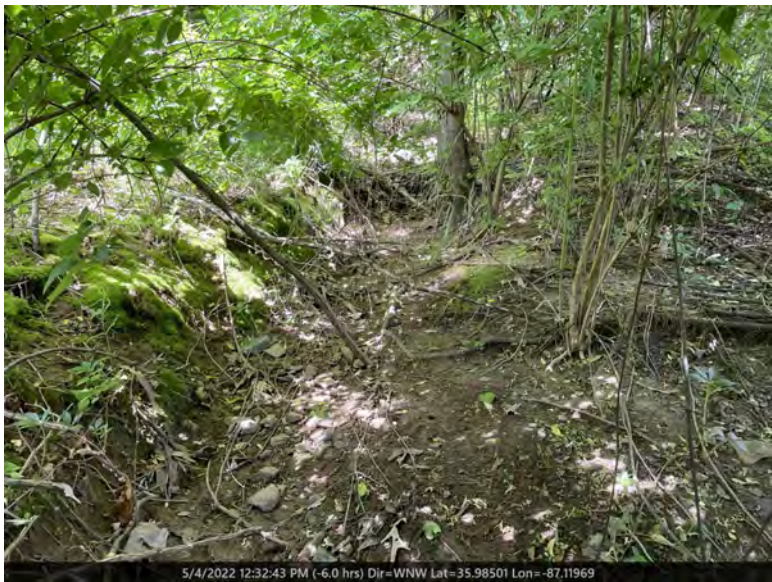
9 View of D-1 lower reach showing increased bed/bank definition, organic debris, and cobble/gravel on soil-dominant substrate, facing upgradient to the northwest.

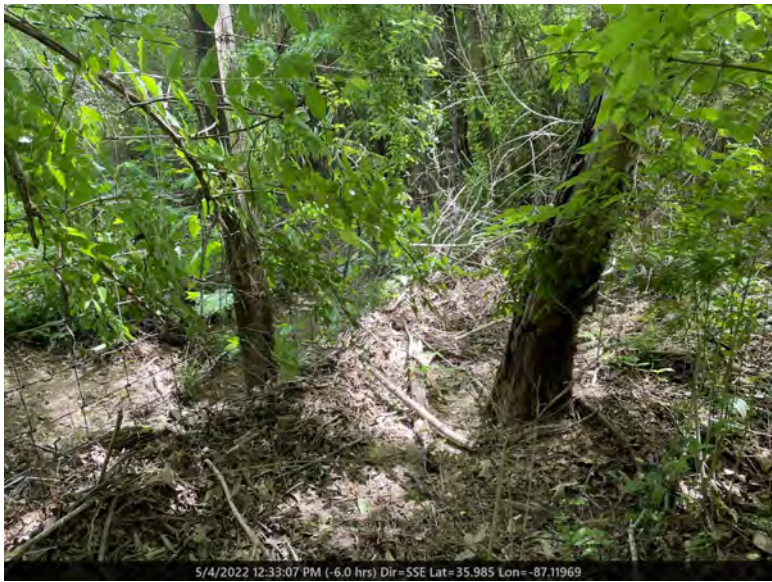
10 View of D-1 at the eastern site boundary, showing large leaf pack against the fence line; facing downgradient to the southeast

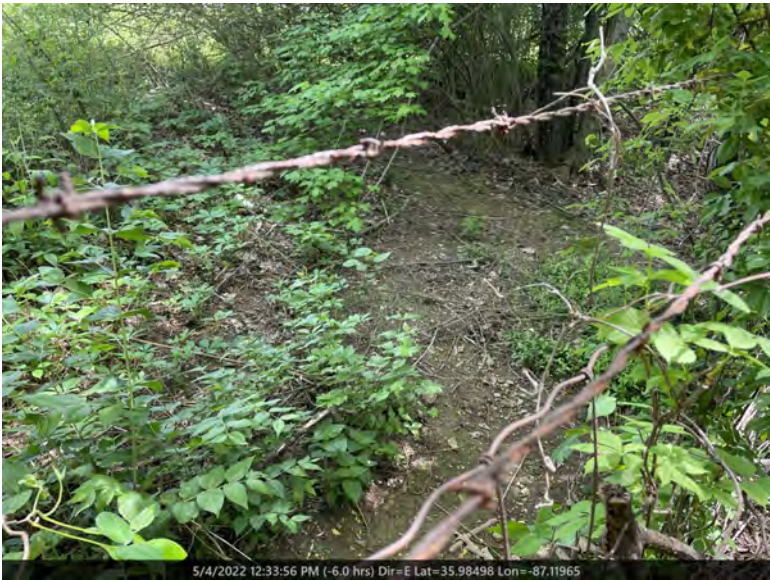
11      View of D-1 beyond the site boundary, showing loss of definition as the channel approaches residential yards; facing downgradient to the southeast.

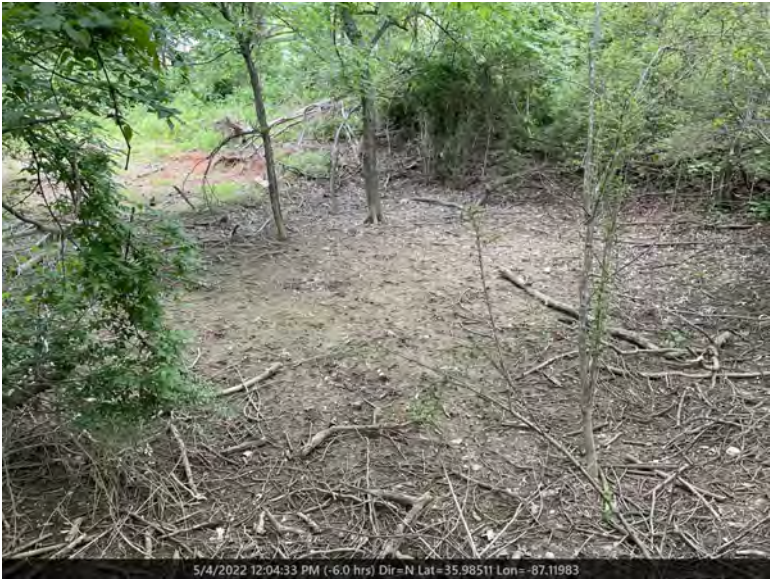
12      View of dry conditions within Pond-A, facing north.

Based on the observed conditions, this feature appears to be a seasonal non-jurisdictional farm pond that has been constructed in uplands.

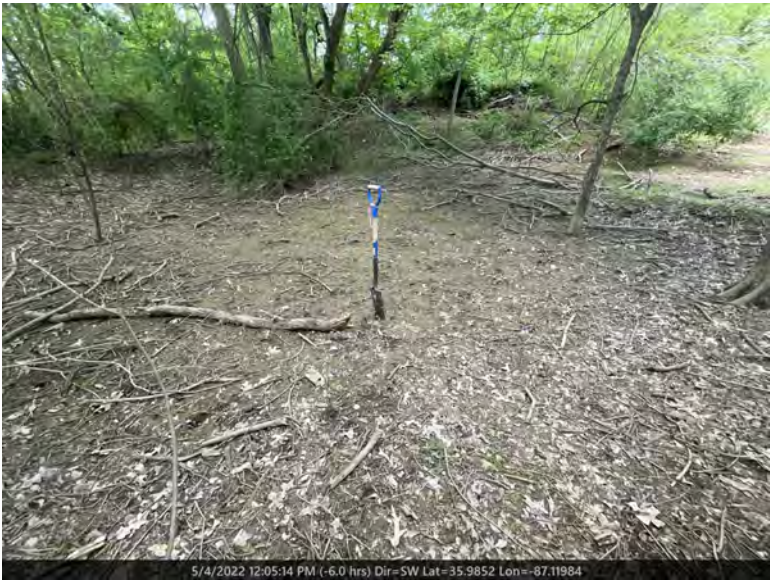
13      View of dry conditions within Pond-A, showing disturbed areas and breached berm in background, facing southwest.

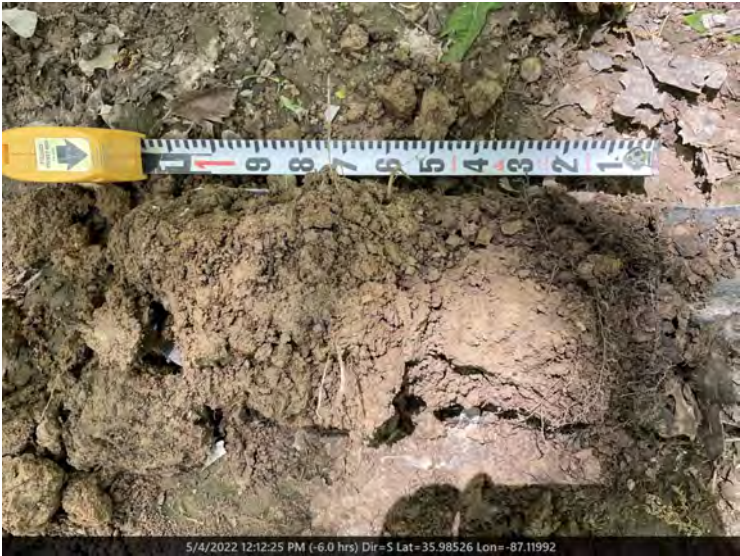
14      View of upland soils (10YR 5/3) within Pond-A, facing down.
