Re: Jurisdictional Waters Evaluation Report

20 Sanker Road; Dickson, Tennessee

TriAD Project No.: 19-TEN01-01

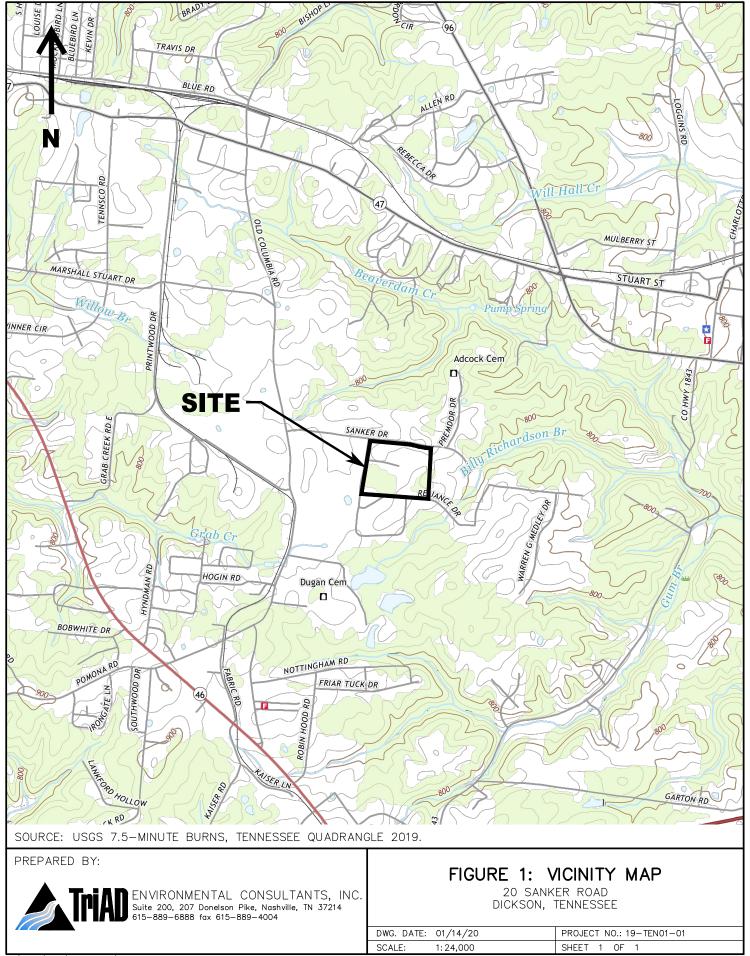
Figure 1

- <u>2019 USGS Burns, Tennessee Topographic Map (Figure 1)</u> No hydrologic features are identified on or immediately adjacent to the Site.
- <u>U.S. Fish and Wildlife Service, NWI Map (Figure 3)</u> A freshwater pond is identified
  in the central portion of the Site. No other hydrologic features are identified on or
  immediately adjacent to the Site.
- NRCS Websoil Survey for Dickson County, Tennessee (Attachment 1) Site soils are identified as Dickson silt loam, 2 to 5 percent slopes; Melvin silt loam, frequently flooded; Sengtown gravelly silt loam, 5 to 12 percent slopes; and Sengtown gravelly silt loam, 30 to 60 percent slopes. Melvin silt loam, frequently flooded, is listed on the NRCS Hydric Soils List for Dickson County, Tennessee.
- <u>TDEC Water Quality Assessment and Permits Map Viewer</u> No hydrologic features are identified on or immediately adjacent to the Site.

Vicinity Map

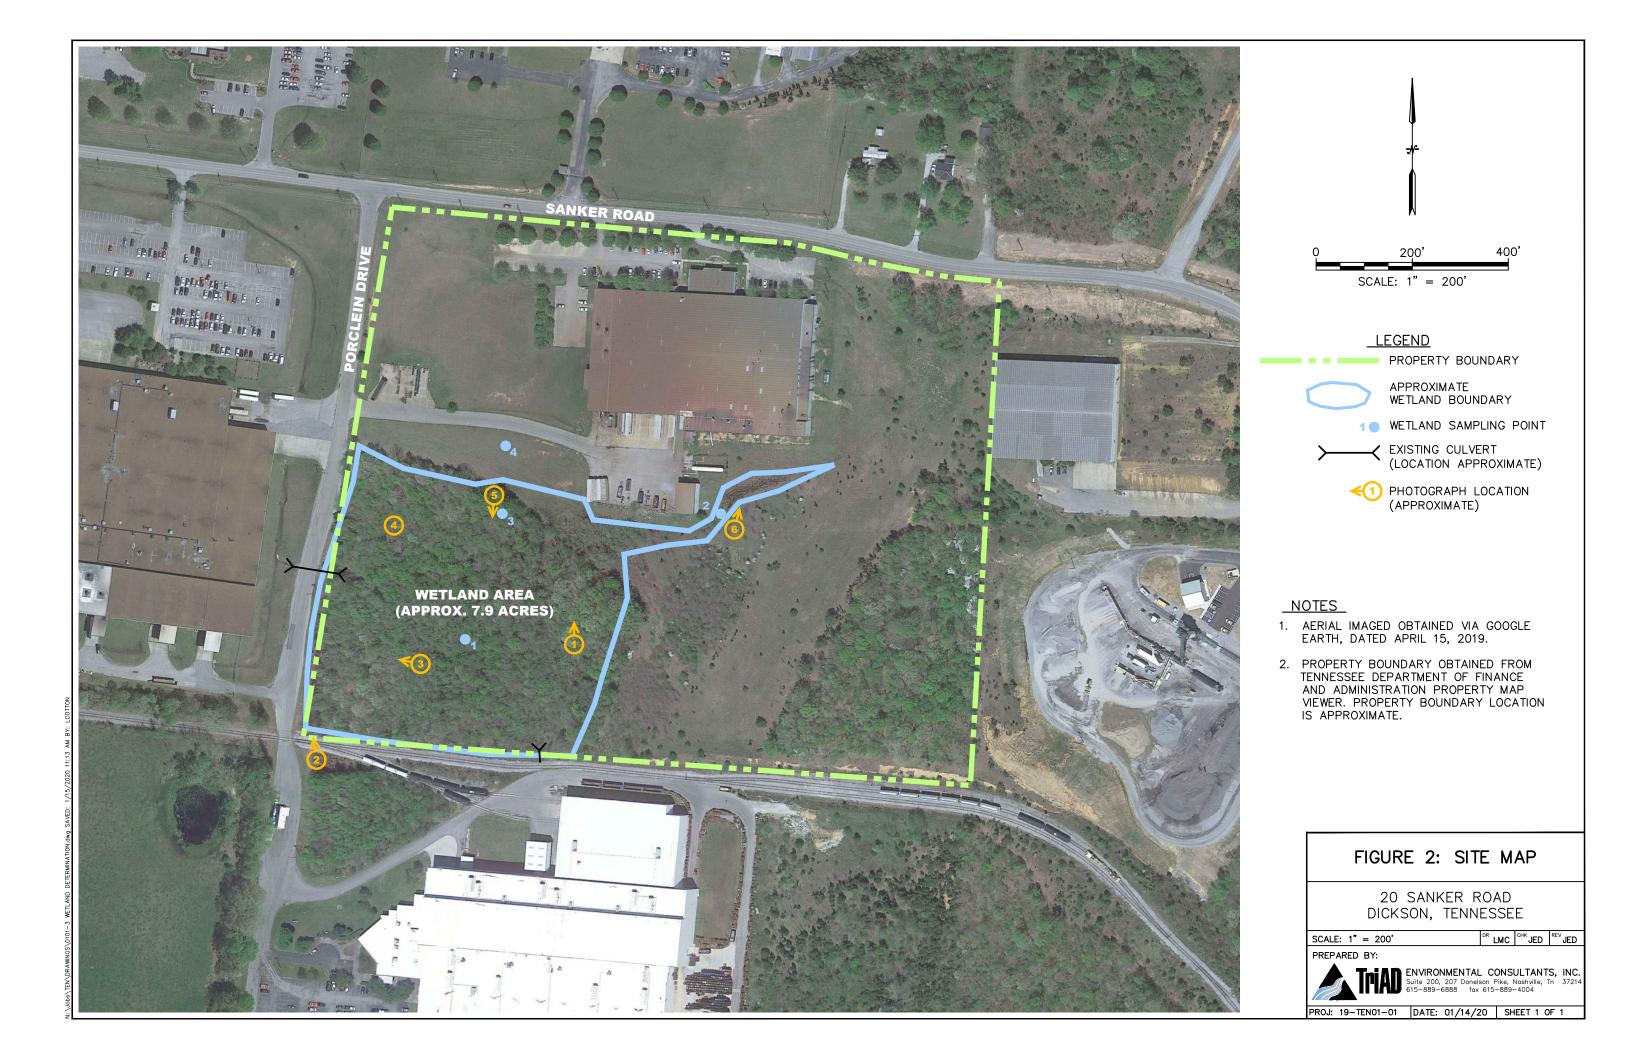
Figure 2

During the field survey, low-lying areas of standing water and saturated soils were noted immediately south of the developed portions of the facility and within the wooded areas of the Site located in the southwest portion of the property. The previous 7-day rainfall at the time of the survey was approximately 1.86 inches (NOAA – Dickson, TN) with approximately 0.2 inches occurring within the previous 48 hours. Stormwater runoff from the property is restricted to the southwest by Porclein Drive and the railroad along the southern property boundary. A culvert running under Porclein Drive was identified actively conveying flow from the low-lying southwest portions of the Site to a roadside ditch on the west side of Porclein Drive. A second culvert was identified under the railroad along the southern property boundary and appeared to be a stormwater conveyance originating from the adjacent property to the south.

Site Map

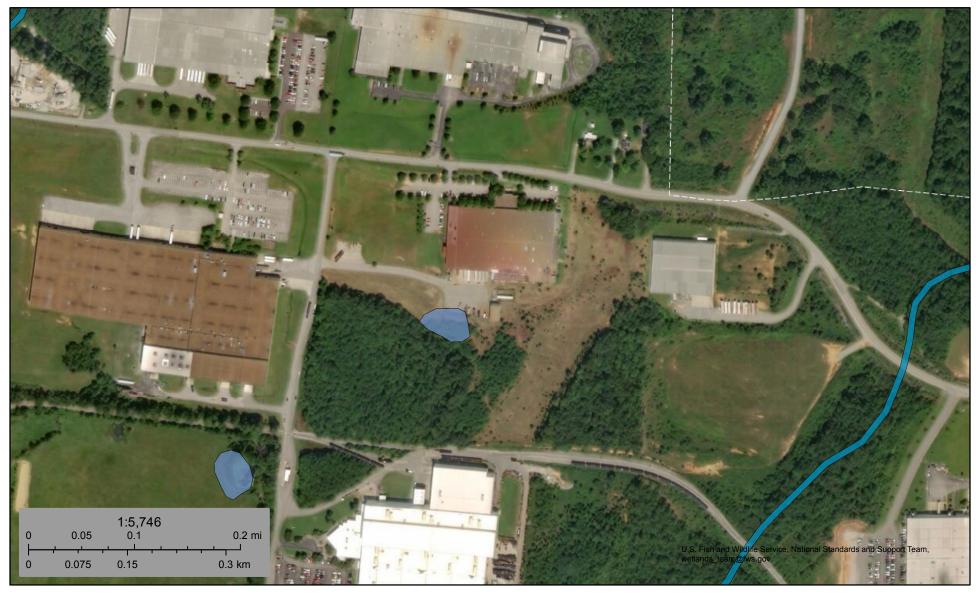
Figure 3

**NWI Map**

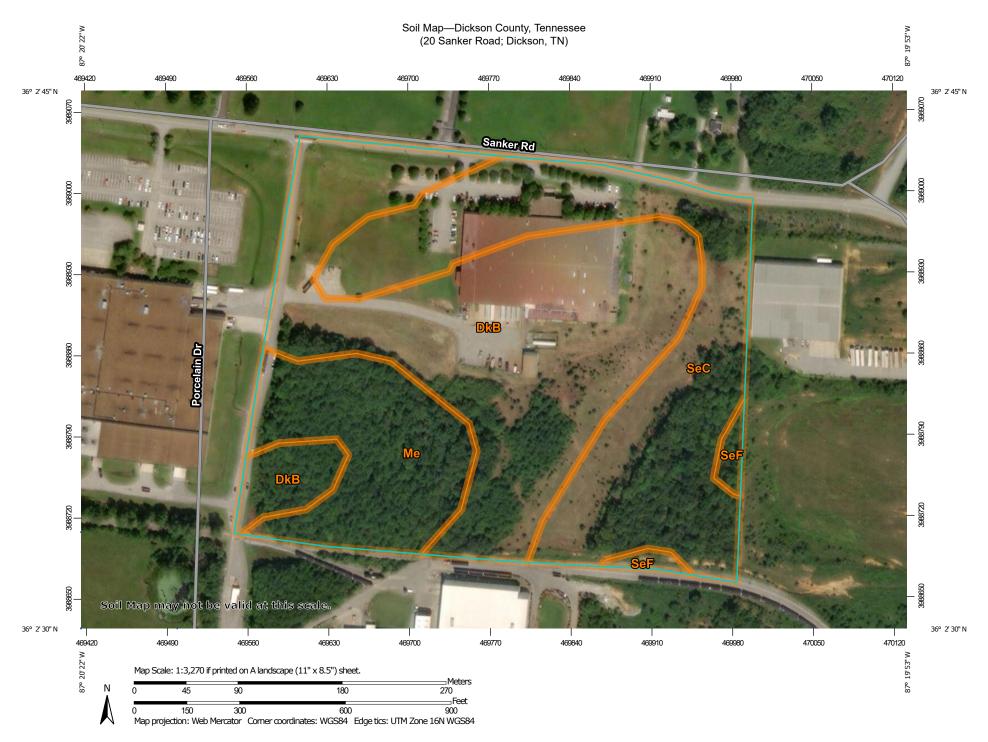
Attachment 1
Web Soil Survey Soil Map

Map Unit Symbol	Map Unit Name	Acres in AOI	Percent of AOI
DkB	Dickson silt loam, 2 to 5 percent slopes	16.9	47.5%
Me	Melvin silt loam, frequently flooded	5.9	16.5%
SeC	Sengtown gravelly silt loam, 5 to 12 percent slopes	12.3	34.4%
SeF	Sengtown gravelly silt loam, 30 to 60 percent slopes	0.5	1.5%
Totals for Area of Interest	,	35.6	100.0%

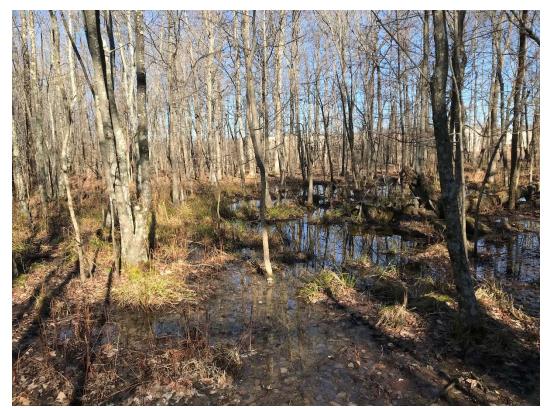
Photo No. 1: Low-lying wooded area; facing northImage Date: 1/6/20Location: 20 Sanker Road; Dickson, TNPhotographer: JED

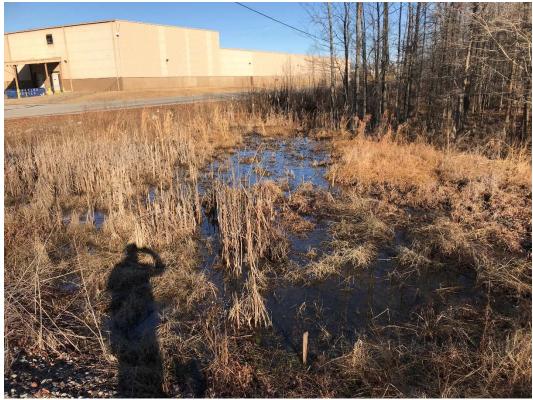
Photo No. 2: Standing water in southwest property cornerImage Date: 1/6/20Location: 20 Sanker Road; Dickson, TNPhotographer: JED

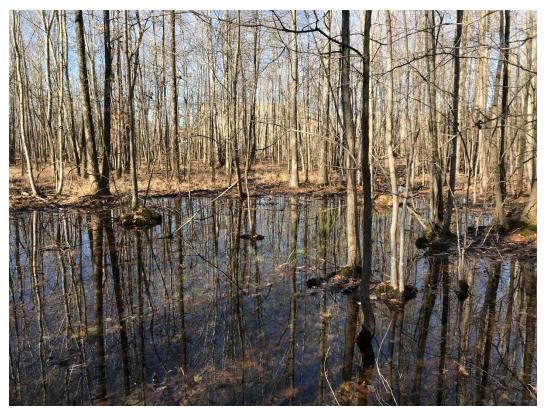
Photo No. 3: Low-lying wooded area; facing westImage Date: 1/6/20Location: 20 Sanker Road; Dickson, TNPhotographer: JED

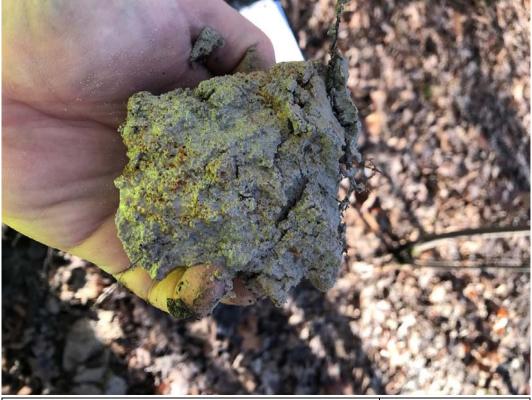
Photo No. 4: Hydric soils in low-lying wooded area.Image Date: 1/6/20Location: 20 Sanker Road; Dickson, TNPhotographer: JED

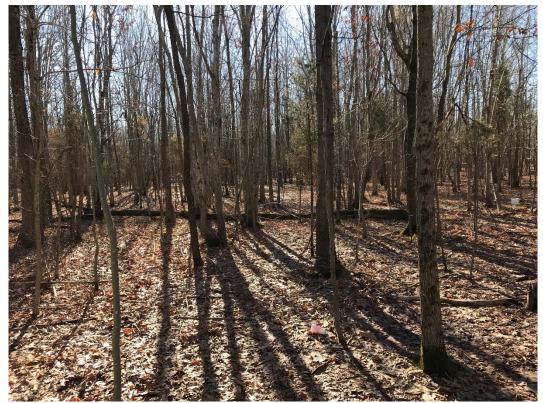
Photo No. 5: Wetland Sample Point 3; facing southImage Date: 1/6/20Location: 20 Sanker Road; Dickson, TNPhotographer: JED

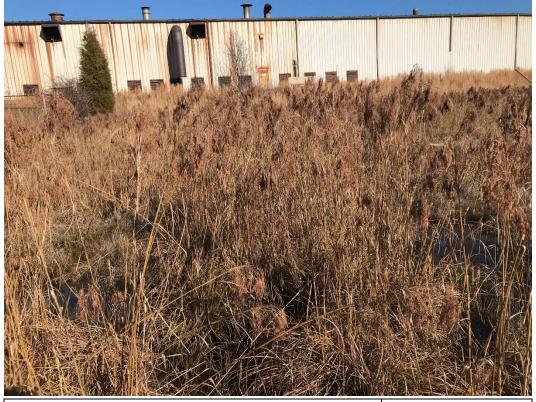
Photo No. 6: Low-lying herbaceous area south of buildingImage Date: 1/6/20Location: 20 Sanker Road; Dickson, TNPhotographer: JED
