Wetlands Delineation and Hydrologic Determination Report

**Cave Road, City of Nashville, Davidson
County, Tennessee**

ES Project No.: 15833

Date: March 7, 2022

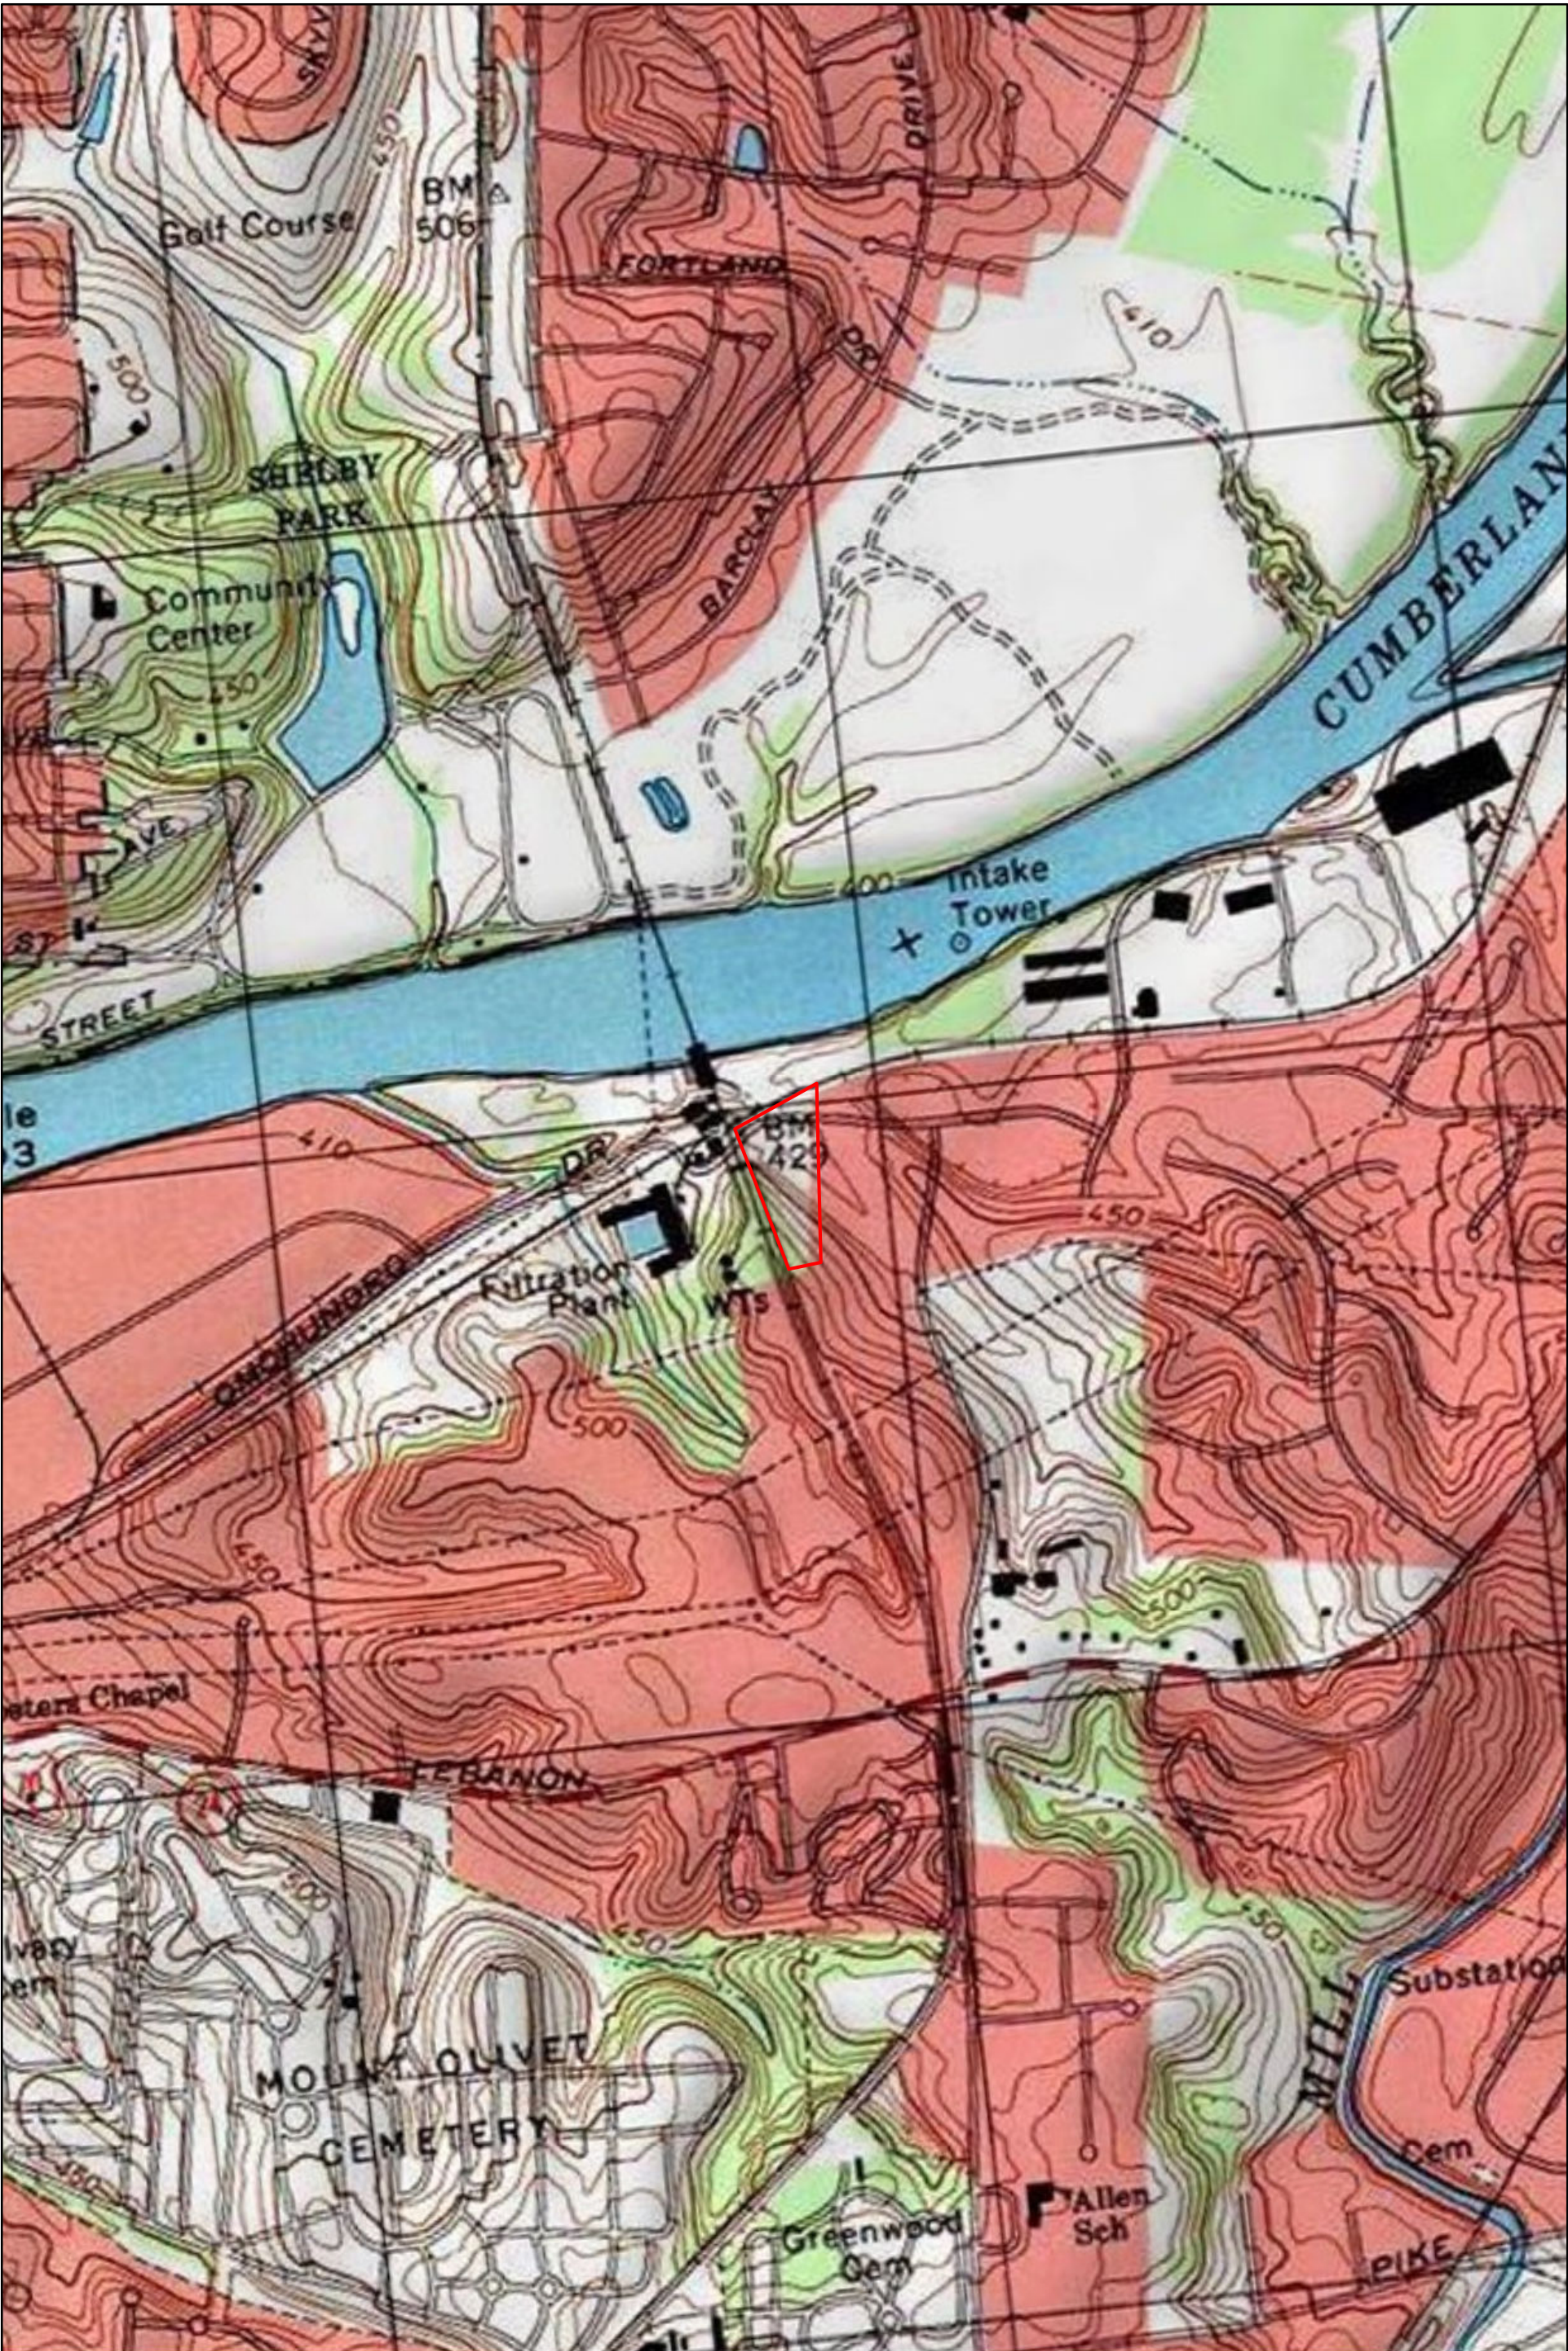
Figure 2. USGS 7.5-minute Topographic Map of Nashville East Quadrangle. Cave Road Wetland Delineation and Hydrologic Determination.

The USGS 7.5-minute topographic series map of the site (Nashville East Quadrangle) is shown in Figure 2 (Appendix A). The project area is shown as sloping to the north, with a drainage valley that empties to the north into the Cumberland River. The elevation is shown to approximately range from 420 to 490 feet above mean sea level (AMSL).

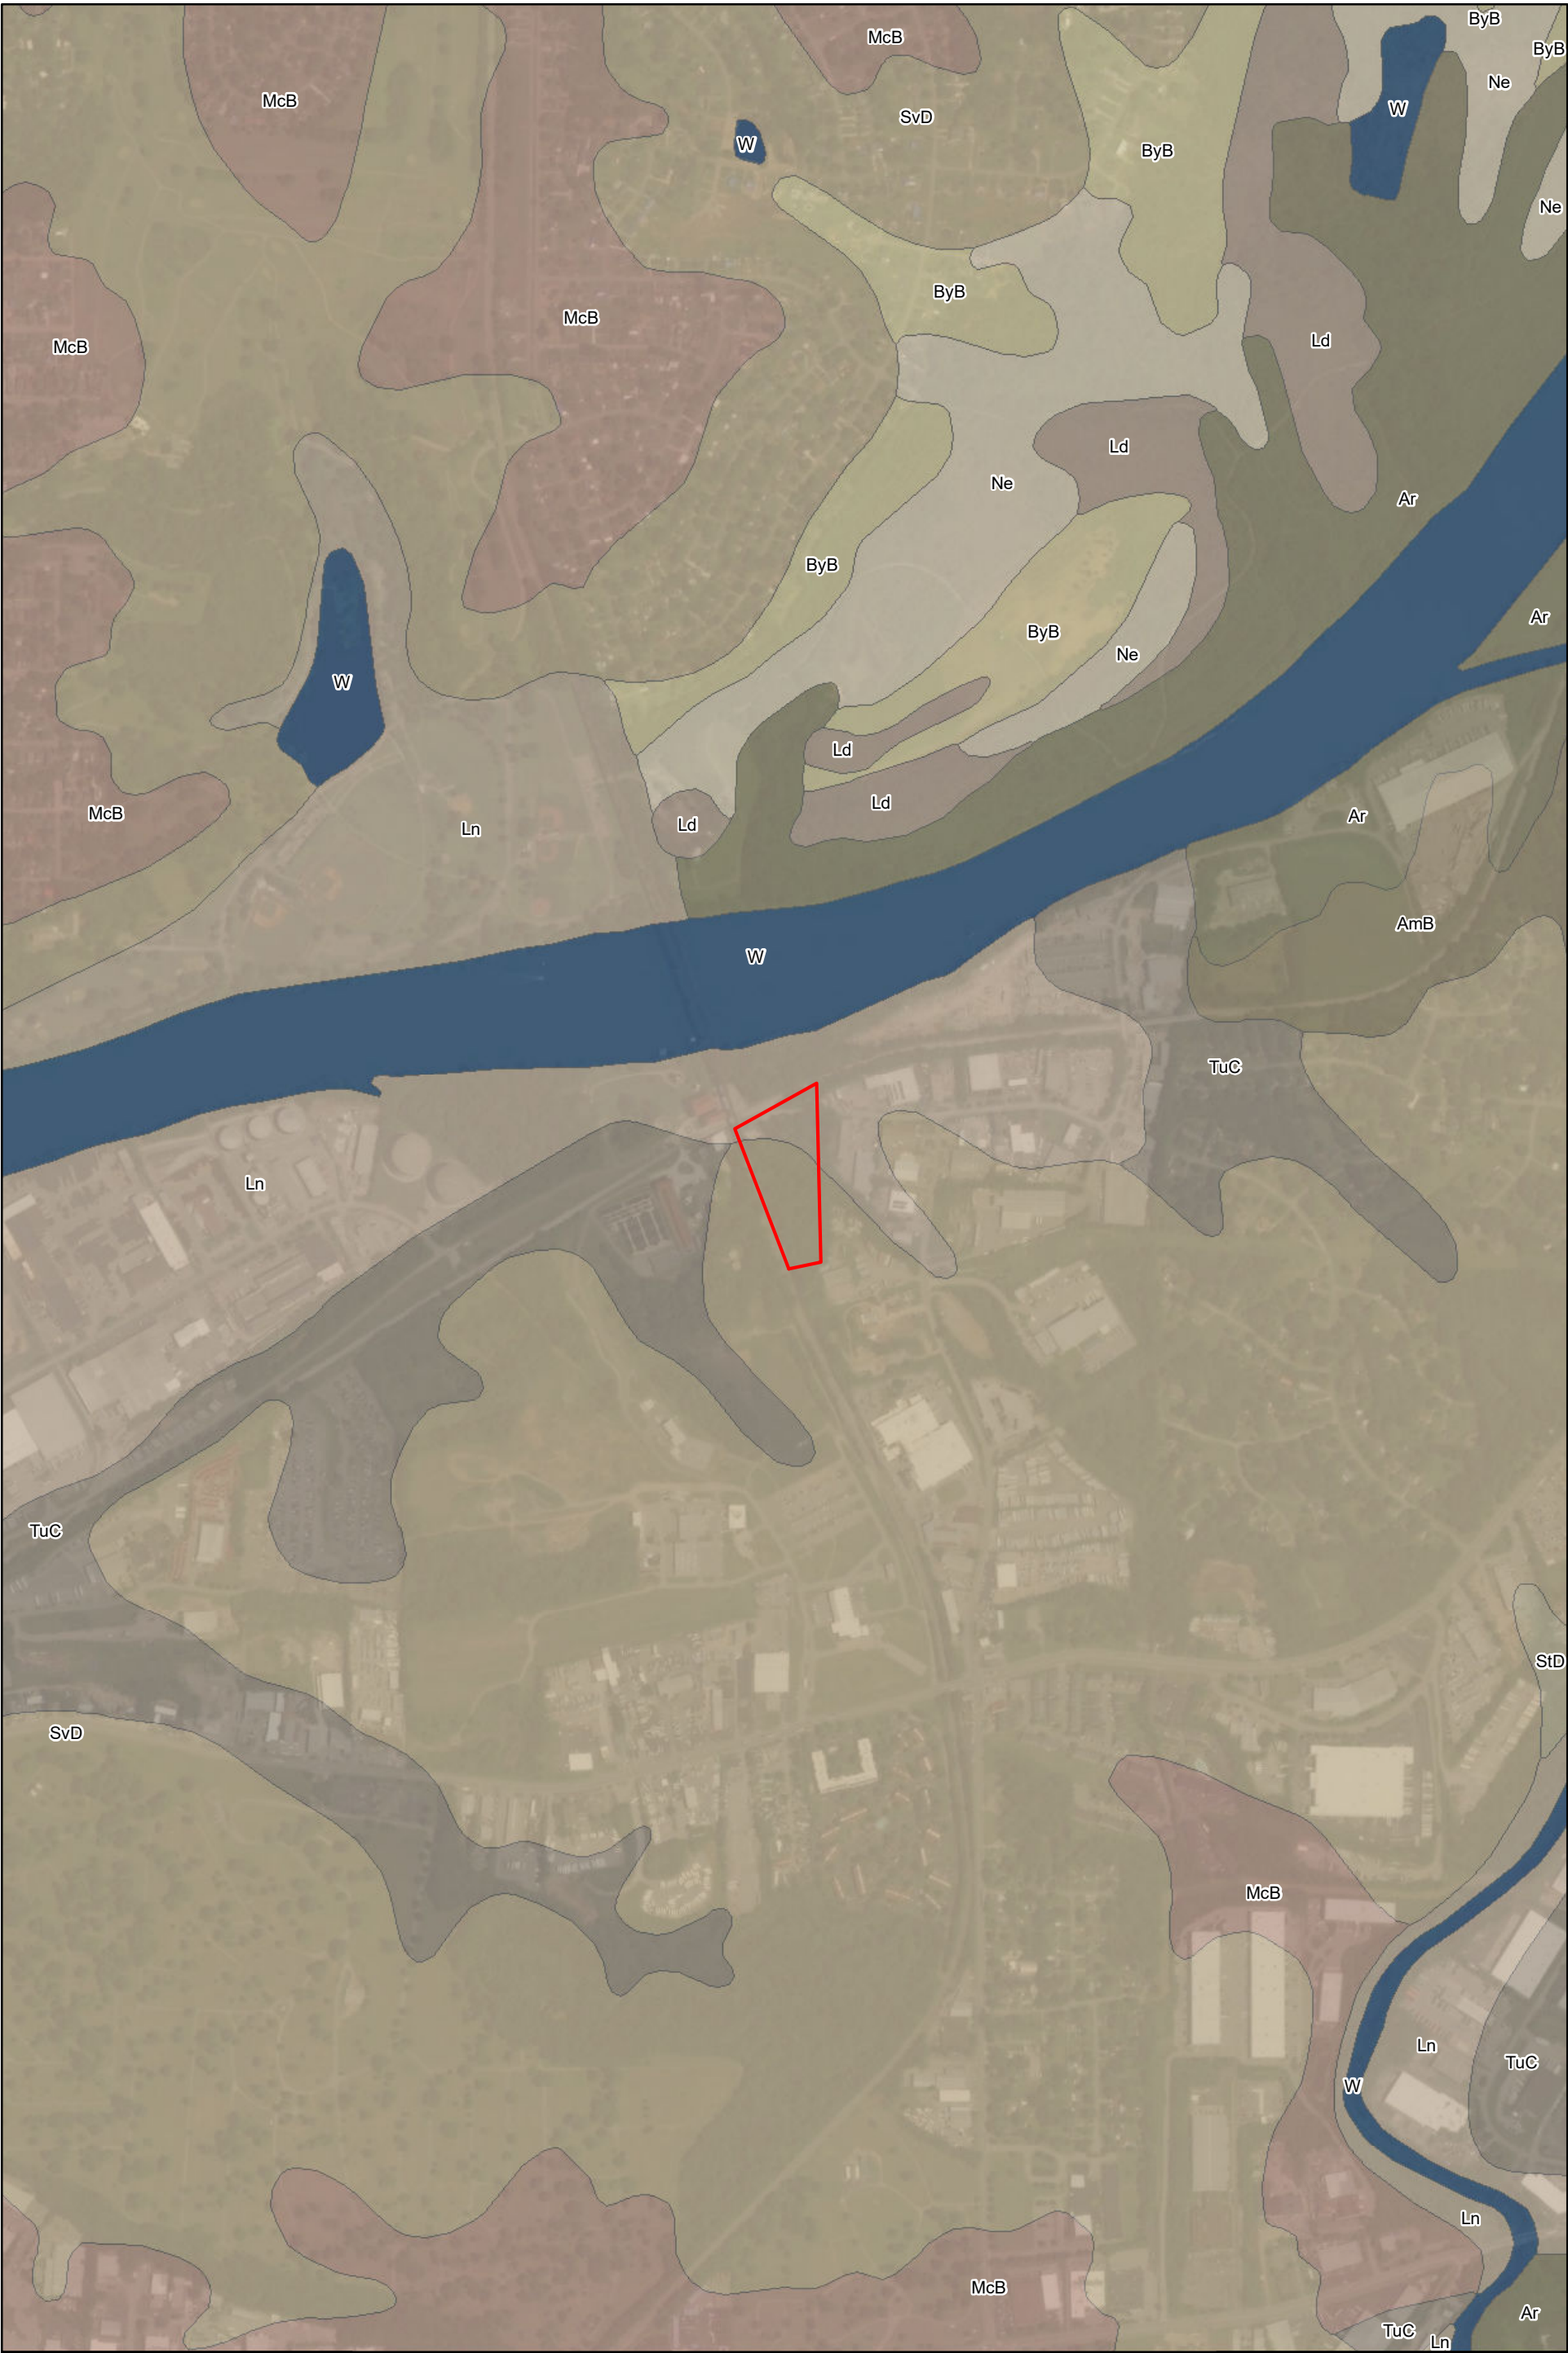
Figure 4.
Soil Map of Site in
Davidson County, Tennessee.
Cave Road Wetland Delineation
and Hydrologic Determination.

The project area is found on the *Soil Survey of Davidson County, Tennessee*, accessed on the Soil Survey Geographic (SSURGO) Database (USDA Web Soil Survey, 2021; Figure 4, Appendix A). Two soil types were identified within the project area. The onsite soils are summarized in Table 3.1 below.

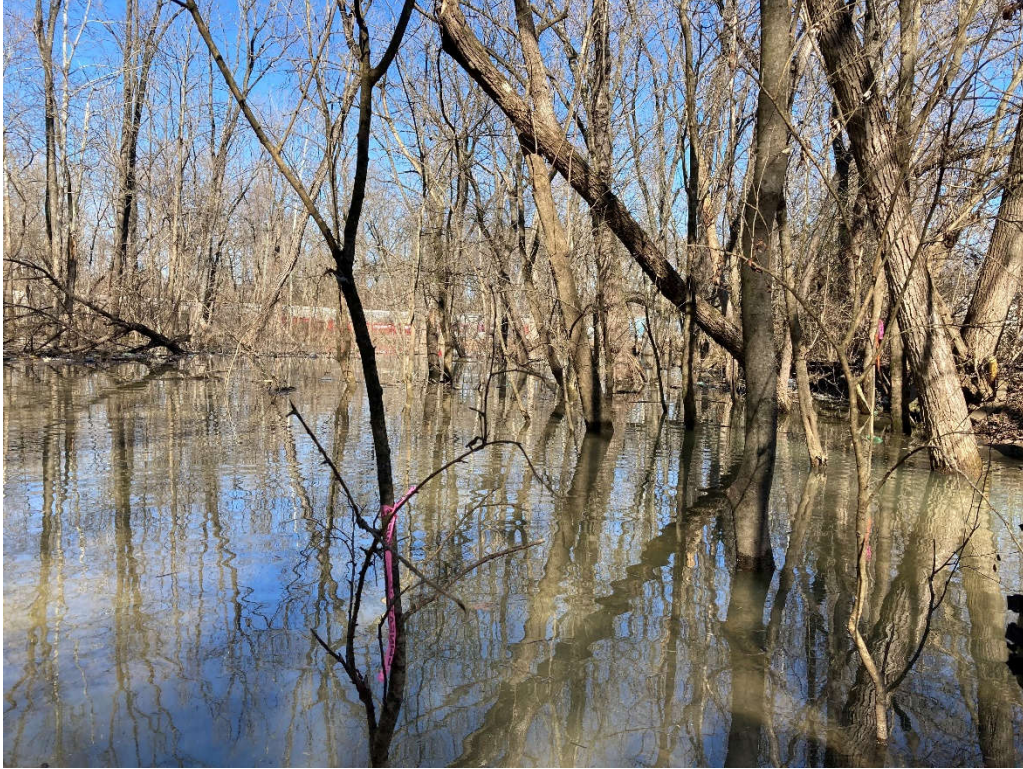
Photo 1. Sample Plot 1 representing palustrine forested (PFO) vegetative community within the project area; facing north.

Sample Plot	Photo*	Community**	Hydrophytic Vegetation	Wetlands Hydrology	Hydric Soil	Status	Location
1	1	PFO	X	X	X	Wetland	W-1
2	2	Forest	-	-	-	Non-Wetland	SP-2

Sample Plot 1 represents the PFO community within W-1. The dominant species observed within the tree stratum community included green ash (*Fraxinus pennsylvanica*, FACW), and swamp chestnut oak (*Quercus michauxii*, FACW). The sample plot is located within a seasonally flooded depression and no herbaceous vegetation was present. No other vegetation was observed within the other strata.

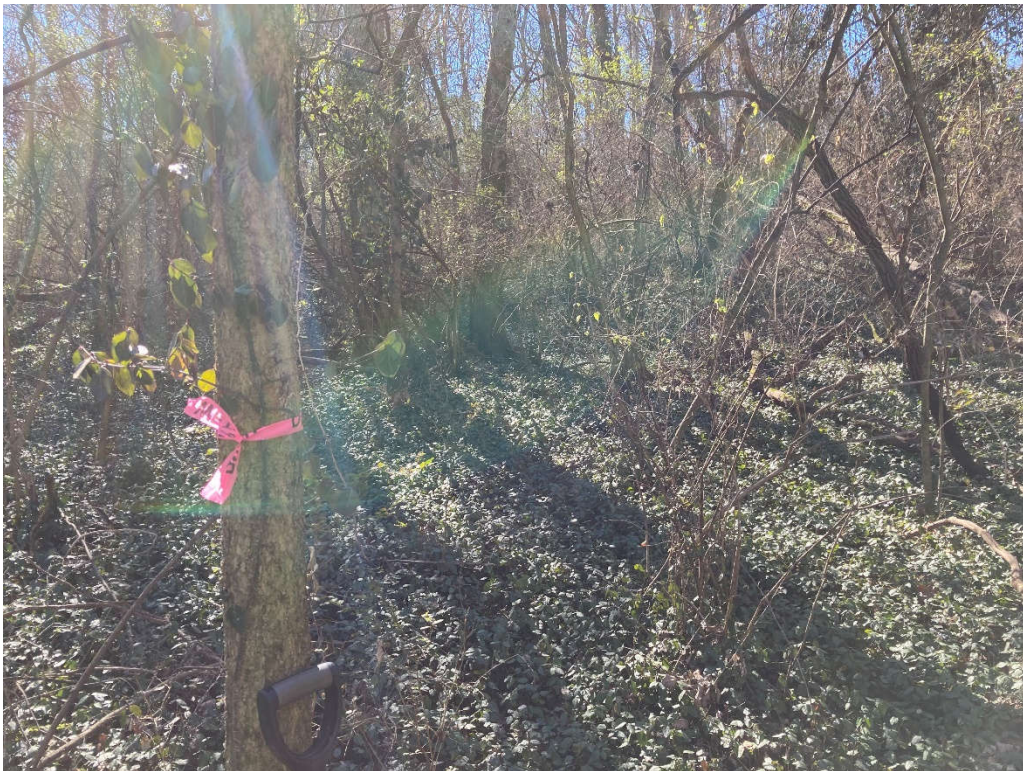
Photo 2. Sample Plot 2 representing the forest vegetative community within the project area; facing north.

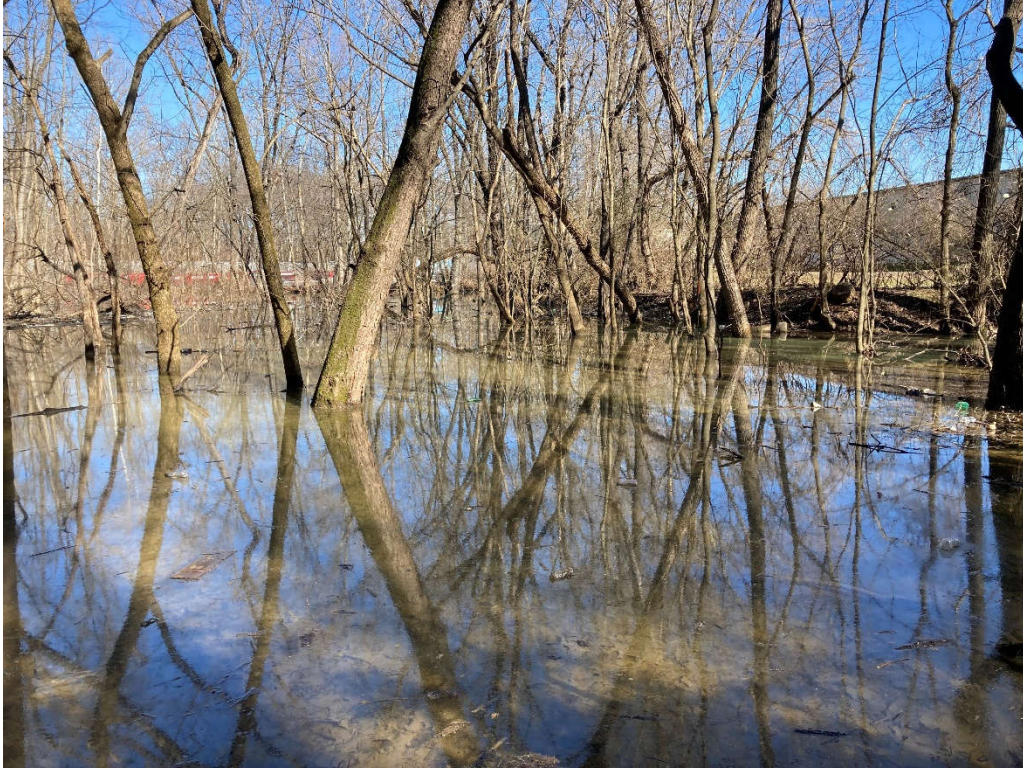
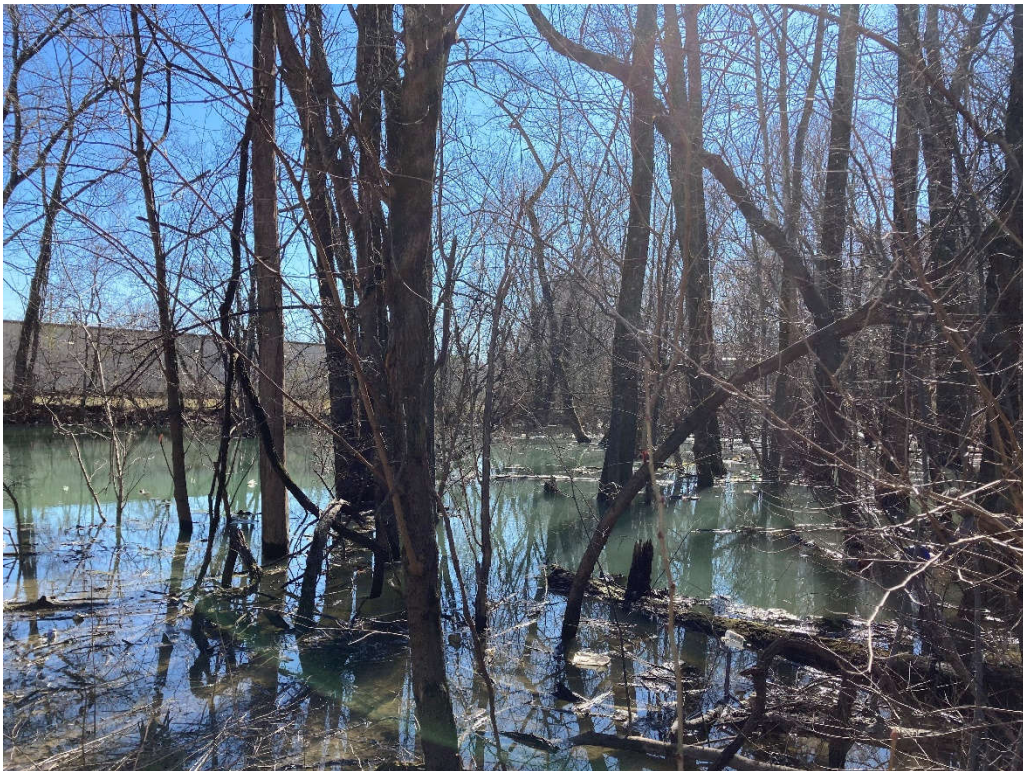
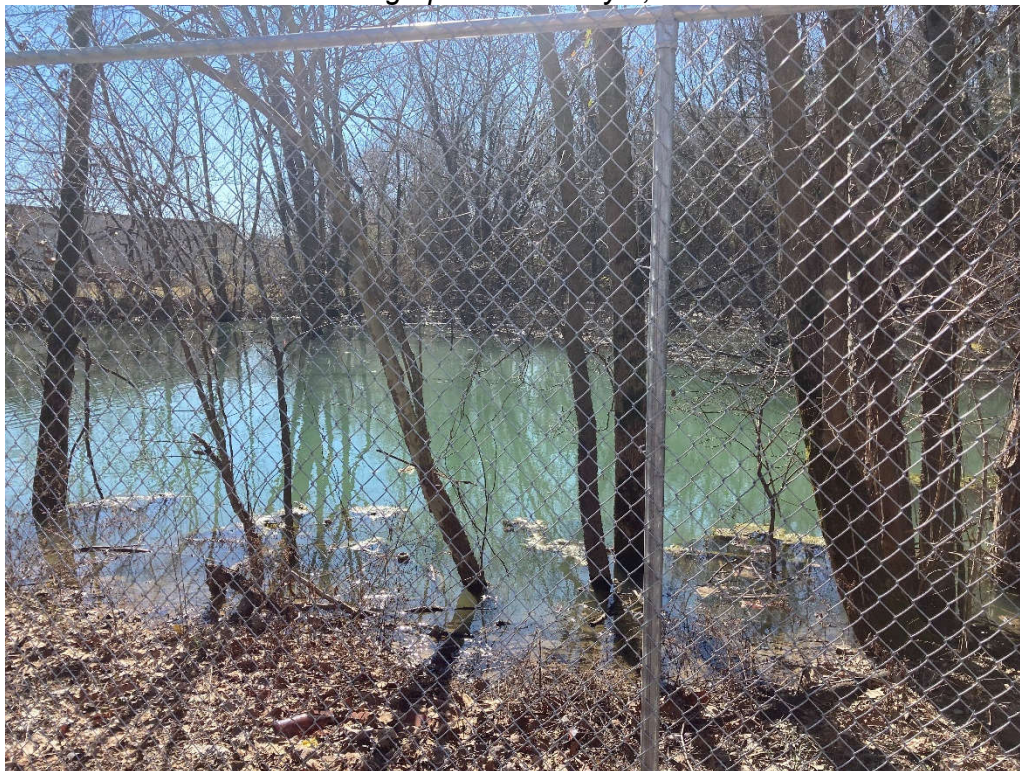
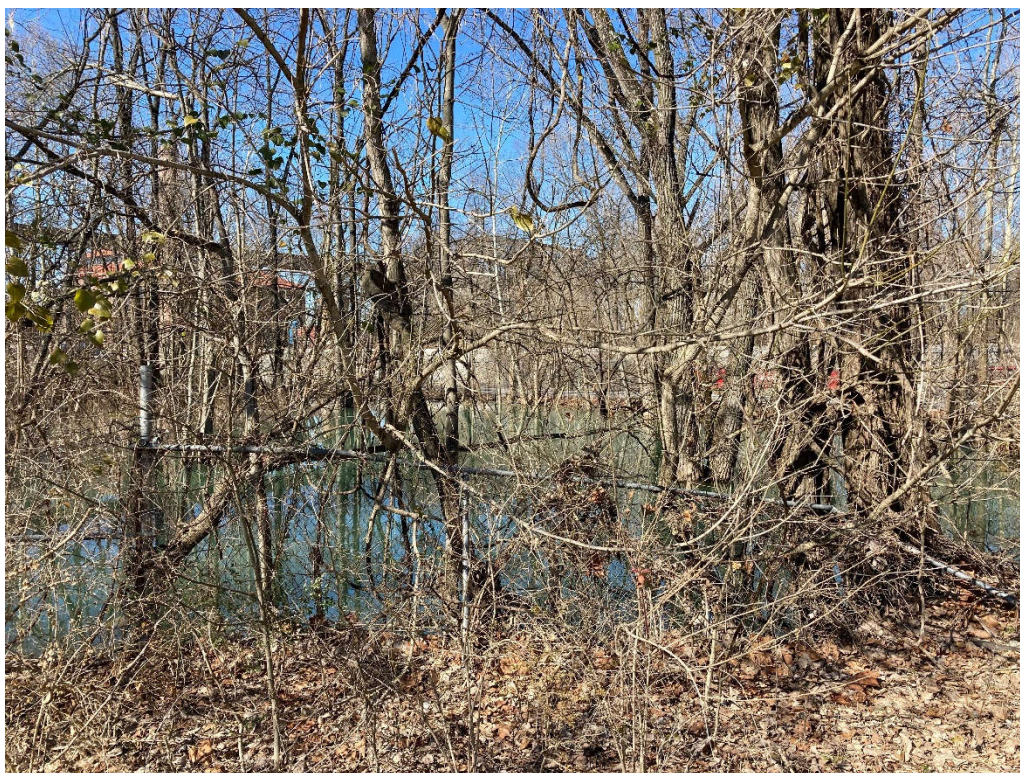
Photo 3. Wetland W-1 facing north.

Photo 4. Wetland W-1 facing east.

Photo 5. Wetland W-1 facing south.

Photo 6. Wetland W-1 facing west.

Wetland	Photo*	Cowardin Class	Size Within Project Area (acres)
W-1	3-6	PFO	0.791
Total Wetlands			0.791

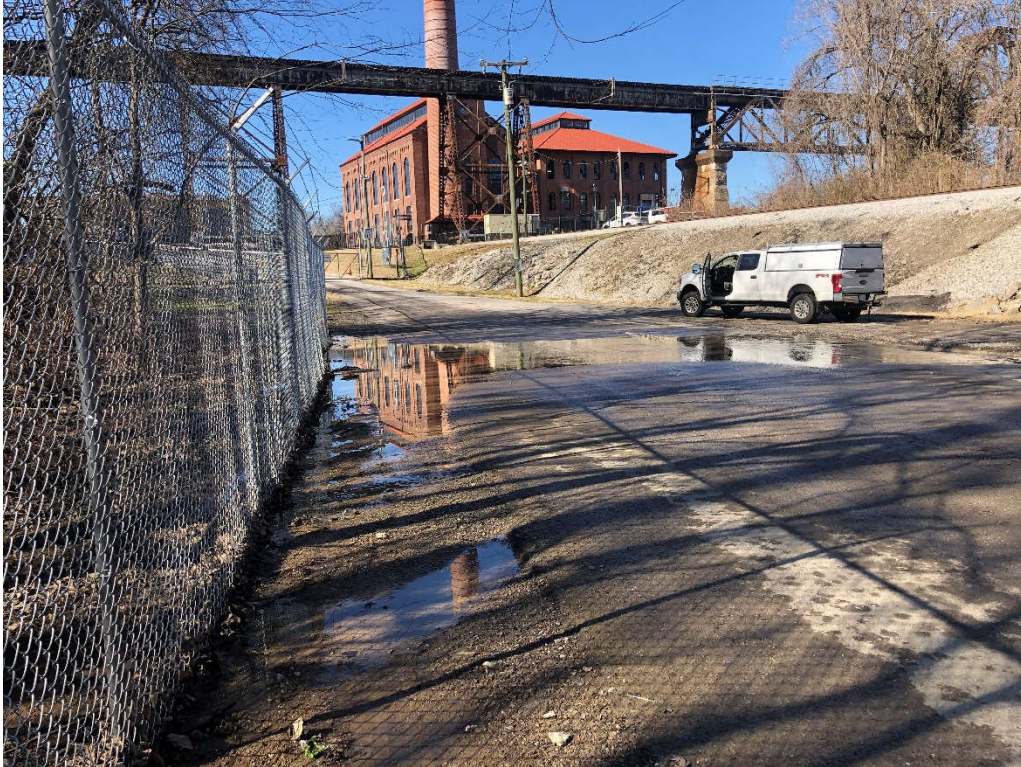
Photo 7. Represents water flowing out of W-1, across Cave Road; facing west.

The channel has gone under severe alterations from the railroad and Cave Road. The channel starts at the northern edge of Cave Rd due to sheet flow across Cave Road from W-1 during high precipitation events. This was observed during the site visit.

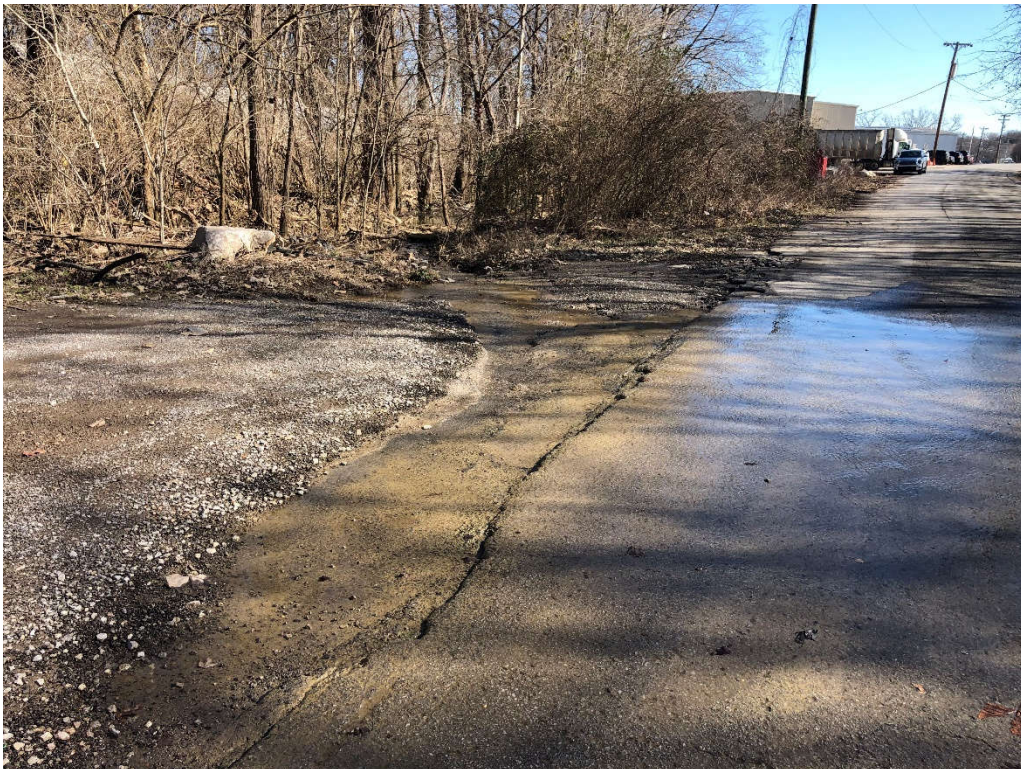
Photo 8. C-1, representing sheet flow across Cave Road and the origin point of the channel facing northeast.

C-1 originates in the northern portion of the project area and flows to the east between Cave Road and the elevated railroad bed. Cave Road, the railroad, and surrounding disturbances appear to influence the path of flow and confine this channel. A significant amount of the contributing hydrology to the channel appears to originate as sheet flow from W-1 and the drainage valley south of Cave Road. At the time of the assessment, high water levels south of Cave Road resulted in flooding of W-1 and water was observed flowing over the road and into the channel of C-1. This observation indicates that at a minimum, C-1 receives surface hydrology from W-1 when it is inundated with water caused by the impoundment of Cave Road. C-1 is considered a stream with ephemeral flow but was also assessed as a WWC following TDEC guidance. The channel was assessed using secondary HD indicators and received a score of 13.5. Channels receiving scores less than 19 are considered WWC by TDEC.

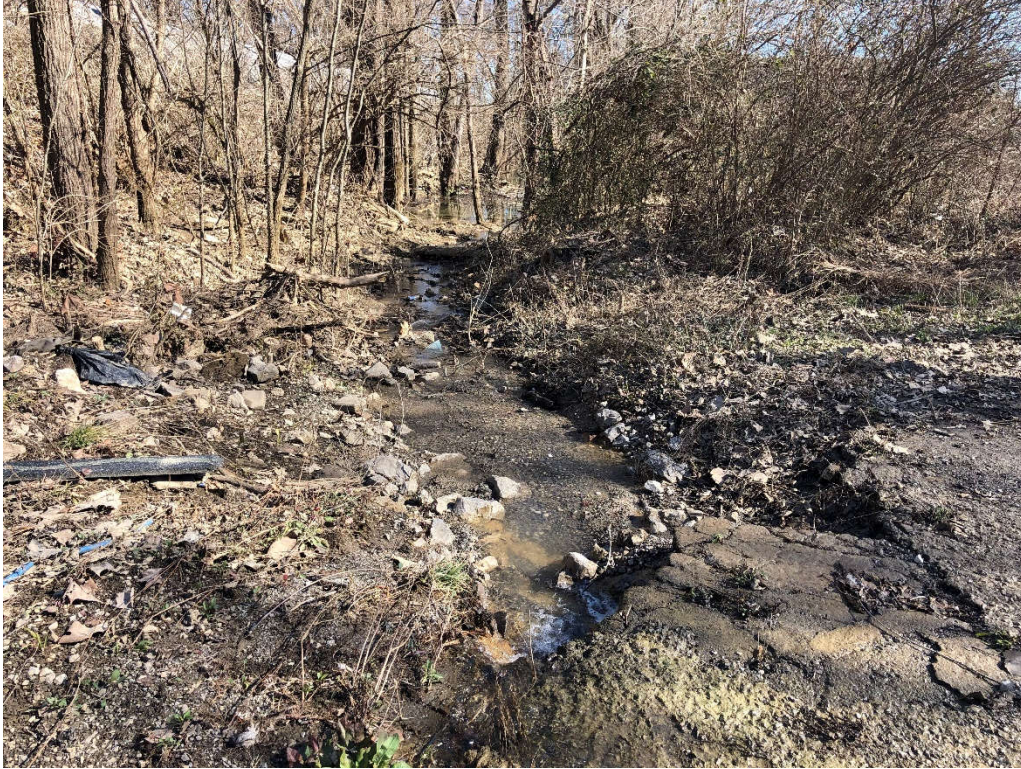
Photo 9. C-1, representing the channel features north of Cave Road; facing north.

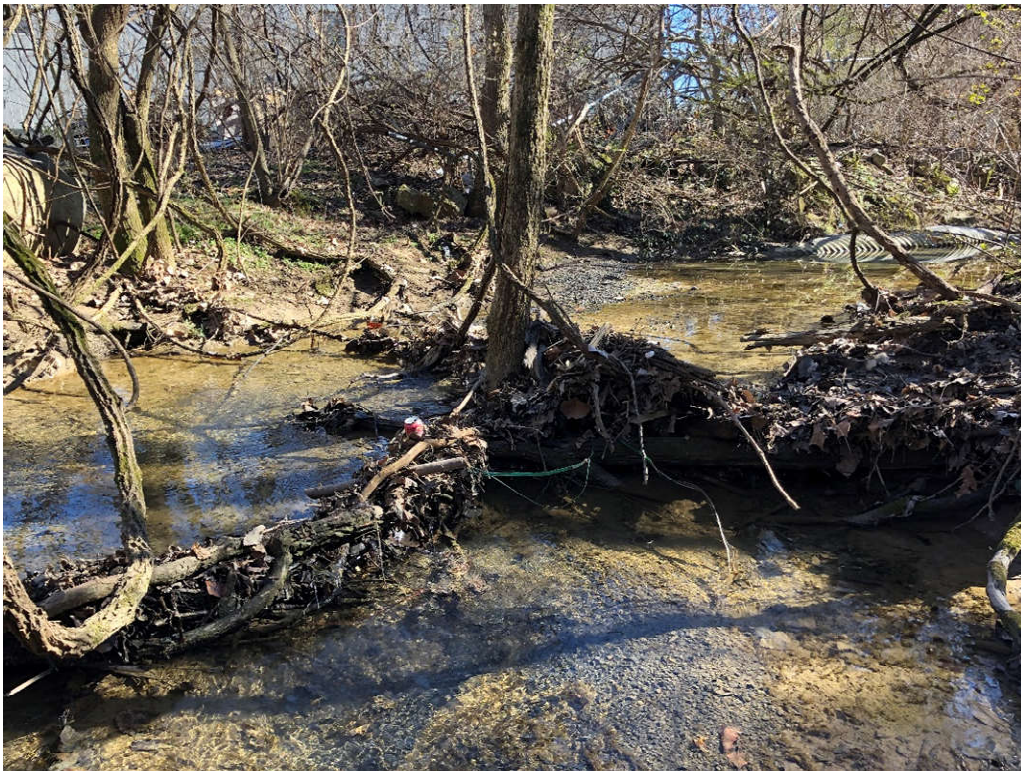
Photo 10. Depicting an offsite watercourse which flows into W-1 along the eastern boundary of the project area from the southeast; facing south.
