RE: Hydrologic Determination Report – 841 Cowan Road, Dickson, Dickson County

# HYDROLOGIC DETERMINATION REPORT

841 Cowan Road  
Dickson County, Tennessee

April 21, 2022

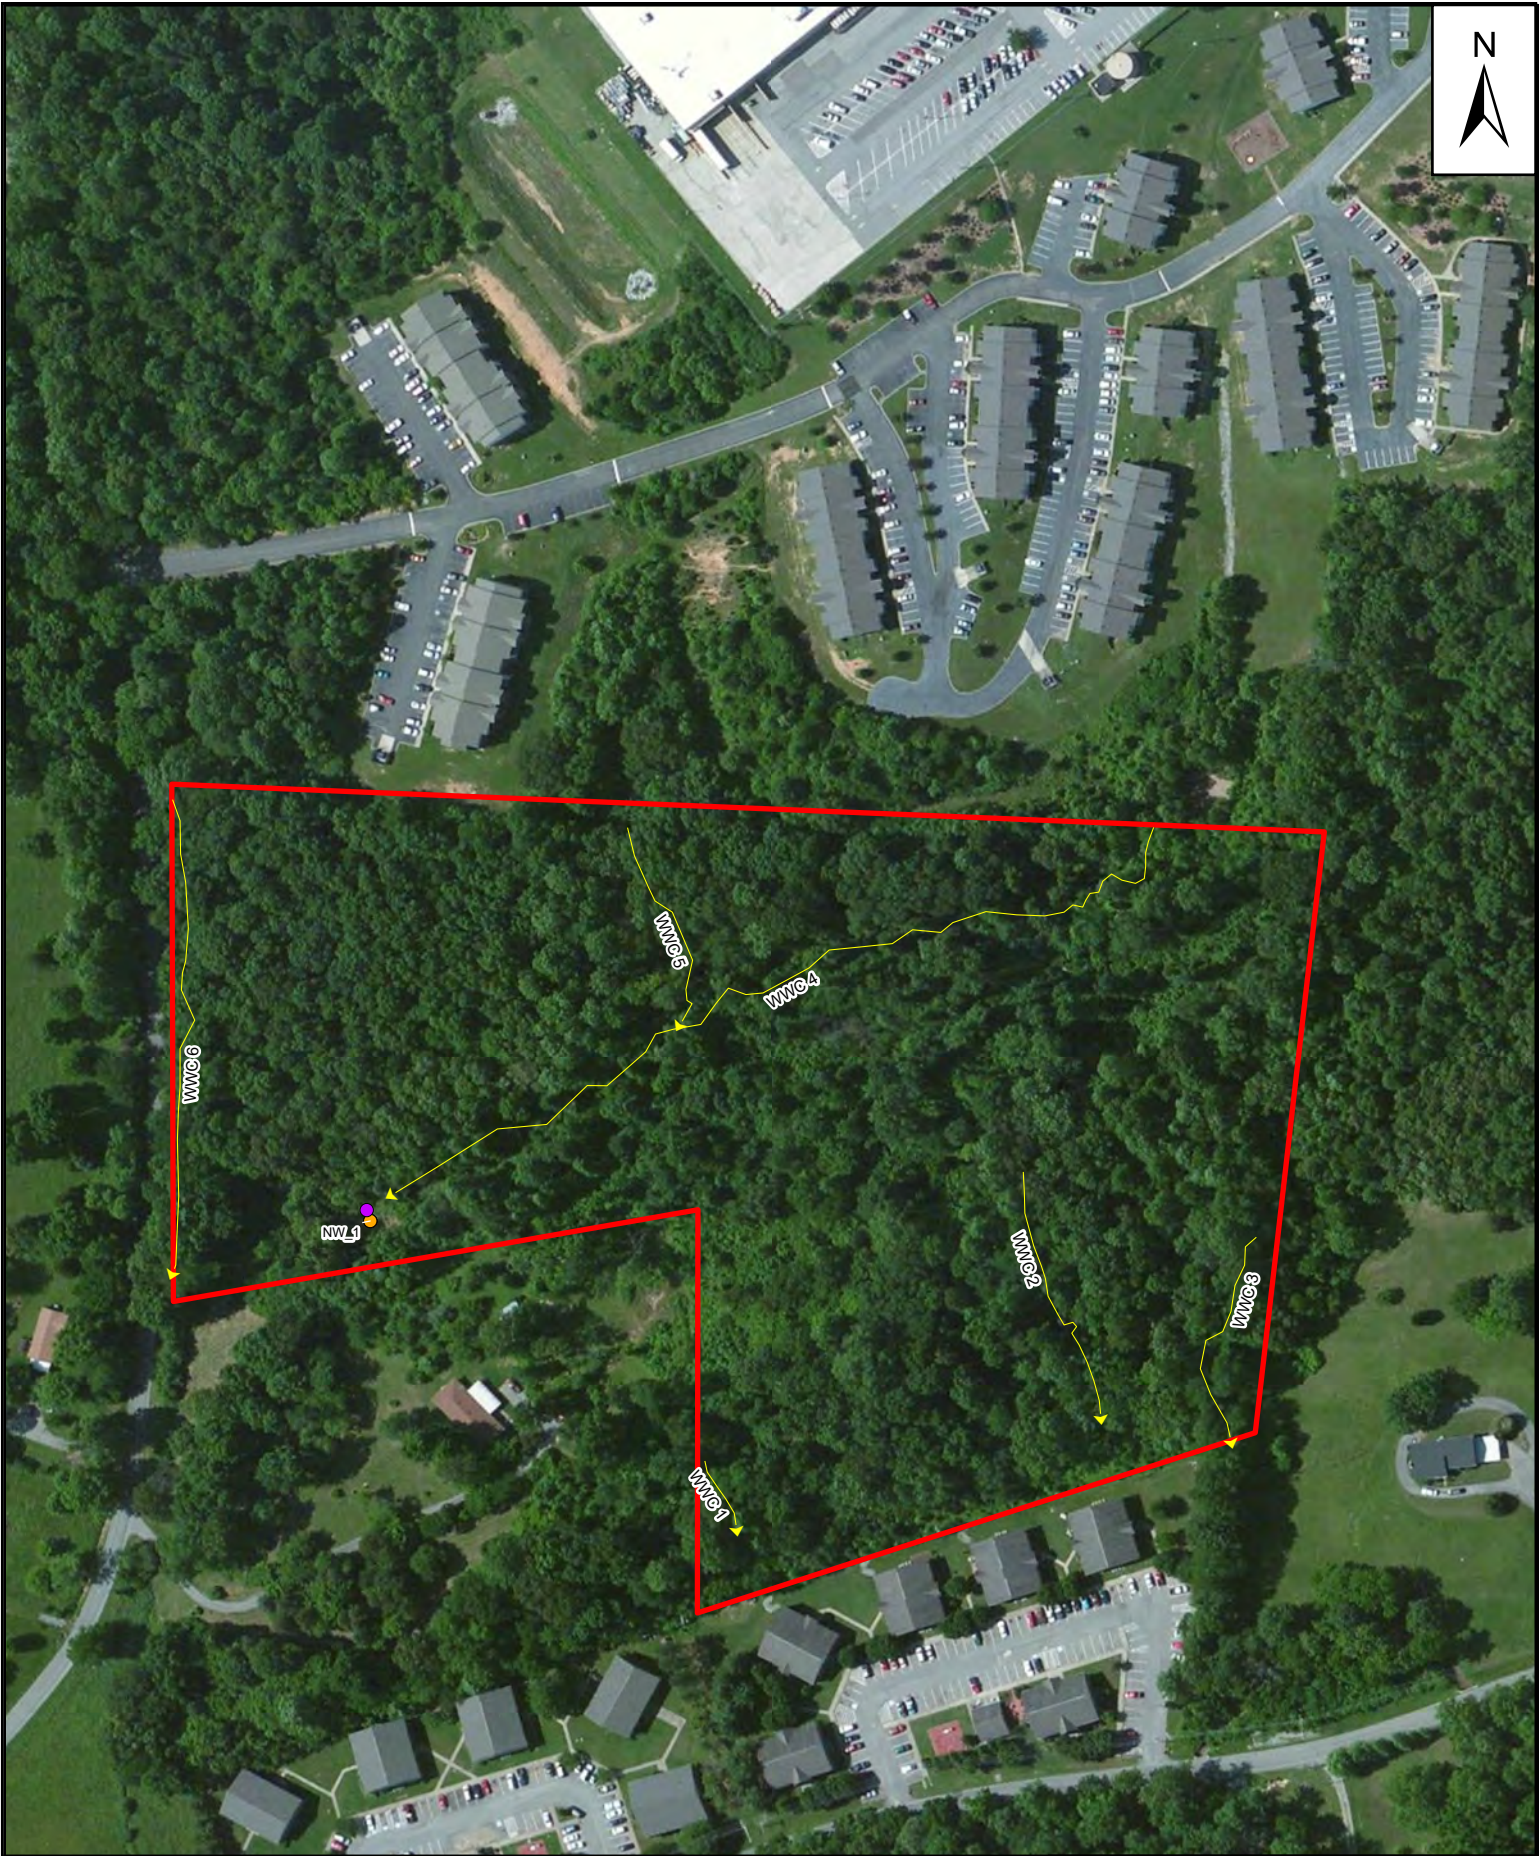
HYDROLOGICAL DETERMINATION MAP  
841 COWAN ROAD  
DICKSON COUNTY, TENNESSEE  
APRIL 21, 2022

WWC 1 – Start: 36.055323, -87.380948, End: 36.055125, -87.380831  
WWC 2 – Start: 36.056163, -87.379839, End: 36.055457, -87.379552  
WWC 3 – Start: 36.055984, -87.379007, End: 36.055396, -87.379093  
WWC 4 – Start: 36.057154, -87.379393, End: 36.055993, -87.382135  
WWC 5 – Start: 36.057132, -87.381253, End: 36.056565, -87.381054  
WWC 6 – Start: 36.057193, -87.382858, End: 36.055836, -87.382829

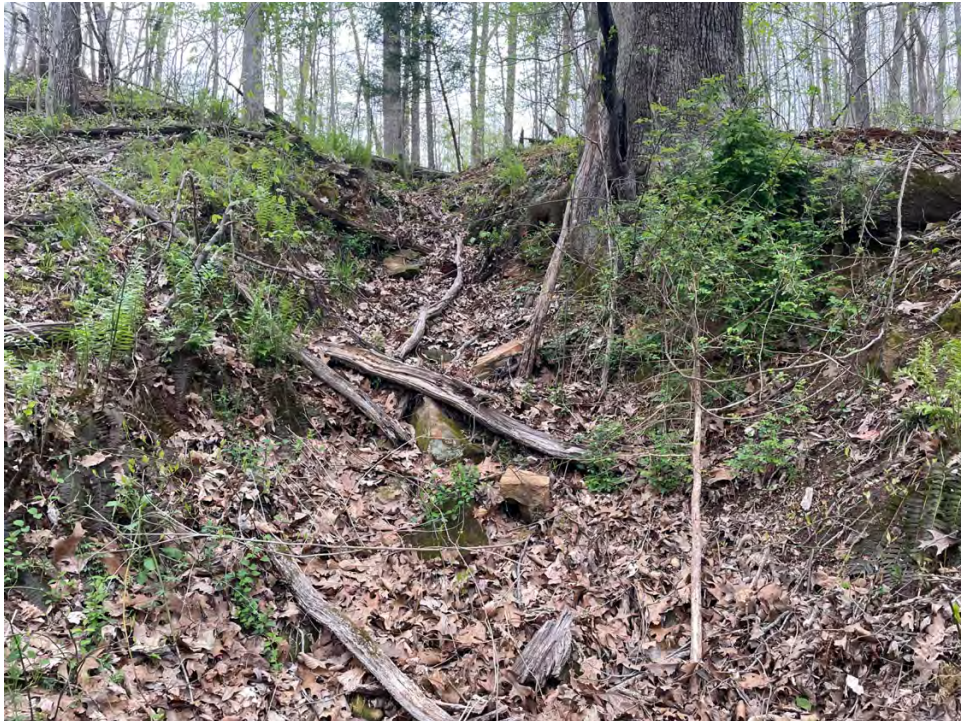
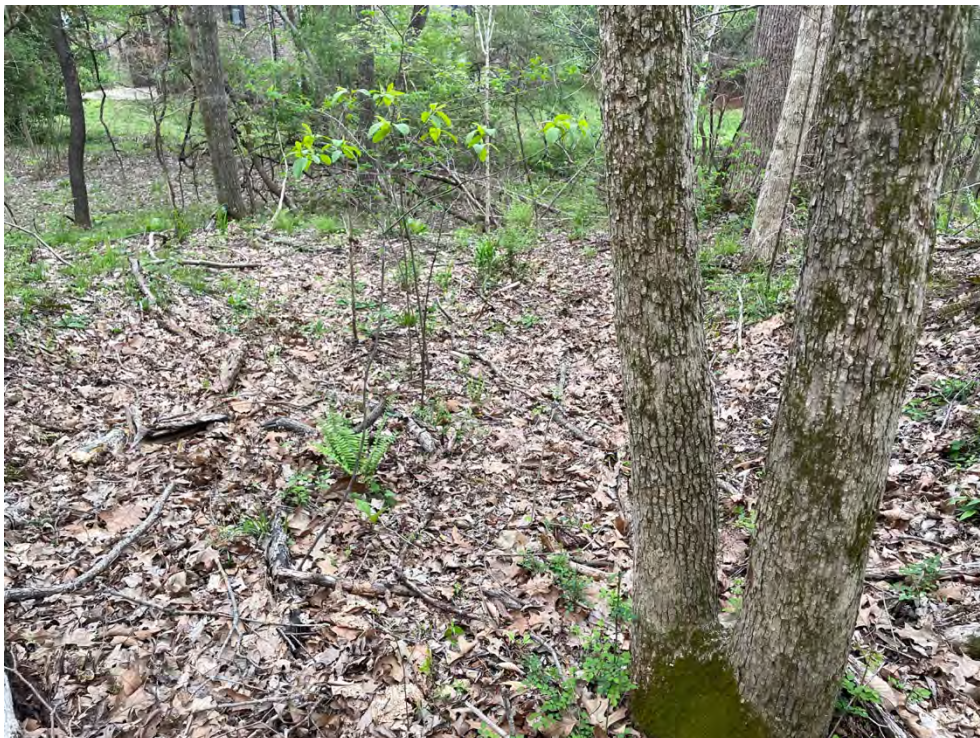
**Justification / Notes:** Channel lacks bed and bank. Channel is covered in leaves and privet

**Photo 1:** Wet Weather Conveyance 1, looking upstream.  
**Coordinates:** 36.055191. -87.380858

**Photo 2:** Wet Weather Conveyance 1, looking downstream.  
**Coordinates:** 36.055191. -87.380858

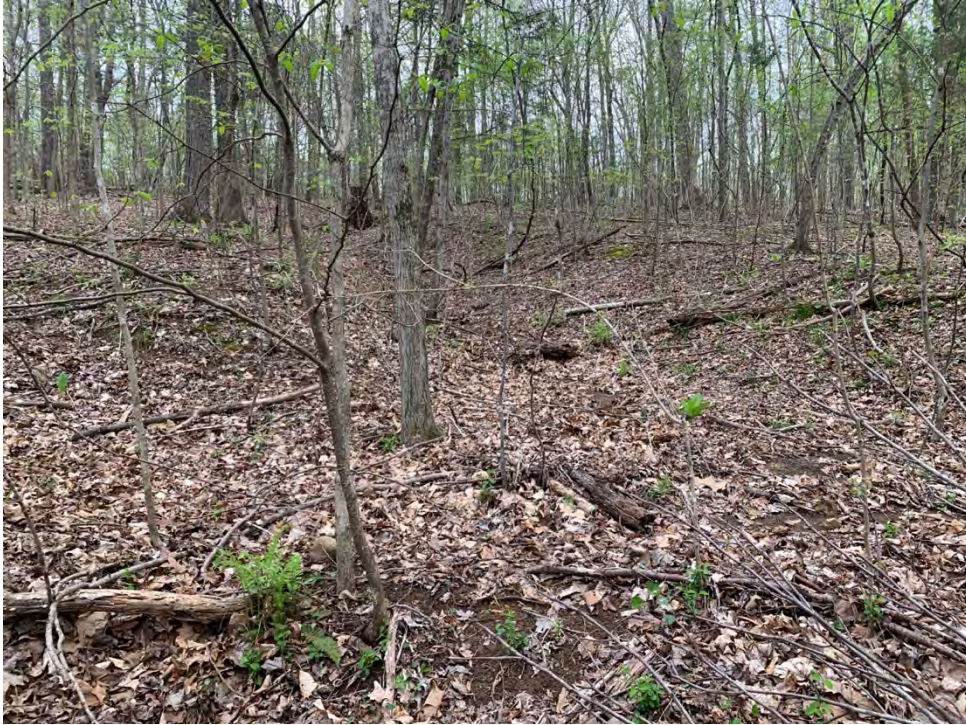
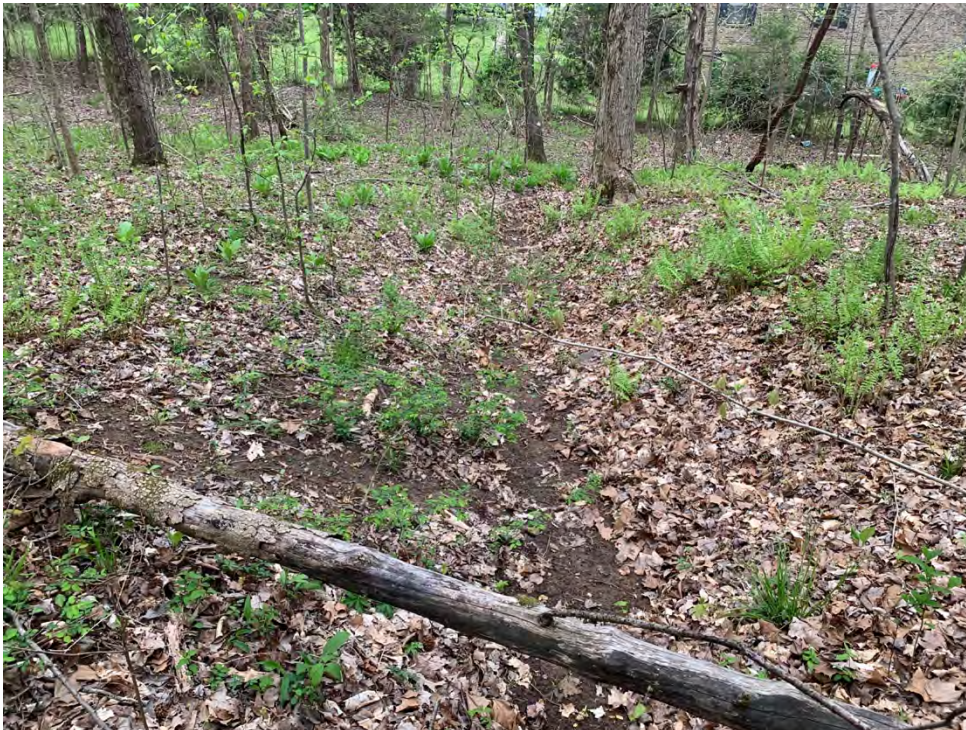
**Justification / Notes:** No defined bed and bank.  
Loticera japonica (FAUP) in conveyance

**Photo 3:** Wet Weather Conveyance 2, looking upstream.  
**Coordinates:** 36.055620, -87.379545

**Photo 4:** Wet Weather Conveyance 2, looking downstream.  
**Coordinates:** 36.055620, -87.379545

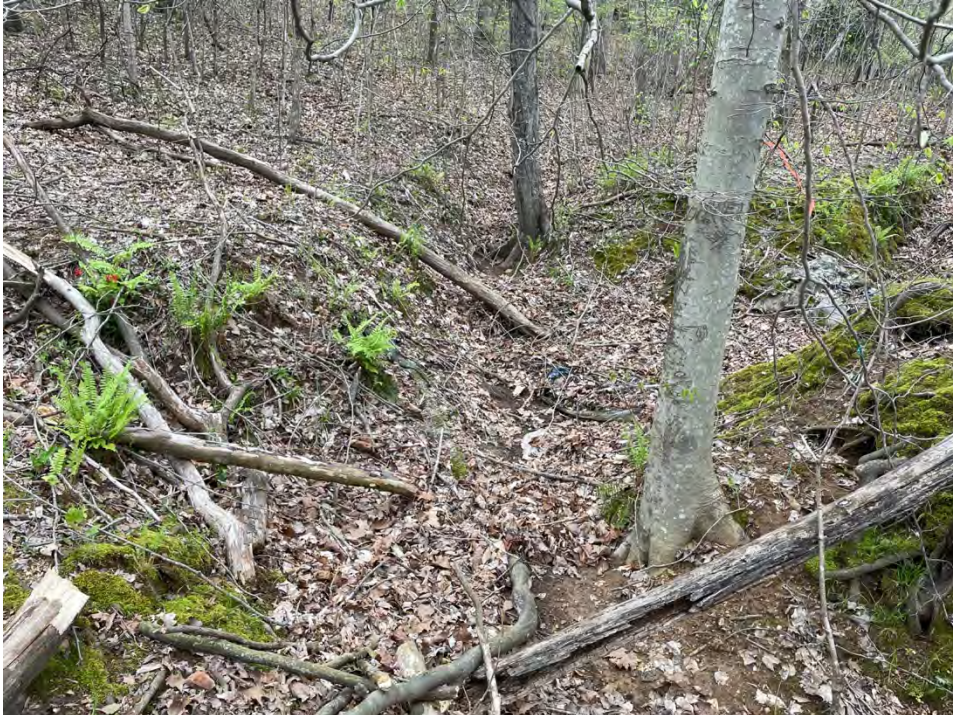
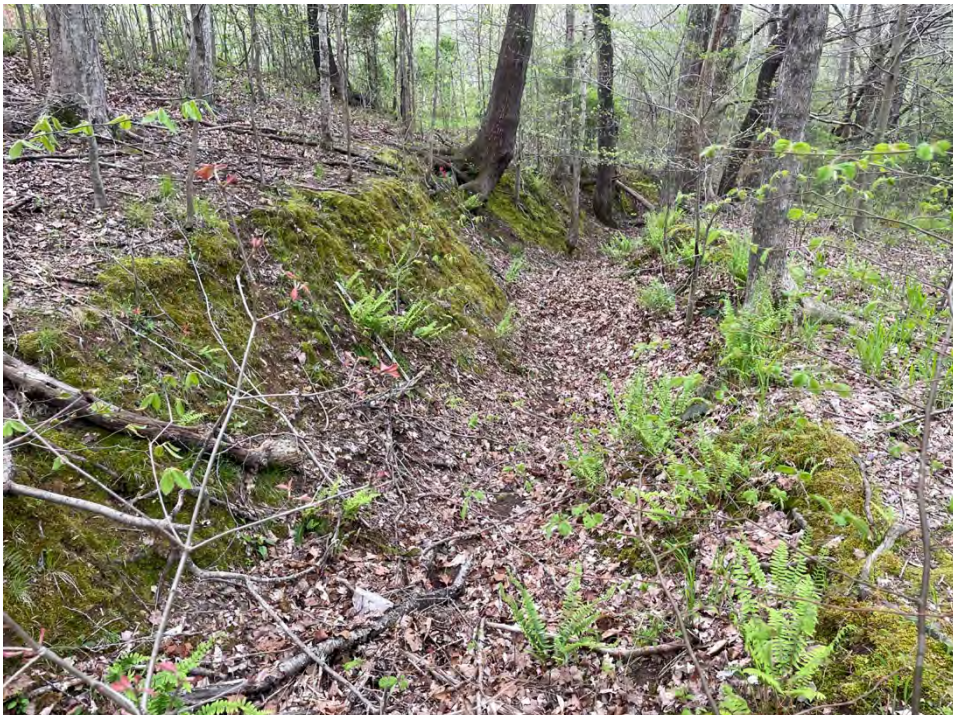
**Justification / Notes:** (1) Lacking secondary indicators.

(2) Leaf litter throughout channel.

(3) Continuous bed and bank throughout most of reach but lacking other geomorphological indicators.

Notes: (1) Bed and bank observed throughout most of reach with some tapering at end of reach.

(2) Little hydrology (No water in channel, leaves throughout the channel)

(3) Some fibrous roots, weak rooted plants.

**Photo 5:** Wet Weather Conveyance 3, looking upstream  
**Coordinates:** 36.055626, -87.379199

**Photo 6:** Wet Weather Conveyance 3, looking downstream  
**Coordinates:** 36.055626, -87.379199

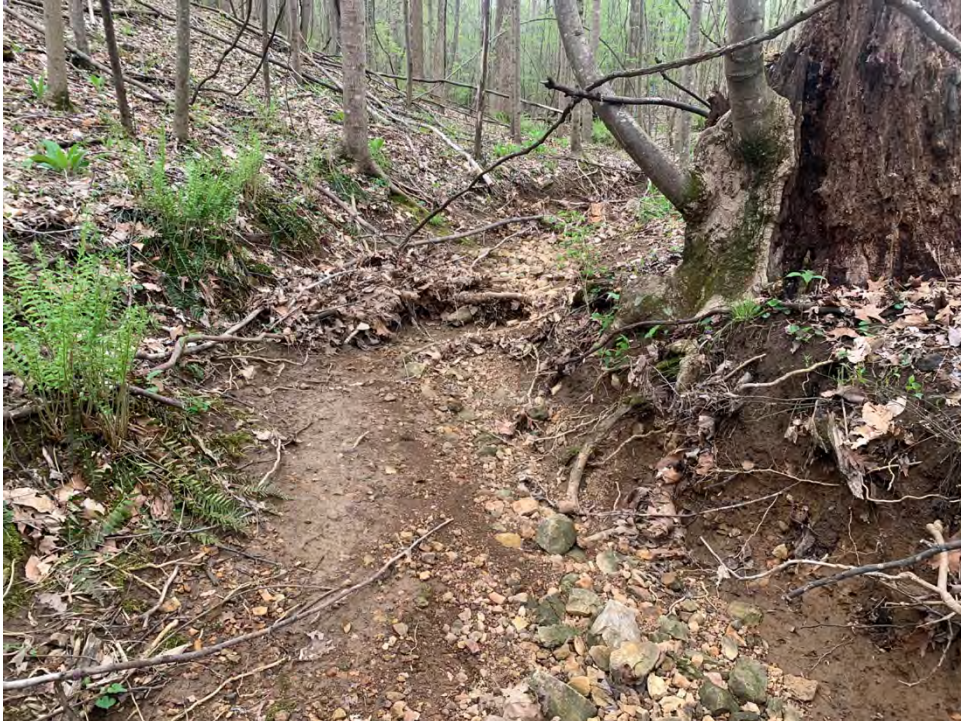
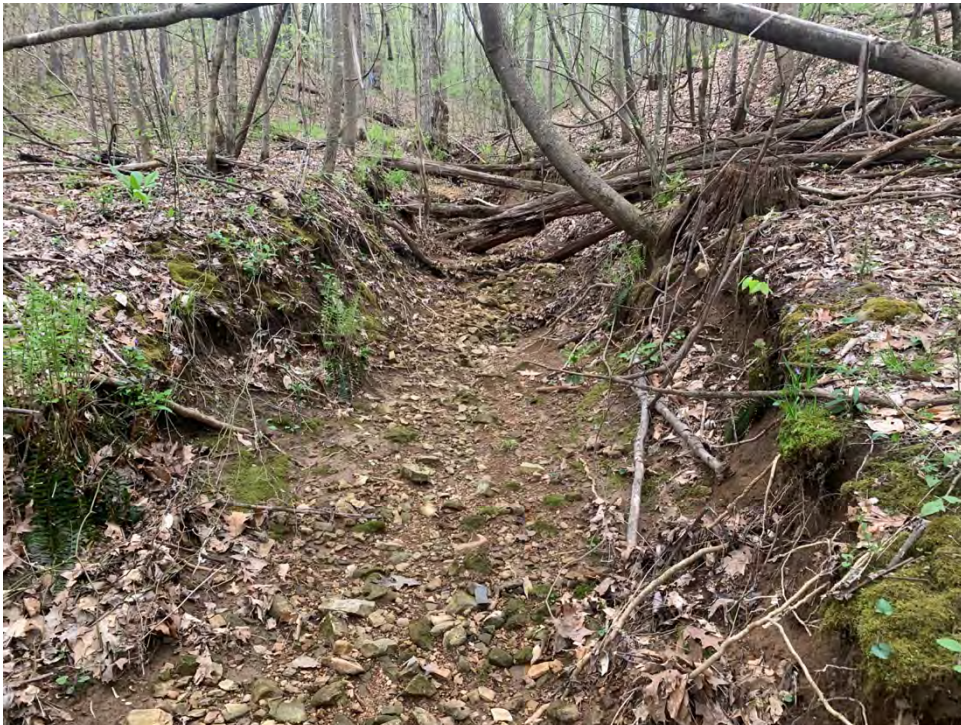
**Notes :** (1) Continuous bed and bank well defined.  
 (2) Some sorting but still weak to moderate

**Photo 7:** Wet Weather Conveyance 4, looking upstream  
**Coordinates:** 36.380676, -87.380676

**Photo 8:** Wet Weather Conveyance 4, looking downstream  
**Coordinates:** 36.380676, -87.380676

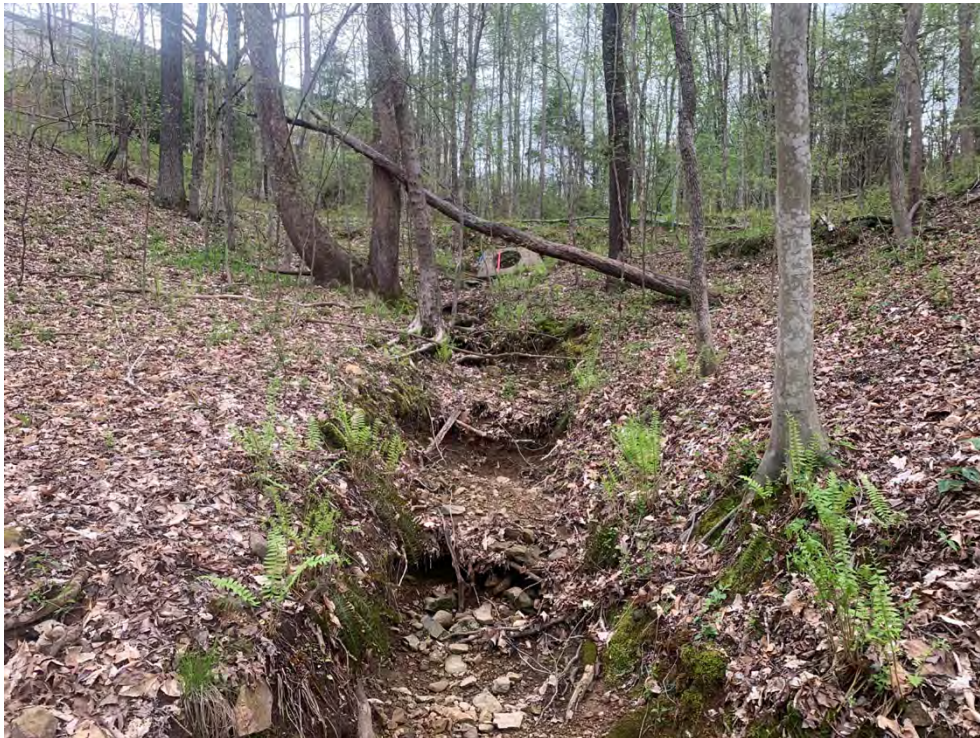
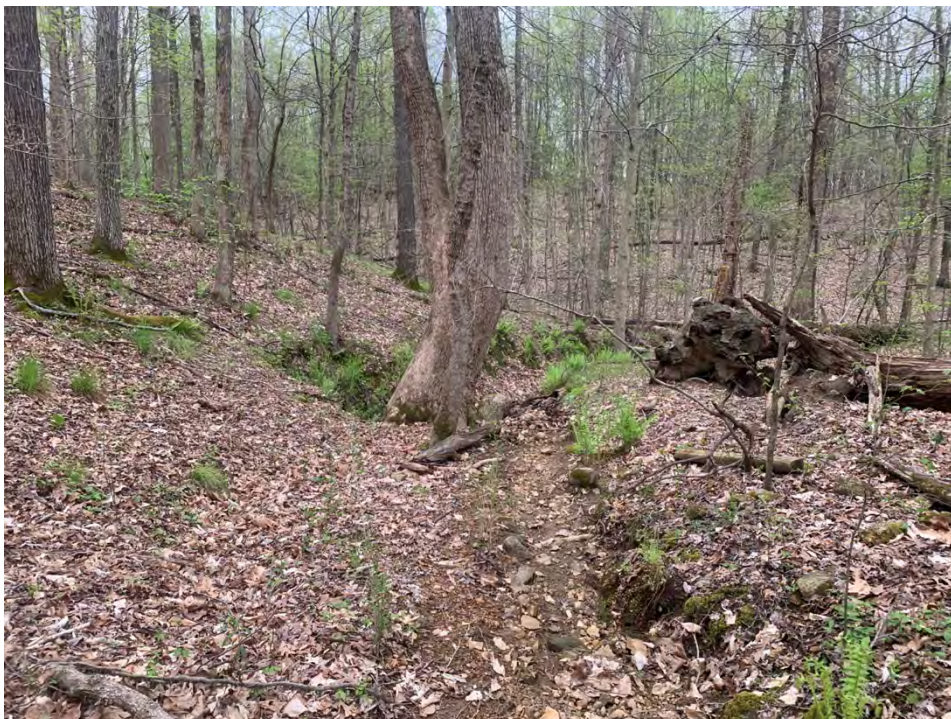
**Notes :** (1) Defined continuous bed and bank  
 (2) Headcuts present  
 (3) Some leaf litter in channel  
 (4) Few rooted plants, moderate fibrous roots

**Photo 9:** Wet Weather Conveyance 5, looking upstream  
**Coordinates:** 36.056962, -87.381263

**Photo 10:** Wet Weather Conveyance 5, looking downstream  
**Coordinates:** 36.056962, -87.381263

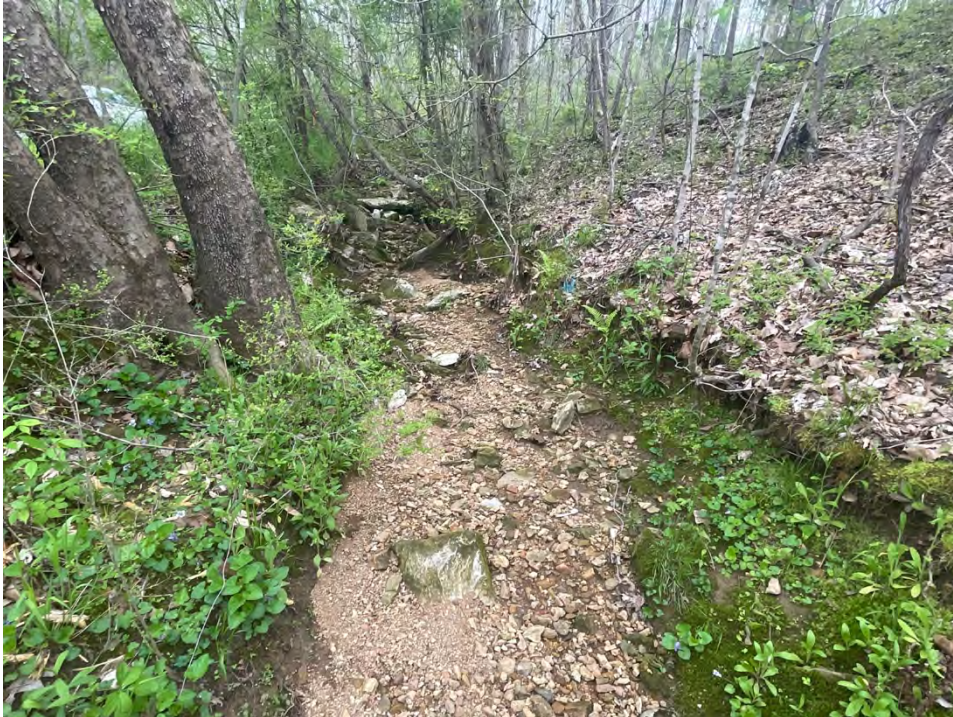
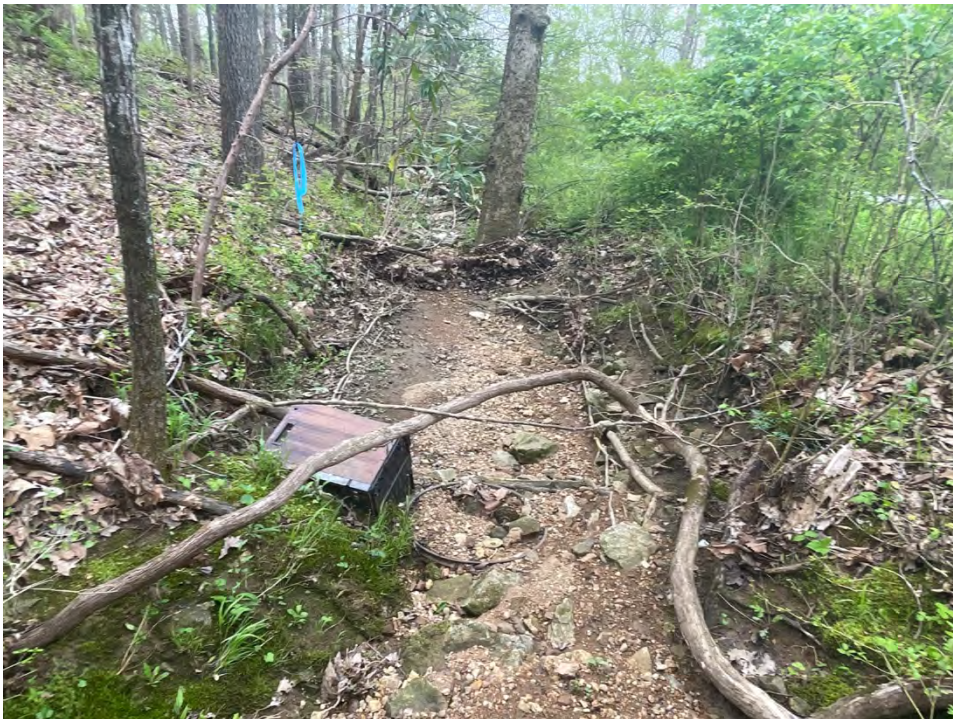
**Notes :** (1) High geomorphological indicators (Strong defined continuous bed and bank, moderate sorting).  
 (2.) Absent leaf litter  
 (3.) moderate wrack lines

**Photo 11:** Wet Weather Conveyance 6, looking upstream  
**Coordinates:** 36.056422, -87.382829

**Photo 12:** Wet Weather Conveyance 6, looking downstream  
**Coordinates:** 36.056422, -87.382829

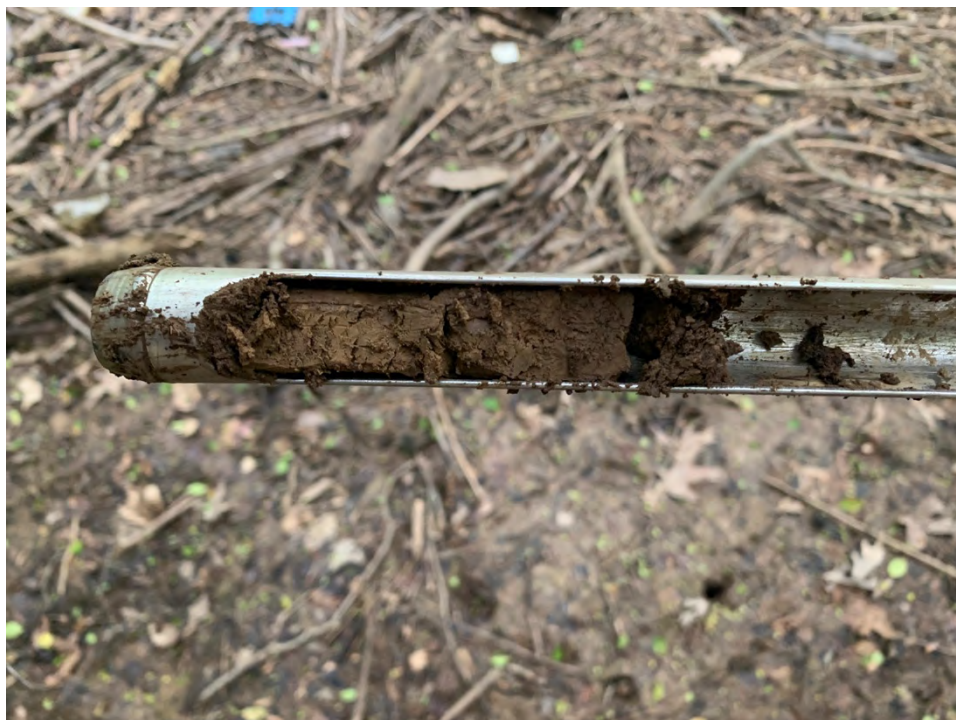
So I had no redox occurring.

**Photo 13:** Soils at NW\_1  
**Coordinates:** 36.055989, -87.382137

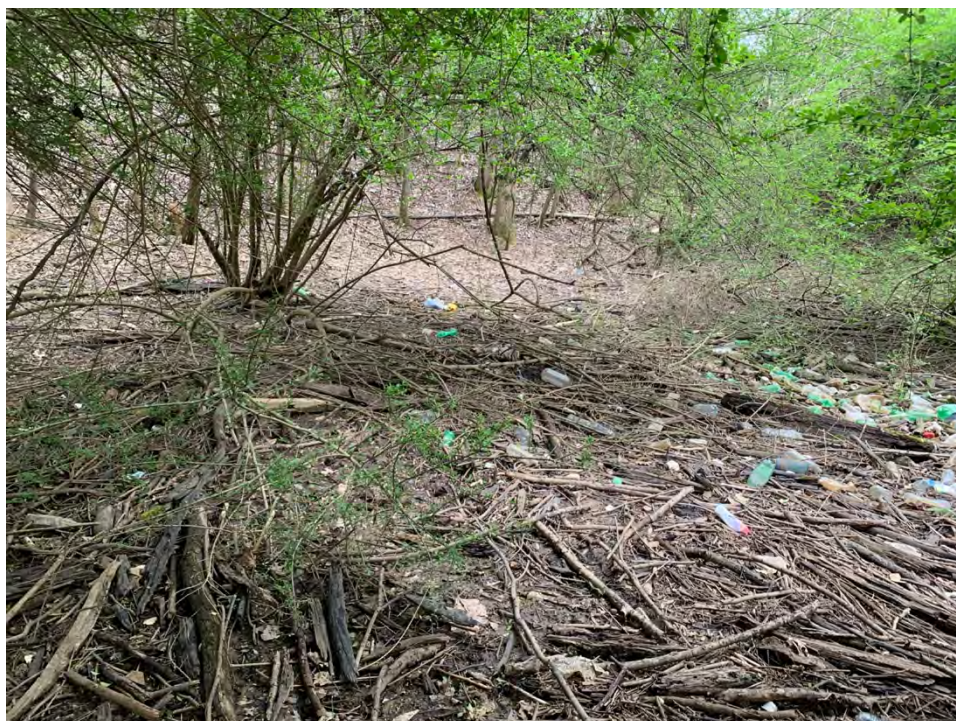
**Photo 14:** Overview of NW\_1  
**Coordinates:** 36.055989, -87.382137
