AQUATIC RESOURCES DELINEATION AND HYDROLOGIC DETERMINATION REPORT

CENTRAL VALLEY ROAD (±36.7-ACRES)
PARCEL NUMBERS 047-06703 & 047-06712
MURFREESBORO, RUTHERFORD COUNTY, TENNESSEE

Project No. 000220800898.00

April 28, 2022

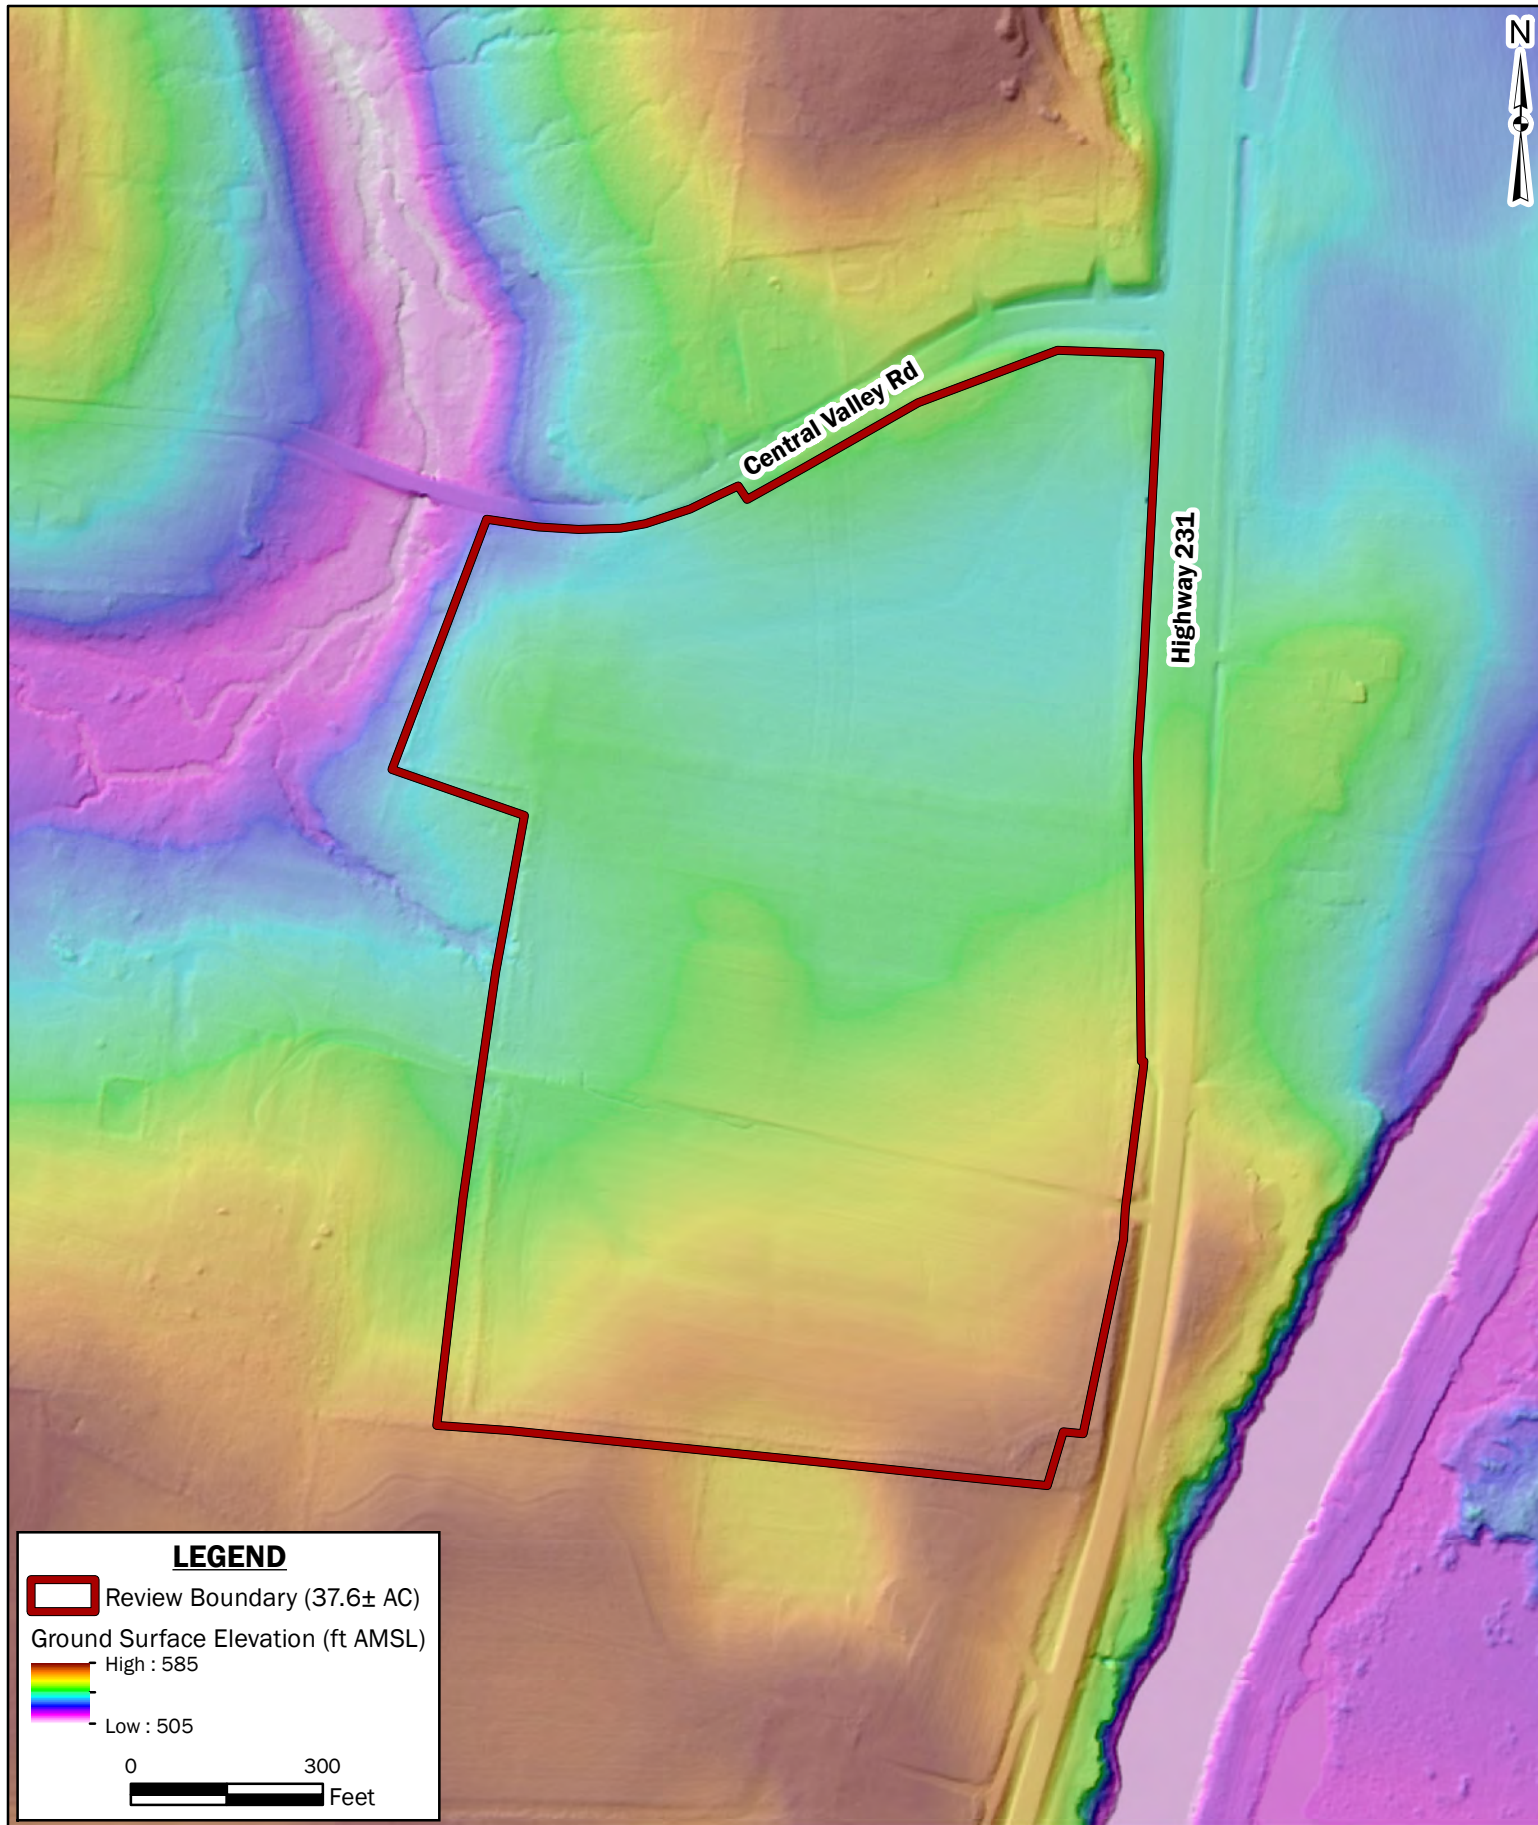
FIGURE 3: LIDAR ELEVATION & HILLSHADE MAP
GEORGIA CAPITAL, LLC - CENTRAL VALLEY ROAD PROPERTY
AQUATIC RESOURCES DELINEATION
MURFREESBORO, RUTHERFORD COUNTY, TENNESSEE

In addition to USGS topographic maps, surrounding elevation data was obtained from the USGS 3D Elevation Program, which is presented in an Elevation and Hillshade map included as **Figure 3**. Based on our review of Figures 1 & 3, surface drainage in the vicinity of the review area drains to the northeast and northwest.

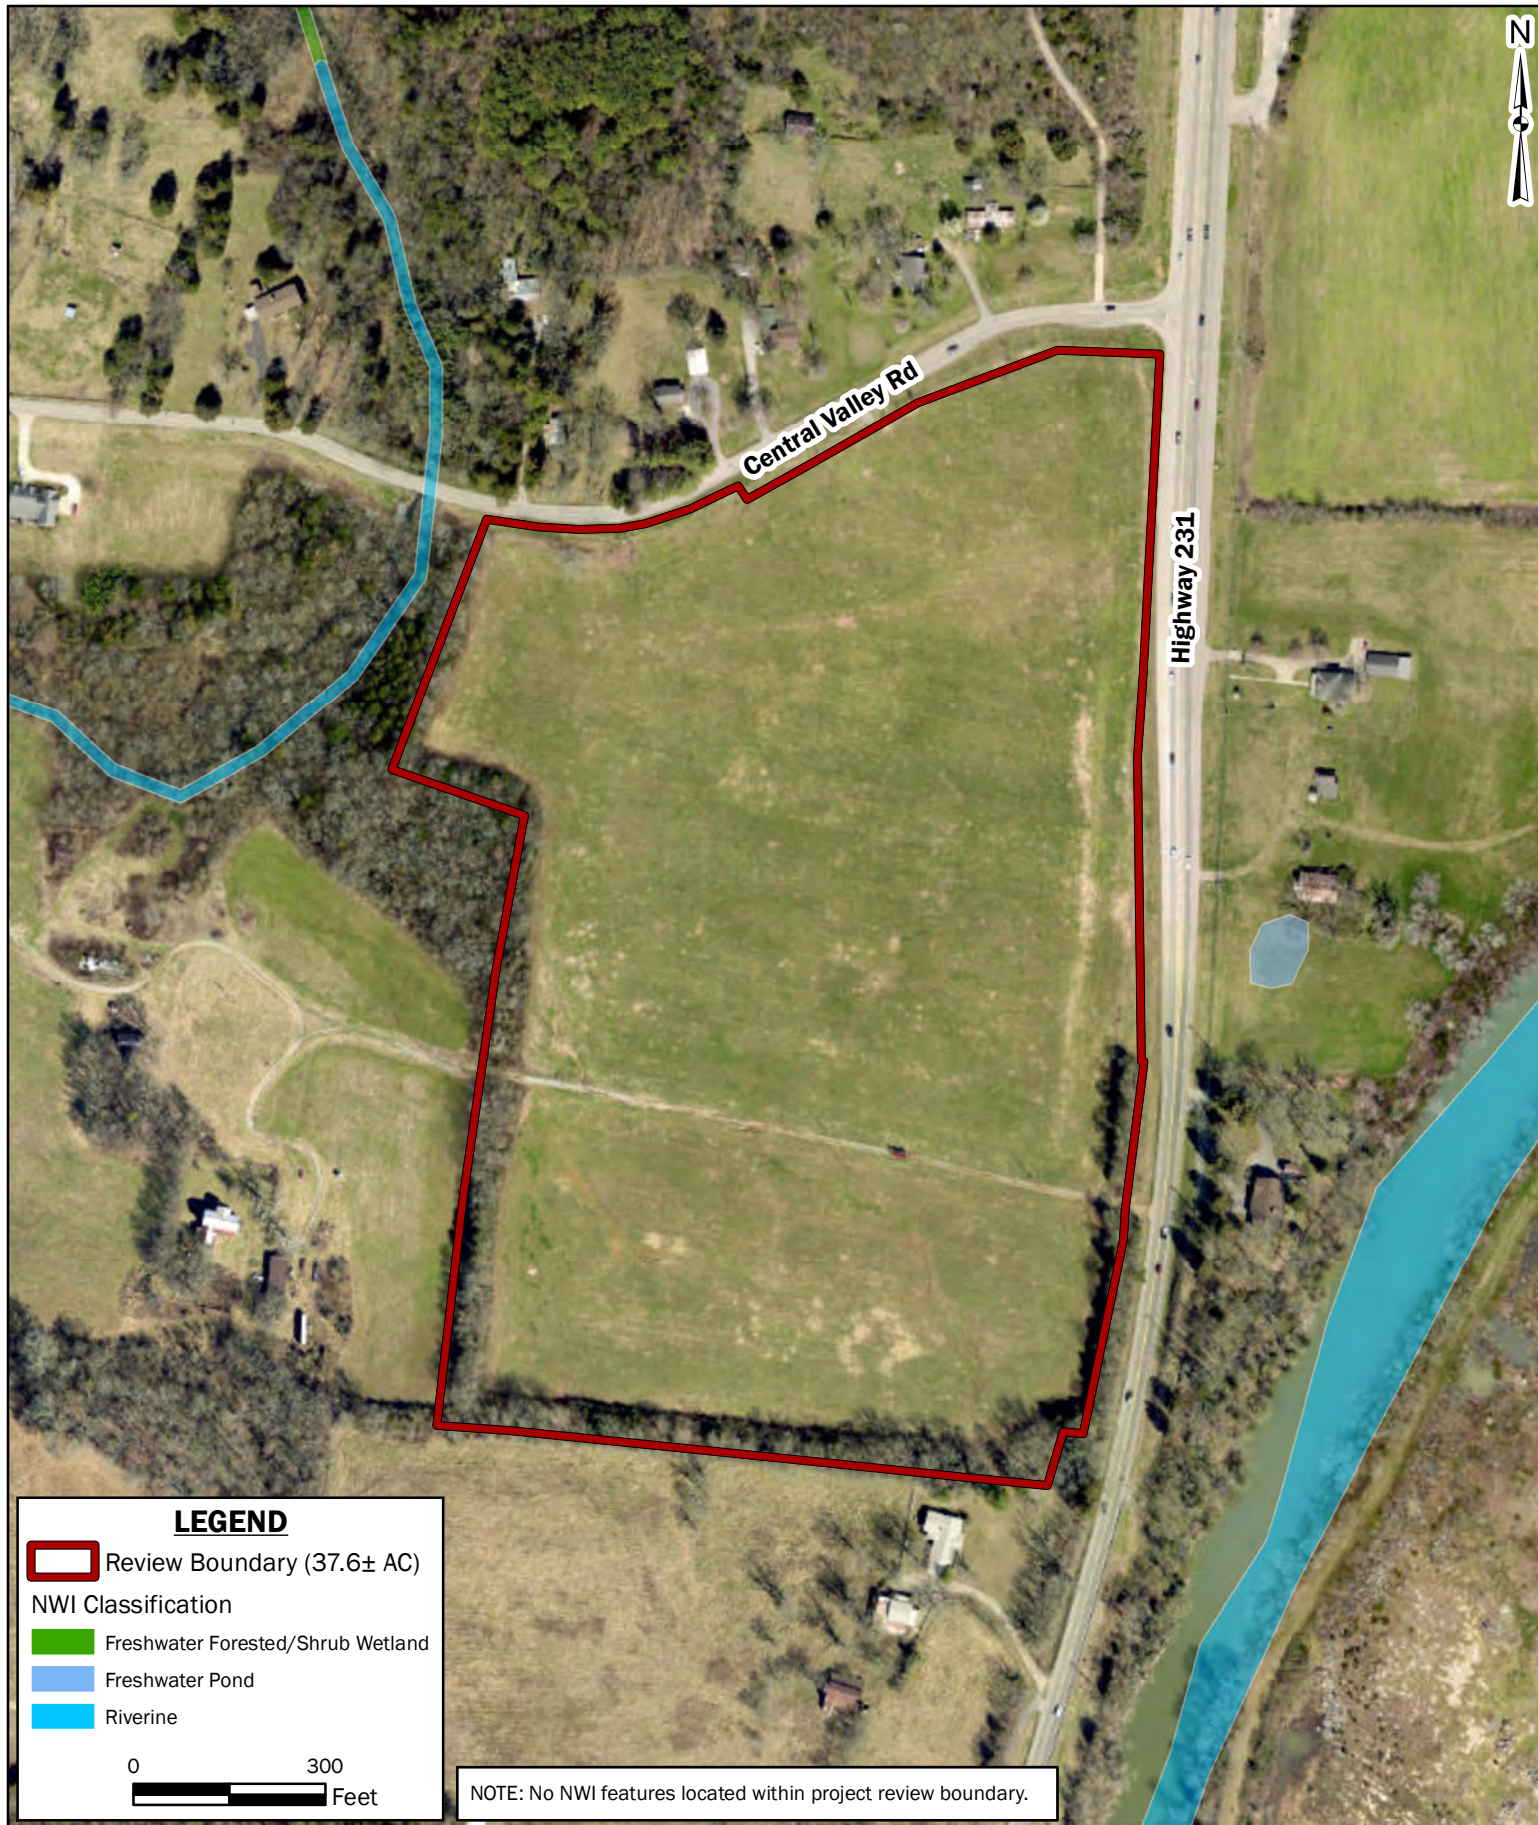
FIGURE 5: NATIONAL WETLAND INVENTORY (NWI) MAP

TTL reviewed the NWI data for the site using the USFWS NWI Wetlands Mapper web-based tool to determine the potential for wetlands to exist on the site. A copy of the NWI map is included as **Figure 5**. Based on our review of the USFWS-NWI Mapper, no aquatic features are shown within the limits of the review area.

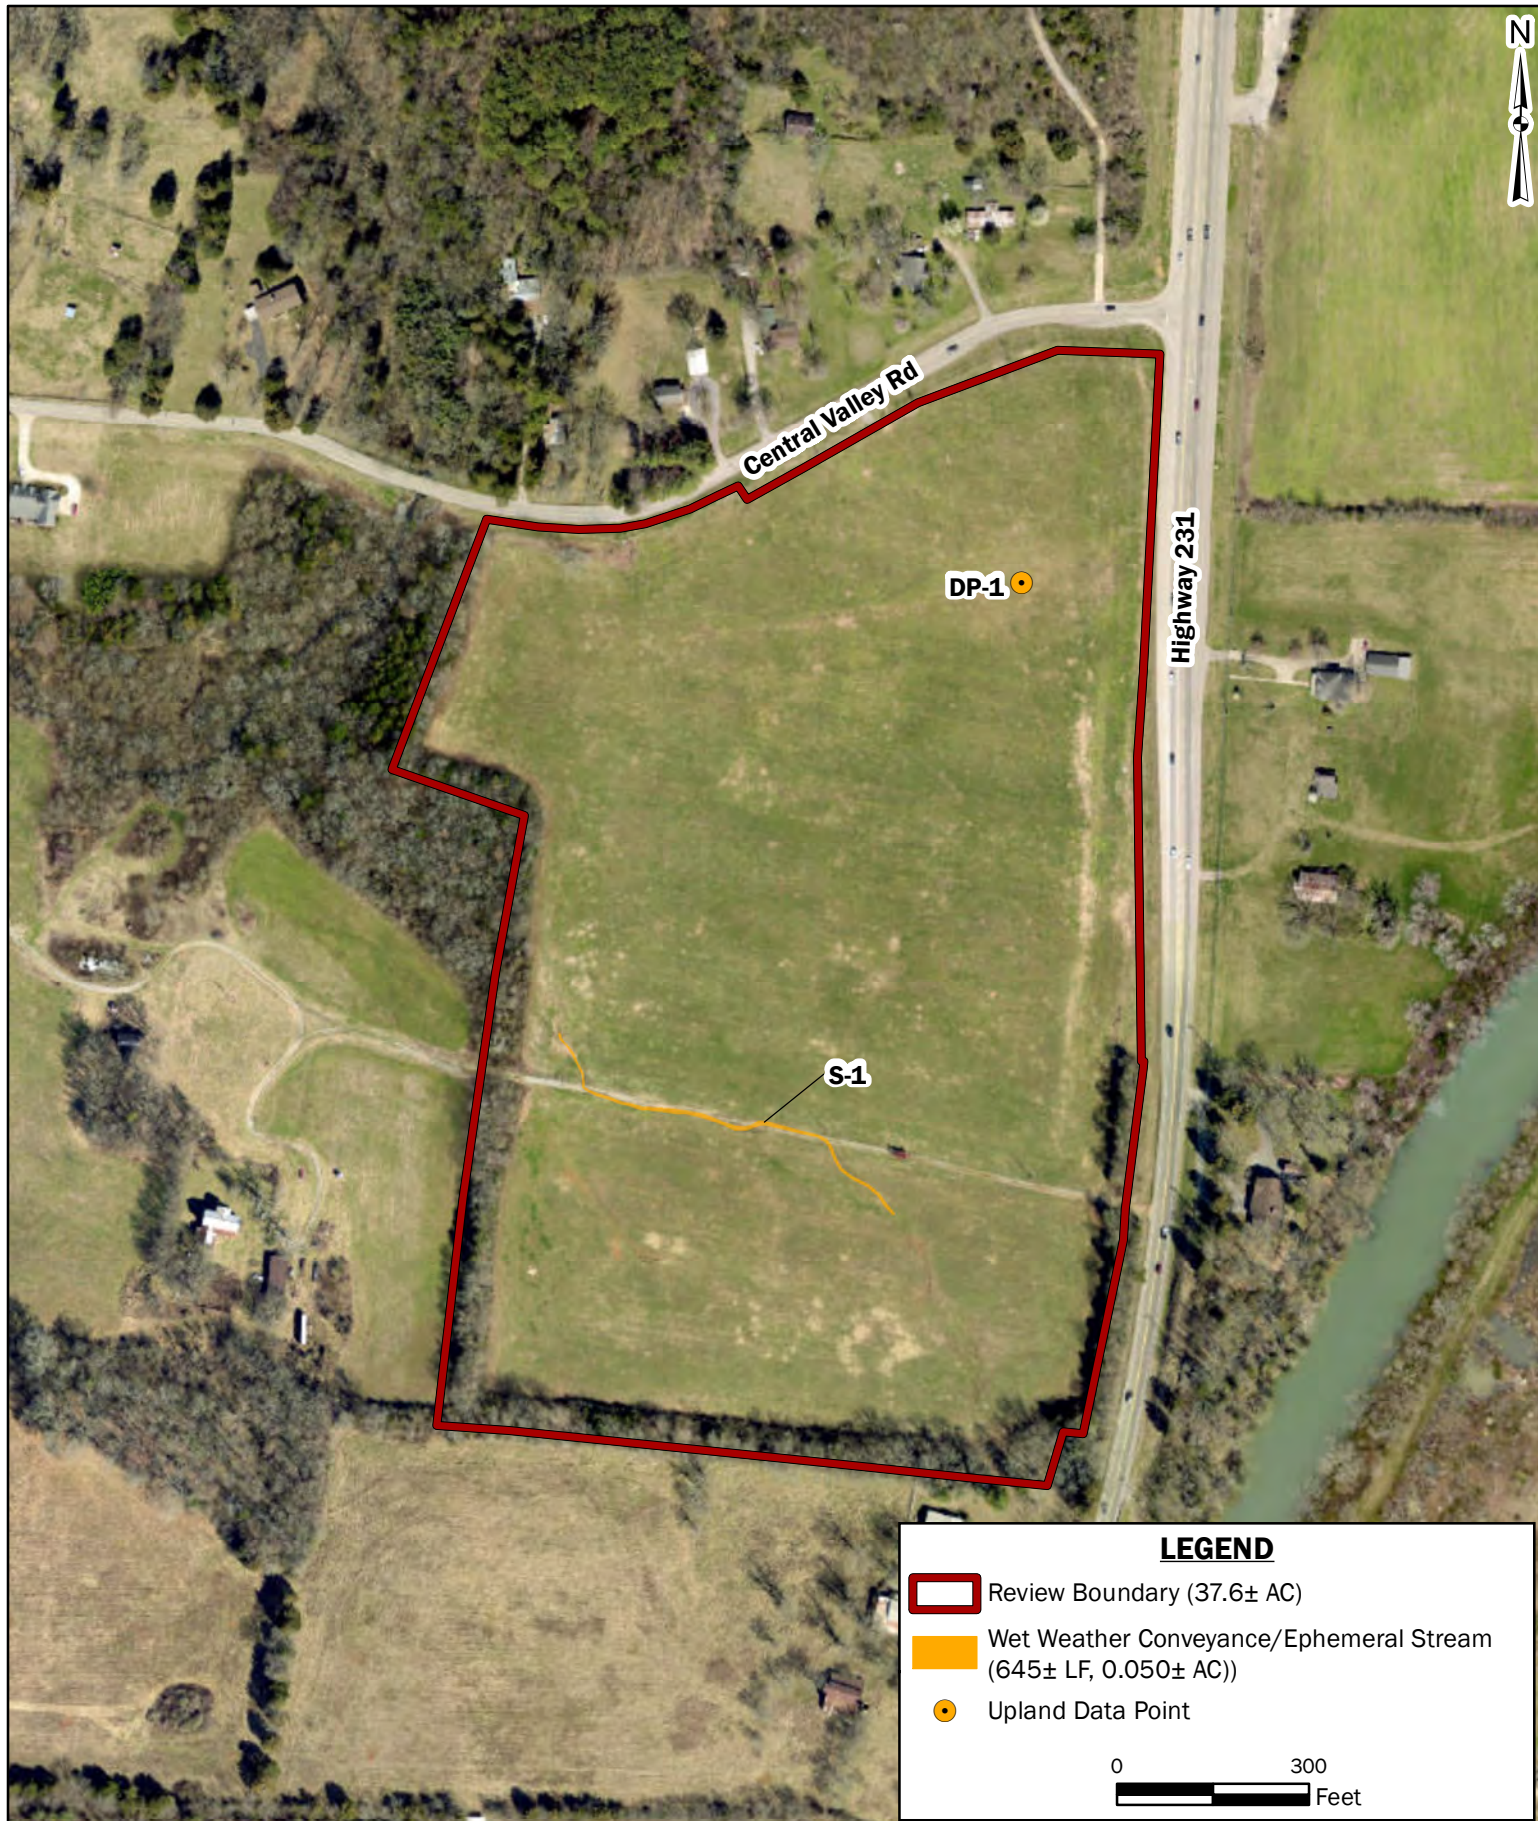
FIGURE 7: AQUATIC RESOURCE DELINEATION MAP

TTL observed a drainage ditch (S-1) that runs parallel to the access road on the southern half of the property for approximately 645 linear feet. Flowing water was observed throughout the S-1 channel which was primarily attributed to rainfall that occurred the day of our site visit. S-1 appears to be a manmade ditch which has been incised through erosion. The entire channel has a reddish-brown silty clay bottom with very little diversity or sinuosity. The S-1 channel directs surface water runoff from the surrounding crop fields towards the western property boundary. As S-1 approaches the western property boundary, the channel definition dissipates. No macroinvertebrates or other biological indicators were observed in the channel. Based on our site observations, S-1 appears to be a wwc/ephemeral channel.

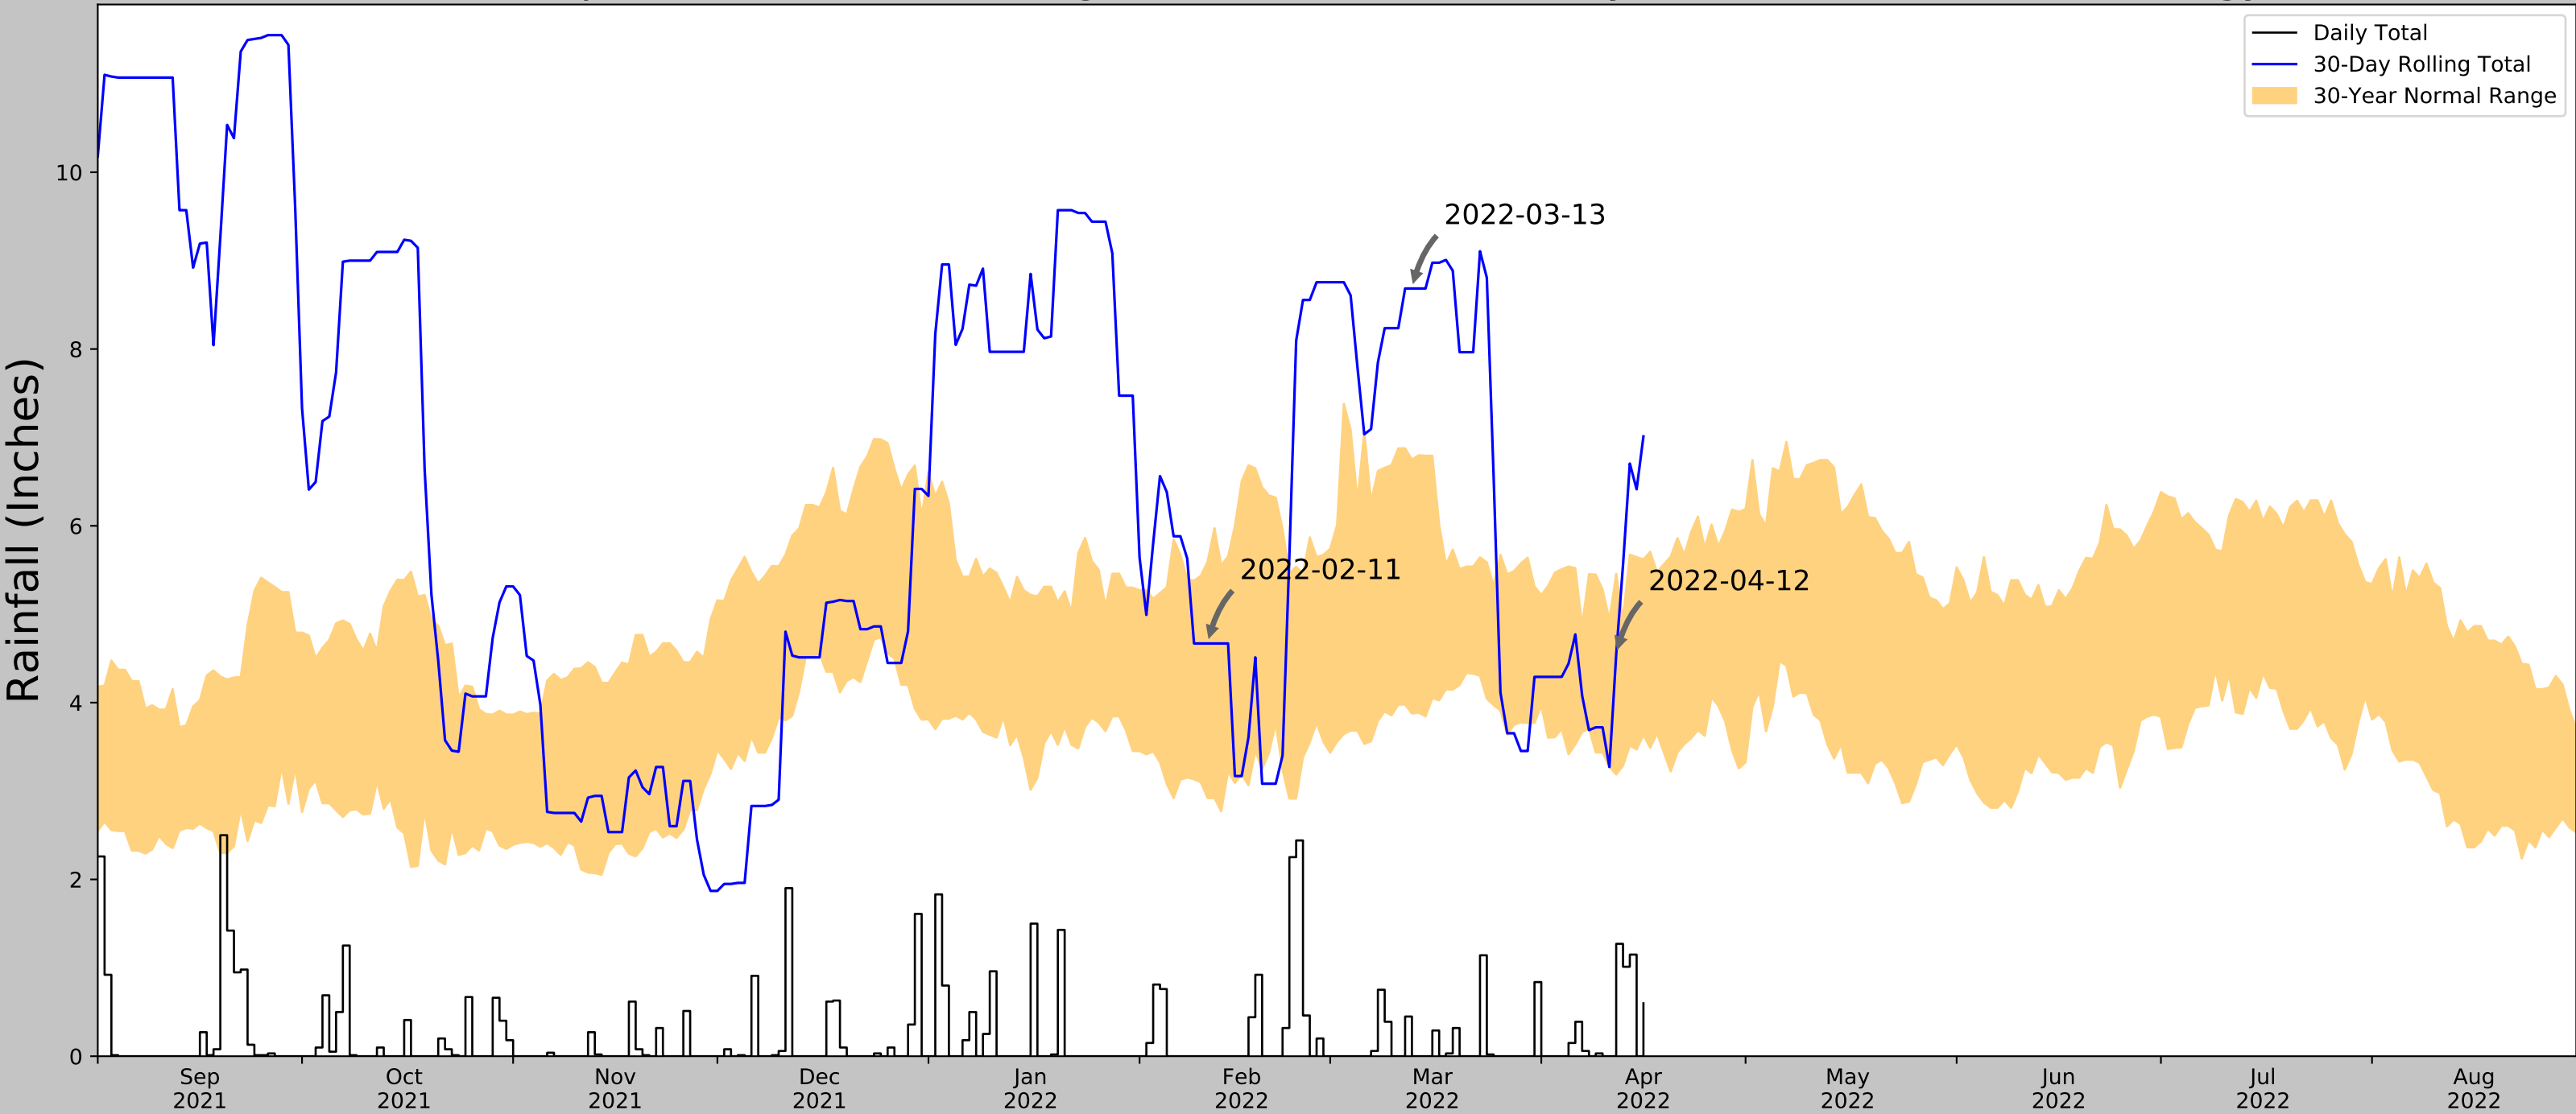
Antecedent Precipitation vs Normal Range based on NOAA's Daily Global Historical Climatology Network

Coordinates	35.936095, -86.380477
Observation Date	2022-04-12
Elevation (ft)	552.83
Drought Index (PDSI)	Severe wetness (2022-03)
WebWIMP H ₂ O Balance	Wet Season

30 Days Ending	30 th %ile (in)	70 th %ile (in)	Observed (in)	Wetness Condition	Condition Value	Month Weight	Product
2022-04-12	3.186614	5.45748	4.543307	Normal	2	3	6
2022-03-13	3.876378	6.750394	8.68504	Wet	3	2	6
2022-02-11	2.920079	5.598425	4.669291	Normal	2	1	2
Result							Normal Conditions - 14

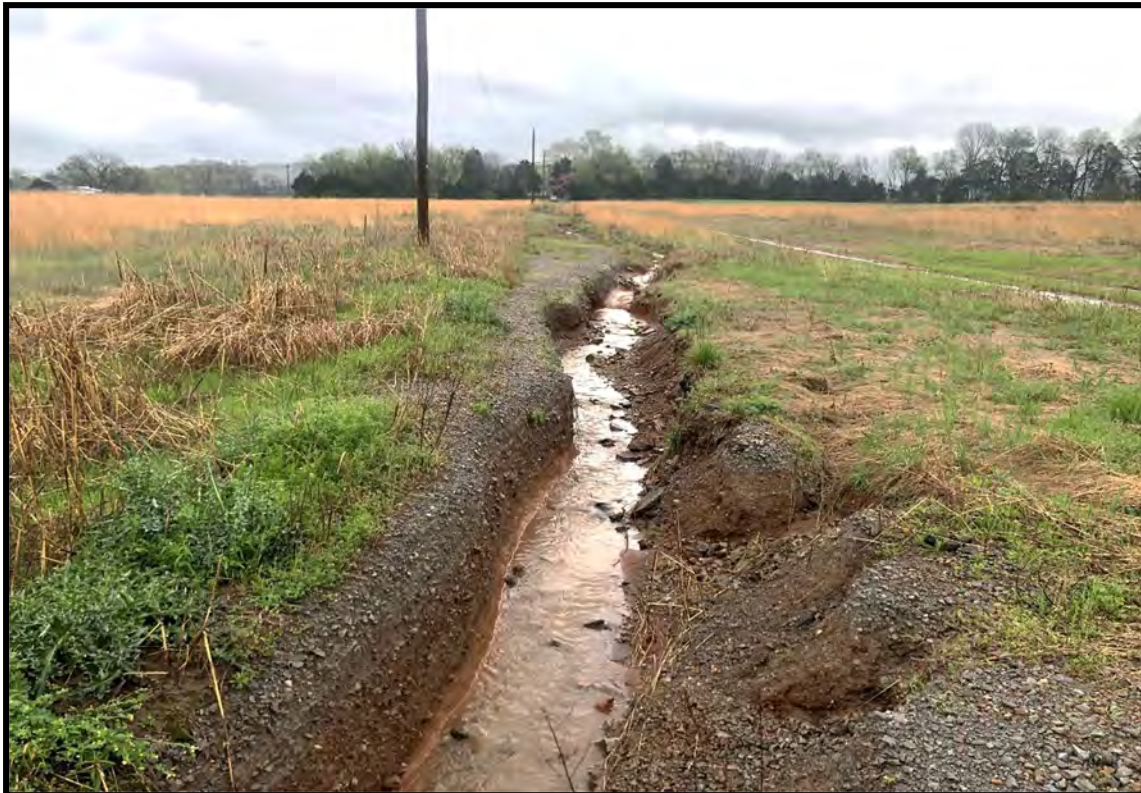
Photo 2 – View of S-1 facing upstream (facing east). 35.935269,-86.380461

Justification / Notes: S-1 appears to be a manmade ditch that carries surface water runoff from the surrounding cropfields. S-1 is incised through erosion. Very little diversity or sinuosity observed. No macroinvertebrates observed within the channel.

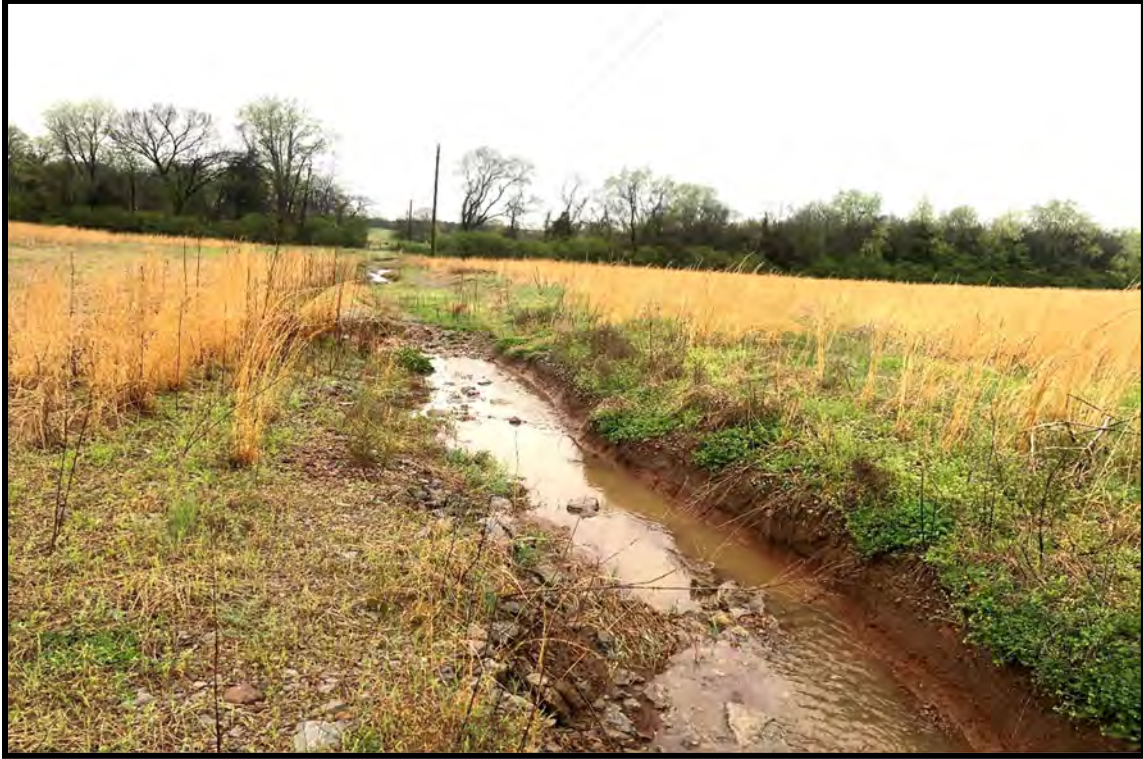
Photo 3 – View of S-1 facing downstream (west). 35.935271,-86.380576

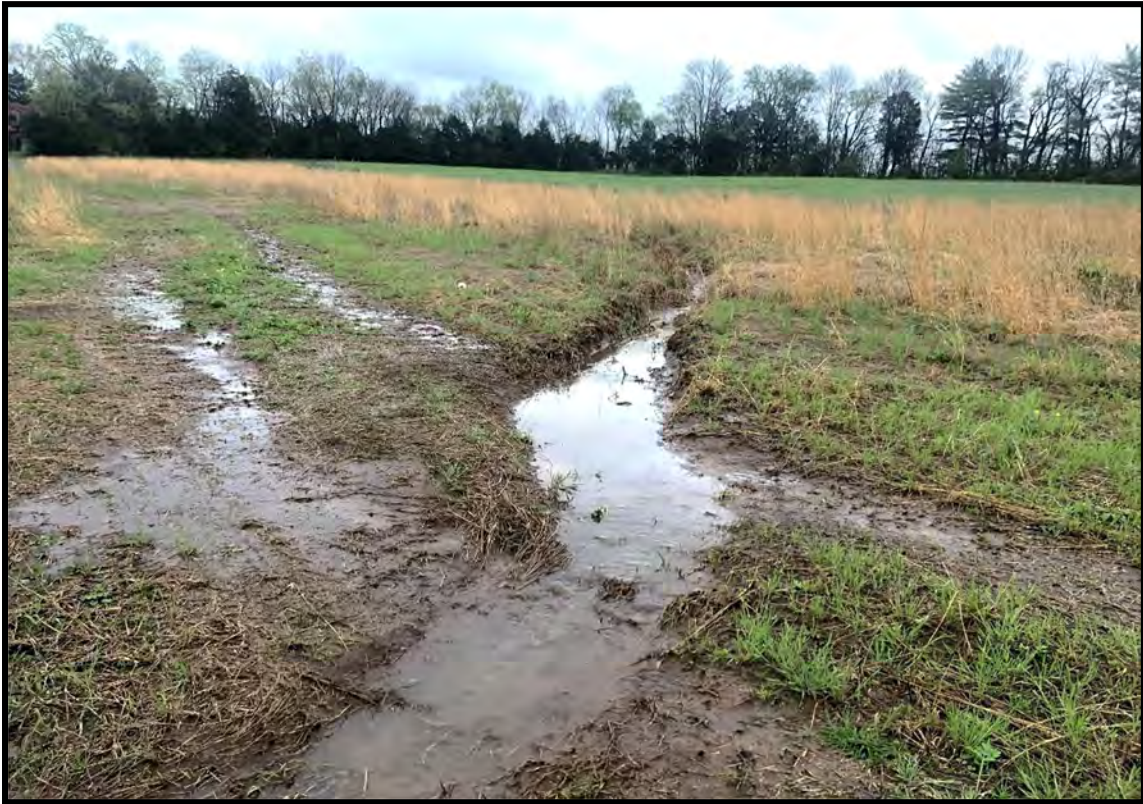
Photo 4 – View of the starting point of S-1 (facing south). 35.934990,-86.380109

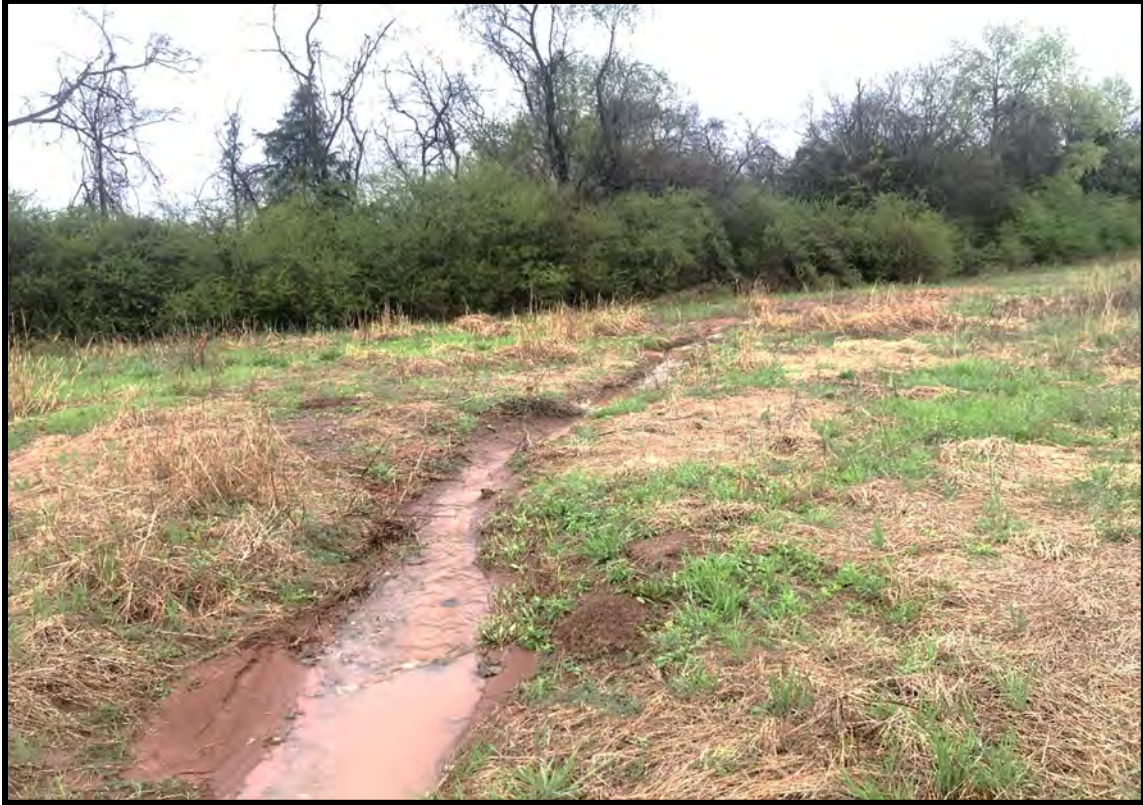
Photo 5 – View of the ending point of S-1 (facing northwest). 35.935599,-86.381753

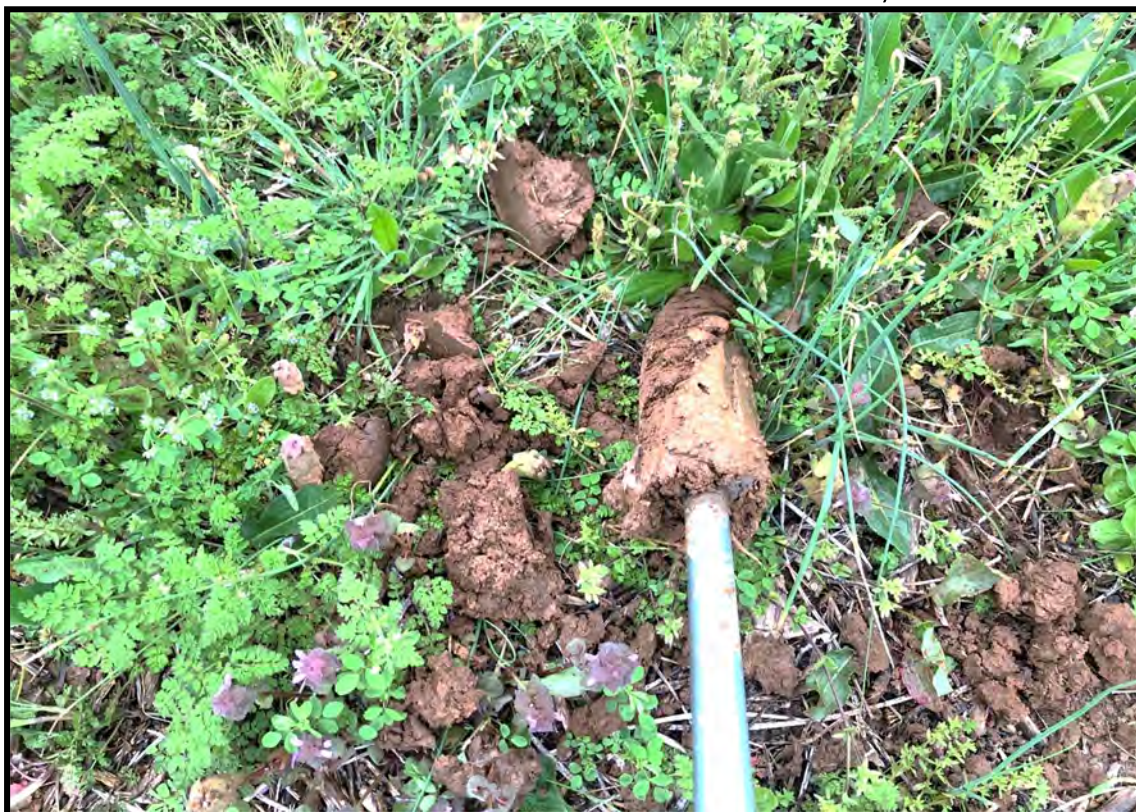
Profile Description: (Describe to the depth needed to document the indicator or confirm the absence of indicators.)								
Depth (inches)	Matrix		Redox Features				Texture	Remarks
	Color (moist)	%	Color (moist)	%	Type ¹	Loc ²		
0-24	10YR 6/4						Loamy/Clayey	
¹ Type: C=Concentration, D=Depletion, RM=Reduced Matrix, MS=Masked Sand Grains.							² Location: PL=Pore Lining, M=Matrix.	
Hydric Soil Indicators:							Indicators for Problematic Hydric Soils³:	
<input type="checkbox"/> Histosol (A1)			<input type="checkbox"/> Polyvalue Below Surface (S8) (MLRA 147, 148)				<input type="checkbox"/> 2 cm Muck (A10) (MLRA 147)	
<input type="checkbox"/> Histic Epipedon (A2)			<input type="checkbox"/> Thin Dark Surface (S9) (MLRA 147, 148)				<input type="checkbox"/> Coast Prairie Redox (A16)	
<input type="checkbox"/> Black Histic (A3)			<input type="checkbox"/> Loamy Mucky Mineral (F1) (MLRA 136)				<input type="checkbox"/> (MLRA 147, 148)

Photo 8 – View of soil from DP-1. 35.937642,-86.37939
