Subject: **HYDROLOGIC DETERMINATION REPORT**  
Old Columbia Road Property  
(Parcel # 111 040.00, 111 040.01 and 111 040.03)  
Dickson, Dickson County, Tennessee  
C&T Project No. 03-22021

*Hydrologic Determination*  
*Old Columbia Road Property – Dickson, Tennessee*

*C&T Project No. 03-22021*  
*May 25, 2022*

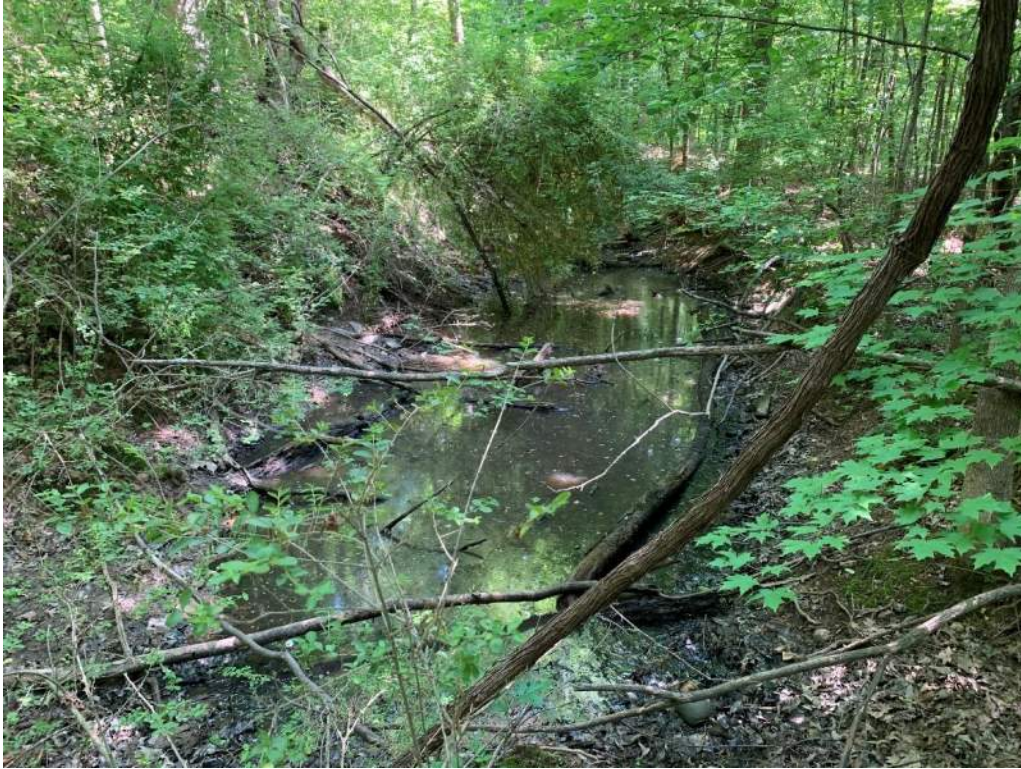
- **Pond A – Latitude: N36.065963° Longitude: W-87.345586°**

**Photograph 1:** View of Pond A located near the southern property boundary.

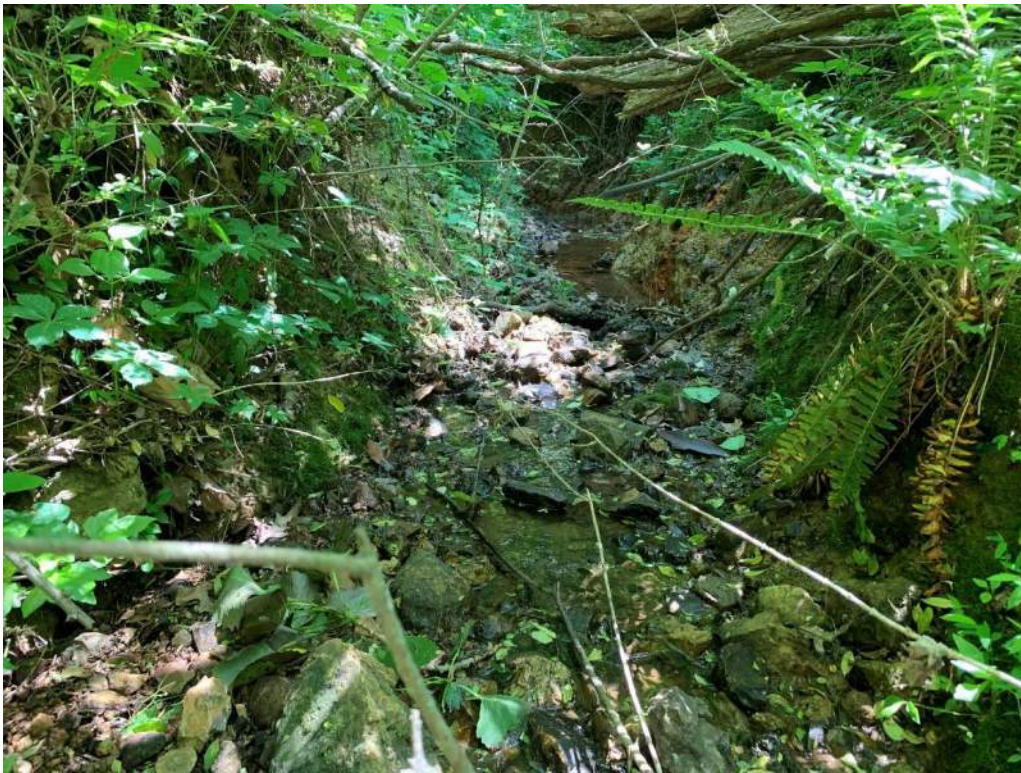
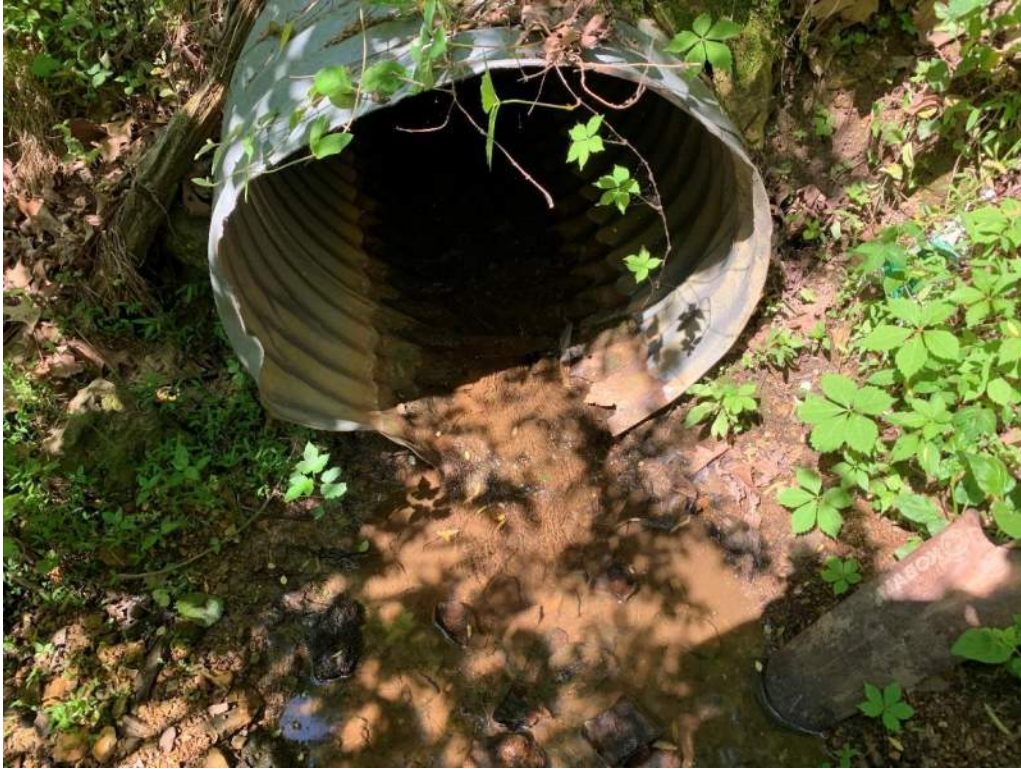
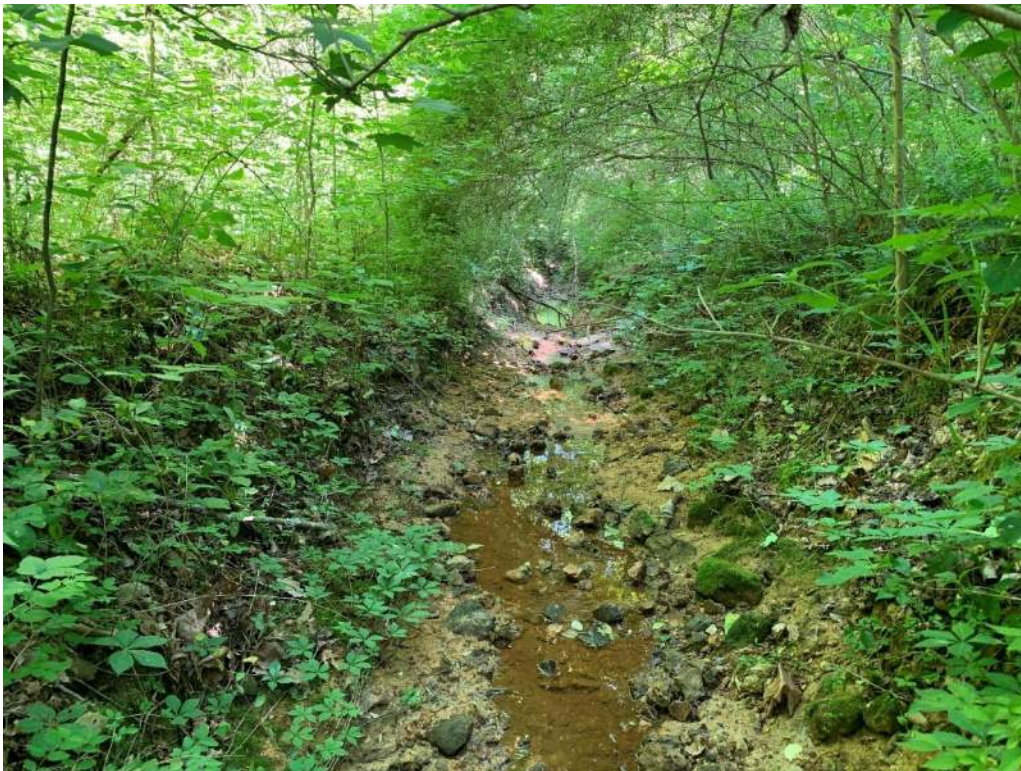
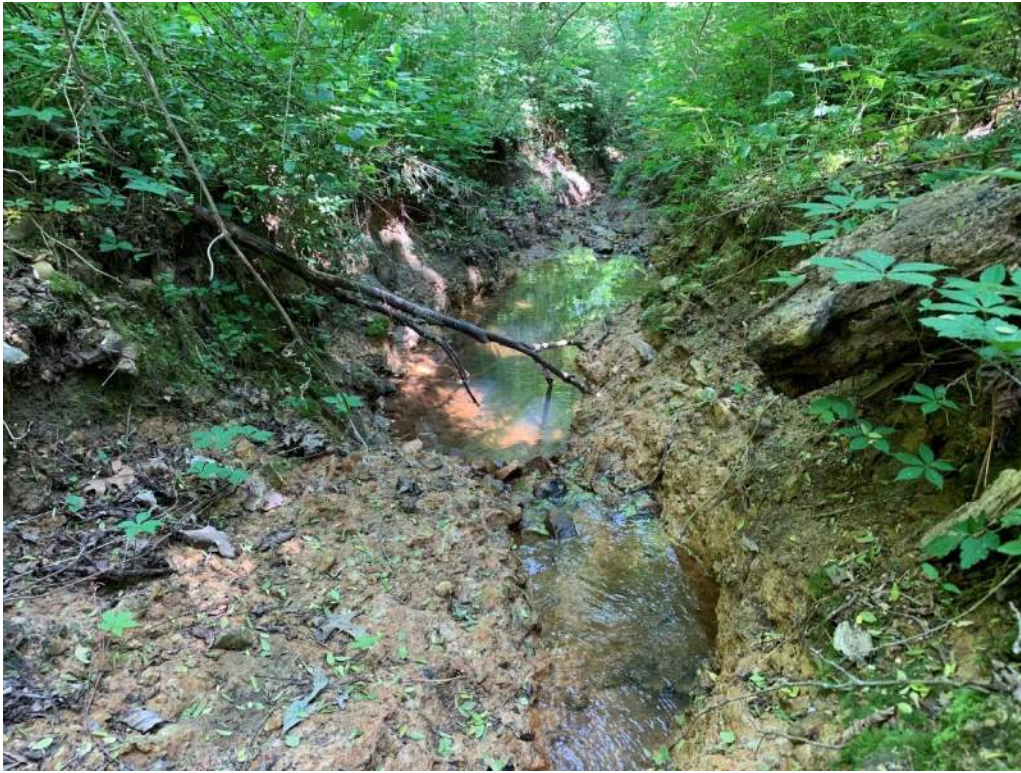
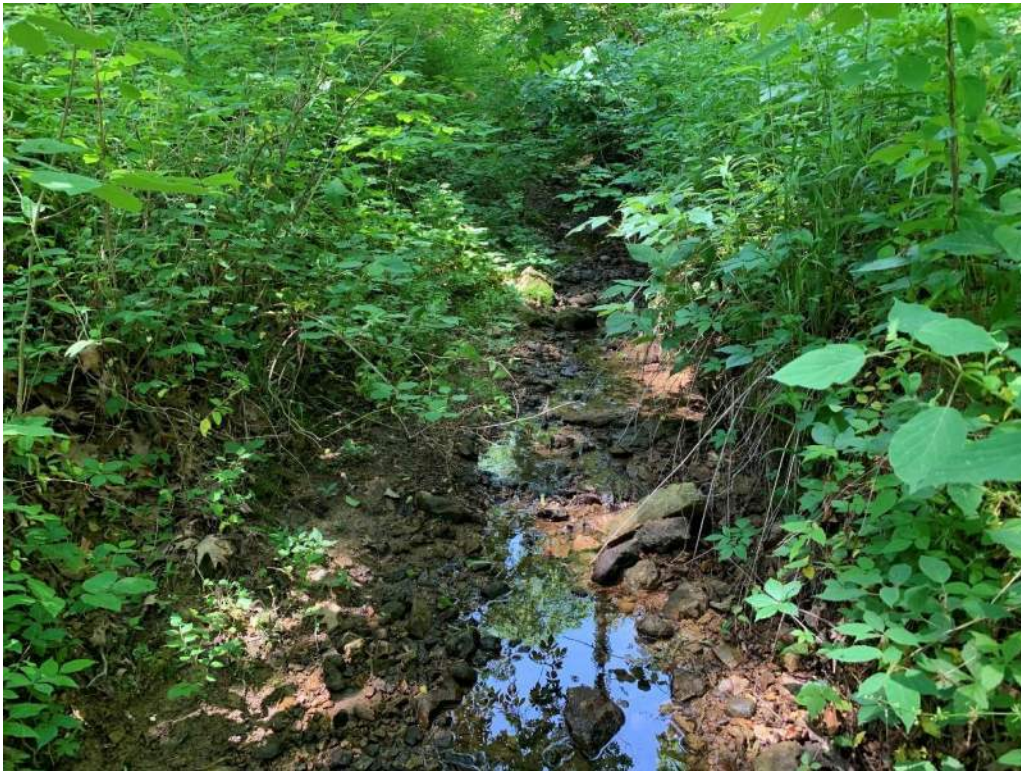
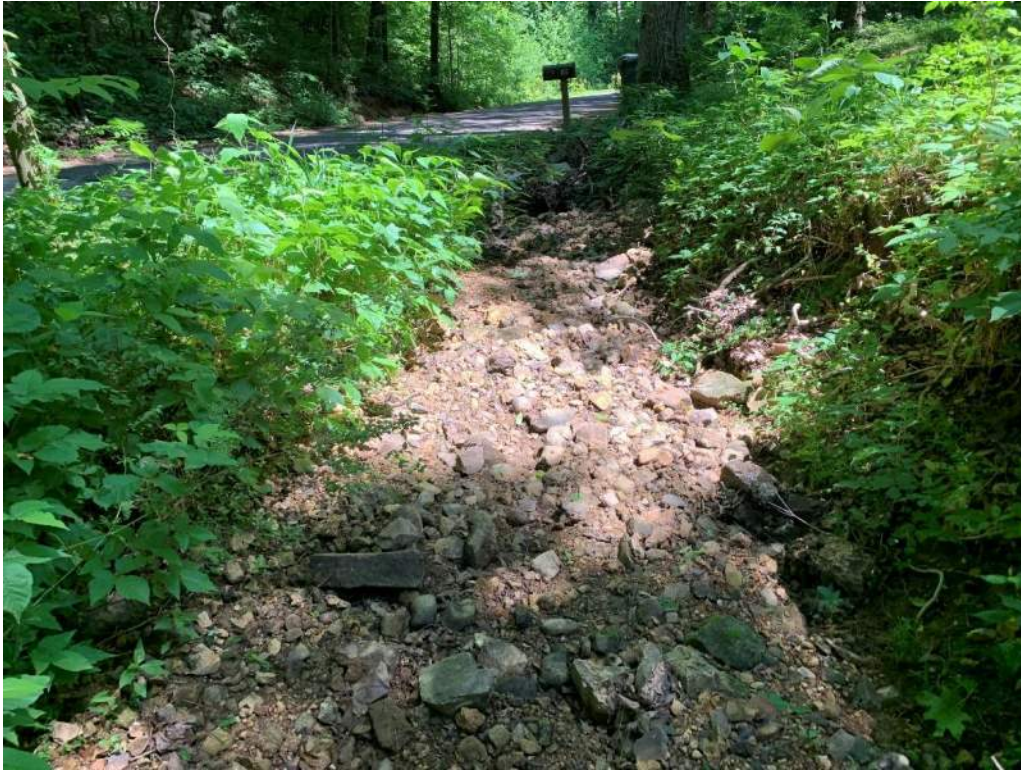
- **STR-1 (Johnson's Creek)** – Enters property at southeastern property corner at **Latitude: N36.065968° Longitude: W-87.345012°** runs along eastern property boundary and appears to go subsurface near a driveway crossing at **Latitude: N36.066418° Longitude: W-87.344489°**. Two primary indicators for stream were observed (presence of naturally occurring groundwater connection, flowing water in channel and 7 days since last precipitation). Secondary indicators were also evaluated. The channel displayed weak to moderate geomorphic secondary indicators. Iron oxidizing bacteria was observed at culvert crossing underneath Bishop Ln. Macroenthos observed included mayfly larvae, scuds and isopods throughout the STR-1 reach. The flow in the stream appears to go subsurface near a driveway culvert crossing at the ending latitude longitude coordinates mentioned above. Downstream, below this location all secondary indicator scores dramatically decrease with

the channel structure weakening and upland rooted plants observed in the channel. The channel from starting to finish coordinates listed above scored 23 on the HDFD sheet and is considered a stream as part of this assessment.

**Photograph 2:** Downstream view of STR-1 just below road crossing under Bishop Ln (N36.066003 W-87.344987)

**Photograph 3:** Upstream view of STR-1 at culvert from Bishop Ln crossing from previous photo location.

**Photograph 4:** Upstream view of STR-1 (N36.066141 W-87.344280)

**Photograph 5:** Downstream view of STR-1 from previous photograph location.

**Photograph 6 :** Upstream view of STR-1 near second crossing underneath Bishop Ln (N36.066343 W-87.344516)

**Photograph 7:** Downstream view of STR-1 from previous photograph location.

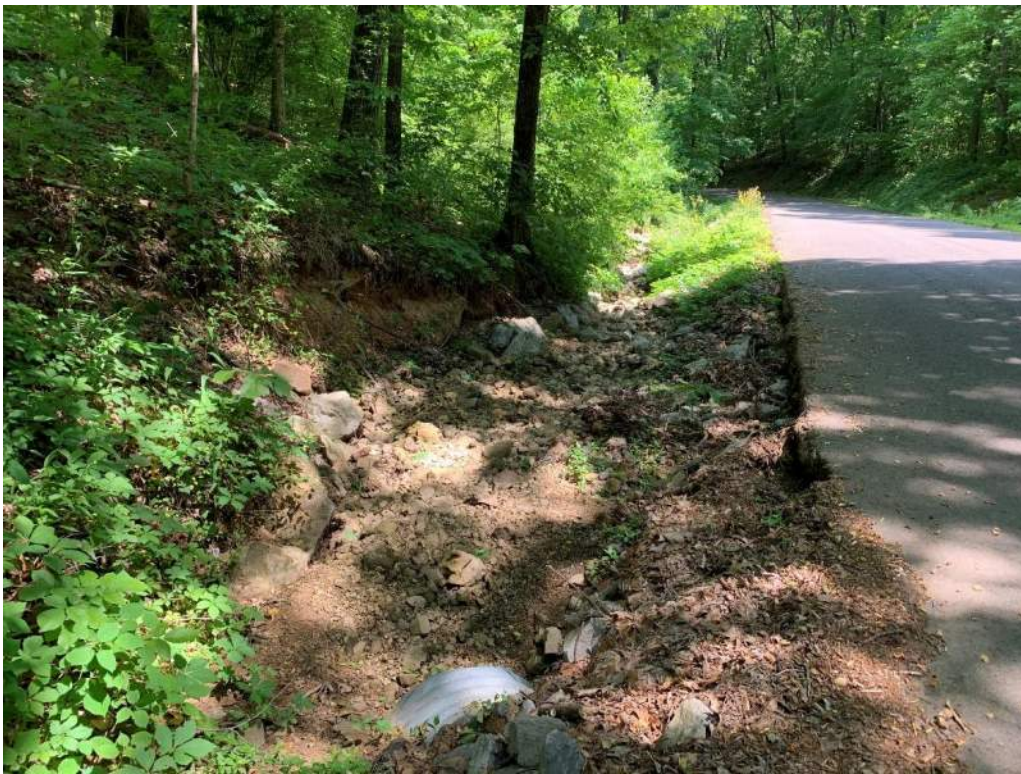
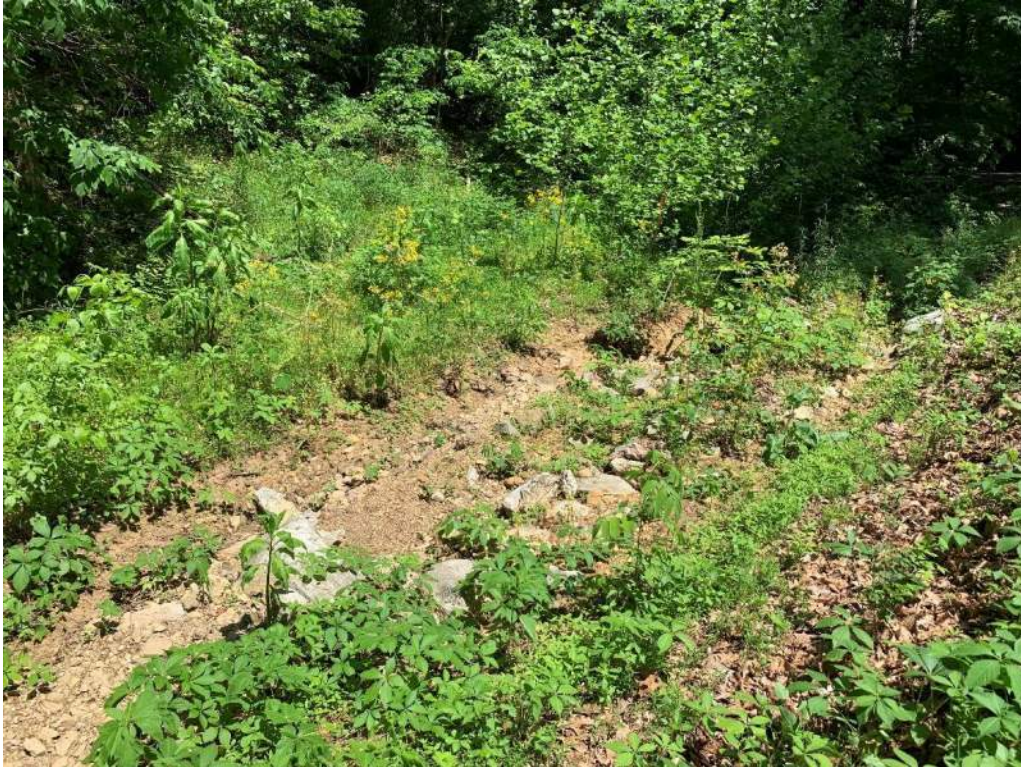
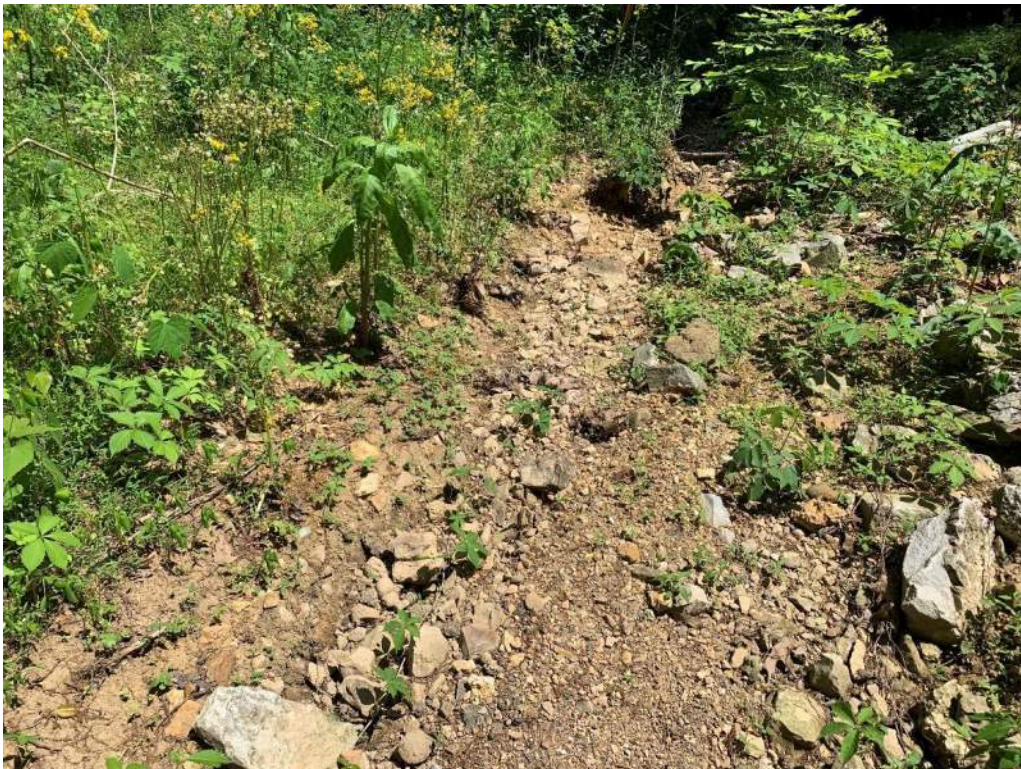
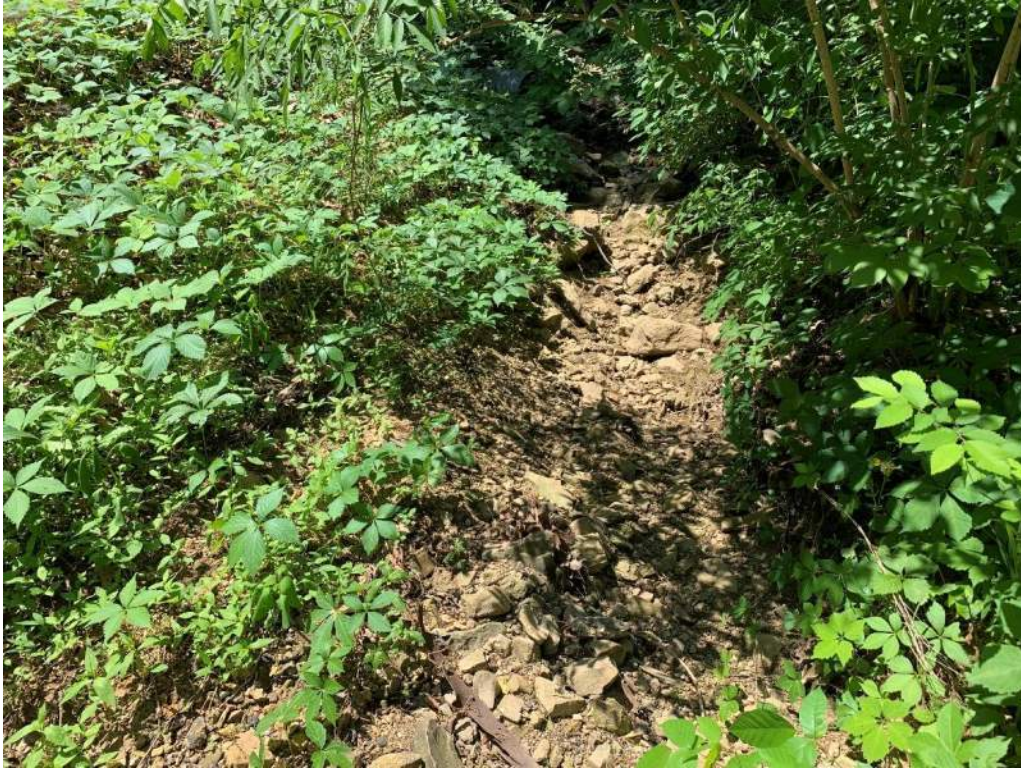
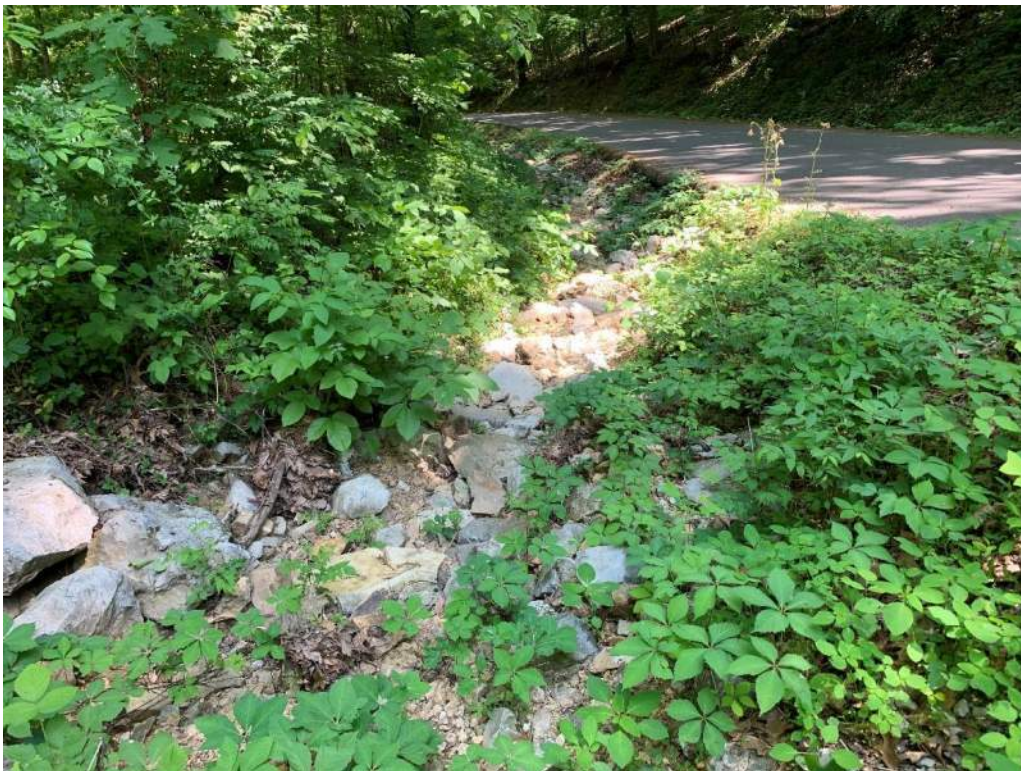
- **WWC-1** – Begins at **Latitude: N36.066557° Longitude: W-87.344538°** at the culvert outlet below Bishop Ln and across and downstream from STR-1 ending coordinates and leaving the property at **Latitude: N36.068304° Longitude: W-87.343337°**. The channel displayed weak secondary indicator scores through all three sub-categories. No flow was observed throughout the channel reach assessed. No macrobenthos was observed with exception to isopods in low amounts. Rooted plants were observed in the channel in multiple locations. No other biological indicators were observed and no other hydrology indicators with exception to weak scores for wrack lines and sediment observed on debris. The channel ultimately scored 15 on the HDFD sheet indicating a wet weather conveyance.

**Photograph 8:** Downstream view of WWC-1 (N36.066523 W-87.344529)

**Photograph 9:** Downstream view of WWC-1 (N36.066878 W-87.344217)

**Photograph 10:** Alternate downstream view of WWC-1 from previous photograph location.

**Photograph 11:** Upstream view of WWC-1 (N36.066984 W-87.344107)

**Photograph 12:** Downstream view of WWC-1 from previous photograph location.

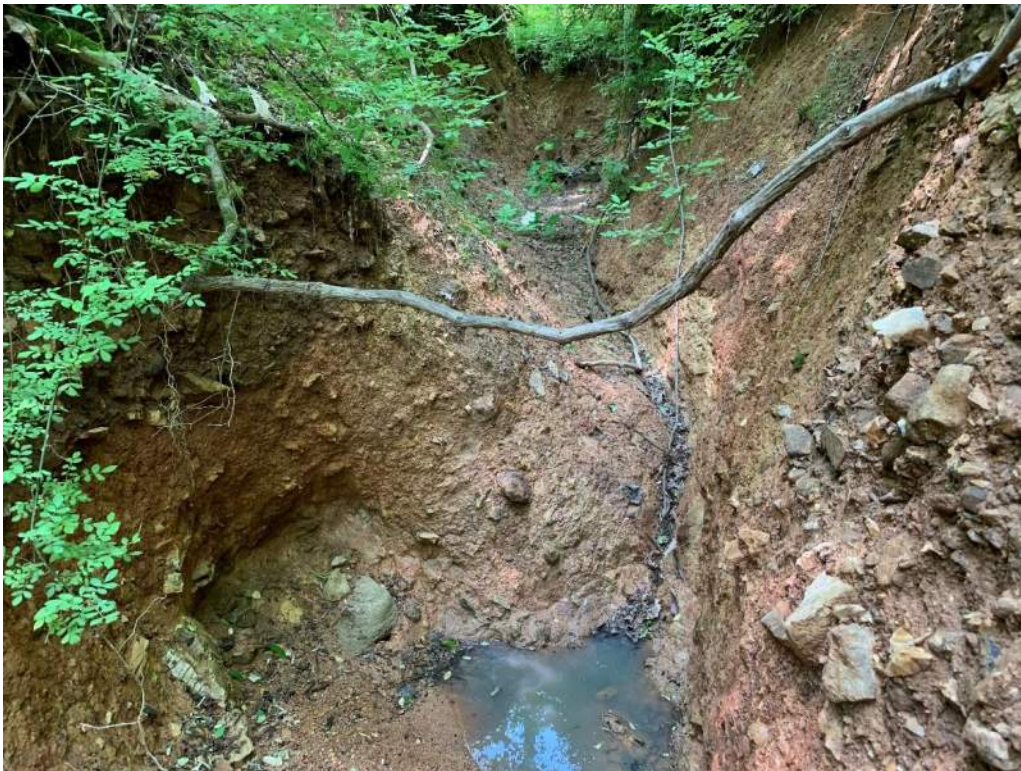
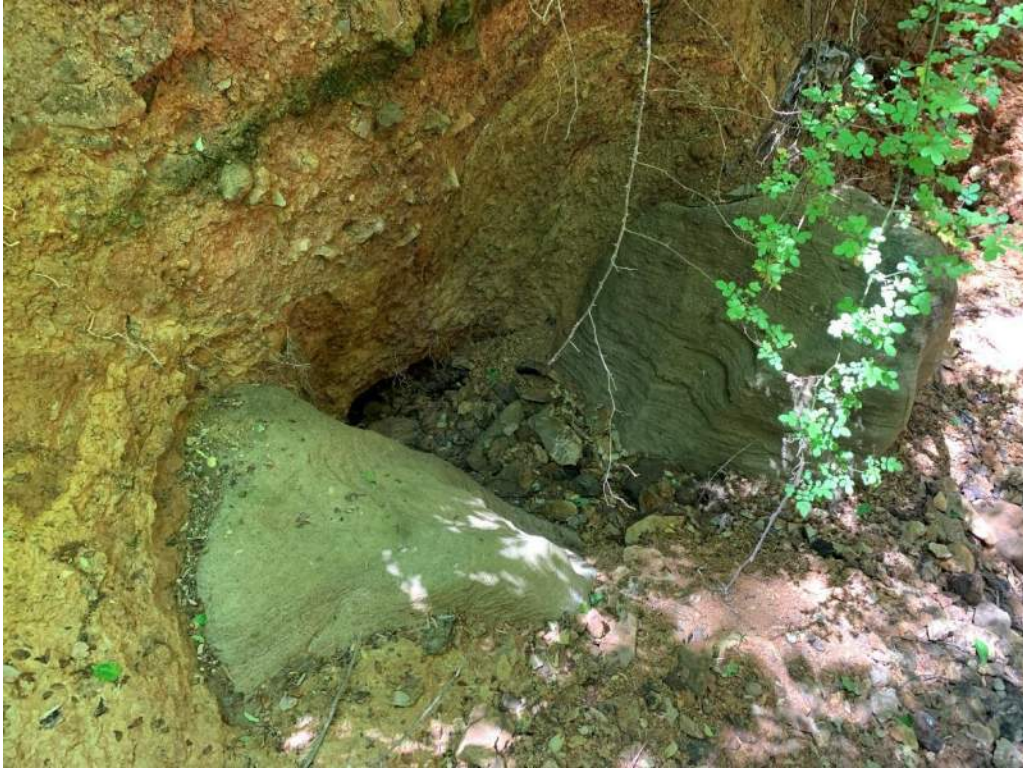
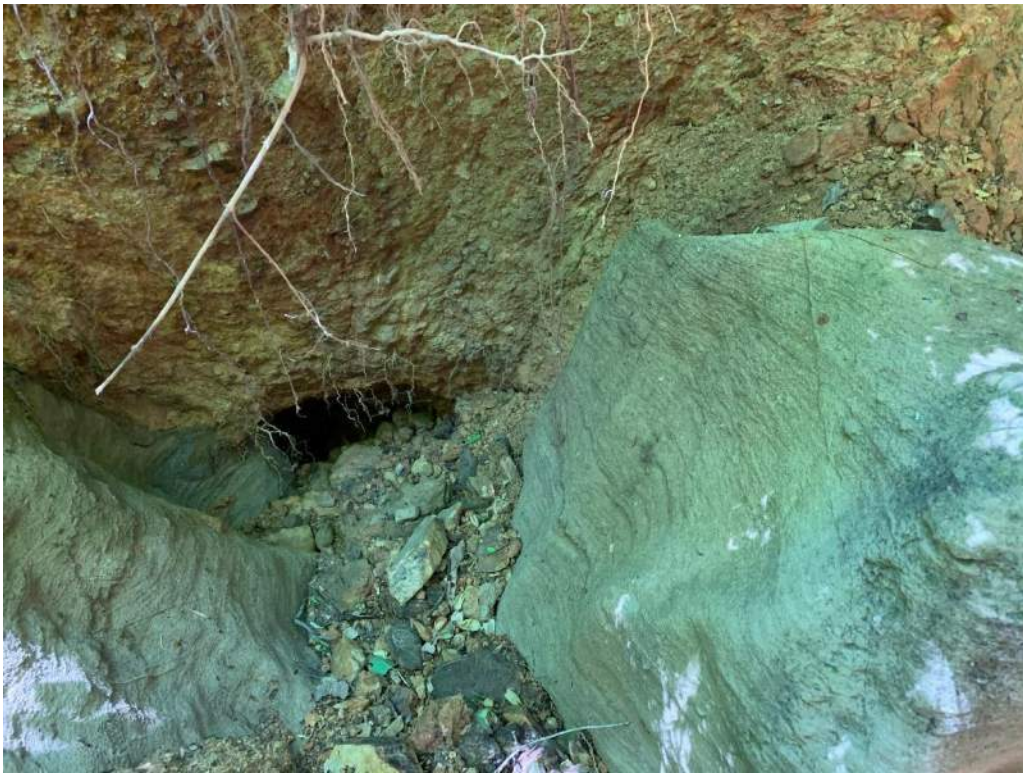
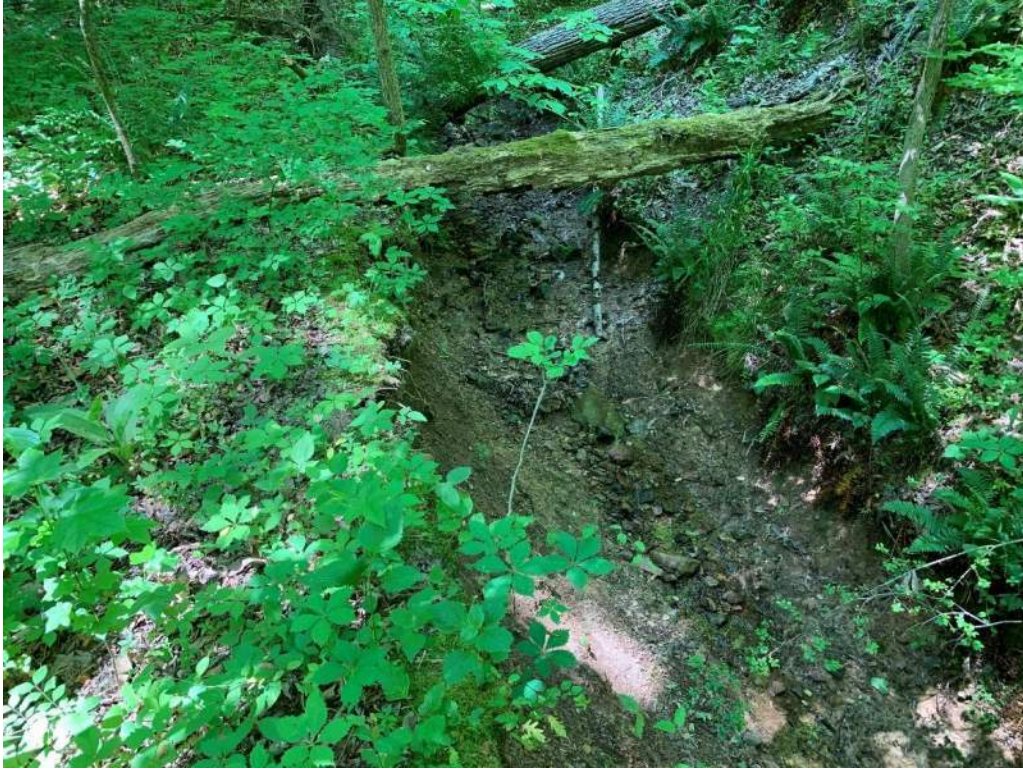
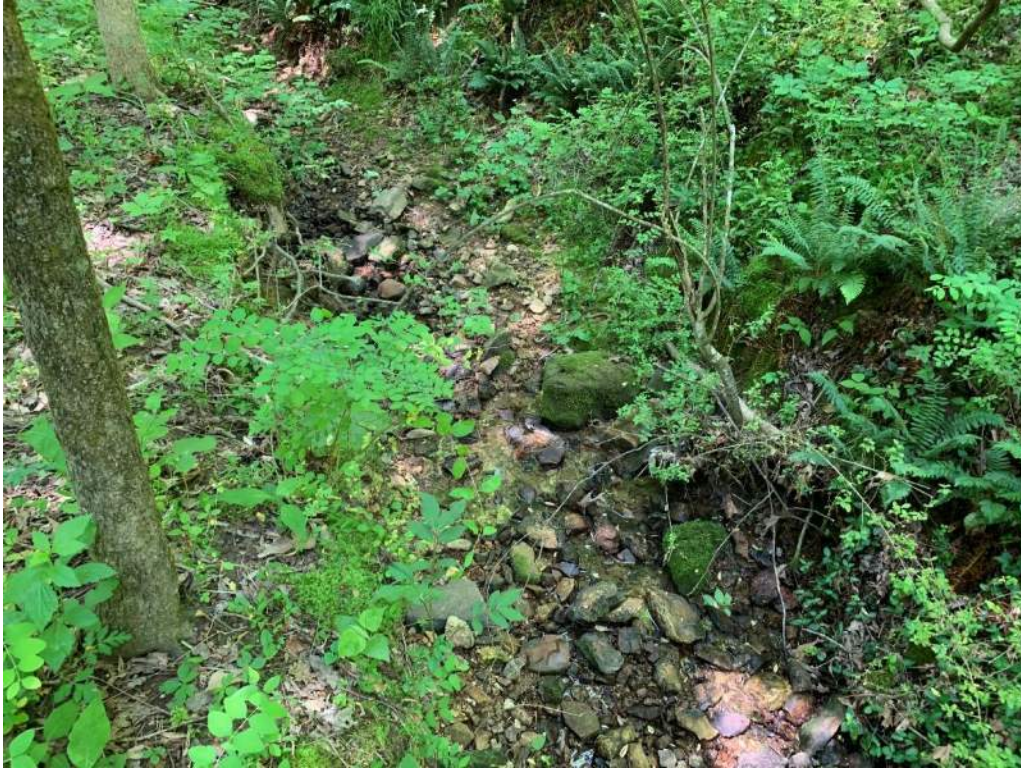
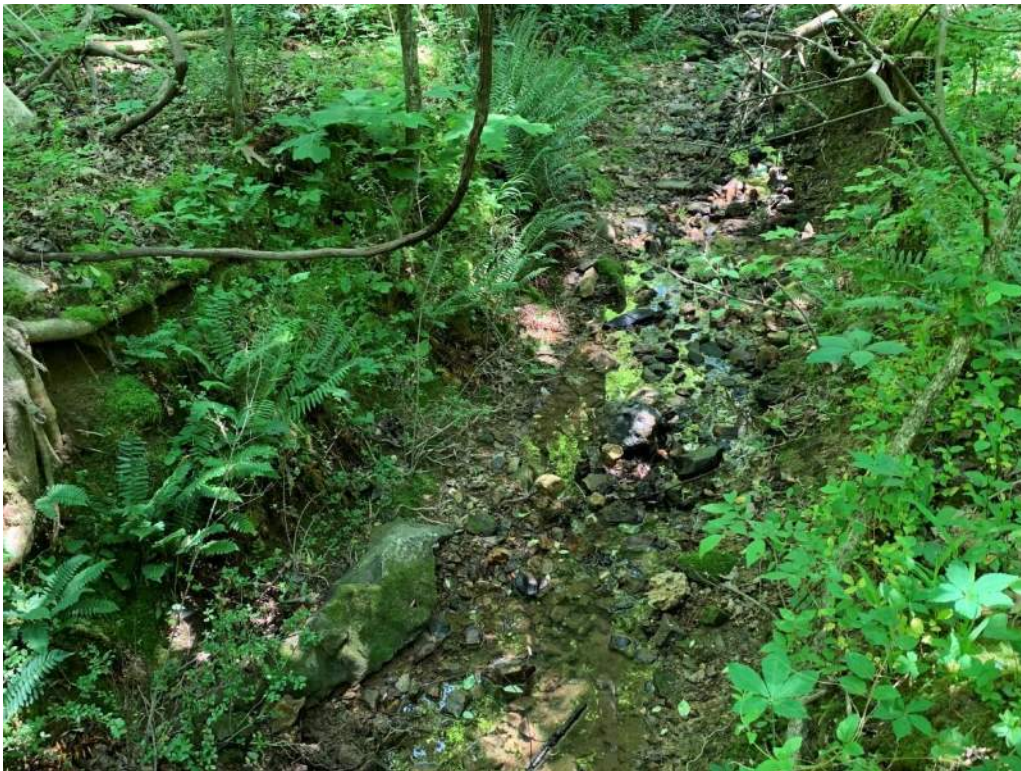
- **STR-2** – Begins at northwestern property corner at **Latitude: N36.067731° Longitude: W-87.346949°** and ending at the location of subsurface flow into an open sinkhole/karst feature throat at **Latitude: N36.068105° Longitude: W-87.343529°**. The channel displayed two primary indicators for stream (flowing water in channel and 7 days since last significant rainfall, presence of naturally occurring groundwater connection). Secondary indicators were also evaluated. The channel included mostly moderate geomorphological indicator scores, weak to moderate hydrologic and biological indicator scores. Macrobenthos observed included mayfly larvae, scuds, isopods and stonefly larvae. Leopard frogs were also observed in channel in some locations. The channel scored 26.5 on the HDFD sheet indicating a stream.

**Photograph 18:** Upstream view of STR-2 at point of subsurface flow beginning of WWC-2 downstream (N36.067962 W-87.345152)

**Photograph 19:** location of flow going subsurface from previous photograph location.

**Photograph 20:** Closeup view of point of STR-2 subsurface flow from previous photograph location.

**Photograph 21:** Upstream view of STR-2 (N36.067862 W-87.345480)

**Photograph 22:** Upstream view of STR-2 (N36.067856 W-87.345595)

**Photograph 23:** Upstream view of STR-2 (N36.067770 W-87.345858)

**Photograph 24:** Downstream view of STR-2 from previous photograph location.

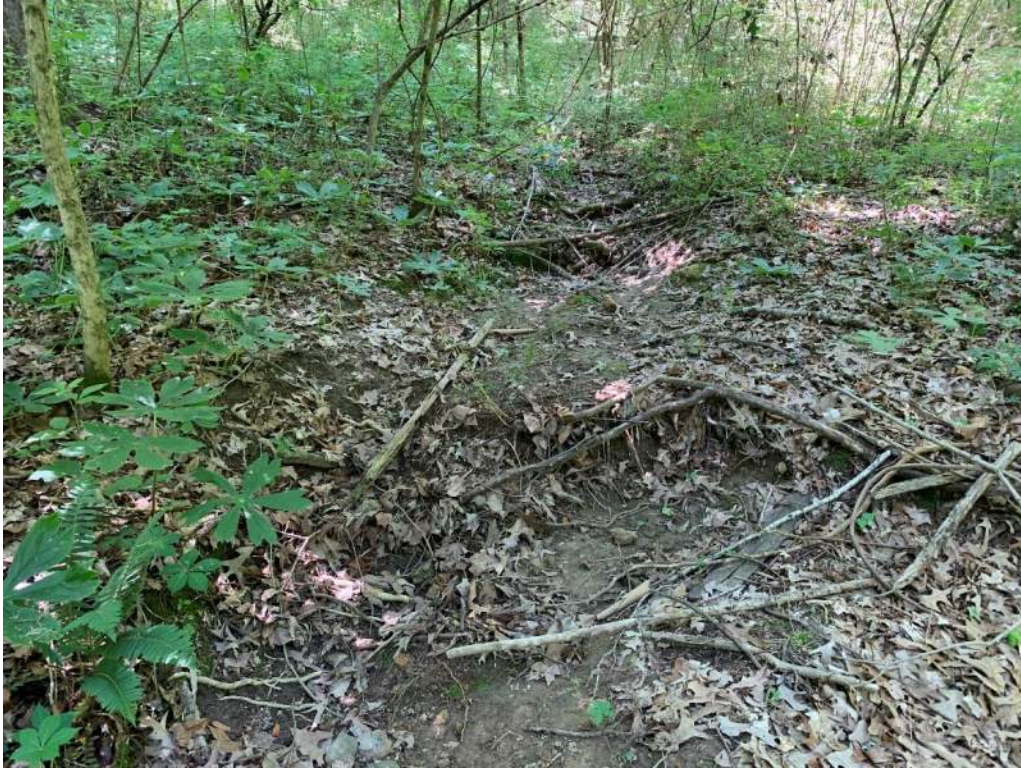
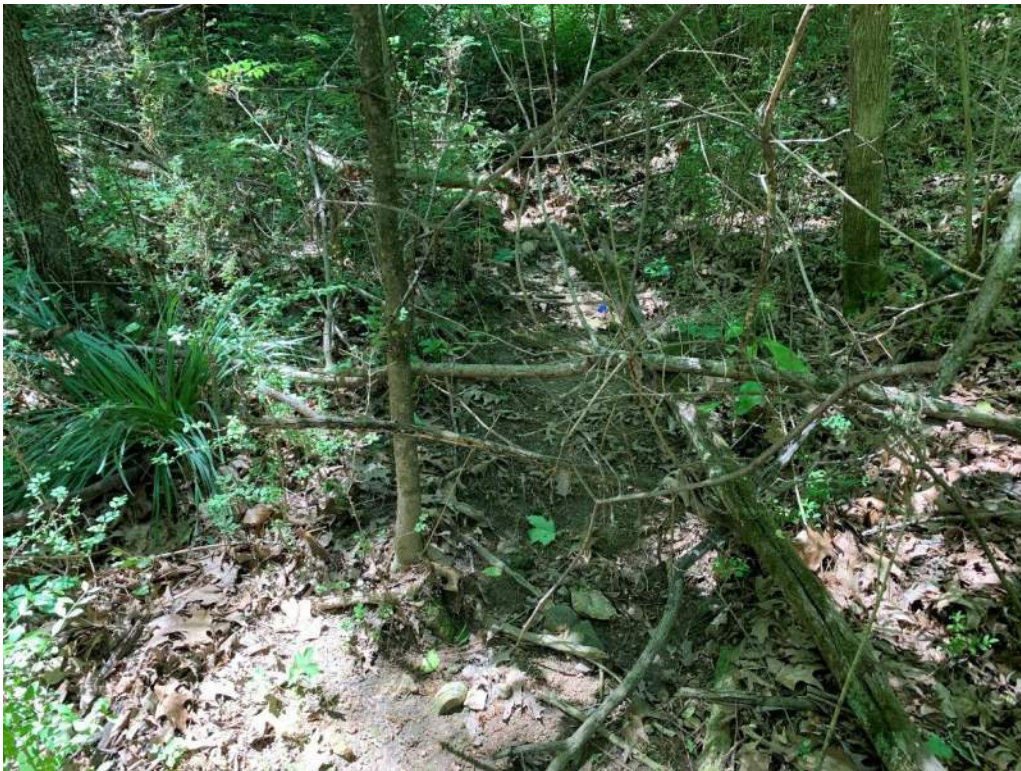
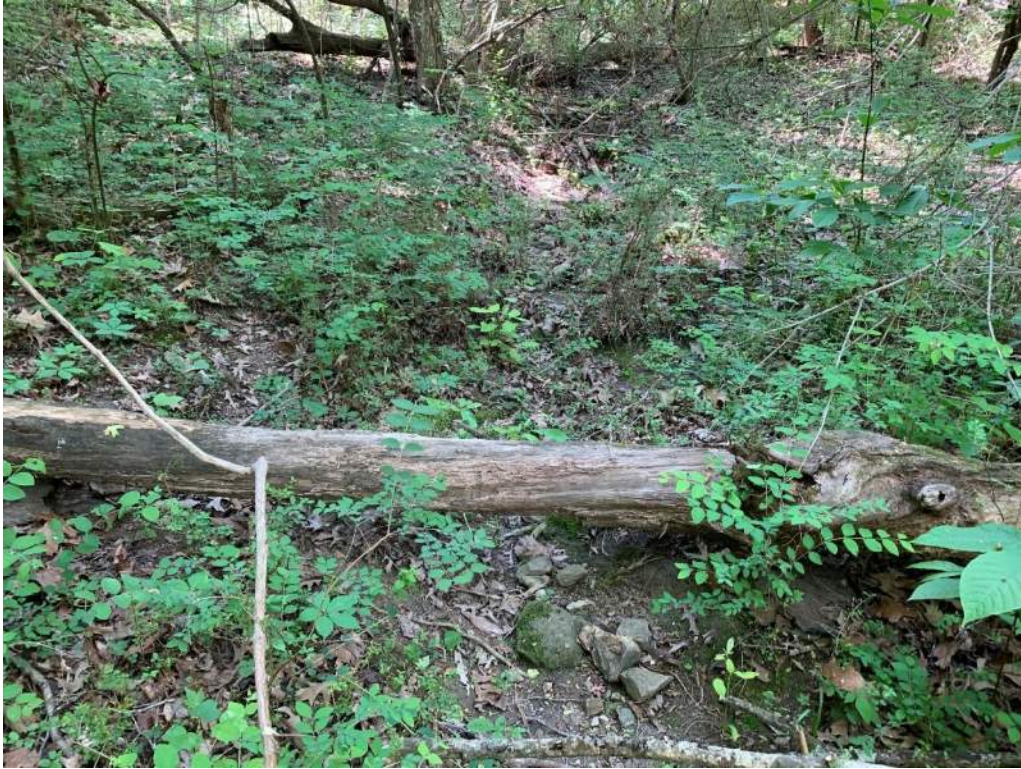
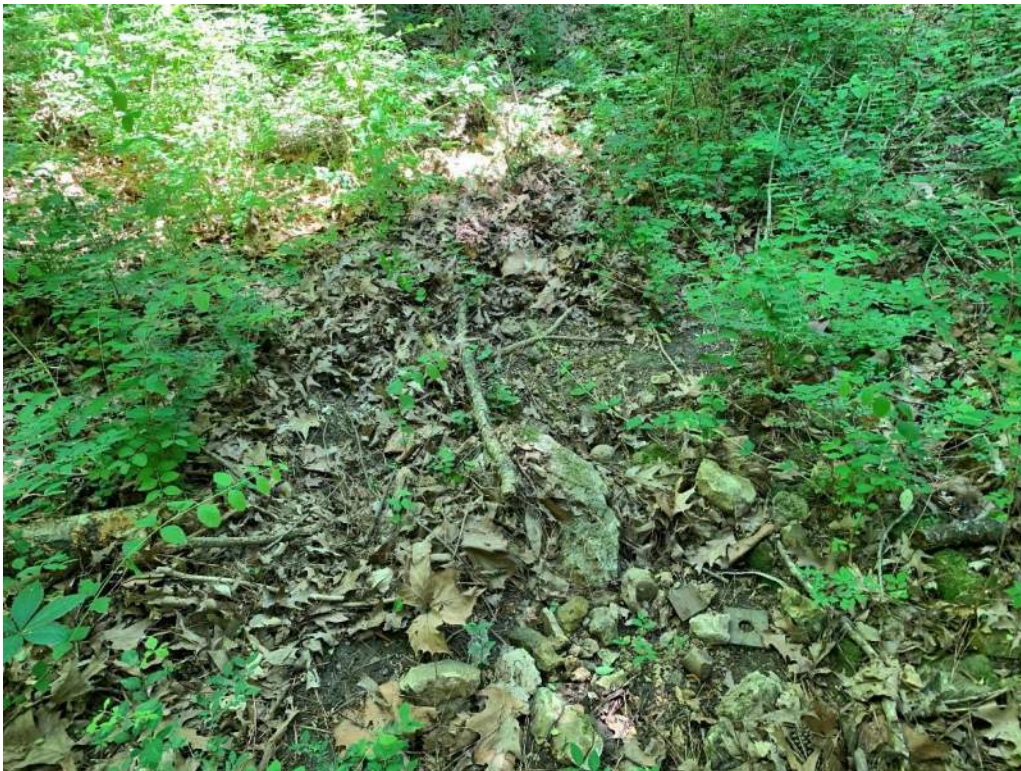
- **WWC-3** - Channel begins at edge of pasture at Latitude: N36.067024° Longitude: W-87.346521° and ends at intersection with STR-2 at Latitude: N36.067721° Longitude: W-87.346105°. No primary indicators were observed but secondary indicators were evaluated. The channel scored weak in all secondary indicators. No flow was observed, no macrobenthos was observed, fibrous roots and upland plants were observed within the channel during the assessment. No macrobenthos was observed during the assessment. The channel ultimately scored 8.5 on the HDFS sheet indicating a wet weather conveyance.

**Photograph 25:** Upstream view of WWC-3 just above intersection with STR-2 (N36.067653 W-87.346085)

**Photograph 26:** Downstream view of WWC3 from previous photograph location.

**Photograph 27:** Downstream view of WWC-3 (N36.067275 W-87.346215)

**Photograph 28:** Upstream view of WWC-3 from previous photograph location.

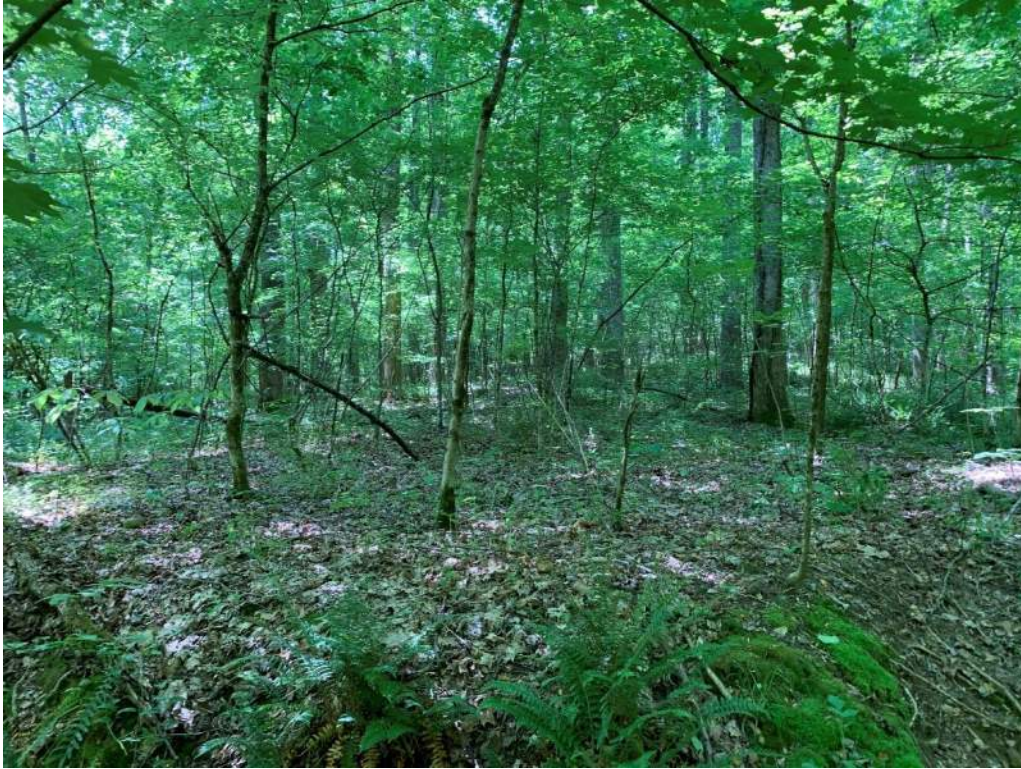
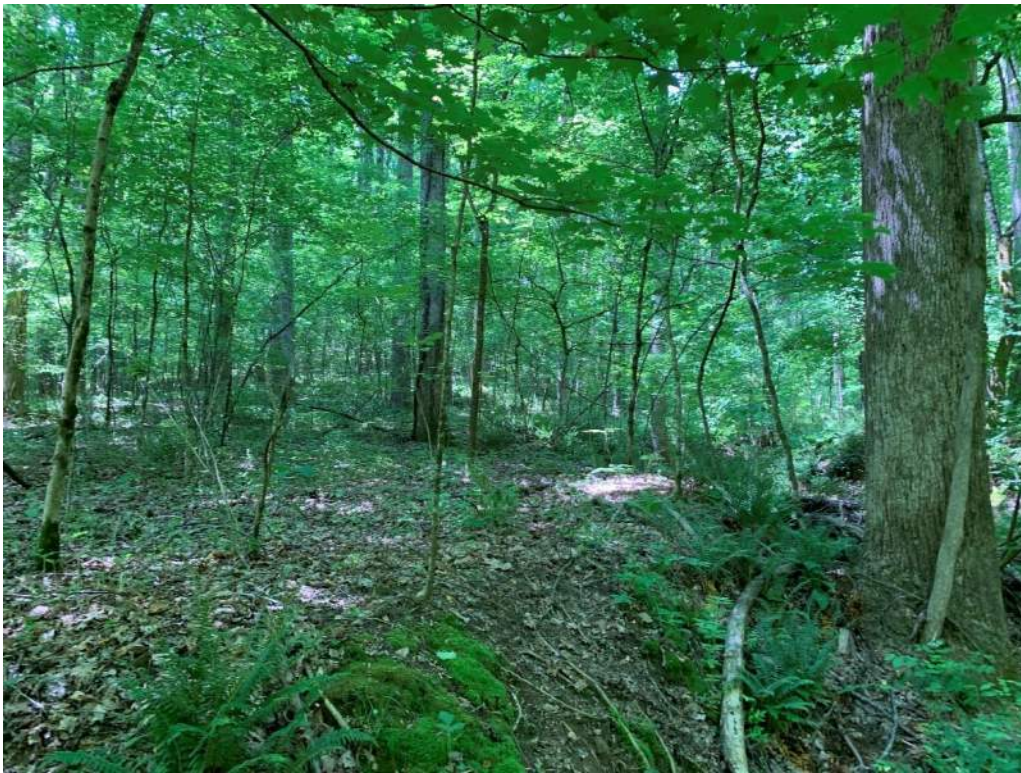
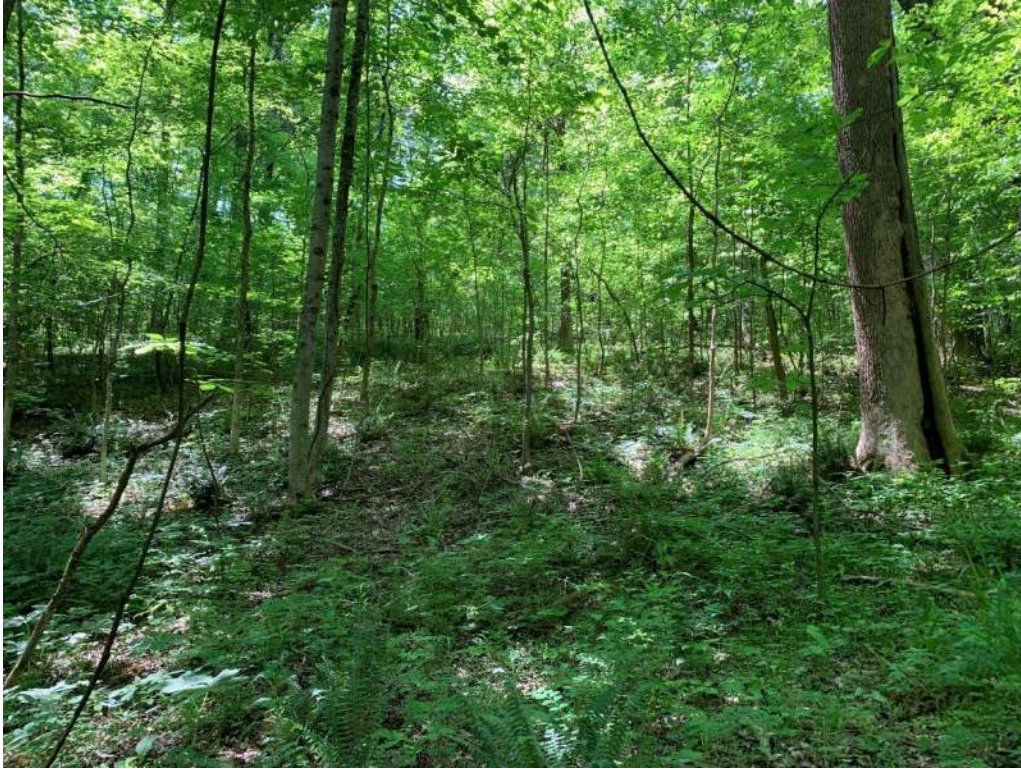
**Photograph 29:** Typical view of topography and vegetation observed along the northeastern portion of property.

**Photograph 30:** Alternate view of topography and vegetation along the northeastern portion of property.

**Photograph 31:** View of topography and vegetation along the wooded eastern portion of the property.
