Subject: **HYDROLOGIC DETERMINATION REPORT**  
Old Columbia Road Property  
(Parcel # 111 040.00, 111 040.01 and 111 040.03)  
Dickson, Dickson County, Tennessee  
C&T Project No. 03-22021

*Hydrologic Determination*  
*Old Columbia Road Property – Dickson, Tennessee*

*C&T Project No. 03-22021*  
*May 25, 2022*

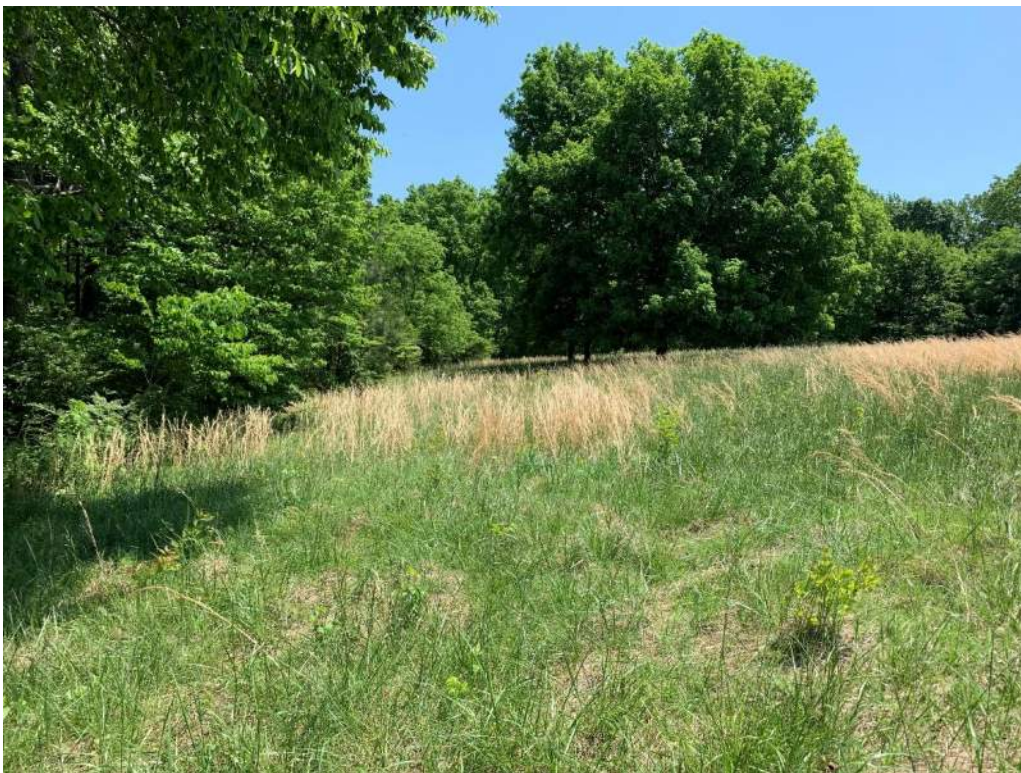
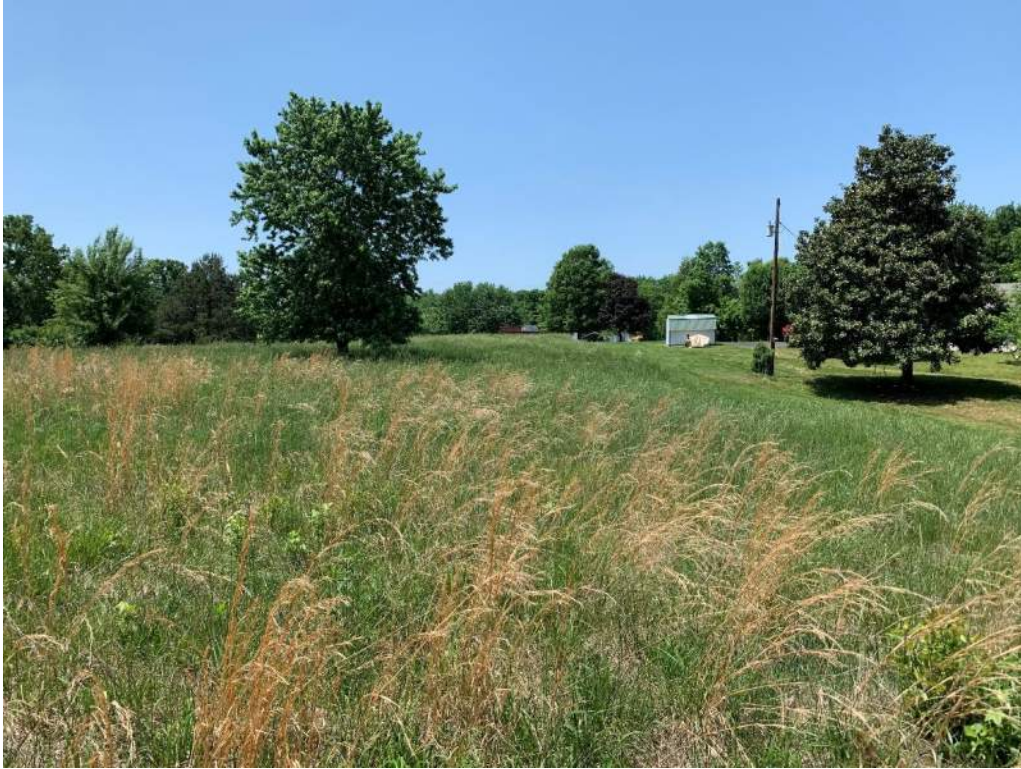
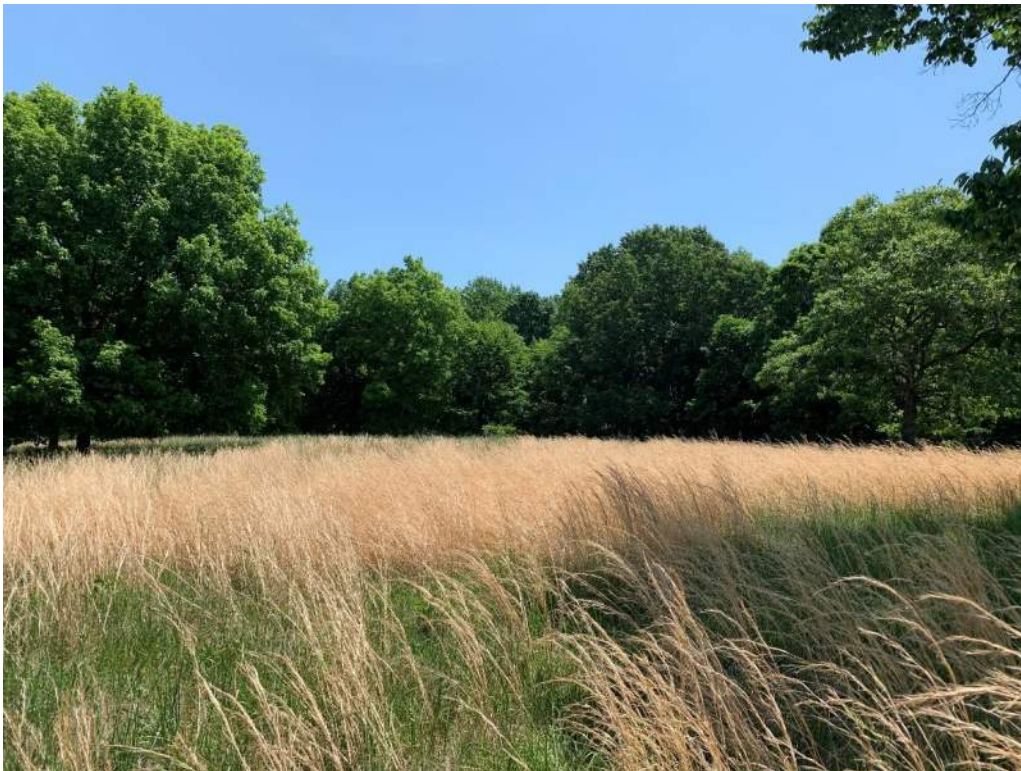
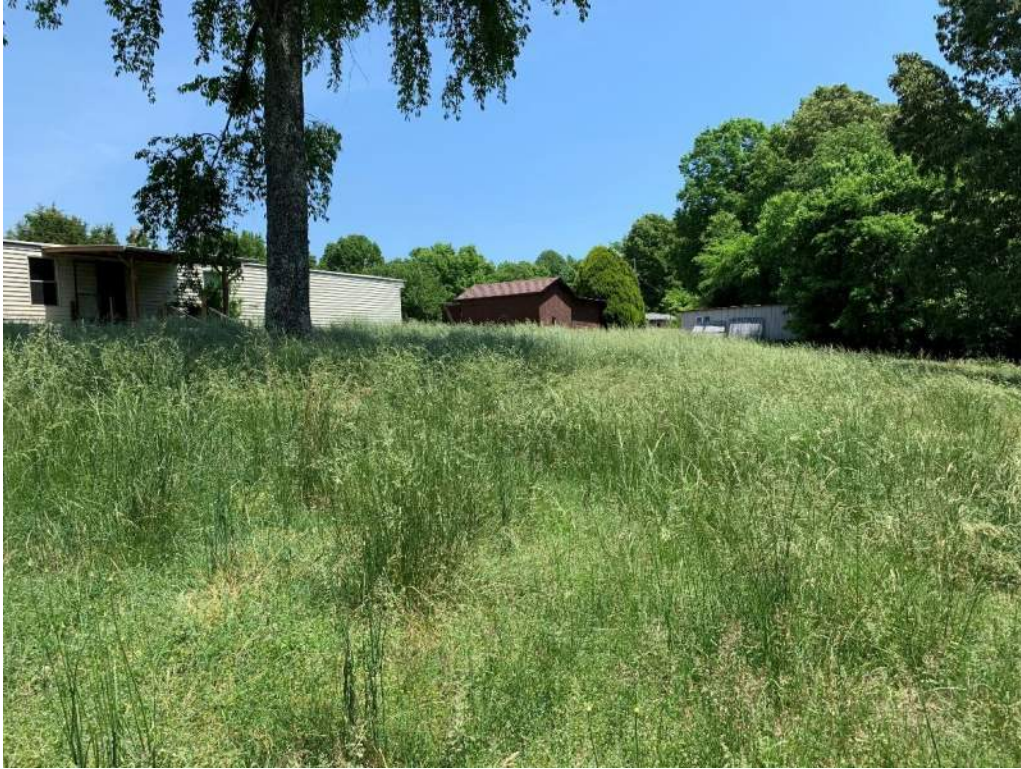
**Photograph 32:** View looking southeast from just above beginning of WWC-3.

**Photograph 33:** View looking southwest from previous photograph location.

**Photograph 34:** View looking northeast across property (N36.066579 W-87.346041)

**Photograph 35:** View looking northeast from near southwestern property corner.

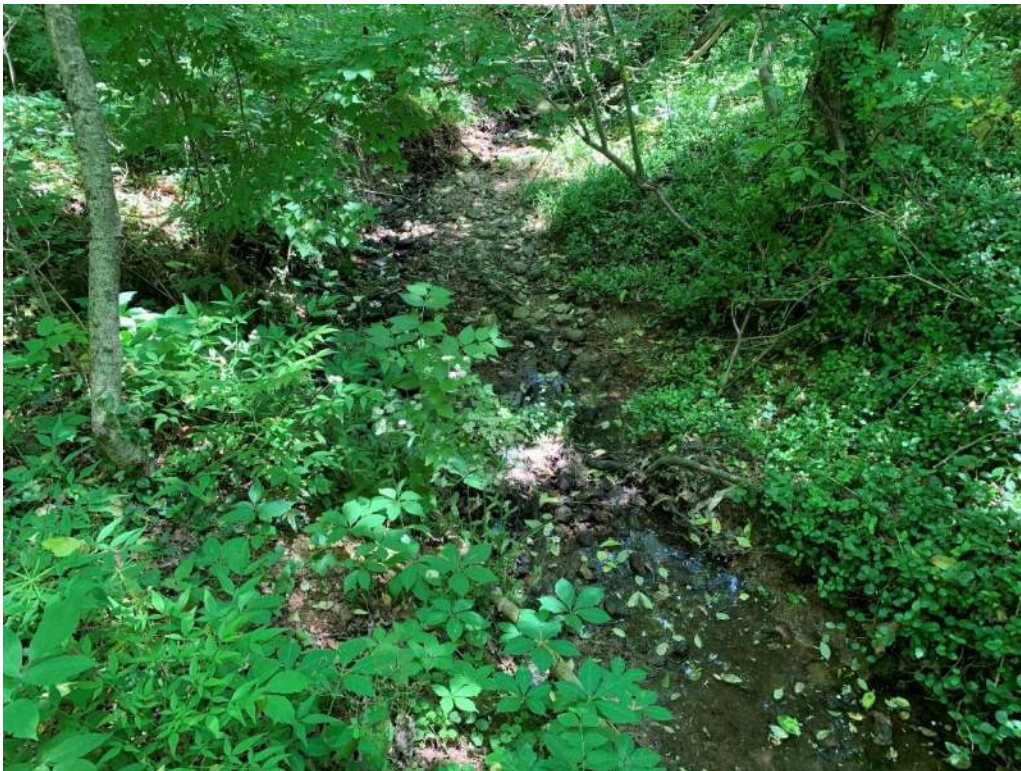
**Photograph 36:** Downstream view of STR-1 from just south of property boundary near southwestern property corner.
