### Hydrologic Determination Field Data Sheet

Tennessee Division of Water Pollution Control, Version 1.5

Project: Clear Development, LLC, Thorn Hill Quarry, 911 TN-131, Thorn Hill, TN 37881.

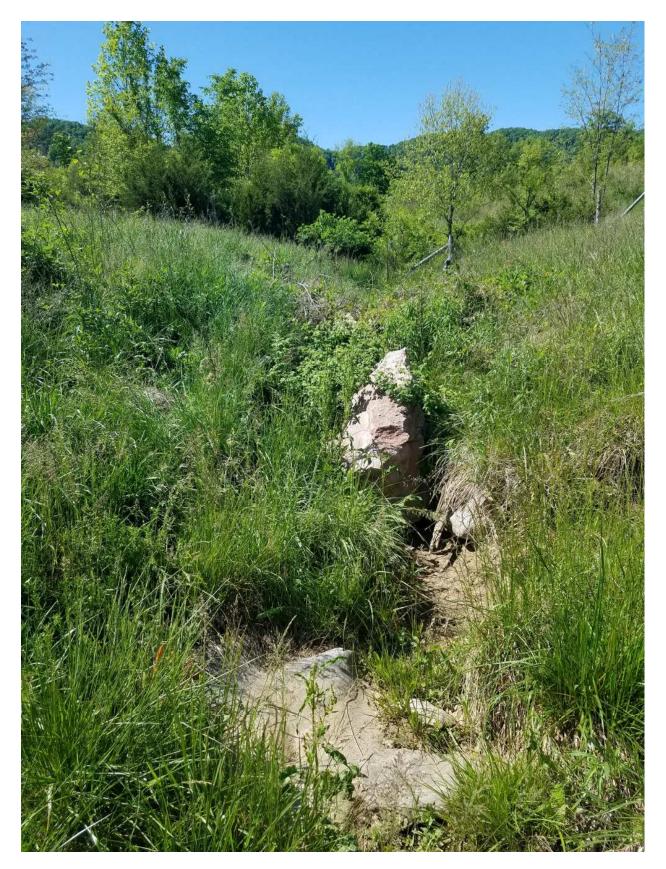
Photograph of upper portion of feature/channel being evaluated showing rock outcropping in channel. Photograph taken by Phil Boggs on May 12, 2022, viewing southwest.

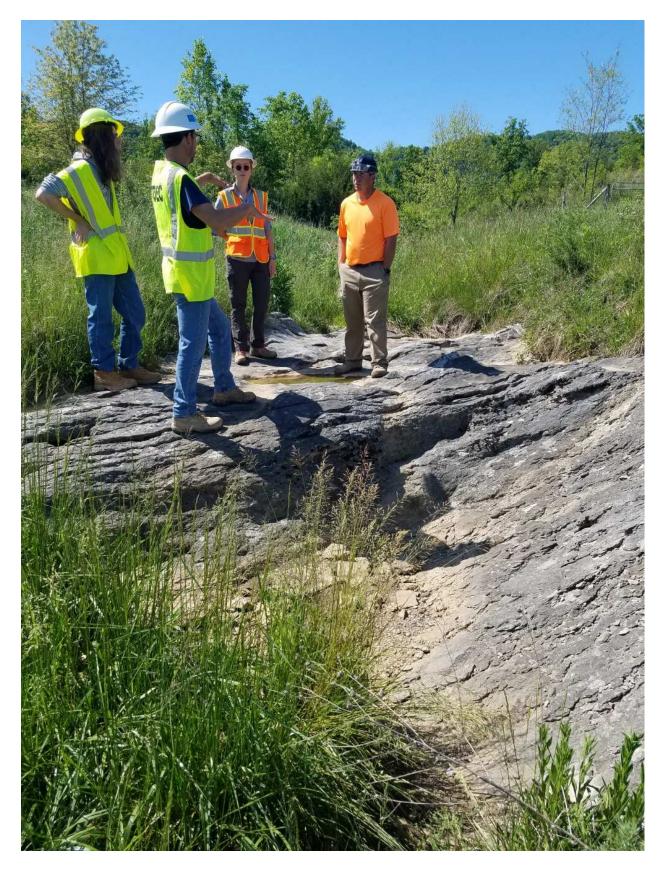
Photograph of rock outcrop within feature/channel being evaluated showing puddle of water on top of rock. Photograph taken by Phil Boggs on May 12, 2022, viewing southwest.

(15.) Small puddles of water were found behind and on top of rock outcrops.

(24.) Tadpoles were found in the small puddles mentioned above.

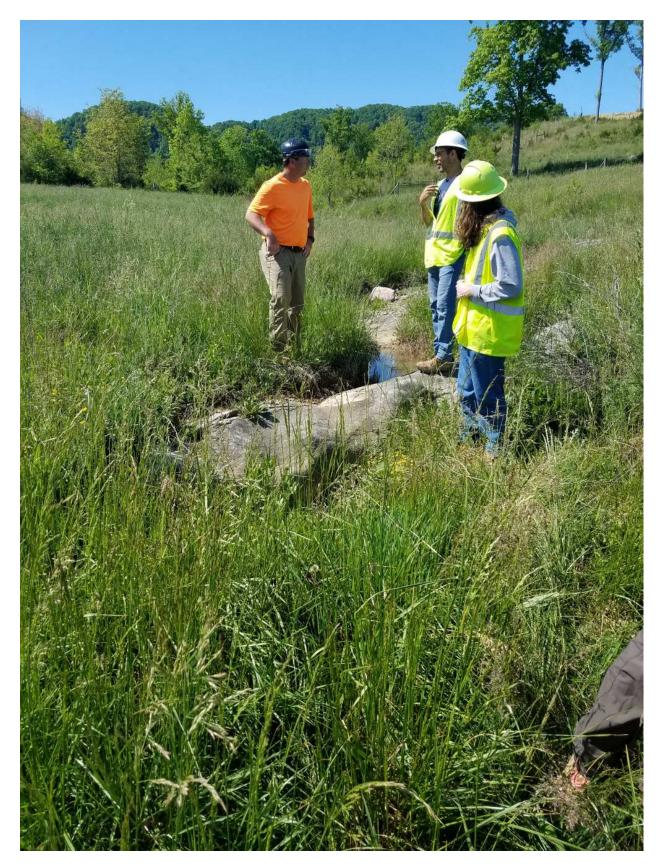
Photograph of rock outcrop within feature/channel being evaluated showing puddle of water above outcrop. Photograph taken by Phil Boggs on May 12, 2022, viewing southwest.
