**HYDROLOGIC FEATURES REPORT
and
CORRECTIVE ACTION PLAN
For
Travel America Truck Stop Project
Putnam County, Tennessee**

2 June 2022

*Saffron Builders
900 South Jefferson Avenue
Cookeville, Tennessee 38501*

*MRW Environmental, LLC
32 North Main Street
Sparta, Tennessee 38583*

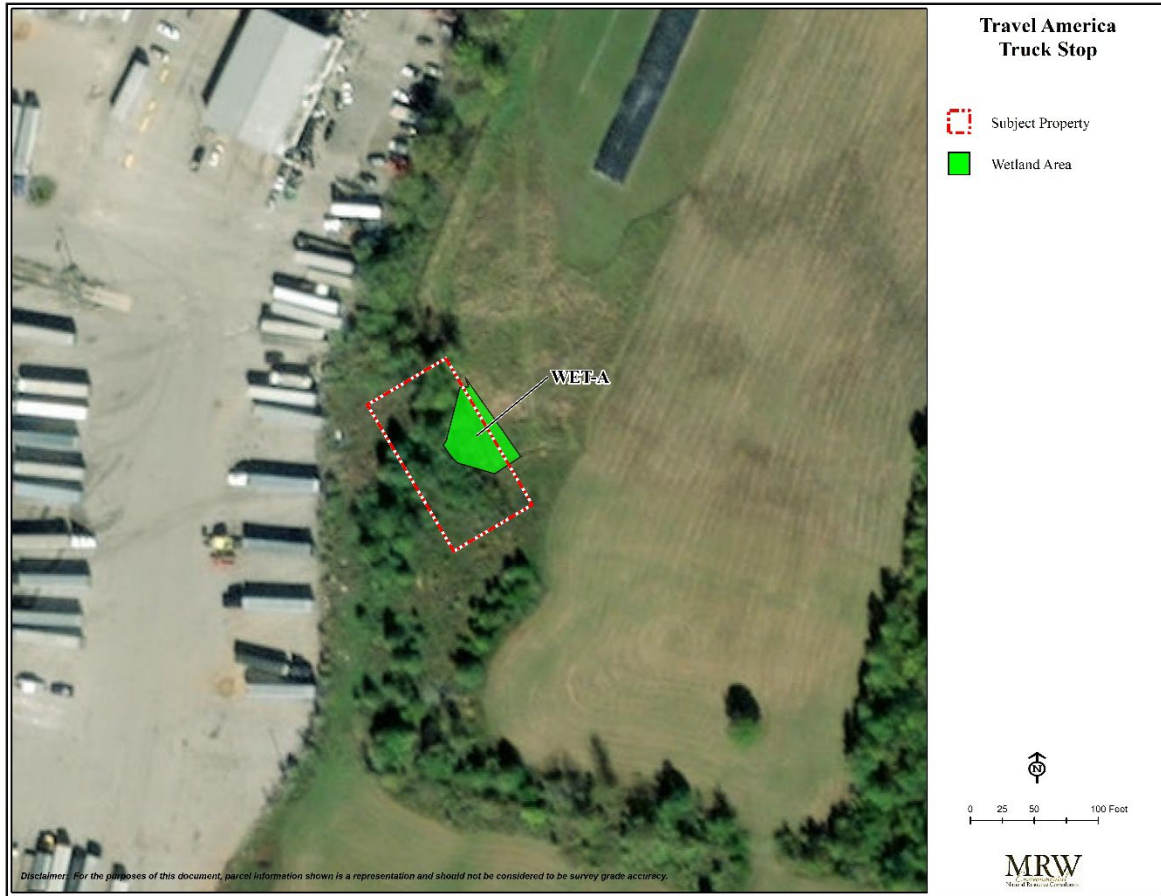
Figure 4. Hydrologic Features (i.e., wetland area) identified within the Subject Property.

Based on the on-site review, one wetland area was identified within the Subject Property (Figure 4). However, note that that a drainage feature is located outside of the Subject Property and the identified wetland area continues across the larger parcel and adjoining lands. The drainage feature appears to be a historic diversion channel.

Wetland-A (“WET-A”), approximately 0.04 acres in size, is a palustrine emergent, slope wetland. Note WET-A continues on to the adjoining lands. Hydrology indicators included; saturation and water-stained leaves. Hydrophytic vegetation dominated the wetland areas and included species such as; green bulrush (*Scirpus atrovirens*), fox sedge (*Carex vulpinoidea*), and shallow sedge (*Carex lurida*).

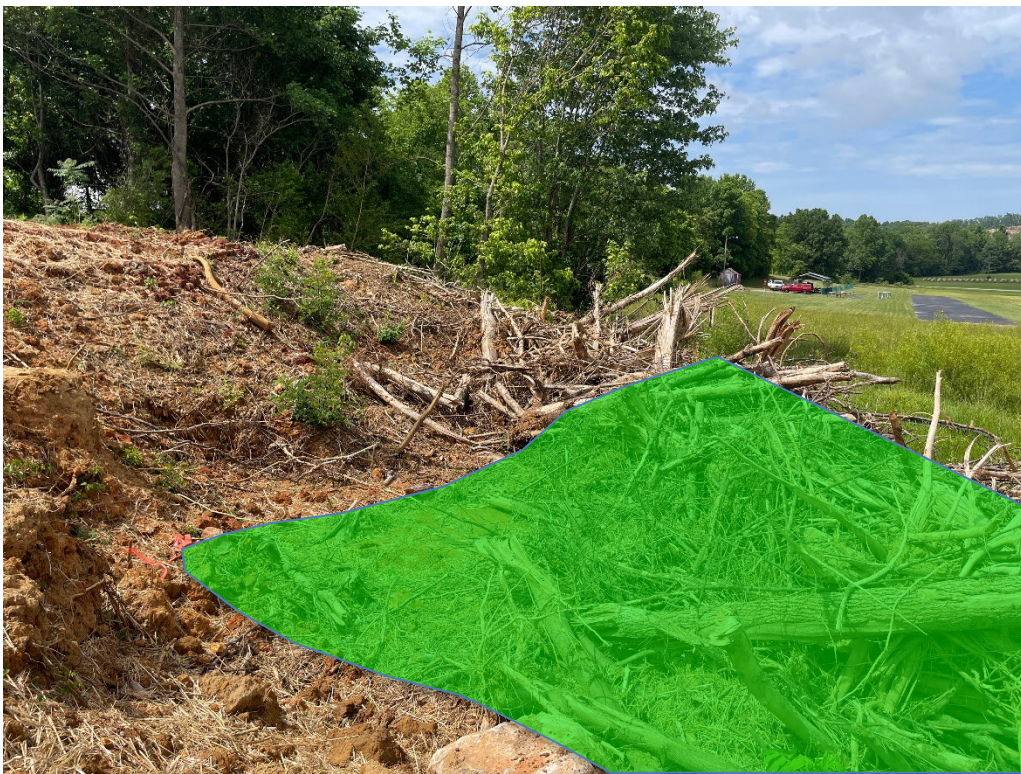
Figure 5. Approximate fill area shown in green, that was placed within the wetland area without proper approvals.

Based on the MRW assessment of the Subject Property, approximately 0.02 acres of fill (i.e., tree tops and loose soil) have been placed within the wetland areas without proper approvals from the appropriate agencies. In order to determine the extent of the wetland impact, MRW excavated through the fill material until the original surface was identified. A soil sample was then taken to determine if wetland hydrology and hydric soils were present.

Following these conversations, MRW, on behalf of our client, is proposing the following:

1. The fill and remainder of the tree tops are to be removed back to the original surface.
2. Unauthorized fill area would then be seeded with an annual rye or wheat at a rate of 50 pounds per acre and then strawed. This would allow for the area to have a temporary coverage allowing for the natural seedbank to reestablish within this area.

3. Banks surrounding the wetland area would be sloped to an approximate 2:1 ratio if not already. Due to the potential for further disturbance, geotextile would then be placed followed by the placement of riprap. This would be an equivalent measure allowing for the buffer width to be reduced and also prevent any future erosion and/or sedimentation from entering WOS.

- a. The riprap proposed to be utilized would be a Class A-1 from the Tennessee Department of Transportation's Standard Specifications for Road and Bridge Construction Section 709.03. "Machined Riprap (Class A-1) shall vary in size from 2 inches to 1.25 feet with no more than 20 percent by weight being less than 4 inches."

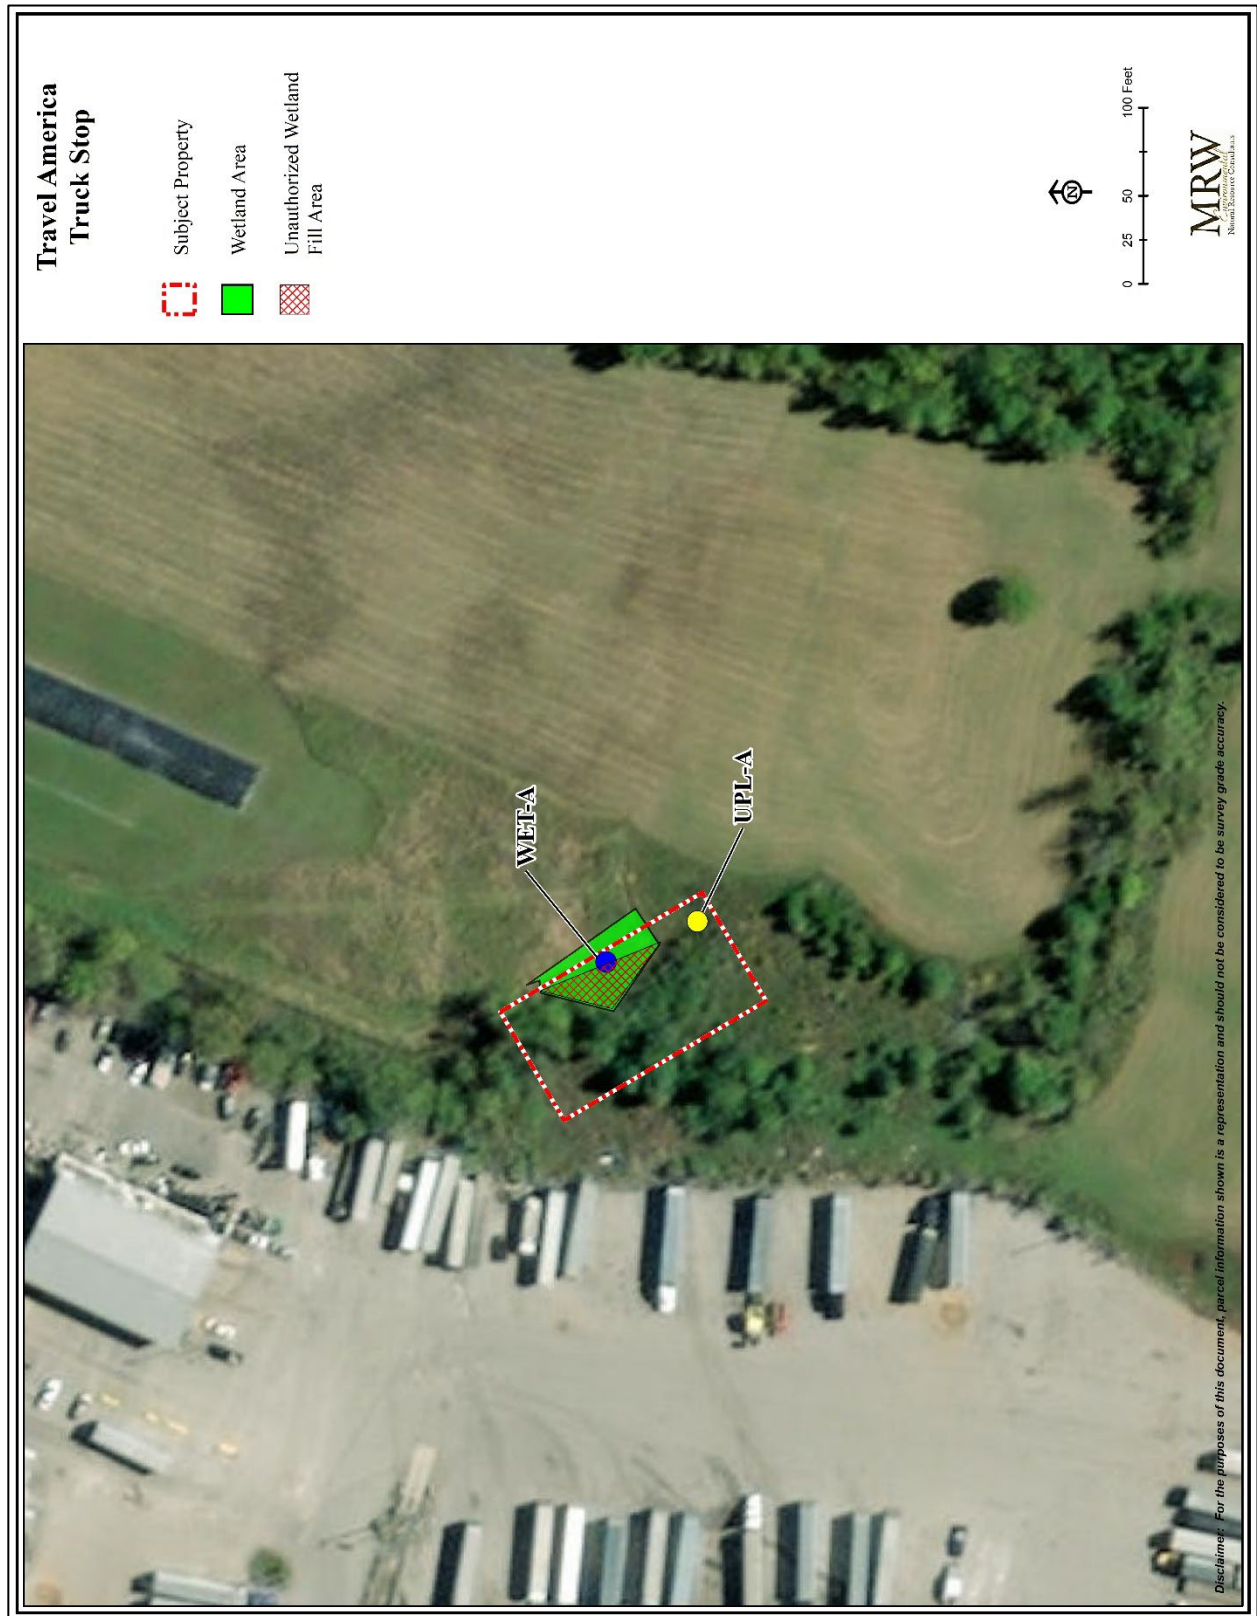
Aerial photo of the Subject Property depicting the location of each aquatic feature and datapoints.

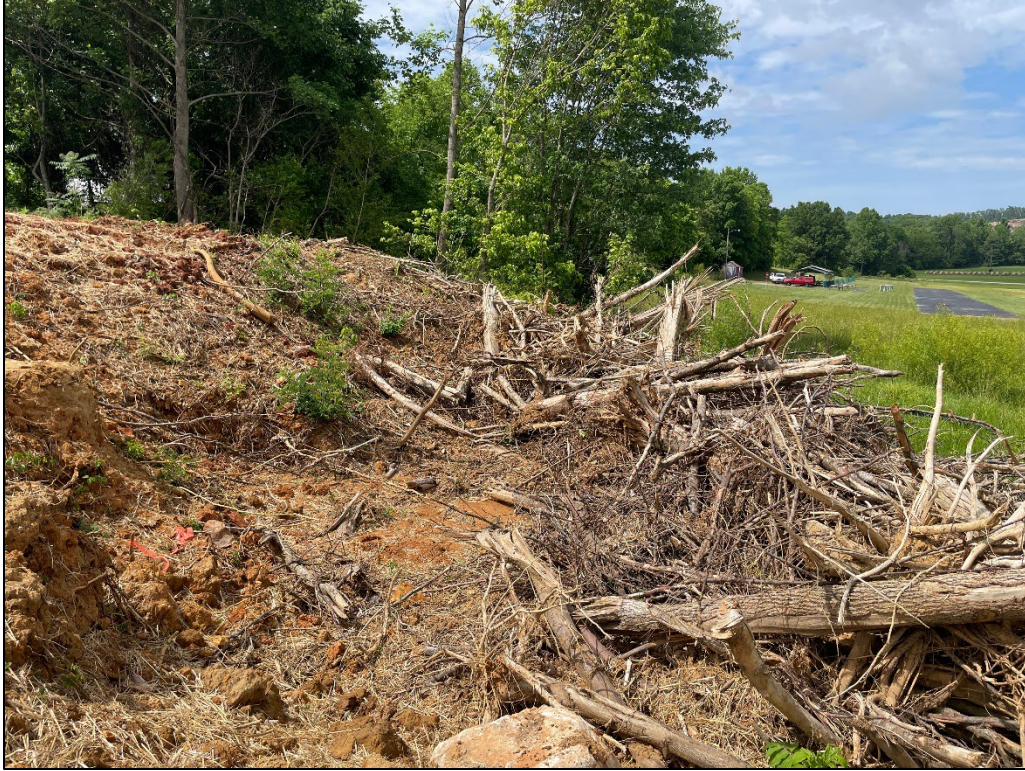
Picture 1. Photograph of WET-A with fill material present.

Remarks: Unauthorized fill material has been placed within the upper end of the wetland area. A large debris pile, fill dirt, and rock is located within the edge of the wetland. Data was able to be collected up gradient of the wetland line in order to determine the extent of the fill. Data depicted below is from the lower side (outside of the fill) of the wetland area within the Subject Property. Note the wetland continue on to the adjoining land.

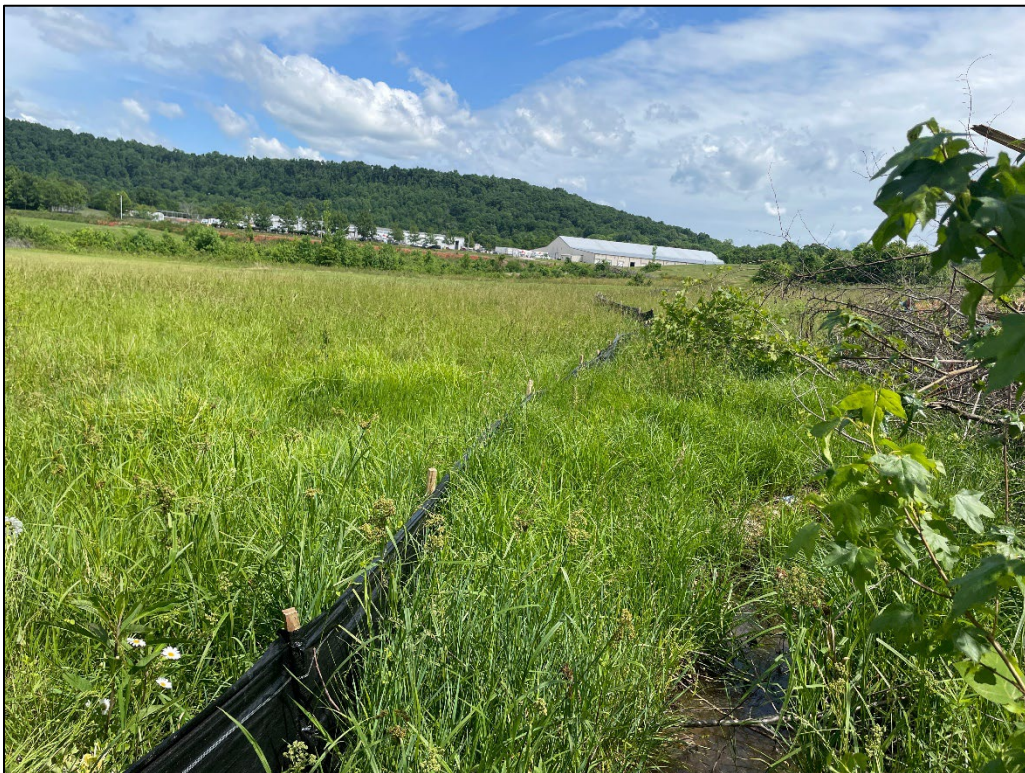
Picture 2. Photograph of WET-A below the fill area within the Subject Property. The silt fence present in the photograph depicts the Subject Property eastern boundary.

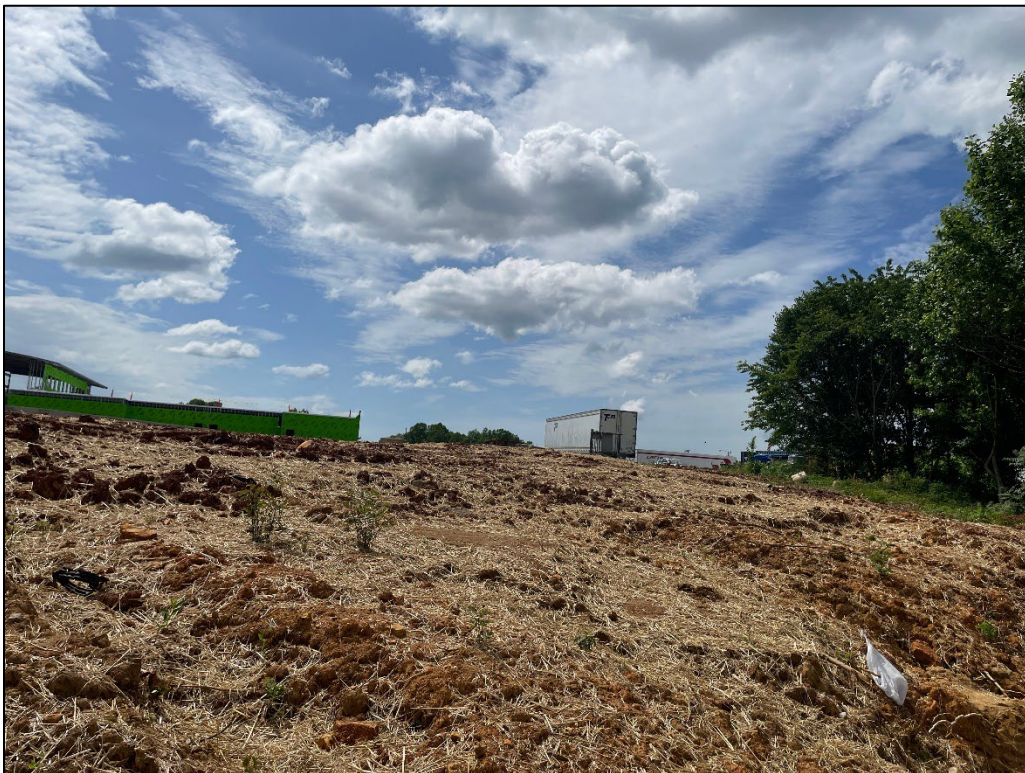
Picture 4. Photograph of fill material to the north of the identified wetland area (WET-A). This area has been seeded and strawed and would be up-gradient from the proposed riprap slopes.
