Woodlands
Memphis, Shelby County, TN
General ARAP – Wetland

Section 6: Project Description

TECHNICAL MEMORANDUM

Re: **Woodlands Development Hydrologic Determination / SWCA Project No. 63003**

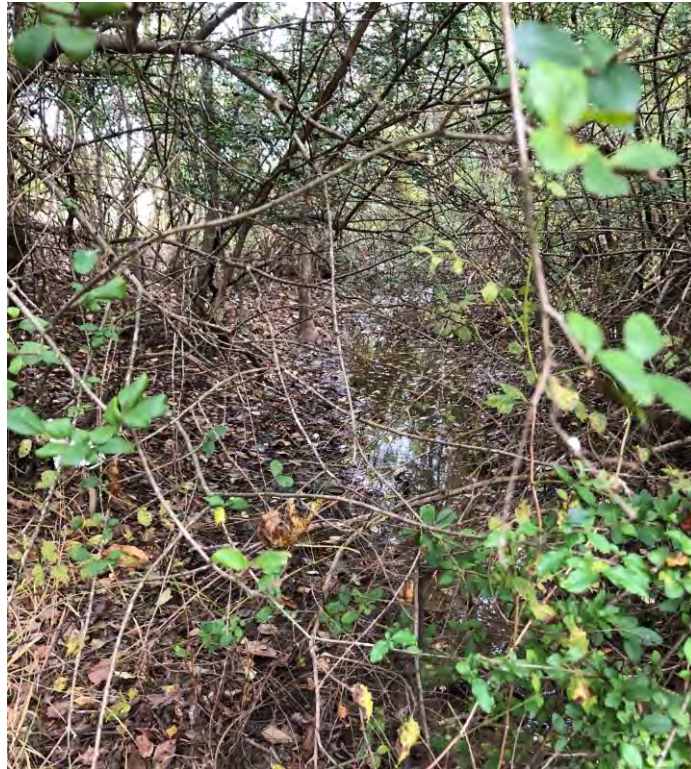
Wetland Image 1
(South, Looking North)

Three wetlands are present on the site. Two wetlands (one forested, the other scrub-shrub) are located on the north portion of the site, south of SR-385. Wetland WA002 is a forested wetland and totals 2.70 acres. Wetland WA003 is a scrub-shrub wetland and totals 3.33 acres. An additional wetland is located on the south side of the property near Shelby Drive. Wetland WA001 is a forested wetland and totals 0.28 acres.

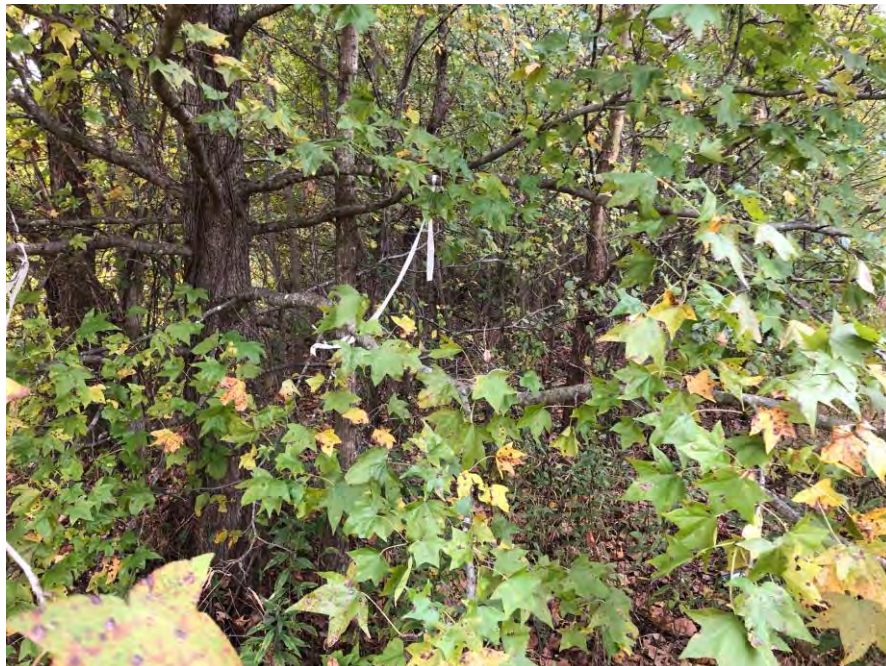
Wetland Image 2
(North, Looking South)

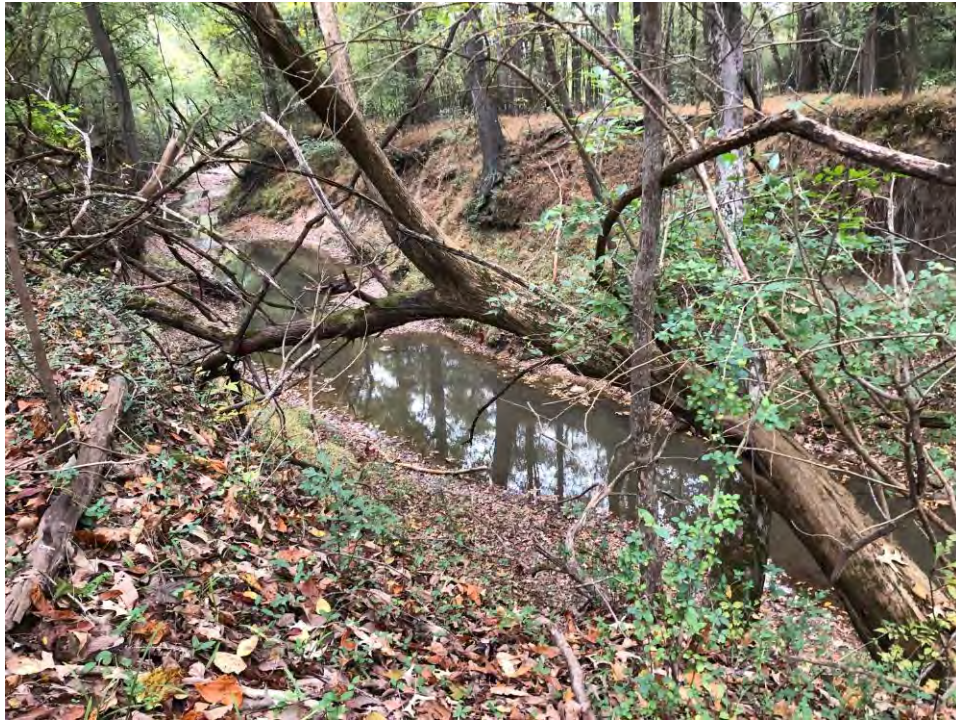
Structure 57 Insertion

(Looking downstream, to the north)

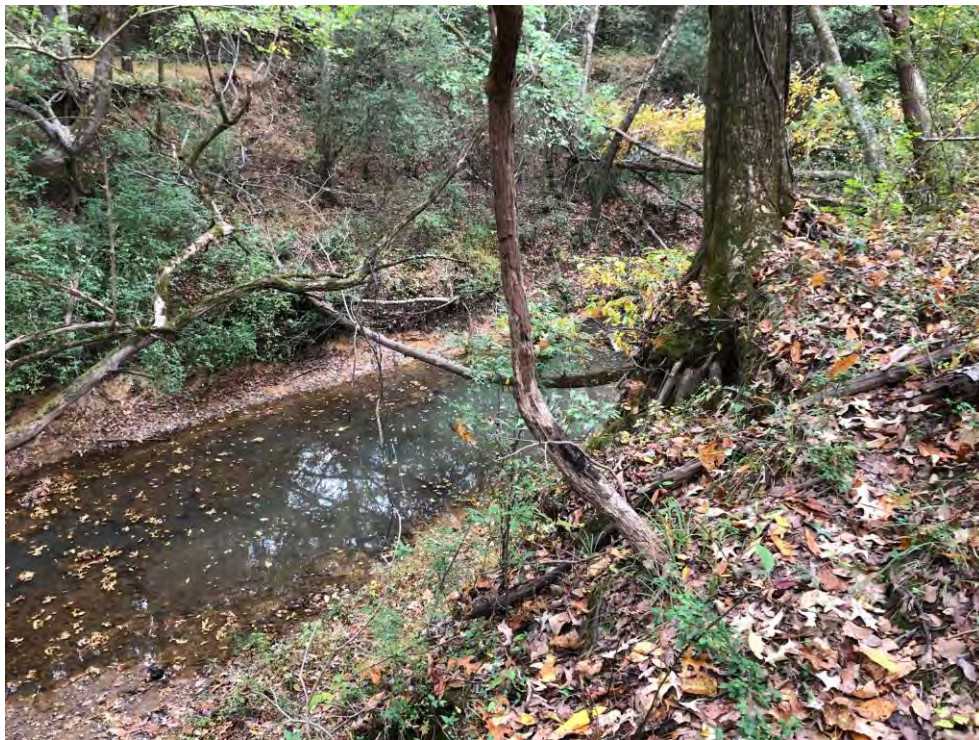
Structure 57 Insertion

(Looking upstream, to the south)

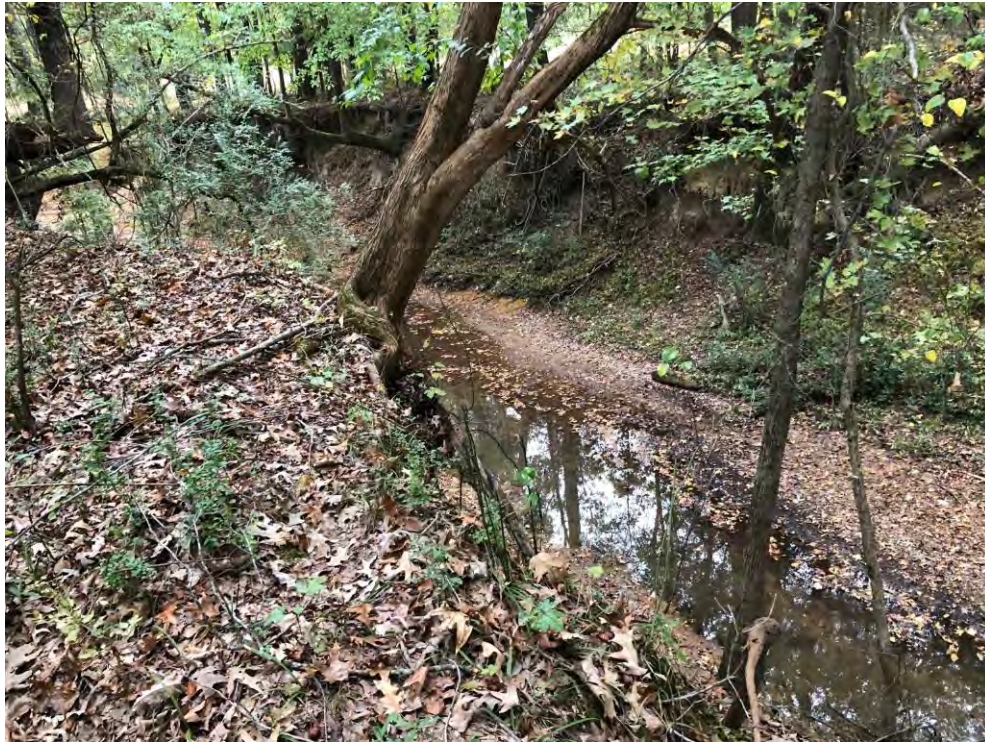
Structure 64 Insertion
(Looking downstream, to the north)

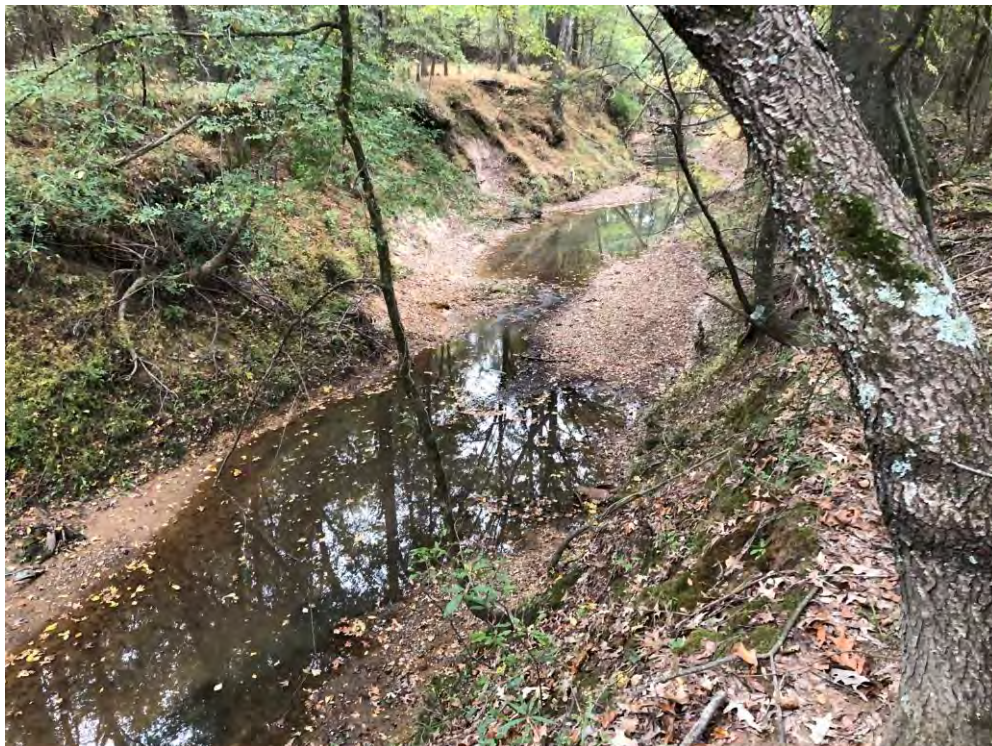
Structure 64 Insertion
(Looking upstream, to the South)

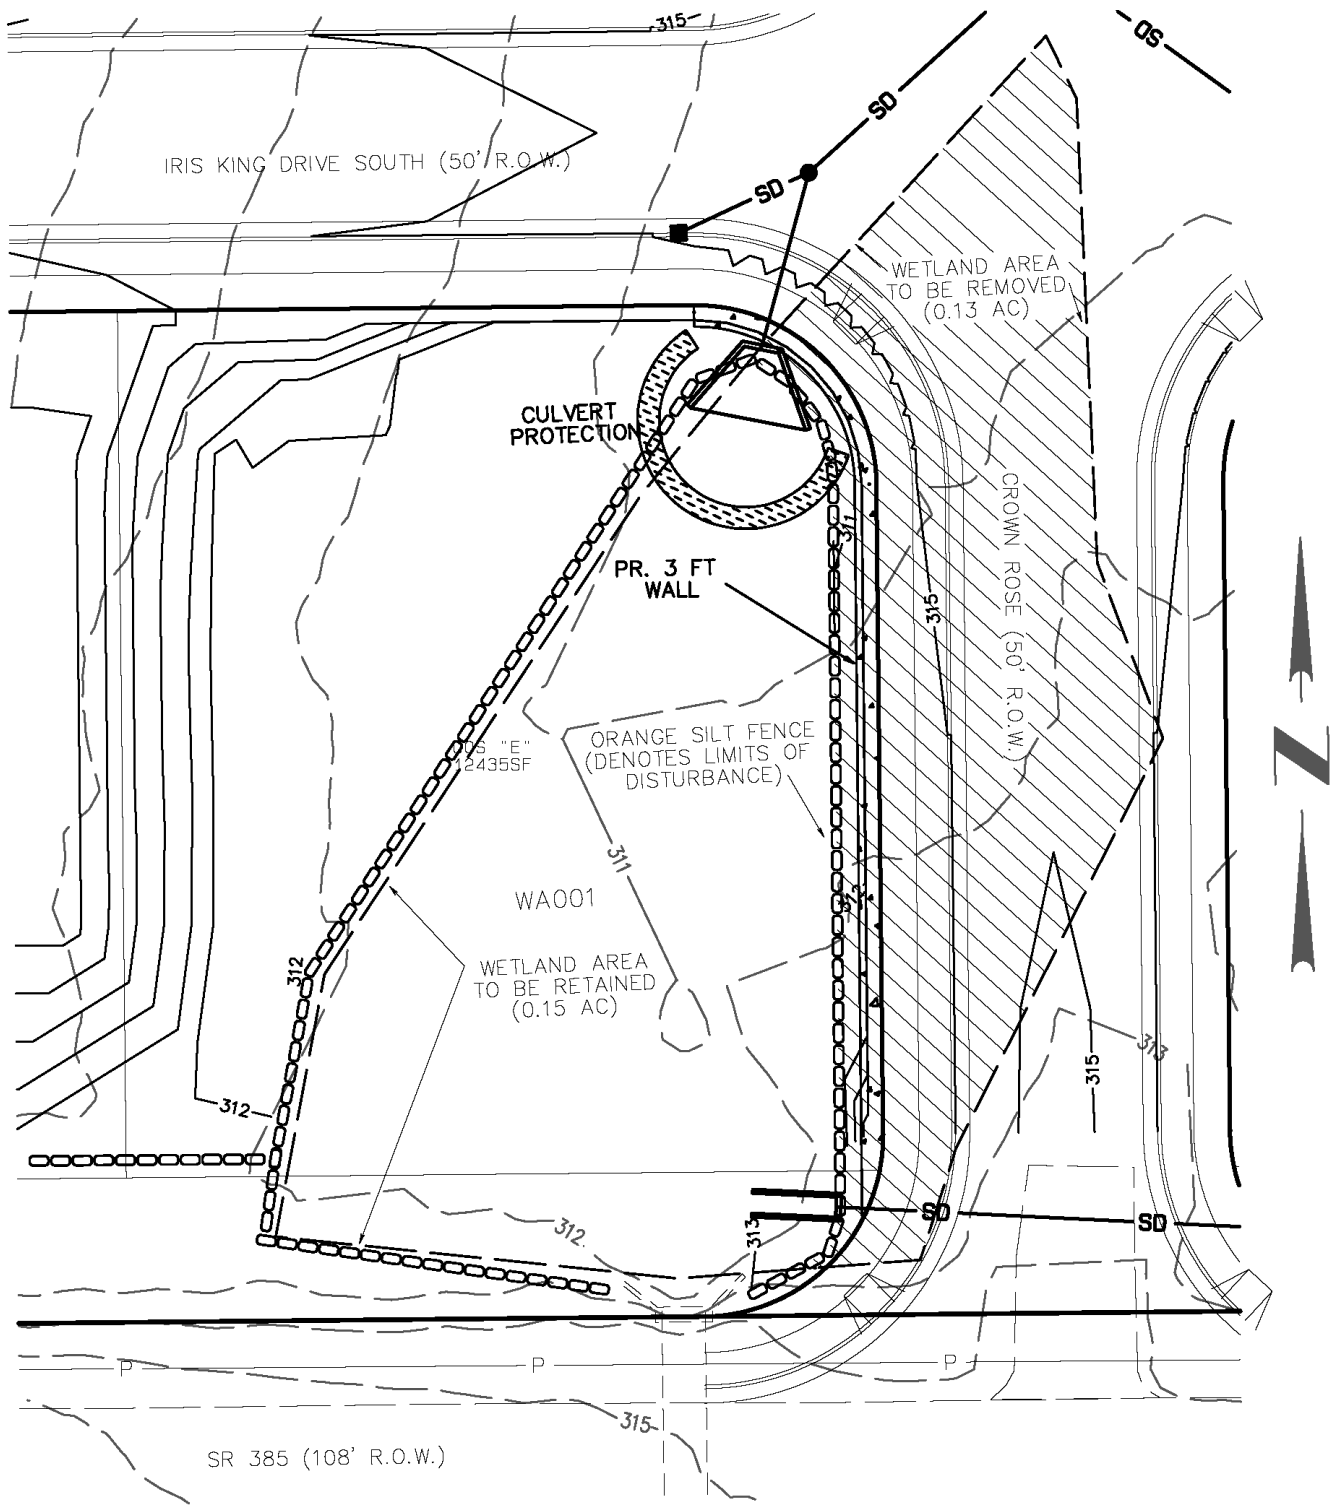
A wetland exists in the southwest quarter of the site and pools around an existing concrete box culvert. A portion of this wetland will be disturbed to make way for the proposed Right-of-Way. The alignment for the Right-of-Way was maintained to keep with the intent of East Shelby Drive's construction of East Shelby Drive has existing median cuts, allowing for direction changes and denoting the intended location for future turning lanes. Additionally, the affected wetland is a man-made wetland. During the construction of East Shelby Drive, a reinforced concrete box culvert was constructed to allow drainage to flow from south to north. However, the outlet of the box culvert is located within a low spot on the property, and without proper maintenance, the area was allowed to become a wetland.

The location of the western subdivision entrance was controlled by the median cut, which also coincides with the existing wetland. Due to the proximity of the wetland adjacent to East Shelby Drive, outright avoidance was not practicable. Therefore, impact minimization was the reasonable approach. The entrance road nearly bisects the wetland and an elevation about three feet of embankment. In an effort to impact the least amount of wetland possible, a retaining wall is proposed outside the proposed road's right-of-way. The retaining wall will create a barrier between the proposed improvements and the existing wetland. Silt-fence will be installed behind the retaining wall to limit the amount sediment leaving the disturbed area.

Exhibit 1 – Wetland Disturbance – Plan

First, orange silt-fence will be placed three (3) feet off of the proposed retaining wall. No alterations to the wetlands will occur beyond this point. Once the silt-fence has been installed, construction of the retaining wall may begin. When the retaining wall is complete, grading activities may begin for the road embankment over the exiting wetland to be removed. During construction activities, it is imperative that no silt shall be allowed to enter the wetland. The contractor shall be responsible for installing additional BMPs to ensure that the wetland remains protected.

Silt-fence will be placed three (3) feet off the embankment limits of the retaining wall. No work shall be allowed past this point. The contractor shall have the option of placing additional silt-fence or other BMPs to ensure that no run-off from the site enters the unaltered wetlands.

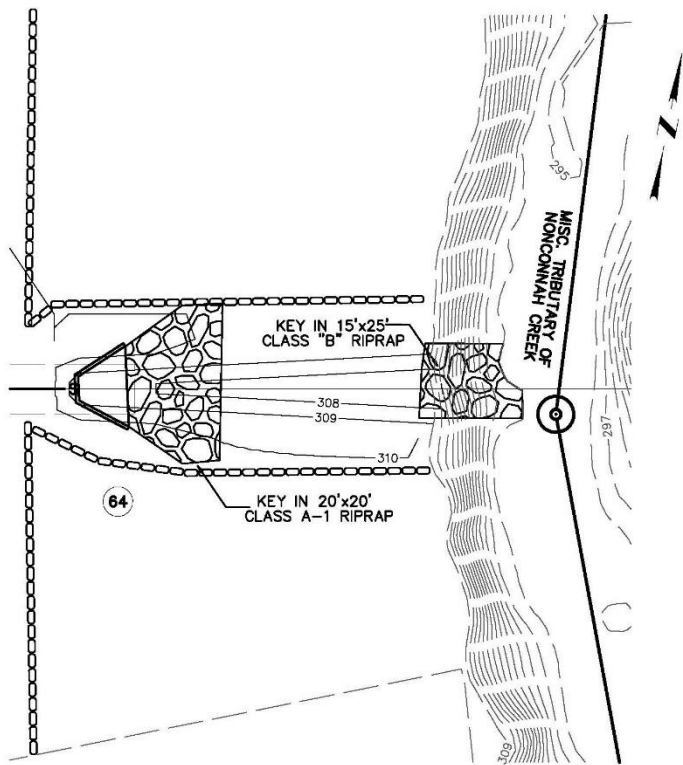
Channels will be constructed for drainage structures 57 and 64. These channels will serve the dual purpose of creating a constant slope, to prevent the creation of future wetlands, and to reduce erosion flowing into the tributary of Nonconnah Creek. Class B riprap will be placed directly at the headwall, and class A riprap will be placed along the bank slope.

Exhibit 2 – Structure 64 Outfall – Plan

The storm drainage system will connect to the eastern stream in two locations. Prior to excavation work, the silt-fence shall be installed adjacent to the proposed swale. The contractor will begin work by excavating a swale from the proposed headwall locations to the western bank of the stream. Once the swale has is complete, sod shall be installed to immediately stabilize the ditch. The headwalls will be installed and work associated with the storm sewer system shall commence. Finally, rip-rap shall be installed at the headwall to control scouring and rip-rap shall be installed along the western bank of the stream at its confluence with the proposed ditch. The rip-rap shall be installed flush with the surface of the stream.

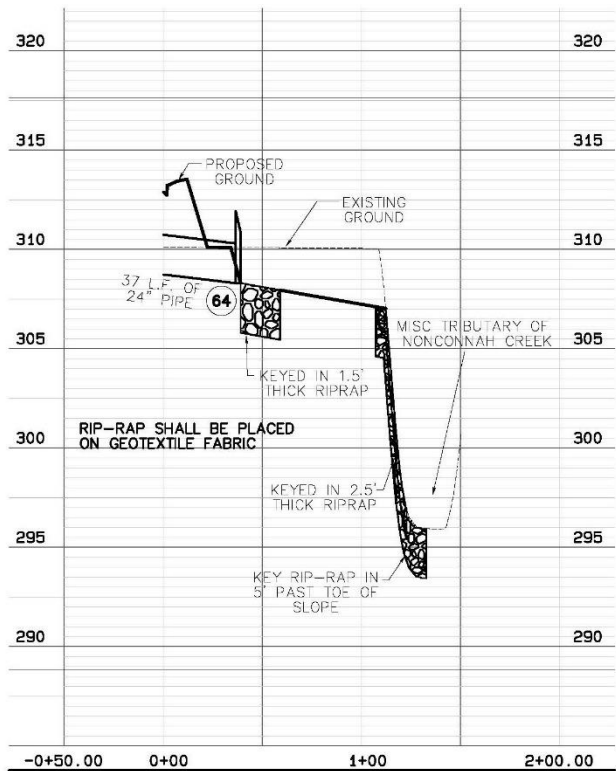
Exhibit 3 – Structure 64 Outfall – Profile

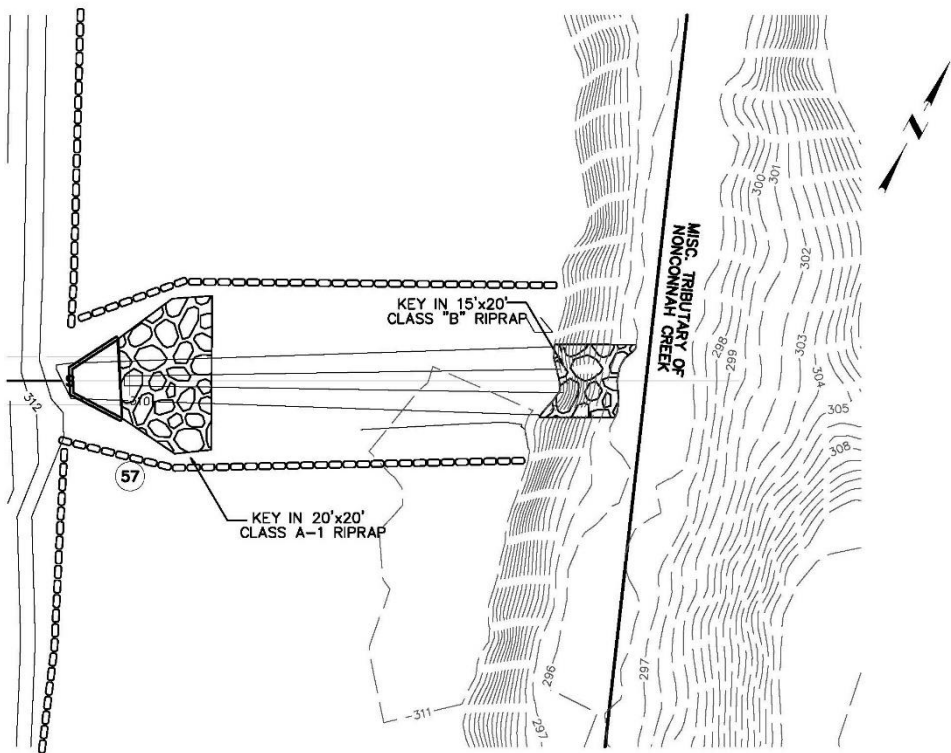
Exhibit 4 – Structure 57 Outfall – Plan

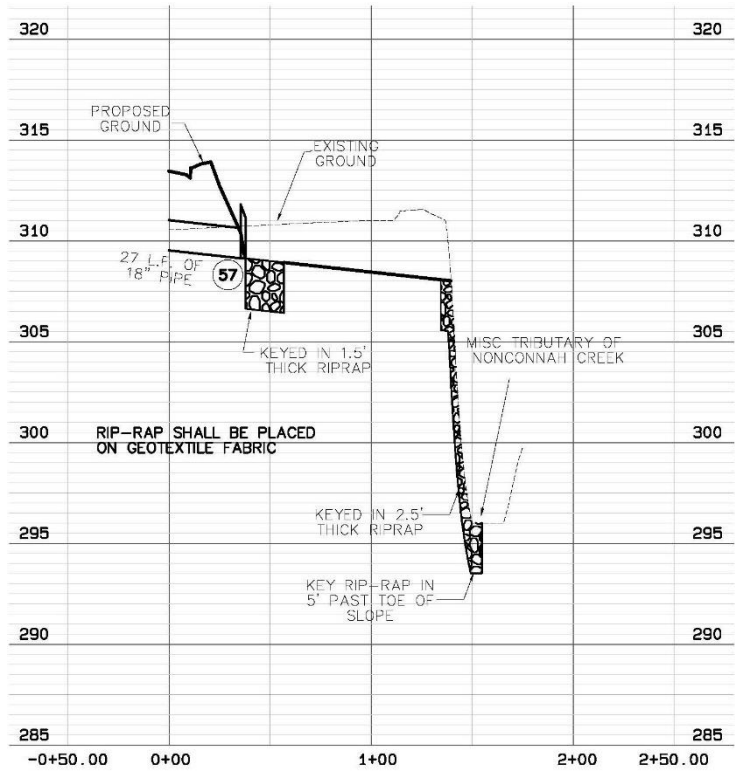
Exhibit 5 – Structure 57 Outfall – Profile

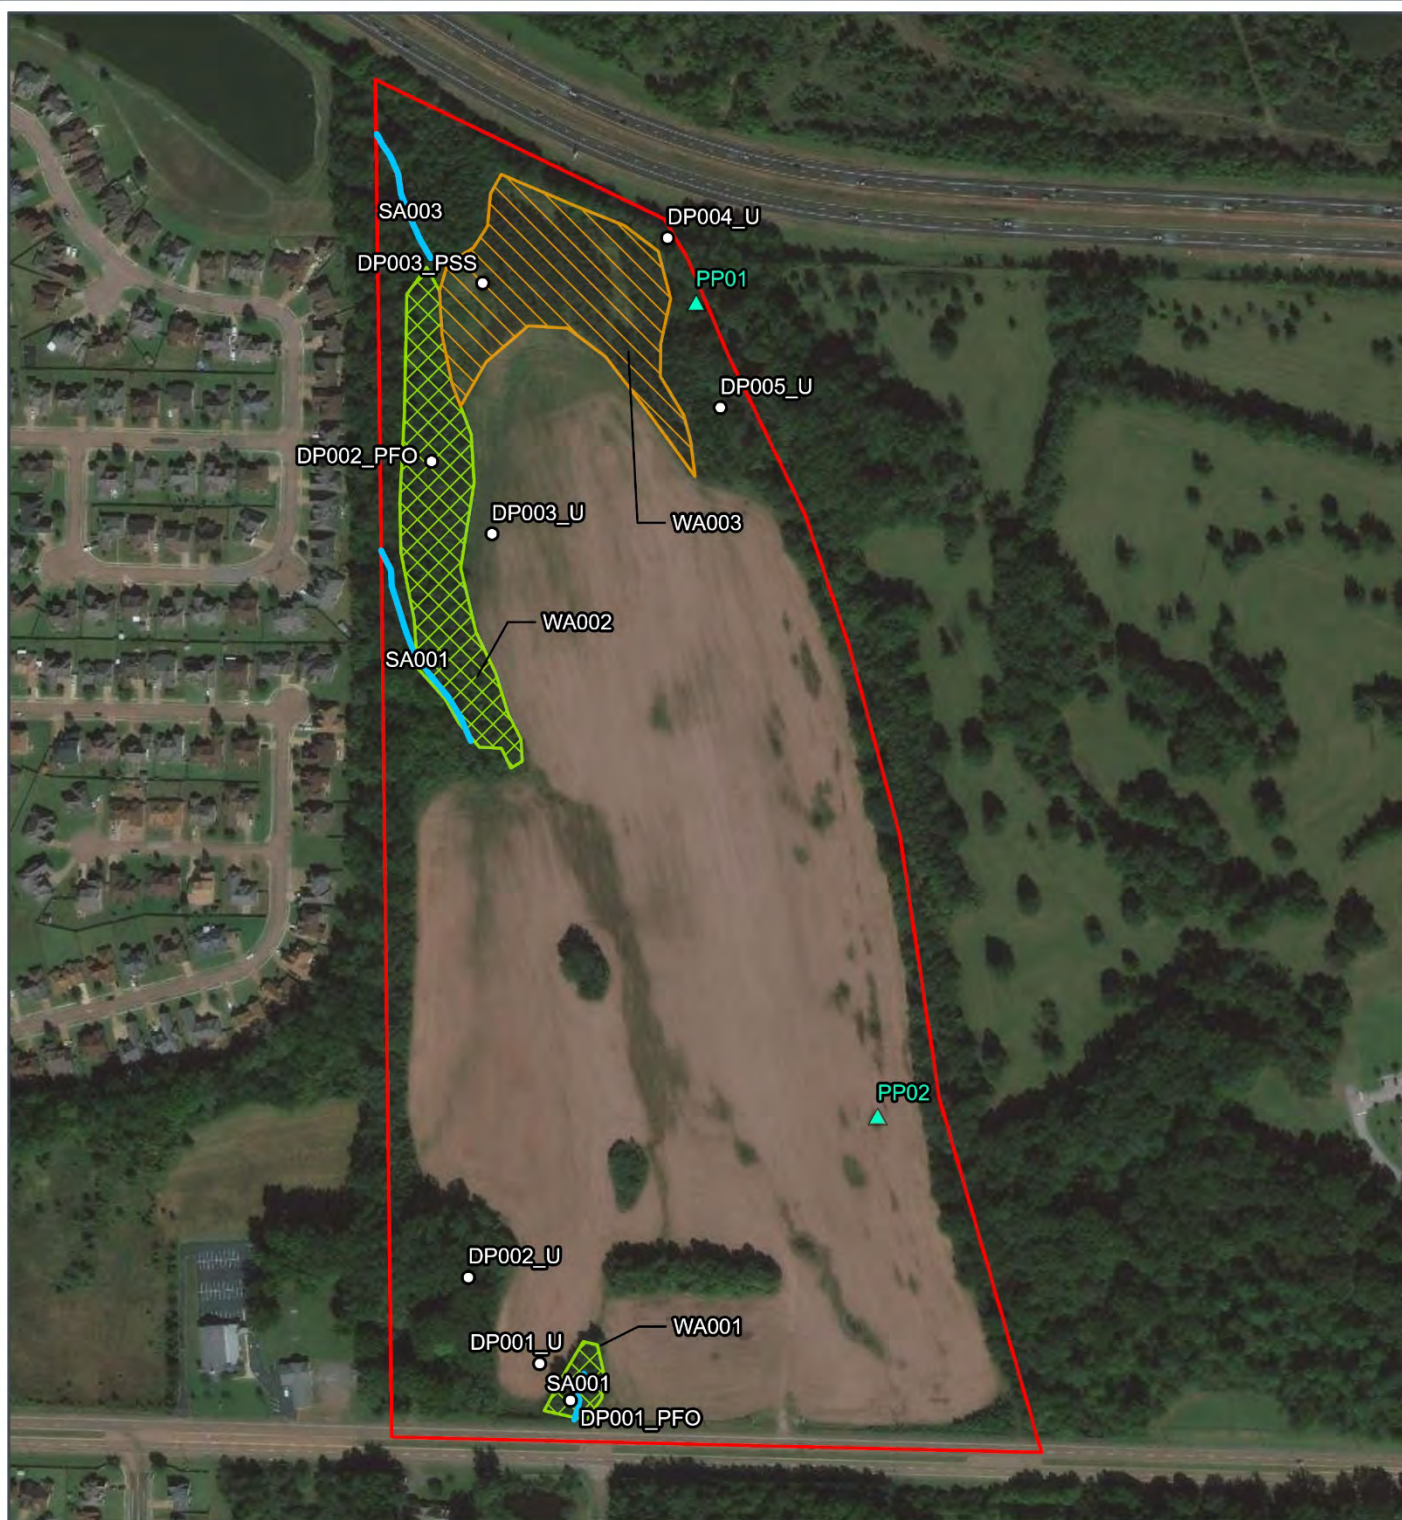
WOODLANDS DEVELOPMENT
**Aquatic Resource
Delineation Map**

SWCA identified and delineated a total of three watercourses within the proposed project area including one contiguous, and one broken ephemeral WWCs (consisting of two residual segments). Table 2 provides the OHWM widths, hydrologic determinations, lengths, acreages for each of the watercourses delineated within the project area. Refer to Appendix C for representative photographs of each type of watercourse encountered within the project area.

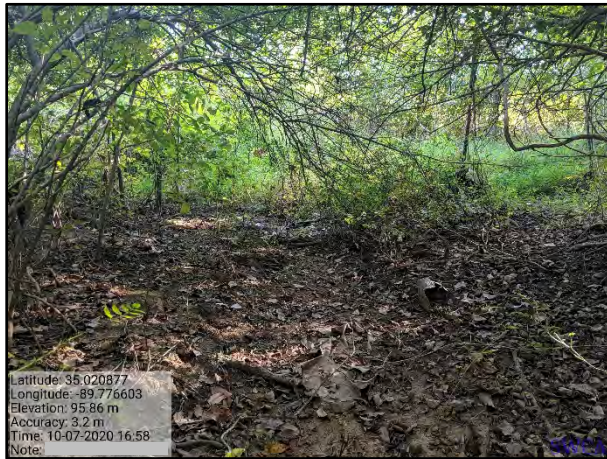
Photo C-1. Ephemeral drainage SA001 entrance to AOD

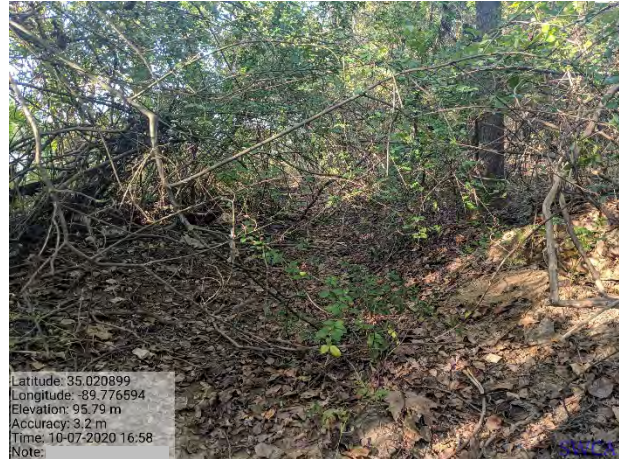
Photo C-2. Ephemeral drainage SA001 within PFO Wetland WA001

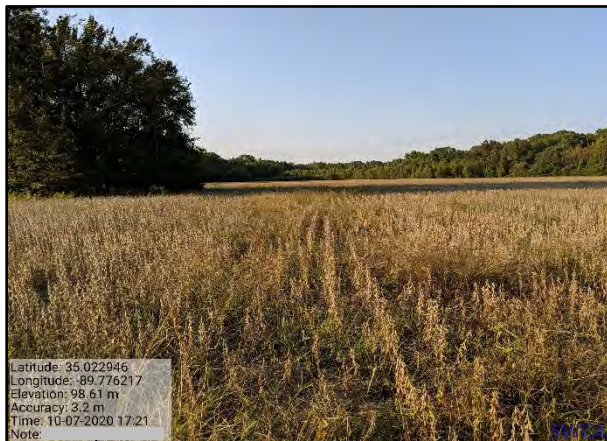
Photo C-3. NHD-mapped location of SA001

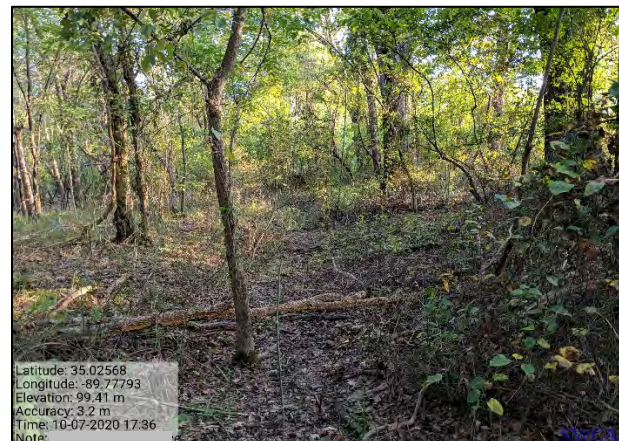
Photo C-4. Ephemeral drainage SA001 exiting AOD

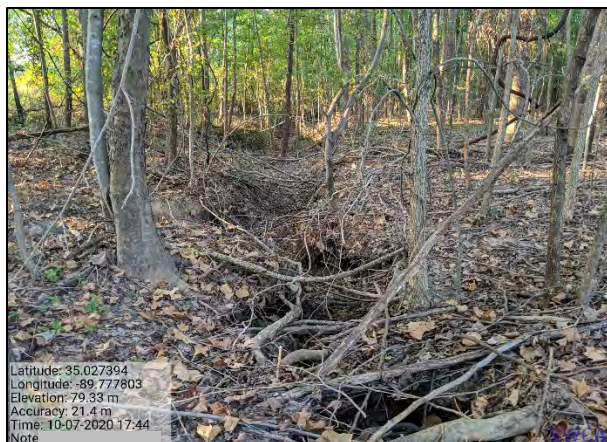
Photo C-5. Ephemeral eroded drainage SA002.

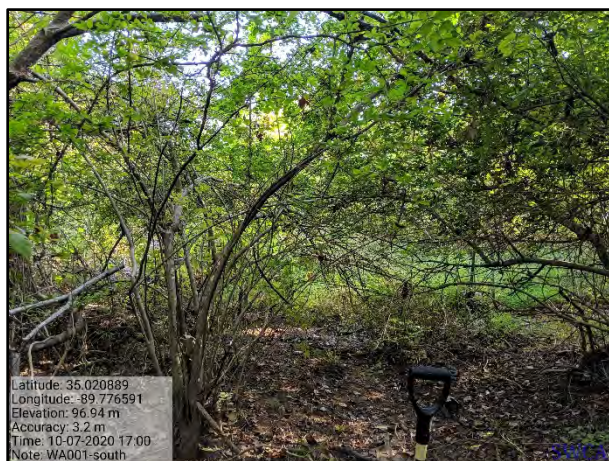
Photo C-6. Palustrine forested wetland WA001 (at datapoint DP001_PFO).

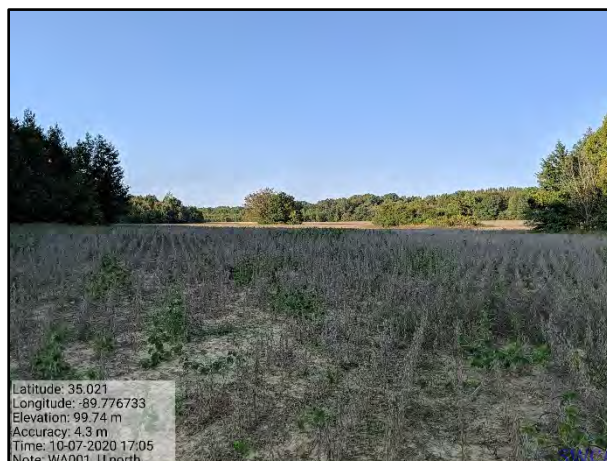
Photo C-7. Herbaceous (agri) upland at datapoint DP001_U associated with WA001.

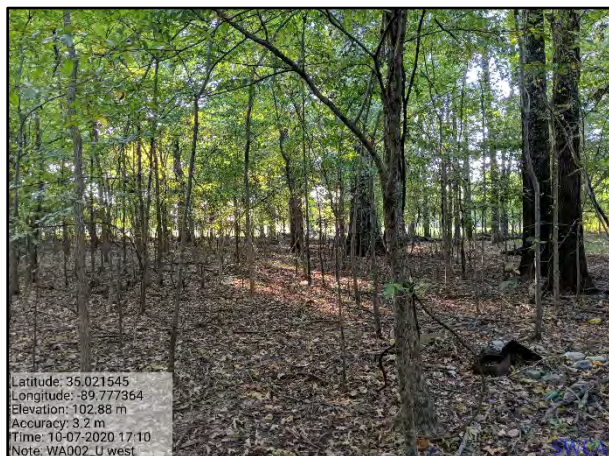
Photo C-8. Forested upland (at datapoint DP002_U).

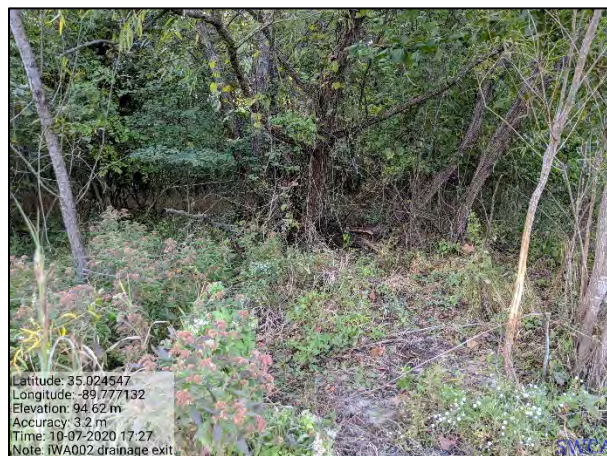
Photo C-9. Palustrine forested wetland WA002 (at SA001b start).

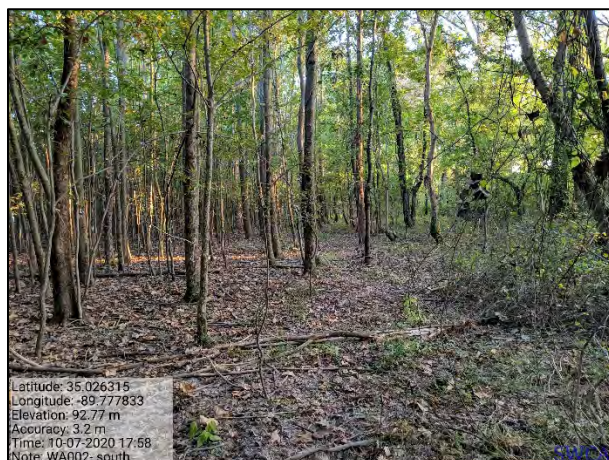
Photo C-10. Palustrine forested wetland WA002 (at DP002_PFO)

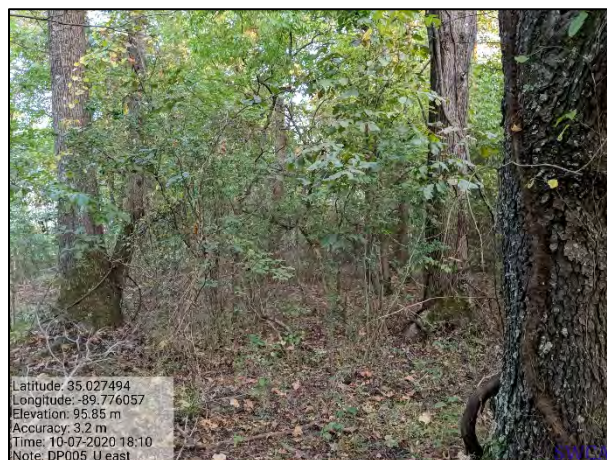
Photo C-11. Forested upland (at datapoint DP005_U)

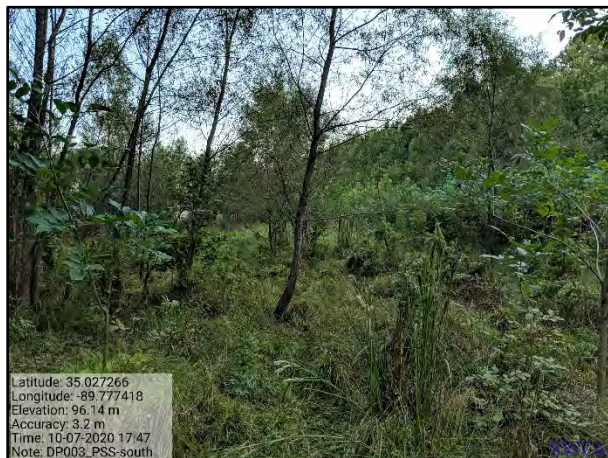
Photo C-12. Palustrine scrub-shrub wetland WA003 (at datapoint DP003_PSS)

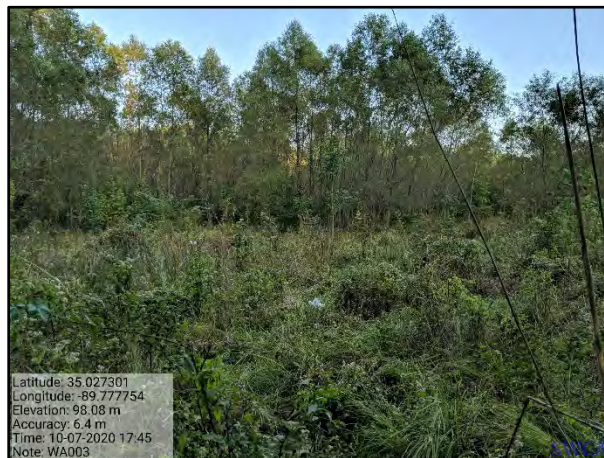
Figure C-13. Representative photo of palustrine scrub-shrub wetland WA003

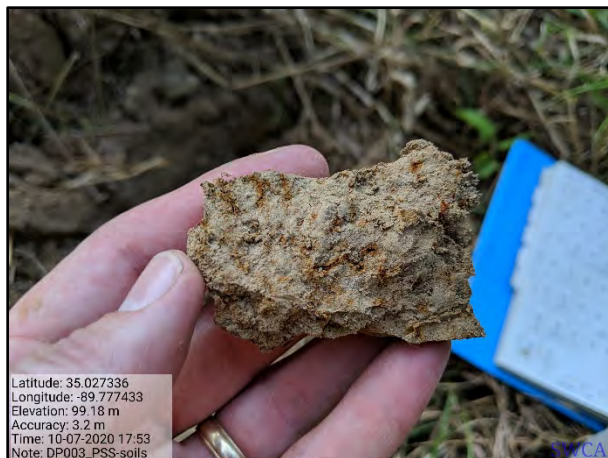
Photo C-14. Representative photo of hydric soil indicators (Falaya silt loam) within WA001, WA002, and WA003.

Wetland classes display at least one hydric soil indicator, as defined by the USACE (2010). Typical hydric soil indicators identified included depleted matrix and stripped matrix. Upland classes either fail to display hydric soil indicators or fail to meet one or more of the other two wetland criteria, as defined by the USACE (2010). Additionally, streams usually have hydric soils associated with their bed and/or bank. According to the USDA NRCS (2020a) soil surveys for Shelby County, Tennessee, four soil map units are present within the project area, one of which meets the hydric soil criteria. Table 1 below shows the names and hydric characteristics of the soil map units within the project area. Refer to Appendix D for a detailed description of each soil map unit within the project area.

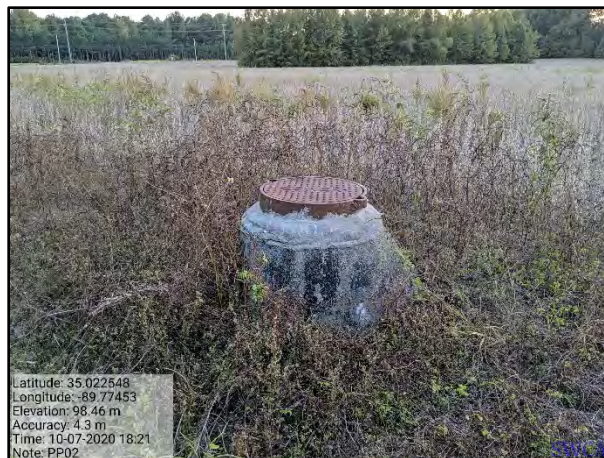
Photo C-15. Sewer line access (manhole) within eastern side of AOD (within soybean field).

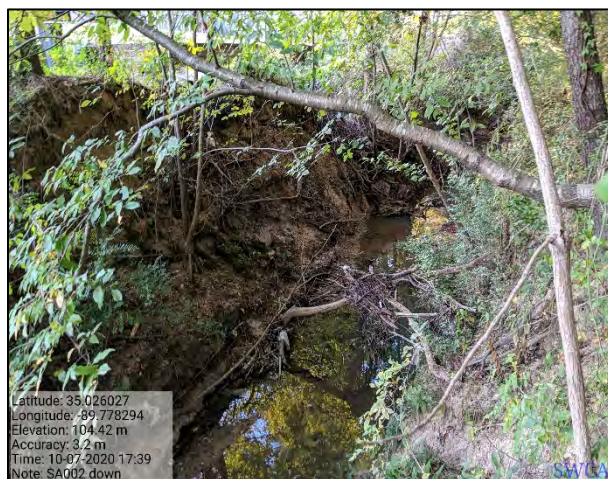
Photo C-16. Intermittent stream adjoining west boundary of AOD

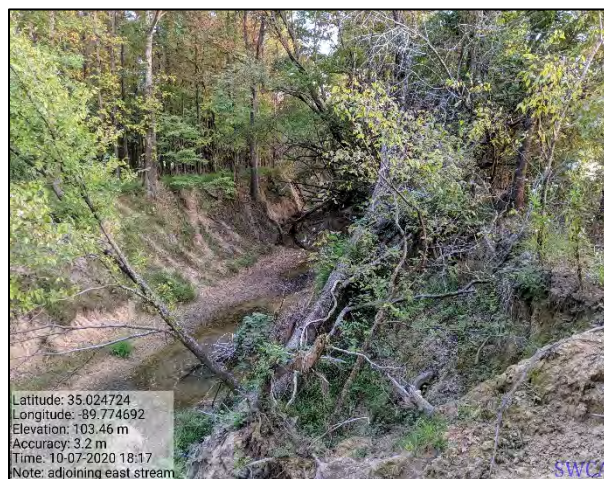
Photo C-17. Intermittent stream adjoining east boundary of AOD.
