**Woodlands**  
**Memphis, Shelby County, TN**  
**General ARAP – Wetland**

General ARAP

## TECHNICAL MEMORANDUM

**Re:** **Woodlands Development Hydrologic Determination / SWCA Project No. 63003**

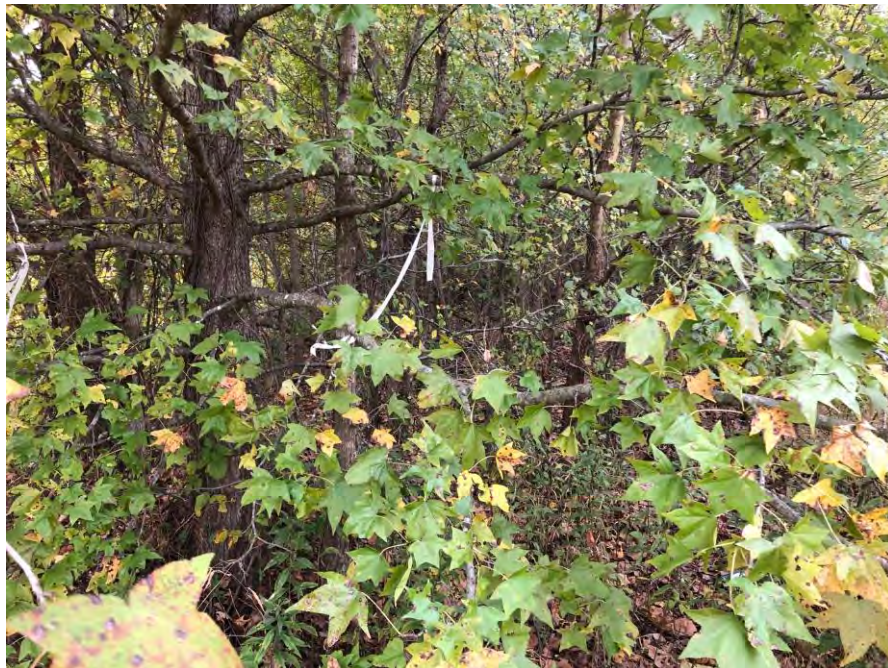
Wetland Image 2  
(North, Looking South)

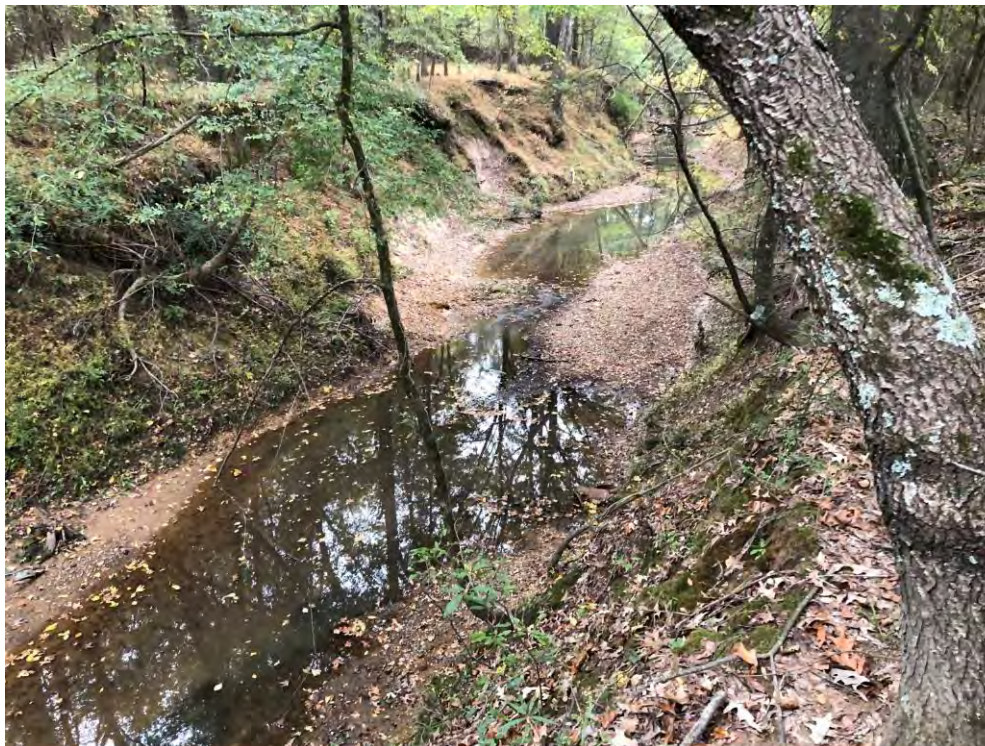
Structure 64 Insertion  
(Looking upstream, to the South)

Channels will be constructed for drainage structures 57 and 64. These channels will serve the dual purpose of creating a constant slope, to prevent the creation of future wetlands, and to reduce erosion flowing into the tributary of Nonconnah Creek. Class B riprap will be placed directly at the headwall, and class A riprap will be placed along the bank slope.

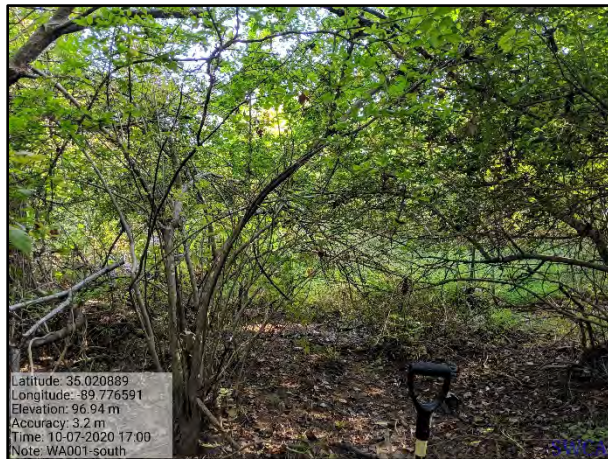
Photo C-6. Palustrine forested wetland WA001 (at datapoint DP001\_PFO).

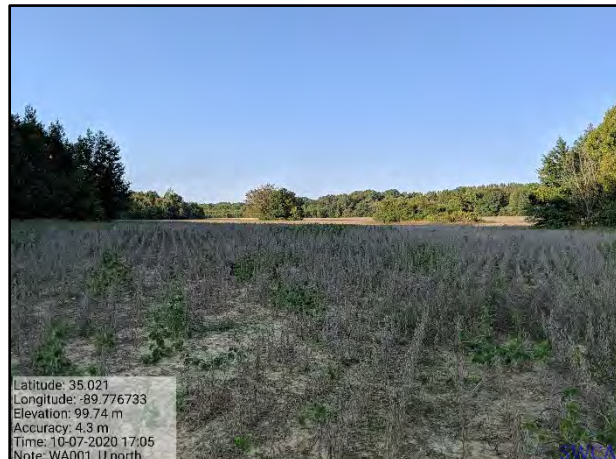
Photo C-7. Herbaceous (agri) upland at datapoint DP001\_U associated with WA001.

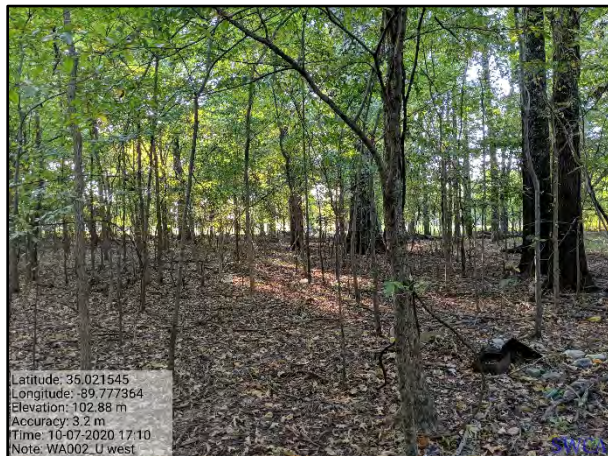
Photo C-8. Forested upland (at datapoint DP002\_U).

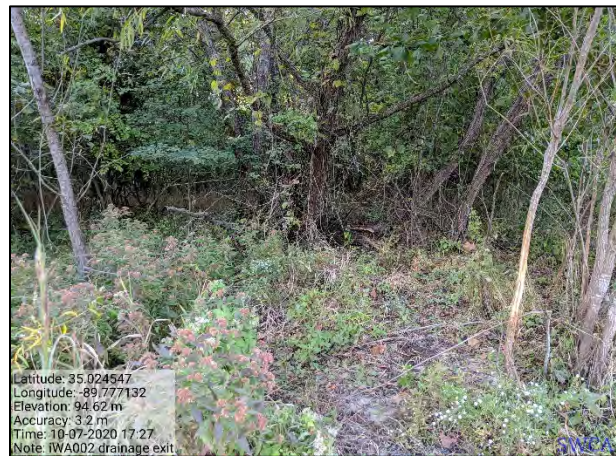
Photo C-9. Palustrine forested wetland WA002 (at SA001b start).

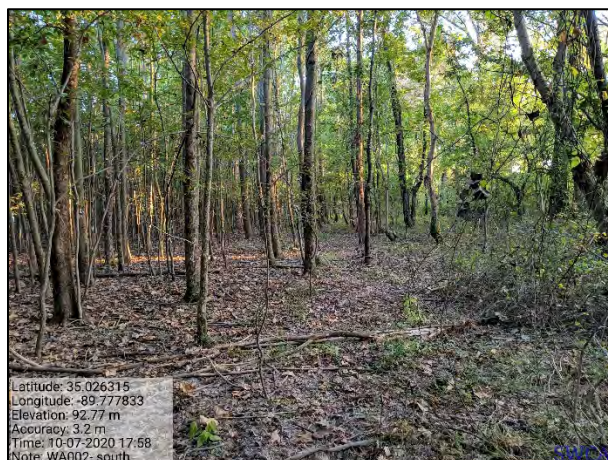
Photo C-10. Palustrine forested wetland WA002 (at DP002\_PFO)

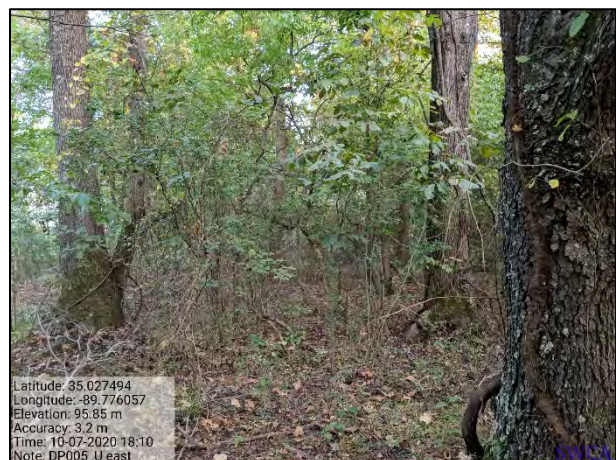
Photo C-11. Forested upland (at datapoint DP005\_U)

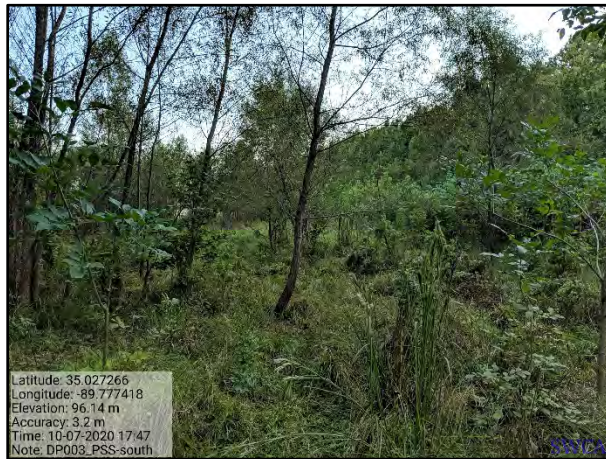
Photo C-12. Palustrine scrub-shrub wetland WA003 (at datapoint DP003\_PSS)

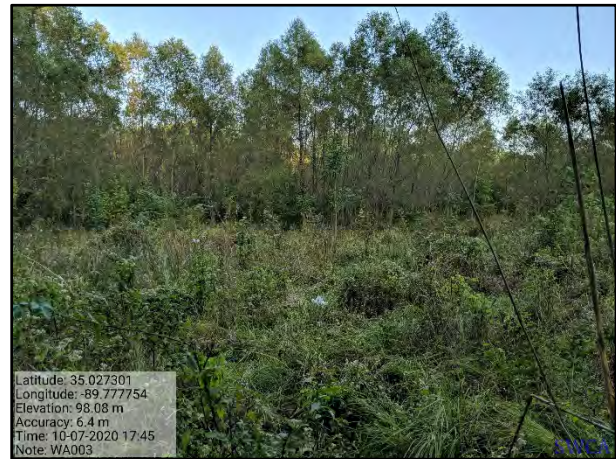
Figure C-13. Representative photo of palustrine scrub-shrub wetland WA003

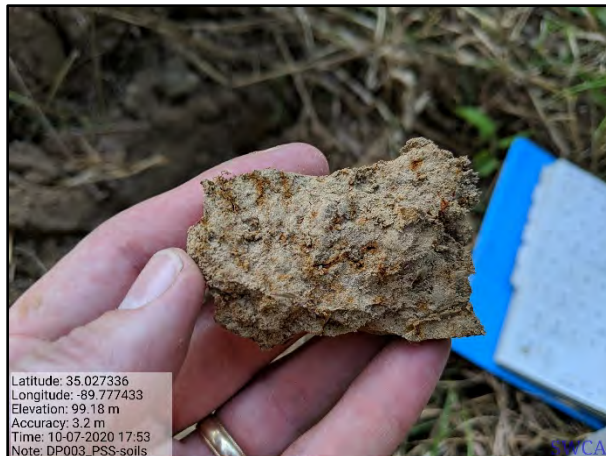
Photo C-14. Representative photo of hydric soil indicators (Falaya silt loam) within WA001, WA002, and WA003.

Wetland classes display at least one hydric soil indicator, as defined by the USACE (2010). Typical hydric soil indicators identified included depleted matrix and stripped matrix. Upland classes either fail to display hydric soil indicators or fail to meet one or more of the other two wetland criteria, as defined by the USACE (2010). Additionally, streams usually have hydric soils associated with their bed and/or bank. According to the USDA NRCS (2020a) soil surveys for Shelby County, Tennessee, four soil map units are present within the project area, one of which meets the hydric soil criteria. Table 1 below shows the names and hydric characteristics of the soil map units within the project area. Refer to Appendix D for a detailed description of each soil map unit within the project area.

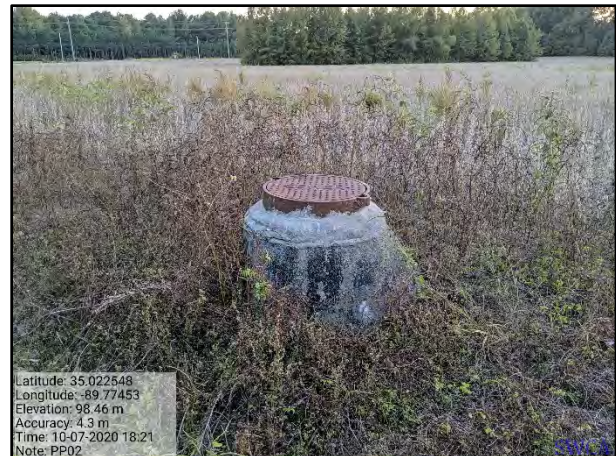
Photo C-15. Sewer line access (manhole) within eastern side of AOD (within soybean field).

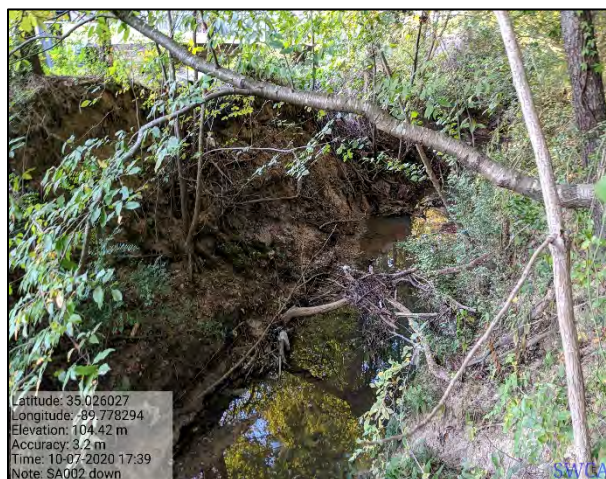
Photo C-16. Intermittent stream adjoining west boundary of AOD

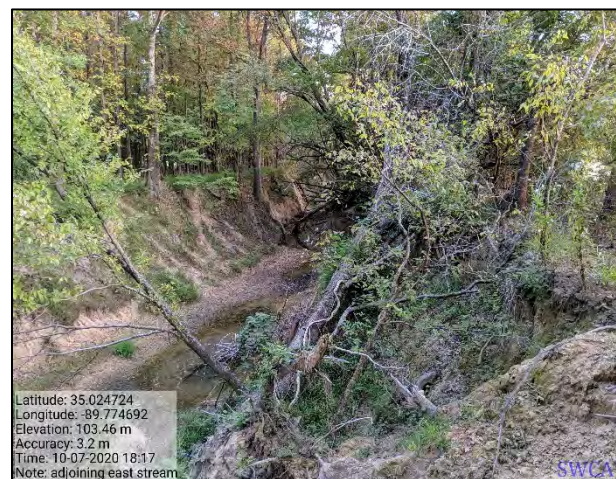
Photo C-17. Intermittent stream adjoining east boundary of AOD.
