Application for Aquatic Resource Alteration Permit (ARAP) & State §401 Water Quality Permit

Site or Project Name: Wolf River Lateral J; from confluence to Shelton Road Crossing      Nearest City, Town or Major Landmark: Collierville, TN

**WOLF RIVER LATERAL "J"  
COLLIERVILLE, TN  
FIELD INVENTORY  
APRIL 22, 2016 PHOTO LOG**

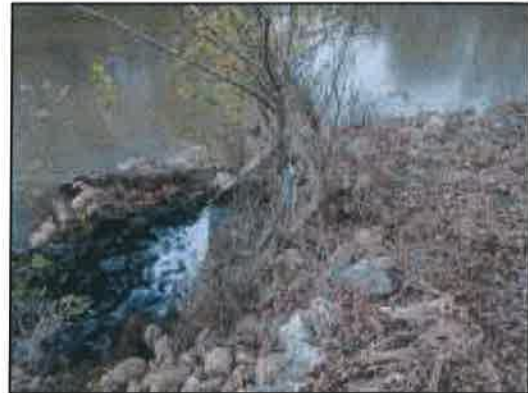
**Figure 2:** Sanitary Sewer Outfall into the Wolf River

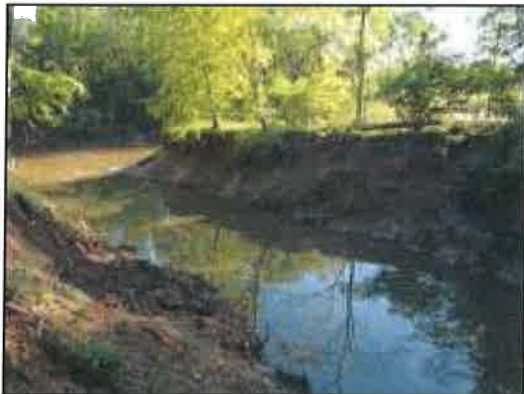
**Figure 3:** Evidence of recent bank erosion of the Lateral at the confluence

The outfall line for the Shelton Road Waste Water Treatment Plant (WWTP) is located adjacent and parallel to the west bank of Lateral "J". The lateral intercepts the Wolf River at approximately the mid-point of a "hairpin" bend in the Wolf River. There is active erosion of the river bank on the outside of the bend as evidenced by the shear vertical bank (see Figure 1). The top bank of the bend has migrated south and is threatening the sewer outfall. The banks of the lateral immediately upstream are sloughing. A short distance upstream there is evidence of recent degradation of the bottom as evidenced by the vertical lower bank and the sloping upper bank. The change in slope is denoted by the red arrow in figure 4.

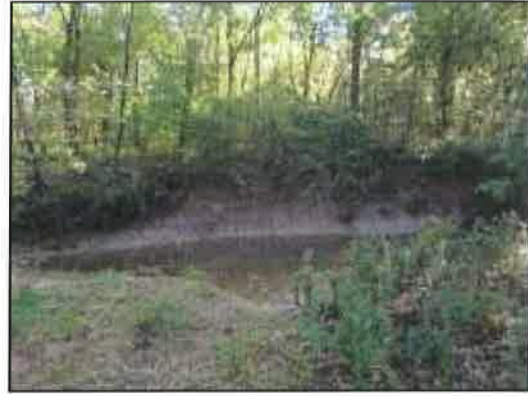
**Figure 9:** Mid-point of bend looking at the east bank

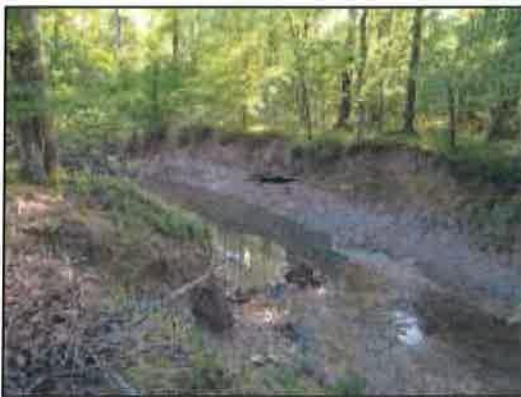
**Figure 13:** Looking downstream from approximately the mid-point of the bend; the change where the soil profile changes for the upper silty loam to the underlying clay is clearly evident (denoted by black arrow)

Both banks of the section of the stream represented in photos 11, 12, and 14 are eroded and standing at a near vertical slope. There has been a recent slope failure occur near the downstream of the bend shown in these photos. At the failure the soils from the slope have “slid” out into the channel (see the area in figure 11 boxed in red).

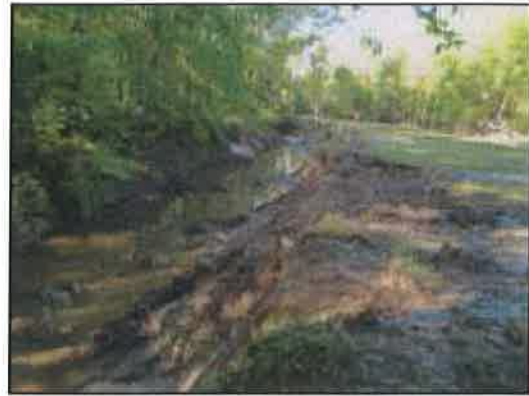
**Figure 16:** Looking upstream at the recently disturbed slope from same vantage point as figure 15

The 500± lineal feet of the west bank shown in figures 15, 16, 18, 19 and 21 is unstable and has recently failed and/or there are indications of imminent failure.

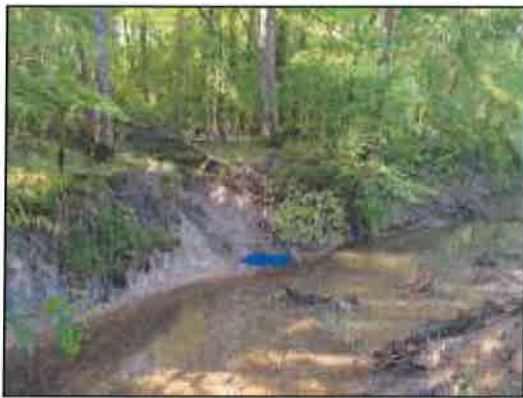
**Figure 17:** Blue arrow indicates the point where a side ditch from the east enters the Lateral

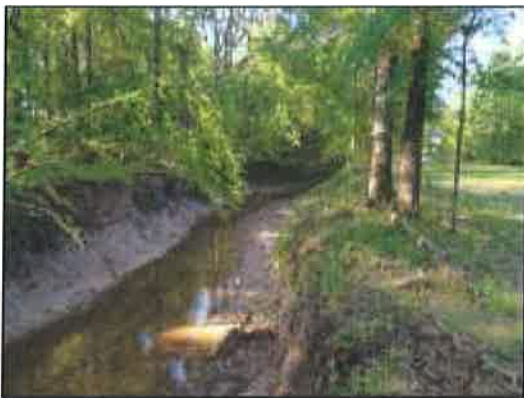
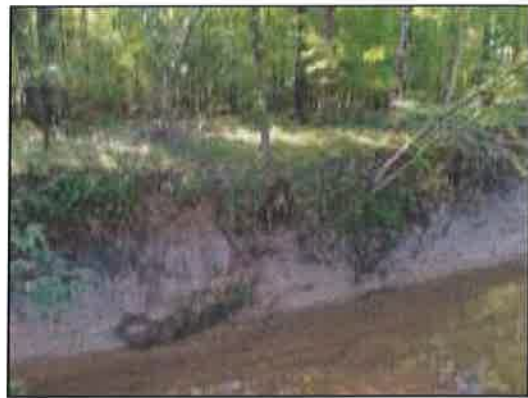
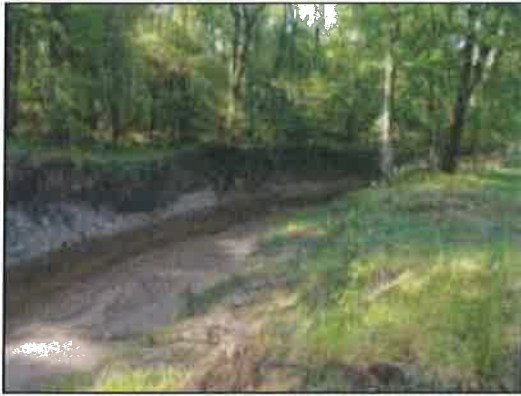
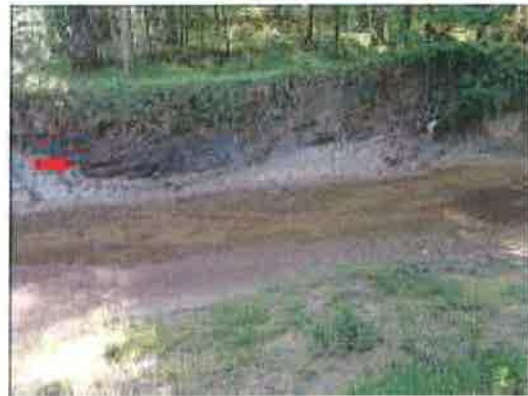
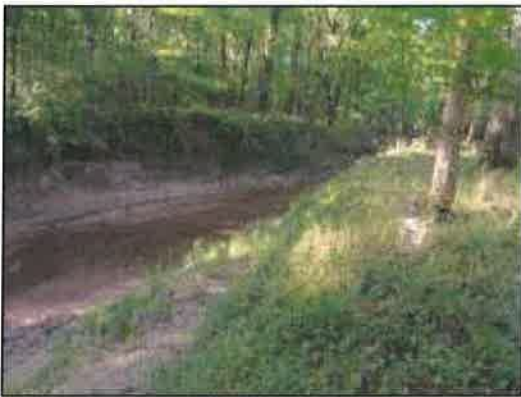
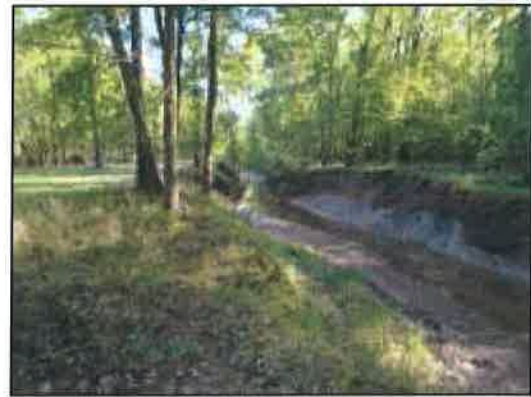
**Figure 22:** Looking upstream at the Beginning of a bend in the stream

**Figure 23:** East bank at the beginning of of the bend

**Figure 24:** Mid-point of bend with deposits on the inside of the bend; note the bank has laid back on an approximation of a 2:1 slope

**Figure 25:** Isolated deposit of sedimentary rock (possible a conglomerate)

**Figure 26:** Looking upstream near the end of the bend

**Figure 27:** Just beyond the end of the bend looking downstream.

The bend shown in figures 22 through 27 exhibits the typical pattern of erosion of the bend in a stream with active erosion of the bank on the outside of the bend and the deposition of material on the inside of the bend. There are areas near the mid-point of the bend where the west (inside) slope of the bend has laid back on a slope that is approximately a 2:1 slope.

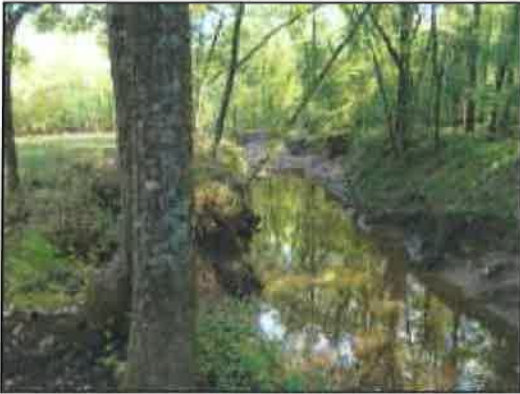
**Figure 28:** The beginning of a relatively Long stream section where only minor meanders occurring

The bank conditions along the slightly meandering stream section depicted in figures 28 through 35 demonstrate the effects that trees can have upon the slope stability. The majority of the bank slopes on the west side of the stream are vertical and near vertical. The root systems of the trees along the top of the west bank are serving to temporarily stabilize the vertical slopes. Much of the slopes along the east bank have a curved alignment that becomes steeper near the top of bank. There are areas along the east bank where trees are growing near the toe of slope. There is evidence of a past slope failure downstream of some of the trees near the toe of slope as evidenced by the sandy deposits in the area where you would expect an eddy to occur (see figure 35).

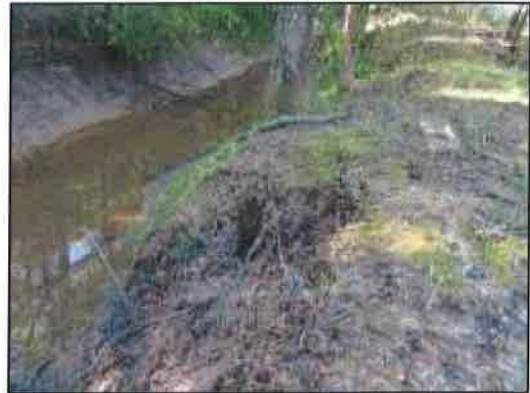
**Figure 31:** Close up of erosion around a root ball on the east bank

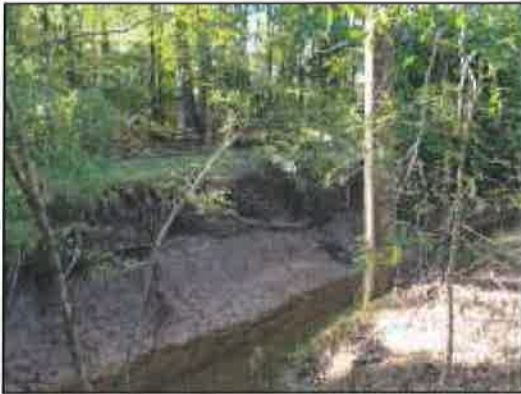
**Figure 32:** West bank erosion; note the vertical slope of the upper layer of silty loam and sloping gradient of the lower clay soils

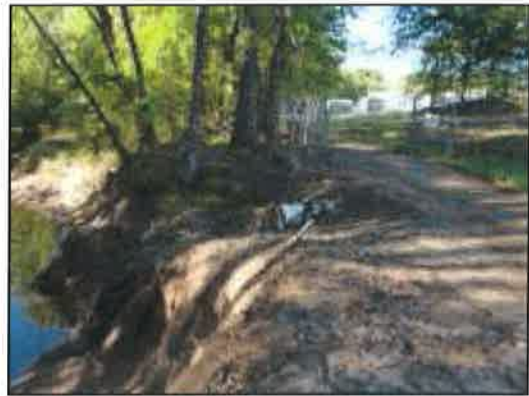
**Figure 37:** Second view of culvert crossing of access road; note how close to the top of the vertical bank is to the road

There is the potential for a washout to occur downstream of several culvert discharge points along the stream bank. The culvert shown in figures 36 and 37 is the first encountered during the inventory.

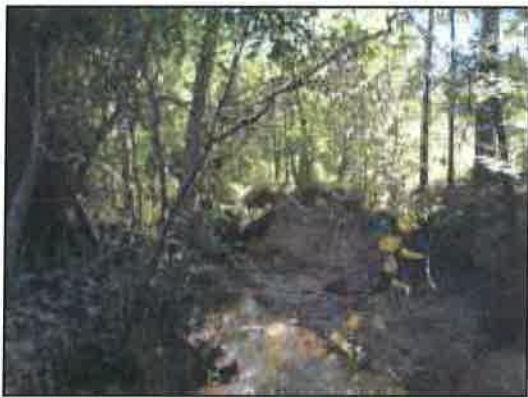
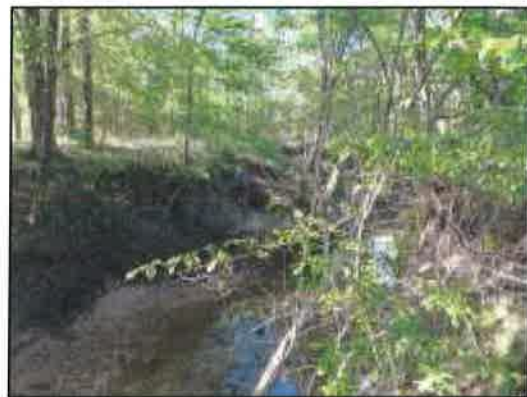
**Figure 42:** Looking downstream at bank Erosion shown in figures 40 and 42

**Figure 43:** Looking upstream from same vantage point as figure 42

There appear to be several factors contributing to the ongoing erosion along the stream reach represented in figures 38 through 43. The reach contains a series of tight bends (see figure 38). There is the indication of silt deposits and active bank erosion on alternate banks of the stream. There is a side ditch that enters the stream from the east that serves as the discharge for the large pond located in the adjacent subdivision. Apparently the flows from the side ditch have undermined the root ball of a large tree has slid and is leaning into the channel of the Lateral and has altered the stream flow causing erosion of both banks.

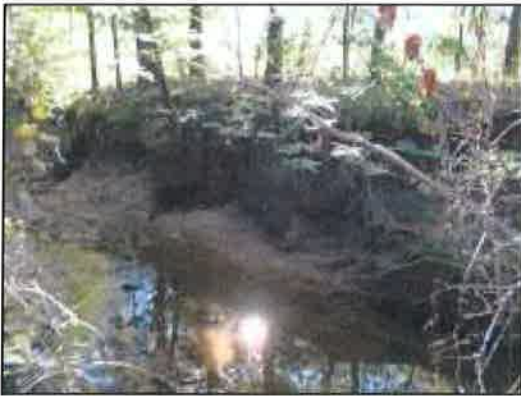
**Figure 44:** Looking downstream at east bank undercut by erosion

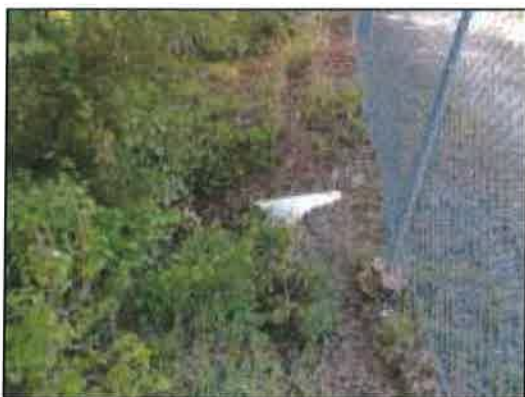
**Figure 48:** End of culvert from under gravel Drive; washout is overgrown.

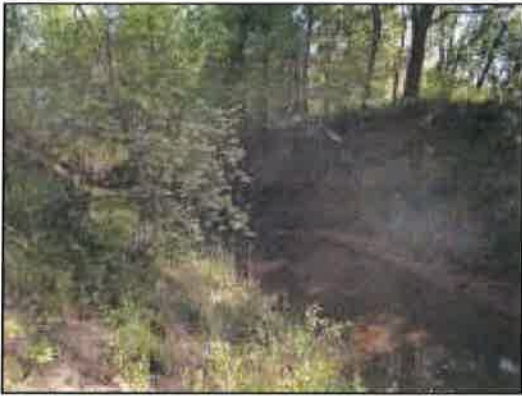
**Figure 50:** Looking downstream at outside bend erosion of east bank; standing on toe of the silt deposits on the inside of the bend

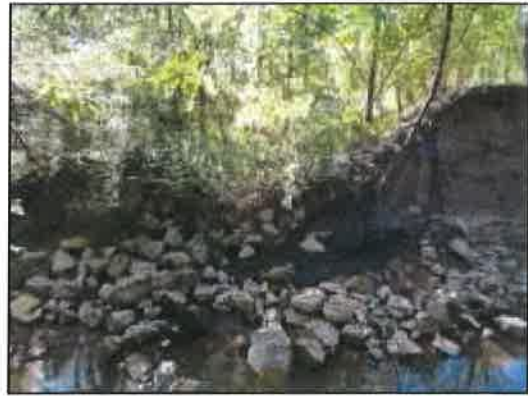
**Figure 51:** Looking up ditch serving as an outfall for part of the storm sewer system serving the adjacent subdivision

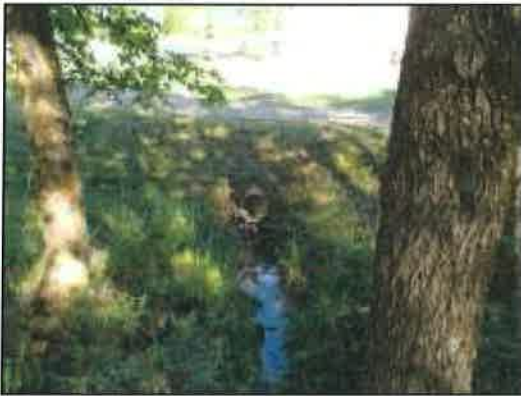
**Figure 55:** Outlet end of culvert from under gravel drive that discharges into the cantilevered pipe

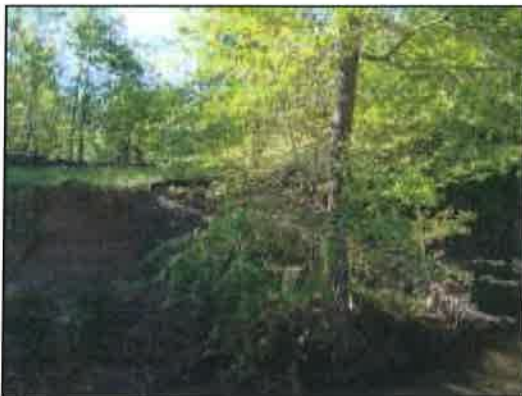
**Figure 57:** Outside bend erosion along a high bank on the east bank; note the tree that has re-rooted at the toe of the near vertical slope

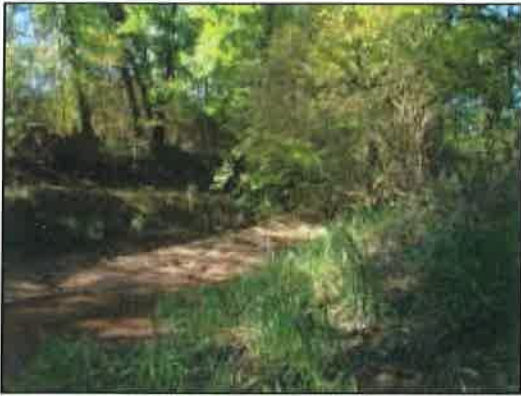
**Figure 59:** Standing on nearly vertical west Bank looking at outside bend on east side; Note the stepped bank on the east

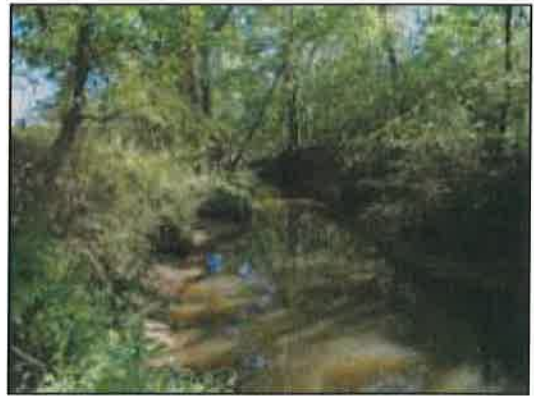
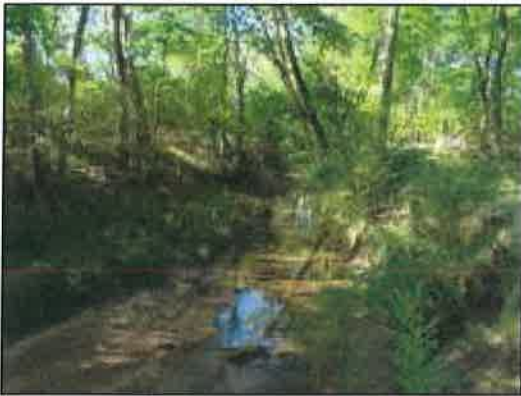
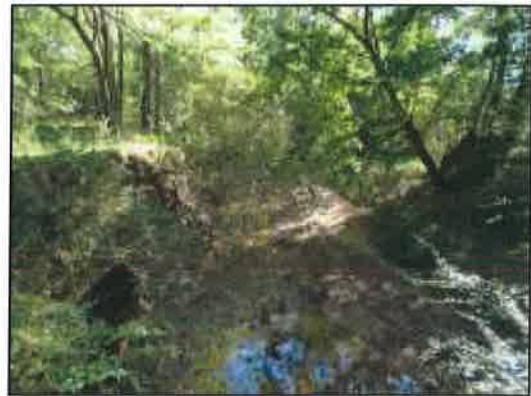
**Figure 60:** Looking downstream along a straight channel reach toward a downstream bend

**Figure 61:** Looking upstream; note the Naturally formed mild bank slope on the east side

**Figure 62:** Looking downstream from the same vantage point as figure 61; note the near vertical slope on the west side

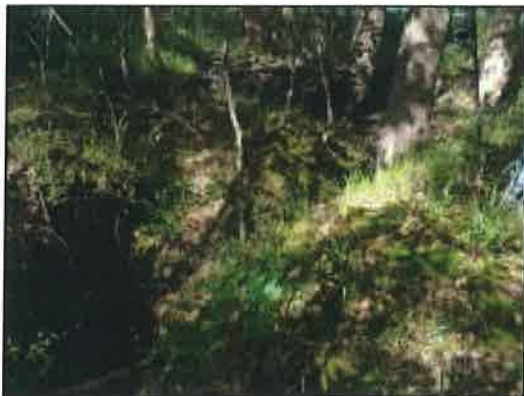
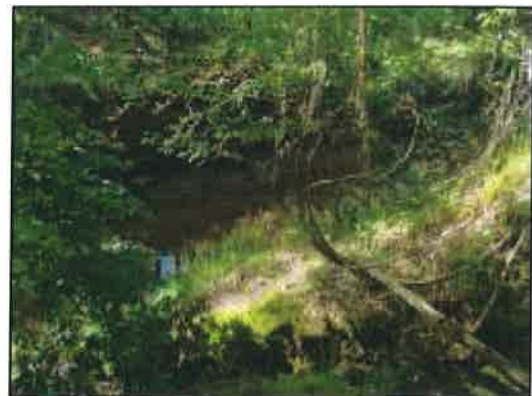
**Figure 63:** Crevice isolating an area on the west bank

**Figure 64:** Close up of the leading edge of the crevice

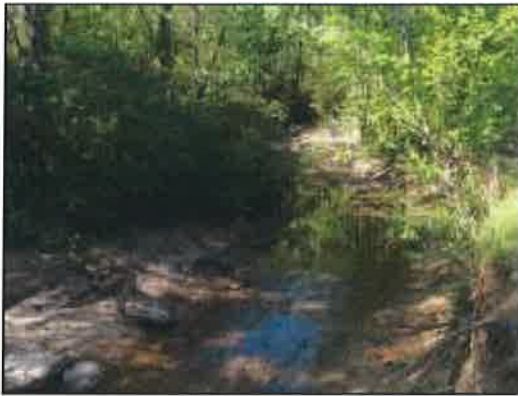
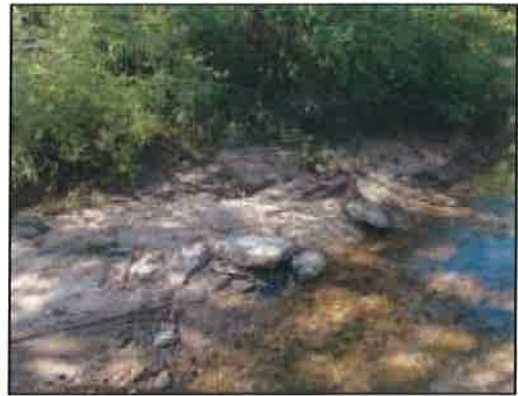
**Figure 65:** Looking upstream from the Middle of the outside (west) bank of a meander

**Figure 66:** Close up of sand and gravel deposits on the inside bend

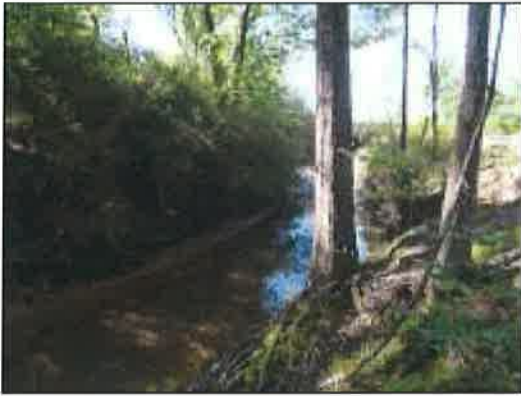
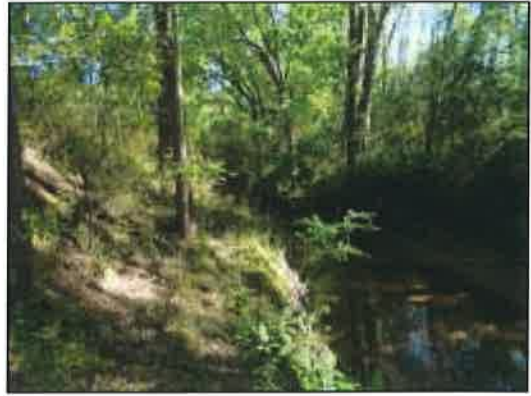
**Figure 70:** Approximately 300 feet downstream of Shelton Road looking upstream

**Figure 71:** Looking downstream from the same vantage point as figure 70

The conditions at the bridge crossing of Shelton Road are a dramatic example of the recent and potential future negative impacts due to head cutting.

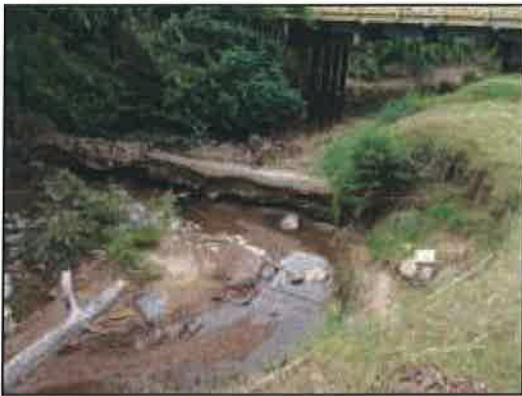
**Figure 72:** Water line crossing in 2013

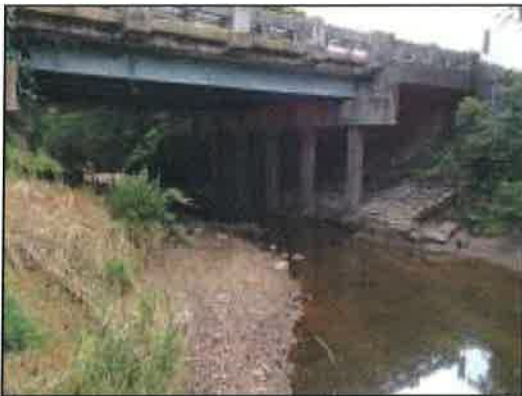
**Figure 74:** Bridge pilings in 2013
