Attached are photos in taken of the unnamed tributary to Carr Creek that is the receiving stream for the Greenbrier STP. These are the upstream photos. Note there appear to be normal stream conditions except some thin sediment deposits on the substrate.

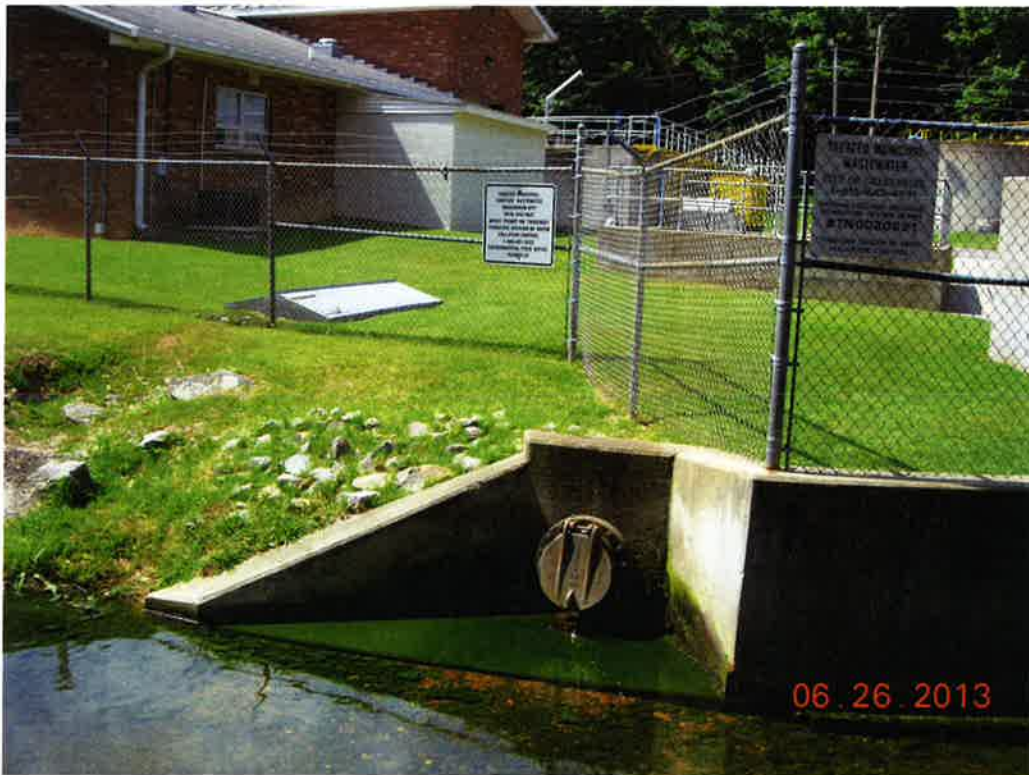
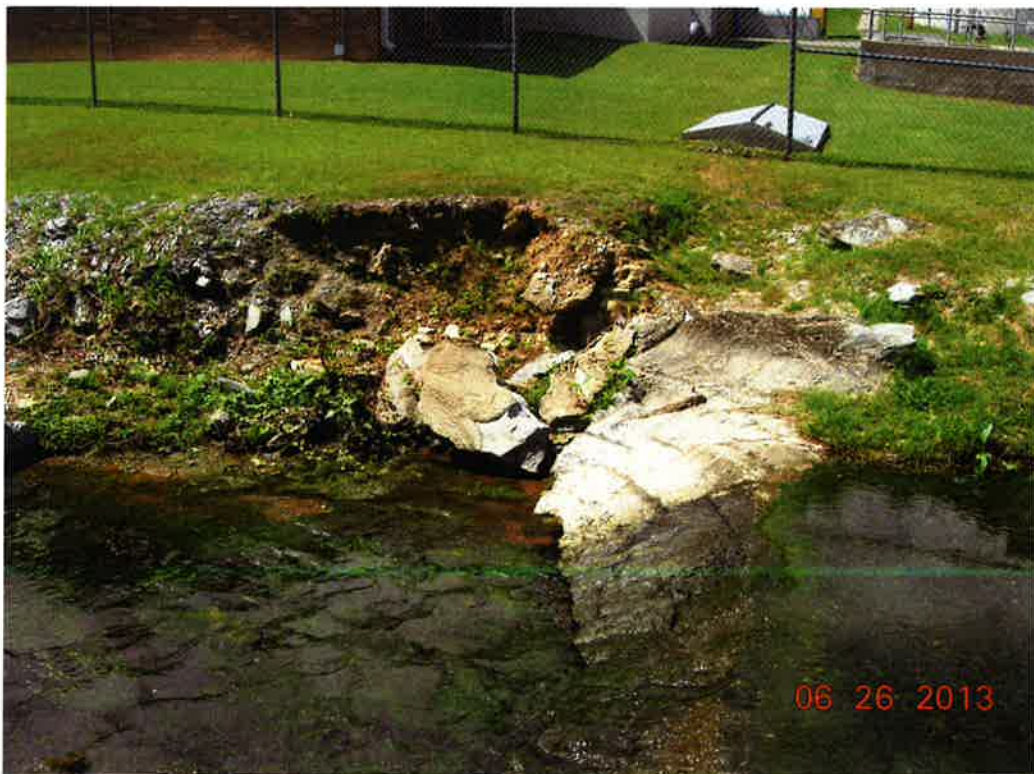
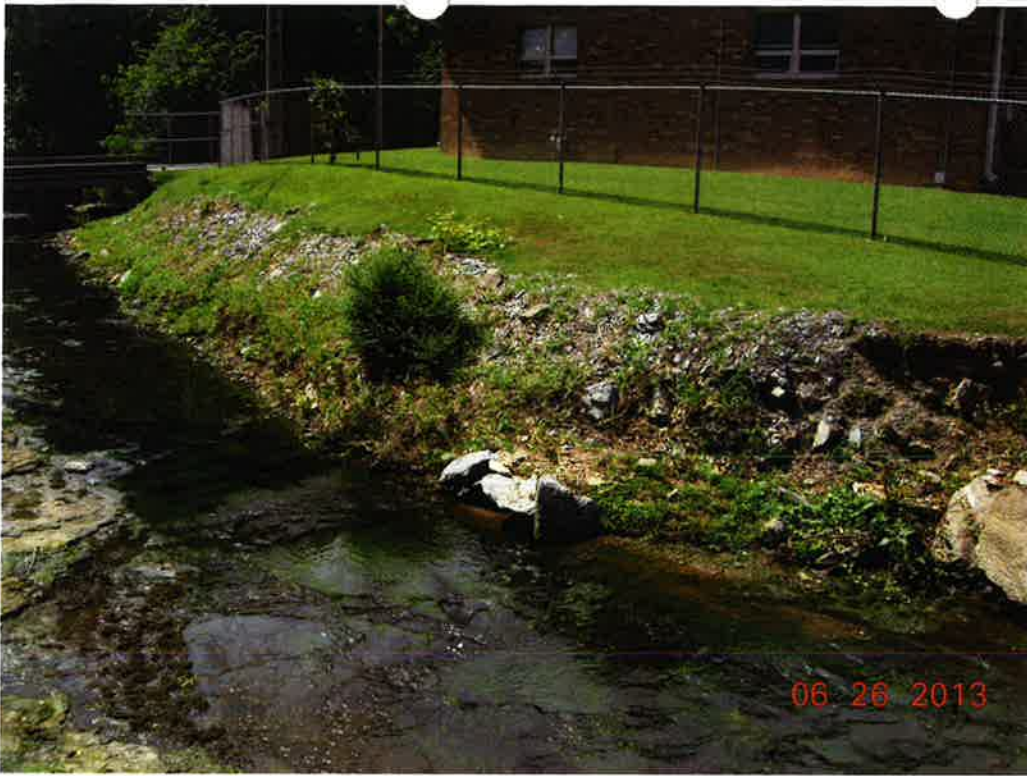
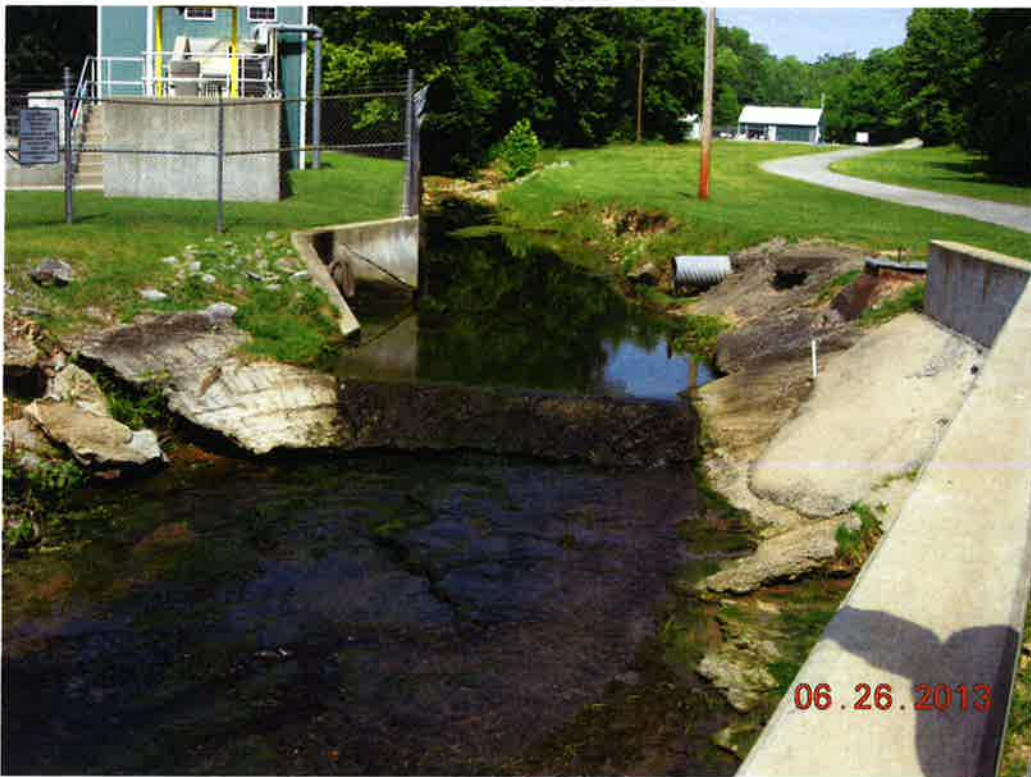
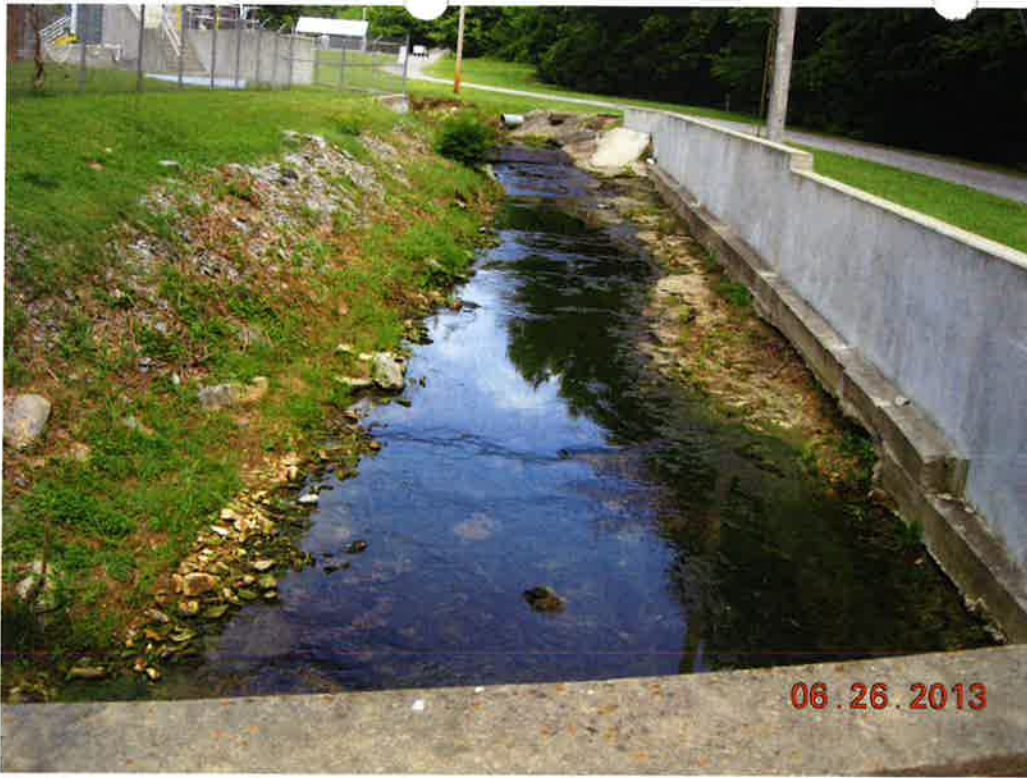
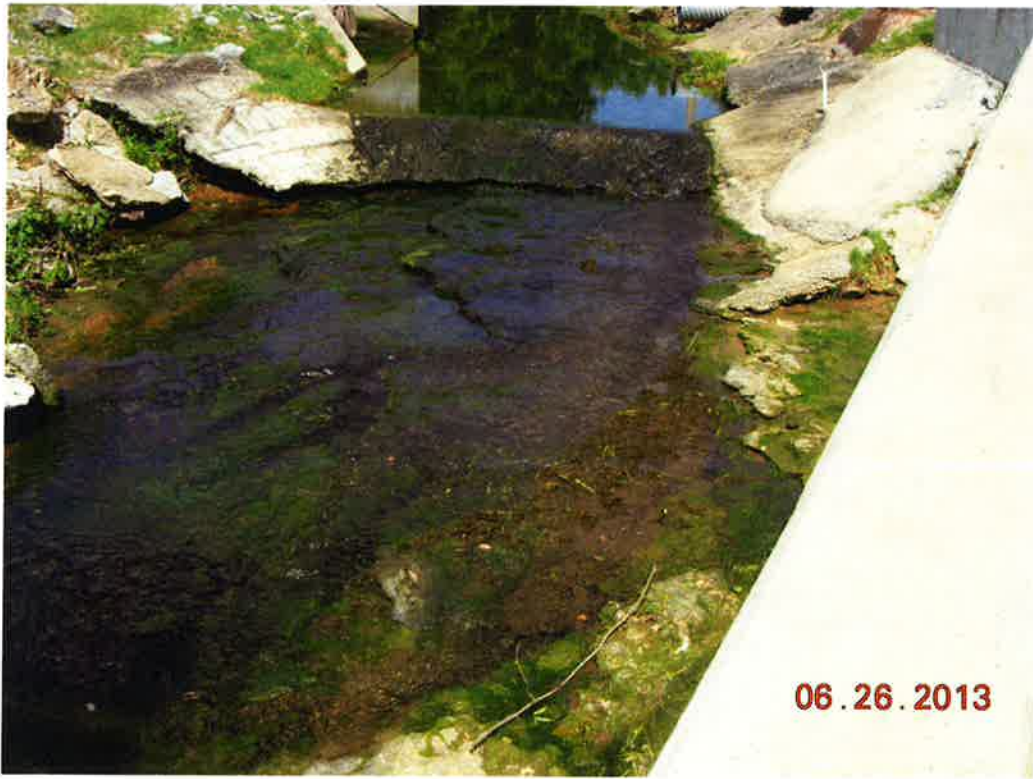
These are photos showing the outfall and just downstream. The heavy algae growth continues here due to both the permitted discharge and the manhole overflow. The system is an sequencing batch reactor (SBR), so the discharge is not continuous. The periodic discharges are released and flush downstream in a slug, then the stream flow returns to the normal low levels.
