**QUALITY ASSURANCE
MONTHLY SITE
ASSESSMENT REPORT**

Airfield Modernization Program
Runway 5L-23R Reconstruction
Project 2 / Project 3
Project 4 / Repair TWY Lighting
Project 5 / Project 6

QUALITY ASSURANCE SITE ASSESSMENT

AIRFIELD MODERNIZATION PROGRAM RUNWAY 5L-23R RECONSTRUCTION

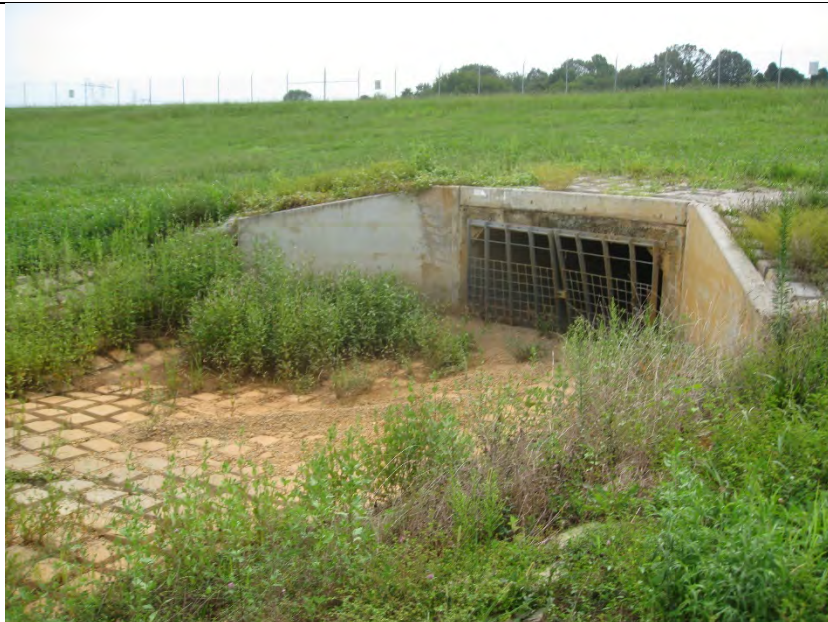
Photo 2
Sta. 111+56 RT
(Line LB)
NLET 01
Project 2

North Lateral End Treatment 01 (Outfall A).
No flow observed.

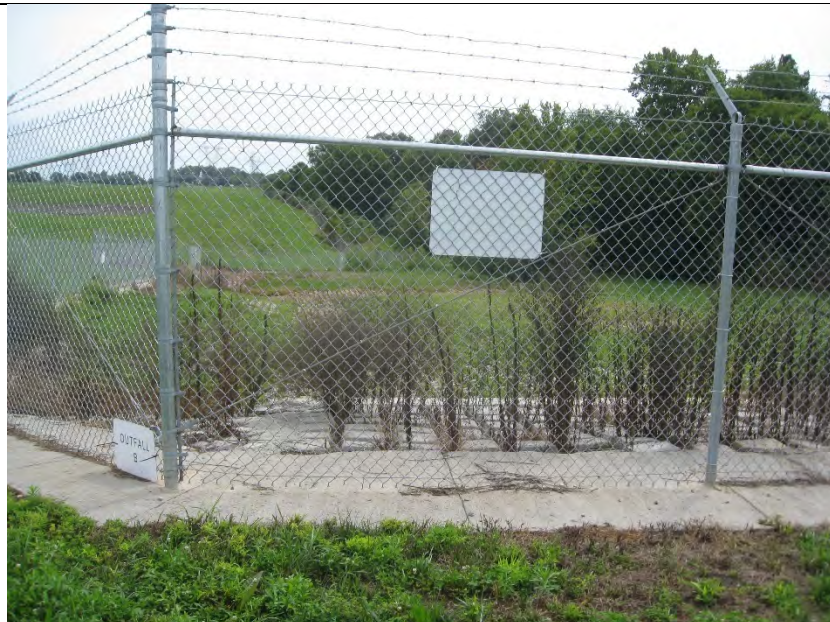
Photo 4
Sta. 114+00
(Line LB)
Project 2

Guard Lateral End Treatment 02.
This section of the site was inaccessible at time of inspection.

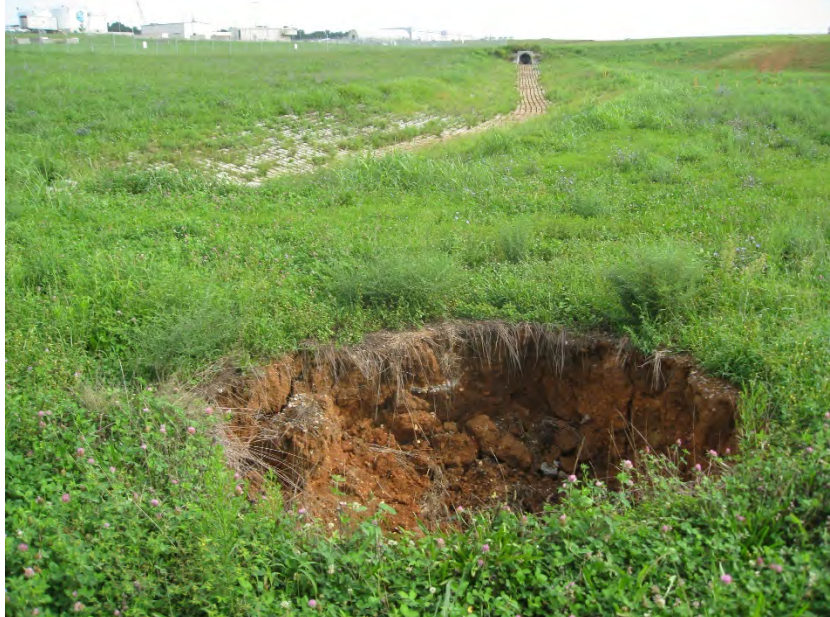
Photo 6
Sta. 117+00
(Line LB)
Project 2

Above the Guard Lateral Ditch (Outfall B).
Construction fall out present. Recommend coordinating remediation with CHA.

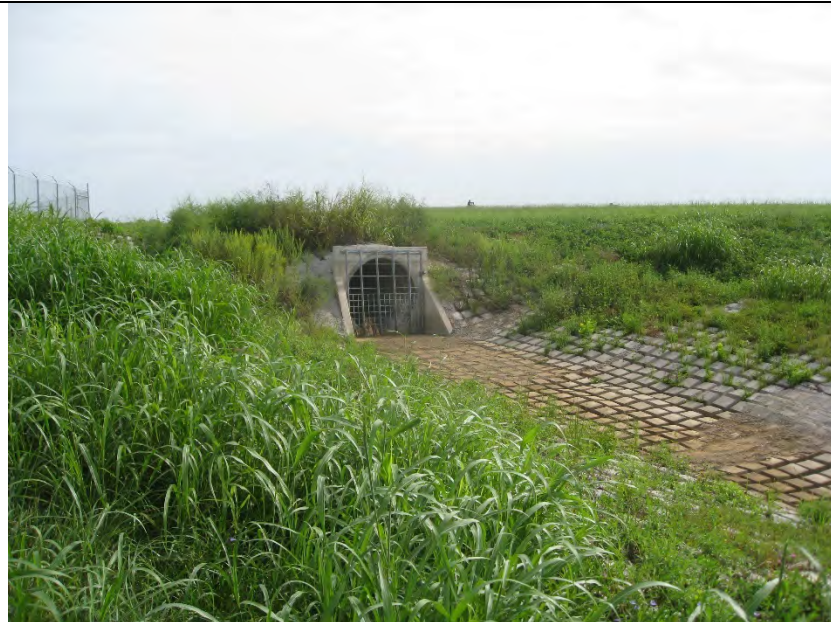
Photo 8
Sta. 117+00 (RT)
Project 2

78" culvert in the Guard Lateral Ditch.

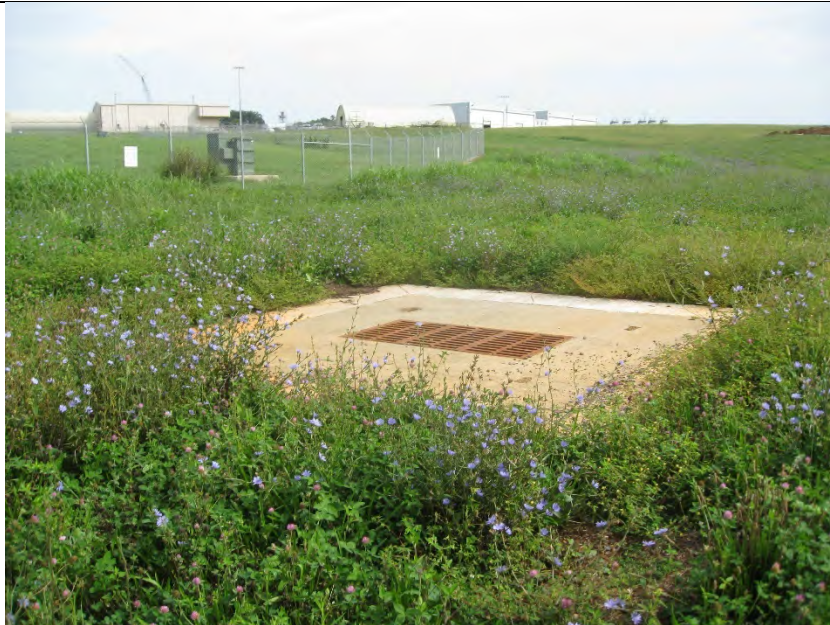
Photo 9
Sta. 287+21 LT
(RW 5L-23R)
Structure 124
Project 3

Structure 124.

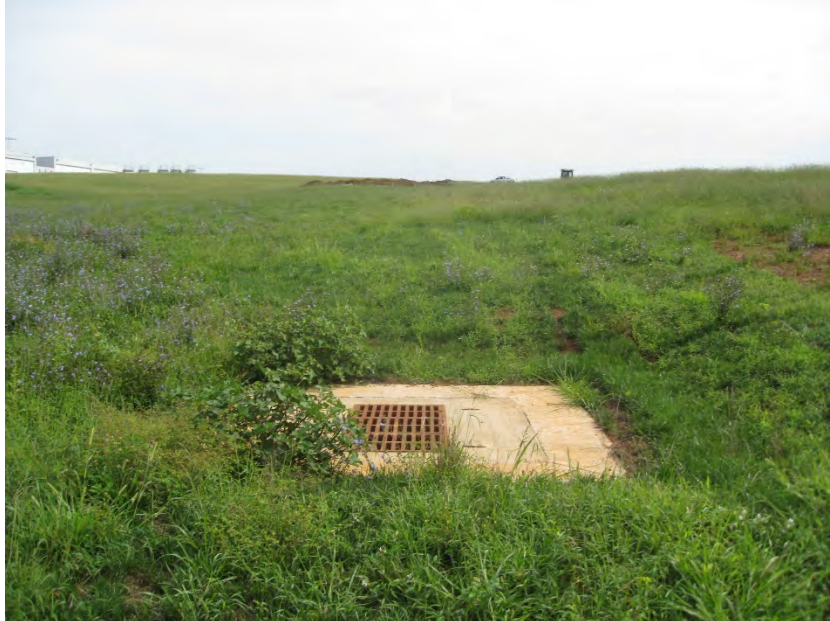
Photo 10
Sta. 289+13 LT
(RW 5L-23R)
Structure 122
Project 3

Structure 122.
Recommend stabilizing remaining bare areas.

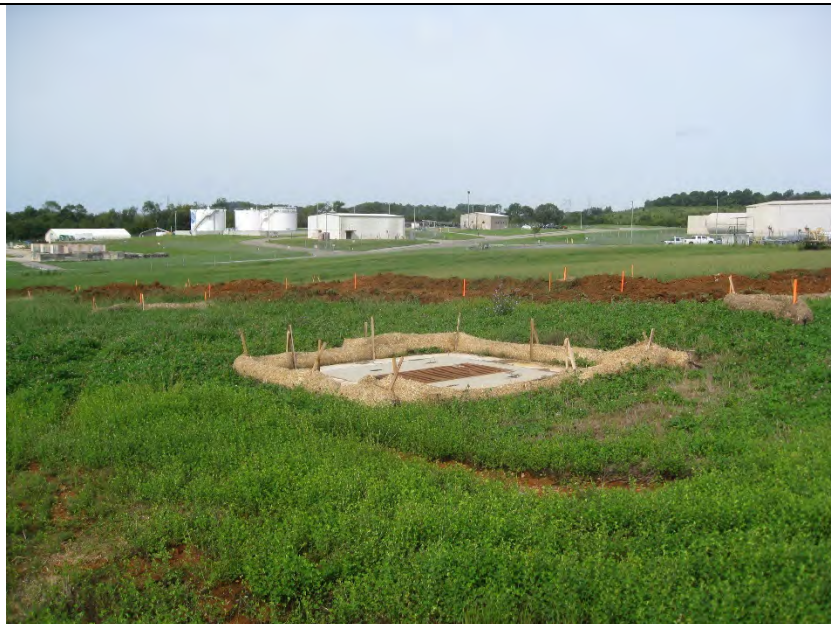
Photo 12
Sta. 294+31 LT
(RW 5L-23R)
Structure 118
Project 3

Structure 118. See Project 5/6 for additional information.

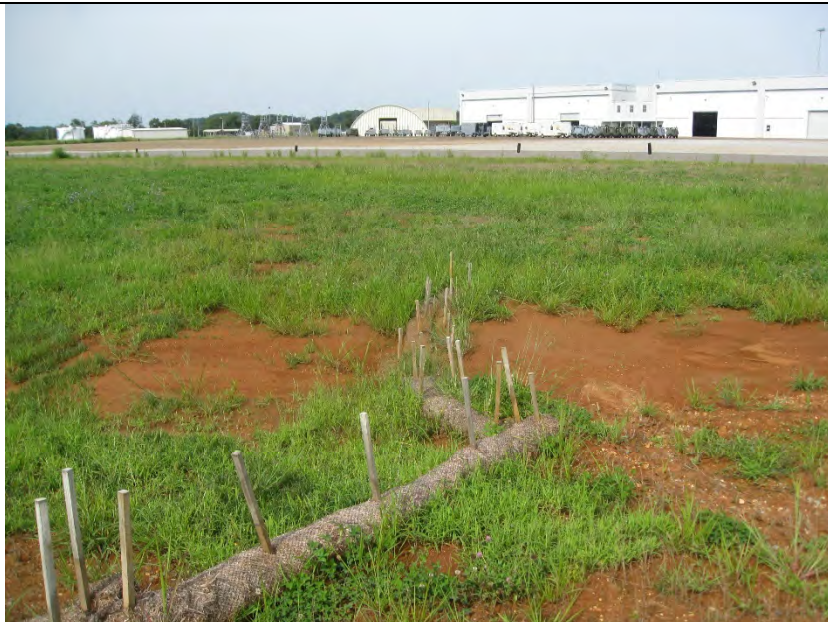
Photo 14
Sta. 298+71 LT
(RW 5L-23R)
Structure 116
Project 3

Above Structure 116.
Due to recent storm events, rills have started to form and sediment has accumulated in ditch line.
Recommend removing accumulated sediment. Recommend stabilizing remaining bare areas.

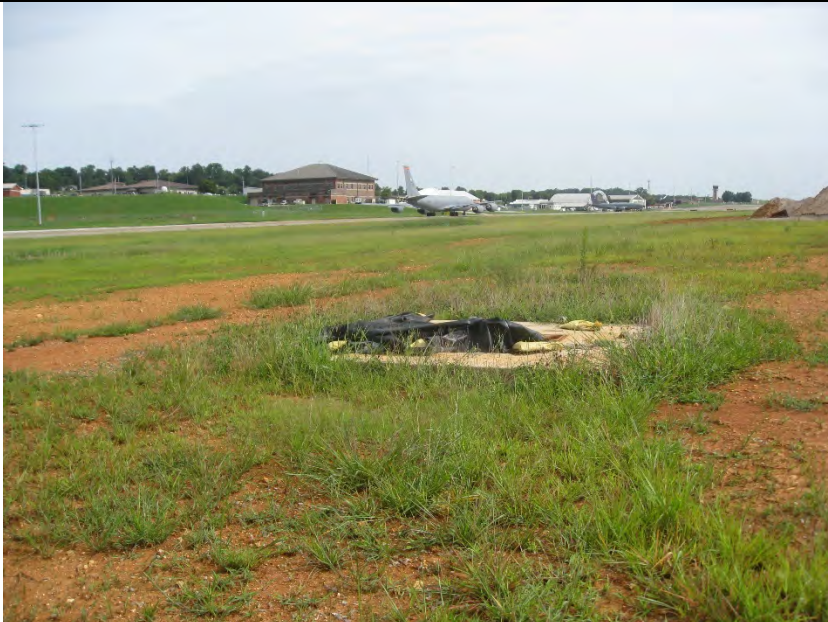
Photo 16
Sta. 302+54 LT
(RW 5L-23R)
Structure 114
Project 3

Structure 114.
Bare areas have been sprayed with hydroseeding and mulch; however, many areas remain bare and grass has not established. Coordinate with CHA on final stabilization options.

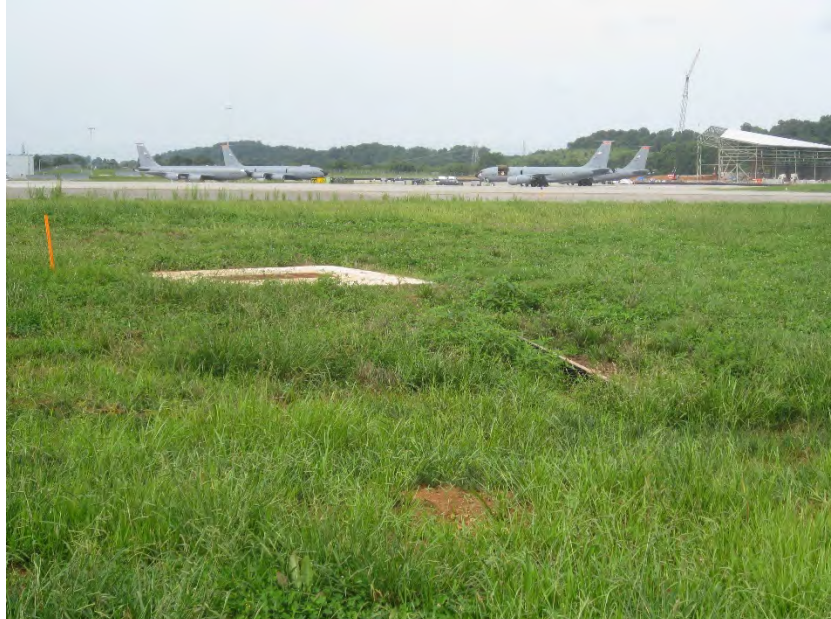
Photo 20
Sta. 314+48 LT
(RW 5L-23R)
ES Endwall 108
Project 3

Enhanced Swale Endwall 108.
Recommend repairing rills above endwall.

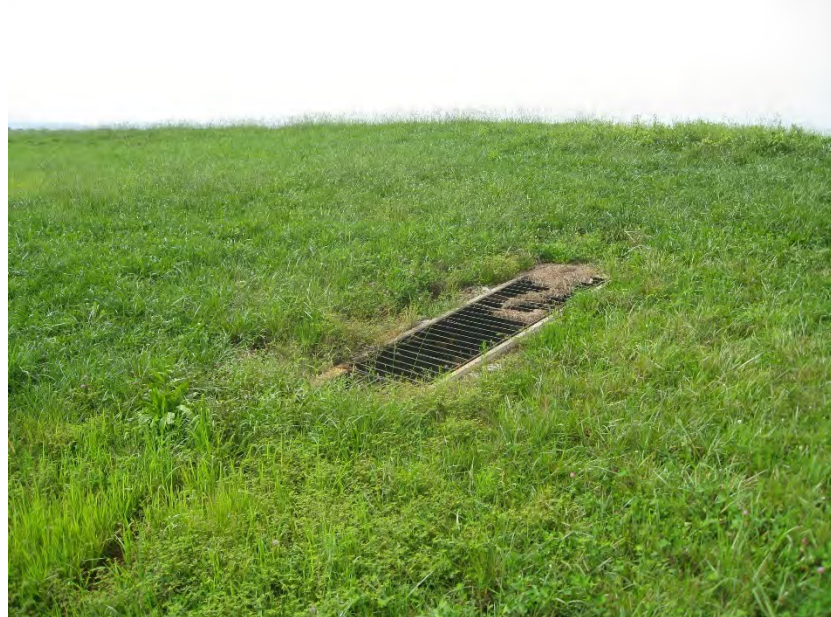
Photo 22
Sta. 324+86 LT
(RW 5L-23R)
ES Endwall 106
Project 3

Enhanced Swale Endwall 106.

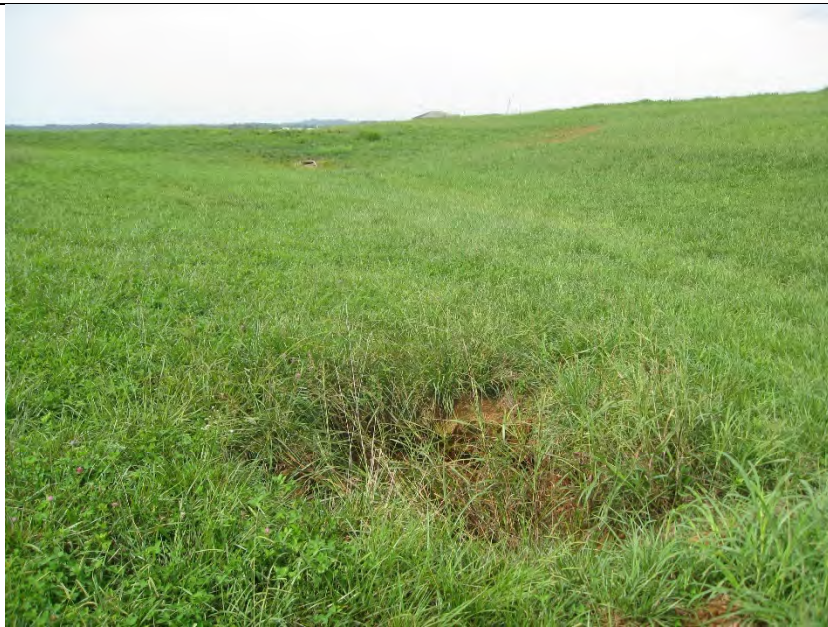
Photo 27
Sta. 341+50 LT
(RW 5L-23R)
Between ES Endwall 104 and 102
Project 3

Second construction fallout on Storm Line 1 between ES Endwall 104 and 102.
Coordinate remediation with CHA.

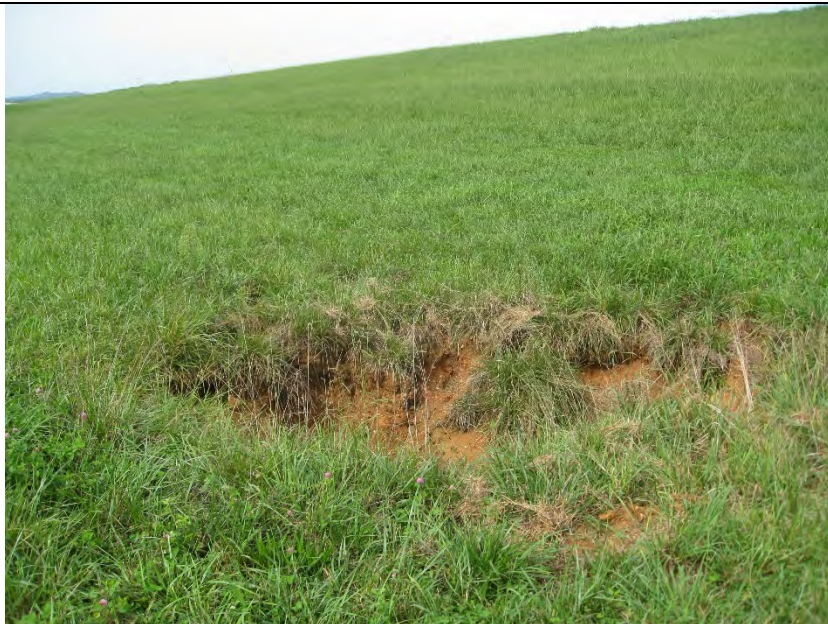
Photo 28
Sta. 341+50 LT
(RW 5L-23R)
Between ES Endwall 104 and 102
Project 3

Third construction fallout on Storm Line 1 between ES Endwall 104 and 102.
Coordinate remediation with CHA.

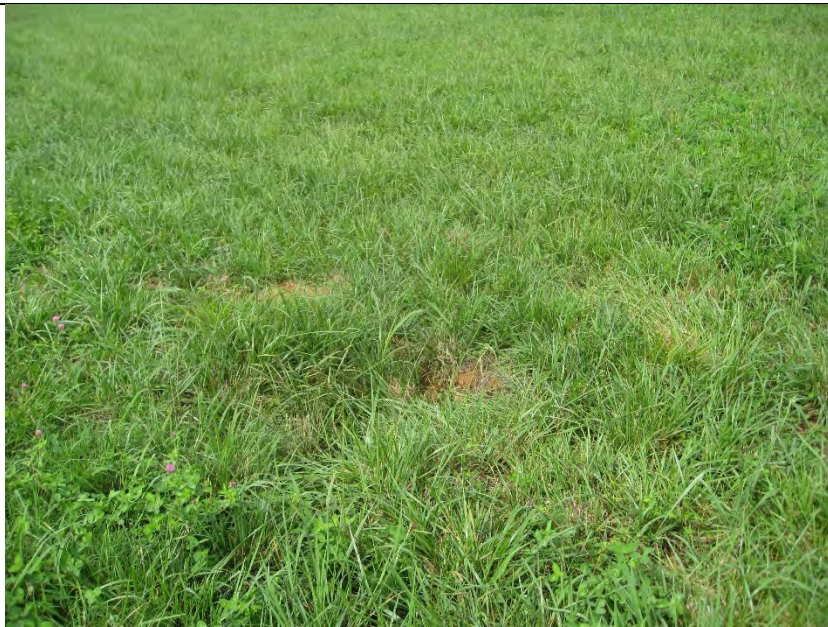
Photo 29
Sta. 341+50 LT
(RW 5L-23R)
Between ES Endwall 104 and 102
Project 3

Fourth construction fallout on Storm Line 1 between ES Endwall 104 and 102.
Coordinate remediation with CHA.

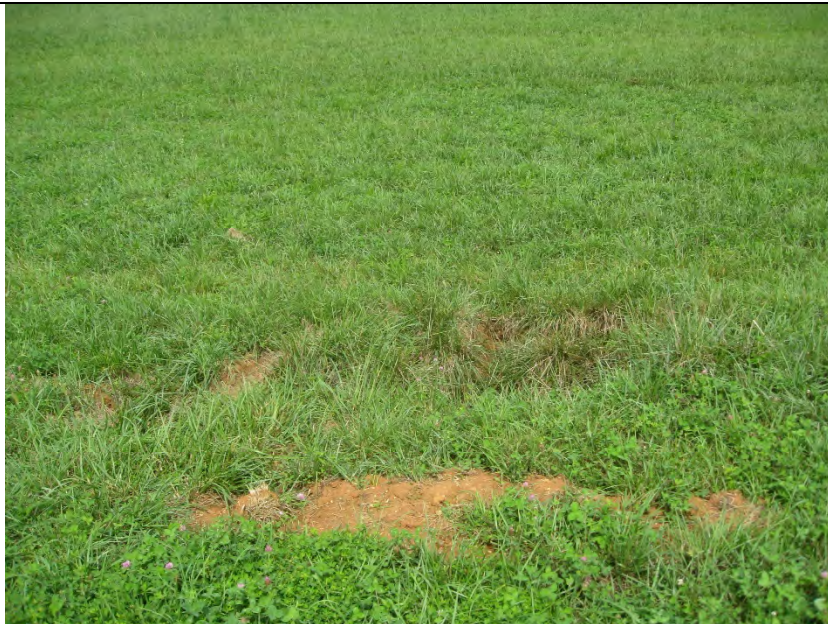
Photo 30
Sta. 341+50 LT
(RW 5L-23R)
Between ES Endwall 104 and 102
Project 3

Fifth construction fallout on Storm Line 1 between ES Endwall 104 and 102.
Coordinate remediation with CHA.

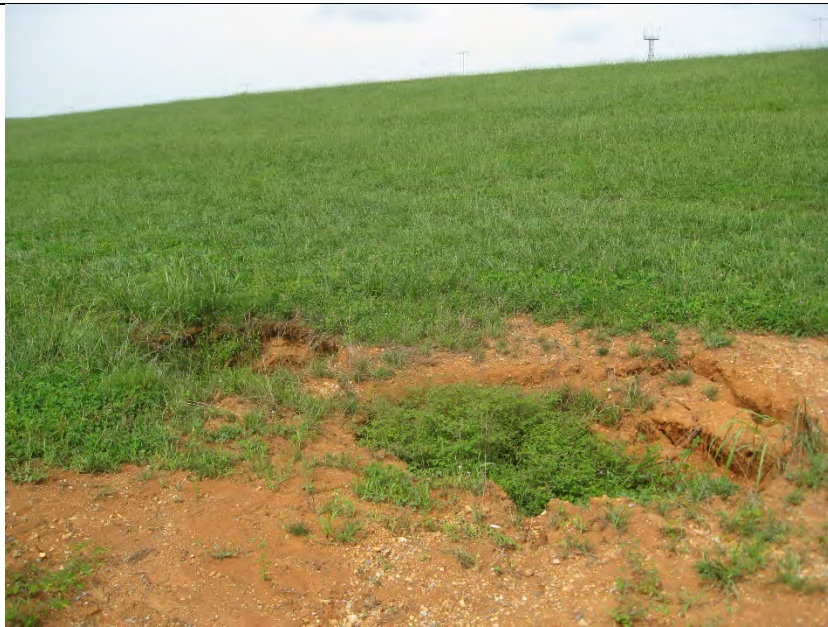
Photo 31
Sta. 341+50 LT
(RW 5L-23R)
Between ES Endwall 104 and 102
Project 3

Sixth construction fallout on Storm Line 1 between ES Endwall 104 and 102.
Coordinate remediation with CHA.

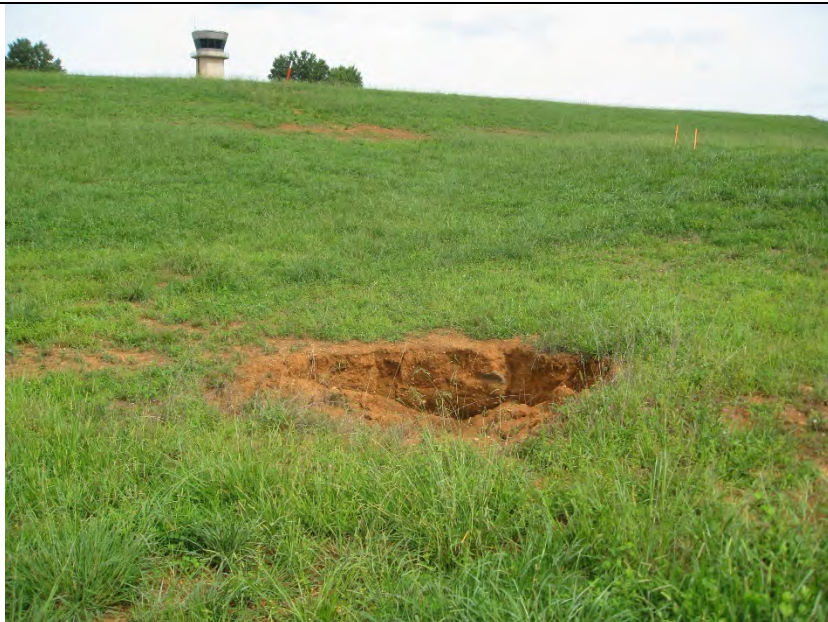
Photo 32
Sta. 341+50 LT
(RW 5L-23R)
Between ES Endwall 104 and 102
Project 3

Seventh construction fallout on Storm Line 1 between ES Endwall 104 and 102.
Coordinate remediation with CHA.

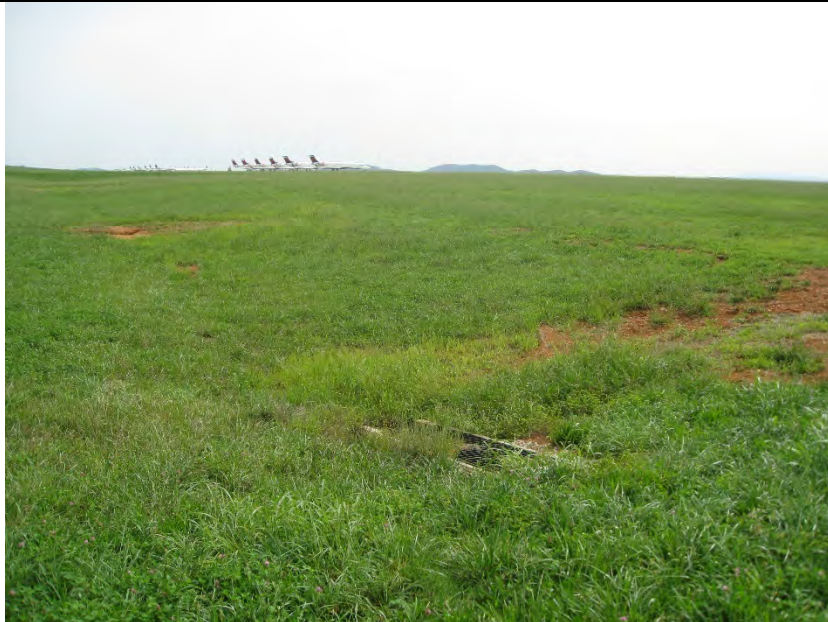
Photo 34
Sta. 347+31 LT
(RW 5L-23R)
ES Endwall 102
Project 3

Enhanced Swale Endwall 102.
Recommend stabilizing remaining bare areas.

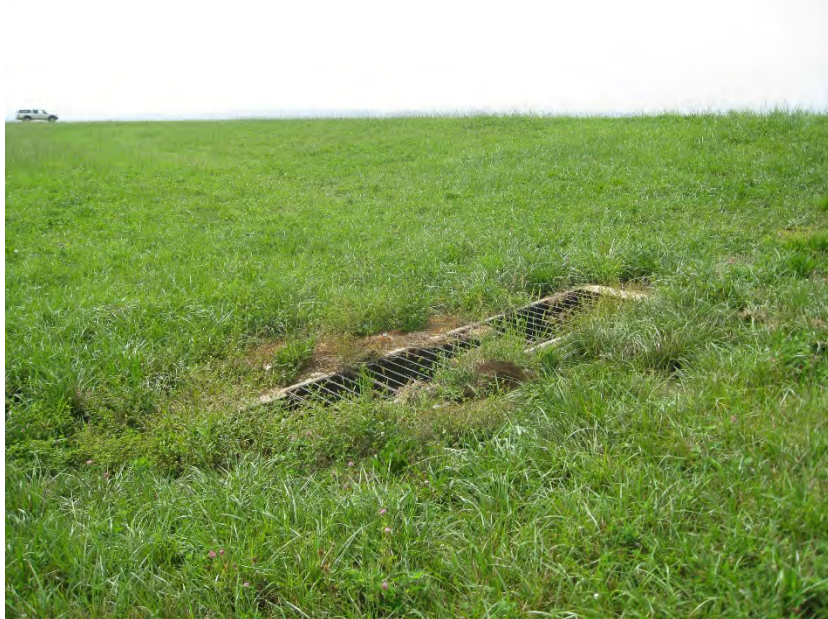
Photo 36
Sta. 354+75 LT
(RW 5L-23R)
ES Endwall 100
Project 2

Enhanced Swale Endwall 100.

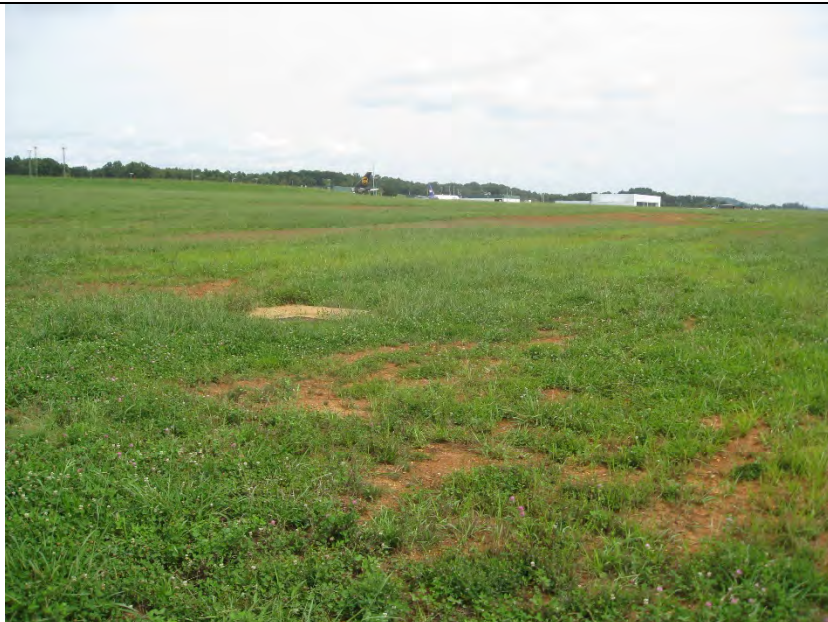
Photo 40
Sta. 366+25 LT
(RW 5L-23R)
Existing Structure
Project 2

Existing Structure.
Recommend stabilizing bare areas.

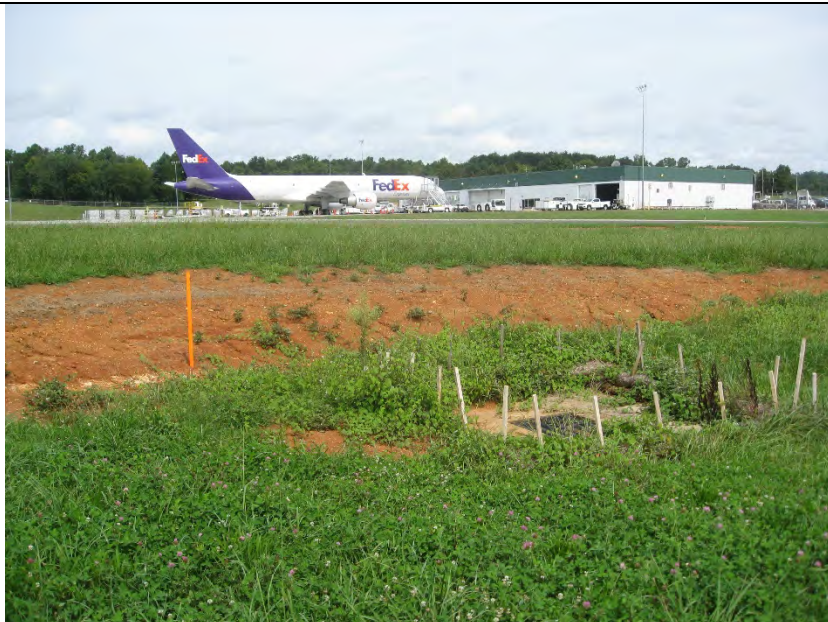
Photo 42
Sta. 677+00 RT
(RW 5L-23R)
Existing Structure
Project 4

Structure south of Taxiway "G".
Slopes continue to rill and deposit sediment at the structure.
Recommend repairing rills and replacing sediment tubes.
Recommend stabilizing bare areas.

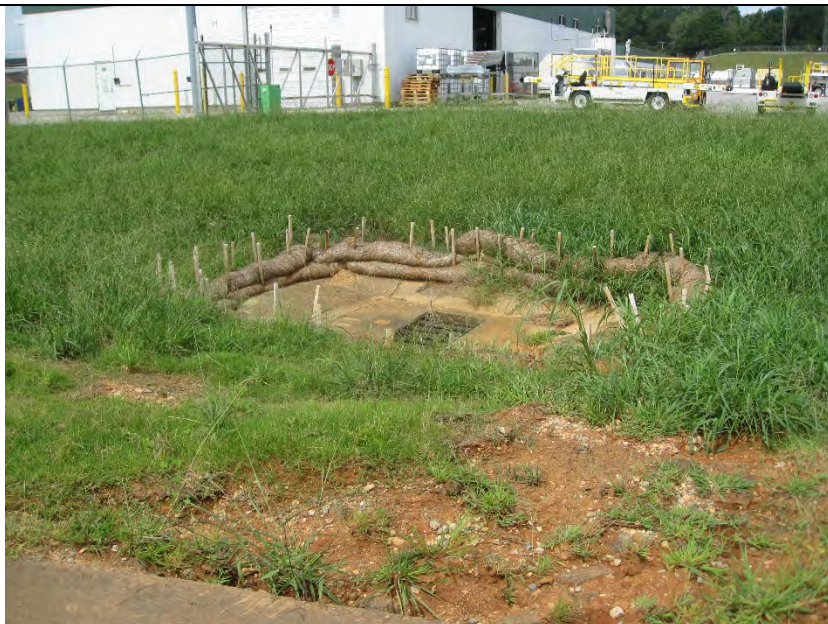
Photo 44
Sta. 677+00 RT
(RW 5L-23R)
Project 4

Structure between Taxiway G and UPS Facility.

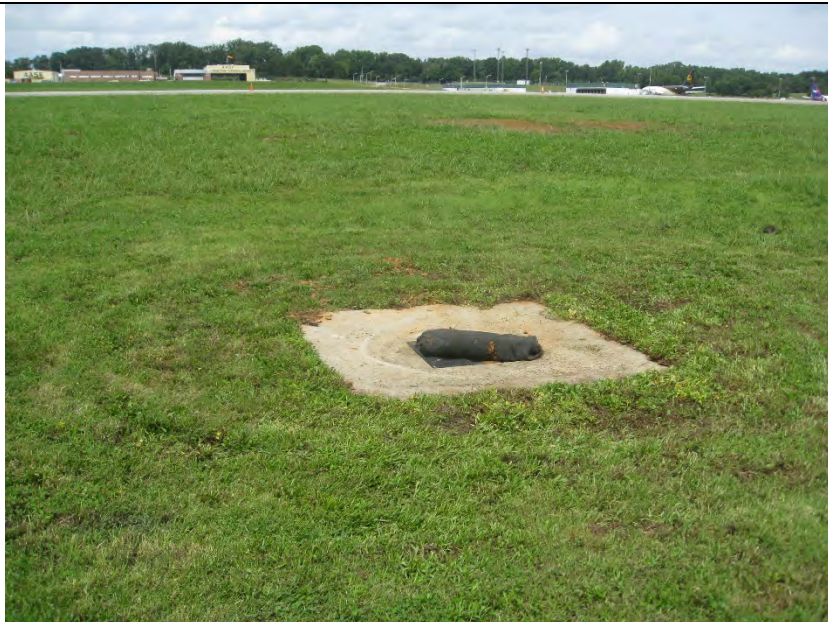
Photo 48
Sta. 366+89 RT
(RW 5L-23R)
Existing Structure
Project 4

Existing Structure adjacent to Outfall C.

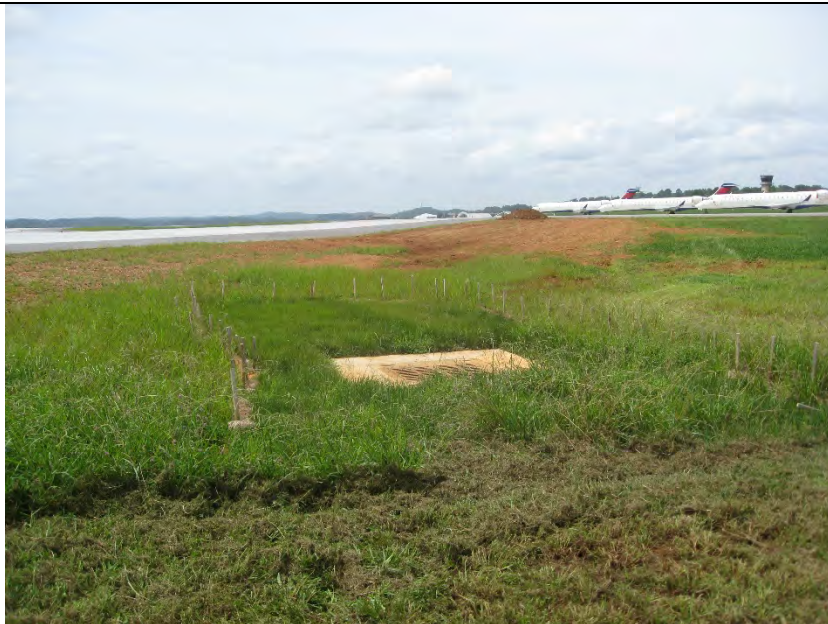
Photo 50
Sta. 365+69 RT
(RW 5L-23R)
Structure 300
Project 4

Structure 300

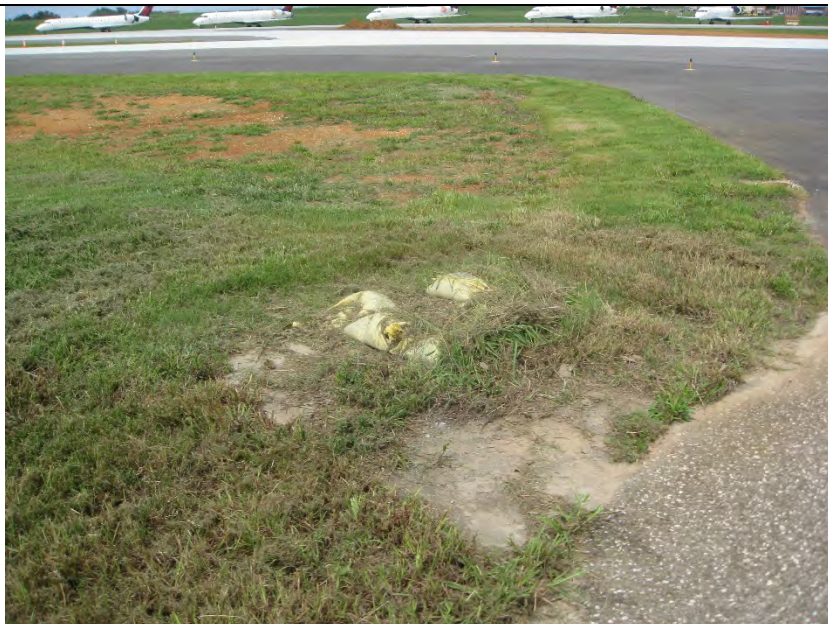
Photo 52
(RW 5L-23R)
TWY Y Tie-in
Project 4

Existing structure south of Taxiway Y.
Recommend removing inlet protection.

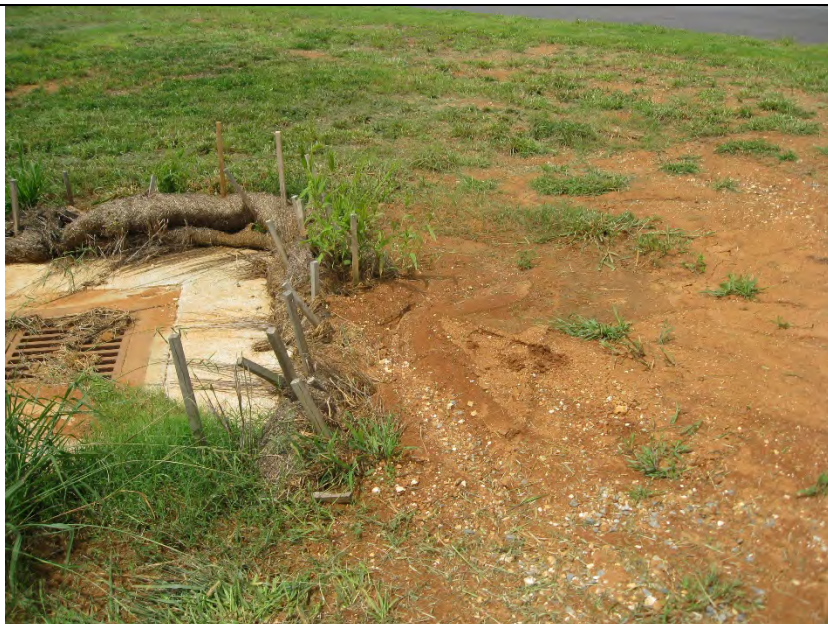
Photo 54
Sta. 362+02 LT
(RW 5L-23R)
Structure 400
Project 4

Structure 400.
Recommend stabilizing remaining bare areas.

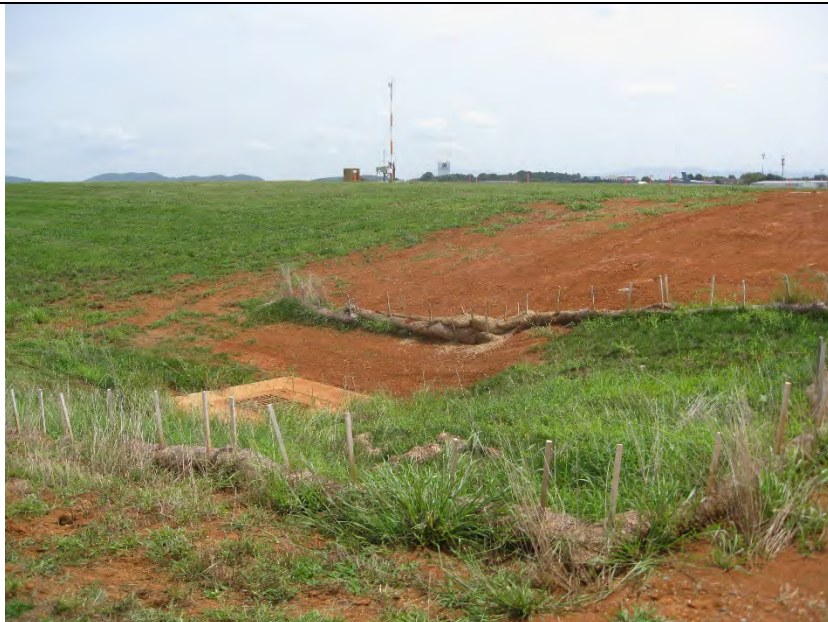
Photo 56
Sta. 347+26 RT
(RW 5L-23R)
Structure 22
Project 4

Structure 22.
Sediment recently removed from top structure.
If unable to immediately stabilize, recommend adding sediment tubes.
Recommend stabilizing bare areas.

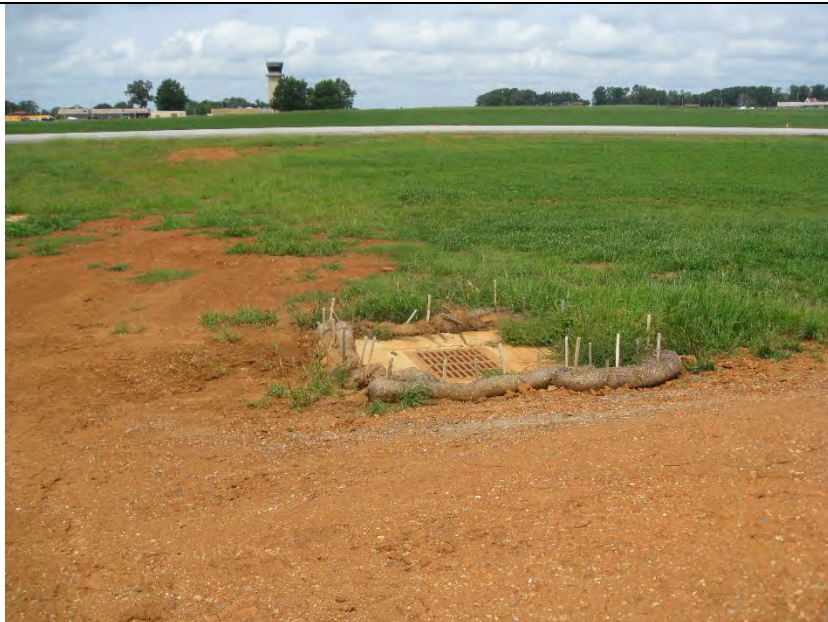
Photo 58
Sta. 347+26 RT
(RW 5L-23R)
Structure 202
Project 4

Structure 202.
Area recently regraded.
Recommend stabilizing bare areas.

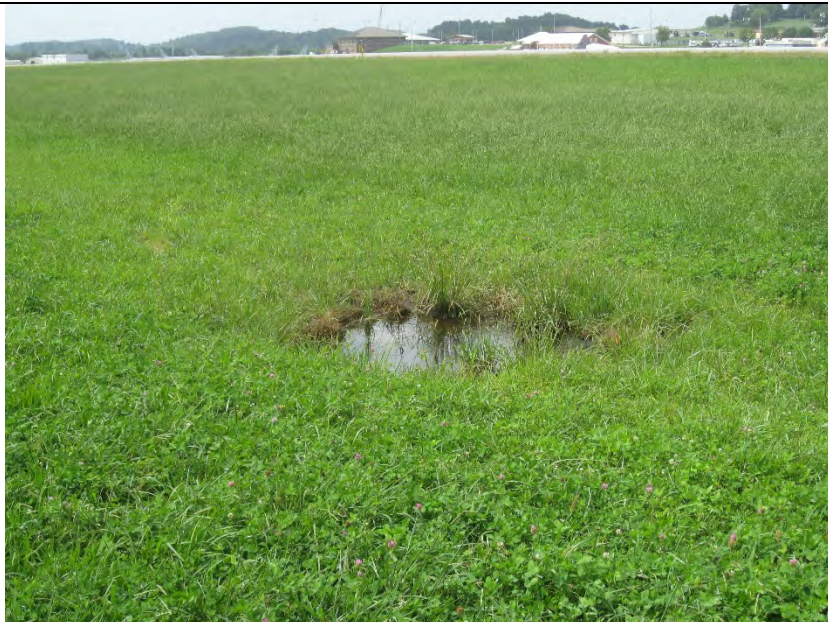
Photo 59
Sta. 341+86 RT
(RW 5L-23R)
Structure 204
Project 4

Structure 204.

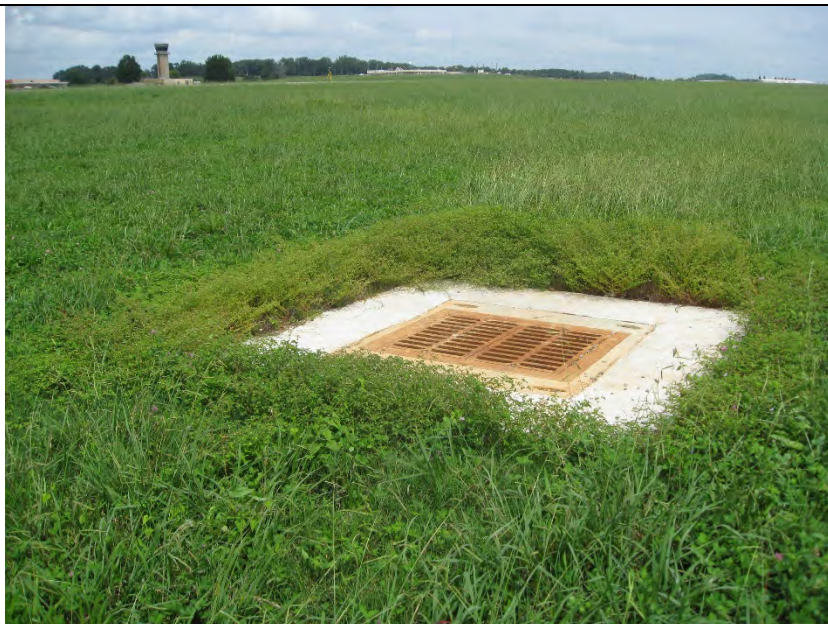
Photo 63
(RW 5L-23R)
Project 4

Construction fallout on Storm Line 2 between structures 206 and 208.
Recommend coordinating remediation with CHA.

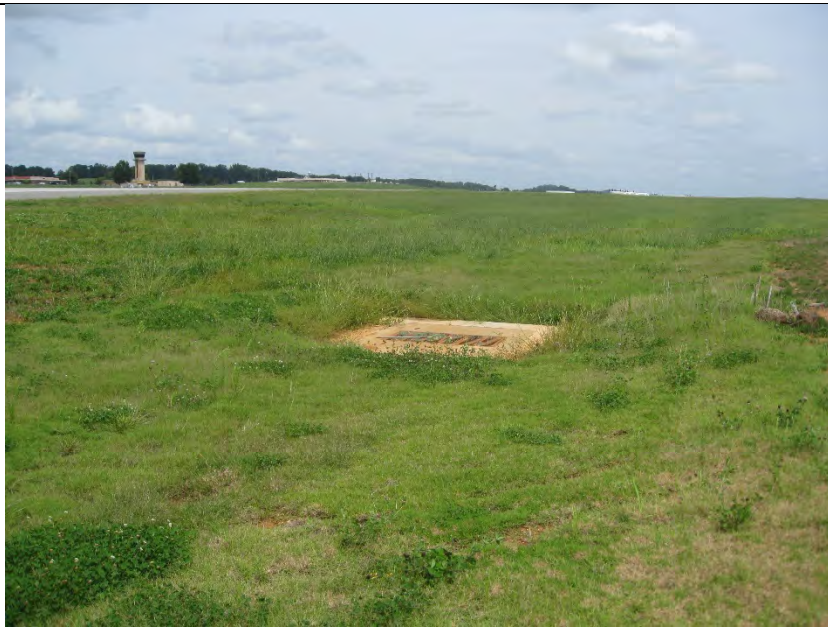
Photo 64
Sta. 338+02 RT
(RW 5L-23R)
Structure 208
Project 4

Structure 208.

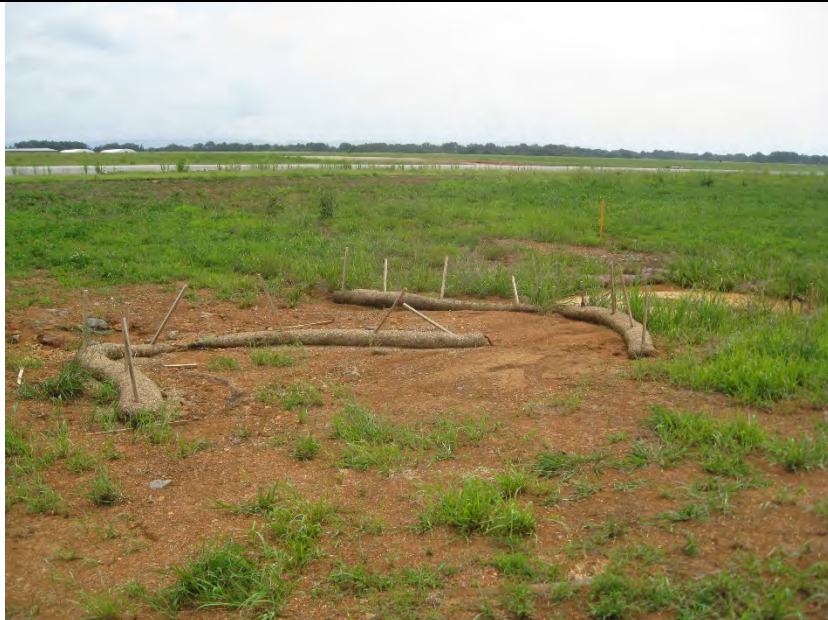
Photo 65
Sta. 329+86 RT
(RW 5L-23R)
Structure 210
Project 3

Structure 210.

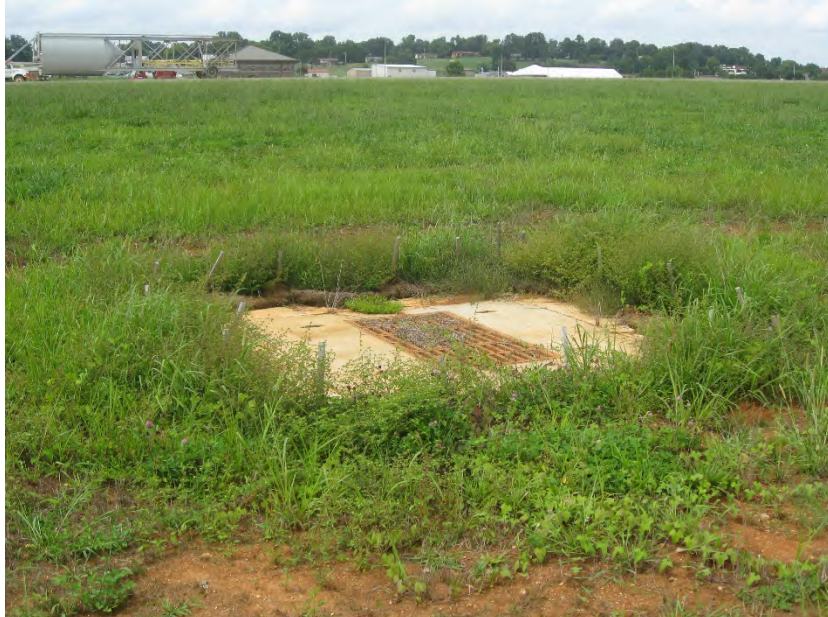
Photo 67
Sta. 314+32 RT
(RW 5L-23R)
Structure 214
Project 3

Structure 214.

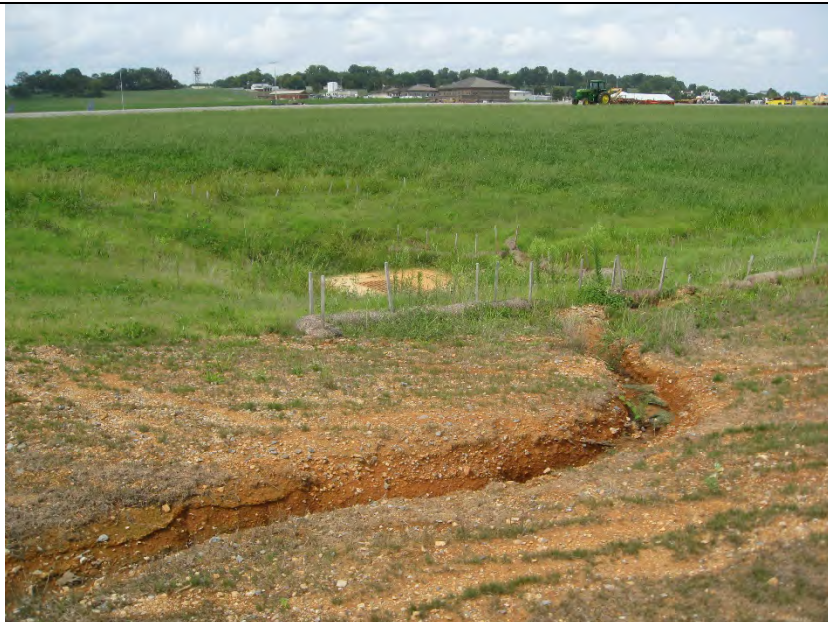
Photo 69
Sta. 301+87 RT
(RW 5L-23R)
Structure 218
Project 3

Structure 218.
Recommend stabilizing remaining bare areas and repairing rill above structure (see photo below).

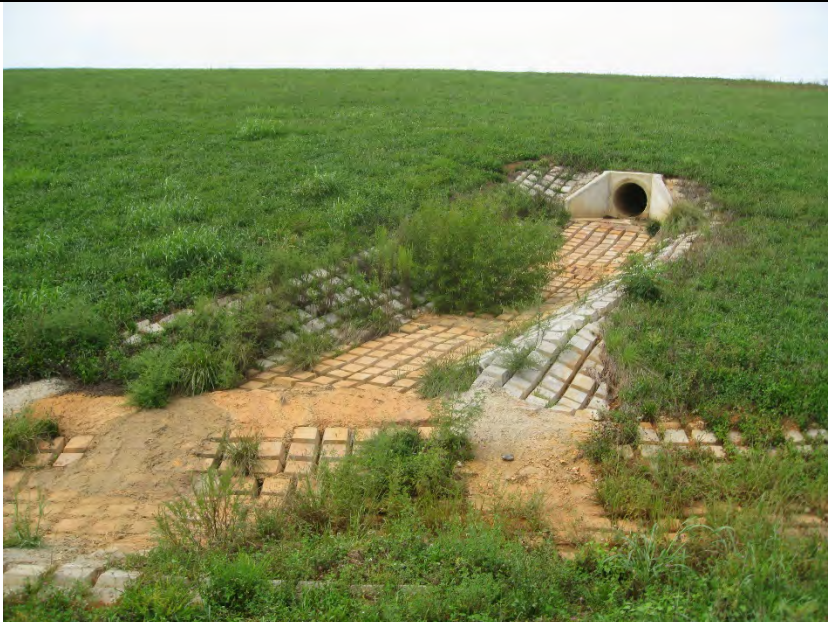
Photo 71
Sta. 296+83 RT
(RW 5L-23R)
Structure 220
Project 2

Structure 220.
Recommend stabilizing remaining bare areas.

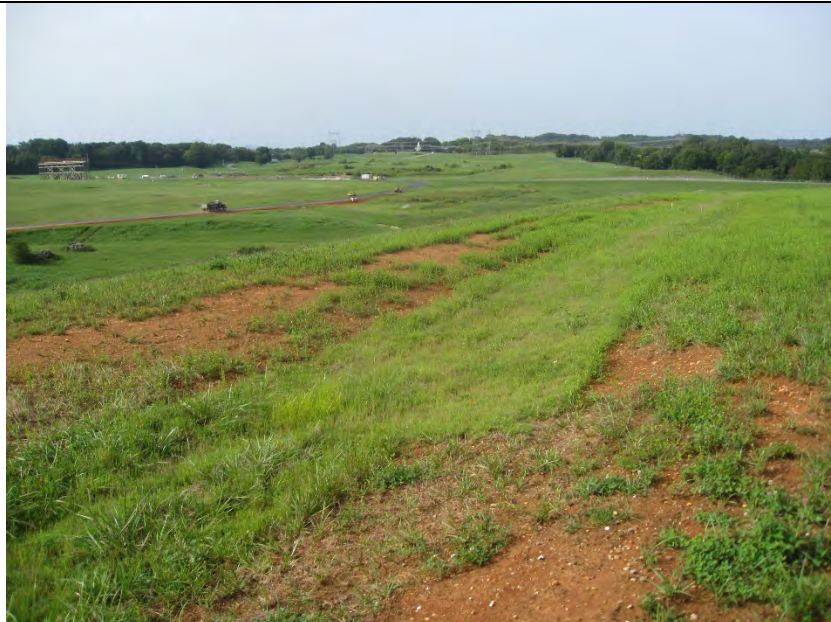
Photo 73
Sta. 288+26
(RW 5L-23R)
Structure 224
Project 2

Below structure 224.
Side slope has eroded causing damage to the articulated concrete block.
CHA, Harper and KMAA were already aware of the issue as discussed in a progress meeting dated 07/16/2020.

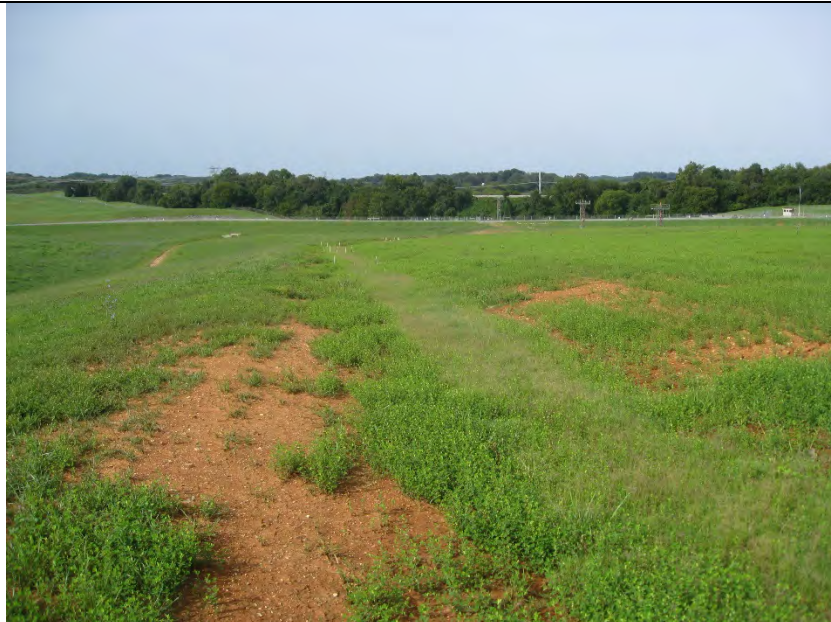
Photo 75
Sta. 290+26 RT
(RW 5L-23R)
Structure 222
Project 2

Structure 222.
Recommend removing inlet protection.
Recommend stabilizing bare areas.

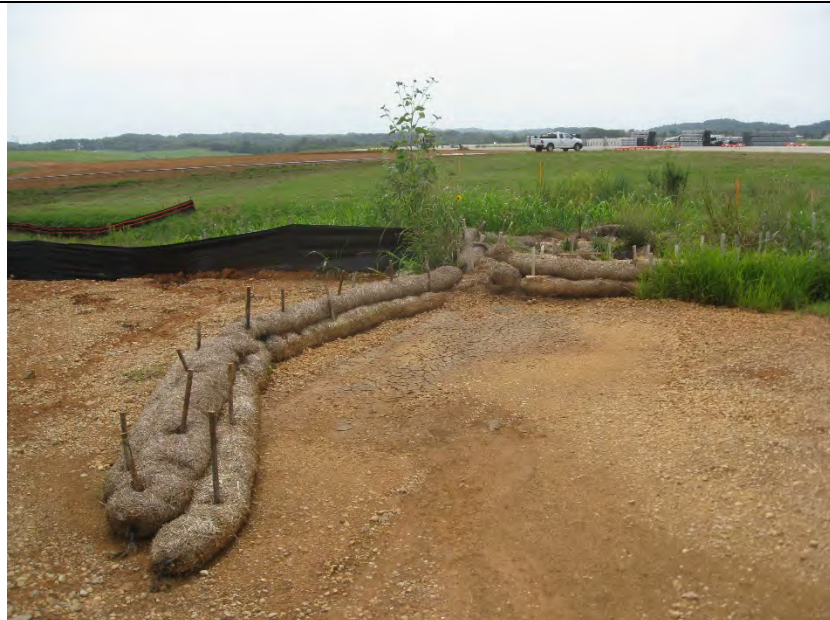
Photo 77
Sta. 284+59
(RW 5L-23R)
Structure 600
Project 3

Structure 600.
Sediment recently removed and sediment tubes repaired.

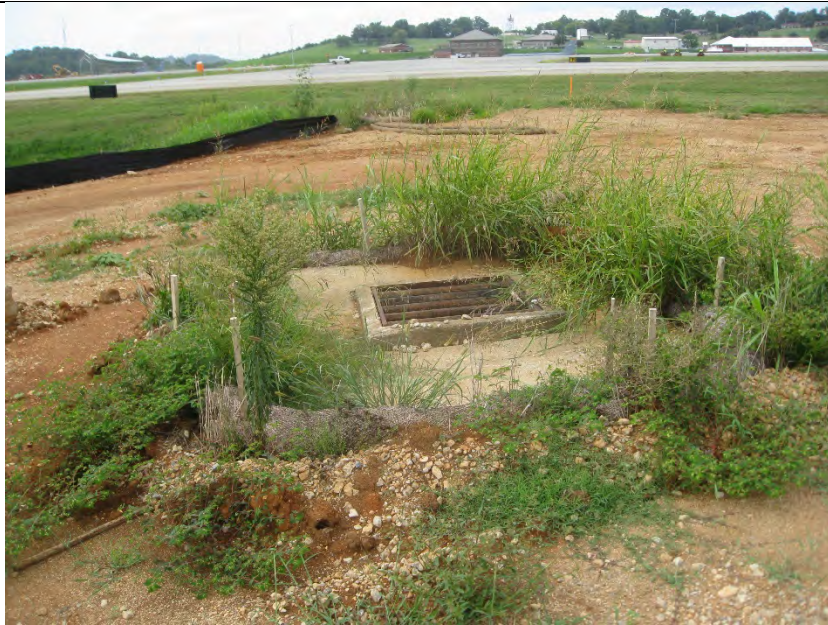
Photo 78
(RW 5L-23R)
Project 3

Existing structure adjacent to crushing operations.
Rills have started to form adjacent to existing structure.

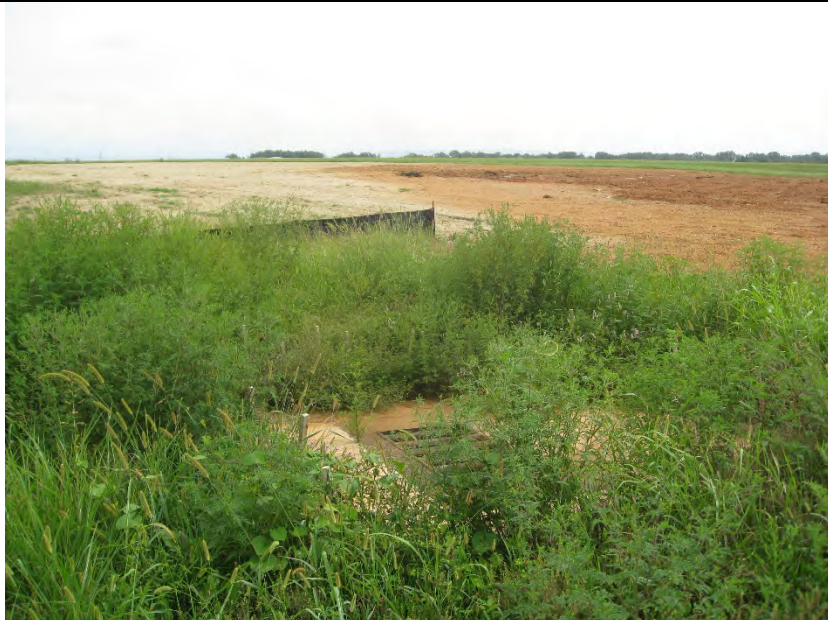
Photo 79
(RW 5L-23R)
Project 3

Existing structure at stone stockpile area.

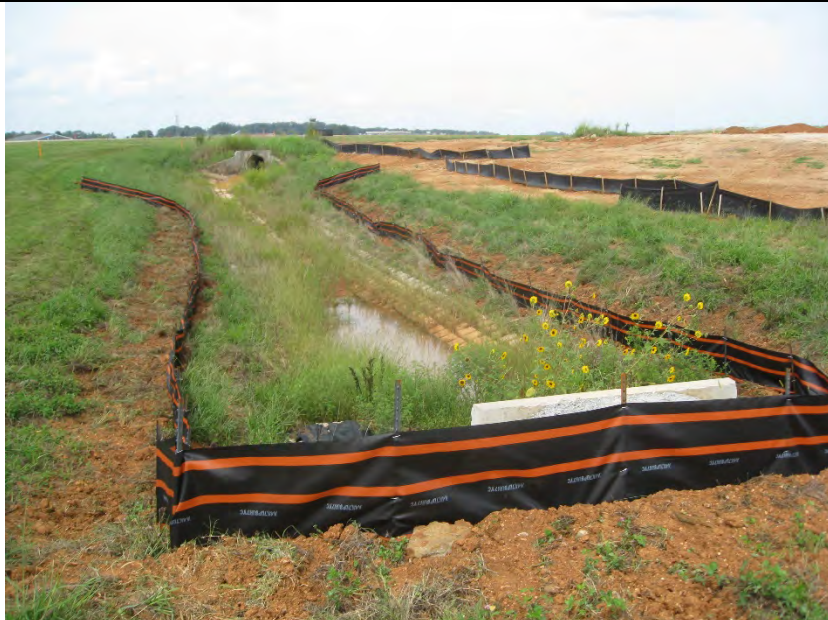
Photo 81
(RW 5L-23R)
Project 3

Silt fence above North Lateral Ditch at stone stockpile area.
Silt fence continues to erode during storm events.
Recommend repairing silt fence.
