**QUALITY ASSURANCE
MONTHLY SITE
ASSESSMENT REPORT**

Airfield Modernization Program
Runway 5L-23R Reconstruction
Project 2 / Project 3
Project 4 / Repair TWY Lighting
Project 5 / Project 6

QUALITY ASSURANCE SITE ASSESSMENT

AIRFIELD MODERNIZATION PROGRAM RUNWAY 5L-23R RECONSTRUCTION

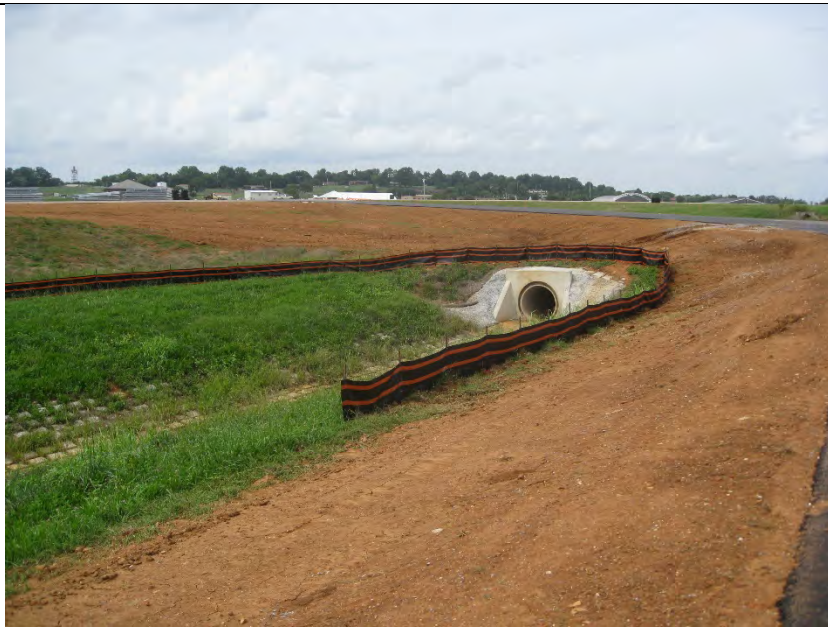
Photo 82
Sta. 39+00 CL
Proposed Haul Route
Project 3

Inlet side of 54" haul route crossing culvert.
Silt fence installed for Project 5/6 (see additional photos).

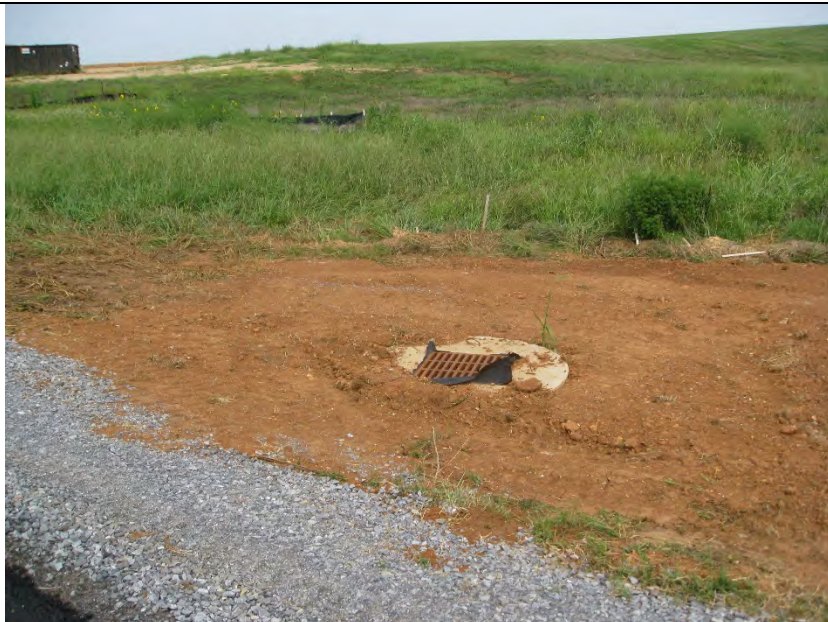
Photo 83
Sta. 39+00 CL
Proposed Haul Route
Project 3

Outlet side of 54" haul route crossing culvert.
Silt fence installed for Project 5/6 (see additional photos).

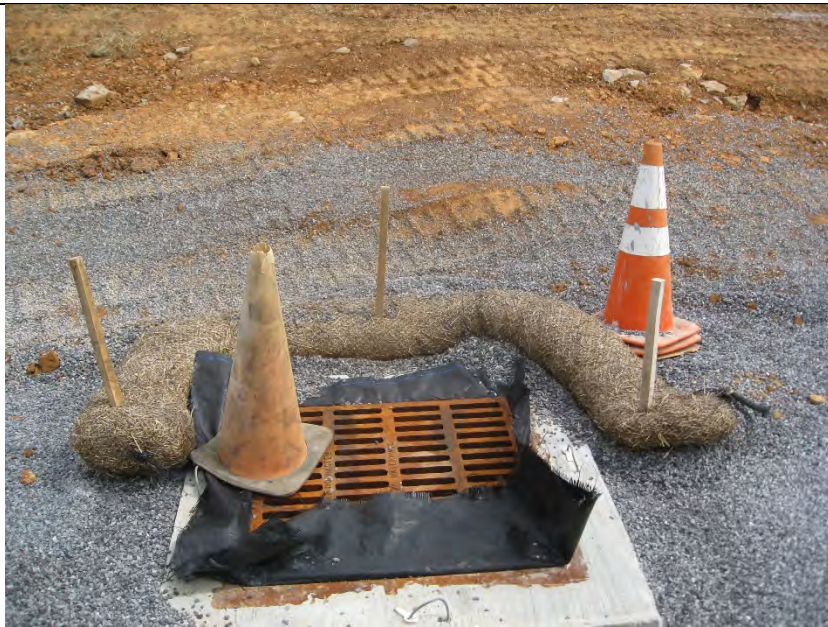
Photo 84
Sta. 37+25 RT
Proposed Haul Route
Project 3

Inlet structure along haul road.

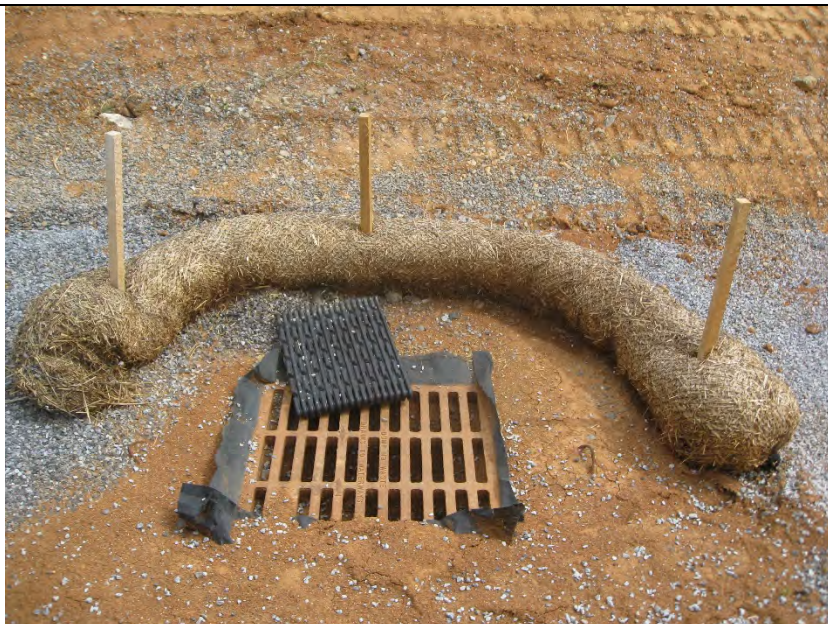
Photo 85
Sta. 37+25 RT
Proposed Haul Route
Project 3

New storm structure installed along haul road.

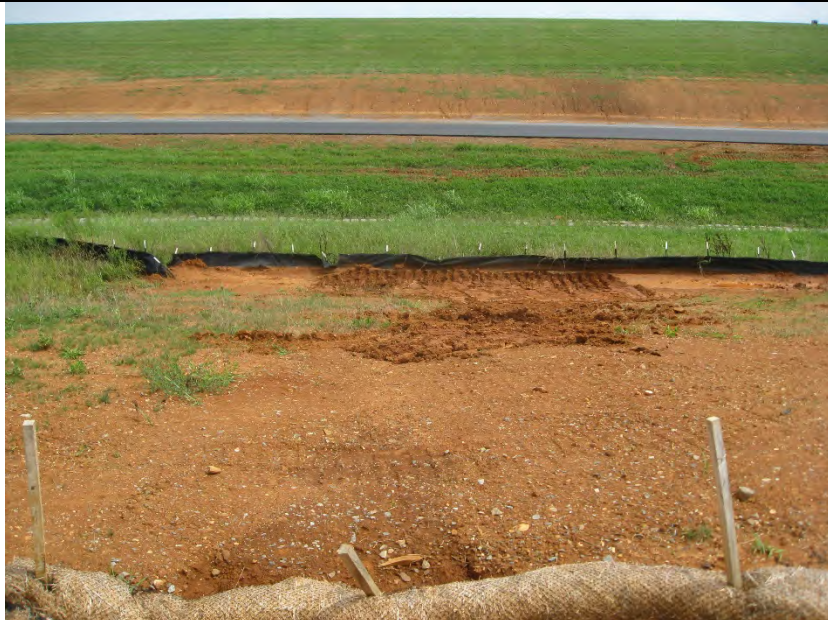
Photo 87
Sta. 32+50 RT
Proposed Haul Route
Project 3

Haul Route recently paved.
Recommend stabilizing slope as soon as practical.

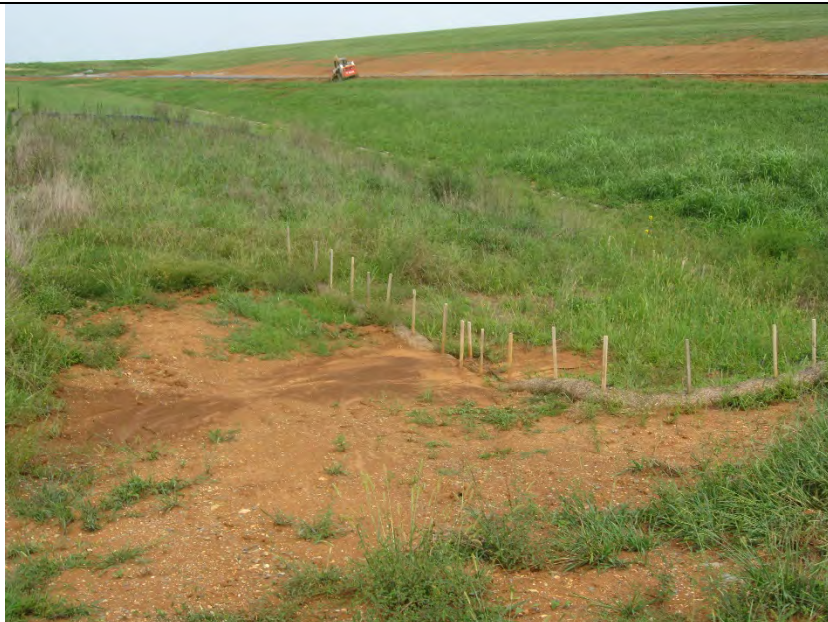
Photo 89
Sta. 302+54
(RW 5L-23R)
Project 2

Above North Lateral Endwall 100.
Sediment recently removed.
Recommend stabilizing bare areas.

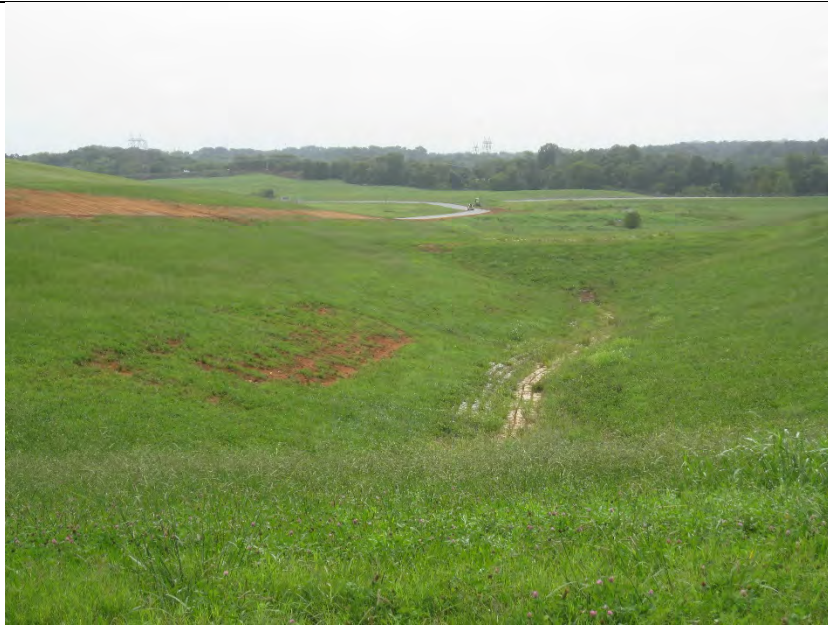
Photo 92
Sta. 302+54 to Sta. 313+50
(RW 5L-23R)
Project 2

North Lateral Endwall 100.
Recommend stabilizing bare areas.

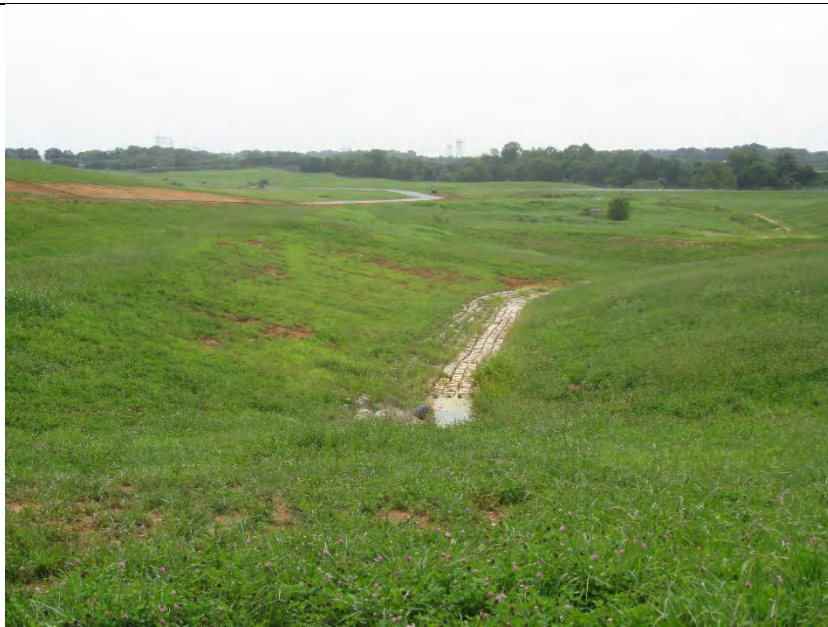
Photo 96
Sta. 297+01
(RW 5L-23R)
Project 2

North Lateral Endwall 104.

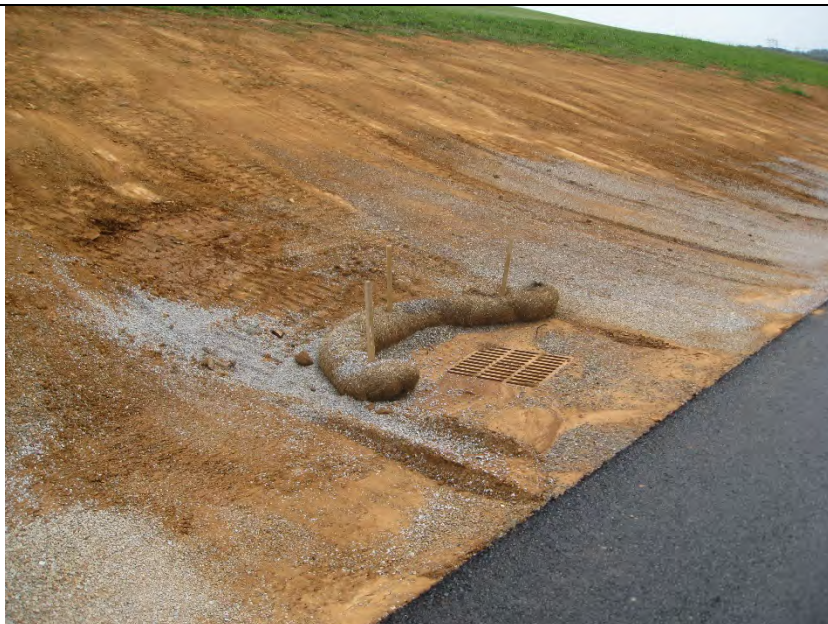
Photo 97
Sta. 295+10
(RW 5L-23R)
Project 2

North Lateral Endwall 106.

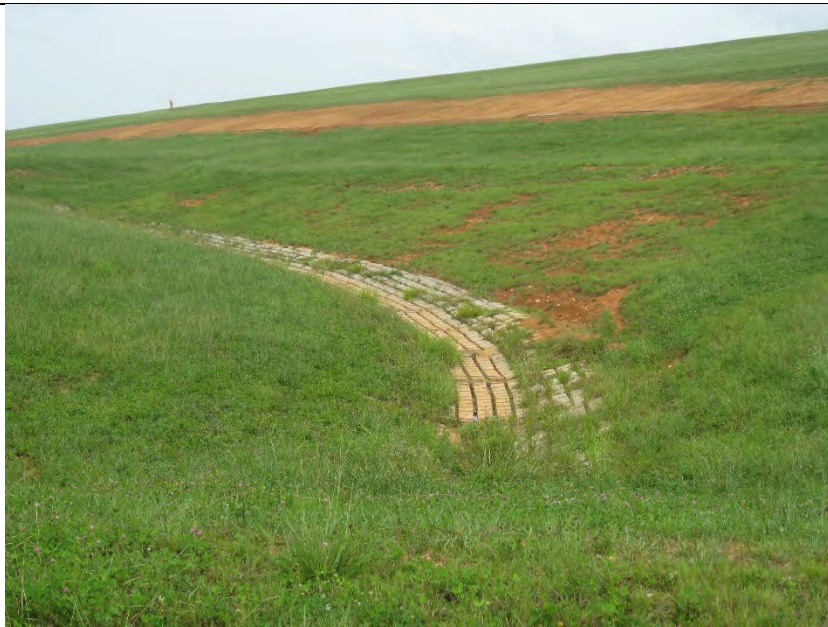
Photo 98
Sta. 22+00 RT
Proposed Haul Route
Project 3

Inlet structure along haul road.
Underdrain/French drain recently installed and slope regraded.
Recommend stabilizing slope as soon as practical.

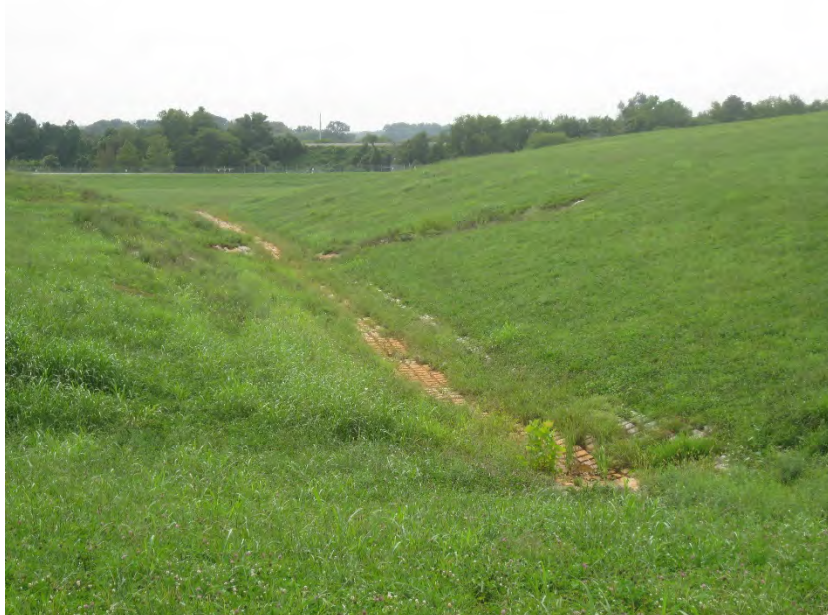
Photo 99
Sta. 292+08
(RW 5L-23R)
Project 2

North Lateral Endwall 108.

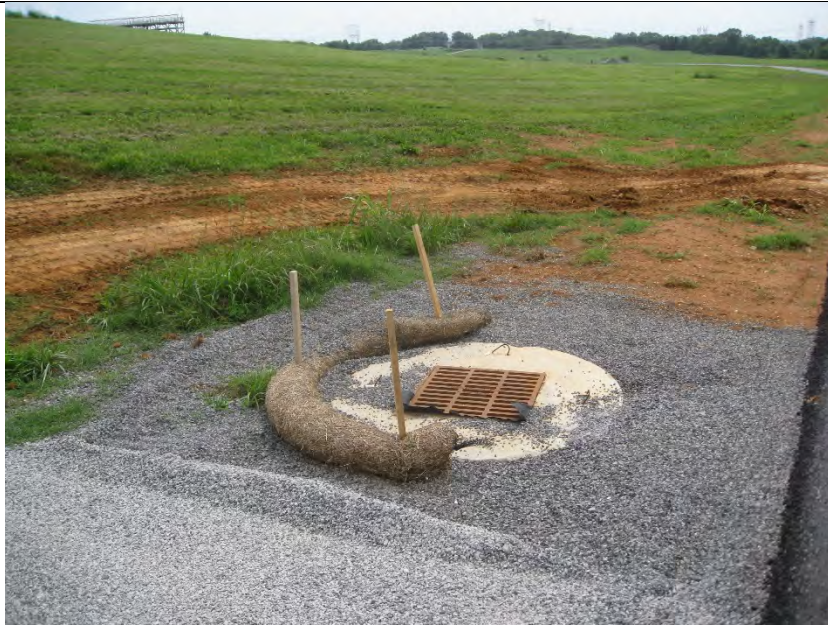
Photo 100
Sta. 290+50 LT
(RW 5L-23R)
Project 2

North Lateral Endwall 110.

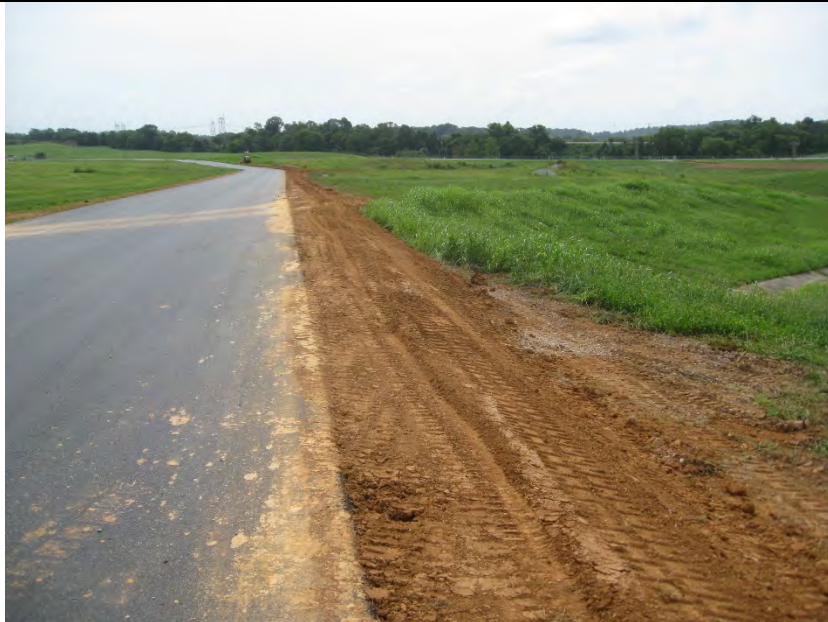
Photo 101
Sta. 15+50 RT
Proposed Haul Route
Project 3

Inlet structure along haul road.
Underdrain/French drain recently installed and slope regraded.
Recommend stabilizing slope as soon as practical.

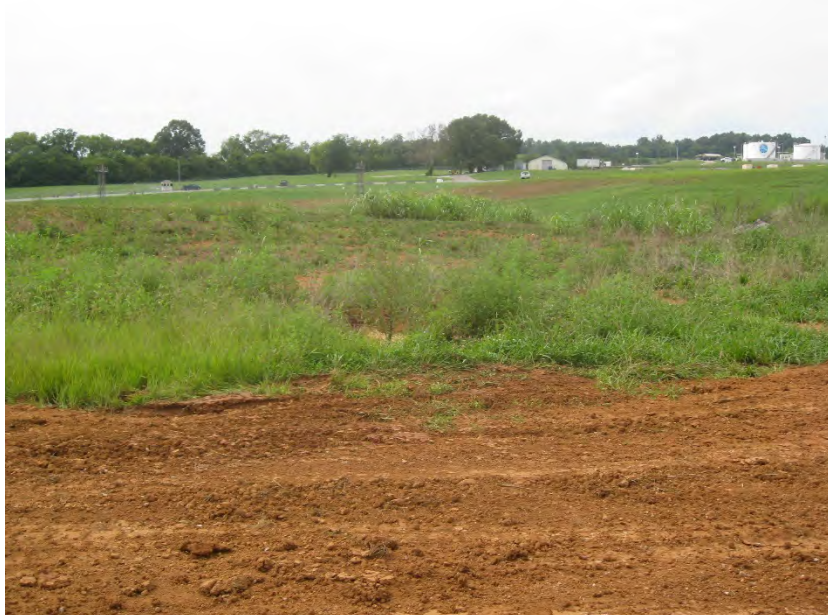
Photo 103
Sta. 284+00 LT
(RW 5L-23R)
Project 2

Existing vault at old Liberty street.
Construction fallout present. Recommend coordinating with CHA on remediation.

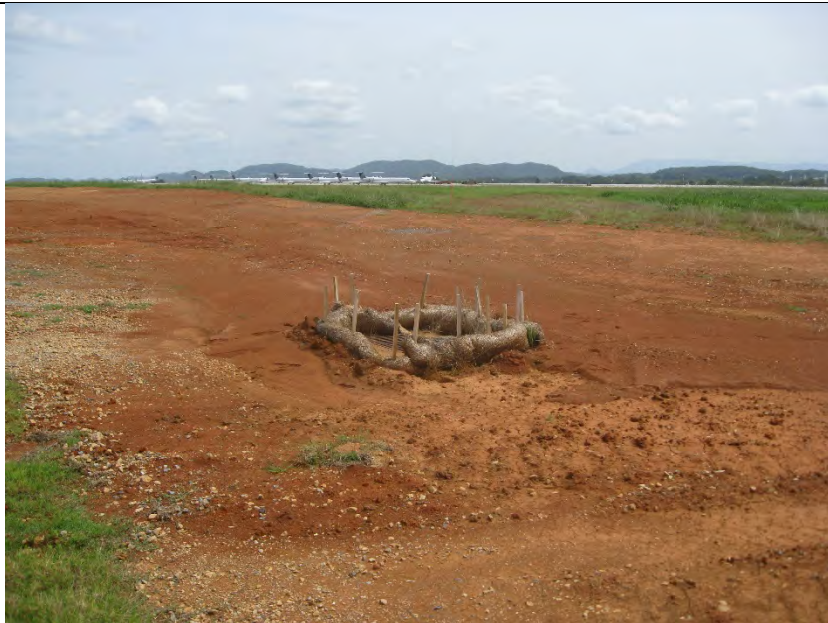
Photo 105
(Repair TWY Lighting)

Fill area adjacent to Liberty Street.
Grading operations have moved towards ditch line.
Recommend monitoring for sediment movement.

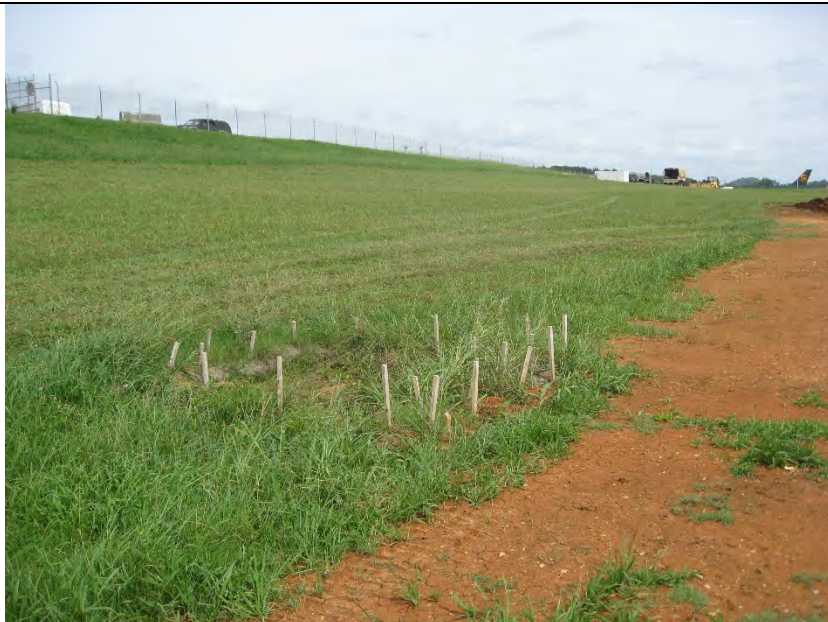
Photo 107
(Repair TWY Lighting)
Existing Structure

Existing structure south of Taxiway G.
Recommend stabilizing bare areas.

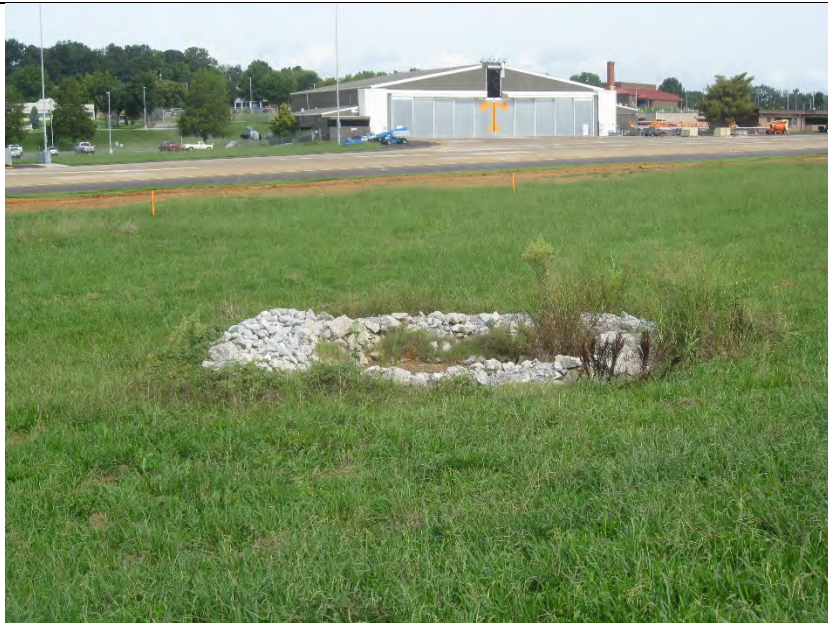
Photo 109
(Repair TWY Lighting)

Sod establishing along Taxiway G.
Recommend stabilizing remaining bare areas.

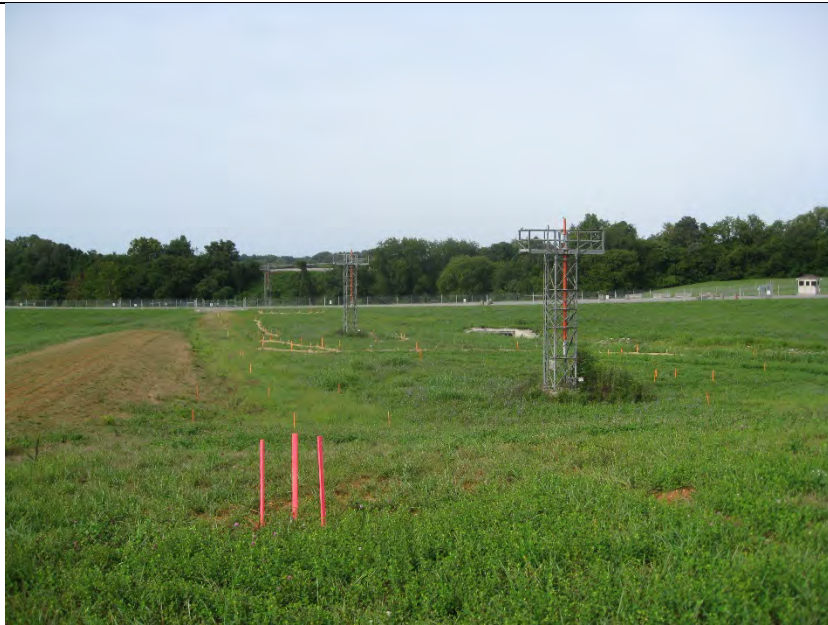
Photo 111
(Repair TWY Lighting)

Demolished old Taxiway G4 and shoulder.
Recommend stabilizing bare areas.

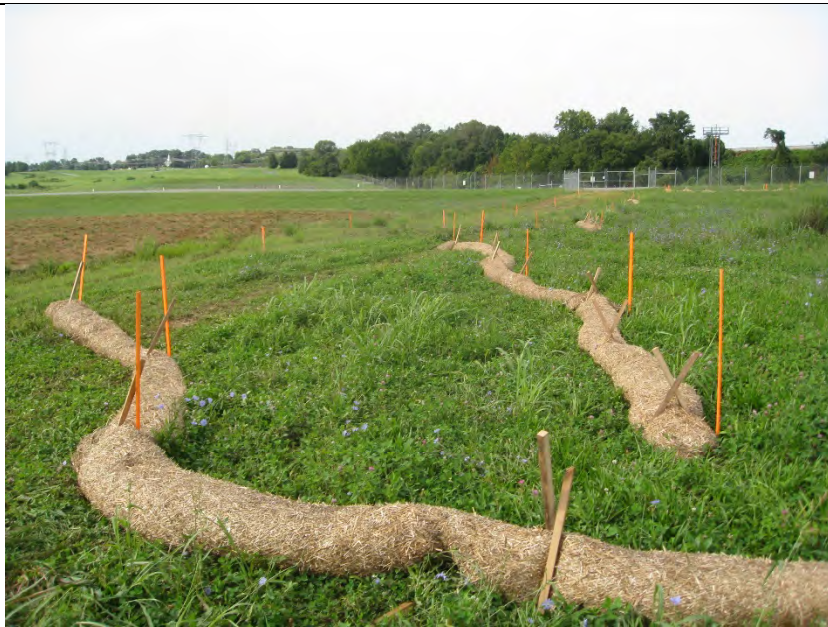
Photo 112
(Project 5/6)

Proposed access road
Sediment tubes recently installed.

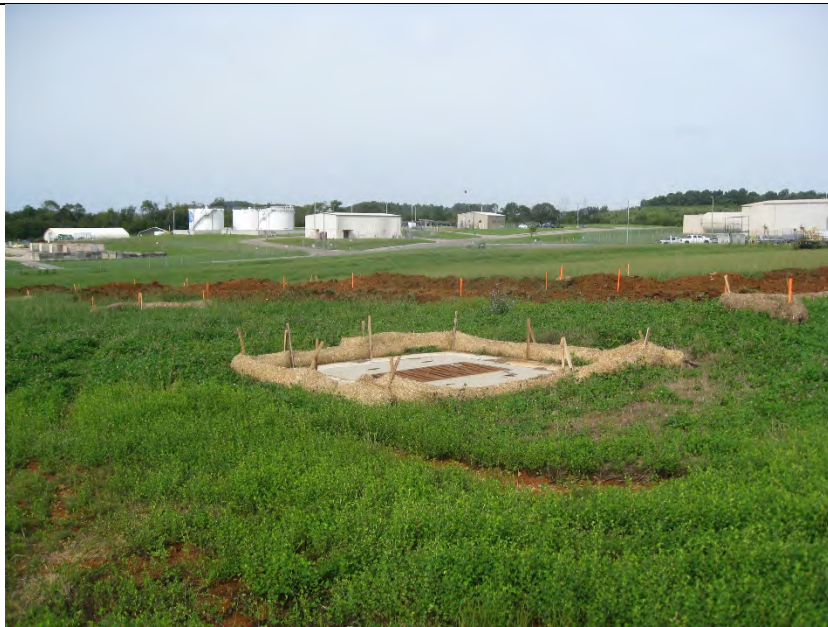
Photo 114
(Project 5/6)

Existing structure #120.
Sediment tubes recently installed above structure.

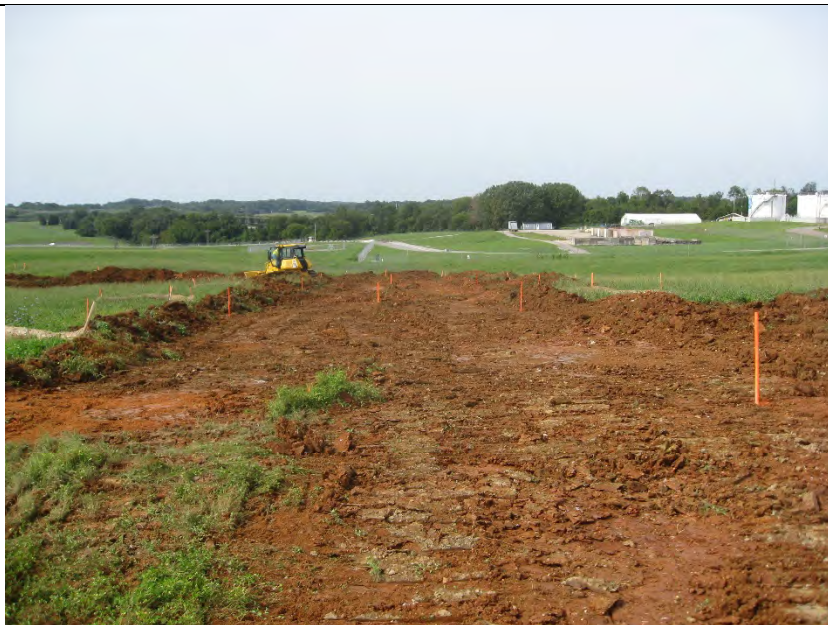
Photo 115
(Project 5/6)

Existing structure #118.
Inlet protection recently installed.

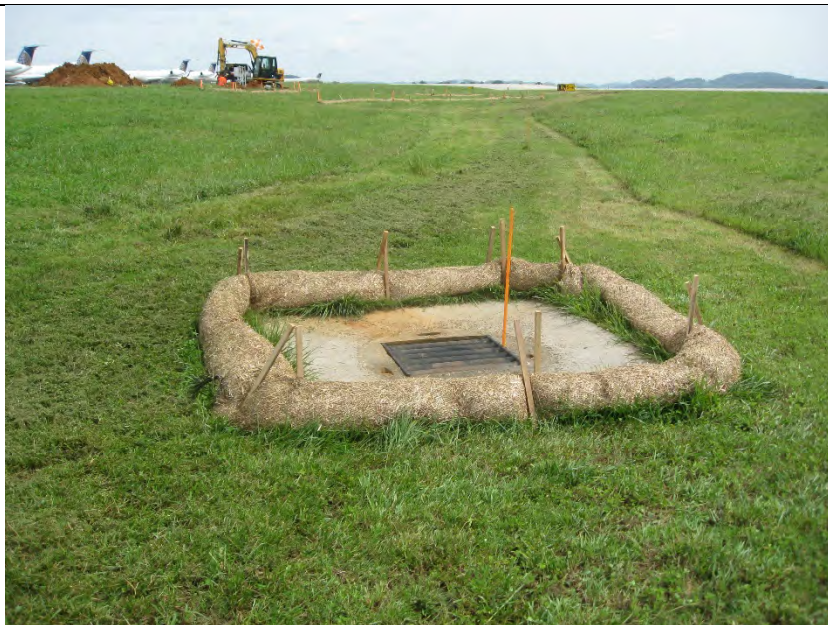
Photo 117
(Project 5/6)

Construction activities taking place at time of inspection.
Inlet protection recently installed.

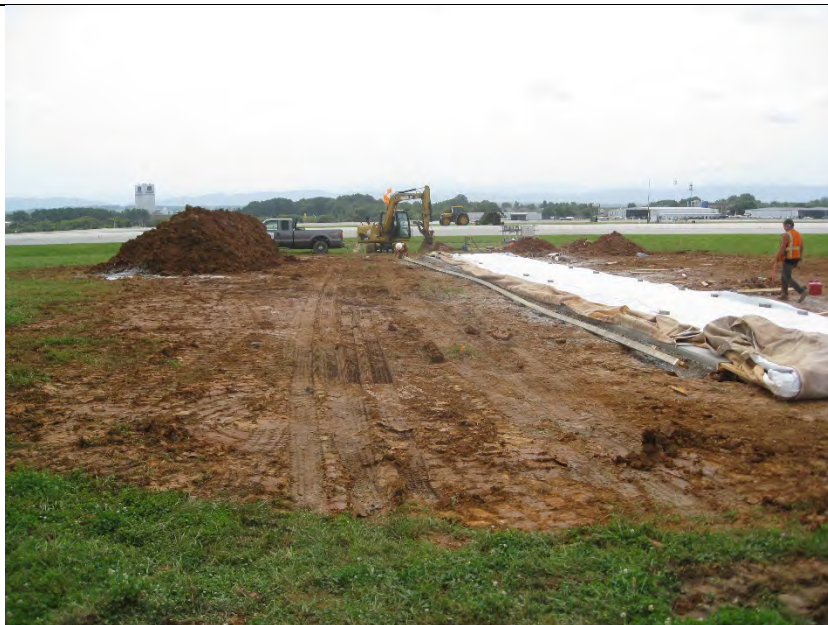
Photo 119
(Project 5/6)

Sediment tubes recently installed. Spacing of stakes appeared to be too far apart (typical throughout project). Recommend adding stakes.

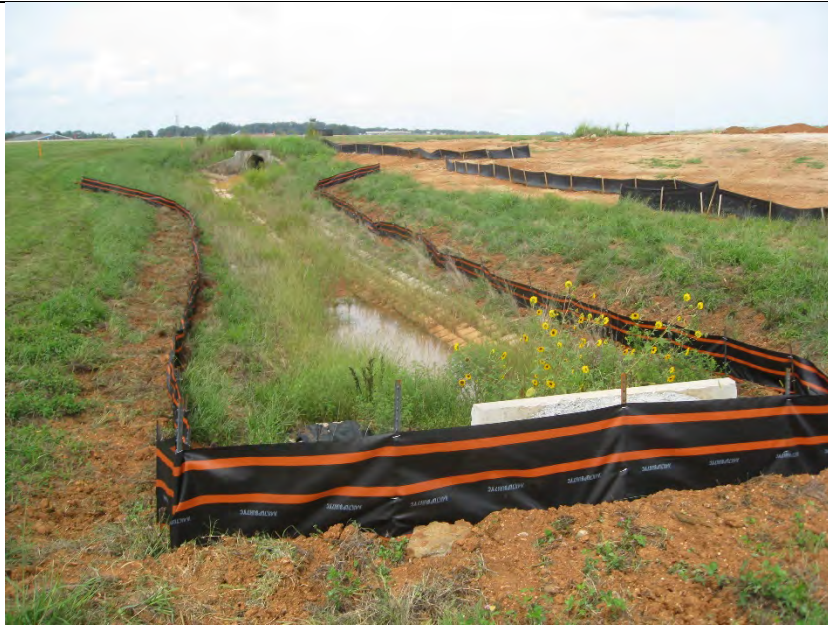
Photo 120
(Project 5/6)

ILS area under construction.

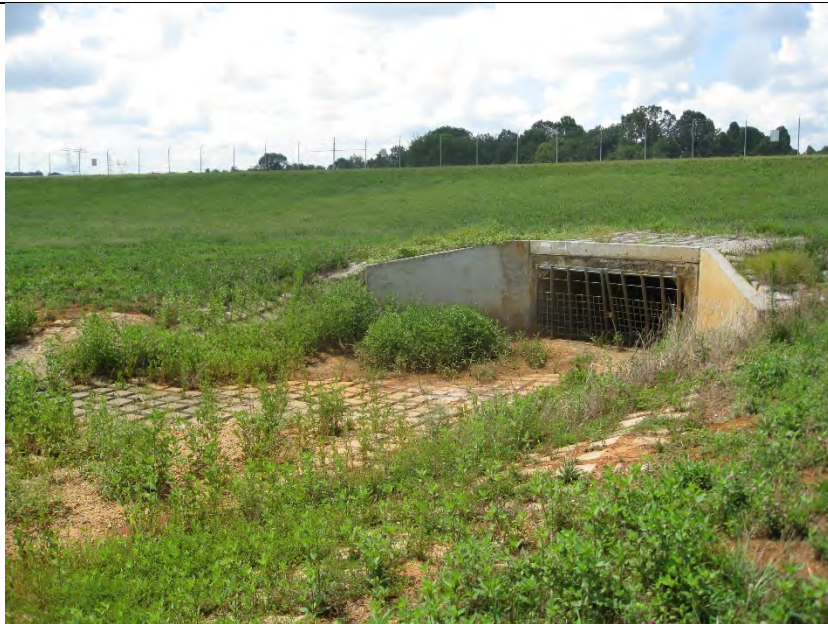
Photo 1
Sta. 111+56 RT
(Line LB)
NLET 01
Project 2

North Lateral End Treatment 01 (Outfall A).
No flow observed.

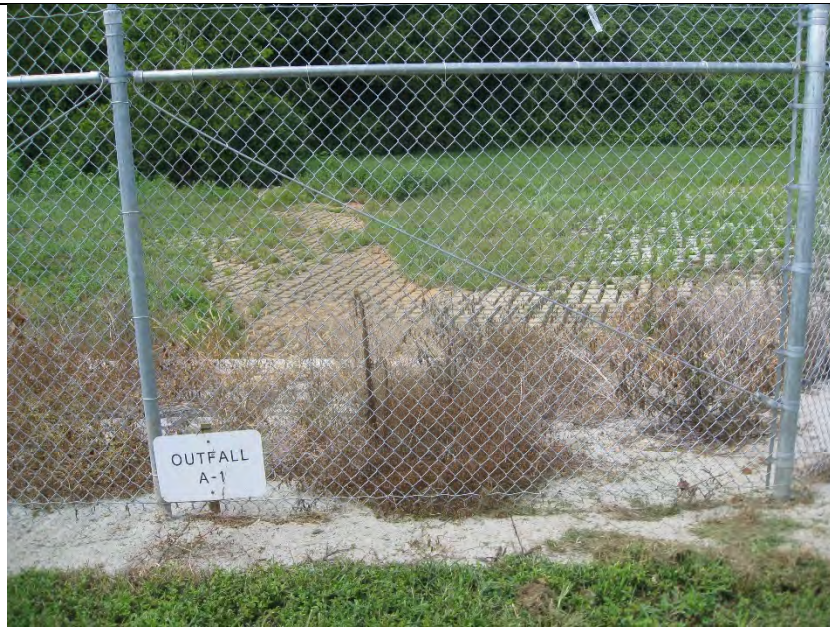
Photo 2
Sta. 111+56 RT
(Line LB)
NLET 01
Project 2

North Lateral End Treatment 01 (Outfall A).
No flow observed.

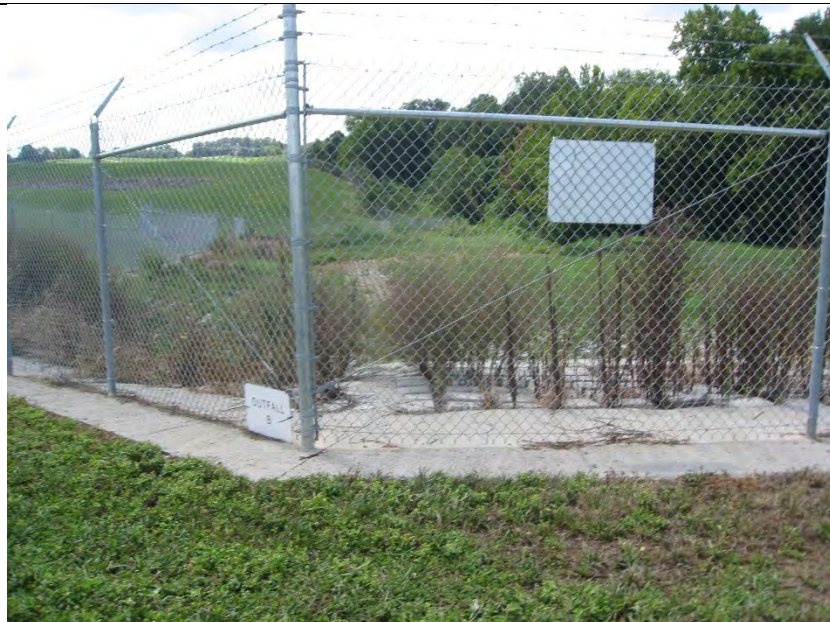
Photo 3
Sta. 111+82 LT
(Line LB)
NLET 02
Project 2

Main outfall to Lackey Creek. This section of the site was inaccessible at time of inspection.

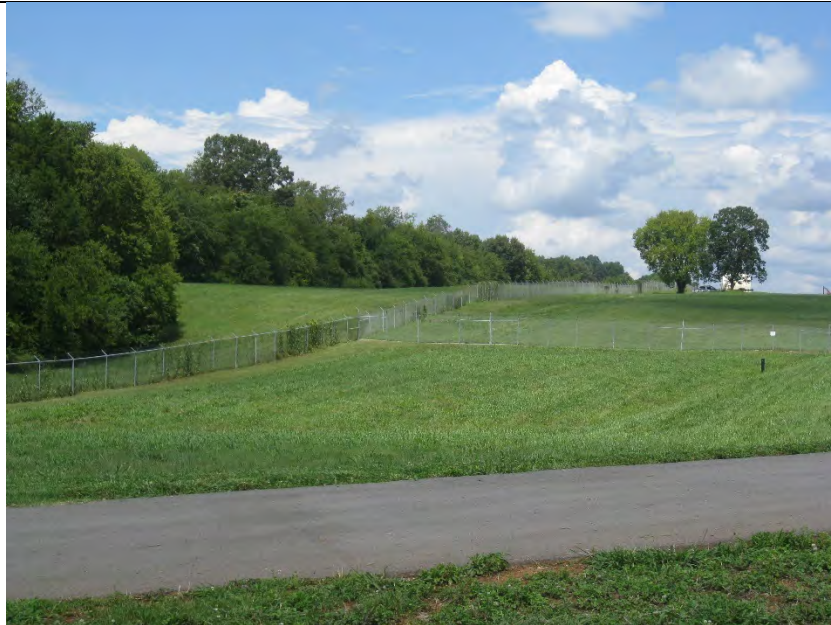
Photo 4
Sta. 114+00
(Line LB)
Project 2

Guard Lateral End Treatment 02.
This section of the site was inaccessible at time of inspection.

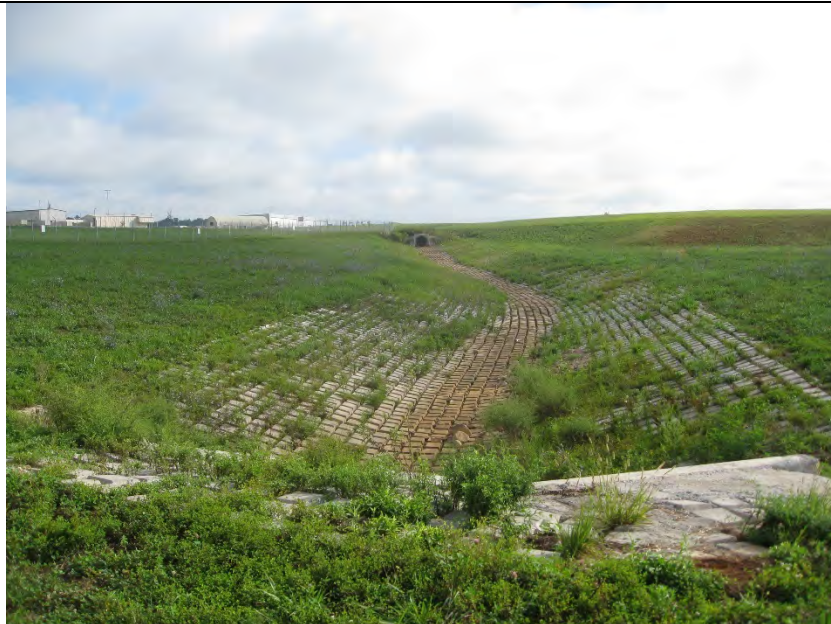
Photo 7
Sta. 117+00
(Line LB)
Project 2

Above the Guard Lateral Ditch (Outfall B).
Construction fall out present. Recommend coordinating remediation with CHA.

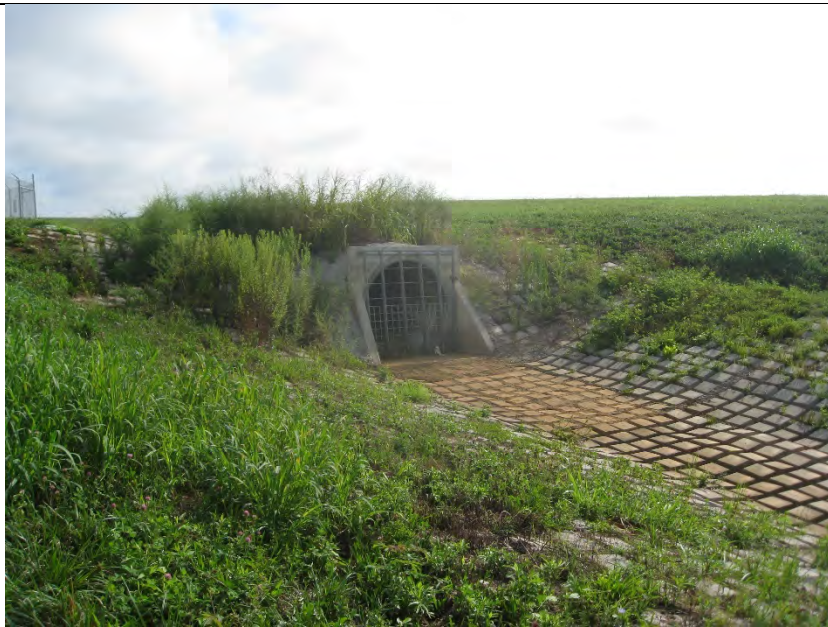
Photo 8
Sta. 117+00
(Line LB)
Project 2

Guard Lateral Ditch (Outfall B).

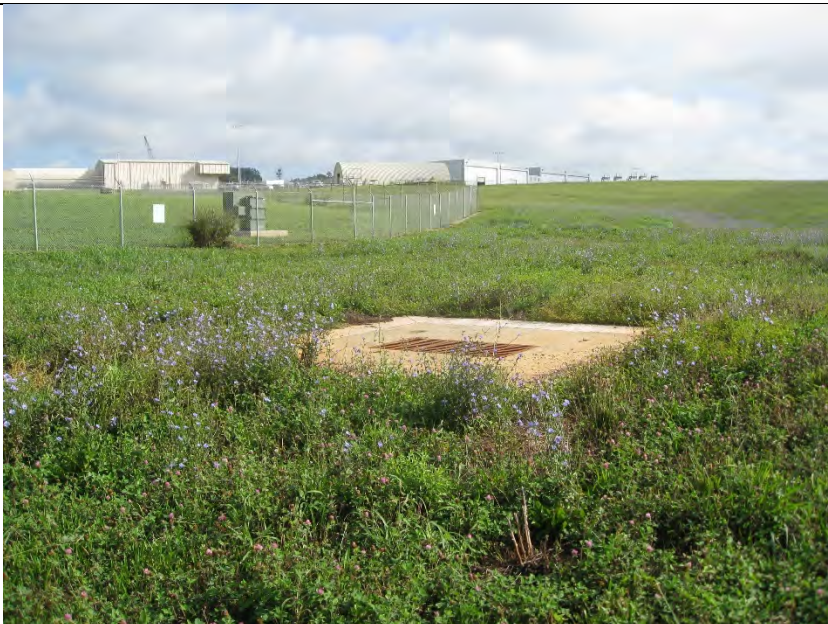
Photo 9
Sta. 117+00 (RT)
Project 2

78" culvert in the Guard Lateral Ditch.

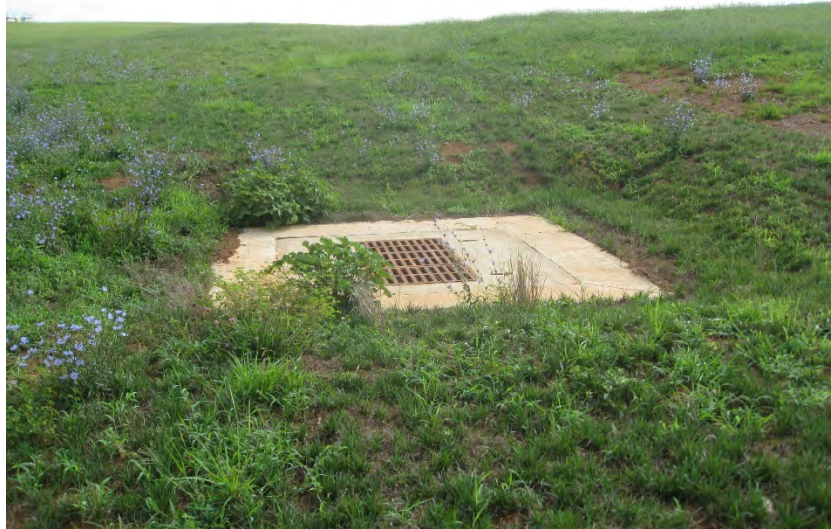
Photo 10
Sta. 287+21 LT
(RW 5L-23R)
Structure 124
Project 3

Structure 124.

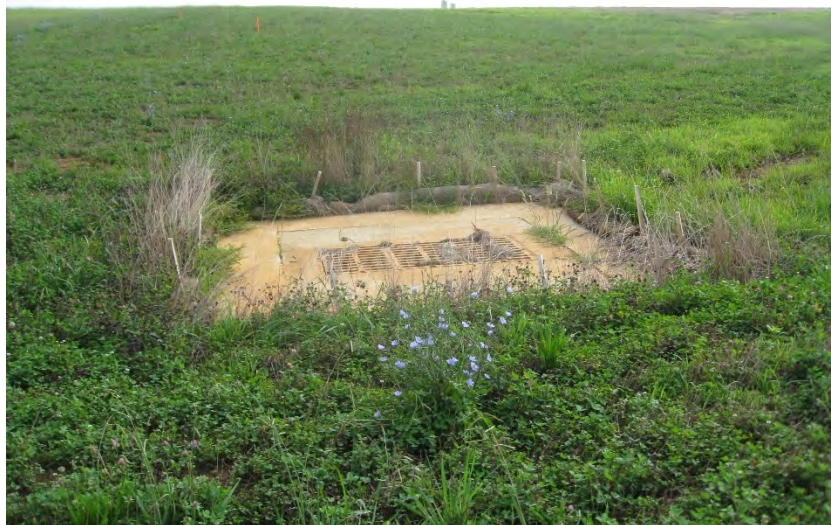
Photo 11
Sta. 289+13 LT
(RW 5L-23R)
Structure 122
Project 3

Structure 122.
Recommend stabilizing remaining bare areas.

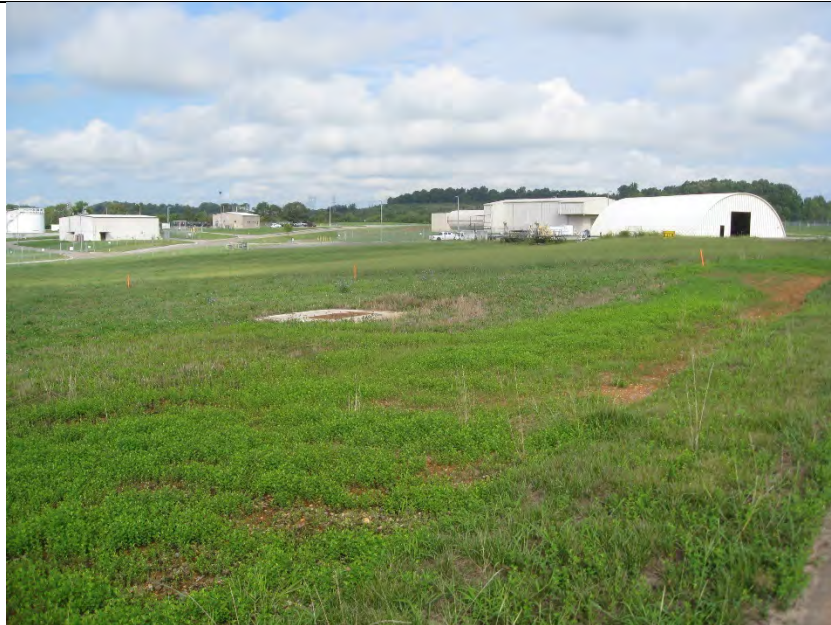
Photo 12
Sta. 291+51 LT
(RW 5L-23R)
Structure 120
Project 3

Structure 120.

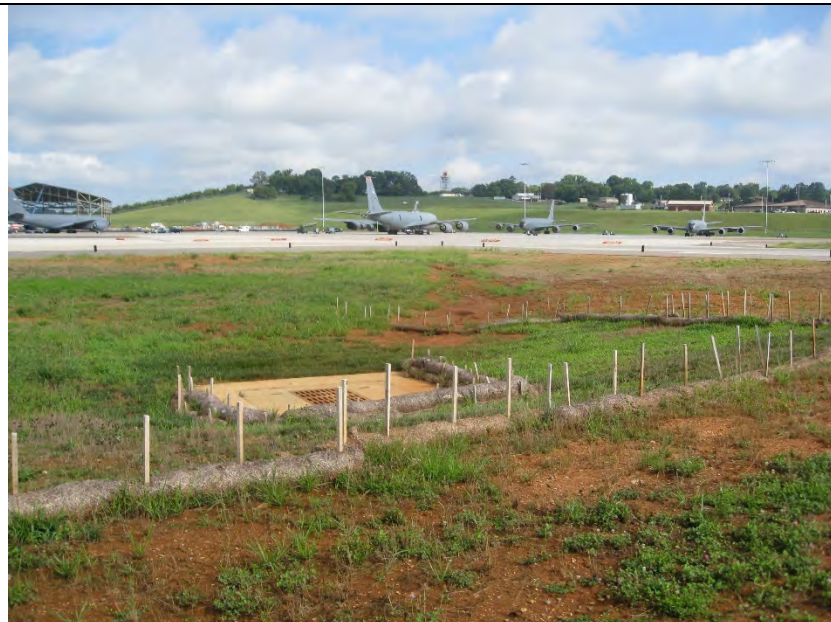
Photo 13
Sta. 294+31 LT
(RW 5L-23R)
Structure 118
Project 3

Structure 118.

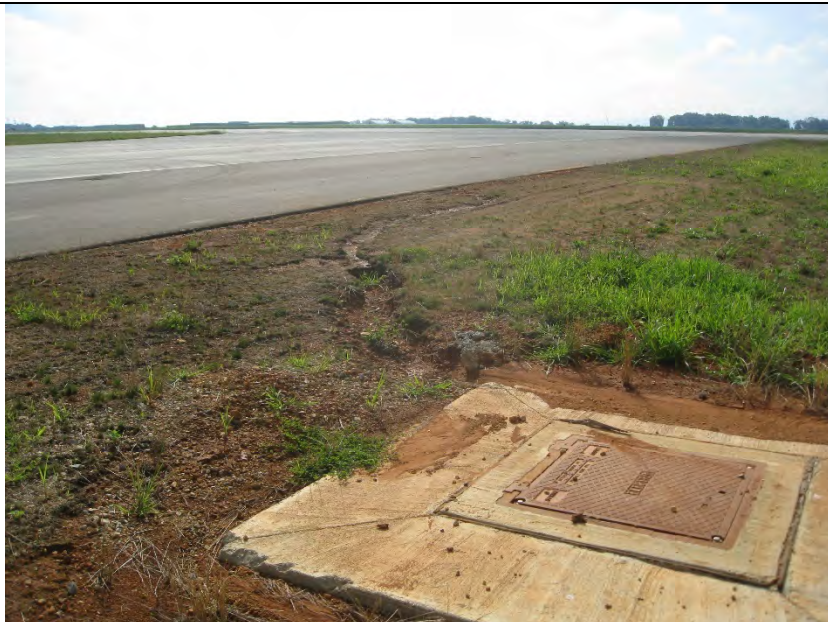
Photo 15
Sta. 298+71 LT
(RW 5L-23R)
Structure 116
Project 3

Above Structure 116.
Due to recent storm events, rills have started to form and sediment has accumulated in ditch line.
Recommend removing accumulated sediment. Recommend stabilizing remaining bare areas.

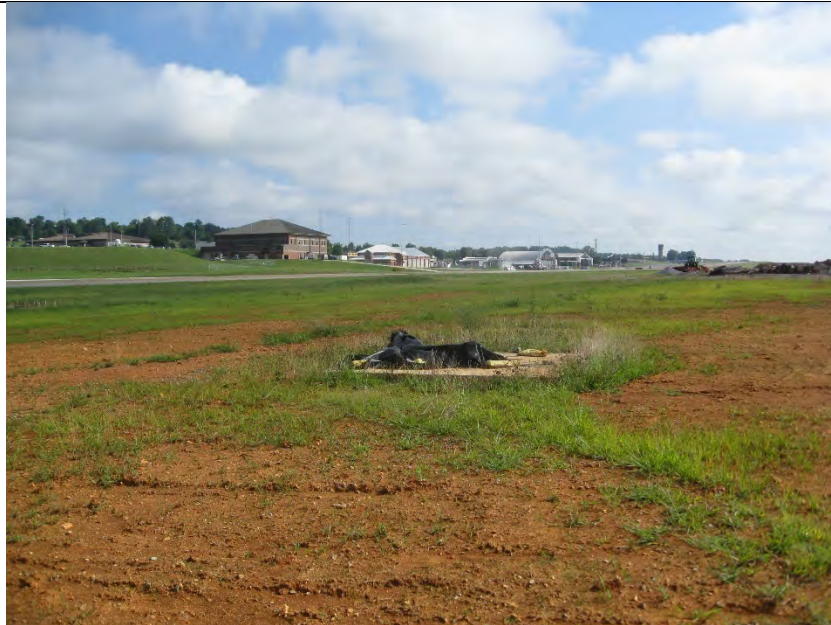
Photo 16
Sta. 298+71 LT
(RW 5L-23R)
Structure 116
Project 3

Above Structure 116 on Taxiway G2.
Recommend repairing rills and stabilizing bare areas.

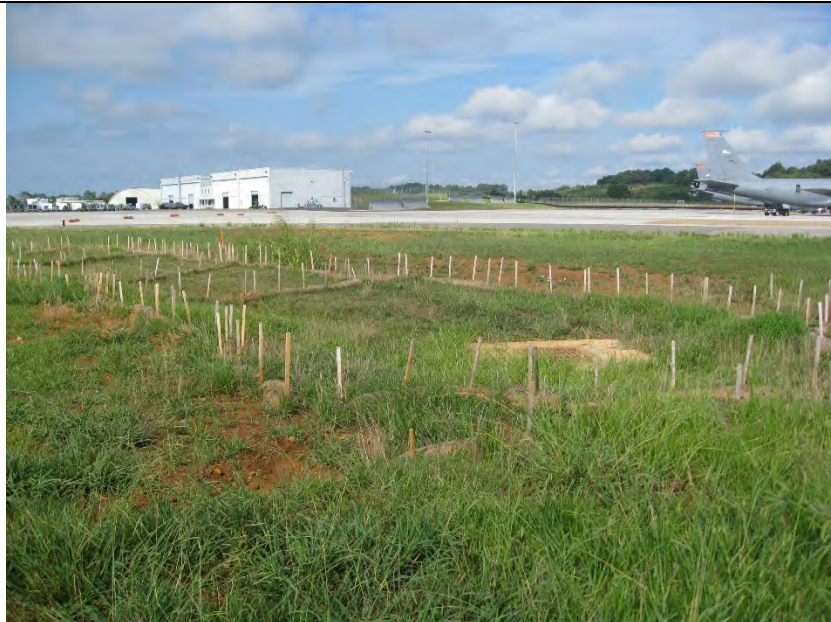
Photo 17
Sta. 302+54 LT
(RW 5L-23R)
Structure 114
Project 3

Structure 114.
Bare areas have been sprayed with hydroseeding and mulch; however, many areas remain bare and grass has not established. Coordinate with CHA on final stabilization options.

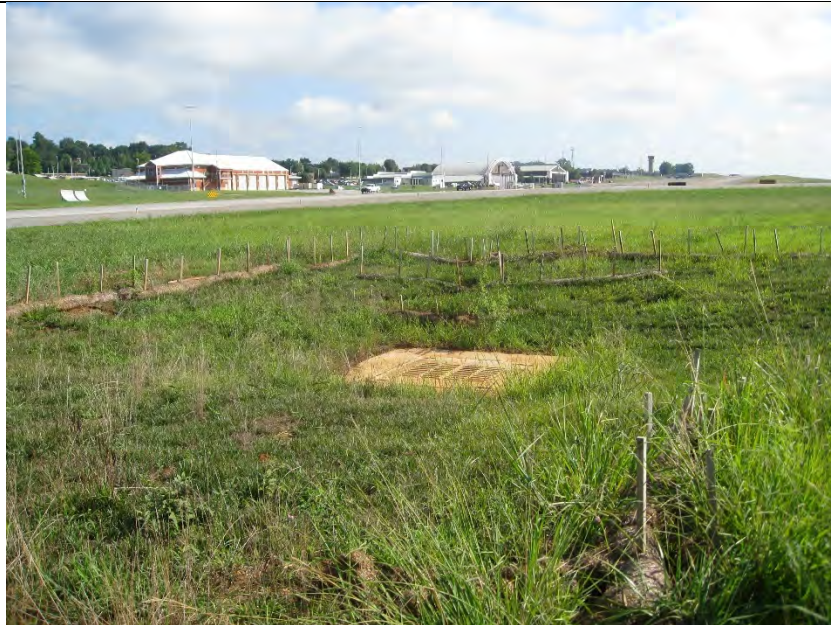
Photo 18
Sta. 303+36 LT
(RW 5L-23R)
Structure 12
Project 3

Structure 12.

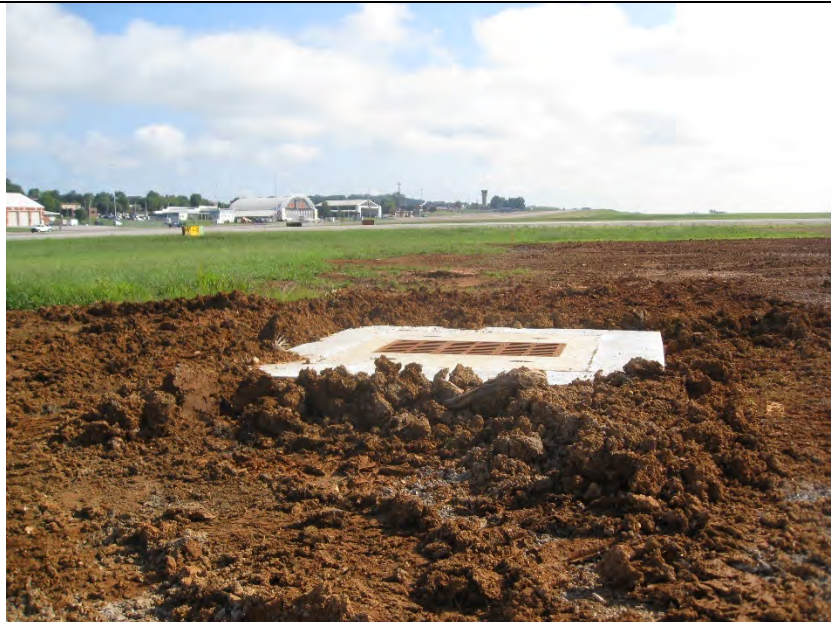
Photo 19
Sta. 310+04 LT
(RW 5L-23R)
Structure 10
Project 3

Structure 10.

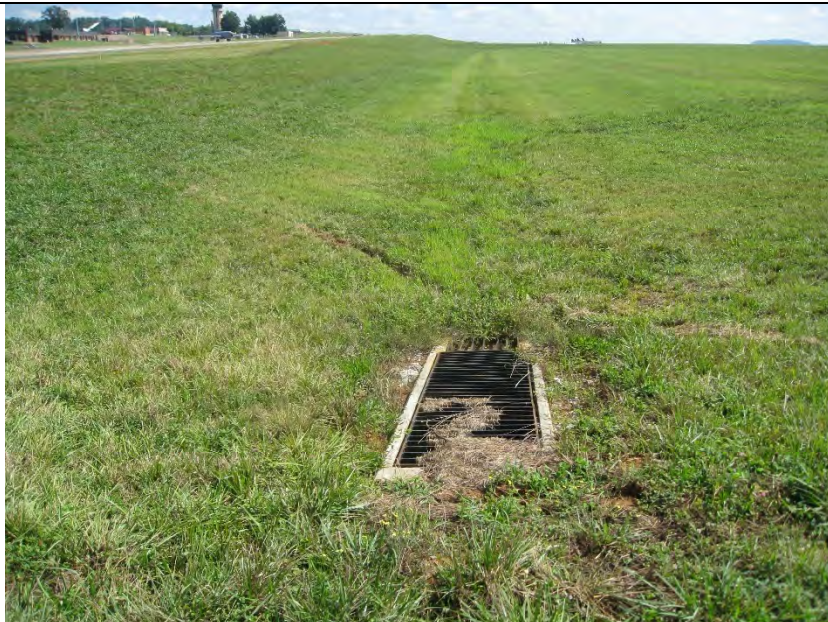
Photo 21
Sta. 324+86 LT
(RW 5L-23R)
ES Endwall 106
Project 3

Enhanced Swale Endwall 106.

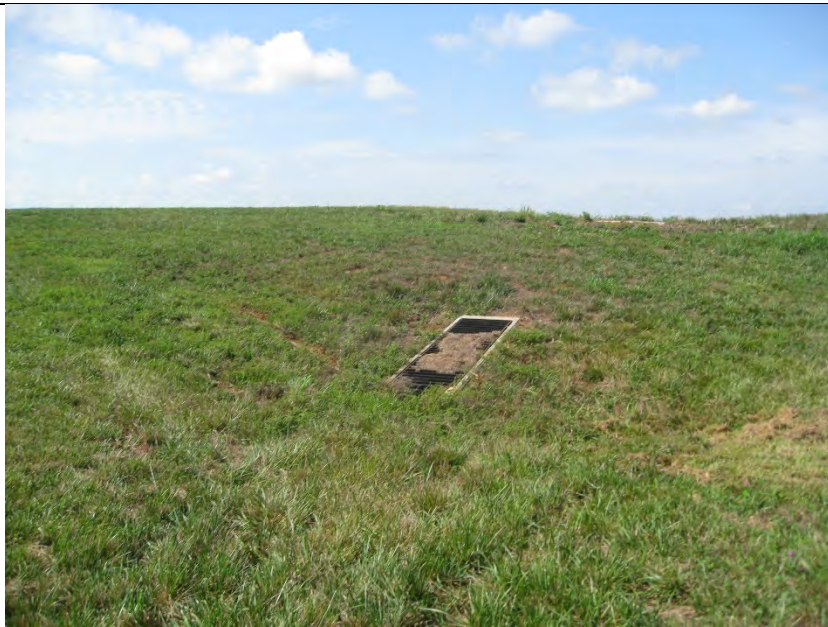
Photo 22
Sta. 324+86 to Sta. 335+73 LT
(RW 5L-23R)
ES Endwall 106
Project 3

Enhanced Swale Endwall 106.
