**QUALITY ASSURANCE
MONTHLY SITE
ASSESSMENT REPORT**

Airfield Modernization Program
Runway 5L-23R Reconstruction
Project 2 / Project 3
Project 4 / Repair TWY Lighting
Project 5 / Project 6

QUALITY ASSURANCE SITE ASSESSMENT

AIRFIELD MODERNIZATION PROGRAM RUNWAY 5L-23R RECONSTRUCTION

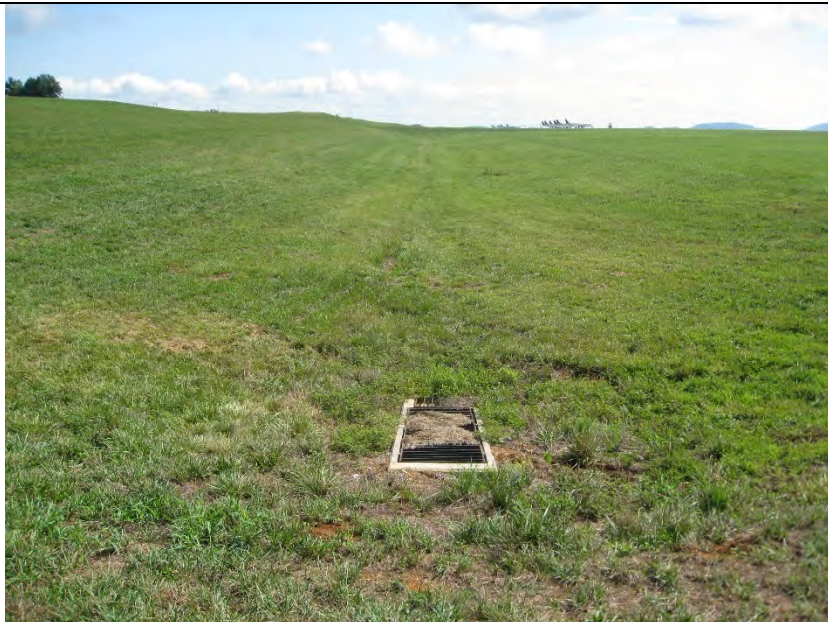
Photo 23
Sta. 335+73 LT
(RW 5L-23R)
ES Endwall 104
Project 3

Enhanced Swale Endwall 104.

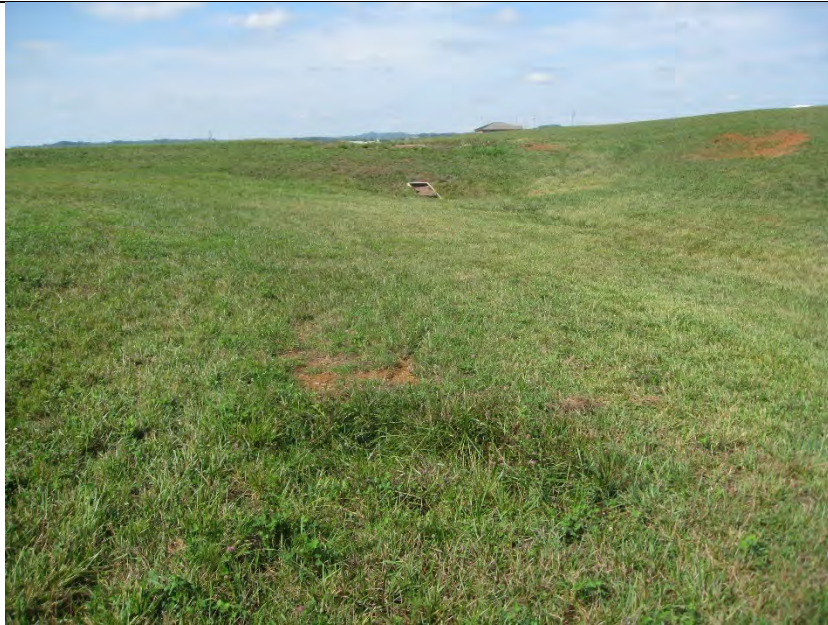
Photo 24
Sta. 335+73 LT
(RW 5L-23R)
ES Endwall 104
Project 3

Enhanced Swale Endwall 104.

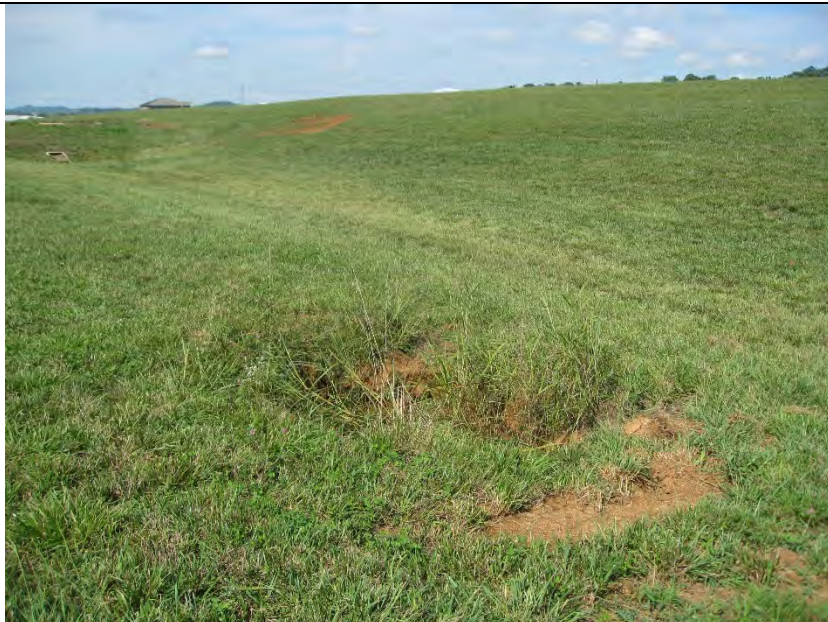
Photo 25
Sta. 341+50 LT
(RW 5L-23R)
Between ES Endwall 104 and 102
Project 3

First potential construction fallout on Storm Line 1 between ES Endwall 104 and 102.

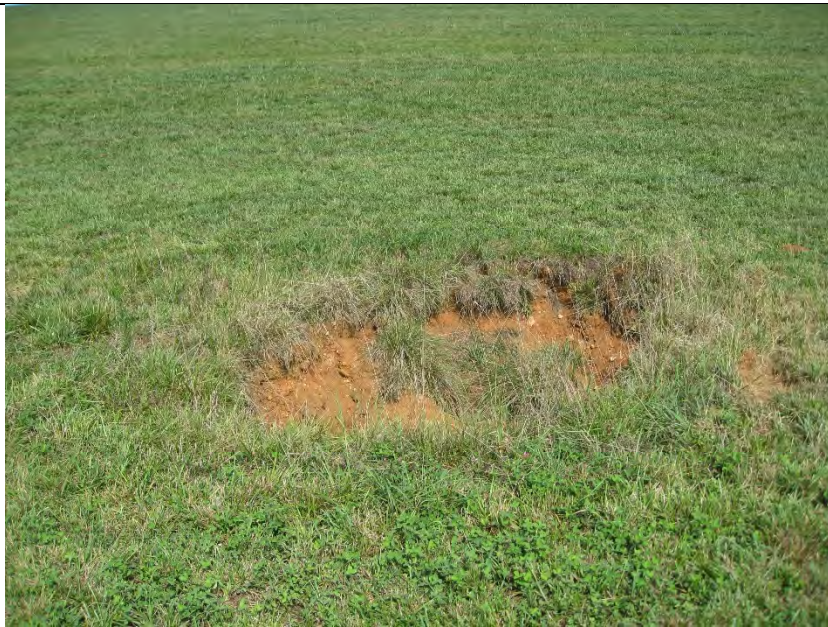
Photo 26
Sta. 341+50 LT
(RW 5L-23R)
Between ES Endwall 104 and 102
Project 3

Second construction fallout on Storm Line 1 between ES Endwall 104 and 102.
Coordinate remediation with CHA.

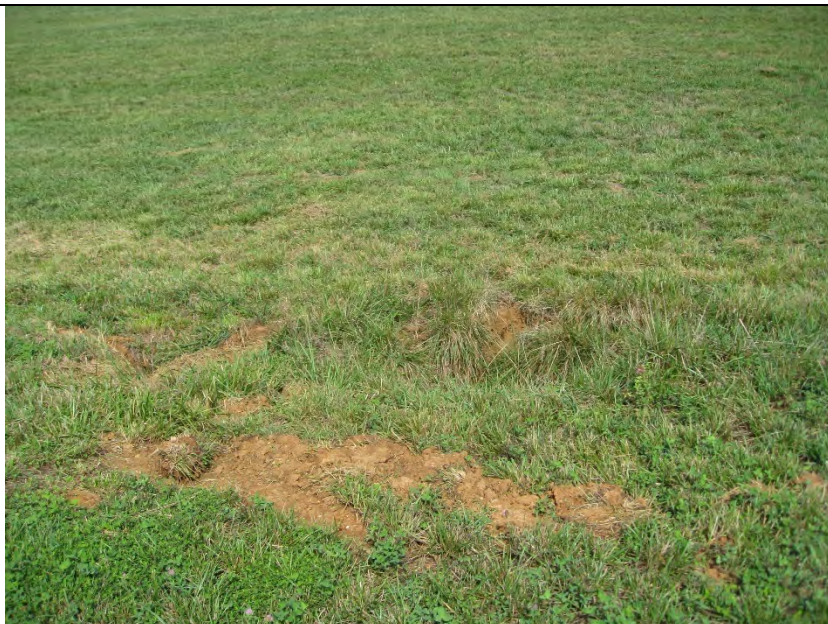
Photo 27
Sta. 341+50 LT
(RW 5L-23R)
Between ES Endwall 104 and 102
Project 3

Third construction fallout on Storm Line 1 between ES Endwall 104 and 102.
Coordinate remediation with CHA.

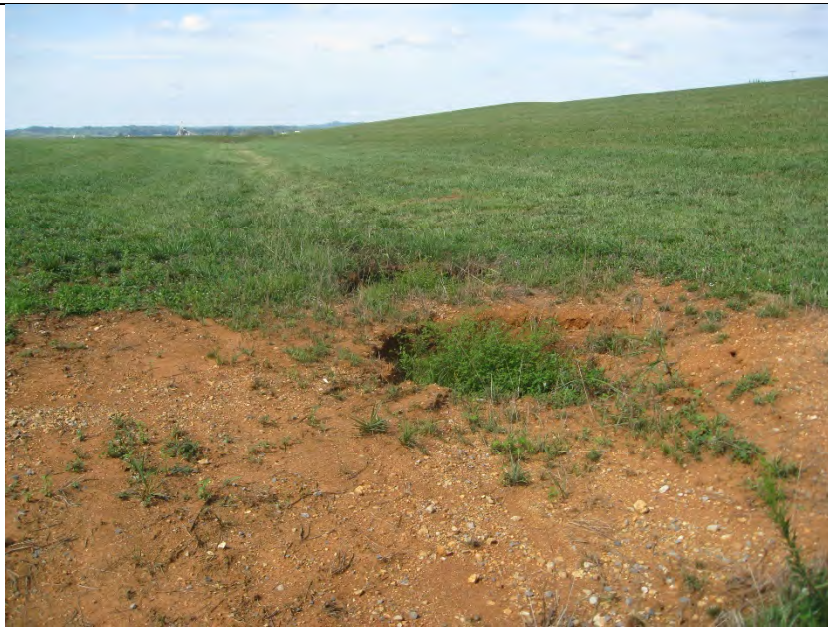
Photo 28
Sta. 341+50 LT
(RW 5L-23R)
Between ES Endwall 104 and 102
Project 3

Fourth construction fallout on Storm Line 1 between ES Endwall 104 and 102.
Coordinate remediation with CHA.

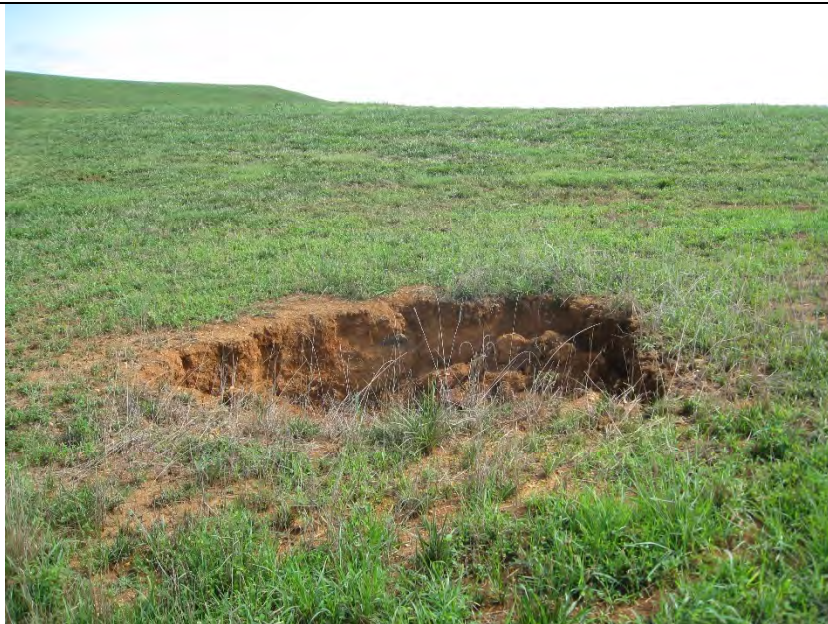
Photo 29
Sta. 341+50 LT
(RW 5L-23R)
Between ES Endwall 104 and 102
Project 3

Fifth construction fallout on Storm Line 1 between ES Endwall 104 and 102.
Coordinate remediation with CHA.

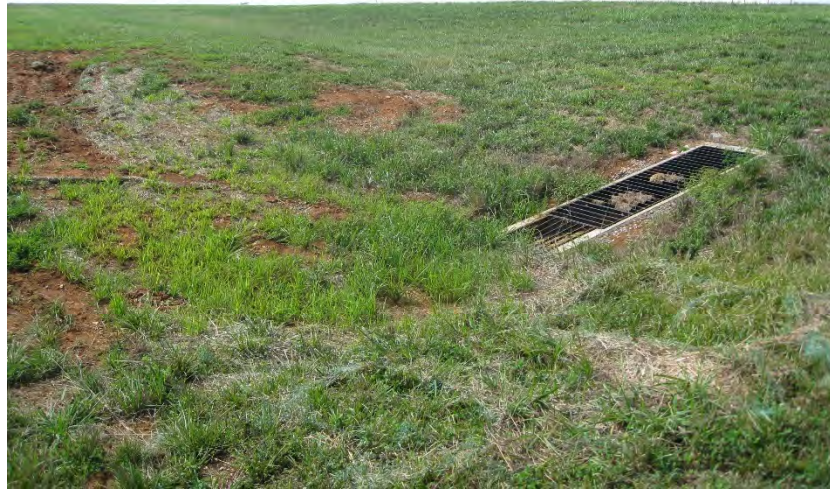
Photo 30
Sta. 341+50 LT
(RW 5L-23R)
Between ES Endwall 104 and 102
Project 3

Sixth construction fallout on Storm Line 1 between ES Endwall 104 and 102.
Coordinate remediation with CHA.

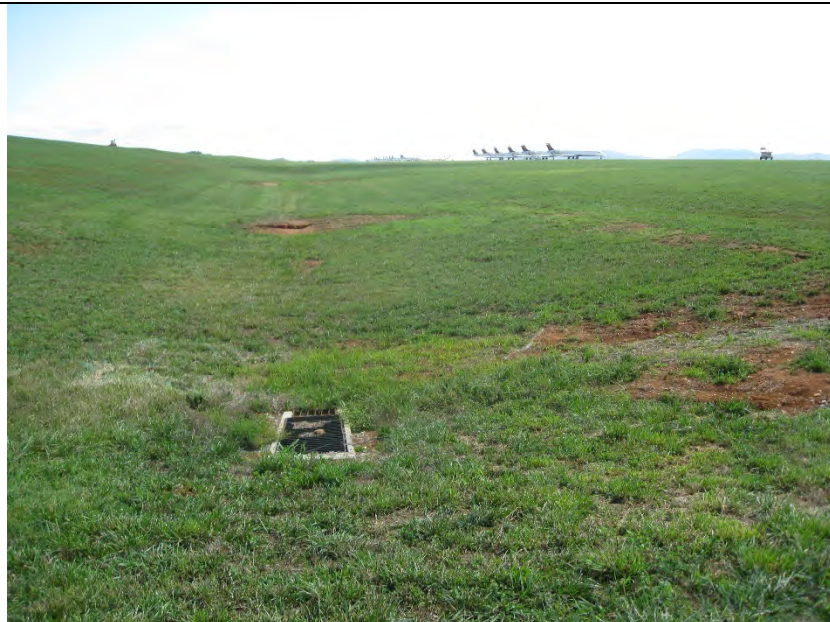
Photo 31
Sta. 347+31 LT
(RW 5L-23R)
ES Endwall 102
Project 3

Enhanced Swale Endwall 102.
Recommend stabilizing remaining bare areas.

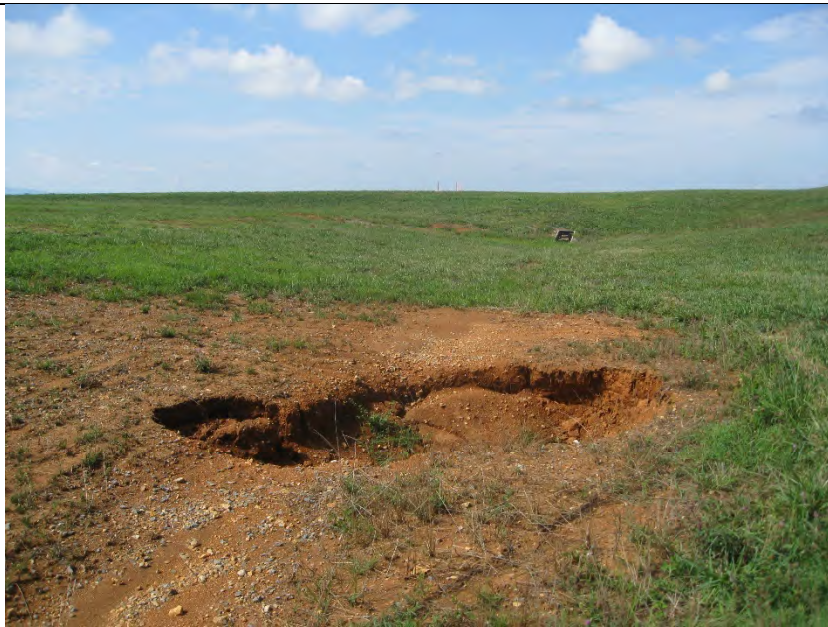
Photo 32
Sta. 347+31 LT
(RW 5L-23R)
ES Endwall 102
Project 3

Enhanced Swale Endwall 102.
Recommend stabilizing remaining bare areas.

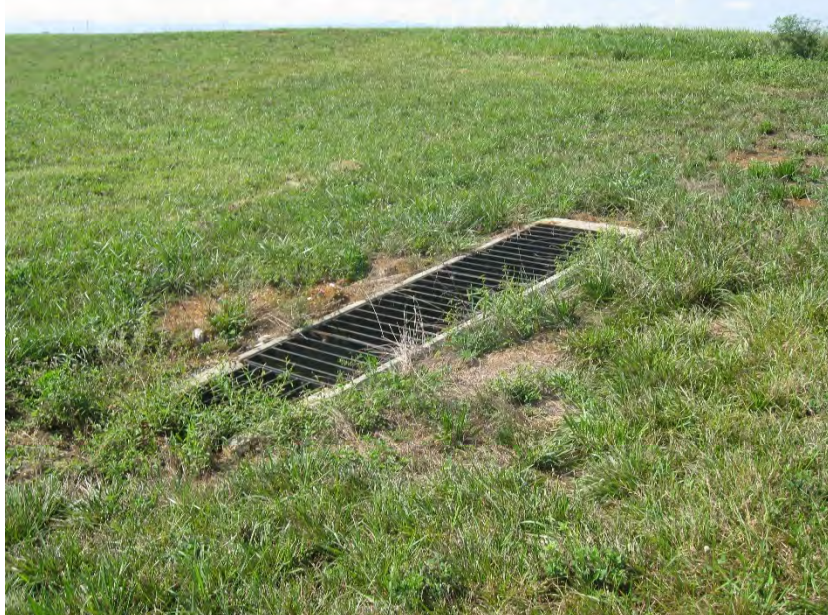
Photo 33
Sta. 341+50 LT
(RW 5L-23R)
ES Endwall 102
Project 3

Seventh construction fallout on Storm Line 1 between ES Endwall 102 and 100.
Coordinate remediation with CHA.

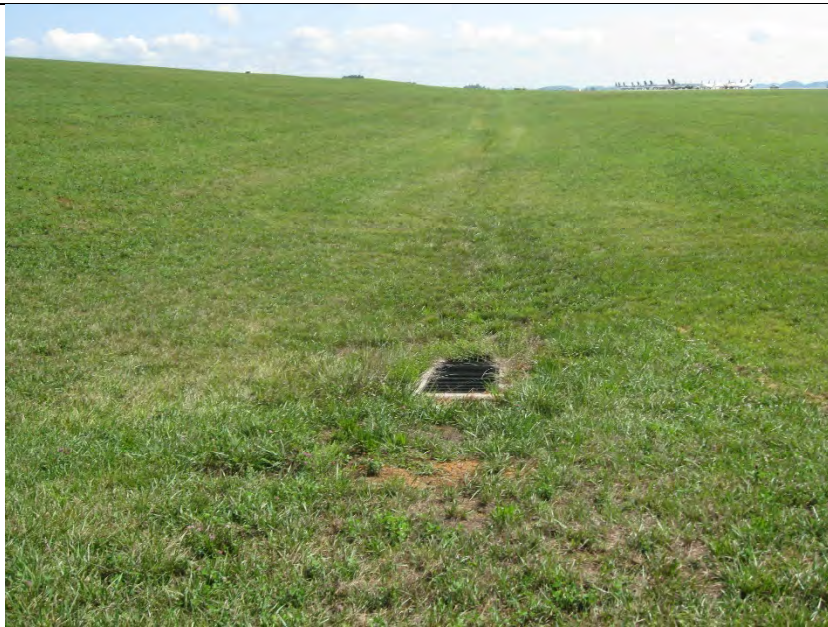
Photo 34
Sta. 354+75 LT
(RW 5L-23R)
ES Endwall 100
Project 2

Enhanced Swale Endwall 100.

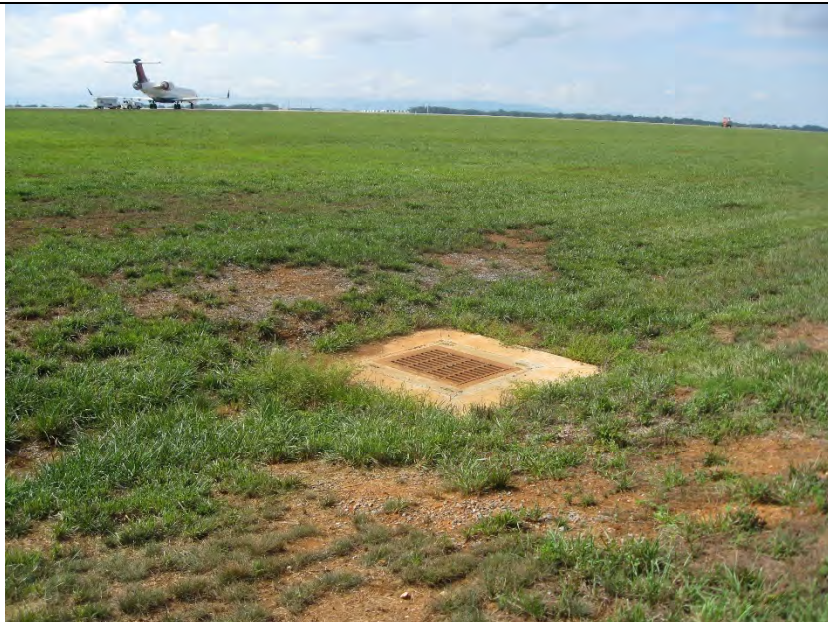
Photo 35
Sta. 354+75 LT
(RW 5L-23R)
ES Endwall 100
Project 3

Enhanced Swale Endwall 100.

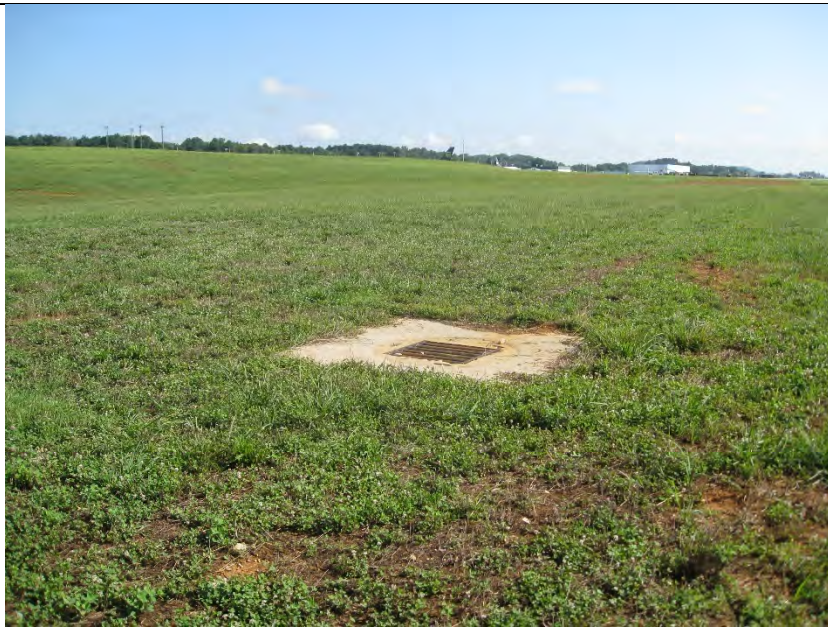
Photo 36
Sta. 361+39 LT
(RW 5L-23R)
Structure 100
Project 3

Structure 100.
Recommend stabilizing remaining bare areas.

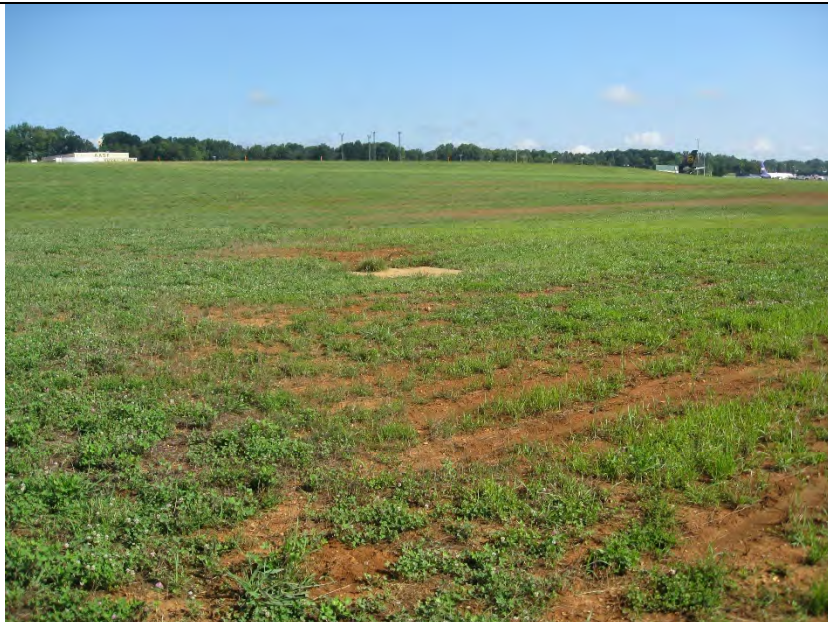
Photo 37
Sta. 363+35 LT
(RW 5L-23R)
Existing Structure
Project 2

Existing Structure.

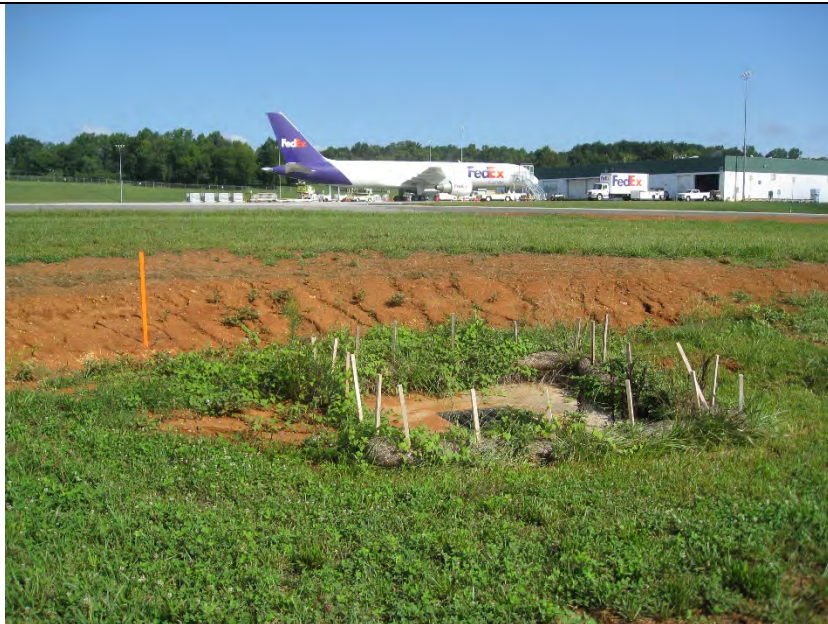
Photo 39
Sta. 369+11 LT
(RW 5L-23R)
Existing Structure
Project 2

Existing Structure.
Recommend stabilizing bare areas.

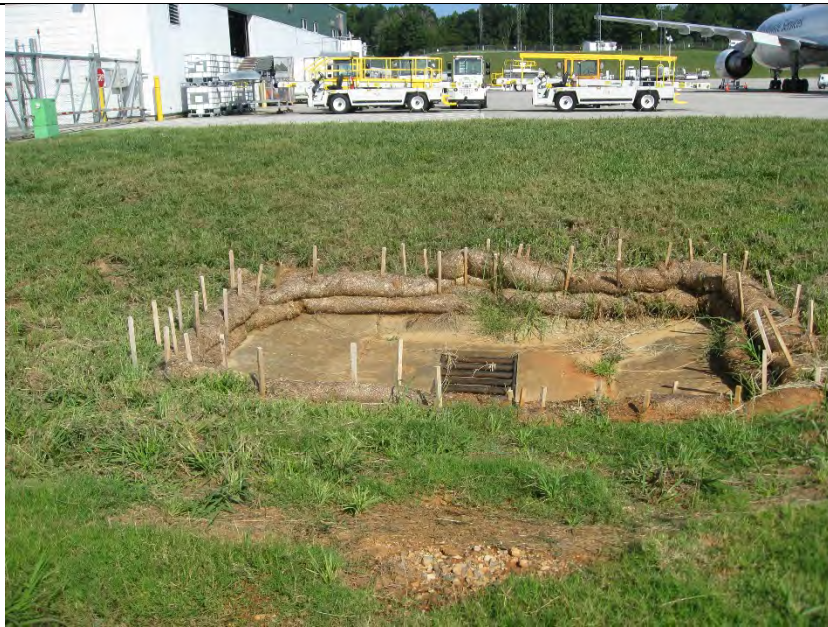
Photo 40
Sta. 677+00 RT
(RW 5L-23R)
Existing Structure
Project 4

Structure south of Taxiway "G".
Slopes continue to rill and deposit sediment at the structure.
Recommend repairing rills, removing accumulated sediment, and replacing sediment tubes.
Recommend stabilizing bare areas.

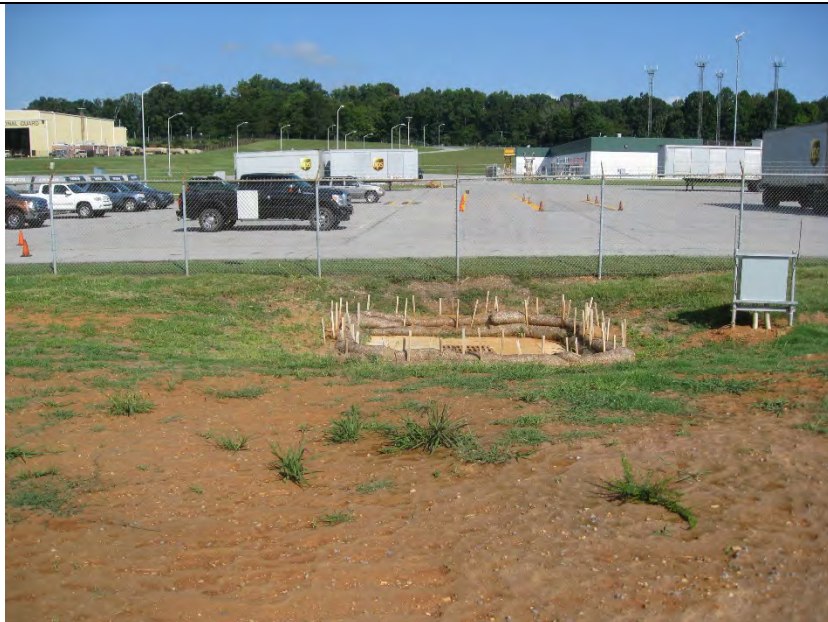
Photo 41
Sta. 677+00 RT
(RW 5L-23R)
Project 4

Structure between Taxiway G and UPS Facility.

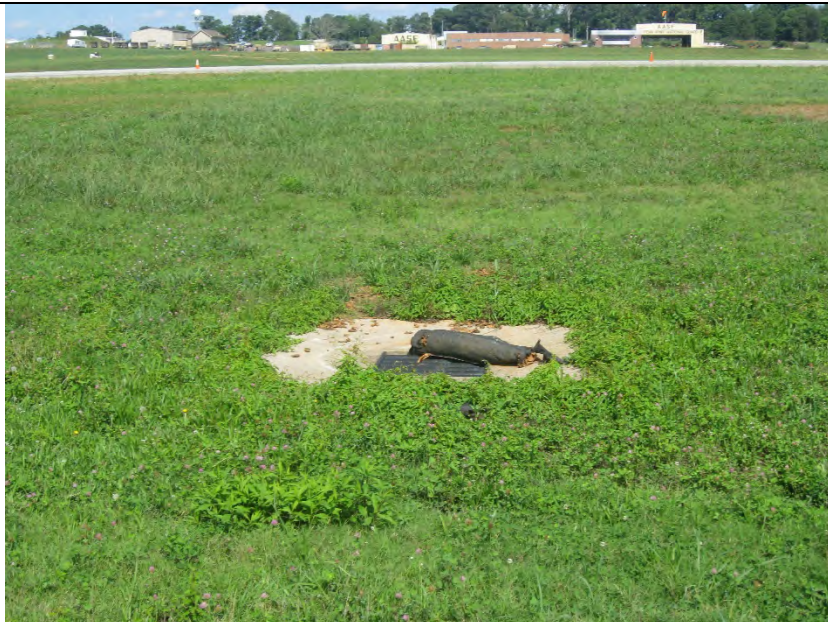
Photo 43
New structure
Project 4

New storm structure located north of Taxiway G.
Area recently regraded to capture runoff from the helipad apron.
Recommend stabilizing bare areas once grading is complete.

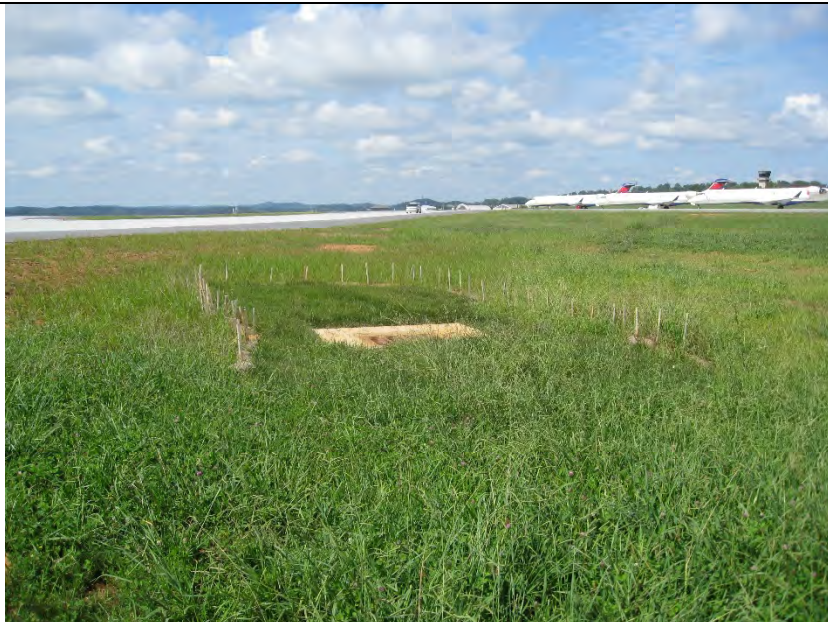
Photo 45
Sta. 366+89 RT
(RW 5L-23R)
Outfall C
Project 4

Recommend removing filter fabric from this structure.
(Outfall C).

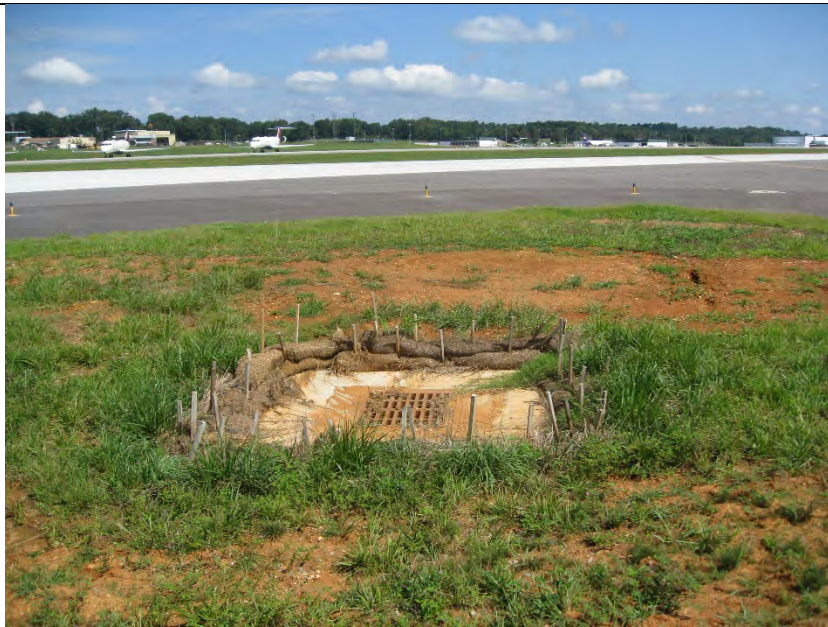
Photo 48
(RW 5L-23R)
TWY Y Tie-in
Project 4

Existing structure south of Taxiway Y.
Recommend removing inlet protection.

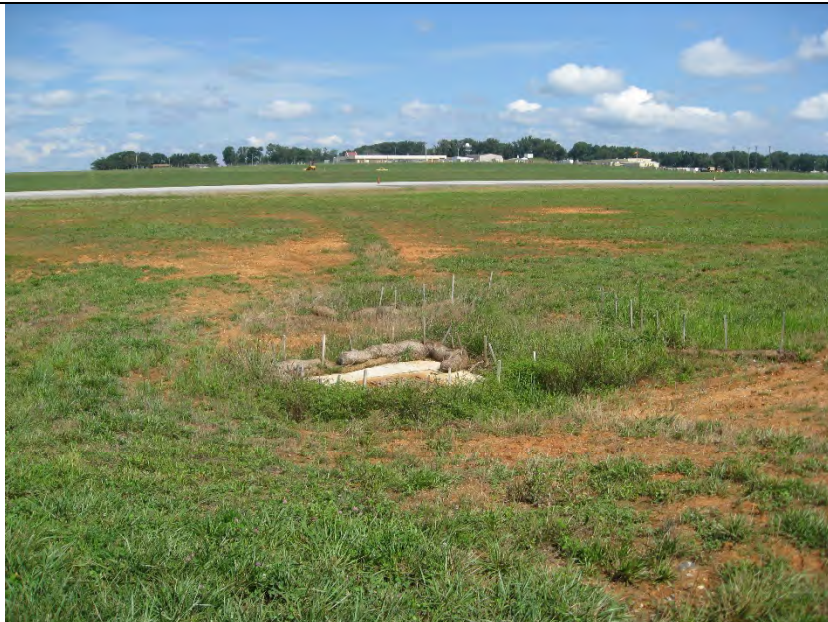
Photo 51
Sta. 347+26 RT
(RW 5L-23R)
Structure 22
Project 4

Structure 22.
Construction activities taking place at time of inspection.
Recommend stabilizing bare areas once operations are complete.

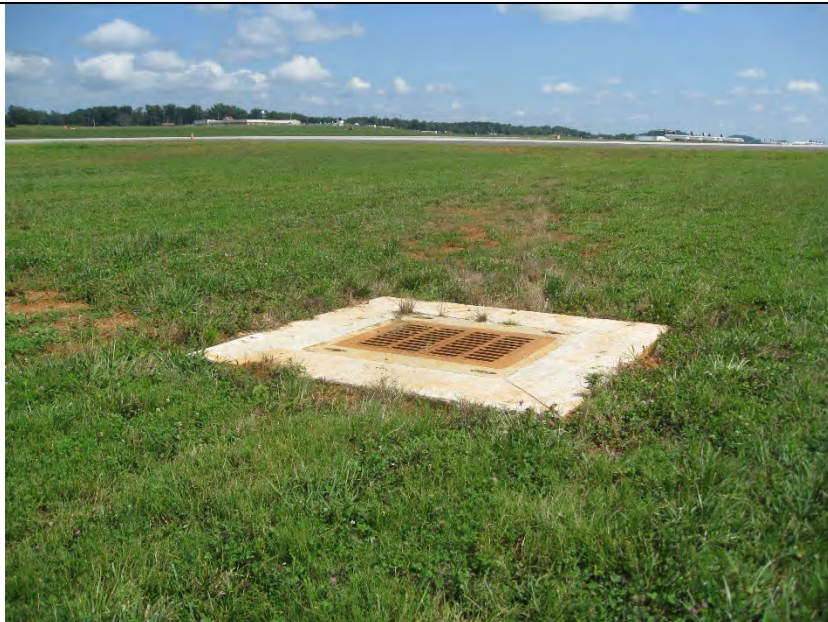
Photo 53
Sta. 347+26 RT
(RW 5L-23R)
Structure 202
Project 4

Structure 202.
Bare areas recently stabilized.
Rills and sediment migration occurred after recent storm events.

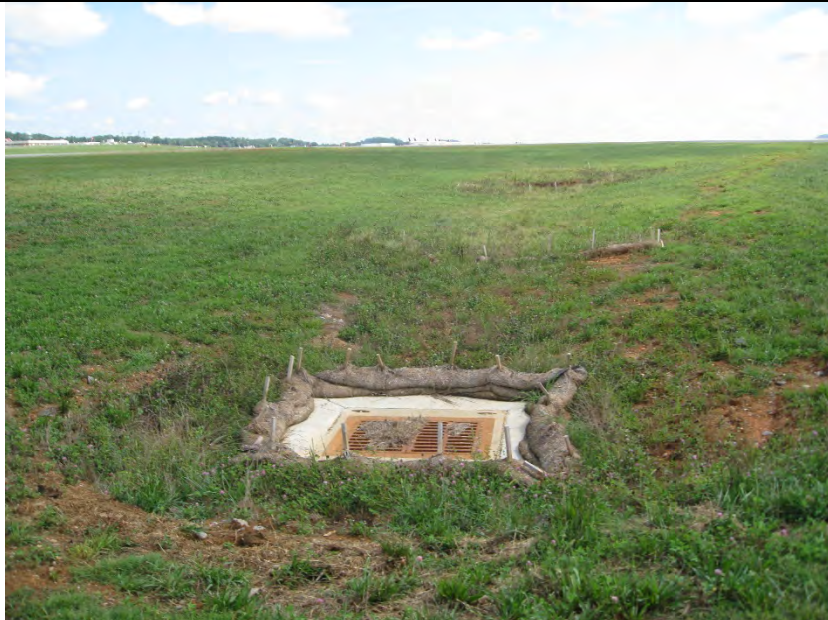
Photo 55
Sta. 341+86 RT
(RW 5L-23R)
Project 4

Construction fallout on Storm Line 2 between structures 204 and 206.
Recommend coordinating remediation with CHA.

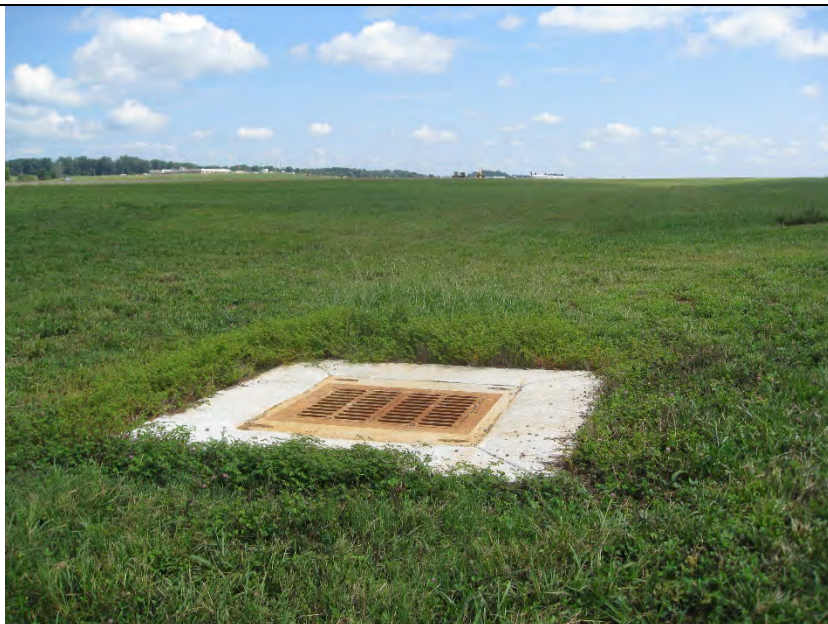
Photo 57
(RW 5L-23R)
Project 4

Construction fallout on Storm Line 2 between structures 206 and 208.
Recommend coordinating remediation with CHA.

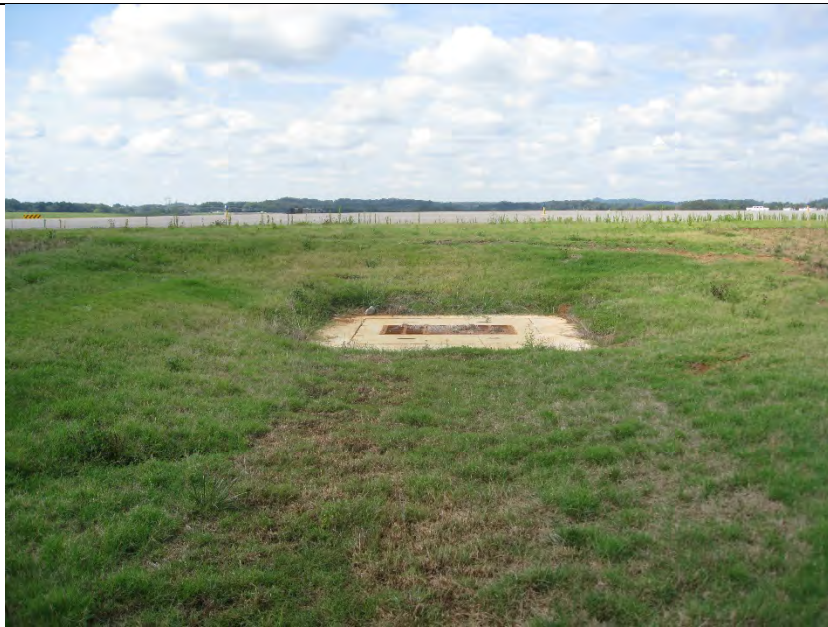
Photo 60
Sta. 321+73 RT
(RW 5L-23R)
Structure 212
Project 3

Structure 212.
Recommend removing accumulated sediment and replacing damaged sediment tubes.
Recommend stabilizing remaining bare areas.

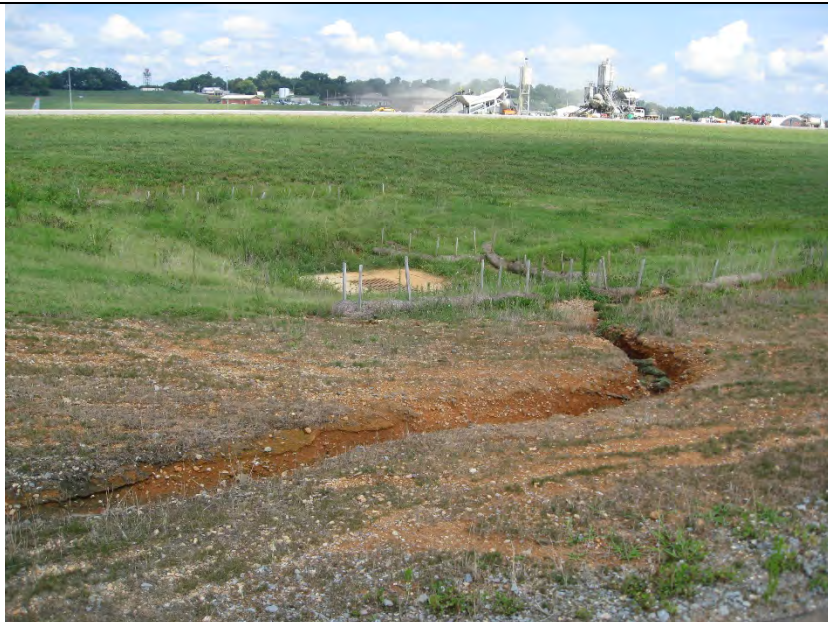
Photo 63
Sta. 301+87 RT
(RW 5L-23R)
Structure 218
Project 3

Structure 218.
Recommend stabilizing bare areas and repairing rill above structure (see photo below).

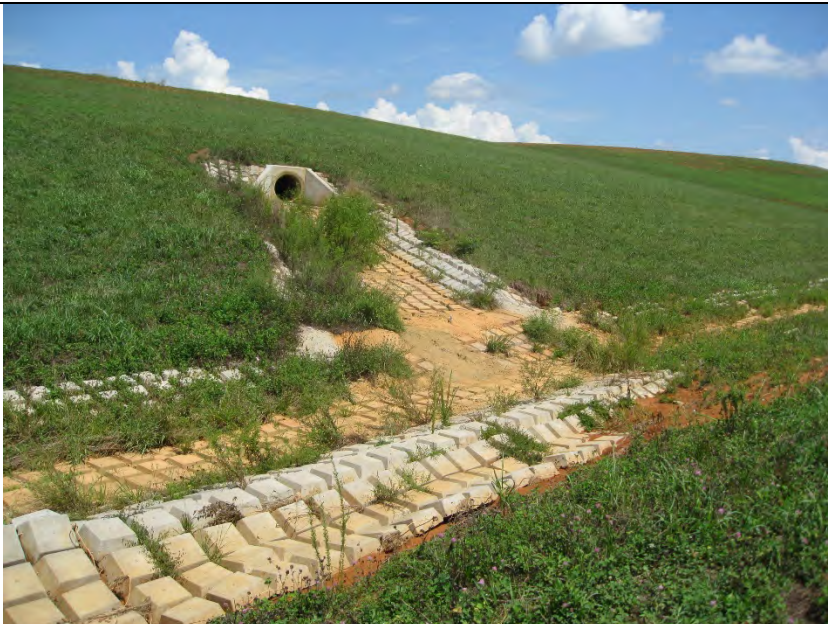
Photo 65
Sta. 296+83 RT
(RW 5L-23R)
Structure 220
Project 2

Structure 220.
Recommend stabilizing remaining bare areas.

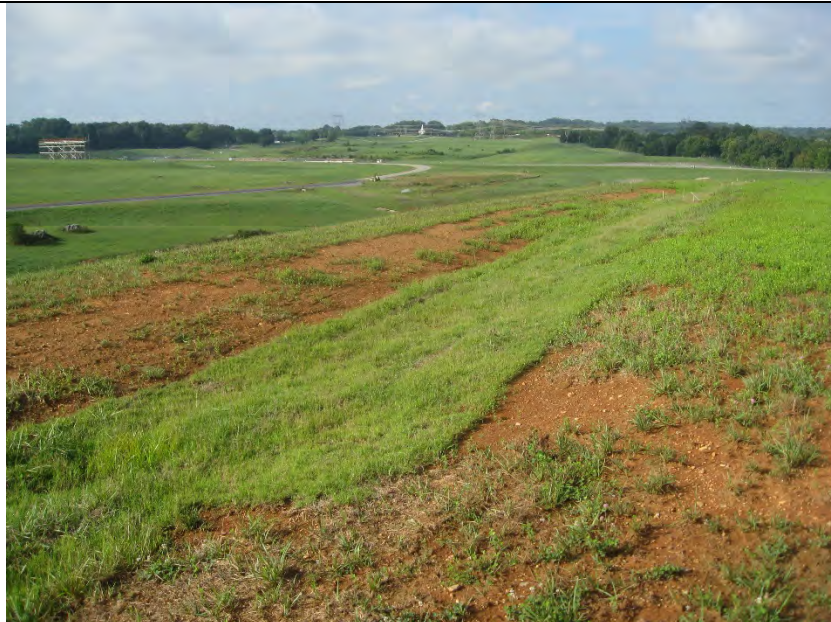
Photo 67
Sta. 288+26
(RW 5L-23R)
Structure 224
Project 2

Below structure 224.
Side slope has eroded causing damage to the articulated concrete block.
CHA, Harper and KMAA were already aware of the issue as discussed in a progress meeting dated 07/16/2020.

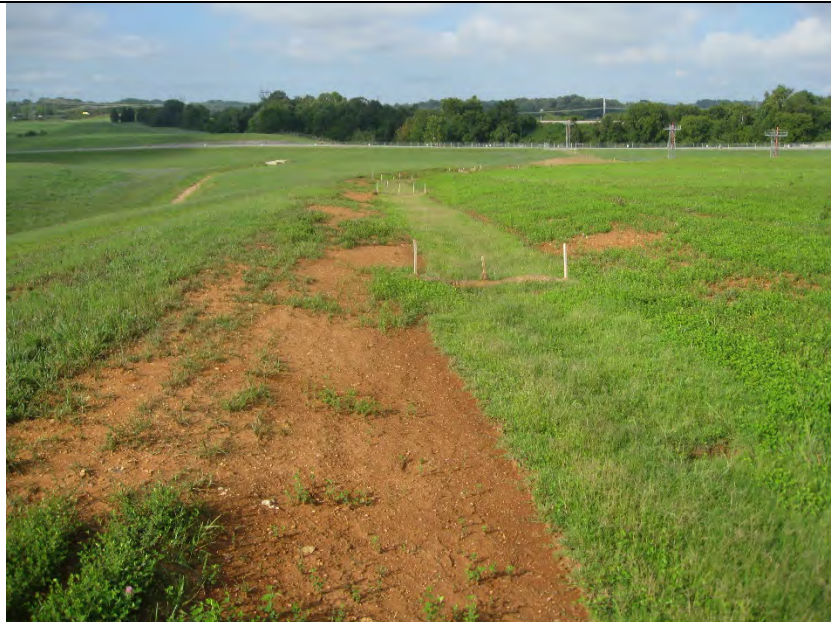
Photo 69
Sta. 290+26 RT
(RW 5L-23R)
Structure 222
Project 2

Structure 222.
Recommend removing inlet protection.
Recommend stabilizing bare areas.

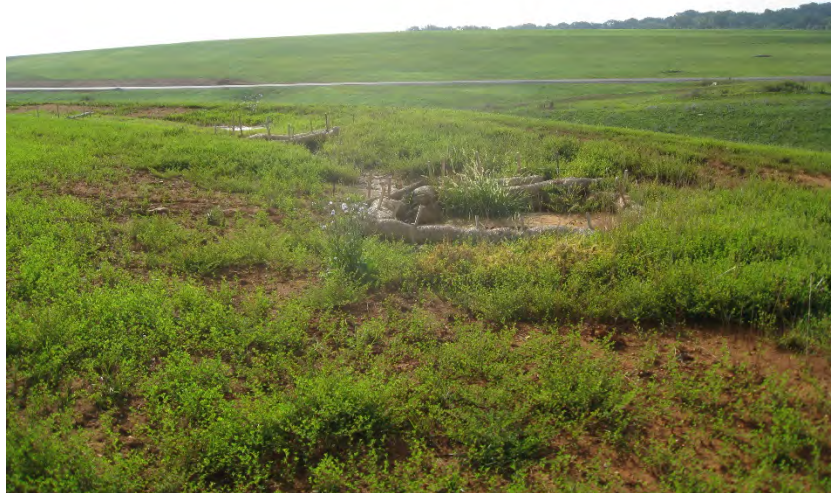
Photo 70
Sta. 290+26 RT
(RW 5L-23R)
Structure 600 Ditch
Project 2

Structure 600 ditch.
Recommend stabilizing remaining bare areas.

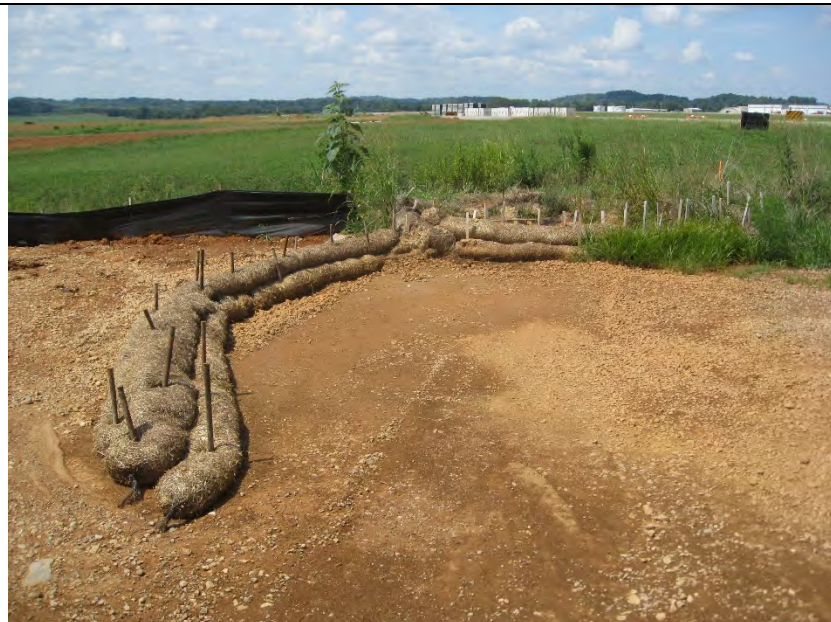
Photo 71
Sta. 284+59
(RW 5L-23R)
Structure 600
Project 3

Structure 600.
Sediment recently removed and sediment tubes repaired.

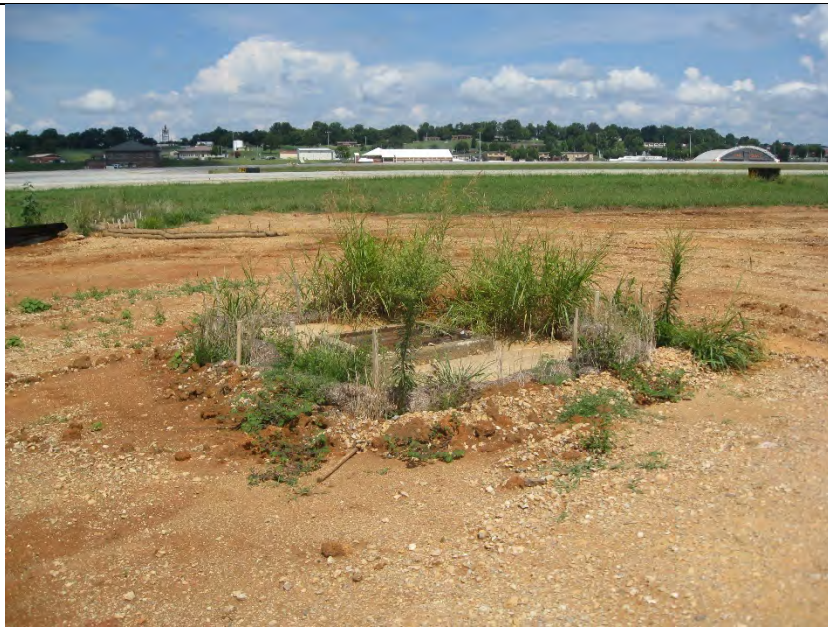
Photo 72
(RW 5L-23R)
Project 3

Existing structure adjacent to crushing operations.
Additional sediment tubes recently added.

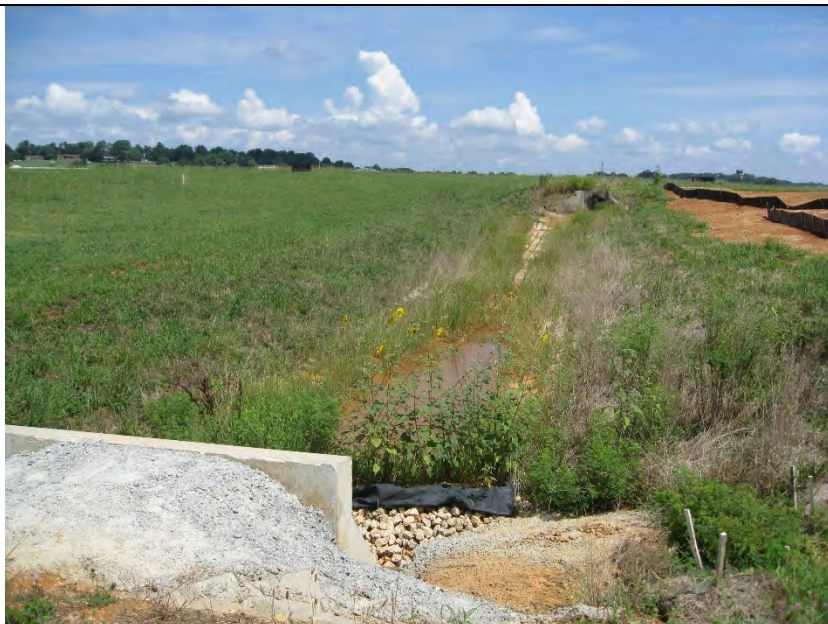
Photo 75
(RW 5L-23R)
Project 3

Silt fence above North Lateral Ditch at stone stockpile area.
Silt fence toppled from recent storm events.
Recommend repairing silt fence.

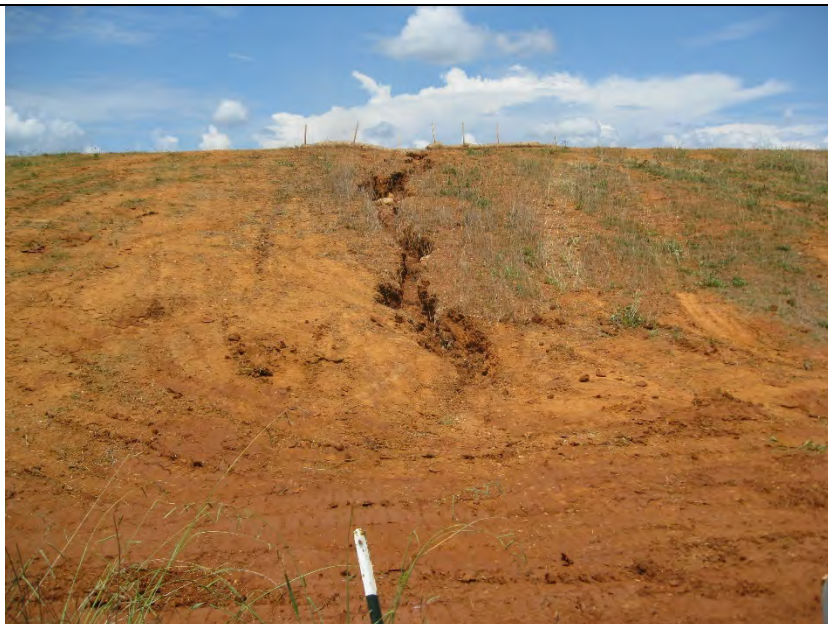
Photo 81
Sta. 32+50 RT
Proposed Haul Route
Project 3

Haul Route.
Underdrain/French drain recently installed and slope regraded. Recommend tracking slope perpendicular to prevent creation of rills.
Recommend stabilizing slope as soon as practical.

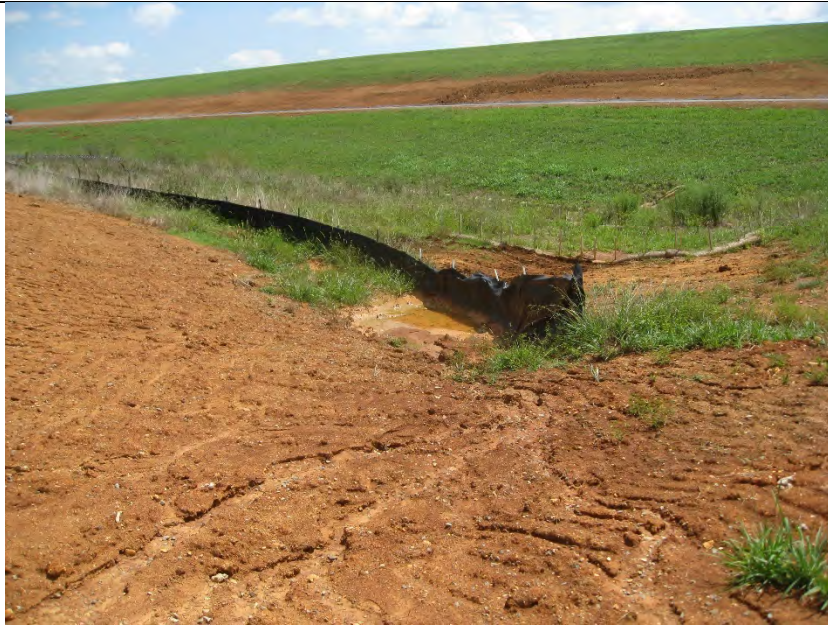
Photo 82
Sta. 302+54
(RW 5L-23R)
Project 2

North Lateral Fill Area
Rills have formed and sediment has migrated to silt fence.
Recommend removing accumulated sediment.
Recommend coordinating with CHA on remediating rills.

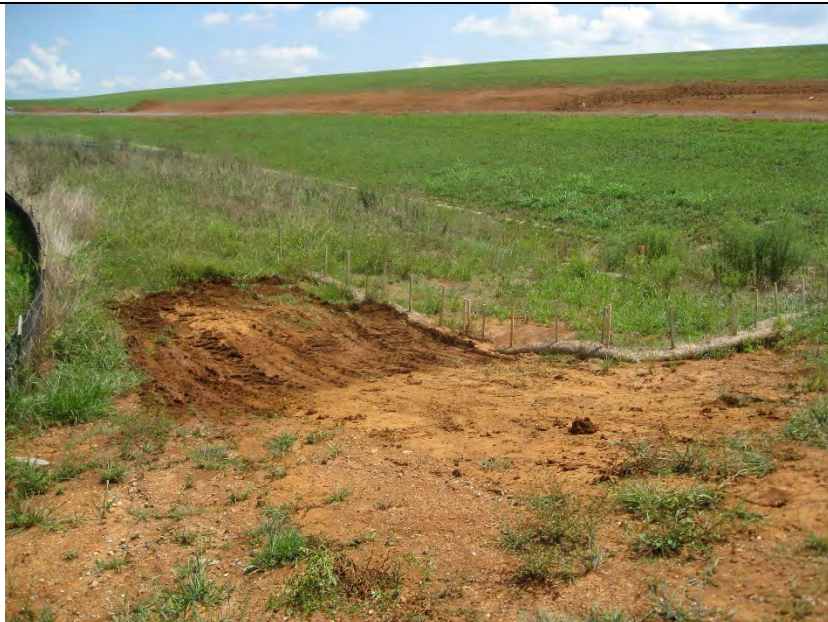
Photo 83
Sta. 302+54
(RW 5L-23R)
Project 2

Above North Lateral Endwall 100.
Sediment recently removed.
Recommend stabilizing bare areas.

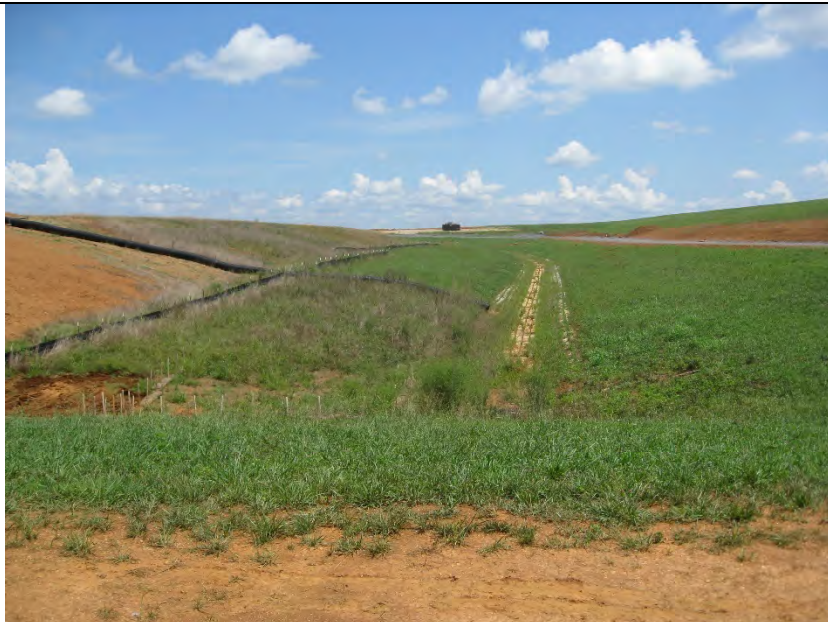
Photo 85
Sta. 302+54
(RW 5L-23R)
Project 2

Soil stockpile area next to haul road at Taxiway B.
Sediment tubes at slope drain have been undermined. Recommend repairing or adding tubes to prevent runoff under the sediment tubes.
Recommend stabilizing all bare areas.

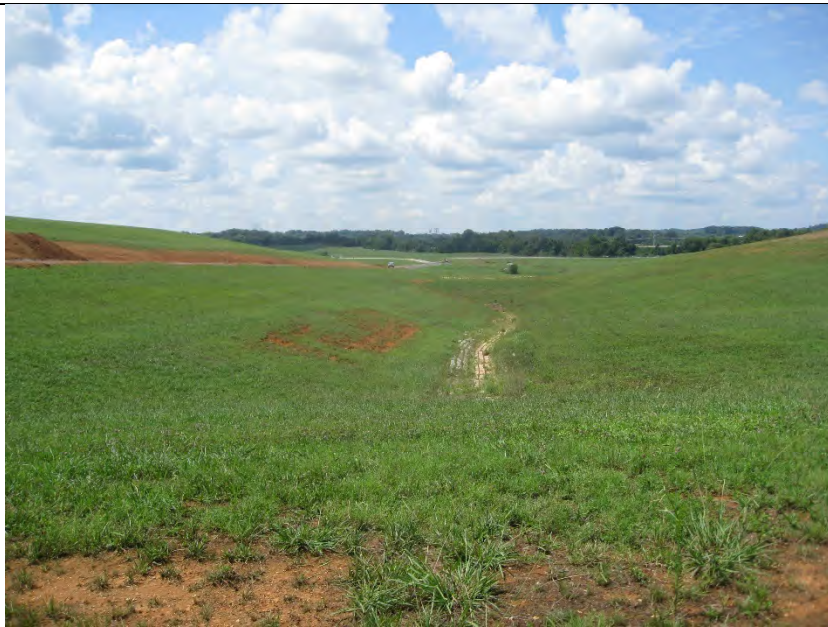
Photo 86
Sta. 302+54 to Sta. 313+50
(RW 5L-23R)
Project 2

North Lateral Endwall 100.
Recommend stabilizing bare areas.

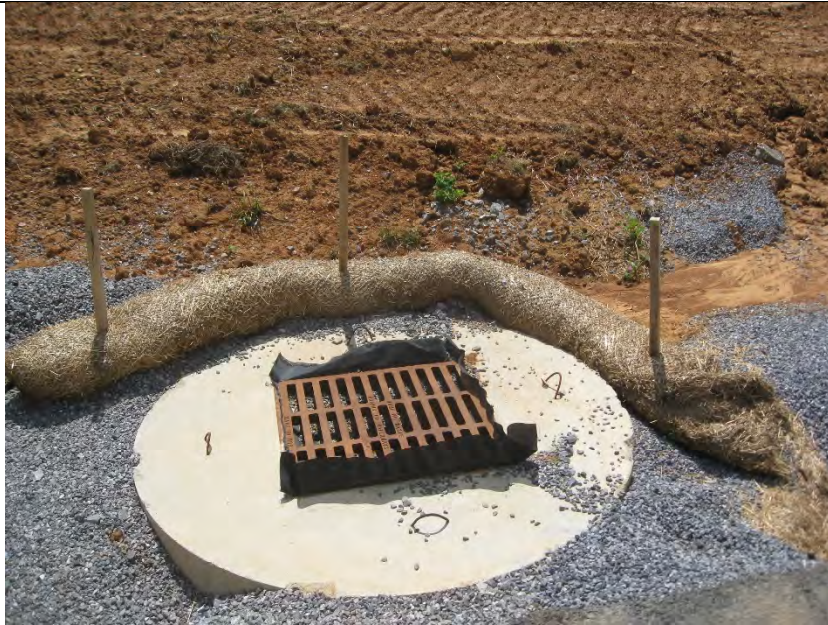
Photo 88
Sta. 29+00 RT
Proposed Haul Route
Project 3

Inlet structure along haul road.
Underdrain/French drain recently installed and slope regraded. Recommend tracking slope perpendicular to prevent creation of rills.
Recommend stabilizing slope as soon as practical.

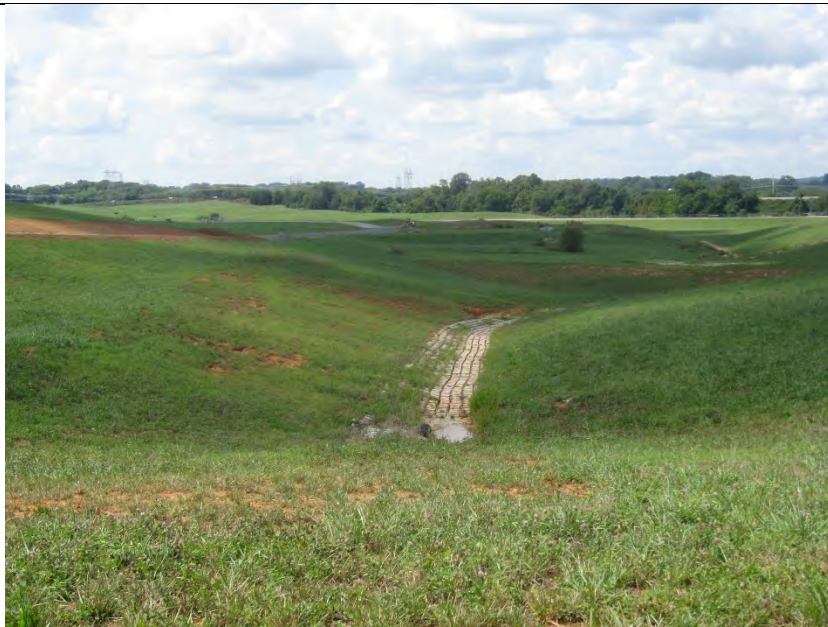
Photo 90
Sta. 297+01
(RW 5L-23R)
Project 2

North Lateral Endwall 104.
