**QUALITY ASSURANCE
MONTHLY SITE
ASSESSMENT REPORT**

Airfield Modernization Program
Runway 5L-23R Reconstruction
Project 2 / Project 3
Project 4 / Repair TWY Lighting
Project 5 / Project 6

QUALITY ASSURANCE SITE ASSESSMENT

AIRFIELD MODERNIZATION PROGRAM RUNWAY 5L-23R RECONSTRUCTION

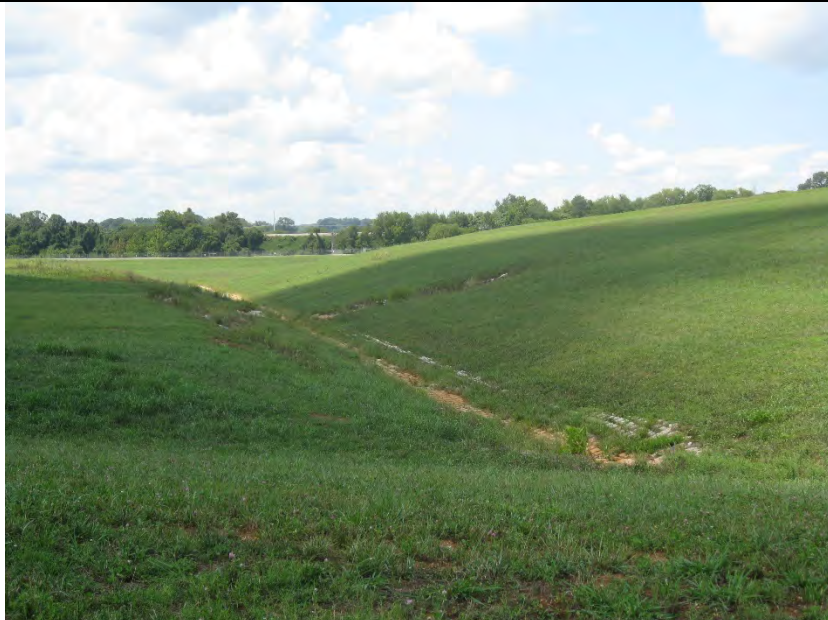
Photo 93
Sta. 292+08
(RW 5L-23R)
Project 2

North Lateral Endwall 108.

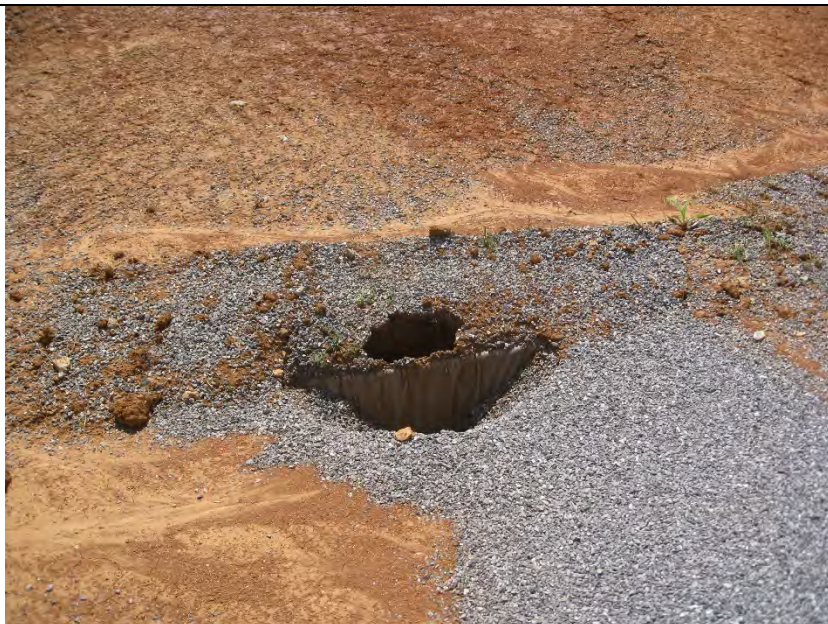
Photo 95
Sta. 15+50 RT
Proposed Haul Route
Project 3

Inlet structure along haul road.
Underdrain/French drain recently installed and slope regraded. Recommend tracking slope perpendicular to prevent creation of rills.
Recommend stabilizing slope as soon as practical.

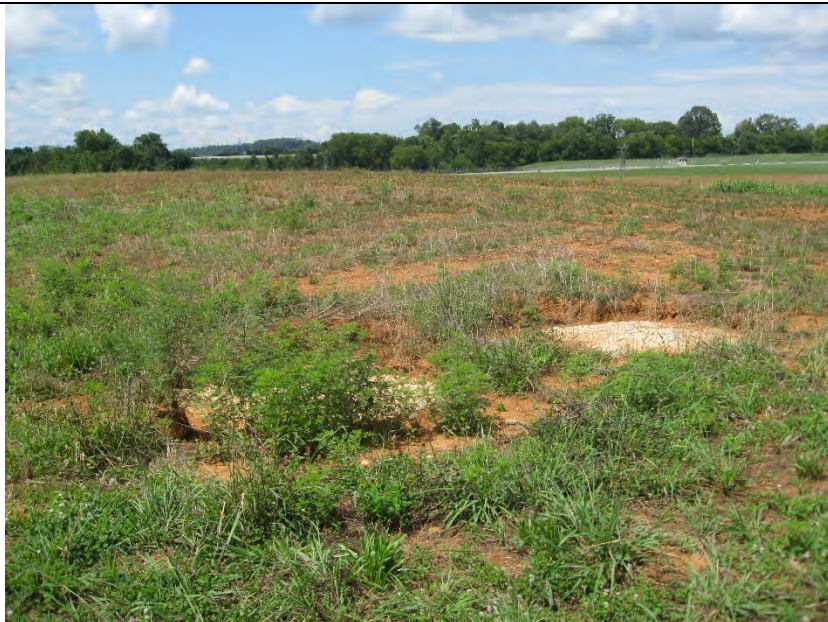
Photo 97
Sta. 284+00 LT
(RW 5L-23R)
Project 2

Existing vault at old Liberty street.
Construction fallout present. Recommend coordinating with CHA on remediation.

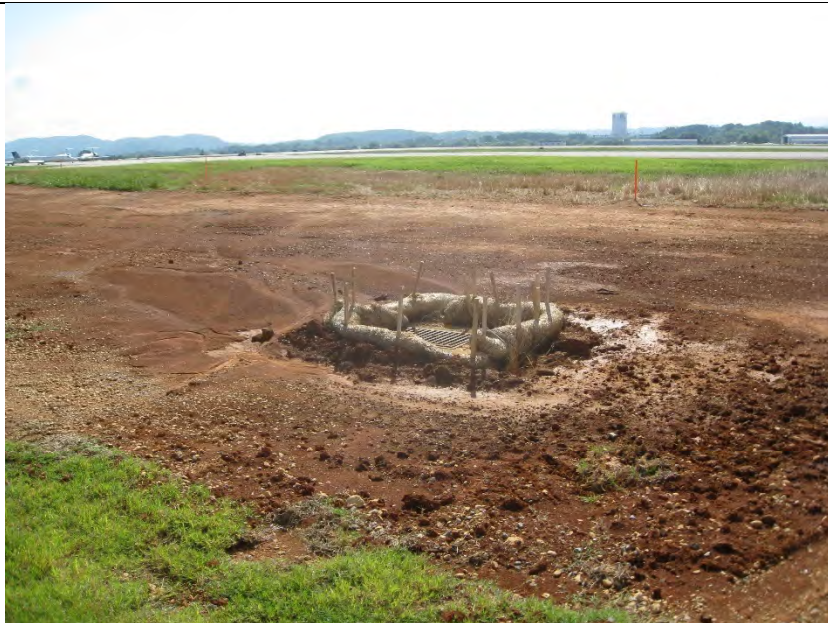
Photo 99
(Repair TWY Lighting)

Fill area adjacent to Liberty Street from Taxiway shoulder removal.
Sediment has migrated to silt fence. Recommend removing accumulated sediment.

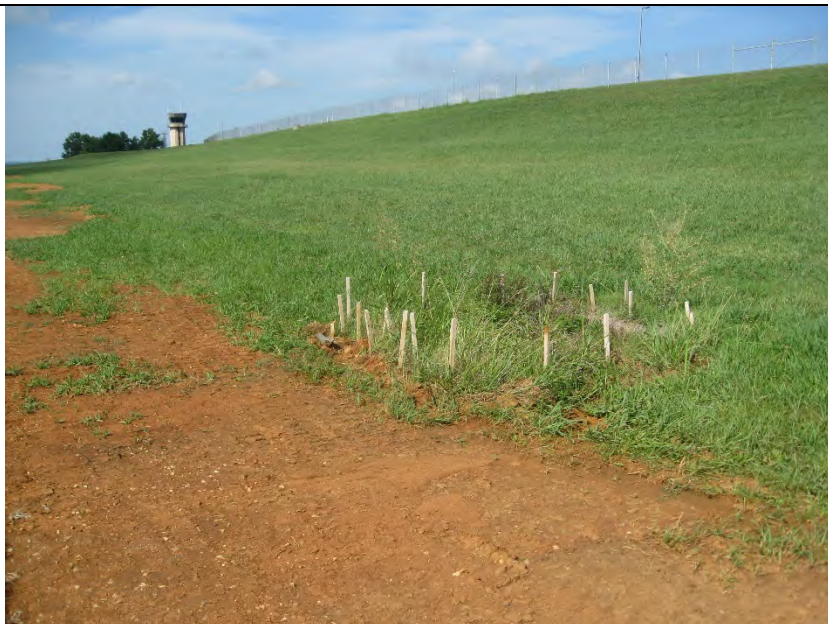
Photo 101
(Repair TWY Lighting)
Existing Structure

Existing structure south of Taxiway G.
Recommend stabilizing bare areas.

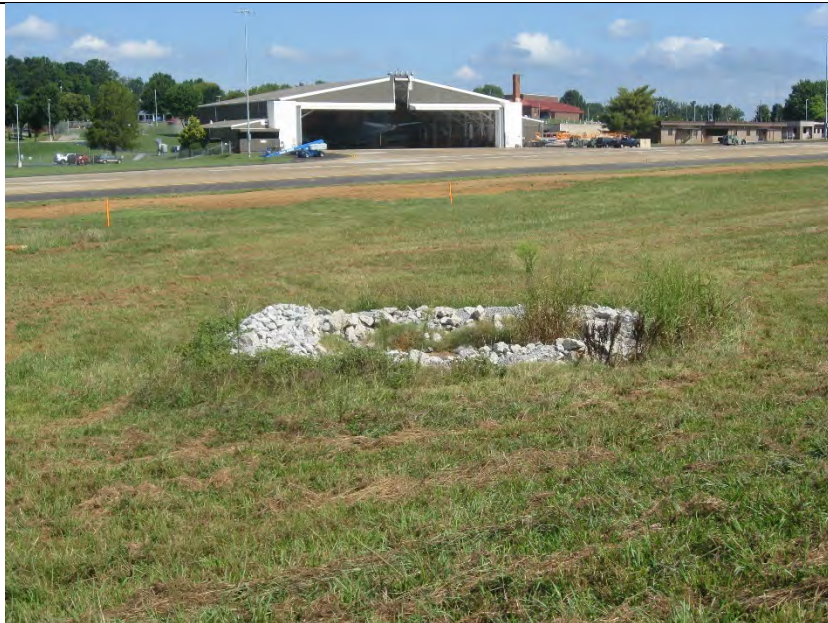
Photo 103
(Repair TWY Lighting)

Sod establishing along Taxiway G.
Recommend stabilizing remaining bare areas.
