QUALITY ASSURANCE MONTHLY SITE ASSESSMENT REPORT

Airfield Modernization Program
Runway 5L-23R Reconstruction
Project 2 / Project 3
Project 4 / Repair TWY Lighting
Project 5 / Project 6

QUALITY ASSURANCE SITE ASSESSMENT

10/29/2020

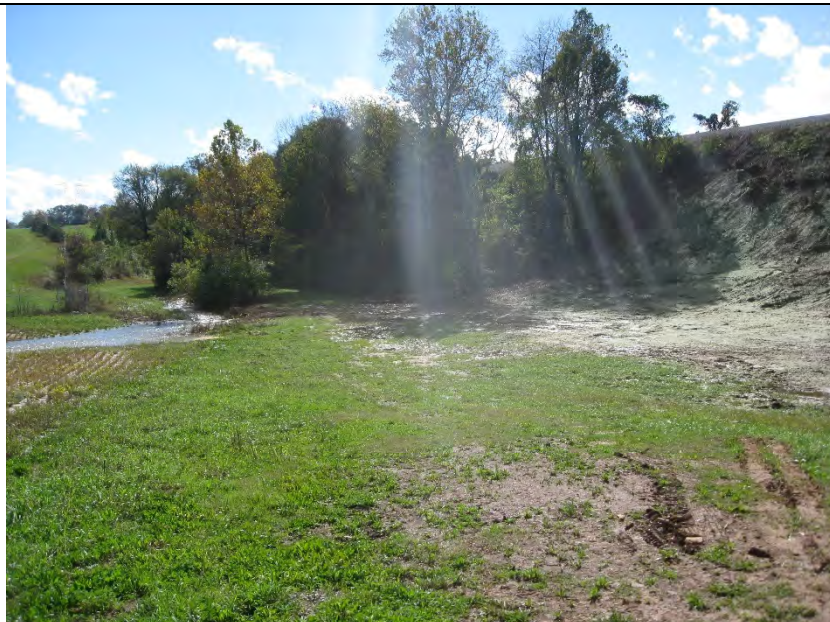
Photo 1
Sta. 111+56 RT
(Line LB)
NLET 01
Project 2

North Lateral End Treatment 01 (Outfall A).
Clear flow observed.

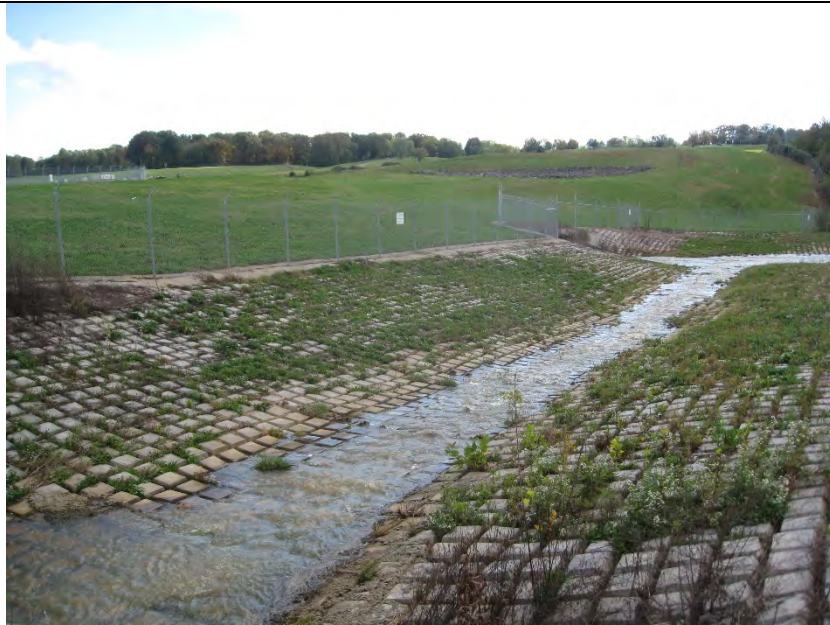
Photo 2
Sta. 111+82 LT
(Line LB)
NLET 02
Project 2

Main outfall to Lackey Creek. This section of the site was inaccessible at time of inspection.

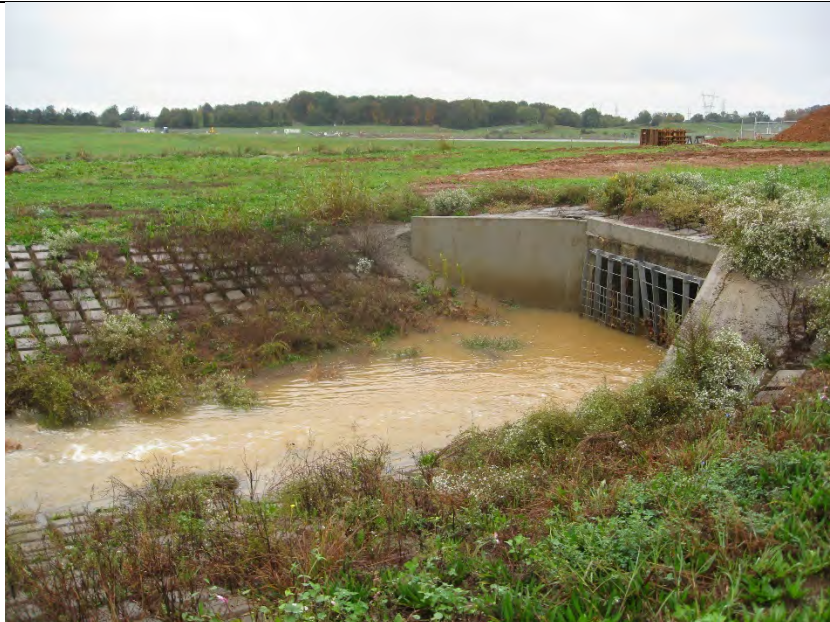
Photo 3
Sta. 114+00
(Line LB)
Project 2

Guard Lateral End Treatment 02.
This section of the site was inaccessible at time of inspection.

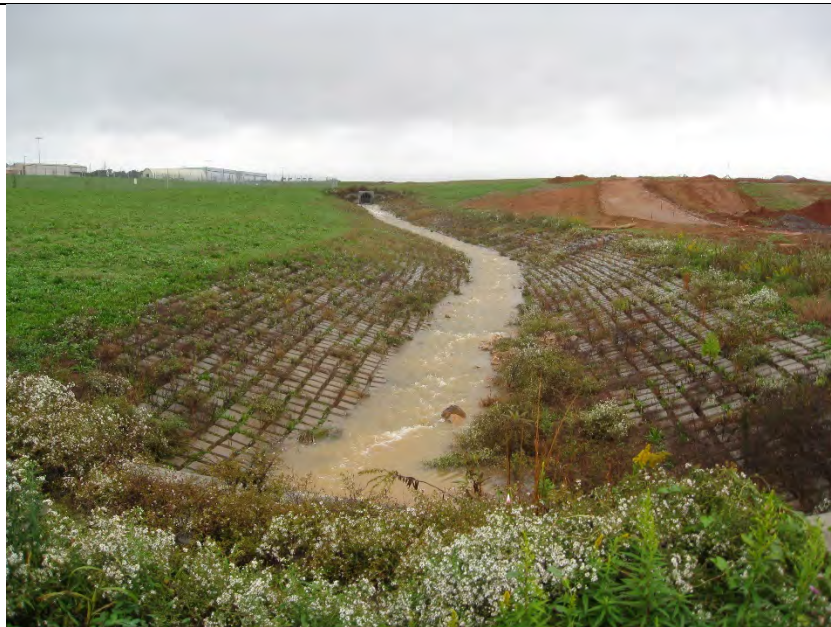
Photo 4
Sta. 117+00
(Line LB)
Project 2

Guard Lateral End Treatment 01.
Color contrast present at time of inspection.

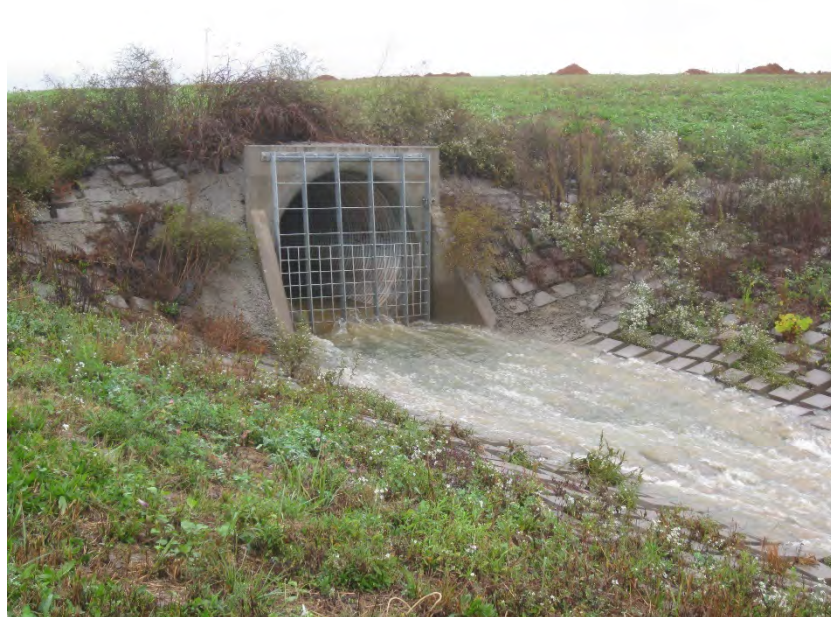
Photo 5
Sta. 117+00
(Line LB)
Project 2

Guard Lateral Ditch (Outfall B).
Color contrast present at time of inspection.

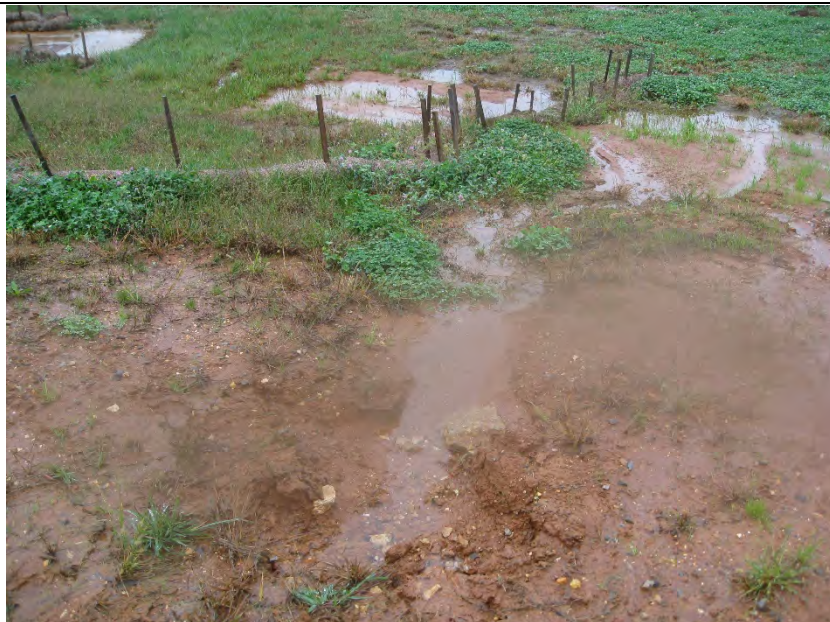
Photo 9
Sta. 298+71 LT
(RW 5L-23R)
Structure 116
Project 3

Structure 116.
Recommend removing accumulated sediment and immediately stabilizing bare areas to reduce the probability of future erosion issues (see photos #10 and #111 below).

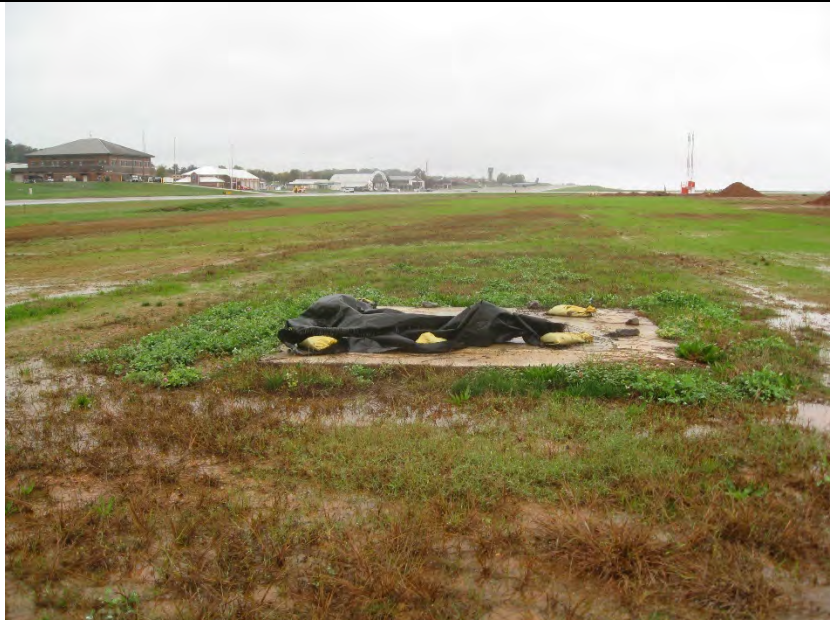
Photo 11
Sta. 298+71 LT
(RW 5L-23R)
Structure 116
Project 3

Above Structure 116 on Taxiway G2.
Recommend repairing rills and stabilizing bare areas.

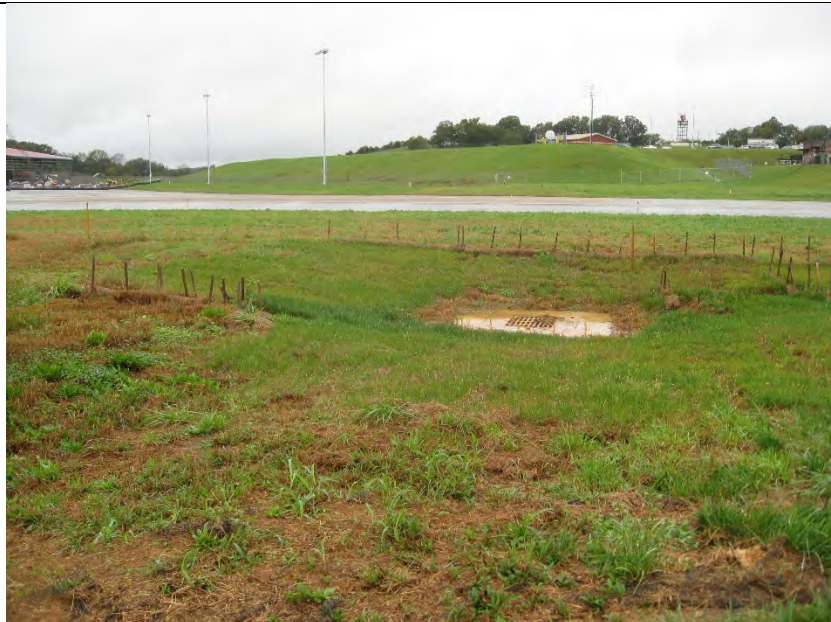
Photo 13
Sta. 303+36 LT
(RW 5L-23R)
Structure 12
Project 3

Structure 12.
Recommend removing sediment tubes.

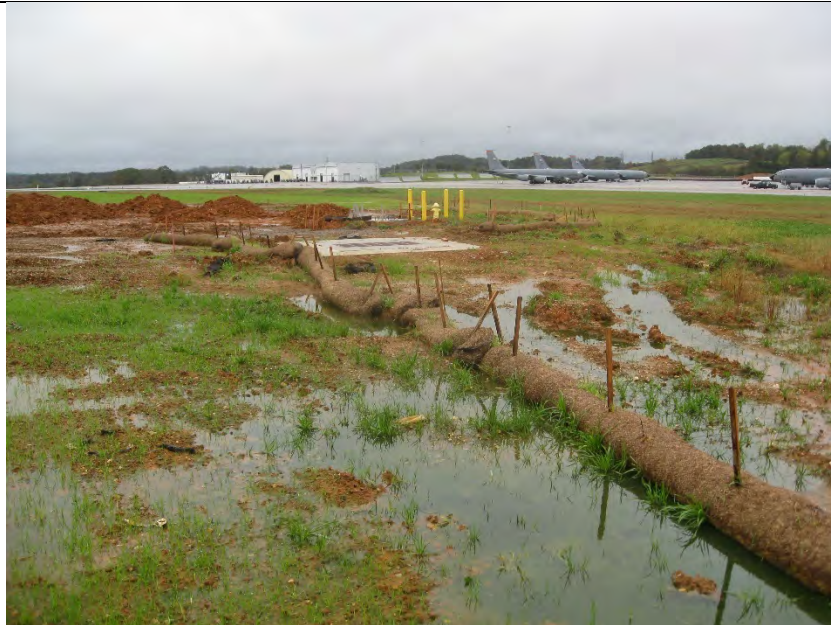
Photo 14
Sta. 310+04 LT
(RW 5L-23R)
Structure 10
Project 3

Structure 10.
Bare areas above structure have been stabilized, recommend removing all sediment tubes.

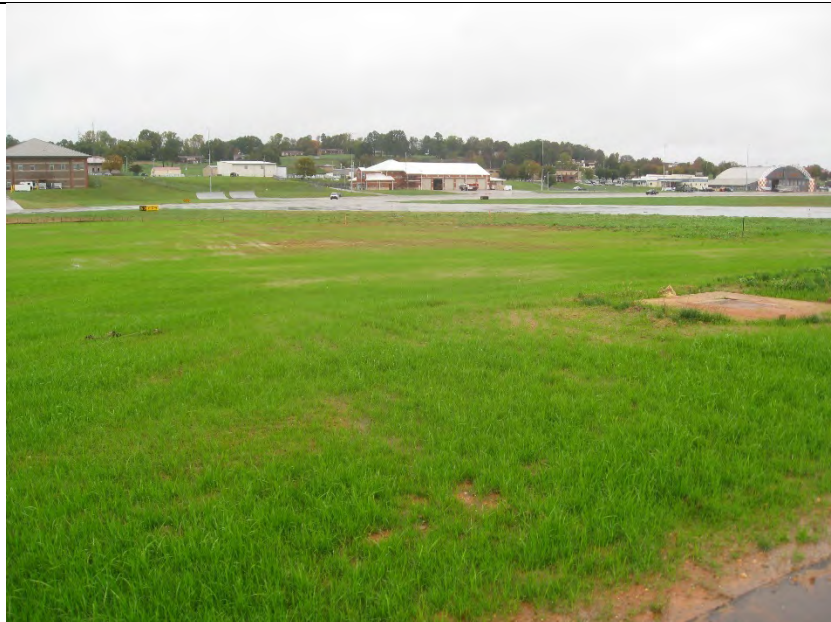
Photo 15
Sta. 310+00 LT
(RW 5L-23R)
Project 3

Structure 112 and Concrete Washout Area.
Site of recently demolished concrete batch plant.
Bare areas recently stabilized.

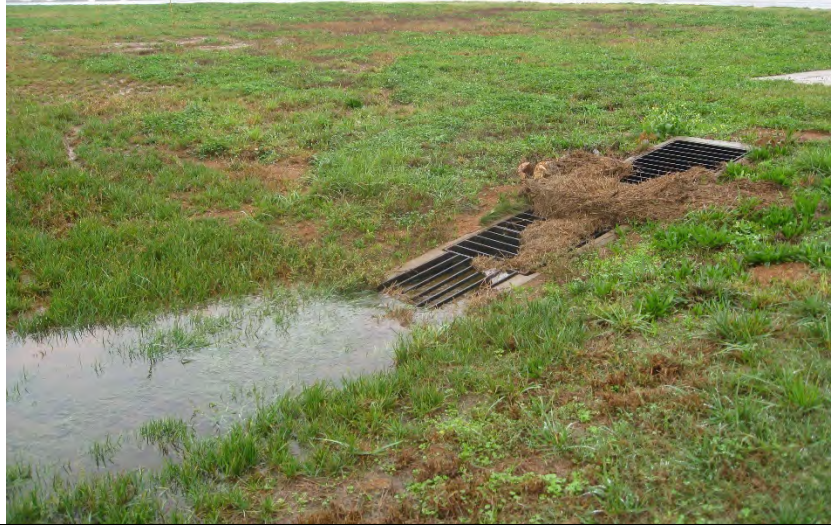
Photo 16
Sta. 310+00 LT
(RW 5L-23R)
Project 3

Site of recently demolished concrete batch plant.
Bare areas recently stabilized. Grass establishing.

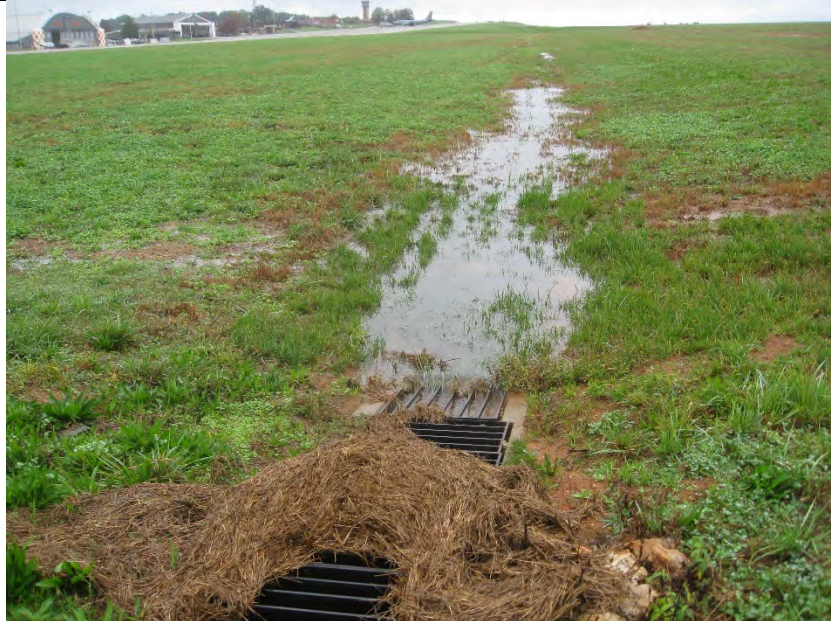
Photo 17
Sta. 314+48 LT
(RW 5L-23R)
ES Endwall 108
Project 3

Enhanced Swale Endwall 108.
Rills never repaired.
Recommend repairing long-standing rills and immediately stabilizing bare areas (see next photo).

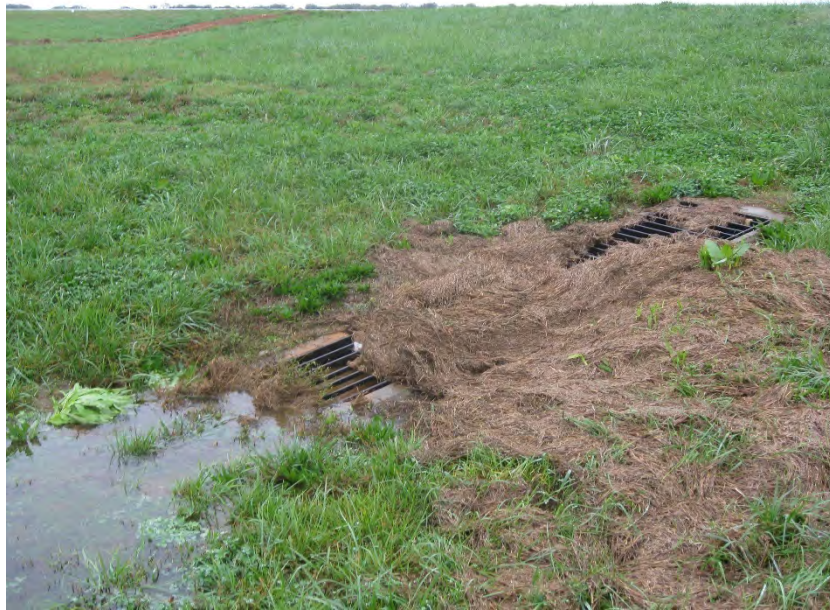
Photo 18
Sta. 314+48 LT
(RW 5L-23R)
ES Endwall 108
Project 3

Enhanced Swale Endwall 108.
Rills never repaired.
Recommend repairing long-standing rills and immediately stabilizing bare areas.

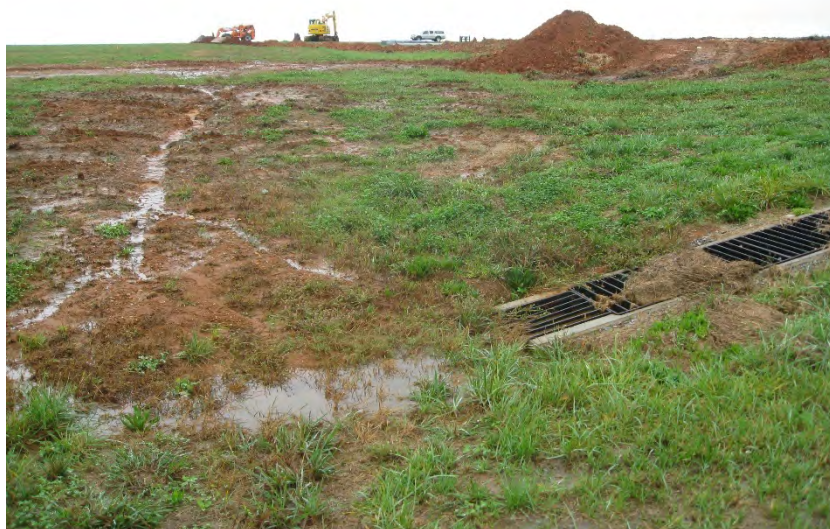
Photo 23
Sta. 341+50 LT
(RW 5L-23R)
Between ES Endwall 104 and 102
Project 3

Repaired construction fallouts recently stabilized.

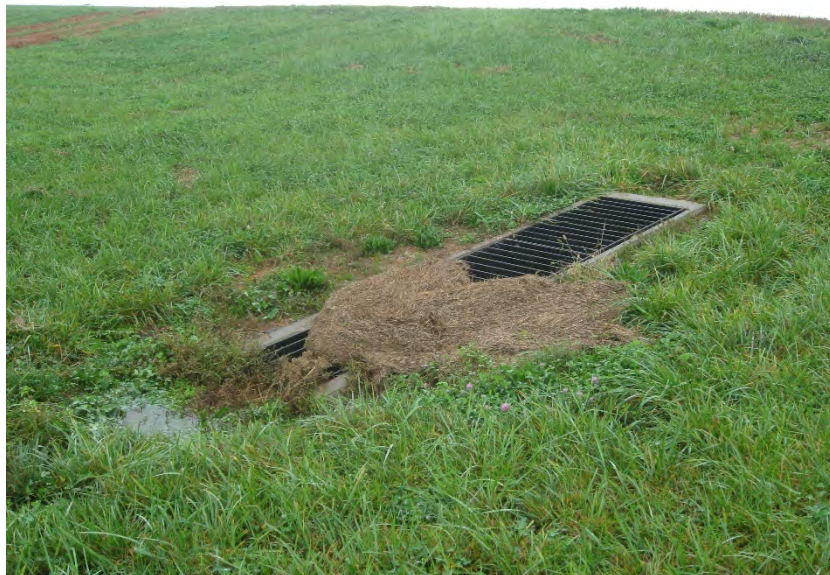
Photo 25
Sta. 347+31 LT
(RW 5L-23R)
ES Endwall 102
Project 3

Enhanced Swale Endwall 102
Recommend repairing long-standing rills.
Recommend coordinating with CHA on possible use of matting to help stabilization.
Recommend stabilizing all remaining bare areas.
Construction activities are per Project 6 (EUTAW).

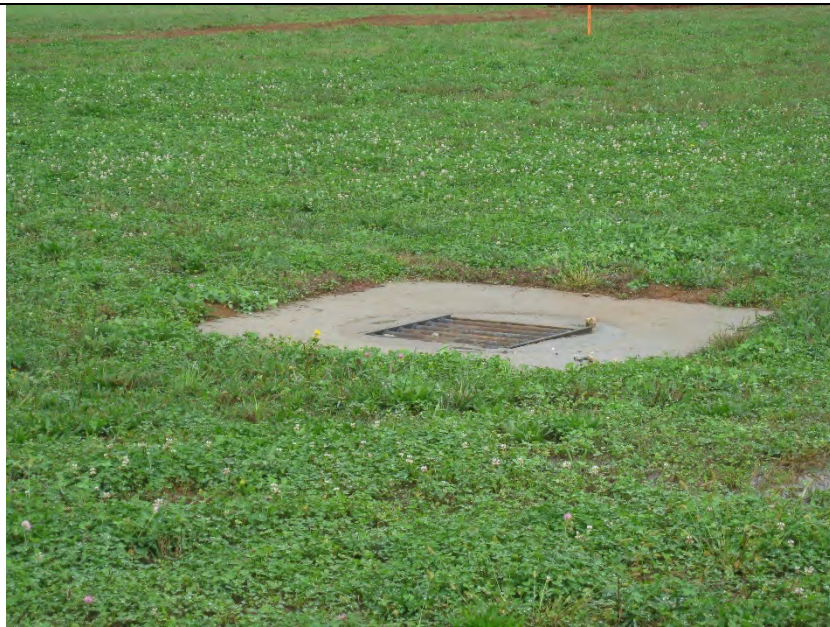
Photo 28
Sta. 361+39 LT
(RW 5L-23R)
Structure 100
Project 3

Structure 100.

Bare areas are mostly covered in stone and are considered stable at the time of inspection.

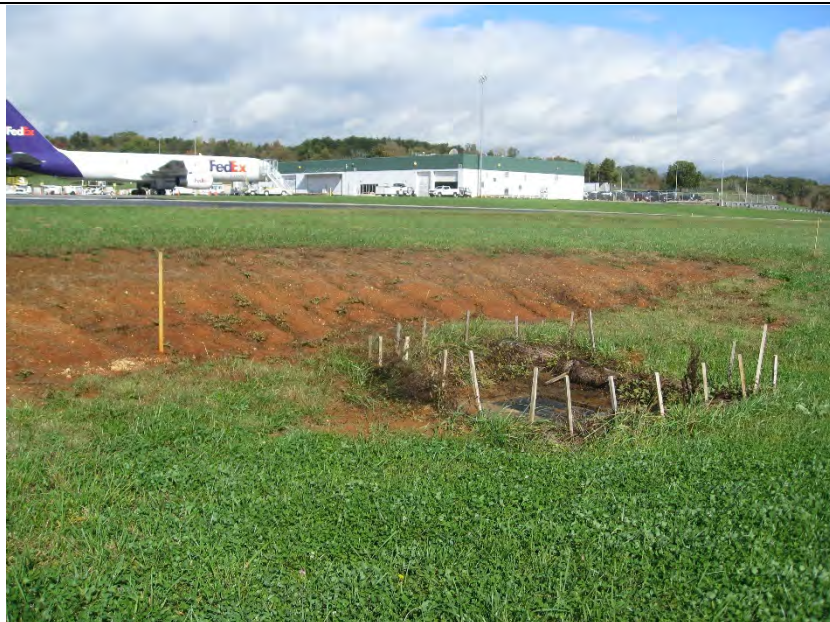
Photo 31
Sta. 369+11 LT
(RW 5L-23R)
Existing Structure
Project 2

Existing Structure.
Recommend stabilizing long-standing bare areas.
Recommend repairing damaged sediment tubes.
Construction activities are per Project 6 (EUTAW)

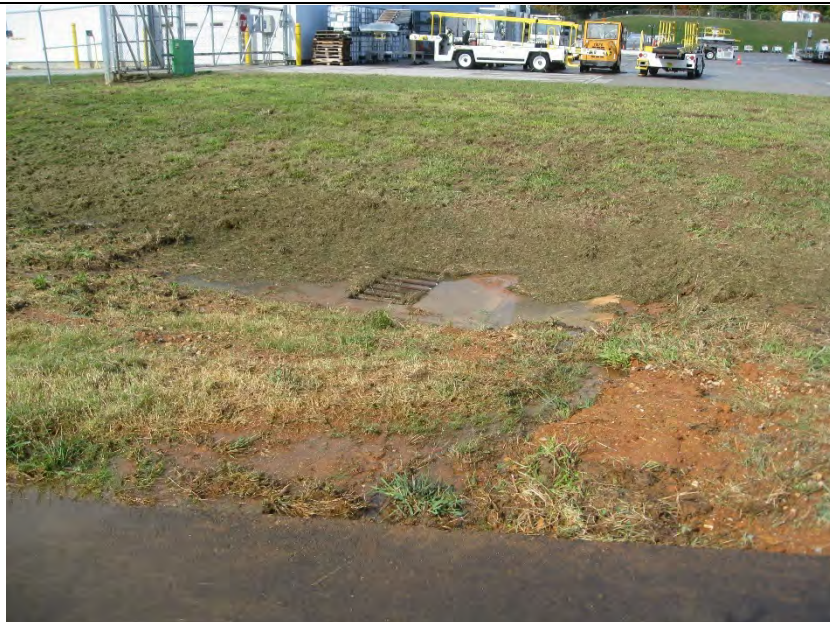
Photo 33
Sta. 677+00 RT
(RW 5L-23R)
Existing Structure
Project 4

Existing structure south of Taxiway "G" (see previous photo).
Recommend removing long-standing sediment from behind sediment tubes and on top of structure. Recommend replacing sediment tubes.

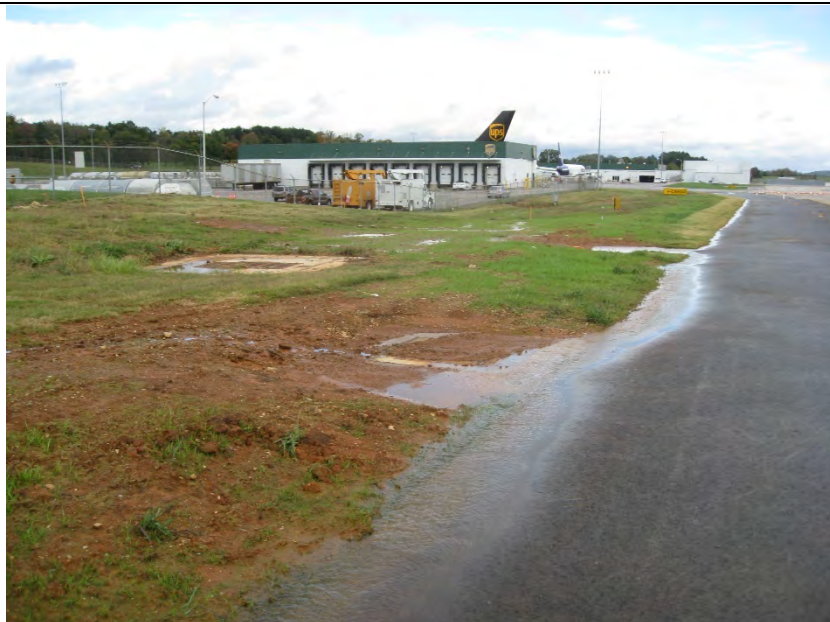
Photo 35
Sta. 676+00 RT
(RW 5L-23R)
Project 4

Structure adjacent to UPS.
Sediment tubes recently removed and not replaced. Area not stable.
Recommend reseeding bare areas.

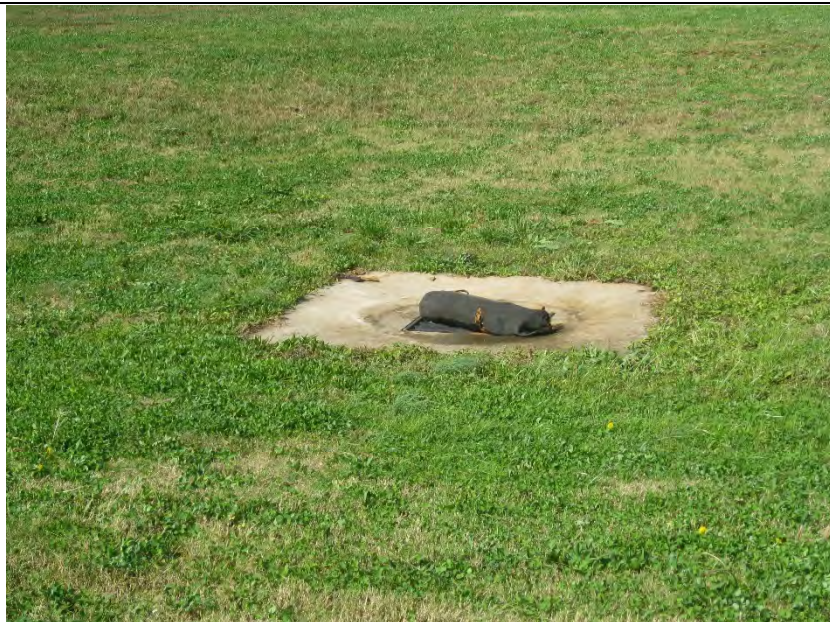
Photo 37
New structure
Project 4

Bare areas recently stabilized.

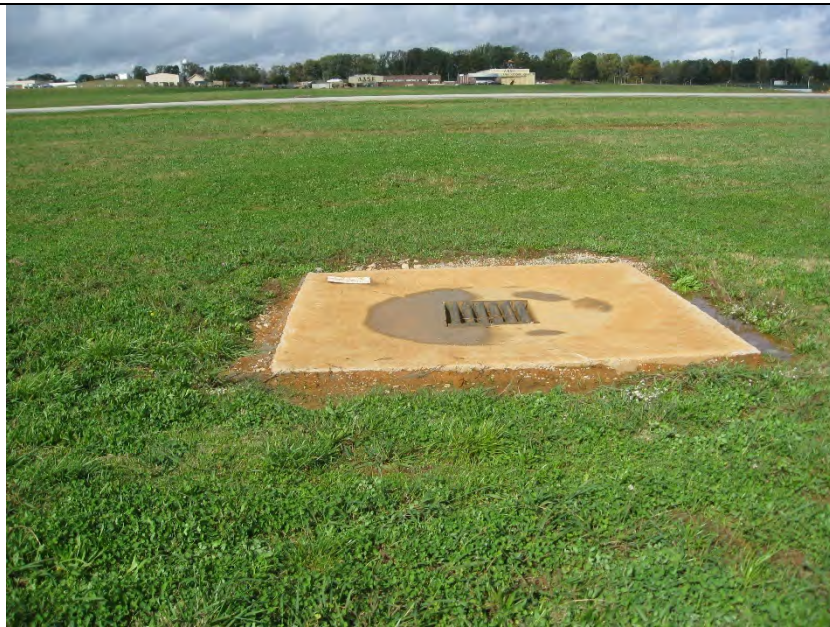
Photo 38
Sta. 366+89 RT
(RW 5L-23R)
Existing Structure
Project 4

Existing Structure adjacent to Outfall C.
Recommend removing old inlet protection.

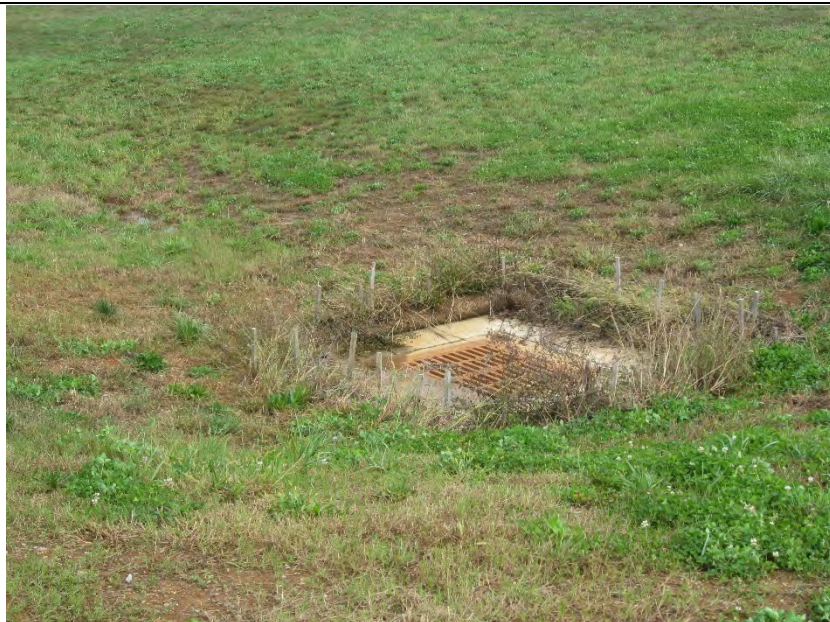
Photo 43
Sta. 362+02 LT
(RW 5L-23R)
Structure 400
Project 4

Structure 400.
Bare areas never stabilized and continue to push sediment onto existing structure.
Recommend stabilizing long-standing bare areas after removing accumulated sediment.

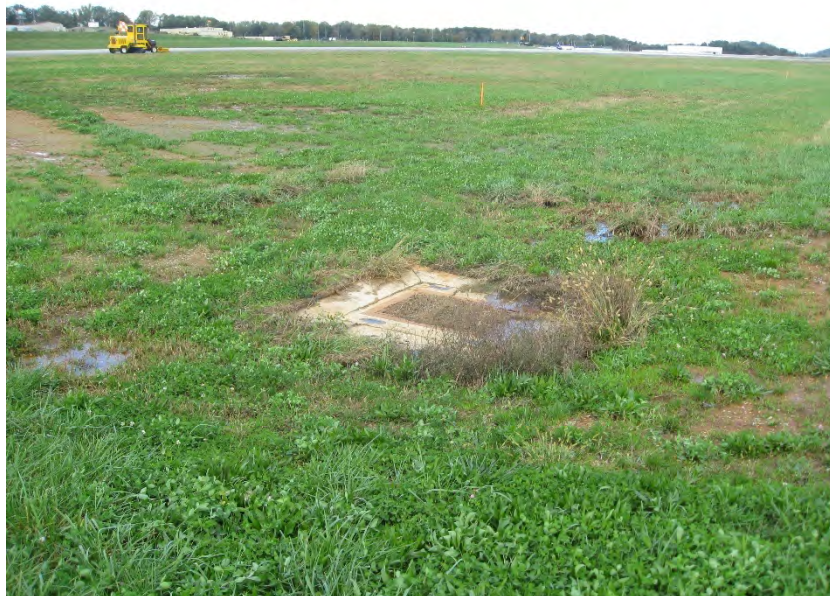
Photo 45
Sta. 347+26 RT
(RW 5L-23R)
Structure 22
Project 4

Structure 22.
Sediment never removed from top of structure.
Recommend removing long-standing sediment from top of structure.

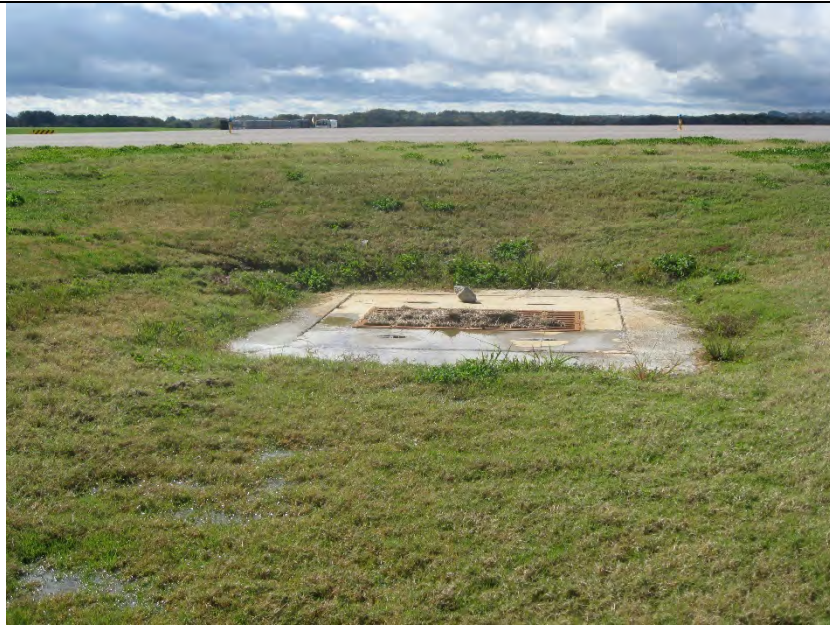
Photo 52
Sta. 321+73 RT
(RW 5L-23R)
Structure 212
Project 3

Structure 212.
Area was never stabilized but erosion control measures were removed.
Recommend adding sediment tubes. Recommend coordinating with CHA on use of matting with seed (or sod) to help achieve stabilization.

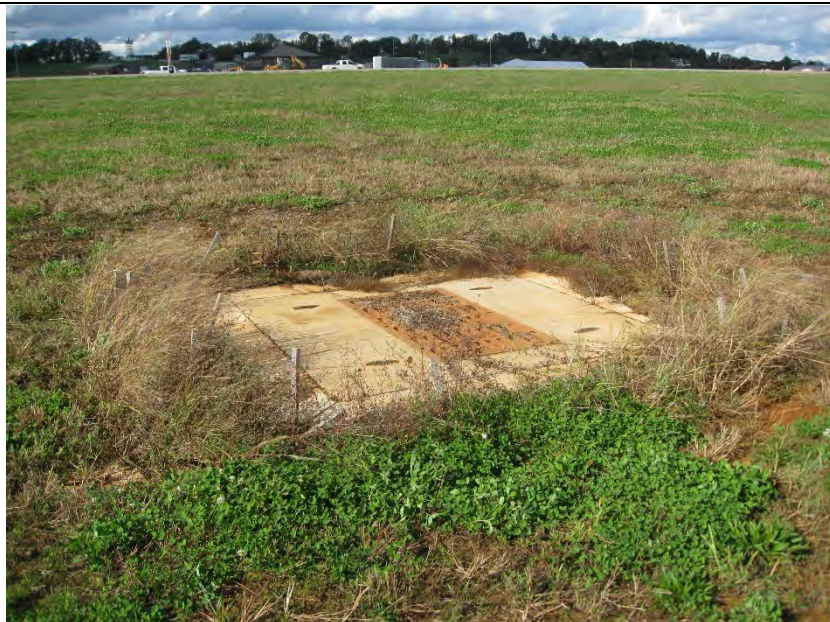
Photo 53
Sta. 314+32 RT
(RW 5L-23R)
Structure 214
Project 3

Structure 214.

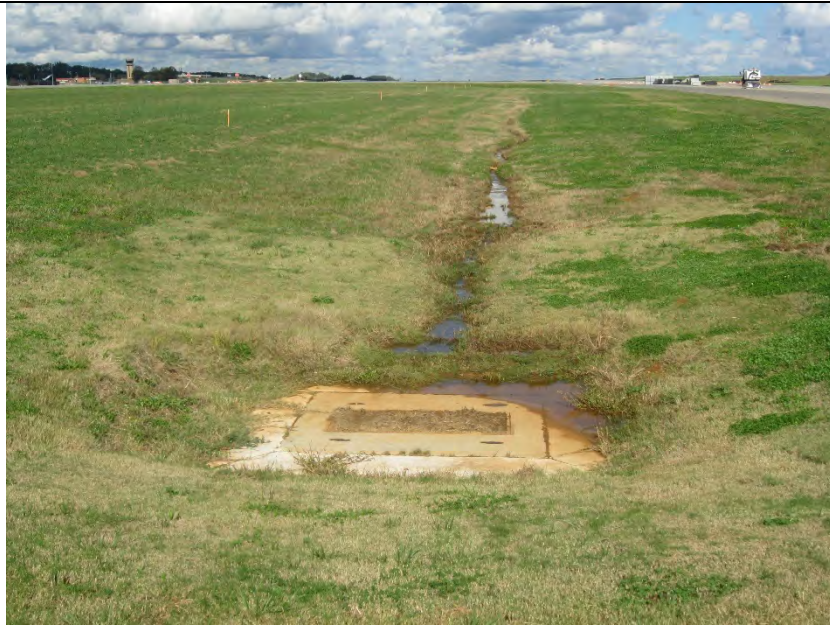
Photo 54
Sta. 307+99 RT
(RW 5L-23R)
Structure 216
Project 3

Structure 216.

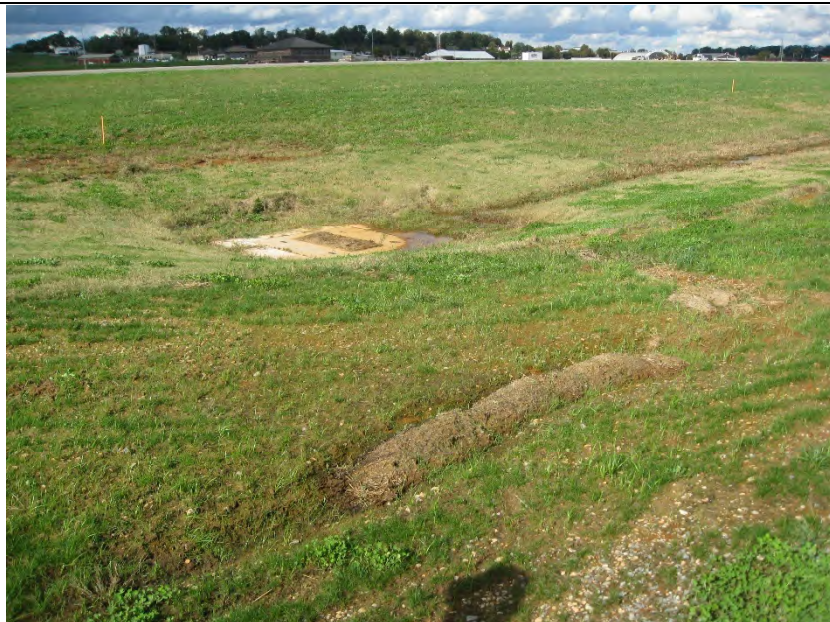
Photo 55
Sta. 301+87 RT
(RW 5L-23R)
Structure 218
Project 3

Structure 218.
Rill above structure continues to erode (see photo below).

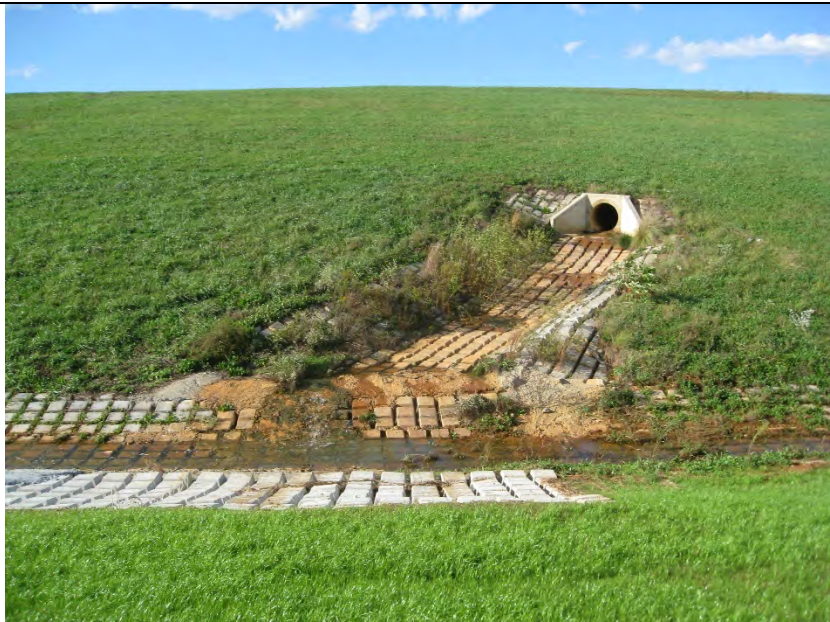
Photo 57
Sta. 296+83 RT
(RW 5L-23R)
Structure 220
Project 2

Structure 220.
Recommend stabilizing remaining bare areas.

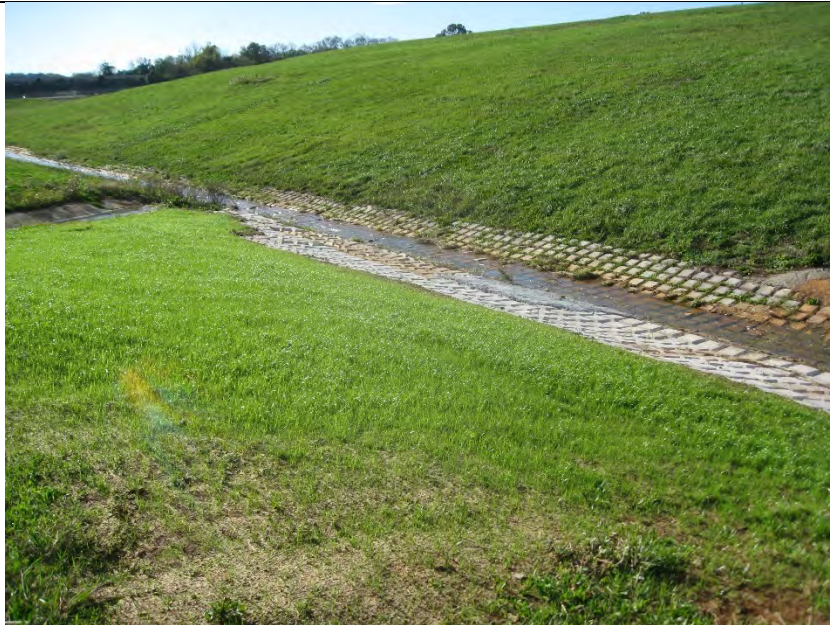
Photo 58
Sta. 288+26
(RW 5L-23R)
Structure 224
Project 2

Structure 224.
Grass established at recently stabilized areas.

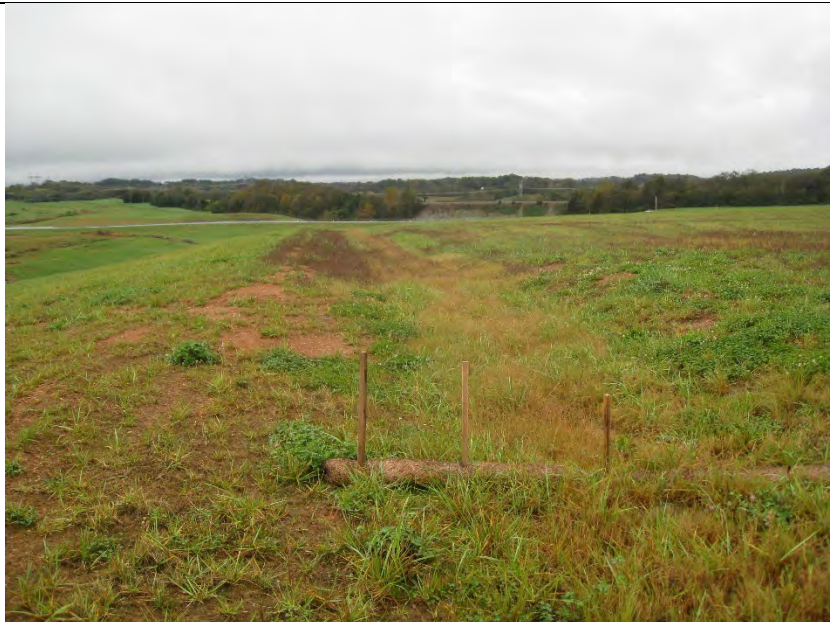
Photo 59
Sta. 288+26
(RW 5L-23R)
Structure 224
Project 2

Below structure 224.
Grass established at recently stabilized areas.

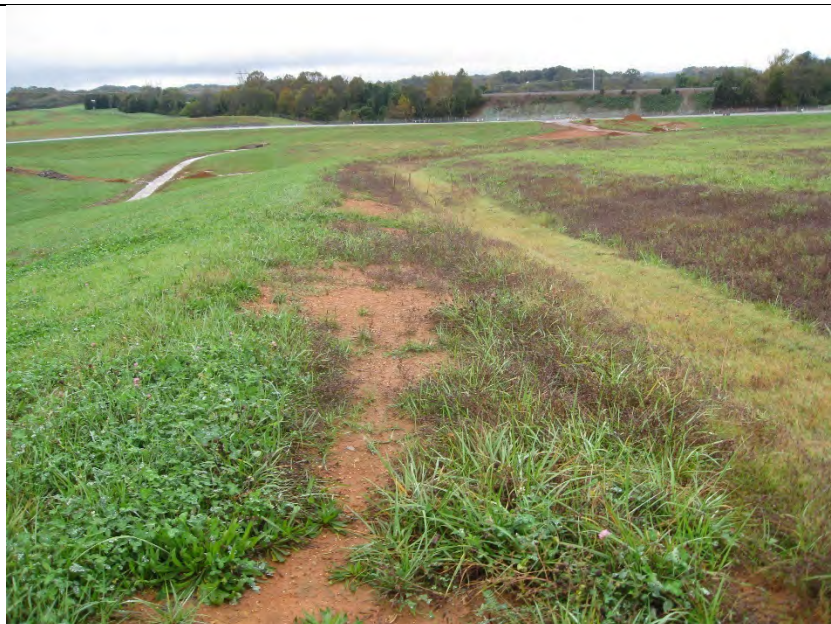
Photo 61
Sta. 290+26 RT
(RW 5L-23R)
Structure 222
Project 2

Structure 222.
Recommend removing inlet protection.
Recommend stabilizing bare areas.

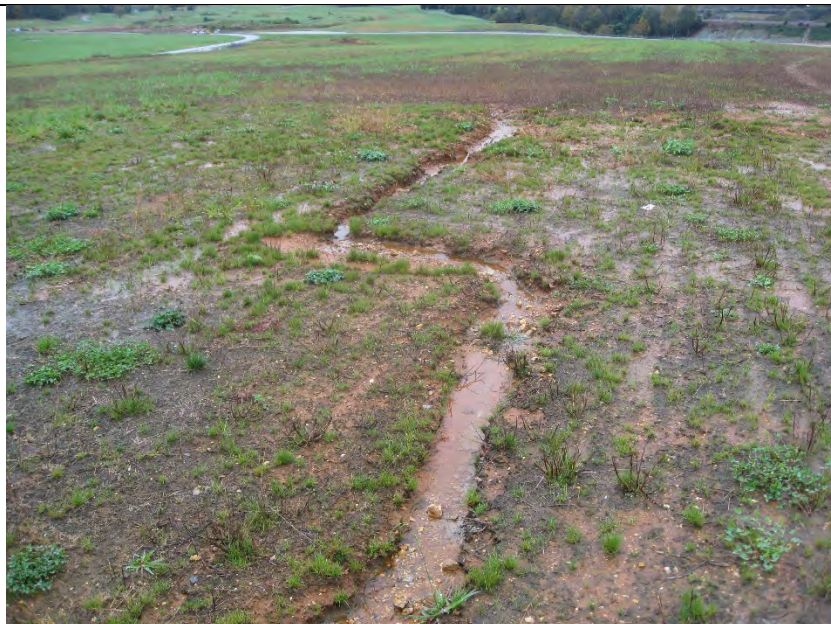
Photo 63
Sta. 284+59
(RW 5L-23R)
Structure 600
Project 3

Structure 600.
Recommend removing inlet protection and stabilizing bare areas.

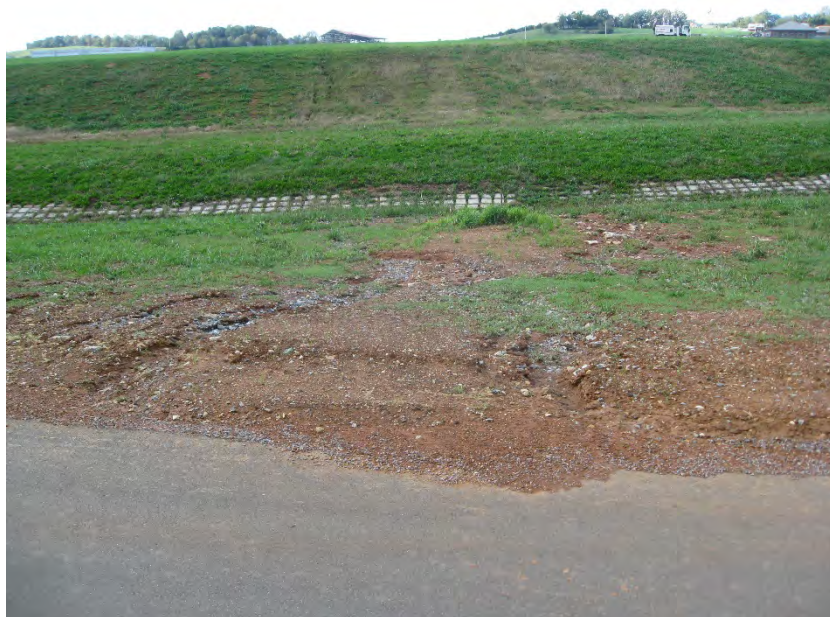
Photo 65
Sta. 37+25 RT
Proposed Haul Route
Project 3

Haul Road.
Due to recent storm events, Rills have formed.
Recommend coordinating with CHA on remediation of rills.

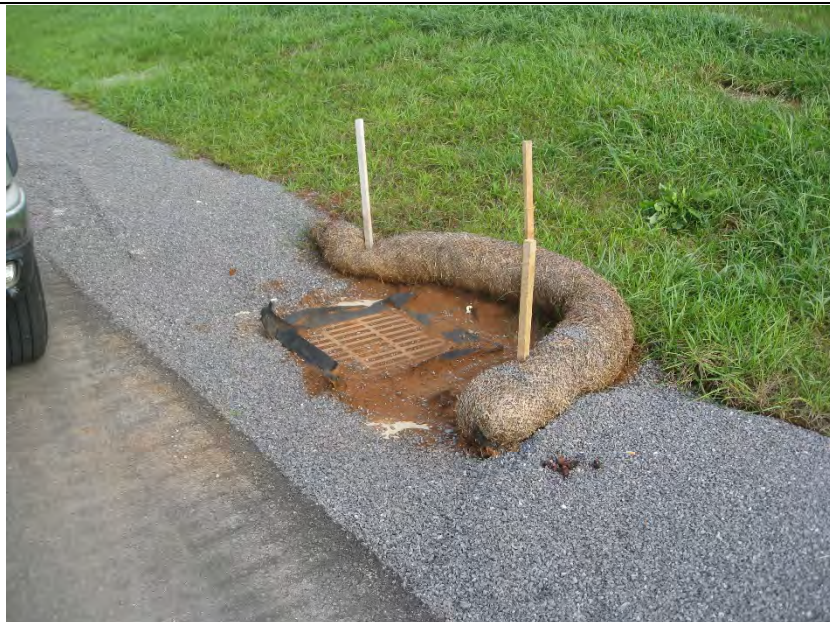
Photo 67
Sta. 37+25 RT
Proposed Haul Route
Project 3

Haul Road.
Recommend removing filter fabric and sediment tubes.

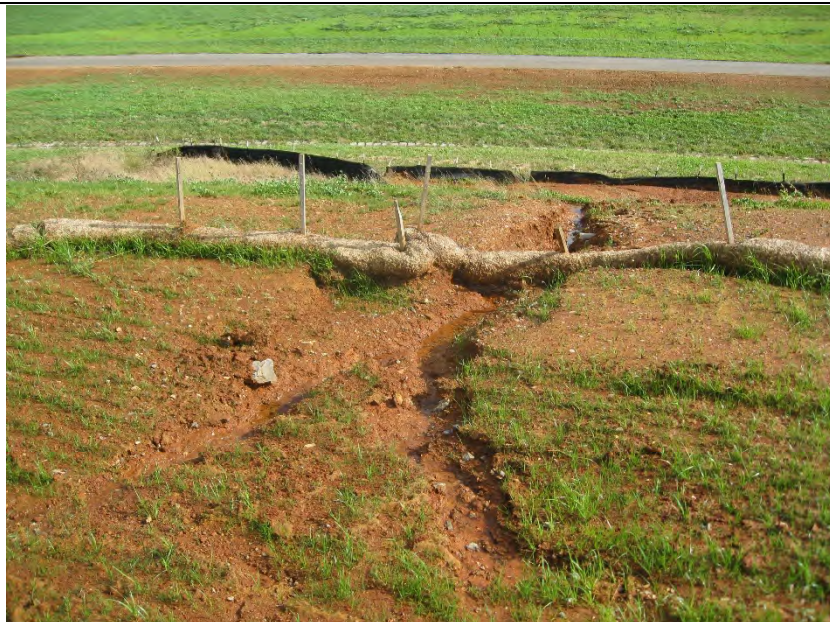
Photo 69
Sta. 32+50 RT
Proposed Haul Route
Project 3

Haul Road.
Recommend repairing rills (including any not pictured) and stabilizing resulting bare areas. Once rills are repaired and slope stabilized, recommend removing filter fabric and sediment tubes from storm structures along Haul Road.

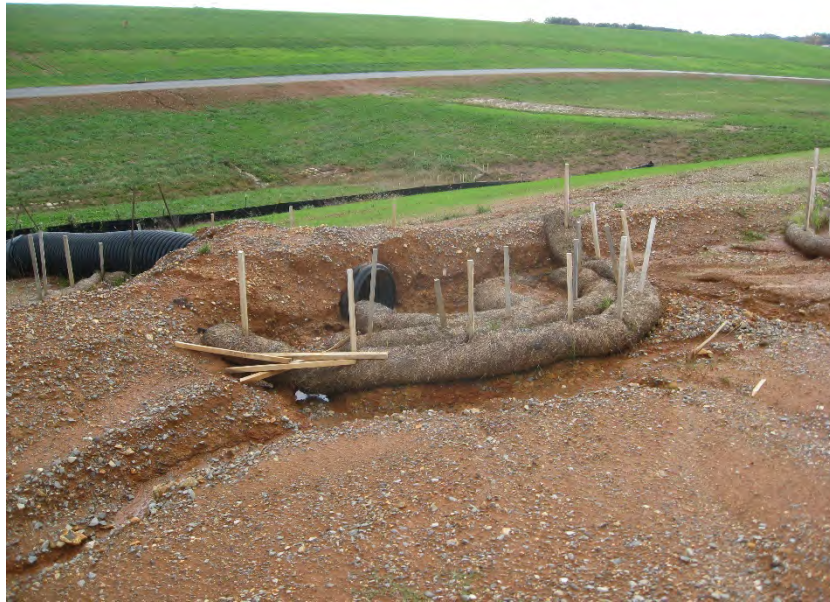
Photo 70
Sta. 302+54
(RW 5L-23R)
Project 3

North Lateral Fill Area
Rills continue to erode. Recommend filling rills, removing sediment and stabilizing bare areas. Recommend adding slope drain at this location.

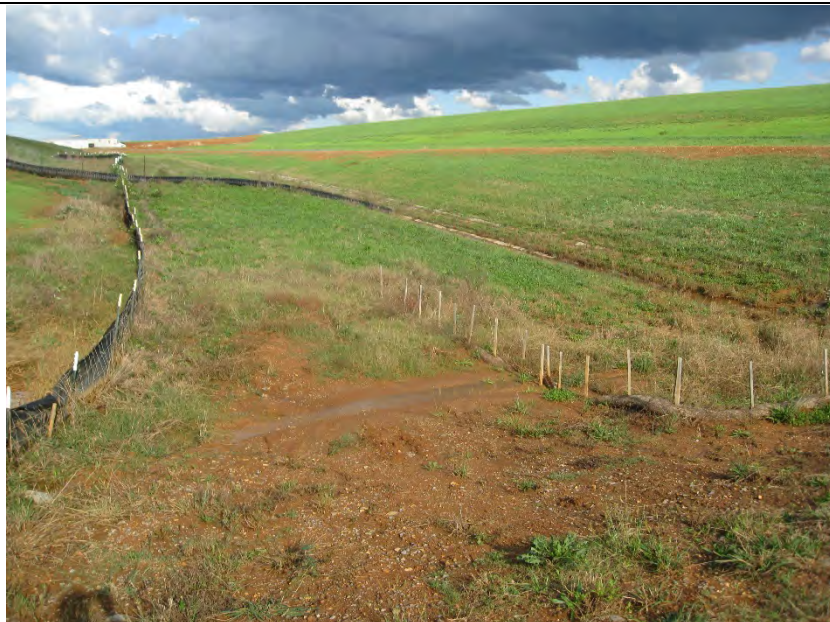
Photo 71
Sta. 302+54
(RW 5L-23R)
Project 3

Soil stockpile area next to haul road at Taxiway B.
Bare area in front of slope drain is full of stone and was never stabilized.
Recommend stabilizing bare area. Undermined sediment tubes never repaired.
Recommend repairing or adding tubes to close gap and capture future sediment before it enters drain.

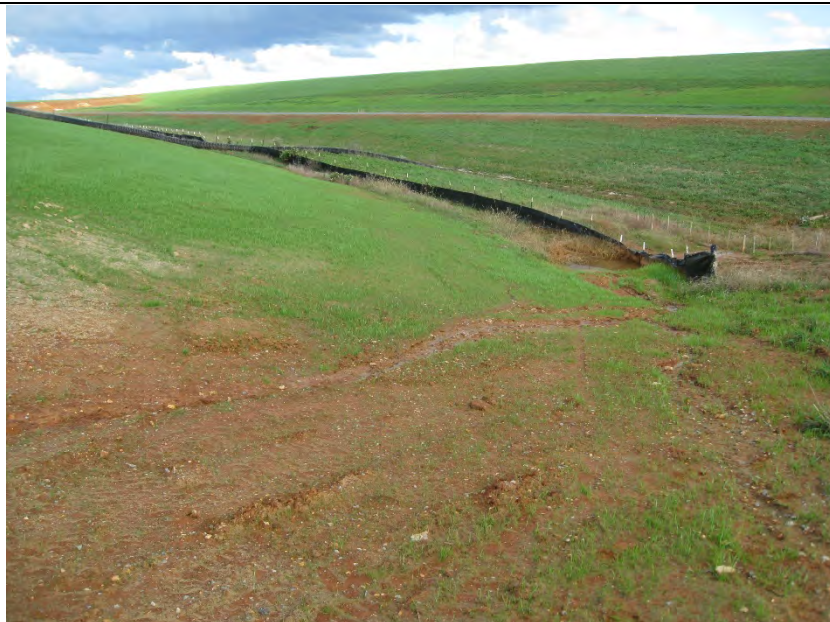
Photo 73
Sta. 302+54
(RW 5L-23R)
Project 3

Above North Lateral Endwall 100.
Sediment has settled in the North lateral ditch.
Recommend removing sediment.
See previous photo.

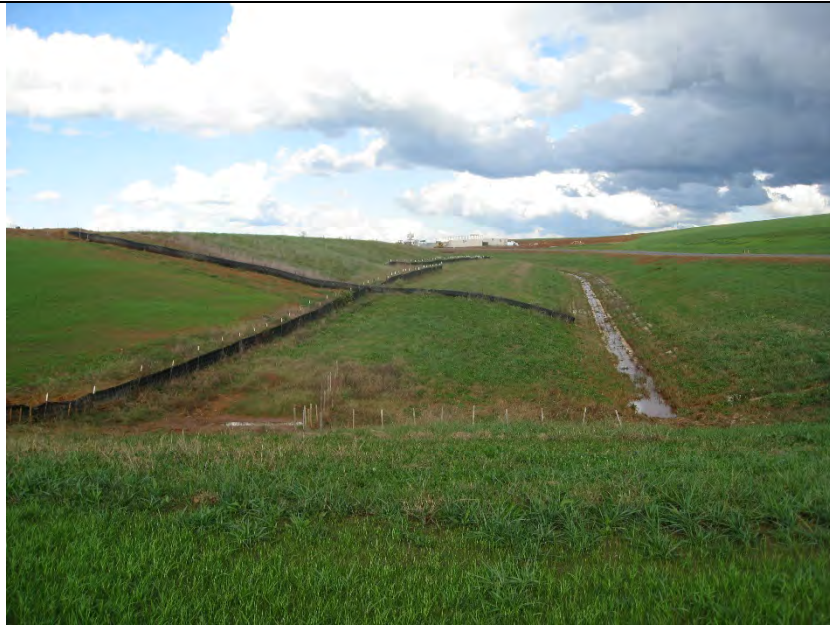
Photo 74
Sta. 302+54
(RW 5L-23R)
Project 3

Above North Lateral Endwall 100.
Slopes recently stabilized.
Rills have formed and have dropped sediment at toe of slope.
Recommend removing sediment and repairing rills.

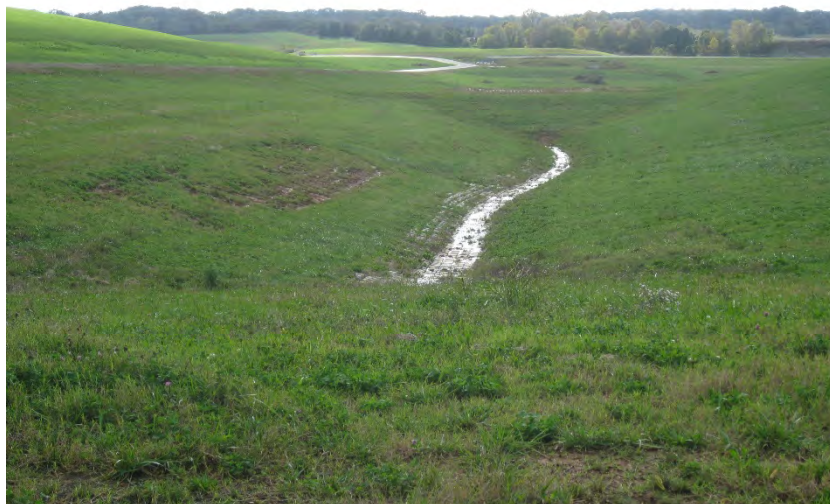
Photo 75
Sta. 302+54 to Sta. 313+50
(RW 5L-23R)
Project 2

North Lateral Endwall 100.
Slopes recently stabilized.

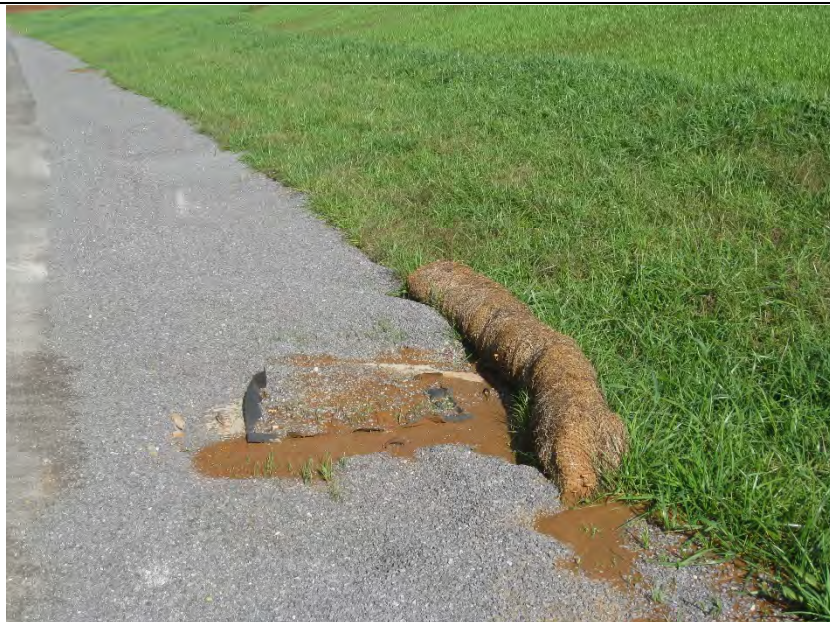
Photo 77
Sta. 29+00 RT
Proposed Haul Route
Project 3

Inlet structure along haul road.
Sod recently installed.
Recommend stabilizing remaining bare areas as soon as practical.
