QUALITY ASSURANCE MONTHLY SITE ASSESSMENT REPORT

Airfield Modernization Program
Runway 5L-23R Reconstruction
Project 2 / Project 3
Project 4 / Repair TWY Lighting
Project 5 / Project 6

QUALITY ASSURANCE SITE ASSESSMENT

10/29/2020

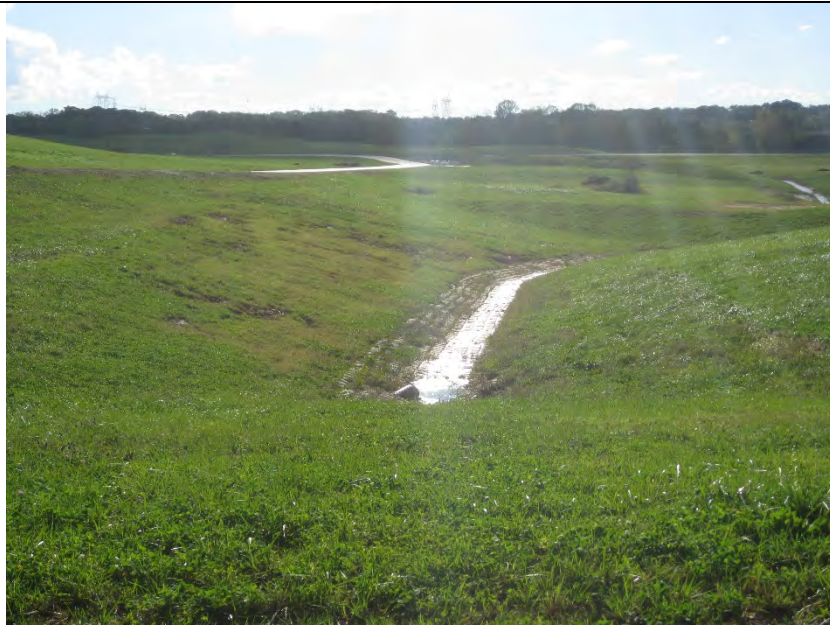
Photo 80
Sta. 297+01
(RW 5L-23R)
Project 2

North Lateral Endwall 104.

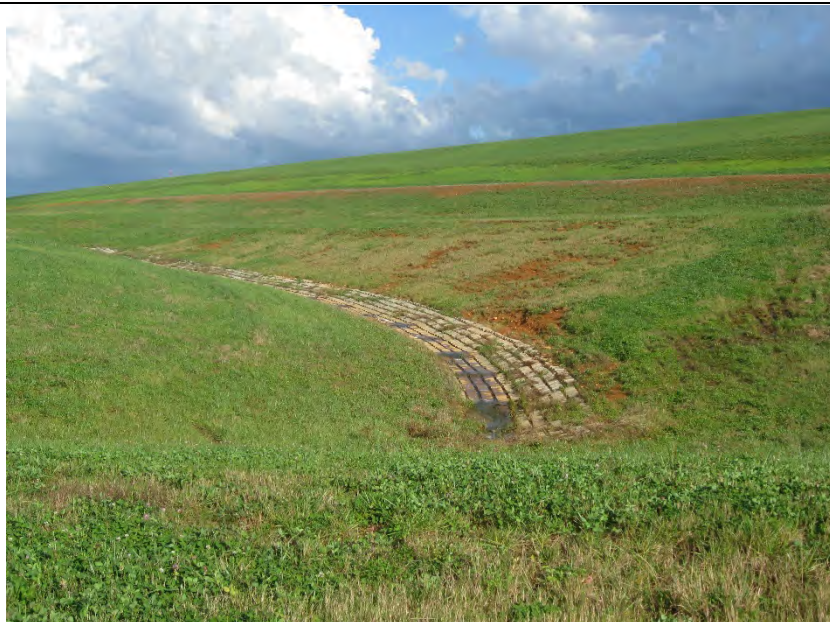
Photo 81
Sta. 295+10
(RW 5L-23R)
Project 2

North Lateral Endwall 106.

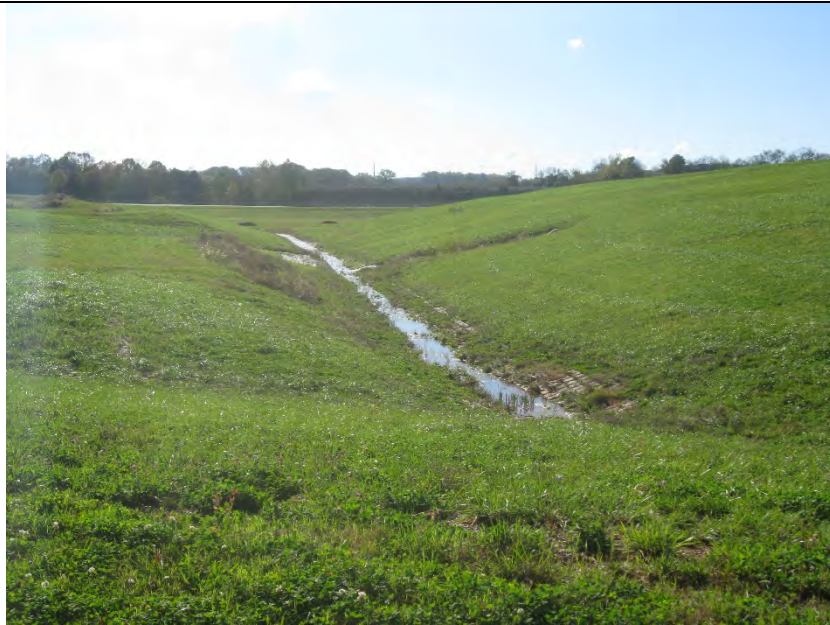
Photo 82
Sta. 292+08
(RW 5L-23R)
Project 2

North Lateral Endwall 108.

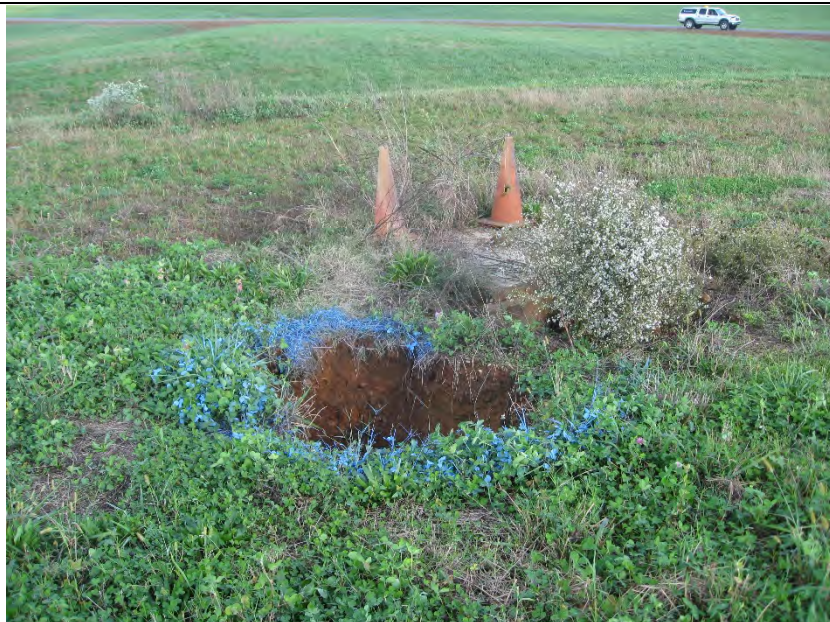
Photo 85
Sta. 15+50 RT
Proposed Haul Route
Project 3

Recommend stabilizing bare areas along haul route as soon as practical.

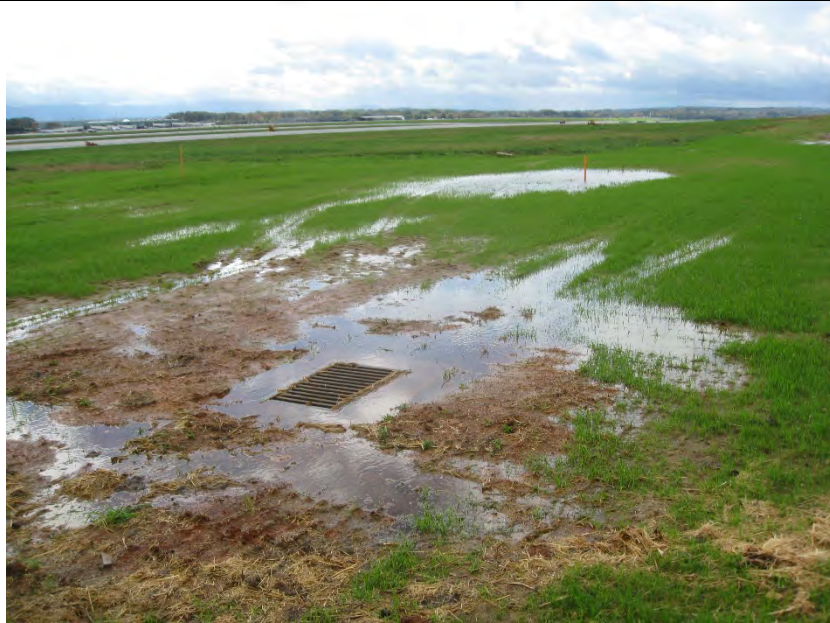
Photo 86
Sta. 284+00 LT
(RW 5L-23R)
Project 2

Existing vault at old Liberty street.
Construction fallout present. Recommend coordinating with CHA on remediation.

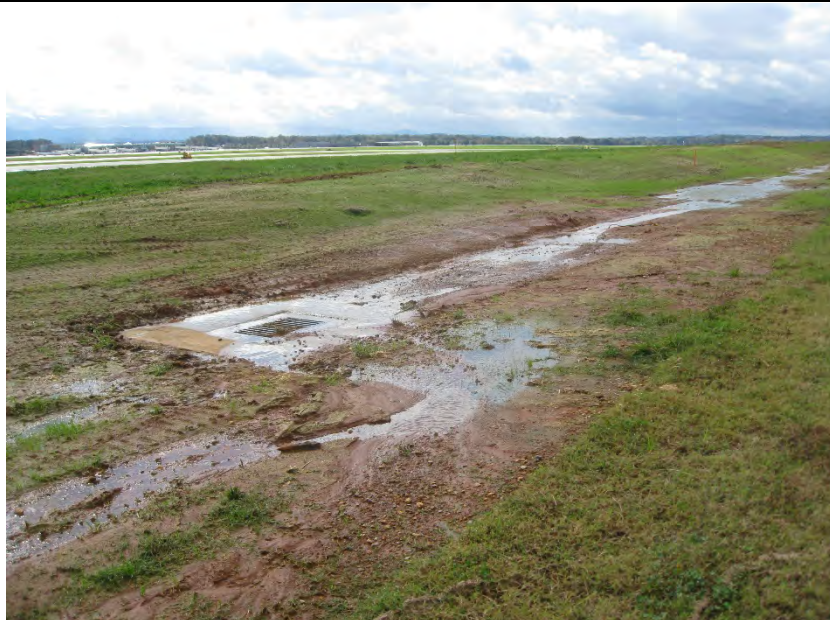
Photo 87
(Repair TWY Lighting)
Existing Structure

Existing structure south of Taxiway G.

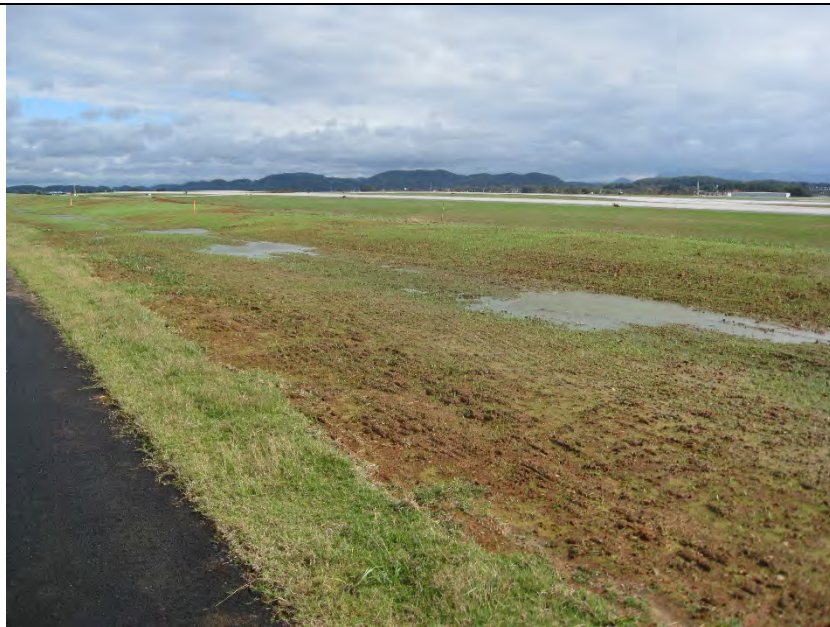
Photo 88
(Repair TWY Lighting)
Existing Structure

Existing structure south of Taxiway G.

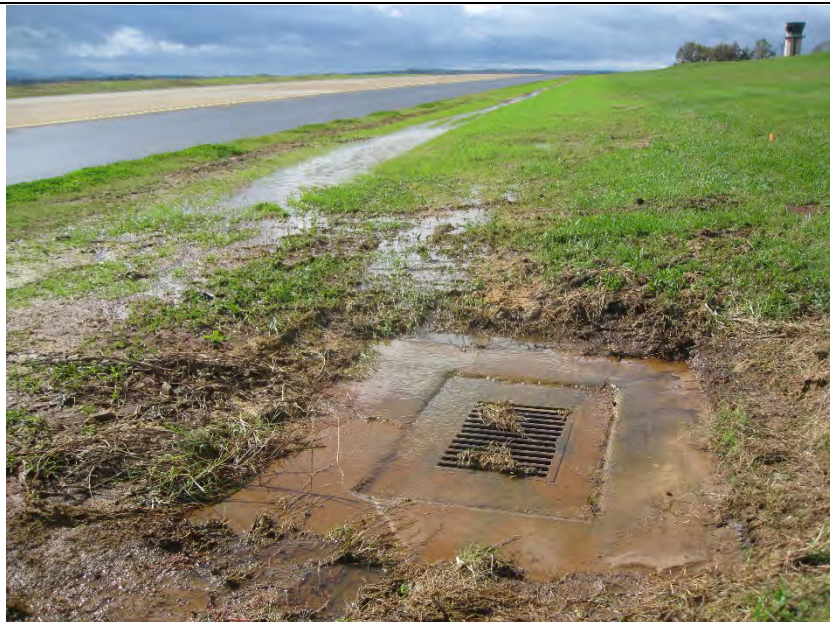
Photo 89
(Repair TWY Lighting)
Existing Structure

Taxiway G
Bare areas recently stabilized.

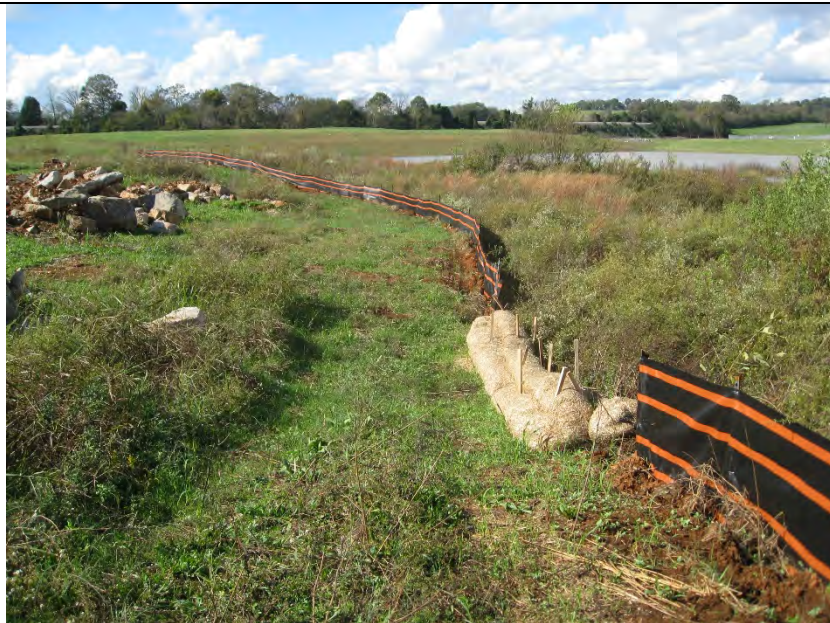
Photo 91
(Repair TWY Lighting)

Shoulder of Taxiway G (Looking back towards cargo apron)
Bare areas recently stabilized.
Recent storm events have moved the seed downstream.
Recommend restabilizing resulting bare areas.

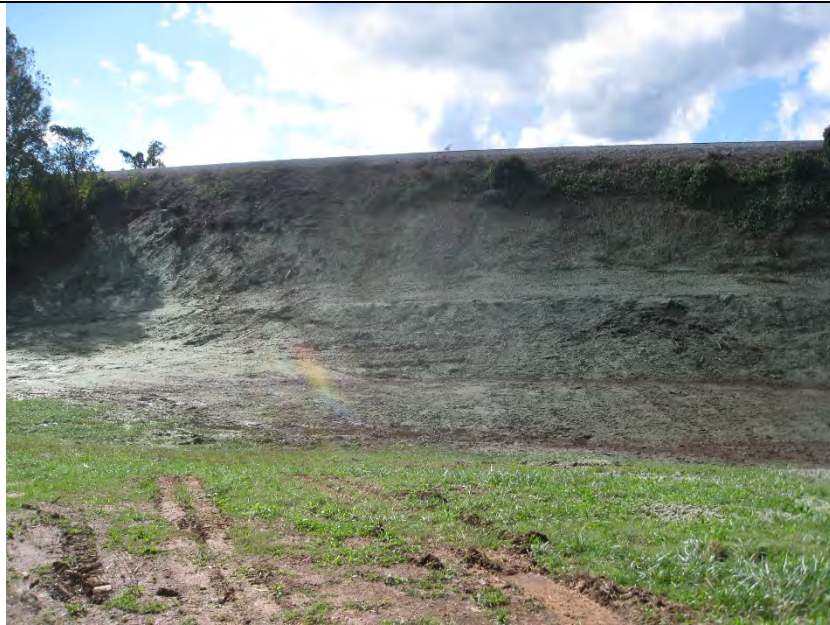
Photo 92
(Project 5/6)

Fill area adjacent to Liberty Street.

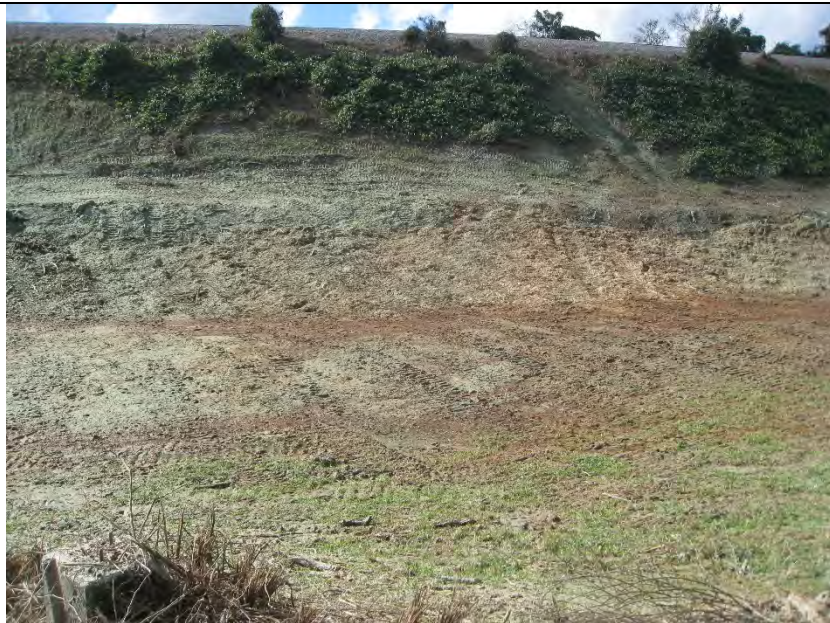
Photo 93
(Project 5/6)

Above main outfall to Lackey Creek.
This section of the site was inaccessible at time of inspection.
Slopes were recently stabilized.

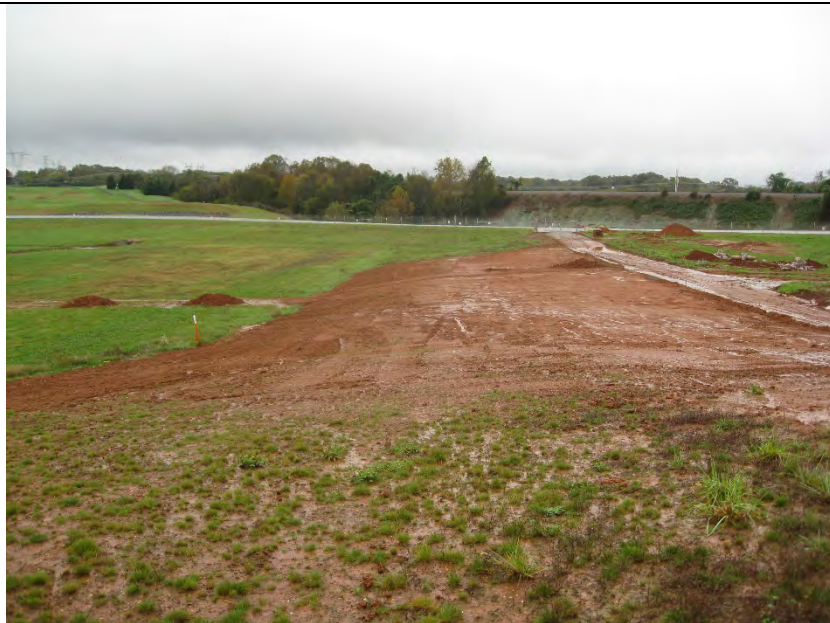
Photo 95
(Project 5/6)

Area adjacent to haul road.
Signage recently added. Concrete washout facility is at capacity.
Recommend dewatering washout with approved methods or adding second facility.

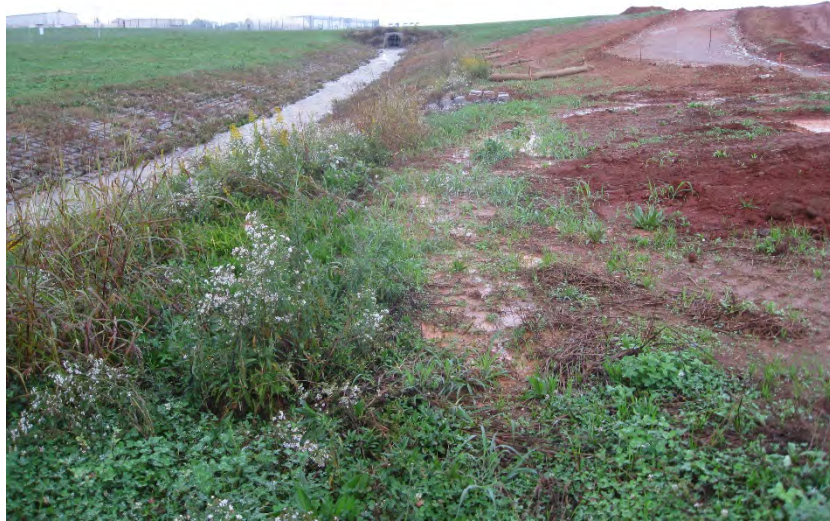
Photo 96
(Project 5/6)

Proposed MALSR access road.
After the last rain event, small rills have started to form on portions of graded side slope.
Side slopes have remained un-stabilized past the allowable 14 days as per the permit.
Recommend stabilizing side slopes outside of active roadway construction area.

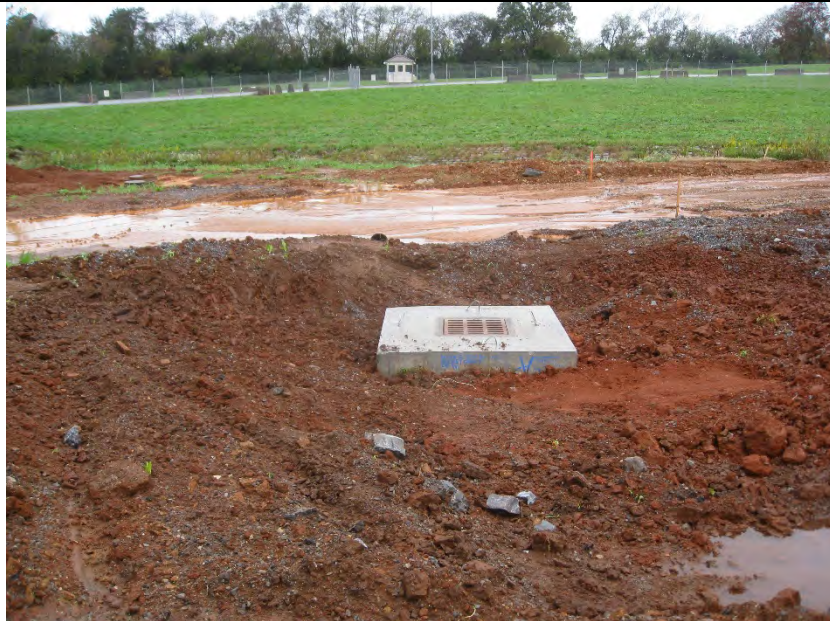
Photo 97
(Project 5/6)

Proposed MALSR access road.
Side slopes have remained un-stabilized past the allowable 14 days as per the permit.
Recommend stabilizing side slopes outside of active roadway construction area.

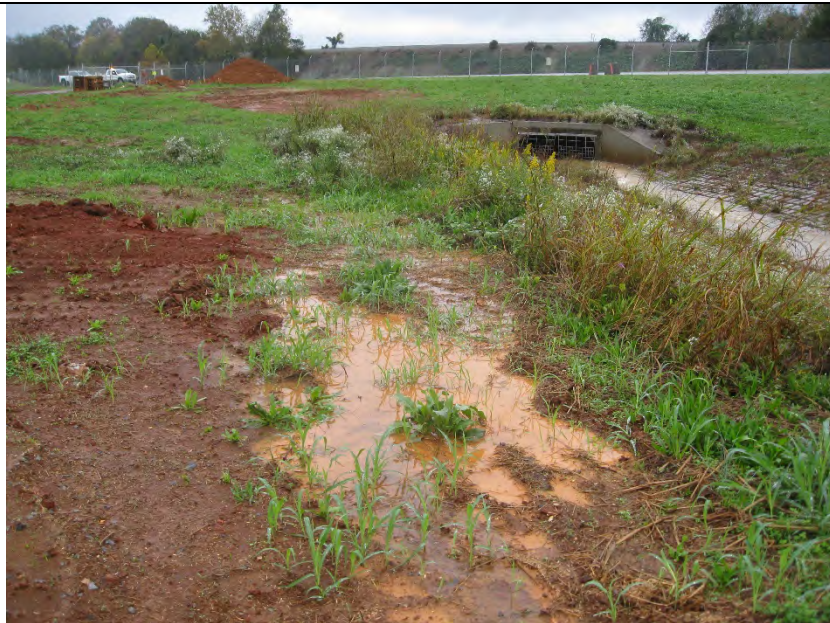
Photo 99
(Project 5/6)

Proposed MALSR access road.
Sediment shown in pipe from previous report has exited the endwall and entered the Guard Lateral ditch. Recommend removing sediment.

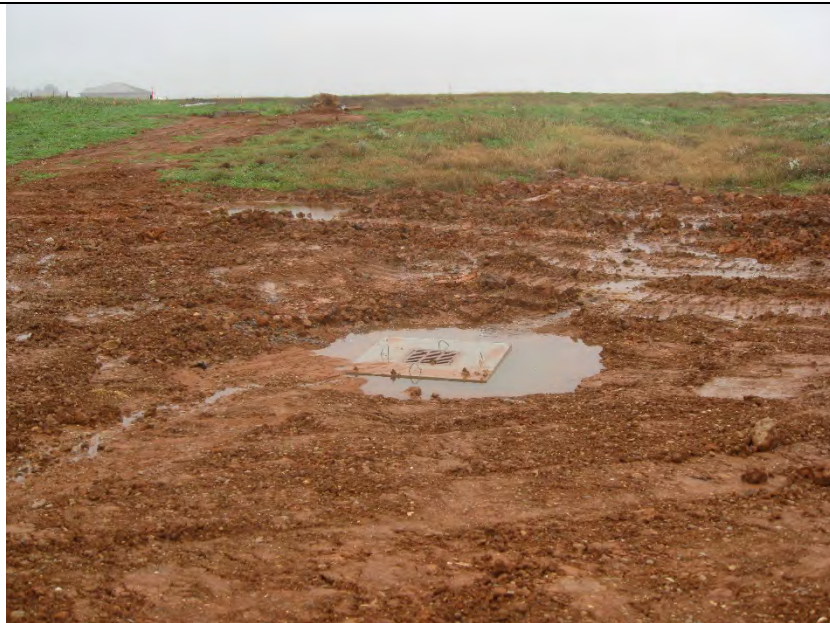
Photo 101
(Project 5/6)

Existing structure #120 adjacent to proposed MALSR access road.
Once area is to grade and structure receives run-off, recommend adding inlet protection per the plans. Recommend monitoring back side of structure that is already at grade for sediment migration.

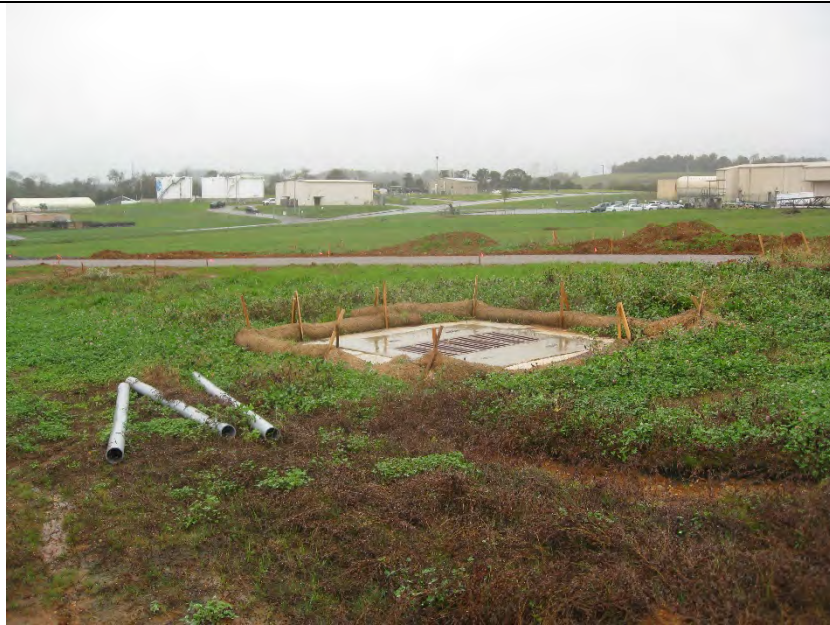
Photo 102
(Project 5/6)

Above existing structure #120.
Sediment is entering new structure.
Recommend adding temporary sediment tubes.
Once area is to grade, recommend adding inlet protection per the plans.

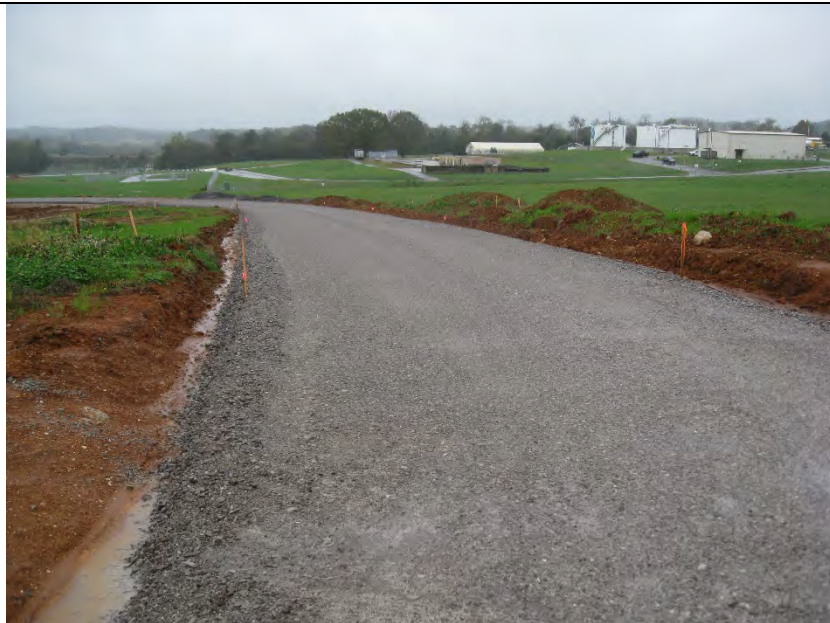
Photo 103
(Project 5/6)

Existing structure #118 adjacent to proposed MALSR access road.

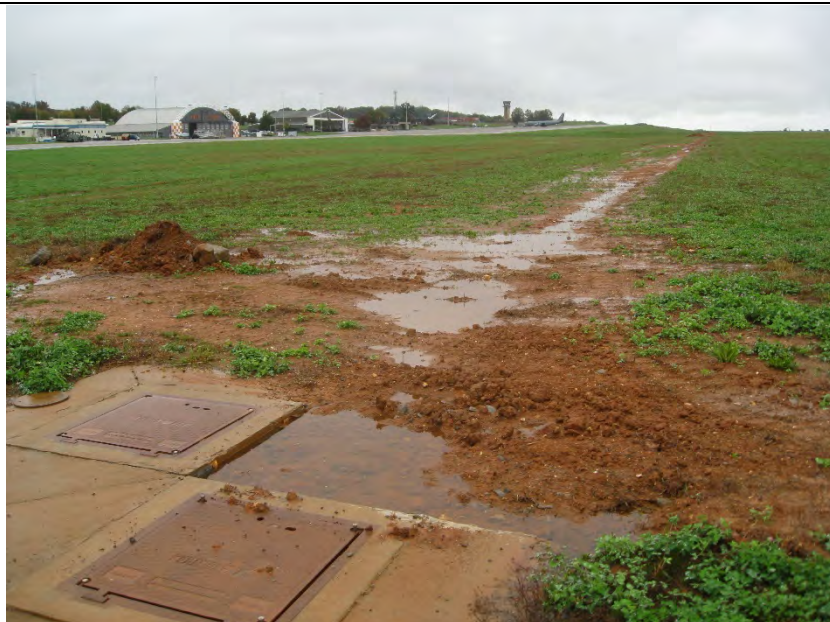
Photo 105
(Project 5/6)

Structure 116.
Recommend stabilizing all bare areas above structure from duct bank installation.

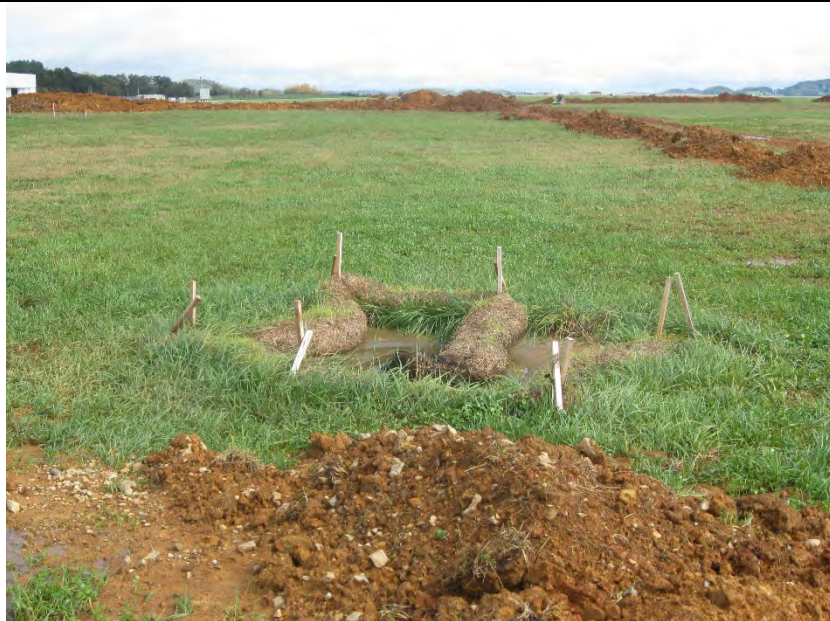
Photo 107
(Project 5/6)

23R Midpoint RVR
Side slopes appear to be at grade.
Recommend adding sediment tubes per the plans.
Recommend stabilizing bare areas.

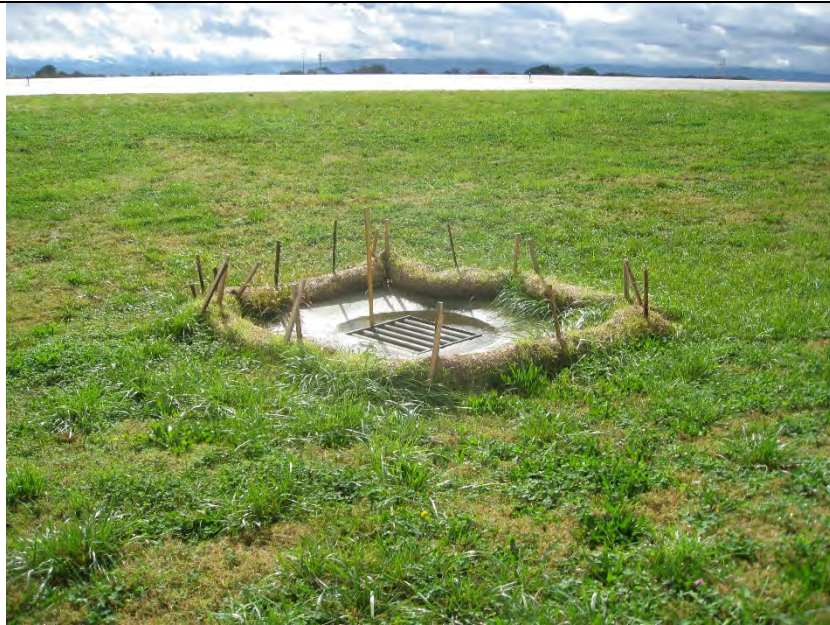
Photo 108
(Project 5/6)

23R Glide Slope and Touchdown RVR
Recommend repairing/replacing damaged sediment tubes.

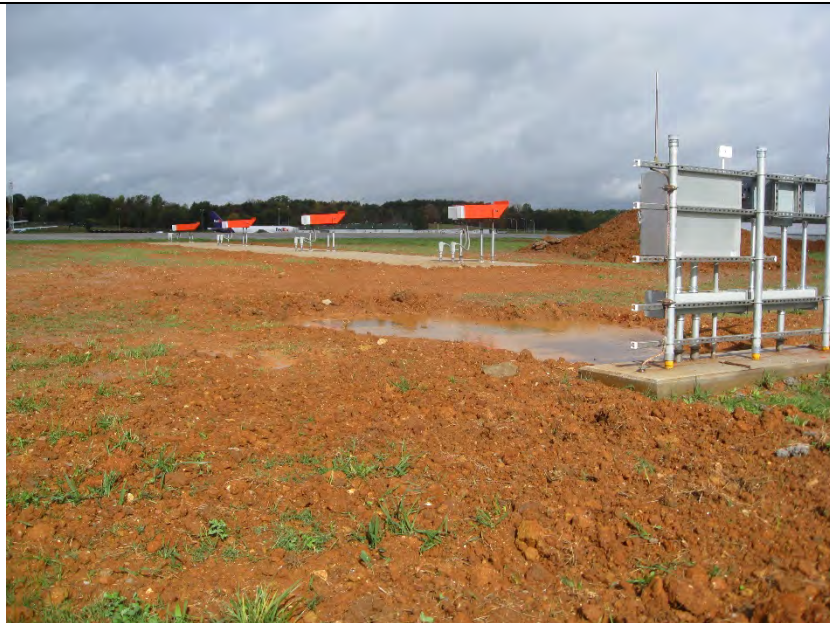
Photo 109
(Project 5/6)

Inlet protection in place near TWY A.

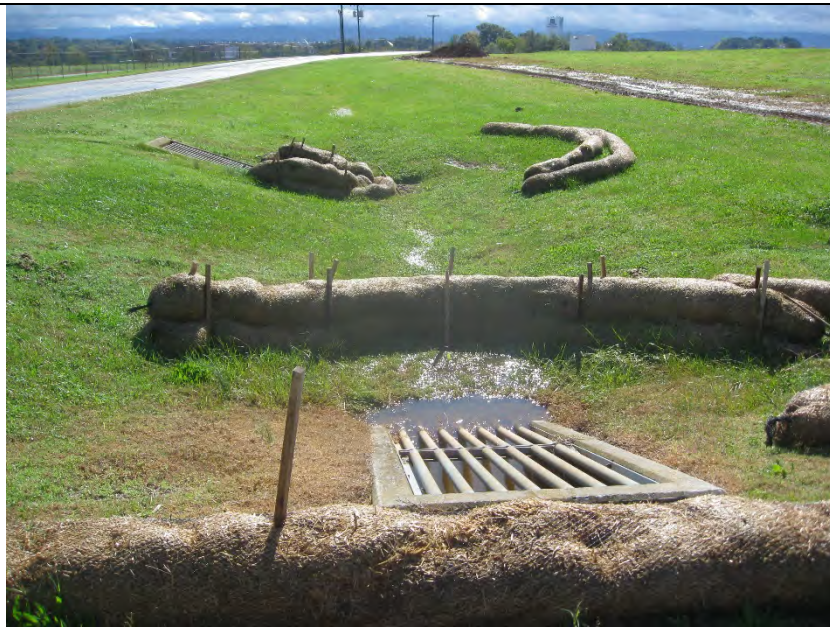
Photo 110
(Project 5/6)

23R PAPI
Area recently backfilled.
Recommend removing remaining spoil piles and stabilizing bare areas.

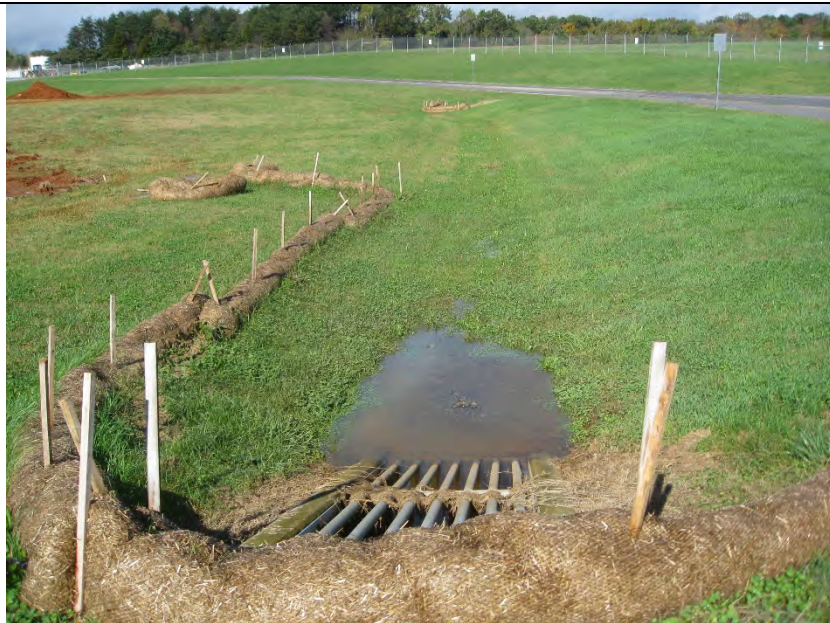
Photo 111
(Project 5/6)

5L Localizer
Construction activities underway.

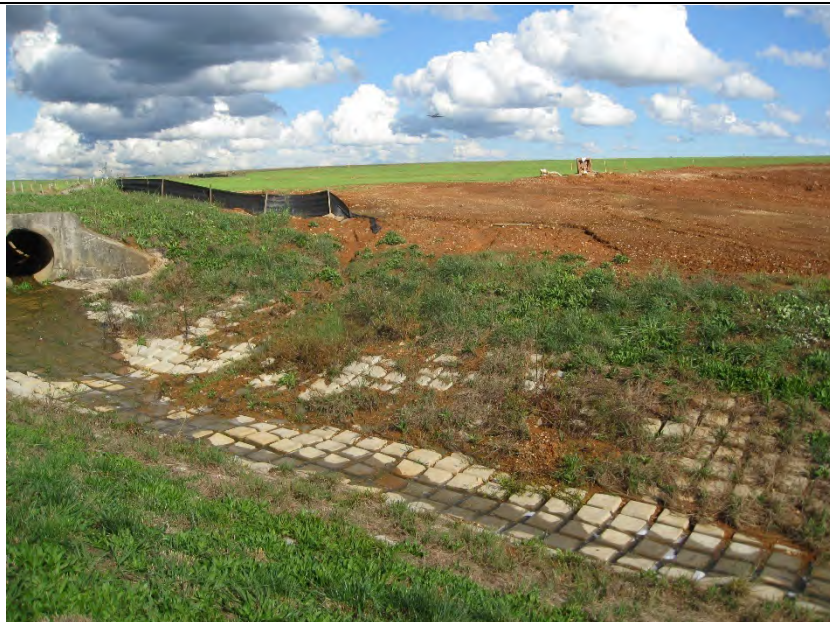
Photo 113
(Project 5/6)

Airfield Lighting Vault
Storm events continue to cause rills and erosion issues while depositing sediment in the North Lateral Ditch. Recommend on site coordination with CCI and CHA on possible shaping of area to direct runoff into existing structure. See next photo.

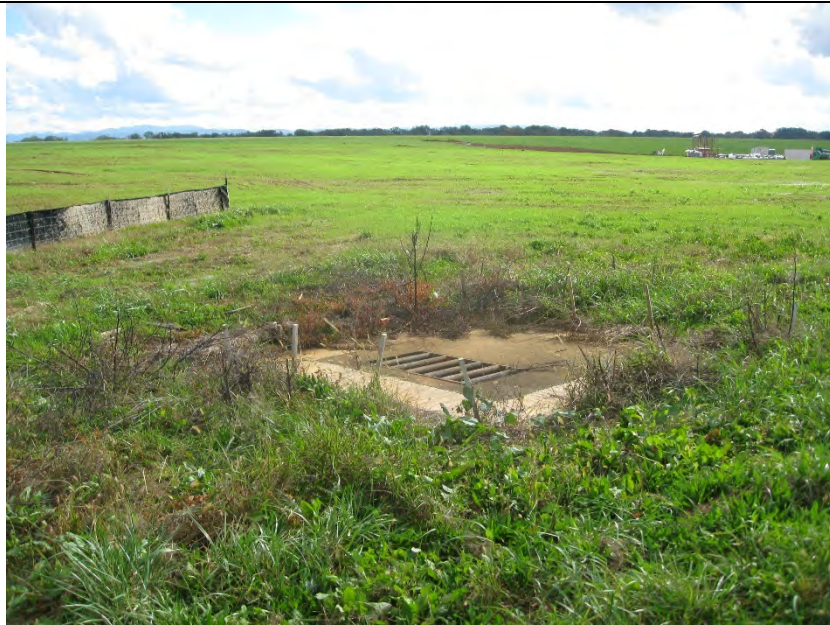
Photo 114
(Project 5/6)

Airfield Lighting Vault
Rills have formed on side slope.
See previous photo.

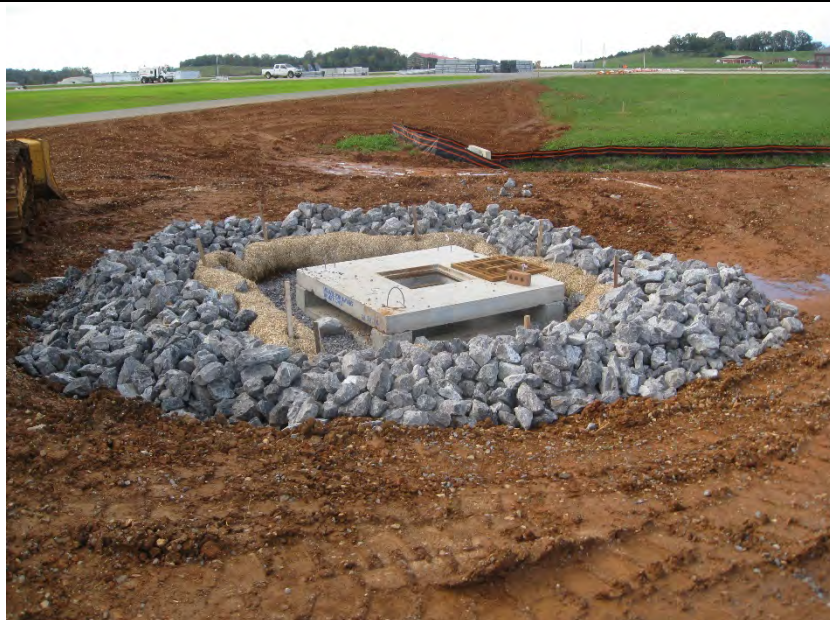
Photo 115
(Project 5/6)

Existing structure.

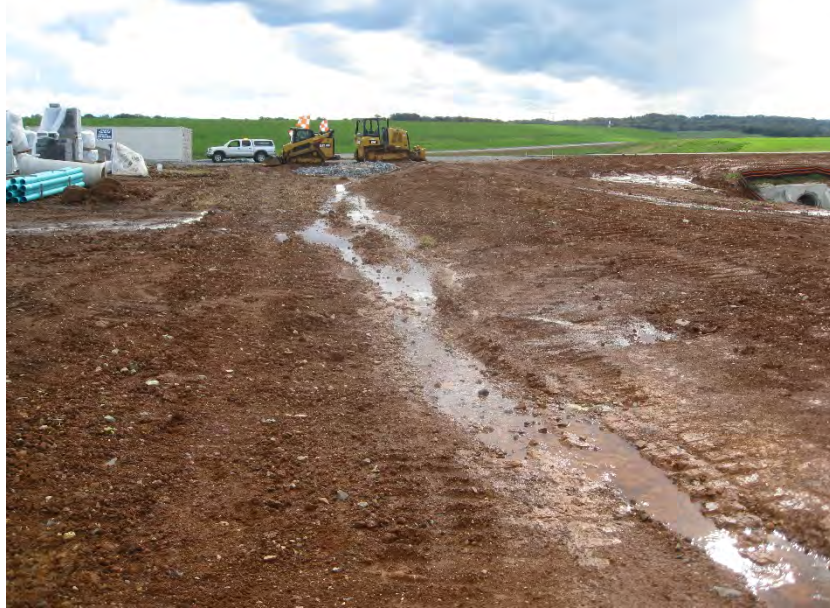
Photo 116
(Project 5/6)

Airfield Lighting Vault
Structure and inlet protection recently installed.
See next photo.

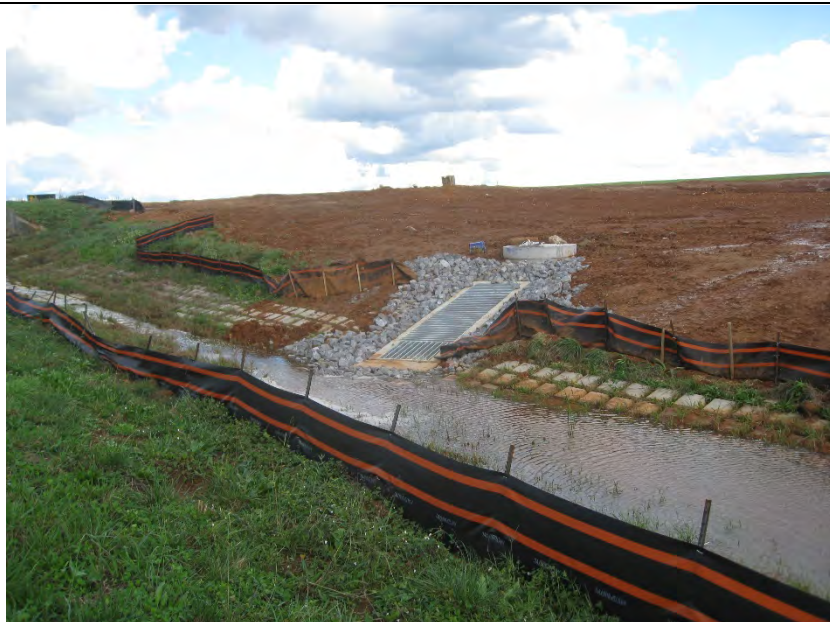
Photo 119
(Project 5/6)

Airfield Lighting Vault
Concrete washout facility.
Recommend adding signage per detail #6 on sheet EC201.

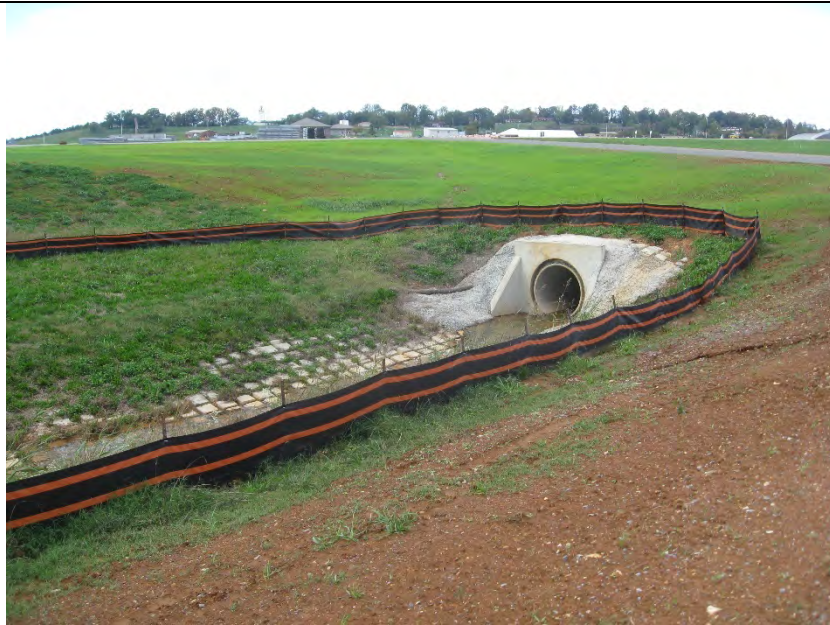
Photo 120
(Project 5/6)

Airfield Lighting Vault
Headwall recently installed at North Lateral Ditch.

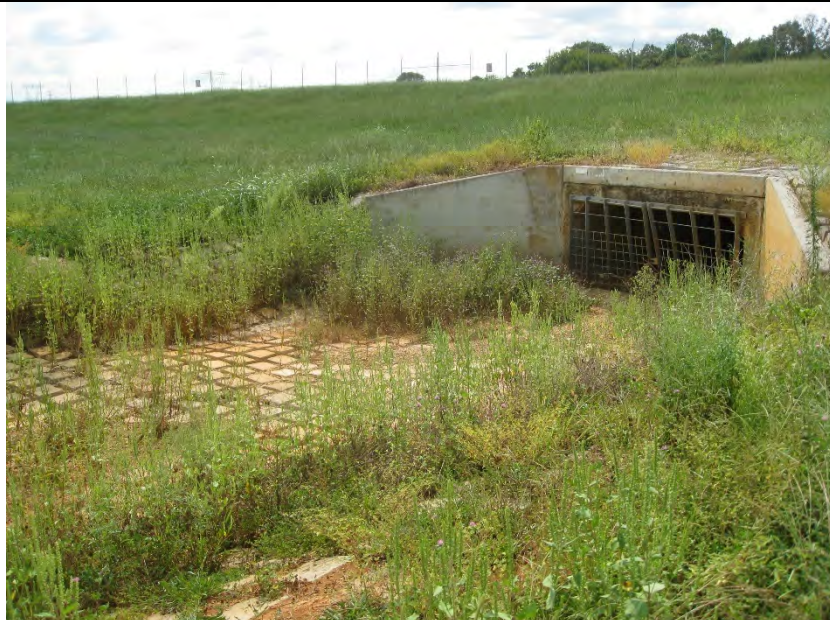
Photo 1
Sta. 111+56 RT
(Line LB)
NLET 01
Project 2

North Lateral End Treatment 01 (Outfall A).
No flow observed.

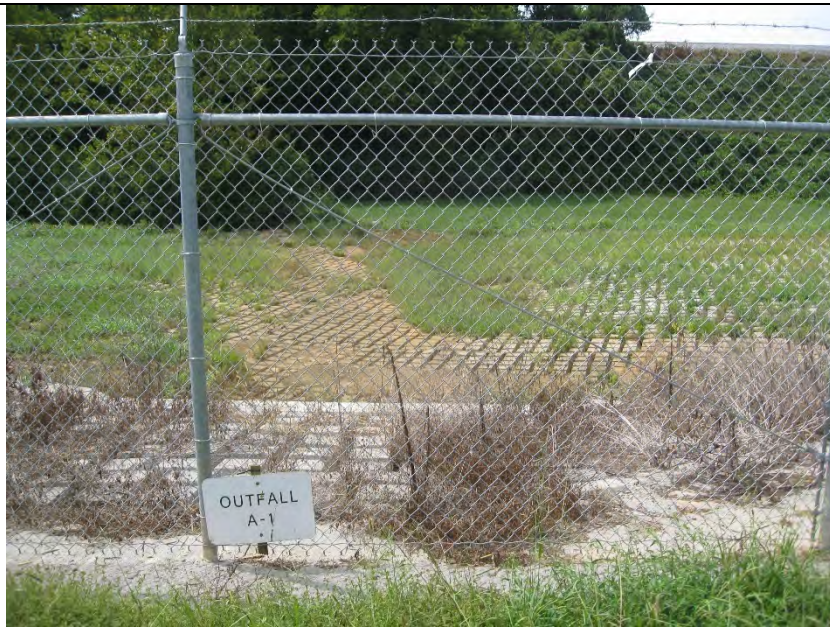
Photo 2
Sta. 111+56 RT
(Line LB)
NLET 01
Project 2

North Lateral End Treatment 01 (Outfall A).
No flow observed.

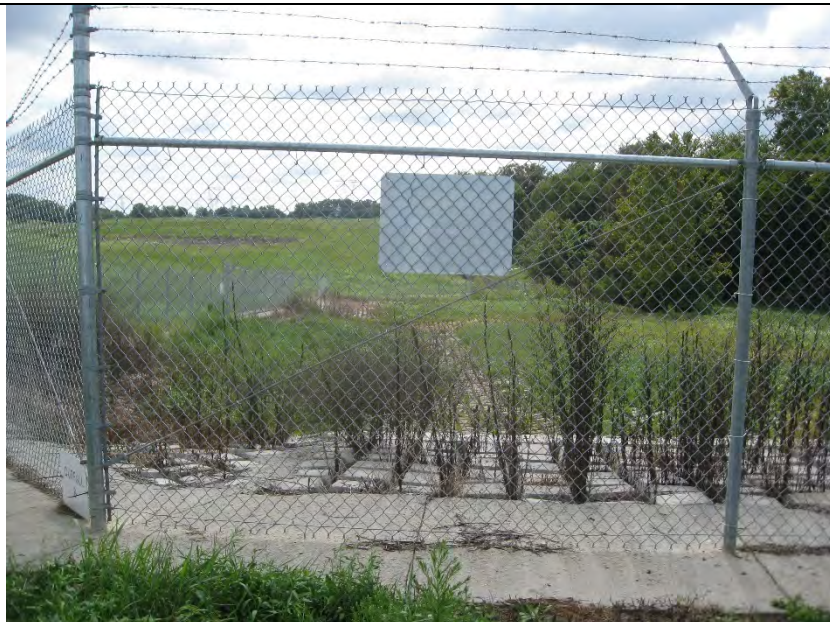
Photo 3
Sta. 111+82 LT
(Line LB)
NLET 02
Project 2

Main outfall to Lackey Creek. This section of the site was inaccessible at time of inspection.

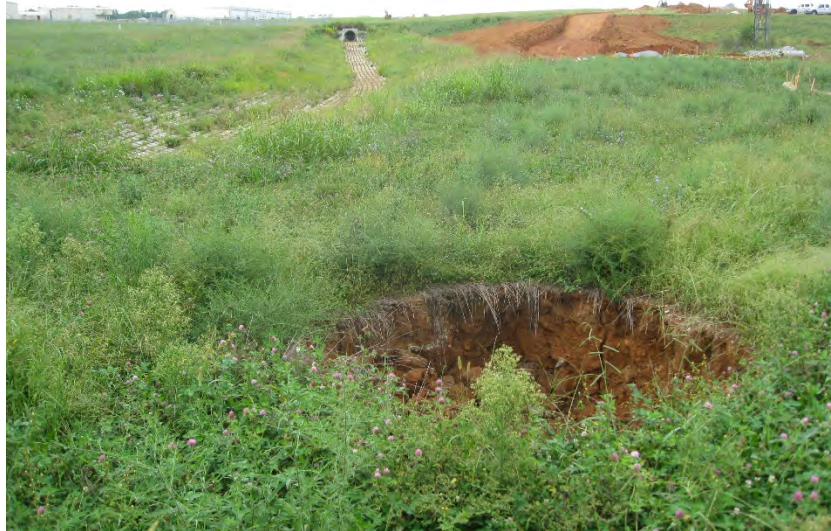
Photo 4
Sta. 114+00
(Line LB)
Project 2

Guard Lateral End Treatment 02.
This section of the site was inaccessible at time of inspection.

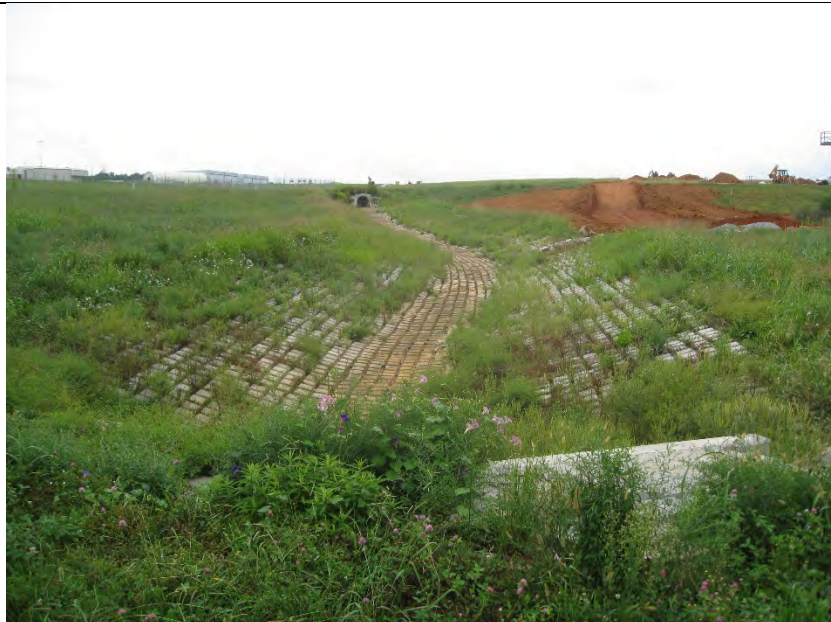
Photo 5
Sta. 117+00
(Line LB)
Project 2

Above the Guard Lateral Ditch (Outfall B).
Construction fall out present. Recommend coordinating remediation with CHA.

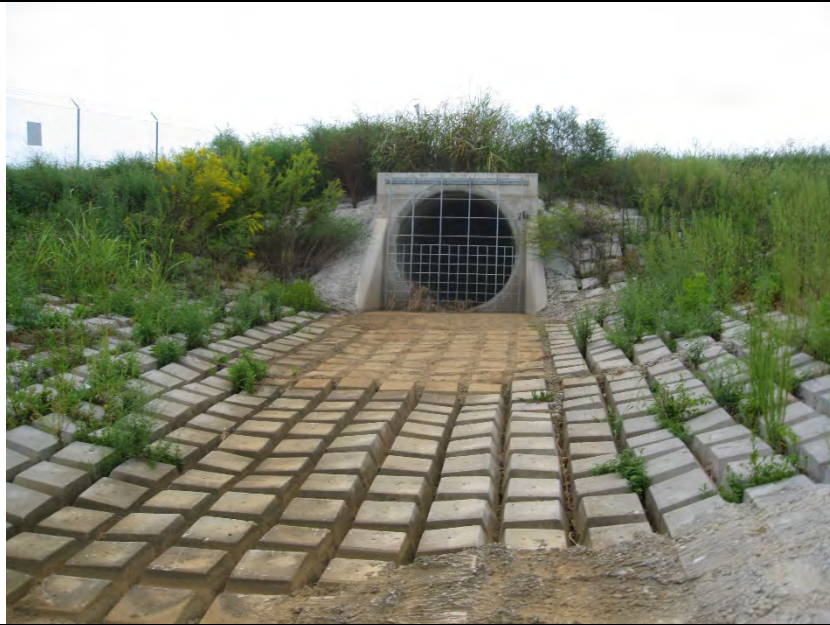
Photo 6
Sta. 117+00
(Line LB)
Project 2

Guard Lateral Ditch (Outfall B).

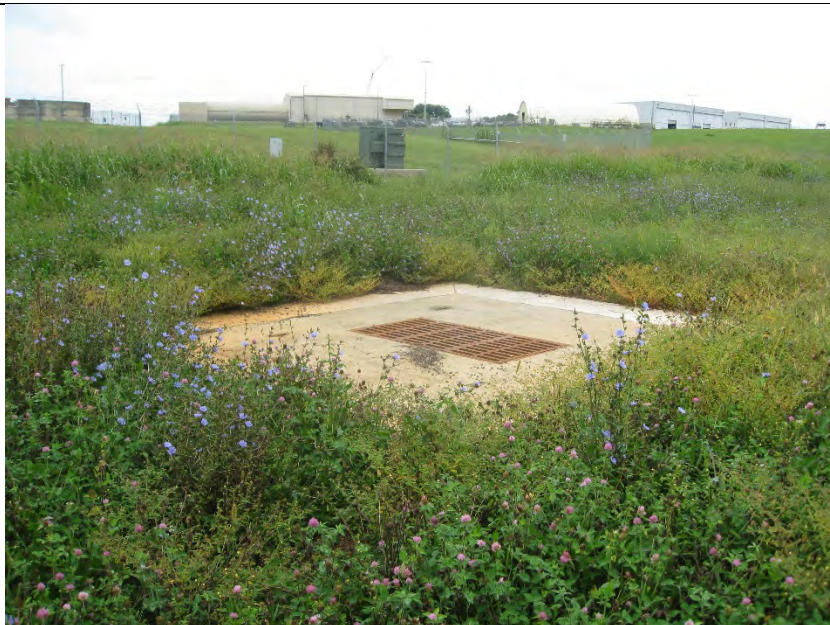
Photo 7
Sta. 117+00 (RT)
Project 2

78" culvert in the Guard Lateral Ditch.

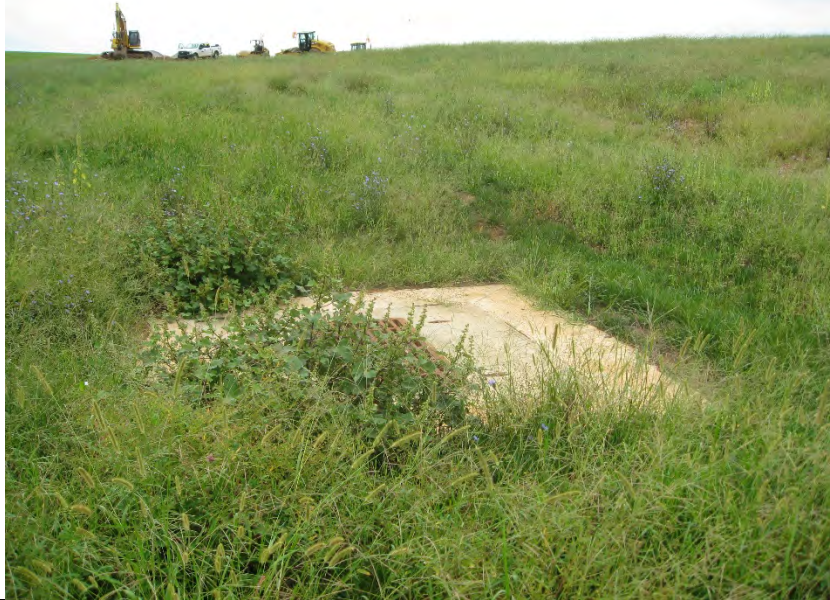
Photo 8
Sta. 287+21 LT
(RW 5L-23R)
Structure 124
Project 3

Structure 124.

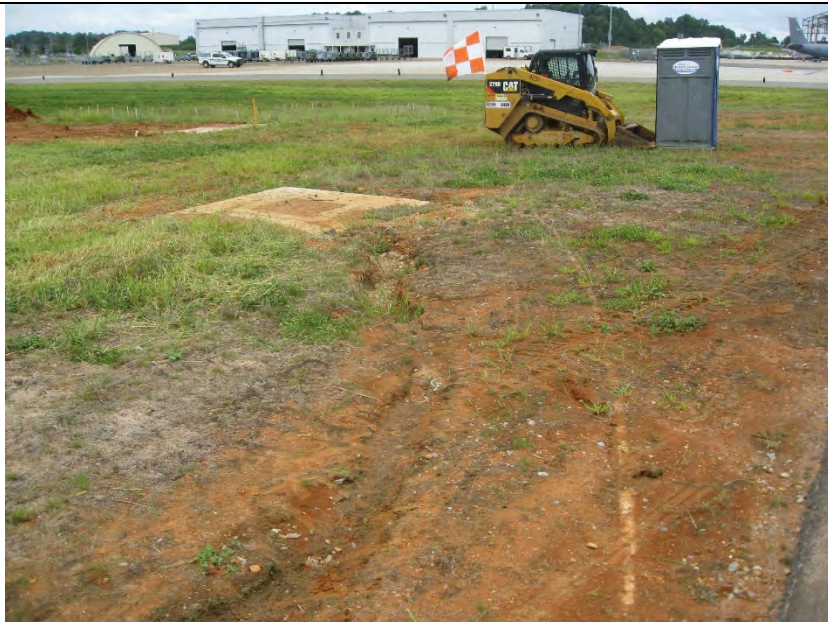
Photo 11
Sta. 298+71 LT
(RW 5L-23R)
Structure 116
Project 3

Structure 116.
Recommend stabilizing bare areas and repairing rills (see photos #11 and #12 below).

Above Structure 116.
Due to recent storm events, rills have started to form and sediment has accumulated in ditch line.
Recommend removing accumulated sediment. Recommend stabilizing remaining bare areas.

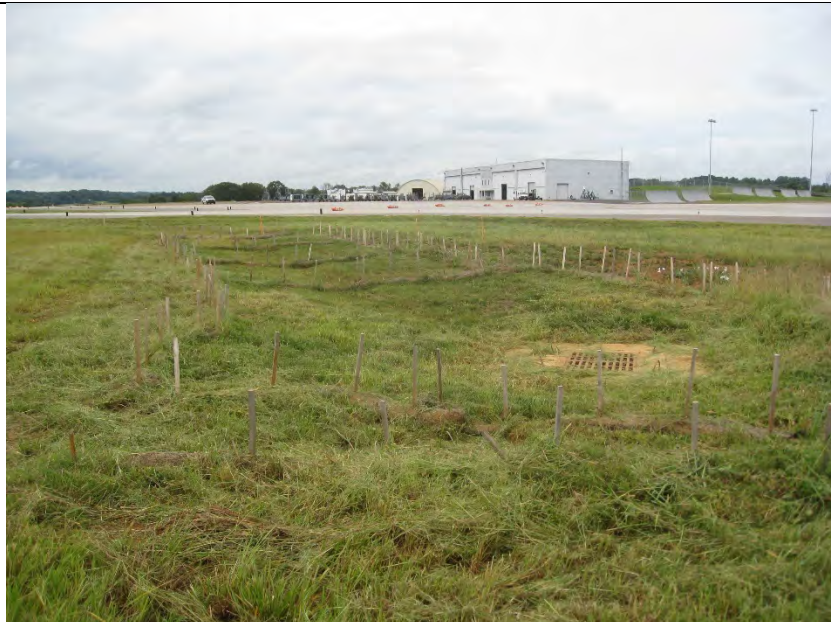
Photo 13
Sta. 302+54 LT
(RW 5L-23R)
Structure 114
Project 3

Structure 114.
Recommend stabilizing remaining bare areas.

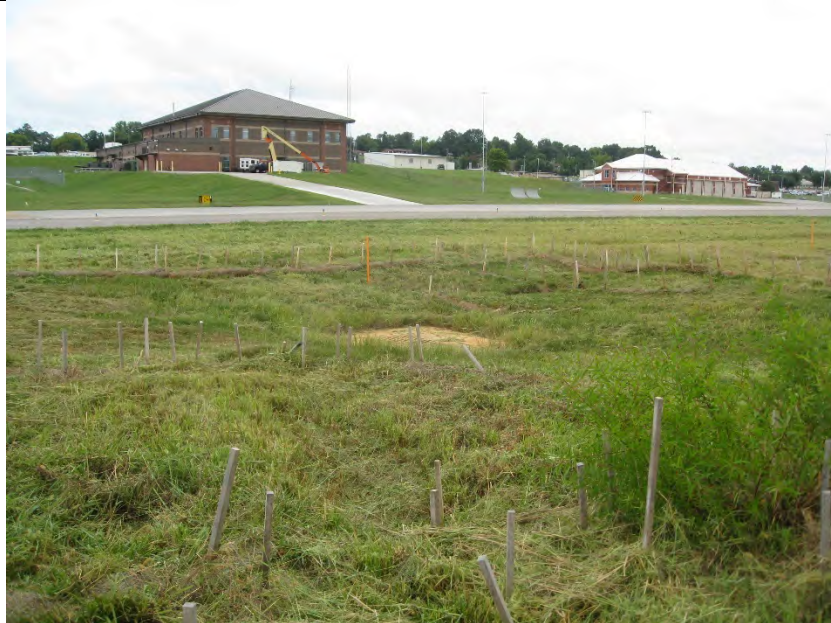
Photo 14
Sta. 303+36 LT
(RW 5L-23R)
Structure 12
Project 3

Structure 12.
Once bare areas above structure have been stabilized, recommend removing all sediment tubes.
See previous photo.

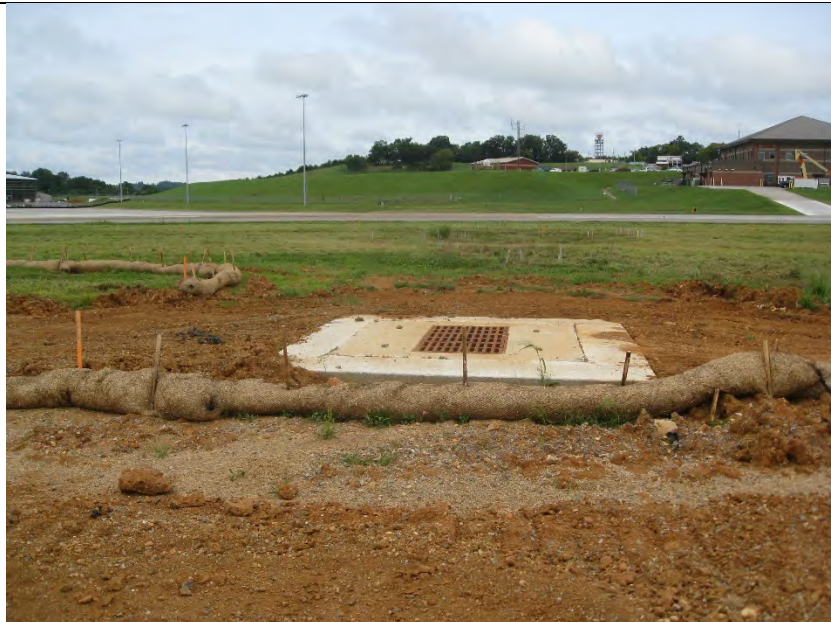
Photo 15
Sta. 310+04 LT
(RW 5L-23R)
Structure 10
Project 3

Structure 10.
Once bare areas above structure have been stabilized, recommend removing all sediment tubes.
