QUALITY ASSURANCE MONTHLY SITE ASSESSMENT REPORT

Airfield Modernization Program
Runway 5L-23R Reconstruction
Project 2 / Project 3
Project 4 / Repair TWY Lighting
Project 5 / Project 6

QUALITY ASSURANCE SITE ASSESSMENT

10/29/2020

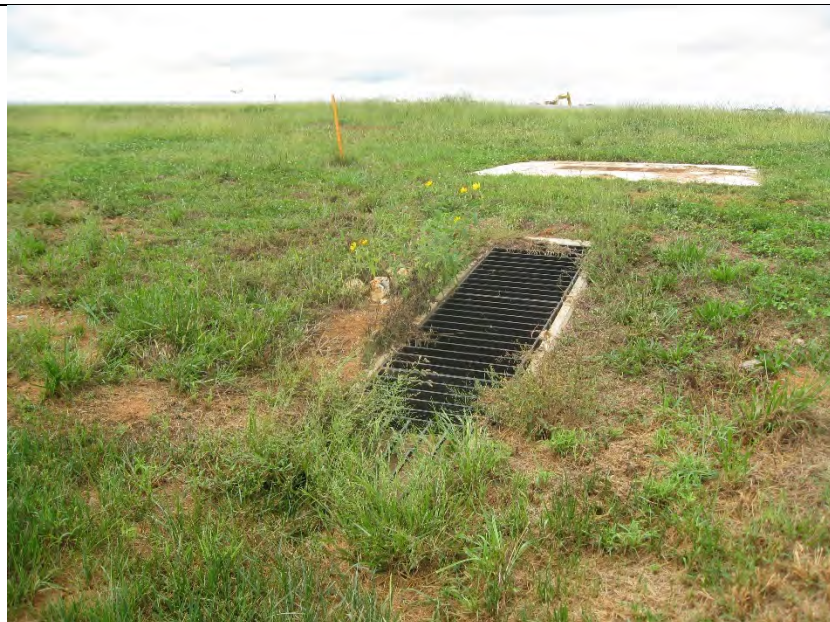
Photo 19
Sta. 314+48 LT
(RW 5L-23R)
ES Endwall 108
Project 3

Enhanced Swale Endwall 108.
Recommend repairing rills above endwall.

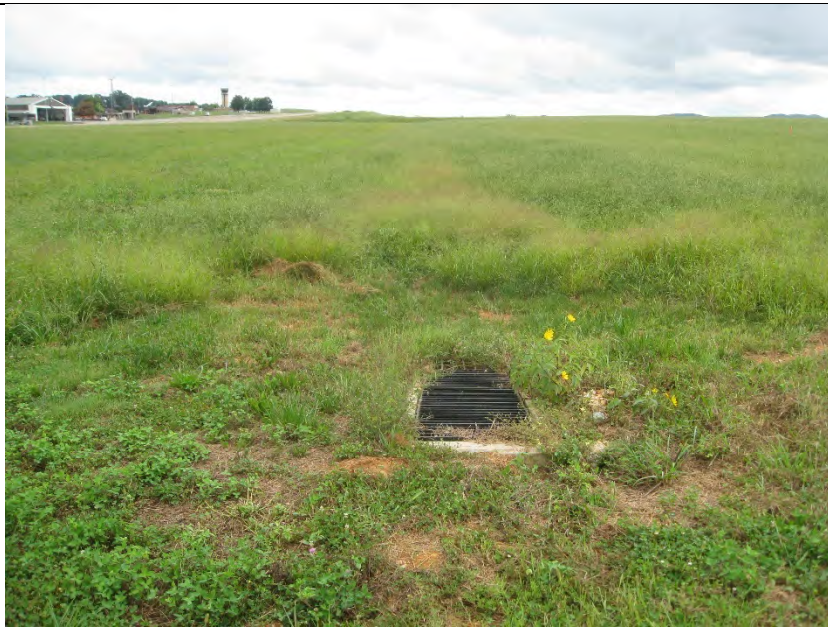
Photo 20
Sta. 324+86 LT
(RW 5L-23R)
ES Endwall 106
Project 3

Enhanced Swale Endwall 106.

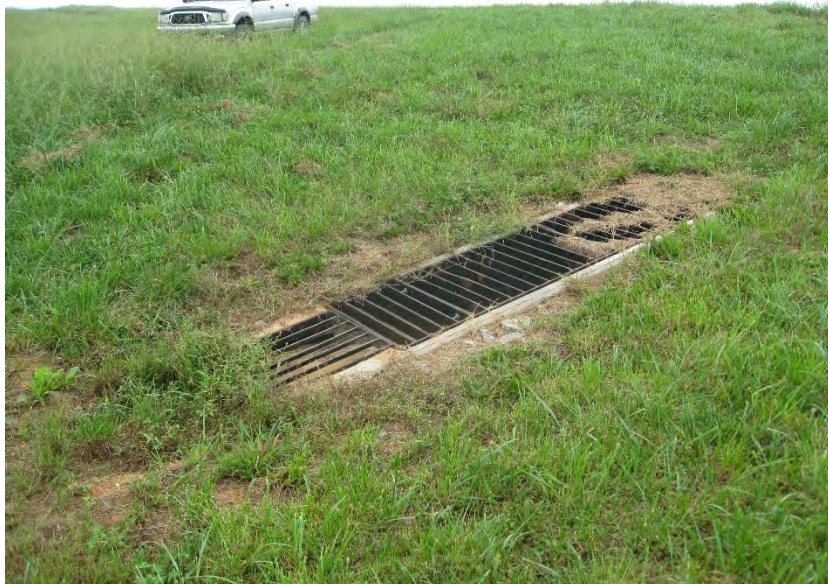
Photo 21
Sta. 324+86 to Sta. 335+73 LT
(RW 5L-23R)
ES Endwall 106
Project 3

Enhanced Swale Endwall 106.

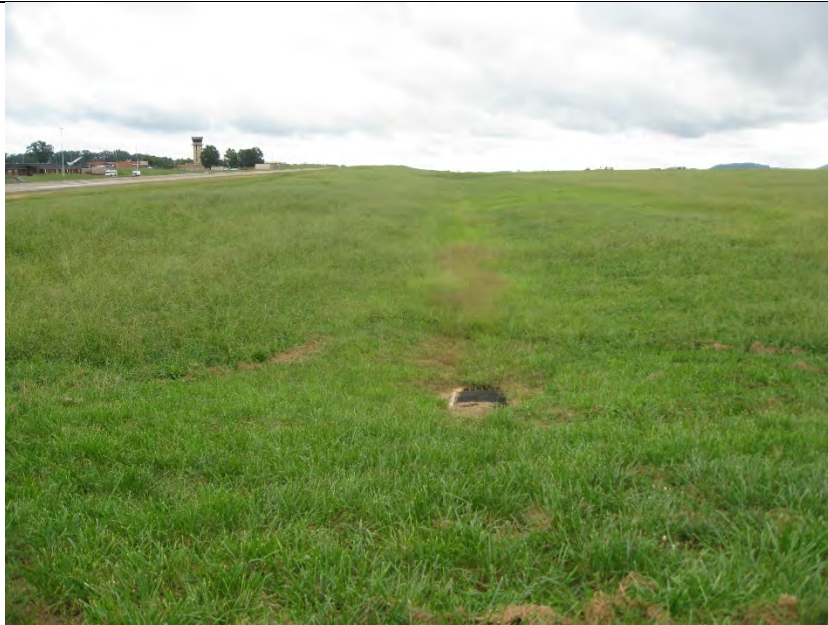
Photo 22
Sta. 335+73 LT
(RW 5L-23R)
ES Endwall 104
Project 3

Enhanced Swale Endwall 104.

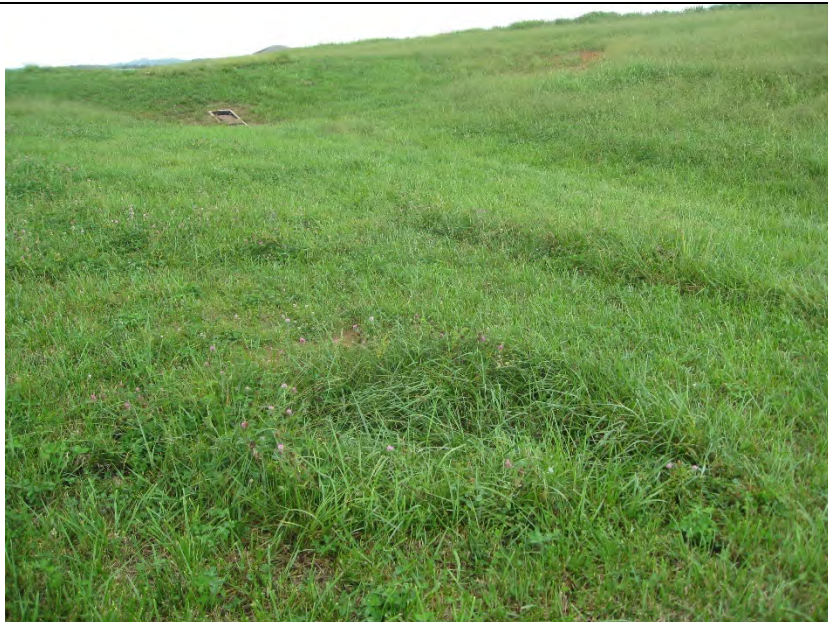
Photo 23
Sta. 335+73 LT
(RW 5L-23R)
ES Endwall 104
Project 3

Enhanced Swale Endwall 104.

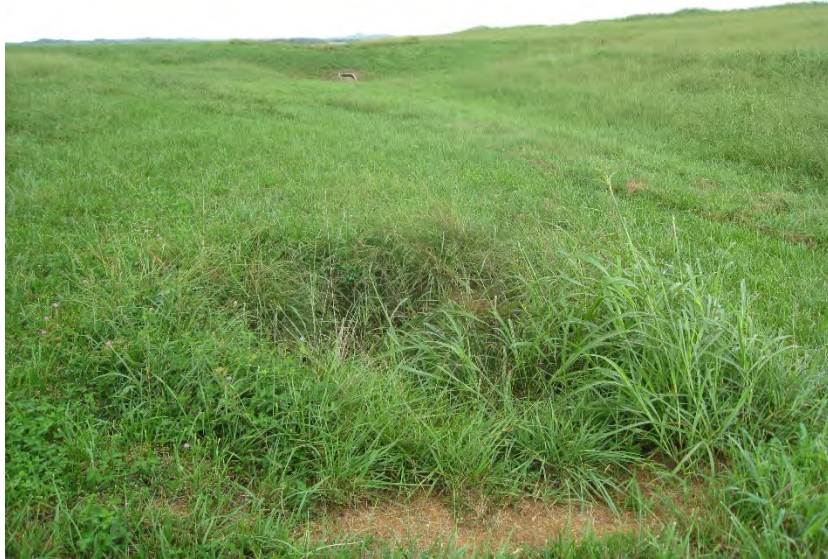
Photo 24
Sta. 341+50 LT
(RW 5L-23R)
Between ES Endwall 104 and 102
Project 3

First potential construction fallout on Storm Line 1 between ES Endwall 104 and 102.

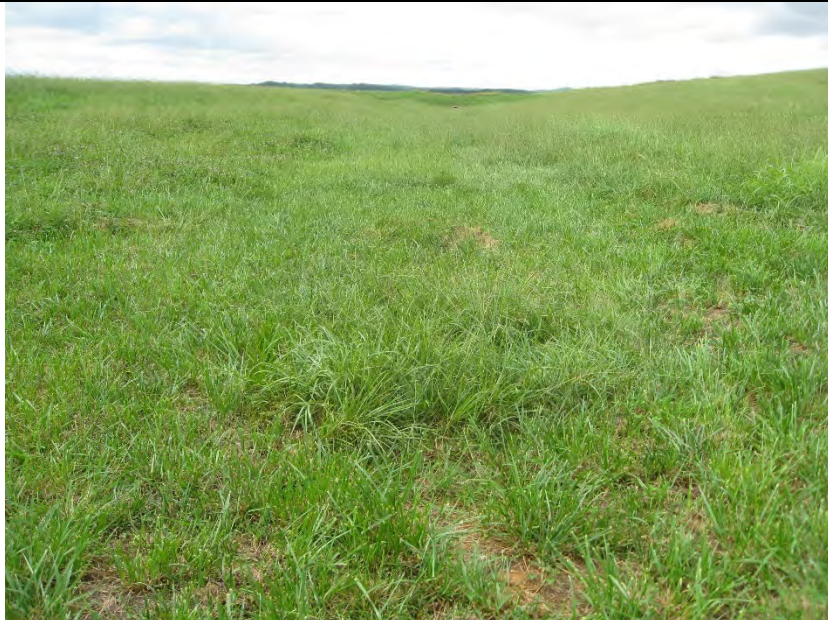
Photo 25
Sta. 341+50 LT
(RW 5L-23R)
Between ES Endwall 104 and 102
Project 3

Second construction fallout on Storm Line 1 between ES Endwall 104 and 102.
Coordinate remediation with CHA.

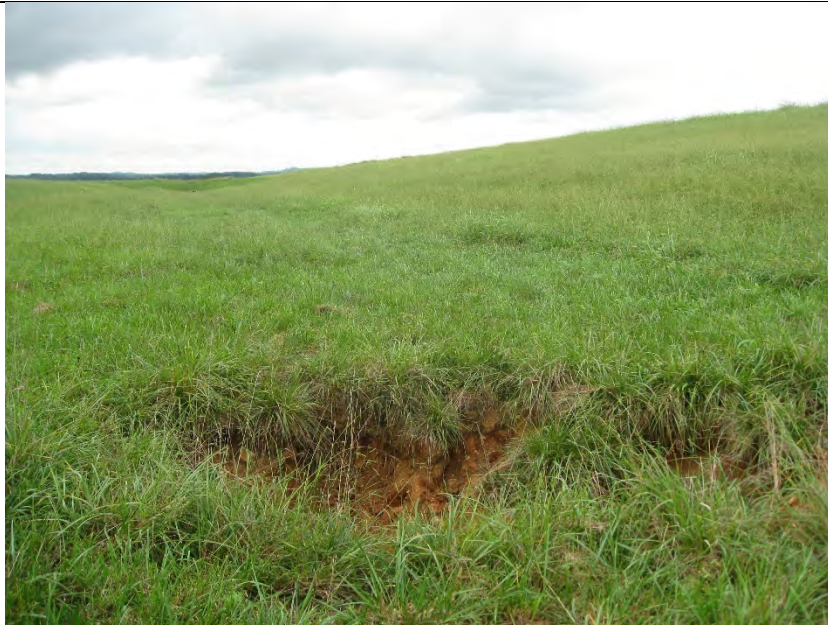
Photo 26
Sta. 341+50 LT
(RW 5L-23R)
Between ES Endwall 104 and 102
Project 3

Third construction fallout on Storm Line 1 between ES Endwall 104 and 102.
Coordinate remediation with CHA.

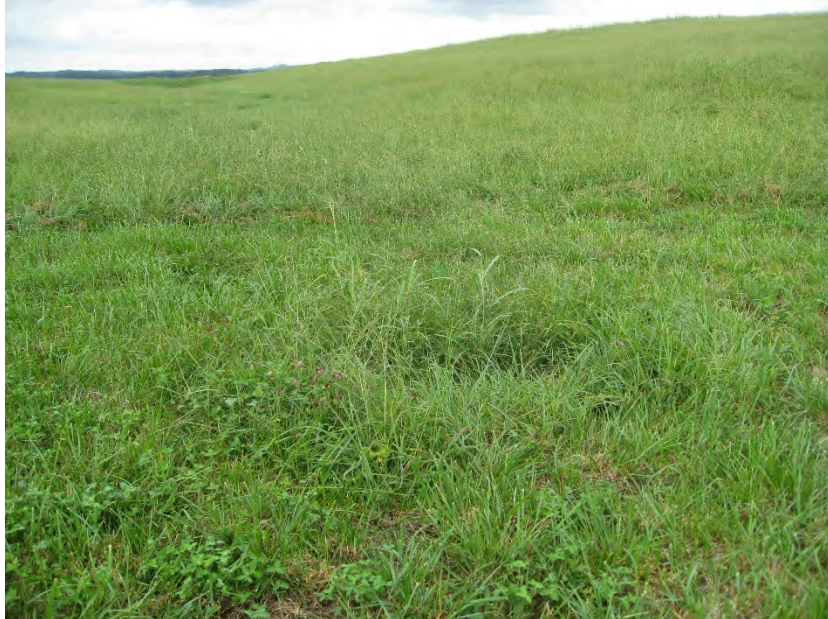
Photo 27
Sta. 341+50 LT
(RW 5L-23R)
Between ES Endwall 104 and 102
Project 3

Fourth construction fallout on Storm Line 1 between ES Endwall 104 and 102.
Coordinate remediation with CHA.

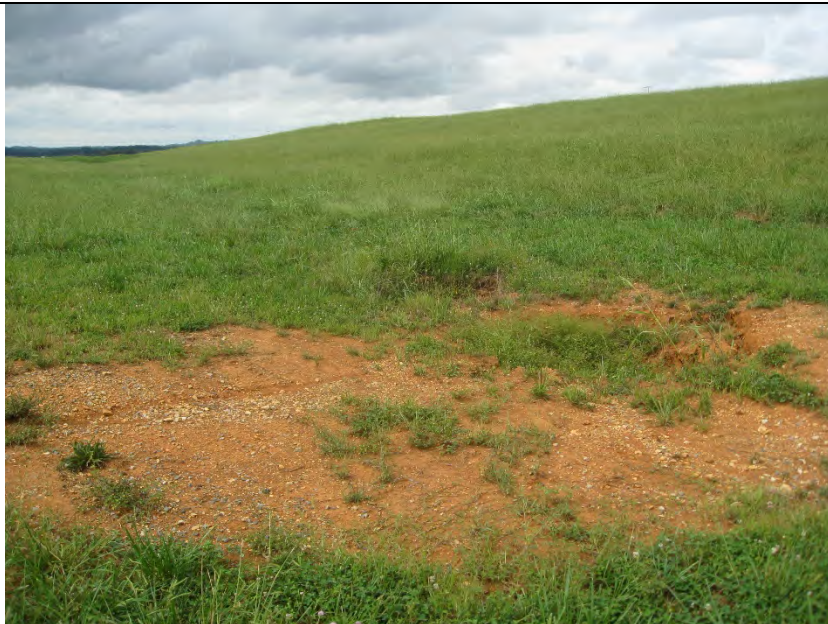
Photo 29
Sta. 341+50 LT
(RW 5L-23R)
Between ES Endwall 104 and 102
Project 3

Sixth construction fallout on Storm Line 1 between ES Endwall 104 and 102.
Coordinate remediation with CHA.

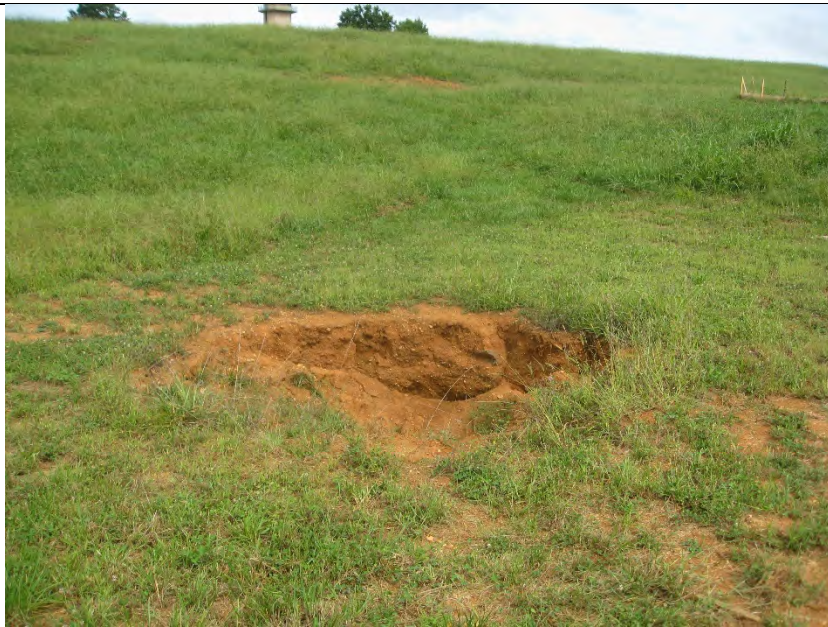
Photo 30
Sta. 341+50 LT
(RW 5L-23R)
Between ES Endwall 104 and 102
Project 3

Seventh construction fallout on Storm Line 1 between ES Endwall 104 and 102.
Coordinate remediation with CHA.

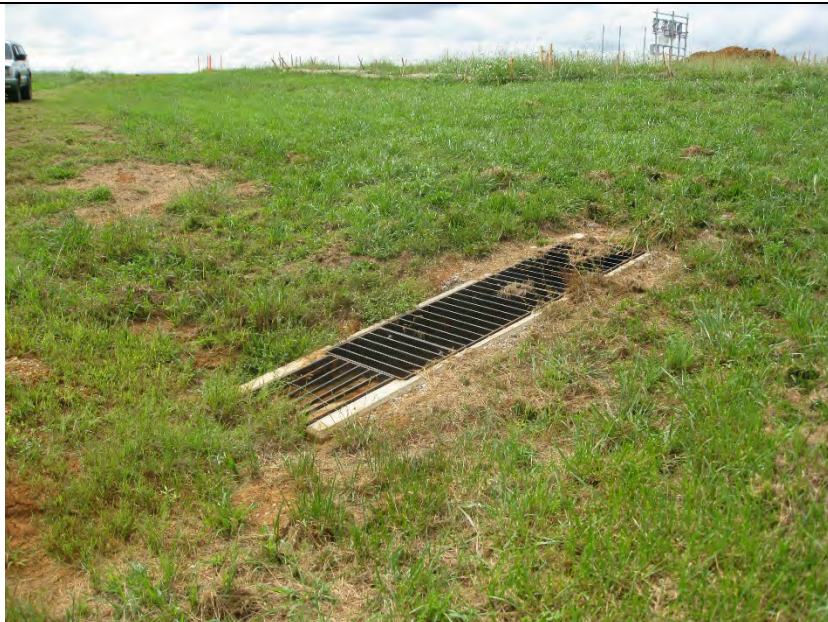
Photo 31
Sta. 341+50 LT
(RW 5L-23R)
Between ES Endwall 104 and 102
Project 3

Eighth construction fallout on Storm Line 1 between ES Endwall 104 and 102.
Coordinate remediation with CHA.

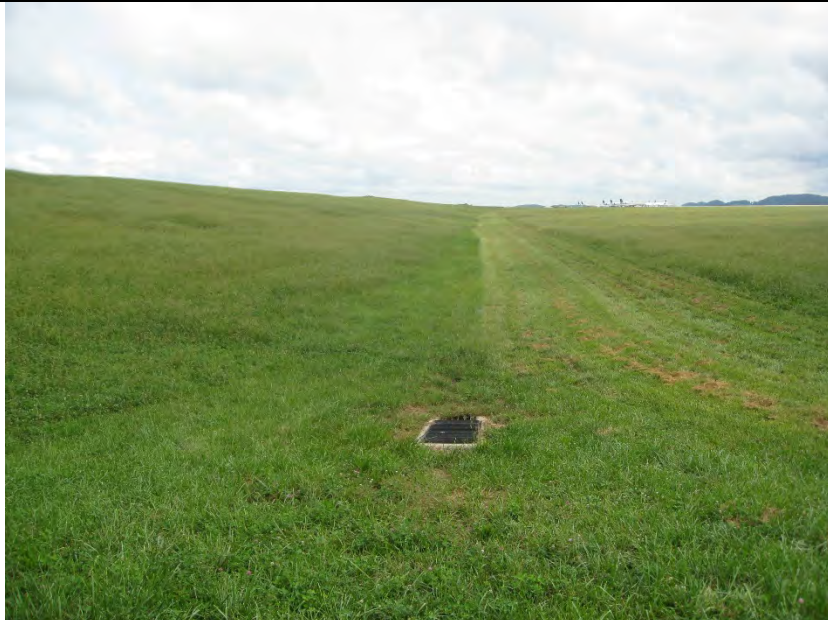
Photo 35
Sta. 354+75 LT
(RW 5L-23R)
ES Endwall 100
Project 2

Enhanced Swale Endwall 100.

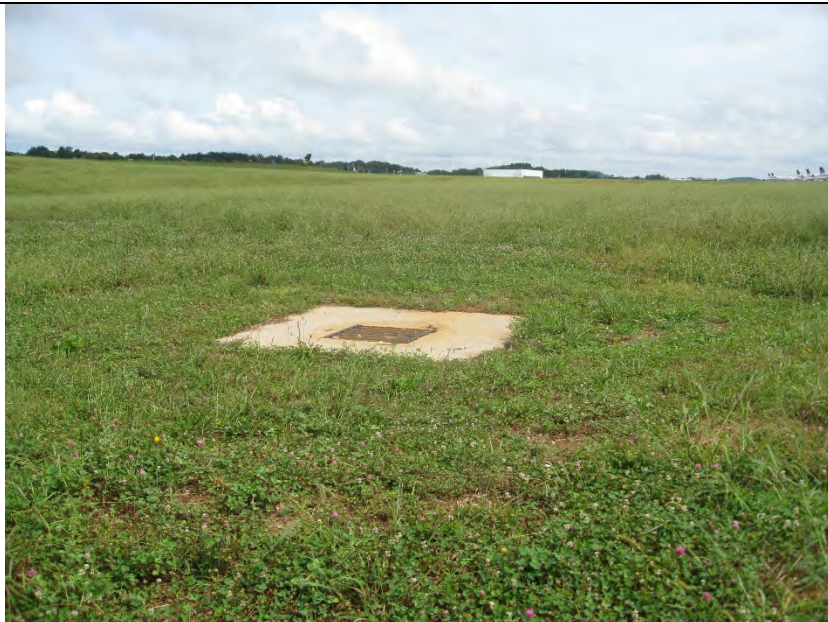
Photo 37
Sta. 361+39 LT
(RW 5L-23R)
Structure 100
Project 3

Structure 100.
Recommend stabilizing remaining bare areas.

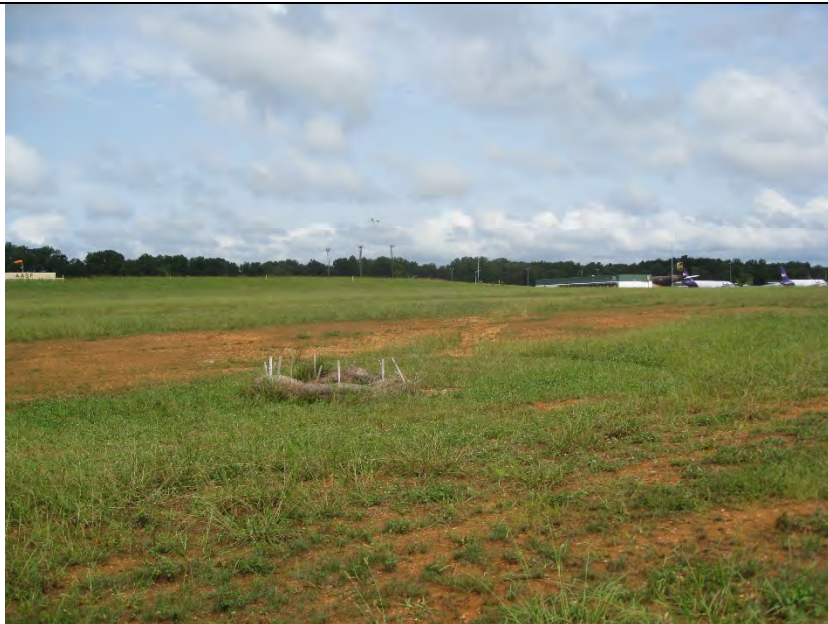
Photo 39
Sta. 366+25 LT
(RW 5L-23R)
Existing Structure
Project 2

Existing Structure.
Recommend stabilizing bare areas.

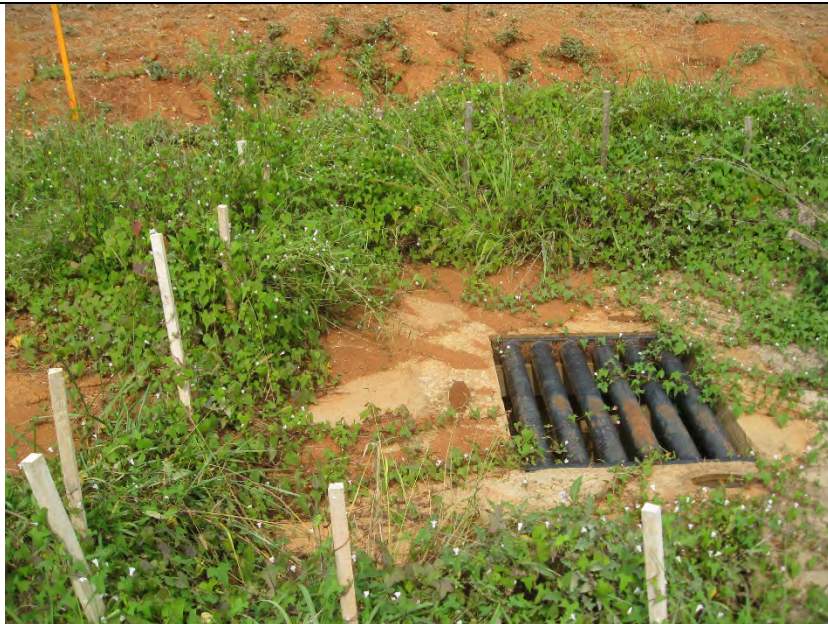
Photo 41
Sta. 677+00 RT
(RW 5L-23R)
Existing Structure
Project 4

Structure south of Taxiway "G".
Erosion and rills continue to occur along the graded slope.
Recommend repairing eroded areas, removing accumulated sediment, and immediately stabilizing slope to reduce the probability of future erosion issues.
See photo below.

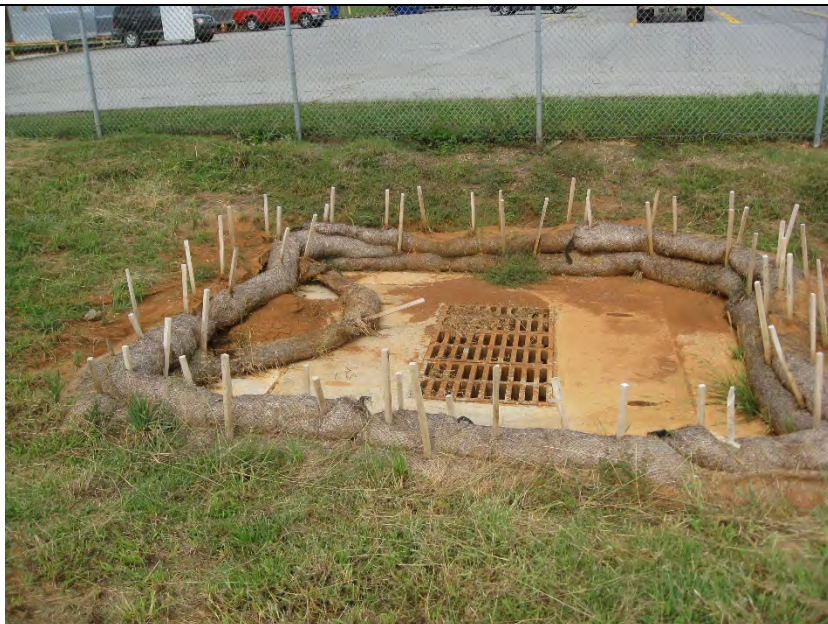
Photo 43
Sta. 677+00 RT
(RW 5L-23R)
Project 4

Structure between taxiway and UPS.
Recommend repairing rills as needed and stabilizing remaining bare areas.

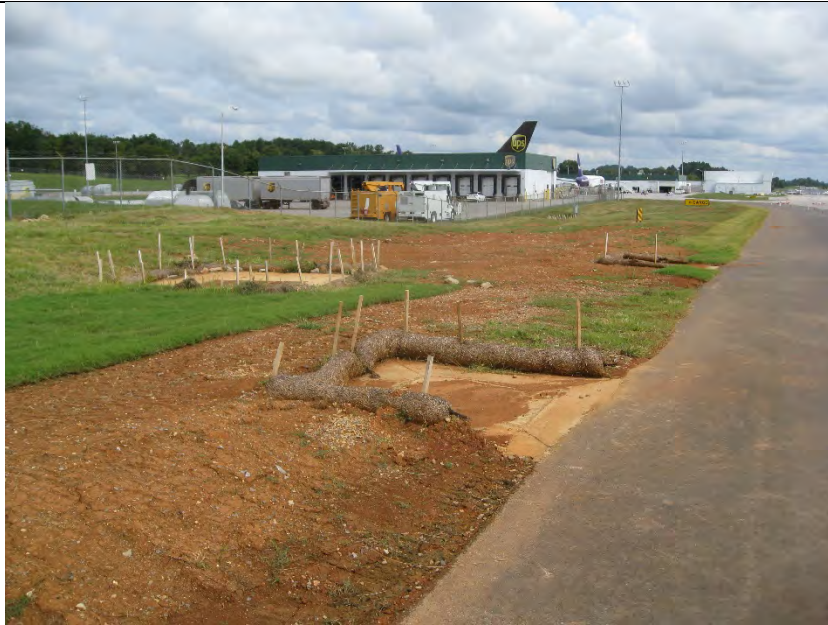
Photo 44
Sta. 676+00 RT
(RW 5L-23R)
Project 4

Storm structure adjacent to UPS.
Recommend removing sediment and repairing sediment tubes.

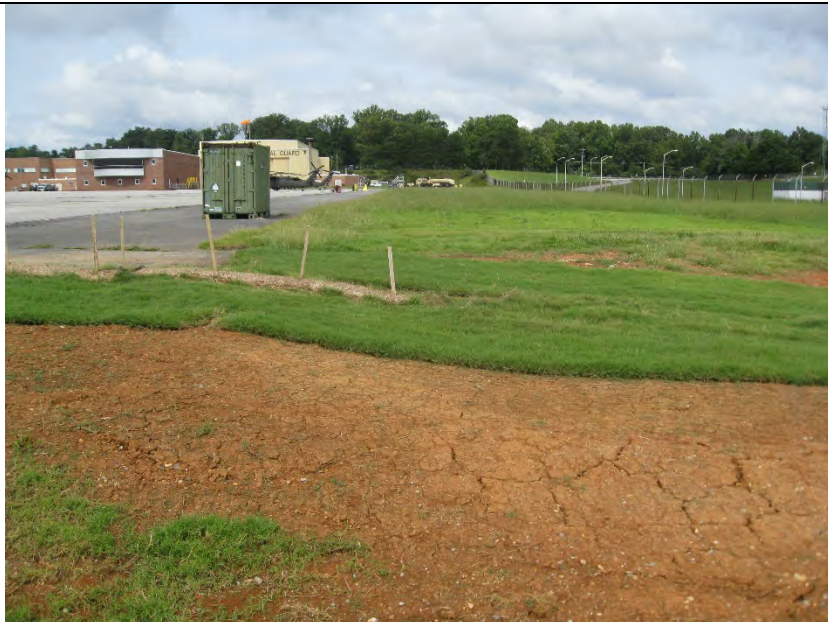
Photo 45
New structure
Project 4

New storm structure located north of Taxiway G.
Area recently regraded to capture runoff from the helipad apron. Sod recently installed.
Recommend stabilizing remaining bare areas.

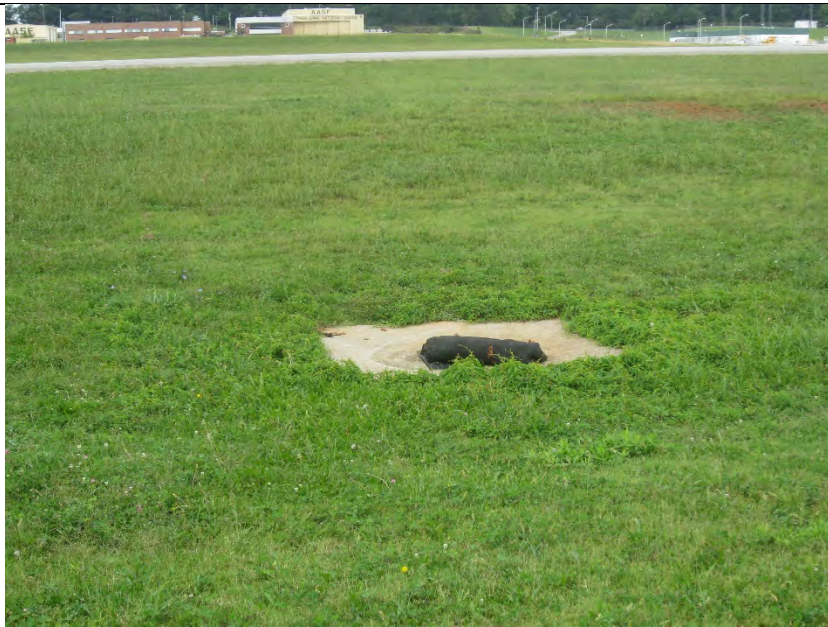
Photo 46
New structure
Project 4

New storm structure located north of Taxiway G.
Area recently regraded to capture runoff from the helipad apron. Sod recently installed.
Recommend stabilizing remaining bare areas.

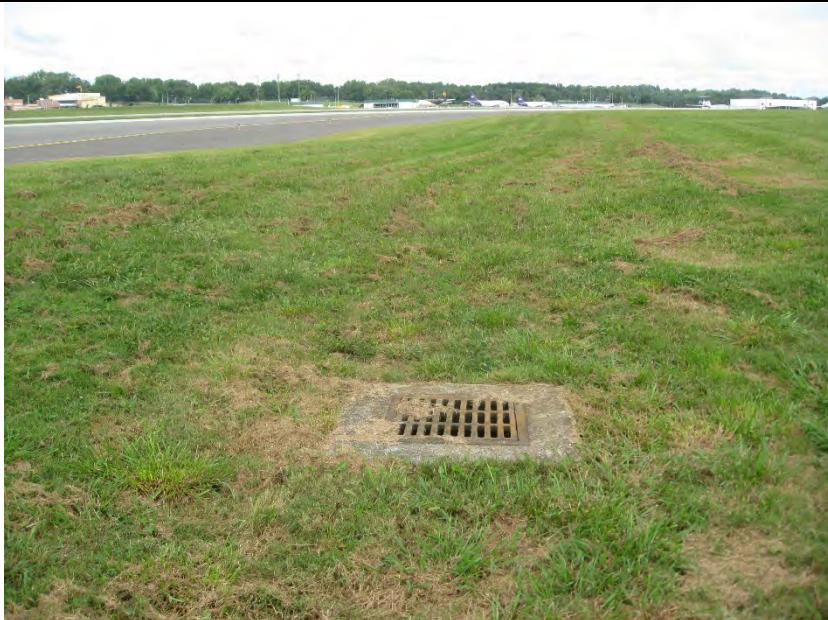
Photo 47
Sta. 366+89 RT
(RW 5L-23R)
Existing Structure
Project 4

Existing Structure adjacent to Outfall C.

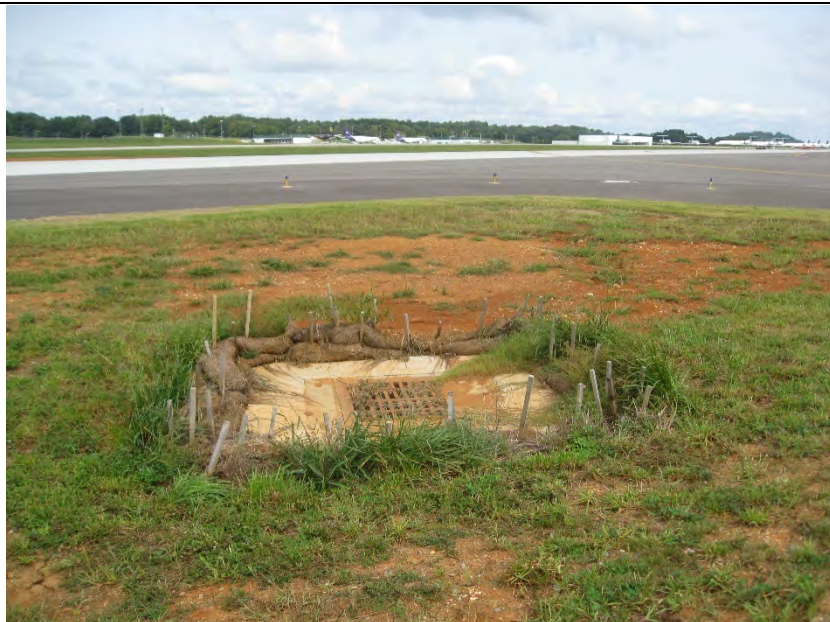
Photo 49
(RW 5L-23R)
TWY Y Tie-in
Project 4

Existing structure south of Taxiway Y.
Recommend removing inlet protection.

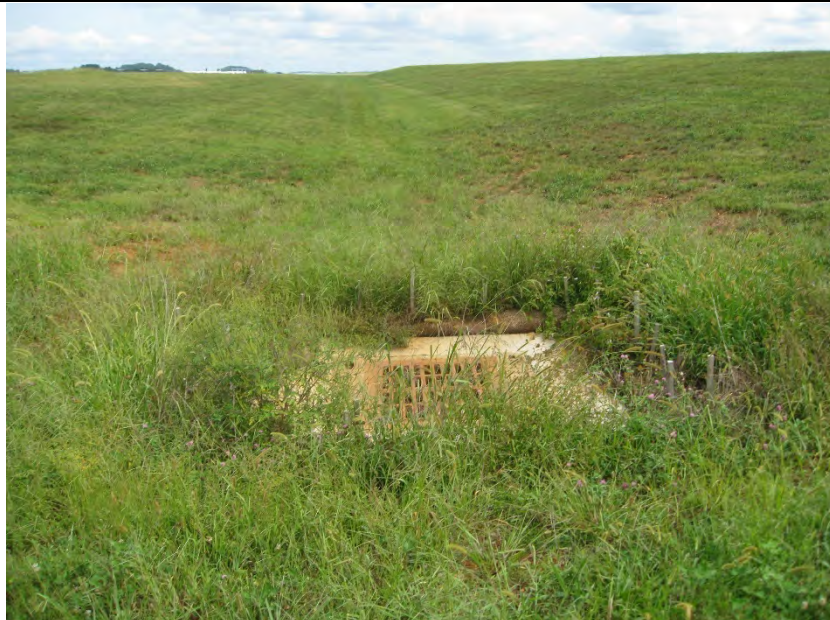
Photo 51
Sta. 362+02 LT
(RW 5L-23R)
Structure 400
Project 4

Structure 400.
Recommend removing accumulated sediment, regrading area as needed, and immediately stabilizing remaining bare areas to reduce the probability of future erosion issues.

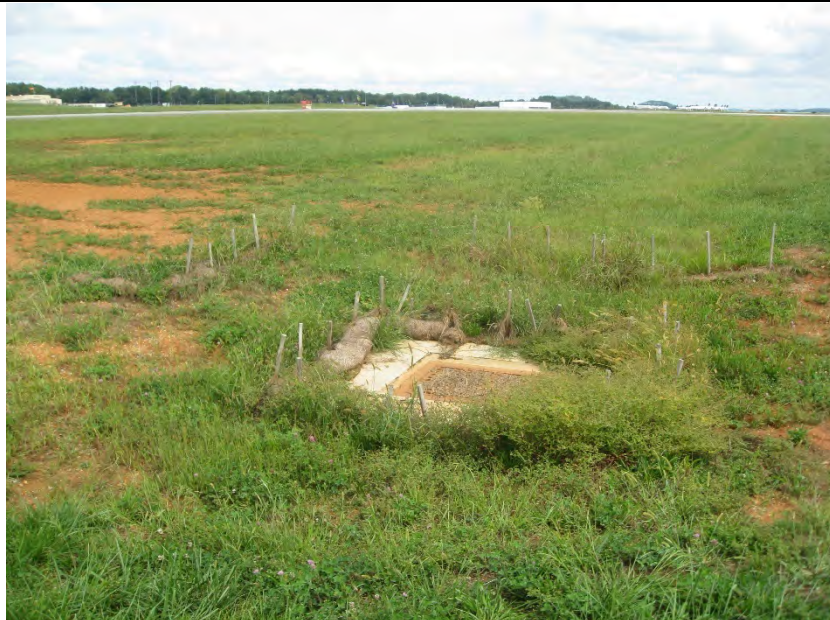
Photo 53
Sta. 347+26 RT
(RW 5L-23R)
Structure 22
Project 4

Structure 22.
Recommend removing sediment from top of structure.
Recommend adding sediment tubes.
Recommend stabilizing bare areas.

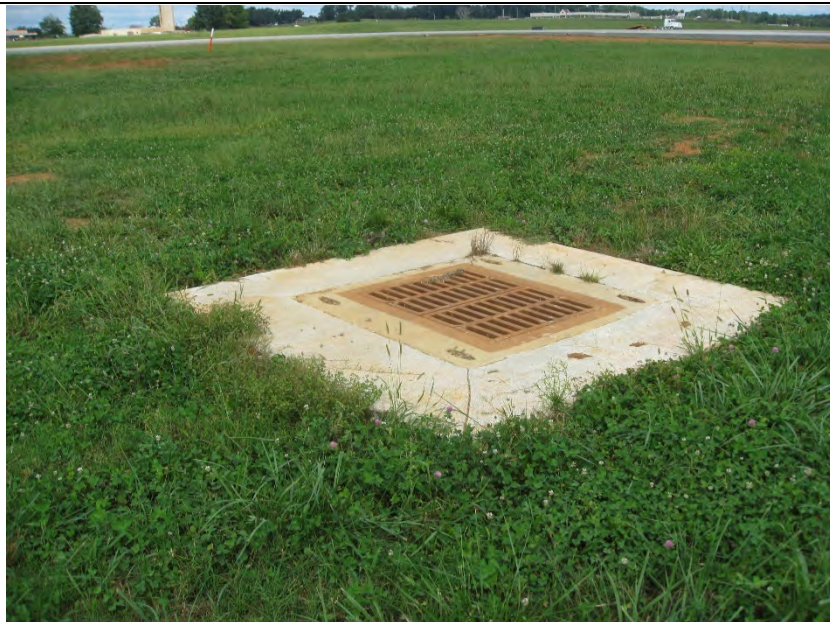
Photo 55
Sta. 347+26 RT
(RW 5L-23R)
Structure 202
Project 4

Structure 202.
Sod recently installed.
Recommend stabilizing remaining bare areas and then removing inlet protection.

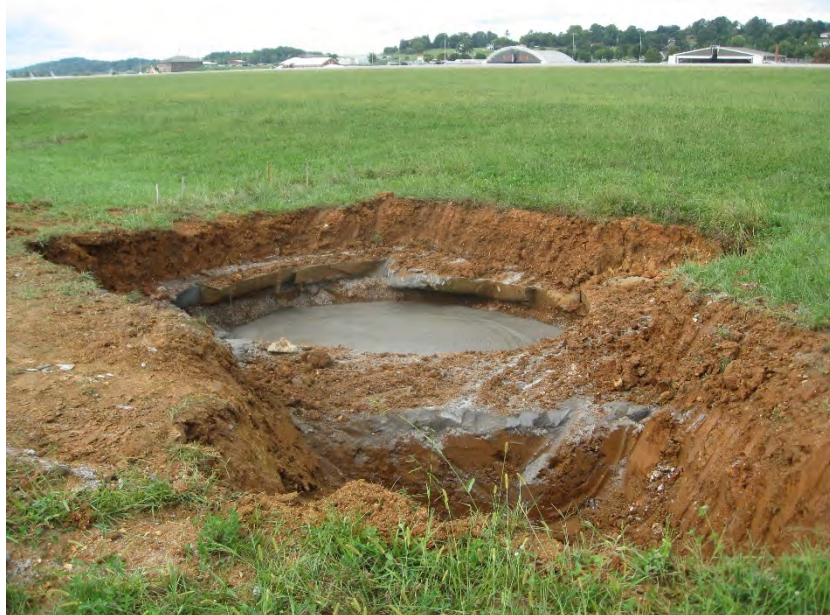
Photo 57
Sta. 341+86 RT
(RW 5L-23R)
Project 4

Potential construction fallout on Storm Line 2 between structures 204 and 206 just downgradient of an underdrain outlet.
Recommend coordinating remediation with CHA.

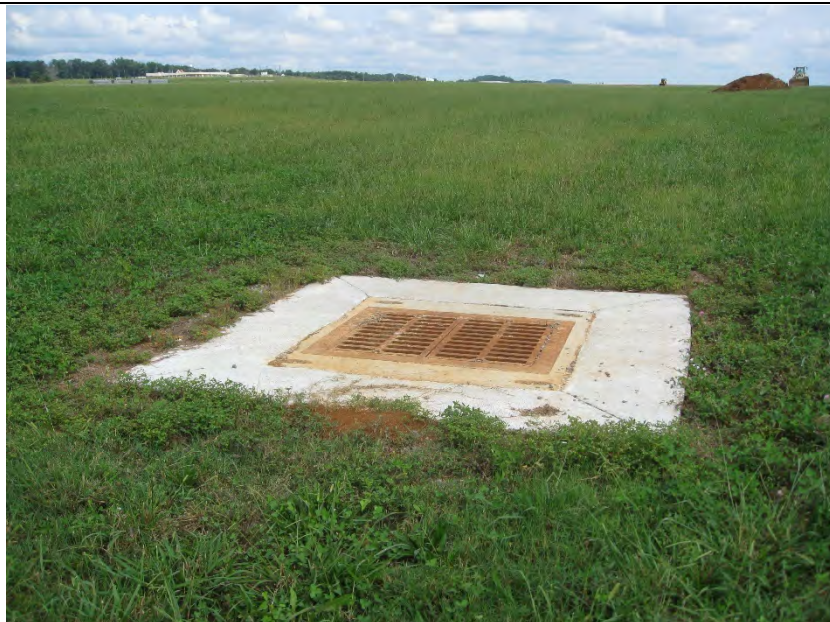
Photo 59
Sta. 338+02 RT
(RW 5L-23R)
Structure 206
Project 4

Structure 206.
Recommend removing inlet protection.

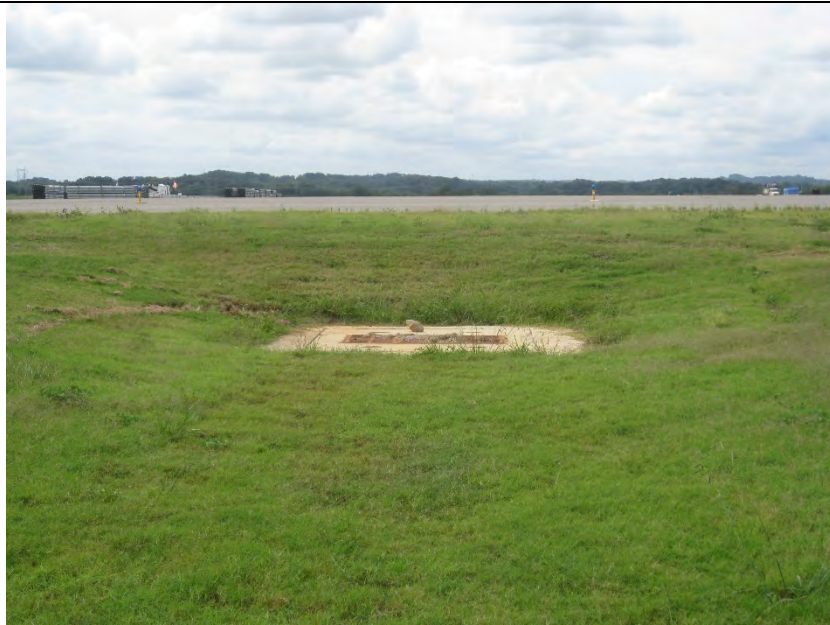
Photo 62
Sta. 321+73 RT
(RW 5L-23R)
Structure 212
Project 3

Structure 212.
Recommend repairing eroded ditch line
Recommend removing sediment. Recommend replacing all sediment tubes.
Recommend stabilizing remaining bare areas.

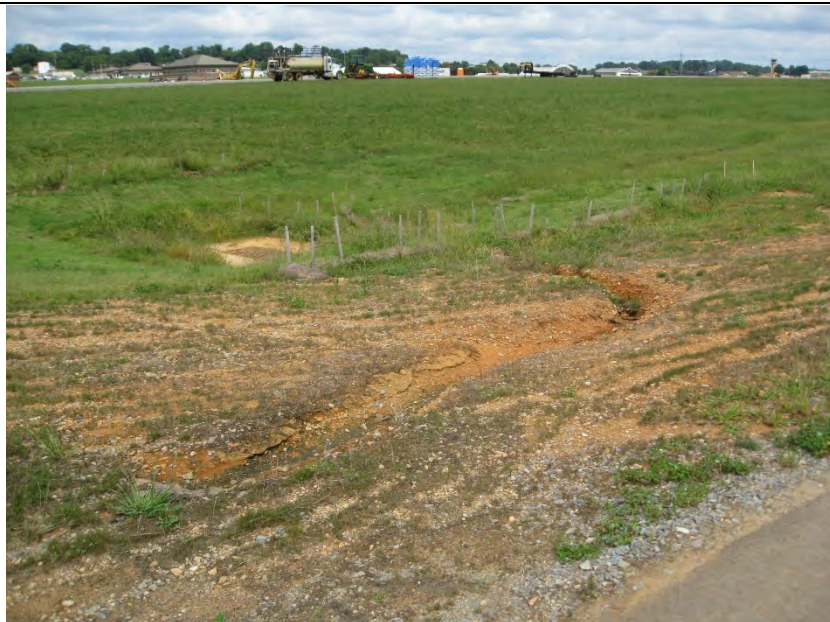
Photo 65
Sta. 301+87 RT
(RW 5L-23R)
Structure 218
Project 3

Structure 218.
Rill above structure continues to erode (see photo below).

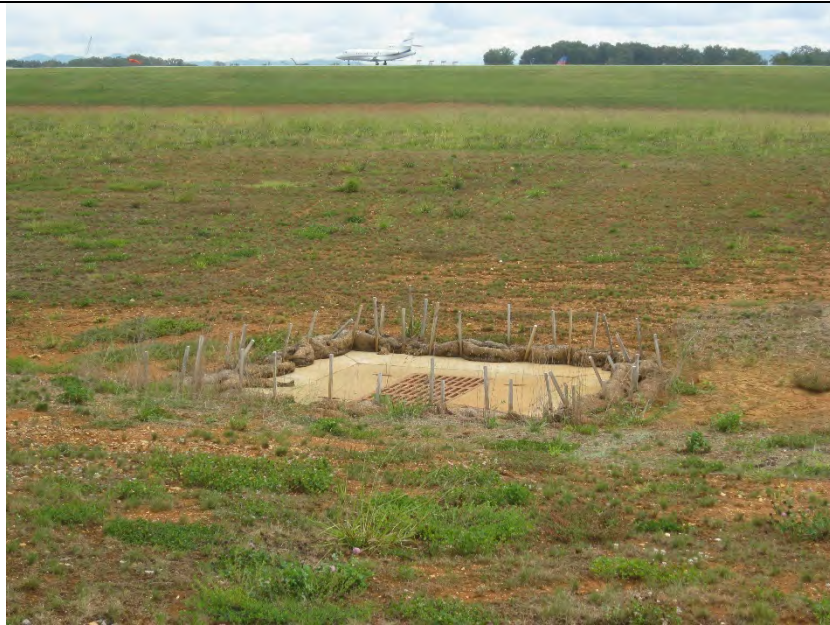
Photo 66
Sta. 301+87 RT
(RW 5L-23R)
Structure 218
Project 3

Structure 218.
Recommend stabilizing bare areas and repairing rill above structure.

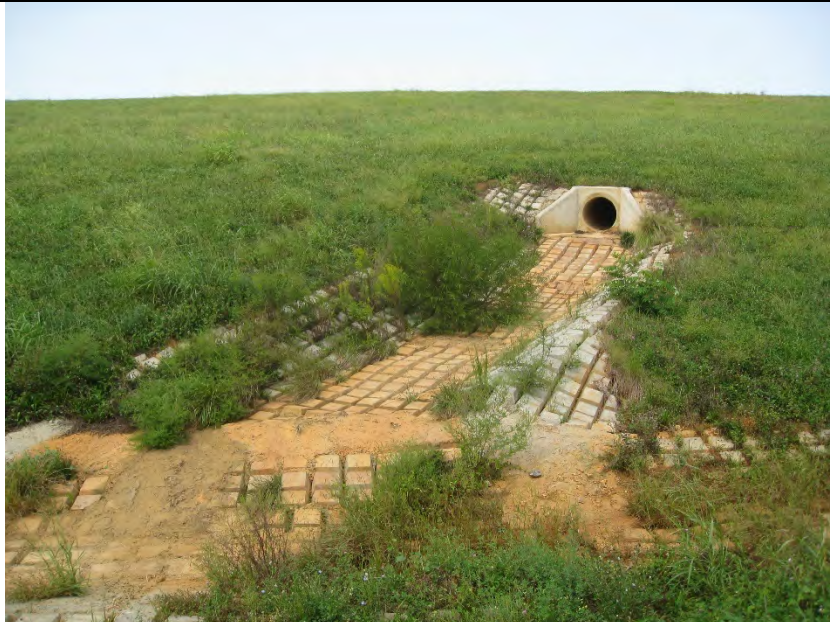
Photo 67
Sta. 296+83 RT
(RW 5L-23R)
Structure 220
Project 2

Structure 220.
Recommend stabilizing remaining bare areas.

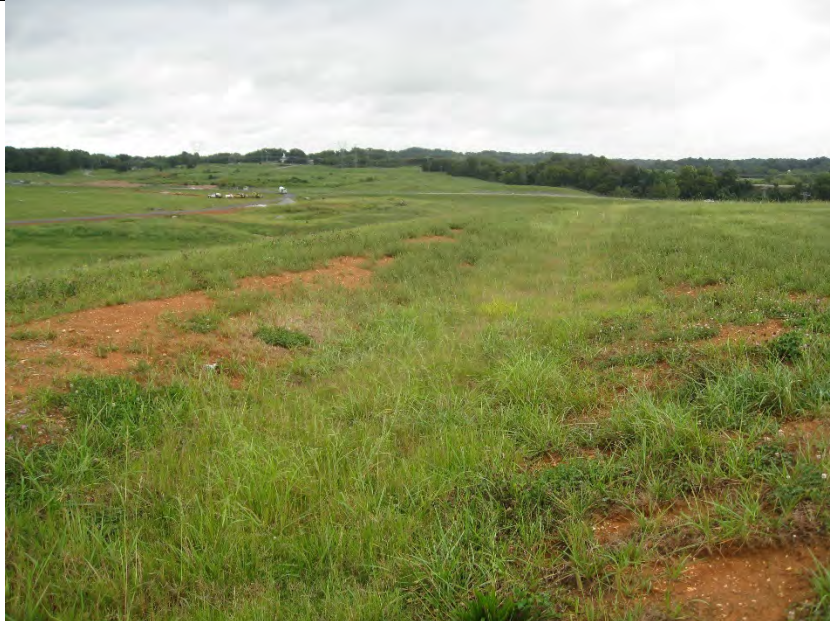
Photo 69
Sta. 288+26
(RW 5L-23R)
Structure 224
Project 2

Below structure 224.
Side slope has eroded causing damage to the articulated concrete block.
CHA, Harper and KMAA were already aware of the issue as discussed in a progress meeting dated 07/16/2020.

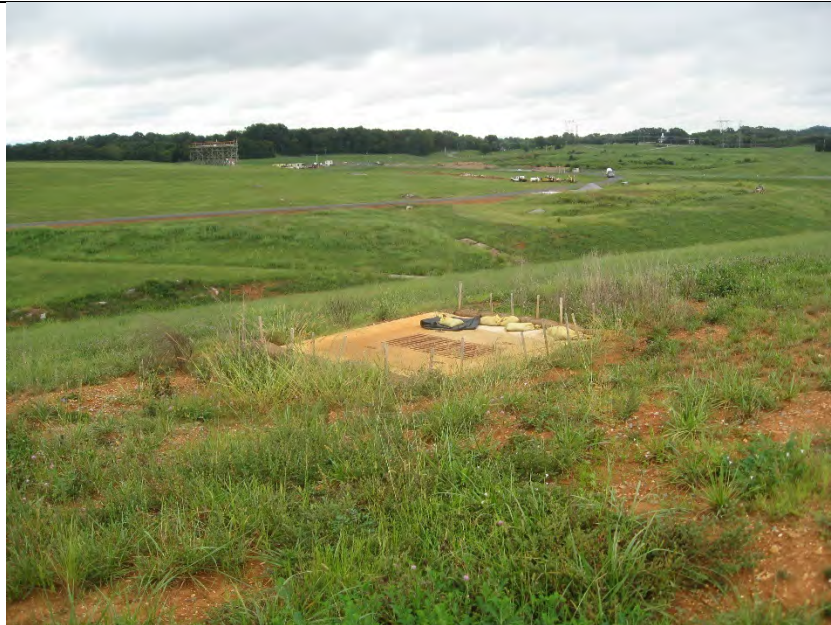
Photo 70
Sta. 290+26 RT
(RW 5L-23R)
Structure 600 Ditch
Project 2

Structure 600 Ditch.
Recommend removing sediment tubes from entire 600 ditch and stabilizing bare areas.

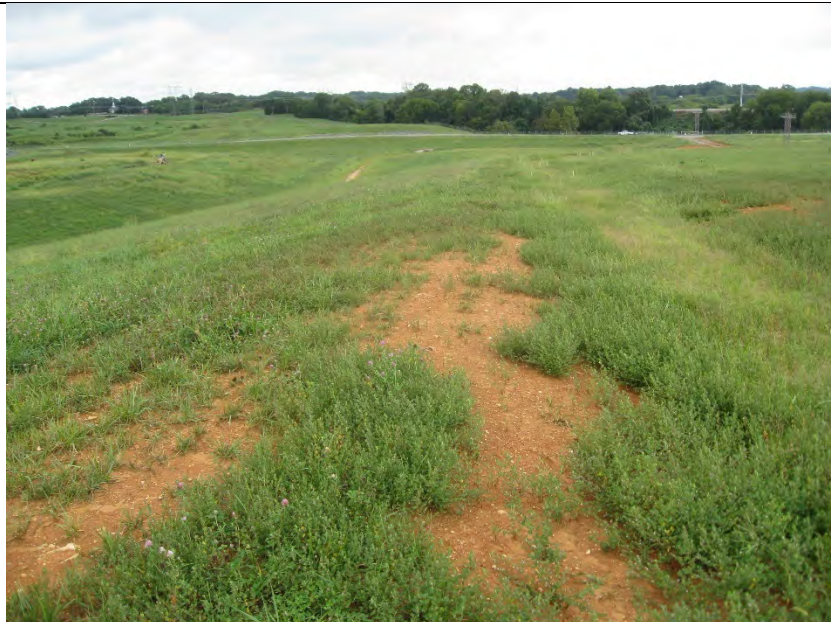
Photo 71
Sta. 290+26 RT
(RW 5L-23R)
Structure 222
Project 2

Structure 222.
Recommend removing inlet protection.
Recommend stabilizing bare areas.

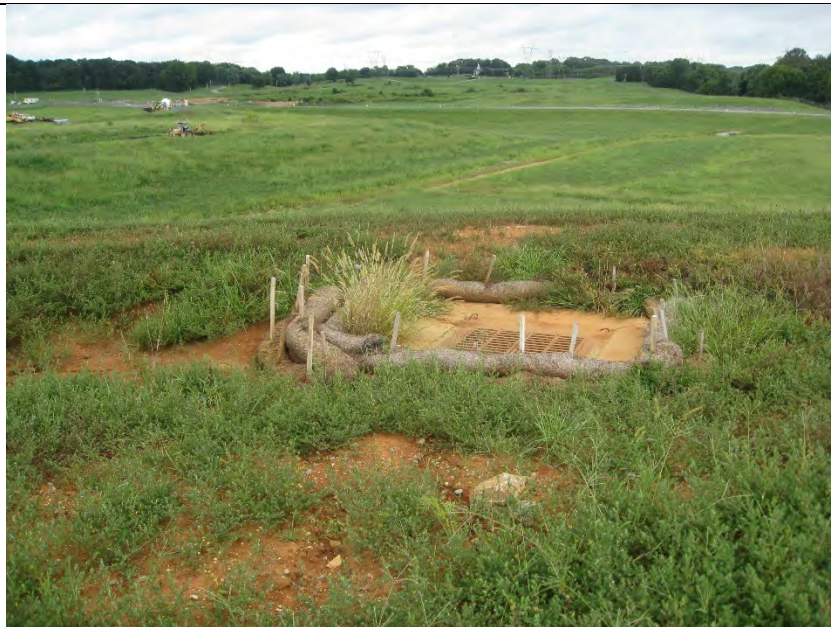
Photo 72
Sta. 290+26 RT
(RW 5L-23R)
Structure 600 Ditch
Project 2

Structure 600 ditch.
Recommend removing sediment tubes from entire 600 ditch and stabilizing bare areas.

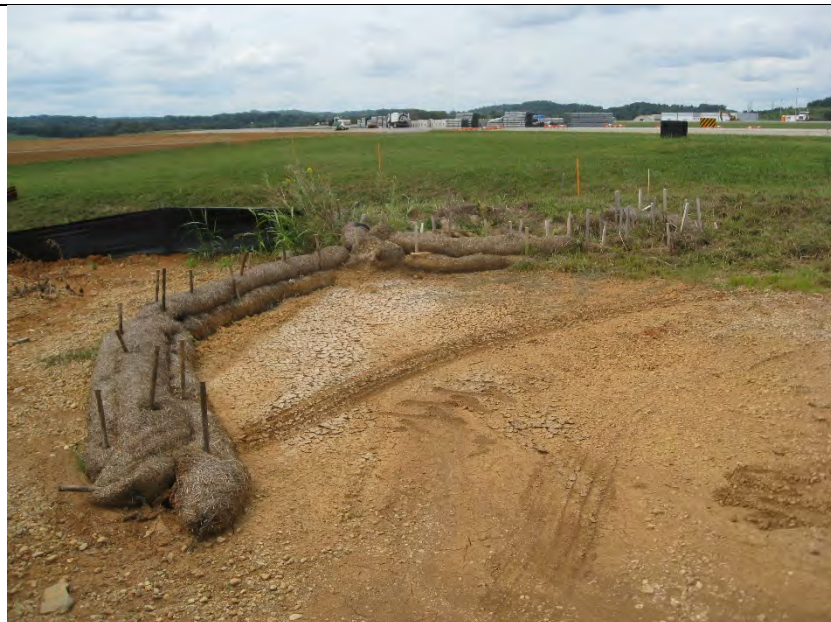
Photo 73
Sta. 284+59
(RW 5L-23R)
Structure 600
Project 3

Structure 600.
Recommend removing inlet protection and stabilizing bare areas.

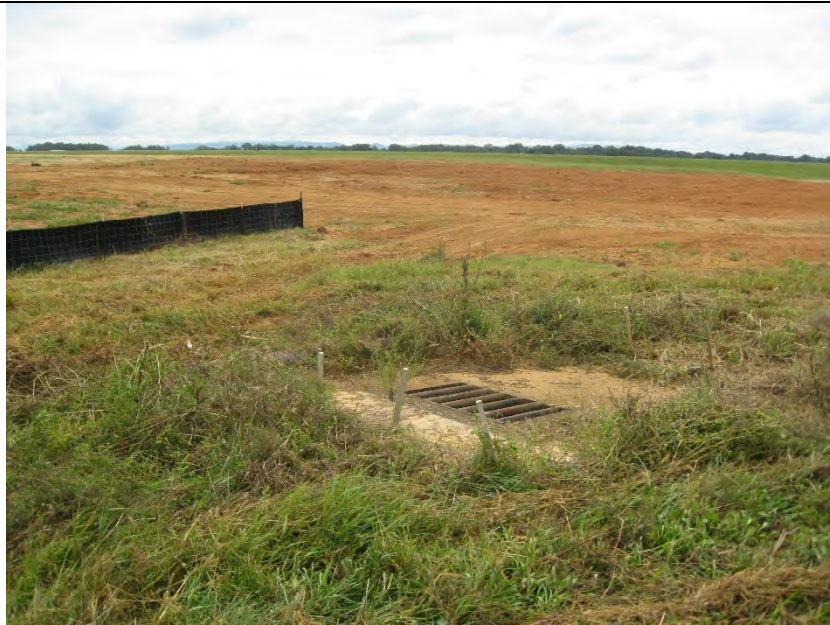
Photo 74
(RW 5L-23R)
Project 3

Existing structure adjacent to crushing operations.
Rills have started to form adjacent to existing structure.

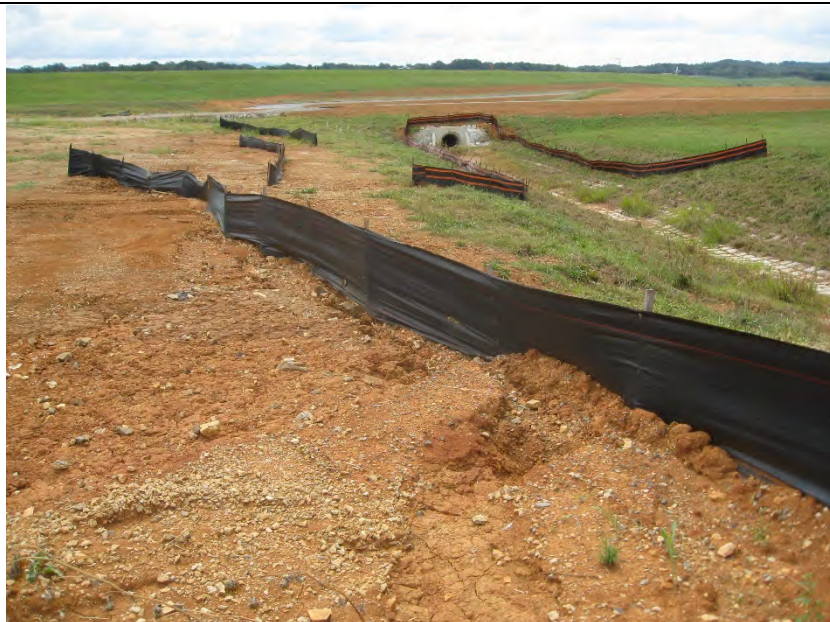
Photo 75
(RW 5L-23R)
Project 3

Existing structure.
Grading operations appear to be complete.
Recommend stabilizing remaining bare areas of entire pad.

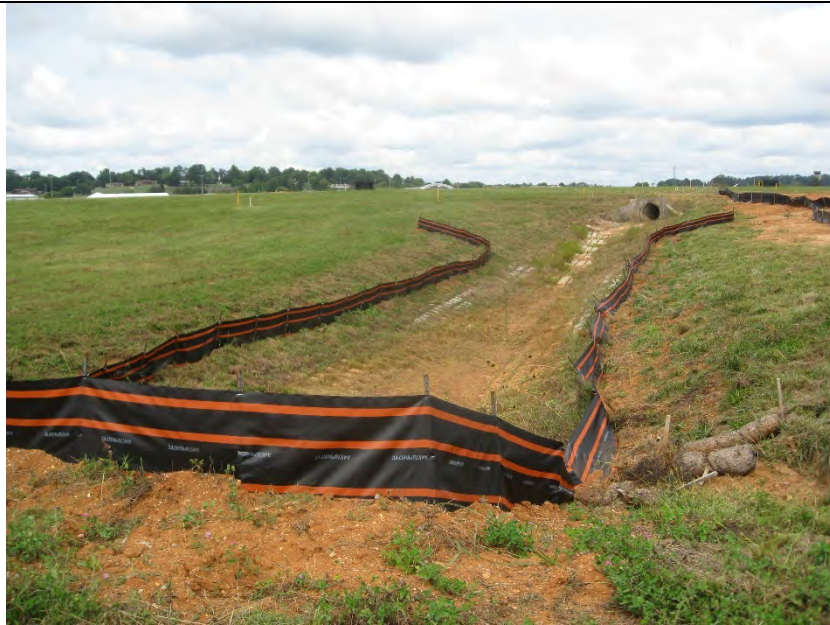
Photo 76
(RW 5L-23R)
Project 3

Silt fence above North Lateral Ditch at stone stockpile area.
Silt fence continues to erode during storm events.
Recommend repairing undermined silt fence and adding sediment tube "J" hooks.

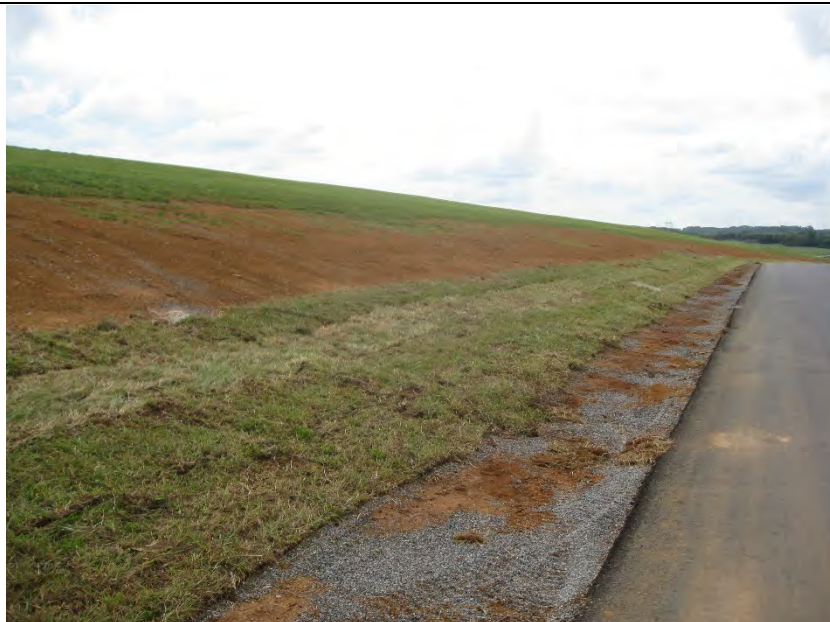
Photo 81
Sta. 32+50 RT
Proposed Haul Route
Project 3

Inlet structure along haul road.
Sod recently installed.
Recommend stabilizing remaining bare areas as soon as practical.

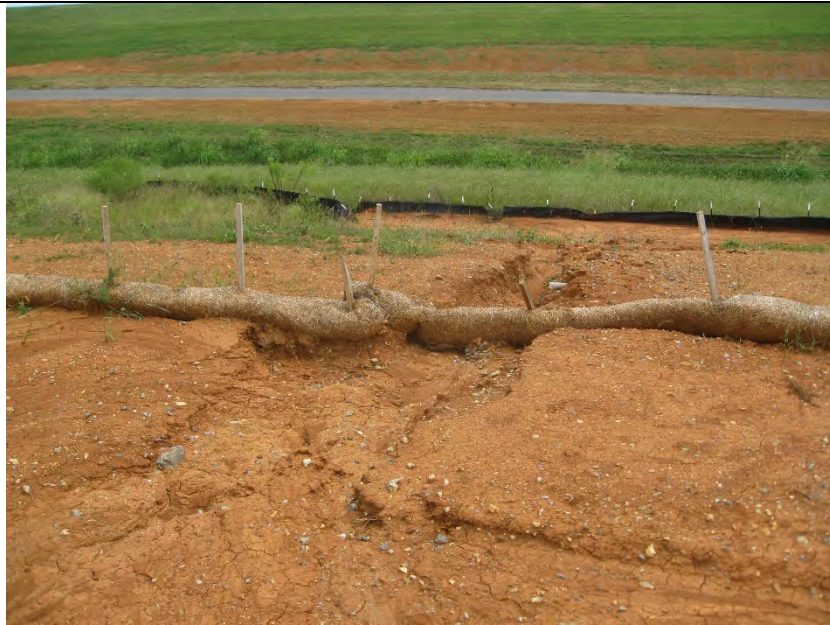
Photo 82
Sta. 32+50 RT
Proposed Haul Route
Project 3

Haul Route recently paved.
Sod recently installed.
Recommend stabilizing remaining bare areas as soon as practical.
