QUALITY ASSURANCE MONTHLY SITE ASSESSMENT REPORT

Airfield Modernization Program
Runway 5L-23R Reconstruction
Project 2 / Project 3
Project 4 / Repair TWY Lighting
Project 5 / Project 6

QUALITY ASSURANCE SITE ASSESSMENT

10/29/2020

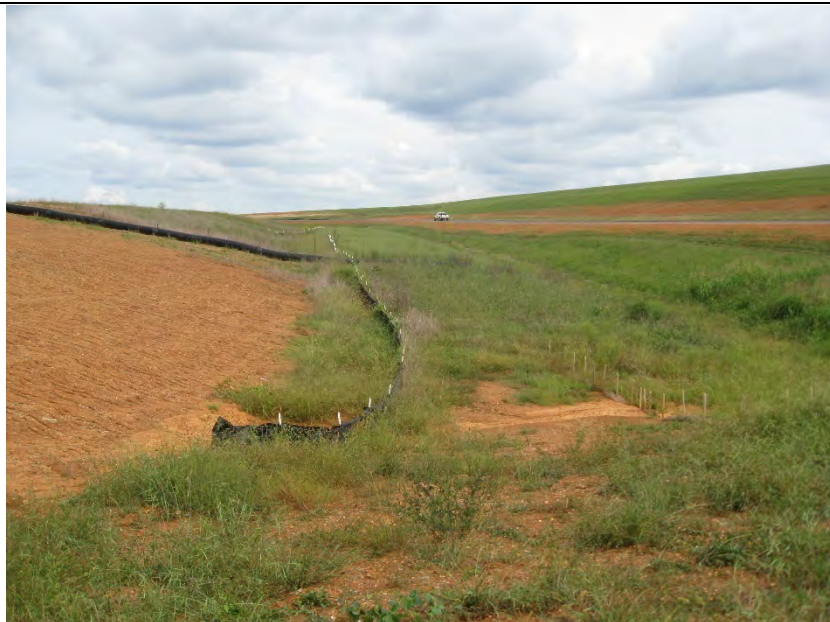
Photo 83
Sta. 302+54
(RW 5L-23R)
Project 2

North Lateral Fill Area
Area was recently regraded. Rills have reformed.
Recommend filling rills, removing sediment and stabilizing bare areas.
Recommend adding slope drain.

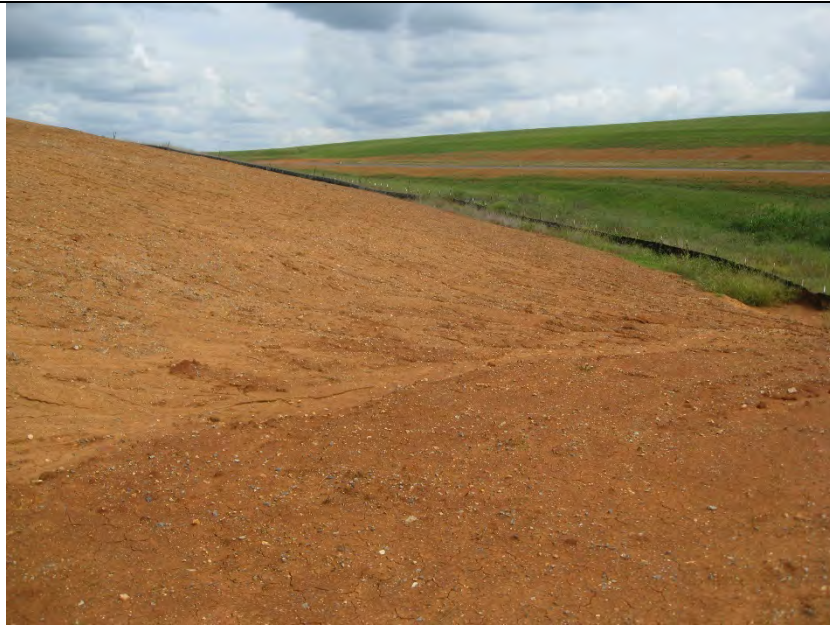
Photo 84
Sta. 302+54
(RW 5L-23R)
Project 2

Above North Lateral Endwall 100.
Recommend stabilizing bare areas.

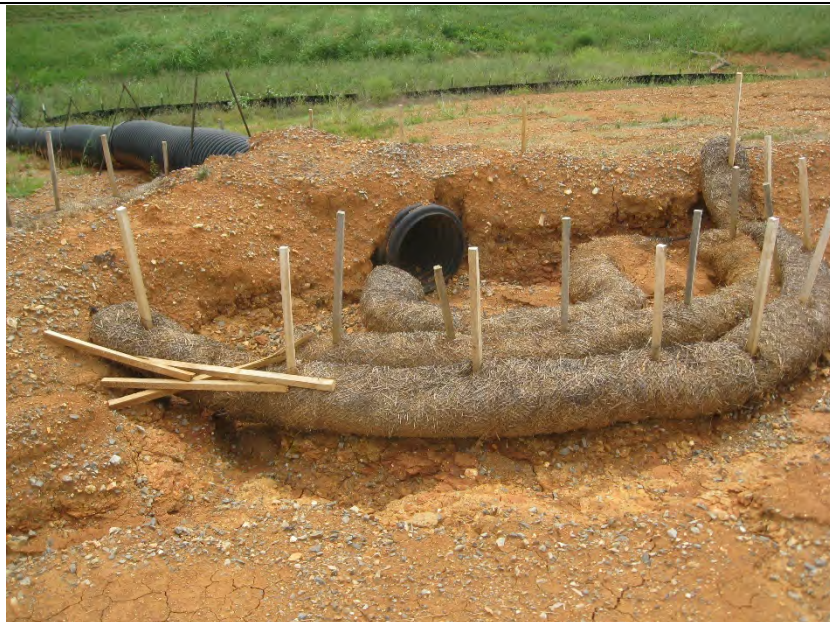
Photo 85
Sta. 302+54
(RW 5L-23R)
Project 2

Above North Lateral Endwall 100.
Rills have formed and have dropped sediment at toe of slope.
Recommend removing sediment and repairing rills.
At the same time, in order to reduce chances of further erosion issues, recommend stabling all bare areas.

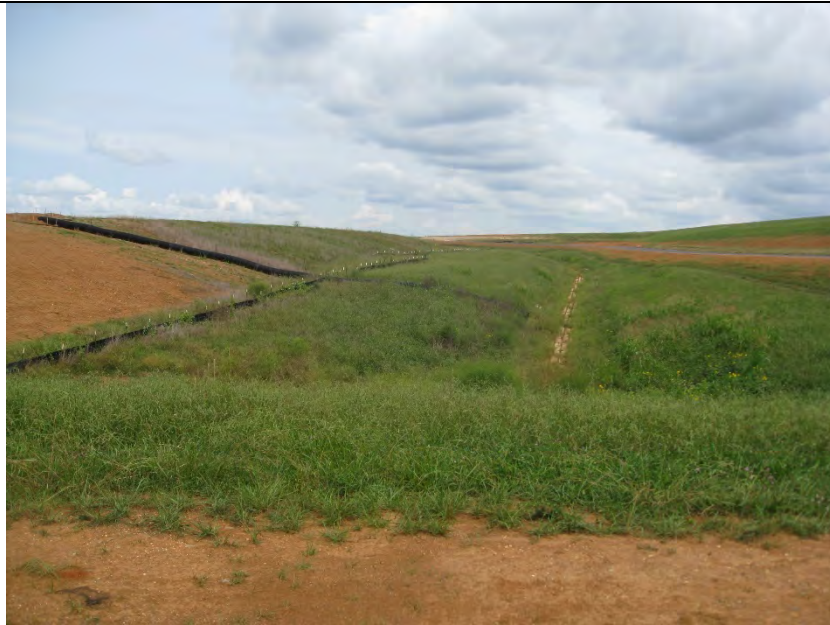
Photo 86
Sta. 302+54
(RW 5L-23R)
Project 2

Soil stockpile area next to haul road at Taxiway B.
Sediment tubes at slope drain have been undermined. Recommend repairing or adding tubes to prevent runoff under the sediment tubes.
Recommend stabilizing all bare areas.

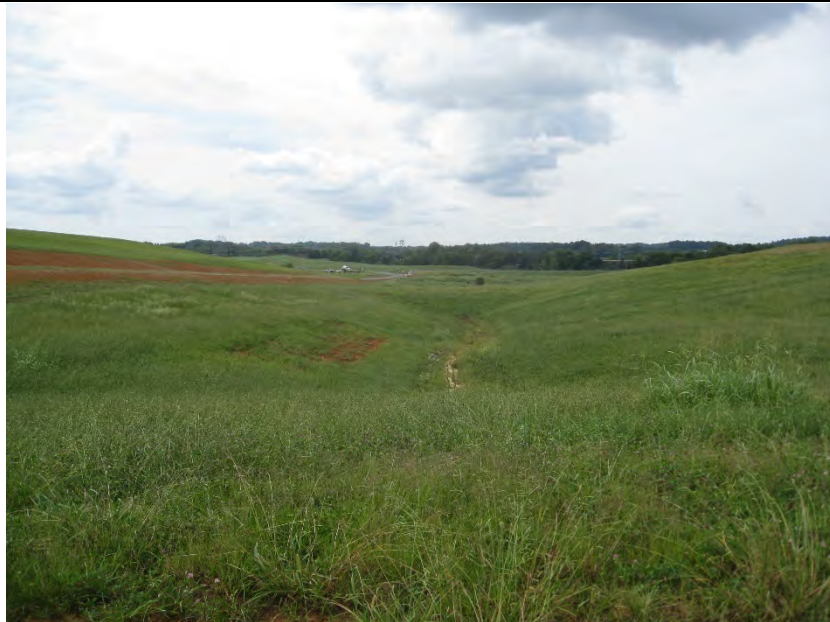
Photo 87
Sta. 302+54 to Sta. 313+50
(RW 5L-23R)
Project 2

North Lateral Endwall 100.
Recommend stabilizing bare areas.

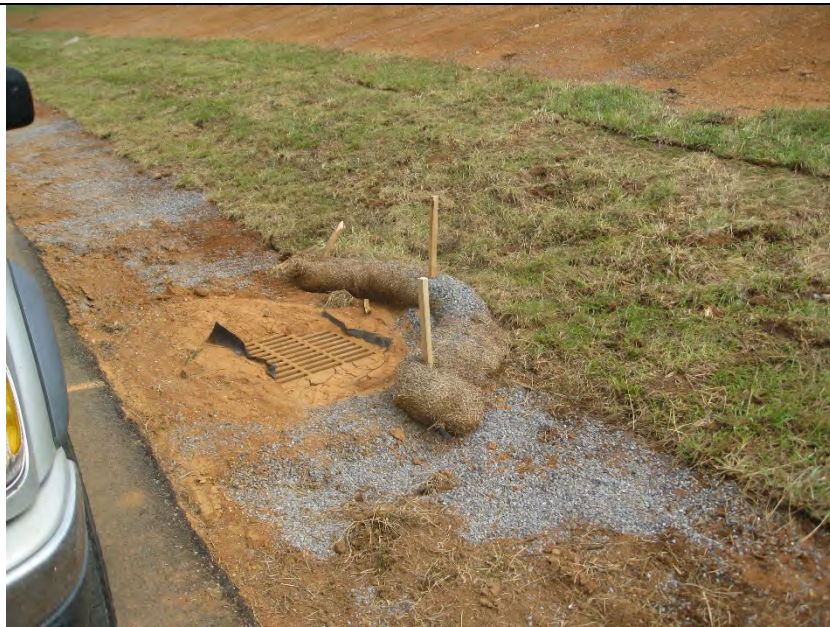
Photo 88
Sta. 300+60
(RW 5L-23R)
Project 2

North Lateral Endwall 102.

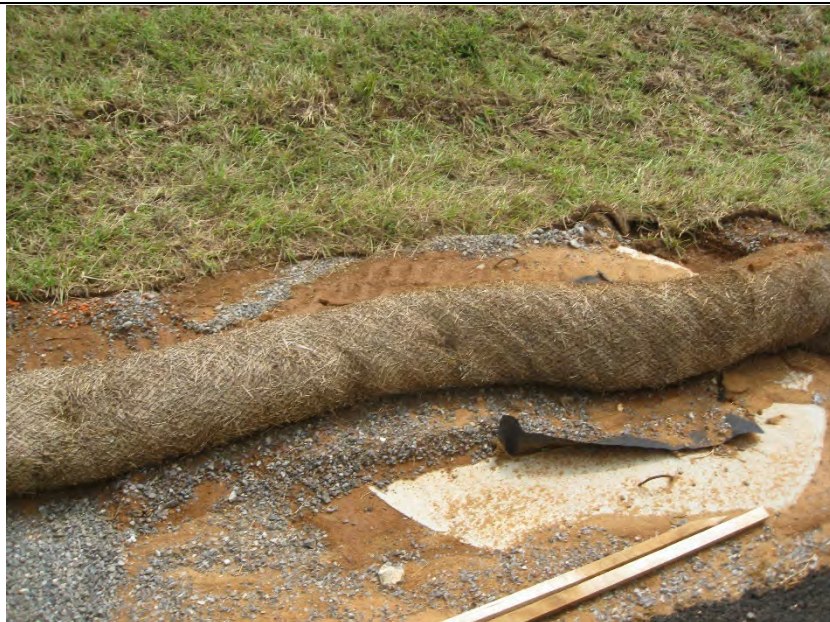
Photo 89
Sta. 29+00 RT
Proposed Haul Route
Project 3

Inlet structure along haul road.
Sod recently installed.
Recommend stabilizing remaining bare areas as soon as practical.

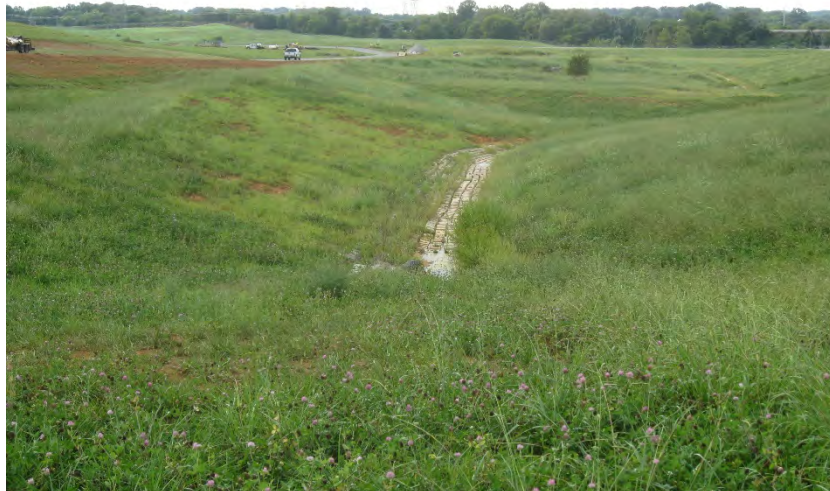
Photo 91
Sta. 297+01
(RW 5L-23R)
Project 2

North Lateral Endwall 104.

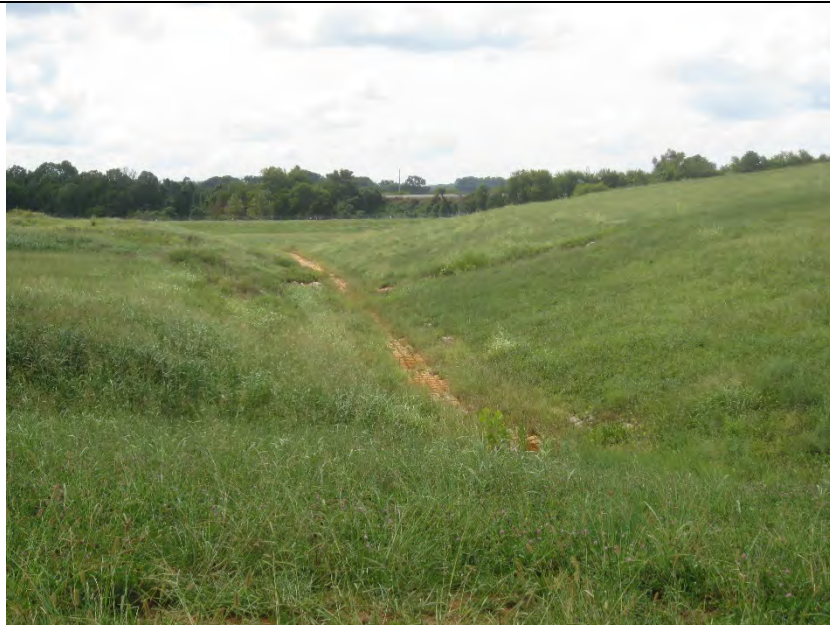
Photo 94
Sta. 292+08
(RW 5L-23R)
Project 2

North Lateral Endwall 108.

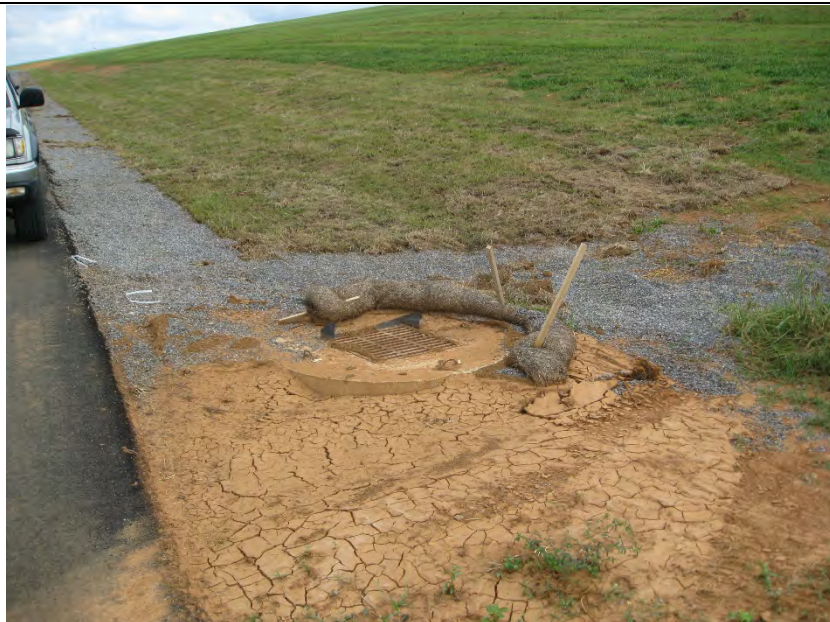
Photo 95
Sta. 290+50 LT
(RW 5L-23R)
Project 2

North Lateral Endwall 110.

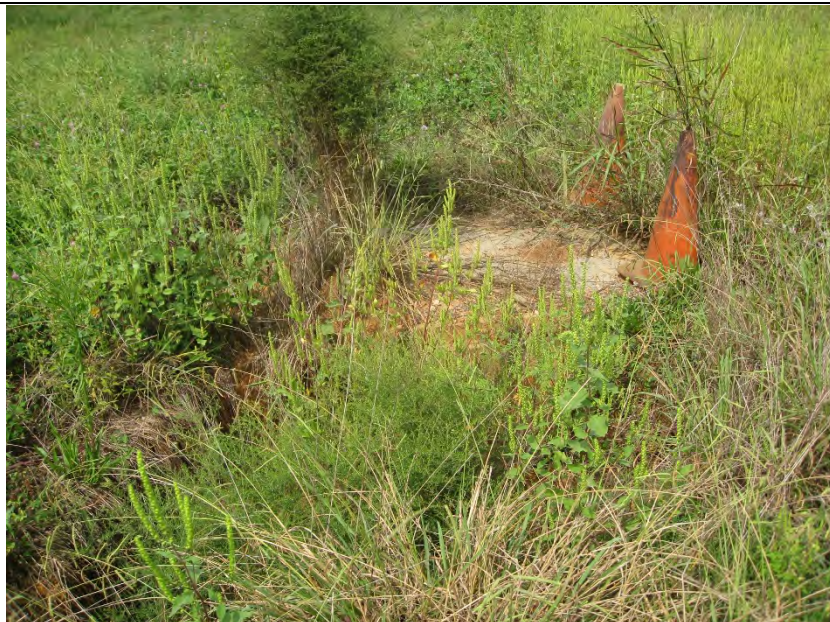
Photo 97
Sta. 15+50 RT
Proposed Haul Route
Project 3

Recommend stabilizing bare areas along haul route as soon as practical.

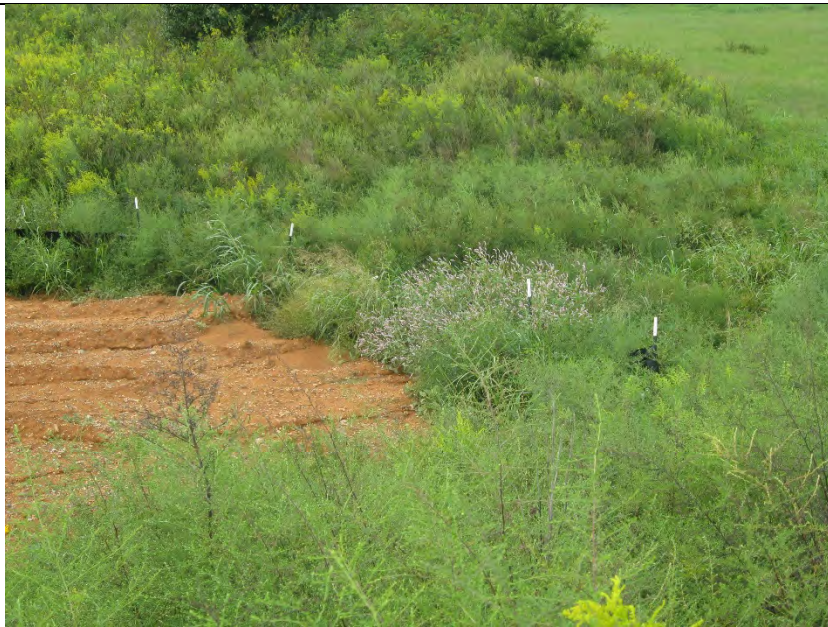
Photo 98
Sta. 284+00 LT
(RW 5L-23R)
Project 2

Existing vault at old Liberty street.
Construction fallout present. Recommend coordinating with CHA on remediation.

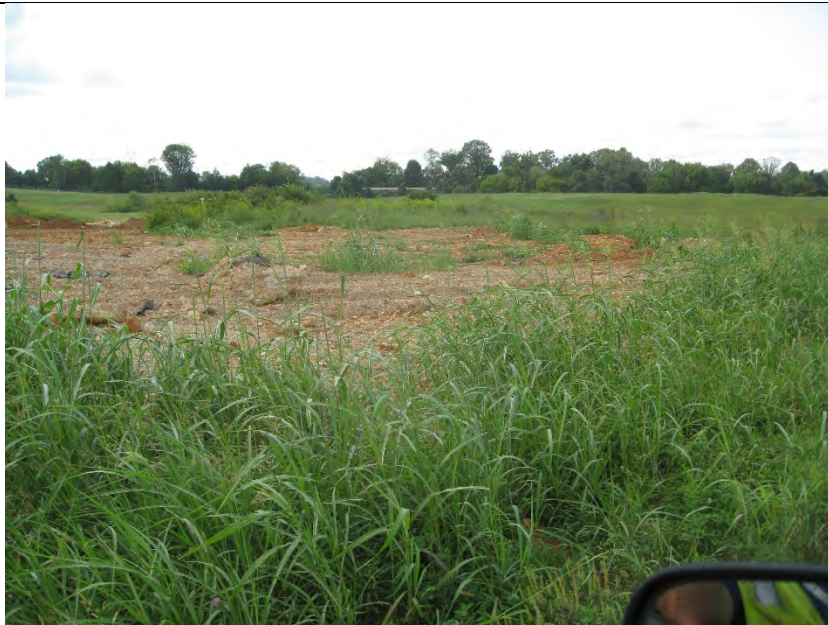
Photo 99
(Repair TWY Lighting)

Fill area adjacent to Liberty Street.
Sediment has migrated and come to rest on silt fence.
Recommend removing accumulated sediment.

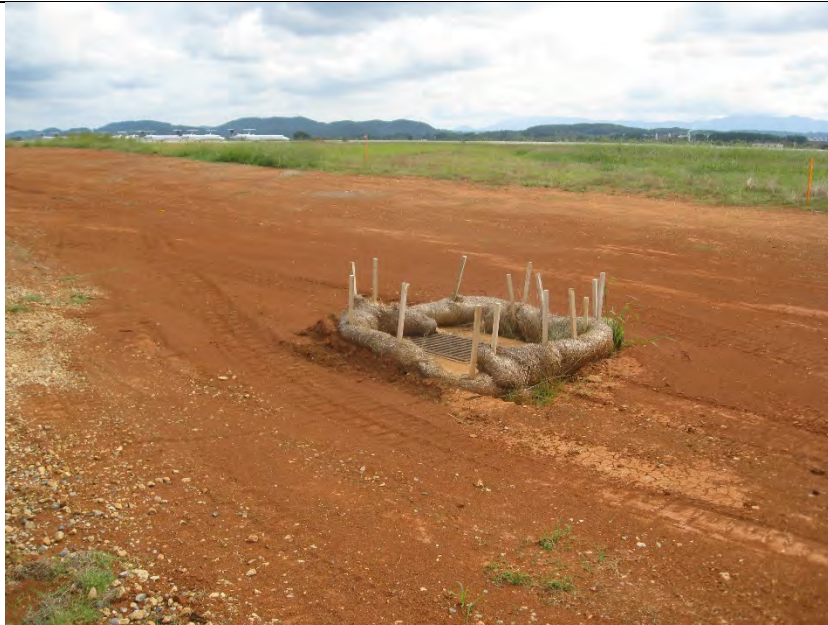
Photo 100
(Repair TWY Lighting)

Fill area adjacent to Liberty Street.
Grading operations have moved towards ditch line.
Recommend monitoring for sediment movement.

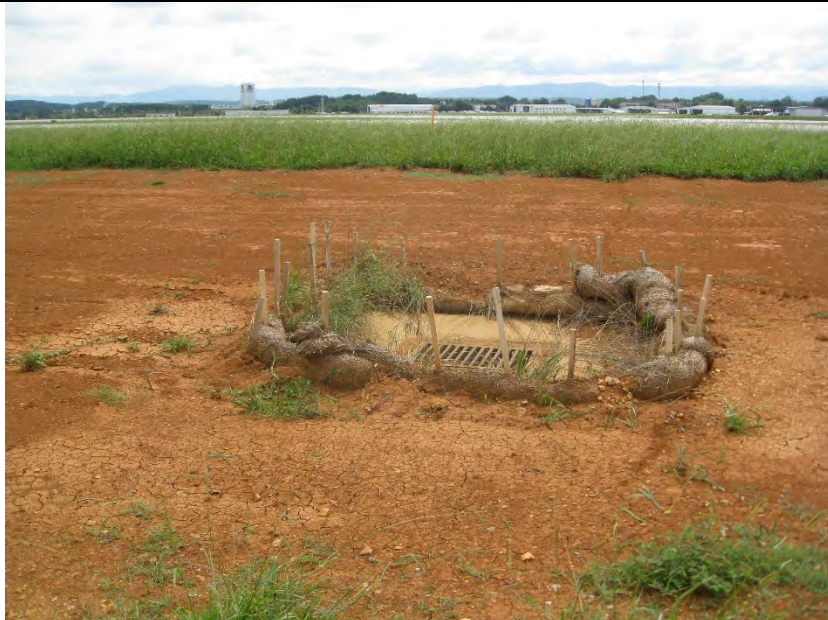
Photo 101
(Repair TWY Lighting)
Existing Structure

Existing structure south of Taxiway G
Recommend stabilizing bare areas.

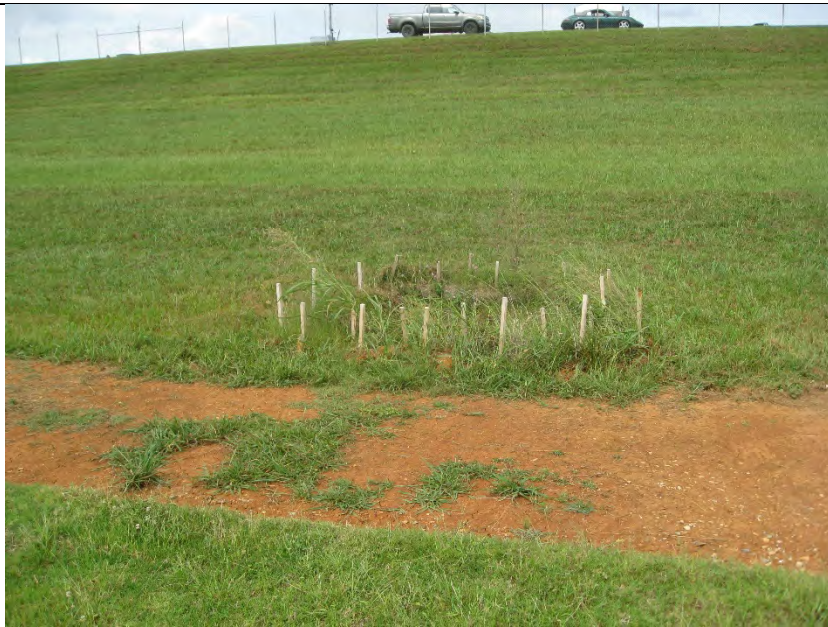
Photo 102
(Repair TWY Lighting)
Existing Structure

Existing structure south of Taxiway G.
Recommend stabilizing bare areas.

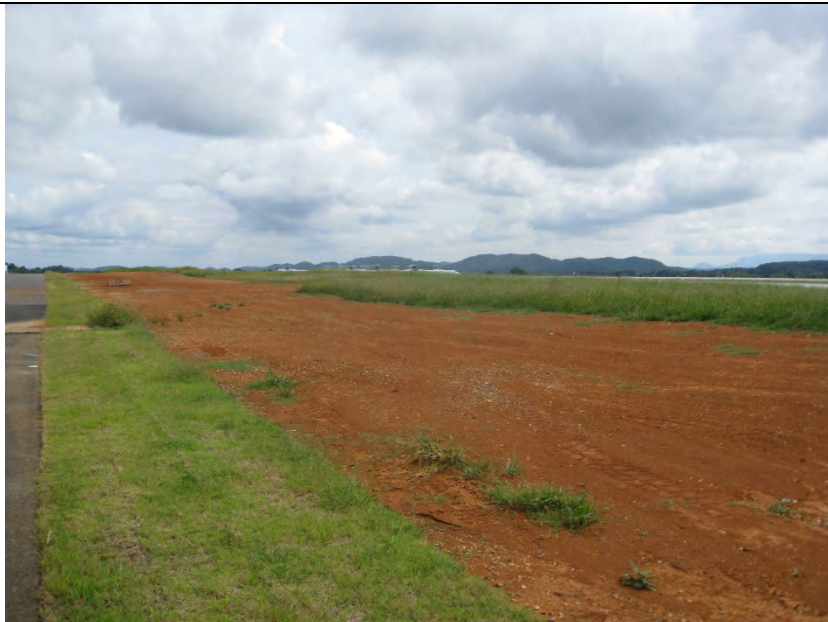
Photo 103
(Repair TWY Lighting)
Existing Structure

Existing structure north of Taxiway G.
Recommend stabilizing bare areas.

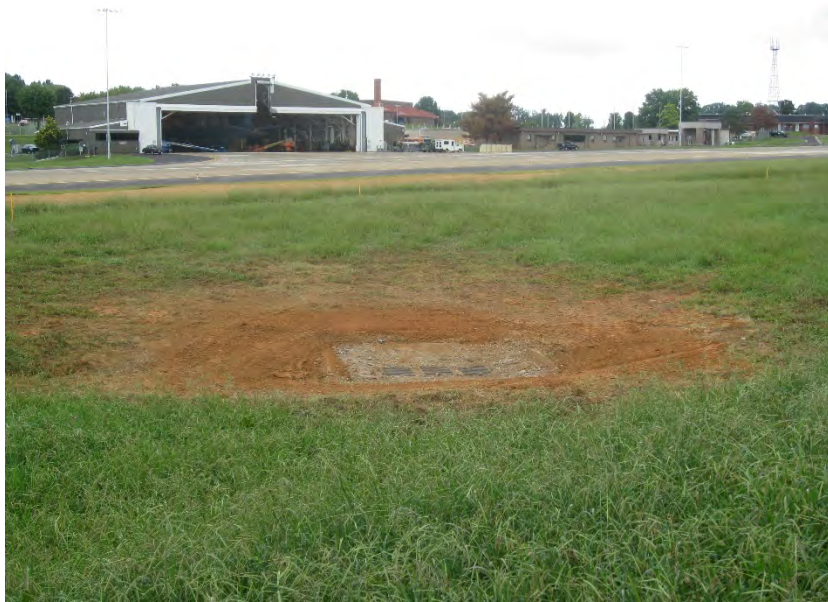
Photo 104
(Repair TWY Lighting)

Sod establishing along Taxiway G.
Recommend stabilizing remaining bare areas.

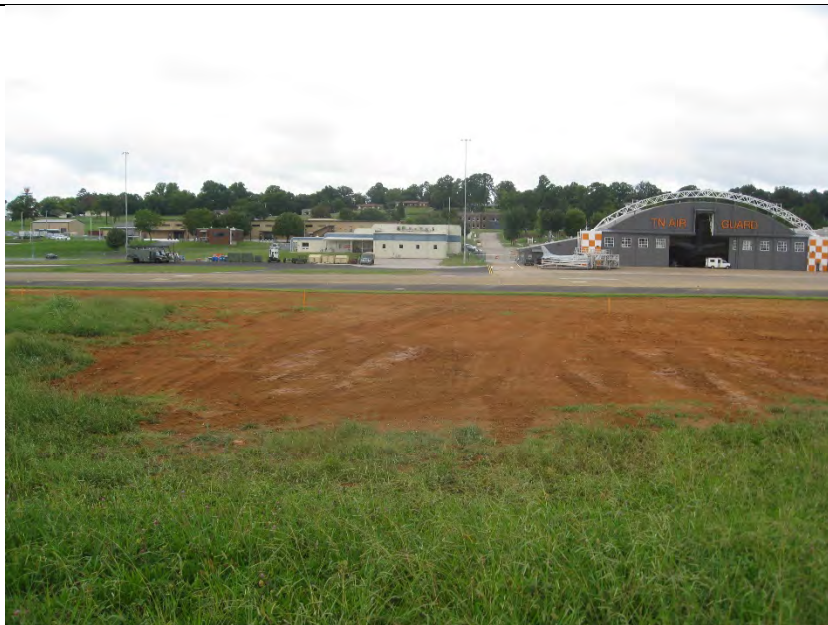
Photo 105
(Repair TWY Lighting)

Existing structure adjacent to old Taxiway G4.
Inlet protection recently removed.
Recommend stabilizing bare areas.

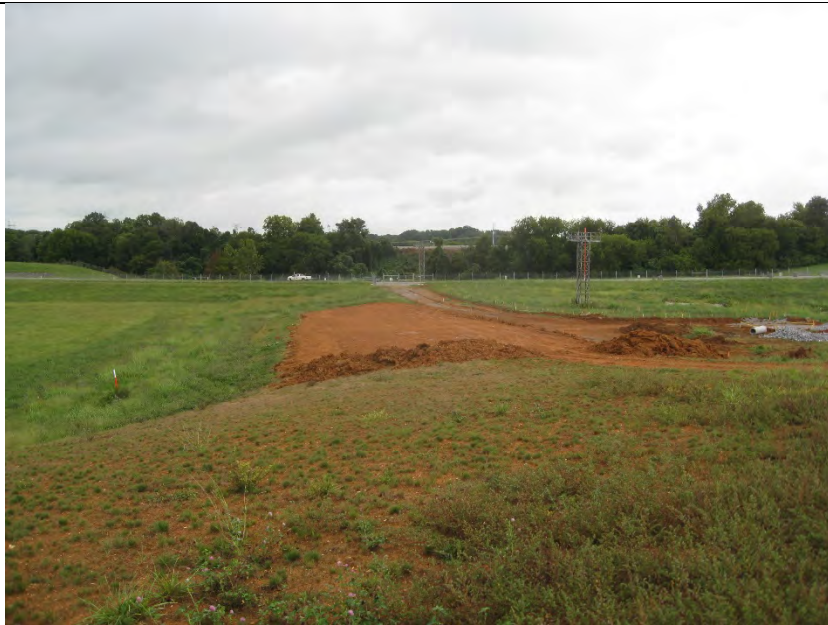
Photo 107
(Project 5/6)

Area adjacent to haul road.
Concrete washout area recently installed.
Recommend adding signage per the permit.

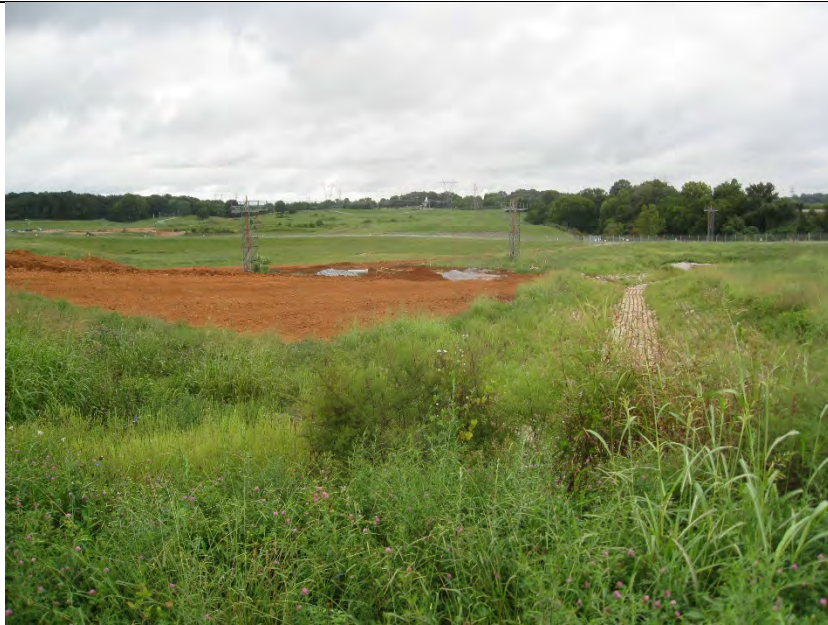
Photo 108
(Project 5/6)

Proposed access road
Fill material recently installed. Contractor to install sediment tubes as needed.

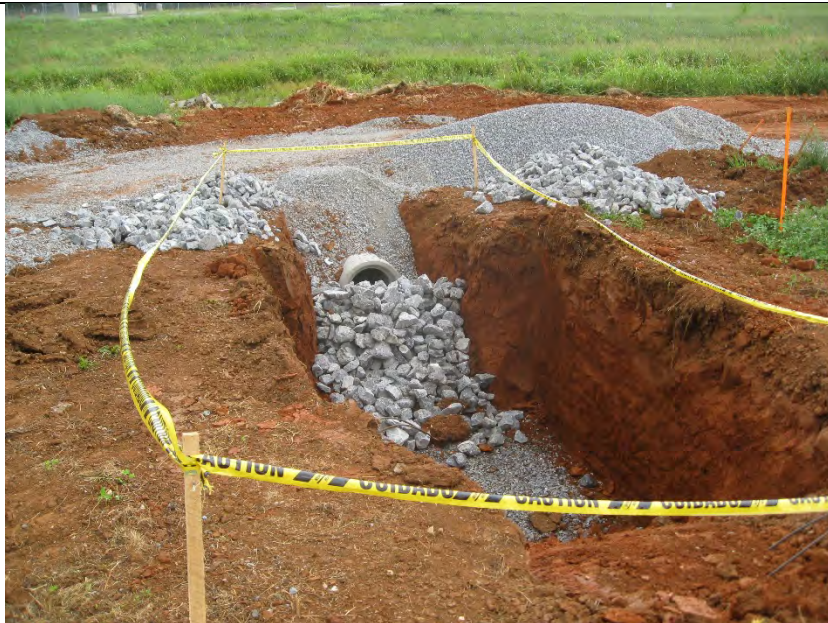
Photo 109
(Project 5/6)

Proposed access road
commend reinstalling sediment tubes at toe of slope per plans before rainfall events, at the end
of the day, or if grading is complete.

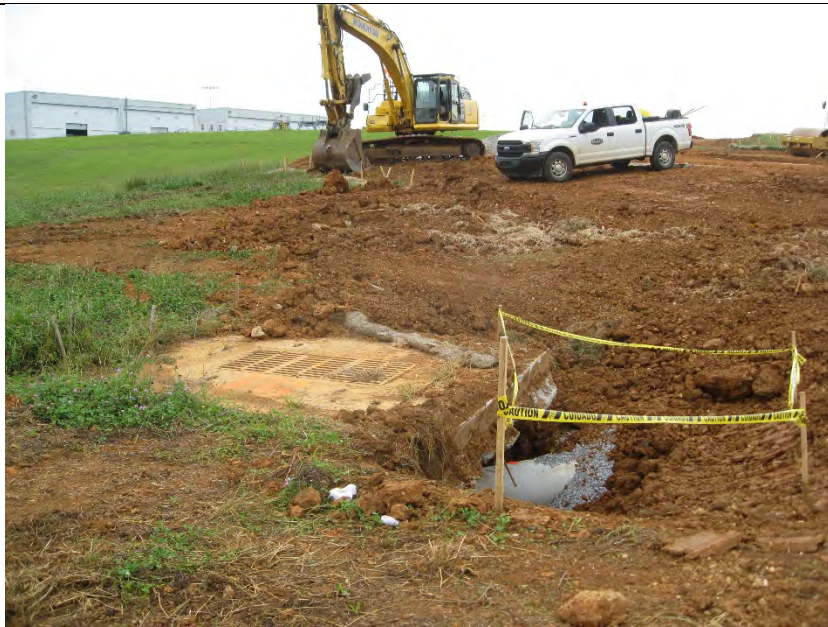
Photo 110
(Project 5/6)

Proposed access road.
Storm pipe recently installed.
Inlet protection recently installed.

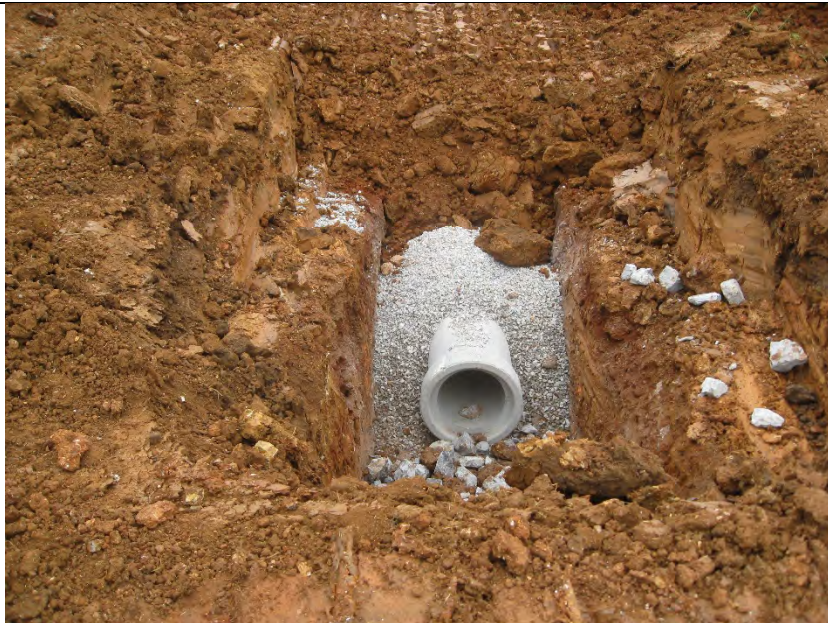
Photo 111
(Project 5/6)

Existing structure #120.
Side of structure recently opened up to receive proposed pipe. Recommend adding sediment tubes (while waiting to close up structure) so that structure does not receive sediment during rain events. Also recommend adding sediment tubes above inlet of structure.
See next photo for upstream end of pipe.

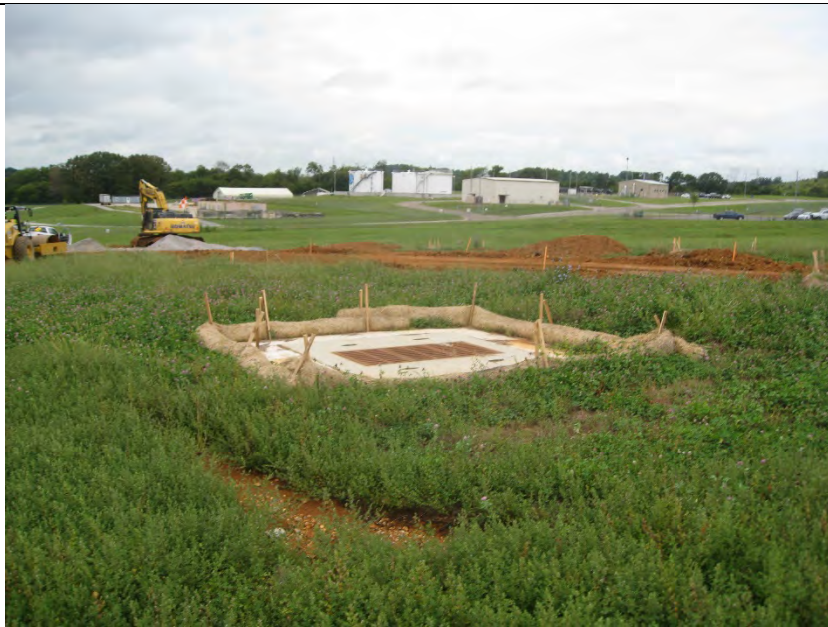
Photo 112
(Project 5/6)

Storm pipe above existing structure #120.
Recommend adding inlet protection to prevent sediment from entering storm system.

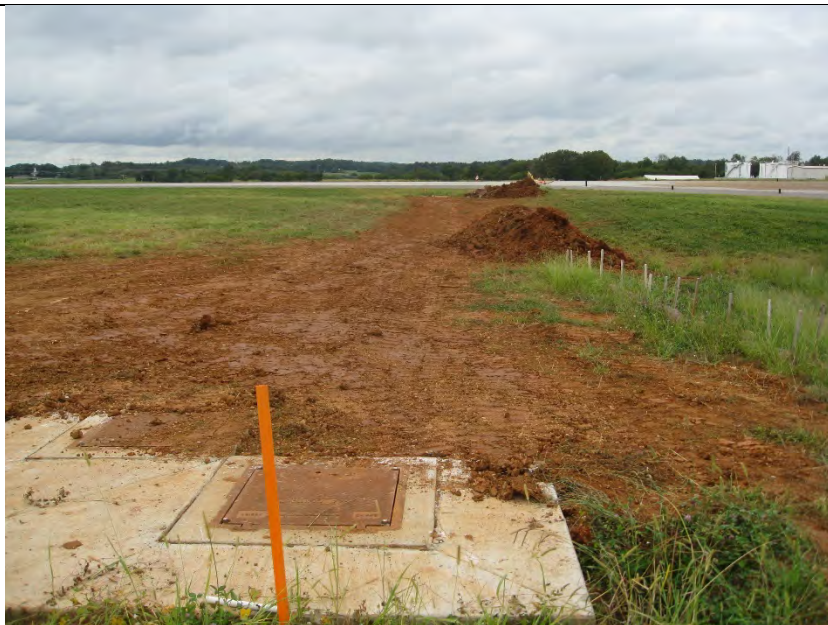
Photo 113
(Project 5/6)

Existing structure #118.
Inlet protection recently installed.

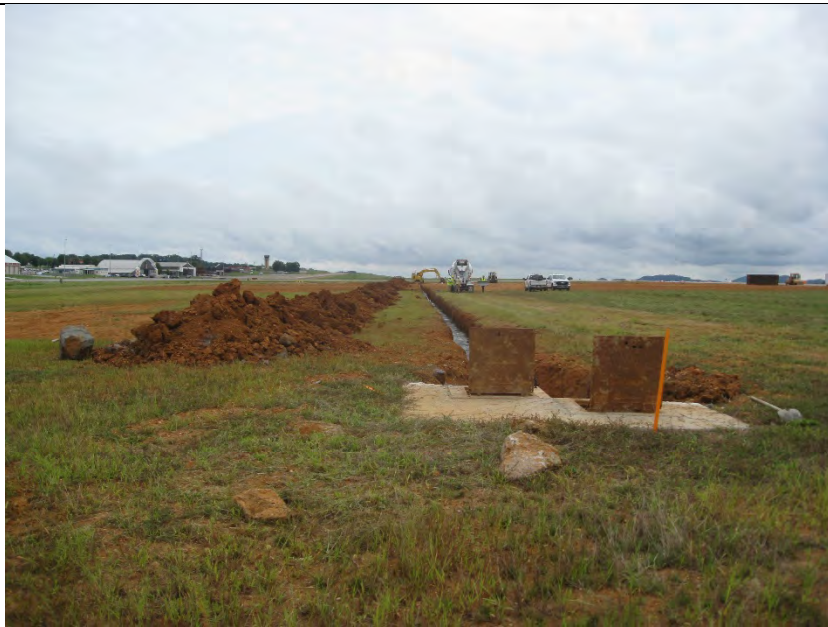
Photo 114
(Project 5/6)

Duct bank recently installed.
Recommend removing spoil piles or adding sediment tubes on downhill side of spoil piles and stabilizing spoil piles.
Recommend stabilizing all bare areas.

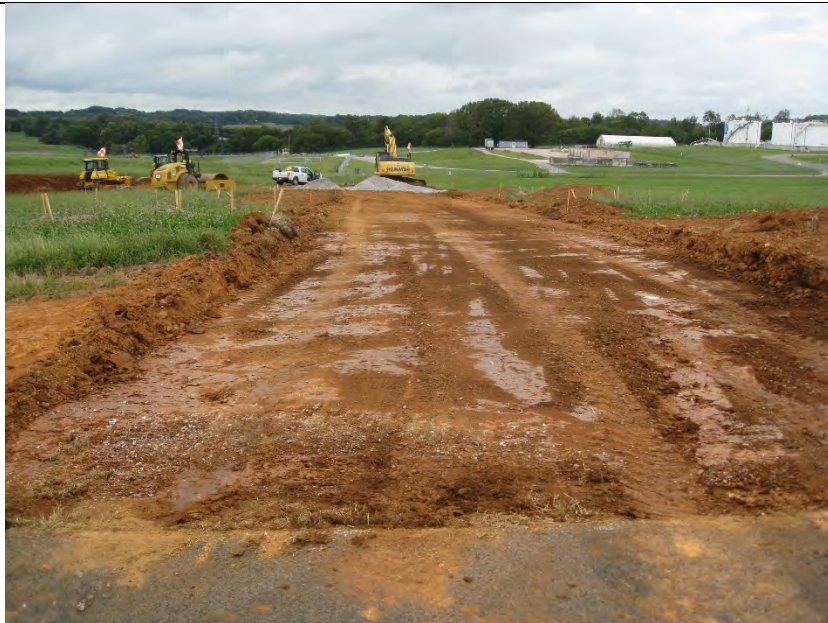
Photo 115
(Project 5/6)

Duct bank being installed at time of inspection.
Once installation is complete, recommend removing any spoil piles or adding sediment tubes on downhill side of spoil piles and stabilizing spoil piles.
Once installation is complete, recommend stabilizing all bare areas.
Some existing bare areas are per Project 4 construction activities (Harper).

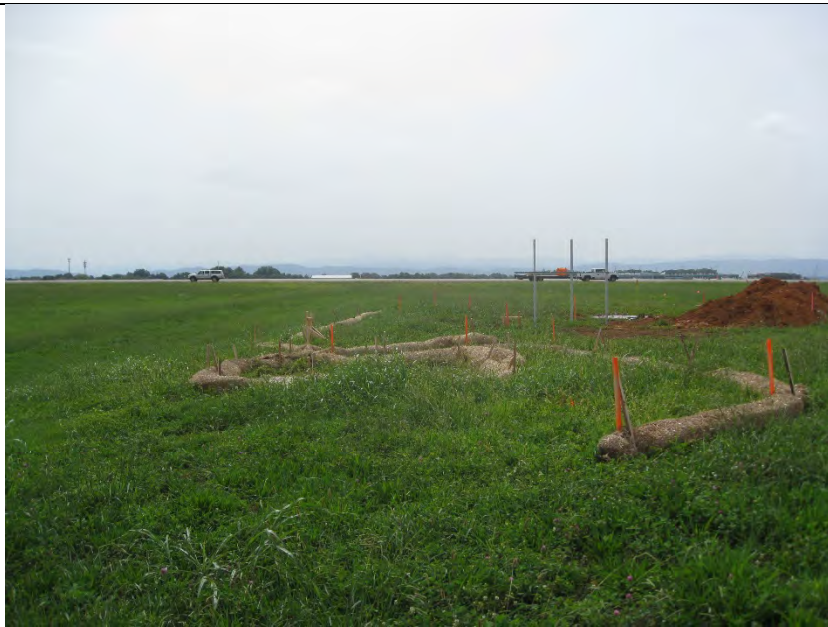
Photo 116
(Project 5/6)

Proposed access road.

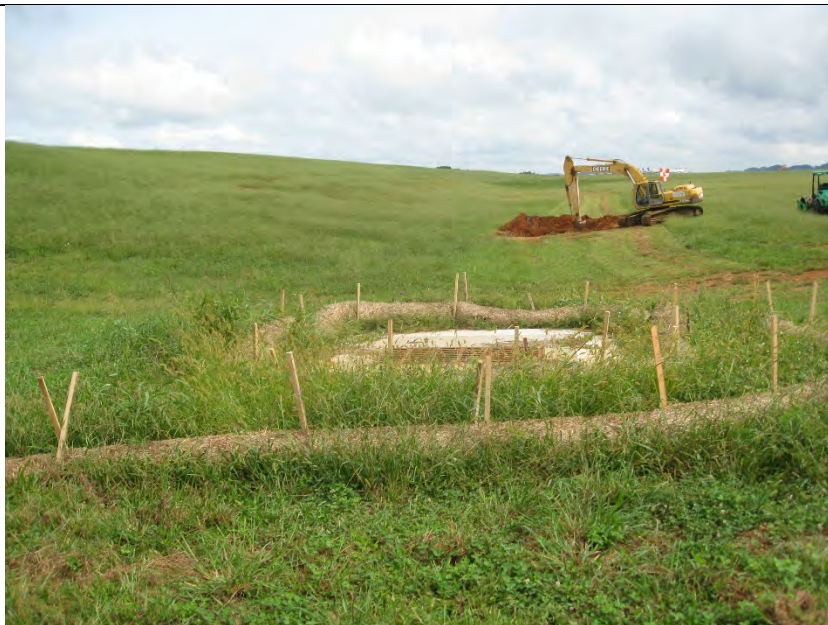
Photo 117
(Project 5/6)

Construction activities taking place at time of inspection.
Inlet protection recently installed.

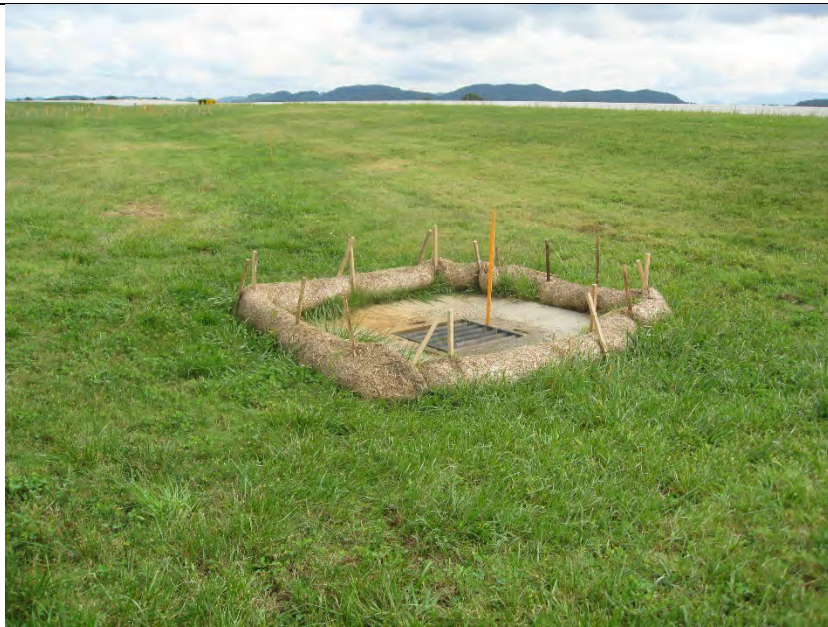
Photo 118
(Project 5/6)

Inlet protection recently installed.
Construction activities are per Project 4 (Harper).

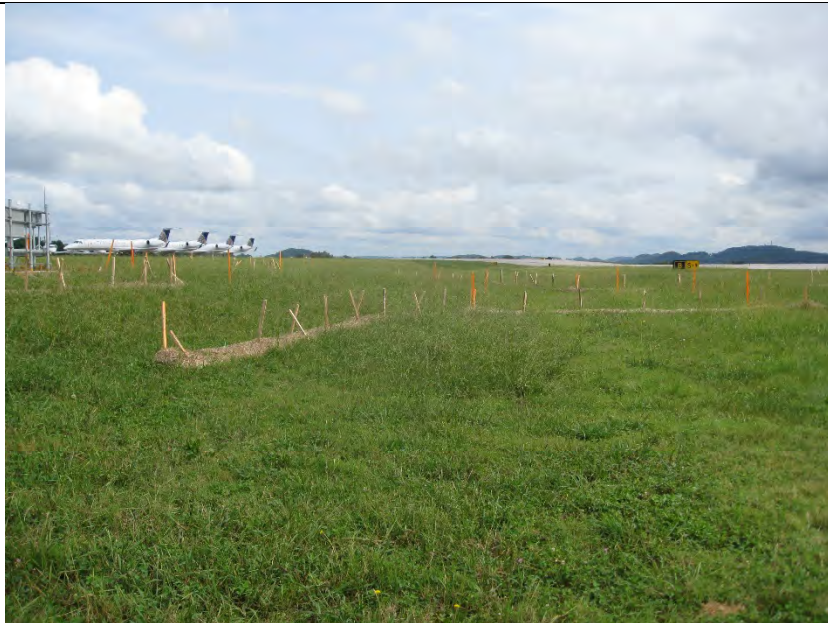
Photo 119
(Project 5/6)

Inlet protection recently installed.
Sediment tubes repaired.

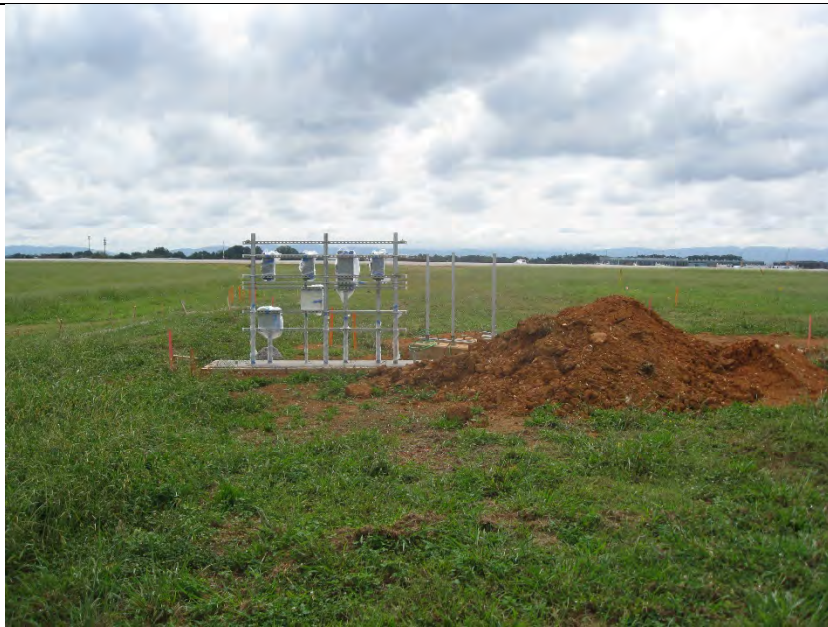
Photo 120
(Project 5/6)

Sediment tubes recently installed.

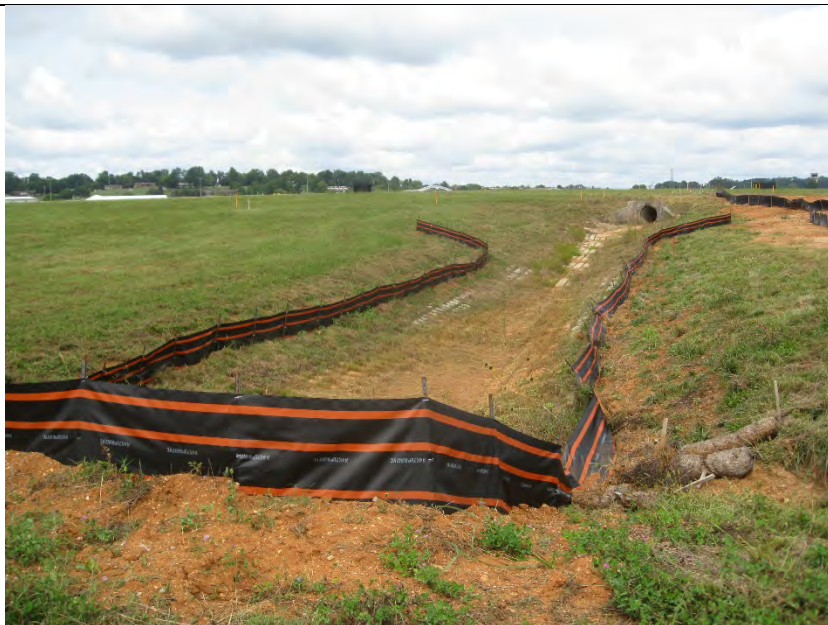
Photo 121
(Project 5/6)

ILS area under construction.
