## QUALITY ASSURANCE MONTHLY SITE ASSESSMENT REPORT

Airfield Modernization Program  
Runway 5L-23R Reconstruction  
Project 2 / Project 3  
Project 4 / Repair TWY Lighting  
Project 5 / Project 6

**QUALITY ASSURANCE  
SITE ASSESSMENT  
EPSC WEEKLY  
INSPECTION**

Airfield Modernization Program  
Runway 5L-23R Reconstruction  
Project 2 / Project 3 /  
PSXE820001-Repair Taxiway  
Lighting

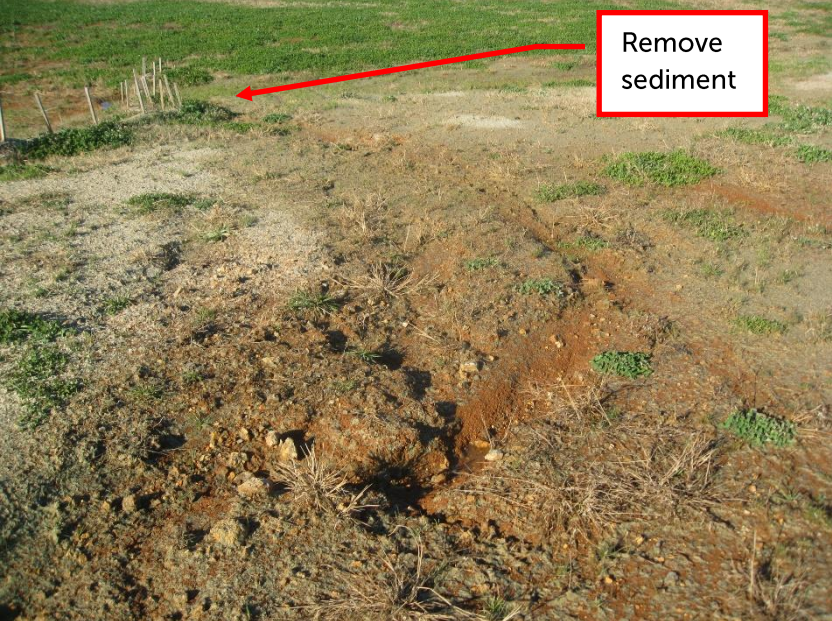
<p>Photo 5 Sta. 298+71 LT (RW 5L-23R) Structure 116 Between Taxiway "G1" and "G2" Project 3</p>

<p>Entry Code: RCA, RCA Action Code: C, TS or PS</p>	<p>Above structure 116. Area recently stabilized. Recommend removing sediment tubes. Recommend removing accumulated sediment (as noted on previous reports) and immediately stabilizing any resulting bare areas.</p>

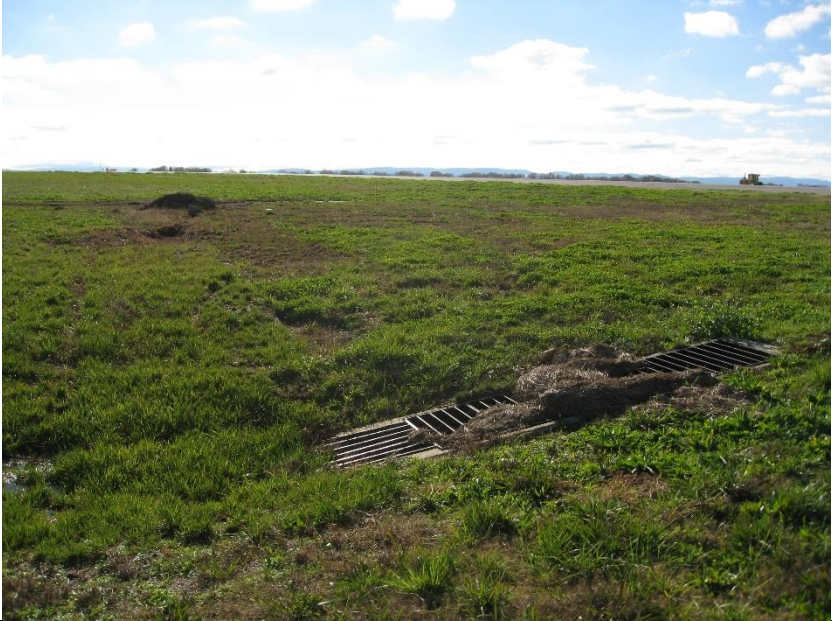
<p>Photo 11 Sta. 314+32 (RW 5L-23R) Structure 110 Enhanced Swale Endwall 108 Project 3</p>

<p>Entry Code: Action Code:</p>	<p>Enhanced Swale Endwall 108 See next photo.</p>

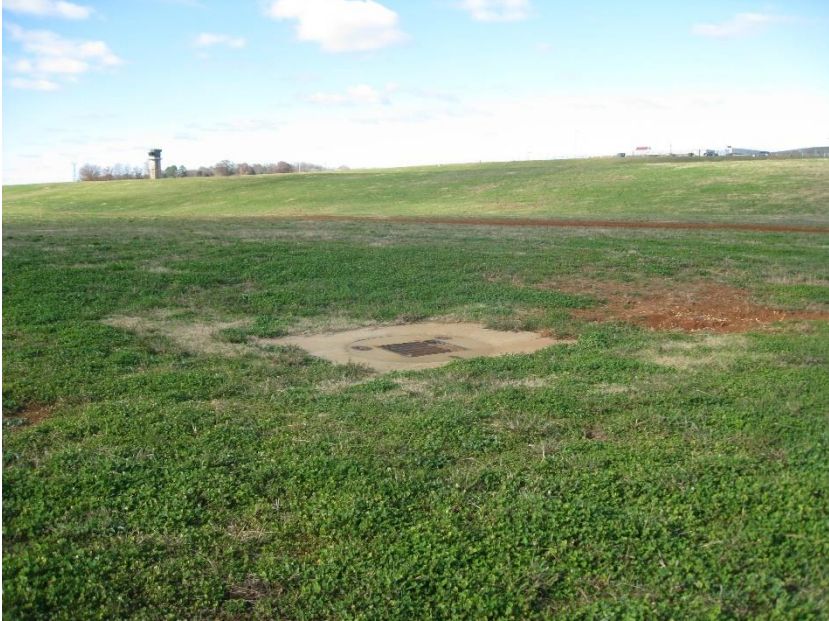
<p>Photo 19 Sta. 366+25 LT (RW 5L-23R) Existing Structure Project 2</p>

<p>Entry Code: S Action Code:</p>	<p>Existing Structure #2. Bare areas are mostly covered in stone and are considered stable at the time of inspection.</p>

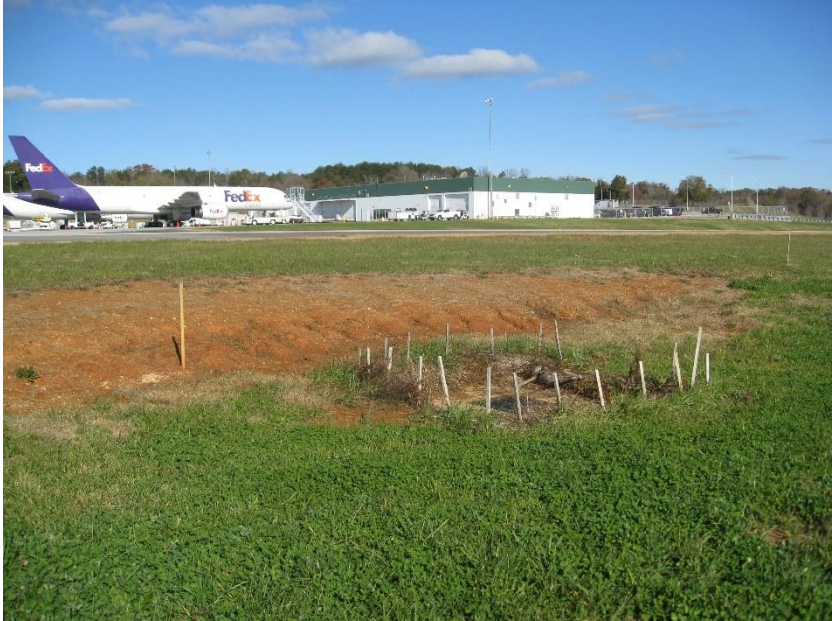
<p>Photo 21 STA 677+00 RT (RW 5L-23R) Existing Structure Project 4</p>

<p>Entry Code: RCA, RCA, RCA Action Code: R, C, TS or PS</p>	<p>Existing structure south of Taxiway "G". Erosion and rills continue to occur along the graded slope. Recommend repairing eroded areas (as noted on previous reports) and immediately stabilizing slope to reduce the probability of future erosion issues. See photo below.</p>

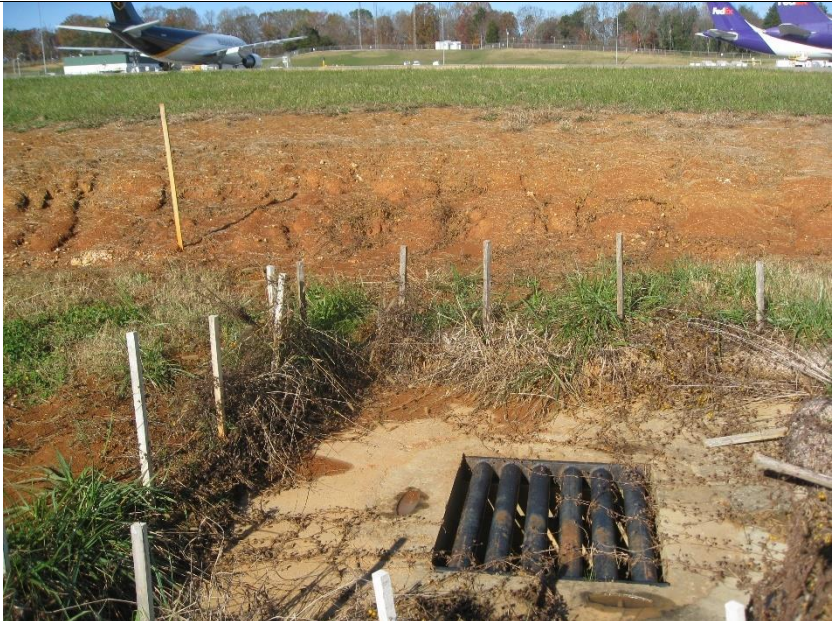
<p>Photo 22 STA 677+00 RT (RW 5L-23R) Existing Structure Project 4</p>

<p>Entry Code: RCA/RCA Action Code: C/R</p>	<p>Existing structure south of Taxiway "G" (see previous photo). Recommend removing sediment (as noted on previous reports) from behind sediment tubes and on top of structure. Recommend replacing sediment tubes.</p>

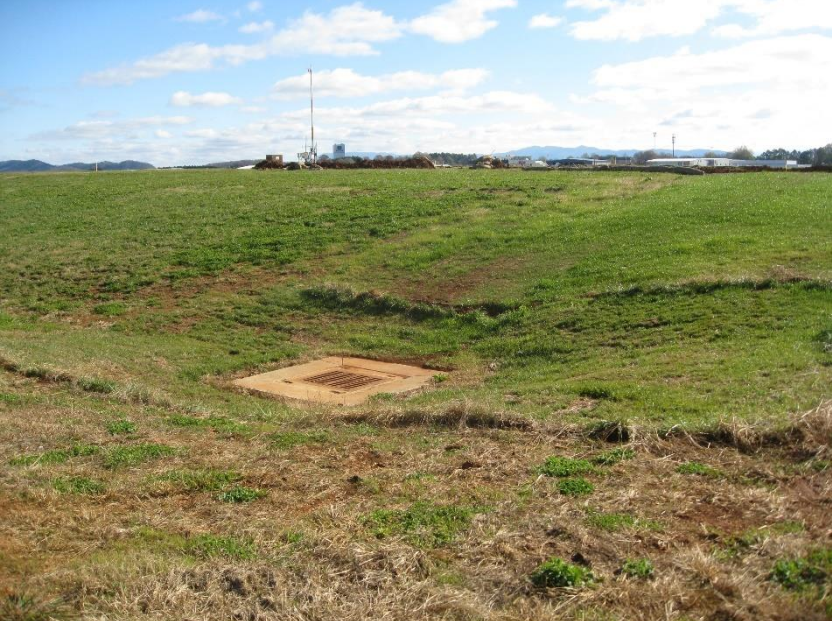
<p>Photo 29 Sta. 347+26 RT (RW 5L-23R) Structure 22 Project 4</p>

<p>Entry Code: S Action Code:</p>	<p>Structure 22 Sediment tubes recently removed. See next photo.</p>

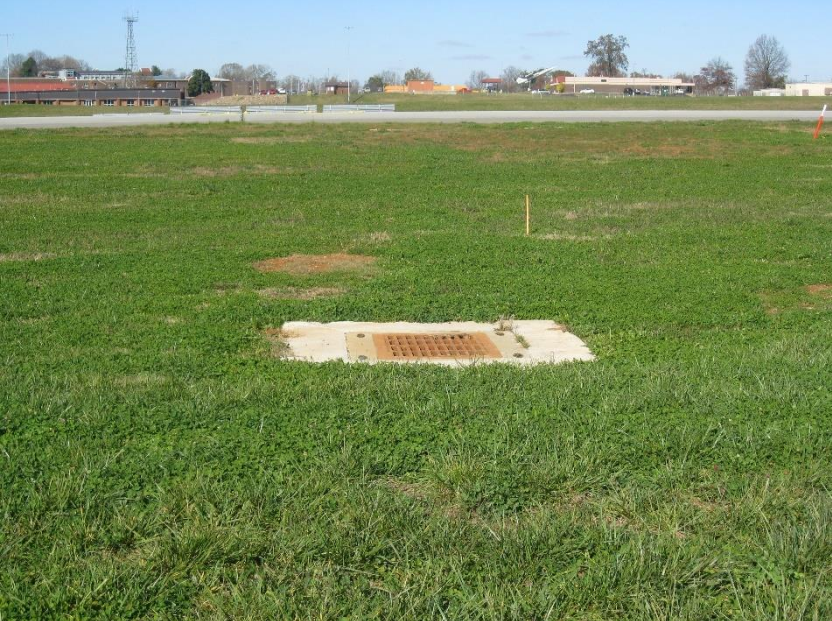
<p>Photo 31 Sta. 341+86 RT (RW 5L-23R) Structure 204 Project 4</p>

<p>Entry Code: S Action Code:</p>	<p>Structure 204</p>

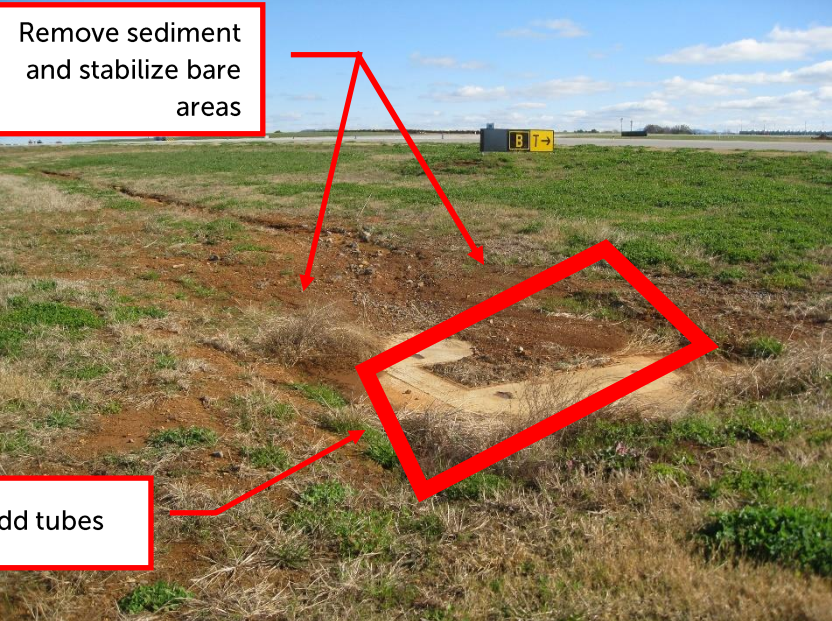
<p>Photo 35 Sta. 321+73 RT (RW 5L-23R) Structure 212 Adjacent to Taxiway "B" Project 3</p>

<p>Remove sediment and stabilize bare areas</p> <p>Add tubes</p>
<p>Entry Code: RCA, RCA, RCA Action Code: I, TS or PS, R</p>	<p>Structure 212. Area was never stabilized; however, erosion control measures were removed. Recommend adding sediment tubes and regrading eroded ditch line (as noted on previous reports). Recommend coordinating with CHA on use of matting or sod to help achieve stabilization. See next Photo.</p>

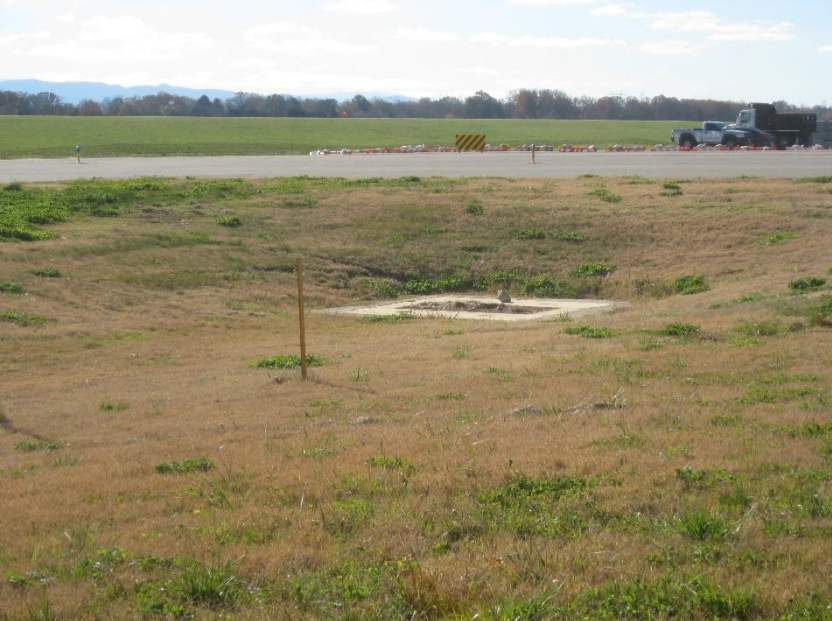
<p>Photo 37 Sta. 314+32 RT (RW 5L-23R) Structure 214 Adjacent to Taxiway "B" Project 3</p>

<p>Entry Code: S Action Code:</p>	<p>Structure 214.</p>

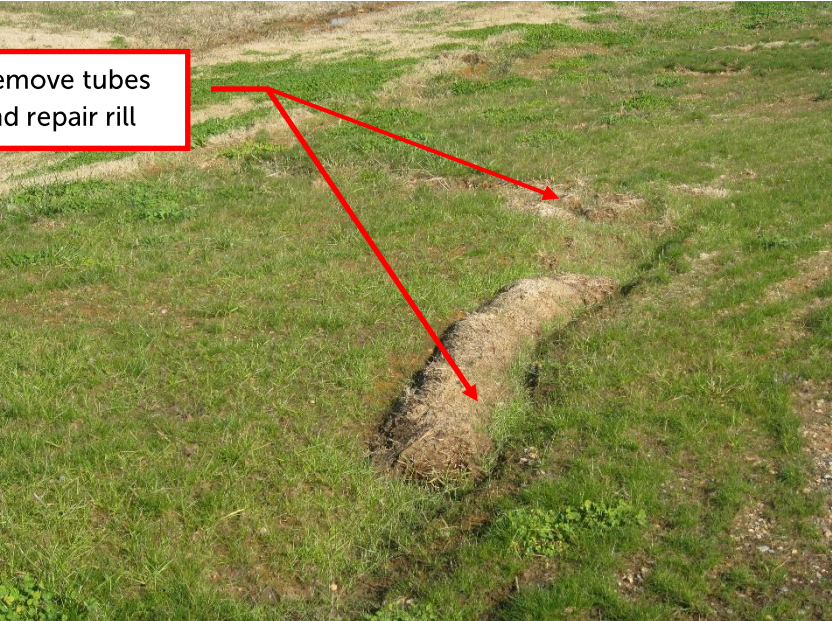
<p>Photo 40 Sta. 301+87 RT (RW 5L-23R) Structure 218 Project 3</p>

<p>Entry Code: RCA Action Code: R</p>	<p>Structure 218. Previously formed rills were never remediated. Sediment tube recently placed in rills and area stabilized. Recommend removing sediment tubes, repairing rills and stabilizing resulting bare areas.</p>

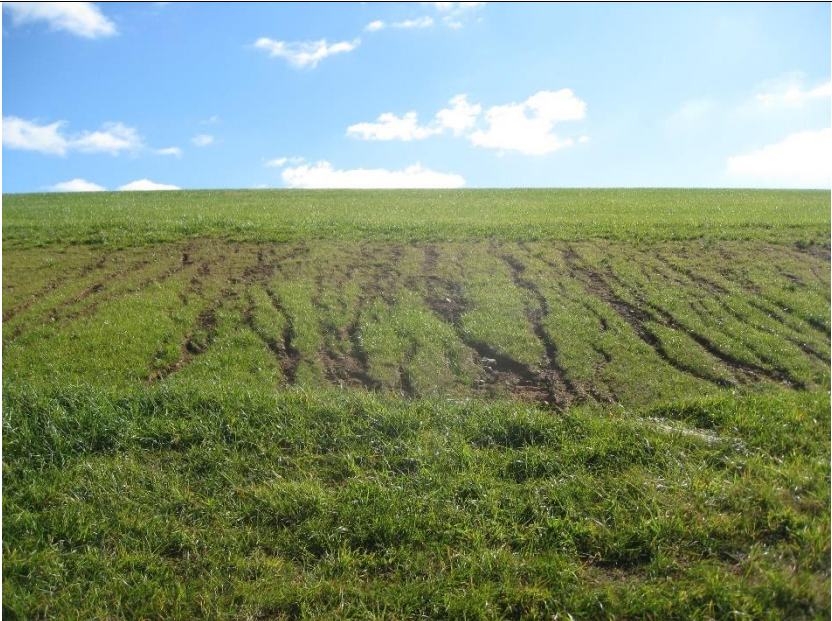
<p>Photo 42 Haul Rd Project 3</p>

<p>Entry Code: RCA, RCA Action Code: R, TS or PS</p>	<p>Haul Road. Recommend coordinating with CHA on remediation of rills and immediately stabilizing any resulting bare areas.</p>

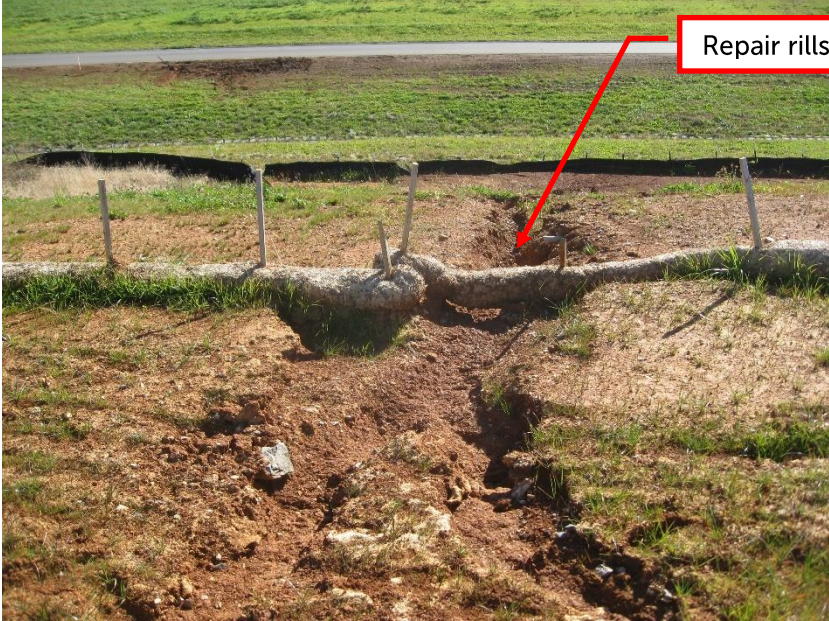
<p>Photo 43 North Lateral Fill Area Project 3</p>

<p>Entry Code: RCA, RCA Action Code: R, I</p>	<p>North Lateral Fill Area. Recommend repairing rills and adding slope drain (as noted on previous reports). See next photo.</p>

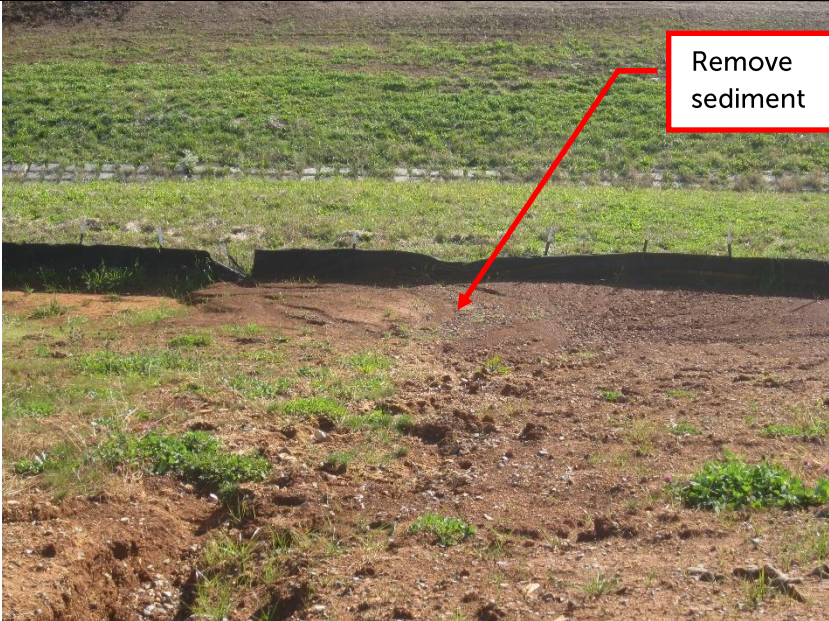
<p>Photo 44 North Lateral Fill Area Project 3</p>

<p>Entry Code: RCA Action Code: C</p>	<p>North Lateral Fill Area. Recommend removing accumulated sediment at toe of slope (as noted on previous reports).</p>

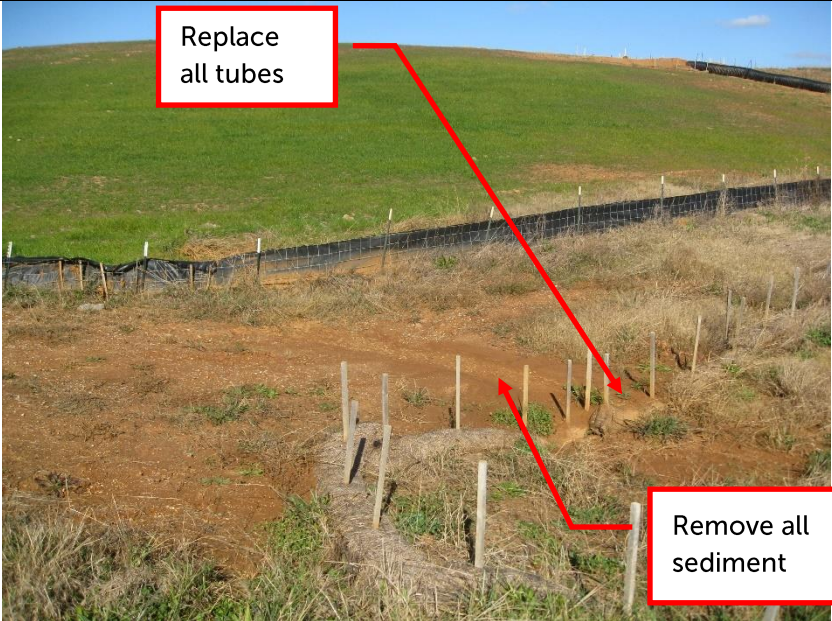
<p>Photo 46 Sta. 302+54 RT (RW 5L-23R) North Lateral Ditch Endwall 100 Project 2</p>

<p>Entry Code: RCA, RCA, RCA Action Code: C, I, TS or PS</p>	<p>North Lateral Endwall 100. Recommend removing sediment, replacing sediment tubes and stabilizing bare areas (as noted on previous reports) at the same time in order to prevent further erosion.</p>

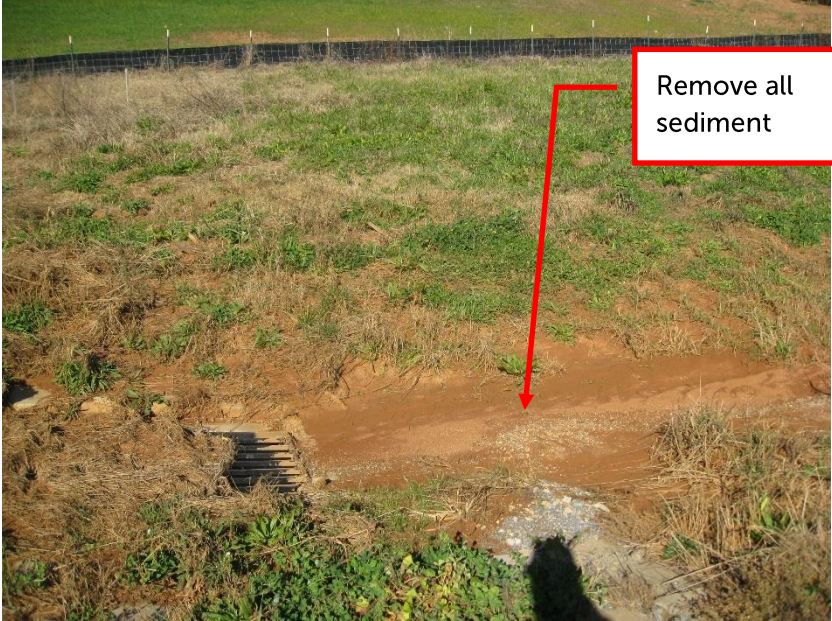
<p>Photo 47 Sta. 302+54 RT (RW 5L-23R) North Lateral Ditch Endwall 100 Project 2</p>

<p>Entry Code: RCA Action Code: C</p>	<p>North Lateral Endwall 100. Area from previous photo has remained un-stabilized and has deposited sediment in the North lateral ditch. Recommend removing sediment. See previous photo.</p>

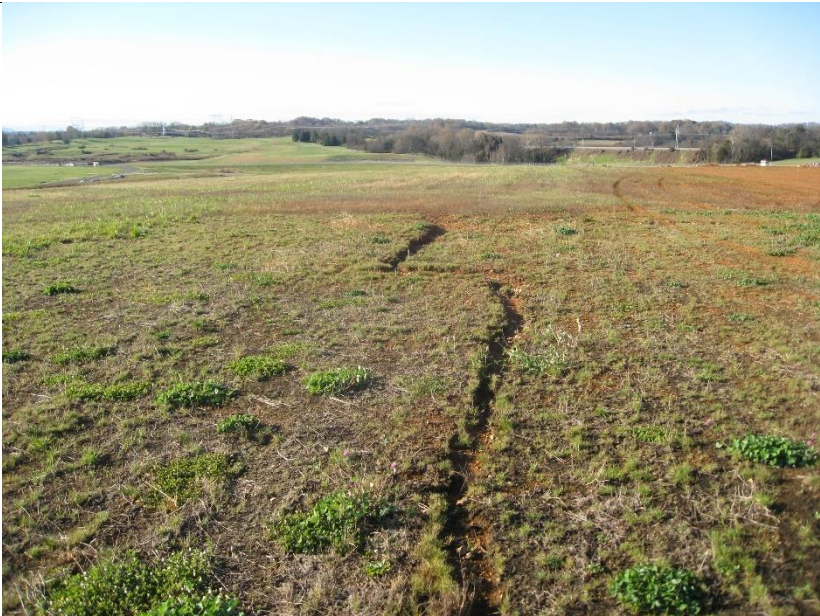
<p>Photo 58          Sta. 284+59 RT          (RW 5L-23R)          Adjacent to blast pad.          Project 2</p>

<p>Entry Code: RCA,          RCA          Action Code: R, TS or          PS</p>	<p>Area adjacent to blast pad.          Rills have formed.          Recommend repairing rills and stabilizing any resulting bare areas.</p>

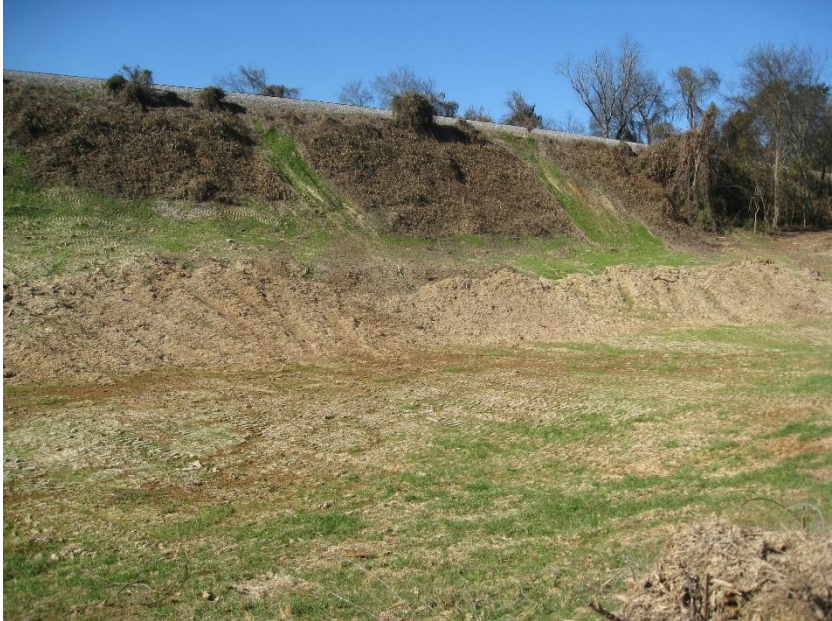
<p>Photo 59 Fill area adjacent to Liberty Street Project 6</p>

<p>Entry Code: S Action Code:</p>	<p>This area of site unavailable for inspection. Slopes were recently stabilized.</p>

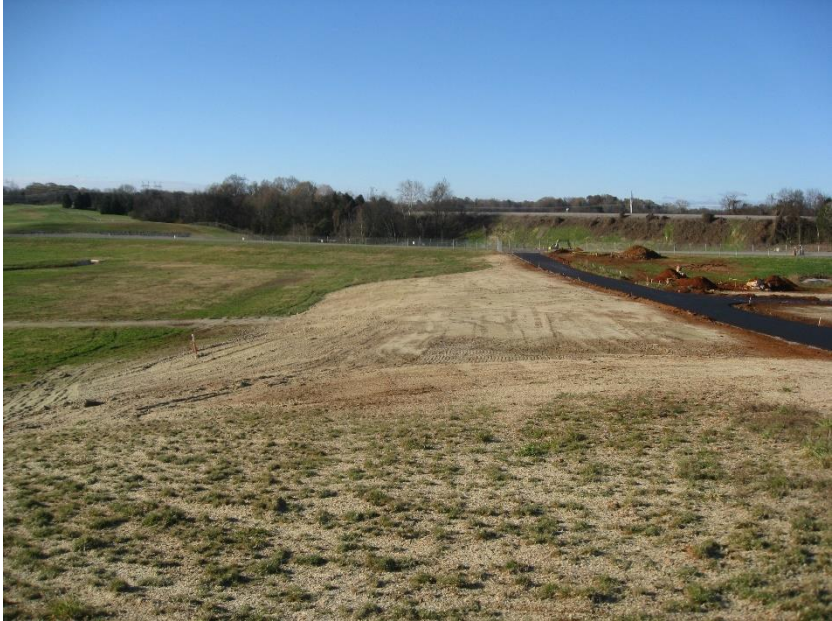
<p>Photo 61 (RW 5L-23R) Sheet EC1.1.1 Project 6</p>

<p>Entry Code: S Action Code:</p>	<p>Proposed Malsr access road Bare areas recently stabilized.</p>

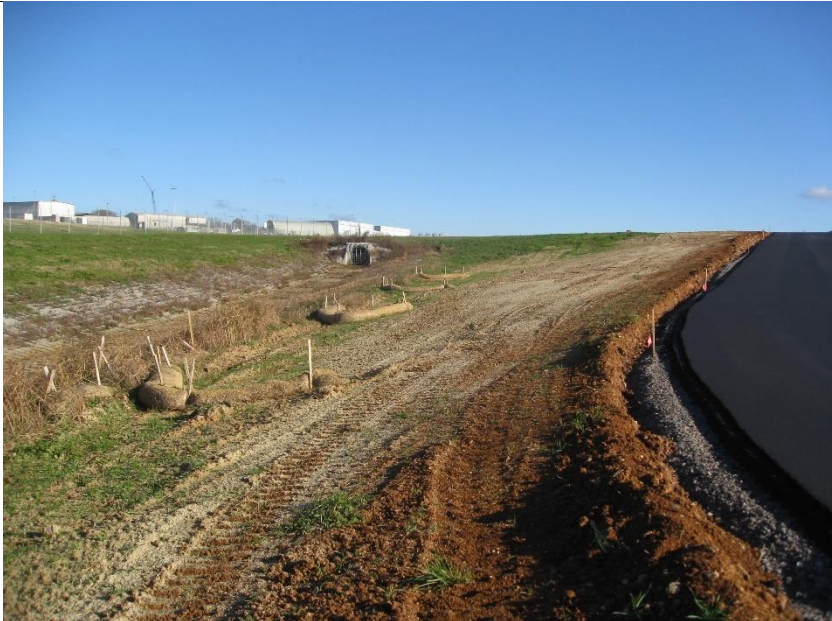
<p>Photo 62 (RW 5L-23R) Sheet EC1.1.1 Project 6</p>

<p>Entry Code: S Action Code:</p>	<p>Proposed Malsr access road. Bare areas outside of active construction zones recently stabilized.</p>

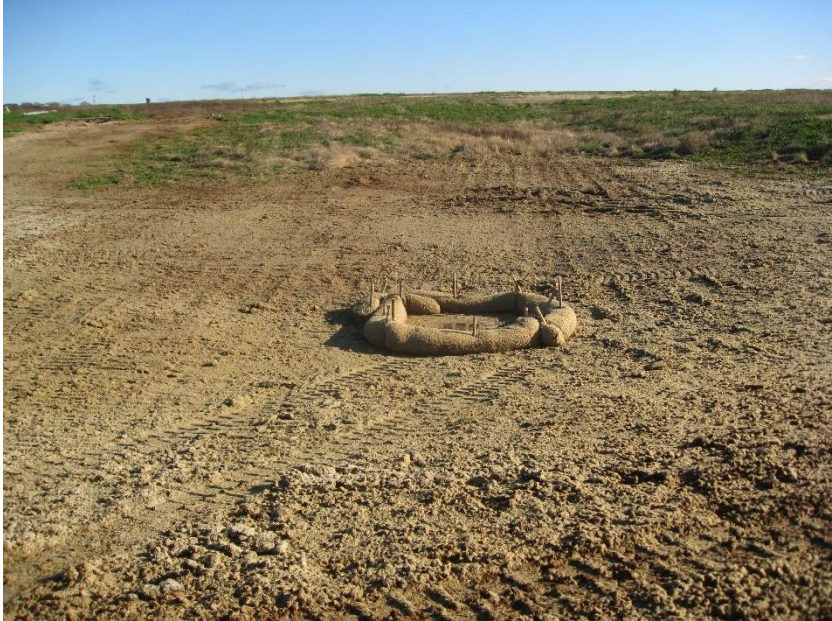
<p>Photo 67  (RW 5L-23R)  Sheet EC1.1.3  Project 6</p>

<p>Entry Code: S  Action Code:</p>	<p>Above existing structure #120.  Remaining bare areas recently stabilized.</p>

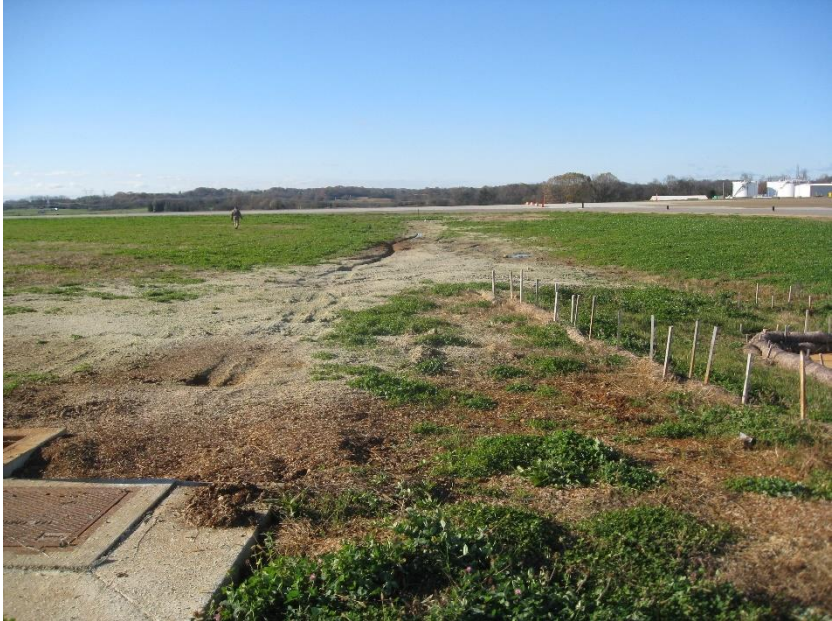
<p>Photo 69 Project 6</p>

<p>Entry Code: S Action Code:</p>	<p>Bare areas recently stabilized.</p>

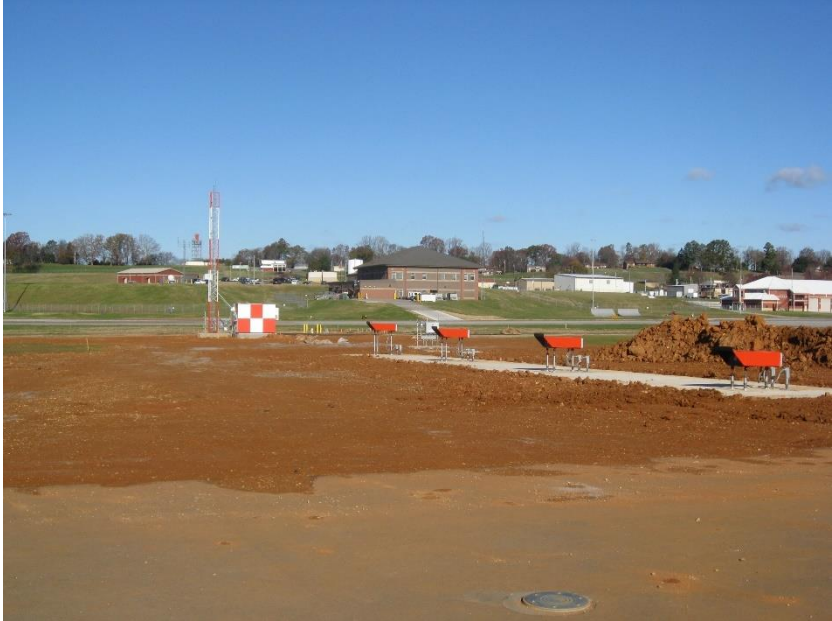
<p>Photo 71 Project 6</p>

<p>Entry Code: FM Action Code: TS or PS</p>	<p>5L PAPI Area recently graded. Recommend stabilizing bare areas.</p>

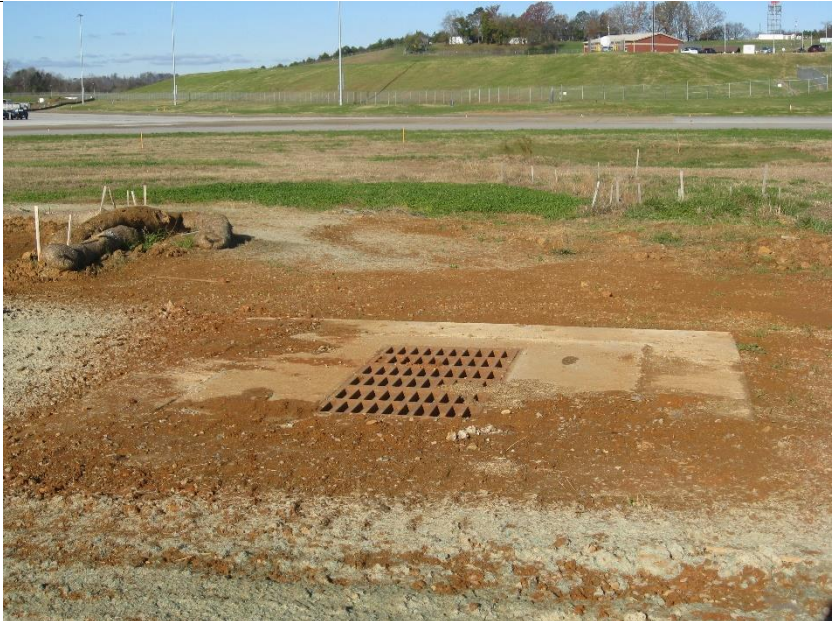
<p>Photo 72 Project 6</p>

<p>Entry Code: CA/FM Action Code: I/TS or PS</p>	<p>5L PAPI Access road completed and backfilled. Recommend installing sediment tubes around inlet of area drain. Recommend stabilizing remaining bare areas.</p>

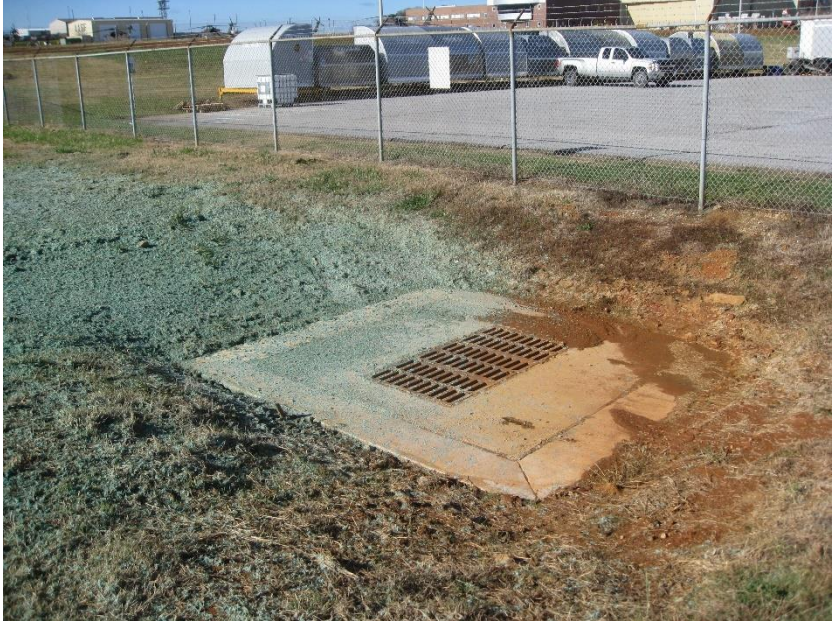
<p>Photo 75 STA 378+00 LT (RW 5L-23R) Project 6</p>

<p>Entry Code: CA/CA Action Code: C/I</p>	<p>Structure adjacent to UPS. Bare areas recently stabilized. Recommend removing sediment from top of structure and adding inlet protection.</p>

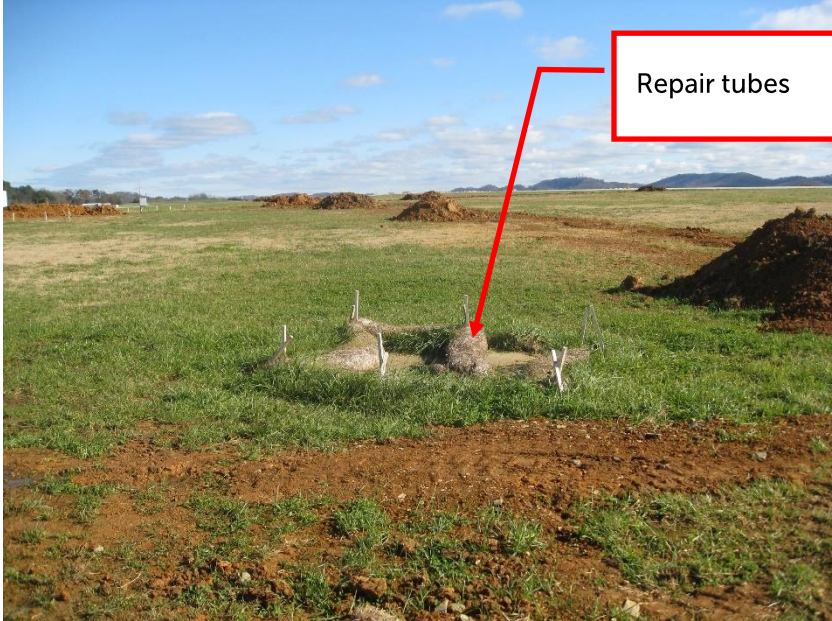
<p>Photo 77 (RW 5L-23R) Sheet EC1.1.7 Project 6</p>

<p>Entry Code: RCA Action Code: I</p>	<p>23R Glide Slope and Touchdown RVR Recommend repairing/replacing damaged sediment tubes.</p>

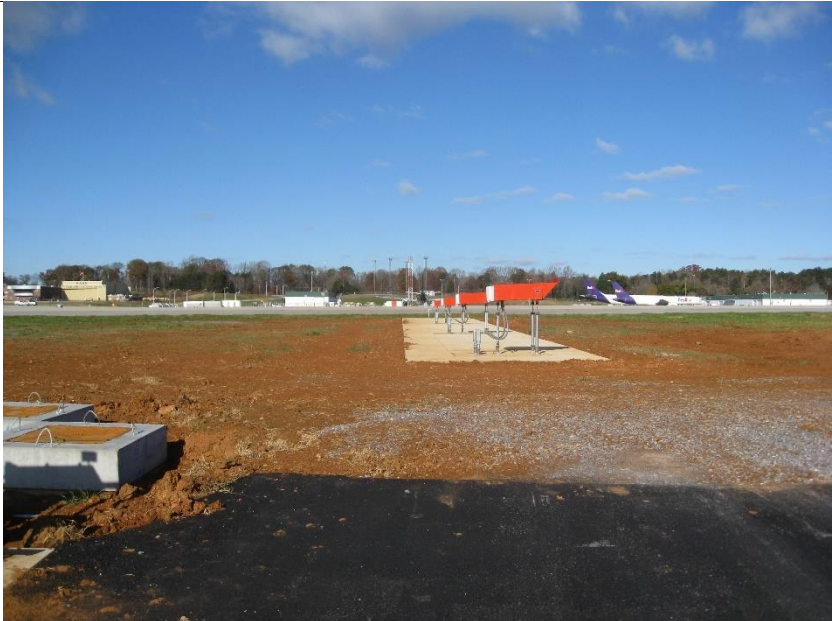
<p>Photo 78 (RW 5L-23R) Sheet EC1.1.7 Project 6</p>

<p>Entry Code: CA Action Code: TS or PS</p>	<p>23R PAPI Area recently backfilled. Recommend stabilizing bare areas.</p>

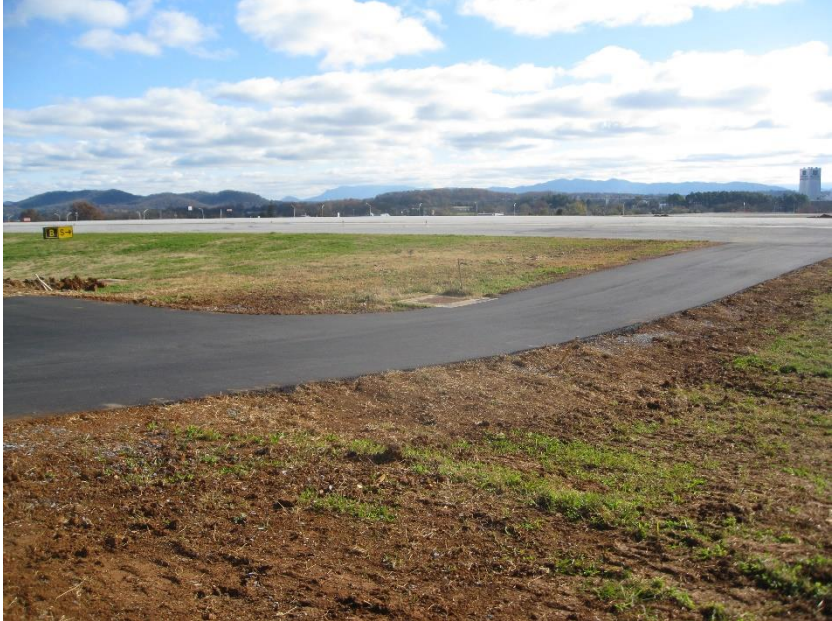
<p>Photo 79 (RW 5L-23R) Sheet EC1.1.5 Project 6</p>

<p>Entry Code: CA Action Code: TS or PS</p>	<p>23R PAPI access road. Access road installed and shoulders recently backfilled. Recommend stabilizing bare areas.</p>

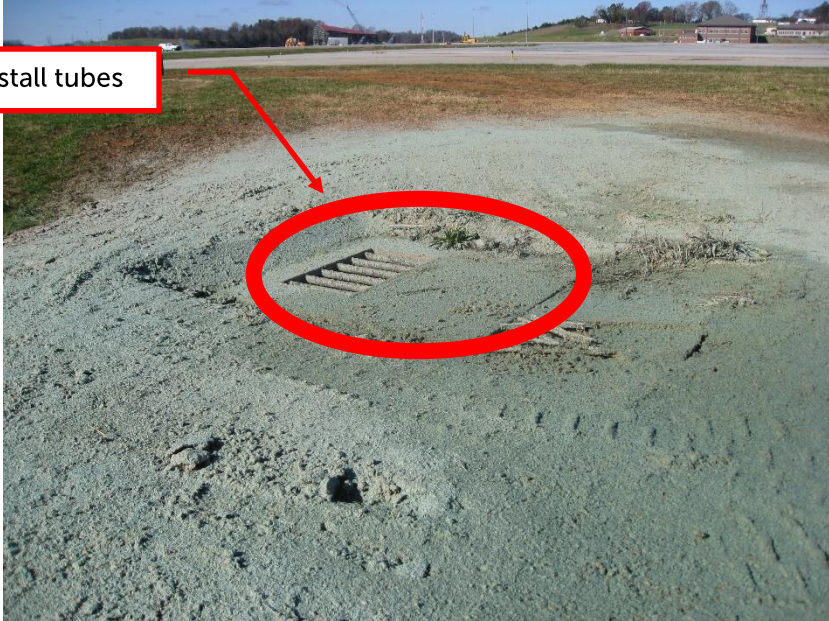
<p>Photo 81 Sheet EC102 Project 5</p>

<p>Entry Code: CA Action Code: I</p>	<p>Airfield Lighting Vault Berm recently constructed to direct run-off into structure. Recommend installing a triple stack of sediment tubes for inlet protection around structure. Bare areas recently stabilized.</p>

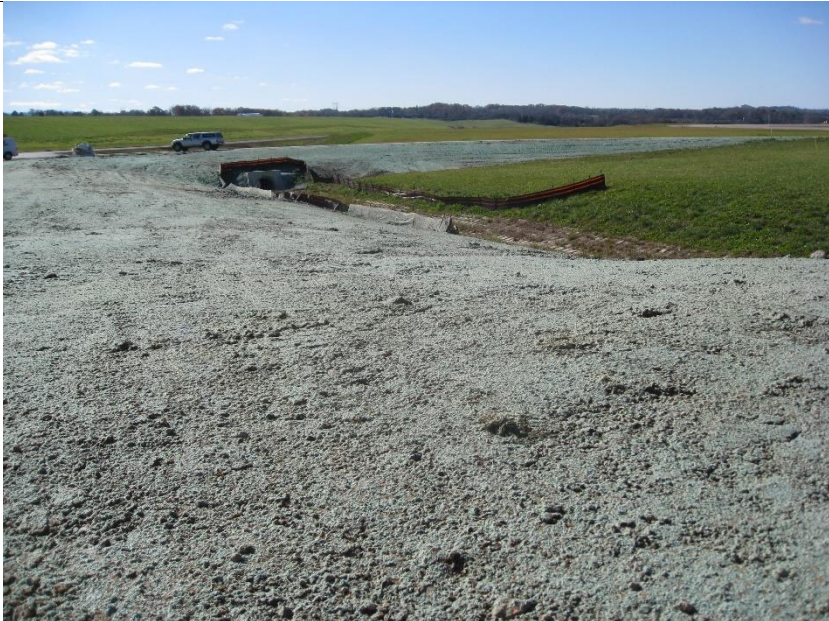
<p>Photo 82 Sheet EC102 Project 5</p>

<p>Entry Code: S Action Code:</p>	<p>Airfield Lighting Vault Slopes recently stabilized. Recommend monitoring slopes to ensure that sediment does not migrate into the north lateral ditch.</p>

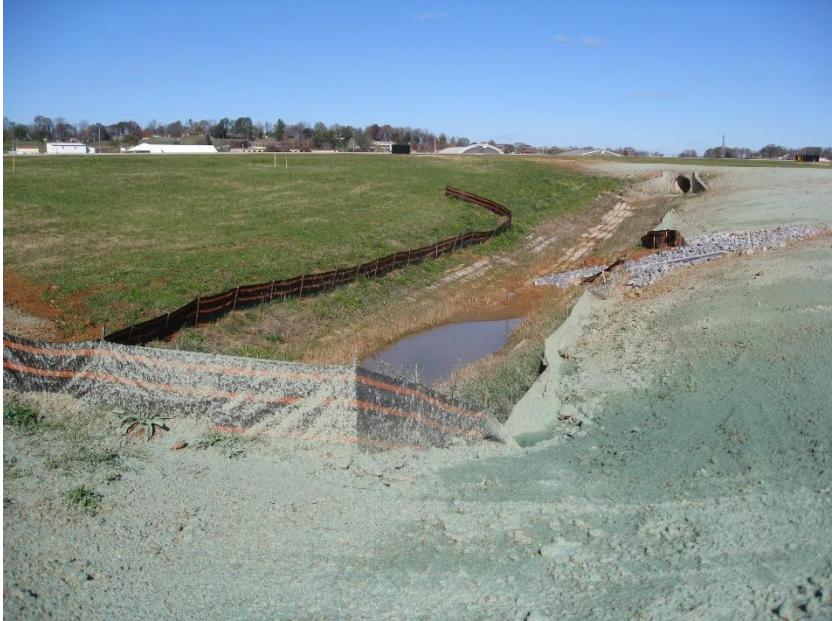
<p>Photo 83 Sheet EC102 Project 5</p>

<p>Entry Code: S Action Code:</p>	<p>Airfield Lighting Vault Bare areas recently stabilized.</p>

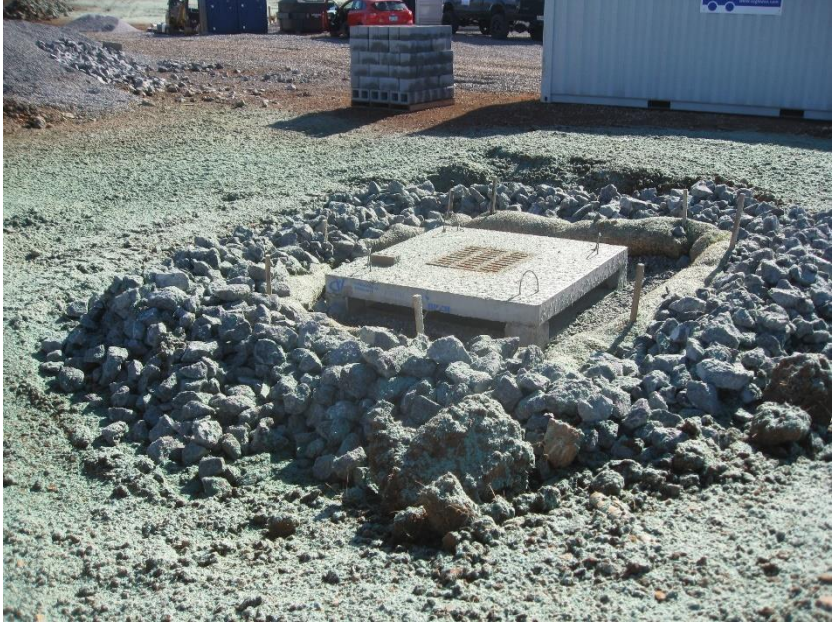
<p>Photo 84 Sheet EC102 Project 5</p>

<p>Entry Code: S Action Code:</p>	<p>Airfield Lighting Vault Structure and inlet protection recently installed. Bare areas recently stabilized.</p>

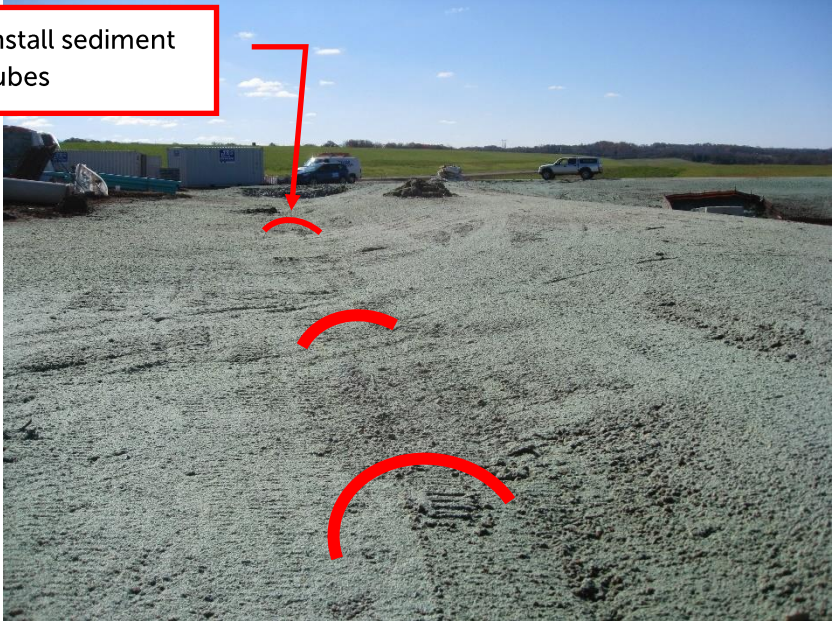
<p>Photo 85 Sheet EC102 Project 5</p>

<p>Entry Code: RCA/CA Action Code: I/TS or PS</p>	<p>Airfield Lighting Vault Ditch line above structure from previous photo. Swale appears to be at grade. Recommend installing erosion control measures in ditch line per the plans. Bare areas recently stabilized.</p>

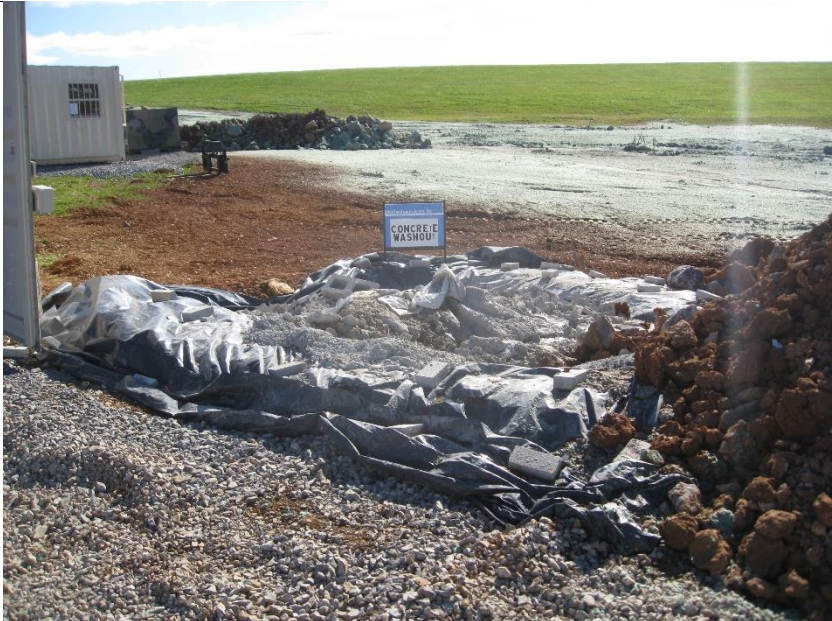
<p>Photo 86 Sheet EC102 Project 5</p>

<p>Entry Code: S Action Code:</p>	<p>Airfield Lighting Vault Concrete washout facility. Signage recently added.</p>

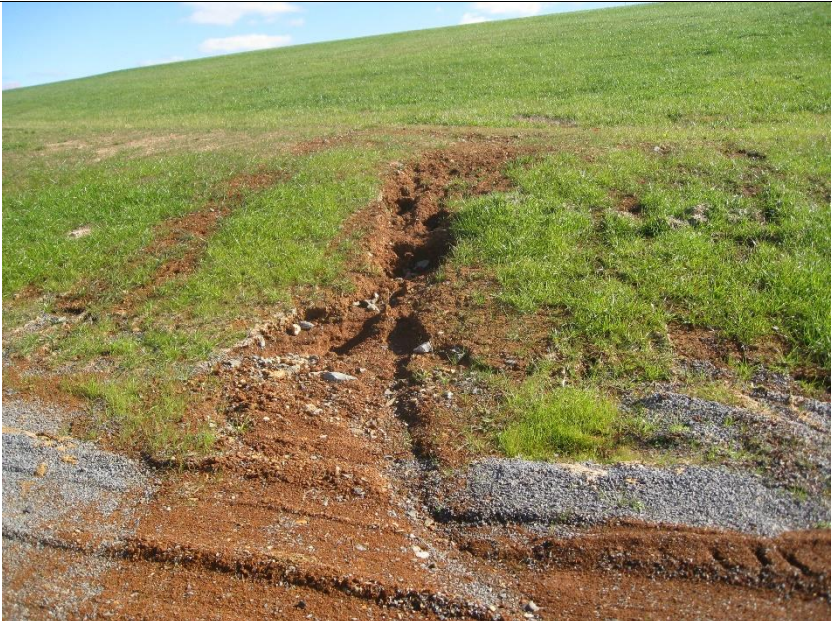
<p>Photo 88 Haul Rd Project 3</p>

<p>Entry Code: FM Action Code: R</p>	<p>Haul Road. Due to recent storm events, Rills have formed. Recommend coordinating with CHA on remediation of rills.</p>

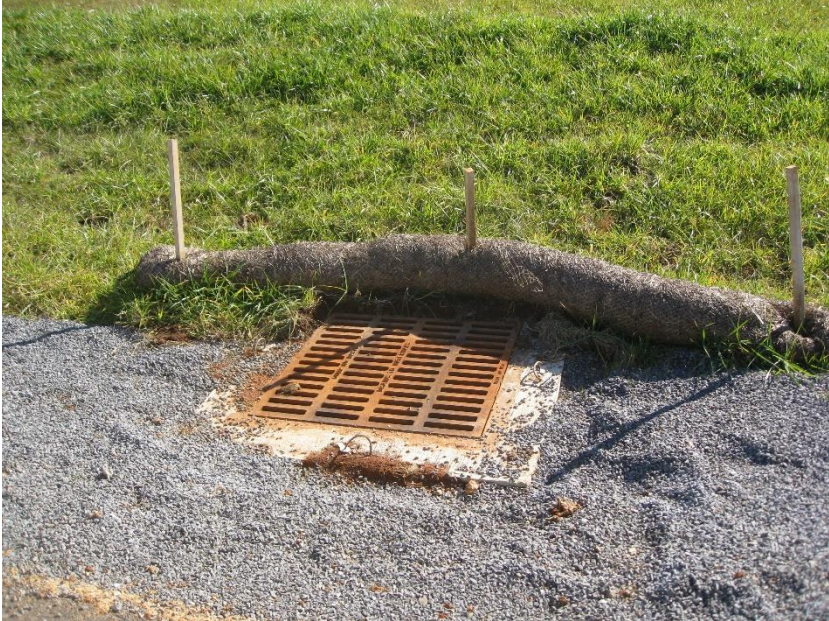
<p>Photo 89 Haul Rd Project 3</p>

<p>Entry Code: S Action Code:</p>	<p>Haul Road. Recommend removing sediment tubes.</p>

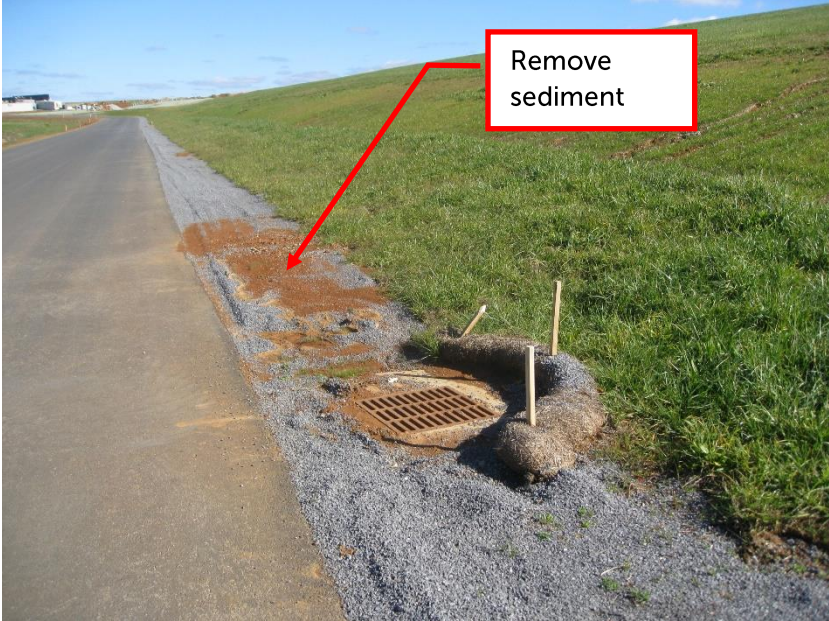
<p>Photo 91 Haul Rd Project 3</p>

<p>Entry Code: CA Action Code: C</p>	<p>Haul Road. Recommend removing sediment on top of stone. Recommend removing sediment tubes.</p>

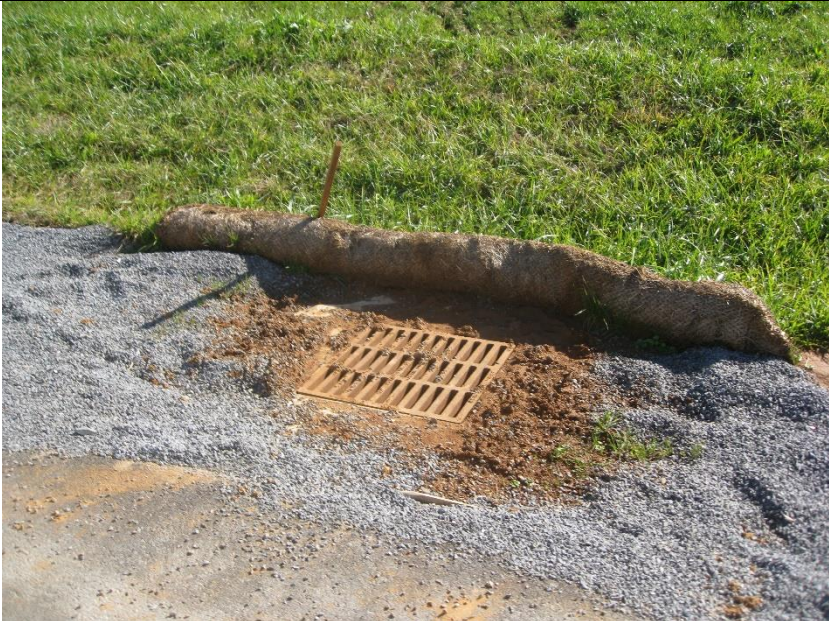
<p>Photo 92 Haul Rd Project 3</p>

<p>Entry Code: S Action Code:</p>	<p>Haul Road. Recommend removing sediment tube.</p>

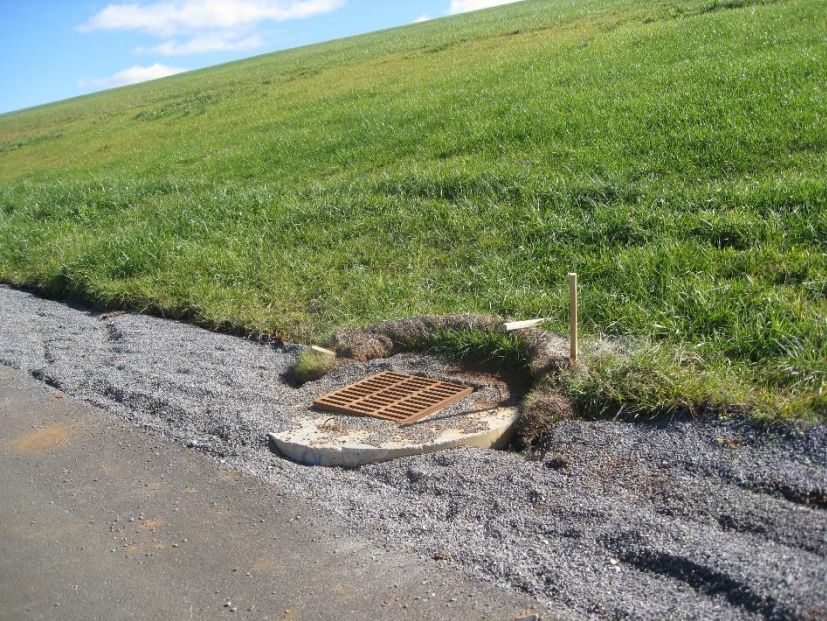
<p>Photo 93 Haul Road Project 3</p>

<p>Entry Code:S Action Code:</p>	<p>Haul Road Stone recently removed from inlet. Recommend removing sediment tube.</p>

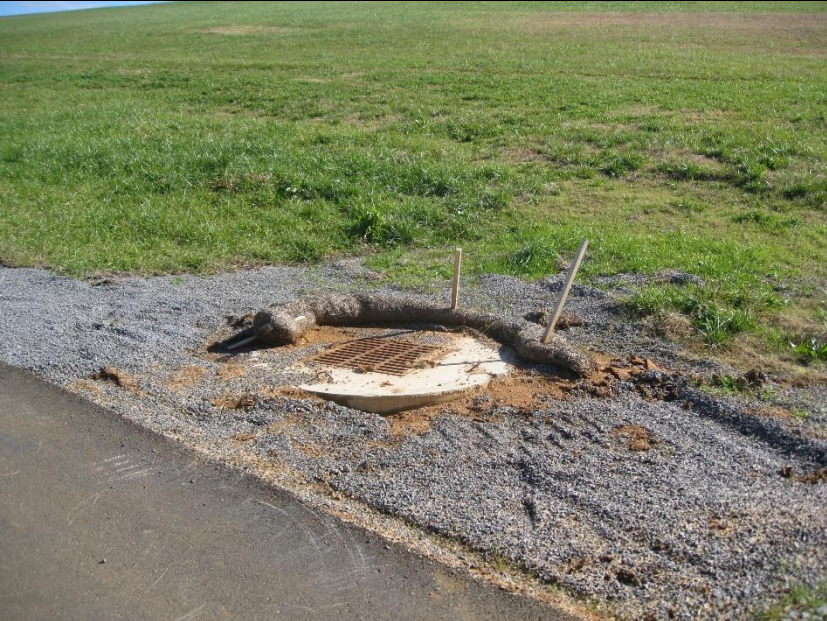
<p>Photo 94 Haul Road Project 3</p>

<p>Entry Code:S Action Code:</p>	<p>Haul Road Recommend removing sediment tubes.</p>

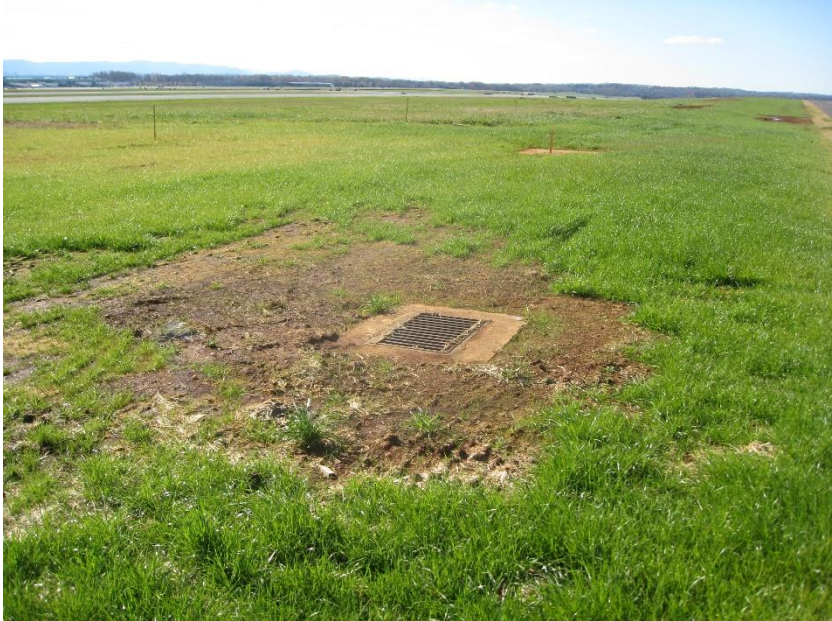
<p>Photo 95 (RW 5L-23R) Existing Structure Sheet EC2.1.9 PSXE82001 Repair Taxiway Lighting</p>

<p>Entry Code: RCA Action Code: TS or PS</p>	<p>Existing structure south of Taxiway G Recommend stabilizing bare areas.</p>
