## QUALITY ASSURANCE MONTHLY SITE ASSESSMENT REPORT

Airfield Modernization Program  
Runway 5L-23R Reconstruction  
Project 2 / Project 3  
Project 4 / Repair TWY Lighting  
Project 5 / Project 6

**QUALITY ASSURANCE  
SITE ASSESSMENT  
EPSC WEEKLY  
INSPECTION**

Airfield Modernization Program  
Runway 5L-23R Reconstruction  
Project 2 / Project 3 /  
PSXE820001-Repair Taxiway  
Lighting

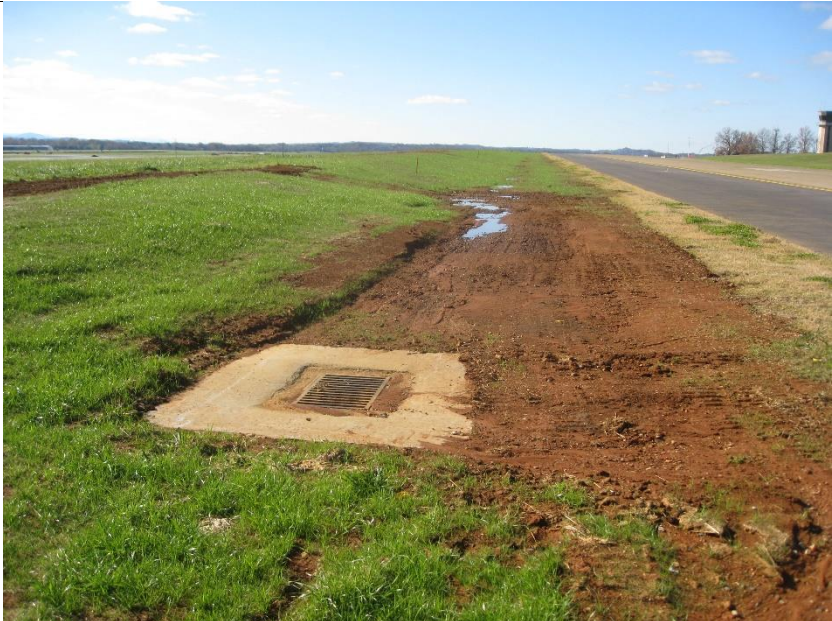
<p>Photo 96 (RW 5L-23R) Existing Structure Sheet EC2.1.9 PSXE82001 Repair Taxiway Lighting</p>

<p>Entry Code: CA/CA Action Code: I/TS or PS</p>	<p>Existing structure south of Taxiway G. Grading activities recently taken place. Recommend installing sediment tubes around structure. Recommend stabilizing bare areas.</p>

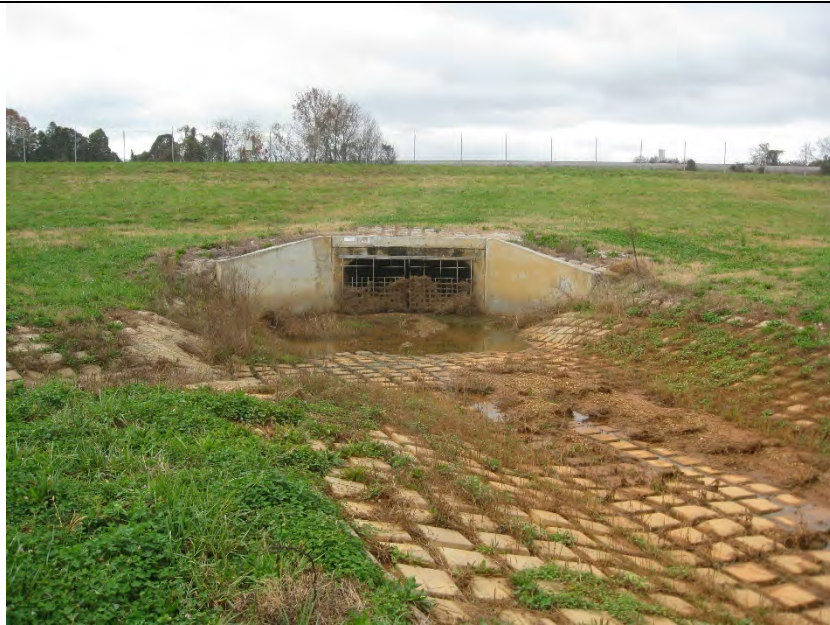
Photo 1  
Sta. 111+56 RT  
(Line LB)  
NLET 01  
Project 2

North Lateral End Treatment 01 (Outfall A).  
Minor flow observed.

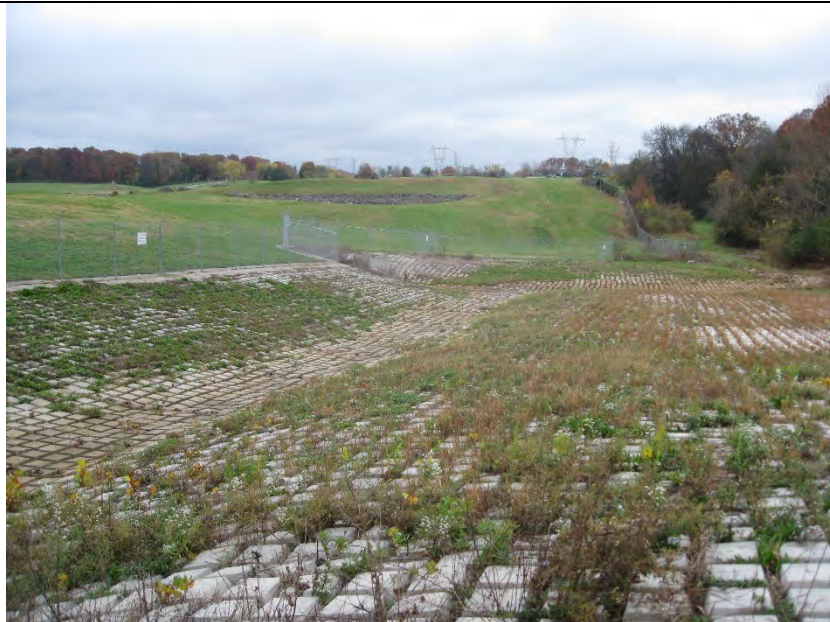
Photo 2  
Sta. 114+00  
(Line LB)  
Project 2

Guard Lateral End Treatment 02.  
This section of the site was inaccessible at time of inspection.

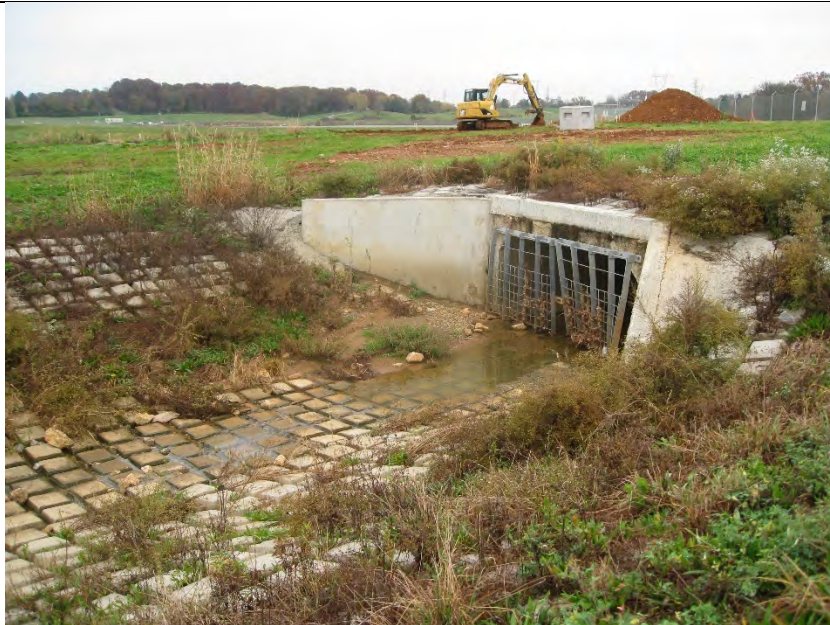
Photo 3  
Sta. 117+00  
(Line LB)  
Project 2

Guard Lateral End Treatment 01.  
Minor flow observed.

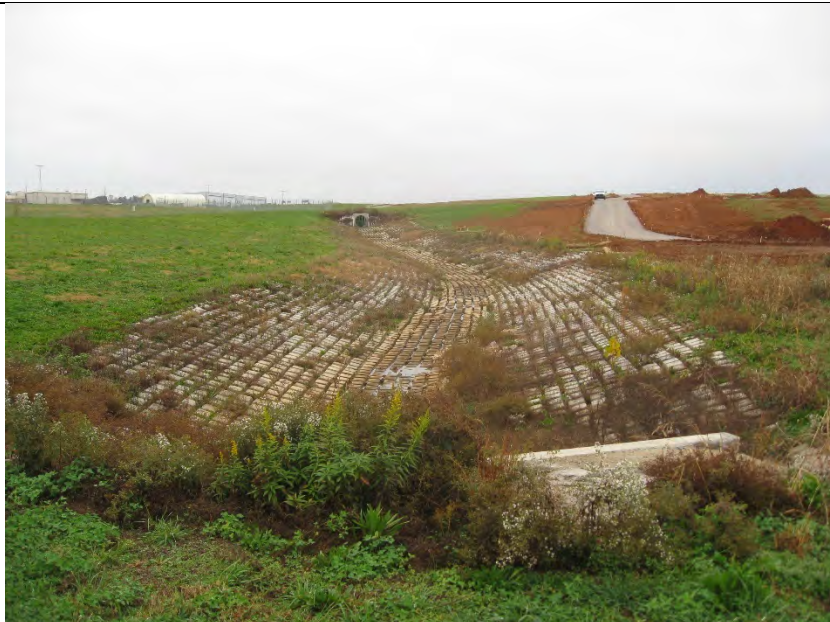
Photo 4  
Sta. 117+00  
(Line LB)  
Project 2

Guard Lateral Ditch (Outfall B).

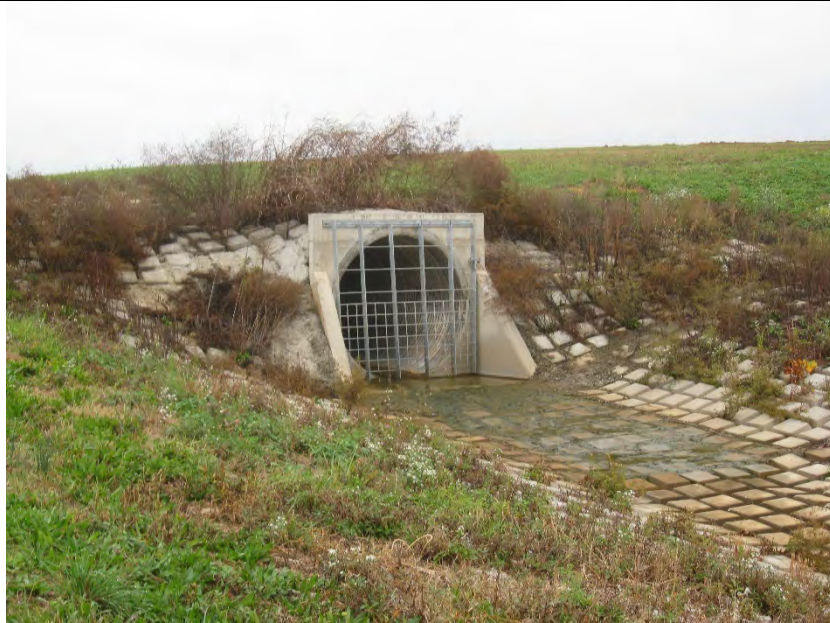
Photo 5  
Sta. 117+00 (RT)  
Project 2

78" culvert in the Guard Lateral Ditch.

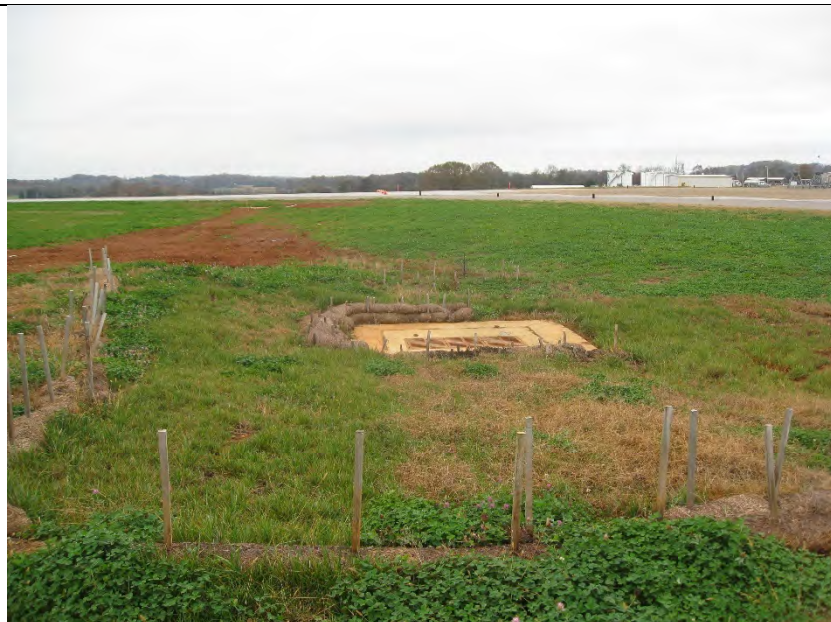
Photo 8  
Sta. 298+71 LT  
(RW 5L-23R)  
Structure 116  
Project 3

Structure 116.

Recommend removing accumulated sediment and immediately stabilizing bare areas to reduce the probability of future erosion issues (see photos #9 and #10 below).

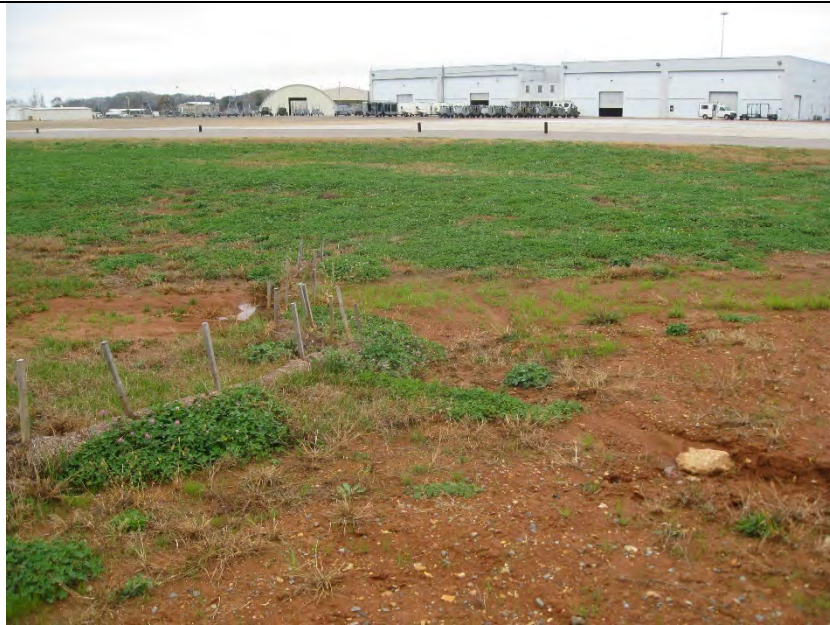
Photo 9  
Sta. 298+71 LT  
(RW 5L-23R)  
Structure 116  
Project 3

Above Structure 116.  
Due to recent storm events, rills have started to form and sediment has accumulated in ditch line.  
Recommend removing accumulated sediment. Recommend stabilizing remaining bare areas.

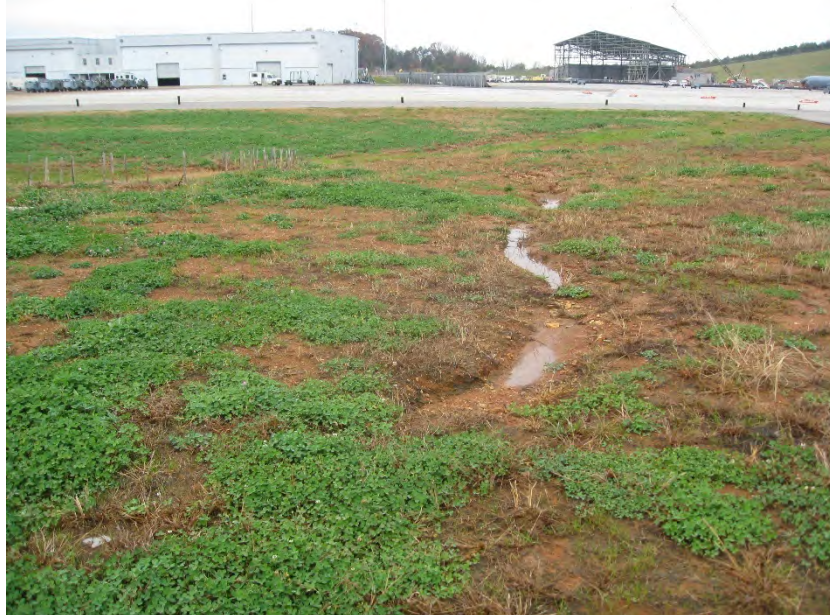
Photo 10  
Sta. 298+71 LT  
(RW 5L-23R)  
Structure 116  
Project 3

Above Structure 116 on Taxiway G2.  
Recommend repairing rills and stabilizing bare areas.

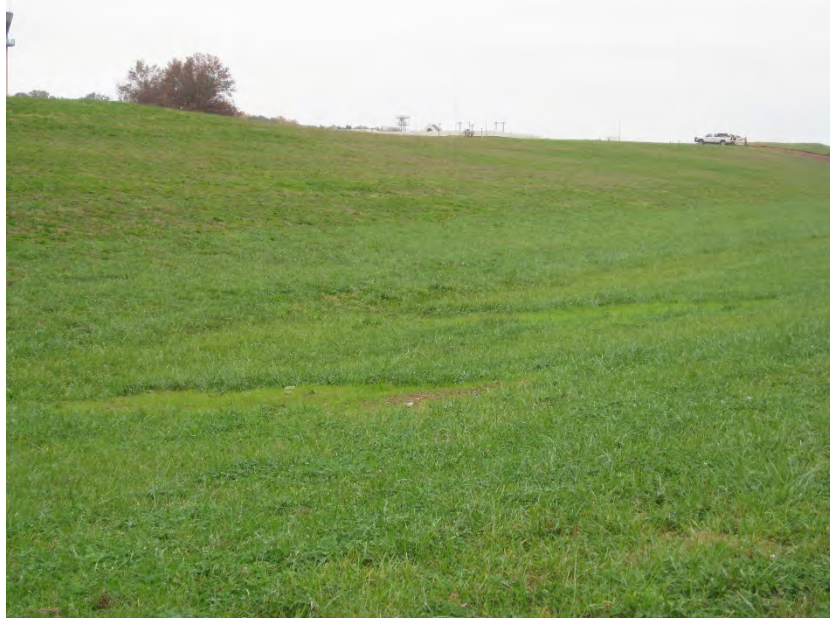
Photo 21  
Sta. 341+50 LT  
(RW 5L-23R)  
Between ES Endwall 104 and 102  
Project 3

Repaired construction fallouts stabilized.

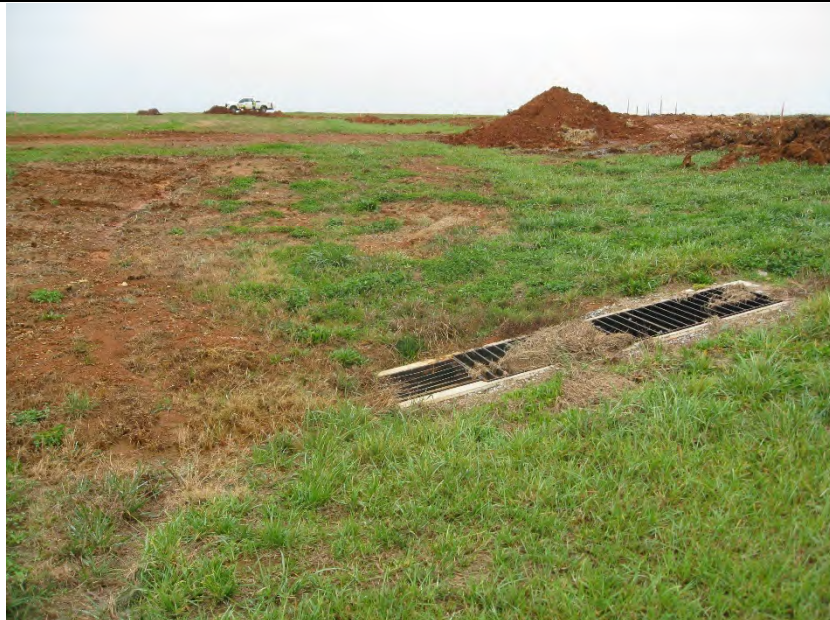
Photo 22  
Sta. 347+31 LT  
(RW 5L-23R)  
ES Endwall 102  
Project 3

Enhanced Swale Endwall 102  
Recommend repairing long-standing rills.  
Recommend coordinating with CHA on possible use of matting to help stabilization.  
Recommend stabilizing all remaining bare areas.  
Construction activities are per Project 6 (EUTAW).

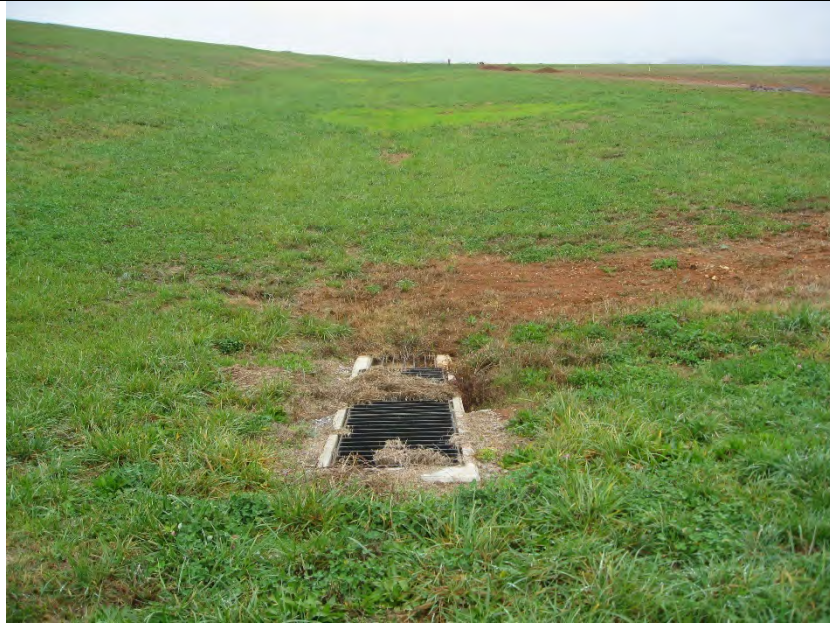
Photo 23  
Sta. 347+31 LT  
(RW 5L-23R)  
ES Endwall 102  
Project 3

Enhanced Swale Endwall 102  
Recommend repairing long-standing rills.  
Recommend coordinating with CHA on possible use of matting to help stabilization.  
Recommend stabilizing all remaining bare areas.  
Construction activities are per Project 6 (EUTAW).

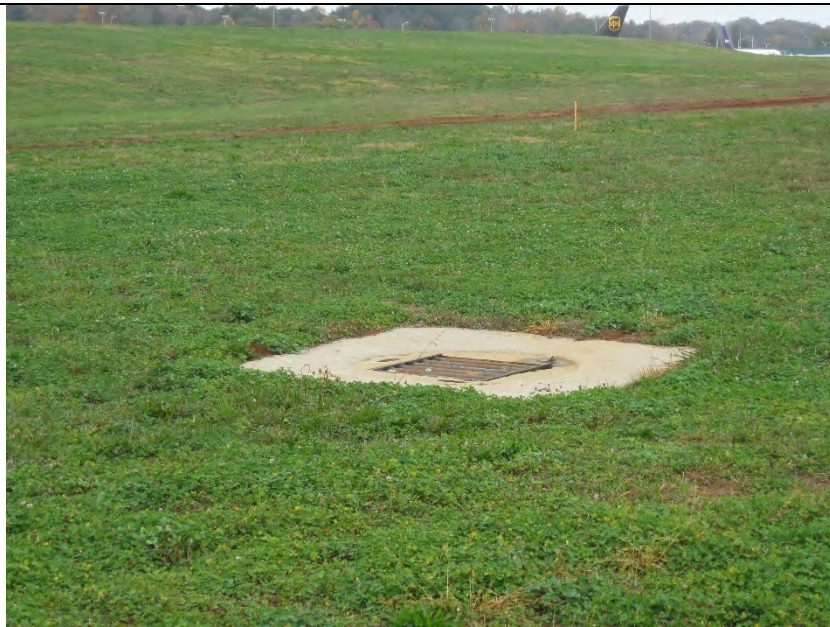
Photo 27  
Sta. 363+35 LT  
(RW 5L-23R)  
Existing Structure  
Project 2

Existing Structure.  
Construction activities are per Project 6 (EUTAW).

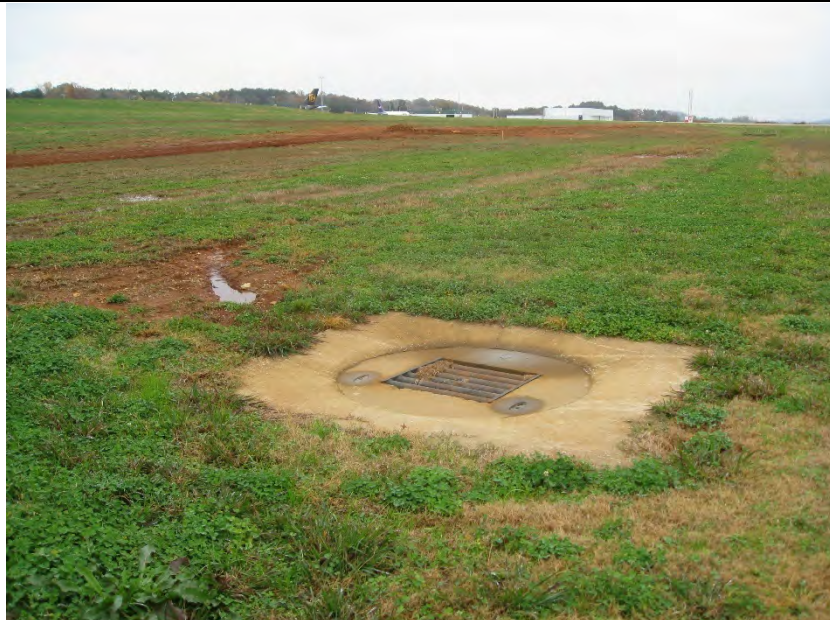
Photo 28  
Sta. 366+25 LT  
(RW 5L-23R)  
Existing Structure  
Project 2

Existing Structure.  
Construction activities are per Project 6 (EUTAW)

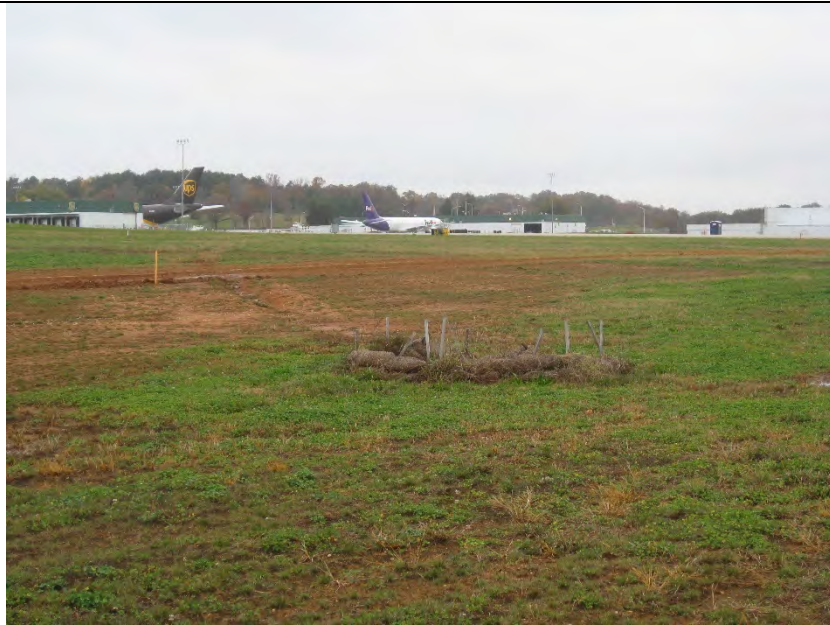
Photo 29  
Sta. 369+11 LT  
(RW 5L-23R)  
Existing Structure  
Project 2

Existing Structure.  
Recommend stabilizing bare areas (as noted on previous reports).  
Recommend repairing damaged sediment tubes.

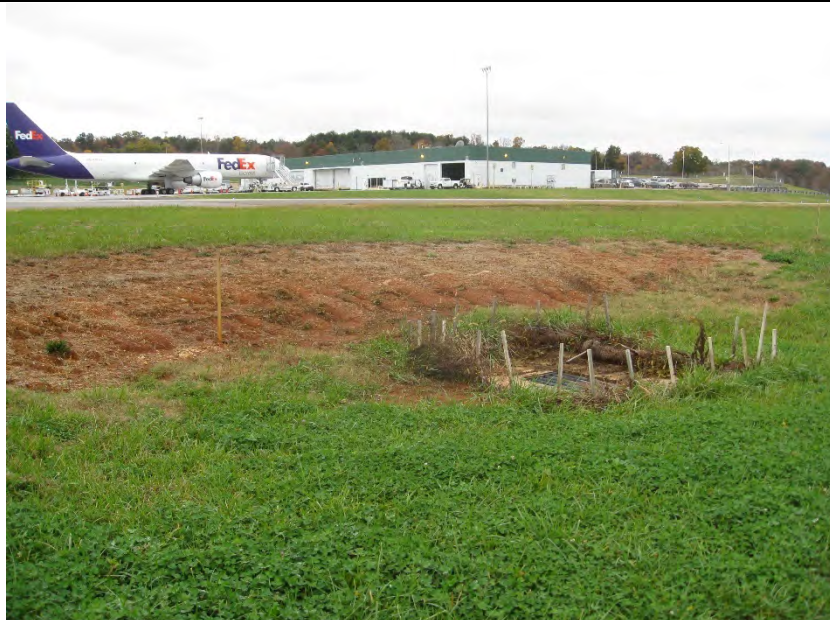
Photo 30  
Sta. 677+00 RT  
(RW 5L-23R)  
Existing Structure  
Project 4

Existing structure south of Taxiway "G".  
Erosion and rills continue to occur along the graded slope that was never stabilized.  
Recommend repairing long-standing eroded areas, removing accumulated sediment, and  
immediately stabilizing slope to reduce the probability of future erosion issues.  
See photo below.

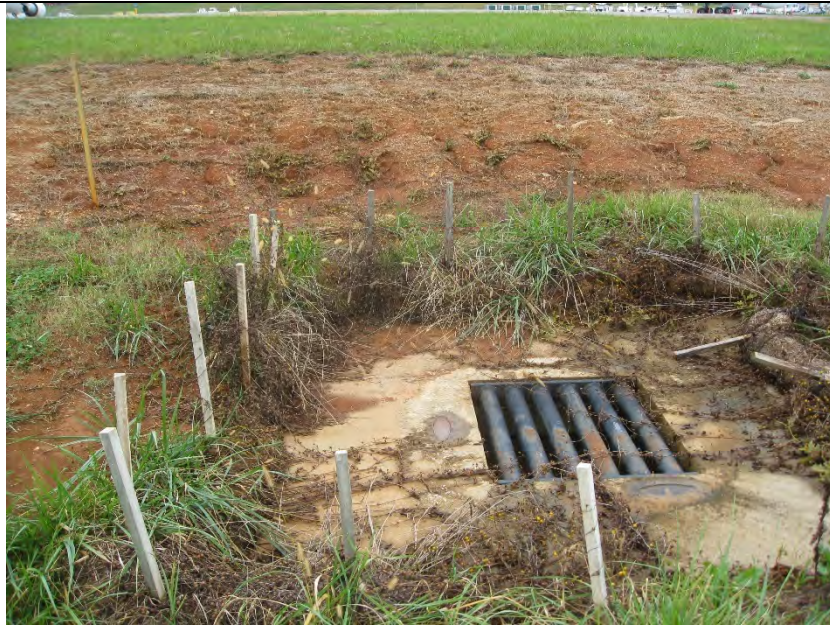
Photo 31  
Sta. 677+00 RT  
(RW 5L-23R)  
Existing Structure  
Project 4

Existing structure south of Taxiway "G" (see previous photo).  
Recommend removing long-standing sediment from behind sediment tubes and on top of structure. Recommend replacing sediment tubes.

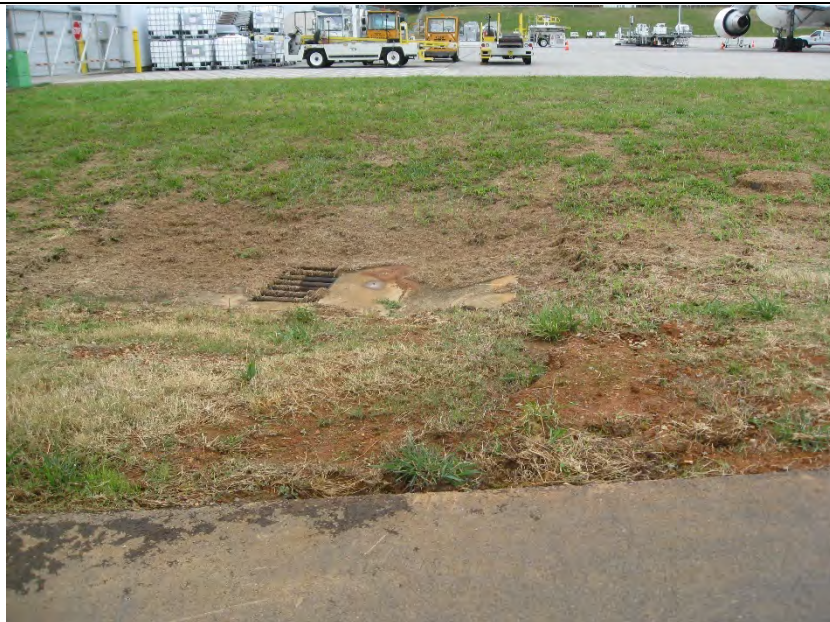
Photo 32  
Sta. 677+00 RT  
(RW 5L-23R)  
Project 4

Structure between taxiway and UPS.  
Recommend repairing rills (as noted on previous reports).  
Recommend immediately stabilizing slope to reduce the probability of future erosion issues.

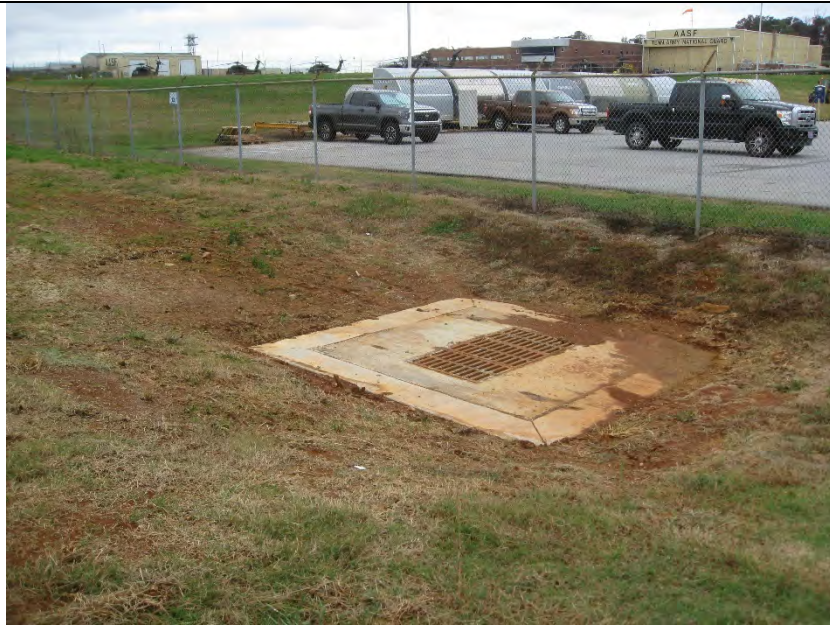
Photo 33  
Sta. 676+00 RT  
(RW 5L-23R)  
Project 4

Structure adjacent to UPS.  
Sediment tubes recently removed and not replaced. Area not stable.  
Recommend reseeding bare areas.

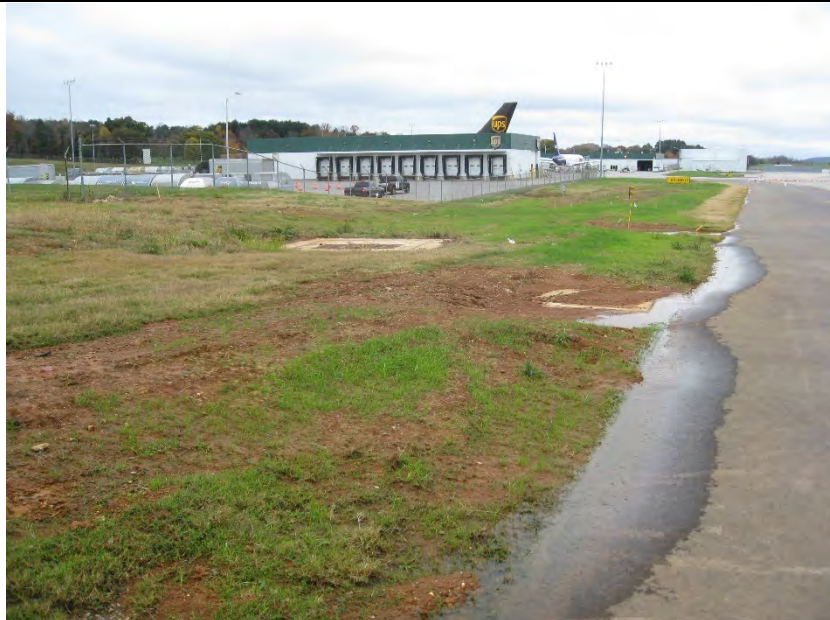
Photo 34  
New structure  
Project 4

New structure north of Taxiway G  
Sediment tubes recently removed and not replaced. Area not stable.  
Recommend reseeding bare areas.

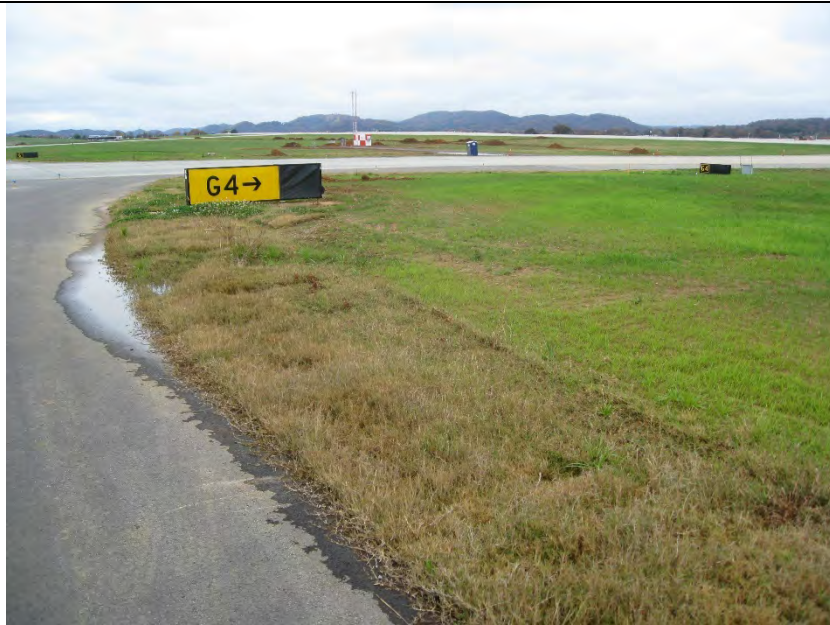
Photo 35  
New structure  
Project 4

Grass established at TWY G4/G.

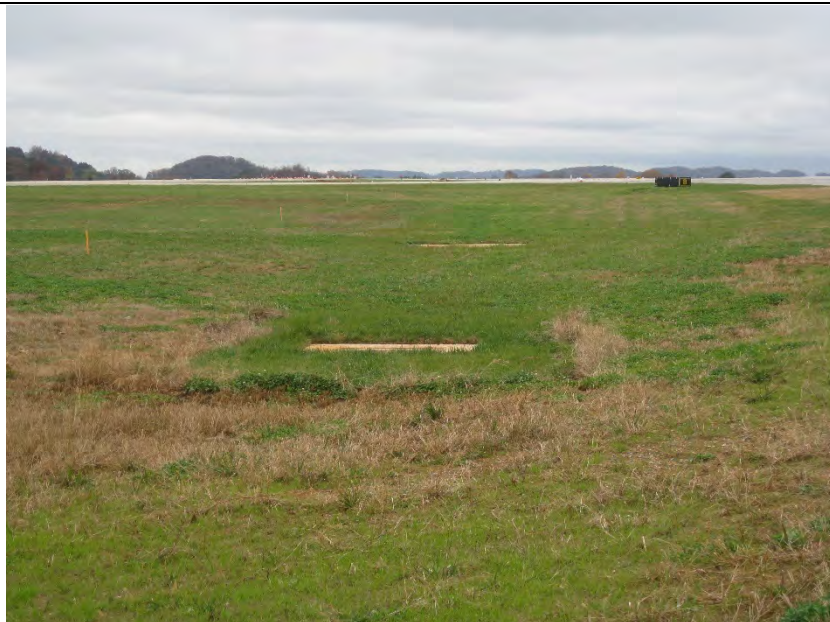
Photo 36  
Sta. 365+89 RT  
(RW 5L-23R)  
Outfall C  
Project 4

Structure 300 and Outfall C  
Portions of the site are now unavailable for inspection due to Taxiway "Y" being open to traffic.

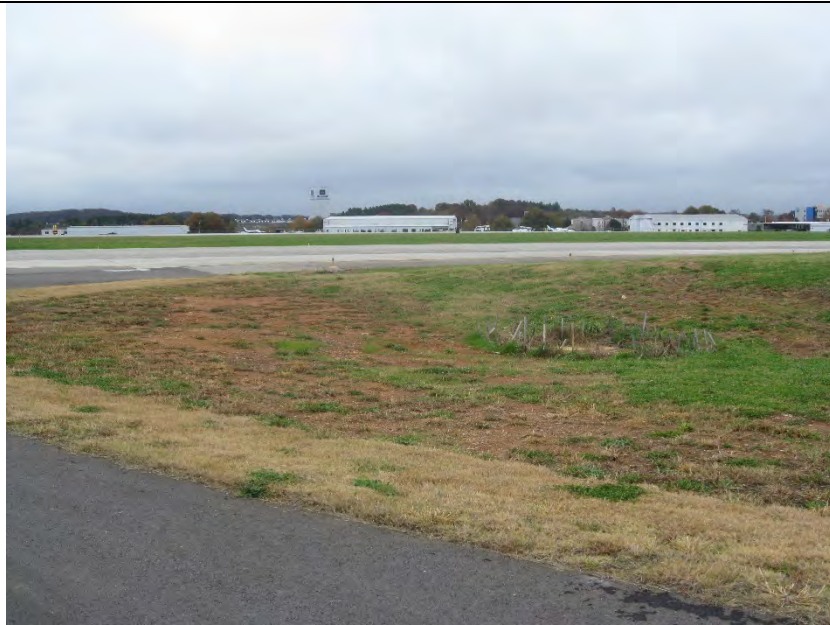
Photo 37  
Sta. 362+02 LT  
(RW 5L-23R)  
Structure 400  
Project 4

Structure 400.  
Bare areas continue to push sediment onto existing structure.  
Recommend stabilizing bare areas (as noted on previous reports) after removing accumulated sediment (as noted on previous reports).

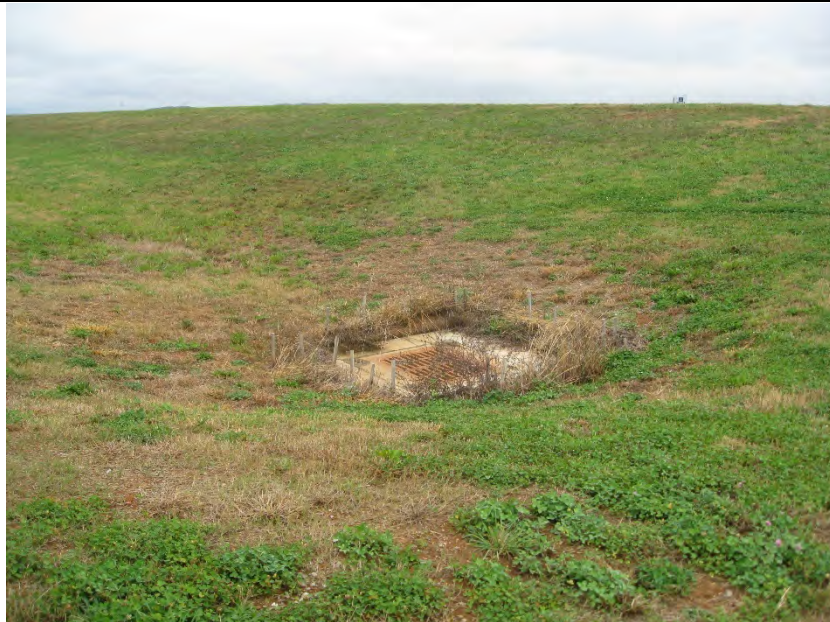
Photo 38  
Sta. 353+56 RT  
(RW 5L-23R)  
Structure 20  
Project 4

Structure 20.  
Recommend removing inlet protection (as noted on previous reports) and stabilizing any remaining bare areas after removal if needed.

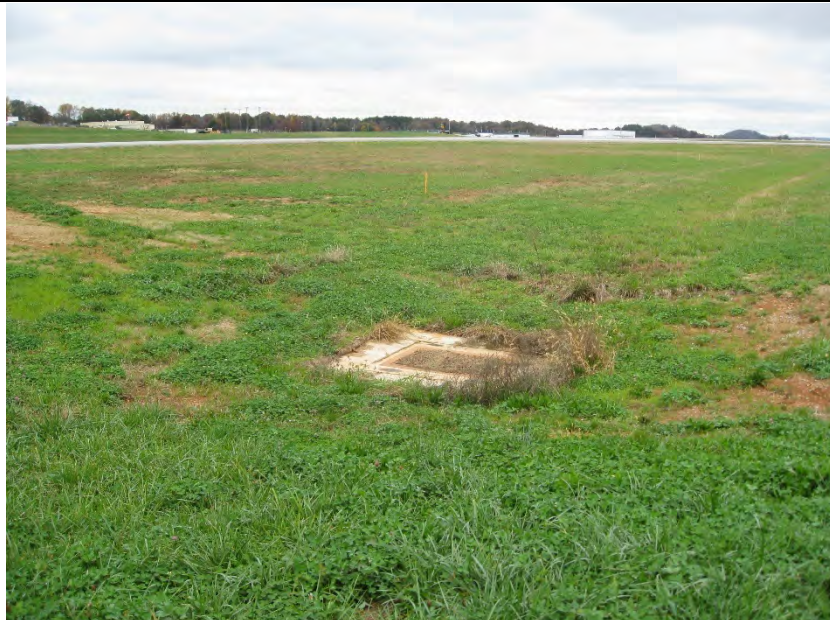
Photo 39  
Sta. 347+26 RT  
(RW 5L-23R)  
Structure 22  
Project 4

Structure 22.  
Recommend removing sediment tubes and stabilizing any remaining bare areas after removal if needed. Recommend removing sediment from top of structure (as noted on previous reports).

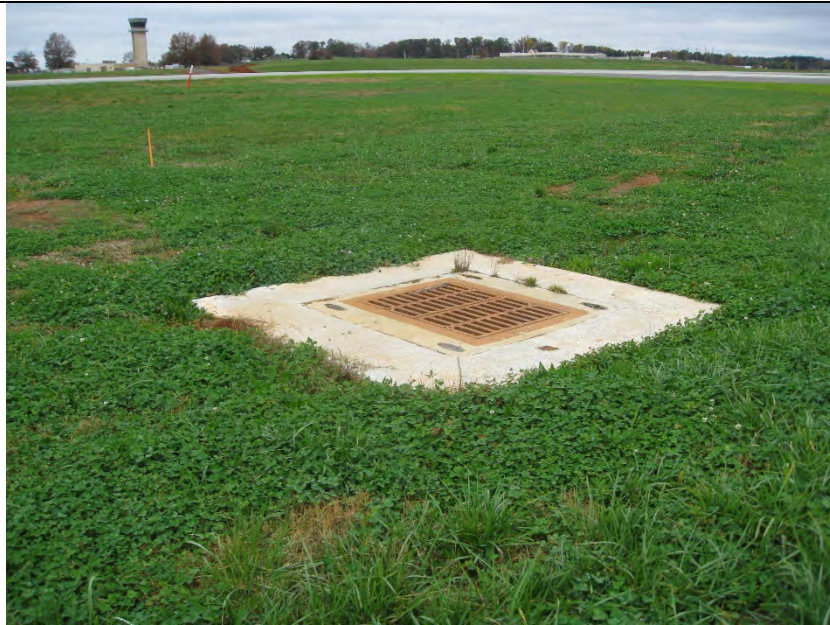
Photo 40  
Sta. 353+56 RT  
(RW 5L-23R)  
Structure 200  
Project 4

Structure 200.

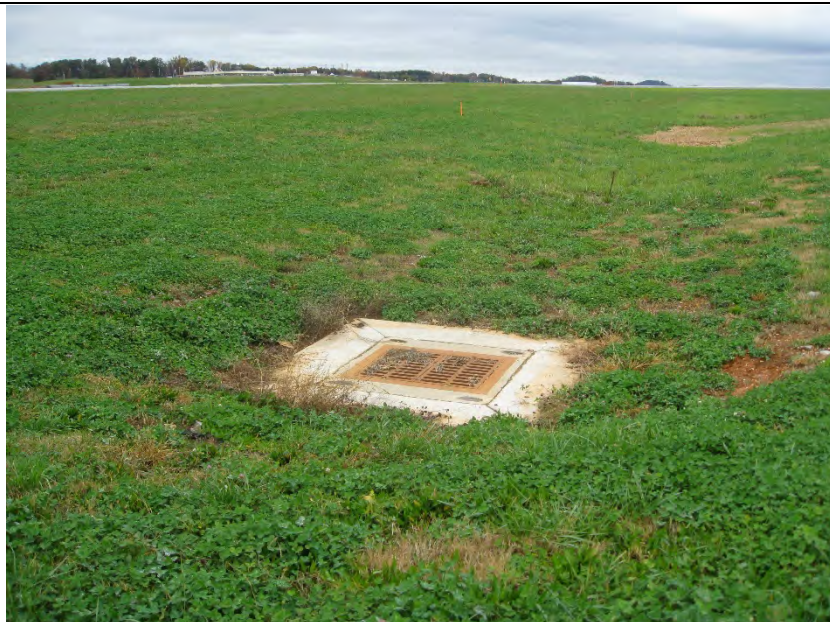
Photo 41  
Sta. 341+86 RT  
(RW 5L-23R)  
Structure 204  
Project 4

Structure 204.

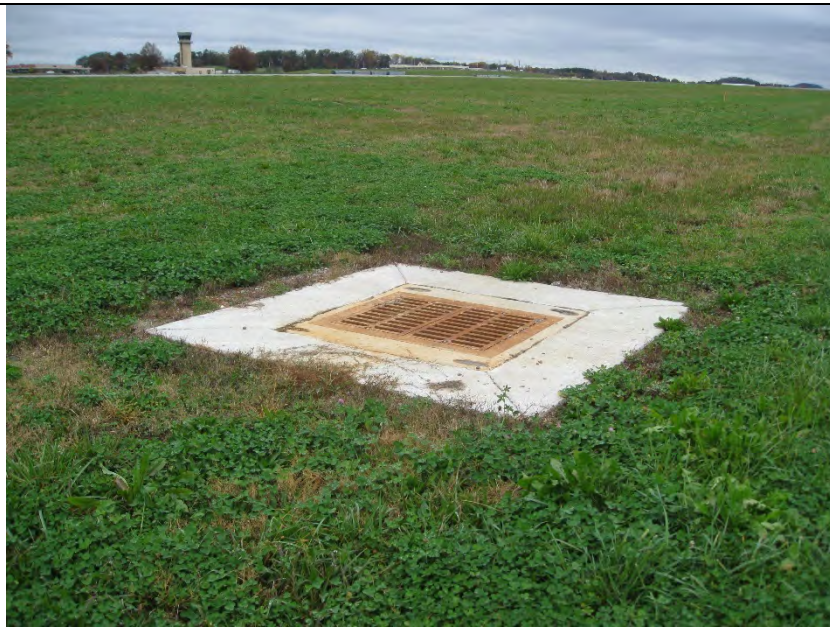
Photo 42  
Sta. 338+02 RT  
(RW 5L-23R)  
Structure 206  
Project 4

Structure 206.

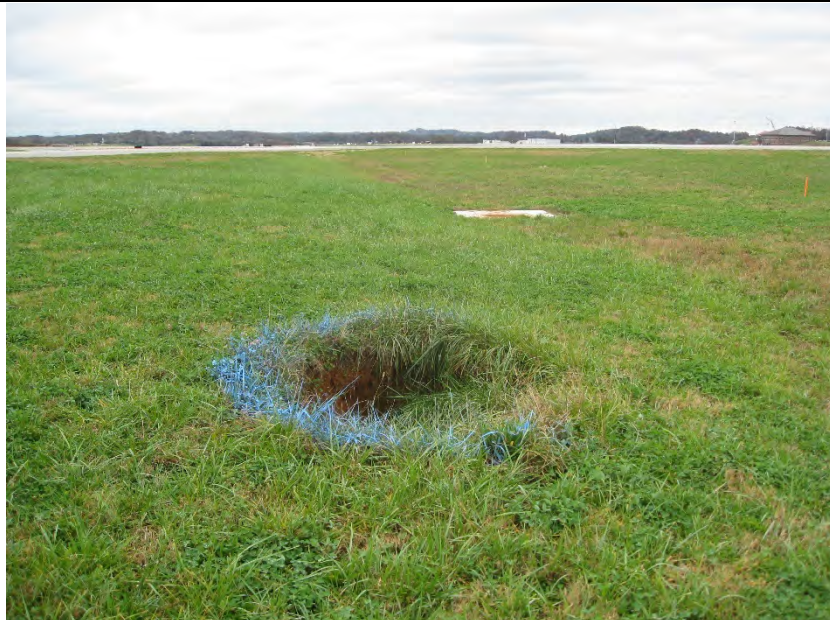
Photo 43  
Sta. 338+02 RT  
(RW 5L-23R)  
Structure 208  
Project 3

Structure 208.

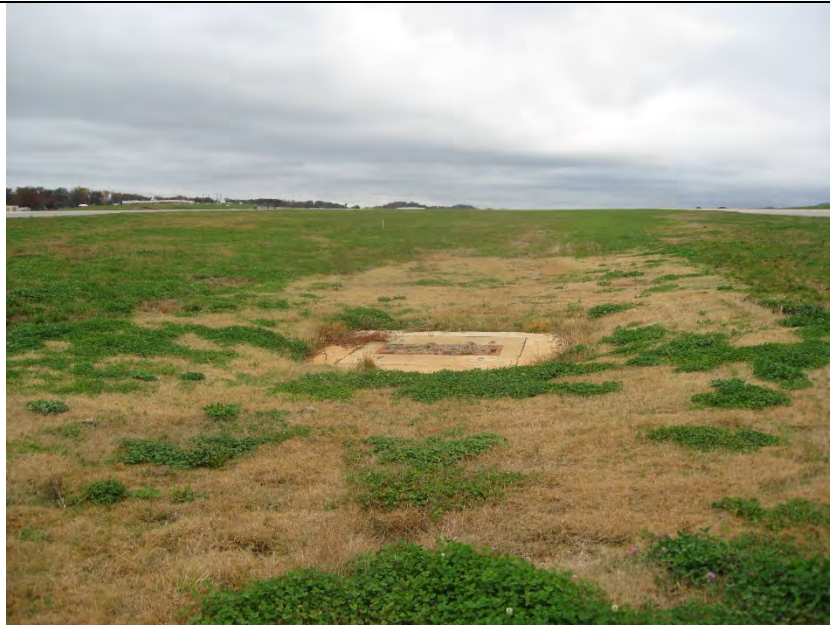
Photo 44  
Sta. 338+02 RT  
(RW 5L-23R)  
Structure 208  
Project 3

Above structure 208.  
Construction fallout present.  
Recommend coordinating with CHA on remediation.

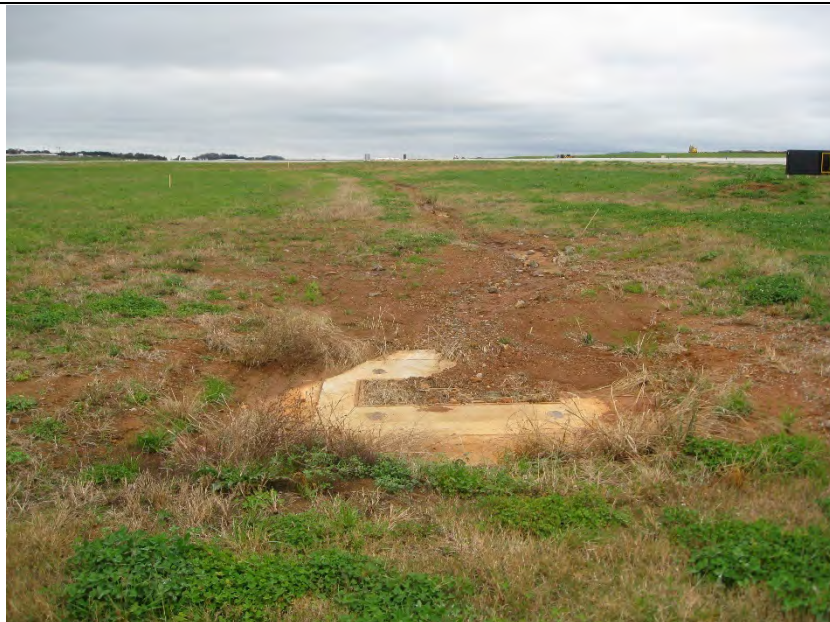
Photo 45  
Sta. 329+86 RT  
(RW 5L-23R)  
Structure 210  
Project 3

Structure 210.

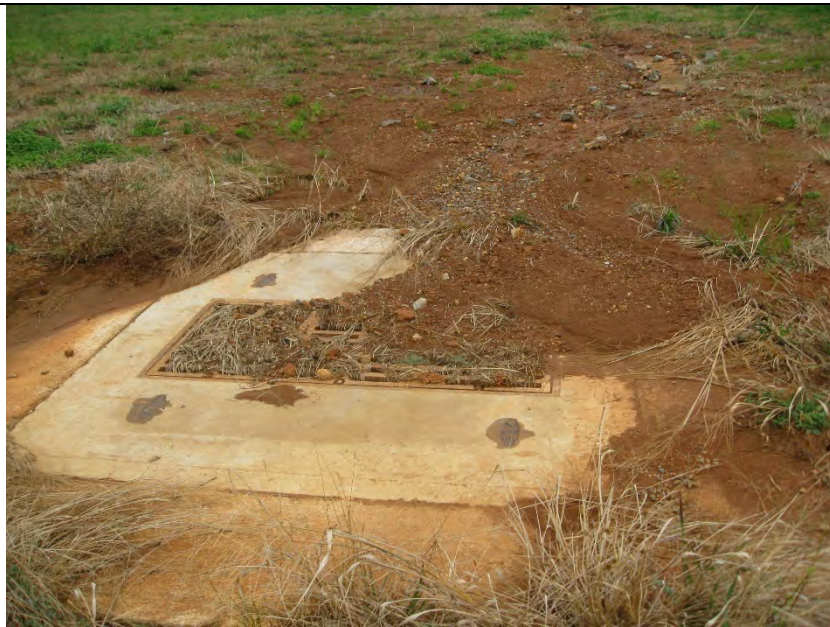
Photo 46  
Sta. 321+73 RT  
(RW 5L-23R)  
Structure 212  
Project 3

Structure 212.

Area was never stabilized; however, erosion control measures were removed. Recommend adding sediment tubes and regrading eroded ditch line (as noted on previous reports). Recommend coordinating with CHA on use of matting or sod to help achieve stabilization. See next Photo.

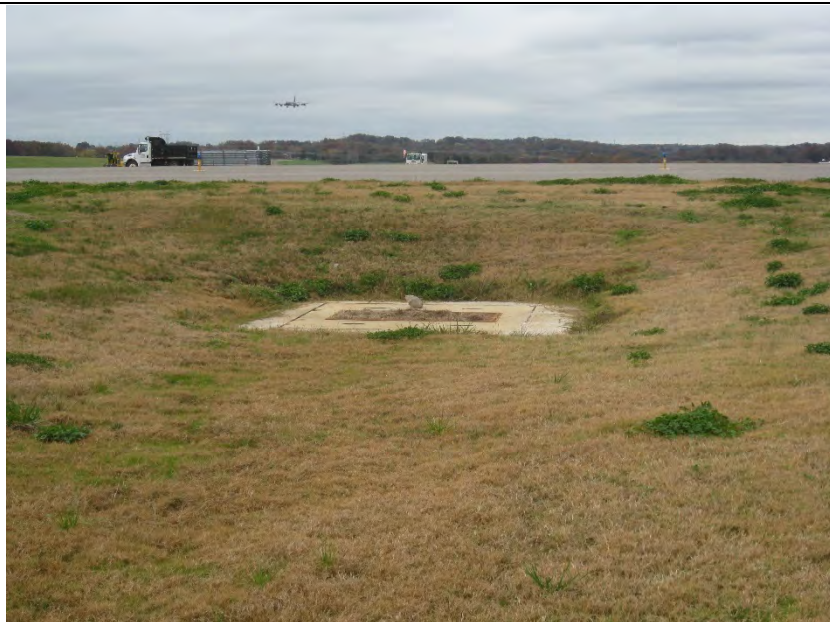
Photo 47  
Sta. 321+73 RT  
(RW 5L-23R)  
Structure 212  
Project 3

Structure 212.  
Sediment is entering the storm system.  
Recommend removing sediment (as noted on previous reports).

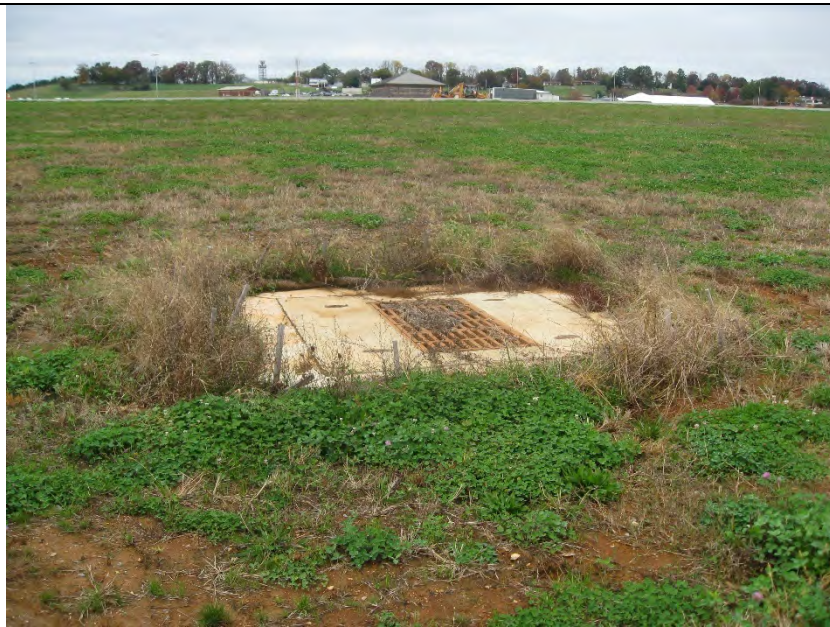
Photo 48  
Sta. 314+32 RT  
(RW 5L-23R)  
Structure 214  
Project 3

Structure 214.

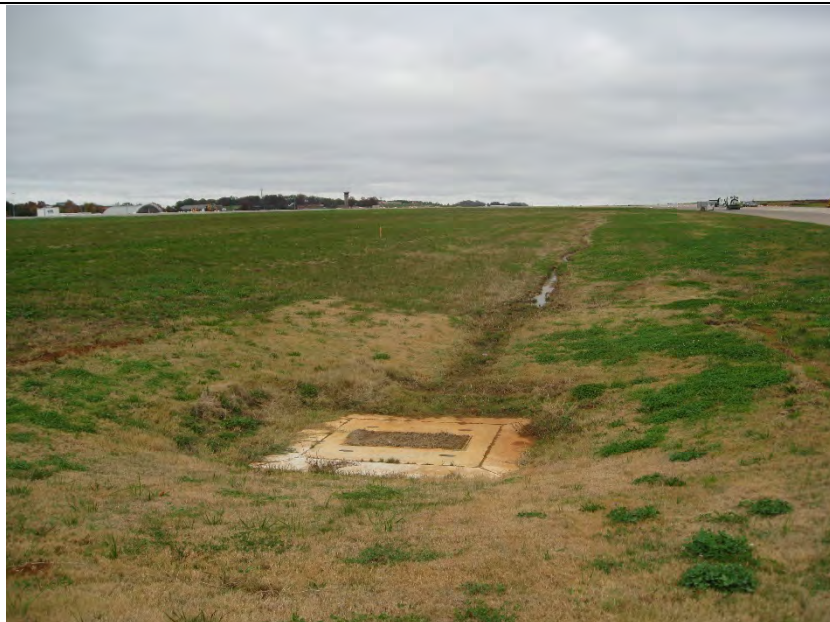
Photo 49  
Sta. 307+99 RT  
(RW 5L-23R)  
Structure 216  
Project 3

Structure 216.

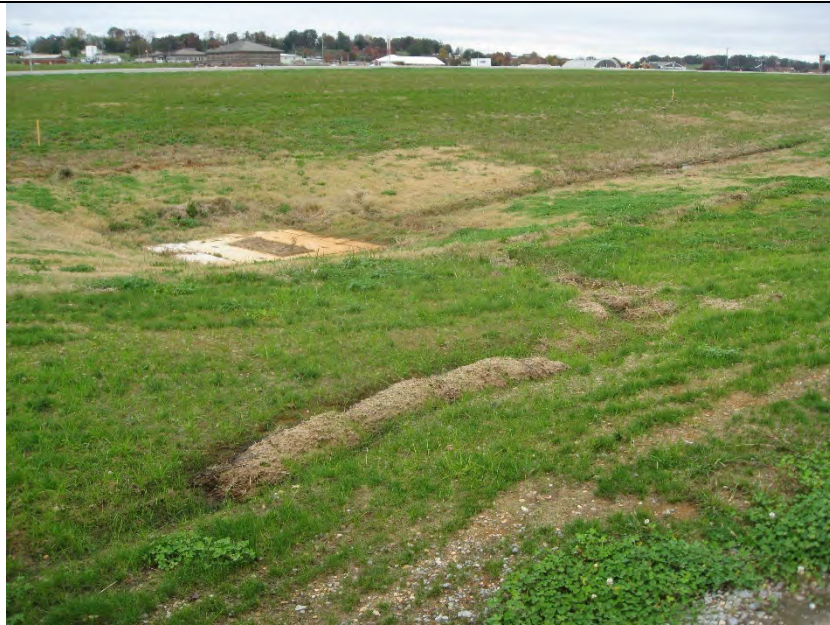
Photo 50  
Sta. 301+87 RT  
(RW 5L-23R)  
Structure 218  
Project 3

Structure 218.  
See photo below.

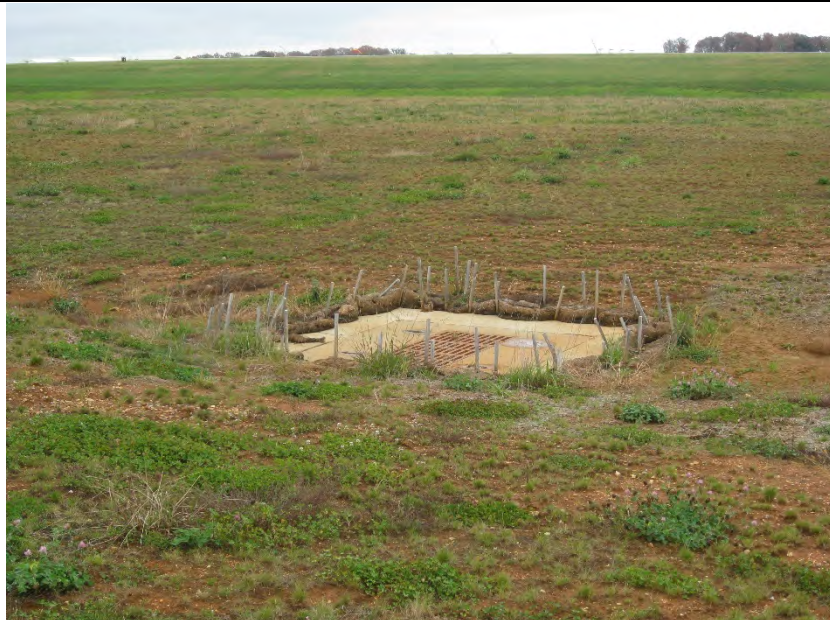
Photo 51  
Sta. 301+87 RT  
(RW 5L-23R)  
Structure 218  
Project 3

Structure 218.  
Previously formed rills were never remediated.  
Sediment tube placed in rills and area stabilized.  
Recommend removing sediment tubes, repairing rills and stabilizing resulting bare areas.

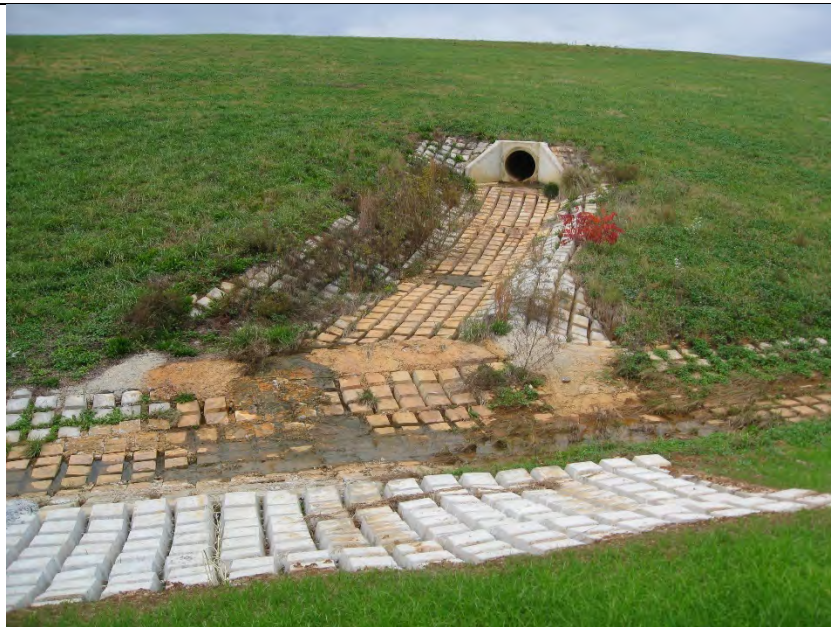
Photo 52  
Sta. 296+83 RT  
(RW 5L-23R)  
Structure 220  
Project 2

Structure 220.  
Recommend stabilizing remaining bare areas.

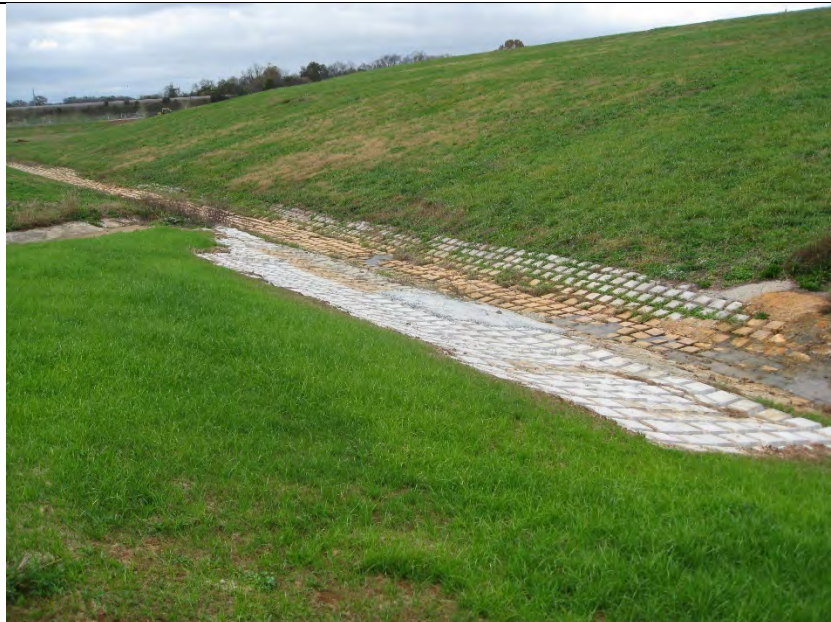
Photo 53  
Sta. 288+26  
(RW 5L-23R)  
Structure 224  
Project 2

Structure 224.  
Grass established at recently stabilized areas.

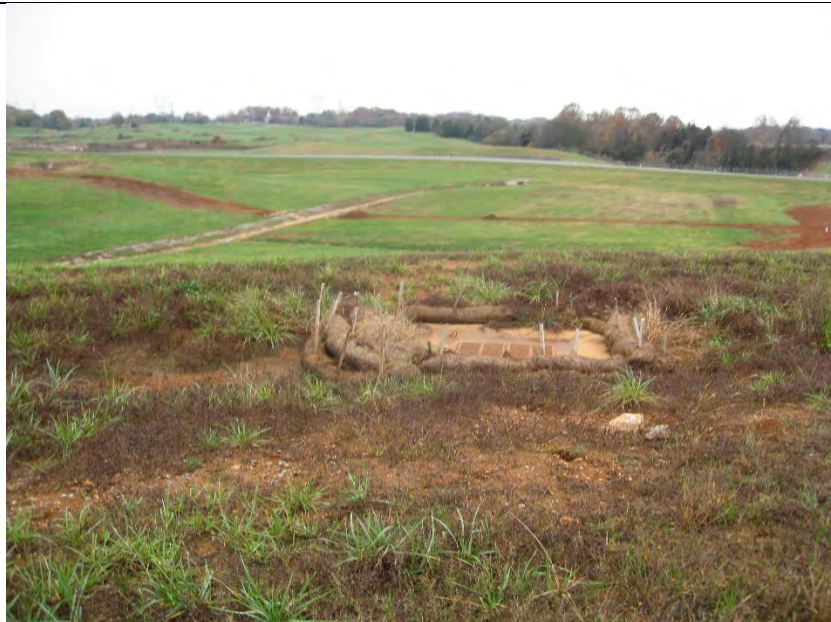
Photo 57  
Sta. 290+26 RT  
(RW 5L-23R)  
Structure 600 Ditch  
Project 2

Structure 600 ditch.  
Recommend removing sediment tubes from entire 600 ditch and stabilizing bare areas.
