## QUALITY ASSURANCE MONTHLY SITE ASSESSMENT REPORT

Airfield Modernization Program  
Runway 5L-23R Reconstruction  
Project 2 / Project 3  
Project 4 / Repair TWY Lighting  
Project 5 / Project 6

**QUALITY ASSURANCE  
SITE ASSESSMENT  
EPSC WEEKLY  
INSPECTION**

Airfield Modernization Program  
Runway 5L-23R Reconstruction  
Project 2 / Project 3 /  
PSXE820001-Repair Taxiway  
Lighting

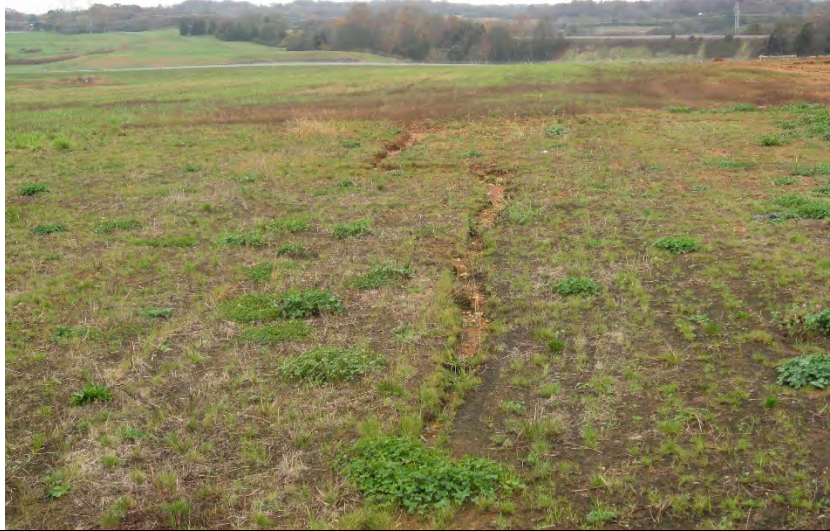
Photo 58  
Sta. 284+59  
(RW 5L-23R)  
Structure 600  
Project 3

Structure 600.  
Recommend removing inlet protection and stabilizing bare areas.

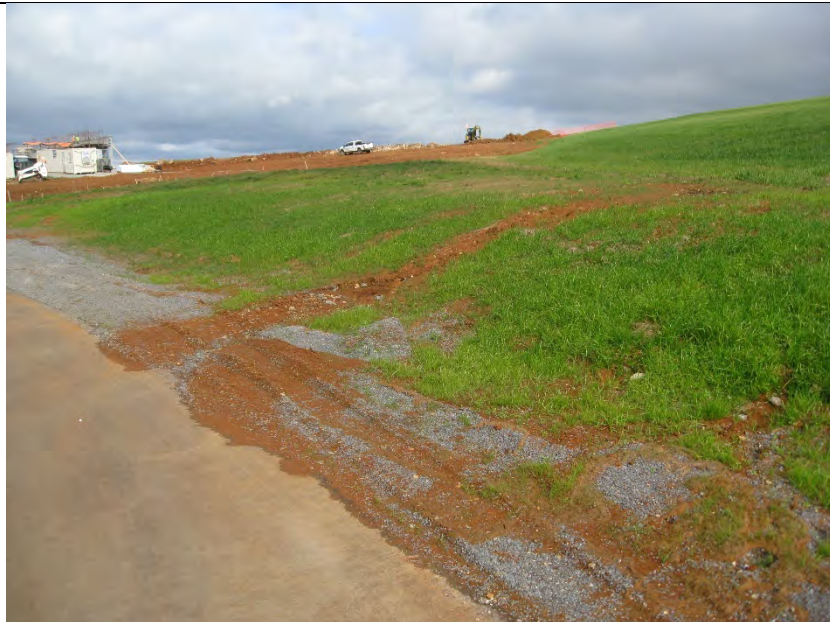
Photo 59  
Sta. 284+59  
(RW 5L-23R)  
Project 3

Area adjacent to blast pad.  
Rills have formed.  
Recommend regrading area and stabilizing any resulting bare areas.

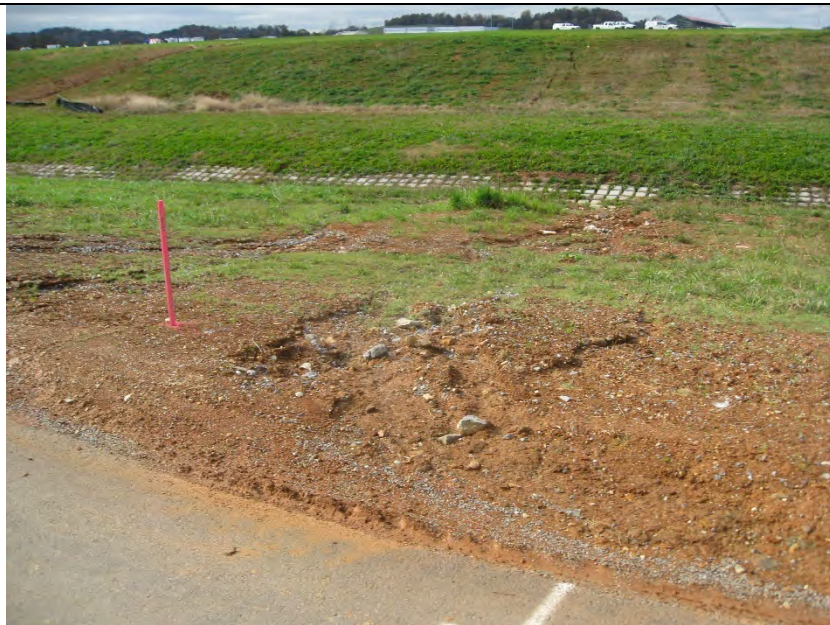
Photo 60  
Sta. 37+25 RT  
Proposed Haul Route  
Project 3

Haul Road.  
Due to recent storm events, rills have formed and sediment has accumulated on the stone shoulder. Recommend coordinating with CHA on remediation of rills.  
Recommend stabilizing bare areas.

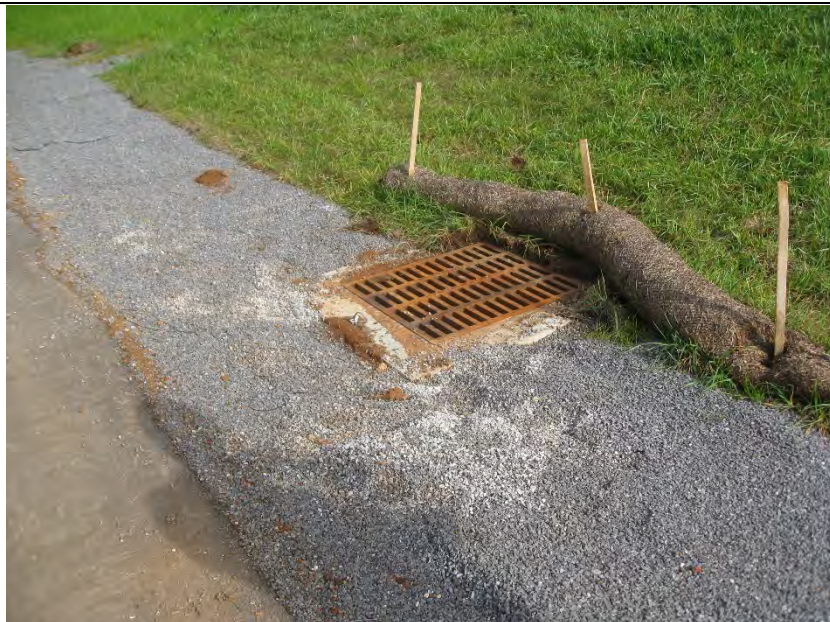
Photo 61  
Sta. 37+25 RT  
Proposed Haul Route  
Project 3

Haul Road.  
Lower side of haul road slopes have not been stabilized since regrading.  
Due to recent storm events, Rills have formed.  
Recommend coordinating with CHA on remediation of rills.  
Recommend stabilizing bare areas.

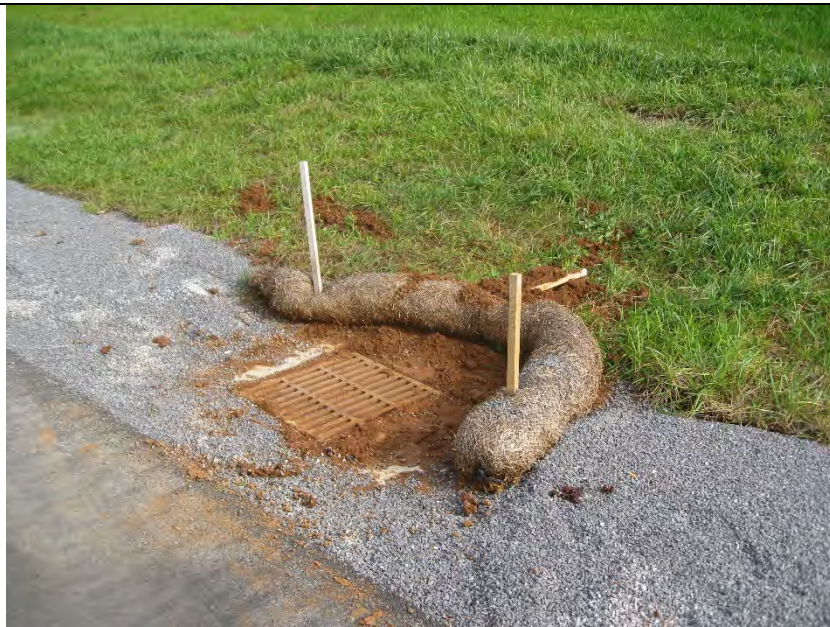
Photo 62  
Sta. 37+25 RT  
Proposed Haul Route  
Project 3

Haul Road.  
Filter fabric recently removed.  
Recommend removing sediment tubes.

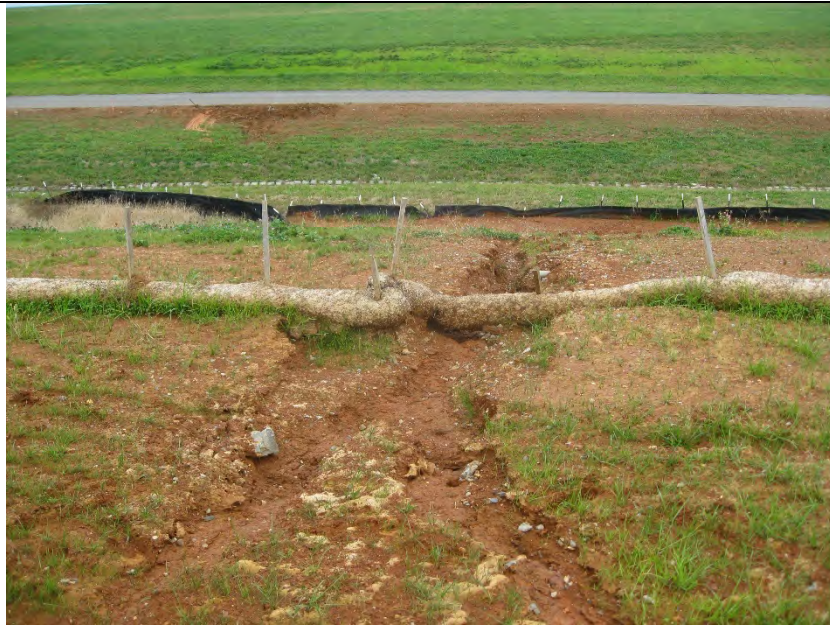
Photo 64  
Sta. 32+50 RT  
Proposed Haul Route  
Project 3

Haul Road.  
Due to recent storm events, Rills have formed in various places.  
Recommend coordinating with CHA on remediation of rills and immediately stabilizing any resulting bare areas.

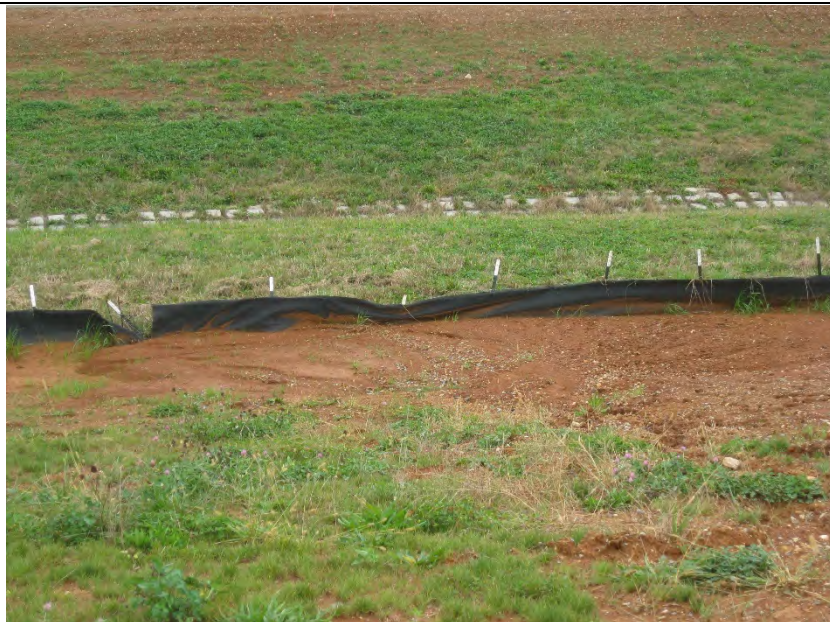
Photo 65  
Sta. 302+54  
(RW 5L-23R)  
Project 3

North Lateral Fill Area.  
Recommend repairing rills and adding slope drain (as noted on previous reports).  
See next photo.

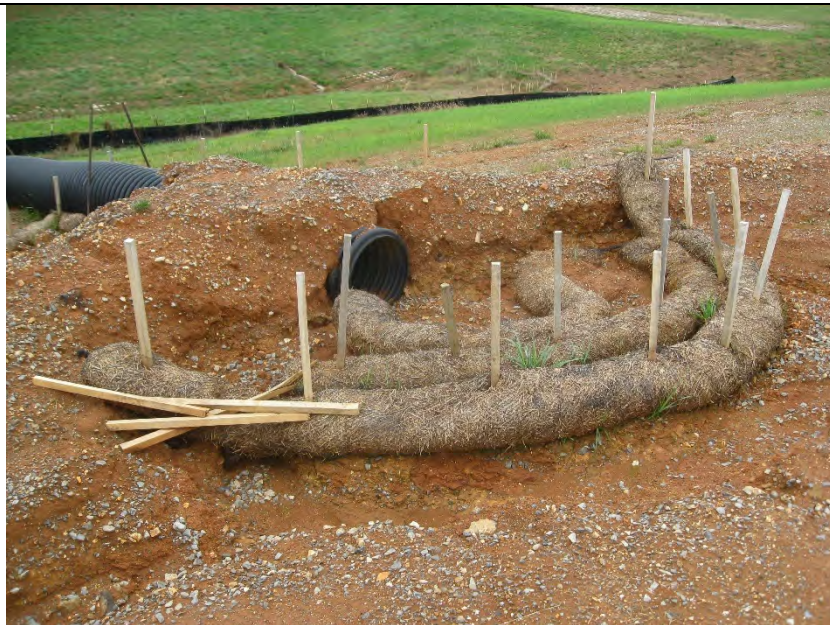
Photo 66  
Sta. 302+54  
(RW 5L-23R)  
Project 3

North Lateral Fill Area.  
Recommend removing accumulated sediment at toe of slope (as noted on previous reports).

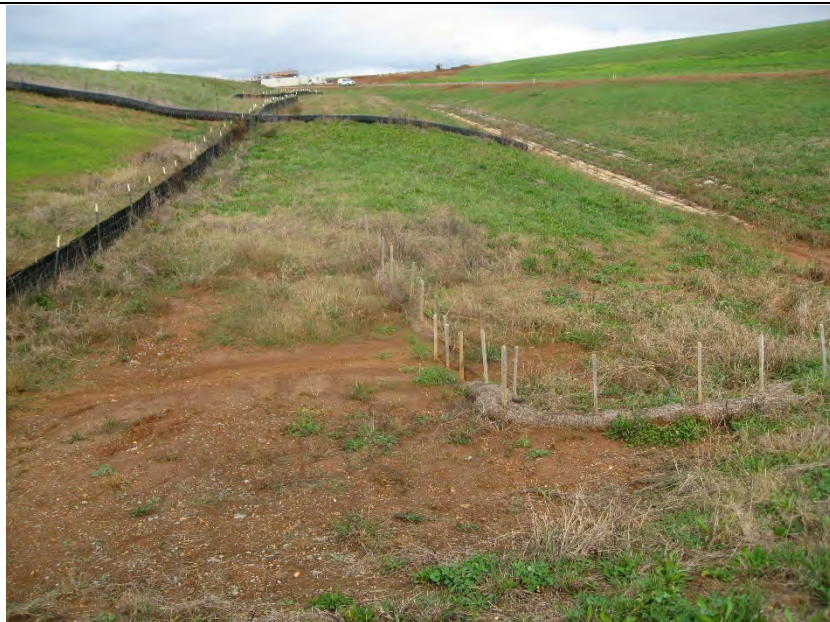
Photo 67  
Sta. 302+54  
(RW 5L-23R)  
Project 3

Soil stockpile area next to haul road at Taxiway B.  
Bare area in front of slope drain is full of stone and was never stabilized.  
Recommend stabilizing bare area. Undermined sediment tubes never repaired.  
Recommend repairing or adding tubes to close gap and capture future sediment before it enters drain.

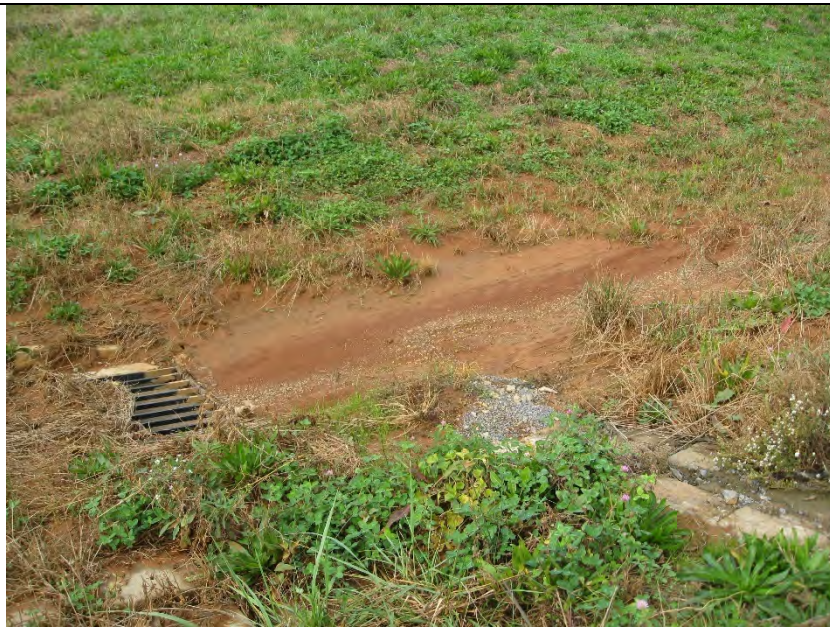
Photo 68  
Sta. 302+54  
(RW 5L-23R)  
Project 3

North Lateral Endwall 100.  
Recommend removing sediment, replacing sediment tubes and stabilizing bare areas (as noted on previous reports) at the same time in order to prevent further erosion.

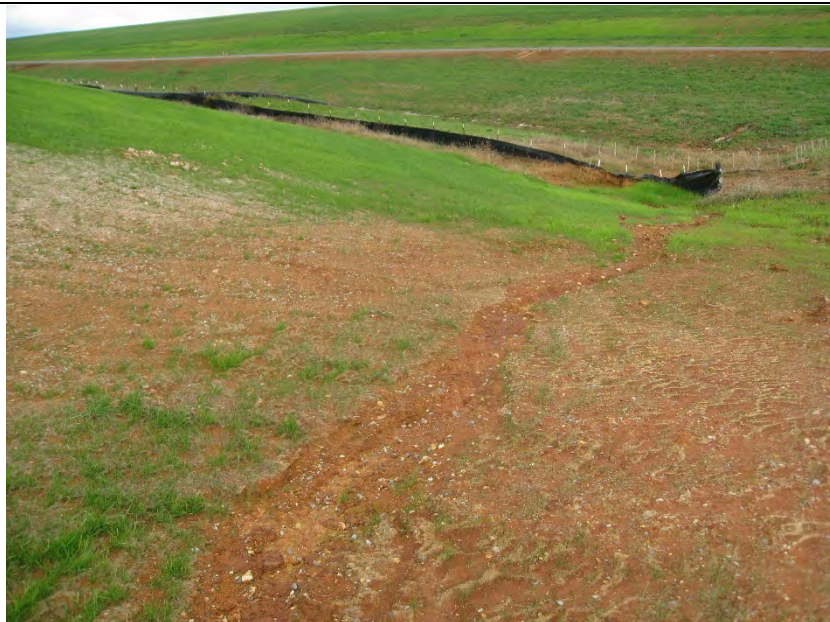
Photo 69  
Sta. 302+54  
(RW 5L-23R)  
Project 3

North Lateral Endwall 100.  
Area from previous photo has remained un-stabilized and has deposited sediment in the North lateral ditch. Recommend removing sediment.  
See previous photo.

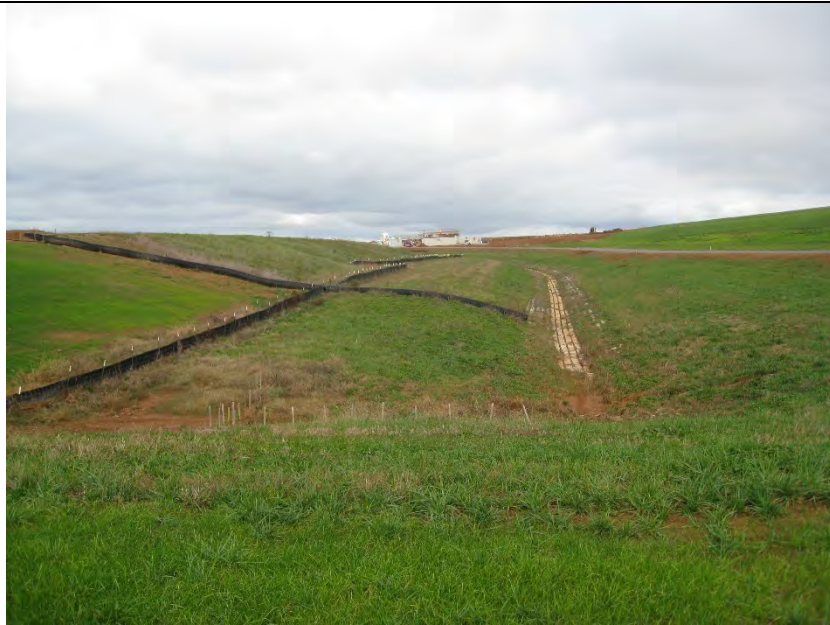
Photo 70  
Sta. 302+54  
(RW 5L-23R)  
Project 3

Above North Lateral Endwall 100.  
Rills have formed and have dropped sediment at toe of slope.  
Recommend removing sediment and repairing rills.

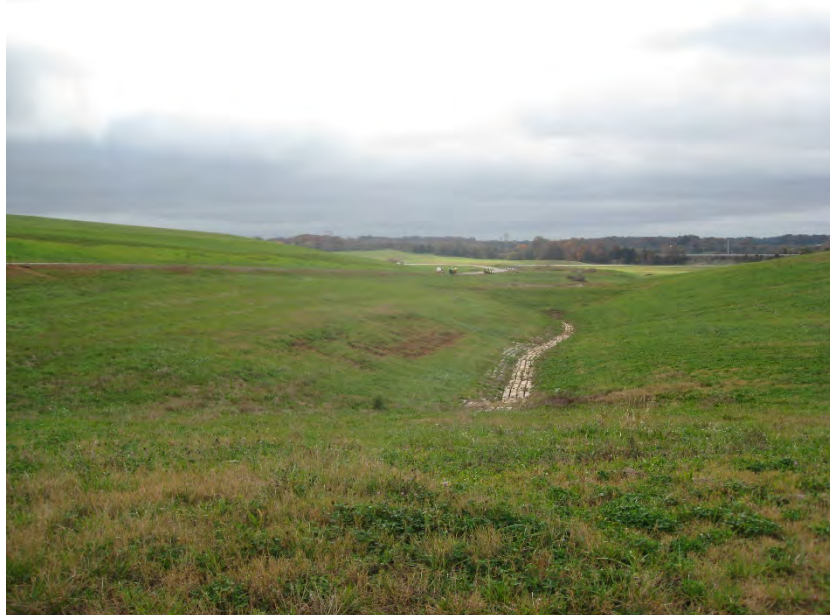
Photo 71  
Sta. 302+54 to Sta. 313+50  
(RW 5L-23R)  
Project 2

North Lateral Endwall 100..

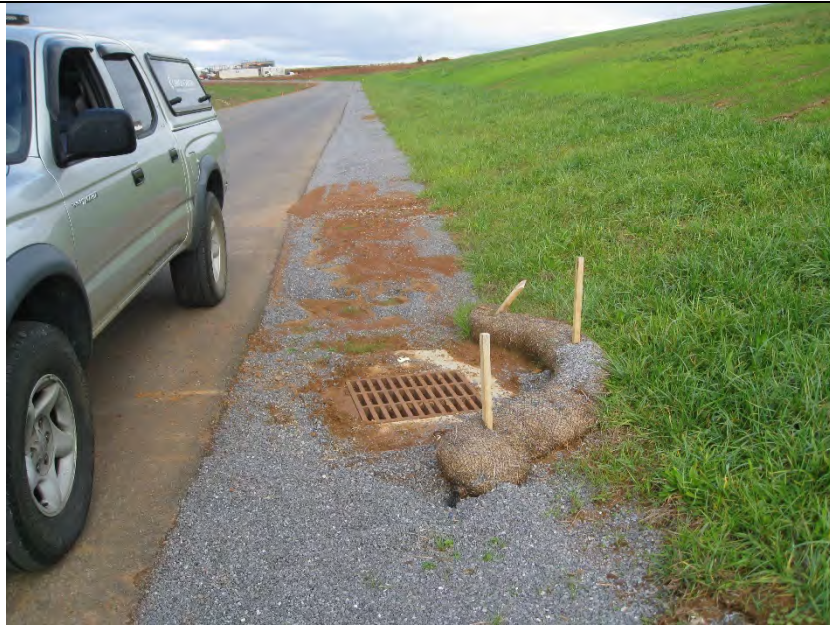
Photo 72  
Sta. 300+60  
(RW 5L-23R)  
Project 2

North Lateral Endwall 102.

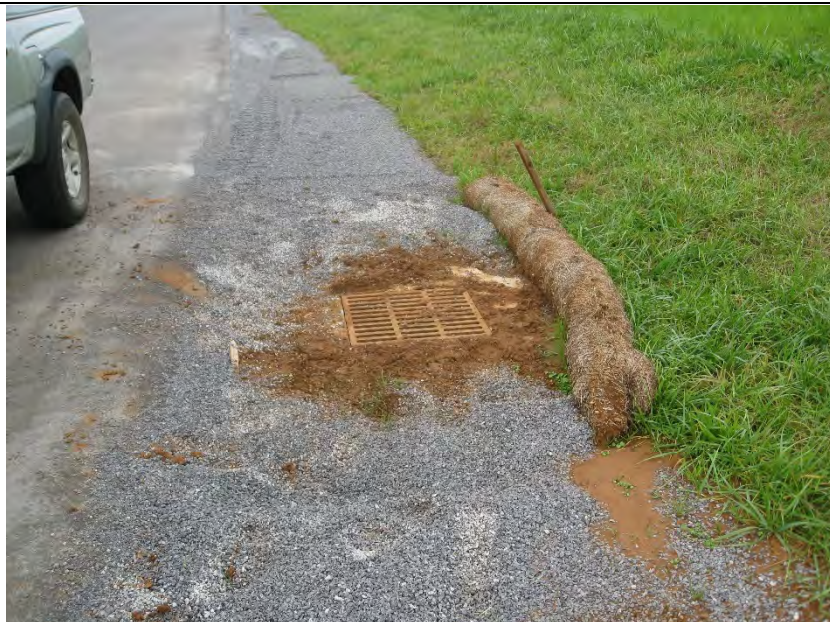
Photo 73  
Sta. 29+00 RT  
Proposed Haul Route  
Project 3

Haul Road.  
Filter fabric recently removed.  
Recommend removing remaining sediment and sediment tube.

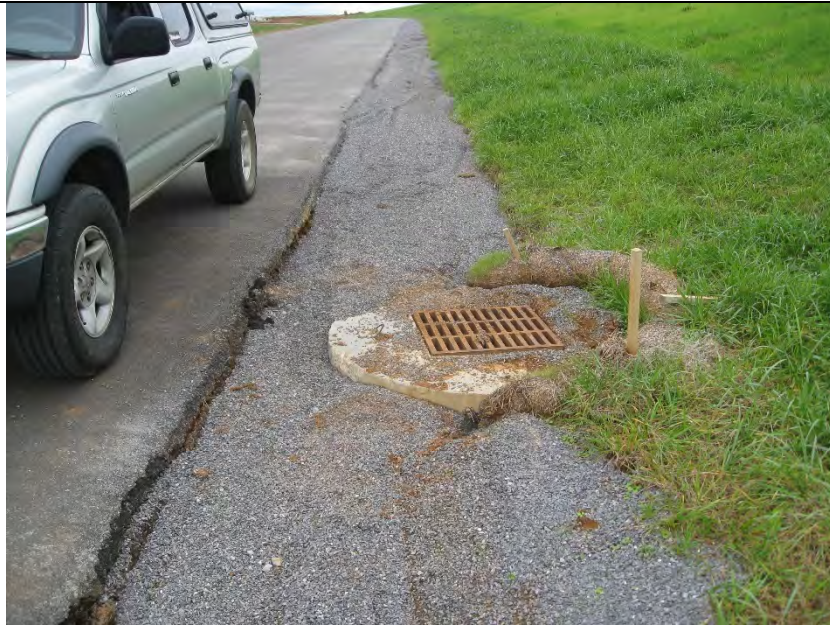
Photo 74  
Sta. 25+50 RT  
Proposed Haul Route  
Project 3

Haul Road.  
Filter fabric recently removed.  
Recommend removing remaining sediment and sediment tube.

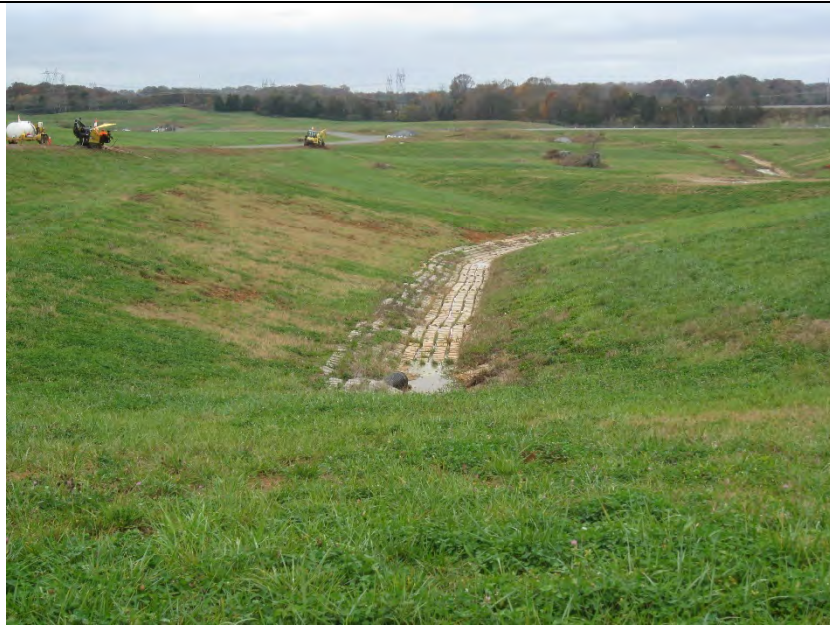
Photo 76  
Sta. 297+01  
(RW 5L-23R)  
Project 2

North Lateral Endwall 104.

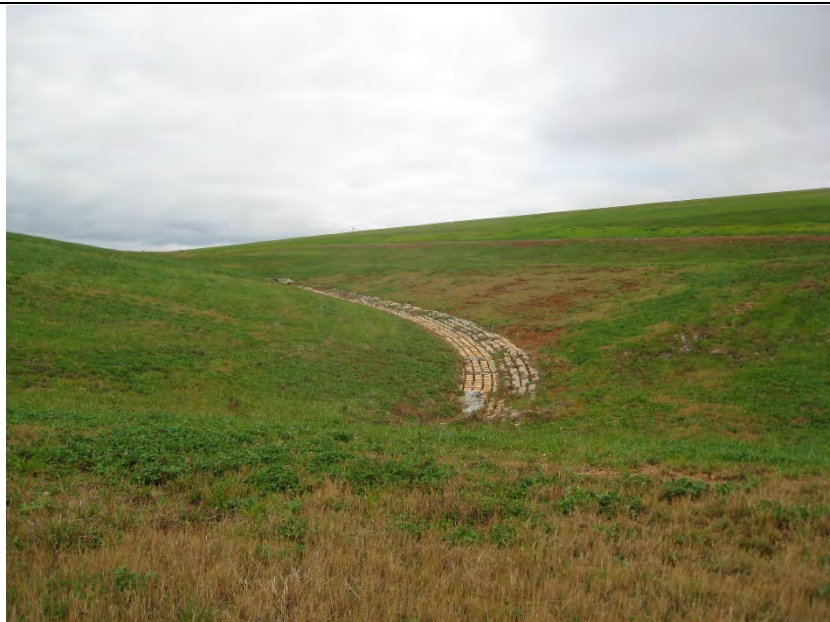
Photo 77  
Sta. 295+10  
(RW 5L-23R)  
Project 2

North Lateral Endwall 106.

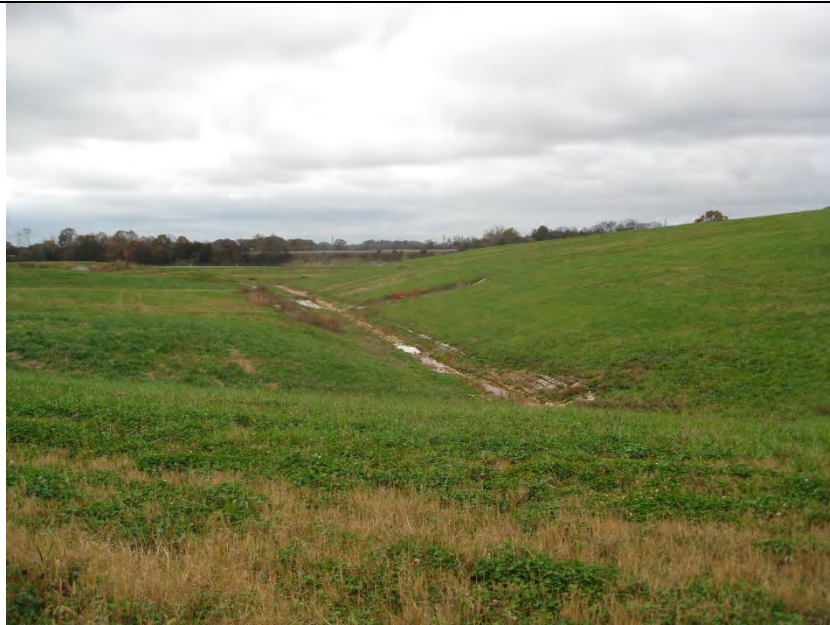
Photo 78  
Sta. 292+08  
(RW 5L-23R)  
Project 2

North Lateral Endwall 108.

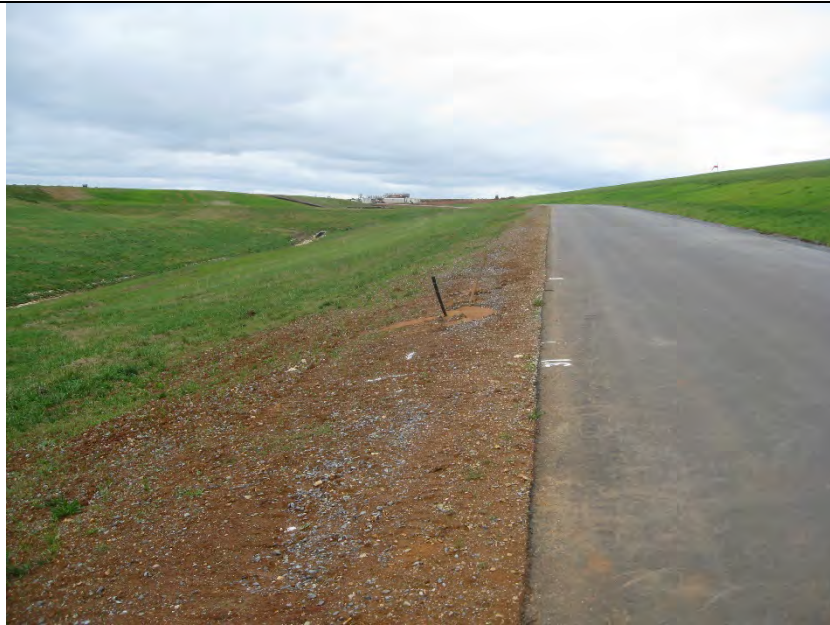
Photo 80  
Sta. 15+50 RT  
Proposed Haul Route  
Project 3

Haul Road  
Recommend removing any filter fabric as well as sediment tubes.

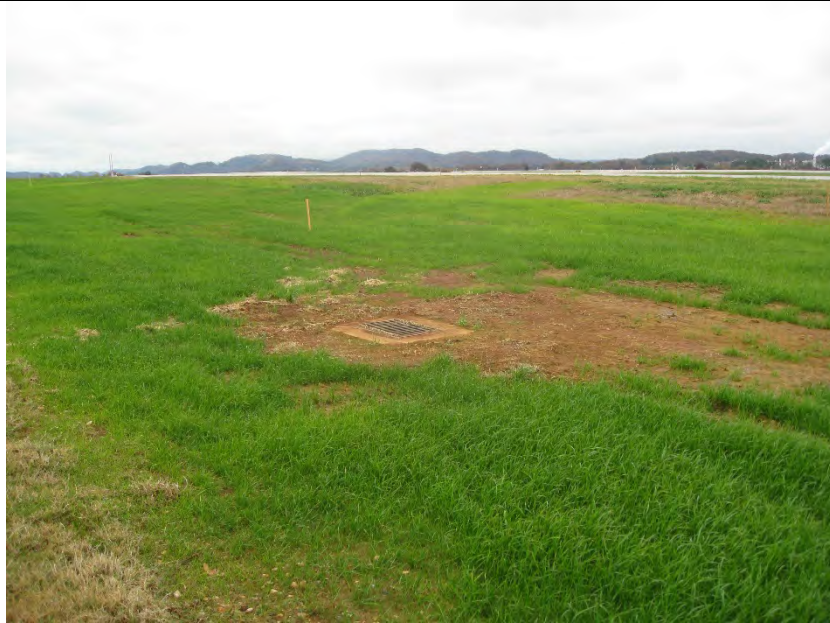
Photo 82  
Sta. 284+00 LT  
(RW 5L-23R)  
Project 2

Existing vault at old Liberty street.  
Construction fallout present. Recommend coordinating with CHA on remediation.

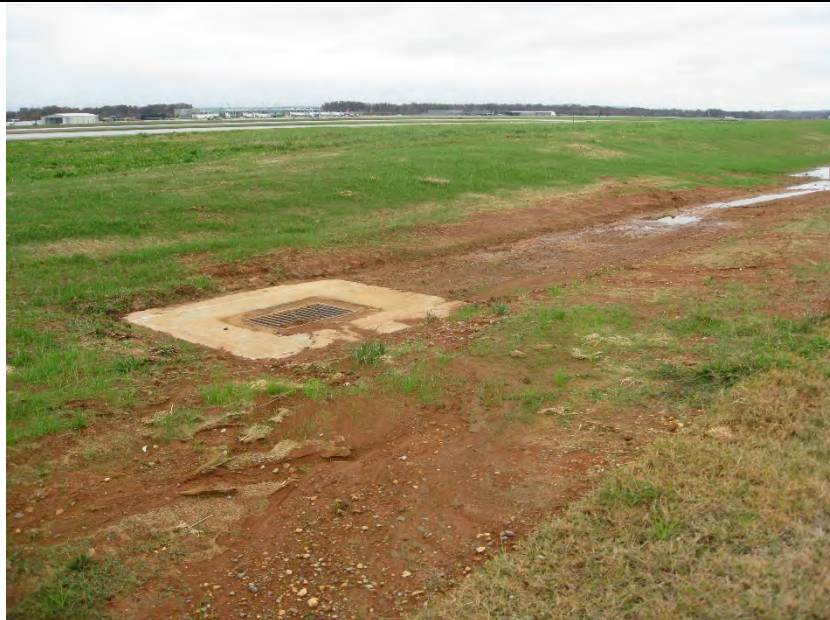
Photo 83  
(Repair TWY Lighting)  
Existing Structure

Existing structure south of Taxiway G  
Sediment tubes recently removed.  
Bare areas remain. Recommend stabilizing bare areas.

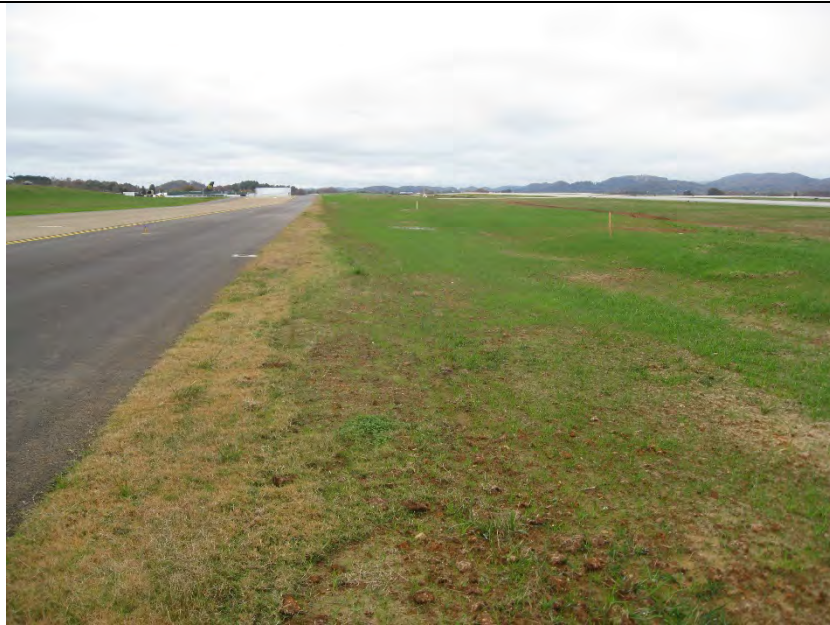
Photo 84  
(Repair TWY Lighting)  
Existing Structure

Existing structure south of Taxiway G  
Sediment tubes recently removed.  
Bare areas remain. Recommend stabilizing bare areas.

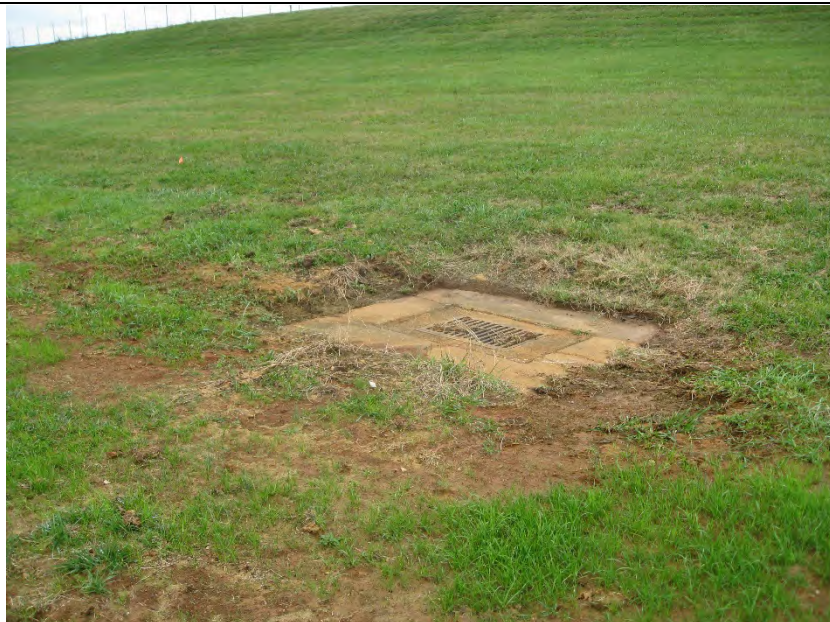
Photo 85  
(Repair TWY Lighting)  
Existing Structure

Taxiway G  
Bare areas recently stabilized.

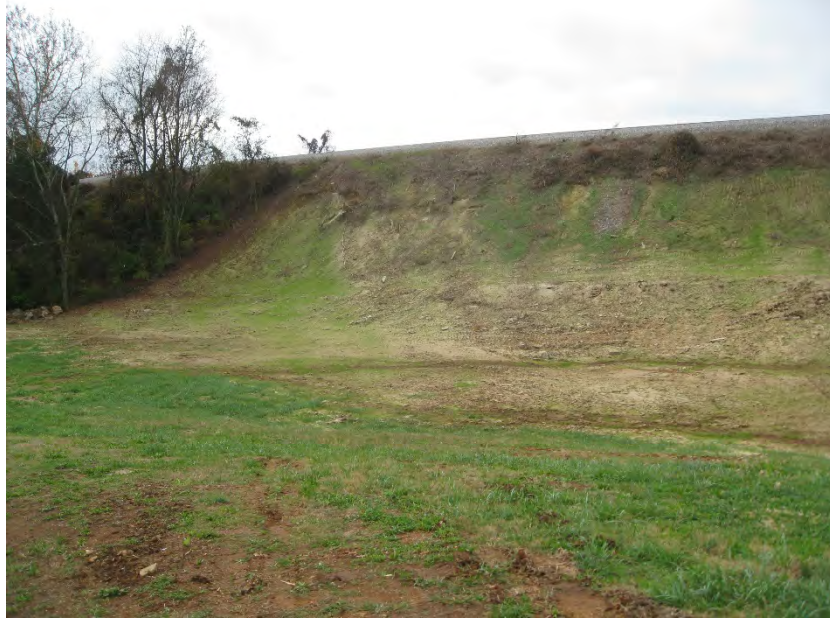
Photo 88  
(Project 5/6)

Fill area adjacent to Liberty Street.

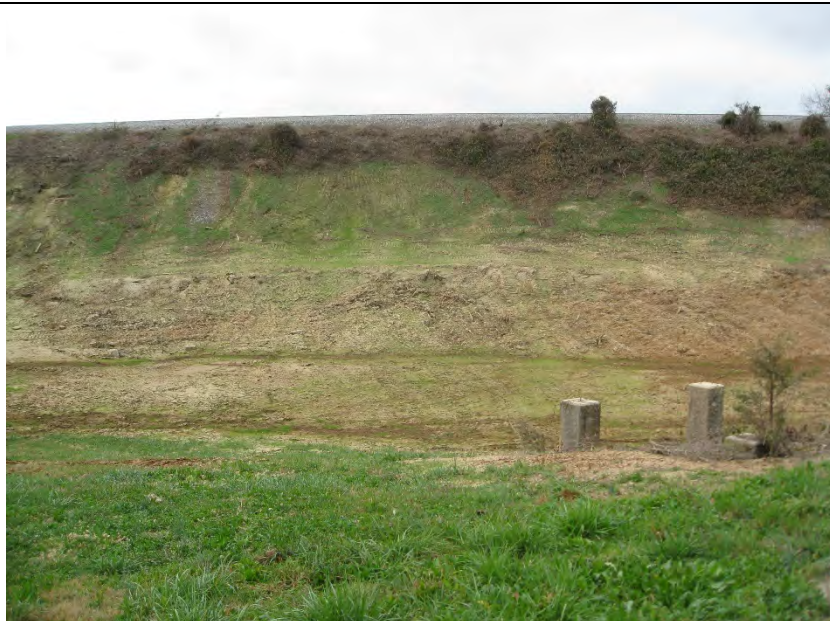
Photo 89  
(Project 5/6)

Above main outfall to Lackey Creek.  
This section of the site was inaccessible at time of inspection.  
Slopes were recently stabilized.

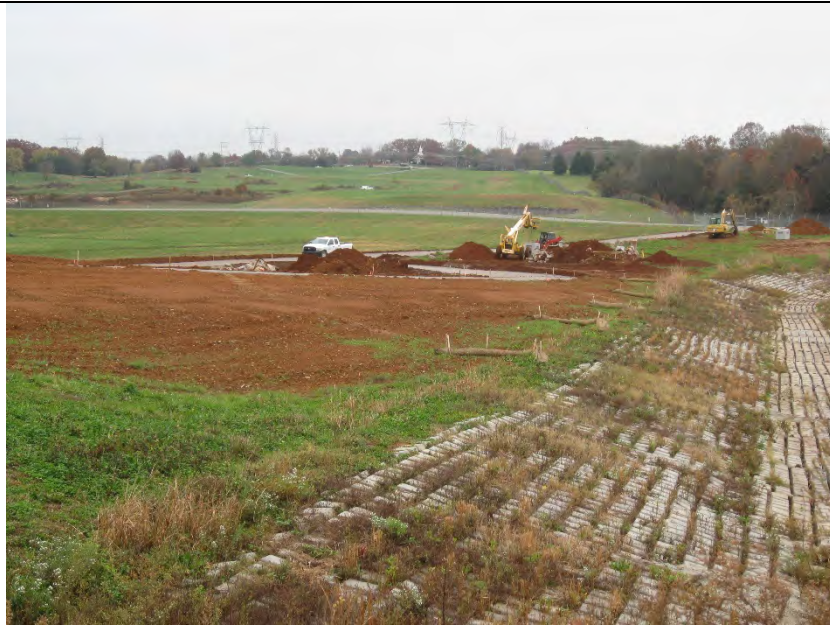
Photo 92  
(Project 5/6)

Proposed MALSR access road.  
Rills appear to have been recently remediated and slopes regraded.  
Recommend stabilizing side slopes outside of active roadway construction area.

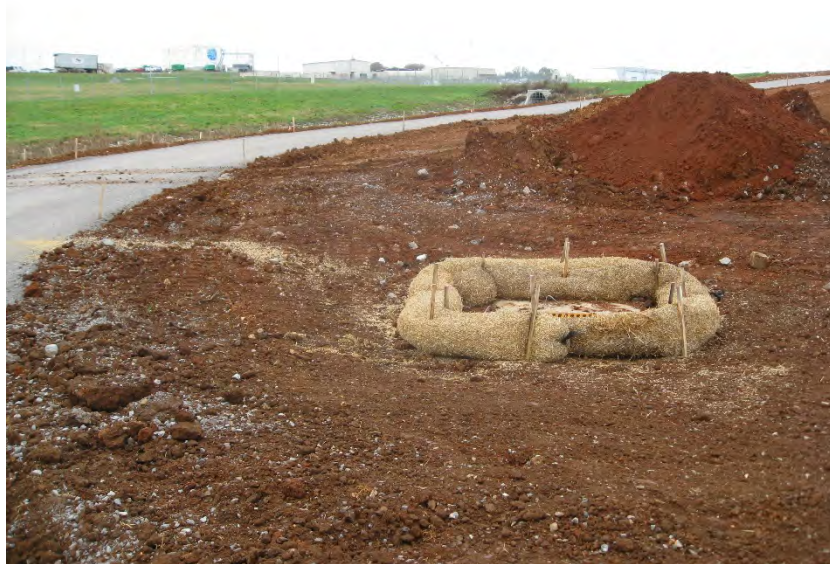
Photo 93  
(Project 5/6)

Proposed MALSR access road.  
Side slopes have remained un-stabilized past the allowable 14 days as per the permit.  
Recommend stabilizing side slopes outside of active roadway construction area.

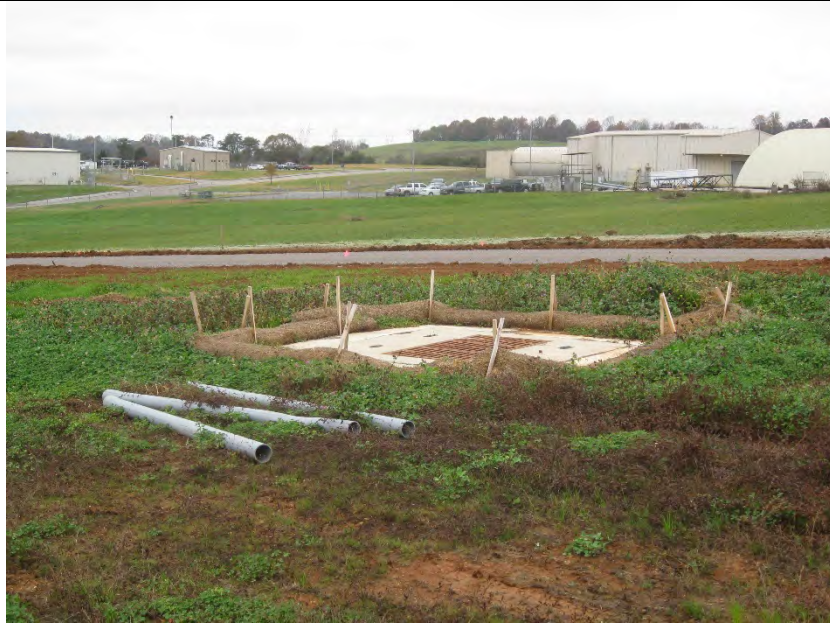
Photo 98  
(Project 5/6)

Above existing structure #120.  
Inlet protection recently added and some bare areas stabilized.  
Recommend stabilizing remaining bare areas.

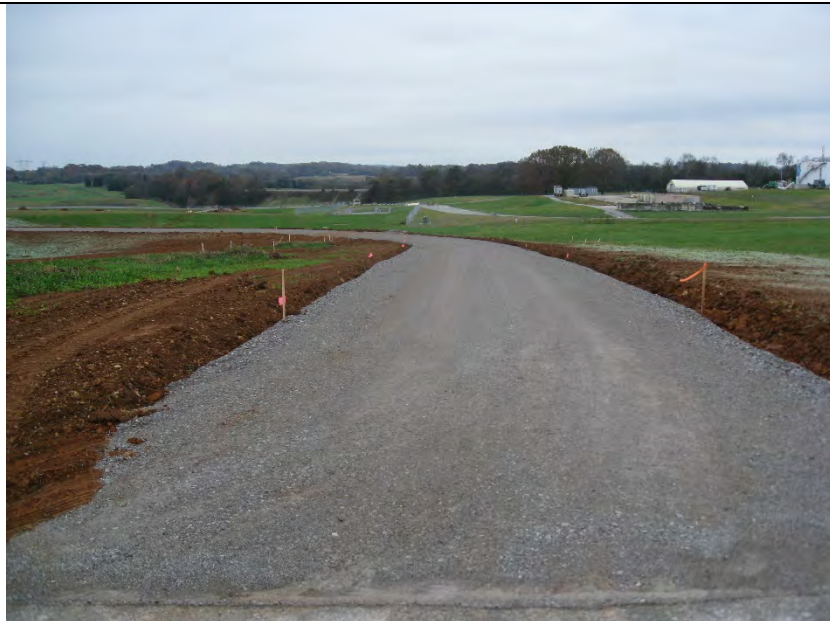
Photo 99  
(Project 5/6)

Existing structure #118 adjacent to proposed MALSR access road.  
Recommend stabilizing bare areas once shoulders are to grade or operations cease for 14 days.

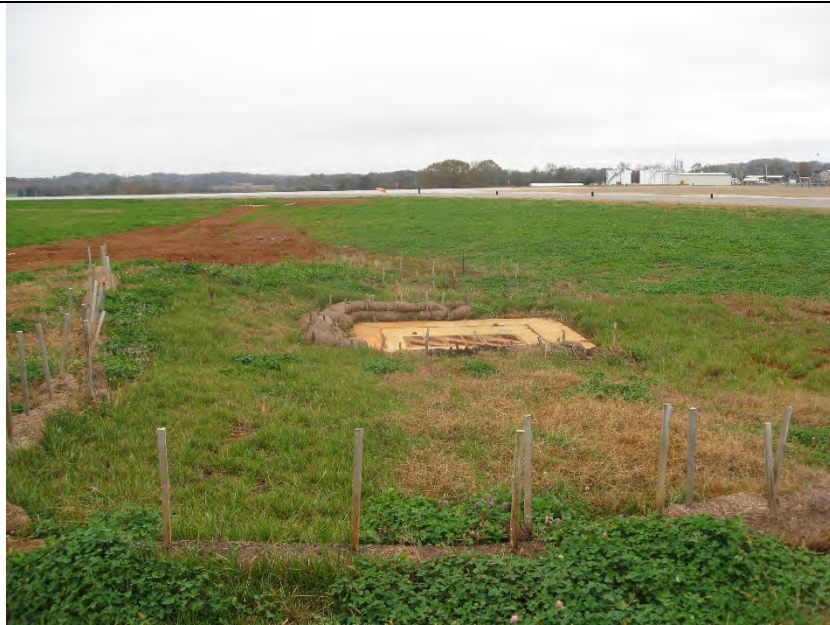
Photo 100  
(Project 5/6)

Proposed MALSR access road.

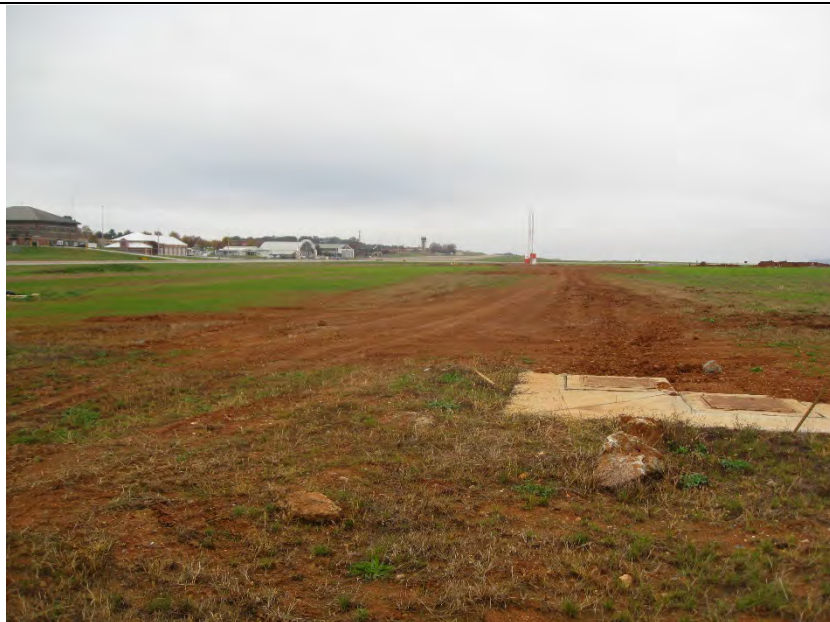
Photo 101  
(Project 5/6)

Structure 116.  
Recommend stabilizing all bare areas above structure from duct bank installation.

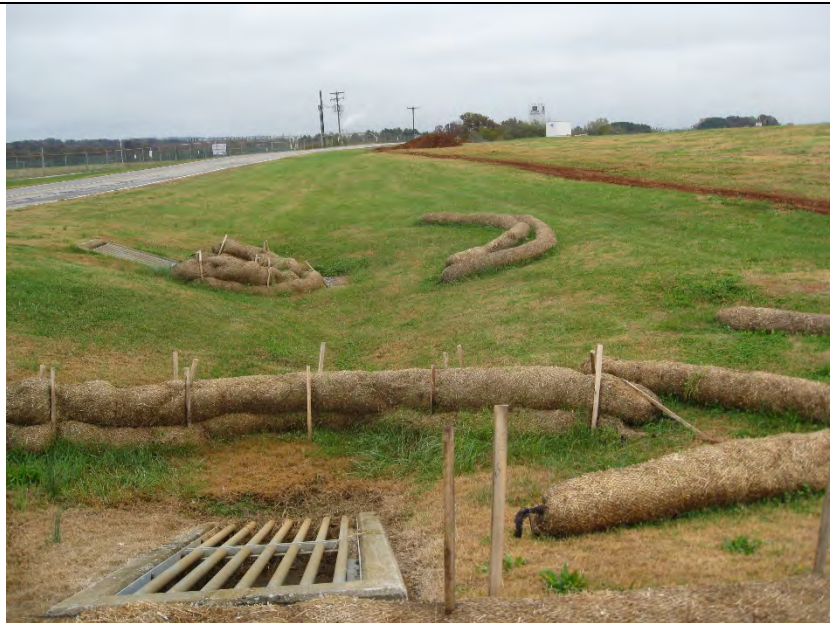
Photo 109  
(Project 5/6)

23R PAPI access road.  
Access road installed and shoulders recently backfilled.  
Recommend stabilizing bare areas.

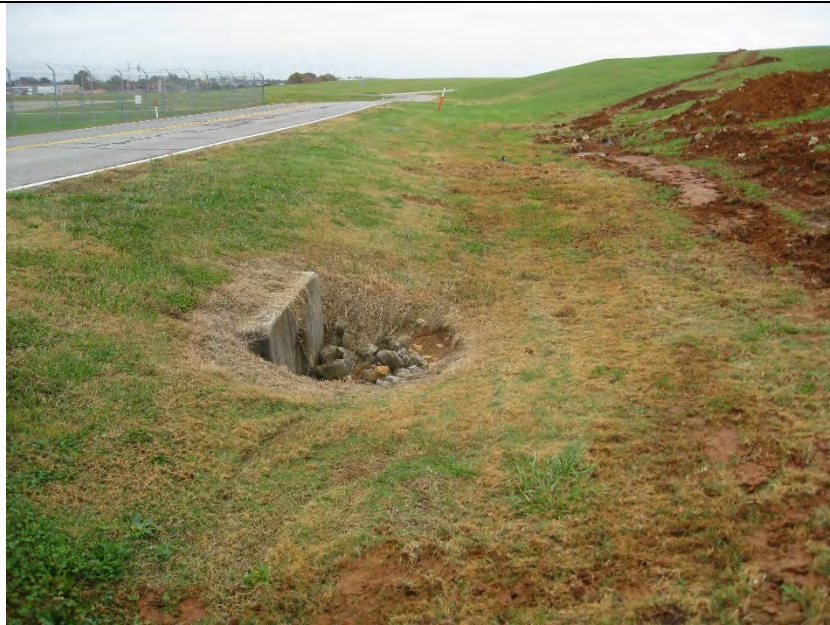
Photo 110  
(Project 5/6)

5L Localizer  
Construction activities underway.  
Duct bank recently backfilled.  
Recommend stabilizing or removing spoil piles and stabilizing duct bank disturbed areas.

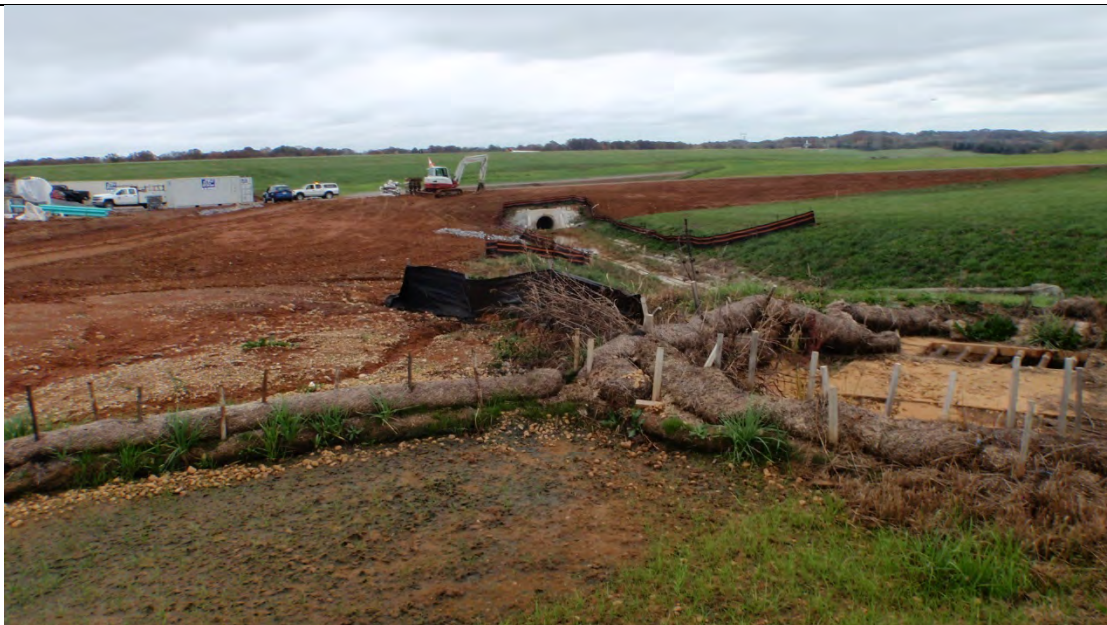
Photo 111  
(Project 5/6)

Access road  
Construction activities underway.  
Duct bank recently backfilled.  
Recommend installing triple stack of sediment tubes at inlet of culvert.  
Recommend stabilizing disturbed areas.

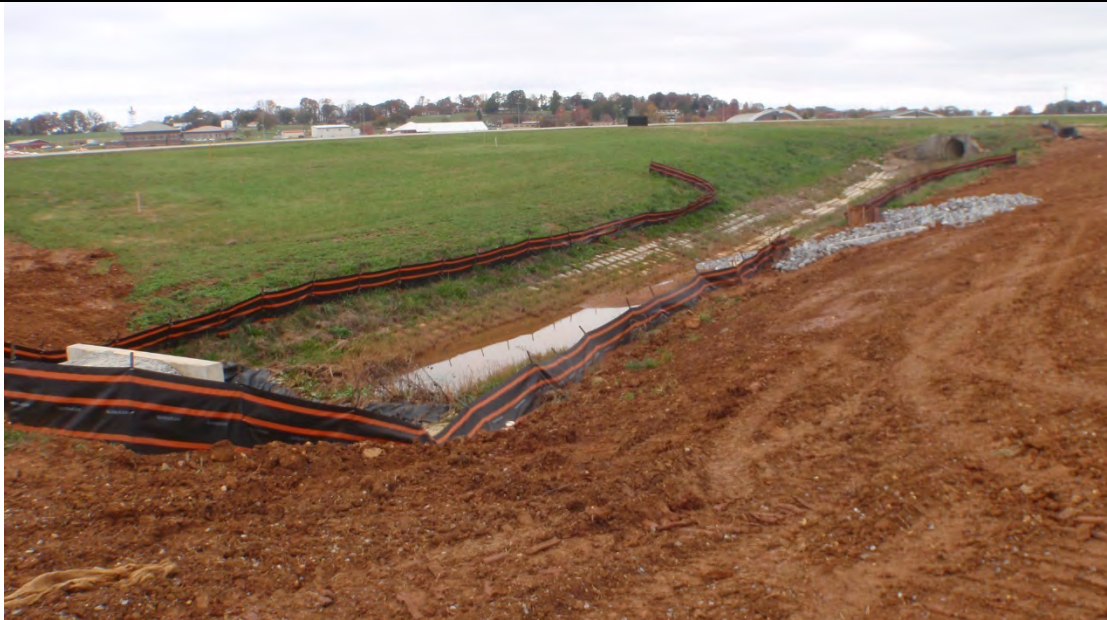
Photo 113  
(Project 5/6)

Airfield Lighting Vault  
Rills have formed on side slope.  
Recommend repairing rills.  
See previous photo.

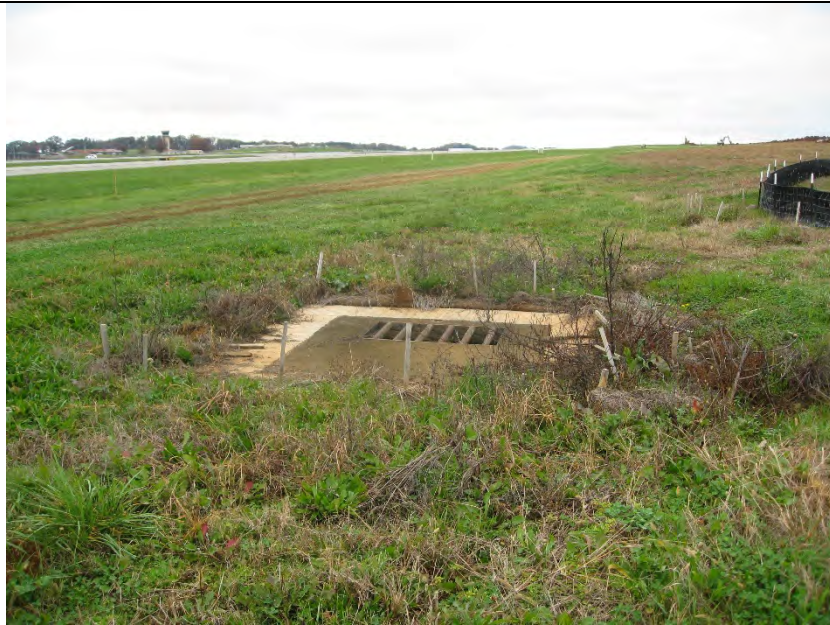
Photo 114  
(Project 5/6)

Airfield Lighting Vault  
Slopes appear to be to grade.  
Recommend stabilizing bare areas.

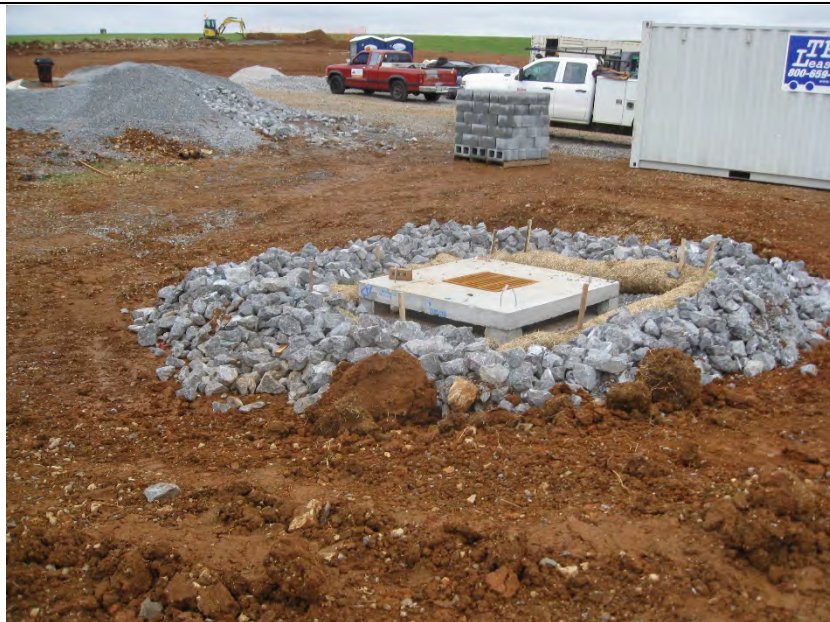
Photo 115  
(Project 5/6)

Existing structure.

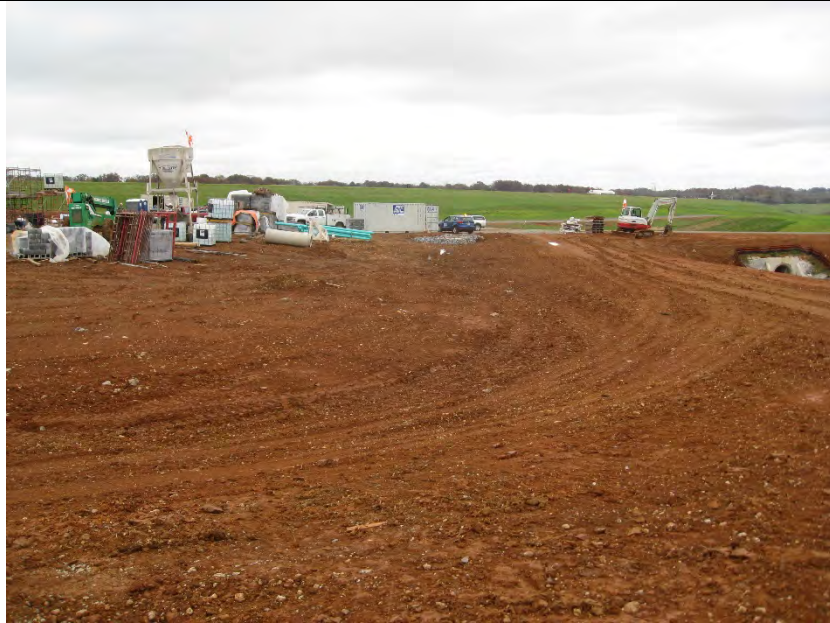
Photo 116  
(Project 5/6)

Airfield Lighting Vault  
Structure and inlet protection recently installed.  
Recommend stabilizing bare areas.  
See next photo.

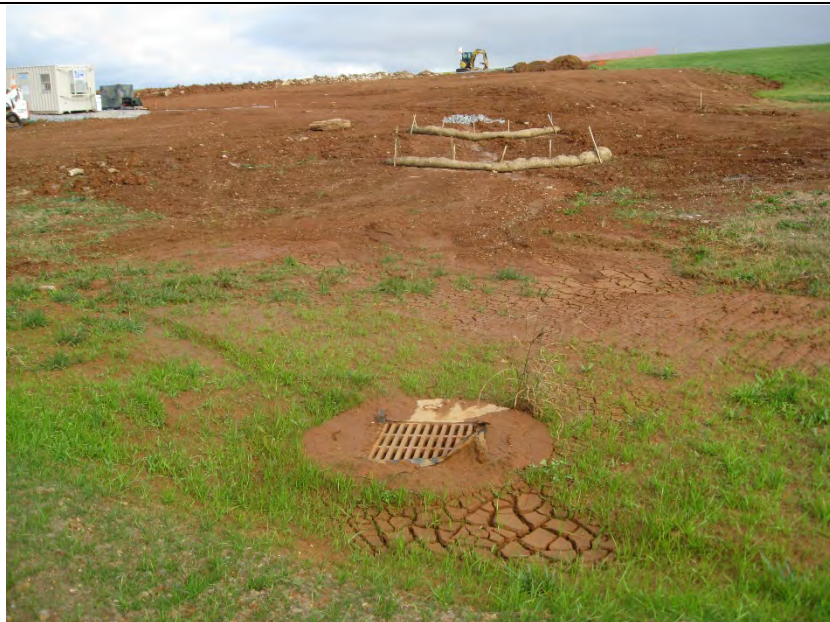
Photo 117  
(Project 5/6)

Airfield Lighting Vault  
Ditch line above structure from previous photo.  
Swale appears to be at grade. Recommend installing erosion control measures in ditch line per the plans and stabilizing bare areas.
