## QUALITY ASSURANCE MONTHLY SITE ASSESSMENT REPORT

Airfield Modernization Program  
Runway 5L-23R Reconstruction  
Project 2 / Project 3  
Project 4 / Repair TWY Lighting  
Project 5 / Project 6

**QUALITY ASSURANCE  
SITE ASSESSMENT  
EPSC WEEKLY  
INSPECTION**

Airfield Modernization Program  
Runway 5L-23R Reconstruction  
Project 2 / Project 3 /  
PSXE820001-Repair Taxiway  
Lighting

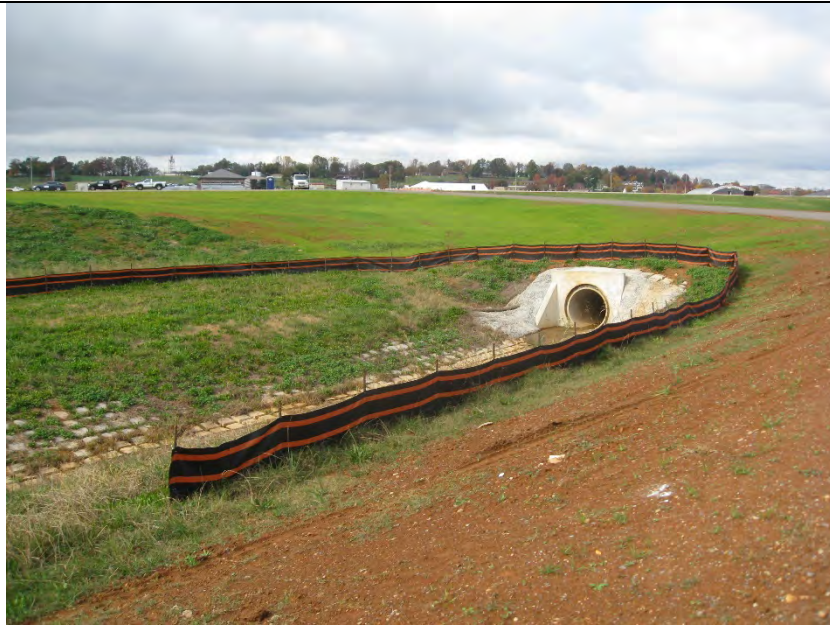
Photo 120  
(Project 5/6)

Airfield Lighting Vault  
Headwall recently installed at North Lateral Ditch.
