STATE OF TENNESSEE
DEPARTMENT OF ENVIRONMENT AND CONSERVATION
DIVISION OF WATER RESOURCES

August 29, 2023

RE: Follow-up Site Inspection
 Blue Oval City – Ford Motor Company
 NPDES Permit Number TN0082368
 Haywood County, Tennessee

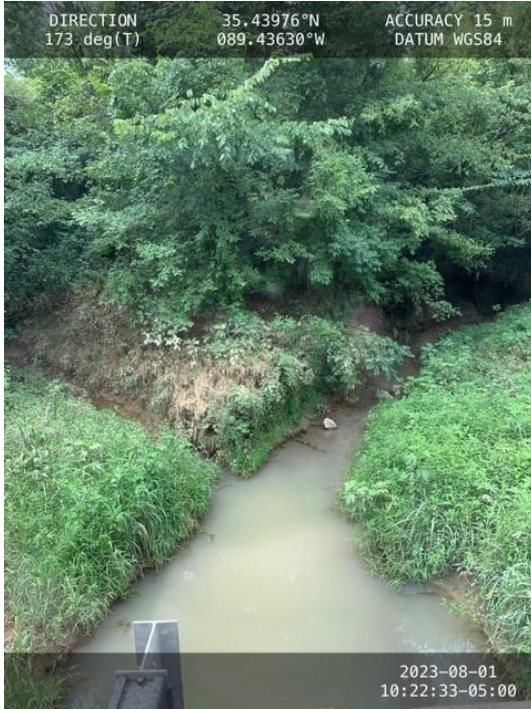
<div style="text-align: right; font-size: 0.8em;"> 2023-08-01 10:05:43-05:00 </div>	
Photo No.	Date		
4	8/1/23		
Description View of Little Muddy Creek at Keeling Road.		<div style="display: flex; justify-content: space-between; font-size: 0.8em;"> DIRECTION 173 deg(T) 35.43976°N 089.43630°W ACCURACY 15 m DATUM WGS84 </div>
