Re: Compliance Evaluation Inspection
Drummonds Elementary School Wastewater Treatment System
NPDES Tracking Number: TN0058092
Drummonds, Tipton County, Tennessee

Compliance Inspection for Individual NPDES Permit

Facility Name: Drummonds Elementary School	NPDES Tracking Number: TN0058092
Permit Effective Date: July 1, 2019	Permit Expiration Date: April 30, 2024
Date and Time of Inspection: 2/5/2020	Inspector Name: Eddy Bouzeid
Official Contact Person Name: Mr. Barnett Hall, Director of Physical Plant and Planning	
Address: 1580 Highway 51 South, Brighton, TN 38019	Phone Number: (901) 508-1796
	Email: bhall@tipton-county.com

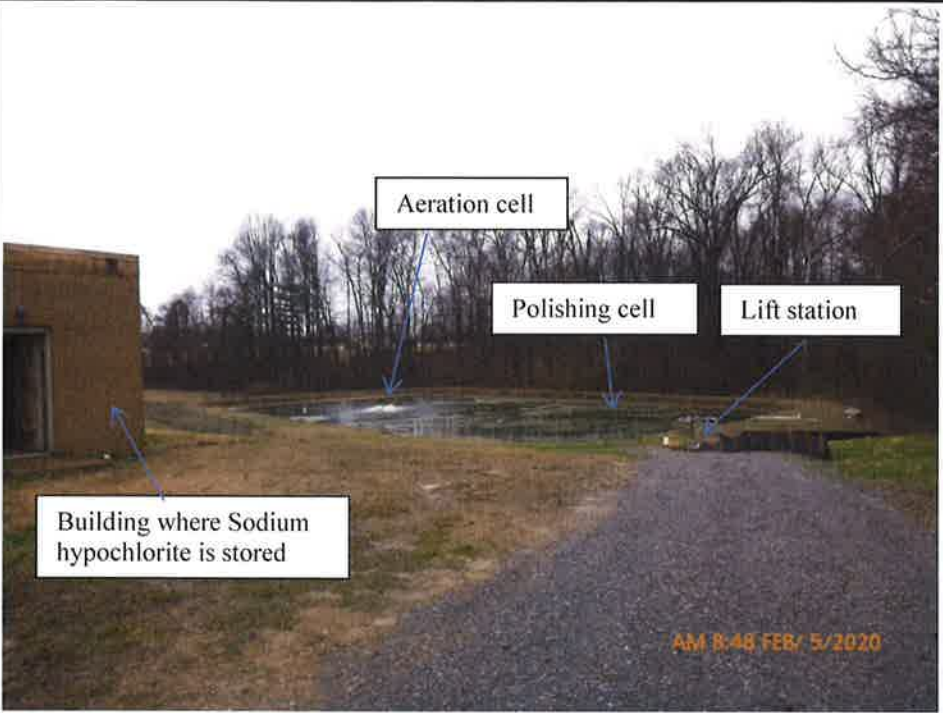
Facility Name: Drummonds Elementary School		Site Location: Drummonds, Tipton County	Tracking No.: TN0058092
Photo No. 1	Date 2-5-20

Description View of the Drummonds Elementary School wastewater treatment lagoon.

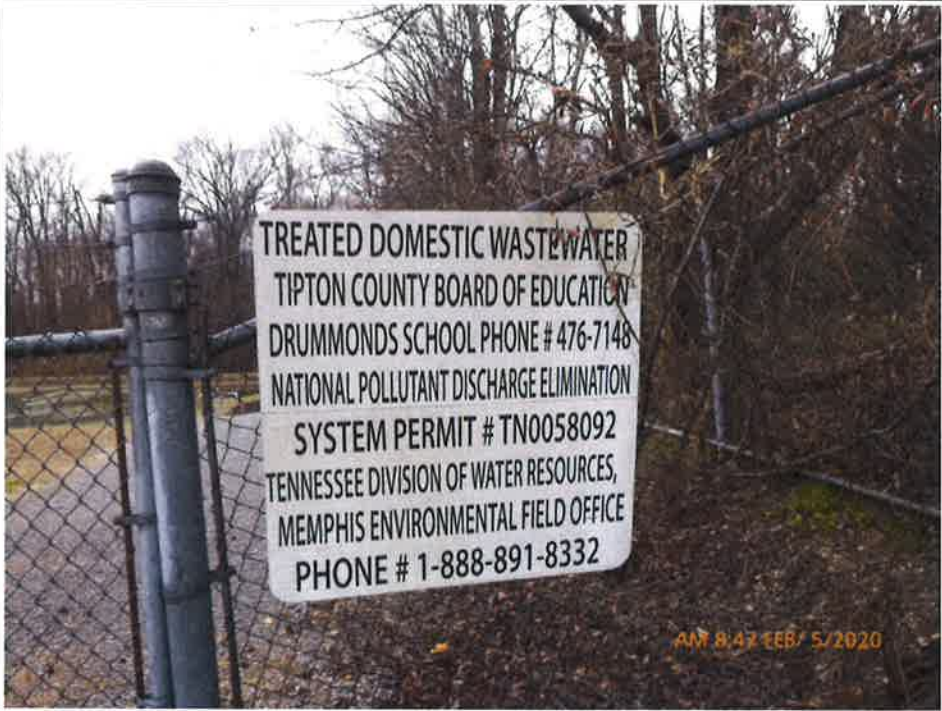
Facility Name: Drummonds Elementary School		Site Location: Drummonds, Tipton County	Tracking No.: TN0058092
Photo No. 3	Date 2-5-20

The sign was in place at the Outfall 002 and the information on the sign was consistent with the requirements of the permit (photo 3).

Description View of the sign at the facility. The information on the sign was consistent with the requirements of the permit.

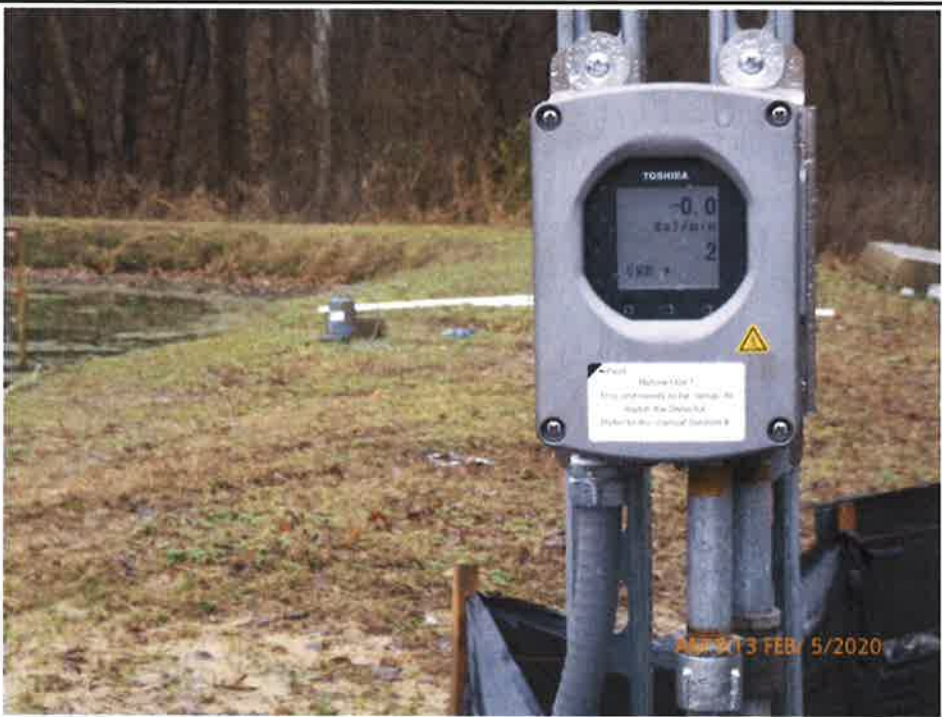
Photo No. 4	Date 2-5-20

A digital flow meter was installed in December 2019 to measure the flow that is being pumped from the lagoon effluent to the Munford force main (photo 4). The digital flow meter measures the flow in gallons per minutes then converted to million gallons per day (MGD).

Description View of the recently installed digital flow meter.

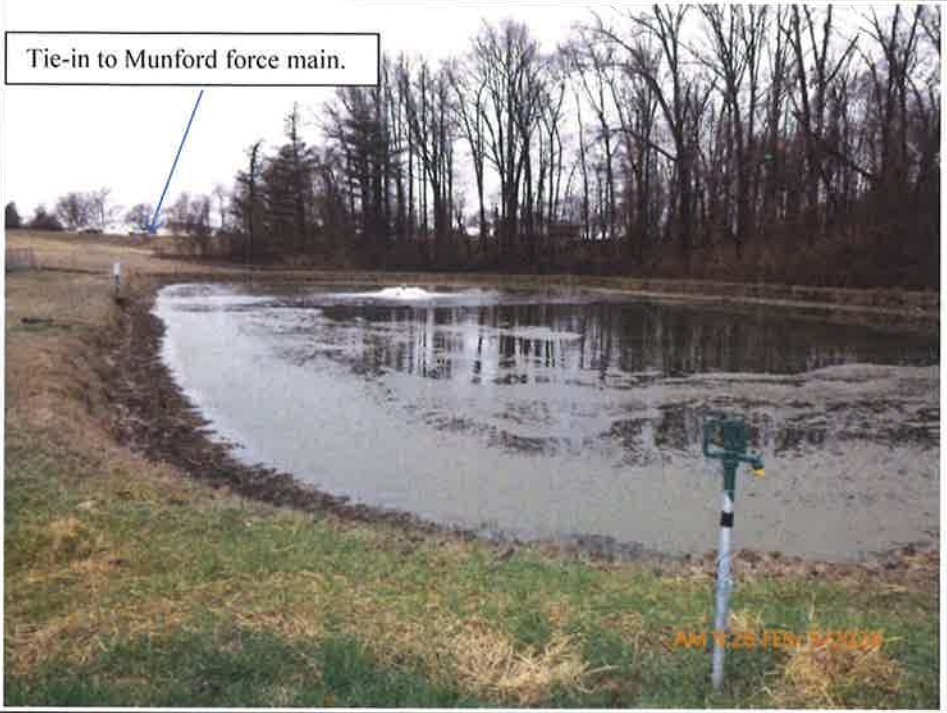
Facility Name: Drummonds Elementary School		Site Location: Drummonds, Tipton County	Tracking No.: TN0058092
Photo No. 5	Date 2-5-20

<p>Tie-in to Munford force main.</p> <p>AW 11.25.18 10:31 AM</p>	
Description Another view of the Drummonds Elementary School wastewater lagoon and the approximate location of the tie-in to the Munford force main. The Munford force main discharges to the Mississippi River.
