Nutrient and Energy Optimization Study
Cowan, Tennessee
Wastewater Treatment Plant
July 2021

2020 Cowan, Tennessee Nutrient and Energy Optimization Study

Executive Summary

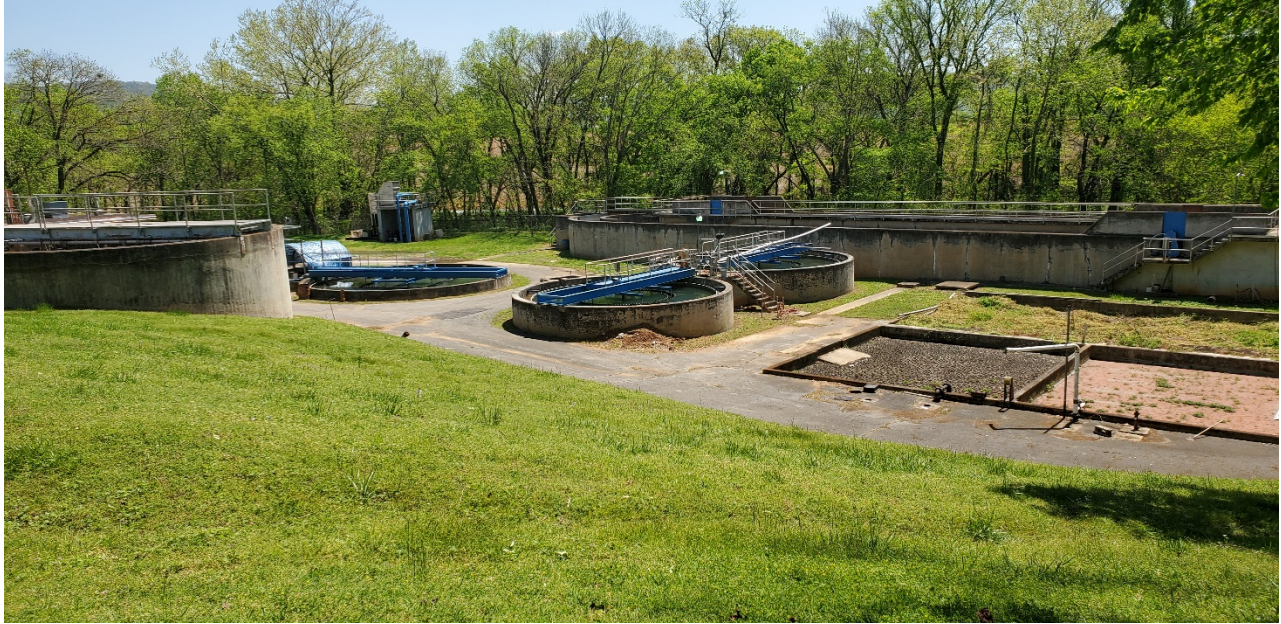
Influent screen. The stationary influent screen routinely plugs. To contain the overflow, a diversion chute was fabricated and installed such that the overflow is directed back to the influent lift station. At best, this is a temporary fix – one that needs to be resolved. At worst, the “fix” does little more than create an endless repumping of influent.

- Continue the minimal aeration time in the aerobic digester.
- The influent screening facility is deplorable. It was poorly designed, cannot be properly operated, is extraordinarily and unavoidably dirty, and at times of high flow contributes to double pumping of influent sewage. This unit should be replaced with a “very fine” drum screen of adequate capacity.

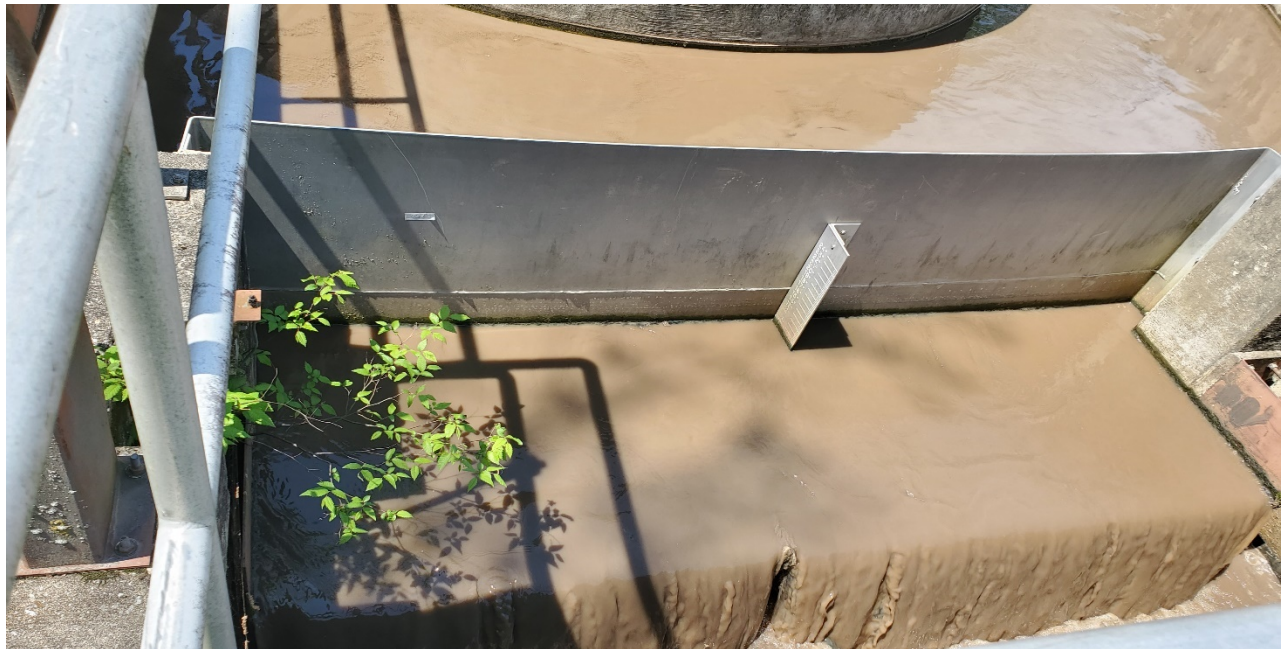
Aged mechanical equipment. The oxidation ditch effluent weir – once adjustable – is frozen in place. Unevenly. As a result, the majority of the flow exiting the oxidation ditch is diverted to one of the two parallel secondary clarifiers while the other clarifier receives little flow. The weir needs to be aligned so that the splitter box can be properly operated to equally divert flow.

Install baffles/stops on the ditch outlet / secondary clarifier inlet distribution box. (Doing so will balance the flow rate to the two clarifiers and thereby minimize washout during high flows.)

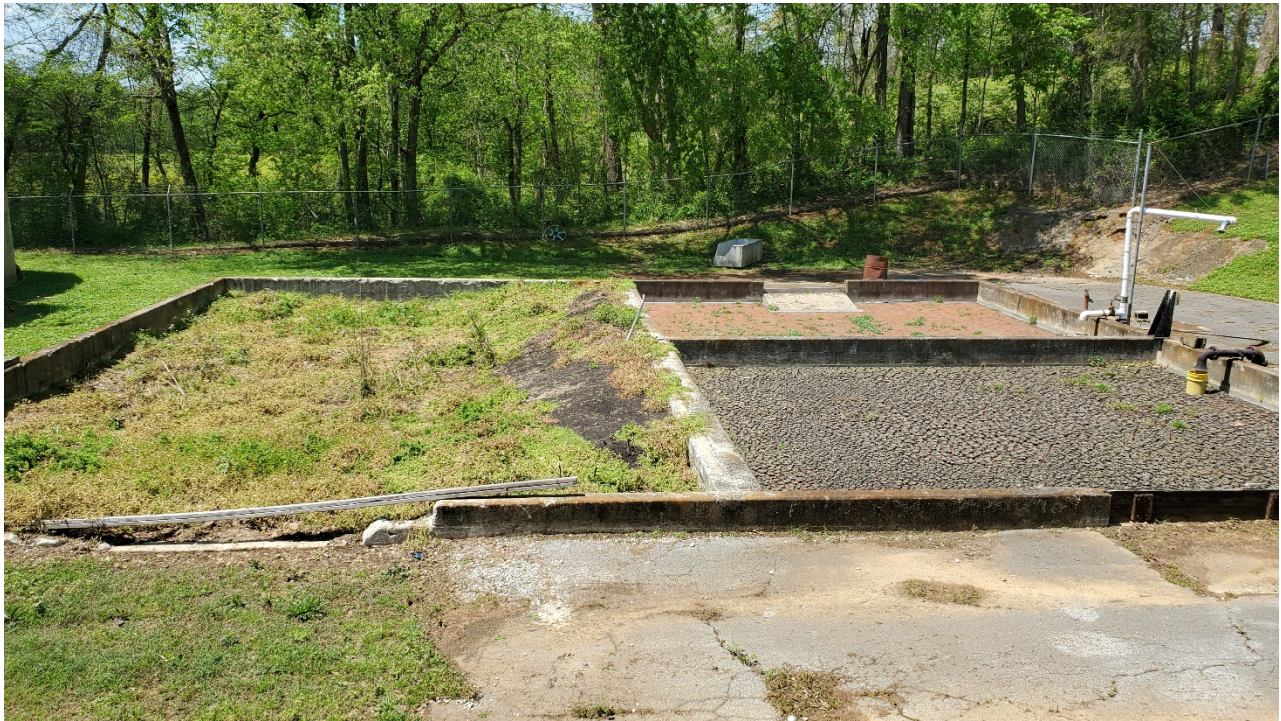
Inadequate solids handling. The wedge wire drying beds routinely plug, as wedge wire drying beds are prone to do. With limited sludge dewatering capability, the aerobic digester becomes full and staff is unable to waste sludge from the oxidation ditch. This results in unacceptably high mixed liquor suspended solids (MLSS) concentration of 5000 to 6000 mg/L; a MLSS concentration of 2500-3000 mg/L is preferable. A better method of sludge handling is needed: thickening, dewatering, and disposal.

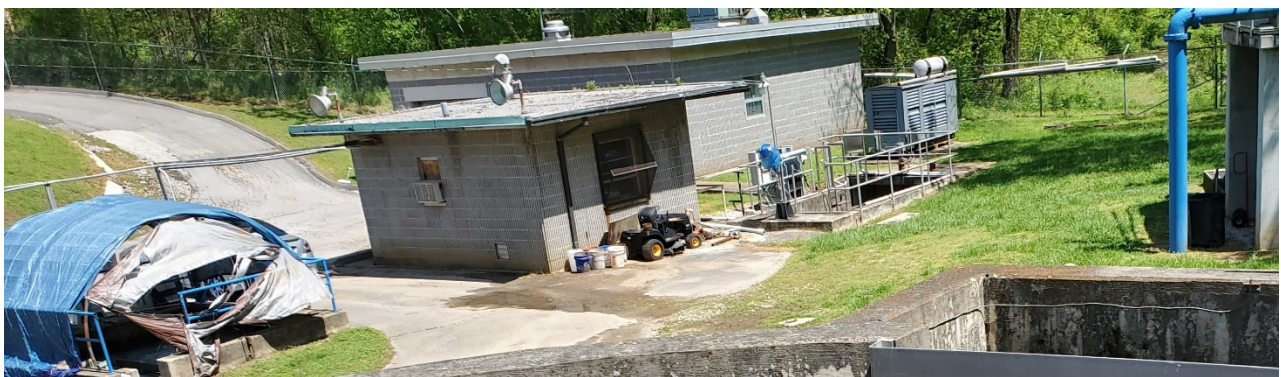
Aging infrastructure. The lab/office roof leaks. The re-aeration chamber is covered with a tarp to minimize algal growth. Permanent repairs to both are called for.

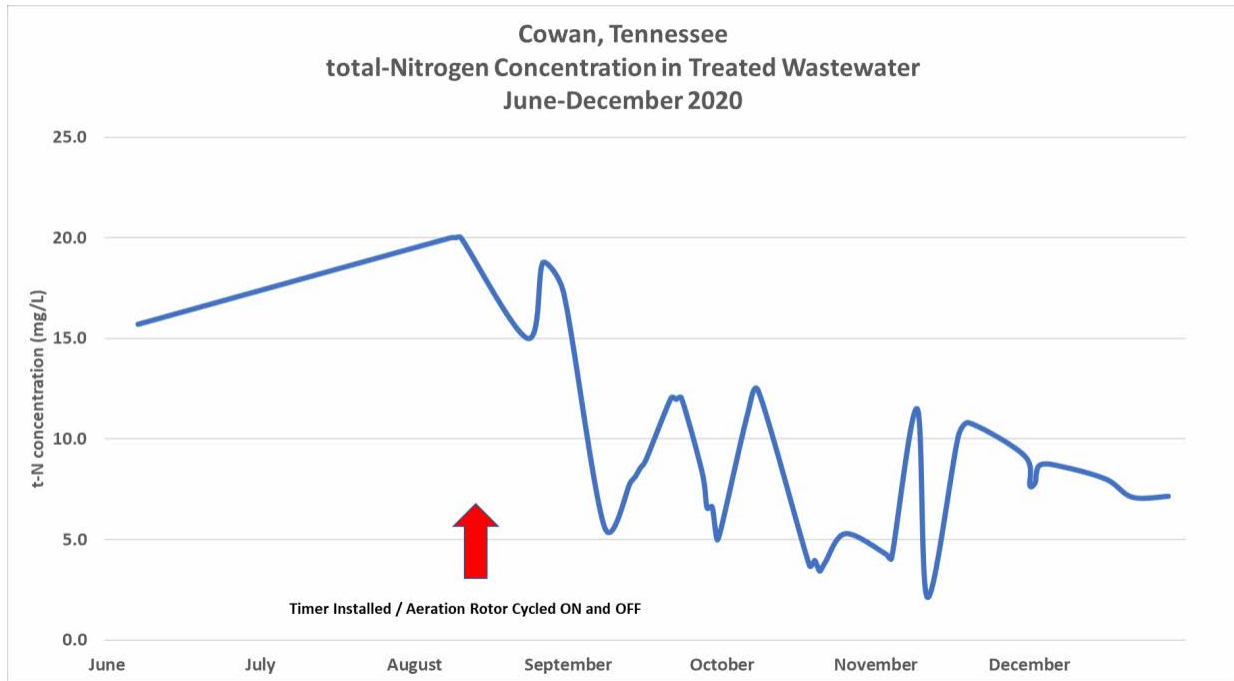
The plan, therefore, was to create aerobic conditions by operating one rotor long enough to complete the conversion of ammonia-nitrogen to nitrate-nitrogen followed by long enough, strong enough, anoxic conditions to support the conversion nitrate-nitrogen to nitrogen gas. A graph illustrating the results follows.

With timers installed, the rotor immediately downstream of the influent channel remained off for 22 hours a day, coming on only twice per day for a period of one hour to resuspend any material that may have settled to the bottom of the tank in the vicinity of the aeration rotor. The far rotor was programmed to operate ON for 2 hours and OFF for one hour with the twice per day operation of the near rotor timed so both rotors would run during the twice per day one hour resuspension cycles. In short order, the timing of the far rotor was changed to 3 hours ON and 2 hours OFF. Then, to 3½ hours ON and 2½ hours OFF. Frequent ammonia and nitrate samples were collected to confirm conditions. Before optimization, the total-nitrogen concentration averaged over 23 mg/L and a pounds per day discharge of 26.4. By study's end, effluent total-nitrogen was averaging less than 8 mg/L (8.4 pounds per day), a 67% improvement.

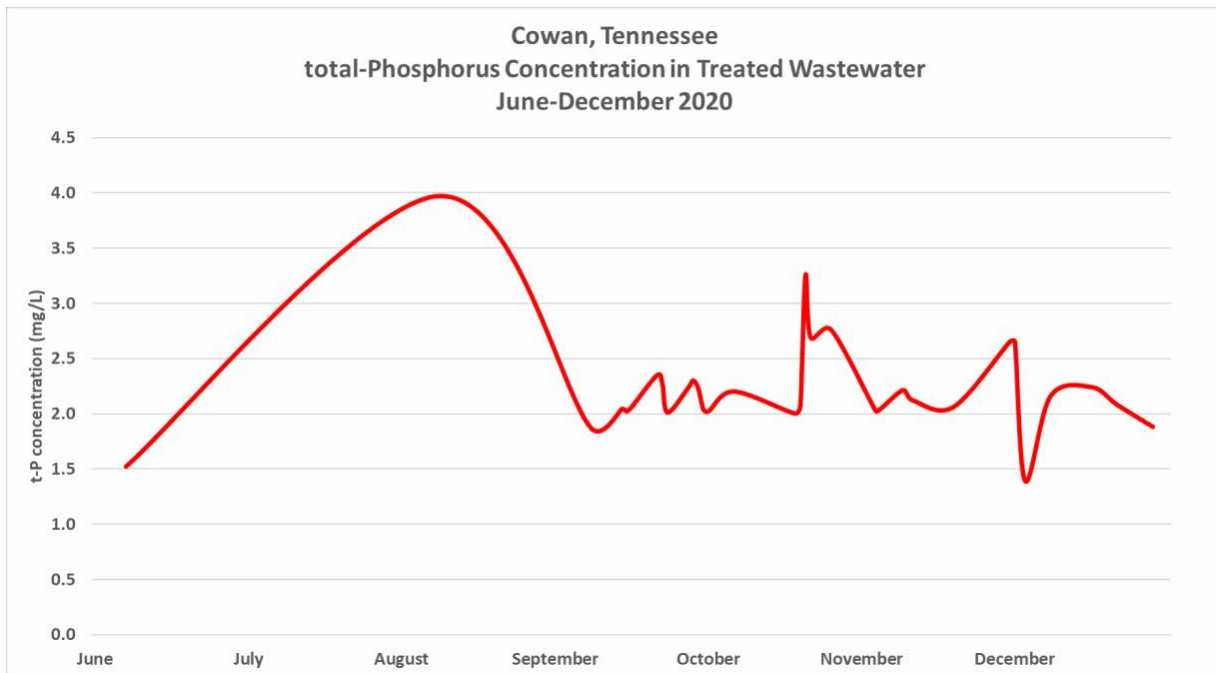
A graph showing phosphorus concentrations throughout the study follow.

Phosphorus removing bacteria can take time to populate a wastewater facility. Perhaps because too little time passed before study end, “before” and “after” phosphorus testing failed to document improvements in phosphorus removal. Prior to the study, the effluent total-phosphorus concentration was typically 2.7 mg/L, 2.9 pounds per day. At study’s end, it was averaging 2.2 mg/L, 2.4 pounds per day.
