**Re: Tennessee Department of Transportation Facility Monitoring Results
Bethel Springs District Garage**

Photographic Log

Bethel Springs District Garage

Region 4
Outfall 55-D-03

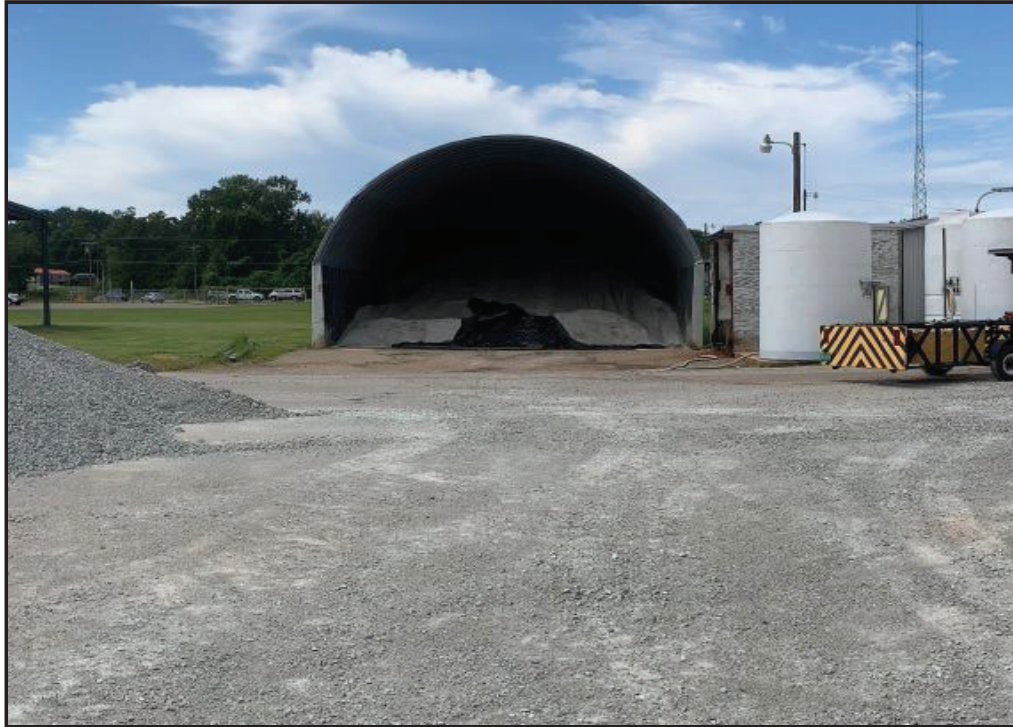
Photograph 1

Note: View of the salt shed and brine tanks. Salt was being kept 5-foot back from the entrance and there was no visible salt-staining on the grounds. Site personnel expect to move the brine tanks under the new shed some time in 2023. Concrete secondary containment will be constructed for the brine tanks after they have been moved.

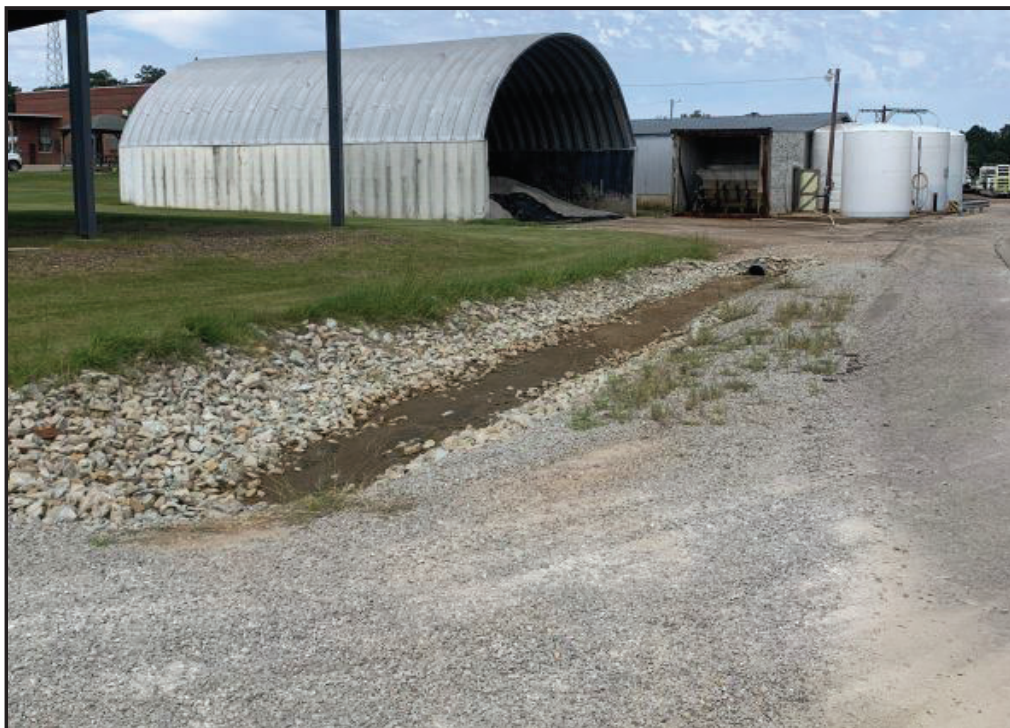
Photograph 2

Note: View of the riprap-lined ditch below the salt shed and brine tanks. The storm water sample collected at Outfall 55-D-03 exceeded the action level for chloride. Exposed salt or salt-staining was not observed, but site personnel said there had been a brine release in March 2022. It is suspected that the brine that settled out in the ditch is the source of the high chloride levels. Sediment should be removed from the ditch to minimize sediment transport and to potentially lower the chloride levels.

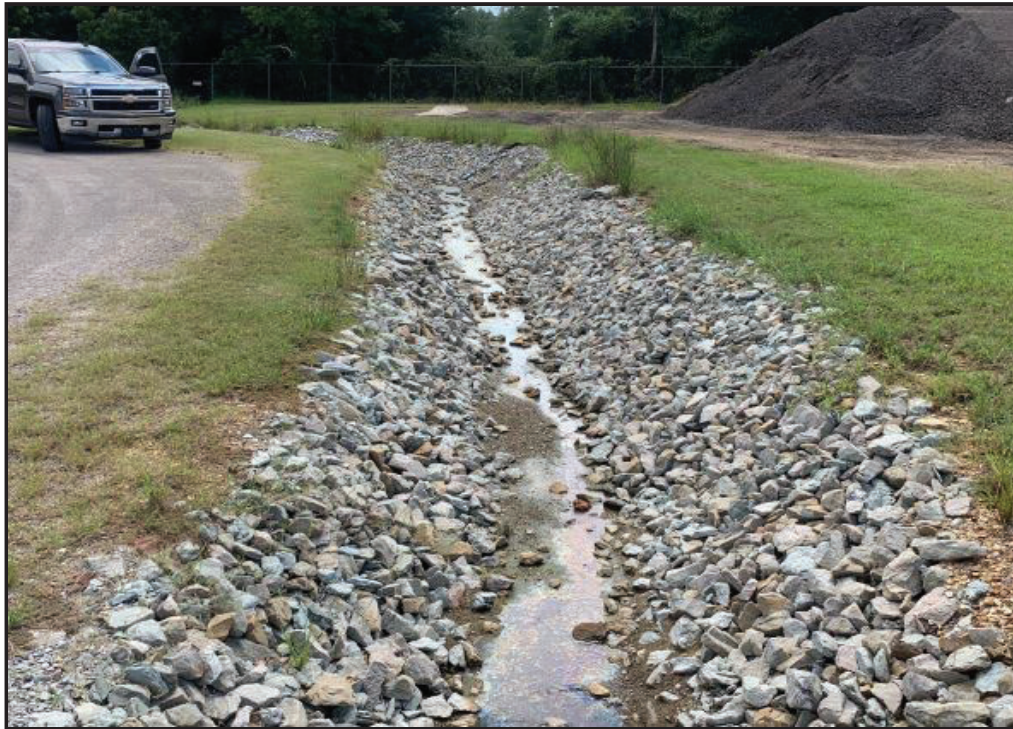
Photograph 3

Note: View of riprap-lined ditch leading to Outfall 55-D-03. Storm water samples indicated high chloride levels. It is suspected that brine from the release in March 2022 settled out in the ditch and got washed out with each rain event. No damaged vegetation was observed at the outfall. Sediment should be removed from the ditch to prevent offsite movement and to potentially lower the chloride levels.

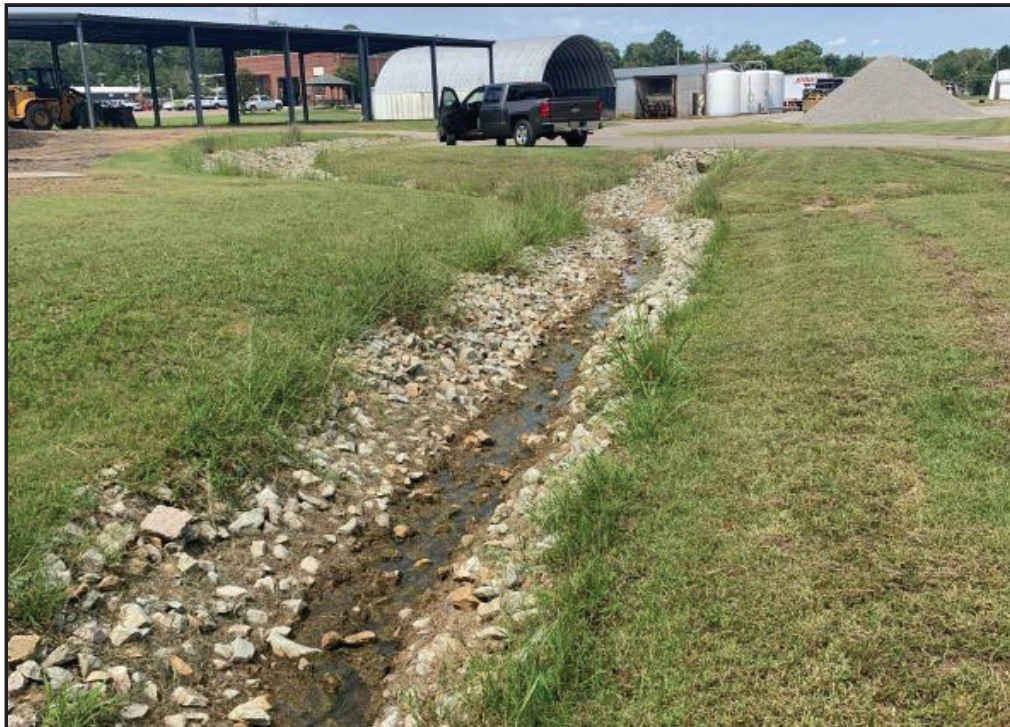
Photograph 4

Note: View of the ditch leading to Outfall 55-D-03. The brine tanks are expected to be moved to the new shed in 2023. Secondary containment will be provided for the tanks to prevent releases from happening in the future.
