**Ford Motor Company
Rotunda Center
17000 Rotunda Drive
Dearborn, MI 48120**

Subject: Follow-Up to 8-1-23 Site Inspection Blue Oval City – Ford Motor Company NPDES Permit
Number TN0082368 Haywood County, Tennessee

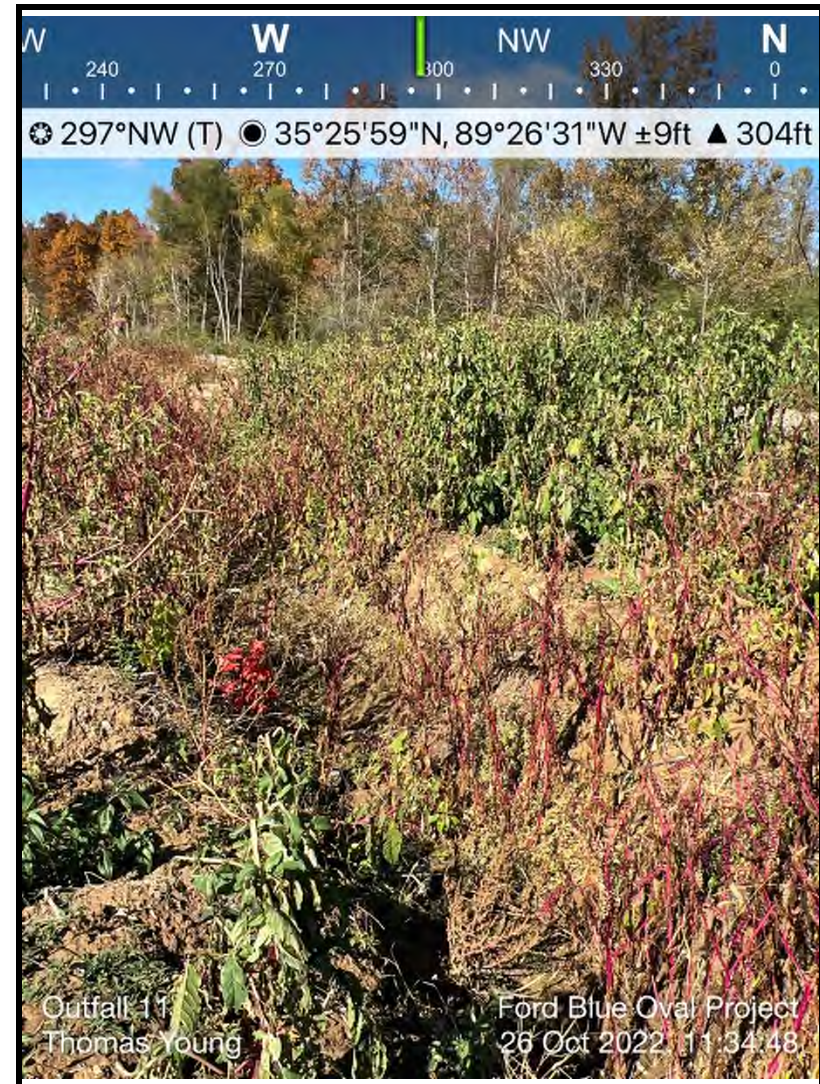
2	Outfall 11 Remarks: Vegetation buffer in good condition.	Date: 9/18/23 Photographer: TY
---	---	---

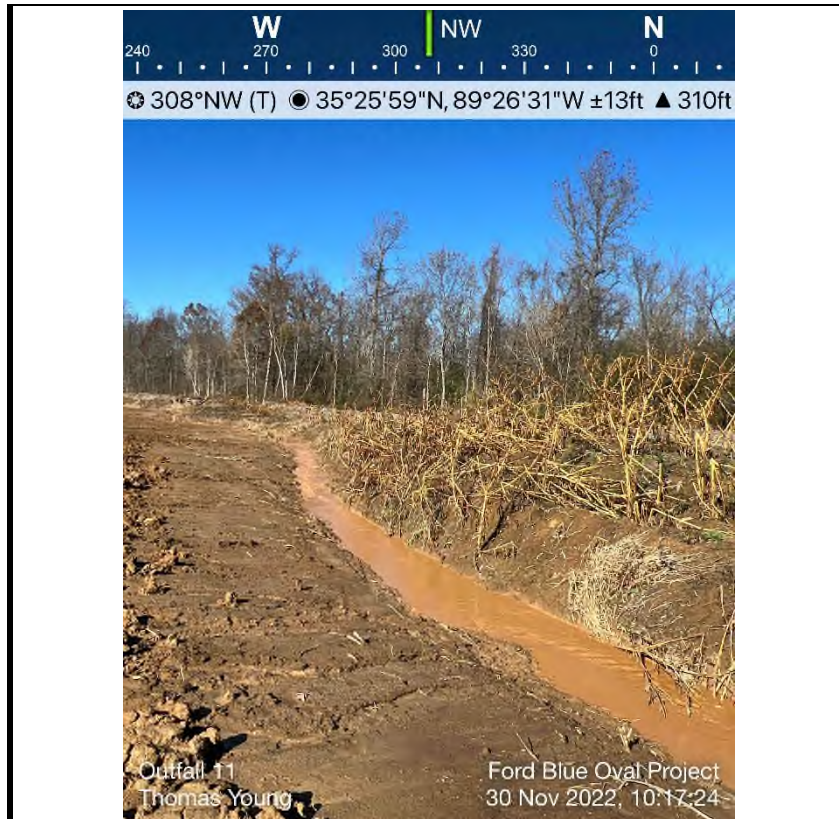
3

Outfall 11

Remarks: Vegetation has been removed. No BMPs installed.

- Riparian buffer for outfall 011 was disturbed in November 2022. Rock check dams for sediment basin S11A and silt fence north of sediment basin S11A was installed. Sediment basin S11A has also been constructed. Attached are before and current pictures of outfall 011.

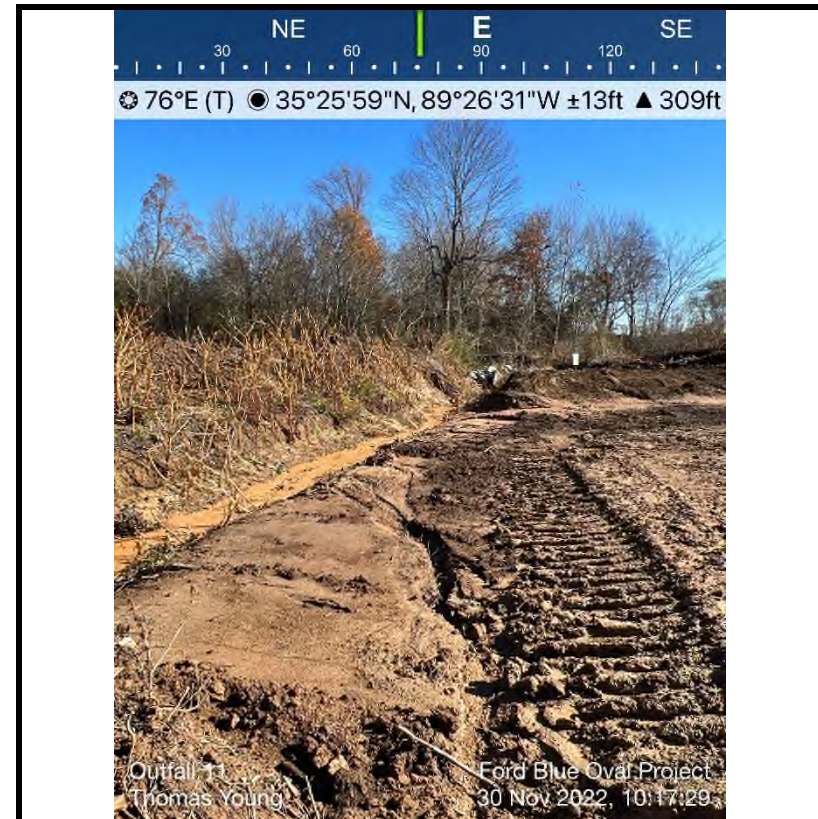
4

Outfall 11

Remarks: Vegetation has been removed. No BMPs installed.

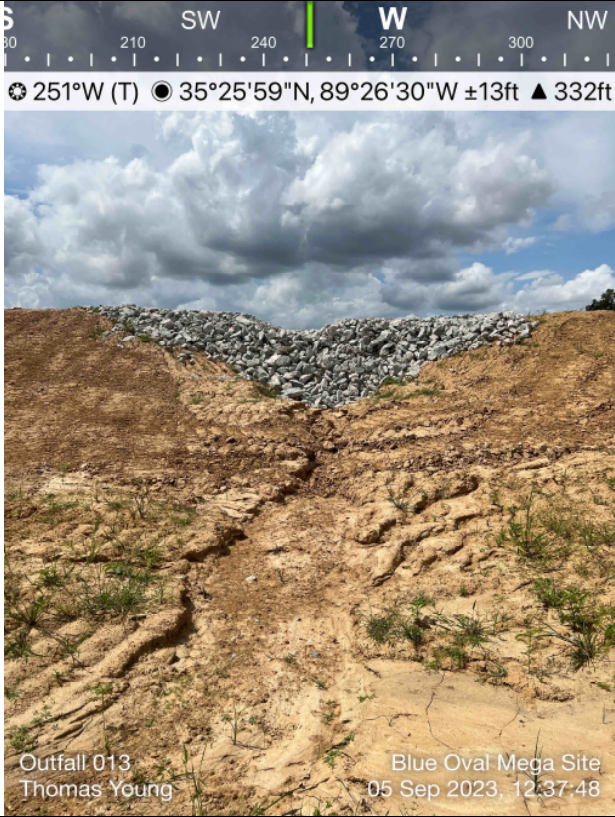
<p>Outfall 013 Thomas Young</p> <p>Blue Oval Mega Site 05 Sep 2023, 12:37:48</p>		
7	Outfall 11 Remarks: Rock check dam for Basin S11A.	Date: 9/5/23 Photographer: TY

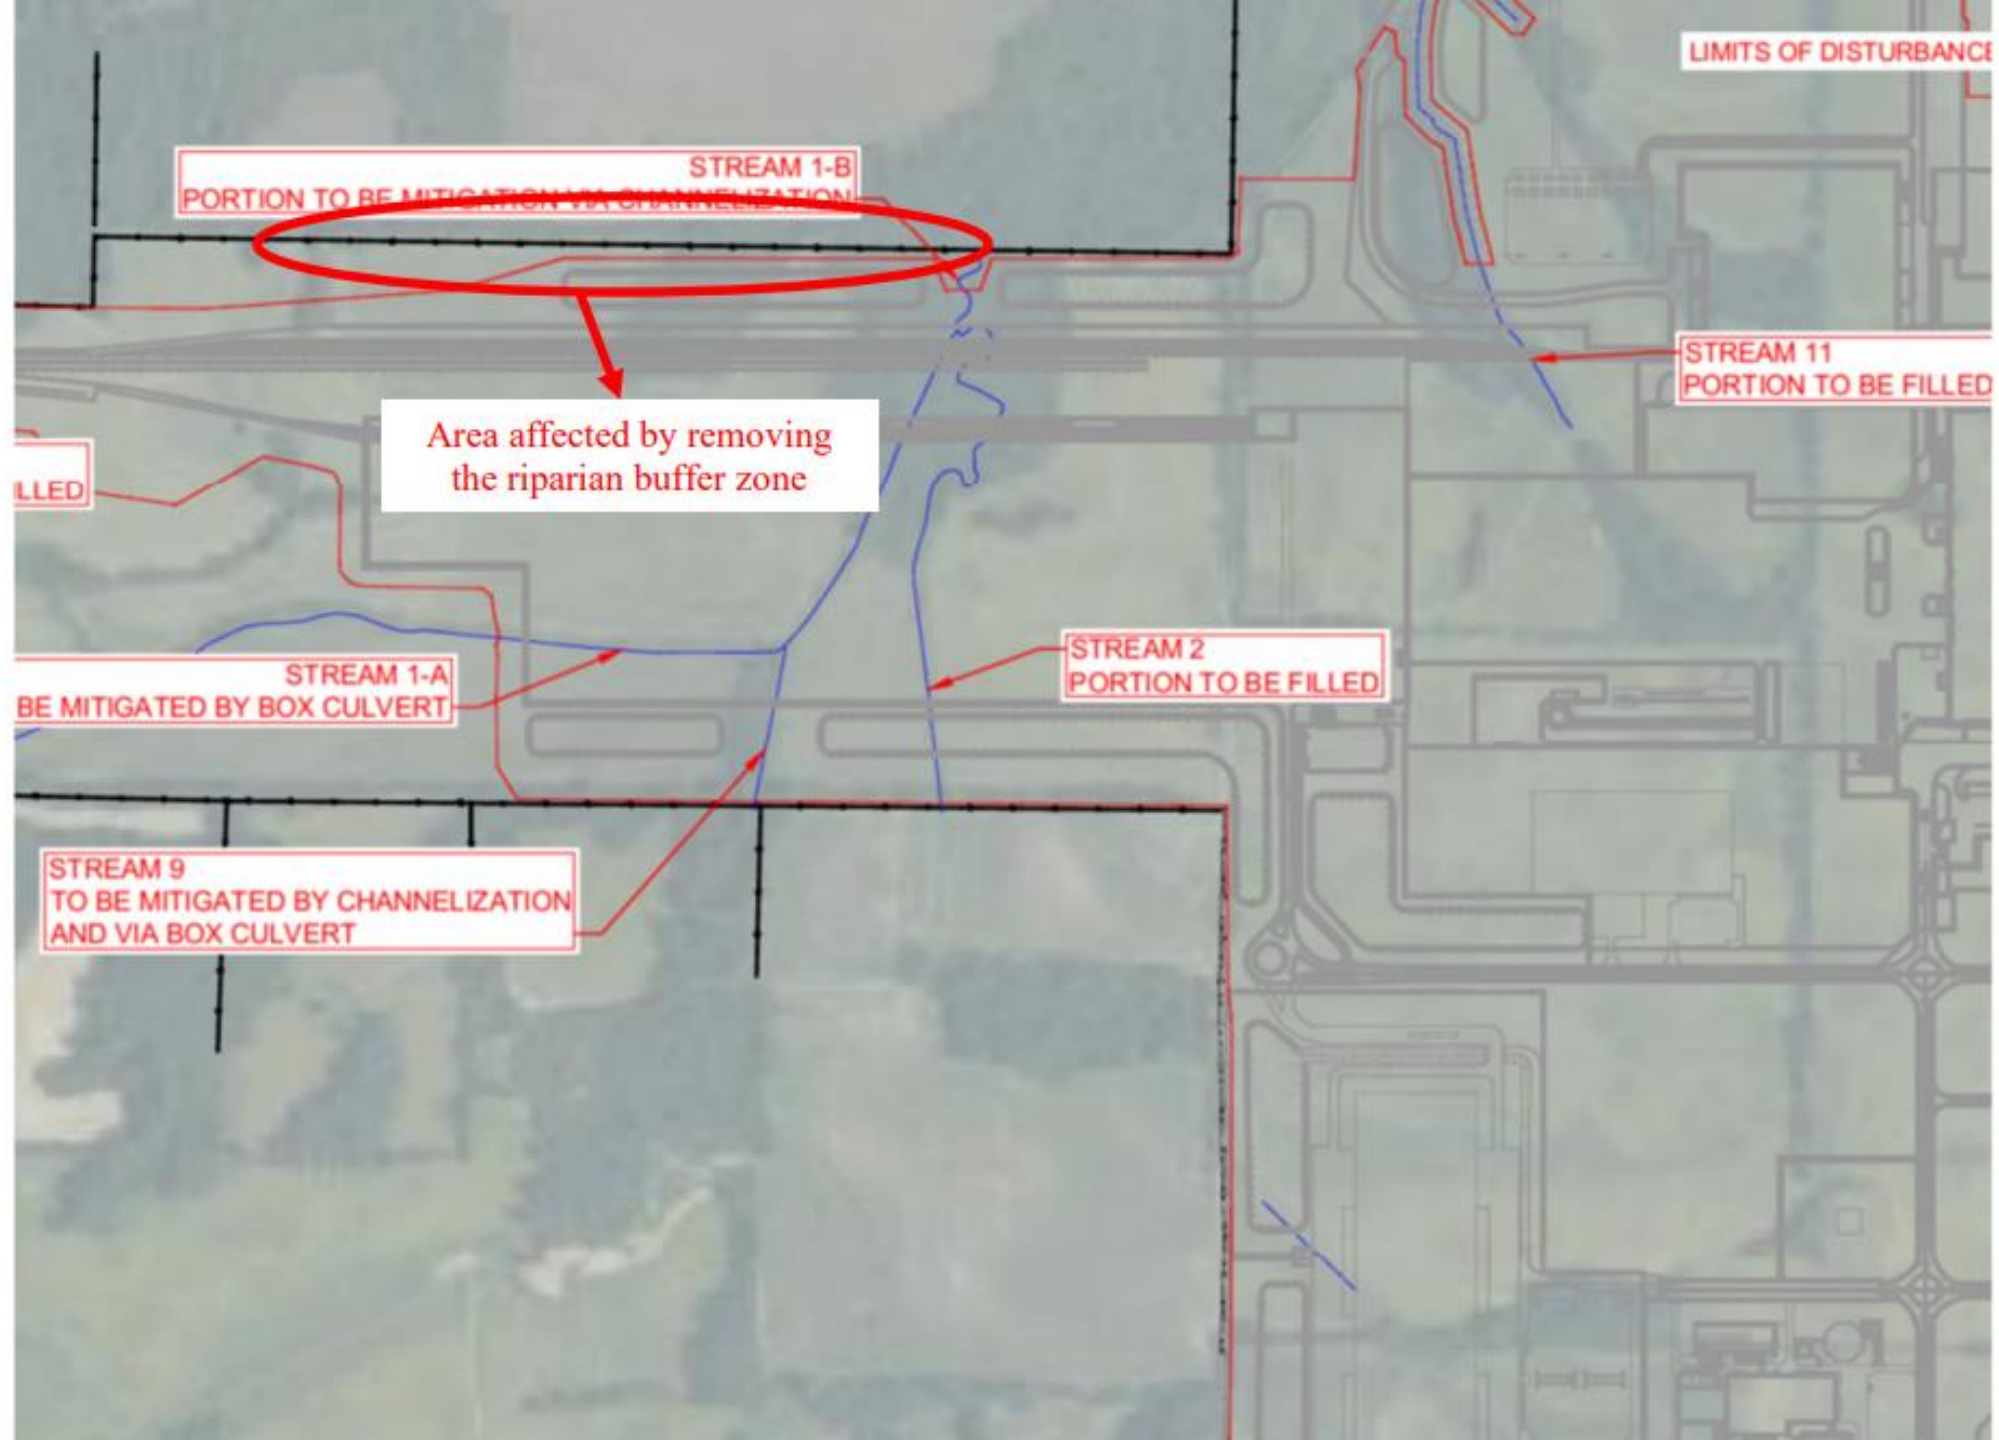
LIMITS OF DISTURBANCE

Area affected by removing
the riparian buffer zone

STREAM 11
PORTION TO BE FILLED

STREAM 1-A
BE MITIGATED BY BOX CULVERT

STREAM 2
PORTION TO BE FILLED

STREAM 9
TO BE MITIGATED BY CHANNELIZATION
AND VIA BOX CULVERT

- Submit a written response providing information regarding where riparian buffer zone disturbance and/or removal has occurred and measures providing equivalent protection that have been installed in lieu of where the buffer could be maintained. Please include a map of the impacted areas with the written response.
