**STATE OF TENNESSEE
DEPARTMENT OF ENVIRONMENT AND CONSERVATION
DIVISION OF WATER RESOURCES**

Re: **NOTICE OF VIOLATION**
Complaint # 122348
Cattle Trails Estates
TNCGP Tracking Number(s): TNR244178
Robertson County, Tennessee

On May 18, 2022, staff from the Division of Water Resources (division) conducted a complaint investigation of Cattle Trails Estate residential subdivision project site and identified violations in need of corrective action(s). Additional information related to these violations, corrective action time frames and request for information can be found below.

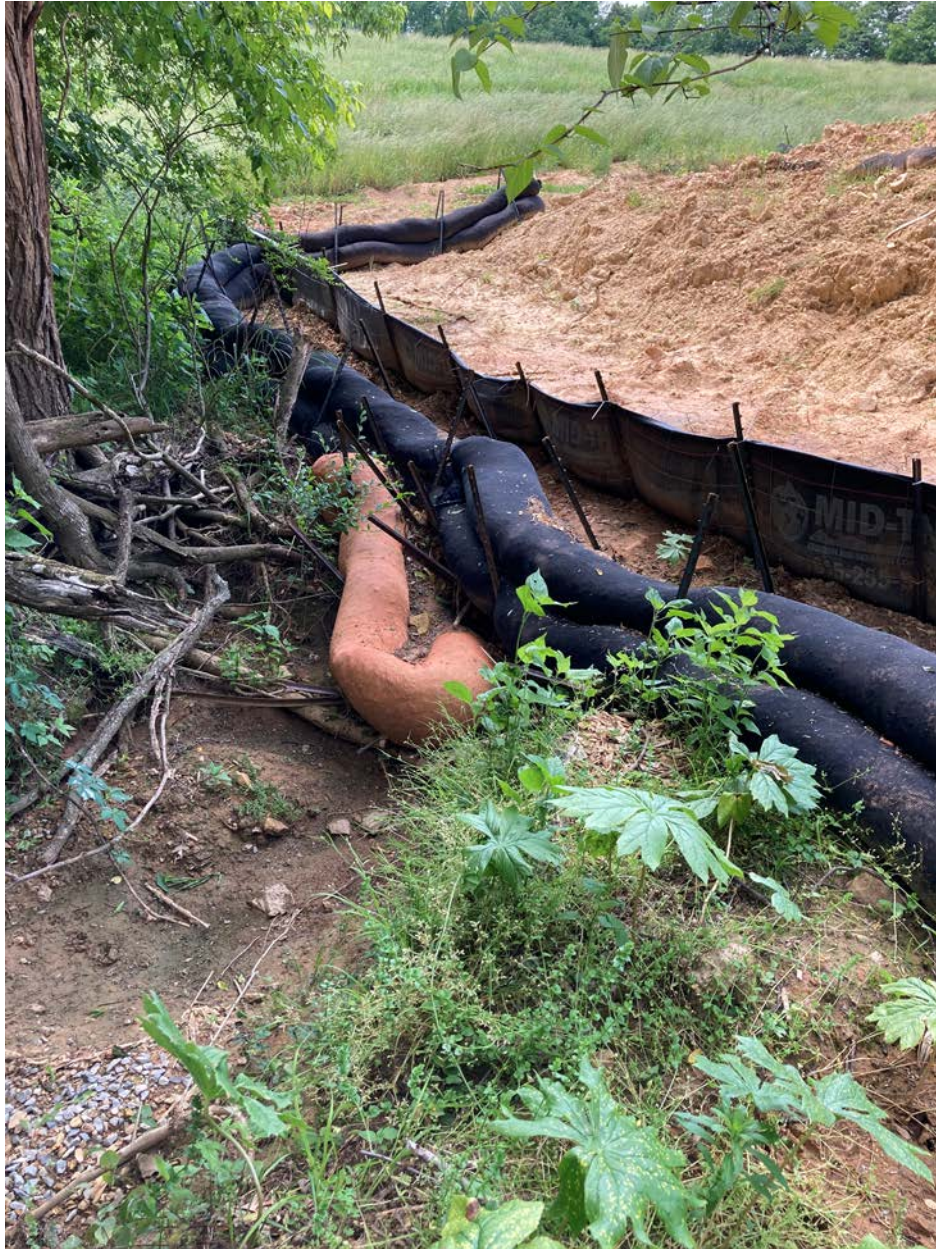
Photo 3. View of sediment entering offsite wet weather conveyance by discharge of untreated stormwater. Photo taken by Division staff on 18-MAY-2022.

1. Immediately install and repair effective EPSC measures to ensure adequate treatment of the site's stormwater discharge.
2. Within 7 days of receipt of this letter, remove sediment from the wet weather conveyance to the maximum extent practicable. Heavy equipment may be used for sediment removal with the exception that the chosen method of removal will not cause further offsite and downstream discharges.
3. Be advised, failure to provide the requested items and address the site's non-compliance within the specified timeframes above, will result in the division initiating enforcement actions, which may include monetary penalties. If you have any questions regarding this correspondence, please contact me at Virginia Lawrence at (615) 714-0730 or by E-mail Virginia.Lawrence@tn.gov.

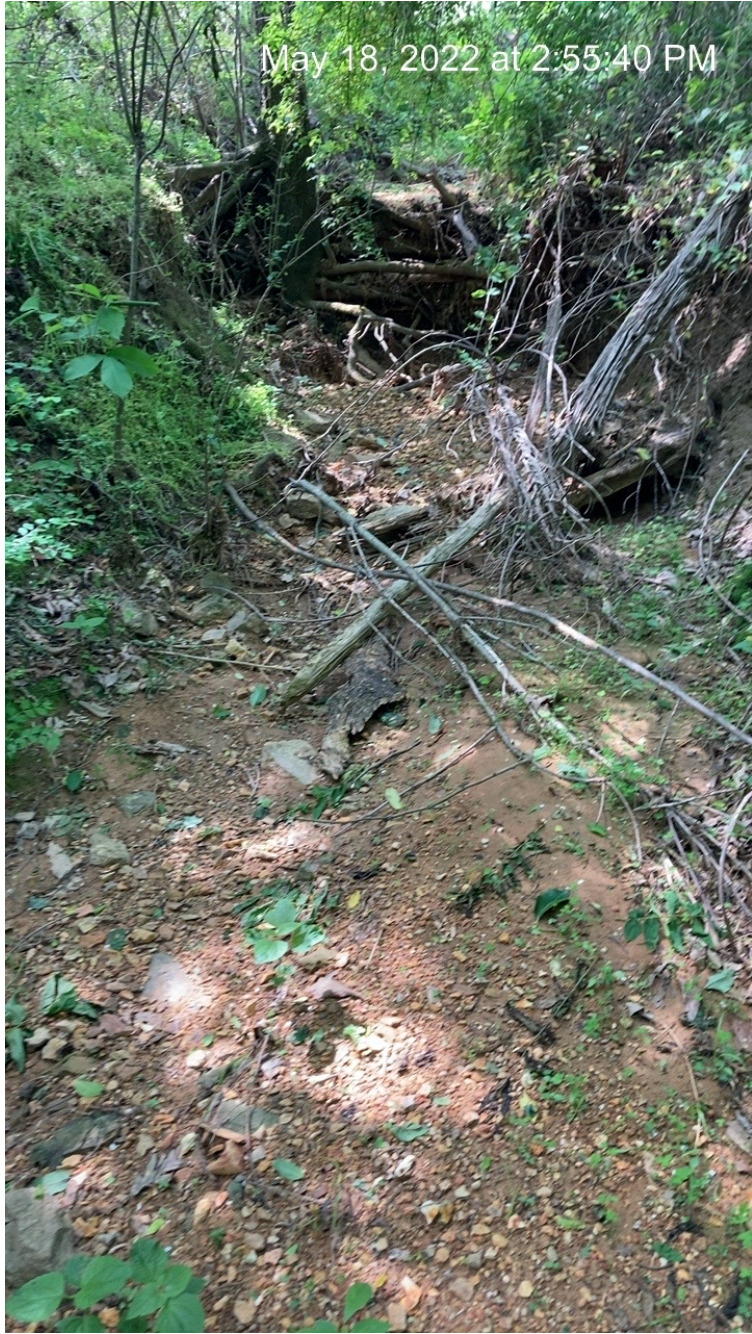
</div>			
Photo 5. Sediment deposited in offsite wet weather conveyance by discharge of untreated stormwater. Photo taken by Division staff on 18-MAY-2022.
