Bays Mountain Park Wastewater System
Preliminary Engineering Report
Revised Nov. 2016

Appendix A: Abandoned Waterline Observation Library

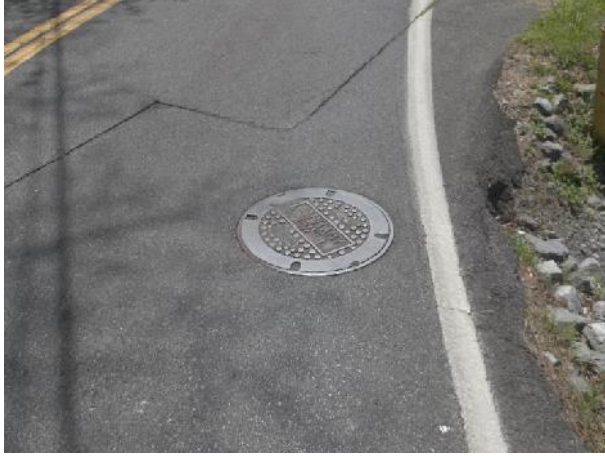
Location of first manhole at bottom of mountain

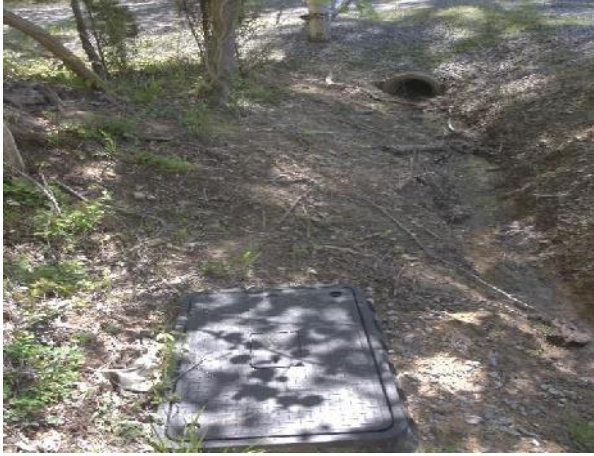
Location of second manhole and water meter at bottom of mountain

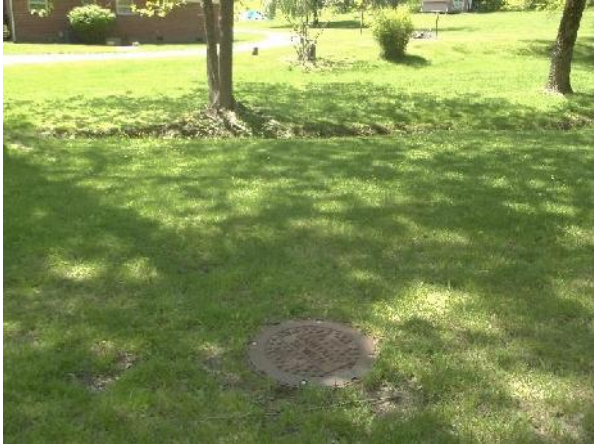
Location of second manhole at bottom of mountain and first stream crossing of abandoned water line

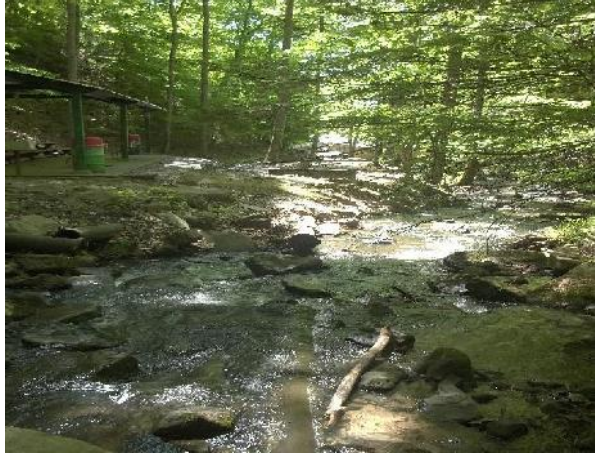
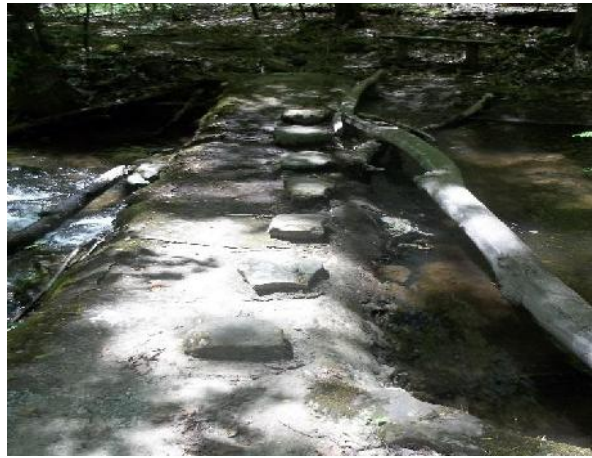
First crossing of abandoned water line across Dolan Branch in Eastman Chemical Company property as well as an abandoned gate valve

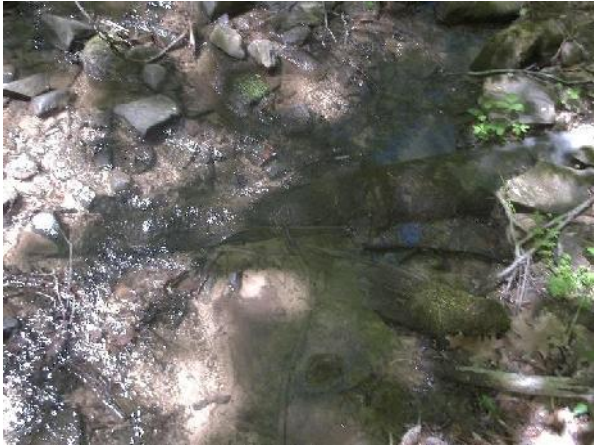
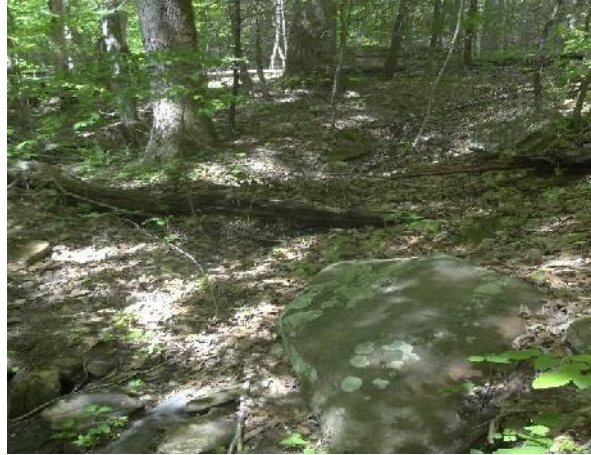
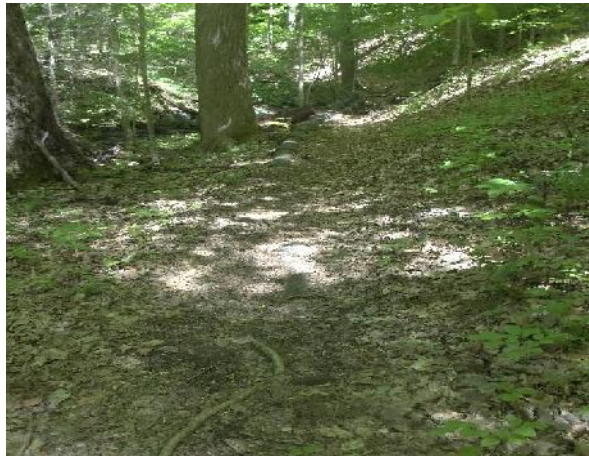
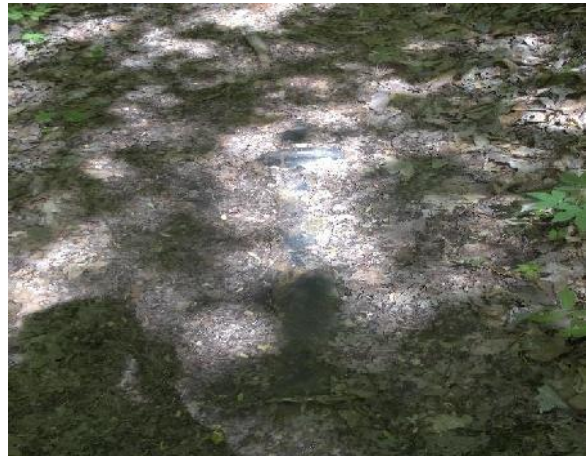
Second crossing of Dolan Branch and depictions of how shallow pipe runs along trail

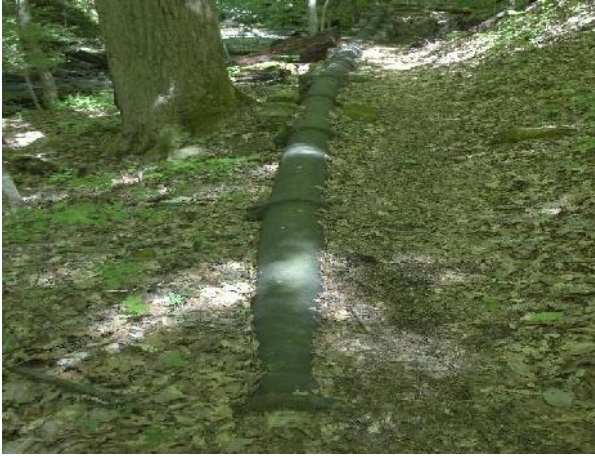
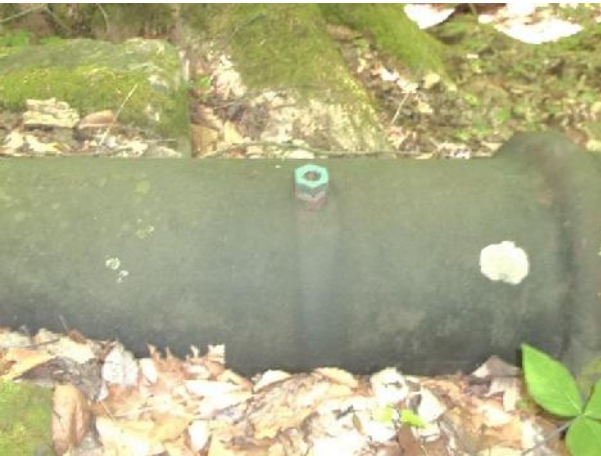
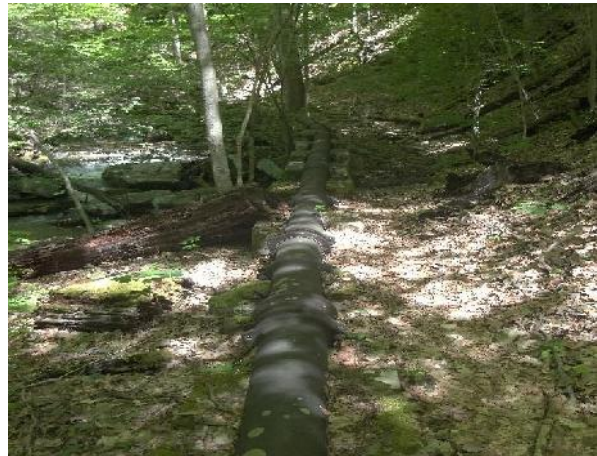
Depictions surface routing and taps in old water line

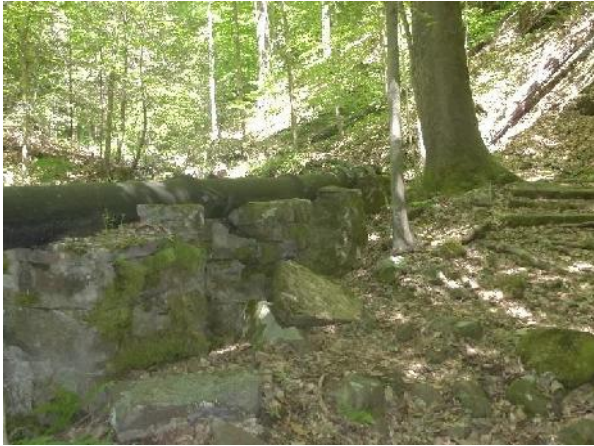
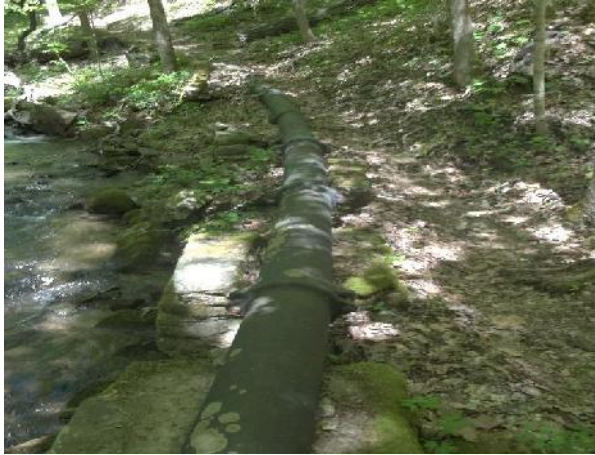
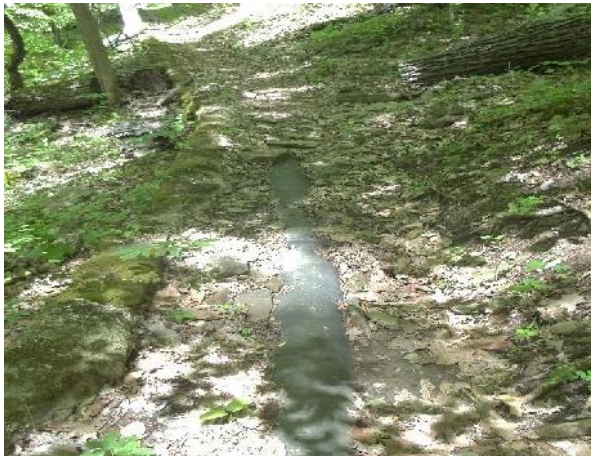
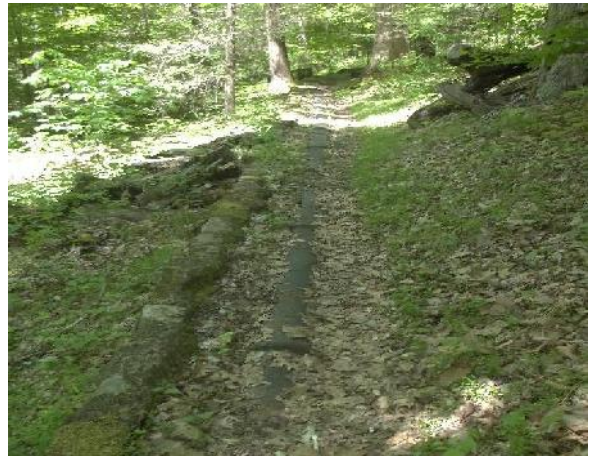
Photos showing rock pipe support and general surface routing of pipe

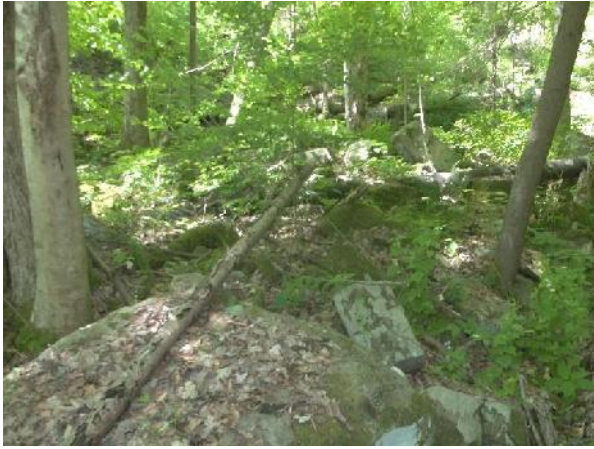
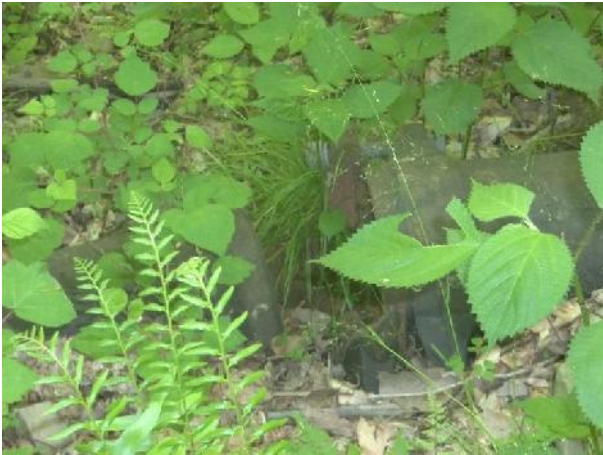
After a field visit to locate the abandoned water line, LDA discovered that the almost 100-year-old eight-inch (8”) cast iron pipe had seen many years of deterioration but was still intact along much of its length. There were several locations along the pipe where trees and rocks had fallen upon the pipe and where the pipe had separated due to the corrosion of the bolts themselves. Additionally, there was some cracking in a few areas as well as two places where the pipe had broken completely. The pipe supports where the water line crosses the stream were serviceable, and some rocks of the supports on the ground showing signs of wear. However, in general the abandoned waterline, as previously noted, is intact.

Photos showing debris around pipe, a tap, rock pipe supports, and complete separation of pipe.

Rehabbing this abandoned line would include the potential of cured-in-place piping (CIPP). An alternative would include sliding a new smaller diameter HDPE pipe through the existing 8” pipe, cutting out sections of broken pipe and replacing them with 8” sleeves and spool pieces, and replacing the bolts. Connecting the existing water line to the City’s sewer system would require construction activities on Eastman Chemical Company’s property. Eastman Recreation

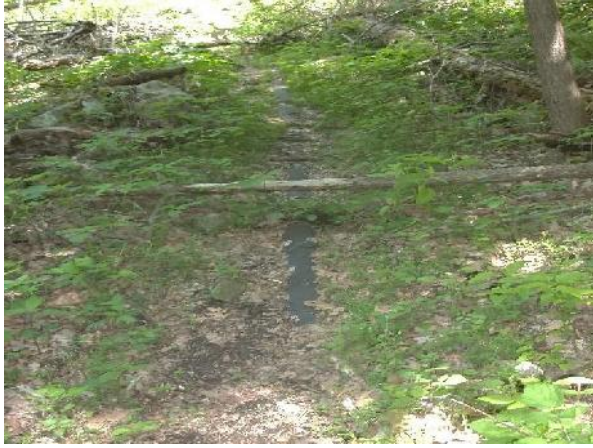
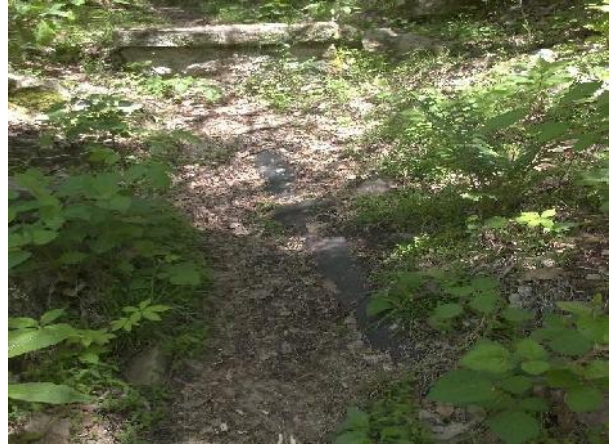
Photos of surface routing as well as a tap house.

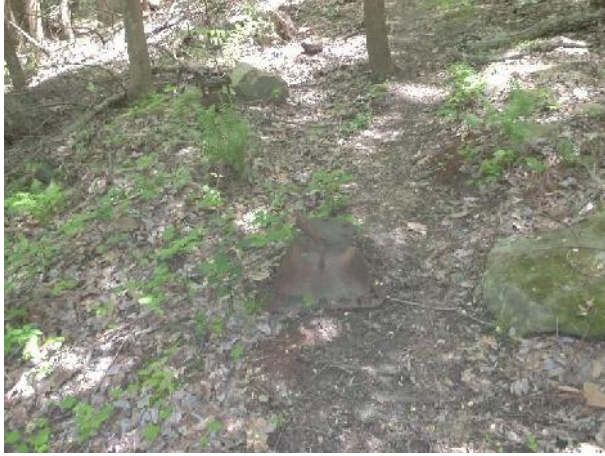
Abandoned gate valve and tap house possibly used for sampling

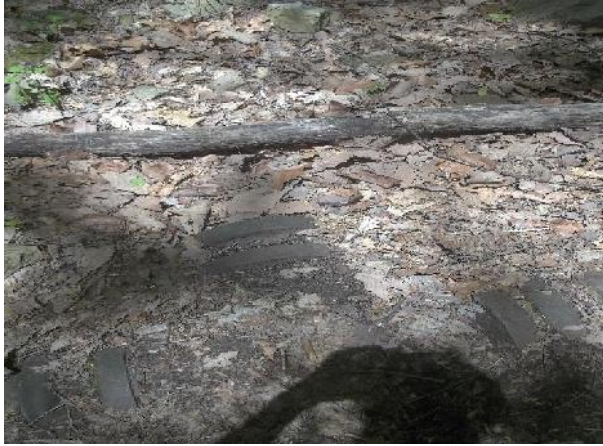
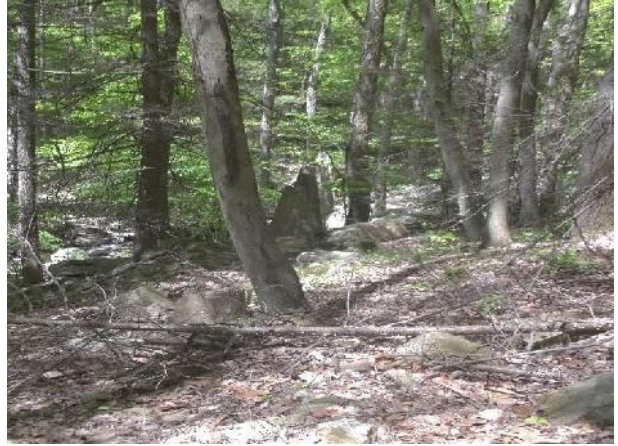
Cast iron tee used to water to concrete structure across stream. Also photos of concrete pipe supports where the discharge from the concrete structure came back across the stream to reconnect with the main water line.

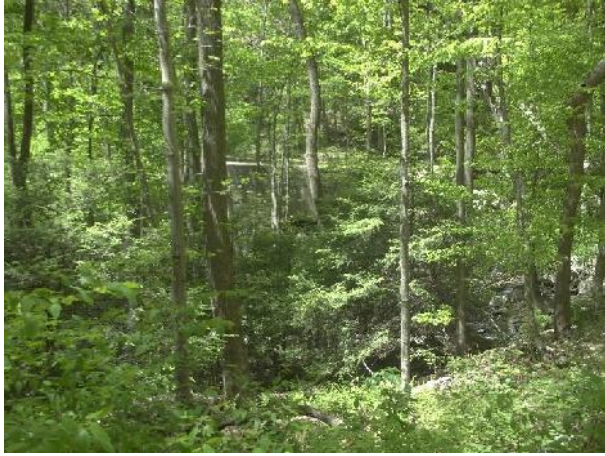
Photos of concrete structure across the stream from the water main

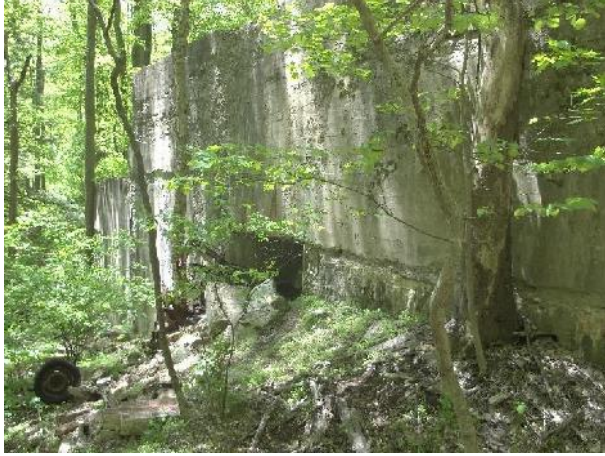
Photos of concrete structure across the stream from the water main as well as photos of the chlorine contact chamber with the newly installed aerator

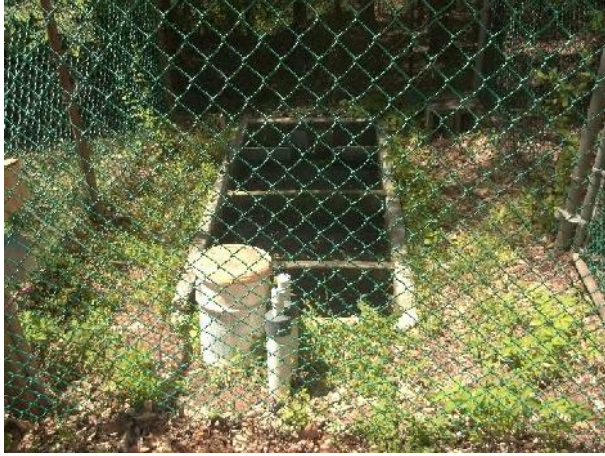
The current sand filter bed would also potentially need to be replaced or rehabilitated with new sand, gravel, and field lines. The current field lines are over thirty years old and may have issues with solids deposited in the pipe or deposited within the sand and gravel layers of the treatment system.

Photos of the current chlorine contact chamber and of the existing sand filtration bed.

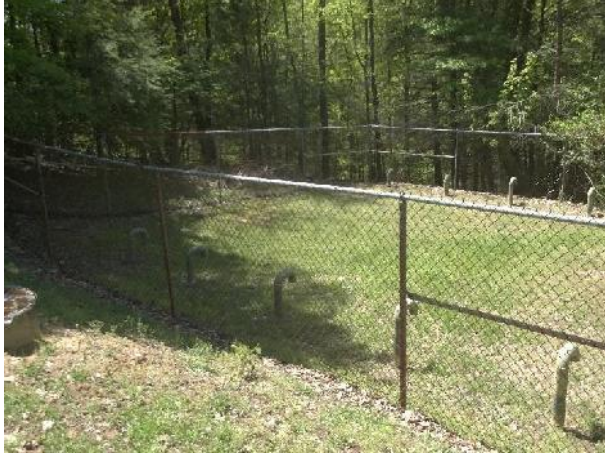
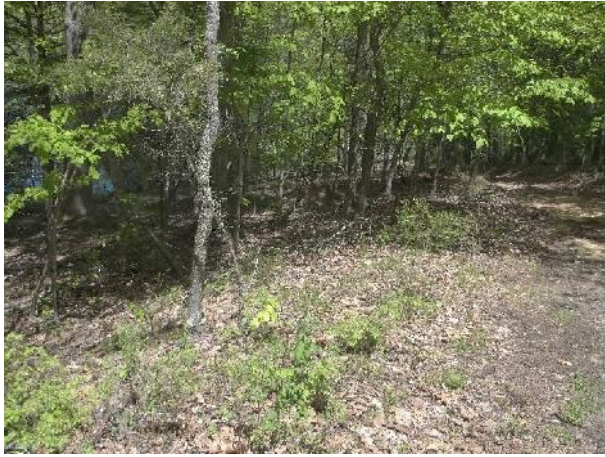
Photos of sand filtration bed as well as potential sites for land application across the dam.

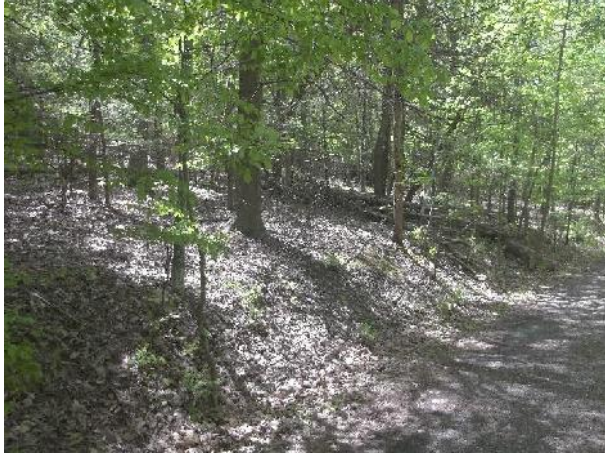
Photos of potential land application located up from the observatory.

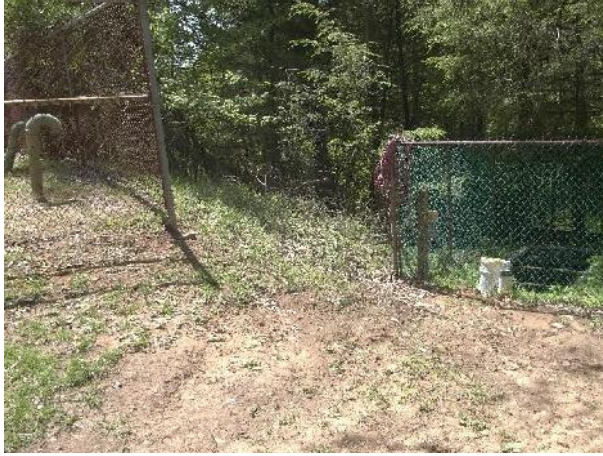
Photos of the grade between the sand filtration bed and the chlorine contact chamber, the flow monitoring method used at the chlorine contact chamber, the newly installed aeration system, and the routing of the pipe to the discharge point.

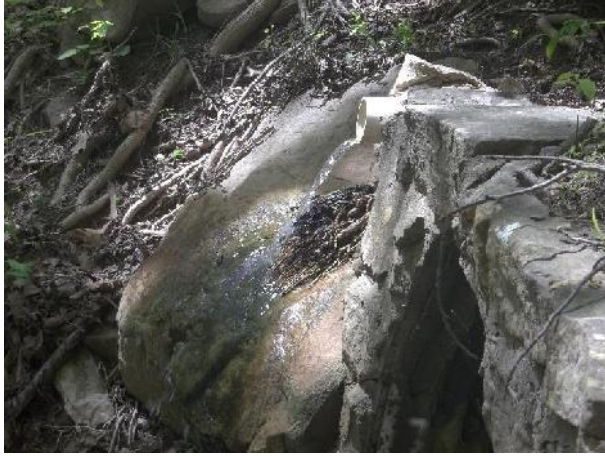
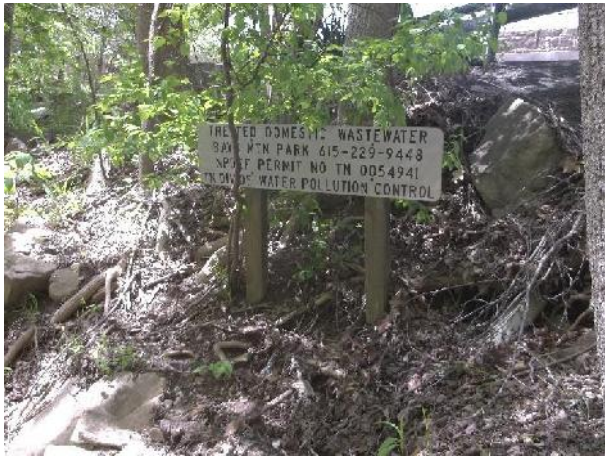
Using the current system without making any improvements to the current treatment method, Bays Mountain Park would continue to see violations with low DO, high residual chlorine, and high ammonia. As the number of visitors to the park continues to increase, the current system will continue to deteriorate and fail to properly treat the effluent before it is discharged into Dolan Branch. Even with the installation of the aerator at the chlorine contact chamber, the current system is not configured to handle the loading rate of wastewater entering the system during peak summer months due to the undersized the septic tank configuration.

Photos depicting the finished effluent as it discharges into the Dolan Branch at stream mile 1.5
