**QUALITY ASSURANCE  
MONTHLY SITE  
ASSESSMENT REPORT**

Airfield Modernization Program  
Runway 5L-23R Reconstruction  
Project 2 / Project 3

## QUALITY ASSURANCE SITE ASSESSMENT

## **AIRFIELD MODERNIZATION PROGRAM RUNWAY 5L-23R RECONSTRUCTION**

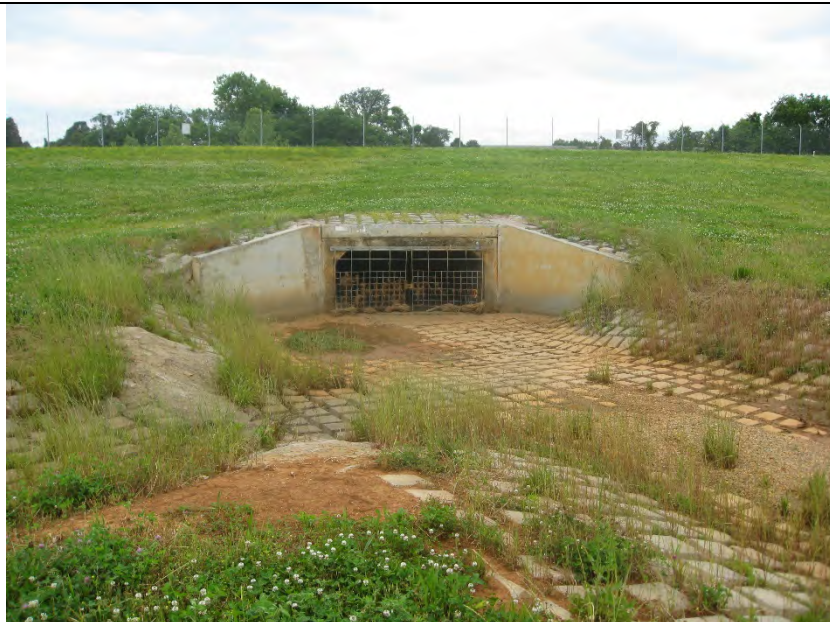
Photo 1  
Sta. 111+56 RT  
(Line LB)  
NLET 01  
Project 2

North Lateral End Treatment 01 (Outfall A).

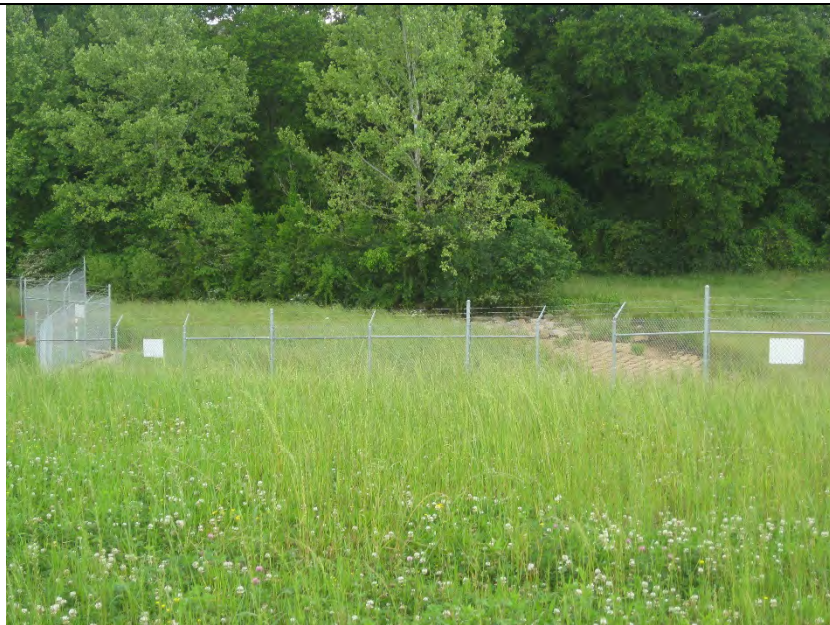
Photo 2  
Sta. 111+56 RT  
(Line LB)  
NLET 01  
Project 2

North Lateral End Treatment 01 (Outfall A).

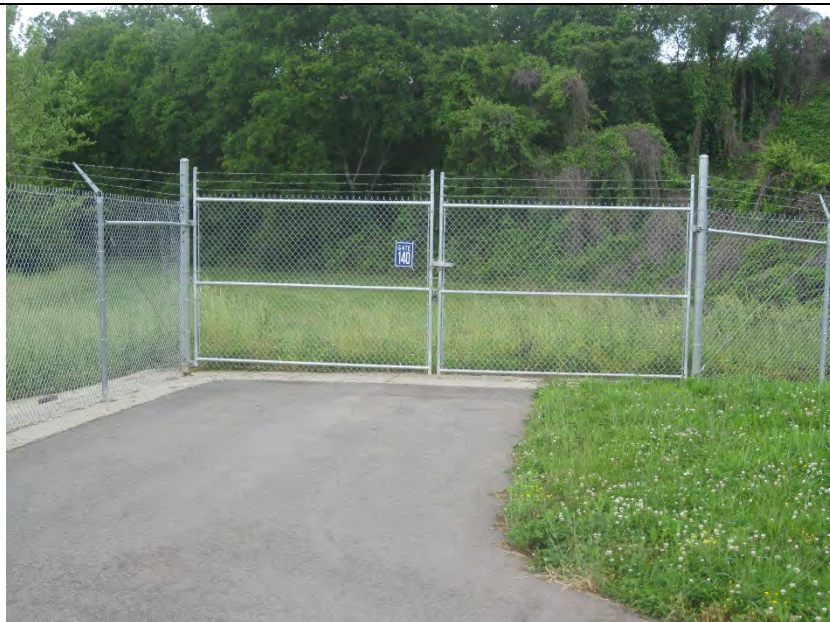
Photo 3  
Sta. 111+82 LT  
(Line LB)  
NLET 02  
Project 2

Main outfall to Lackey Creek. This section of the site was inaccessible at time of inspection.

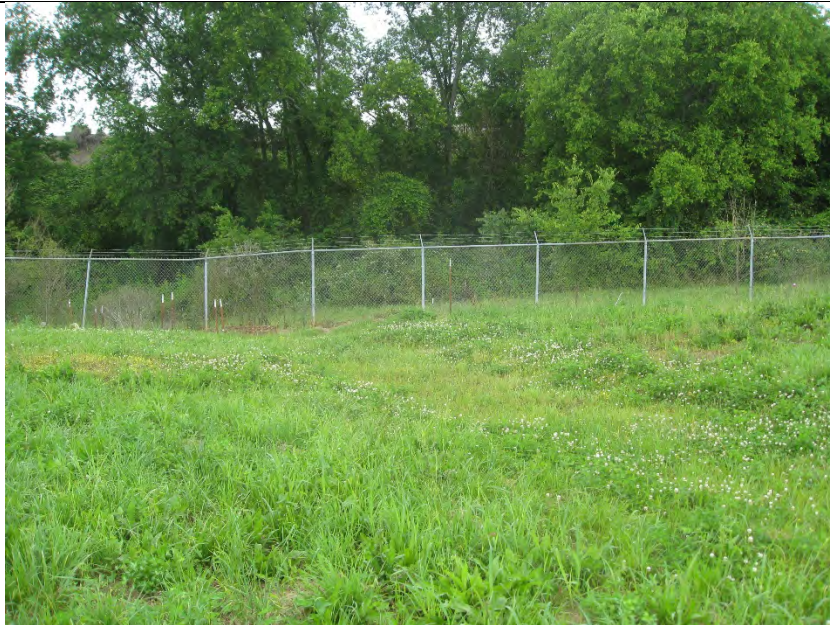
Photo 4  
Sta. 111+82 LT  
(Line LB)  
NLET 02  
Project 2

Main outfall to Lackey Creek was inaccessible at time of inspection.

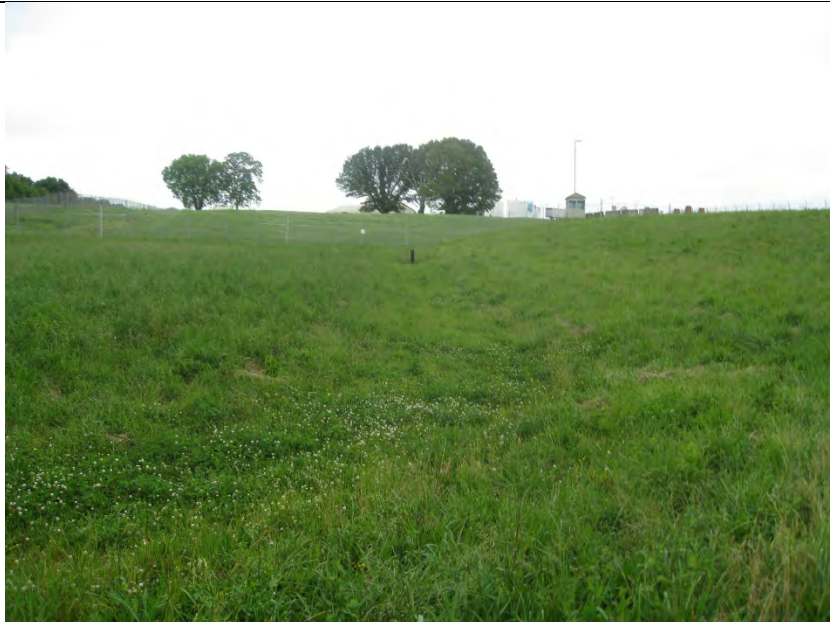
Photo 5  
Sta. 115+28  
(Line LB)  
Project 2

Grass established at ditch line along Liberty Street (Outfall C-1).

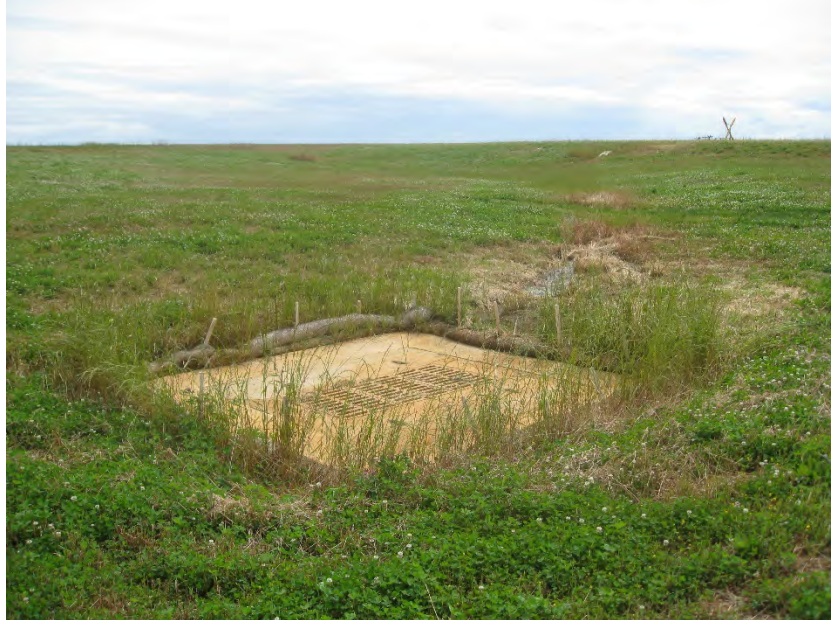
Photo 12  
Sta. 289+13 LT  
(RW 5L-23R)  
Structure 122  
Project 3

Structure 122.  
Recommend stabilizing remaining bare areas.

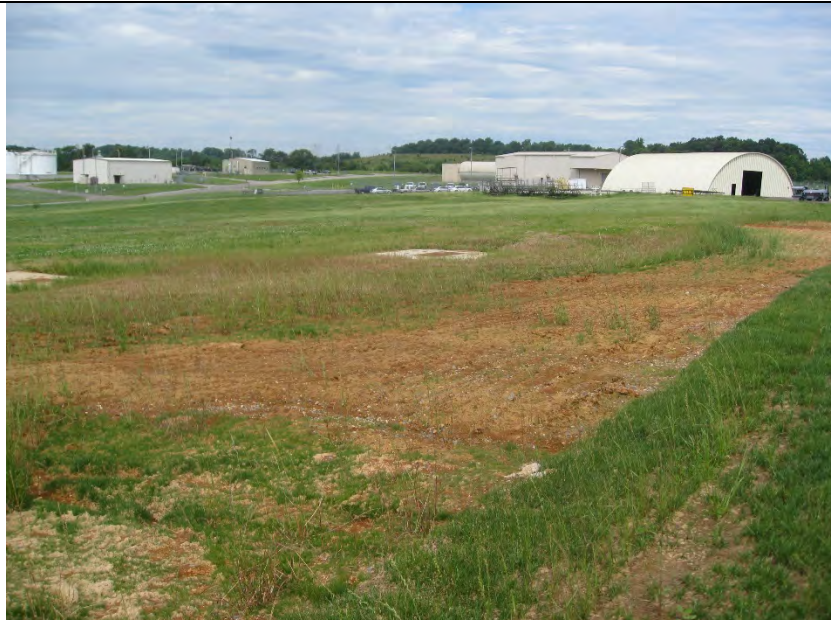
Photo 13  
Sta. 291+51 LT  
(RW 5L-23R)  
Structure 120  
Project 3

Structure 120.

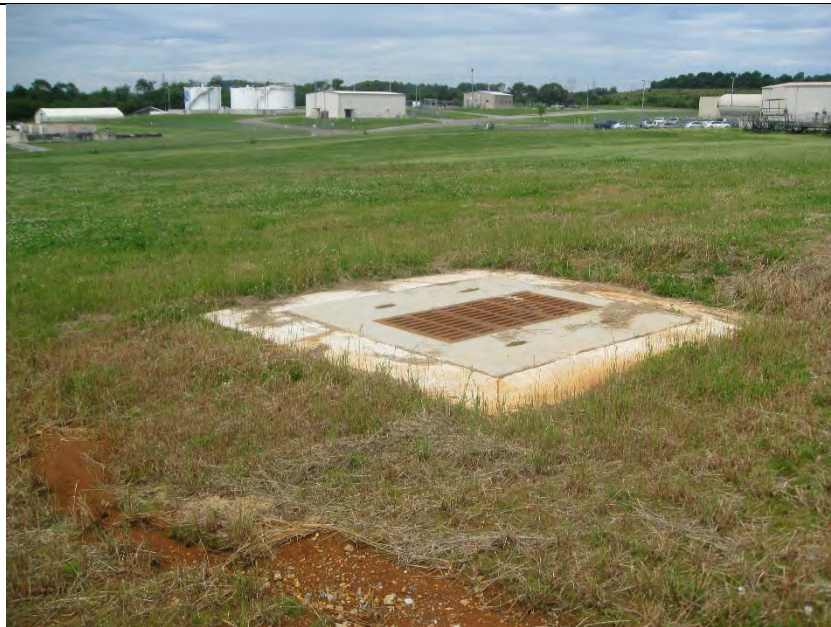
Photo 14  
Sta. 294+31 LT  
(RW 5L-23R)  
Structure 118  
Project 3

Grass starting to establish along Taxiway G1 (area above Structure 118).

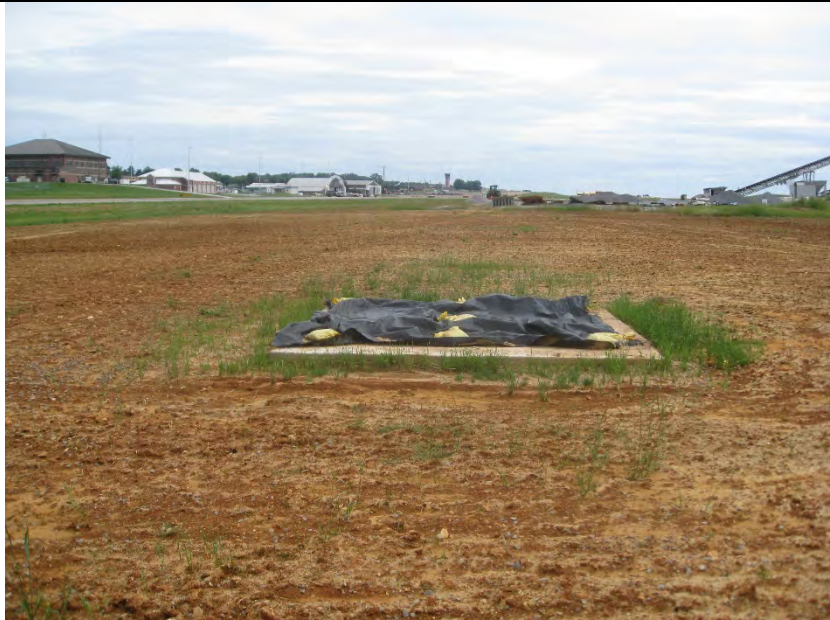
Photo 17  
Sta. 298+71 LT  
(RW 5L-23R)  
Structure 116  
Project 3

Structure 116.  
Recommend stabilizing bare areas.

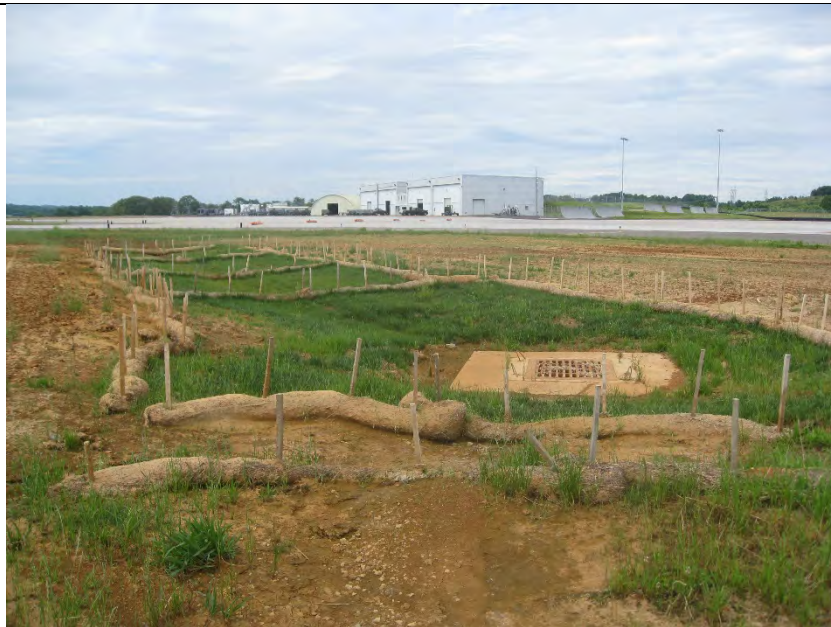
Photo 18  
Sta. 302+54 LT  
(RW 5L-23R)  
Structure 114  
Project 3

Structure 114.  
Bare areas recently stabilized.

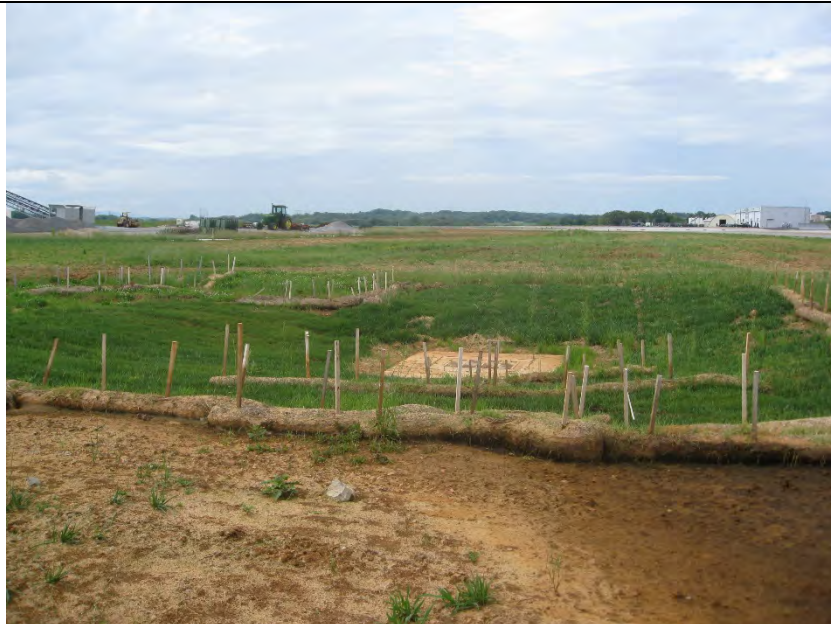
Photo 19  
Sta. 303+36 LT  
(RW 5L-23R)  
Structure 12  
Project 3

Structure 12.  
Bare areas recently stabilized.

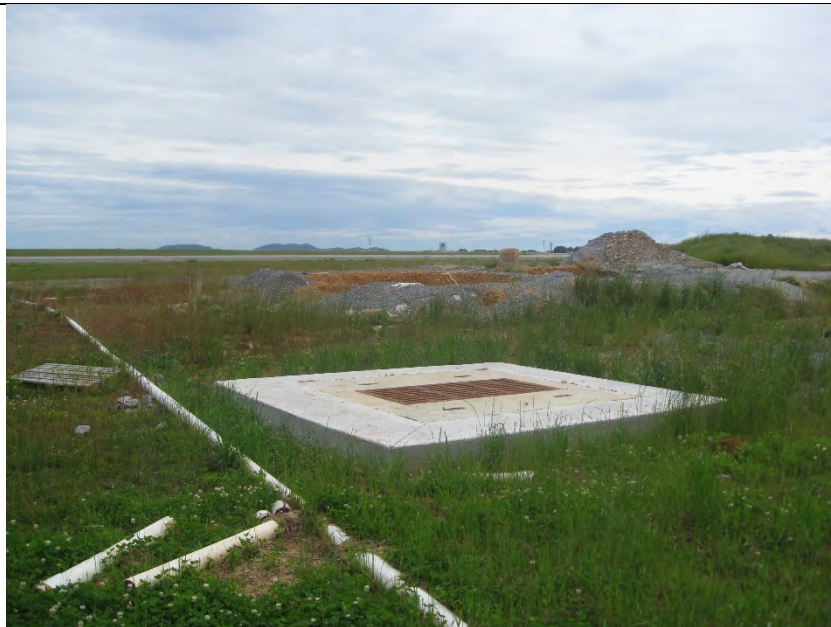
Photo 20  
Sta. 310+04 LT  
(RW 5L-23R)  
Structure 10  
Project 3

Structure 10.  
Bare areas recently stabilized.

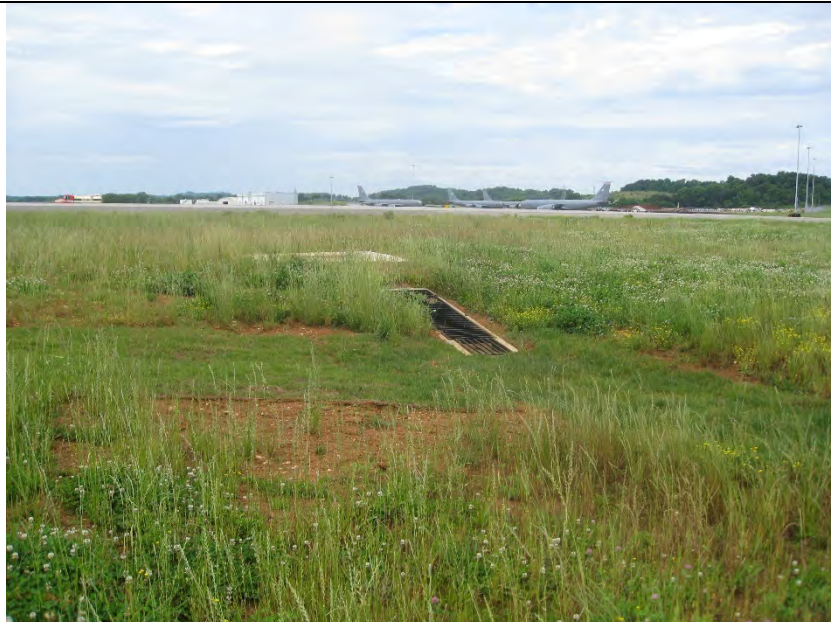
Photo 21  
Sta. 310+00 LT  
(RW 5L-23R)  
Project 3

Structure 112 and concrete washout area adjacent to batch plant.

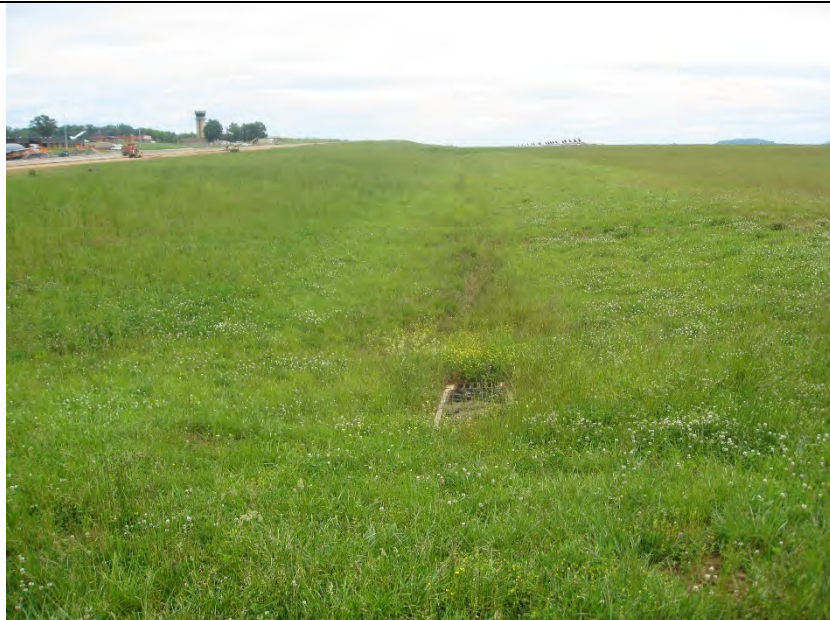
Photo 23  
Sta. 314+48 LT  
(RW 5L-23R)  
ES Endwall 108  
Project 3

Enhanced Swale Endwall 108.  
Recommend stabilizing remaining bare areas.

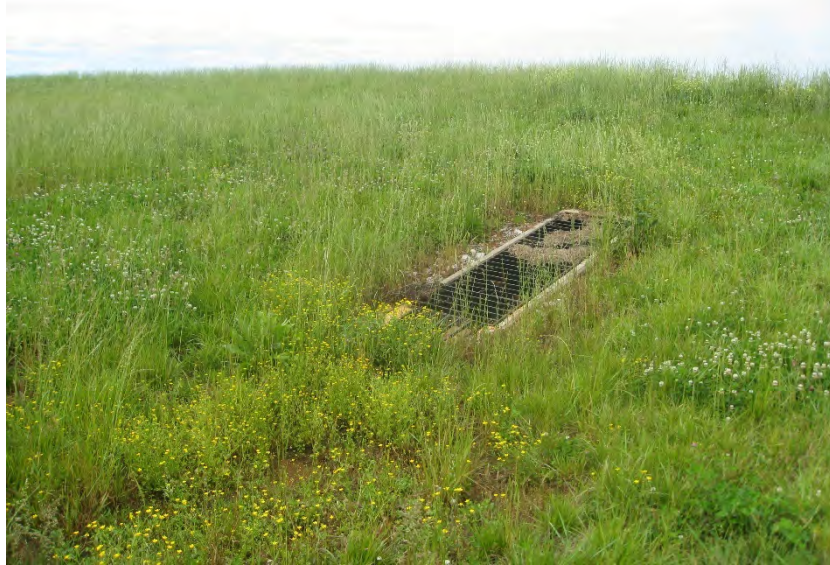
Photo 24  
Sta. 324+86 LT  
(RW 5L-23R)  
ES Endwall 106  
Project 3

Enhanced Swale Endwall 106.

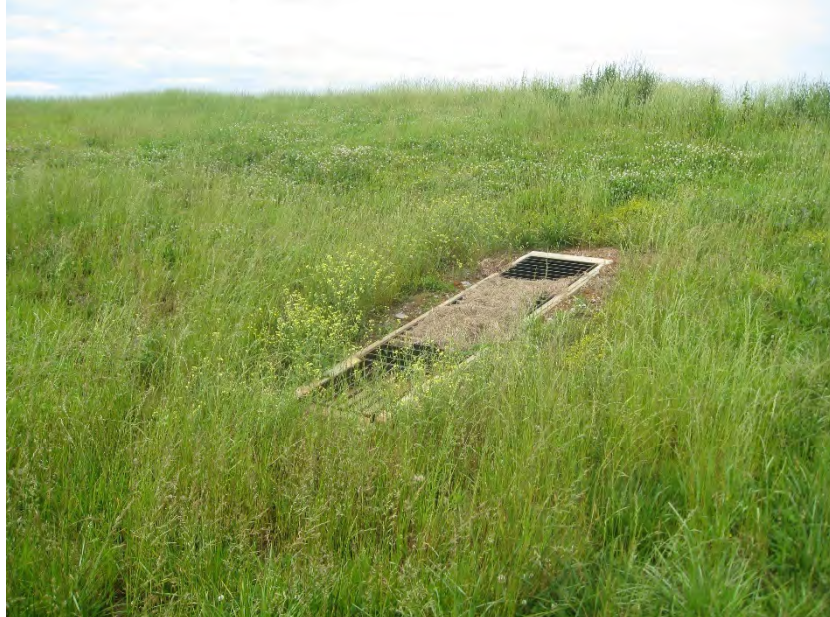
Photo 25  
Sta. 324+86 to Sta. 335+73 LT  
(RW 5L-23R)  
ES Endwall 106  
Project 3

Enhanced Swale Endwall 106.

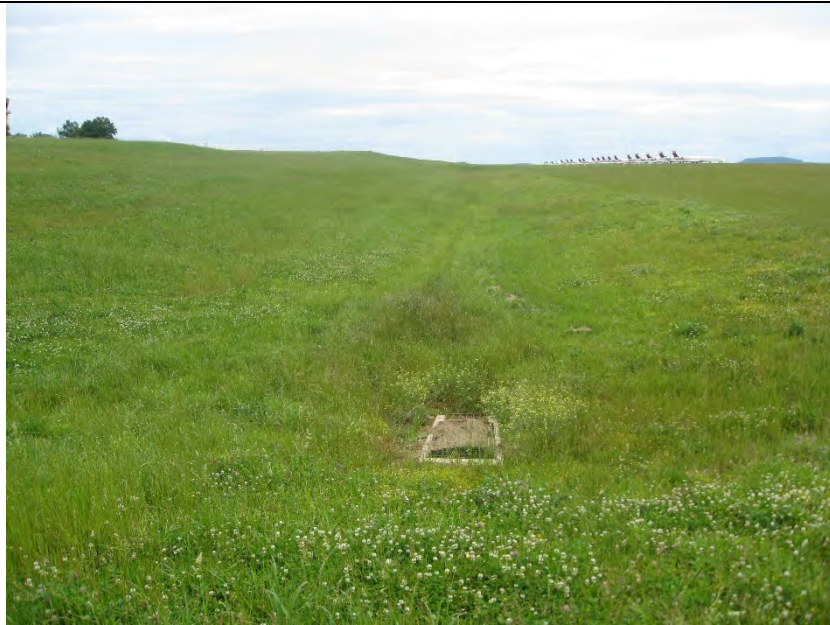
Photo 26  
Sta. 335+73 LT  
(RW 5L-23R)  
ES Endwall 104  
Project 3

Enhanced Swale Endwall 104.

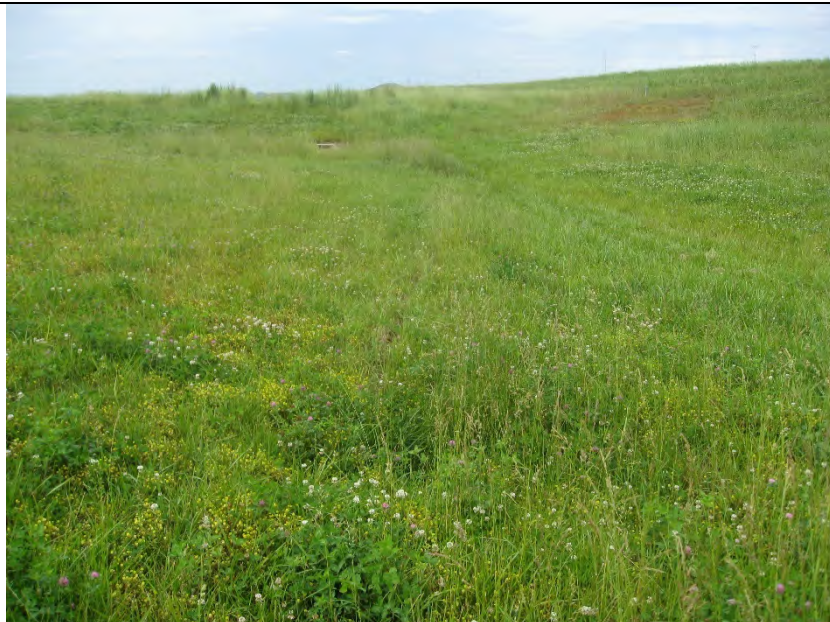
Photo 27  
Sta. 335+73 LT  
(RW 5L-23R)  
ES Endwall 104  
Project 3

Enhanced Swale Endwall 104.

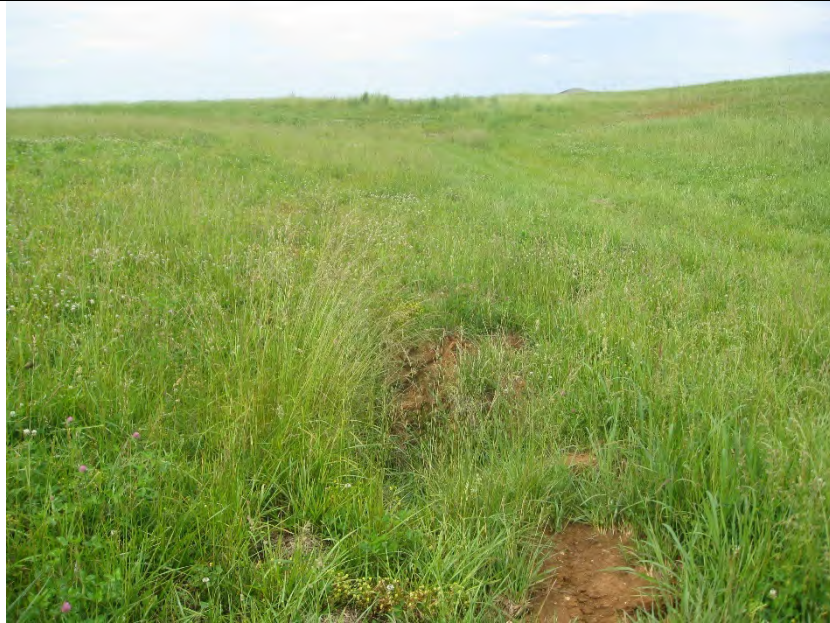
Photo 28  
Sta. 341+50 LT  
(RW 5L-23R)  
Between ES Endwall 104 and 102  
Project 3

Potential construction fallout on Storm Line 1 between ES Endwall 104 and 102.

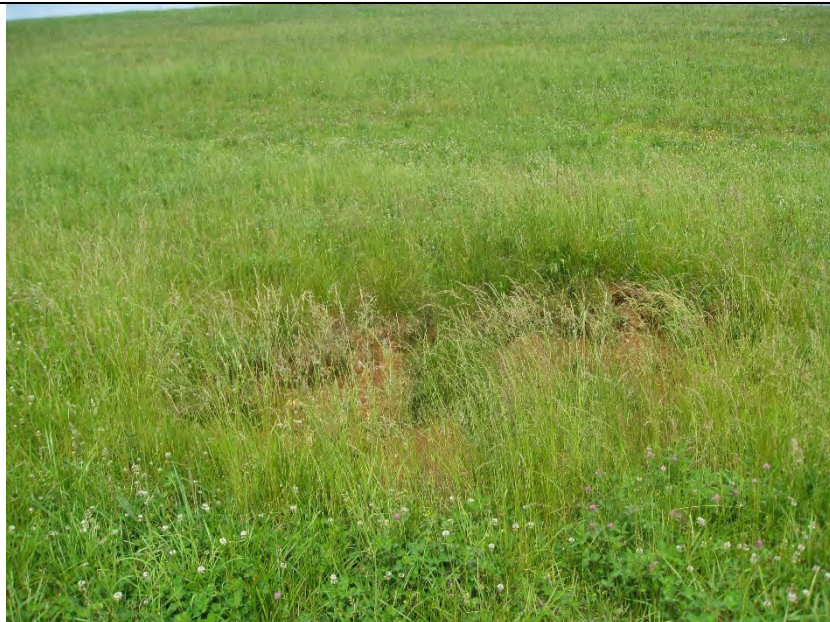
Photo 29  
Sta. 341+50 LT  
(RW 5L-23R)  
Between ES Endwall 104 and 102  
Project 3

First construction fallout on Storm Line 1 between ES Endwall 104 and 102.  
Coordinate remediation with CHA.

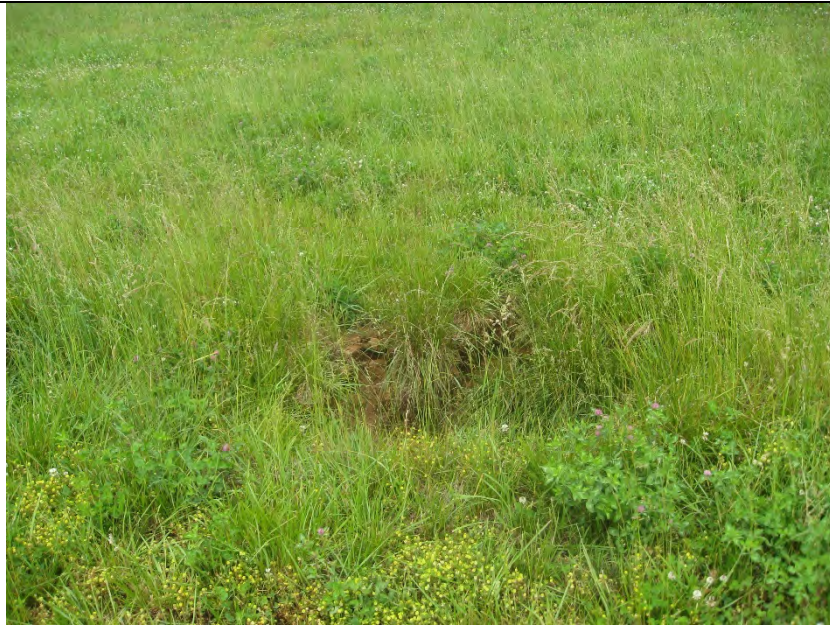
Photo 30  
Sta. 341+50 LT  
(RW 5L-23R)  
Between ES Endwall 104 and 102  
Project 3

Second construction fallout on Storm Line 1 between ES Endwall 104 and 102.  
Coordinate remediation with CHA.

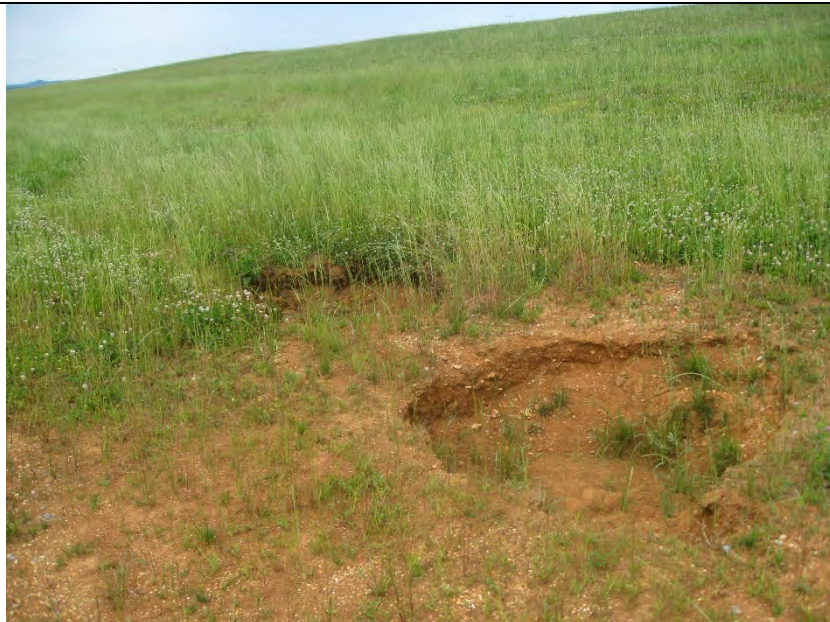
Photo 31  
Sta. 341+50 LT  
(RW 5L-23R)  
Between ES Endwall 104 and 102  
Project 3

Third construction fallout on Storm Line 1 between ES Endwall 104 and 102.  
Coordinate remediation with CHA.

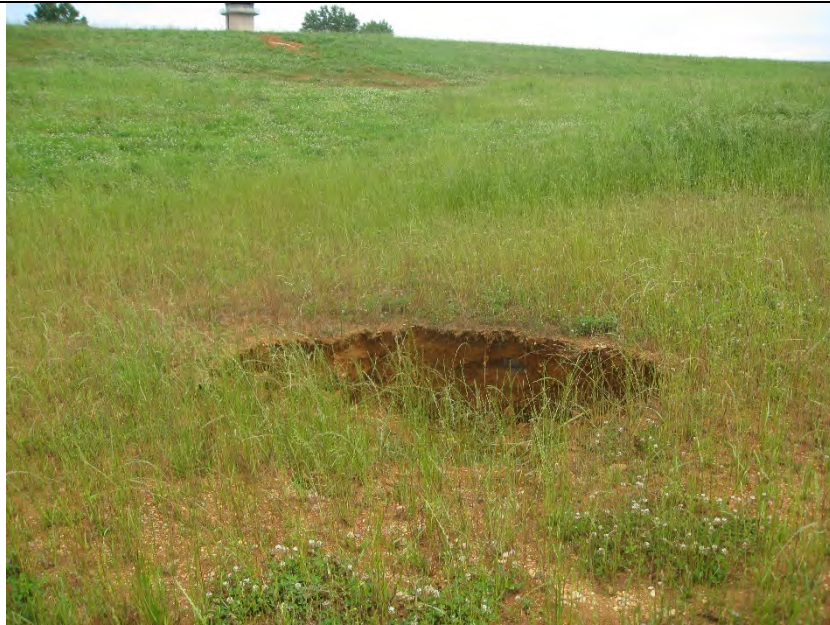
Photo 32  
Sta. 341+50 LT  
(RW 5L-23R)  
Between ES Endwall 104 and 102  
Project 3

Fourth construction fallout on Storm Line 1 between ES Endwall 104 and 102.  
Coordinate remediation with CHA.

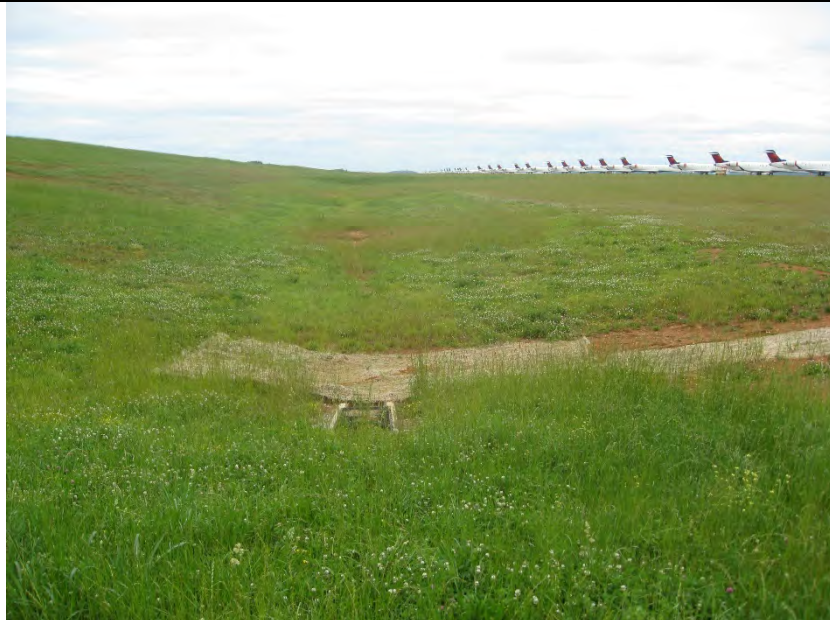
Photo 33  
Sta. 341+50 LT  
(RW 5L-23R)  
Between ES Endwall 104 and 102  
Project 3

Fifth construction fallout on Storm Line 1 between ES Endwall 104 and 102.  
Coordinate remediation with CHA.

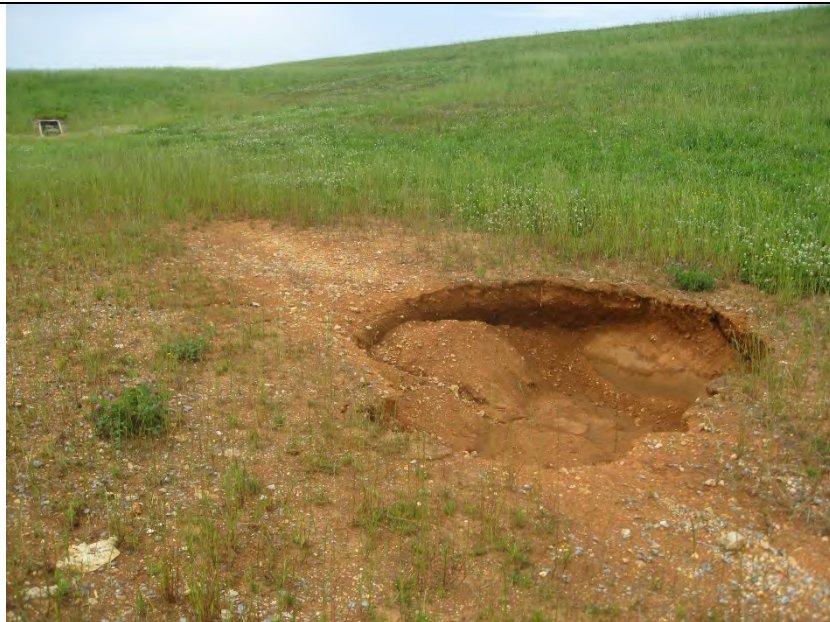
Photo 35  
Sta. 347+31 LT  
(RW 5L-23R)  
ES Endwall 102  
Project 3

Enhanced Swale Endwall 102.  
Recommend stabilizing remaining bare areas.

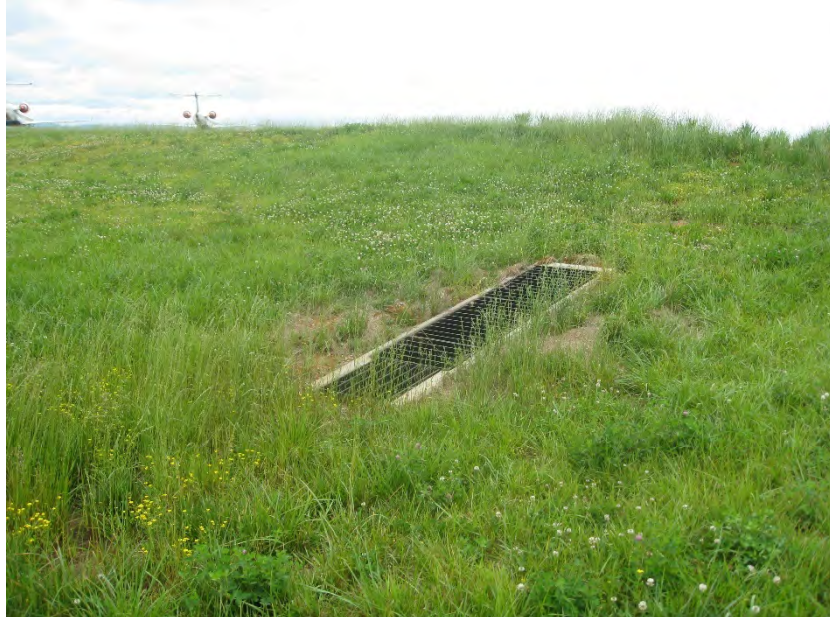
Photo 37  
Sta. 354+75 LT  
(RW 5L-23R)  
ES Endwall 100  
Project 2

Enhanced Swale Endwall 100.

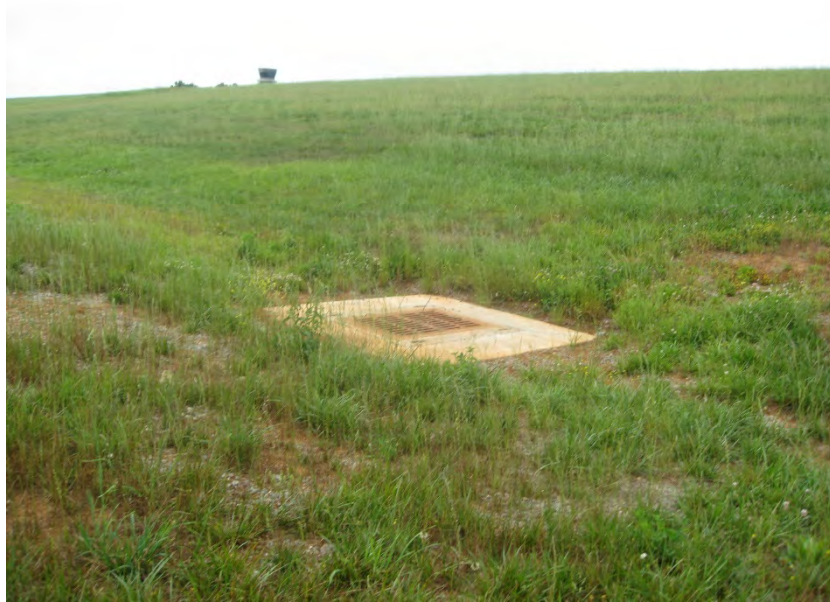
Photo 38  
Sta. 354+75 LT  
(RW 5L-23R)  
ES Endwall 100  
Project 3

Enhanced Swale Endwall 100.

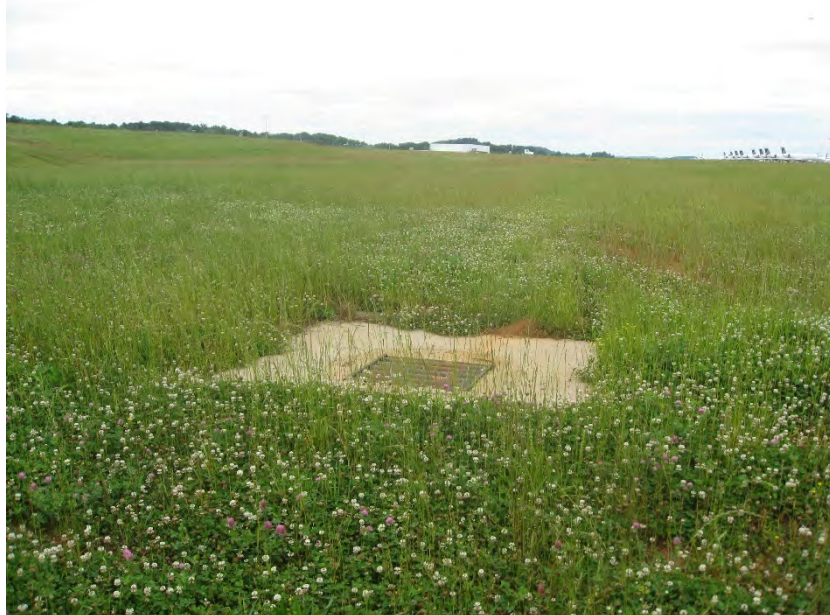
Photo 39  
Sta. 361+39 LT  
(RW 5L-23R)  
Structure 100  
Project 3

Structure 100.  
Recommend stabilizing remaining bare areas.

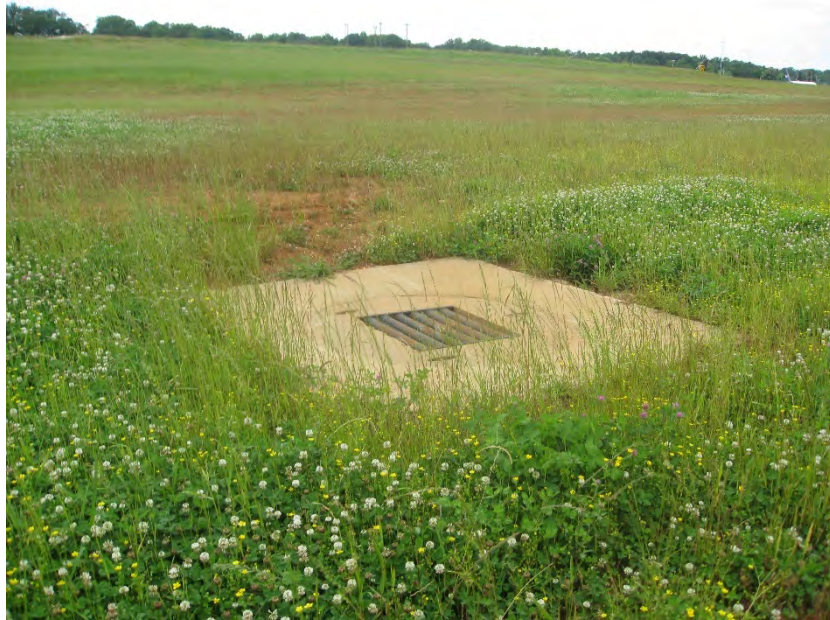
Photo 40  
Sta. 363+35 LT  
(RW 5L-23R)  
Existing Structure  
Project 2

Existing Structure.

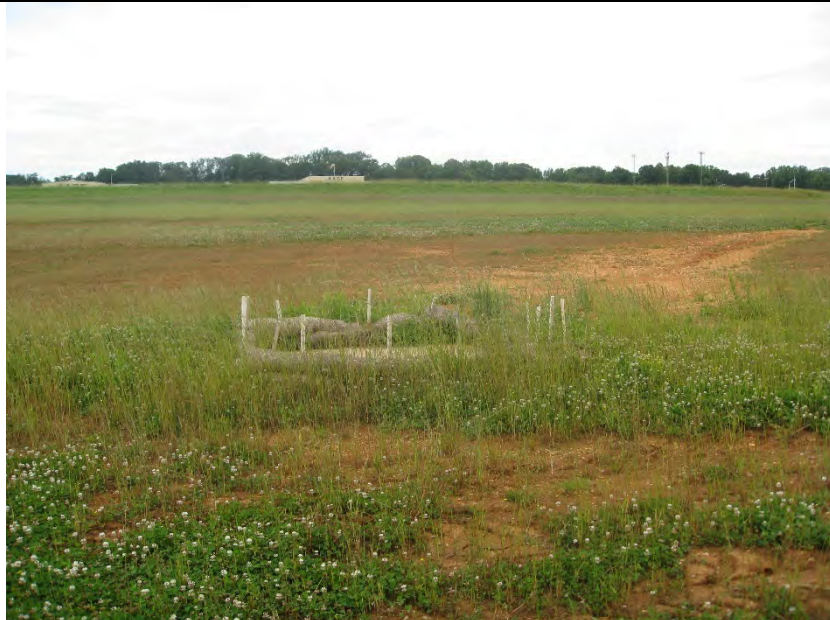
Photo 41  
Sta. 366+25 LT  
(RW 5L-23R)  
Existing Structure  
Project 2

Existing Structure.  
Recommend stabilizing bare areas.

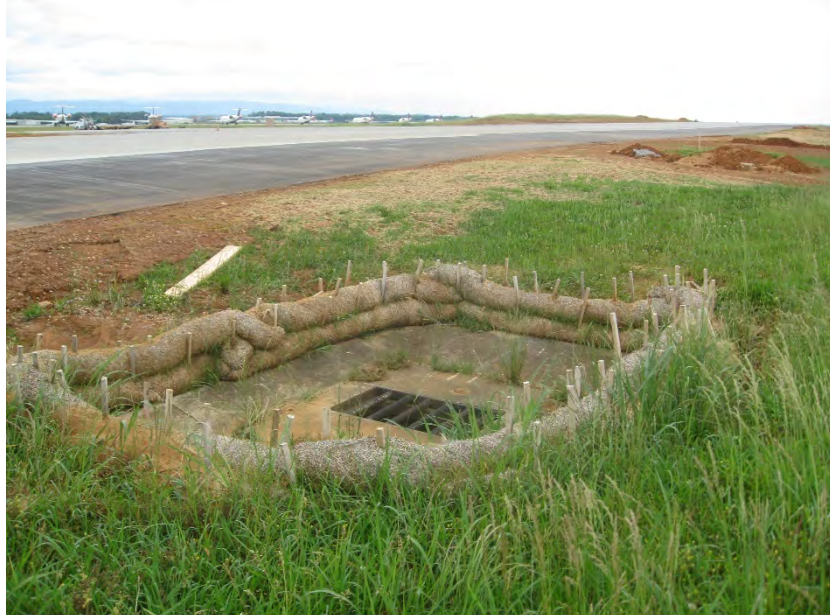
Photo 43  
Sta. 677+00 RT  
(RW 5L-23R)  
Existing Structure  
Project 4

Structure south of Taxiway "G".  
Slopes recently regraded.  
Recommend stabilizing bare areas.

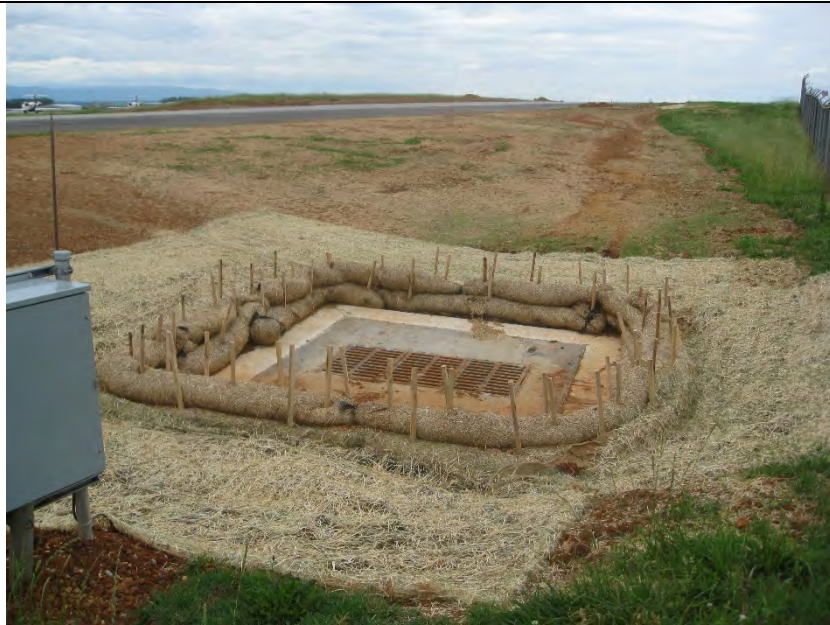
Photo 44  
Sta. 677+00 RT  
(RW 5L-23R)  
Project 4

Structure between Taxiway G and UPS Facility.

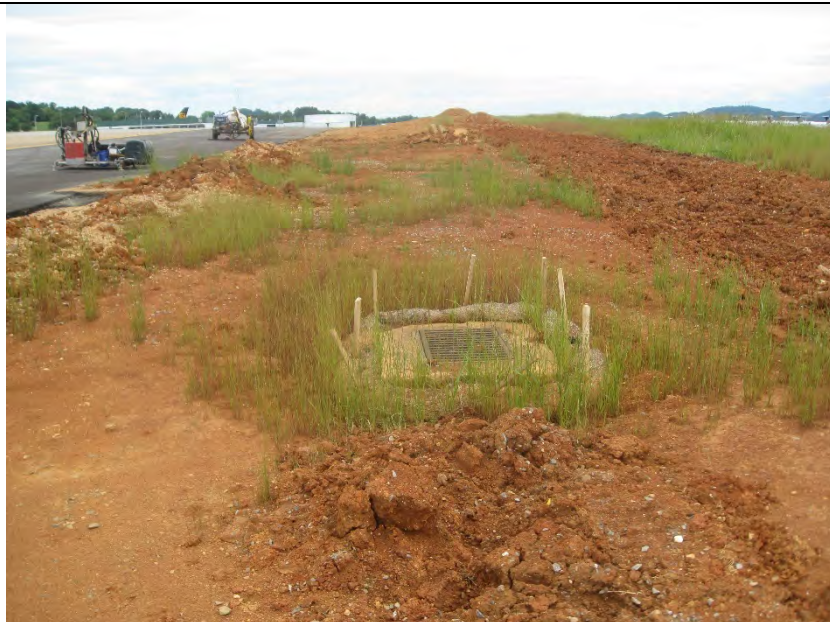
Photo 45  
Sta. 676+00 RT  
(RW 5L-23R)  
Project 4

New structure recently placed.  
Area recently backfilled, inlet protection installed, and erosion control blanket installed.

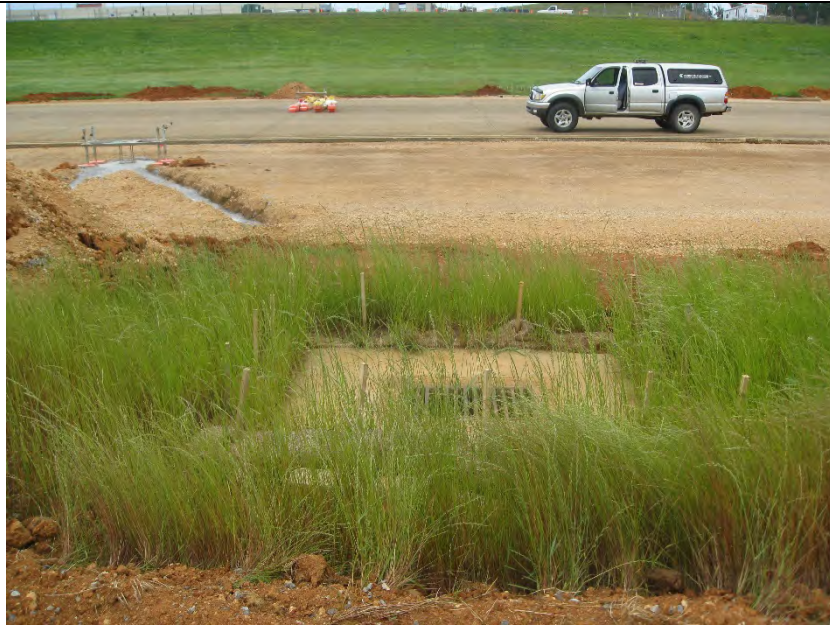
Photo 46  
(RW 5L-23R)  
Existing Structure  
Project 4

Existing structure south of Taxiway G  
Area recently regraded, recommend stabilizing bare areas.

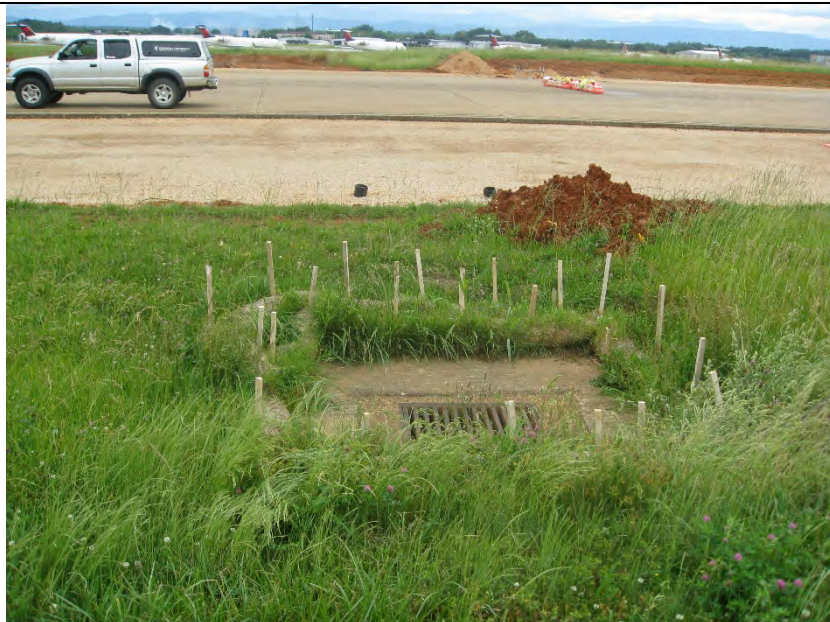
Photo 47  
(RW 5L-23R)  
Existing Structure  
Project 4

Existing structure south of Taxiway G.

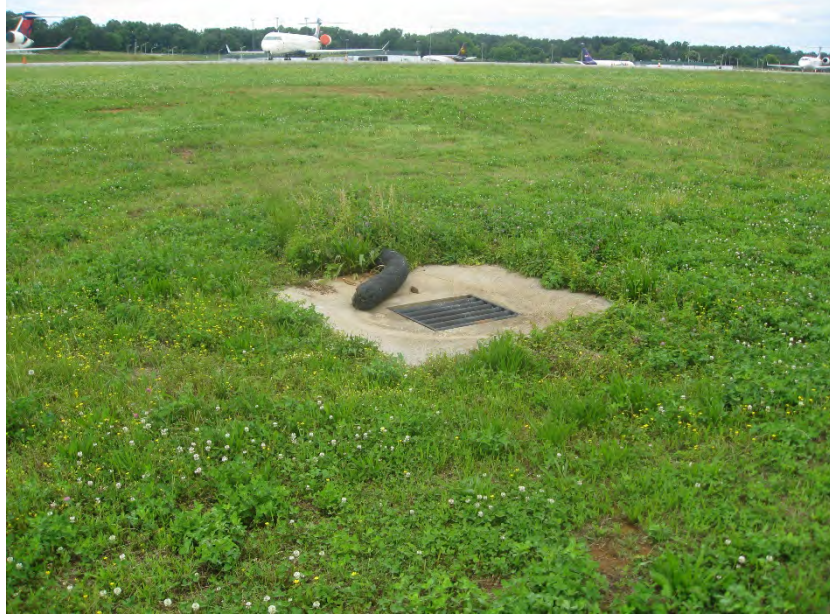
Photo 48  
(RW 5L-23R)  
Existing Structure  
Project 4

Existing structure north of Taxiway G.

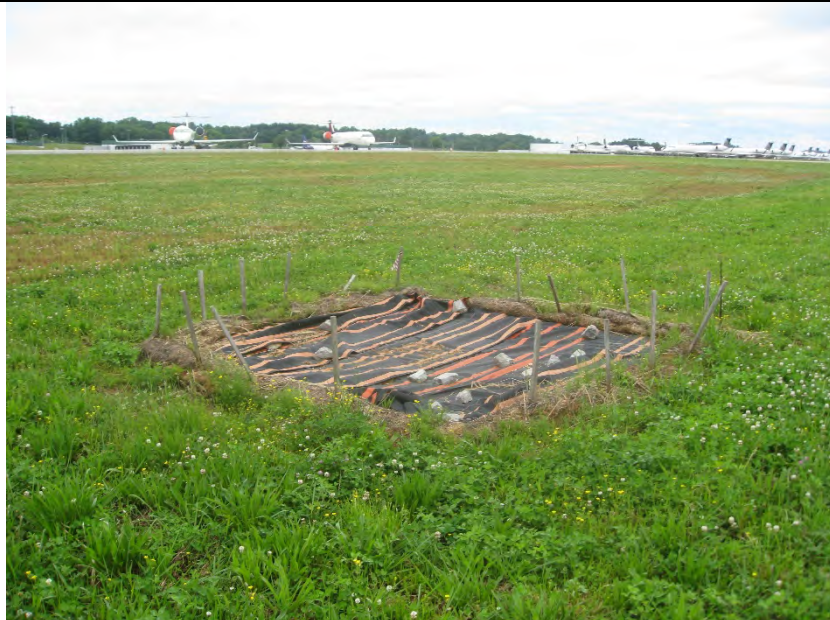
Photo 49  
Sta. 366+89 RT  
(RW 5L-23R)  
Existing Structure  
Project 4

Existing Structure adjacent to Outfall C.

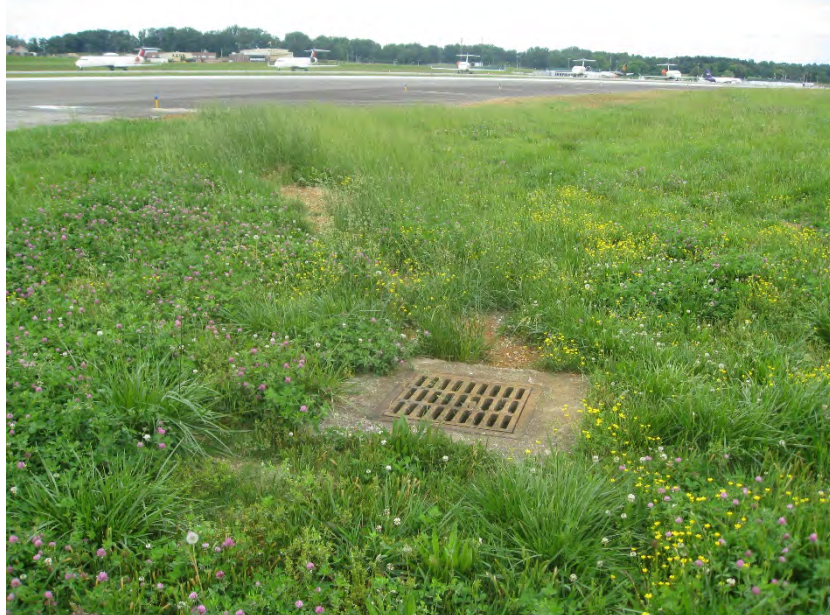
Photo 51  
Sta. 365+69 RT  
(RW 5L-23R)  
Structure 300  
Project 4

Structure 300.  
Recommend stabilizing bare areas.

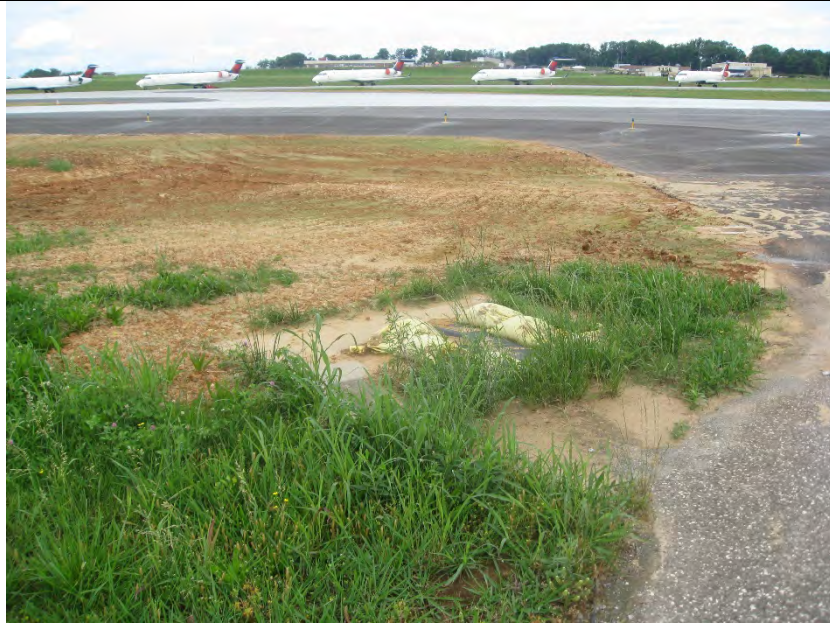
Photo 52  
(RW 5L-23R)  
TWY Y Tie-in  
Project 4

Existing structure north of Taxiway Y.

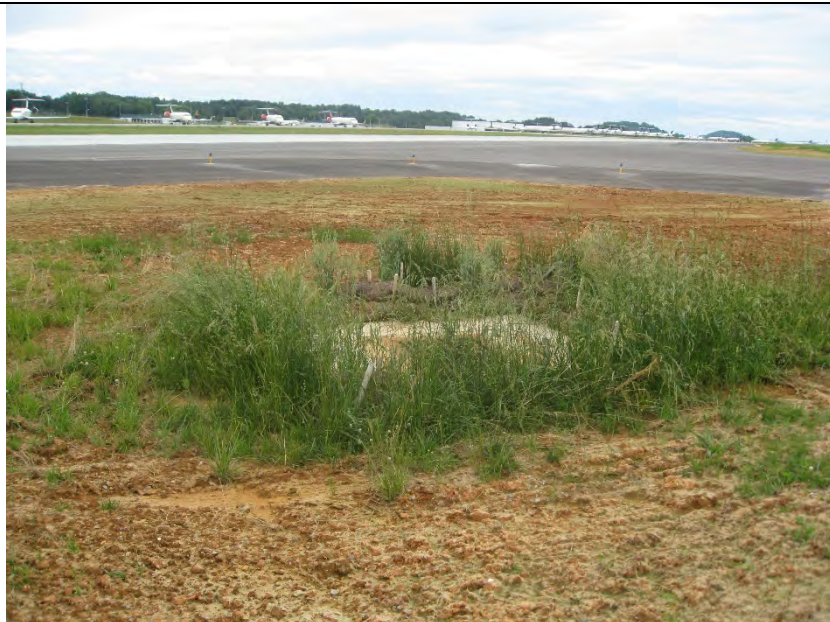
Photo 53  
(RW 5L-23R)  
TWY Y Tie-in  
Project 4

Existing structure south of Taxiway Y.  
Area recently stabilized.

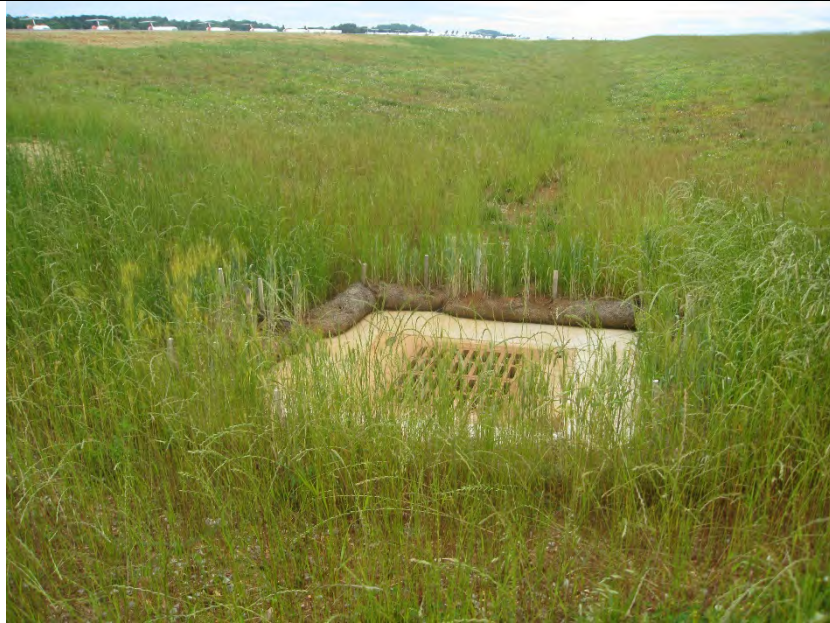
Photo 54  
Sta. 362+02 LT  
(RW 5L-23R)  
Structure 400  
Project 4

Structure 400.  
Area recently stabilized.

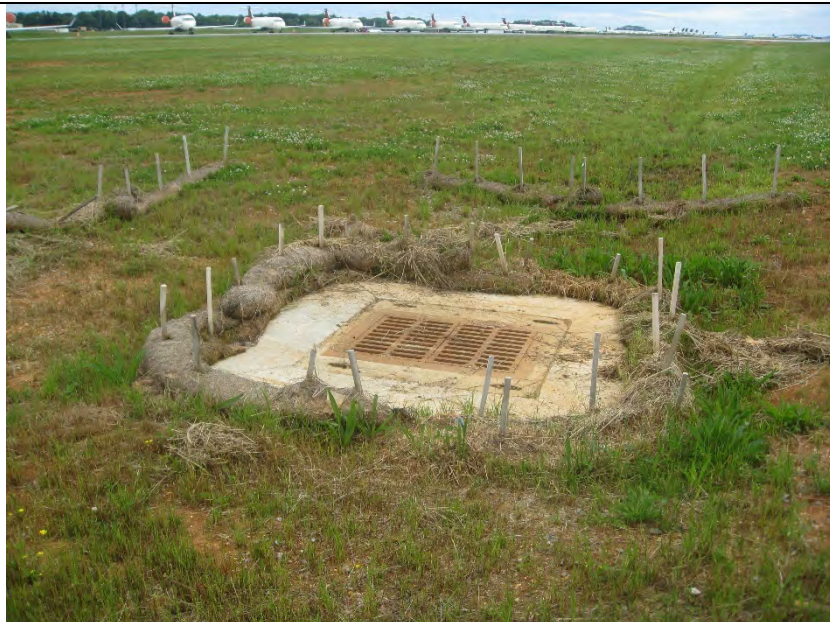
Photo 57  
Sta. 347+26 RT  
(RW 5L-23R)  
Structure 22  
Project 4

Structure 22.  
Sediment tubes recently relocated to edge of sod. Recommend stabilizing bare areas.
