**QUALITY ASSURANCE  
MONTHLY SITE  
ASSESSMENT REPORT**

Airfield Modernization Program  
Runway 5L-23R Reconstruction  
Project 2 / Project 3

## QUALITY ASSURANCE SITE ASSESSMENT

## **AIRFIELD MODERNIZATION PROGRAM RUNWAY 5L-23R RECONSTRUCTION**

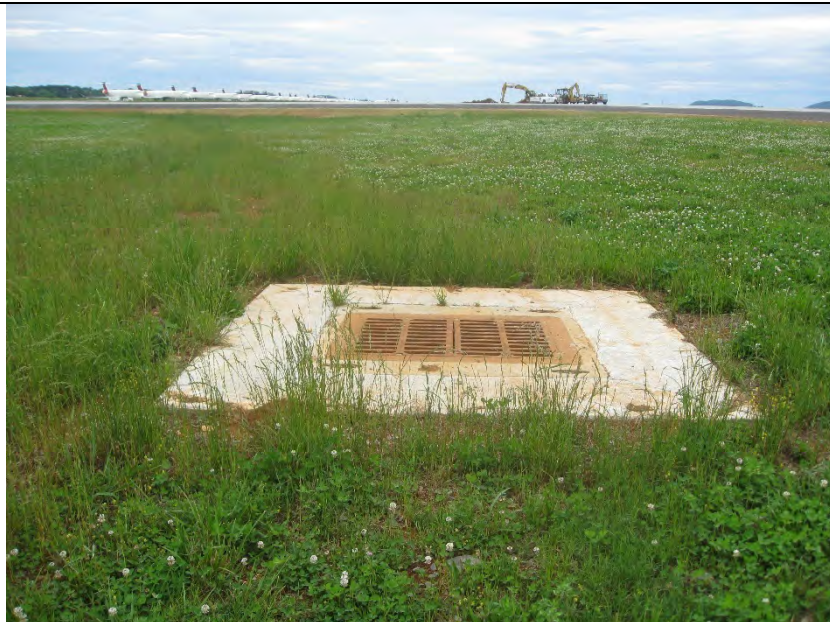
Photo 59  
Sta. 347+26 RT  
(RW 5L-23R)  
Structure 202  
Project 4

Structure 202.  
Shoulders recently stabilized.  
Recommend stabilizing remaining bare areas.

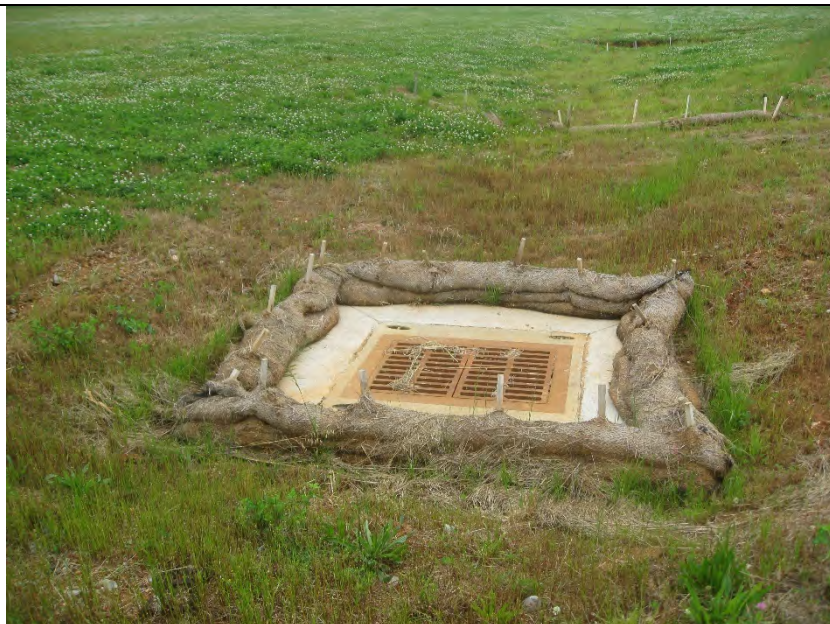
Photo 61  
Sta. 341+86 RT  
(RW 5L-23R)  
Project 4

Construction fallout on Storm Line 2 between structures 204 and 206.  
Recommend coordinating remediation with CHA.

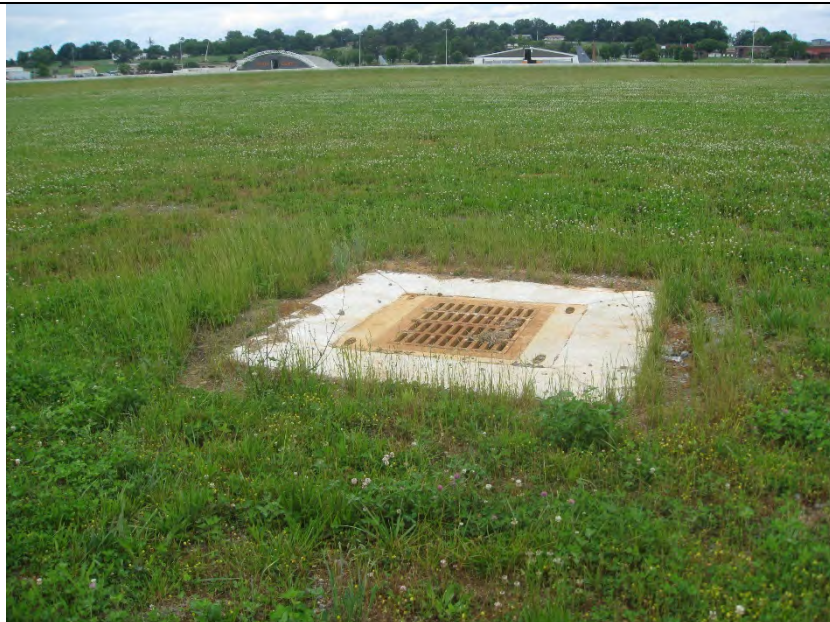
Photo 63  
(RW 5L-23R)  
Project 4

Construction fallout on Storm Line 2 between structures 206 and 208.  
Recommend coordinating remediation with CHA.

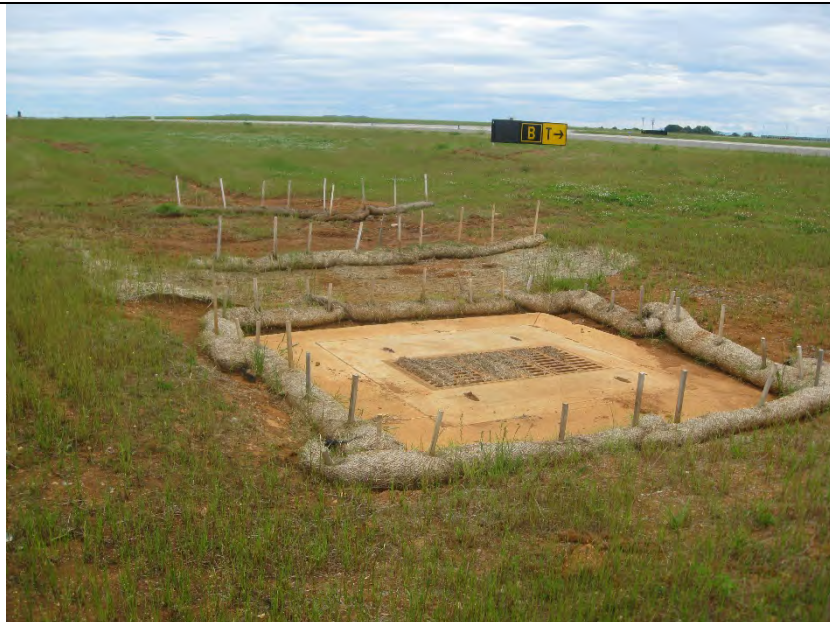
Photo 65  
Sta. 329+86 RT  
(RW 5L-23R)  
Structure 210  
Project 3

Structure 210.  
Recommend stabilizing bare areas above sediment tubes.

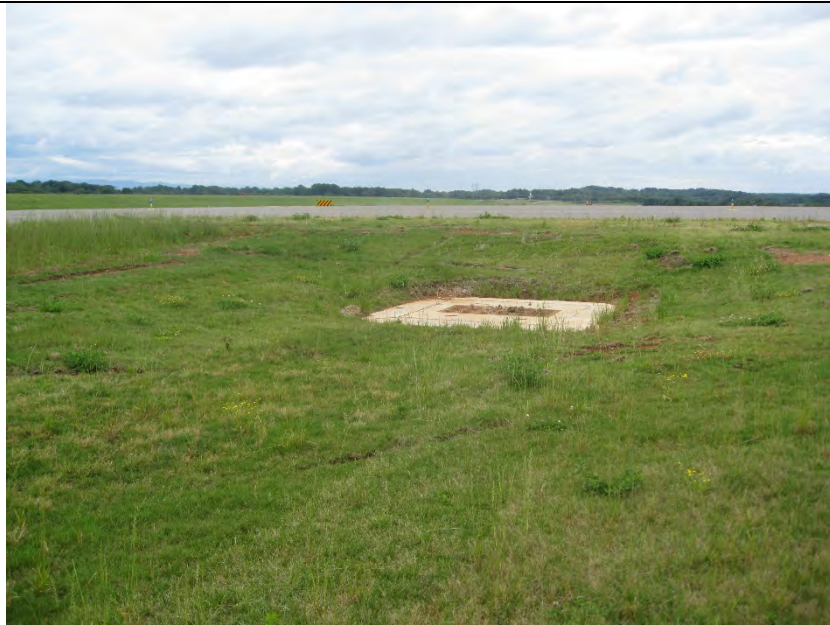
Photo 66  
Sta. 321+73 RT  
(RW 5L-23R)  
Structure 212  
Project 3

Structure 212.  
Sediment removed from top of structure.  
Erosion blanket recently installed.

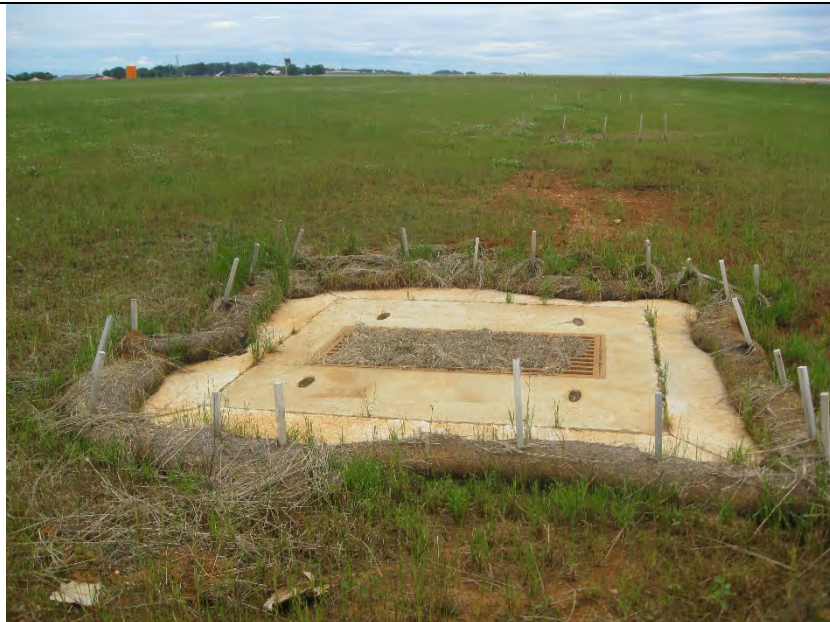
Photo 67  
Sta. 314+32 RT  
(RW 5L-23R)  
Structure 214  
Project 3

Structure 214.

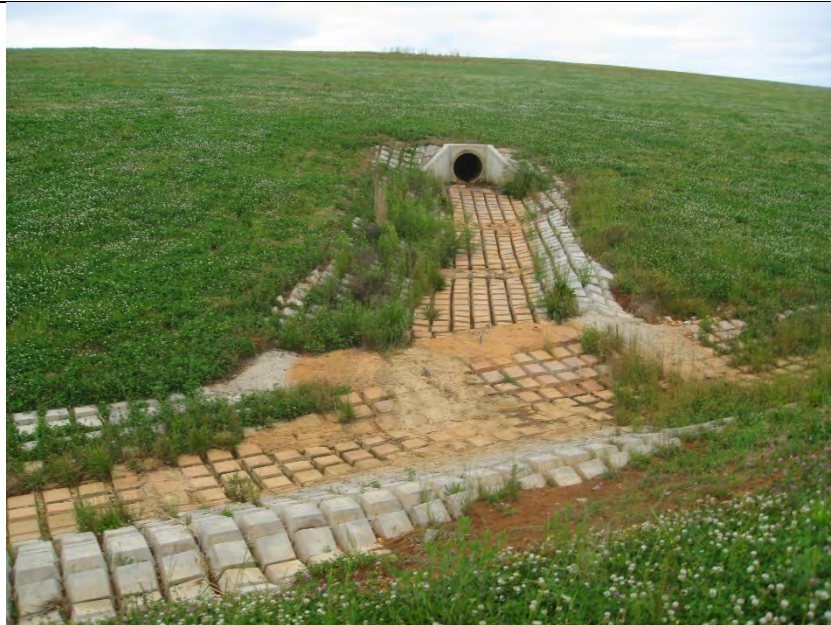
Photo 70  
Sta. 296+83 RT  
(RW 5L-23R)  
Structure 220  
Project 2

Structure 220.  
Recommend stabilizing remaining bare areas.

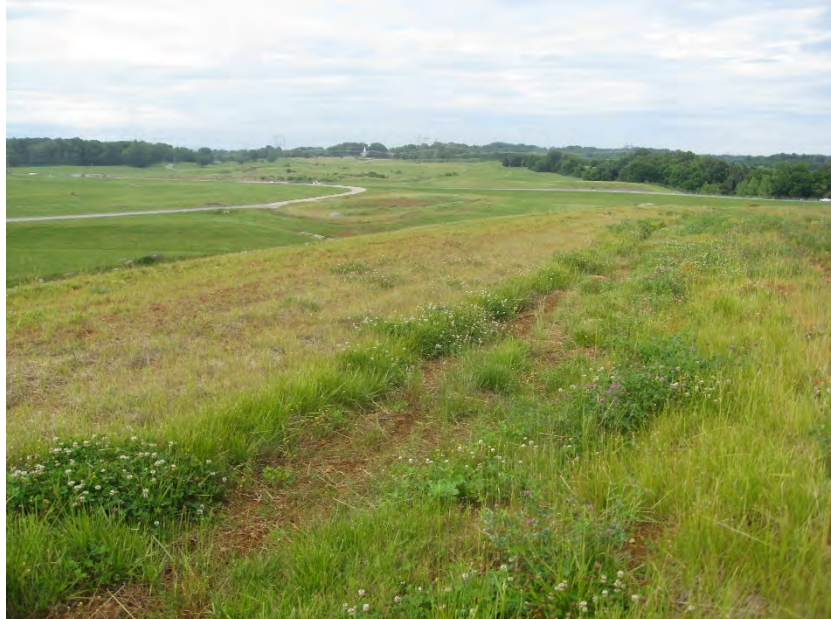
Photo 71  
Sta. 288+26  
(RW 5L-23R)  
Structure 224  
Project 2

Structure 224.

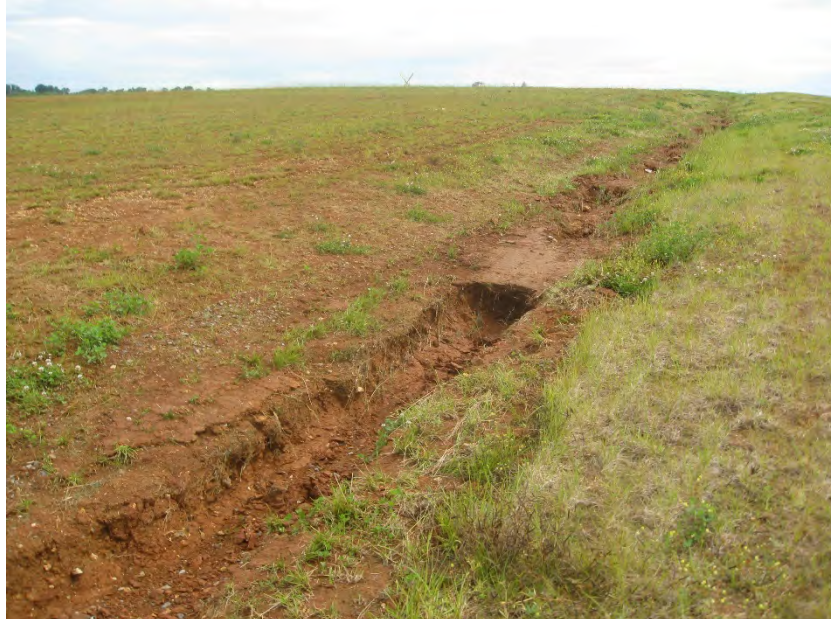
Photo 73  
Sta. 290+26 RT  
(RW 5L-23R)  
Structure 222  
Project 2

Structure 222.  
Recommend removing inlet protection.  
Recommend stabilizing bare areas.

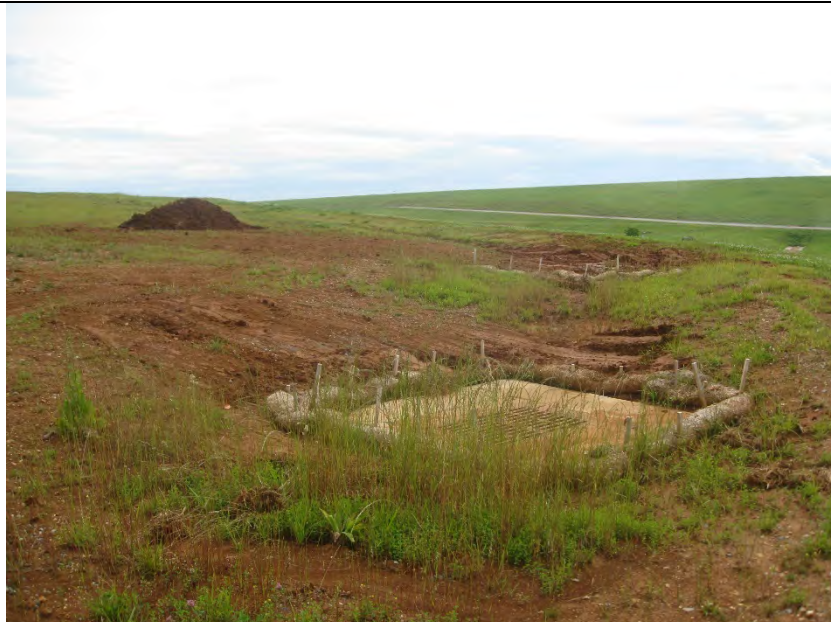
Photo 75  
Sta. 290+26 RT  
(RW 5L-23R)  
Structure 600 Ditch  
Project 2

Structure 600 ditch.  
Sediment recently removed from ditch line and stock piled.  
Recommend stabilizing bare areas.

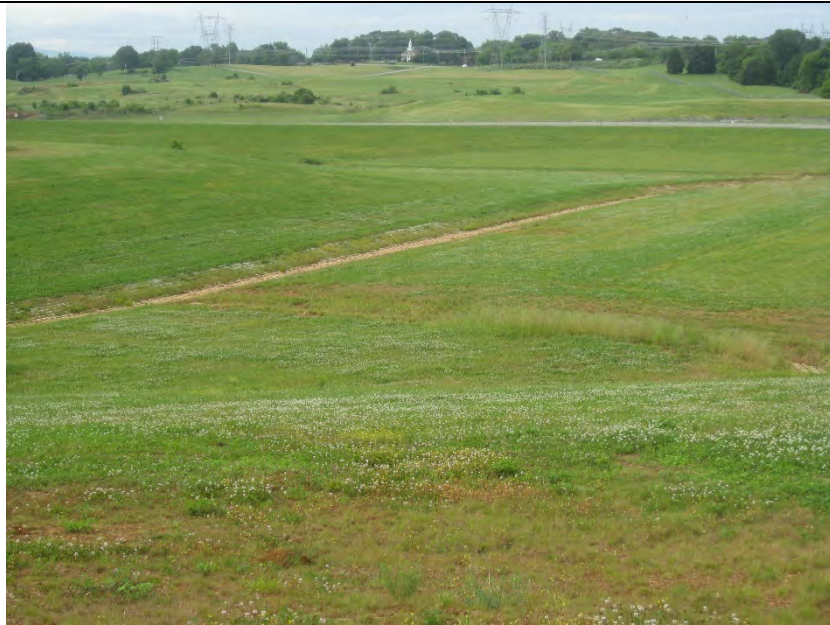
Photo 76  
Sta. 284+59  
(RW 5L-23R)  
Structure 600  
Project 3

Structure 600.  
Recommend stabilizing bare areas.

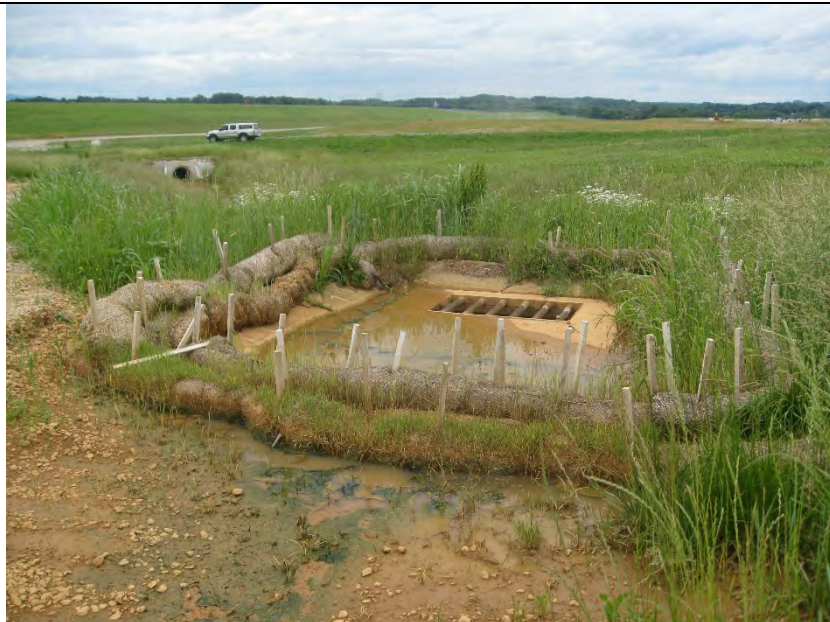
Photo 77  
Sta. 282+45 RT  
(RW 5L-23R)  
Structure 602  
Project 2

Ditch line at Structure 602.

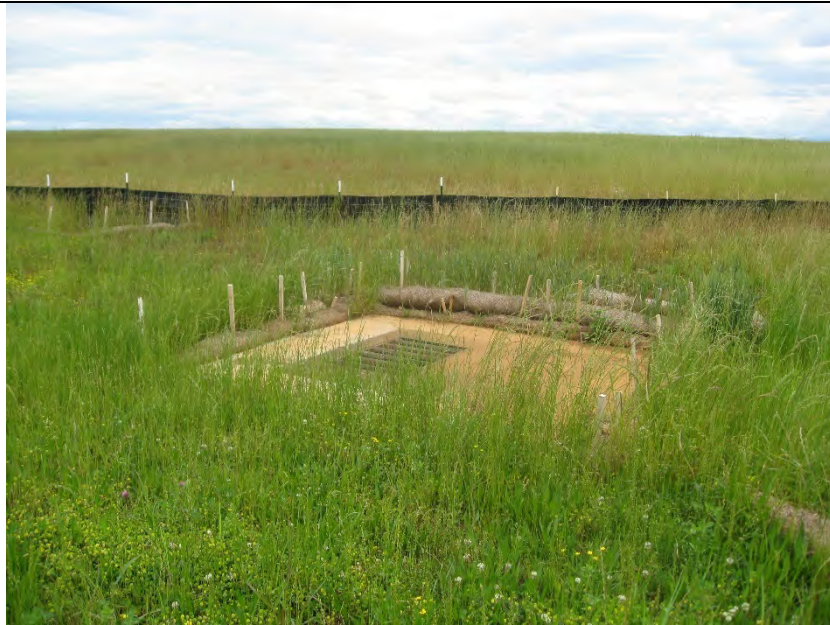
Photo 78  
(RW 5L-23R)  
Project 3

Existing structure at stone stockpile area.

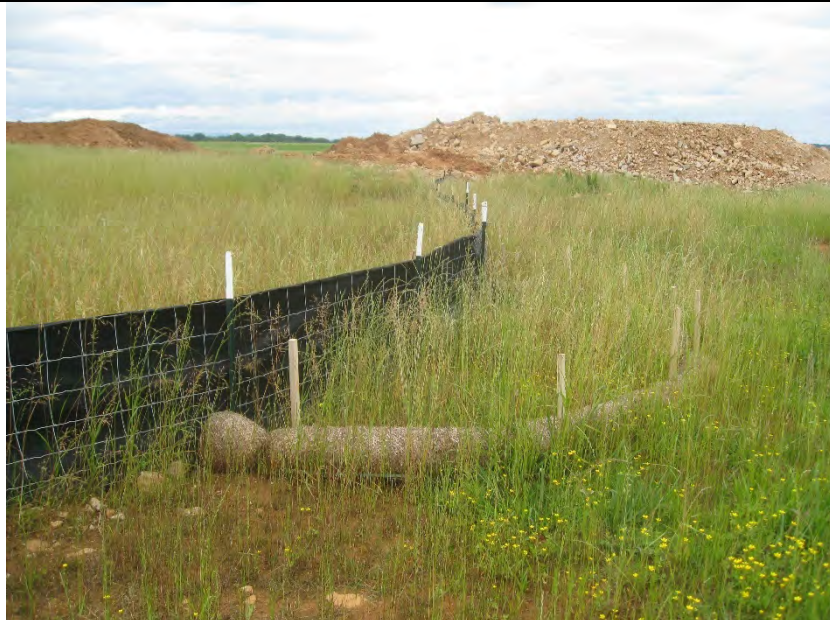
Photo 79  
(RW 5L-23R)  
Project 3

Existing structure.

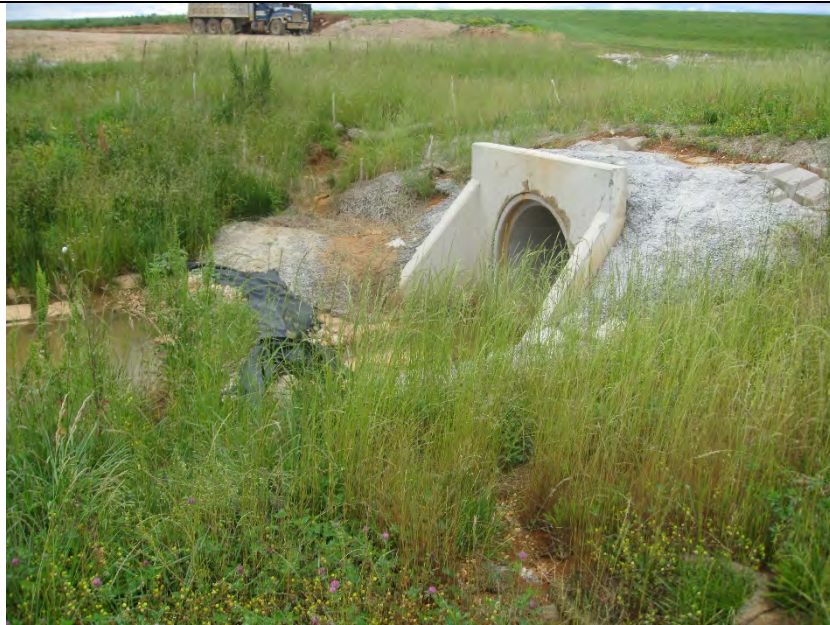
Photo 80  
(RW 5L-23R)  
Project 3

Above existing structure.

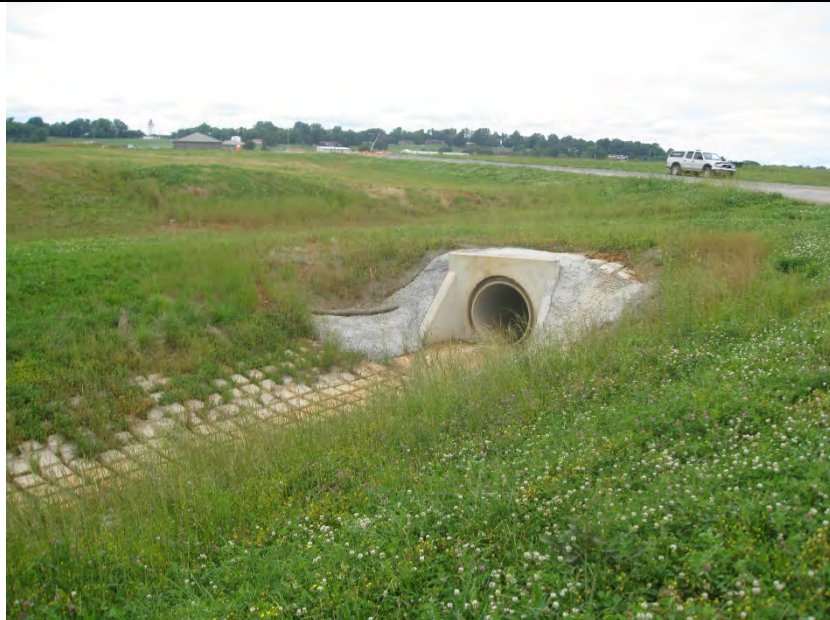
Photo 81  
Sta. 39+00 CL  
Proposed Haul Route  
Project 3

Inlet side of 54" haul route crossing culvert.

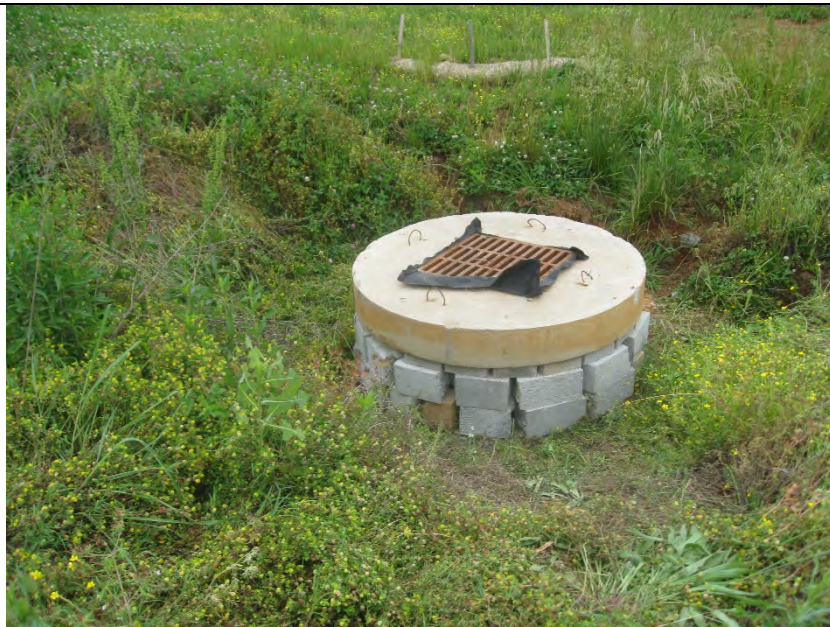
Photo 82  
Sta. 39+00 CL  
Proposed Haul Route  
Project 3

Outlet side of 54" haul route crossing culvert.

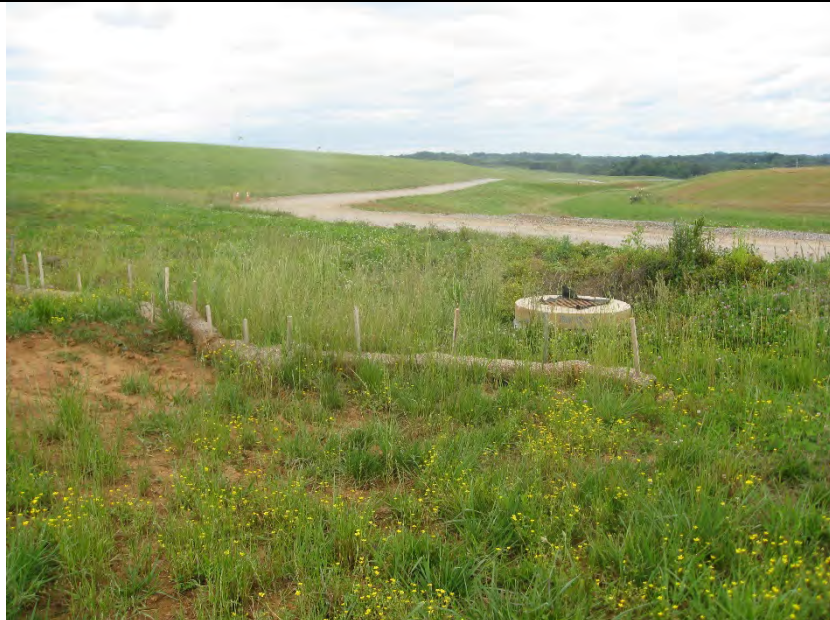
Photo 83  
Sta. 37+25 RT  
Proposed Haul Route  
Project 3

Inlet structures along haul road.  
Structures undergoing reconstruction into traditional man holes at time of inspection.

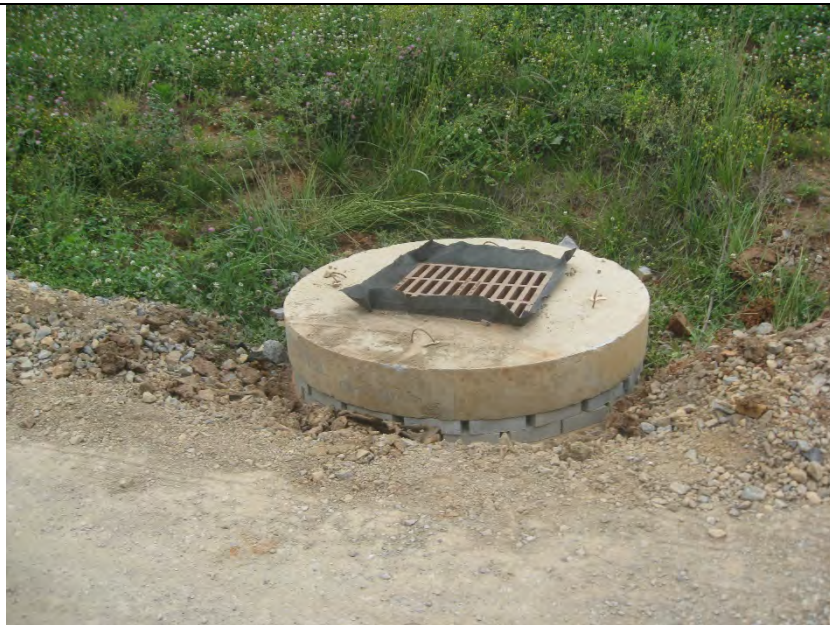
Photo 84  
Sta. 37+25 RT  
Proposed Haul Route  
Project 3

Inlet structures along haul road.  
Recommend stabilizing bare areas.

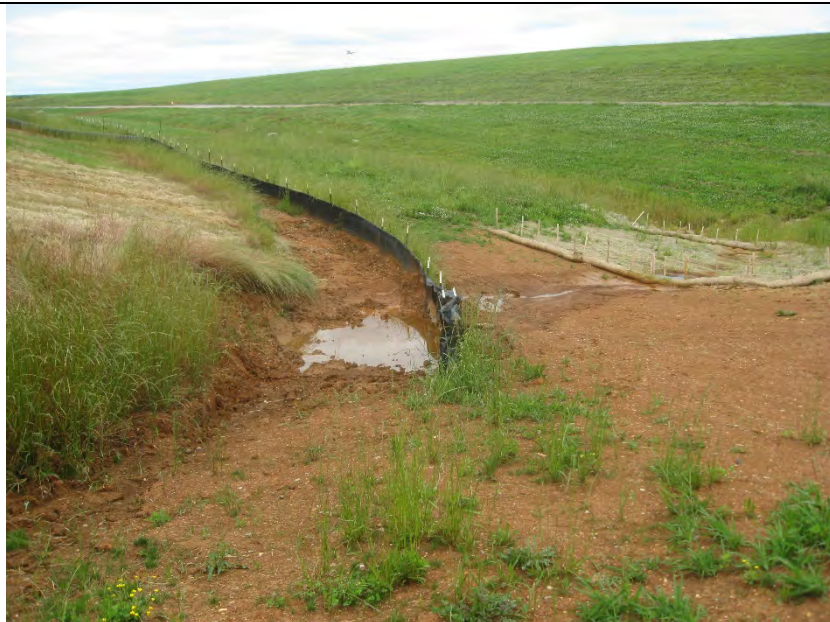
Photo 85  
Sta. 32+50 RT  
Proposed Haul Route  
Project 3

Inlet structures along haul road.  
Structures undergoing reconstruction into traditional man holes at time of inspection.

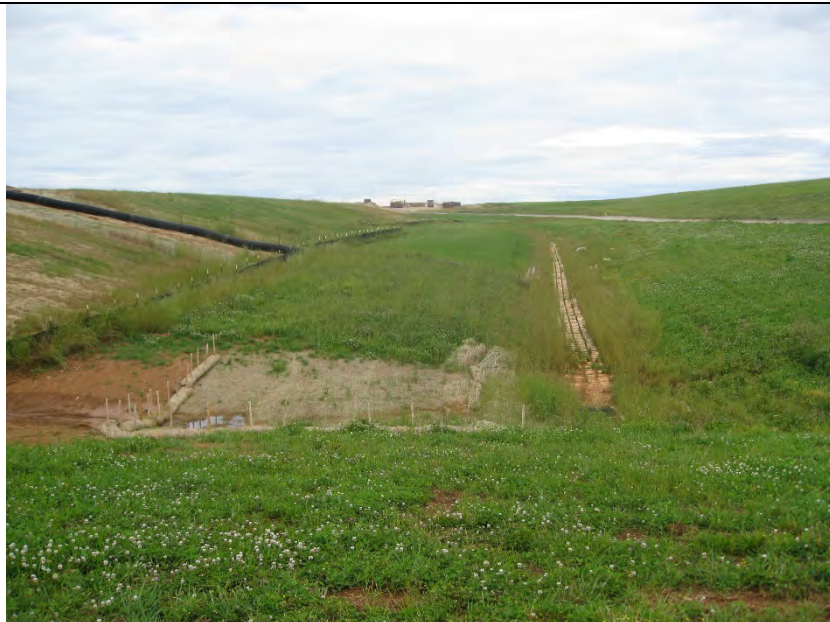
Photo 87  
Sta. 302+54  
(RW 5L-23R)  
Project 2

Soil stockpile area next to haul road at Taxiway B.  
Berm recently reworked.  
Recommend reinstalling sediment tubes to wrap around front of slope drain and tie into berms.

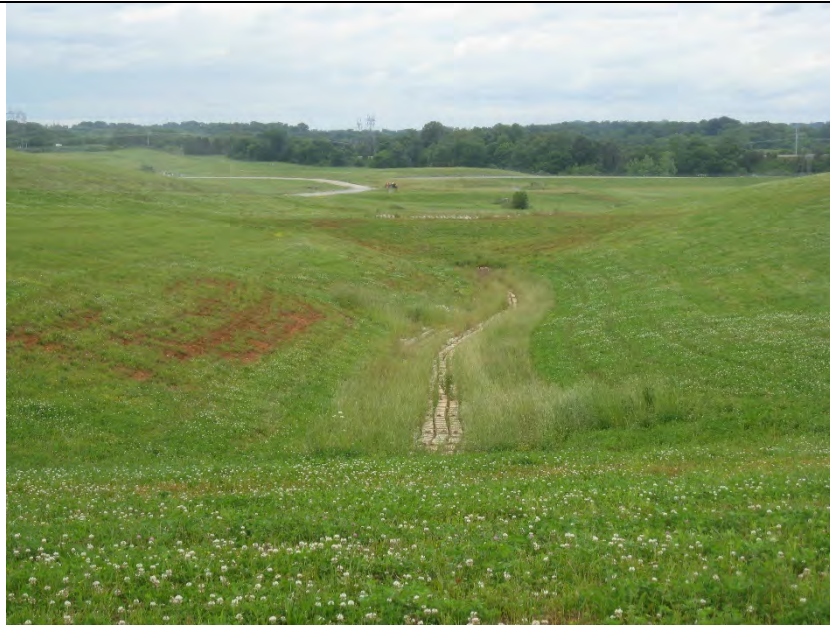
Photo 88  
Sta. 302+54 to Sta. 313+50  
(RW 5L-23R)  
Project 2

North Lateral Endwall 100.  
Erosion control blanket and sediment tubes recently added.  
Recommend stabilizing bare areas.

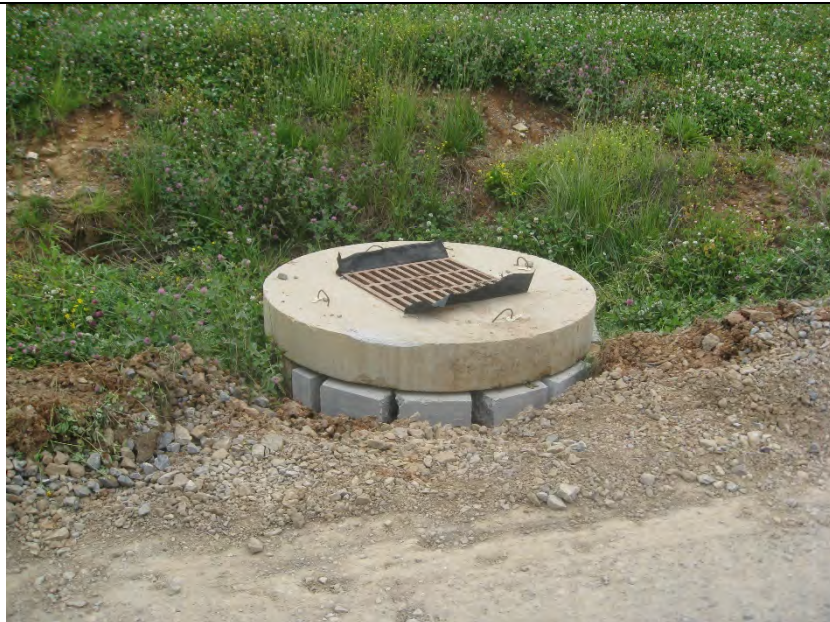
Photo 89  
Sta. 300+60  
(RW 5L-23R)  
Project 2

North Lateral Endwall 102.

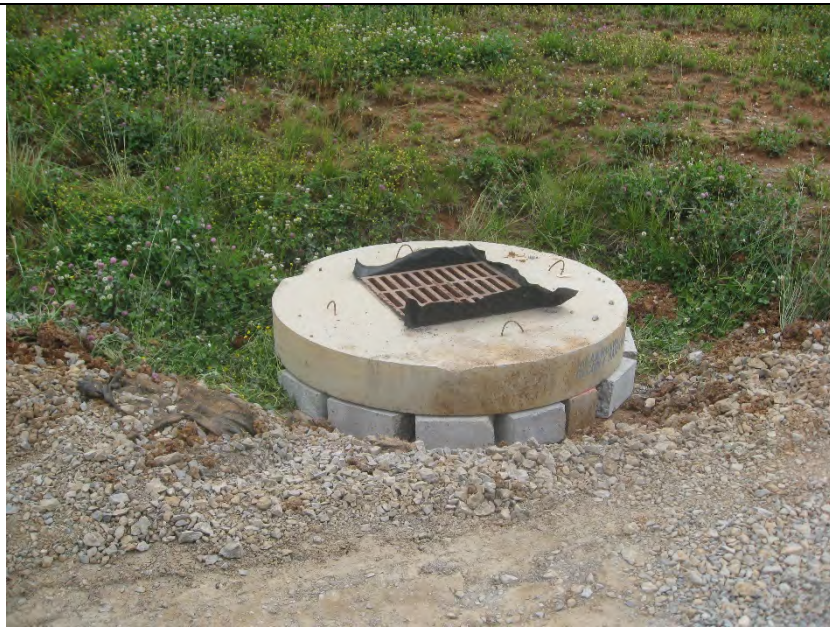
Photo 90  
Sta. 29+00 RT  
Proposed Haul Route  
Project 3

Inlet structures along haul road.

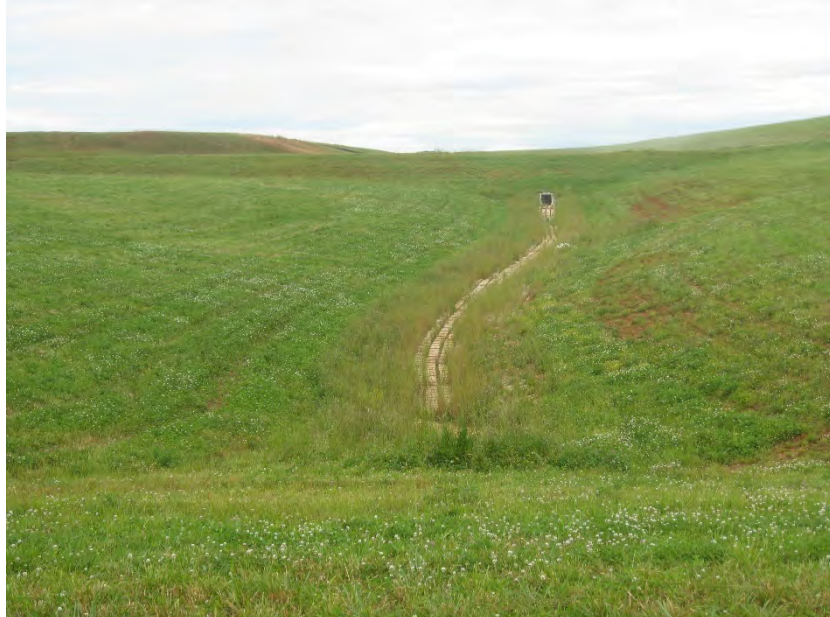
Photo 91  
Sta. 25+50 RT  
Proposed Haul Route  
Project 3

Inlet structures along haul road.

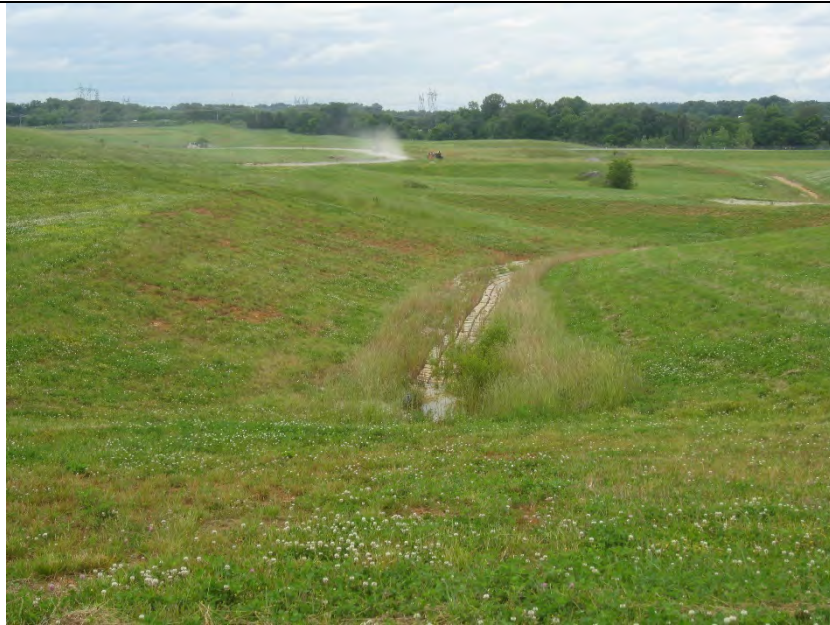
Photo 92  
Sta. 297+01  
(RW 5L-23R)  
Project 2

North Lateral Endwall 104.

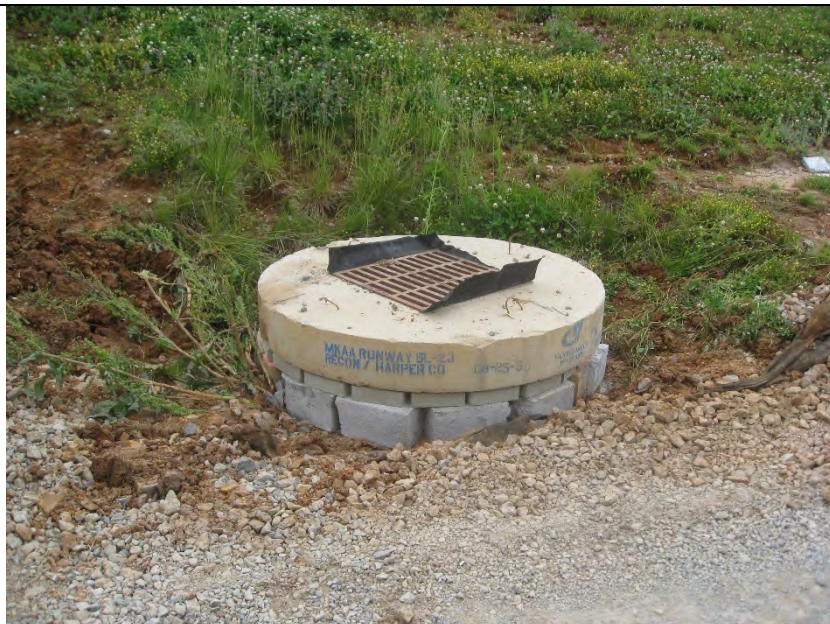
Photo 93  
Sta. 295+10  
(RW 5L-23R)  
Project 2

North Lateral Endwall 106.

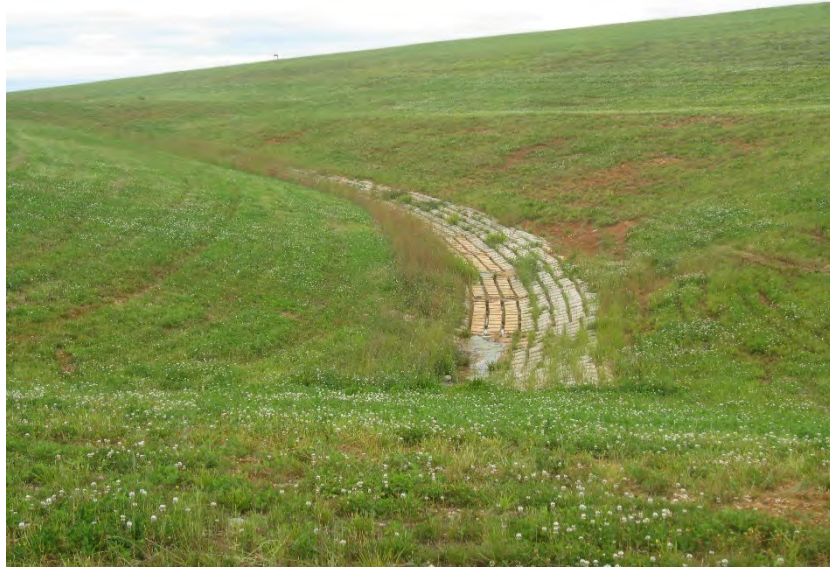
Photo 94  
Sta. 22+00 RT  
Proposed Haul Route  
Project 3

Inlet structures along haul road.

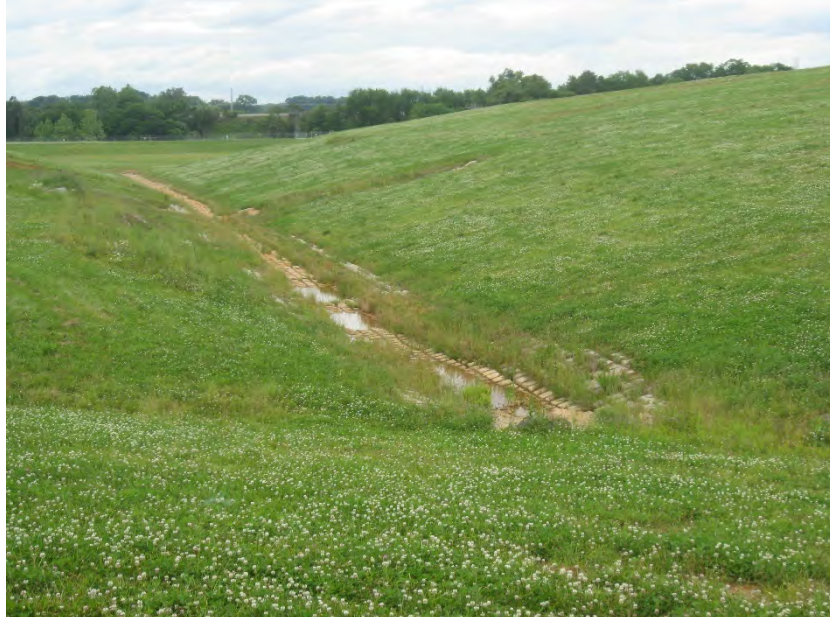
Photo 95  
Sta. 292+08  
(RW 5L-23R)  
Project 2

North Lateral Endwall 108.

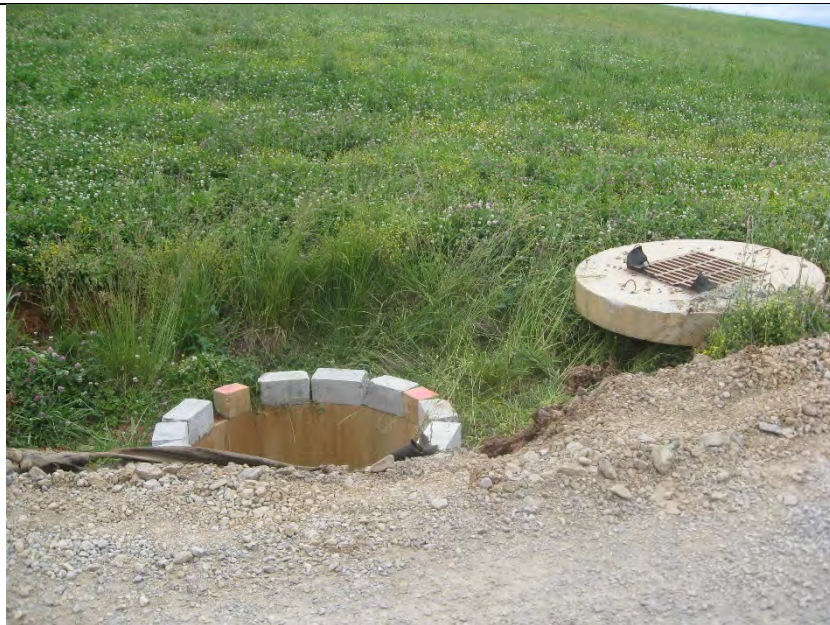
Photo 96  
Sta. 290+50 LT  
(RW 5L-23R)  
Project 2

North Lateral Endwall 110.

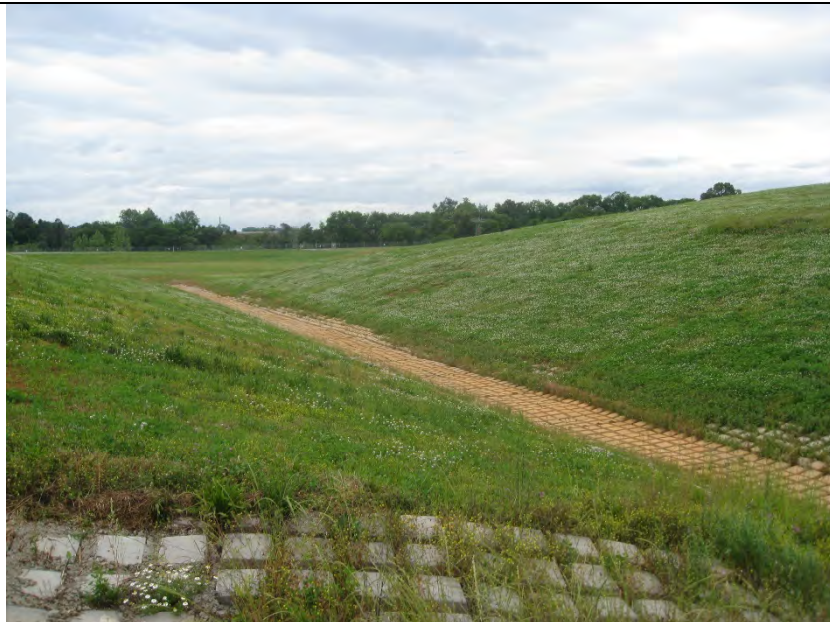
Photo 97  
Sta. 15+50 RT  
Proposed Haul Route  
Project 3

Inlet structures along haul road.

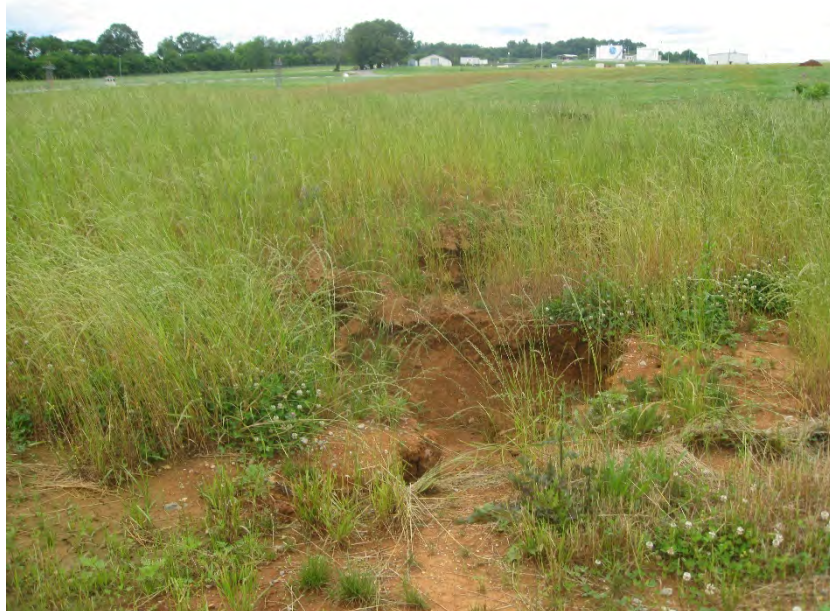
Photo 99  
Sta. 284+00 LT  
(RW 5L-23R)  
Project 2

Existing vault at old Liberty street.  
Construction fallout present. Recommend coordinating with CHA on remediation.

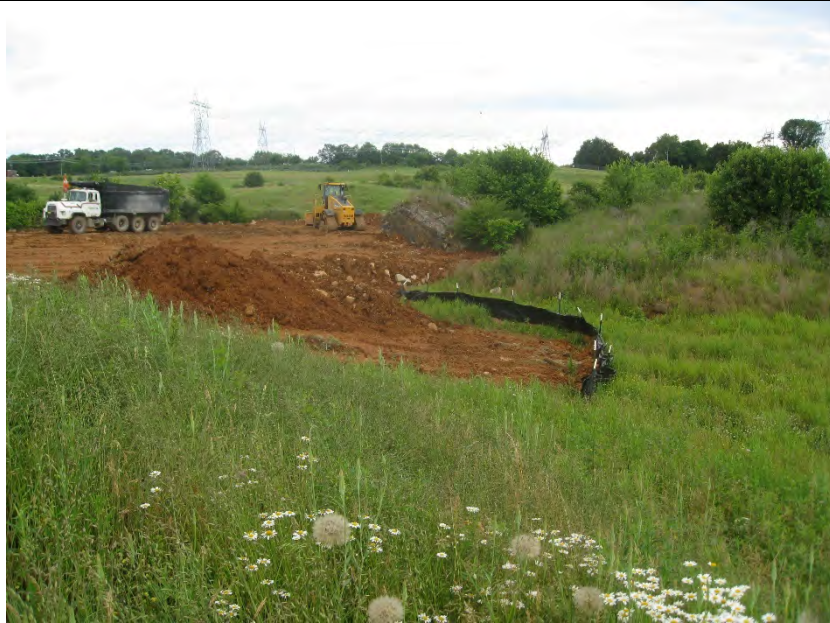
Photo 100  
Sta. 284+00 LT  
(RW 5L-23R)  
Project 2

Previous soil stockpile at old Liberty Street.  
Construction fallout present. Recommend coordinating with CHA on remediation.

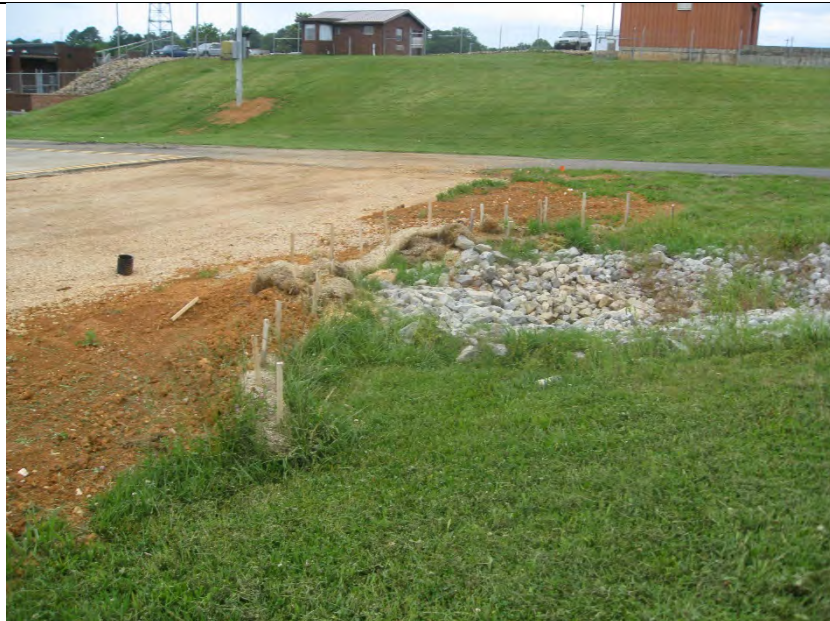
Photo 101  
(Repair TWY Lighting)

Fill area adjacent to Liberty Street from Taxiway shoulder removal.

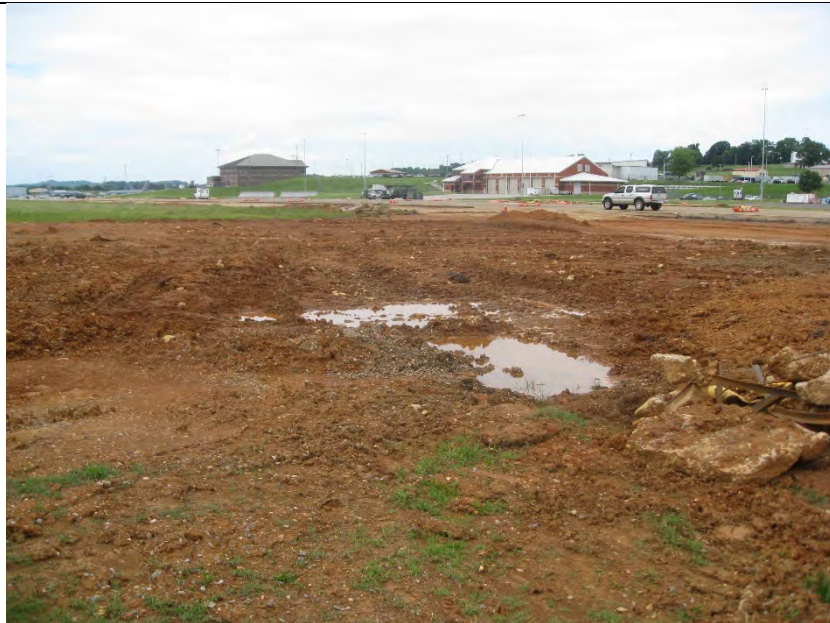
Photo 103  
(Repair TWY Lighting)  
Sheet EC2.1.7

Existing structure at Upper Apron.  
Base stone recently installed. Area appears to be stable.  
Recommend continuing to monitor for possible sediment migration and/or color contrasted water entering apron storm structures.

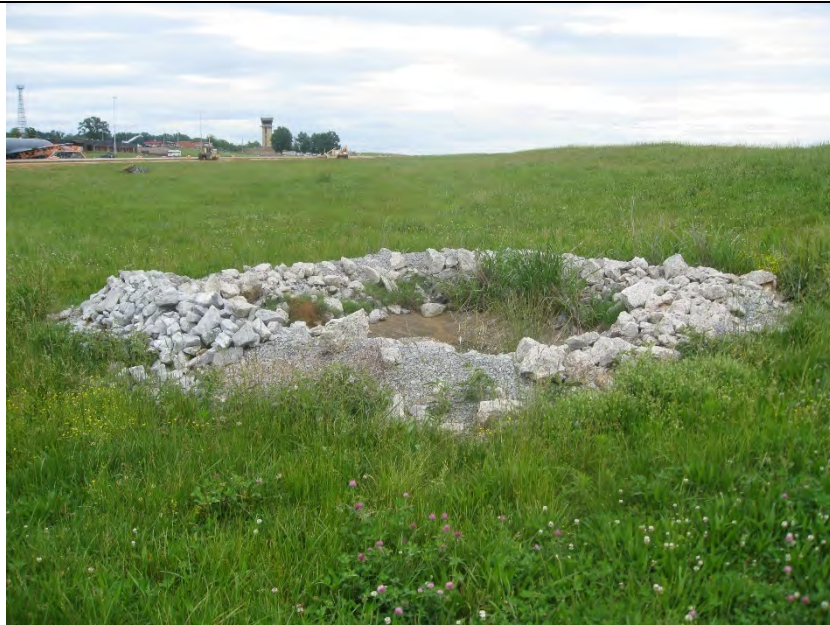
Photo 105  
(Repair TWY Lighting)  
Sheet EC2.1.6

Existing structure adjacent to Taxiway G4 being demolished.  
Original inlet protection from Project 2 in place and appears to be properly functioning.

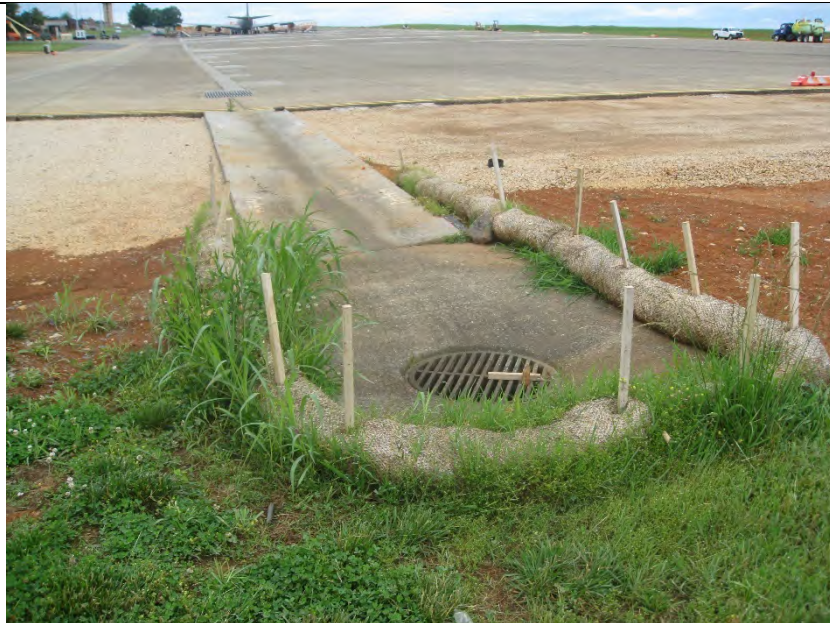
Photo 106  
(Repair TWY Lighting)  
Sheet EC2.1.5

Existing structure at Upper Apron.  
Newly installed underdrain recently backfilled and sediment tubes reinstalled.

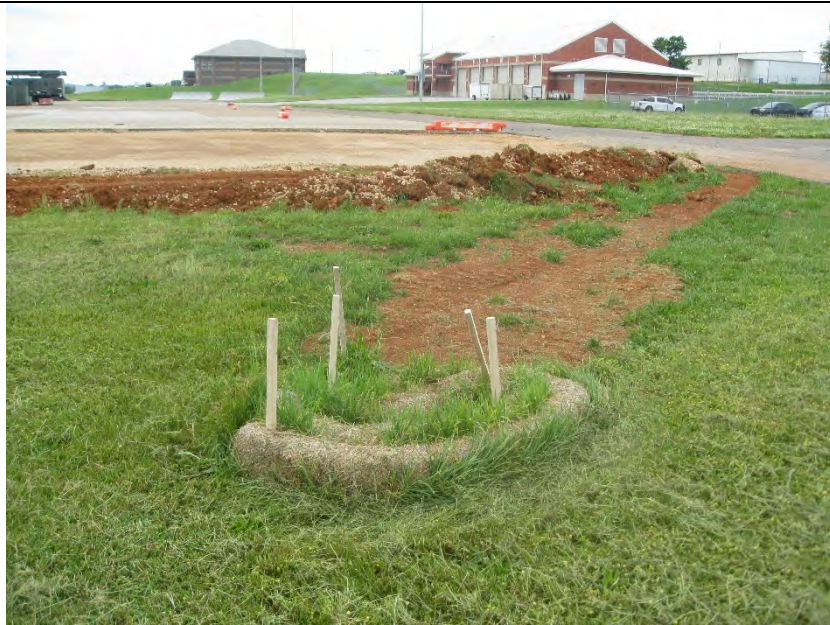
Photo 107  
(Repair TWY Lighting)  
Sheet EC2.1.5

Existing structure at Upper Apron.  
Newly installed underdrain recently backfilled.

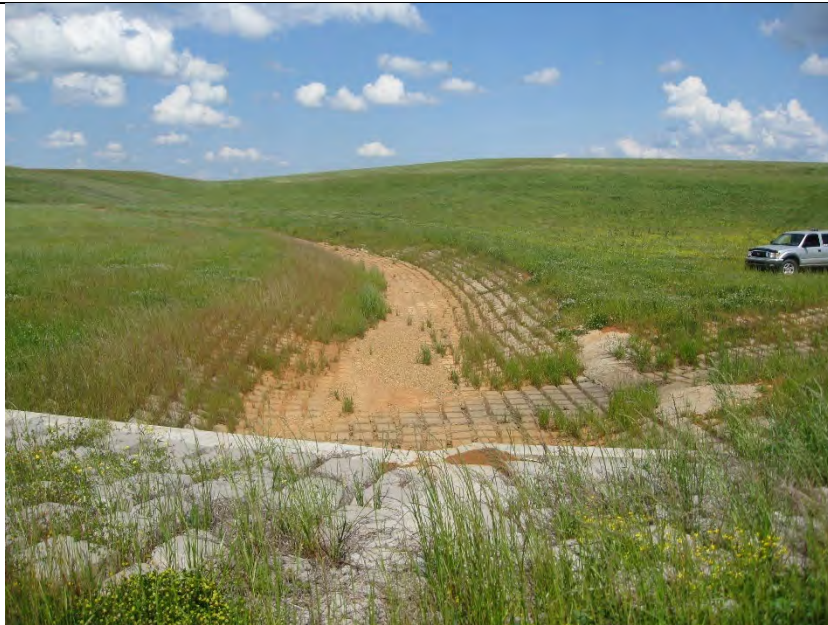
Photo 1  
Sta. 111+56 RT  
(Line LB)  
NLET 01  
Project 2

North Lateral End Treatment 01 (Outfall A).

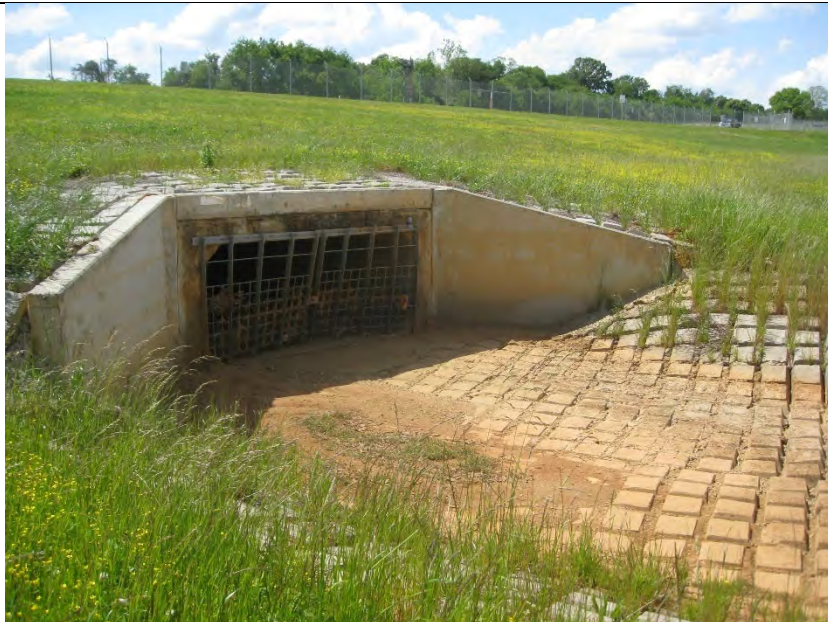
Photo 2  
Sta. 111+56 RT  
(Line LB)  
NLET 01  
Project 2

North Lateral End Treatment 01 (Outfall A).

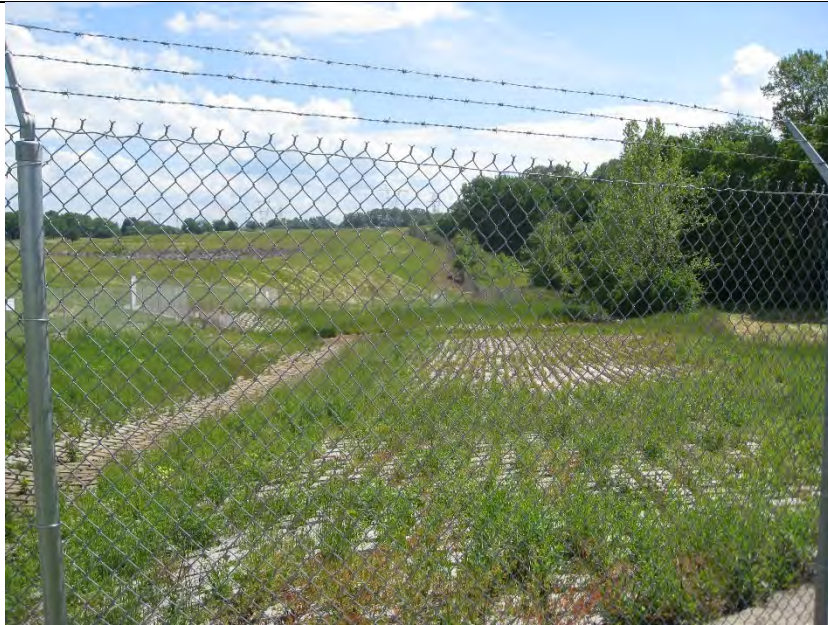
Photo 3  
Sta. 111+82 LT  
(Line LB)  
NLET 02  
Project 2

North Lateral Box Culvert outlet (NLET 02) Outfall A-1.  
This section of the site was inaccessible at time of inspection.

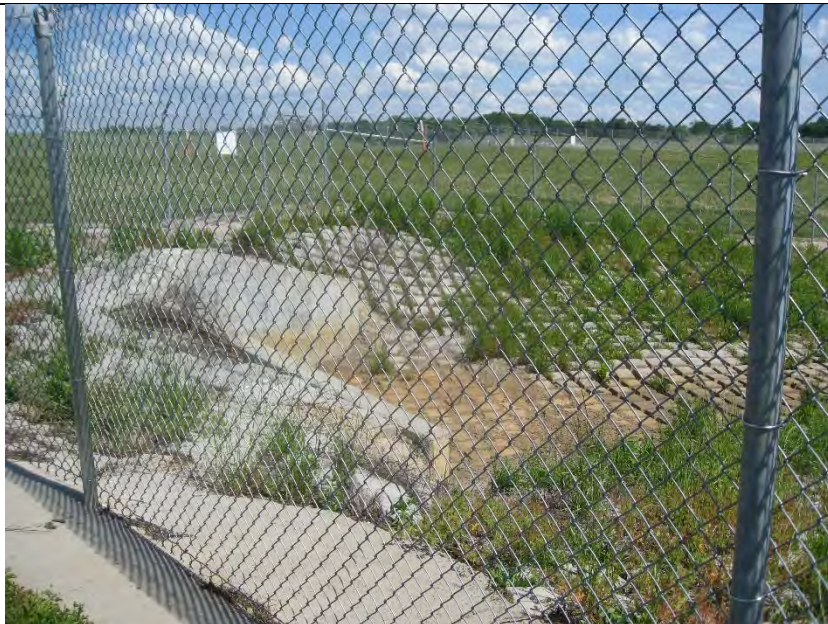
Photo 4  
Sta. 114+00 LT  
(Line LB)  
GLET 02  
Project 2

Guard Lateral Box Culvert outlet (GLET 02) Outfall B-1.  
This section of the site was inaccessible at time of inspection.
