**QUALITY ASSURANCE  
MONTHLY SITE  
ASSESSMENT REPORT**

Airfield Modernization Program  
Runway 5L-23R Reconstruction  
Project 2 / Project 3

## QUALITY ASSURANCE SITE ASSESSMENT

## **AIRFIELD MODERNIZATION PROGRAM RUNWAY 5L-23R RECONSTRUCTION**

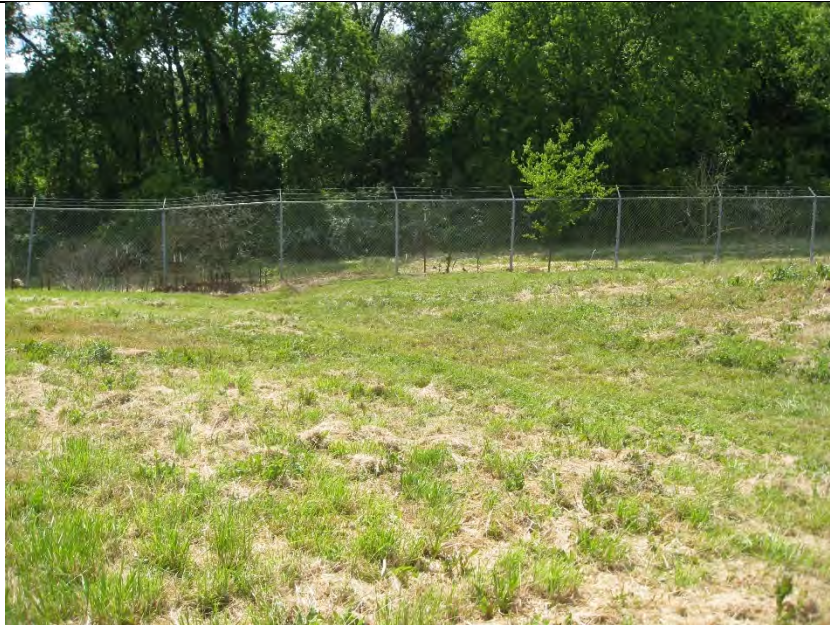
Photo 5  
Sta. 115+28  
(Line LB)  
Project 2

Grass established at ditch line along Liberty Street (Outfall C-1).

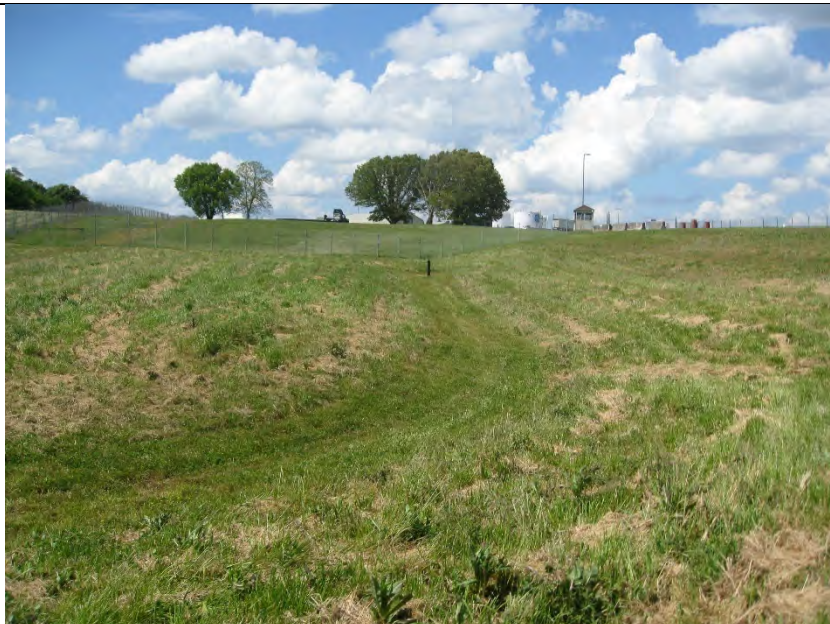
Photo 6  
Sta. 115+28 to Sta. 121+45  
(Line LB)  
Project 2

Grass established at ditch line along Liberty Street.

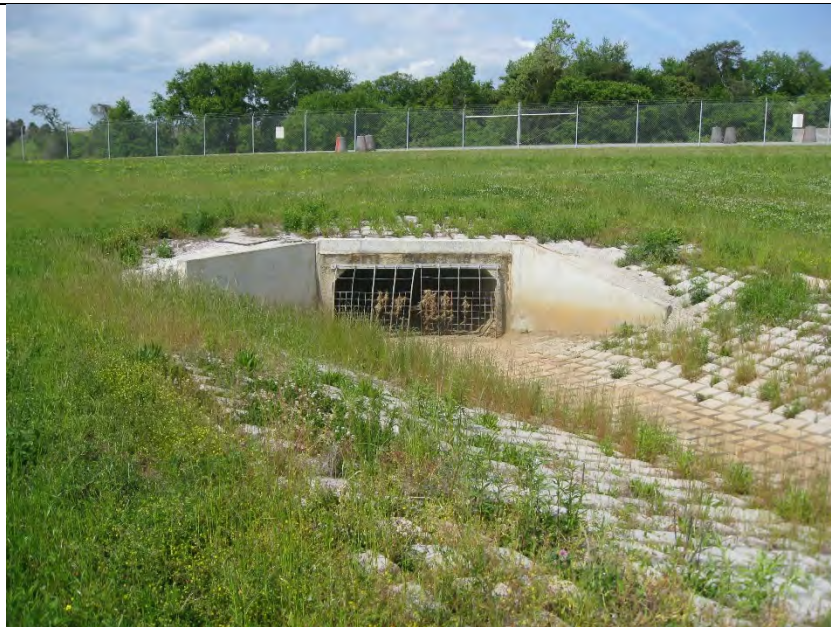
Photo 7  
Sta. 117+00  
(Line LB)  
Project 2

Guard Lateral Ditch (Outfall B).

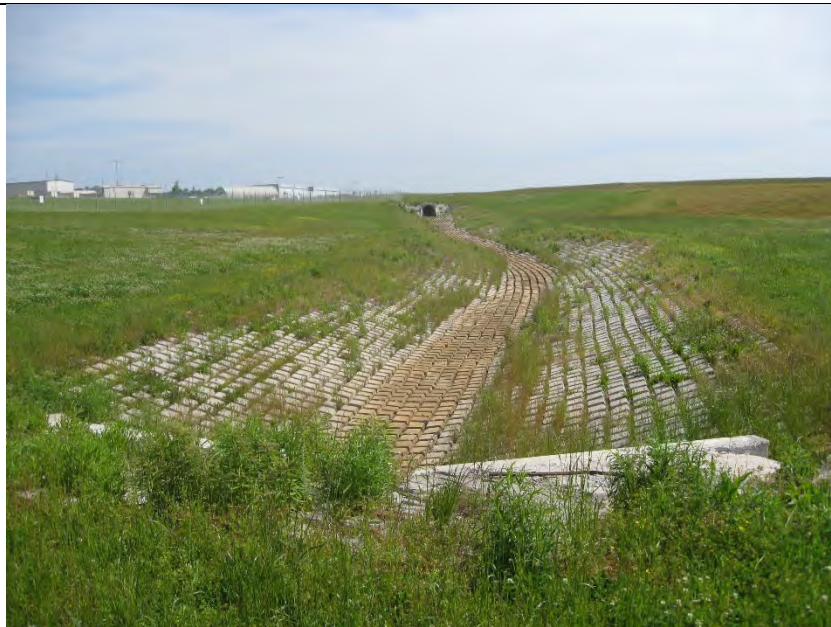
Photo 9  
Sta. 117+00  
(Line LB)  
Project 2

Guard Lateral Ditch (Outfall B).

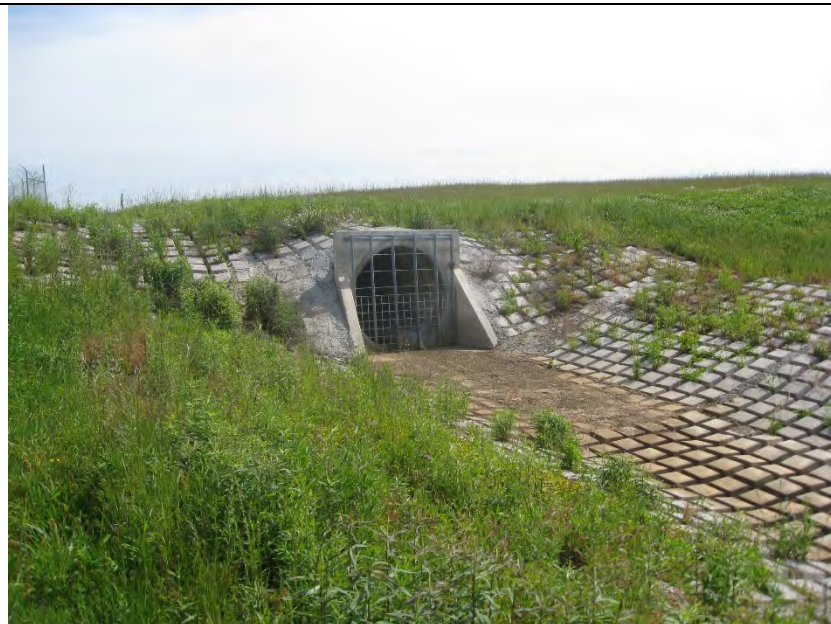
Photo 10  
Sta. 117+00 (RT)  
Project 2

78" culvert in the Guard Lateral Ditch. Clear flow observed at beginning of Site Assessment.

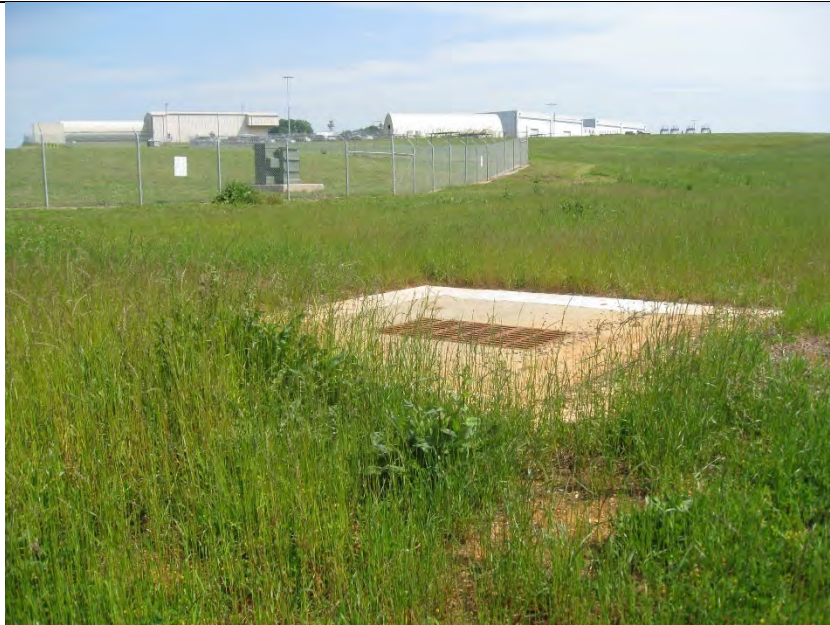
Photo 11  
Sta. 287+21 LT  
(RW 5L-23R)  
Structure 124  
Project 3

Structure 124.

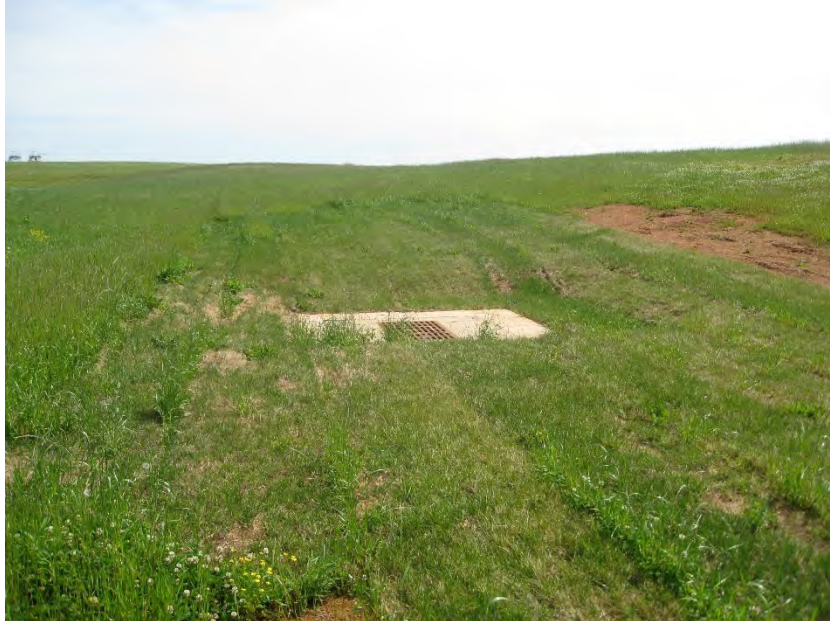
Photo 12  
Sta. 289+13 LT  
(RW 5L-23R)  
Structure 122  
Project 3

Structure 122.  
Recommend stabilizing remaining bare areas.

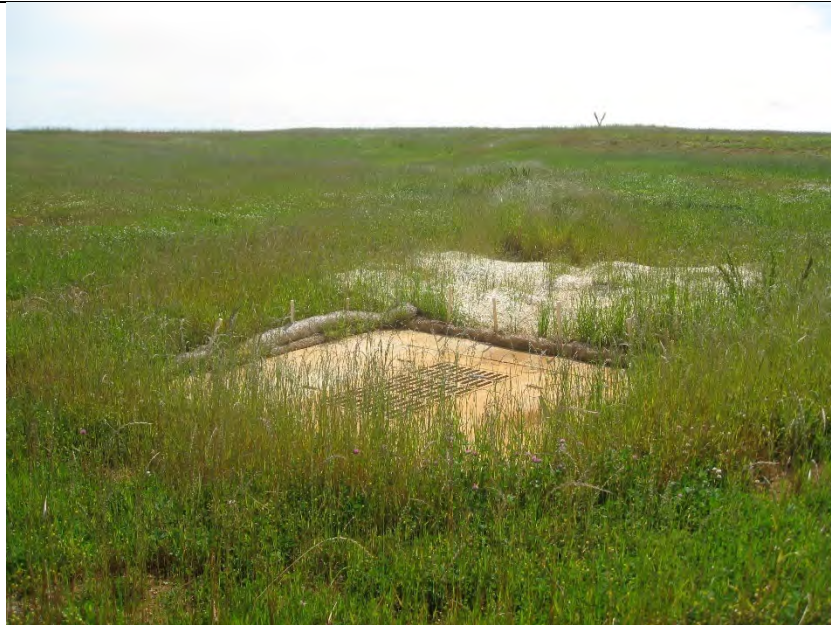
Photo 13  
Sta. 291+51 LT  
(RW 5L-23R)  
Structure 120  
Project 3

Structure 120.

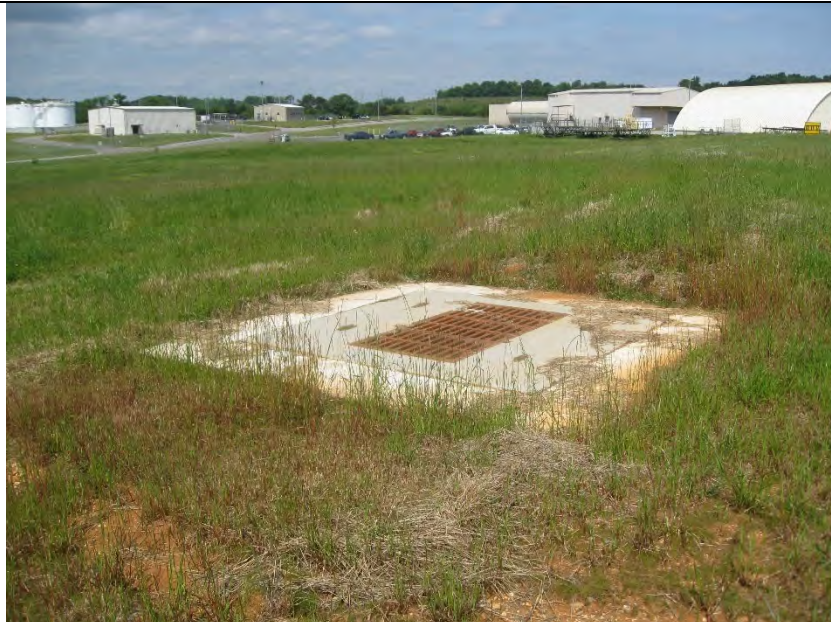
Photo 14  
Sta. 294+31 LT  
(RW 5L-23R)  
Structure 118  
Project 3

Structure 118.

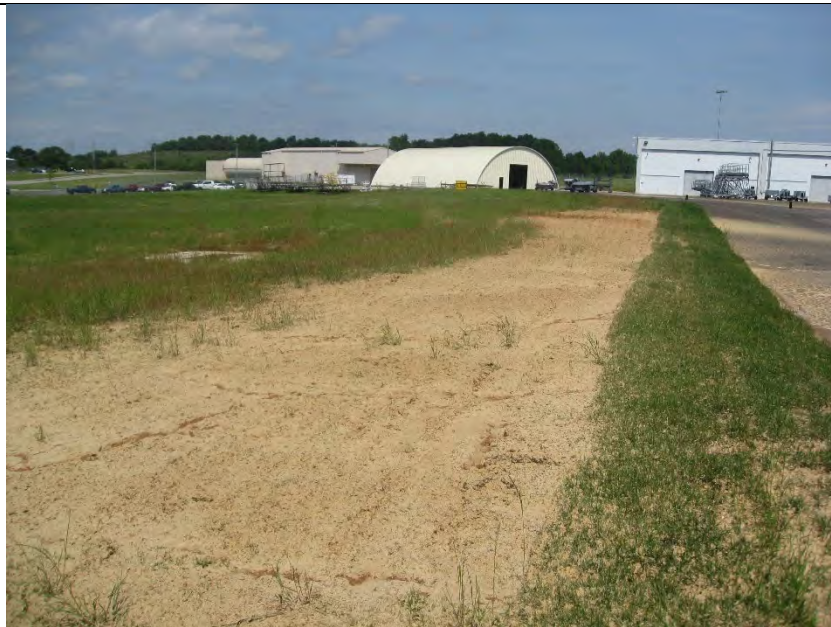
Photo 15  
Sta. 294+31 LT  
(RW 5L-23R)  
Structure 118  
Project 3

Area adjacent to Structure 118.  
Bare areas recently stabilized.

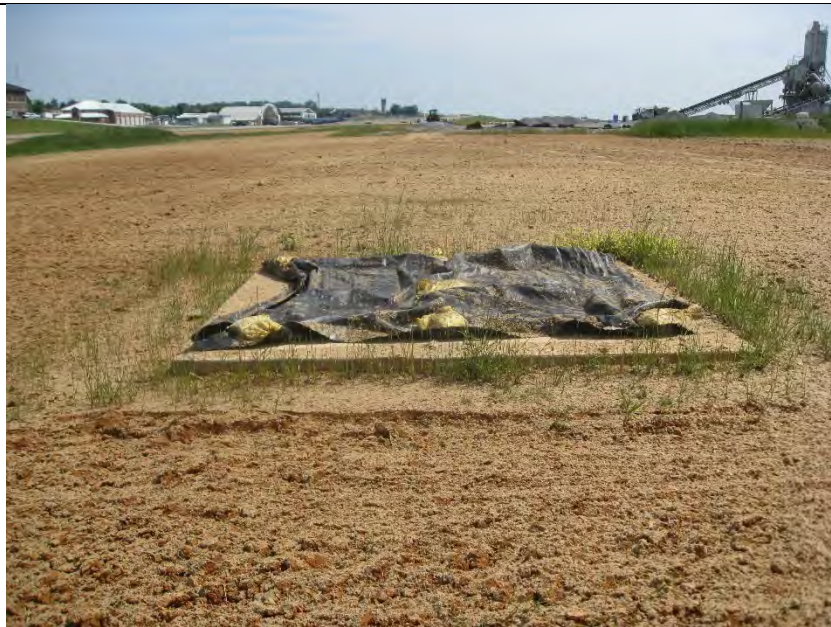
Photo 17  
Sta. 302+54 LT  
(RW 5L-23R)  
Structure 114  
Project 3

Structure 114.  
Bare areas recently stabilized.

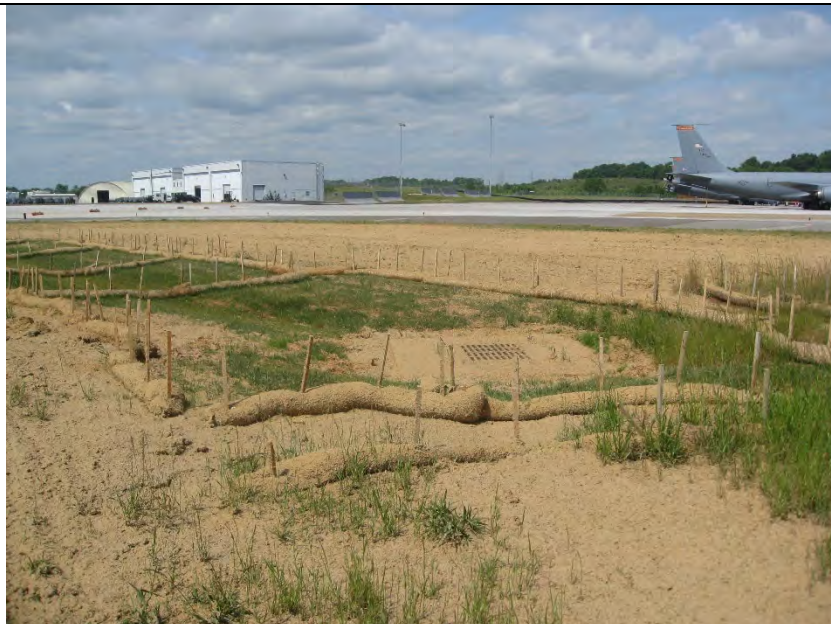
Photo 18  
Sta. 303+36 LT  
(RW 5L-23R)  
Structure 12  
Project 3

Structure 12.  
Bare areas recently stabilized.

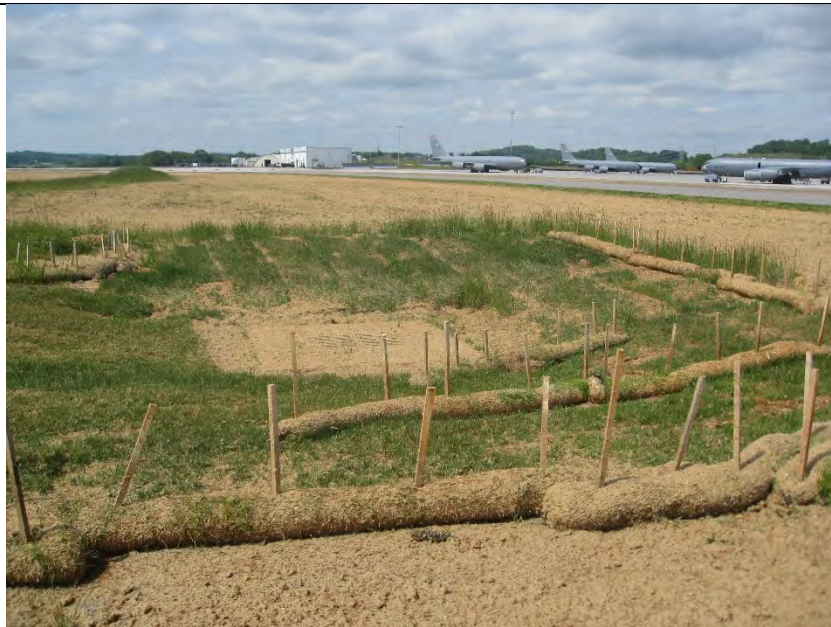
Photo 19  
Sta. 310+04 LT  
(RW 5L-23R)  
Structure 10  
Project 3

Structure 10.  
Bare areas recently stabilized.

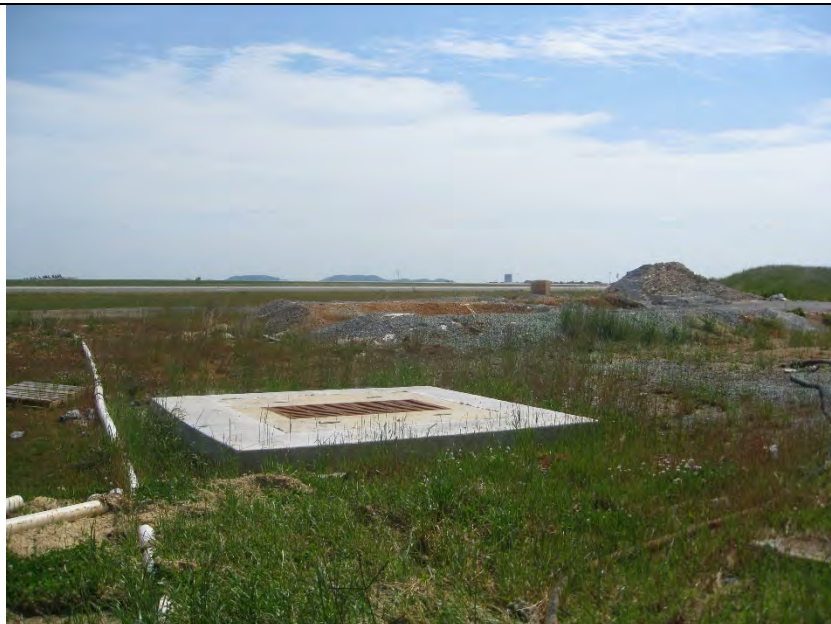
Photo 20  
Sta. 310+00 LT  
(RW 5L-23R)  
Project 3

Structure 112 and concrete washout area adjacent to batch plant.

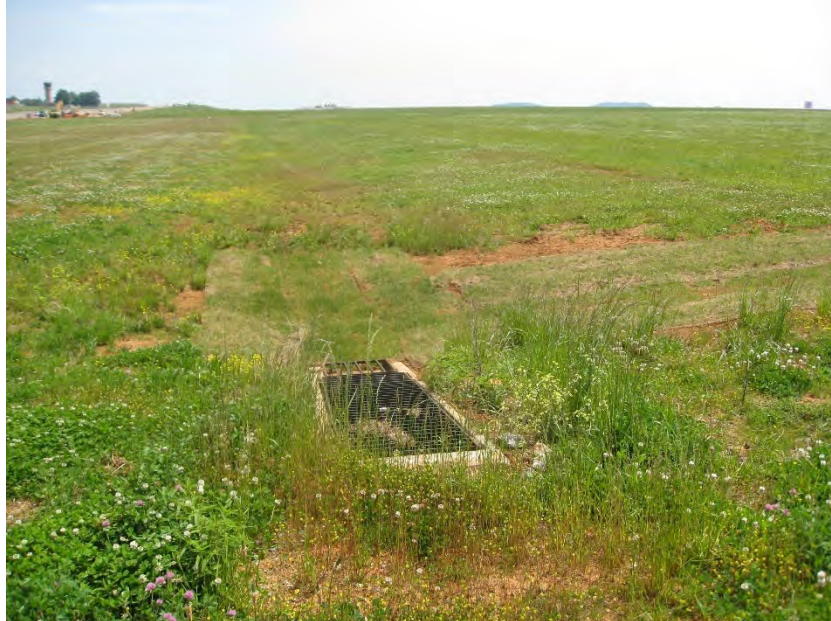
Photo 22  
Sta. 314+48 LT  
(RW 5L-23R)  
ES Endwall 108  
Project 3

Enhanced Swale Endwall 108.  
Recommend stabilizing remaining bare areas.

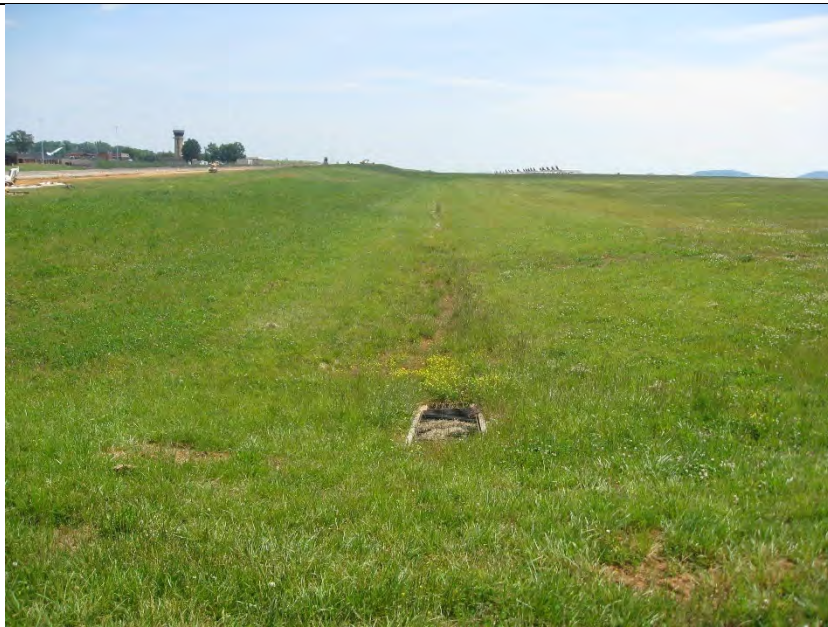
Photo 23  
Sta. 324+86 LT  
(RW 5L-23R)  
ES Endwall 106  
Project 3

Enhanced Swale Endwall 106.

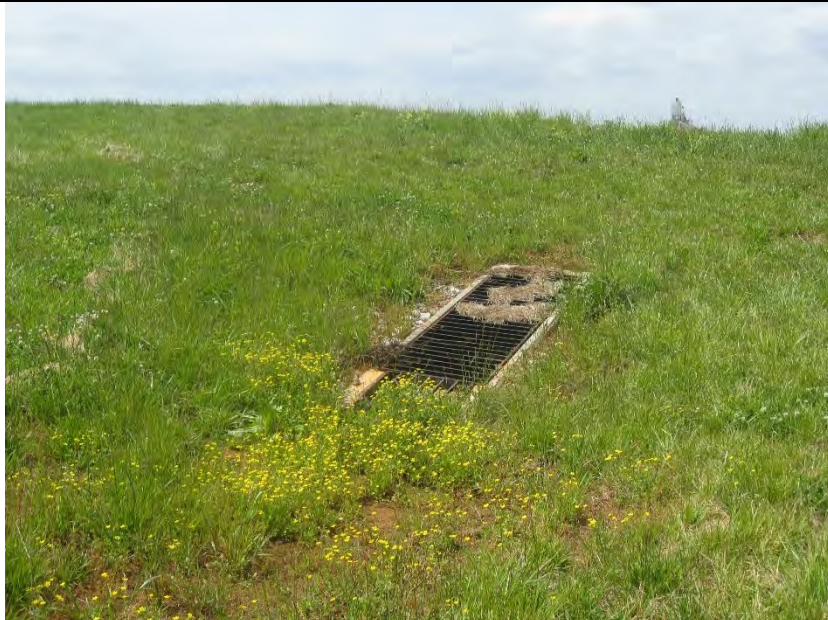
Photo 24  
Sta. 324+86 to Sta. 335+73 LT  
(RW 5L-23R)  
ES Endwall 106  
Project 3

Enhanced Swale Endwall 106.

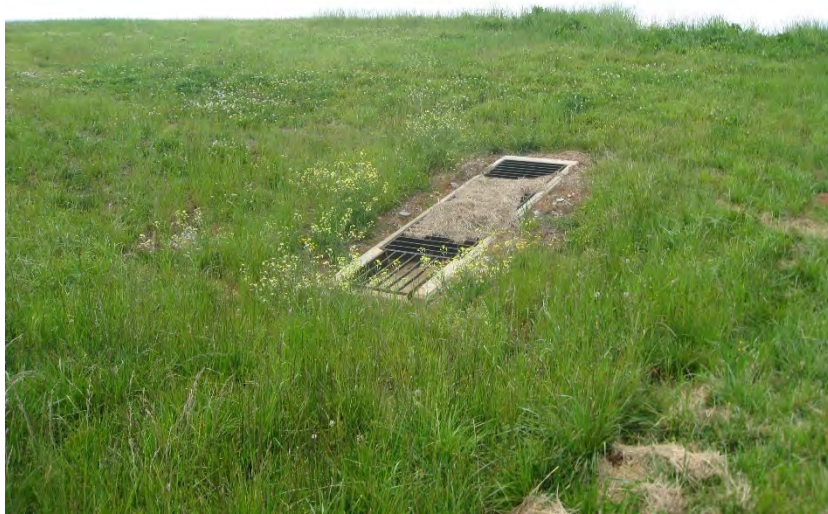
Photo 25  
Sta. 335+73 LT  
(RW 5L-23R)  
ES Endwall 104  
Project 3

Enhanced Swale Endwall 104.

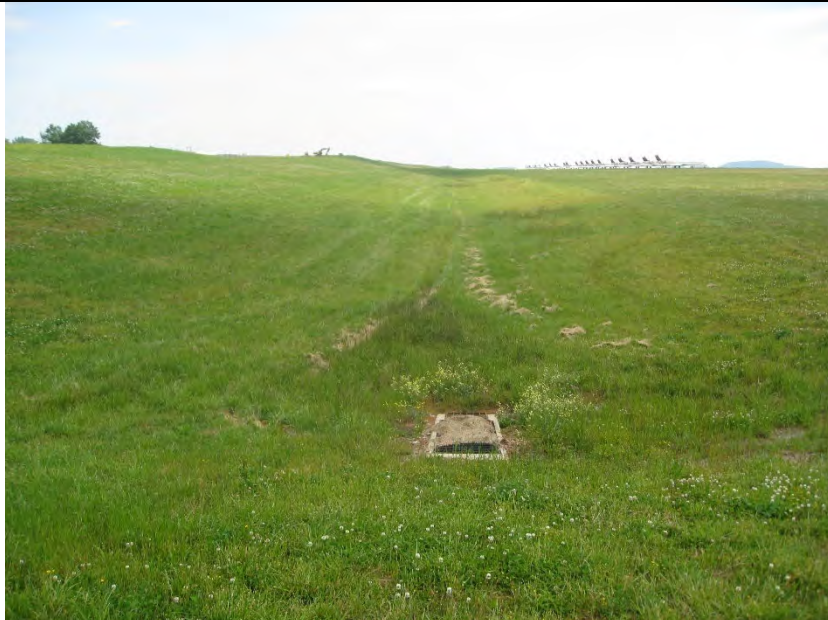
Photo 26  
Sta. 335+73 LT  
(RW 5L-23R)  
ES Endwall 104  
Project 3

Enhanced Swale Endwall 104.

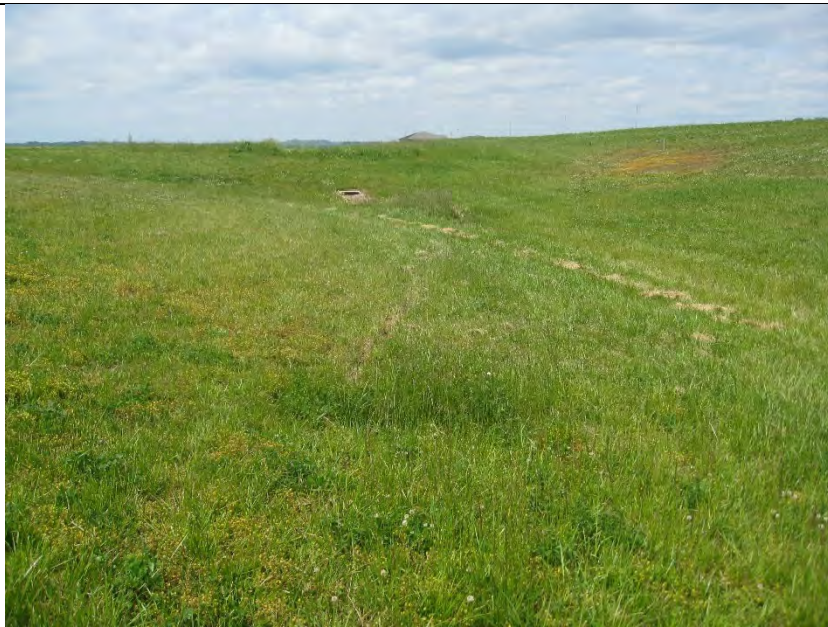
Photo 27  
Sta. 341+50 LT  
(RW 5L-23R)  
Between ES Endwall 104 and 102  
Project 3

Potential construction fallout on Storm Line 1 between ES Endwall 104 and 102.

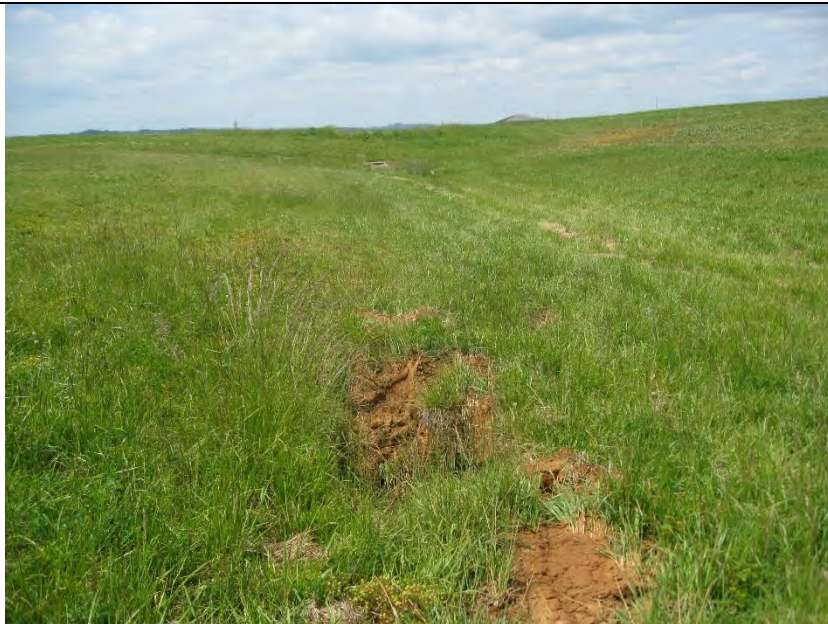
Photo 28  
Sta. 341+50 LT  
(RW 5L-23R)  
Between ES Endwall 104 and 102  
Project 3

First construction fallout on Storm Line 1 between ES Endwall 104 and 102.  
Coordinate remediation with CHA.

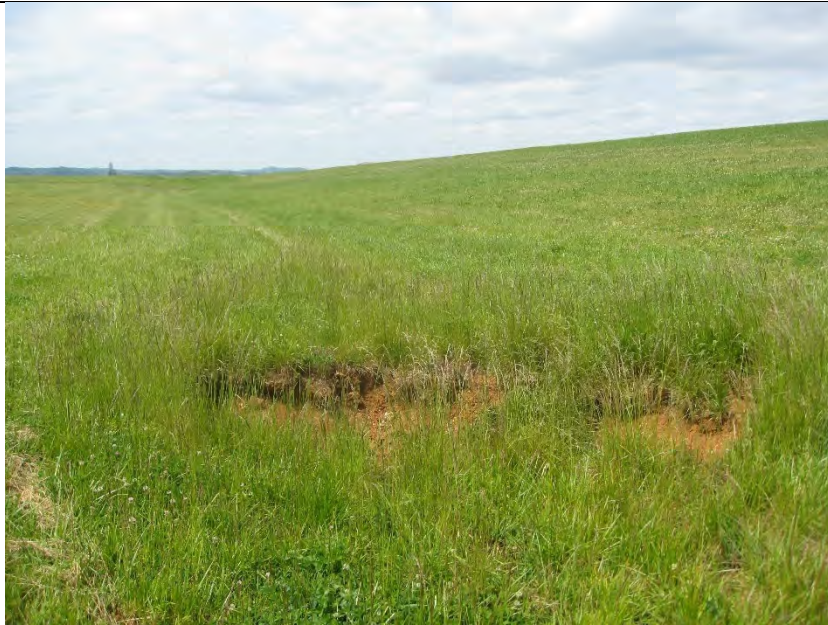
Photo 29  
Sta. 341+50 LT  
(RW 5L-23R)  
Between ES Endwall 104 and 102  
Project 3

Second construction fallout on Storm Line 1 between ES Endwall 104 and 102.  
Coordinate remediation with CHA.

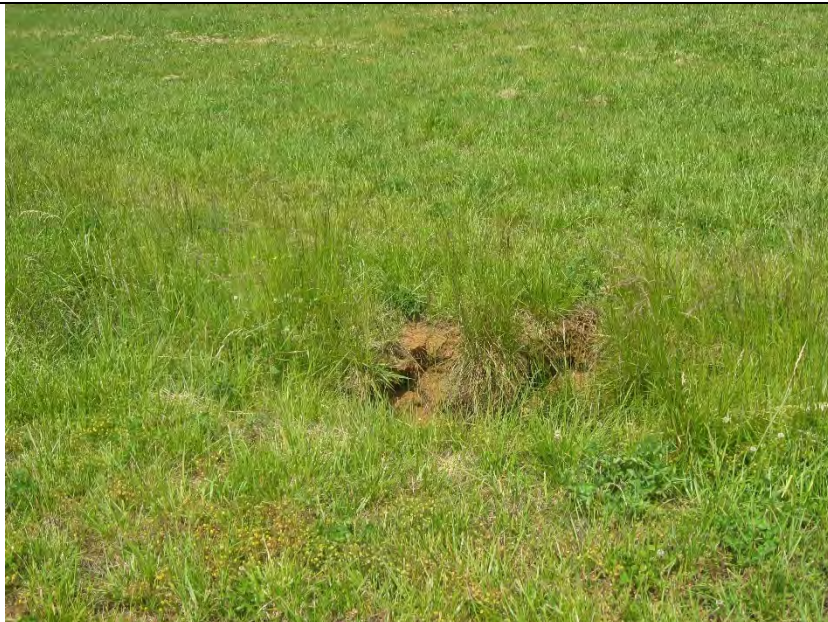
Photo 30  
Sta. 341+50 LT  
(RW 5L-23R)  
Between ES Endwall 104 and 102  
Project 3

Third construction fallout on Storm Line 1 between ES Endwall 104 and 102.  
Coordinate remediation with CHA.

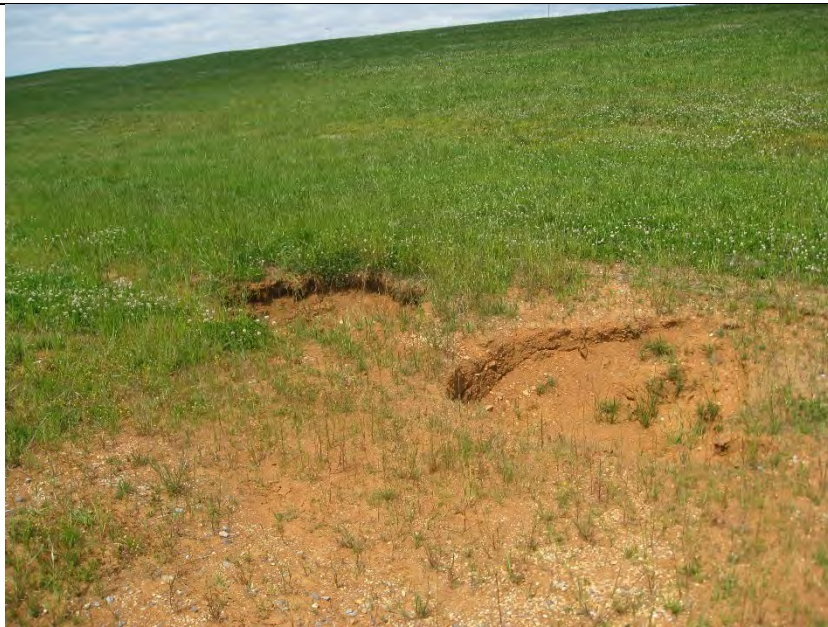
Photo 31  
Sta. 341+50 LT  
(RW 5L-23R)  
Between ES Endwall 104 and 102  
Project 3

Fourth construction fallout on Storm Line 1 between ES Endwall 104 and 102.  
Coordinate remediation with CHA.

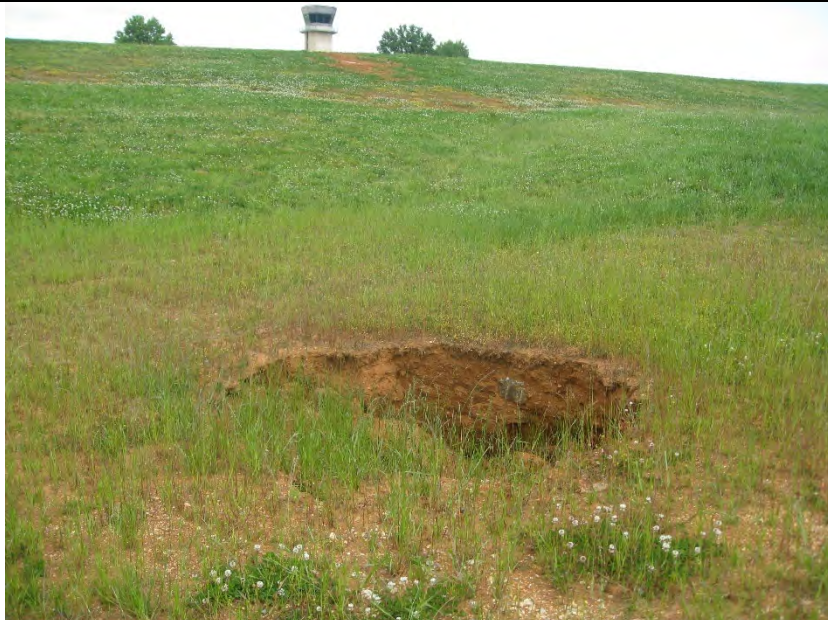
Photo 32  
Sta. 341+50 LT  
(RW 5L-23R)  
Between ES Endwall 104 and 102  
Project 3

Fifth construction fallout on Storm Line 1 between ES Endwall 104 and 102.  
Coordinate remediation with CHA.

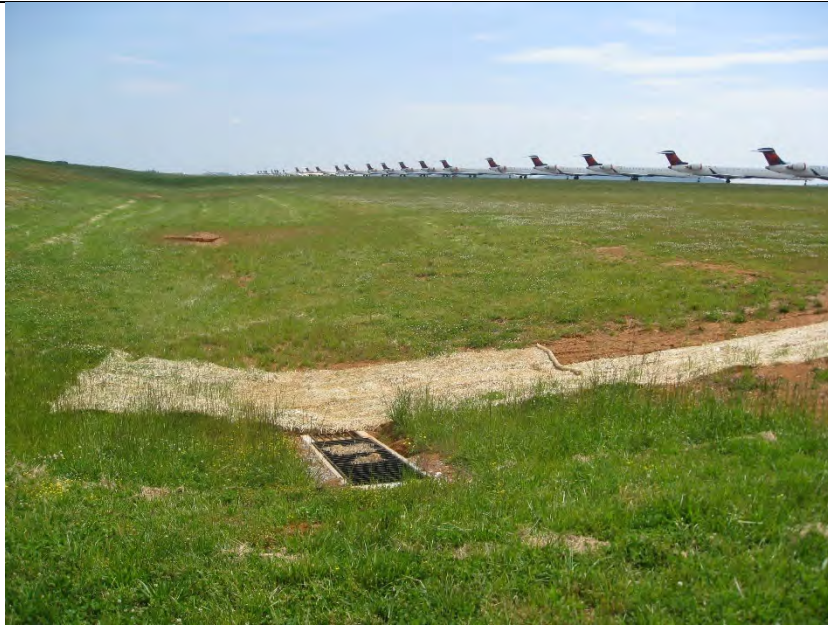
Photo 33  
Sta. 347+31 LT  
(RW 5L-23R)  
ES Endwall 102  
Project 3

Enhanced Swale Endwall 102.  
Recommend stabilizing remaining bare areas.

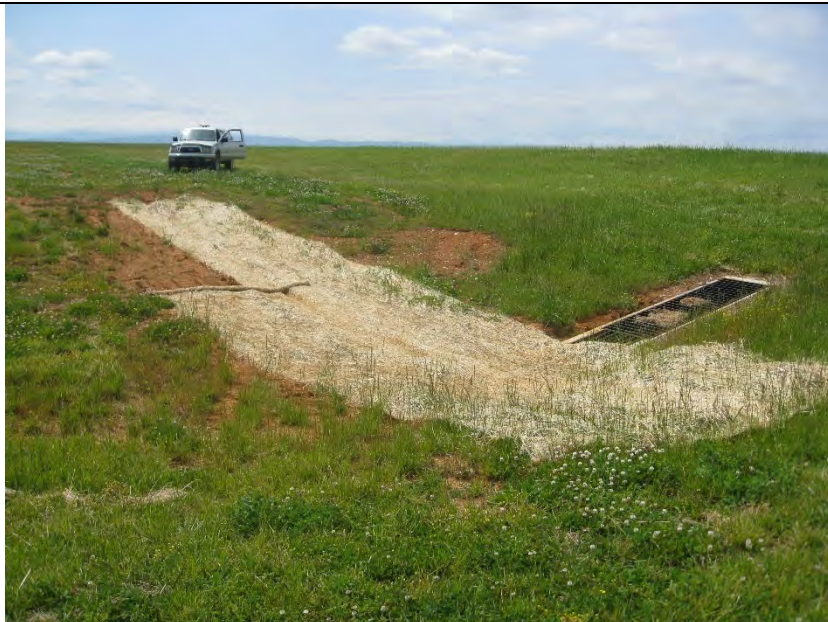
Photo 34  
Sta. 347+31 LT  
(RW 5L-23R)  
ES Endwall 102  
Project 3

Enhanced Swale Endwall 102.  
Recommend stabilizing remaining bare areas.

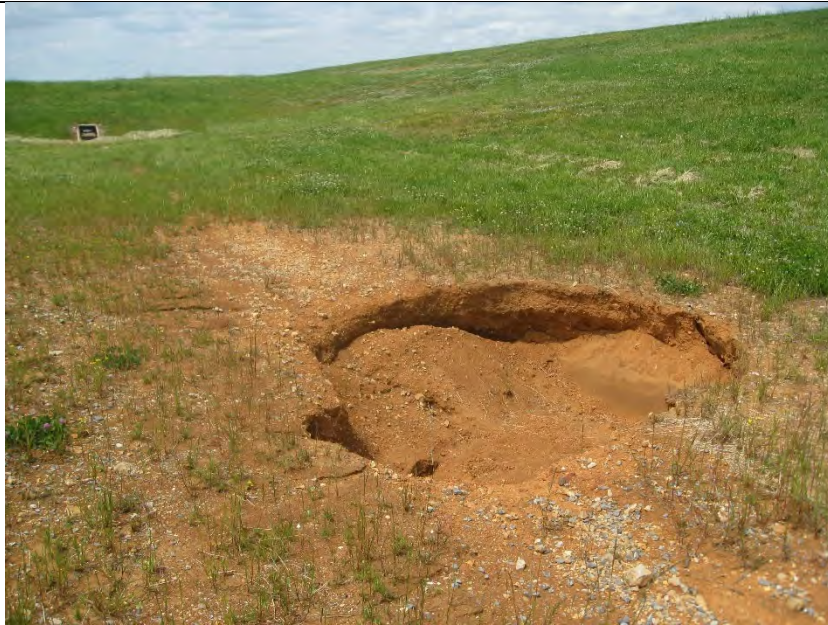
Photo 35  
Sta. 341+50 LT  
(RW 5L-23R)  
ES Endwall 102  
Project 3

Construction fallout on Storm Line 1 between ES Endwall 102 and 100.  
Coordinate remediation with CHA.

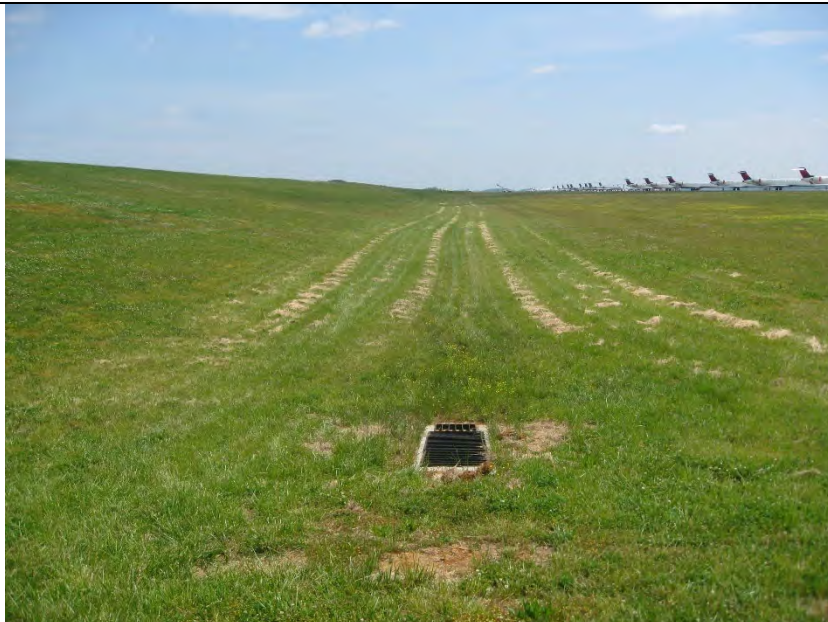
Photo 36  
Sta. 354+75 LT  
(RW 5L-23R)  
ES Endwall 100  
Project 2

Enhanced Swale Endwall 100.

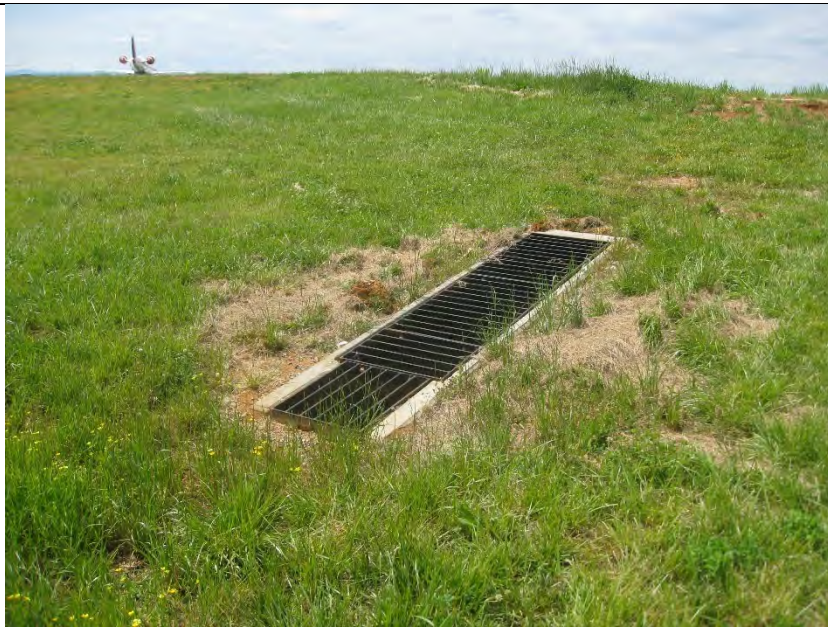
Photo 37  
Sta. 354+75 LT  
(RW 5L-23R)  
ES Endwall 100  
Project 3

Enhanced Swale Endwall 100.

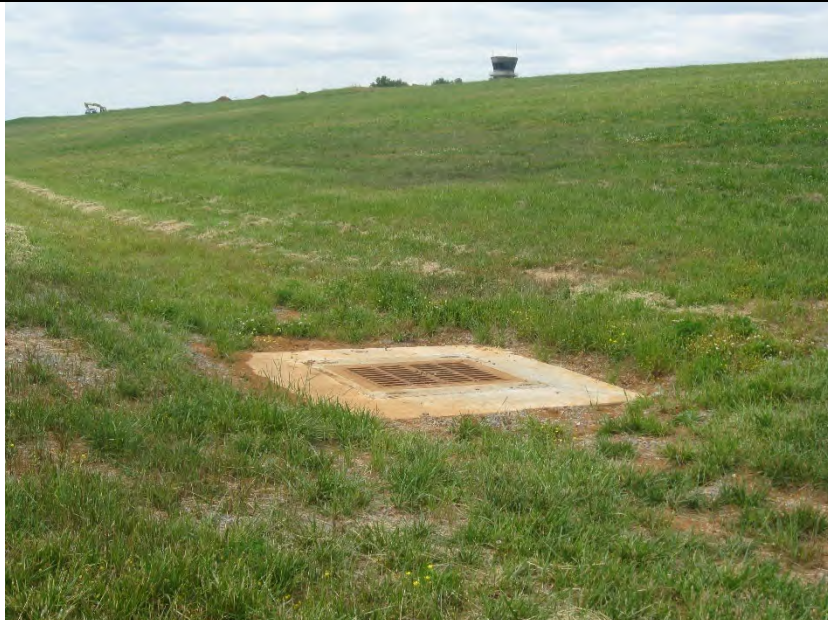
Photo 38  
Sta. 361+39 LT  
(RW 5L-23R)  
Structure 100  
Project 3

Structure 100.  
Recommend stabilizing remaining bare areas.

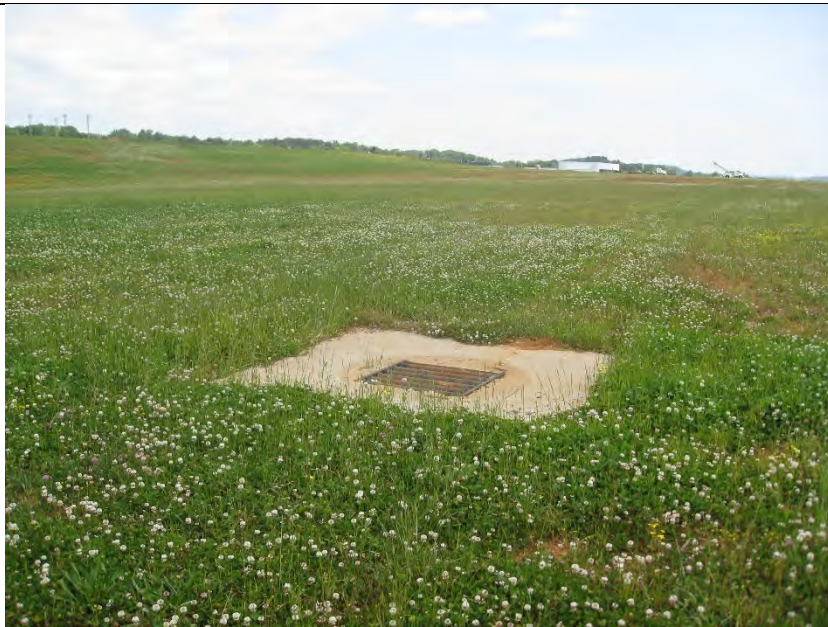
Photo 39  
Sta. 363+35 LT  
(RW 5L-23R)  
Existing Structure  
Project 2

Existing Structure.

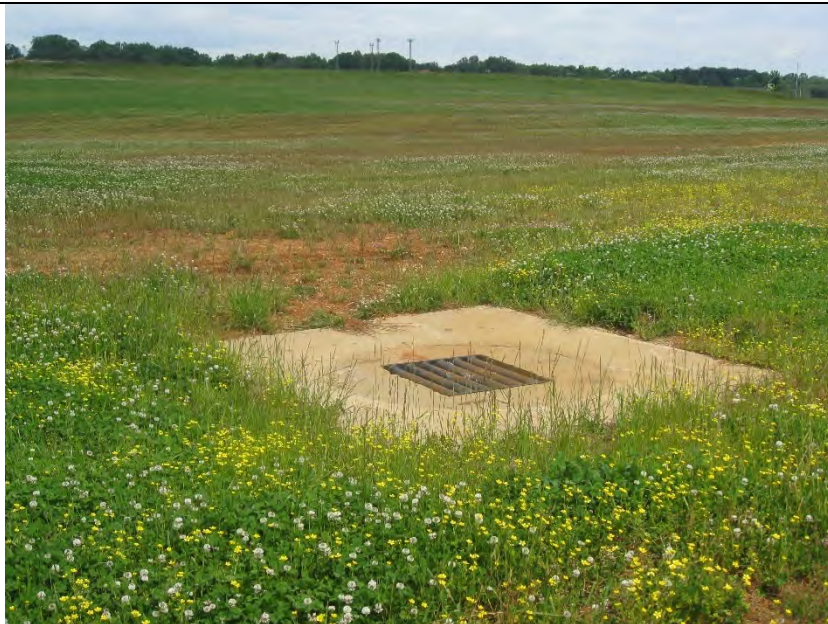
Photo 40  
Sta. 366+25 LT  
(RW 5L-23R)  
Existing Structure  
Project 2

Existing Structure.  
Recommend stabilizing bare areas.

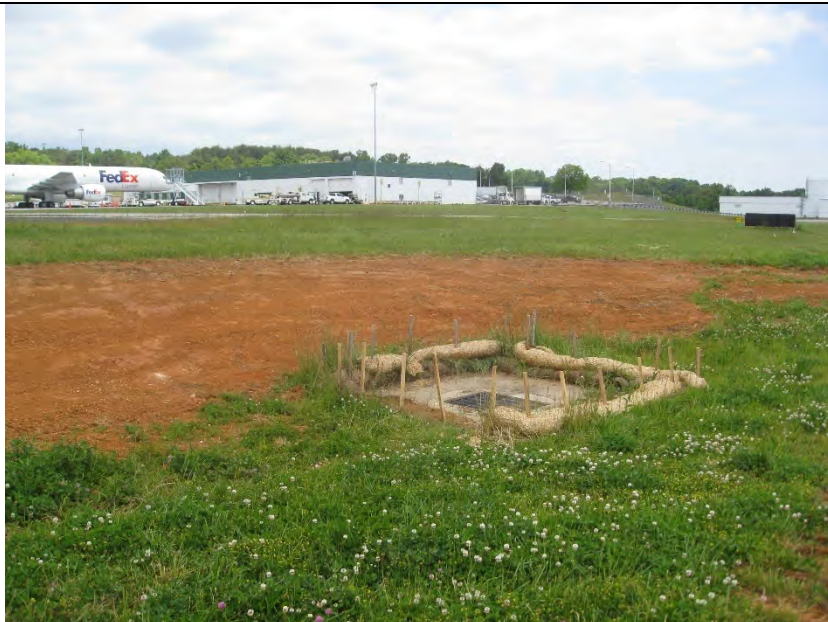
Photo 41  
Sta. 369+11 LT  
(RW 5L-23R)  
Existing Structure  
Project 2

Existing Structure.  
Recommend stabilizing bare areas.

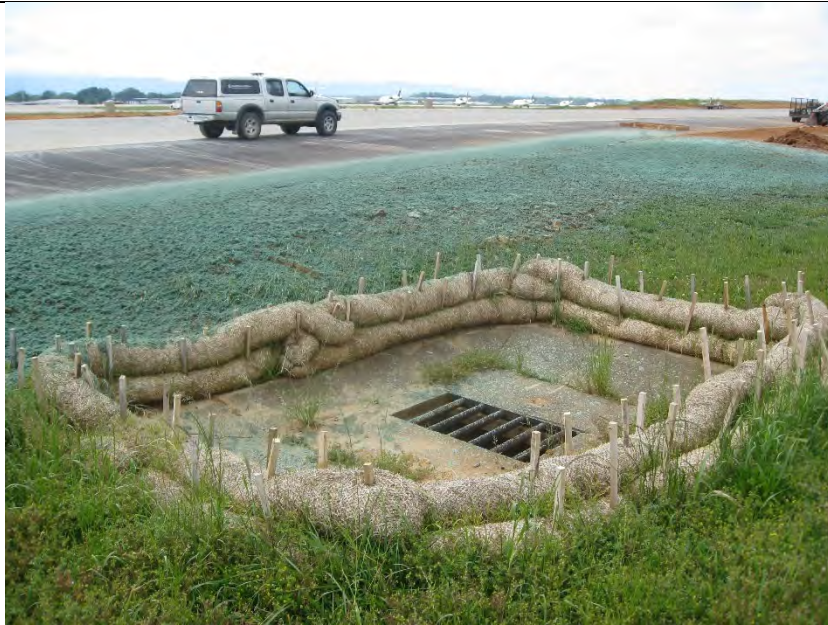
Photo 42  
Sta. 677+00 RT  
(RW 5L-23R)  
Existing Structure  
Project 4

Structure south of Taxiway "G".  
Area recently regraded.  
Recommend stabilizing bare areas.

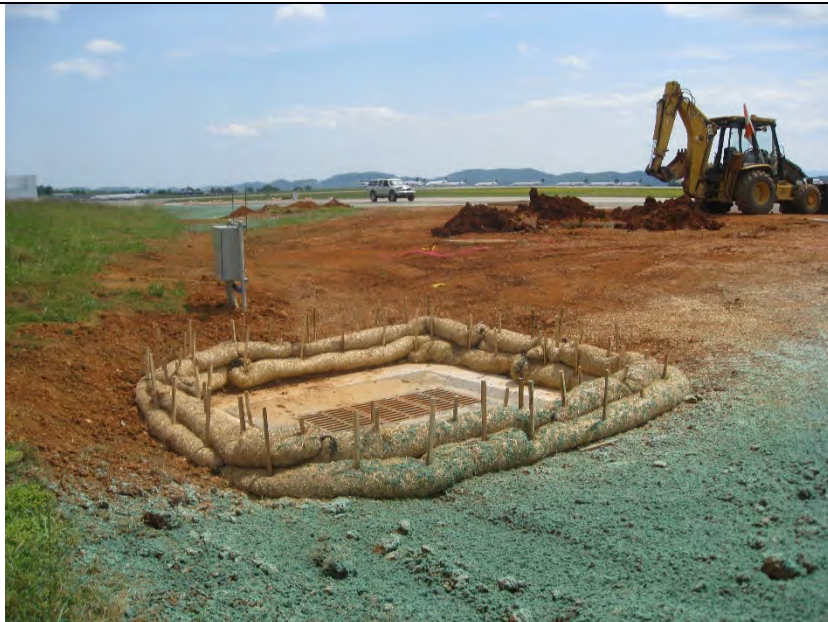
Photo 43  
Sta. 677+00 RT  
(RW 5L-23R)  
Project 4

Structure between Taxiway G and UPS Facility.  
Shoulders recently stabilized.

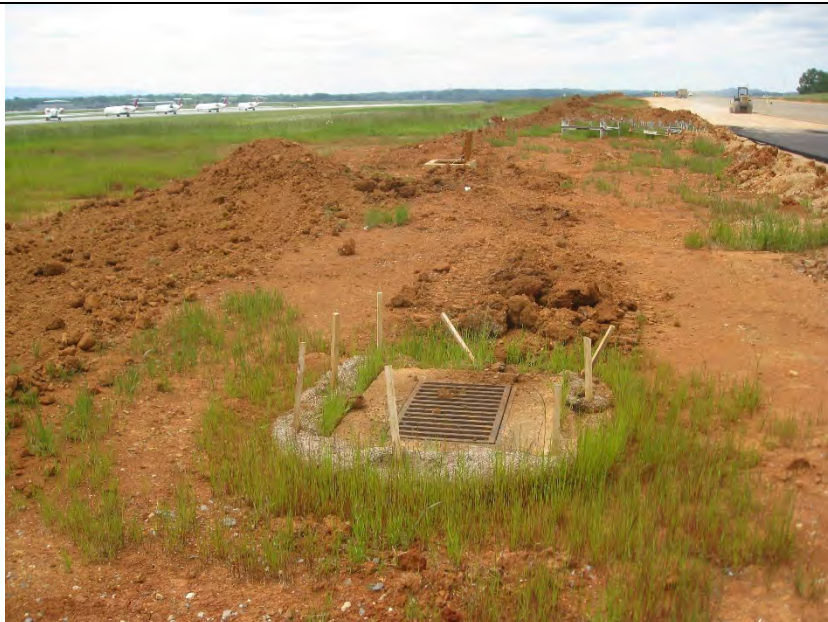
Photo 45  
Sta. 676+00 RT  
(RW 5L-23R)  
Project 4

New structure recently placed.  
Sediment tubes recently installed.  
Area recently backfilled.  
Recommend stabilizing remaining bare areas.

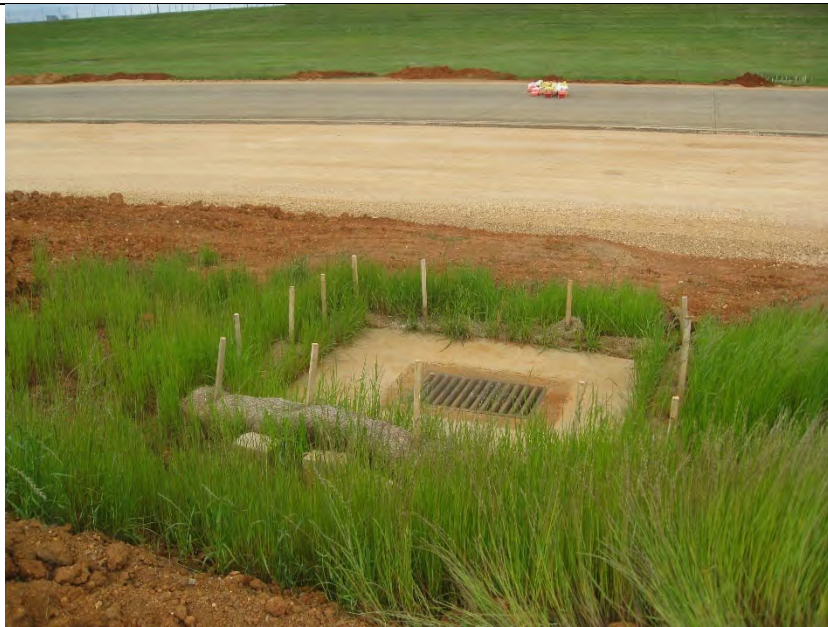
Photo 46  
(RW 5L-23R)  
Existing Structure  
Project 4

Existing structure south of Taxiway G  
Construction activity recently taken place, recommend stabilizing bare areas once activities are complete or remain inactive for longer than 14 days.

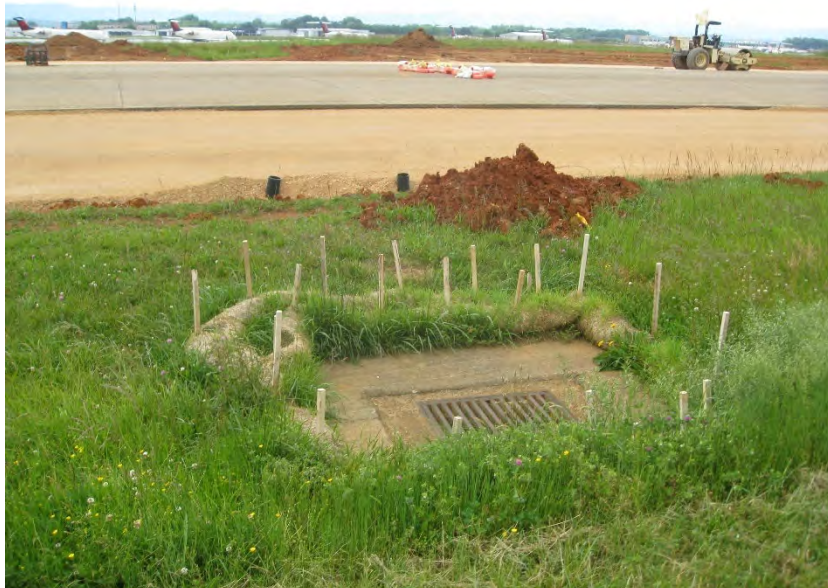
Photo 47  
(RW 5L-23R)  
Existing Structure  
Project 4

Existing structure south of Taxiway G.

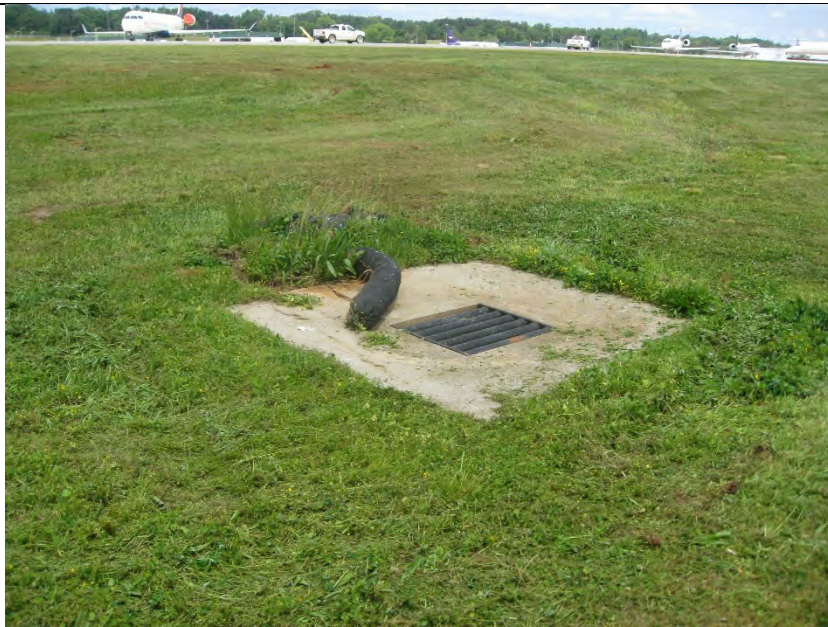
Photo 48  
(RW 5L-23R)  
Existing Structure  
Project 4

Existing structure north of Taxiway G.

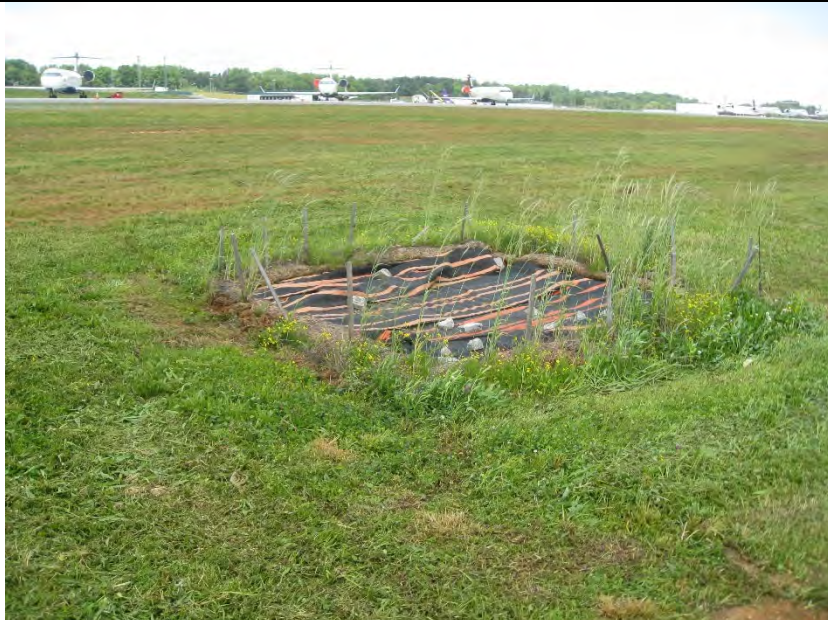
Photo 49  
Sta. 366+89 RT  
(RW 5L-23R)  
Existing Structure  
Project 4

Existing Structure adjacent to Outfall C.

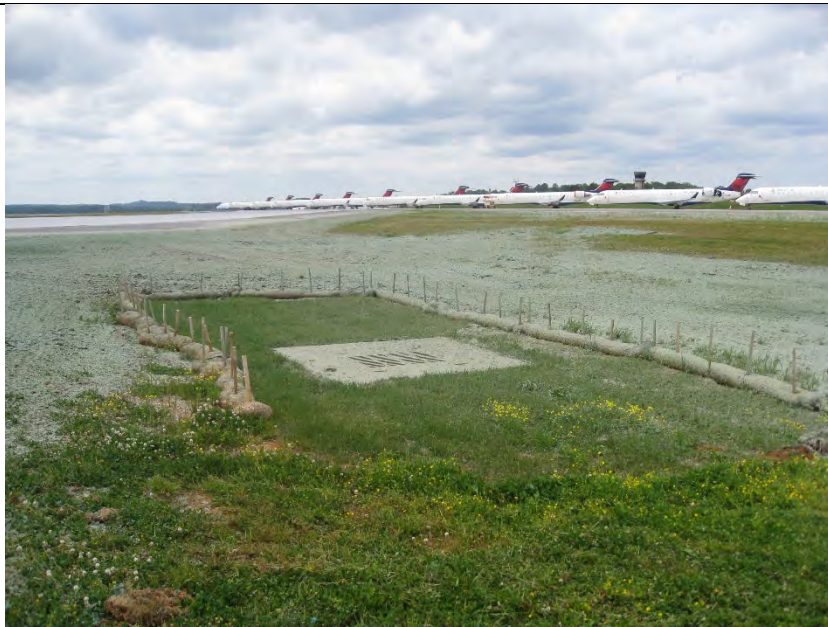
Photo 50  
Sta. 366+89 RT  
(RW 5L-23R)  
Outfall C  
Project 4

Recommend removing filter fabric from this structure to allow sampling for DMR.  
(Outfall C).
