**QUALITY ASSURANCE  
MONTHLY SITE  
ASSESSMENT REPORT**

Airfield Modernization Program  
Runway 5L-23R Reconstruction  
Project 2 / Project 3

## QUALITY ASSURANCE SITE ASSESSMENT

## **AIRFIELD MODERNIZATION PROGRAM RUNWAY 5L-23R RECONSTRUCTION**

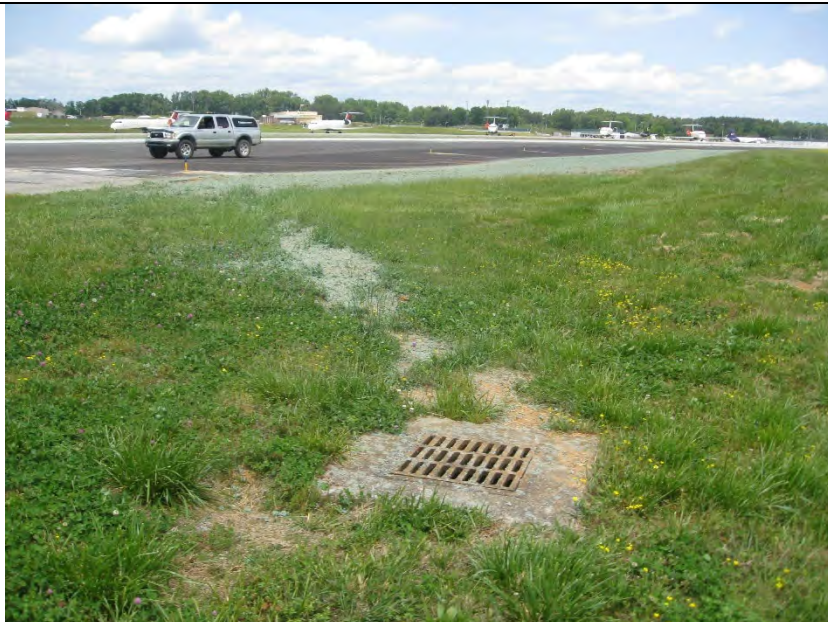
Photo 51  
Sta. 365+69 RT  
(RW 5L-23R)  
Structure 300  
Project 4

Structure 300.  
Bare areas recently stabilized.

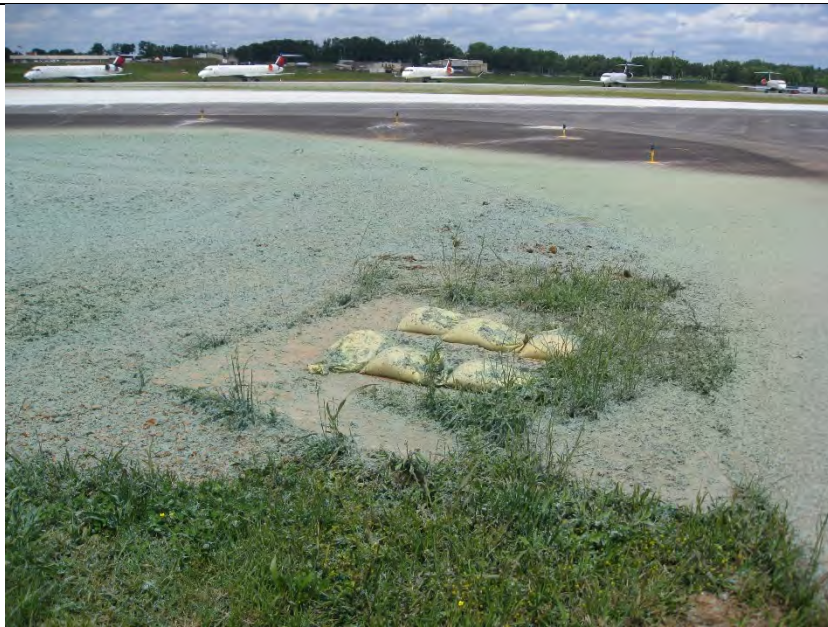
Photo 52  
(RW 5L-23R)  
TWY Y Tie-in  
Project 4

Existing structure north of Taxiway Y.  
Shoulders recently stabilized.

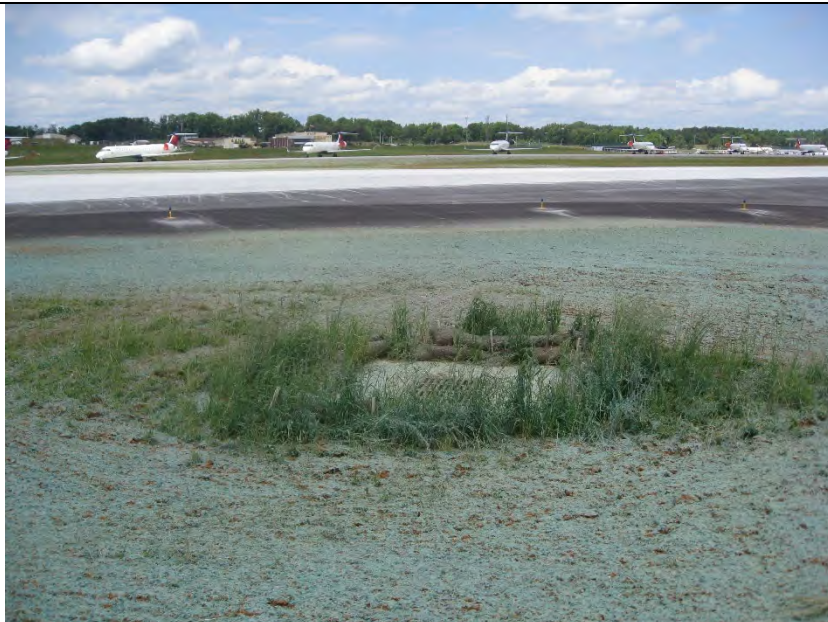
Photo 53  
(RW 5L-23R)  
TWY Y Tie-in  
Project 4

Existing structure south of Taxiway Y.  
Shoulders recently stabilized.

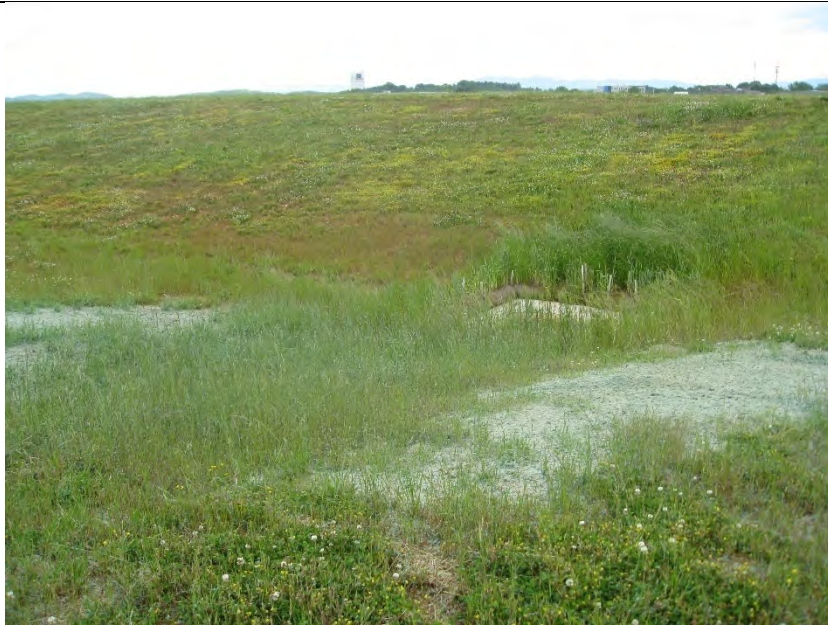
Photo 54  
Sta. 362+02 LT  
(RW 5L-23R)  
Structure 400  
Project 4

Structure 400.  
Shoulders recently stabilized.

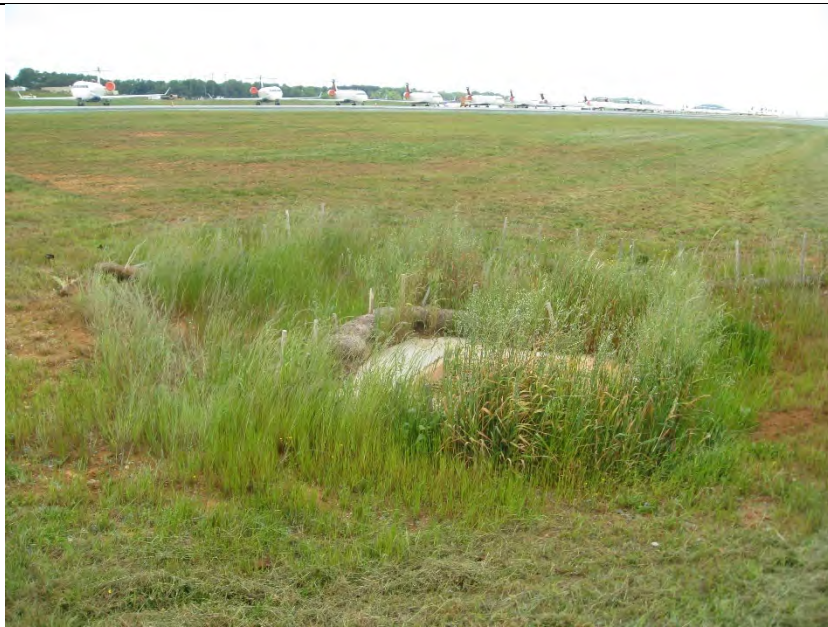
Photo 56  
Sta. 347+26 RT  
(RW 5L-23R)  
Structure 22  
Project 4

Structure 22.  
Recommend stabilizing bare areas.

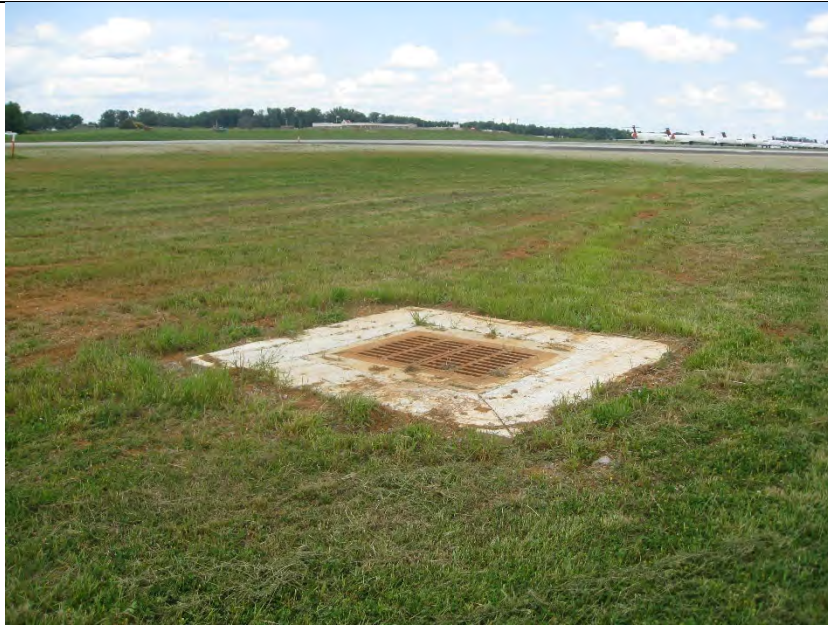
Photo 58  
Sta. 347+26 RT  
(RW 5L-23R)  
Structure 202  
Project 4

Structure 202.  
Bare areas recently stabilized.

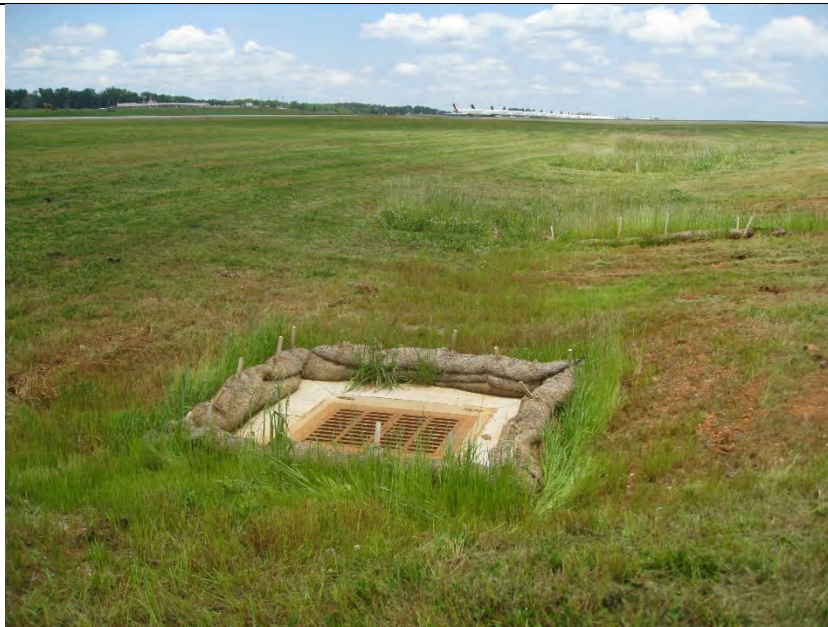
Photo 60  
Sta. 341+86 RT  
(RW 5L-23R)  
Project 4

Construction fallout on Storm Line 2 between structures 204 and 206.  
Recommend coordinating remediation with CHA.

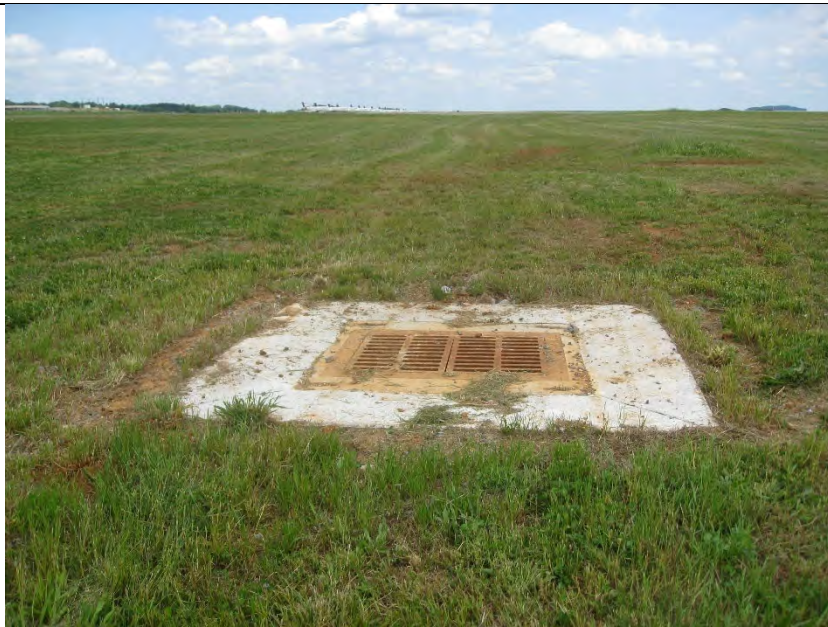
Photo 62  
(RW 5L-23R)  
Project 4

Construction fallout on Storm Line 2 between structures 206 and 208.  
Recommend coordinating remediation with CHA.

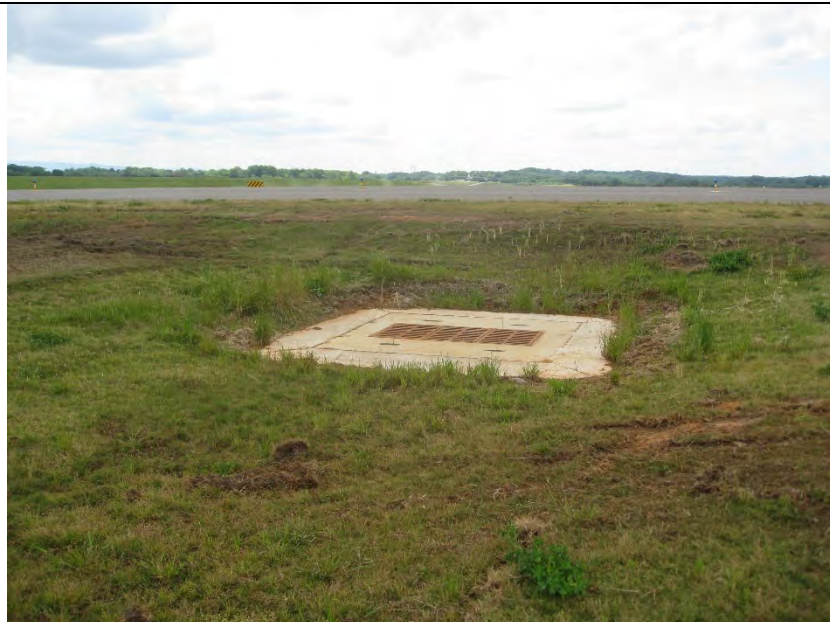
Photo 65  
Sta. 321+73 RT  
(RW 5L-23R)  
Structure 212  
Project 3

Structure 212.  
Sediment recently removed.  
Recommend stabilizing remaining bare areas.

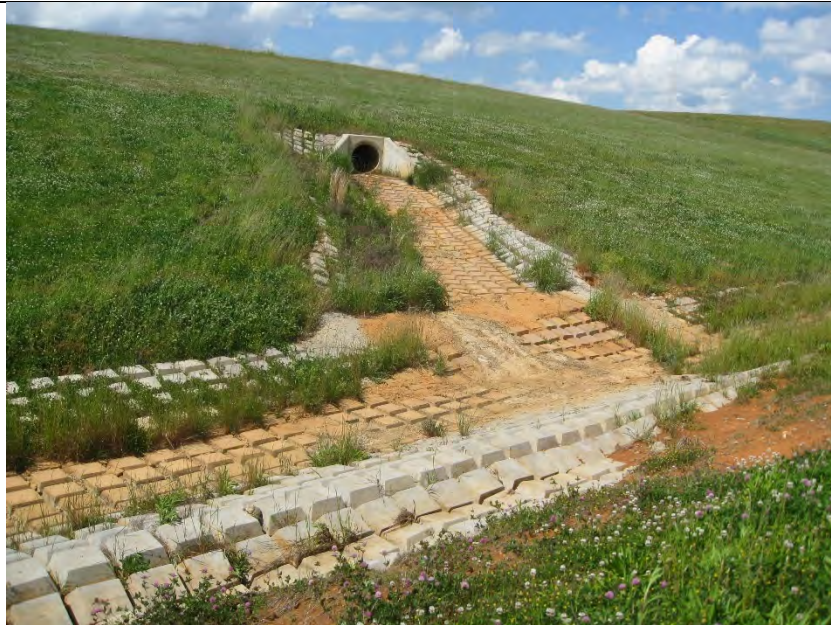
Photo 68  
Sta. 296+83 RT  
(RW 5L-23R)  
Structure 220  
Project 2

Structure 220.  
Recommend stabilizing remaining bare areas.

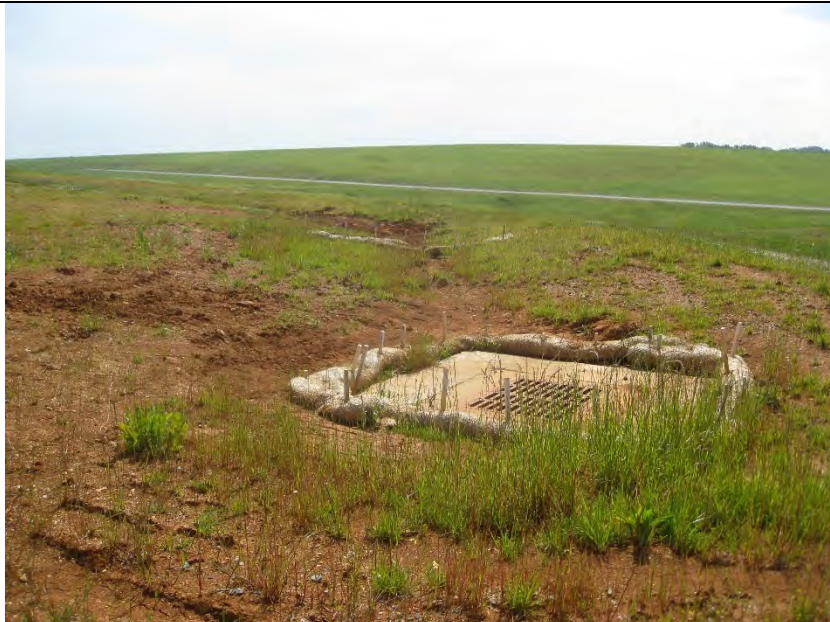
Photo 73  
Sta. 290+26 RT  
(RW 5L-23R)  
Structure 600 Ditch  
Project 2

Structure 600 ditch.  
Sediment continues to accumulate due to erosion of ditch line from storm events  
(see previous photo)  
Recommend stabilizing bare areas.

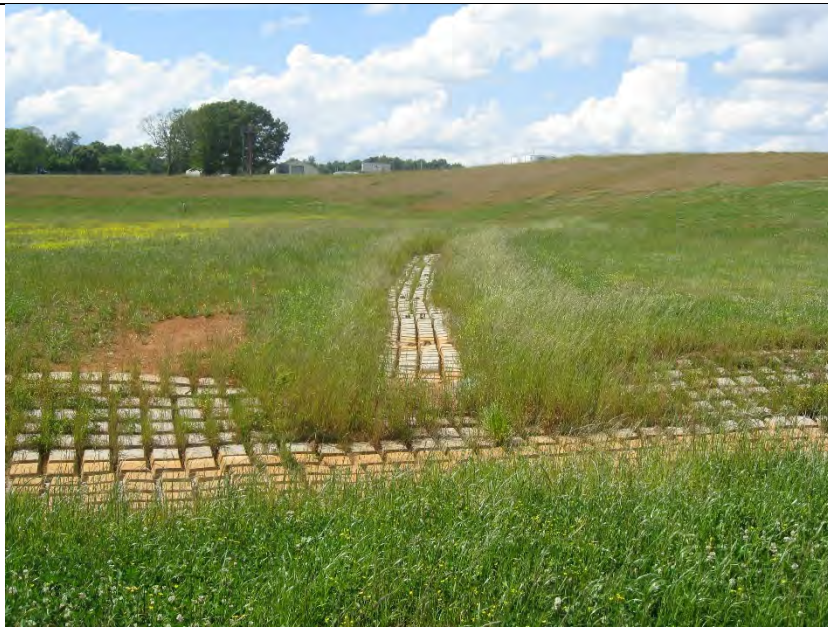
Photo 74  
Sta. 284+59  
(RW 5L-23R)  
Structure 600  
Project 3

Structure 600.  
Recommend stabilizing bare areas.

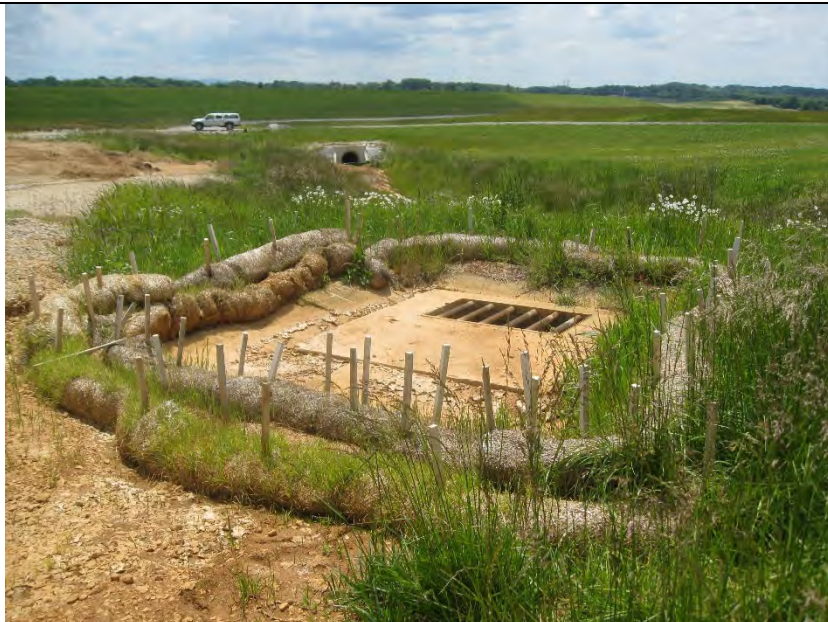
Photo 75  
Sta. 282+45 RT  
(RW 5L-23R)  
Structure 602  
Project 2

Ditch line at Structure 602.

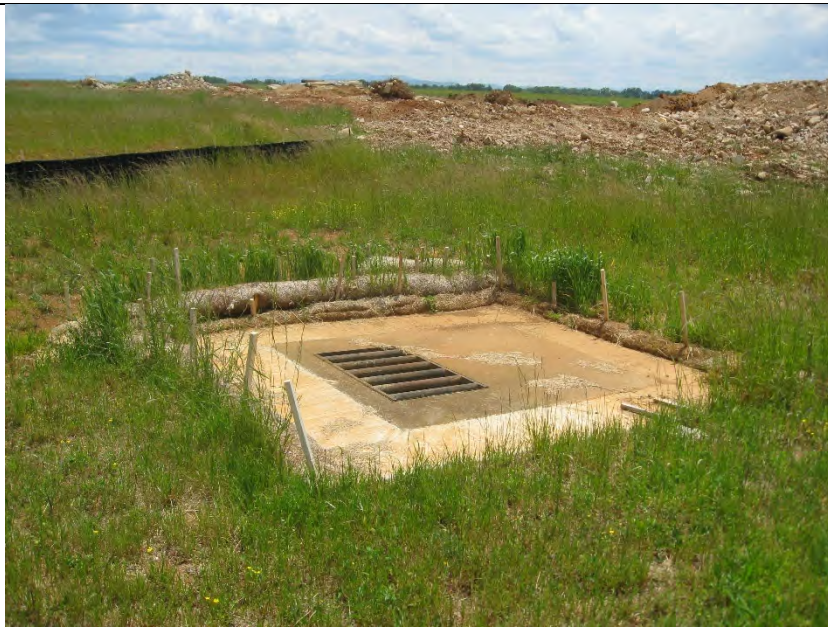
Photo 76  
(RW 5L-23R)  
Project 3

Existing structure at stone stockpile area.

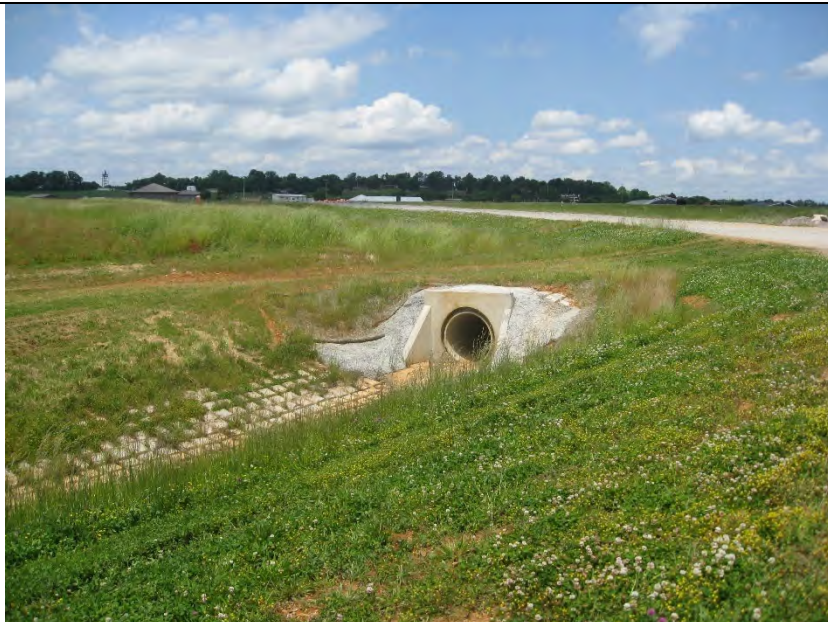
Photo 79  
Sta. 39+00 CL  
Proposed Haul Route  
Project 3

Inlet side of 54" haul route crossing culvert.

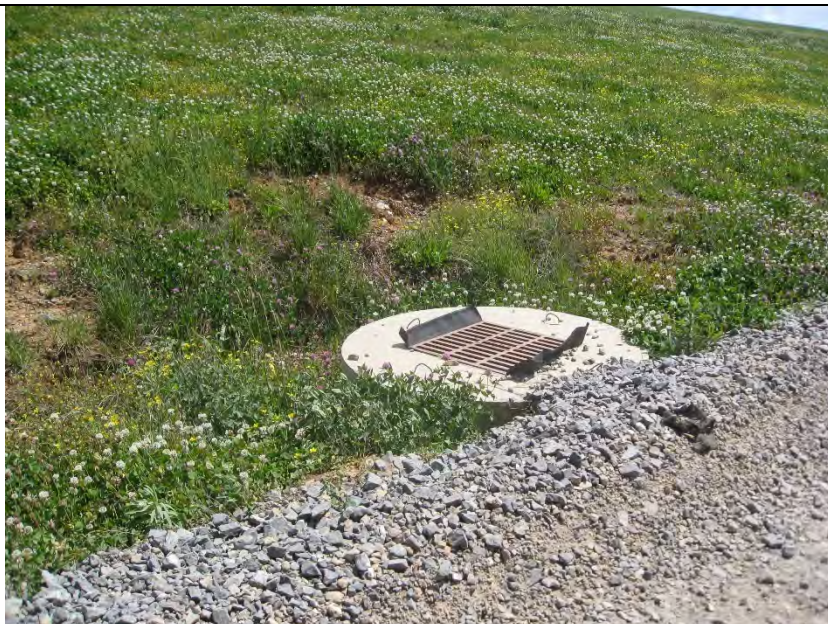
Photo 81  
Sta. 37+25 RT  
Proposed Haul Route  
Project 3

Inlet structures along haul road.  
Recommend stabilizing bare areas.

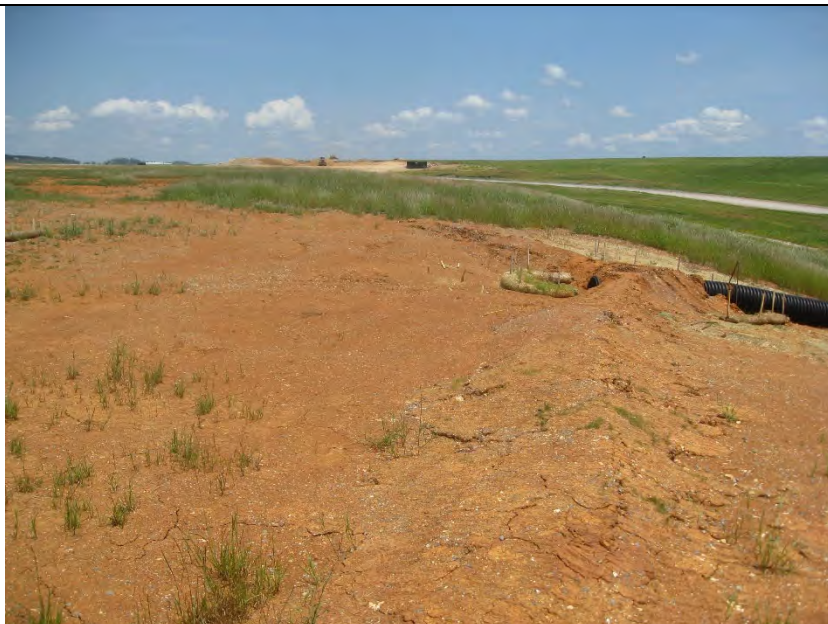
Photo 83  
Sta. 302+54  
(RW 5L-23R)  
Project 2

Above North Lateral Endwall 100.  
Sediment tubes and sediment recently removed.  
Recommend stabilizing remaining bare areas

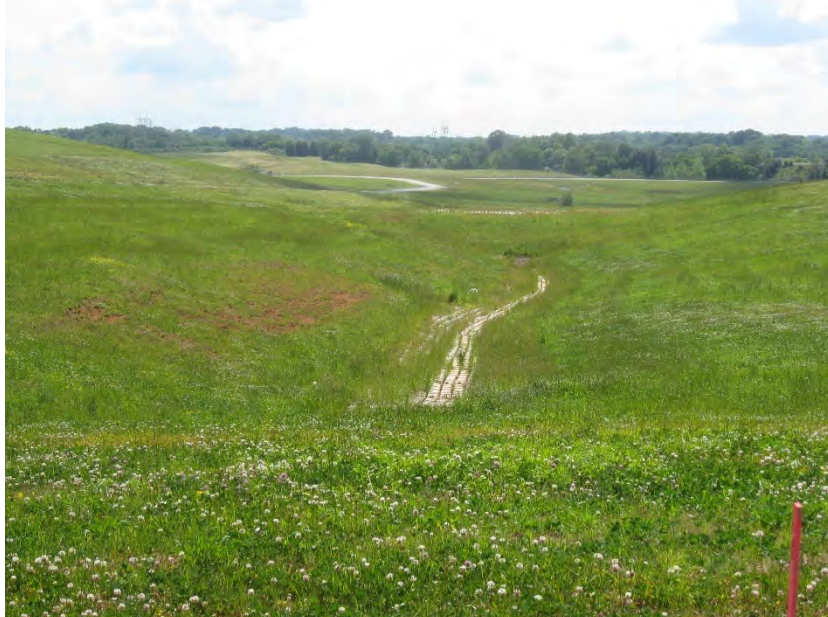
Photo 85  
Sta. 302+54 to Sta. 313+50  
(RW 5L-23R)  
Project 2

North Lateral Endwall 100.  
Recommend stabilizing remaining bare areas

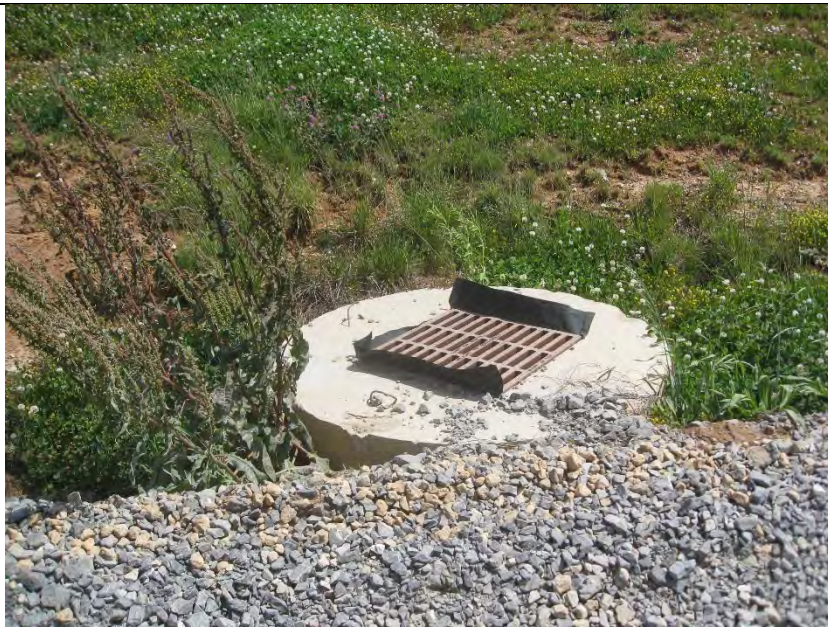
Photo 86  
Sta. 300+60  
(RW 5L-23R)  
Project 2

North Lateral Endwall 102.

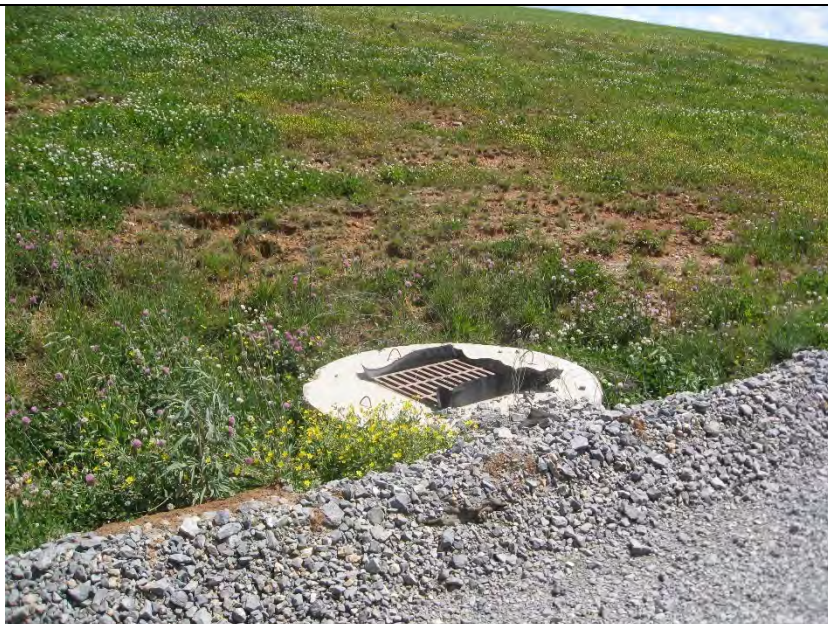
Photo 87  
Sta. 29+00 RT  
Proposed Haul Route  
Project 3

Inlet structures along haul road.

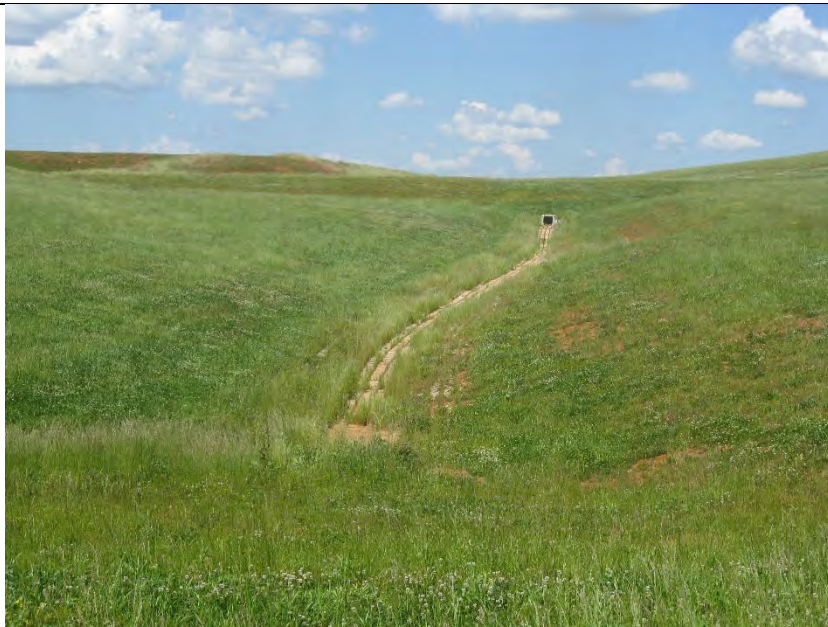
Photo 88  
Sta. 25+50 RT  
Proposed Haul Route  
Project 3

Inlet structures along haul road.

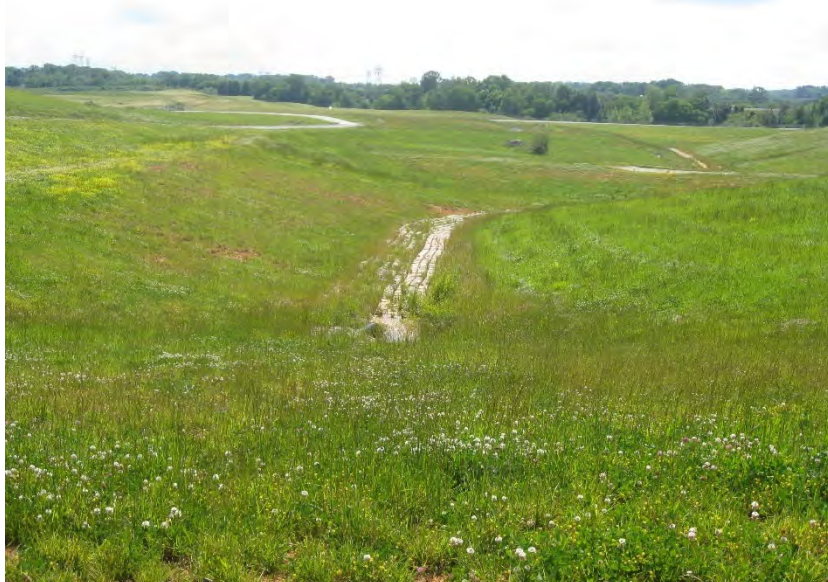
Photo 89  
Sta. 297+01  
(RW 5L-23R)  
Project 2

North Lateral Endwall 104.

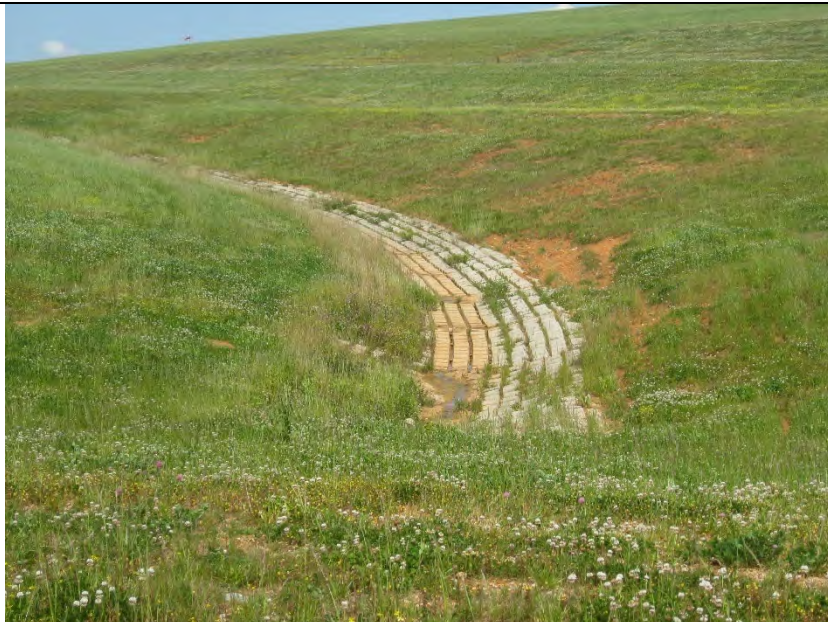
Photo 91  
Sta. 22+00 RT  
Proposed Haul Route  
Project 3

Inlet structures along haul road.

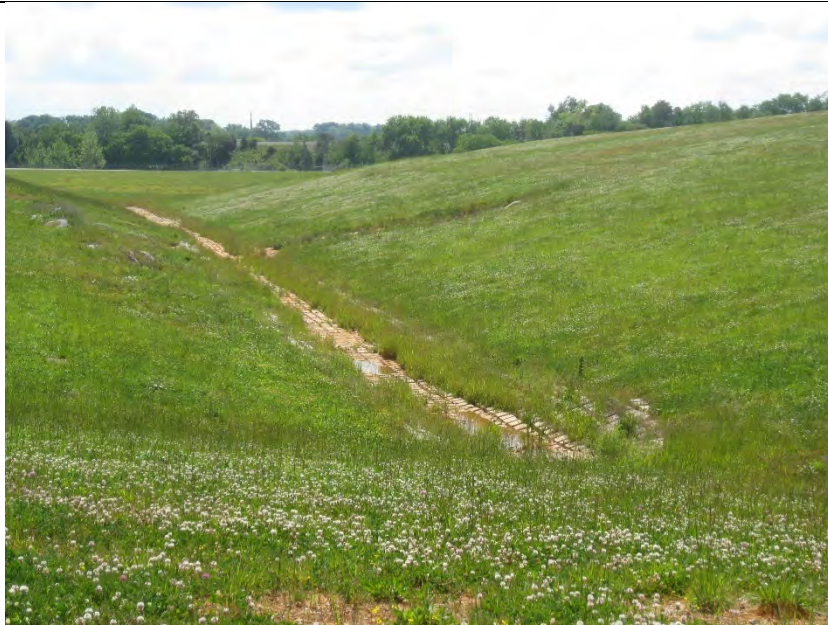
Photo 92  
Sta. 292+08  
(RW 5L-23R)  
Project 2

North Lateral Endwall 108.

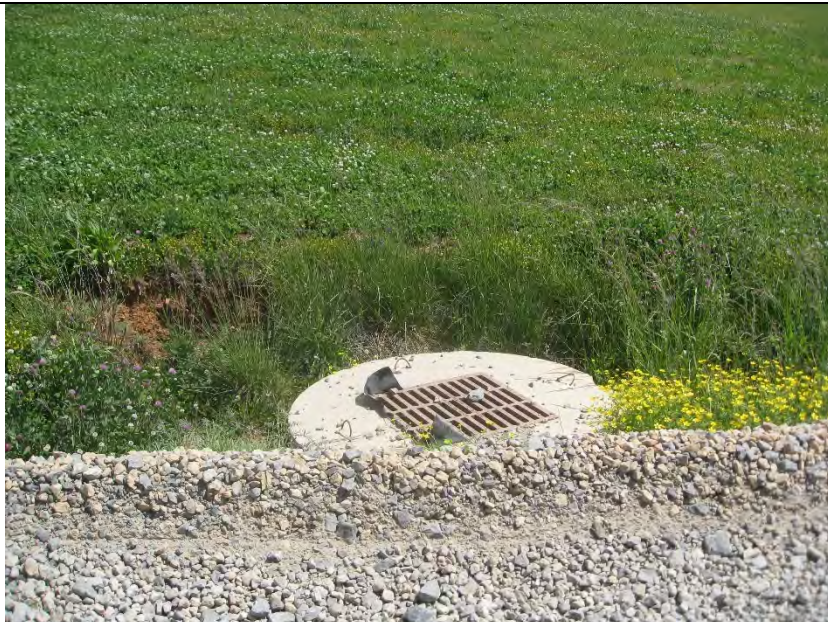
Photo 93  
Sta. 290+50 LT  
(RW 5L-23R)  
Project 2

North Lateral Endwall 110.

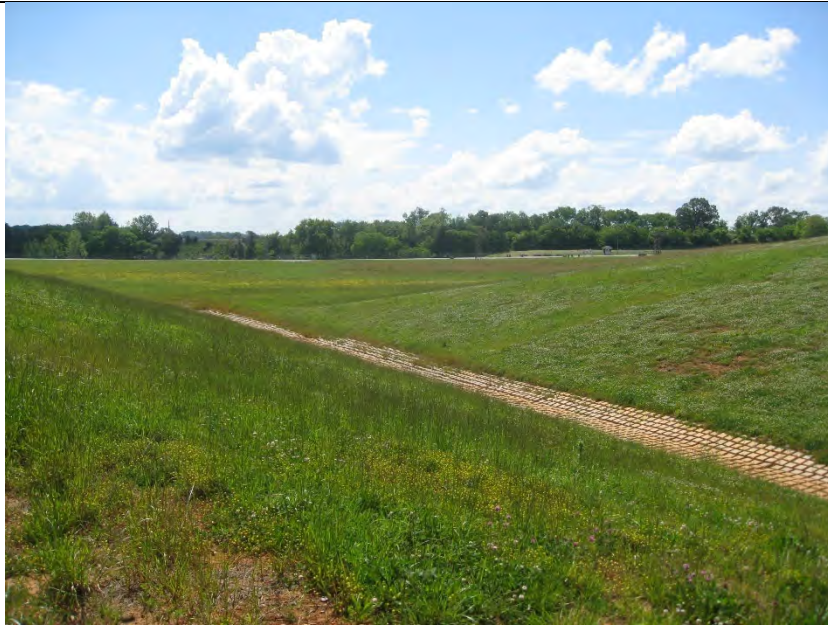
Photo 94  
Sta. 15+50 RT  
Proposed Haul Route  
Project 3

Inlet structures along haul road.

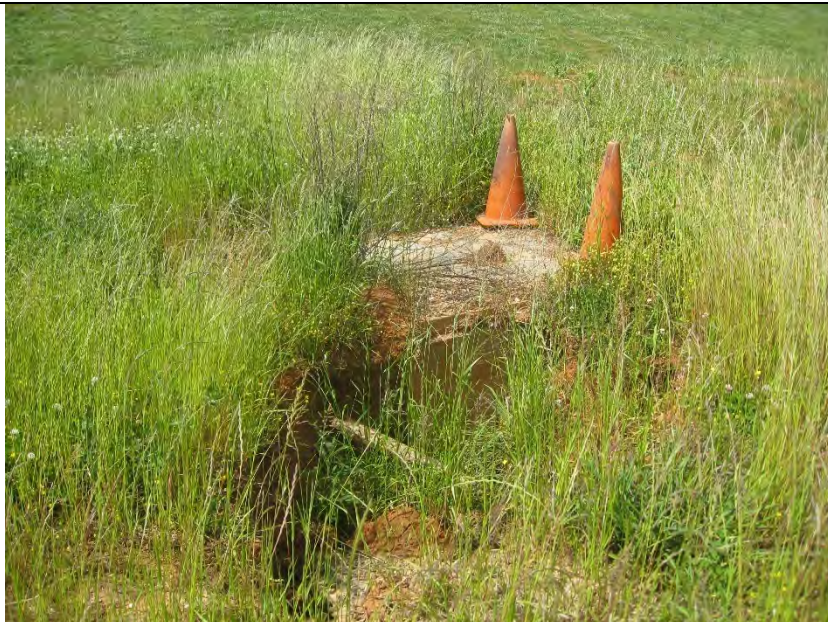
Photo 95  
Sta. 282+45 to 288+26 LT  
(RW 5L-23R)  
Project 2

North Lateral Ditch.

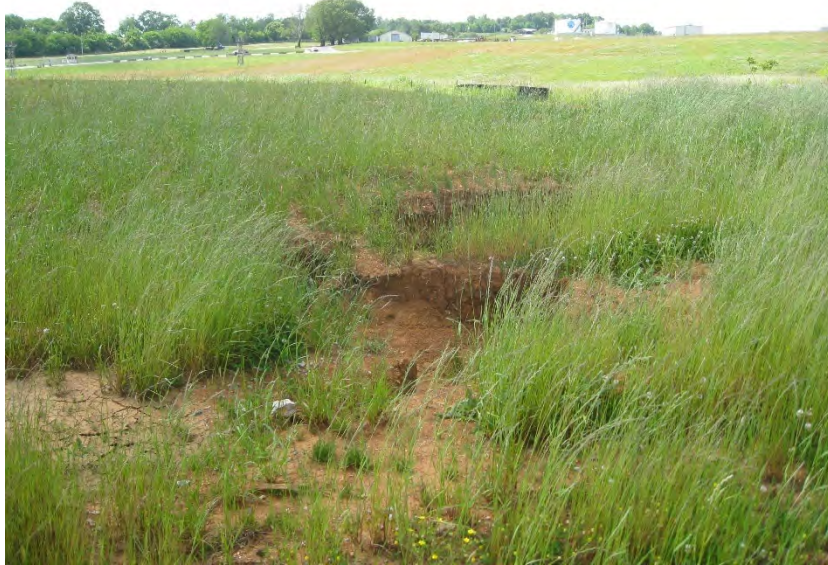
Photo 96  
Sta. 284+00 LT  
(RW 5L-23R)  
Project 2

Existing vault at old Liberty street.  
Construction fallout present. Recommend coordinating with CHA on remediation.

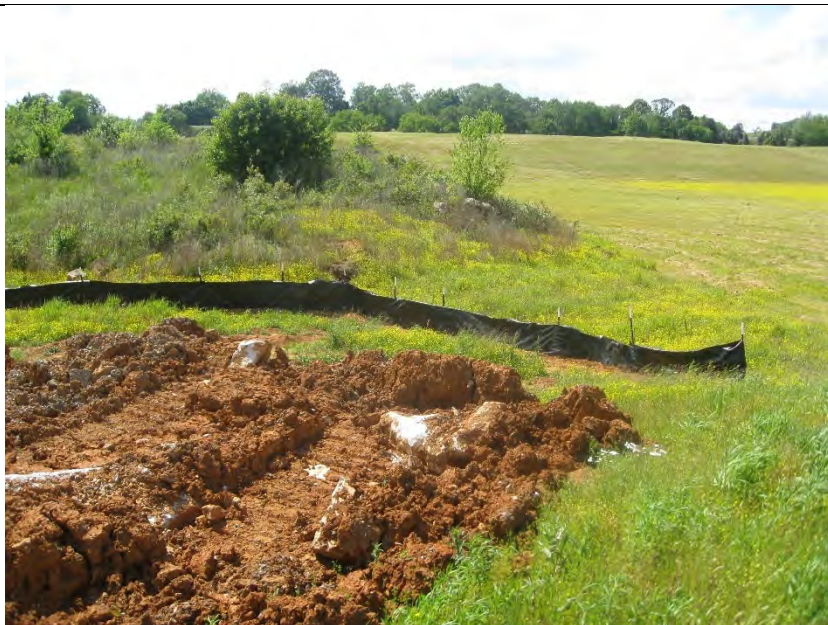
Photo 97  
Sta. 284+00 LT  
(RW 5L-23R)  
Project 2

Previous soil stockpile at old Liberty Street.  
Construction fallout present. Recommend coordinating with CHA on remediation.

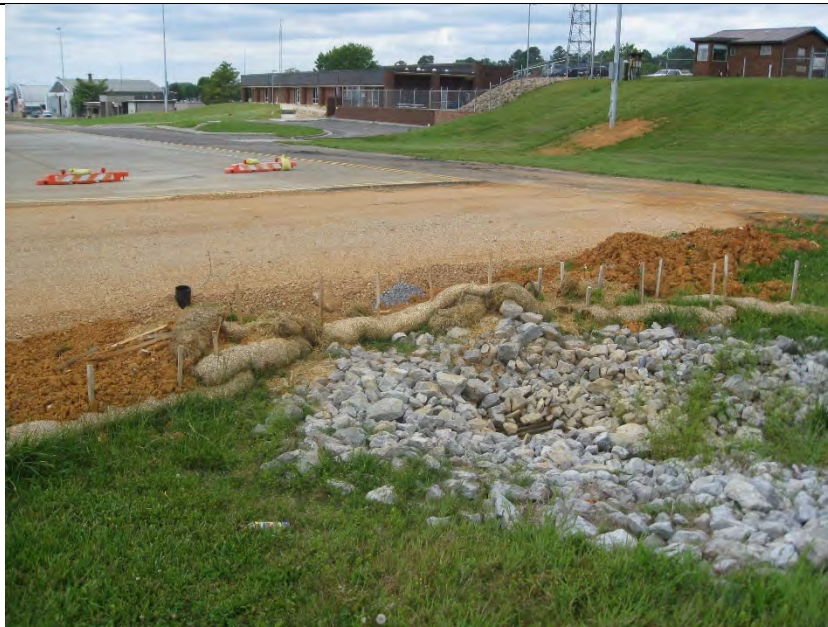
Photo 98  
(Repair TWY Lighting)

Fill area adjacent to Liberty Street from Taxiway shoulder removal.  
Silt fence recently repaired.

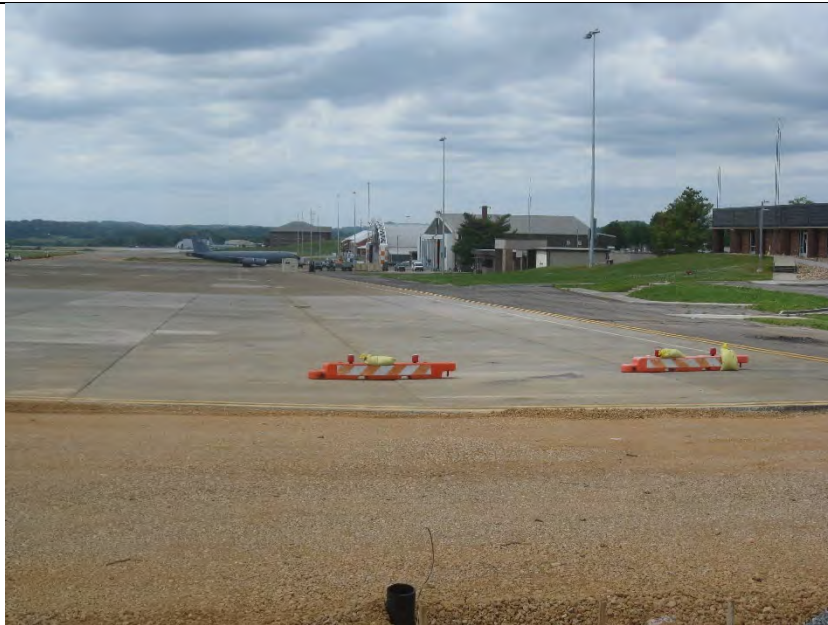
Photo 99  
(Repair TWY Lighting)  
Sheet EC2.1.7

Existing structure at Upper Apron.  
Inlet protection recently installed.

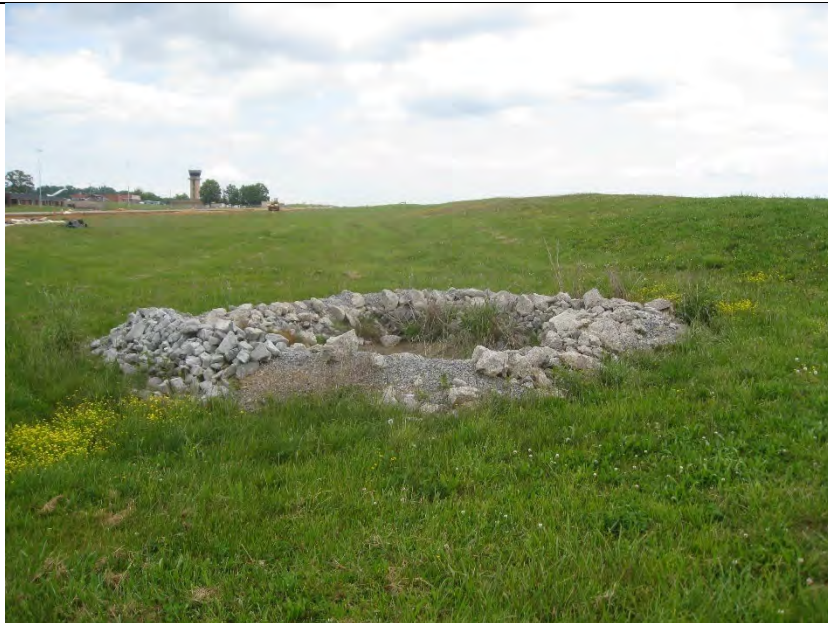
Photo 101  
(Repair TWY Lighting)  
Sheet EC2.1.6

Existing remaining Taxiway G4 recently demolished.  
Existing trench drain recently removed.  
Recommend stabilizing bare areas once activities are complete or remain inactive for longer than 14 days.

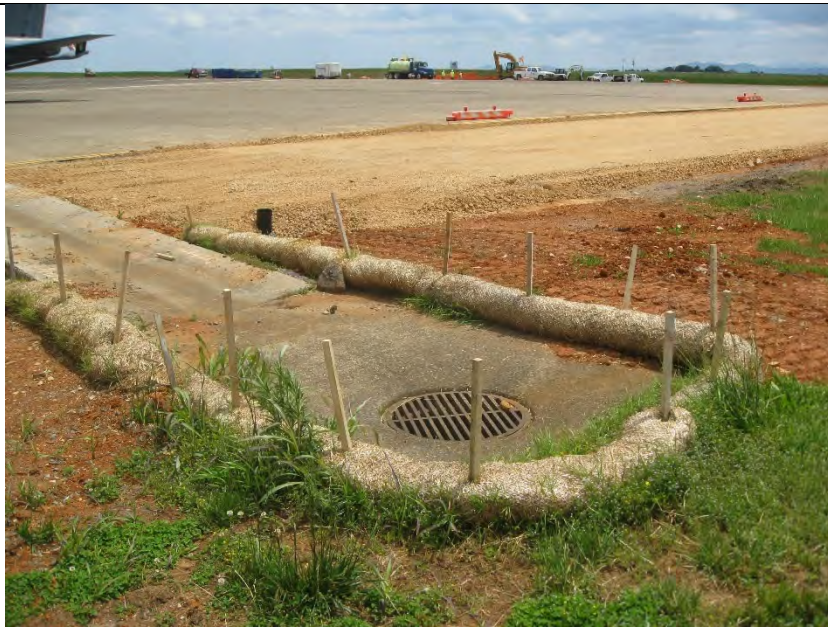
Photo 102  
(Repair TWY Lighting)  
Sheet EC2.1.6

Existing structure adjacent to Taxiway G4 being demolished.  
Original inlet protection from Project 2 in place and appears to be properly functioning.

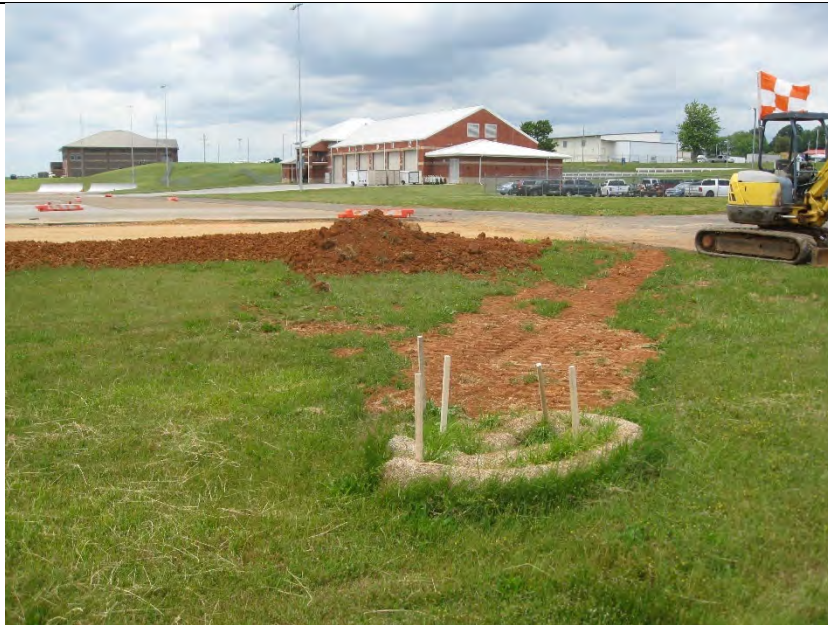
Photo 103  
(Repair TWY Lighting)  
Sheet EC2.1.5

Existing structure at Upper Apron.  
Newly installed underdrain recently backfilled and sediment tubes reinstalled.
