**QUALITY ASSURANCE  
MONTHLY SITE  
ASSESSMENT REPORT**

Airfield Modernization Program  
Runway 5L-23R Reconstruction  
Project 2 / Project 3

## QUALITY ASSURANCE SITE ASSESSMENT

## **AIRFIELD MODERNIZATION PROGRAM RUNWAY 5L-23R RECONSTRUCTION**

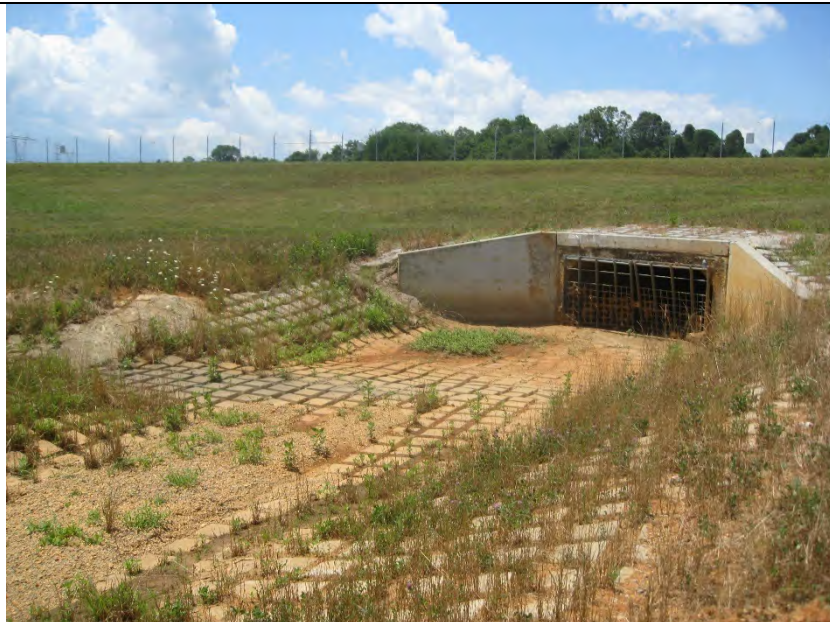
Photo 1  
Sta. 111+56 RT  
(Line LB)  
NLET 01  
Project 2

North Lateral End Treatment 01 (Outfall A).

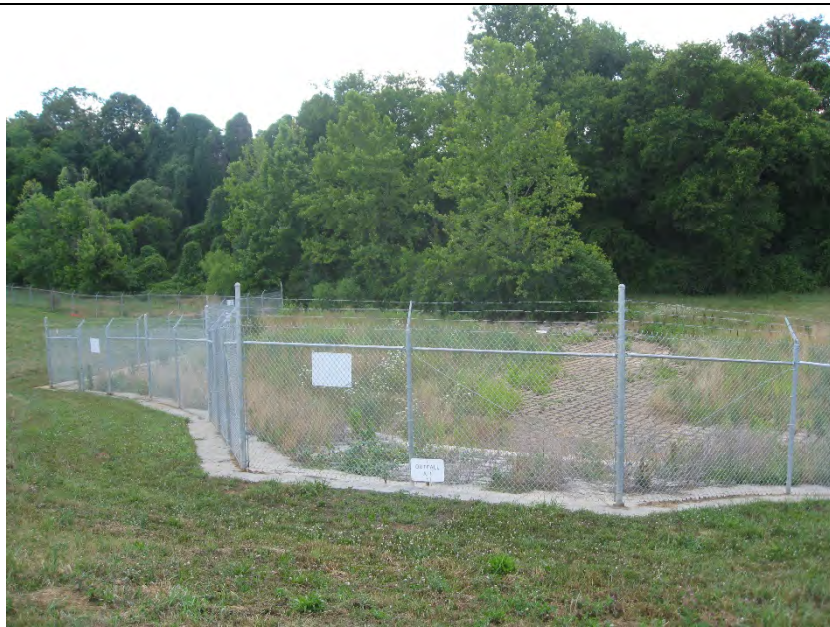
Photo 2  
Sta. 111+56 RT  
(Line LB)  
NLET 01  
Project 2

North Lateral End Treatment 01 (Outfall A).

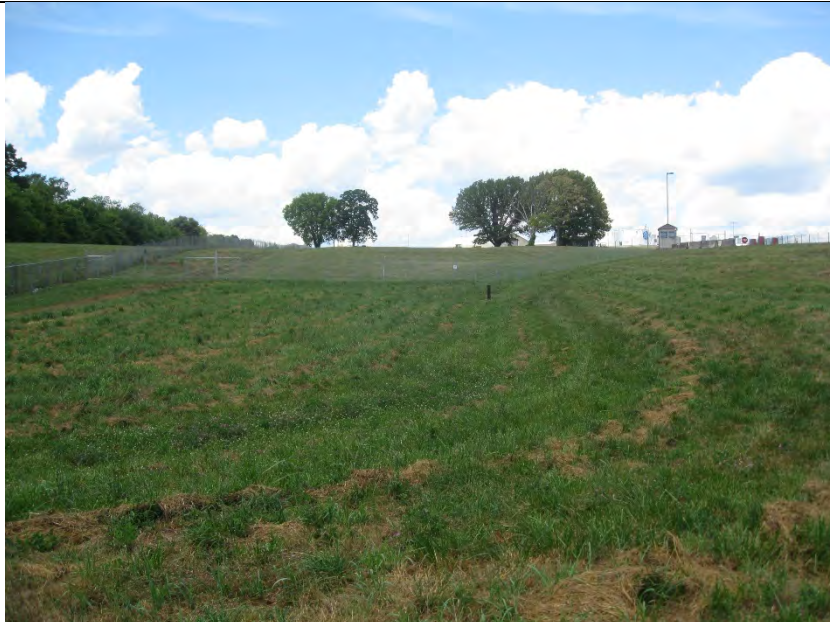
Photo 3  
Sta. 111+82 LT  
(Line LB)  
NLET 02  
Project 2

Main outfall to Lackey Creek. This section of the site was inaccessible at time of inspection.

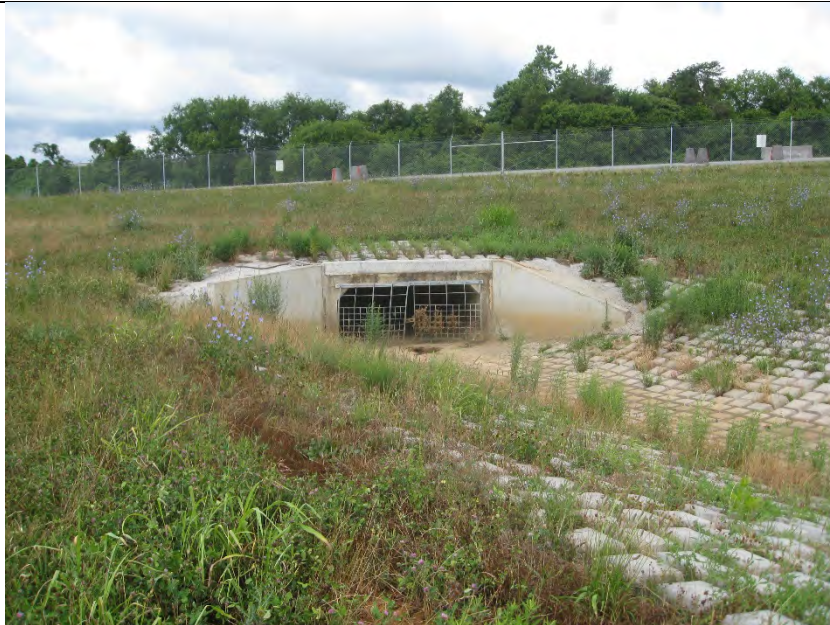
Photo 4  
Sta. 115+28 to Sta. 121+45  
(Line LB)  
Project 2

Grass established at ditch line along Liberty Street.

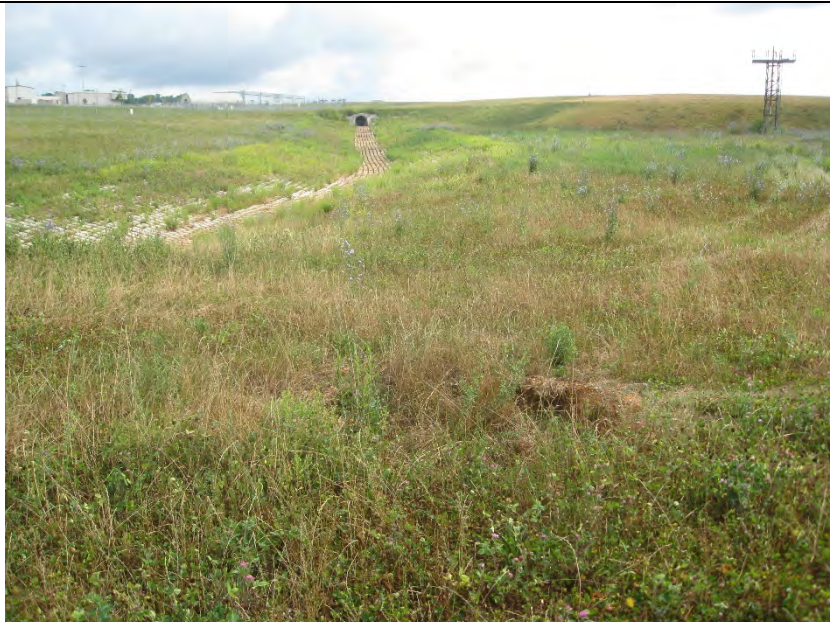
Photo 5  
Sta. 117+00  
(Line LB)  
Project 2

Guard Lateral Ditch (Outfall B).

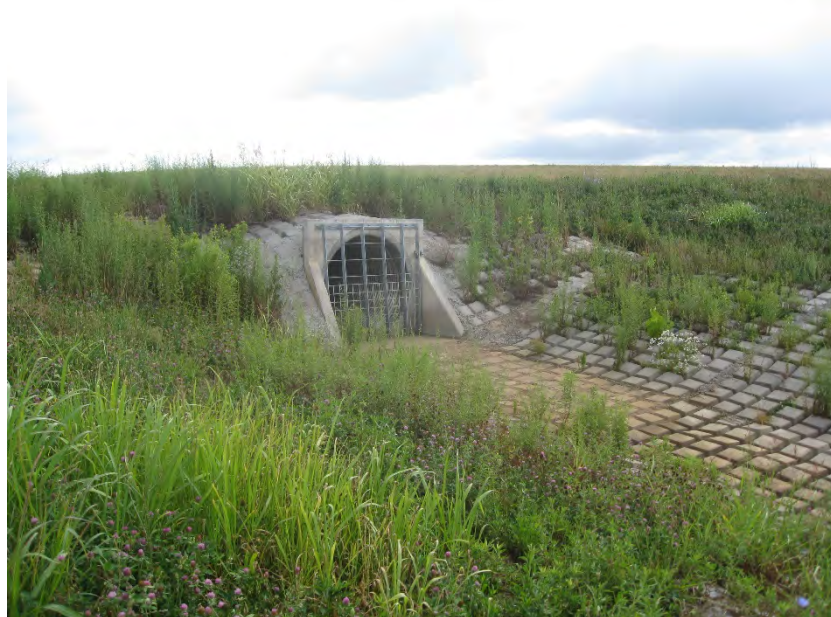
Photo 7  
Sta. 117+00  
(Line LB)  
Project 2

Guard Lateral Ditch (Outfall B).

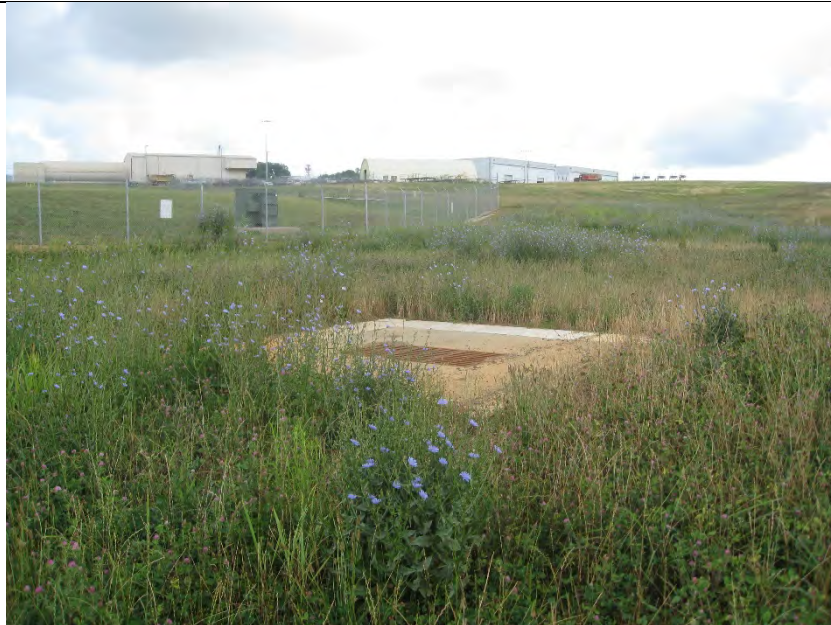
Photo 8  
Sta. 117+00 (RT)  
Project 2

78" culvert in the Guard Lateral Ditch.

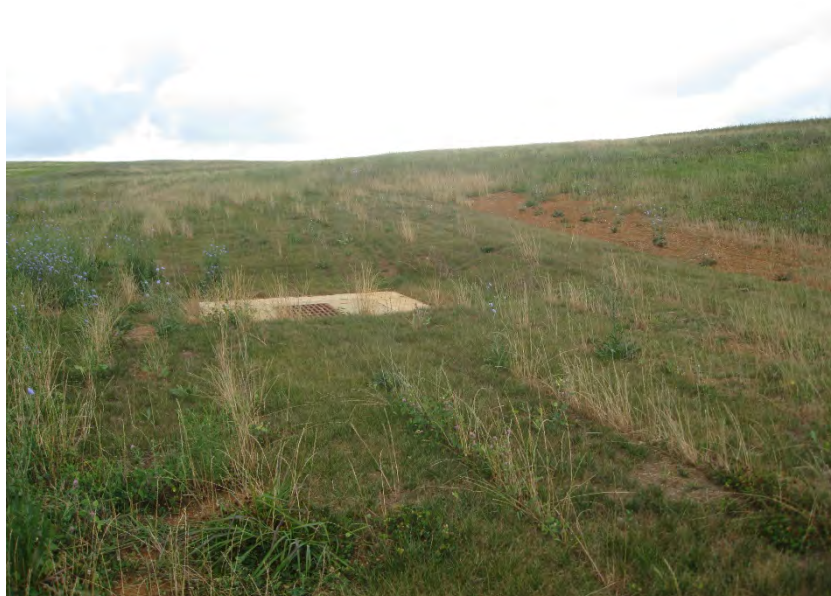
Photo 9  
Sta. 287+21 LT  
(RW 5L-23R)  
Structure 124  
Project 3

Structure 124.

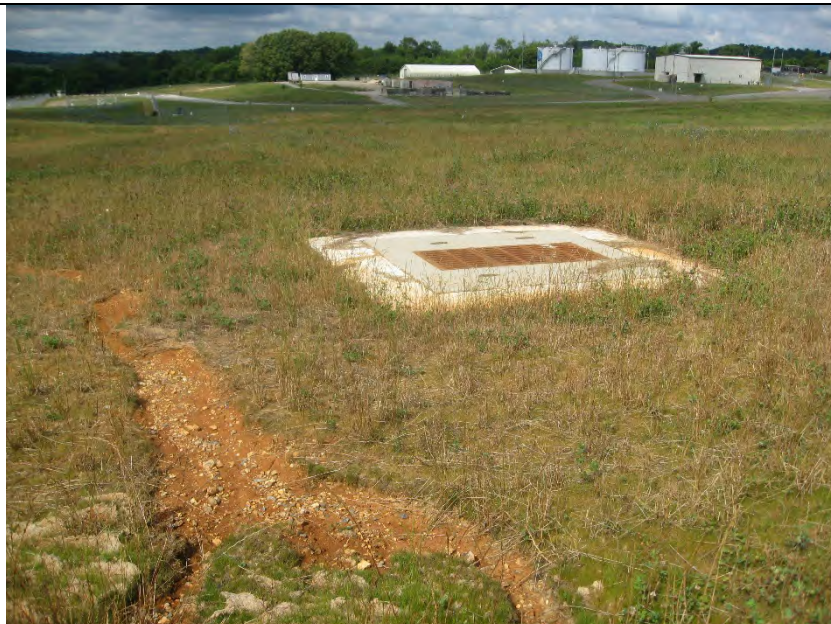
Photo 11  
Sta. 291+51 LT  
(RW 5L-23R)  
Structure 120  
Project 3

Structure 120.

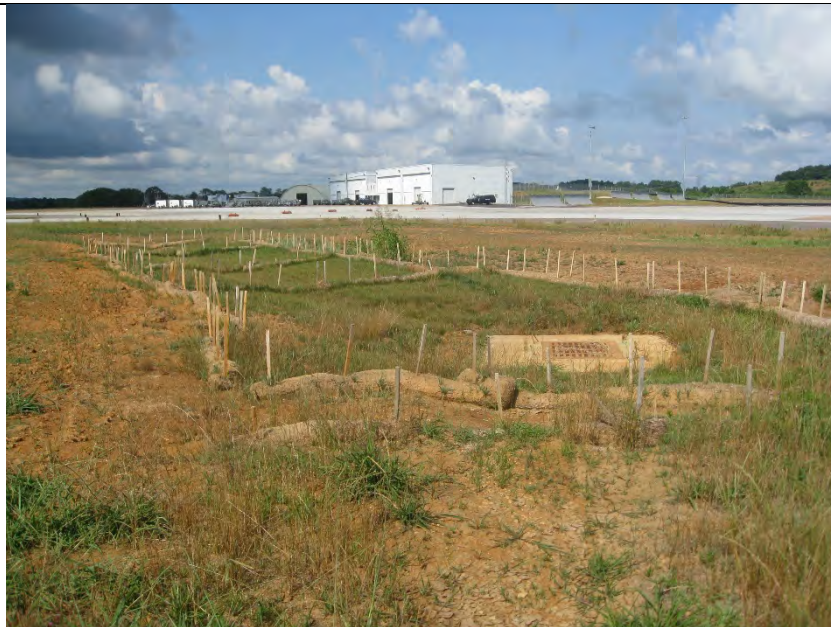
Photo 14  
Sta. 302+54 LT  
(RW 5L-23R)  
Structure 114  
Project 3

Structure 114.  
Bare areas recently stabilized.

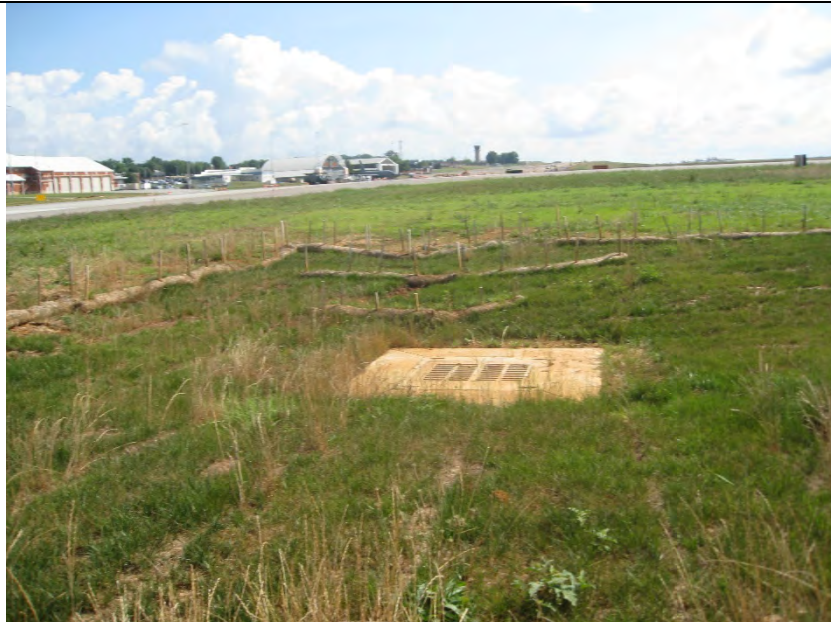
Photo 15  
Sta. 303+36 LT  
(RW 5L-23R)  
Structure 12  
Project 3

Structure 12.  
Bare areas recently stabilized.

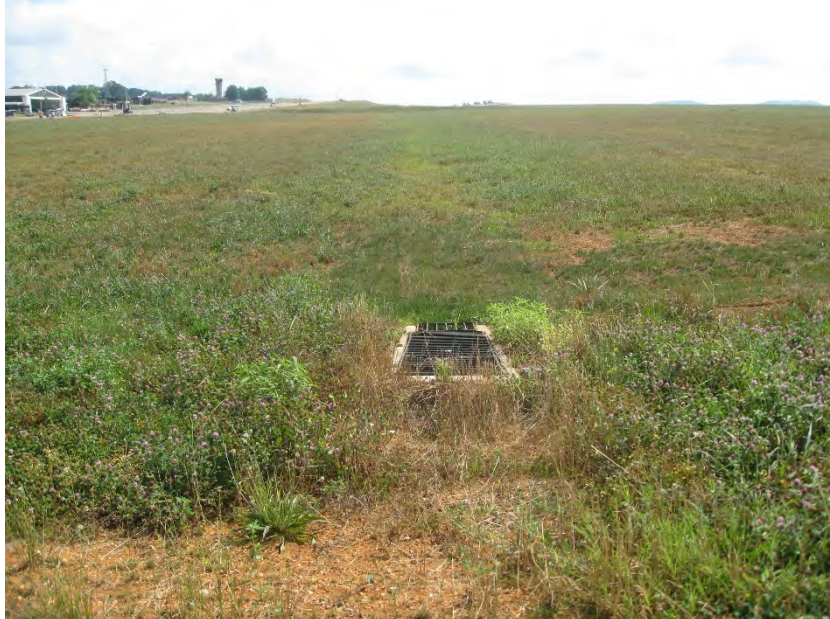
Photo 19  
Sta. 314+48 LT  
(RW 5L-23R)  
ES Endwall 108  
Project 3

Enhanced Swale Endwall 108.  
Recommend stabilizing remaining bare areas.

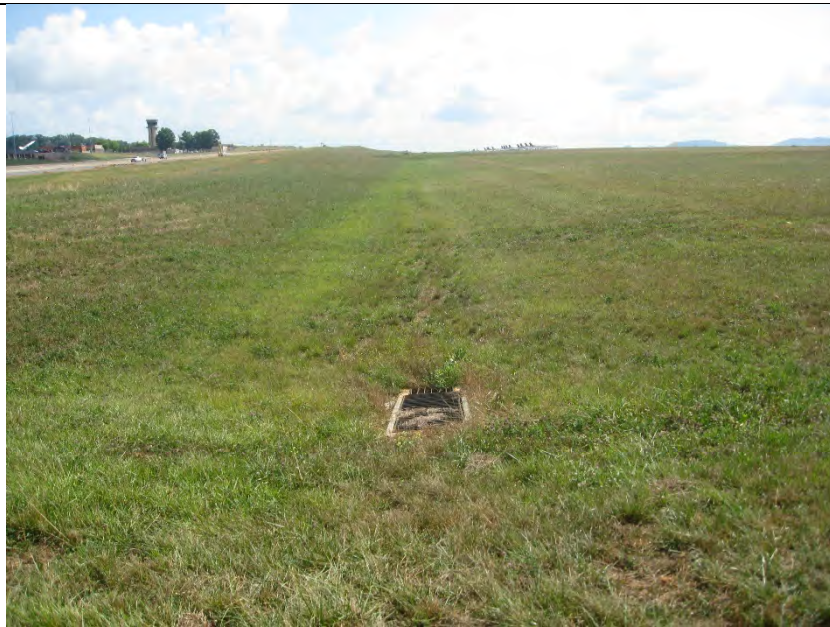
Photo 20  
Sta. 314+48 LT  
(RW 5L-23R)  
ES Endwall 108  
Project 3

Enhanced Swale Endwall 108.  
Recommend stabilizing remaining bare areas.

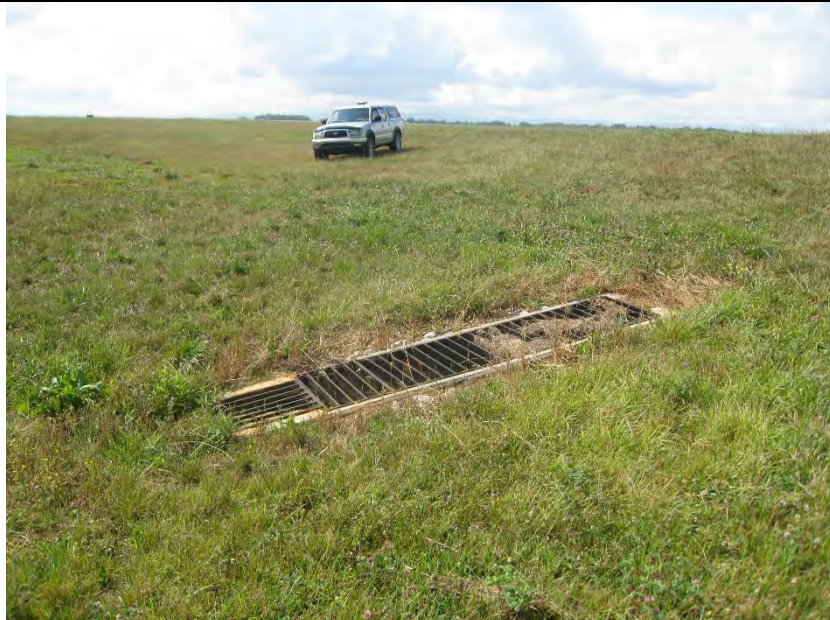
Photo 21  
Sta. 324+86 LT  
(RW 5L-23R)  
ES Endwall 106  
Project 3

Enhanced Swale Endwall 106.

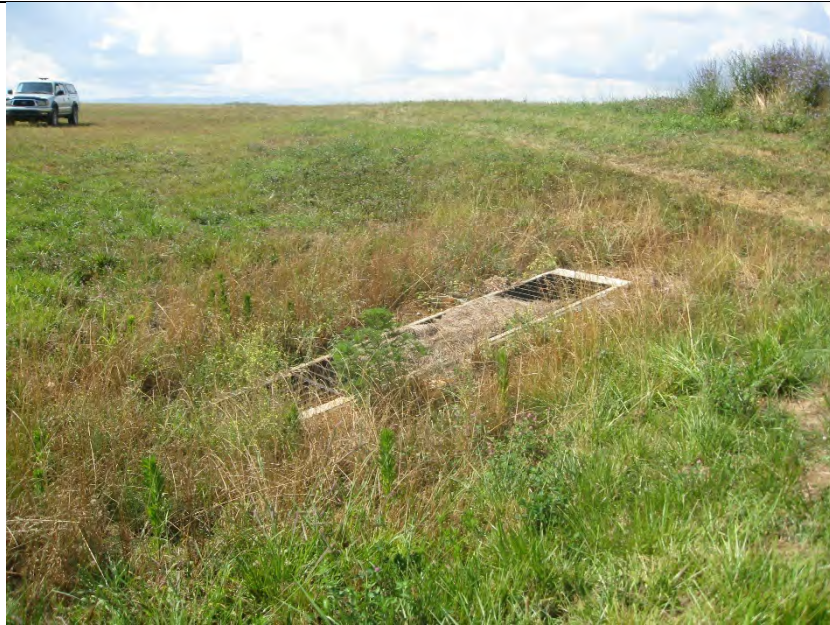
Photo 22  
Sta. 324+86 to Sta. 335+73 LT  
(RW 5L-23R)  
ES Endwall 106  
Project 3

Enhanced Swale Endwall 106.

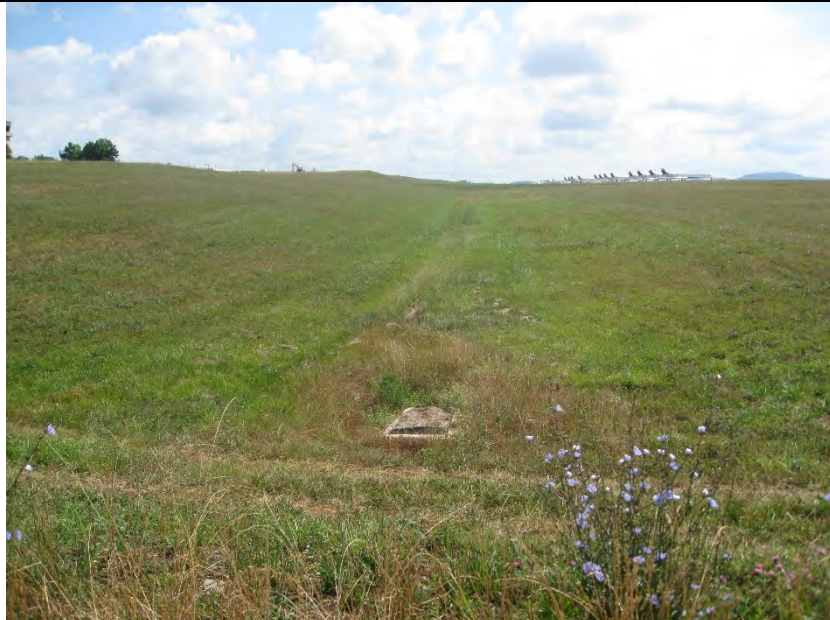
Photo 23  
Sta. 335+73 LT  
(RW 5L-23R)  
ES Endwall 104  
Project 3

Enhanced Swale Endwall 104.

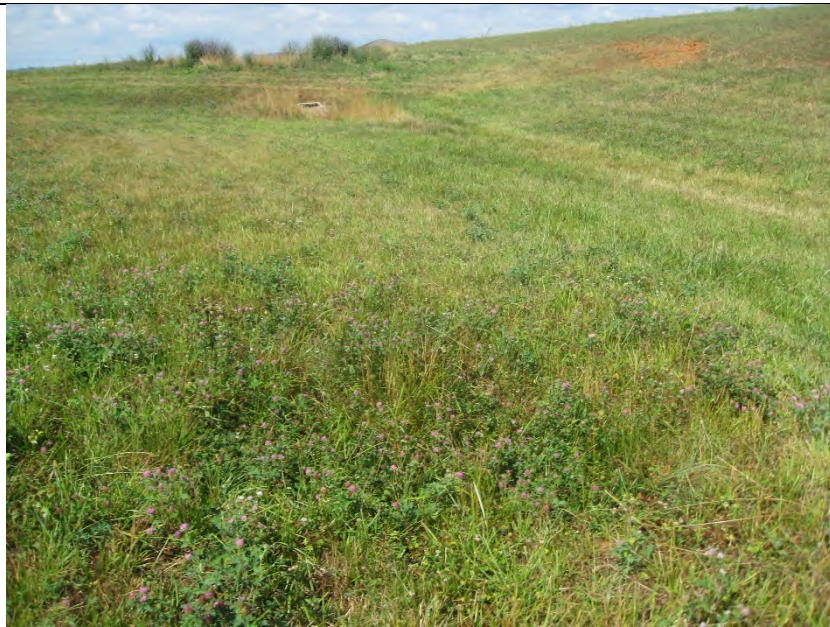
Photo 24  
Sta. 335+73 LT  
(RW 5L-23R)  
ES Endwall 104  
Project 3

Enhanced Swale Endwall 104.

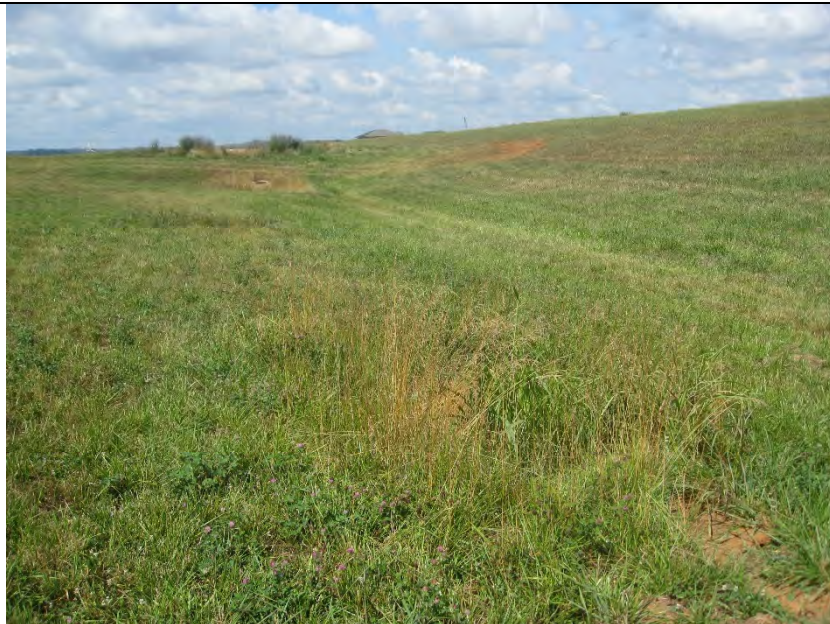
Photo 25  
Sta. 341+50 LT  
(RW 5L-23R)  
Between ES Endwall 104 and 102  
Project 3

Potential construction fallout on Storm Line 1 between ES Endwall 104 and 102.

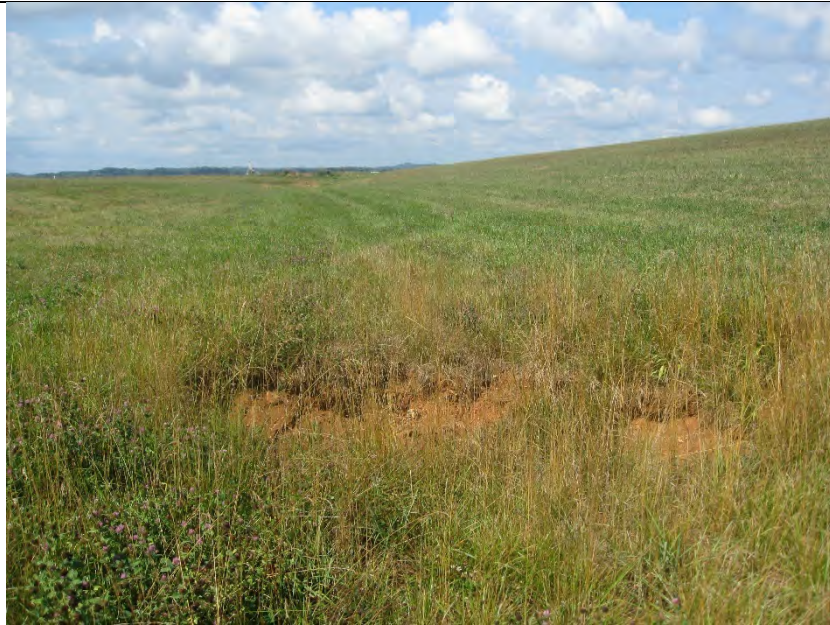
Photo 26  
Sta. 341+50 LT  
(RW 5L-23R)  
Between ES Endwall 104 and 102  
Project 3

First construction fallout on Storm Line 1 between ES Endwall 104 and 102.  
Coordinate remediation with CHA.

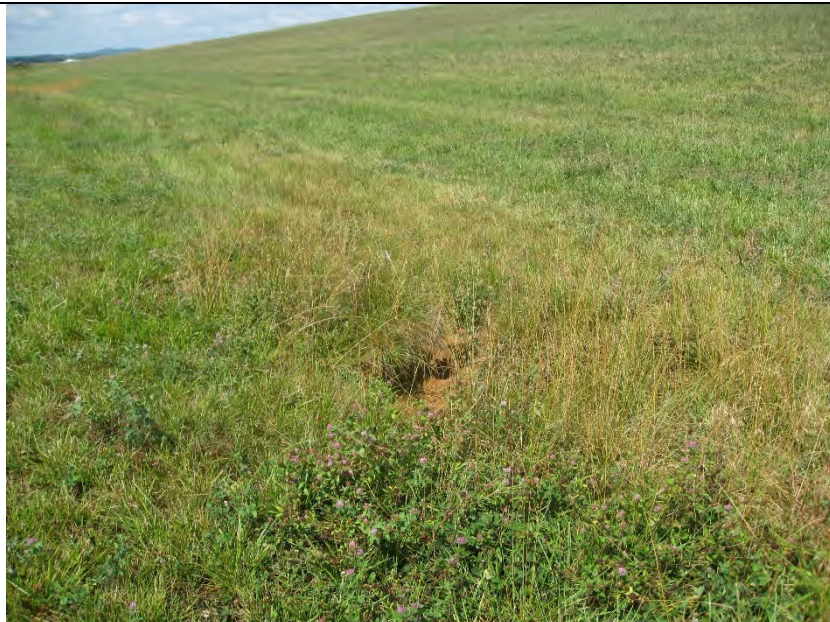
Photo 27  
Sta. 341+50 LT  
(RW 5L-23R)  
Between ES Endwall 104 and 102  
Project 3

Second construction fallout on Storm Line 1 between ES Endwall 104 and 102.  
Coordinate remediation with CHA.

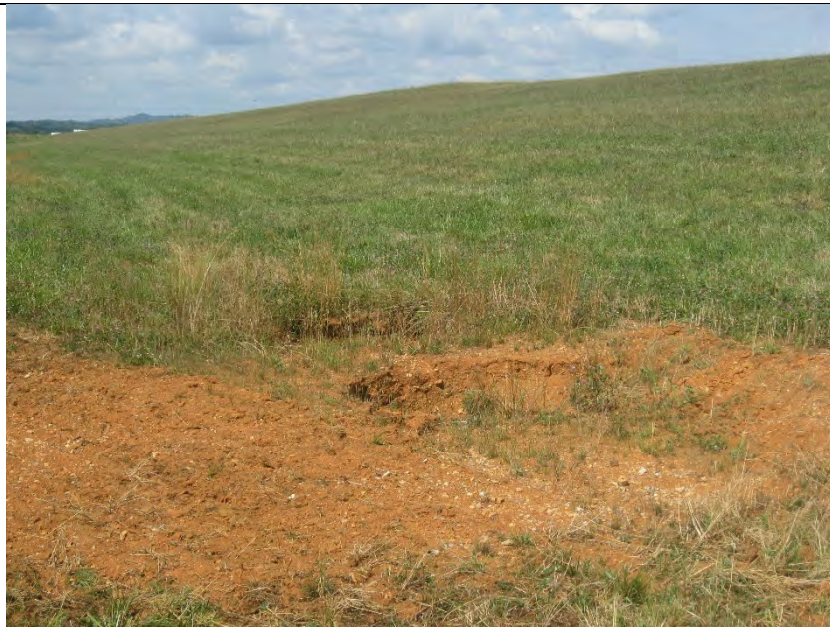
Photo 28  
Sta. 341+50 LT  
(RW 5L-23R)  
Between ES Endwall 104 and 102  
Project 3

Third construction fallout on Storm Line 1 between ES Endwall 104 and 102.  
Coordinate remediation with CHA.

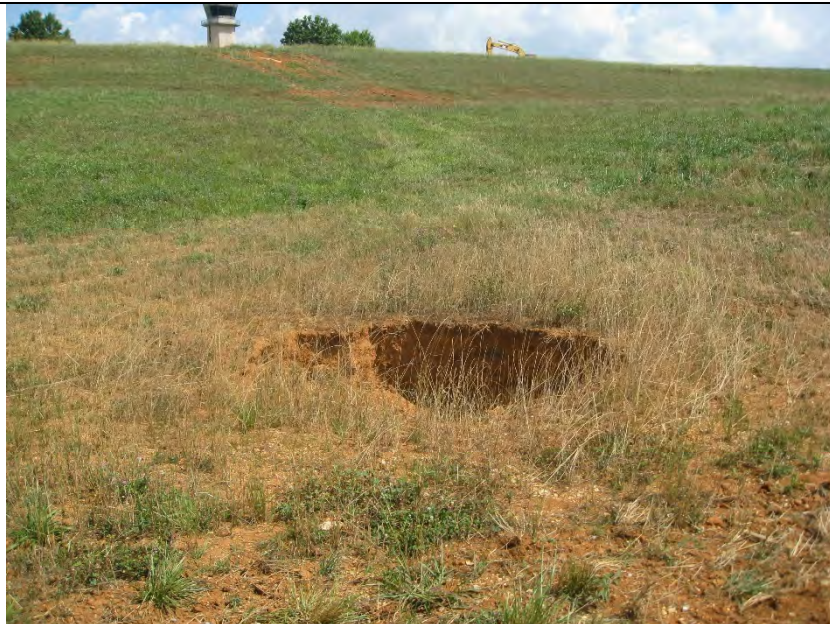
Photo 29  
Sta. 341+50 LT  
(RW 5L-23R)  
Between ES Endwall 104 and 102  
Project 3

Fourth construction fallout on Storm Line 1 between ES Endwall 104 and 102.  
Coordinate remediation with CHA.

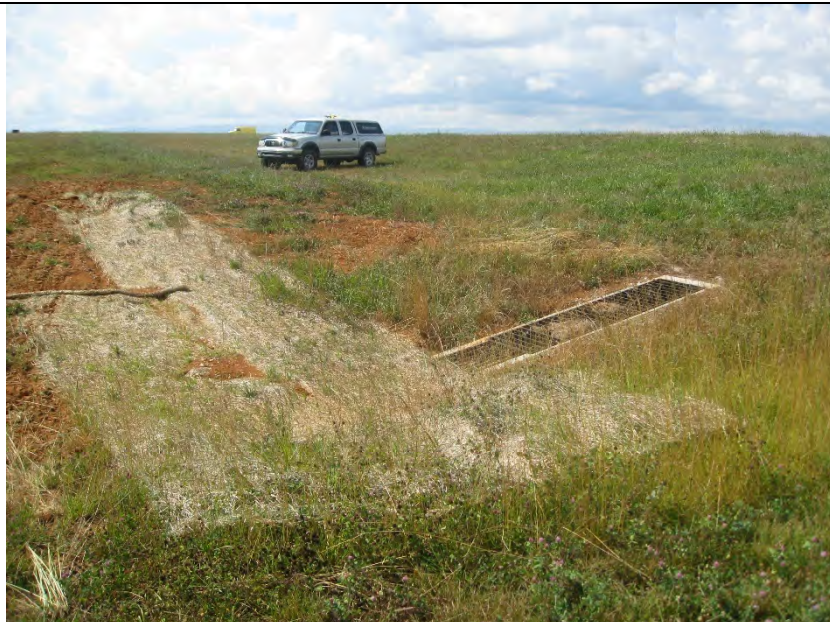
Photo 31  
Sta. 347+31 LT  
(RW 5L-23R)  
ES Endwall 102  
Project 3

Enhanced Swale Endwall 102.  
Recommend stabilizing remaining bare areas.

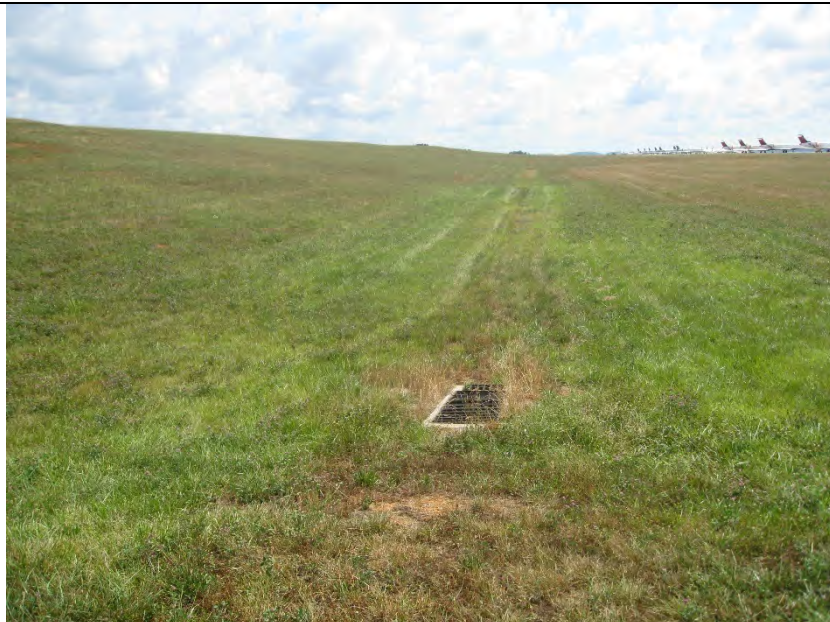
Photo 33  
Sta. 341+50 LT  
(RW 5L-23R)  
ES Endwall 102  
Project 3

Construction fallout on Storm Line 1 between ES Endwall 102 and 100.  
Coordinate remediation with CHA.

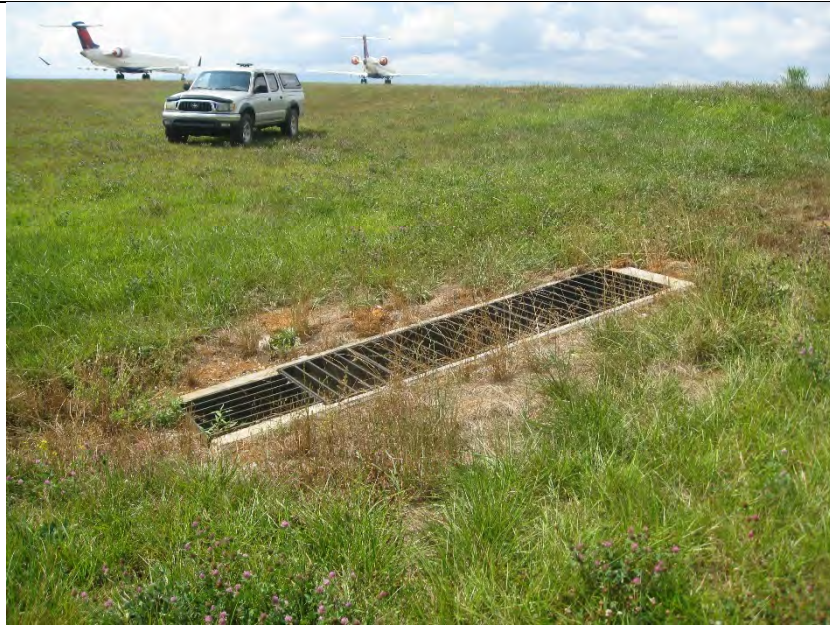
Photo 34  
Sta. 354+75 LT  
(RW 5L-23R)  
ES Endwall 100  
Project 2

Enhanced Swale Endwall 100.

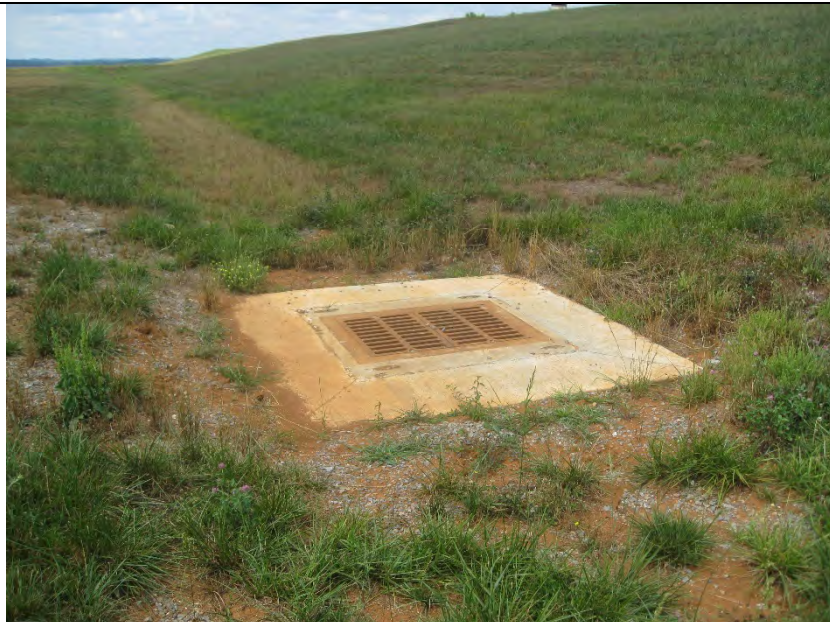
Photo 35  
Sta. 354+75 LT  
(RW 5L-23R)  
ES Endwall 100  
Project 3

Enhanced Swale Endwall 100.

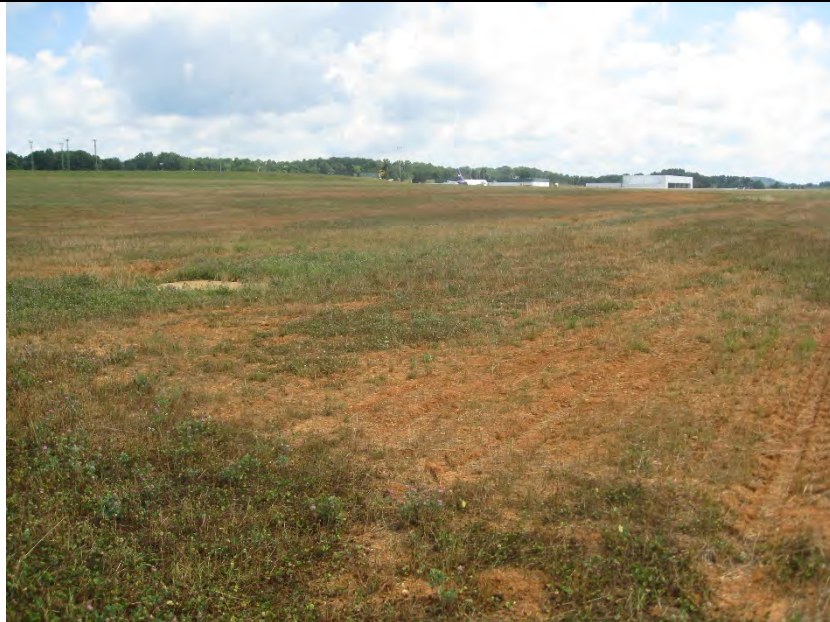
Photo 37  
Sta. 363+35 LT  
(RW 5L-23R)  
Existing Structure  
Project 2

Existing Structure.

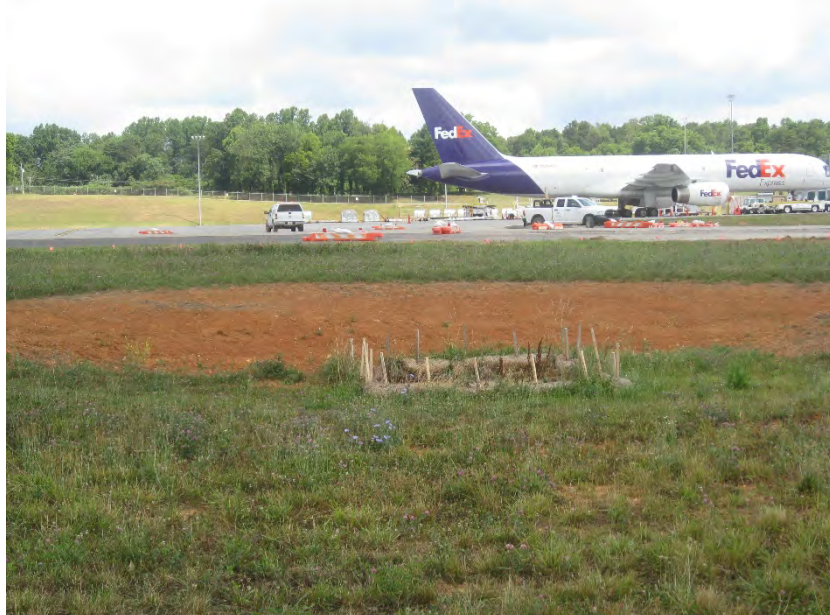
Photo 39  
Sta. 369+11 LT  
(RW 5L-23R)  
Existing Structure  
Project 2

Existing Structure.  
Recommend stabilizing bare areas.

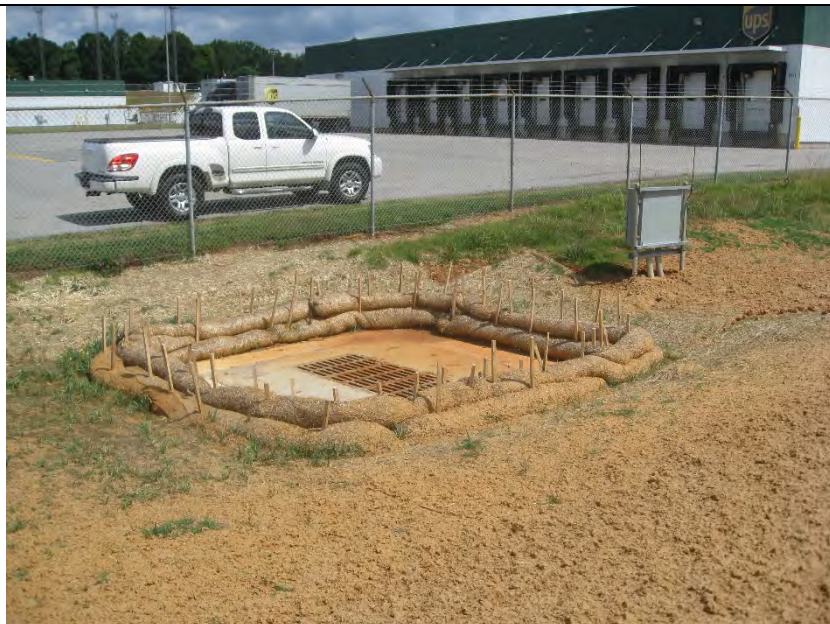
Photo 41  
Sta. 677+00 RT  
(RW 5L-23R)  
Project 4

Structure between Taxiway G and UPS Facility.

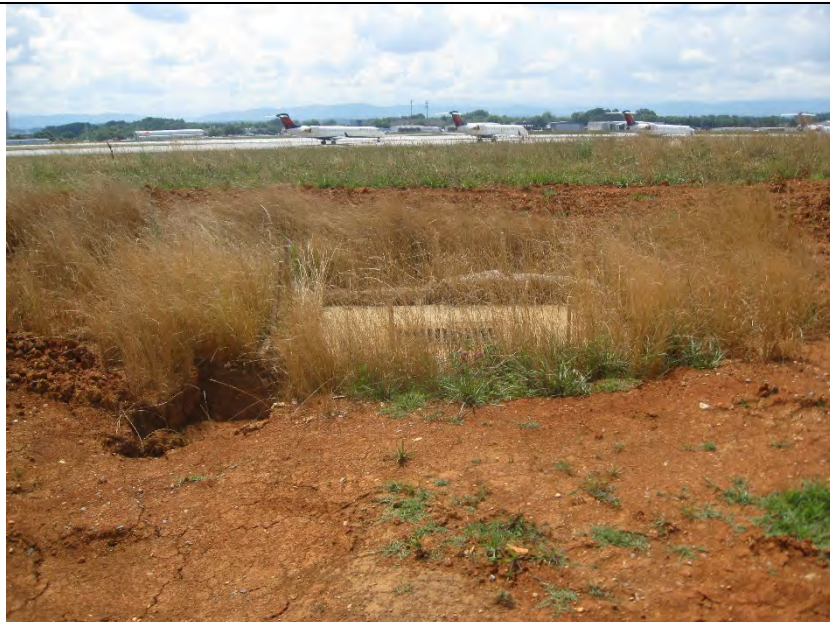
Photo 43  
(RW 5L-23R)  
Existing Structure  
Project 4

Existing structure south of Taxiway G  
Area recently regraded, recommend stabilizing bare areas.

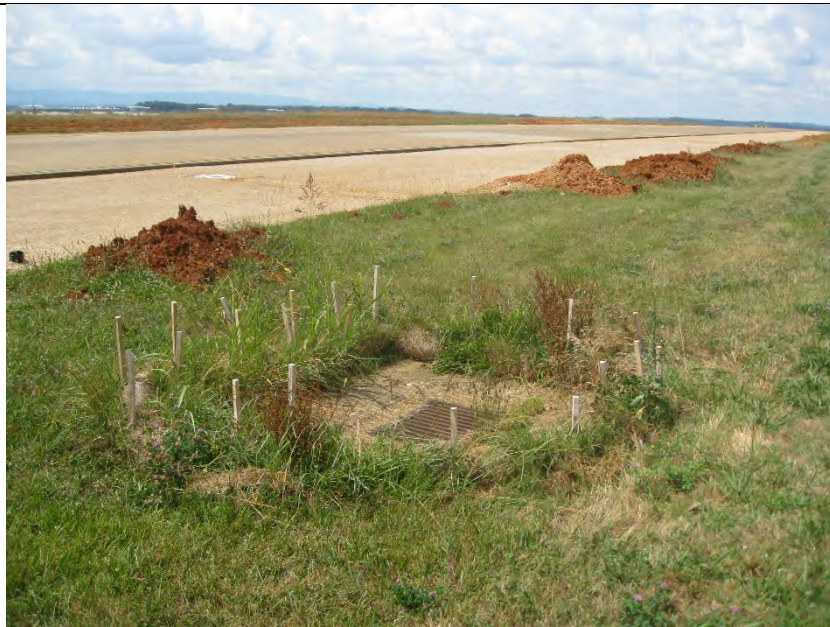
Photo 44  
(RW 5L-23R)  
Existing Structure  
Project 4

Existing structure south of Taxiway G.

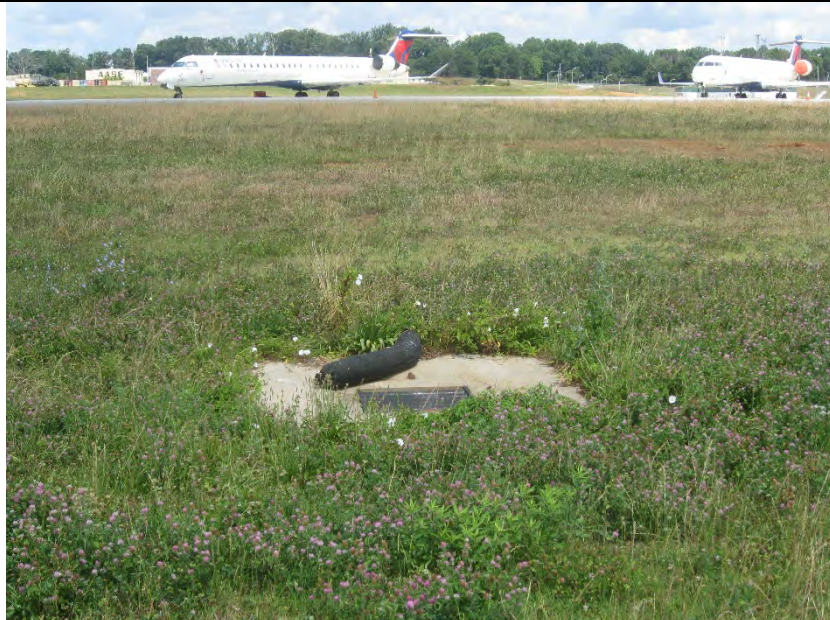
Photo 45  
(RW 5L-23R)  
Existing Structure  
Project 4

Existing structure north of Taxiway G.

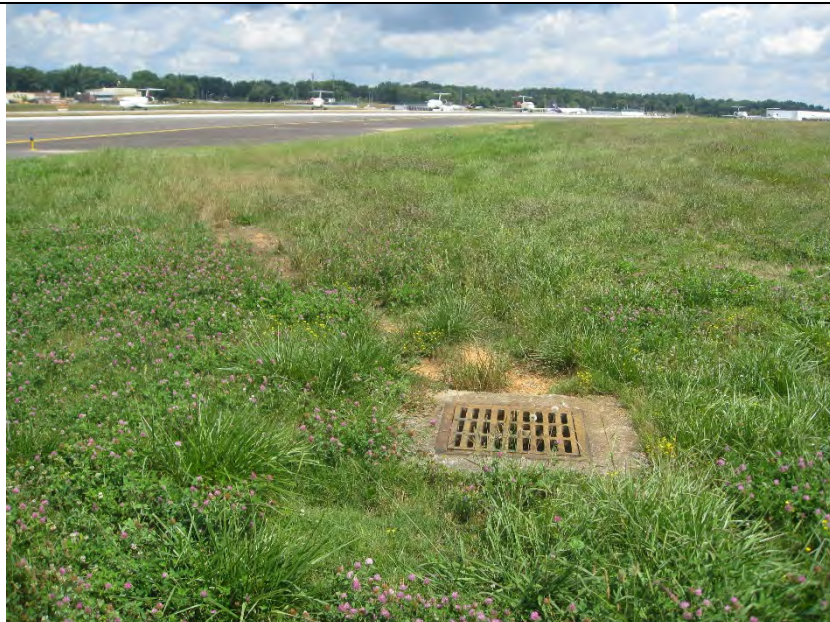
Photo 47  
Sta. 366+89 RT  
(RW 5L-23R)  
Outfall C  
Project 4

Recommend removing filter fabric from this structure to allow sampling for DMR.  
(Outfall C).

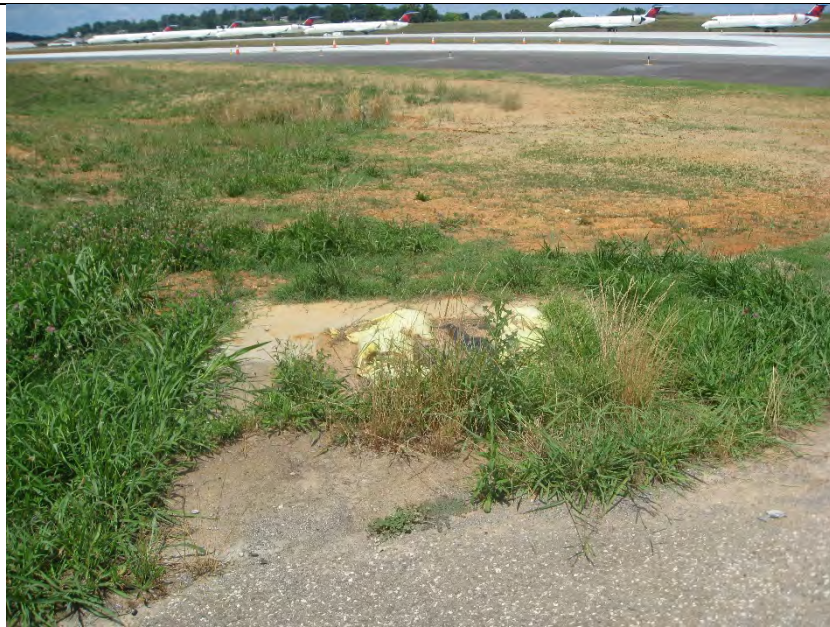
Photo 48  
(RW 5L-23R)  
TWY Y Tie-in  
Project 4

Existing structure north of Taxiway Y.

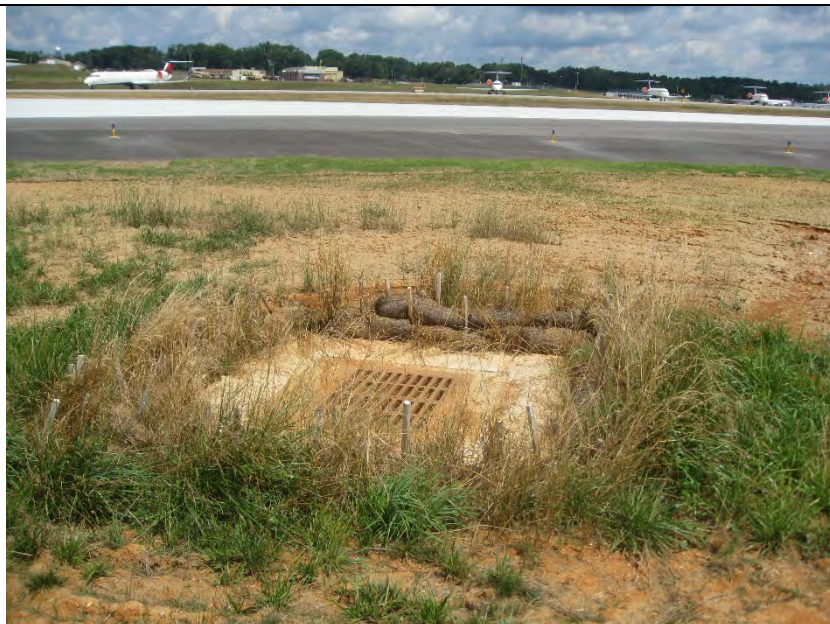
Photo 49  
(RW 5L-23R)  
TWY Y Tie-in  
Project 4

Existing structure south of Taxiway Y.  
Bare areas recently stabilized.

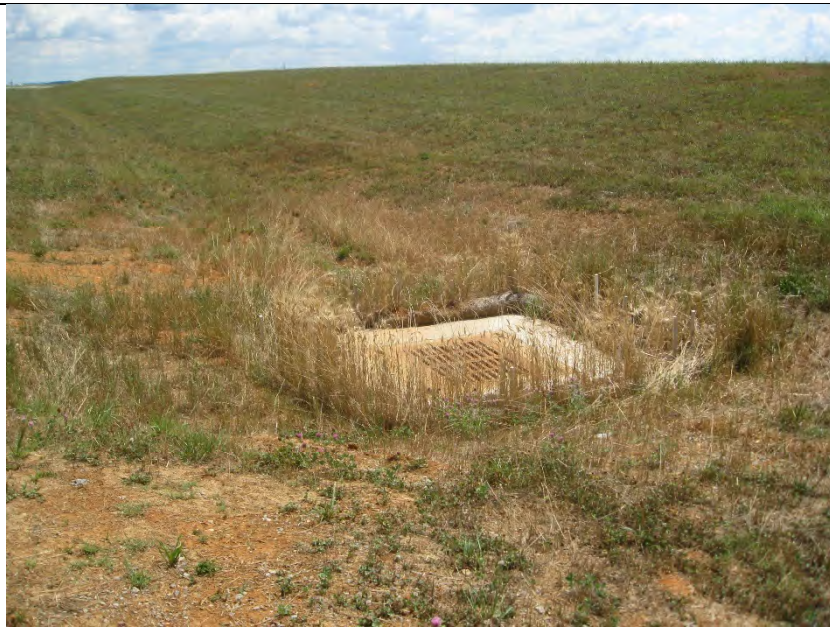
Photo 50  
Sta. 362+02 LT  
(RW 5L-23R)  
Structure 400  
Project 4

Structure 400.  
Bare areas recently stabilized.

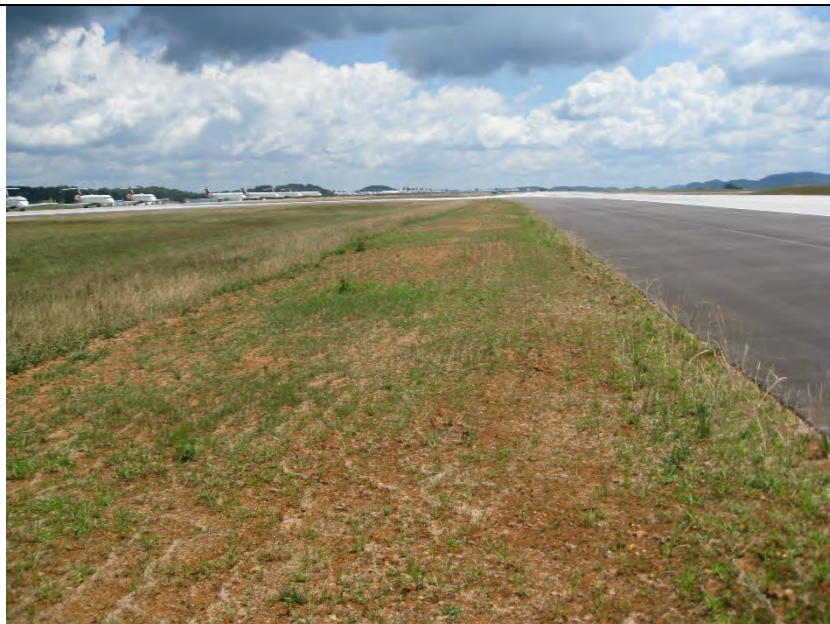
Photo 51  
Sta. 353+56 RT  
(RW 5L-23R)  
Structure 20  
Project 4

Structure 20.

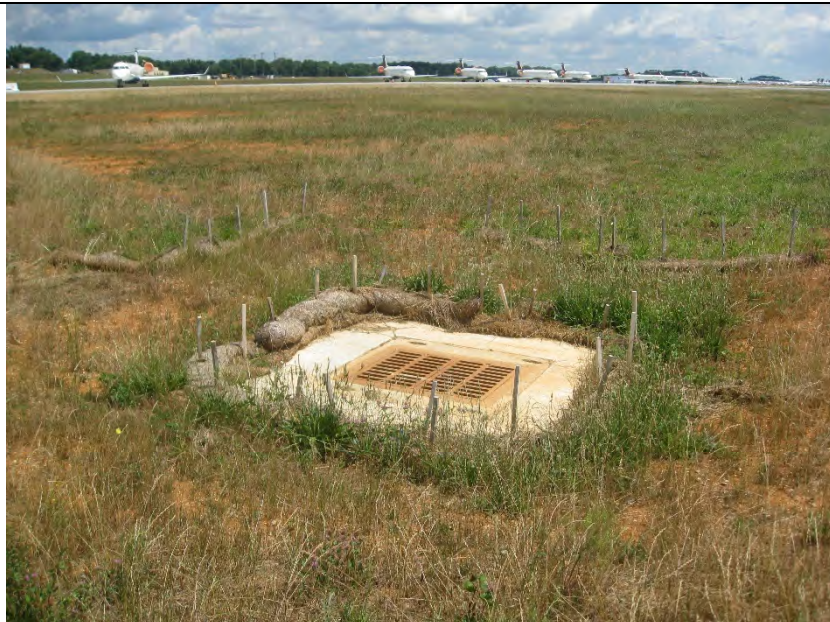
Photo 53  
Sta. 347+26 RT  
(RW 5L-23R)  
Structure 22  
Project 4

Structure 22.  
Sediment tubes recently relocated to edge of sod. Recommend stabilizing bare areas.

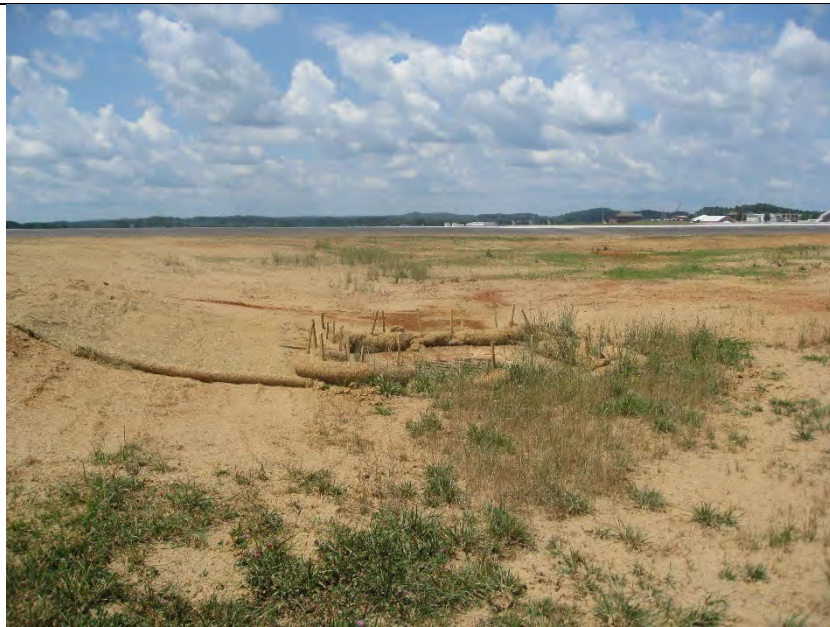
Photo 54  
Sta. 353+56 RT  
(RW 5L-23R)  
Structure 200  
Project 4

Structure 200.

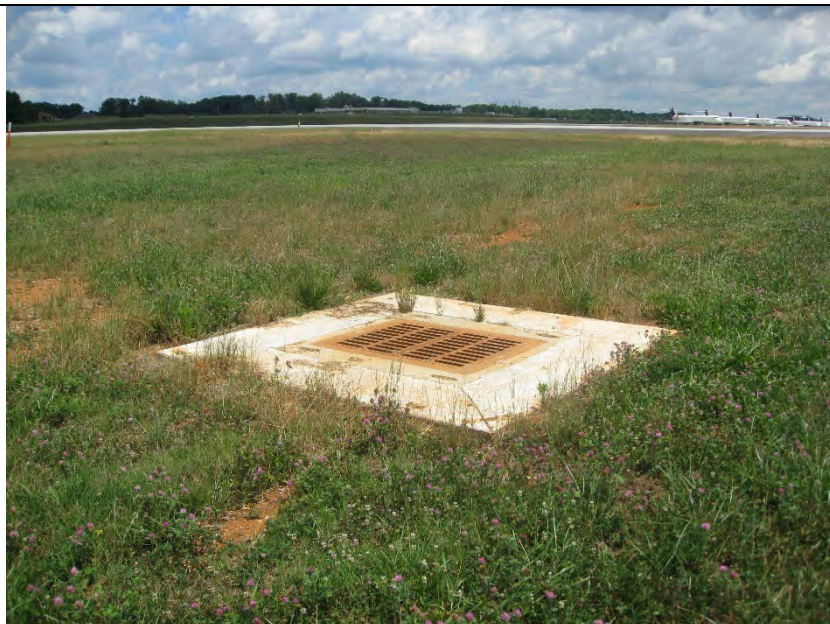
Photo 55  
Sta. 347+26 RT  
(RW 5L-23R)  
Structure 202  
Project 4

Structure 202.  
Bare areas recently stabilized.

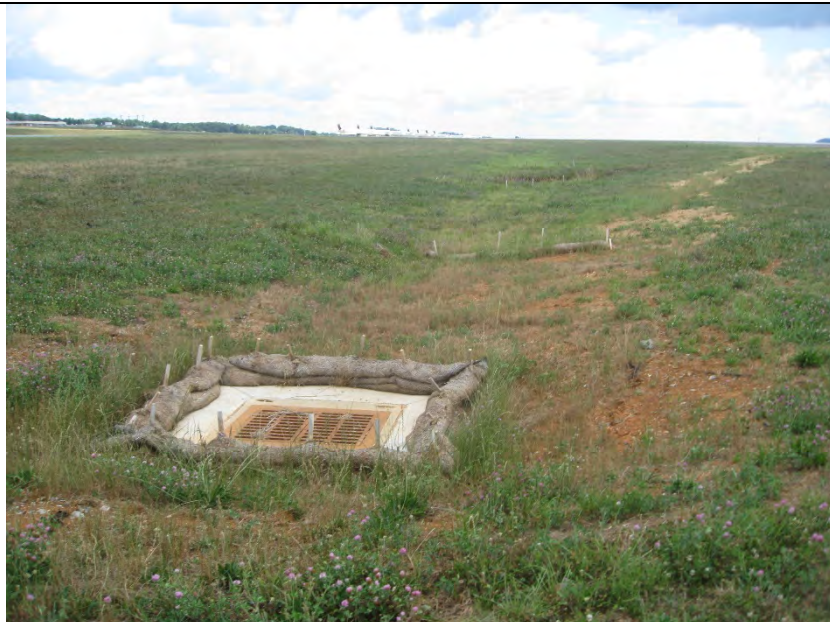
Photo 58  
Sta. 338+02 RT  
(RW 5L-23R)  
Structure 206  
Project 4

Structure 206.

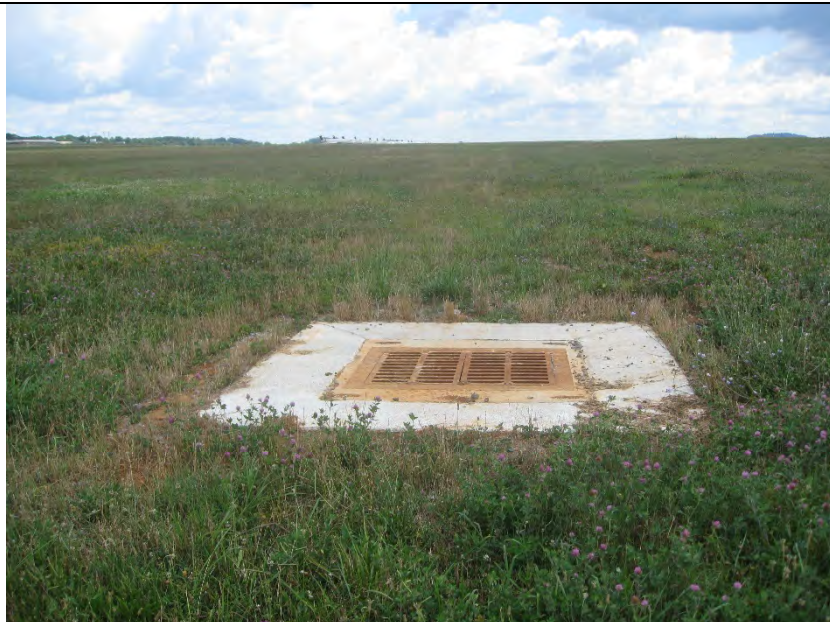
Photo 60  
Sta. 338+02 RT  
(RW 5L-23R)  
Structure 208  
Project 4

Structure 208.
